UNITED STATES
DEPARTMENT OF THE INTERIOR
BUREAU OF RECLAMATION

HYDRAULIC MODEL STUDIES OF THE
TRINITY DAM MORNING-GLORY SPILLWAY
TRINITY RIVER DIVISION
CENTRAL VALLEY PROJECT--CALIFORNIA

Hydraulic Laboratory Report No. Hyd-447

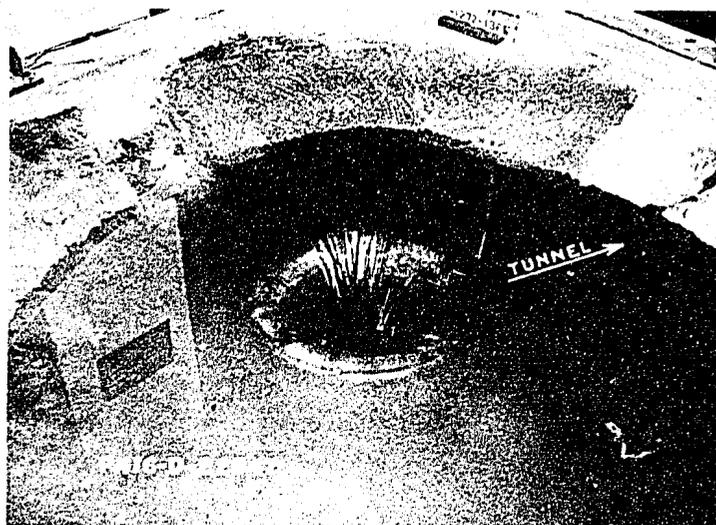
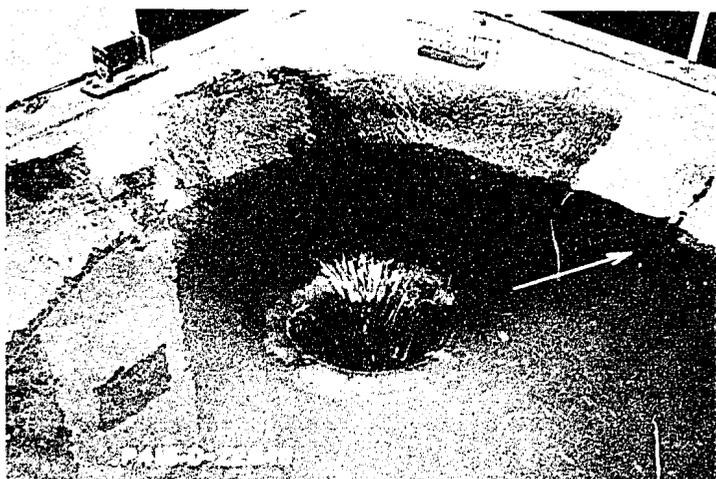
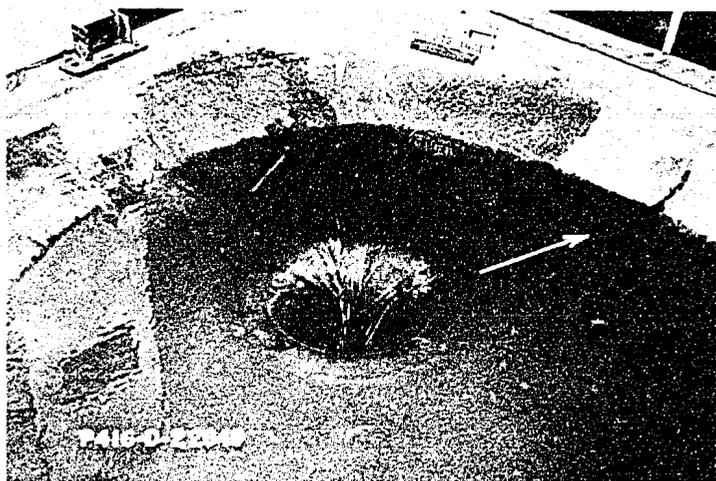
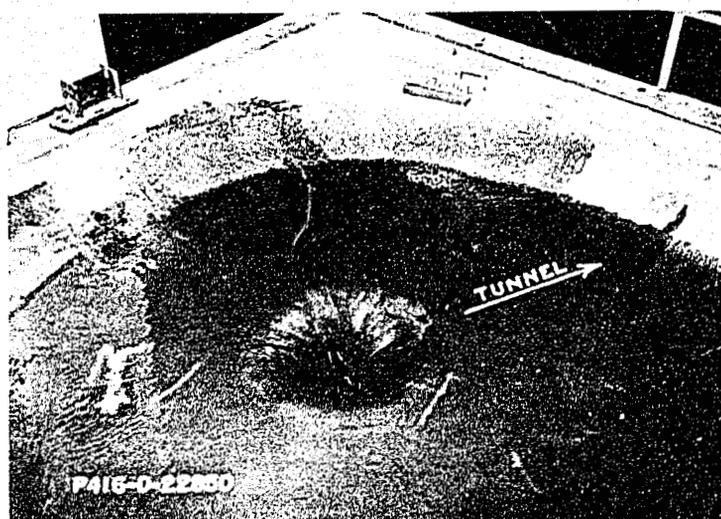
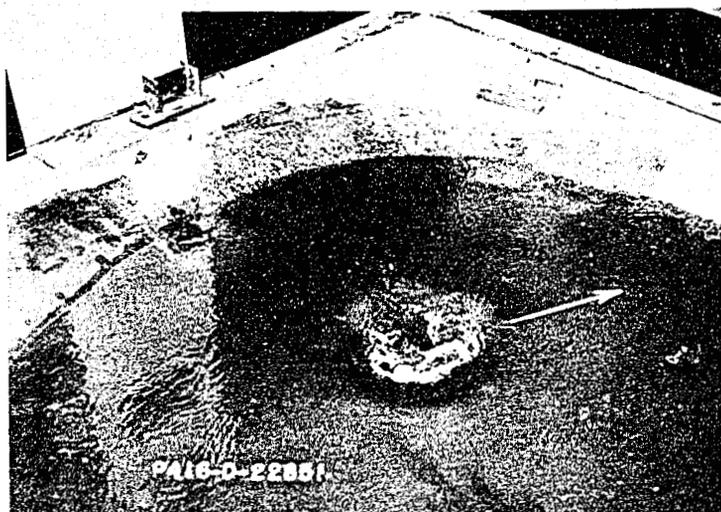
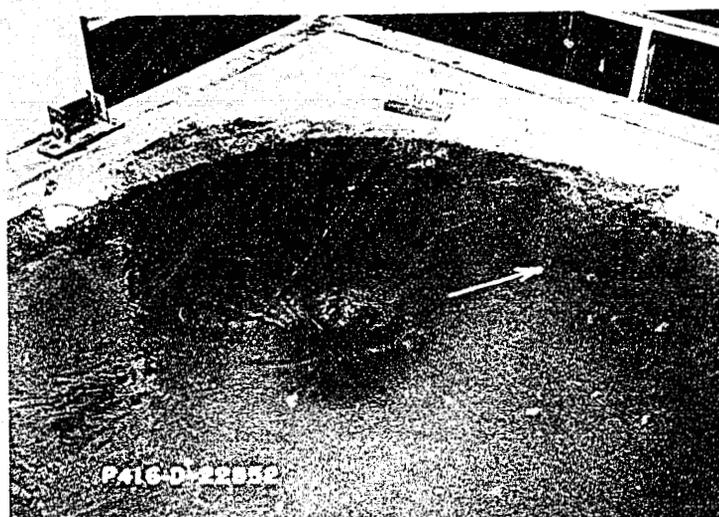
A. Discharge 5,000 cfs

B. Discharge 10,000 cfs

C. Discharge 15,000 cfs

A. Discharge 20,000 cfs

B. Discharge 23,000 cfs

C. Discharge 24,000 cfs

TRINITY MORNING-GLORY SPILLWAY
PERFORMANCE OF RECOMMENDED PROFILE WITH FINAL TOPOGRAPHY
1:30 MODEL

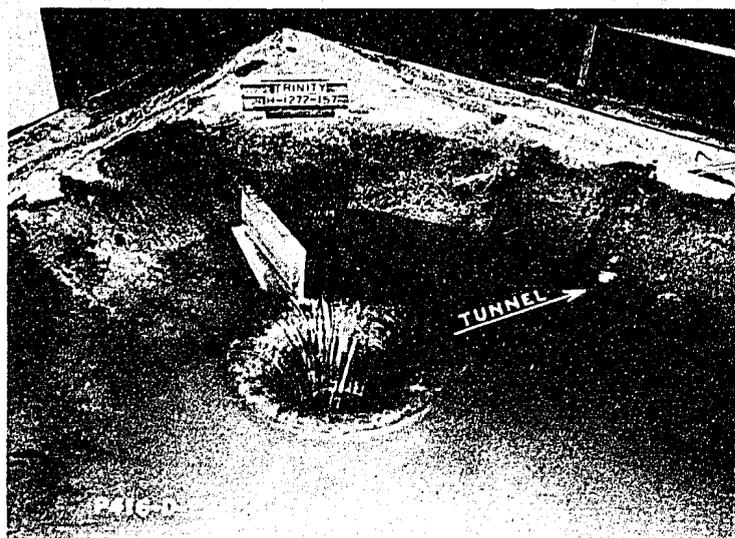
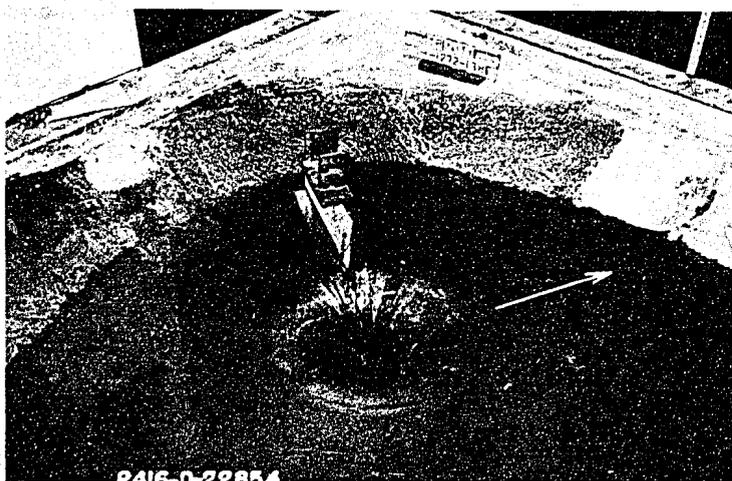
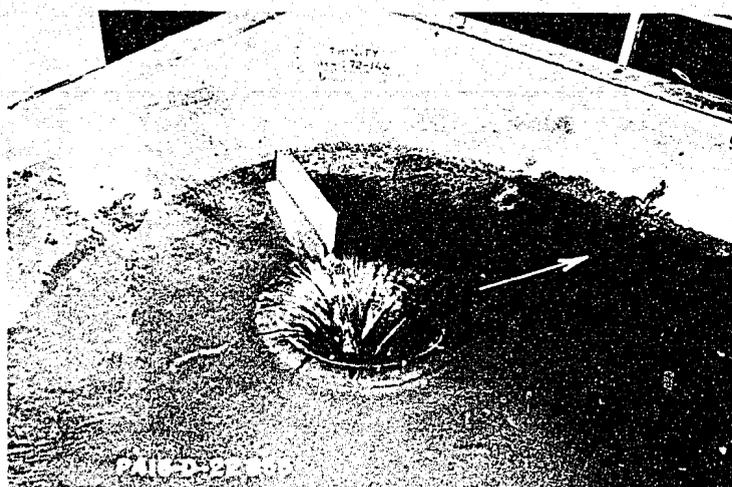
Figure 40
Report HYD - 447

A. Discharge 5,000 cfs

B. Discharge 10,000 cfs

C. Discharge 15,000 cfs

TRINITY MORNING-GLORY SPILLWAY
OPERATION OF RECOMMENDED DESIGN
1:30 MODEL

Flow patterns for five discharges with the spillway pier in place are shown in Figures 39 and 40. These views may be compared with those in which no pier was used. For discharges below that required for submergence of the crest, the advantage of the pier is found in stabilization of the fin. At maximum discharge, Figure 40B, the pier provided a control over vortex formation which had not been possible in any other scheme tried. As shown in the photograph, the water surface was more tranquil than ever before, and no sudden deviation in flow regimen occurred. Small vortices formed and disappeared, singly and in pairs. The directions of rotation were alternately clockwise and counterclockwise.

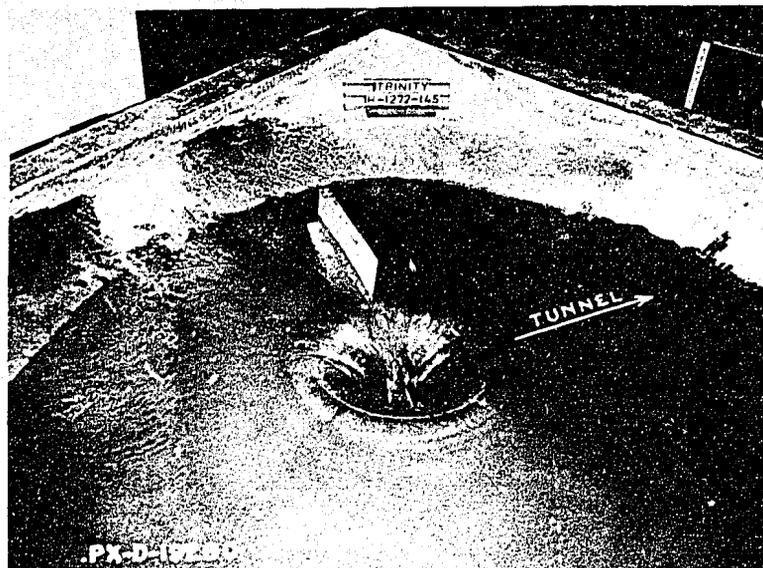
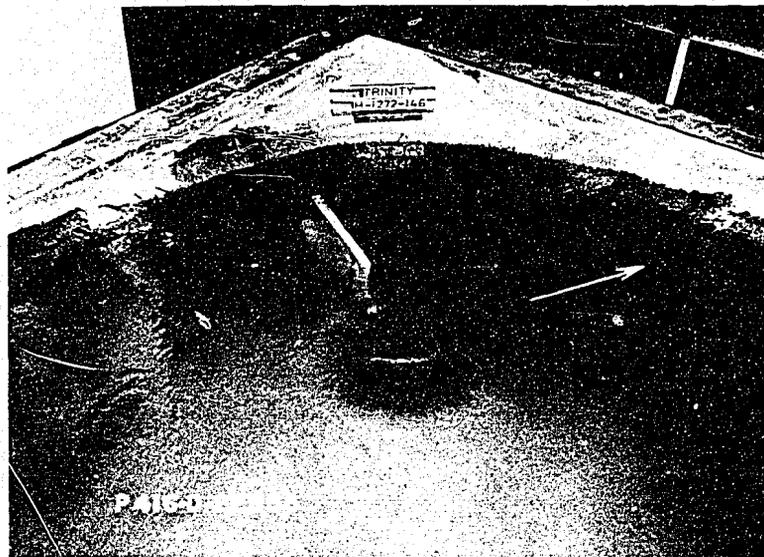
A. Discharge 20,000 cfs

B. Discharge 24,000 cfs

TRINITY MORNING-GLORY SPILLWAY
OPERATION OF RECOMMENDED DESIGN
1:30 MODEL

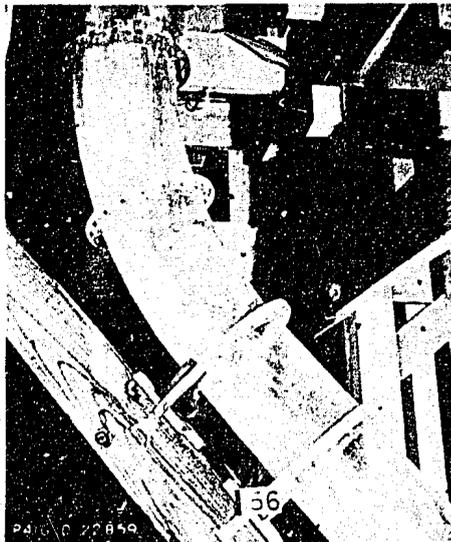
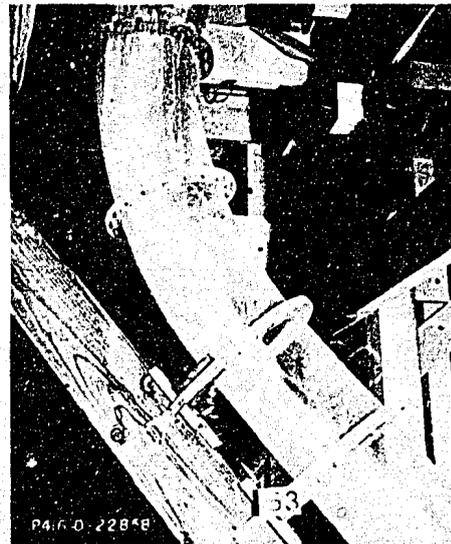
A. Discharge 5,000 cfs

B. Discharge 10,000 cfs

C. Discharge 15,000 cfs

TRINITY MORNING-GLORY SPILLWAY
RECOMMENDED DESIGN
FLOW IN UPPER BEND
1:30 MODEL

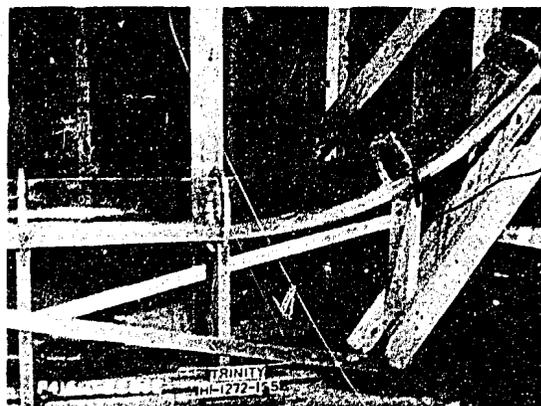
A. Discharge 5,000 cfs

TRINITY MORNING-GLORY SPILLWAY
RECOMMENDED DESIGN
FLOW IN LOWER BEND
1:30 MODEL

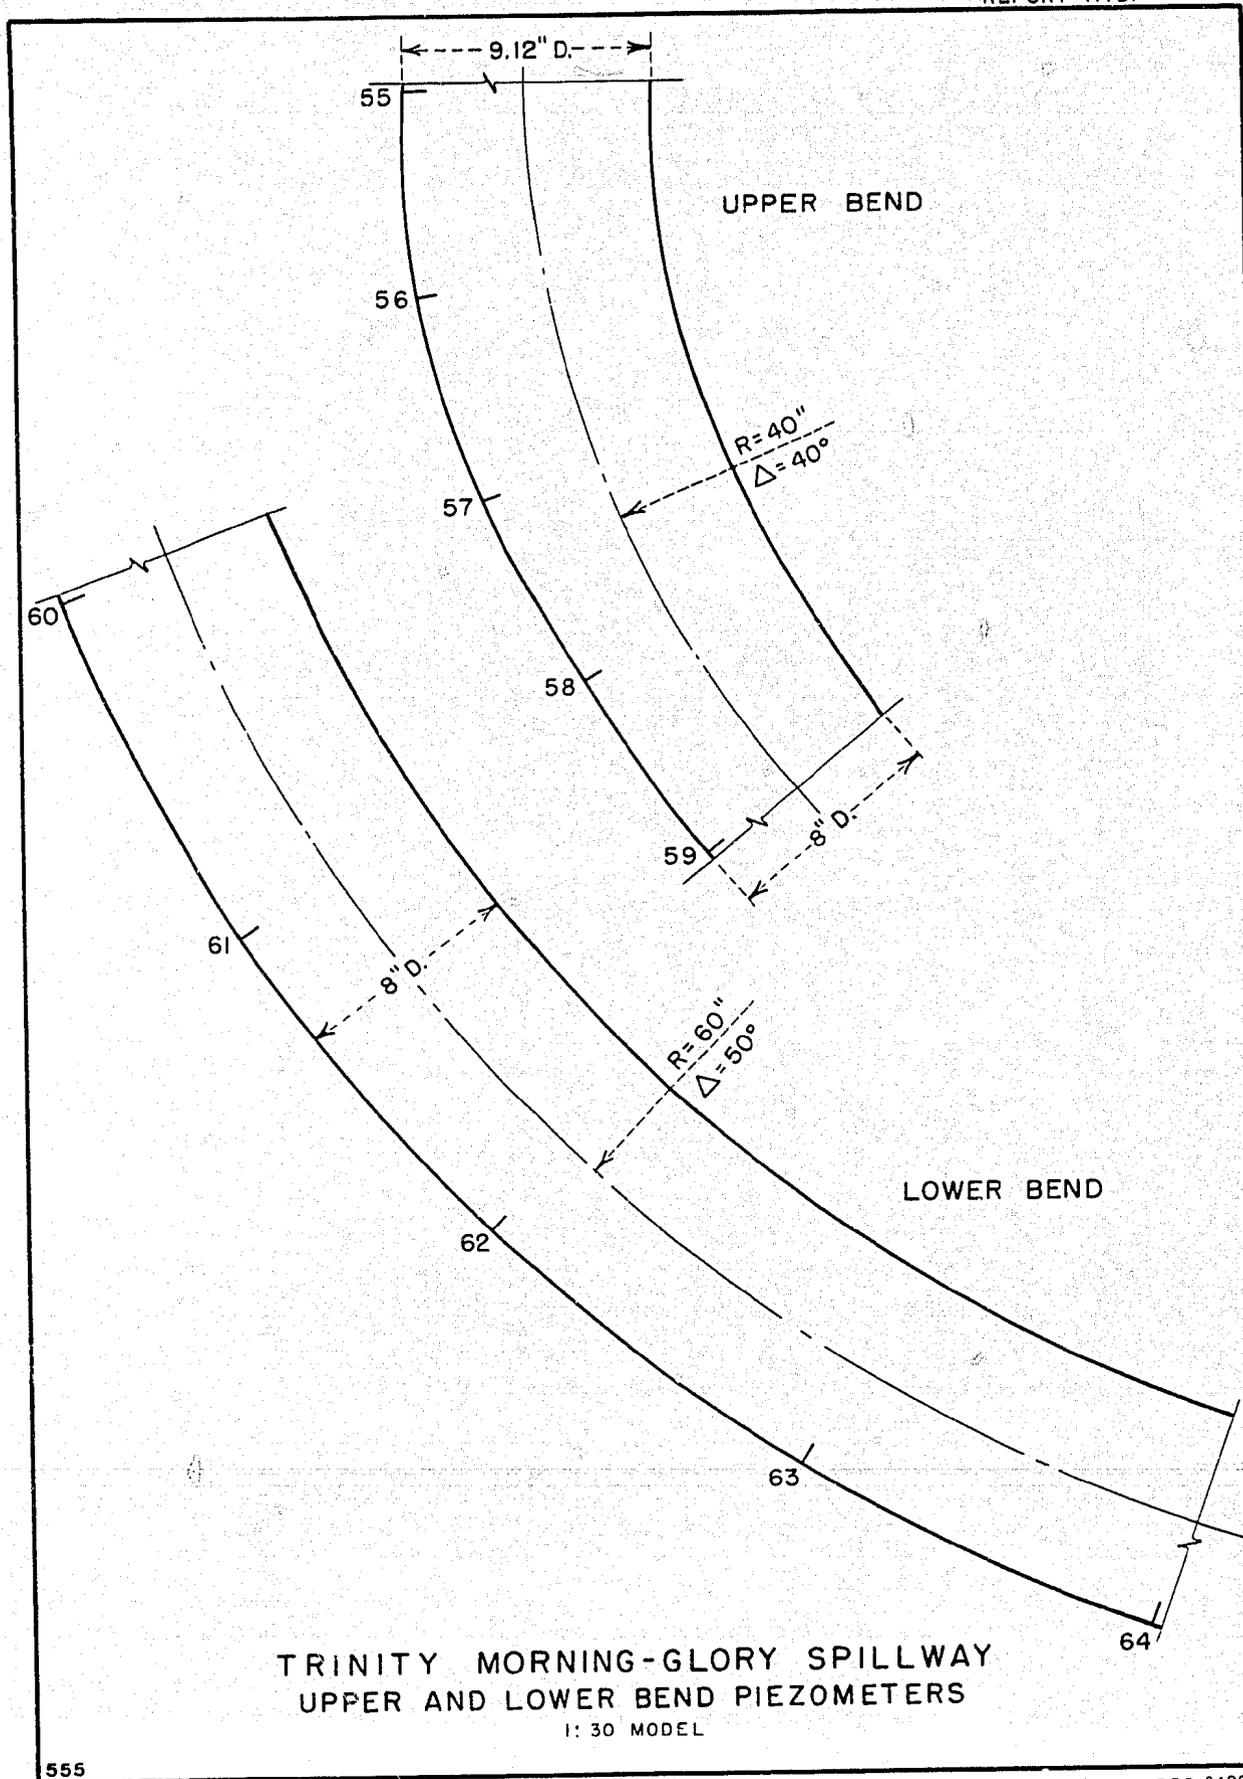
TRINITY MORNING-GLORY SPILLWAY
UPPER AND LOWER BEND PIEZOMETERS
1: 30 MODEL
