BUREAU OF RECLAMATION

SUBJECT: HYDRAULIC MODEL EXPERIMENTS FOR THE DESIGN OF  
THE ALCOVA SPILLWAY

-----  
By JOHN B. DRISKO, ASSISTANT ENGINEER

-----  
TECHNICAL MEMORANDUM NO. 513

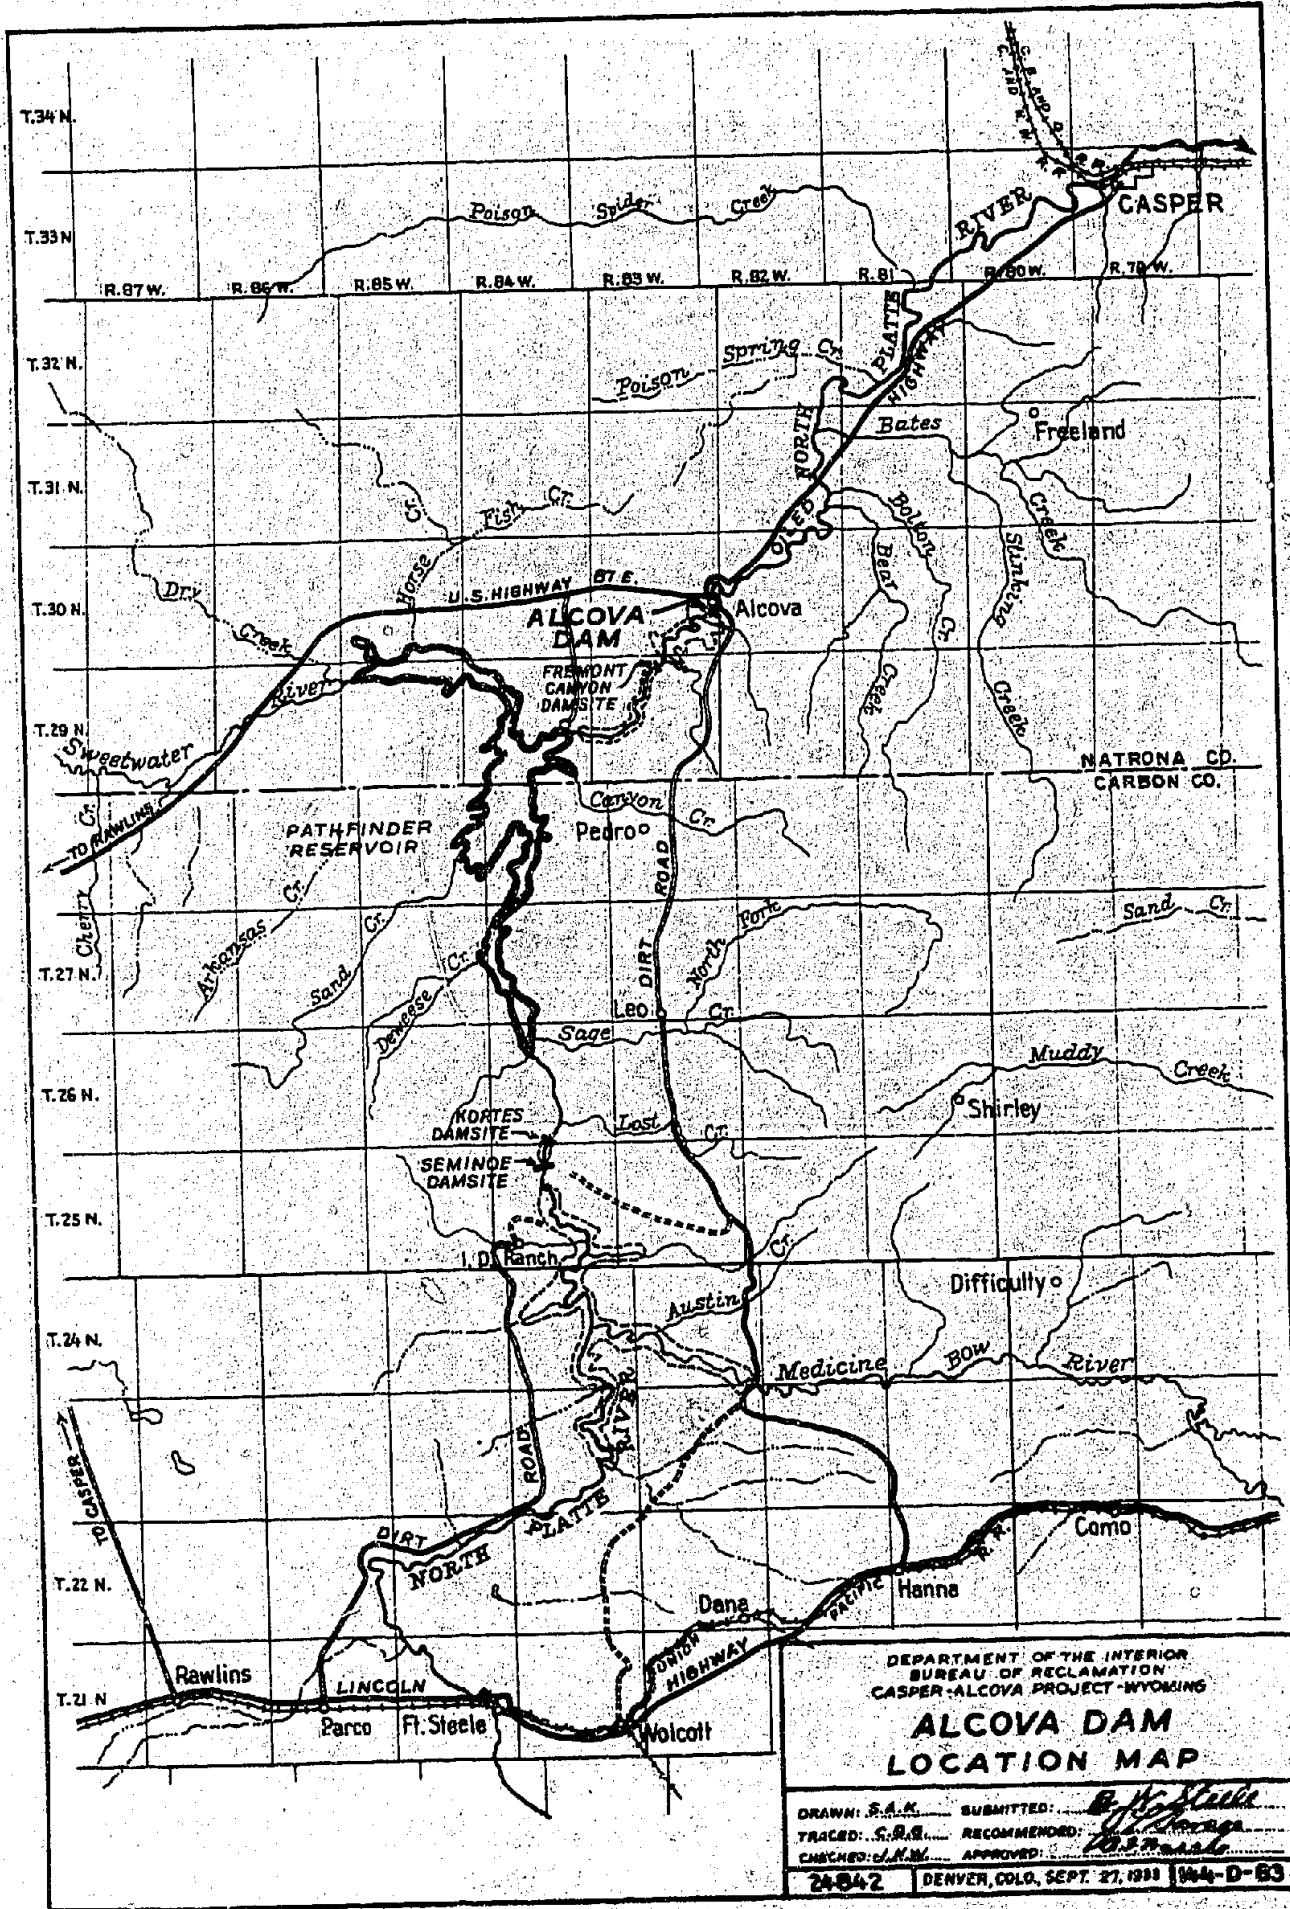
FIG 2

DRAWING NO. 5

The Alcova Dam of the Casper-Alcova Project on the North Platte River will be just south of the town of Alcova, Wyoming, (fig. 1). It is an earth-fill dam, and the flood flows will be passed by a gate-controlled open spillway situated in the valley wall at the north end of the dam (fig. 2). The spillway is designed to handle a maximum flood flow of 55,000 cubic feet per second. Three stoney gates 25 feet 8 inches wide will admit water to the channel, which drops 150 feet in a length of 700 feet, and increases in width from 95 feet at the gates to 150 feet at the stilling pool. A model of the spillway was built and tested to insure satisfactory operation and to investigate the feasibility of proposed economies.

The stilling pool is situated at the downstream toe of the dam, and the right wall of the pool will serve as a retaining wall for the embankment (fig. 2). In order to determine the minimum length of this wall consistent with safety from scouring at the toe of the dam, several lengths of wall were investigated in the model. It was found that a short wall produced very poor hydraulic conditions: water flowed along the toe of the dam and entered the region of the jump from the side, across the sloping end of the stilling-pool wall. Plate II and plate IV show this to be the case. The influx of water from the side interfered with the proper action of the jump, and formed a large whirl or eddy which scoured the river bed near the toe of the dam and at the lower end of the pool wall. The tests indicated that a wall extending to sta. 8+07 at elevation 5367, and with its downstream end sloping off at 1-1/2 to 1 would be satisfactory. A 2 to 1 slope at the lower end of the right wall was also tried, but seemed no better than the steeper slope, and was abandoned because of its greater cost for the same top length.

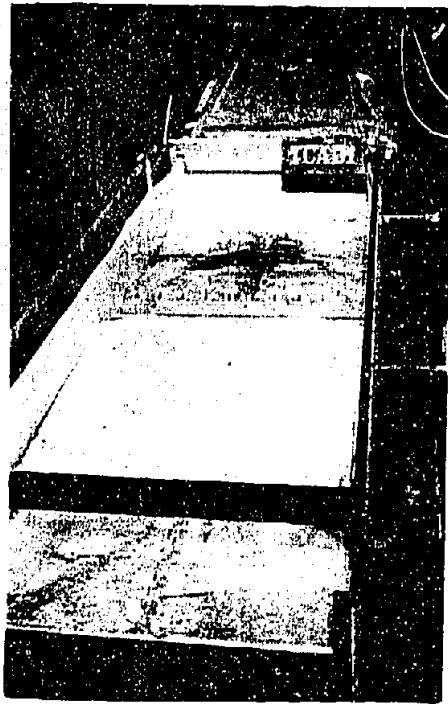
ORIGINAL DESIGN OF STILLING POOL - 200 FEET WIDE.

A. POOL WITH NO FLOW.

B. DISCHARGE 55,000 SECOND-FEET.

C. DISCHARGE 25,000 SECOND-FEET.

D. DISCHARGE 5,000 SECOND-FEET.

The original spillway flared to a pool width of 200 feet. The hydraulic jump forming was very shallow in comparison with the width of the pool, and at small discharges a large whirl formed (plate I). Due to the unsymmetrical approach to the gates, the flow through them and down the spillway was also slightly unsymmetrical, and the whirl in the pool rotated invariably in the same direction.

The few tests made with a pool 200 feet wide showed conclusively that it should be narrower for best hydraulic performance.

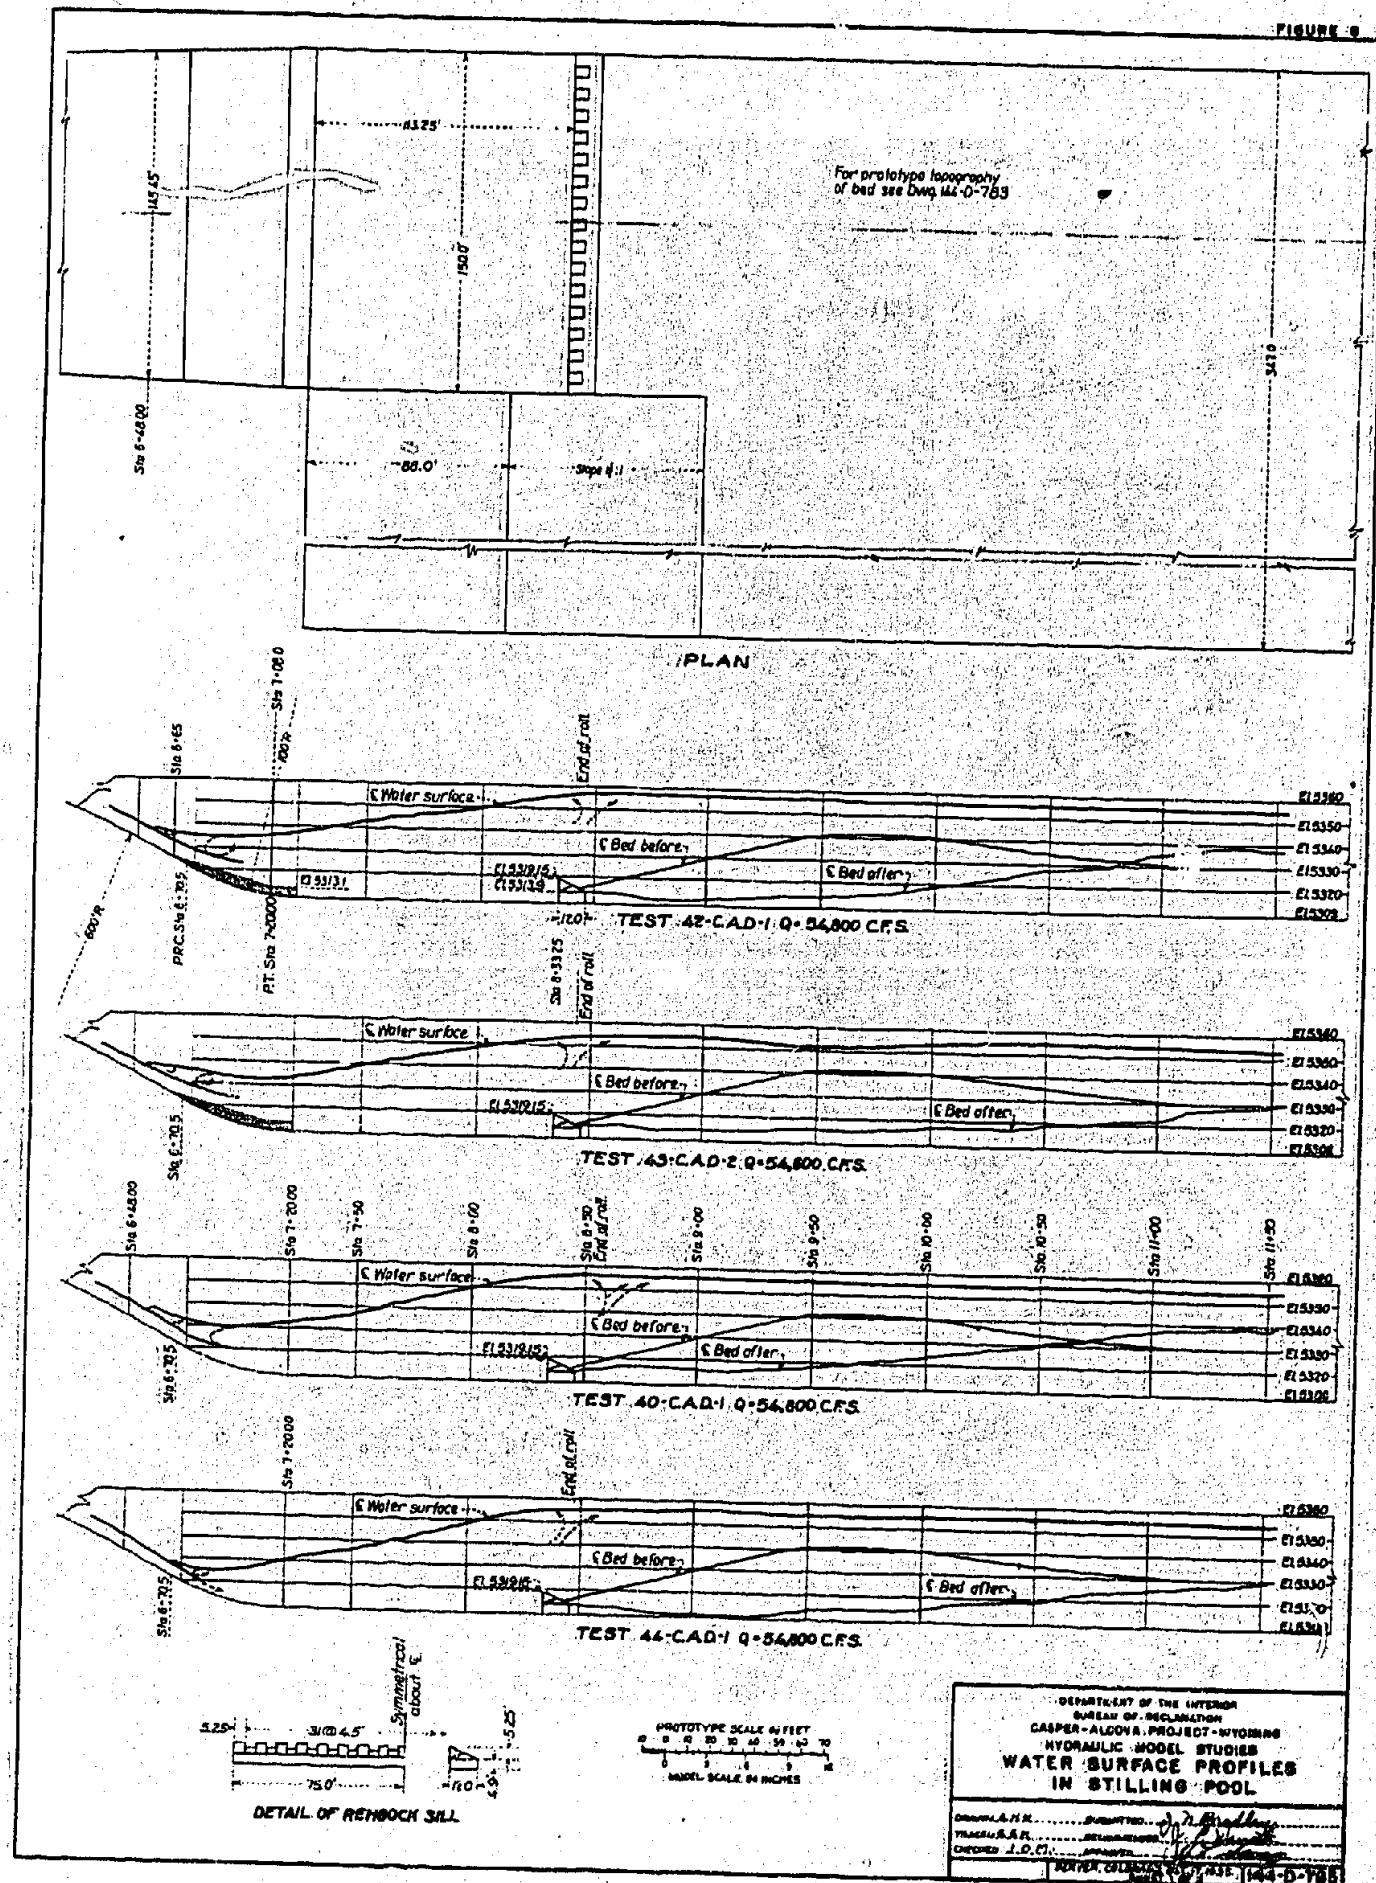
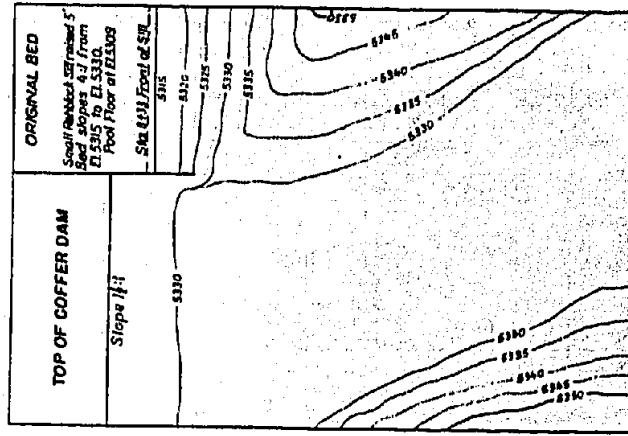
FIGURE 8

**NOTE**  
For details of pool for each test,  
see Drawing No 144-0-785.

CONTINUATION OF THE INTRACOASTAL  
WATERWAY RECLAMATION  
CAGLE - ALICORN PROJECT - PROPOSED  
**HYDRAULIC MODEL STUDY**  
**STREAM BED EROSION**  
**BELOW STILLING POOL**

Tests 41 and 42 (plate VIII) compare the results obtained with high and low aprons, and tests 40 and 42 (figs. 8 and 9) show similar pools with and without an apron.

Test 43 (plate VIII and figs. 8 and 9) shows the scour obtained with fine sand in contrast to that given by coarse sand shown in test 42 (plate VII and figs. 8 and 9).

Tests 42, 43, 47, 48, and 49 (plates VII, VIII, X, XI, and XII), and figures 8, 9, 10, and 11 show the design and hydraulic action of the final design of pool.

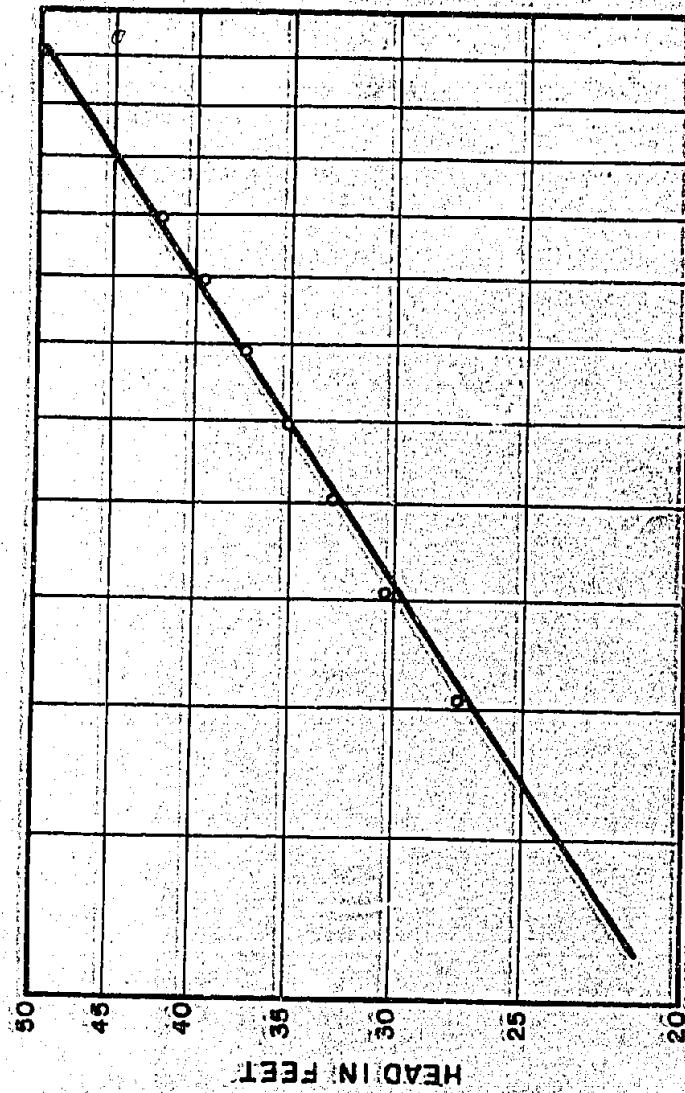
DEPARTMENT OF THE INTERIOR BUREAU OF RECLAMATION CASPER ALCOVA PROJECT - WYOMING HYDRAULIC MODEL STUDIES <b>CASPER ALCOVA SPILLWAY</b>
HEAD-DISCHARGE RELATION THROUGH GATES
DRAWN...V.L.S....SUBMITTED... <i>John Shaffer</i> TRACED BY...J.R.C. RECOMMENDED... <i>John Shaffer</i> CHECKED...J.D.M. APPROVED... <i>John Shaffer</i>
DELIVERED CO. OCT 18 1934   4-8-0-73

DISCHARGE IN C.F.S.

$Q = 2.85 L H^{1.5}$   
 Q = Discharge in C.F.S.  
 L = Net length of openings = 77 feet  
 H = Depth of reservoir above  
 gate sill.  
 W = Total width of pier section  
 = 95'-0"  
 $\frac{L}{W} = \text{Percentage opening} = 0.810$

A series of tests was made to determine the coefficient in the formula  $Q = CLH^{3/2}$  for the discharge through the gates, where  $Q$  is the discharge in cubic feet per second,  $C$  is a coefficient,  $L$  is the total net length of gate opening, and  $H$  is the height of the energy line ( $d + V^2$ ) above the gate sill, measured in the channel just upstream from the gates. Measurements on the Alcova gave a result,  $Q = 2.85LH^{3/2}$  (fig. 13).
