MEMORANDUM TO CHIEF DESIGNING ENGINEER

SUBJECT: HYDRAULIC MODEL STUDY OF THE

ROZA DIVERSION DAM AND APPURTENANT STRUCTURES

TECHNICAL MEMORANDUM NO. 594

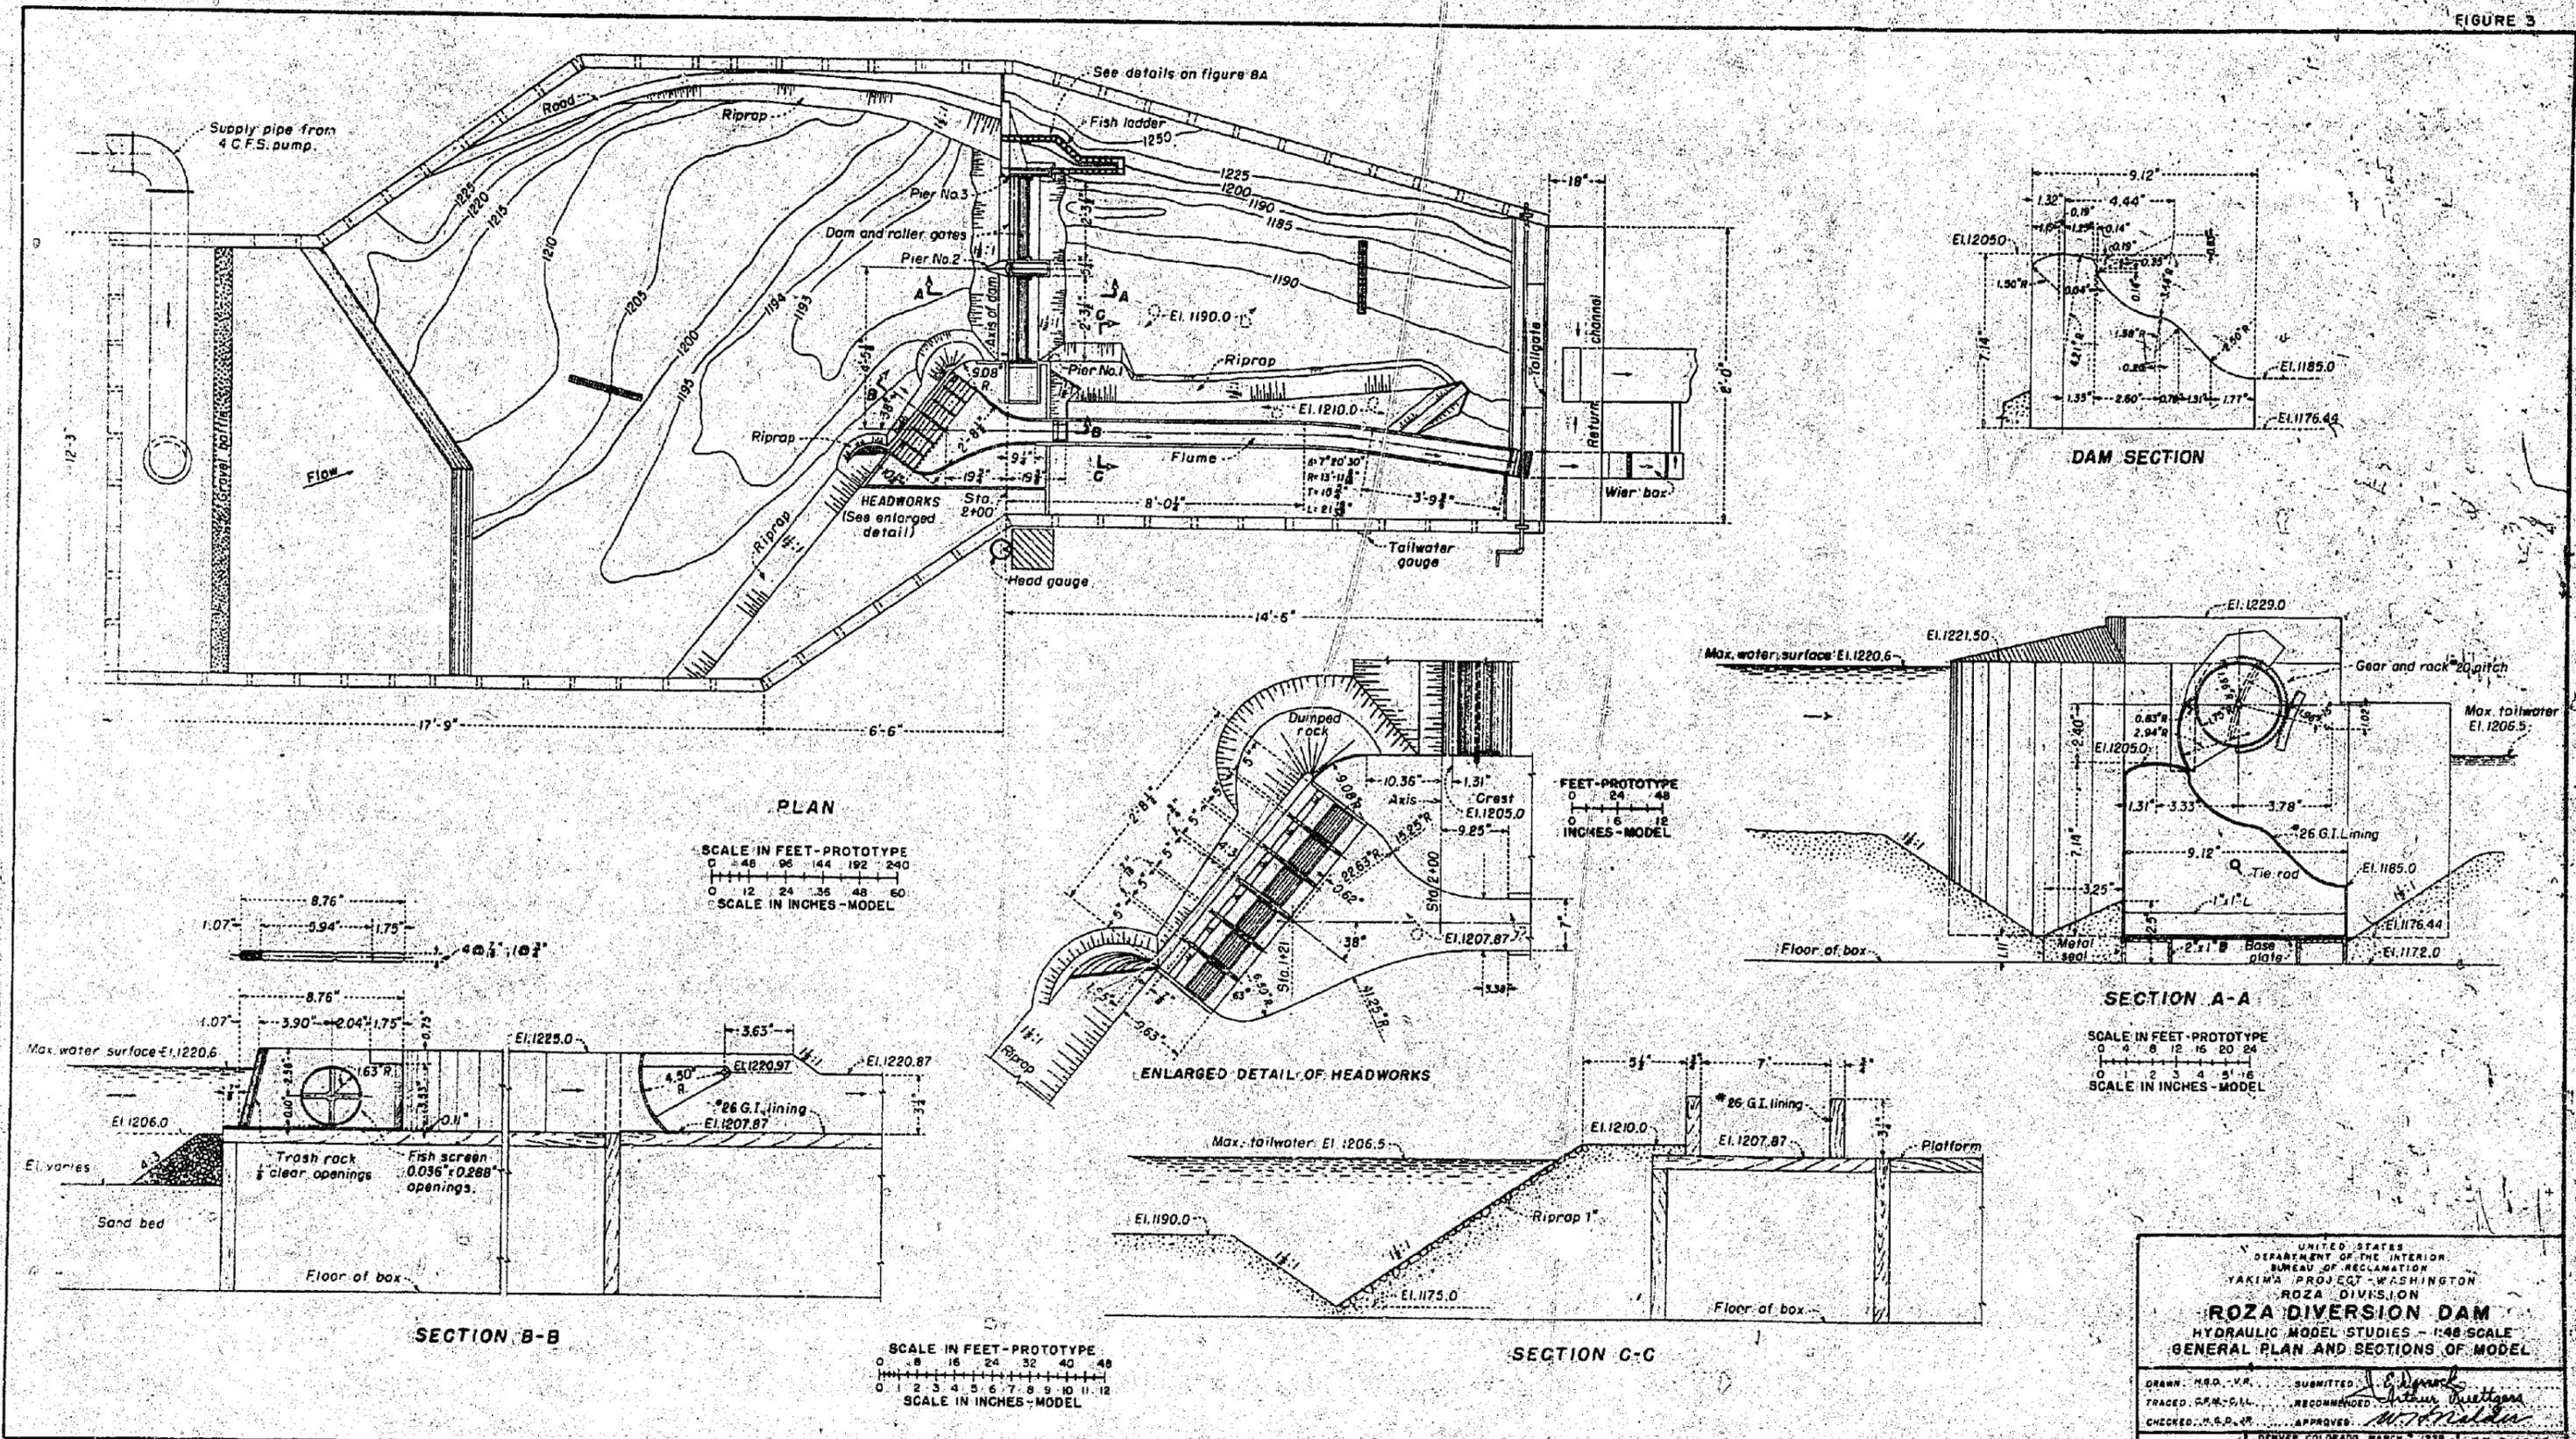
3. Model Construction.--A 1 to 48 scale model was built and tested in the hydraulic laboratory of the Bureau of Reclamation, Denver, Colorado (figures 3 and 4). The roller gates were made of seamless steel tubing and their traveling mechanism was included as shown in Section A-A, figure 3, enabling duplication of prototype gate settings. The diversion dam was made of light-gage sheet metal to facilitate construction and to eliminate warping. Sufficient river topography was installed upstream and downstream from the diversion dam to provide proper flow conditions. The headworks of the canal, complete with piers, trashracks, and fish screens, was constructed as a unit to facilitate changes in alignment. A small weir was installed under the downstream end of the model box enabling separate measurement of the flow in the canal. The fish ladder and adjacent topography was carefully placed to assure the desired relation between the discharge in the fish ladder and in the river.

4. Description of Headworks.--The headworks to the Yakima Ridge canal consists of six openings or panels formed by piers which support a trashrack and fish screen between each opening (section B-B, figure 3; and figure 5A). The width of openings are determined so that the velocity of the flow through them will not be greater than about two feet per second for the maximum discharge of 2,200 second-feet diverted into the headworks. This is necessary to prevent fish, especially fingerlings, from being trapped against the fish screens due to excessive velocities. The fish screens are required to prevent salmon and other fish from entering the canal. The screens will be rotated slowly in the prototype to prevent debris from collecting on them, and a gantry will be provided to remove the fish screens from the headworks for cleaning (section E-E, figure 17). As the flow passes from the reservoir through the openings and into a transition, it is controlled by a radial gate placed downstream from the canal entrance (section B-B, figure 3).

5. Flow in Original Design.--The original alinement of the headworks was rotated 38 degrees clockwise from a line normal to the axis of the dam (figures 3 and 5A). This alinement reduced the length of the vertical training wall extending from the headworks to the right abutment of the dam, but it caused unsymmetrical flow through the headworks. Observations on the model revealed that when 2,200 second-feet was diverted into the headworks, most of the flow entered the two openings at the left side, causing an eddy in the transition to the canal. This eddy directed the flow upstream along the right side of the transition, causing the flow at that point to proceed through the openings and back into the river.

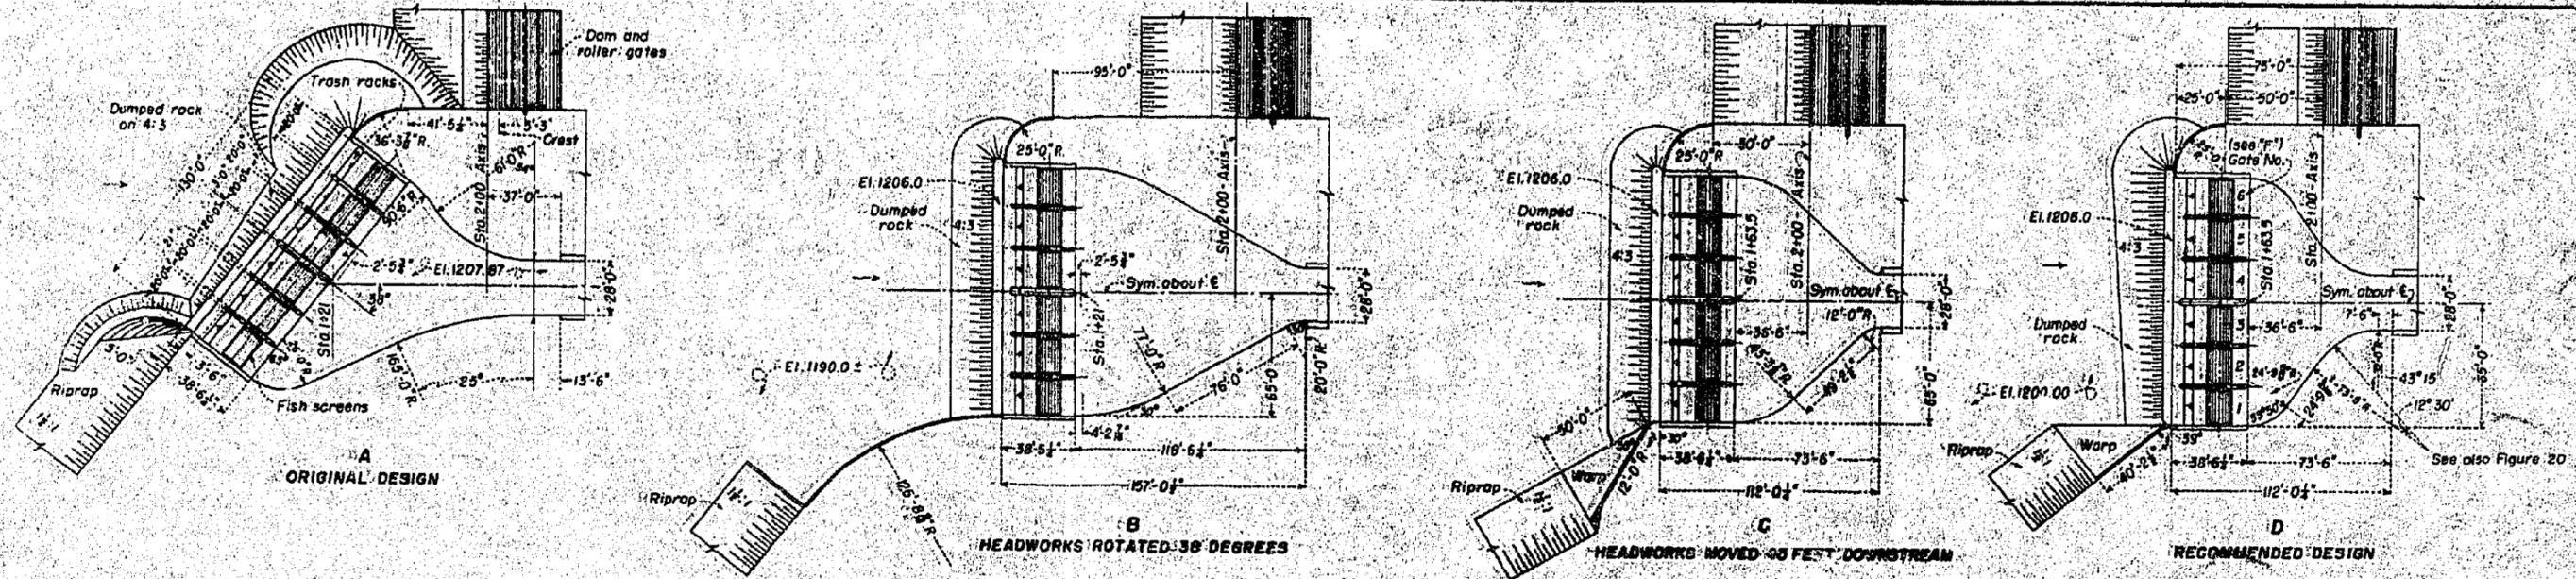
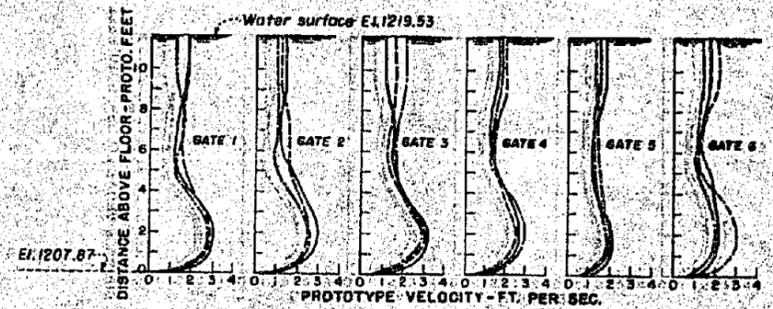
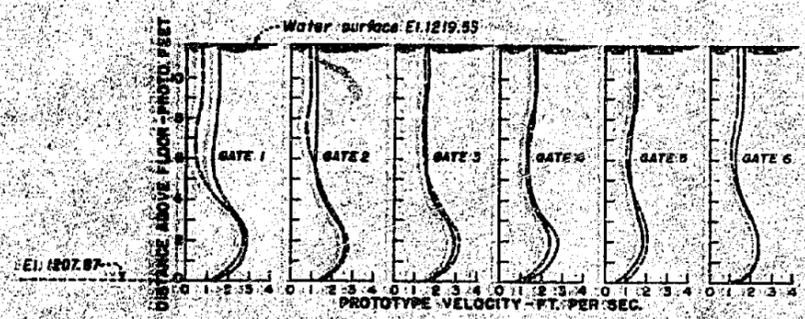
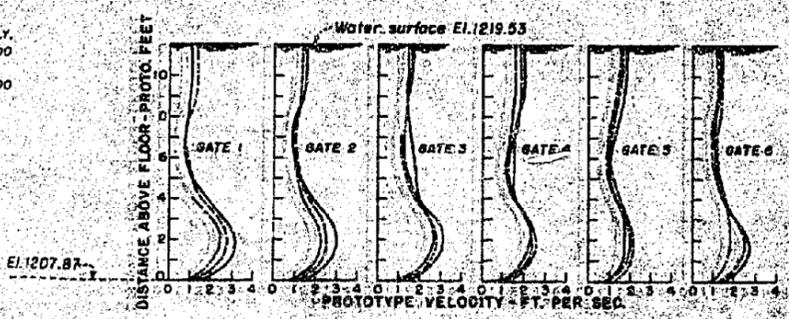
UNITED STATES  
 DEPARTMENT OF THE INTERIOR  
 BUREAU OF RECLAMATION  
 YAKIMA PROJECT - WASHINGTON  
 ROZA DIVISION  
**ROZA DIVERSION DAM**  
 HYDRAULIC MODEL STUDIES - 1:48 SCALE  
 ALIGNMENT OF HEADWORKS STUDIED IN MODEL

F  
 VELOCITY DISTRIBUTION AT CENTER LINE OF GATES  
 AT STA. 1+63.5 - RECOMMENDED DESIGN

EXPLANATION  
 — 2200 SECOND-FOOT - CANAL ONLY.  
 — 10,000 SECOND-FOOT TOTAL (2200 SECOND-FOOT IN CANAL)  
 — 80,000 SECOND-FOOT TOTAL (2800 SECOND-FOOT IN CANAL)  
 RATIO OF MODEL TO PROTOTYPE VELOCITY: 15:1:6.92

H  
 AVERAGE VELOCITY DISTRIBUTION AT CENTER LINE  
 OF GATES AT STA. 1+63.5

EXPLANATION  
 — HEADWORKS ROTATED 10 DEGREES  
 — RECOMMENDED DESIGN  
 RATIO OF MODEL TO PROTOTYPE VELOCITY: 15:1:6.92

G  
 VELOCITY DISTRIBUTION AT CENTER LINE OF GATES  
 AT STA. 1+63.5 - HEADWORKS ROTATED 10 DEGREES

6. Alinement and Position Changed.--To eliminate the unfavorable flow conditions of the original design, the headworks was rotated 38 degrees counterclockwise until its center line became normal with the axis of the dam (figure 5B). With this alinement, the flow entered each opening more uniformly and the eddy in the transition was eliminated, enabling all the flow to

Although the flow conditions were improved, it was necessary to move the headworks 45 feet downstream to reduce the length of the vertical training wall extending from the headworks to the right abutment of the dam (figure 5C). This did not effect the uniform flow distribution, but the reduction in length of the transition caused small waves or ripples on the water surface at the entrance to the canal. A transition was designed, therefore, to give uniform acceleration and reduction in depth in the transition. The waves or ripples were eliminated, but the side walls of this transition (not shown) projected too far in front of each slide opening. As a result, the velocity of the flow through each side opening was apparently deflected upwards at the transition walls, causing eddies or vortices to develop. A slight change in the shape of the transition eliminated the undesirable eddies or vortices, and this shape was adopted in the recommended design.

7. Recommended Design of Headworks.---The alinement of the recommended design (figures 5D and 6B) allowed a uniform flow distribution through each opening of the headworks. Its position, however, did not permit any reduction in the length of the vertical training wall extending from the headworks to the right abutment of the dam. If the headworks had been moved downstream to shorten this wall, the transition to the canal would have been too abrupt. The position of the warp and the  $1\frac{1}{2}$  to 1 side slope (figures 5D and 17) eliminated a large eddy which formed in other designs, during higher discharges, upstream from the headworks along the  $1\frac{1}{2}$  to 1 riprapped slope. Although this eddy did not scour, it prevented the formation of a more uniform velocity distribution in the approach of the headworks. By introducing dye into the flow, a study was made of the streamlines occurring along the side slope and the warp. This permitted the position of the warp and the side slope to be readily determined, which would give a better velocity distribution at the approach.

To check the flow distribution through the headworks of the recommended design, velocity measurements were taken at the center line of each opening (trashracks and fish screen in place) at station 1+63.5 (figure 5D). These measurements were taken with 2,200 second-feet flowing through the headworks into the canal: first, with no flow over the diversion dam, and then with a total combined flow (canal plus diversion dam) of 10,000 and 50,000 second-feet. The flow distribution (figure 5F) is seen to be quite uniform through each opening but also somewhat better in the first two openings than for the alinement shown on

figures 5E and 6A in which the headworks has been rotated 10 degrees. The velocity data for this design are shown on figure 5G. The average velocity of each design for the three discharges is shown on figure 5H.

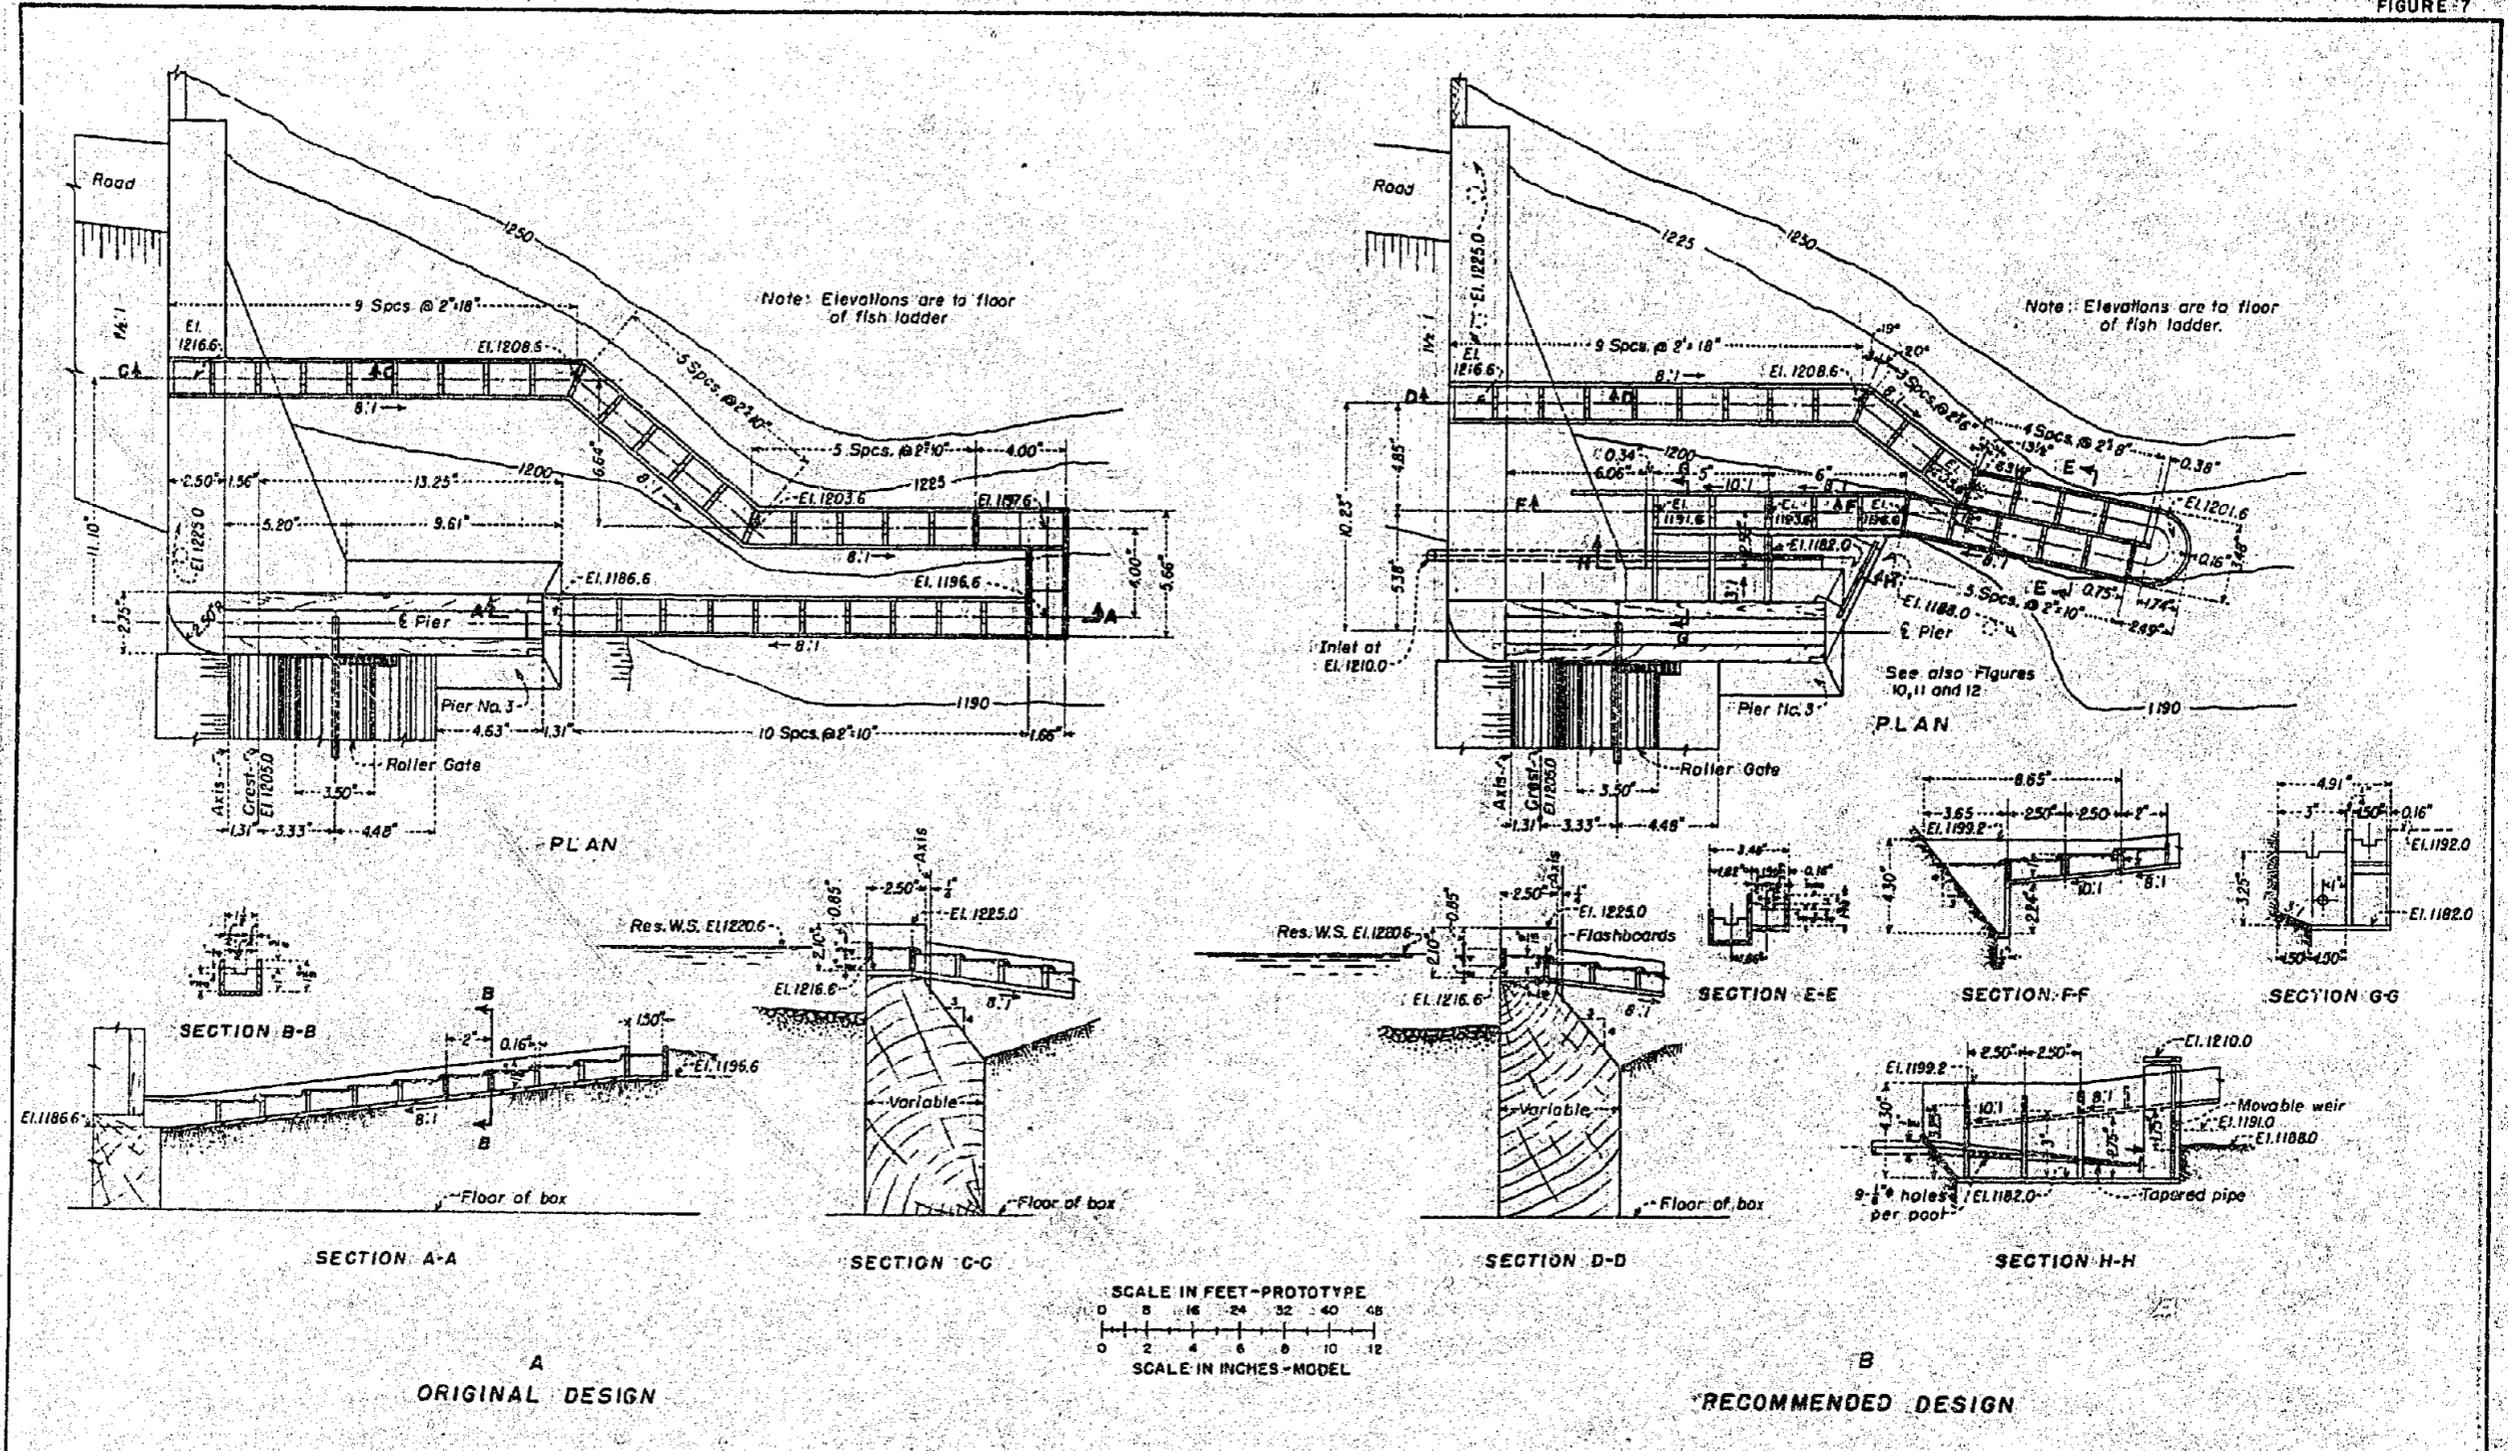
UNITED STATES  
 DEPARTMENT OF THE INTERIOR  
 BUREAU OF RECLAMATION  
 YAKIMA PROJECT-WASHINGTON  
 ROZA DIVISION  
**ROZA DIVERSION DAM**  
 HYDRAULIC MODEL STUDIES - 1/48 SCALE  
 FISH LADDER DESIGNS IN MODEL

A ORIGINAL DESIGN

B RECOMMENDED DESIGN

10. Original Design.--The original fish ladder design (figures 7A and 8A) was inadequate because it did not include

all the foregoing features. Although the position of the exit and the velocity of flow in the ladder was satisfactory, it would be necessary for salmon to reverse their direction to enter the lower leg sloping into the river (section A-A, figure 7A). During the flow over the diversion dam, this leg filled with gravel, which was also undesirable. No definite entrance or attraction was provided, and as the flow in the fish ladder entered the right-angled bend at the top of the lower leg, the flow spilled out of the ladder. This condition probably would have resulted in fish leaping completely out of the ladder.

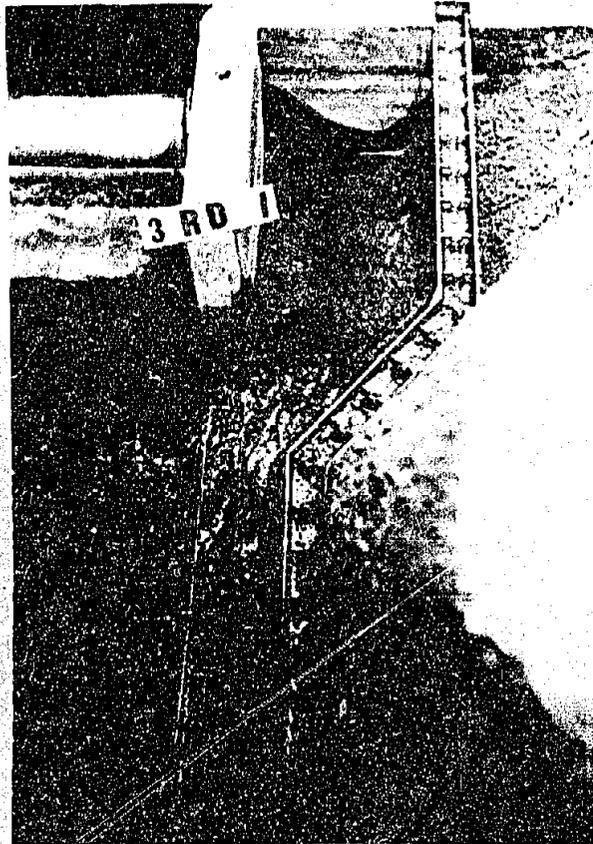
A. ORIGINAL DESIGN.

FISH LADDER.

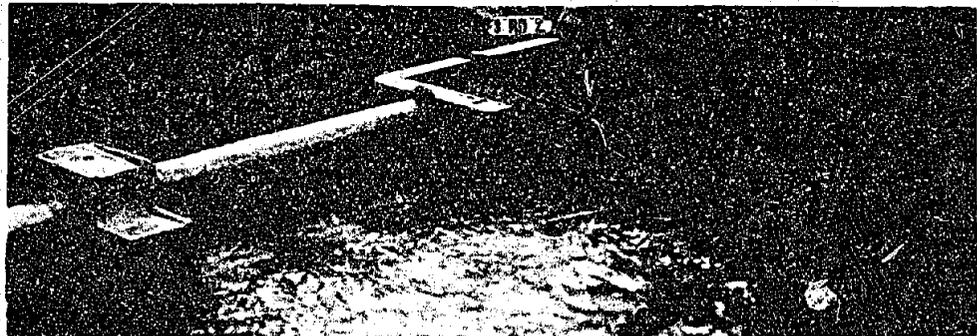
B. RECOMMENDED DESIGN.

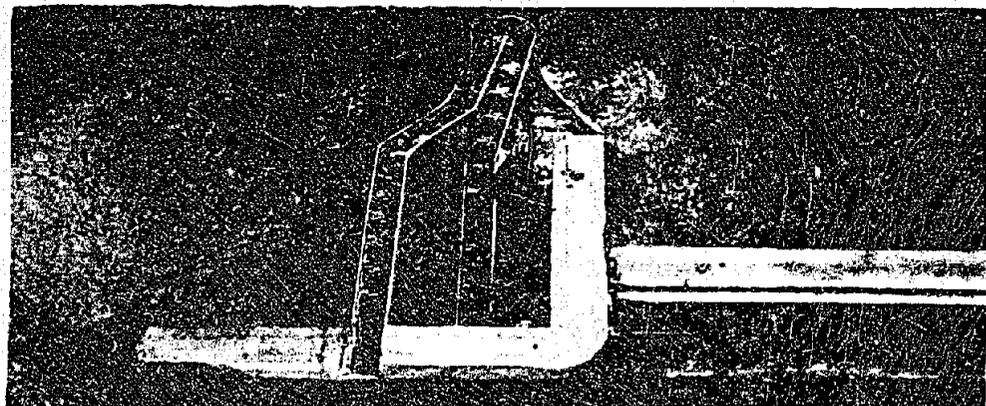
C. RECOMMENDED DESIGN.

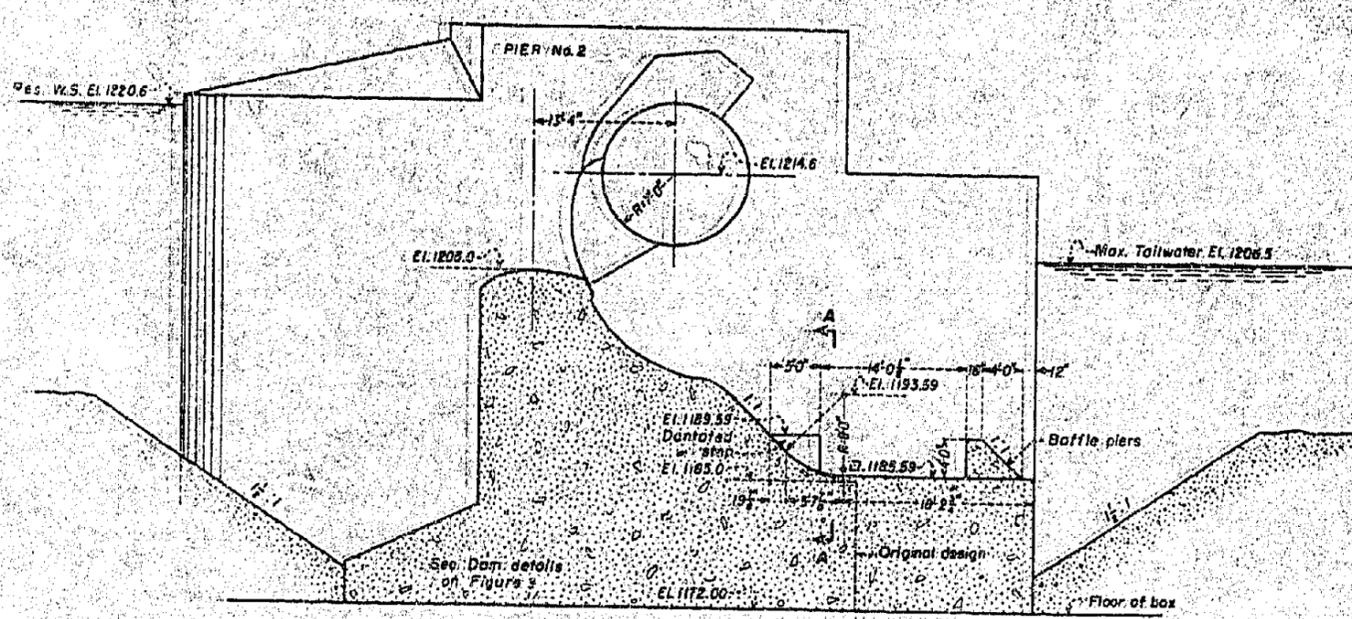
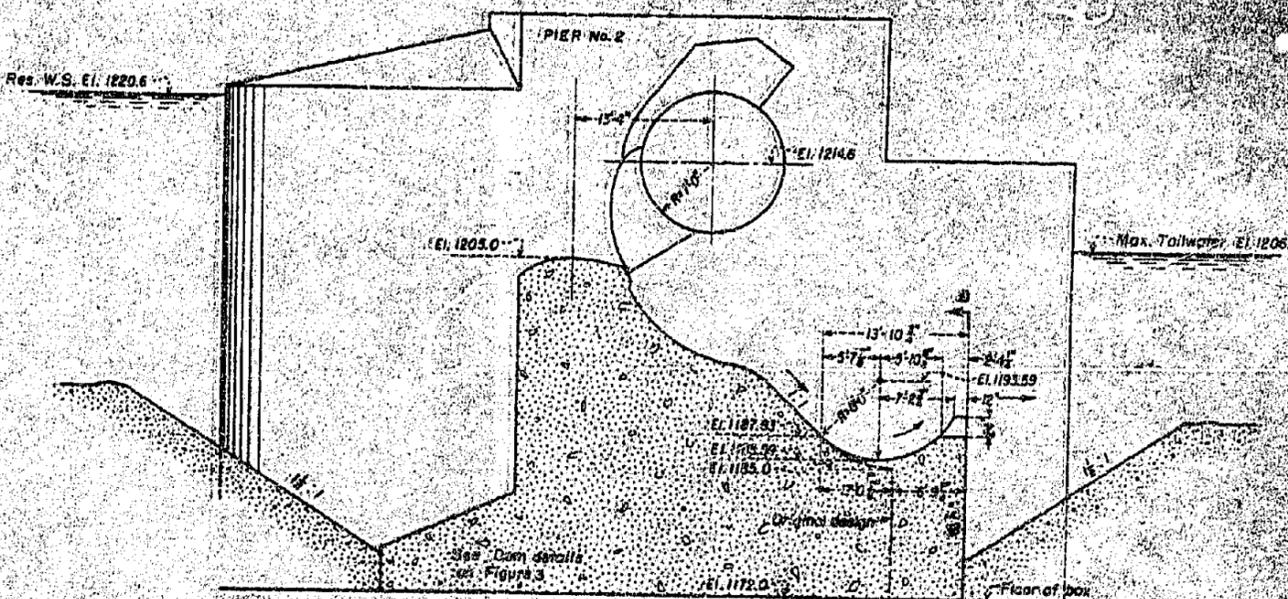
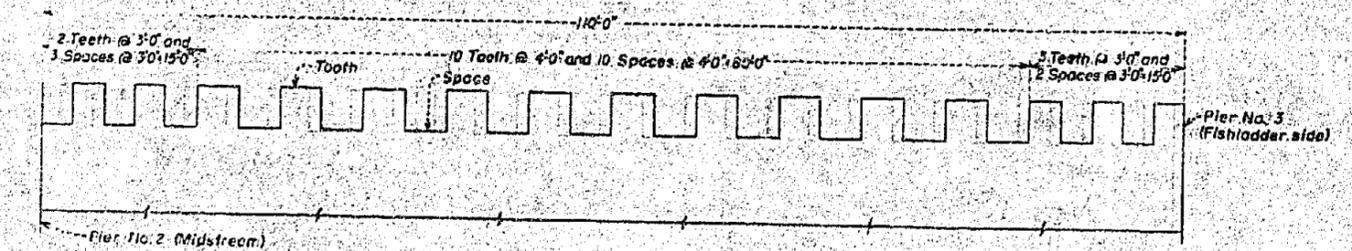
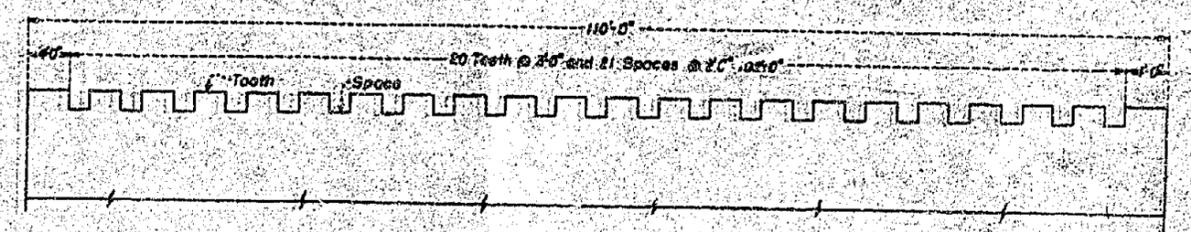
UNITED STATES  
DEPARTMENT OF THE INTERIOR  
BUREAU OF RECLAMATION  
YAKIMA PROJECT - WASHINGTON  
ROZA DIVISION  
**ROZA DIVERSION DAM**  
HYDRAULIC MODEL STUDIES - 1:48 SCALE  
FOUR PREVENTION STUDIES IN MODEL

A  
RECOMMENDED DESIGN

B  
DENTATED BUCKET DESIGN

SECTION A-A  
ARRANGEMENT OF DENTATED STEPS  
(BAFFLE PIERS ARE PLACED OPPOSITE SPACES)

SECTION B-B  
ARRANGEMENT OF TEETH  
(SYMMETRICAL ABOUT CENTER LINE OF PIER No. 2)

13. Dentated Bucket.--Two designs were developed in the model to reduce scouring at the toe of the dam: A dentated bucket and a dentated apron (figure 13). The dentated bucket was developed after tests had been made with various radii and positions of a bucket. It was especially difficult to obtain a bucket which would operate efficiently. At maximum discharge, the thickness of jet flowing over the dam was considerable, and to prevent excessive cost the bucket had to be placed as close as possible to the toe of the dam. As a direct result, it was difficult to deflect the thick jet upwards in a bucket of small radius. Because of this difficulty, the flow oscillated between a diving jet, which scoured severely, and a roller, which prevented excessive scour. The bucket shown on figures 13B and 14A finally eliminated the oscillation in the flow, but the boiling above the bucket was excessive. Dentates were cut into the bucket to reduce this boil, but this did not prove effective (figures 14B and C).

14. Dentated Apron.--The dentated bucket was abandoned in favor of a dentated apron (figures 13A and 15A), which was adopted as the recommended design. Although this design was more costly, the improvement in the flow conditions warranted the added expense. By comparing the flow conditions of the recommended design (figures 15 and 16) with the flow conditions of the dentated bucket (figure 14), the boiling of the latter design is apparent.

18. Stilling Pool.--A dentated apron was developed adopting a hydraulic jump to eliminate excessive scouring at all discharges (figures 13A, 15, and 16). Good design practice includes stilling pools for prevention of scour at the toe of an overfall dam. Even if the bedrock of the foundation is durable and can probably resist scouring, it is advisable to take necessary precautions and provide some means of protecting a channel from scour at the toe of an overfall dam or spillway. Figure 17 shows general plan and sections of complete recommended design.

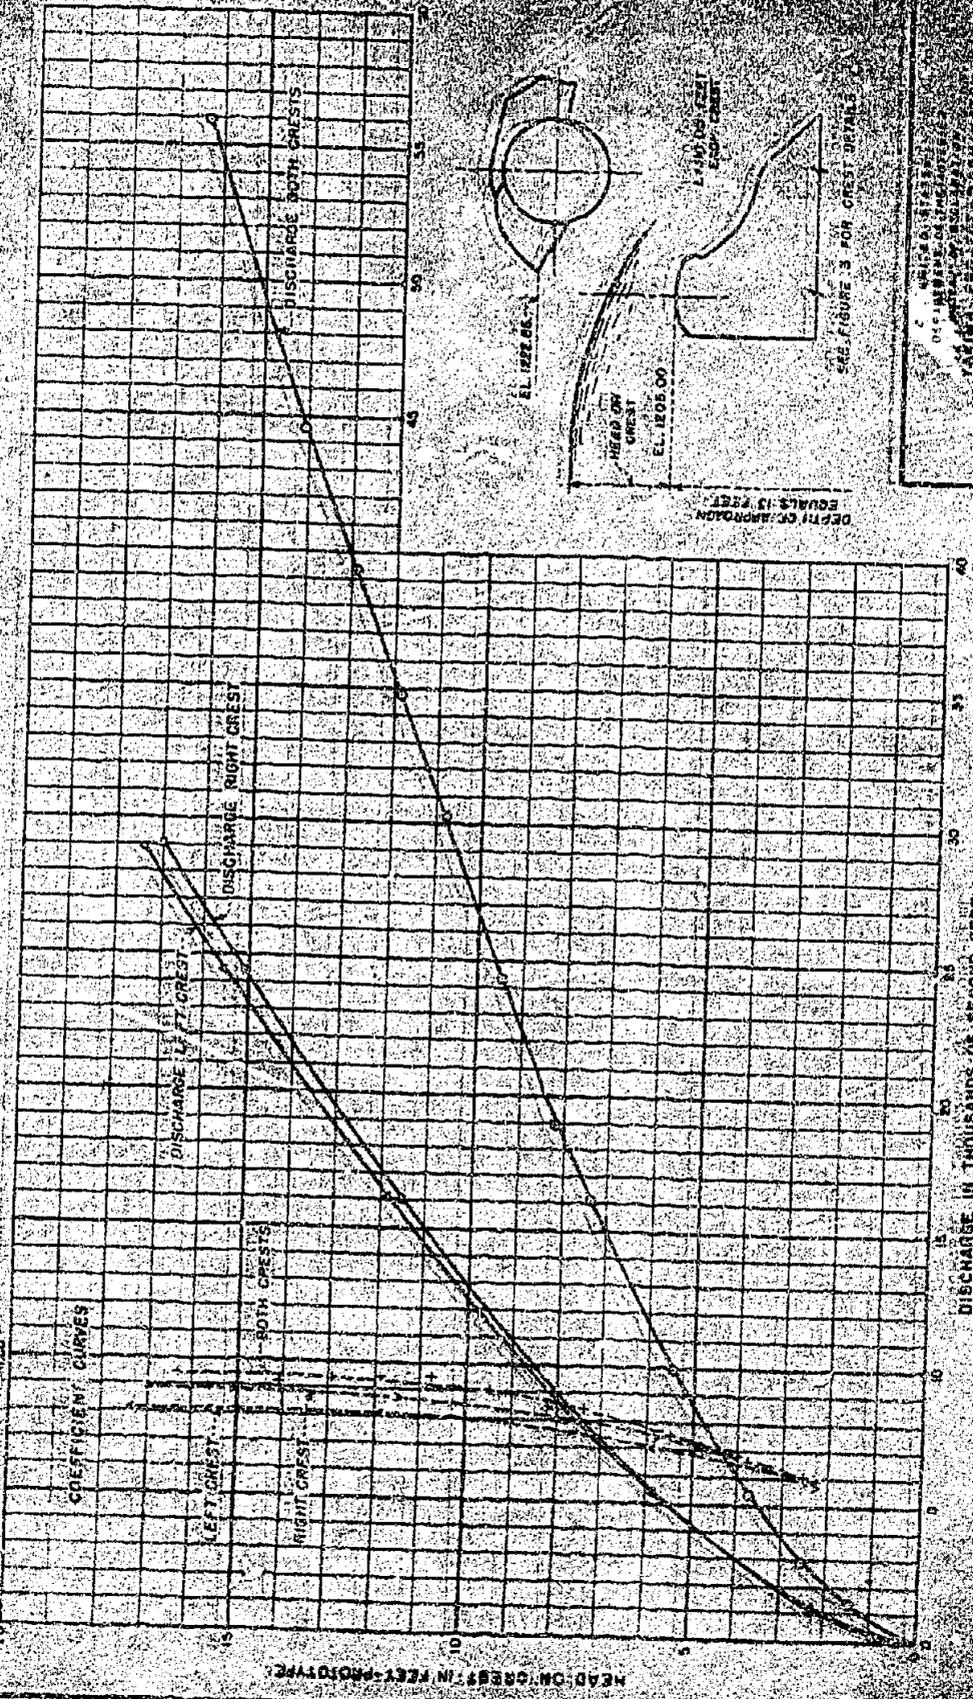
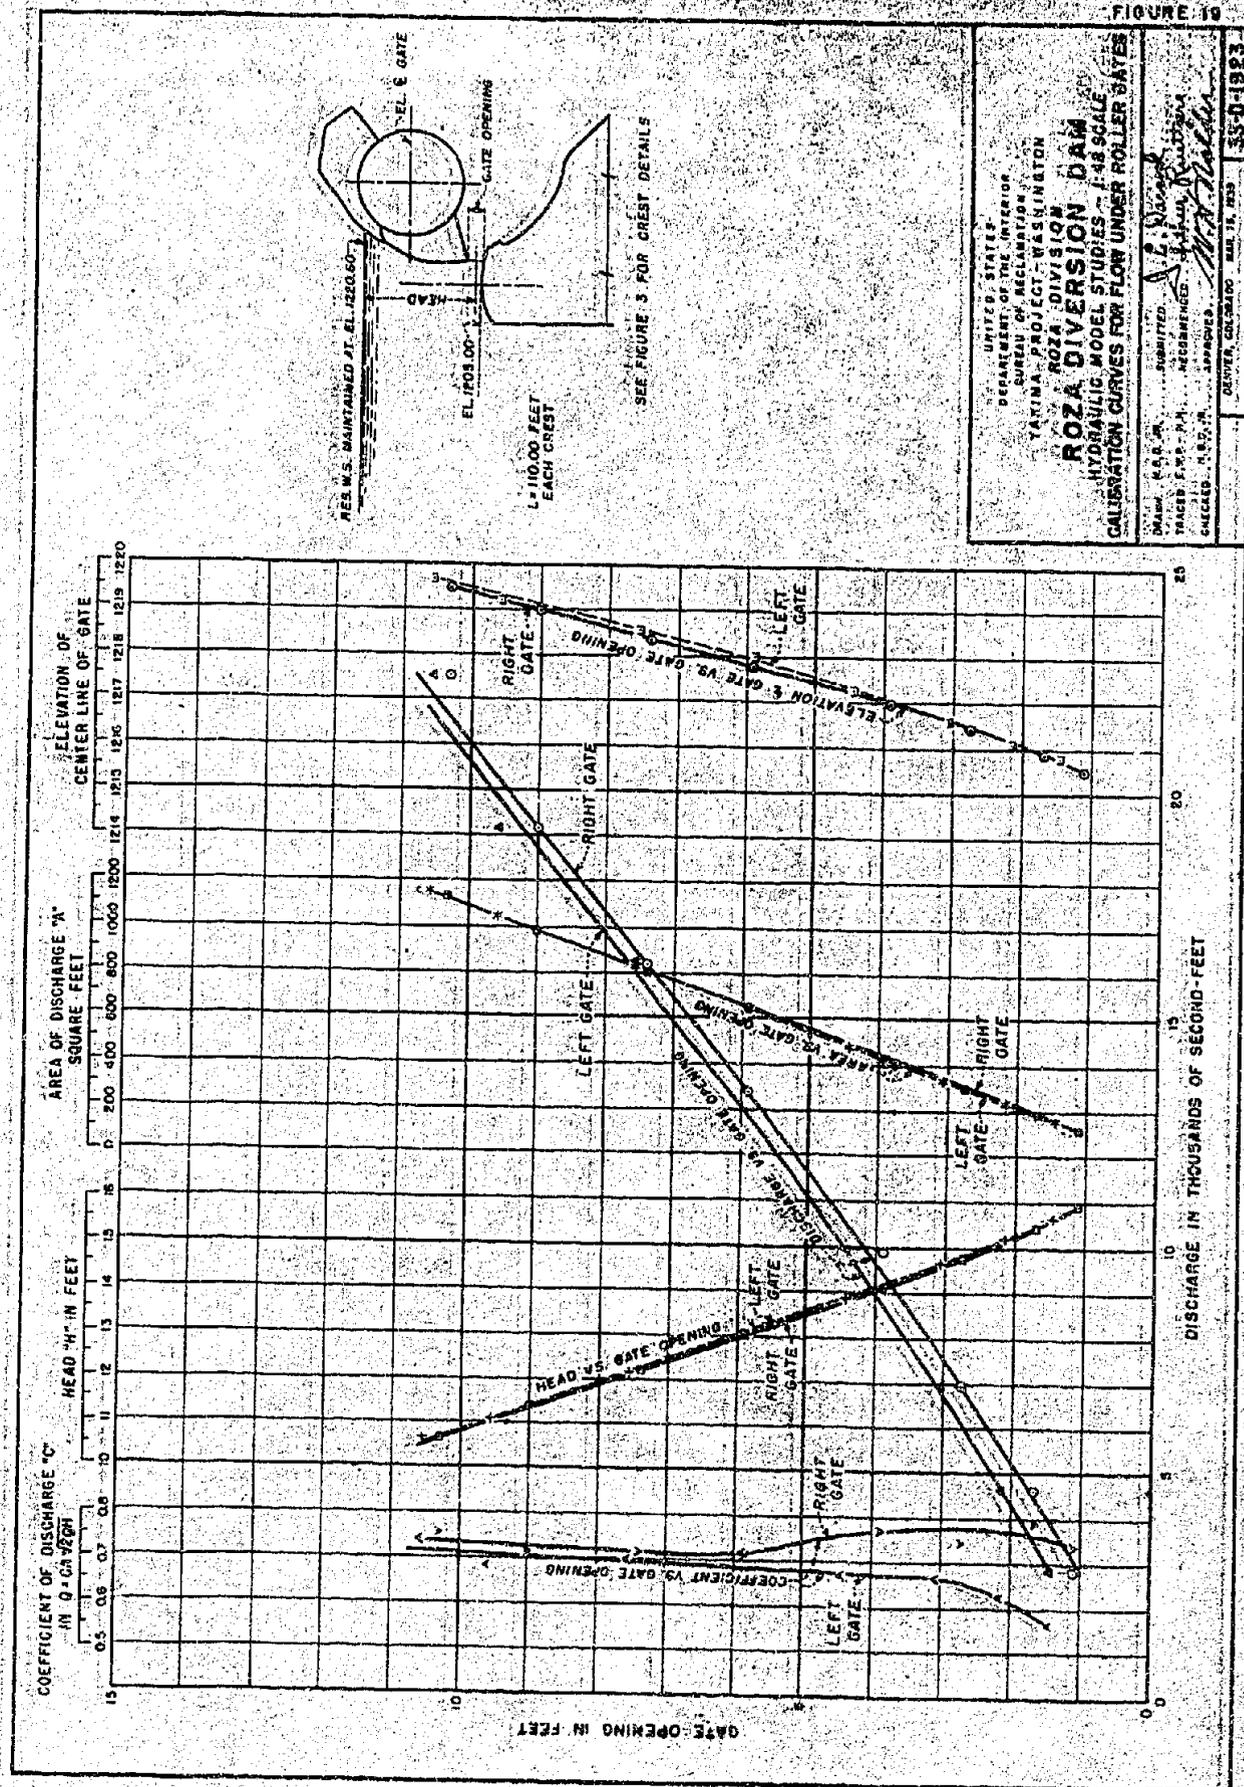
FIGURE 19

Figure 19 shows curves for discharge and coefficient of discharge versus gate opening for flow under each roller gate--a separate calibration for each gate; other basic data are also shown. During this calibration, the reservoir (model) was maintained at elevation 1220.6.

DISCHARGE COEFFICIENT  $C_d$   
IN THIS RELATION  $C_d = \frac{Q}{A \sqrt{2gH}}$

DEPTH OF APPROACH  
EQUALS 13 FEET

SEE FIGURE 3 FOR CREST DETAILS

The coefficients of discharge for flow under the roller gates varies on the average from 0.68 for a gate opening of 1.5 feet, to 0.72 for a gate opening of 10.5 feet. In computing these coefficients from the orifice relation,  $Q = CA \sqrt{2gH}$ , H was measured from the reservoir water surface (maintained constant at elevation 1220.6) to the geometrical center of the gate opening (figure 19).

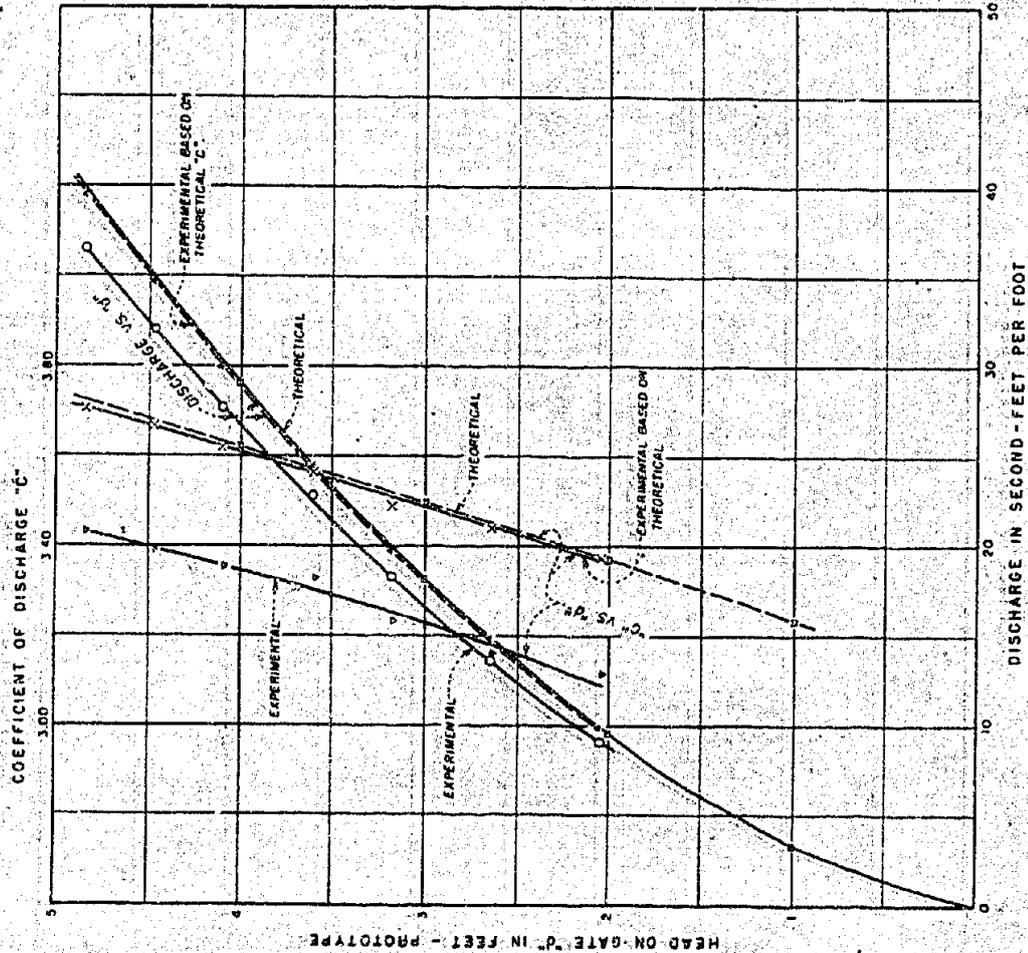
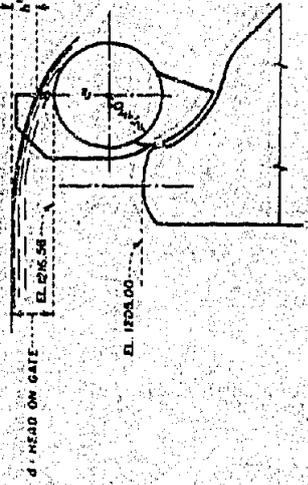
HEAD ON GATE "P" IN FEET - PROTOTYPE

**ROZA DIVERSION DAM**  
 HYDRAULIC MODEL STUDIES - 1/248 SCALE  
 CALIBRATION CURVES FOR FLOW OVER LEFT ROLLER GATE
