BUREAU OF RECLAMATION

Subject: Hydraulic model studies for the redesign of the spillway for Mormon Flat Dam, Salt River project, Arizona.

SALT RIVER PROJECT - ARIZONA
MORMON FLAT SPILLWAY
HYDRAULIC MODEL STUDIES
ORIGINAL DESIGN AND REVISIONS

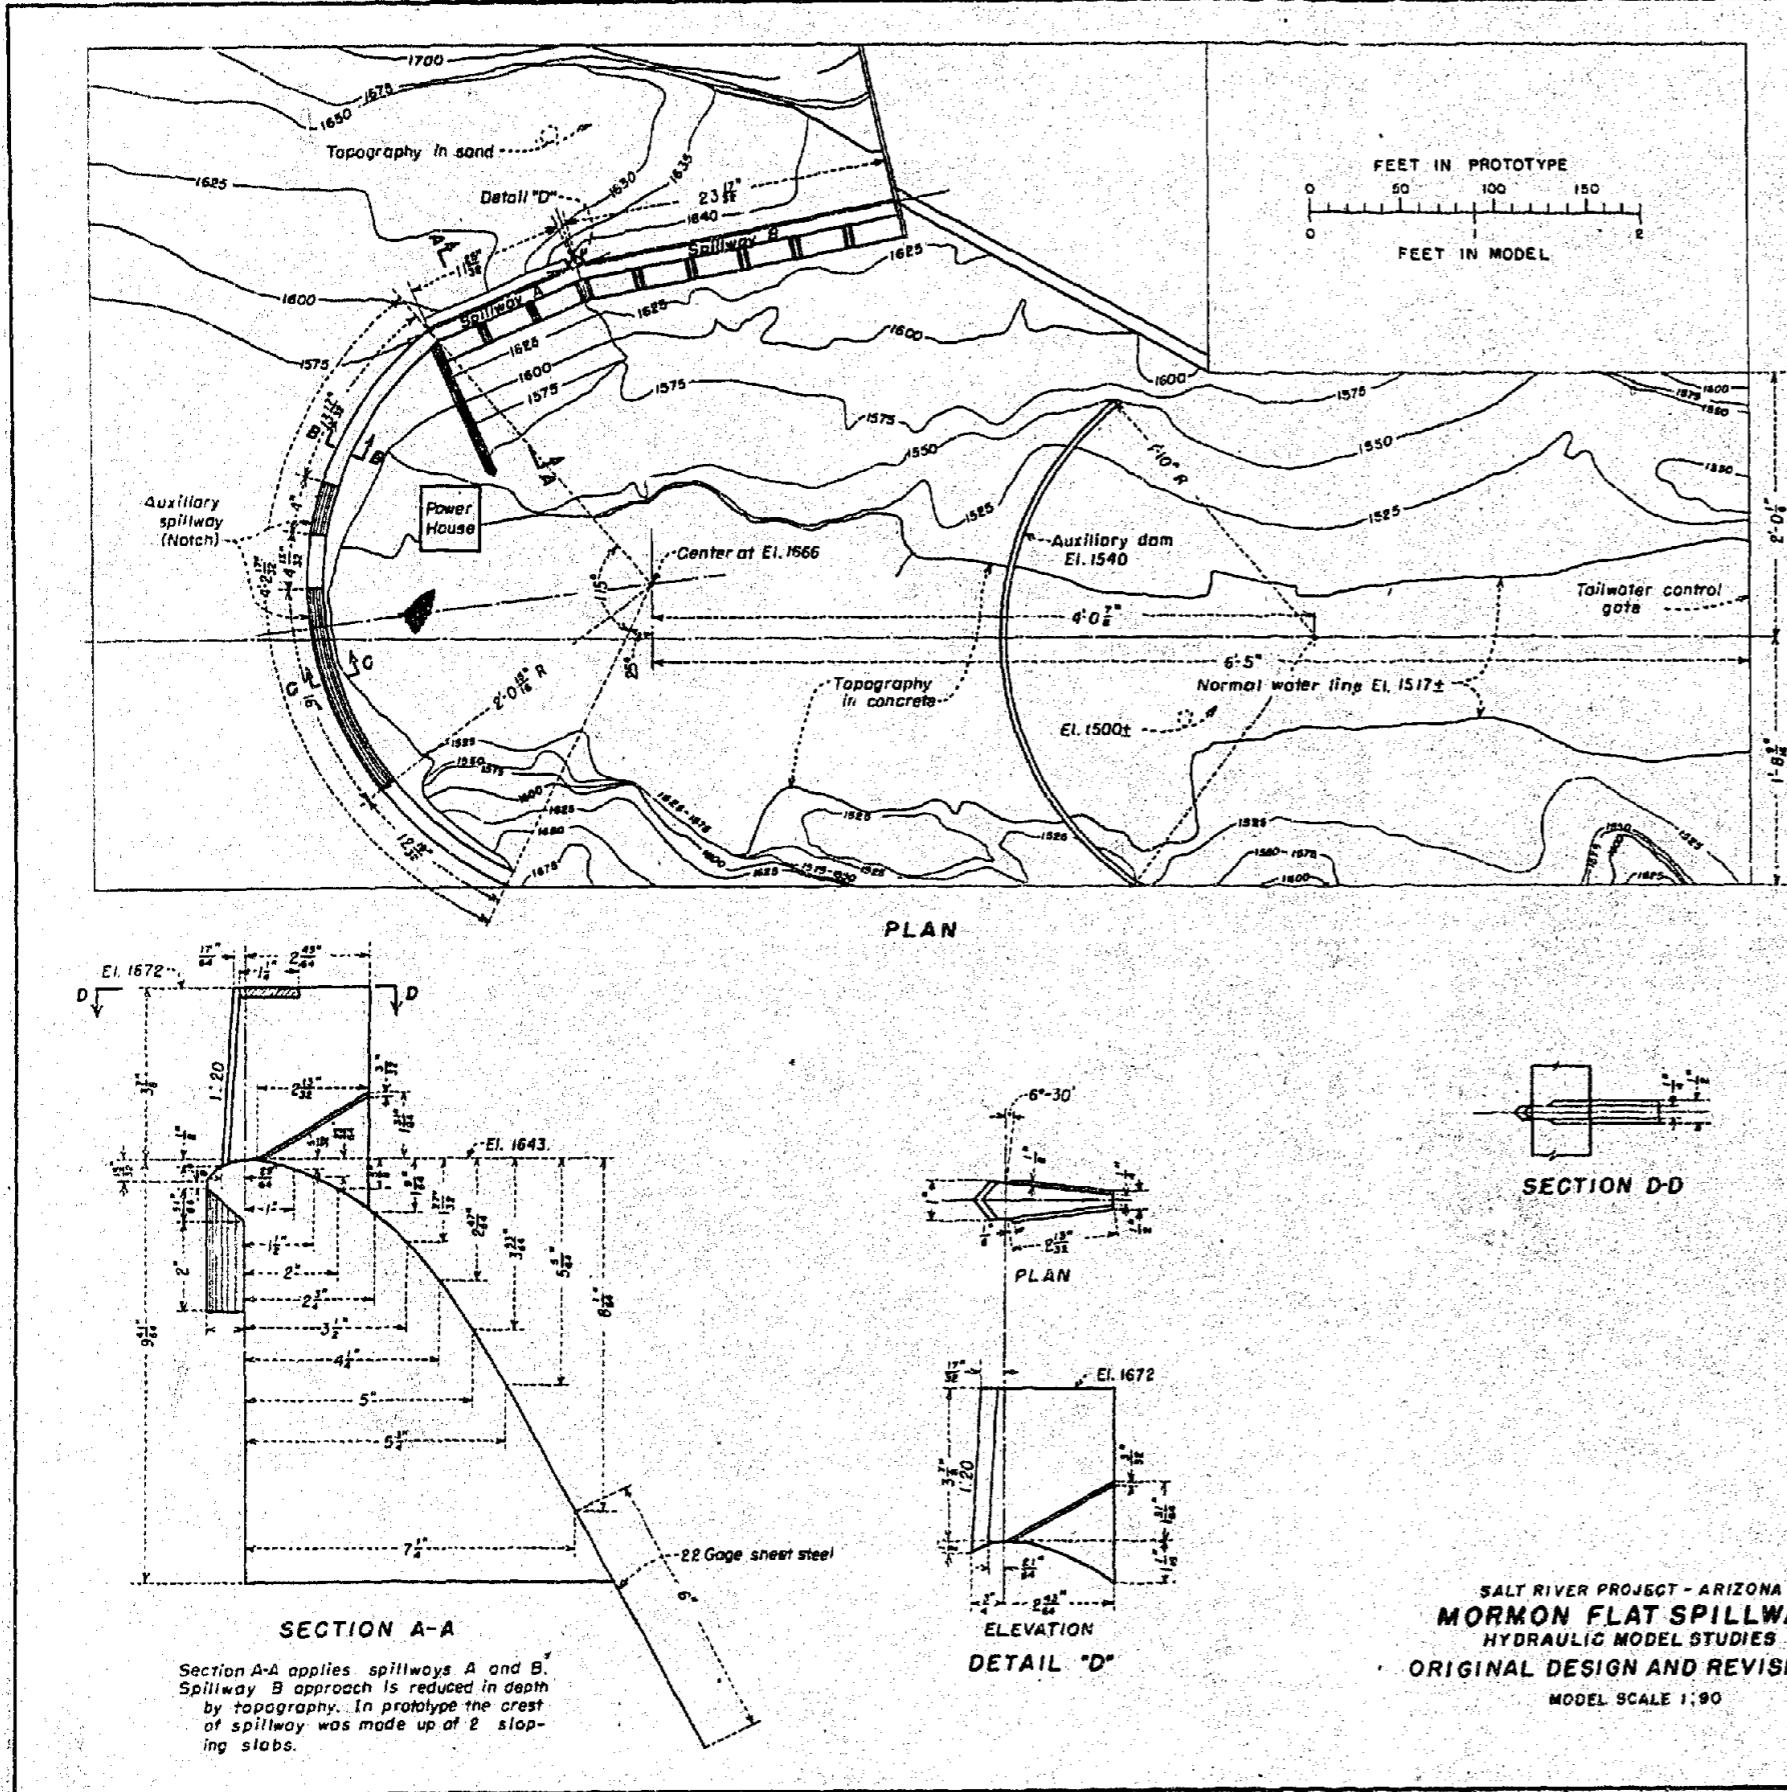
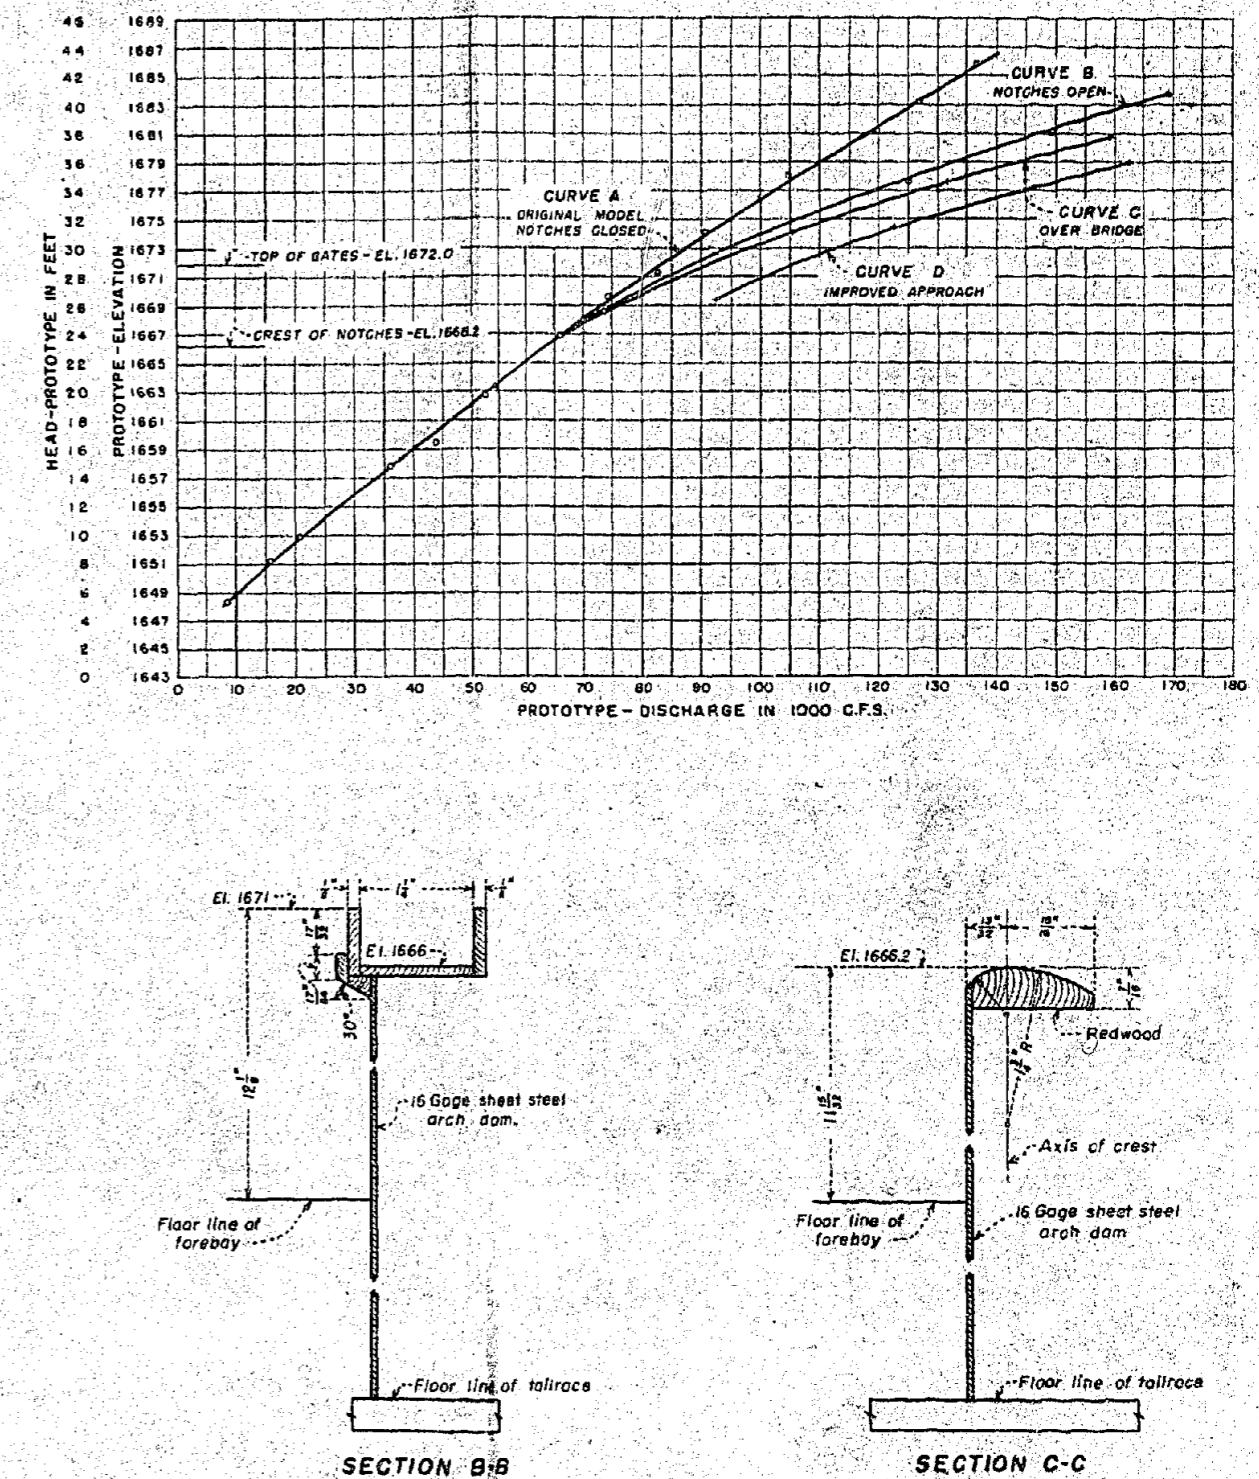
FIGURE I

5. Discharge capacity and flow conditions. At a pond elevation of 1671, top of the parapet of the arch, and with the proposed auxiliary spillways (notches) closed off, the flood flow moved swiftly through the approach and banked on the upstream sides of the piers on the spillway crest. Nearly half of each gateway was void, due to the sudden change of direction of the approaching flood water. The excessive velocity, turbulence, and eddy loss reduced the effective head on the gates. This condition, along with the reduced effective crest length, limited the discharge to approximately 80,000 cubic feet per second at pond elevation 1671. The flow characteristics of the approach channel improved as the discharge decreased. The length of the spillway crest became more effective with the smaller velocities in the approach channel. Curve A, figure 1, indicates the discharge of the original structure.

With the notches in the dam open, it was found that the flow to the ogee spillway was unaffected. The total effect of the notches on the required head for flood flows is shown on curve B, figure 1.

The roadway over the dam and spillway was reproduced in the model. Curve C, figure 1, shows the discharge at reservoir elevations whose floods overtopped the dam and gates.

A restriction in the spillway approach channel near gates 1 to 3 was removed and the approach deepened. The resulting increased capacity is shown on curve D, figure 1.

The curves on figure 1 indicate the progress made in the solution of the approach. Inasmuch as it was required that 150,000 cubic feet per second be passed over the spillway, the problem was left unsolved pending further considerations as to the improvement of the spillway approach.

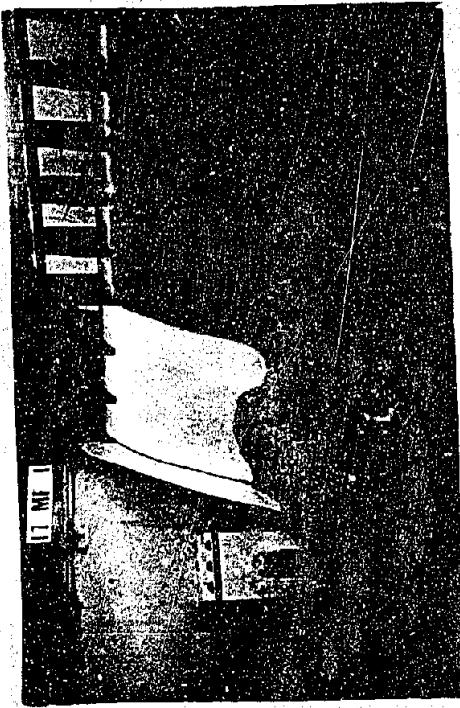
ORIGINAL STRUCTURE

6. Effect of various buckets and auxiliary dam. Various types and combinations of buckets were tried on the original ogee spillway to reduce the erosion and splash in the river below. None of the buckets tried was entirely satisfactory. An auxiliary dam was proposed for installation, about 1,500 feet downstream from the large dam, to control the tail water for the spillway and the powerhouse. In the tests of the buckets, it was found that the auxiliary dam was of little or no benefit in checking erosion and dissipating energy of the spillway discharge. Plate 1 shows the model of original structure before alterations were made.

SPIELWAY

DISCHARGE 150,000 SEC.-FT.

DAM AND SPIELWAY

DISCHARGE 80,000 SEC.-FT.

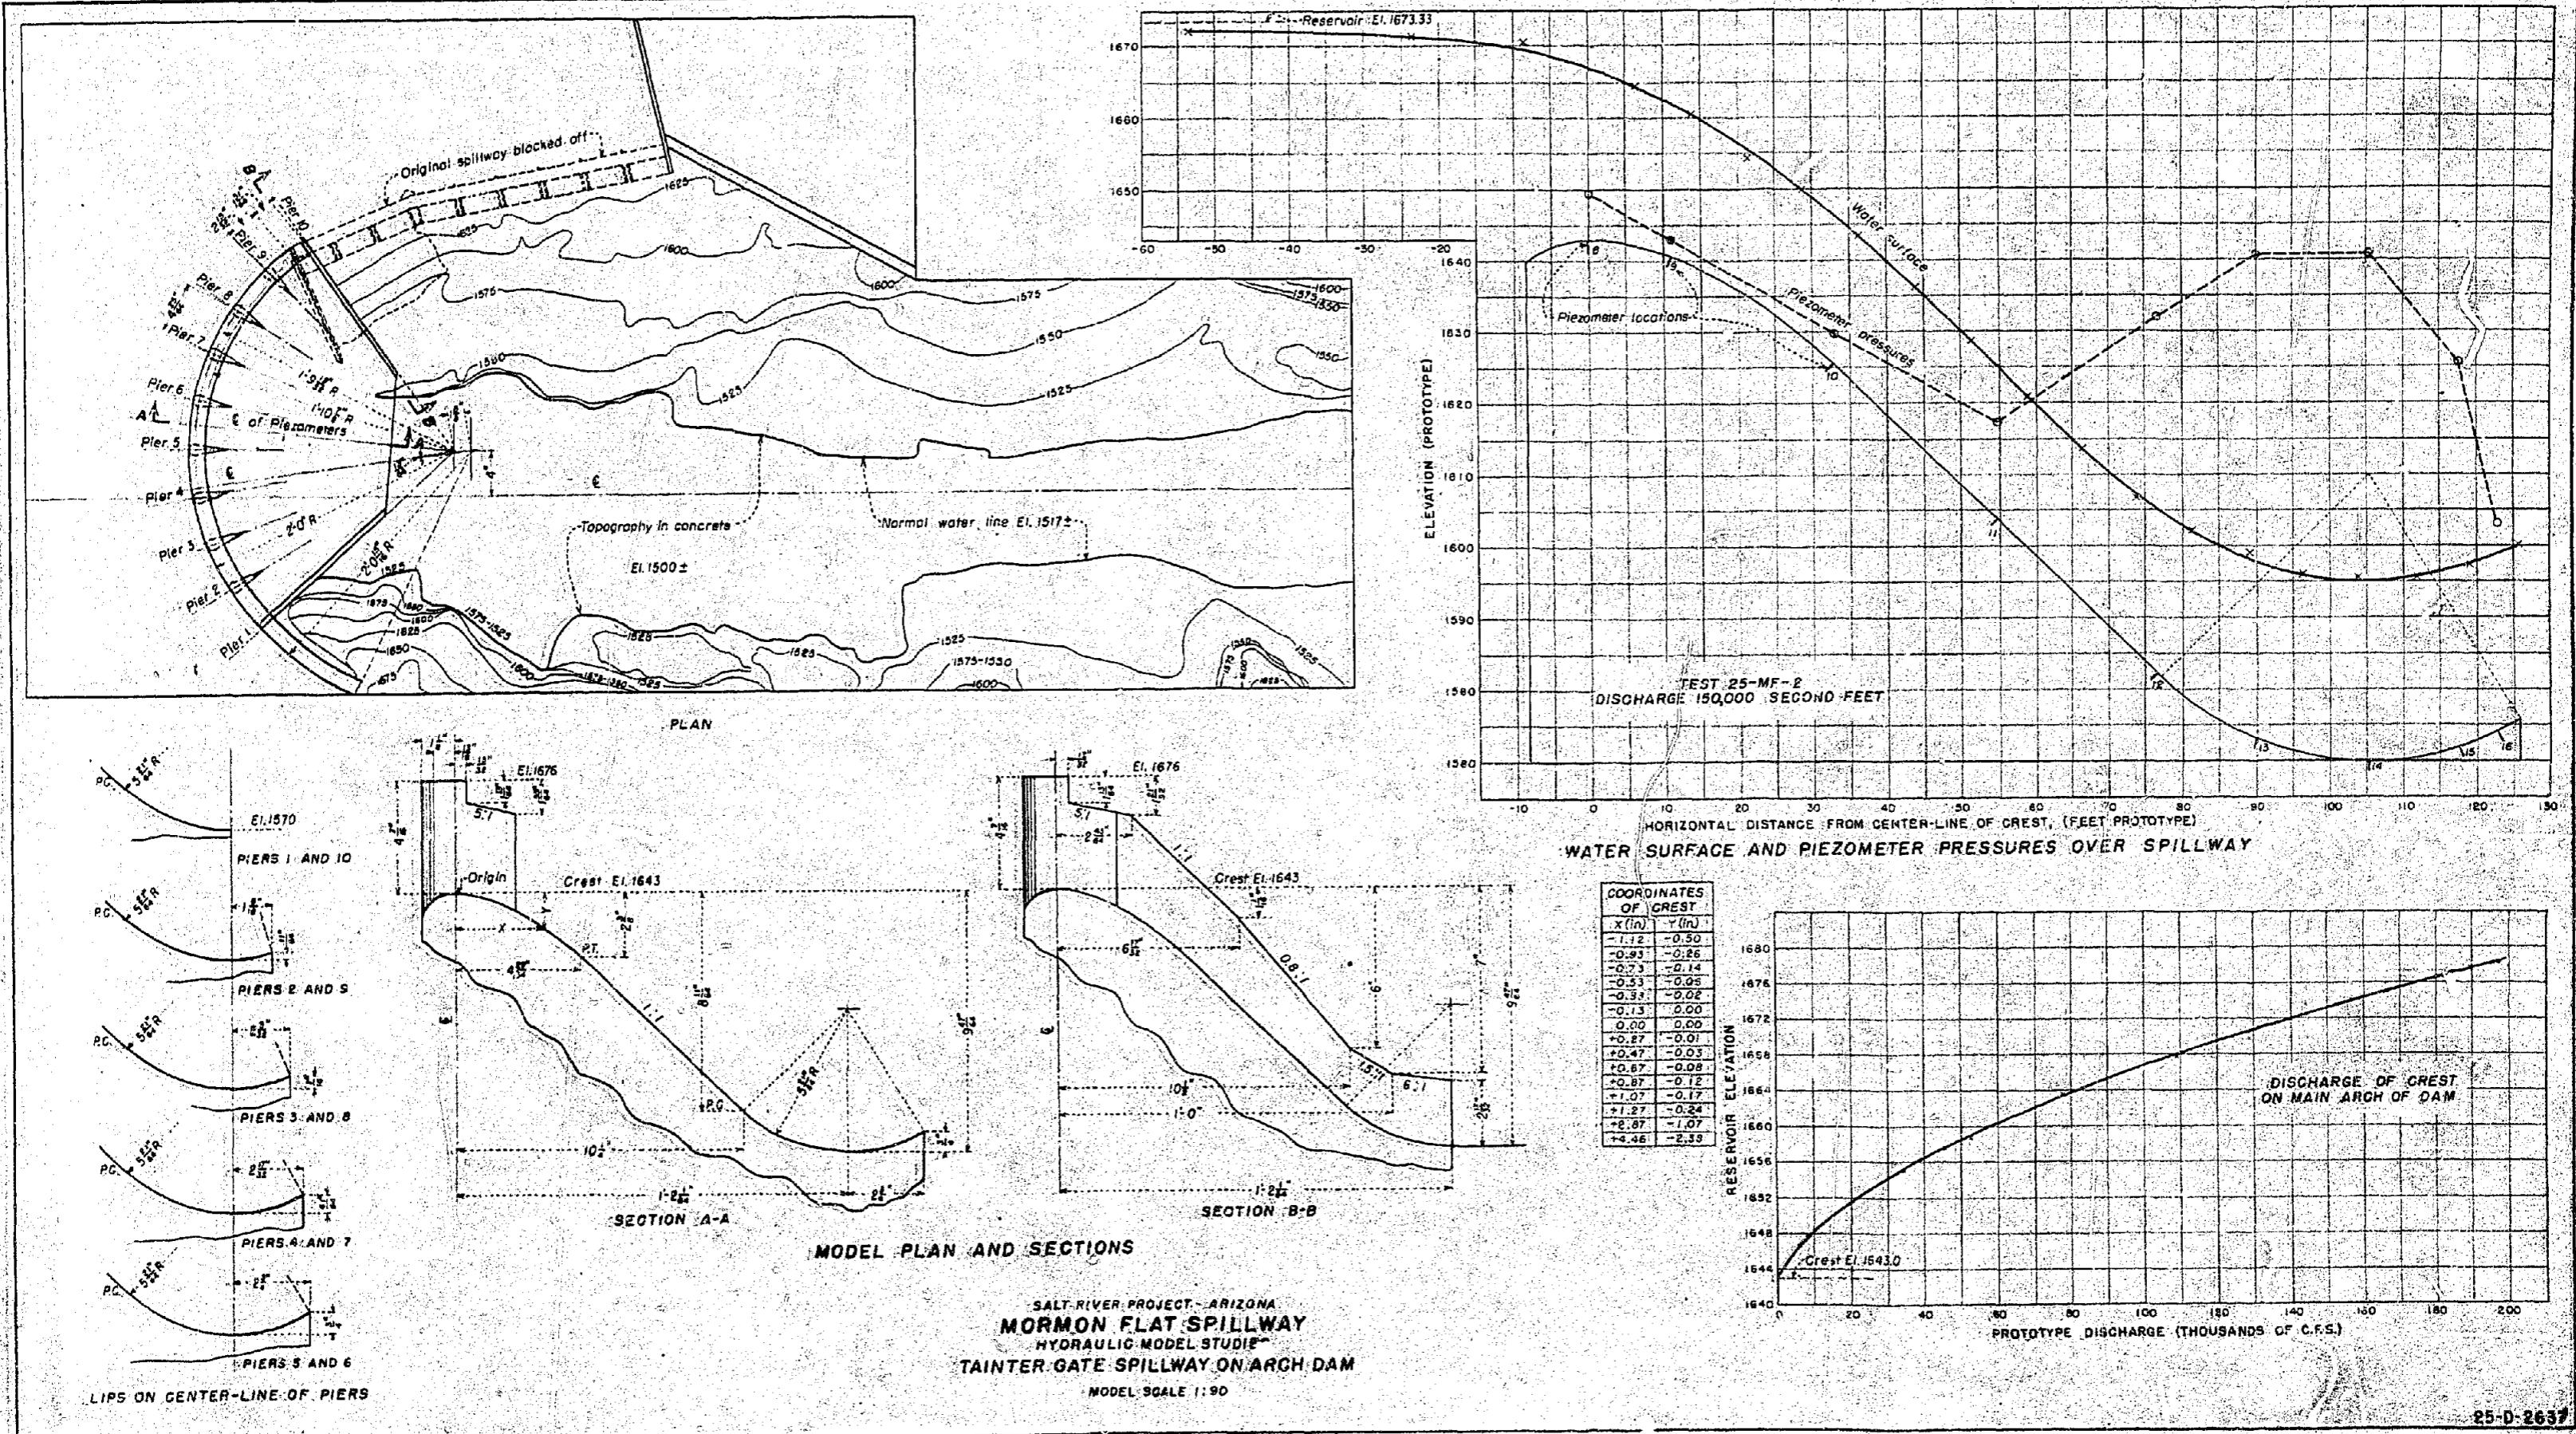
FIGURE 2

The discharge capacity of this spillway is shown in figure 2. The pressures developed on the crest, apron, and bucket are also shown in figure 2.

Plate II shows the best development of the model. This is also shown in figure 2.

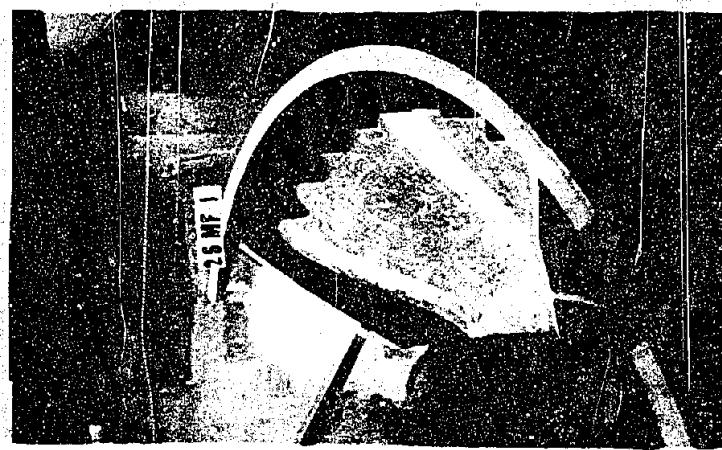
NO FLOW, LOOKING UPSTREAM

DISCHARGE 150,000 SEC.-FT.

FROM LEFT SIDE

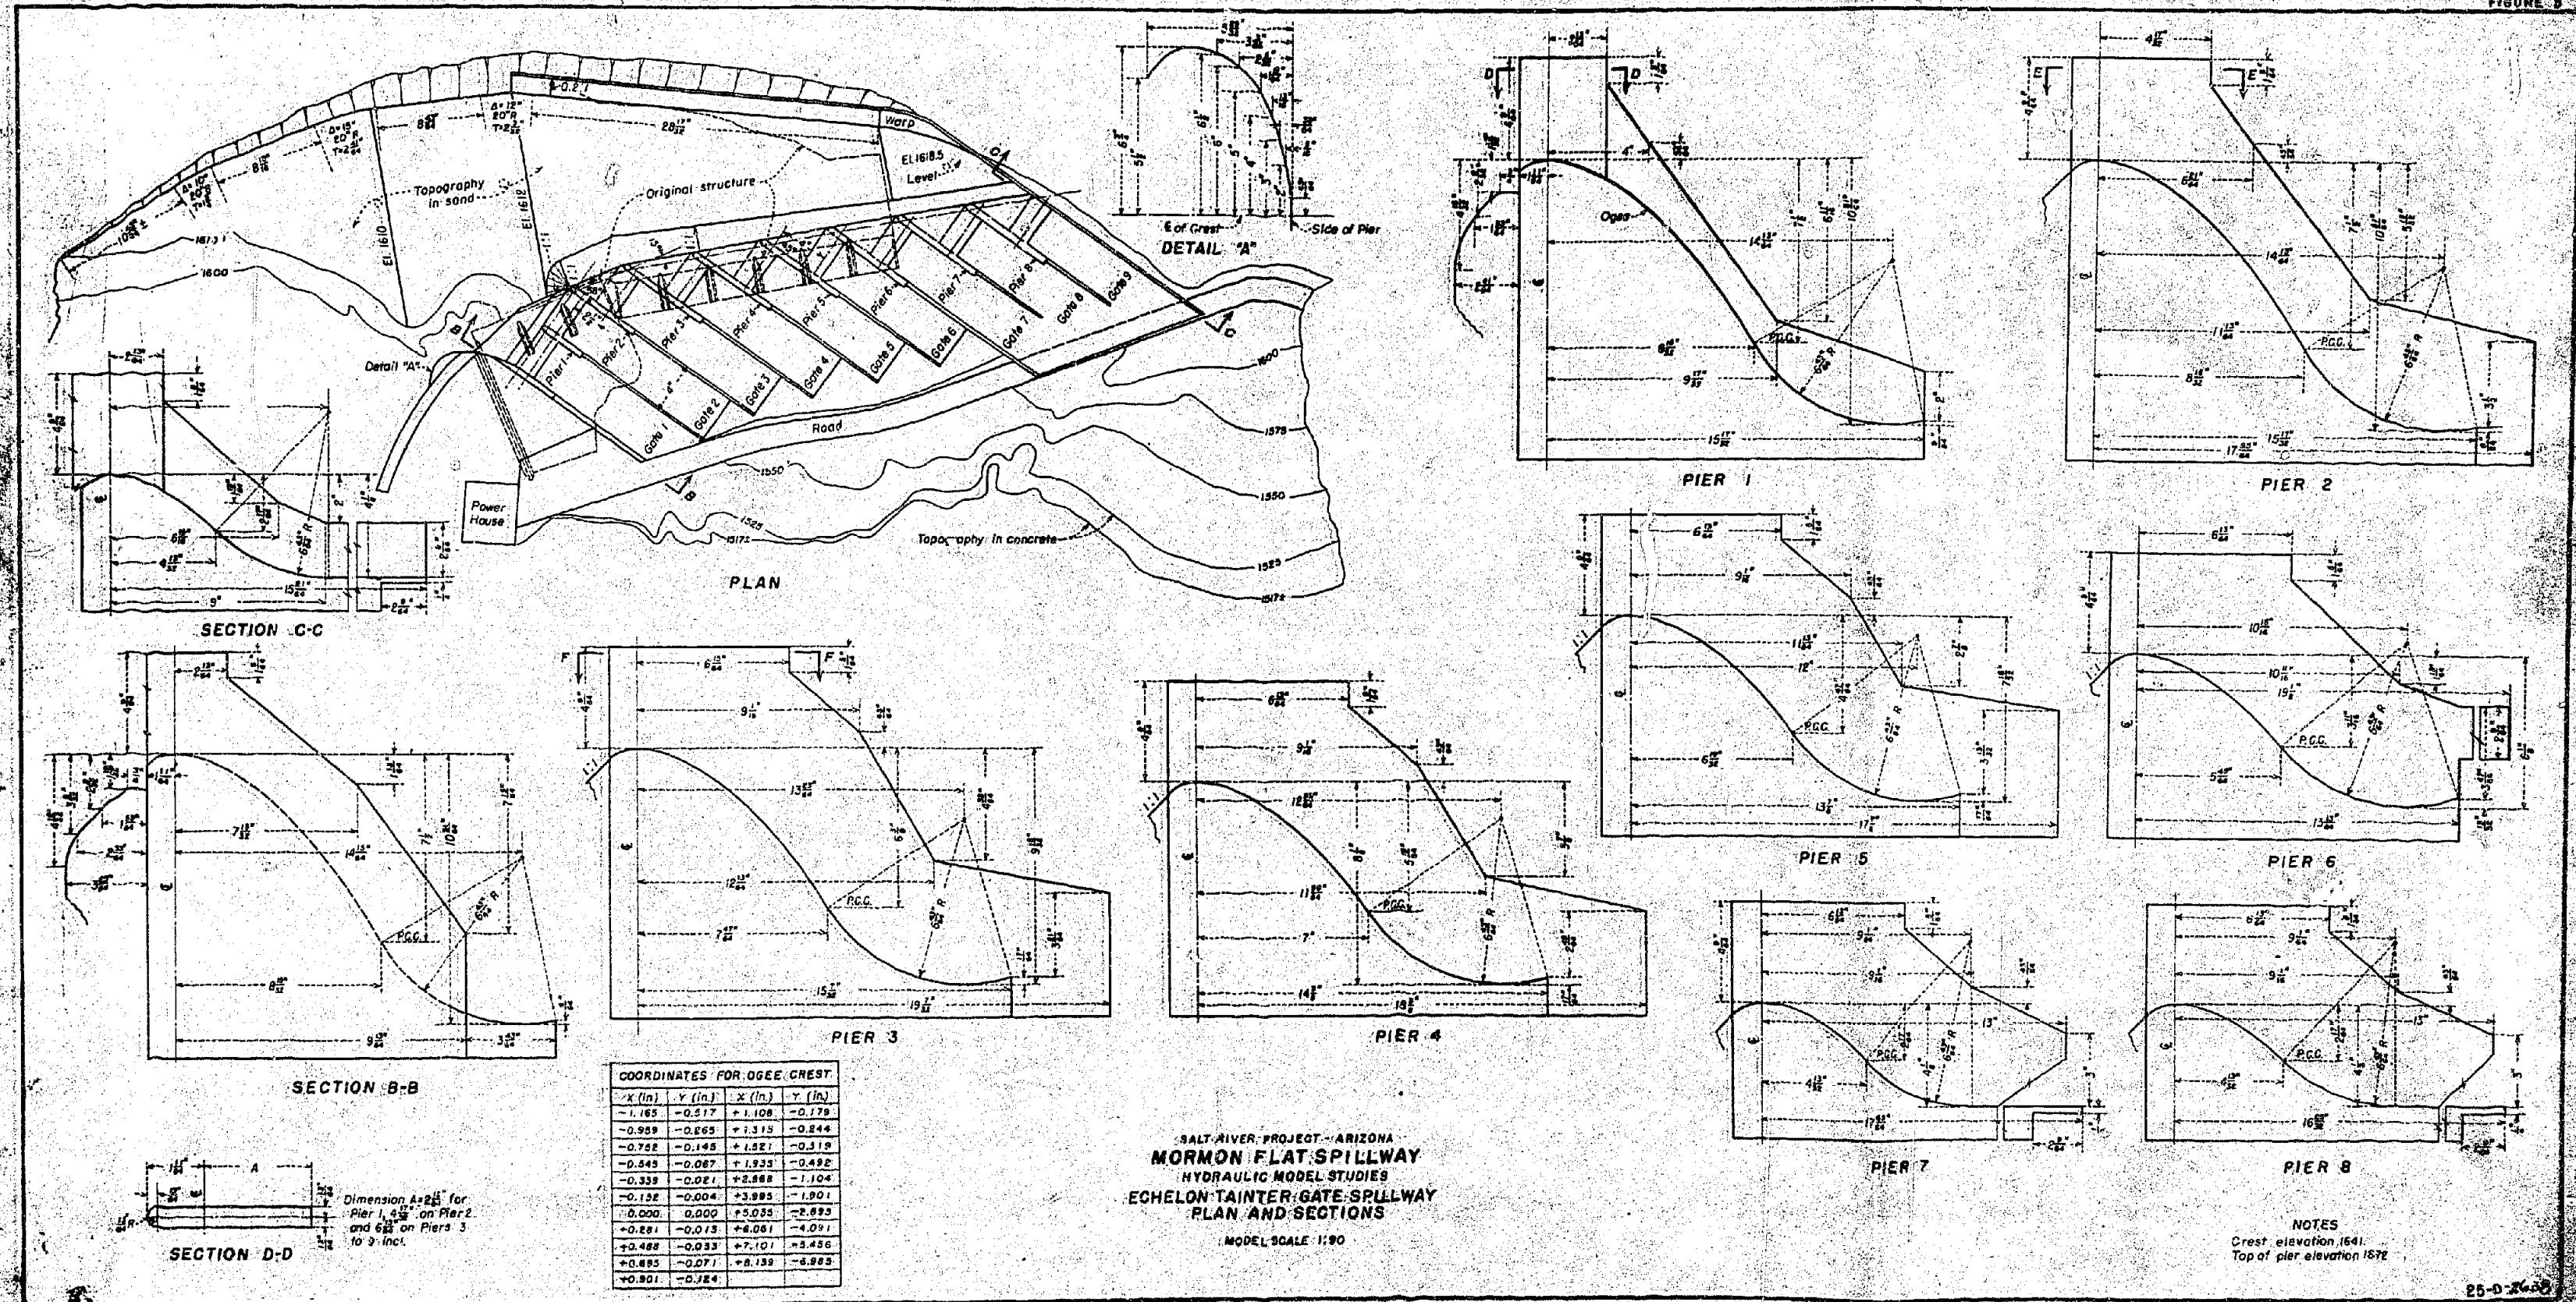
FIGURE 8

This design was removed and the crest was reconstructed, the gates being in echelon with respect to each other in plan and alinement, much the same as shown in figure 3, except that gates 1 and 2 were also echeloned in alinement. The principal difficulty encountered in this type of spillway, situated as shown, was the tremendous drawdown on the scroll wall at the right of gate 1, affecting gates 1 and 2. The drawdown not only limited the discharge due to head loss and limiting the effective length of the crest of gates 1 and 2 but caused excessive overturning moment on the scroll wall. It was found to be impracticable to design for this condition. Various sizes and shapes of scrolls were tried in an effort to arrive at a solution within the limits of practical design.

After an exhaustive study of the drawdown problem at gates 1 and 2, it was decided to move the crest of gate 1 downstream in alinement with gate 2. The right wall of gate 1 was connected to the dam with various smooth-curved walls. Detail A, figure 3, shows the scroll wall giving the best flow conditions. The bench upstream from gates 1 and 2 was rounded off as indicated on section B-B, figure 3. The prototype discharge for the final echelon spillway as shown in figure 4 was 149,959 cubic feet per second at pond elevation 1672.00.

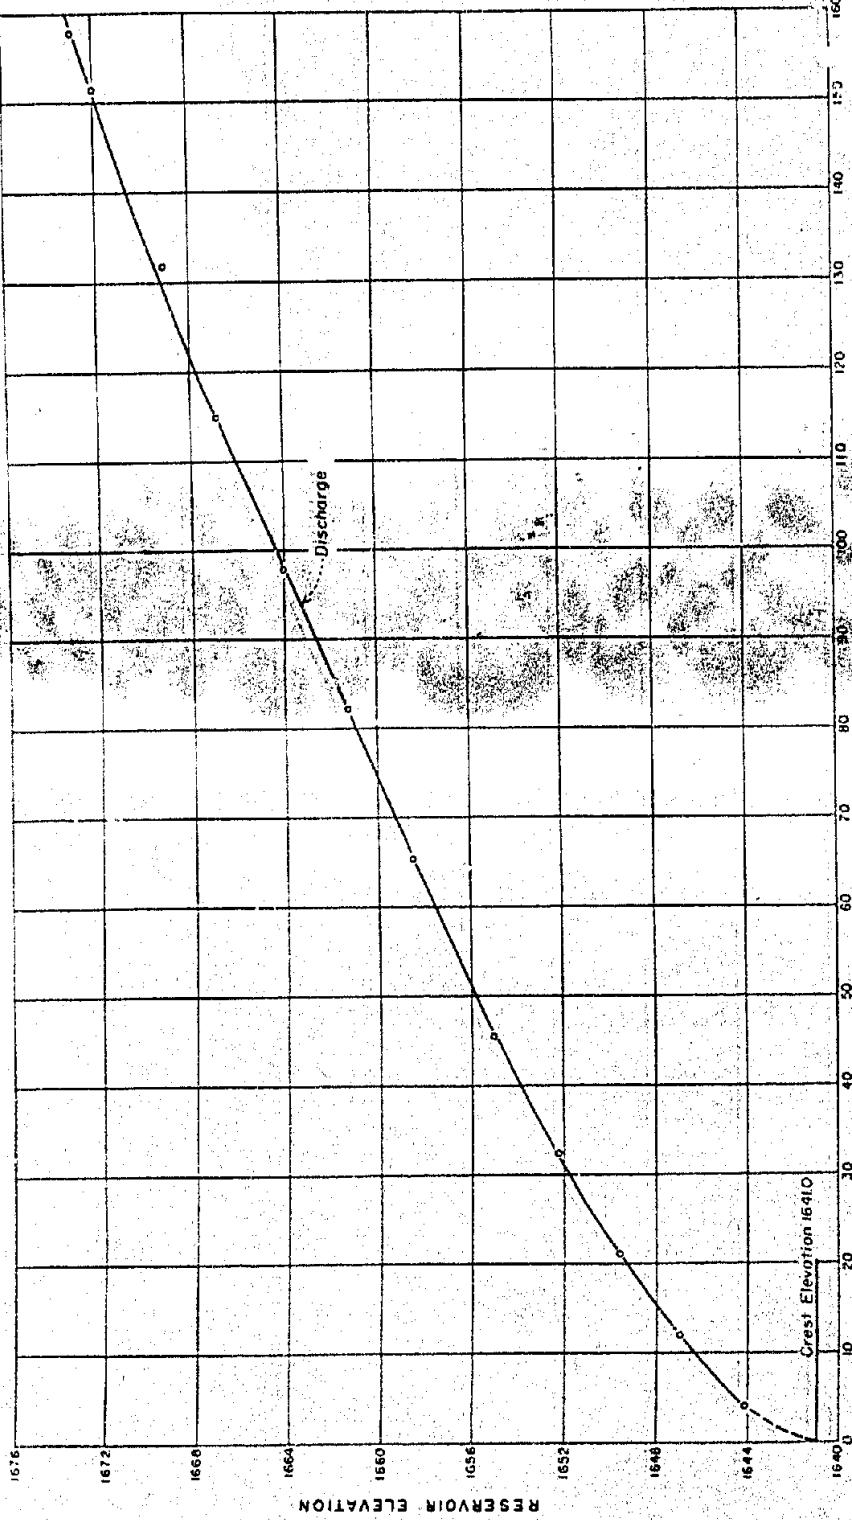
FIGURE 4

UNITED STATES
DEPARTMENT OF THE INTERIOR
BUREAU OF RECLAMATION
SALT RIVER PROJECT - ARIZONA
MORMON FLAT DAM
SPILLWAY
HYDRAULIC MODEL STUDIES
DISCHARGE - ECHELON SPILLWAY

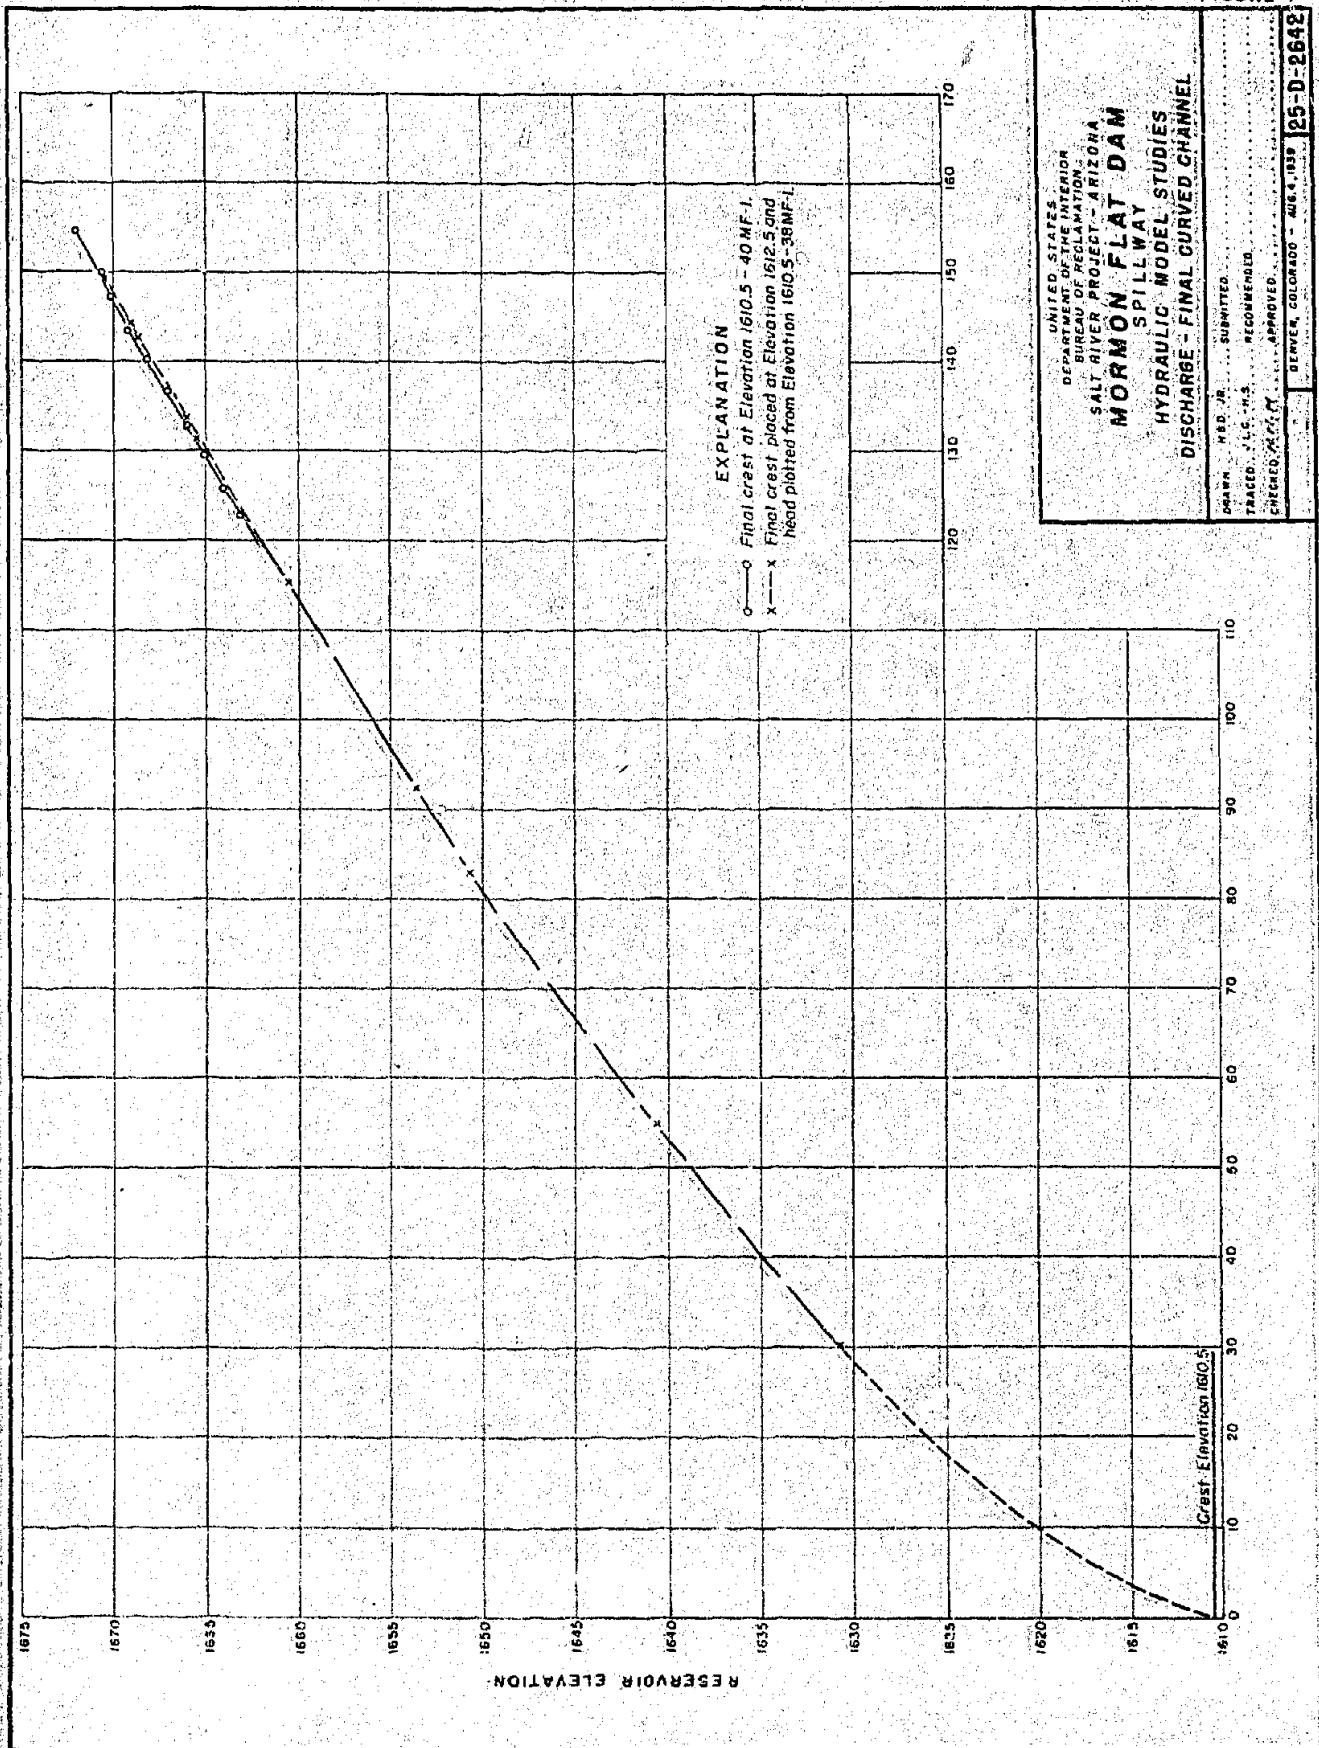
FIGURE 7

The crest was lowered to elevation 1611.0 and was a different shape than that used at elevation 1612.5. The discharge at pond elevation 1671.0 was approximately 145,000 cubic foot per second. As the shape of the crest used at elevation 1612.5 had a larger discharge coefficient than that used at elevation 1611.0, the former was used at elevation 1610.5. Figure 7 shows the relative capacities of the spillways set at the three different elevations.

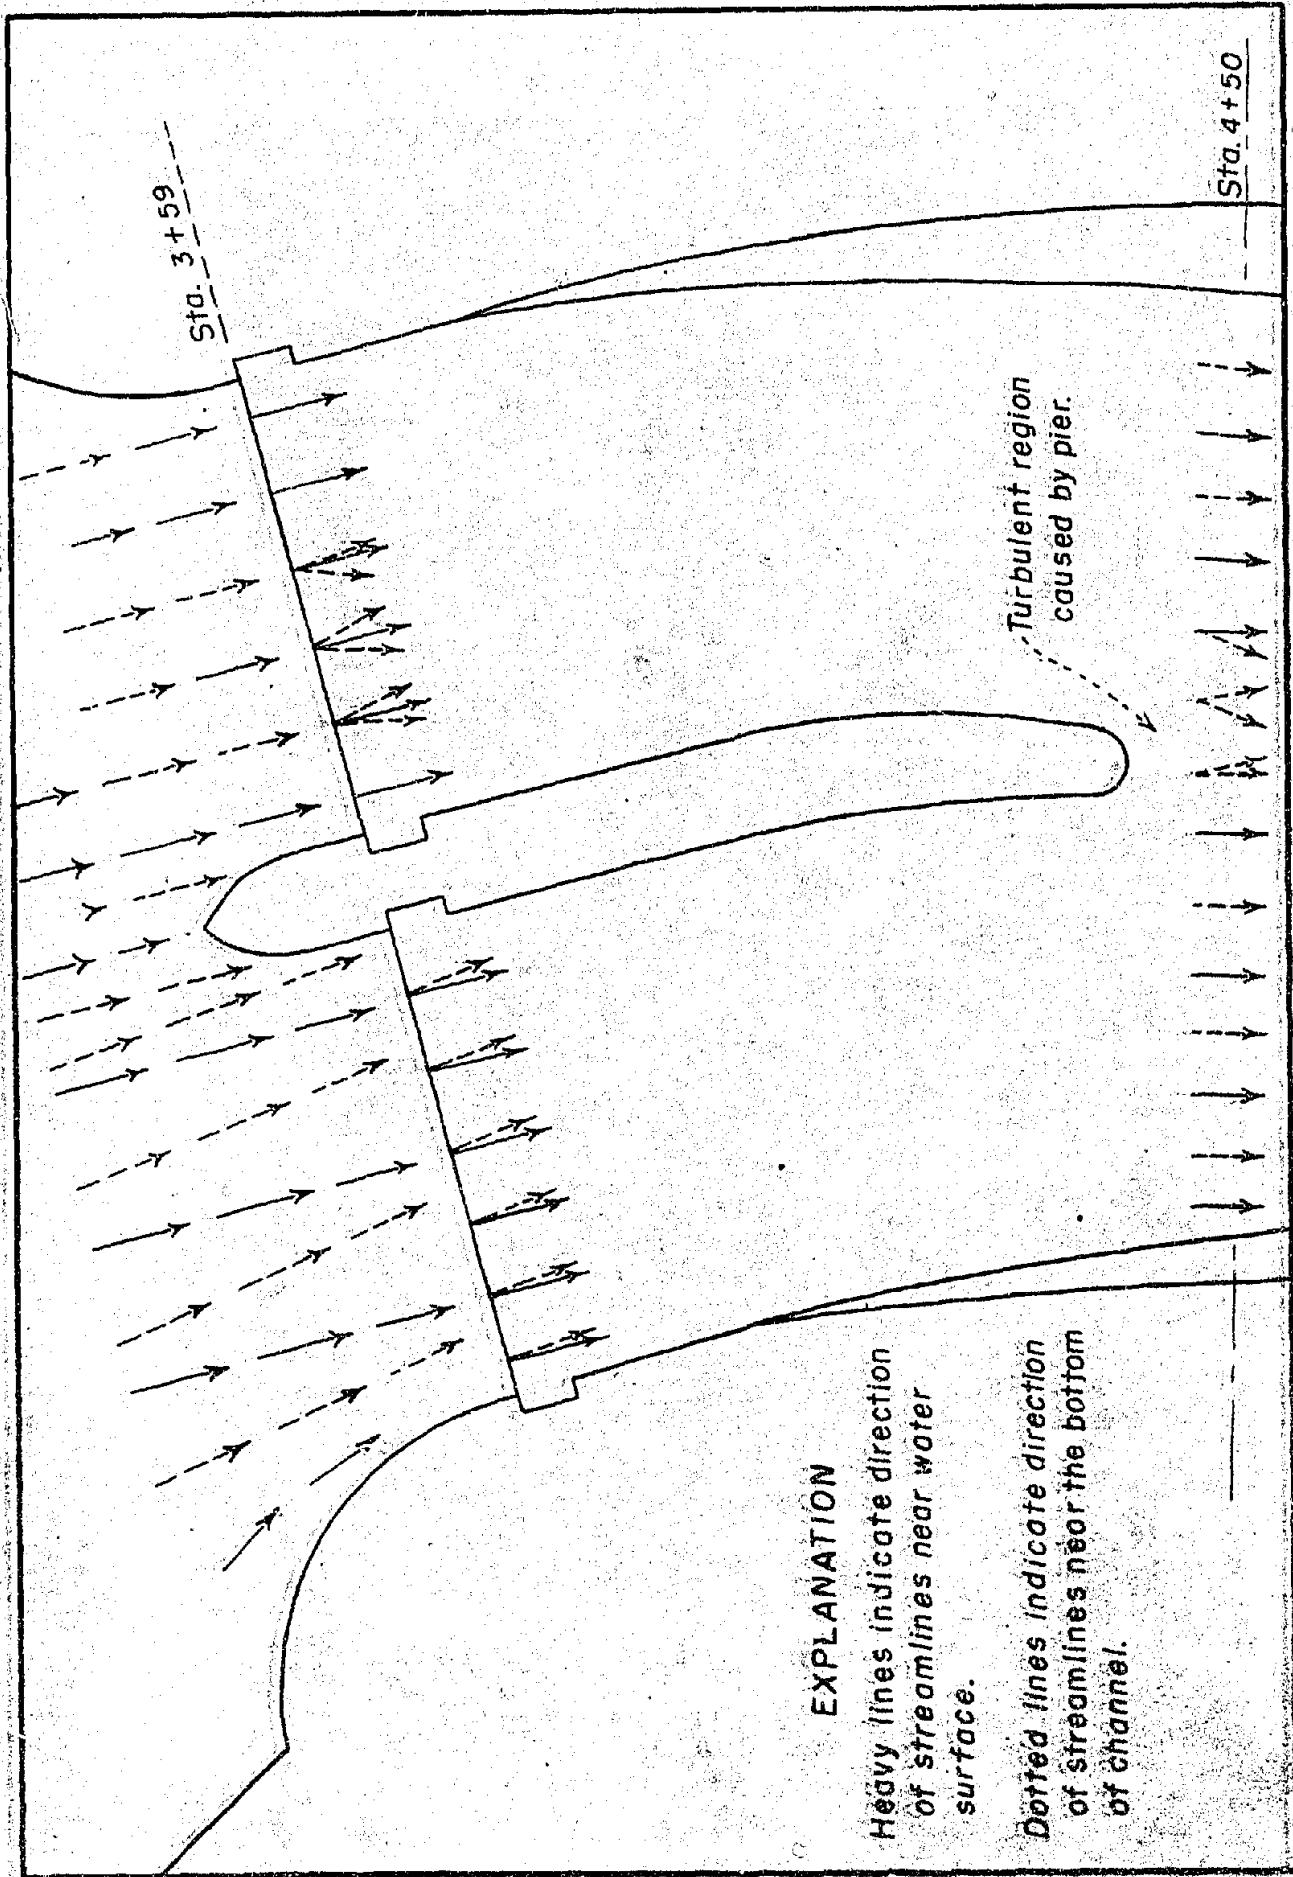
FIGURE 10

10. Streamlines. Velocity direction observations are shown in line diagram form in figure 10. The direction of velocity was determined by suspending short lengths of thread in the stream near the water surface and near the bottom of the channel.

The streamlines upstream from the left gate were normal to the crest. At the crest, the streamlines near the top and bottom were generally normal to the crest, except in a small area near the center of the gate where the velocity oscillated slightly in a direction from right to left.

Upstream from the right gate the flow on the bottom impinged on the pier at quite an appreciable angle and continued in the same general direction through the right gate. The flow at the top of the approach appeared to be almost normal to the crest except at the extreme right near the curved wall.

At station 4+50 the streamlines near the surface and near the bottom were nearly parallel to the center line except in the turbulent area immediately downstream from the pier. The streamlines throughout the remainder of the channel appeared to be ideally patterned.
