HYDRAULIC MODEL STUDIES FOR THE DESIGN OF
THE IMPERIAL DAM.

(To be presented before the regional meeting
of the Section of Hydrology of the American
Geophysical Union on June 23, 1937, in Den-
ver, Colorado.)

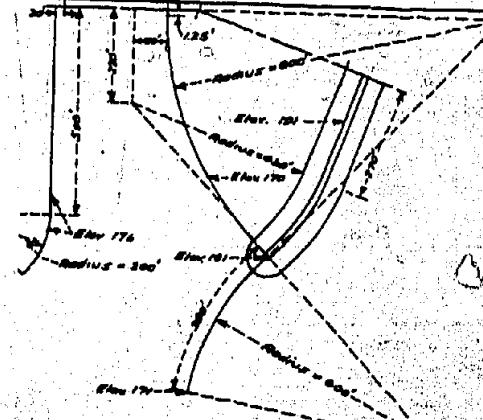
Right	100 ft.	1 hr.	<p>Concentration of flow near end of dike. Good standing wave over right abutment wall. Flow increased outside of left wall base and farthest from dam, turned along dam and flowed over wall and into channel. Flow evenly distributed across front of intake inside of trussback, well on left side effective at curve and at end next to dam. Channel along left abutment wall. Spills far very smooth. Slight channel around end of dike. Area inside of trussback filled. Some silt in channels below roller gates. Raise right wall.</p>
7

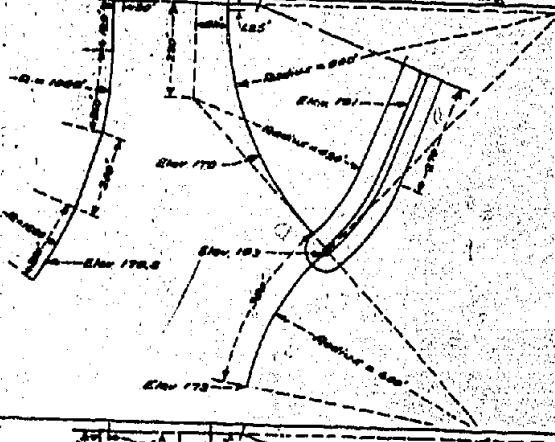
Right	300 ft.	3 hrs.	<p>Drop in head and rough flow conditions around nose of dike saw-in slightly higher velocities next to dike. End of wall next to dike not effective because drop in water surface around end of dike allowed very little water to spill over wall. Good standing wave over wall beyond effect from dike. Slight whirl inside of dike and trussback. Area inside of trussback filled and some silt in channels below roller gates. The conditions at the end of the dike could be corrected by a more efficient and less abrupt transition from the dike to the main.</p>

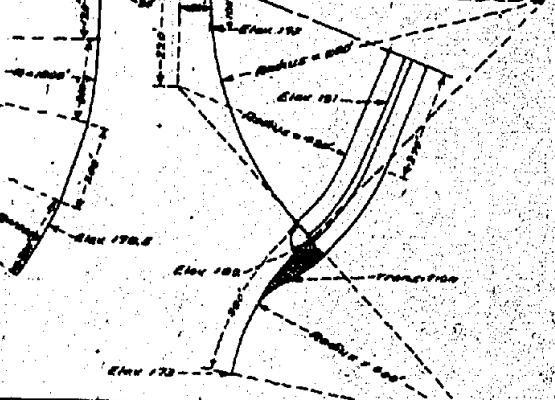
8

Left Center Right	300 ft.	4 hrs. 1 hr.	<p>River on right side. Concentration of flow along dike and right wall. Smooth flow around end of dike. Good standing wave over right wall. Flow to roller gates evenly distributed. Some silt inside of trussback and nose in channels below roller gates. Channel down end of right wall, turned to one of left walls. Good standing wave length of this wall approximately to one half the width of the standing wave on the end next to the abutment. Standing wave gives very undesirable results. River down center - good flow conditions. Considerable silt on right bank continuously and much of it has been forced down river way on right side of river bend. Flow from left side - good standing wave along entire length of left wall. Considerable silt沉积 continuously. Left wall too high and possibly too long.</p>
9

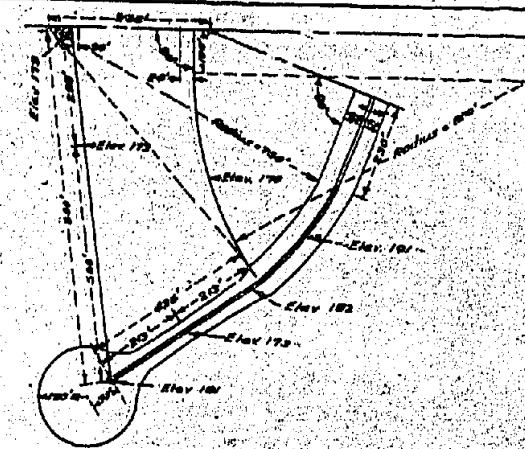
34.

Center	170.0	4 hrs.	<p>1. Flow through trussbank and entrance to roller gates good. Silt divided at junction of straight河 and remainder to left. Silt far above standing. Some silt inside of trussbank. Channel along left wall from standing to low point in side. Small clear space below right wall downstream from low point.</p> <p>2. Flow through trussbank and entrance to roller gates good. Upstream end of left wall above water but remainder was very effective. Silt bar not as large as with flow from center. Some silt inside of trussbank and inside channels below roller gates.</p> <p>3. Flow through trussbank and approach to intake gate. Left wall effective for 300 feet upstream from standing. Right wall effective for 200 feet upstream from nose of silt. Large silt bar in front of standing and considerable silt inside of trussbank but very little outside below roller gates.</p> <p>Standing period unsatisfactory for all three runs.</p> <p>Results generally satisfactory.</p>

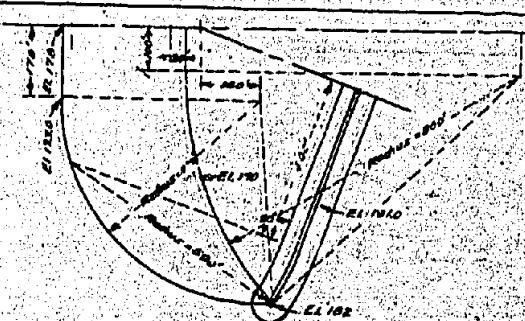
35.

Right	160.0	4 hrs.	<p>Flow conditions, turn trussbank end to roller gates fair. End of right wall seem to like effective for a distance of 300 feet from nose of silt. After 14 mostly outside of wall and approaching channel may over 200 feet of left wall next to silt. Large silt bar formed in front of standing and considerable silt inside of trussbank. Standing period only partially effective. Results unsatisfactory.</p>

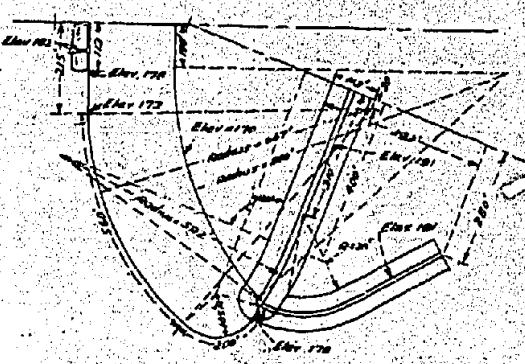
36.

Left	161.	6 hrs.	<p>1. Flow through trussbank and entrance to roller gates good. Left portion of silt very effective. After the run there was no silt inside of the trussbank or in the channel below the roller gates and only a very small amount inside of the walls. No standing period. Results very good for this position of river.</p> <p>2. Flow through trussbank and entrance to roller gates fair. Current around nose of silt and along right portion of silt. Standing was over right section of silt and over entire left end. After run there was some silt inside of the trussbank and some in the inlet channels below the roller gates. A large bar formed in the channel between the trussbank and walls. If trussbank had not been so fine probably more silt would have entered it and approached the roller gates. Results unsatisfactory for this position of river.</p>

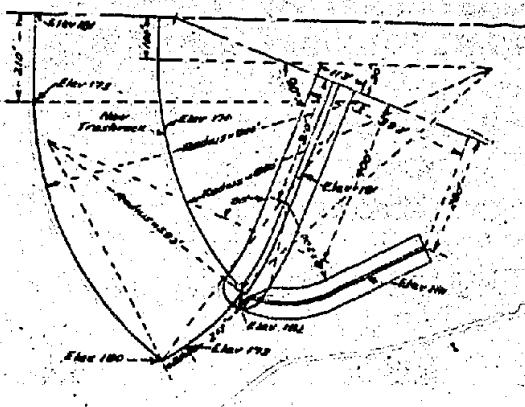
37.

Right	161.	4 hrs.	<p>Flow through trussbank and entrance to roller gates fair. No silt section unsatisfactory. Large silt bar deposited outside of trussbank but did not extend into trussbank. The fine trussbank installed for this test became partially plugged and probably obstructed the advance of the silt bar. Standing period only partially effective. Results not entirely satisfactory.</p>
