Memorandum  
Chief, Hydraulics Branch

Research on Abrasive Materials in Stilling Basins

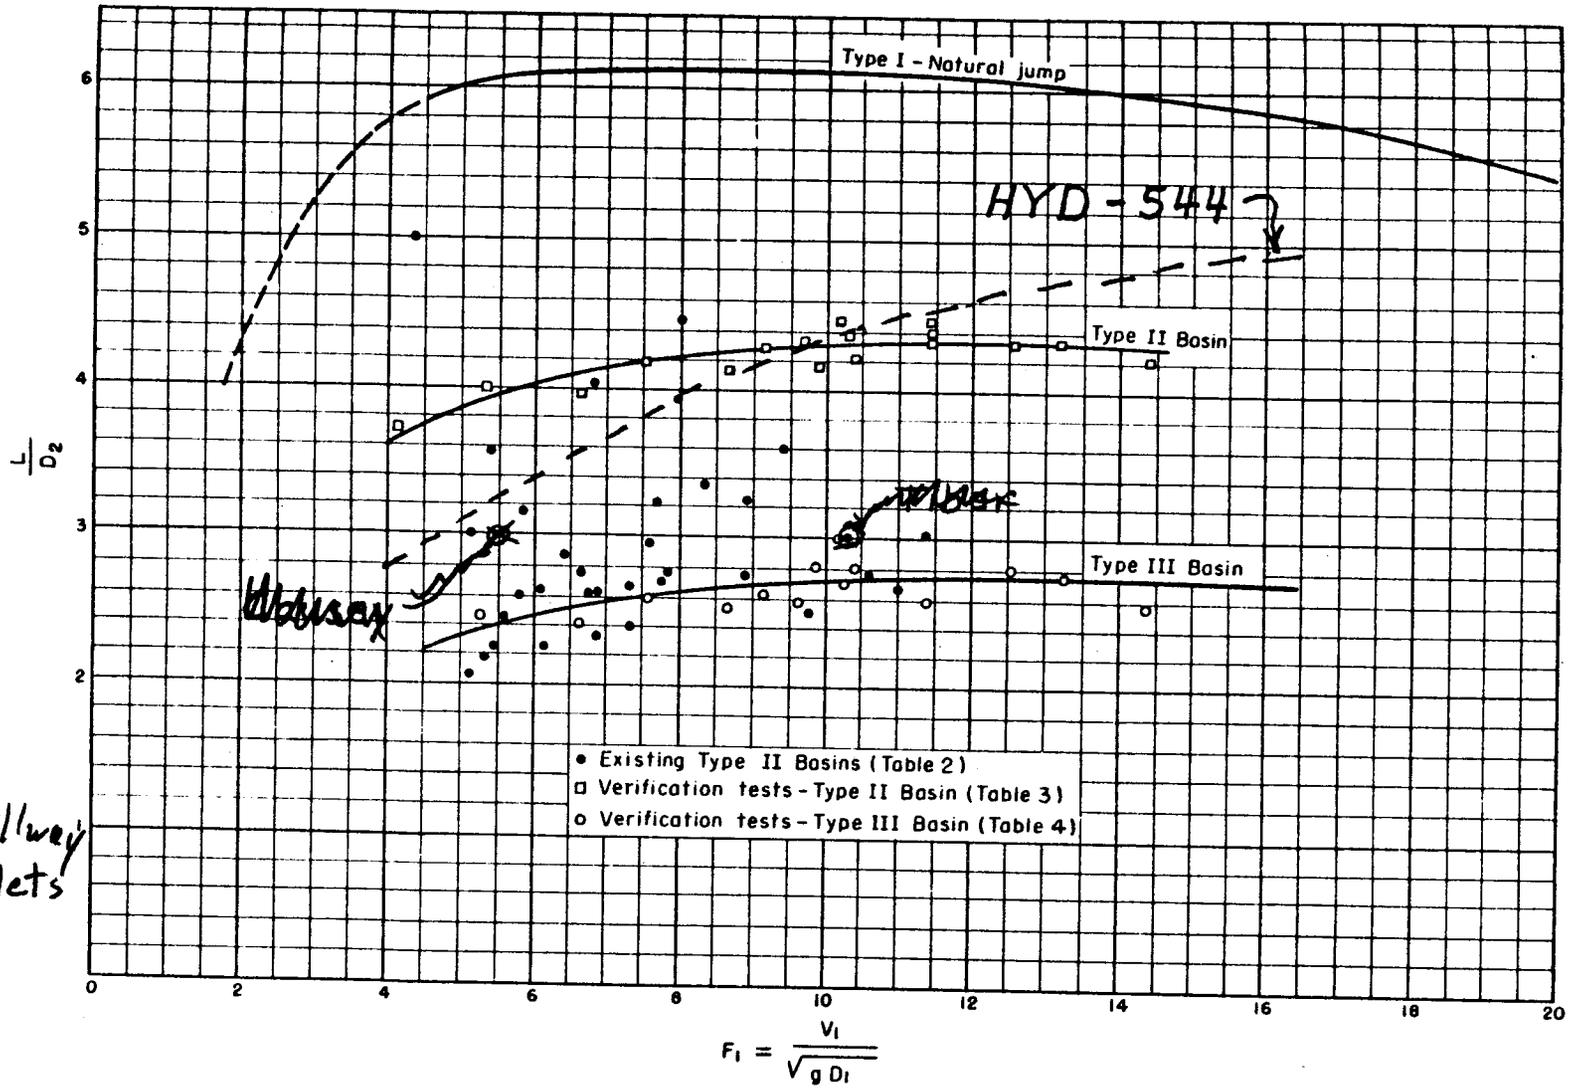
Causey -  
Wrong  $F_1$

Tiber-Spillway  
& not outlets  
works

FIGURE 1 — Length of jump on horizontal floor (Basins I, II, and III).

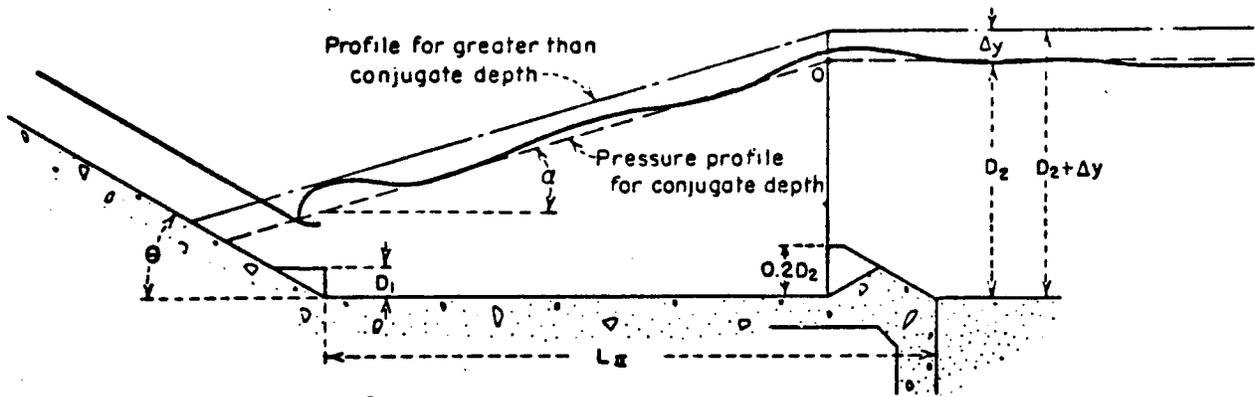
Figure 2a. Shape of jump for verification tests.

Figure 2. Difference in length of basin between verification tests and existing type II Basin data points as shown in Figure 1.

verification tests the toe of the hydraulic jump was established at the chute toe, figure 2a. However, for the existing basins some of the chute length is used and possibly all of the hydraulic jump was not contained entirely within the basin, figure 2b. Earlier in my investigation I wondered if we had economized the length of the basin at the expense of the abrasion problem and pulling debris into the basin.

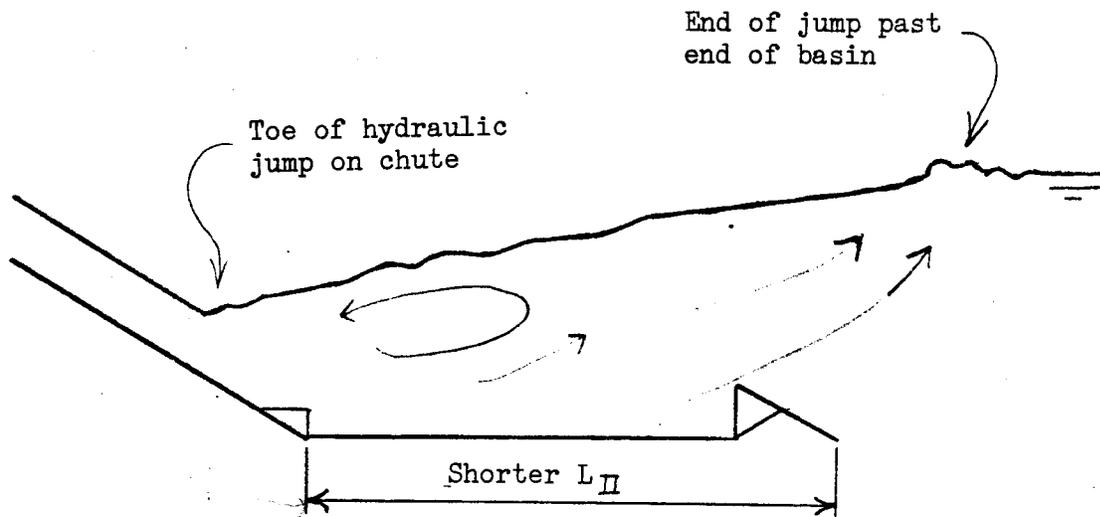
Figure 2b. Possible shape of jump for model tests of prototype basin.

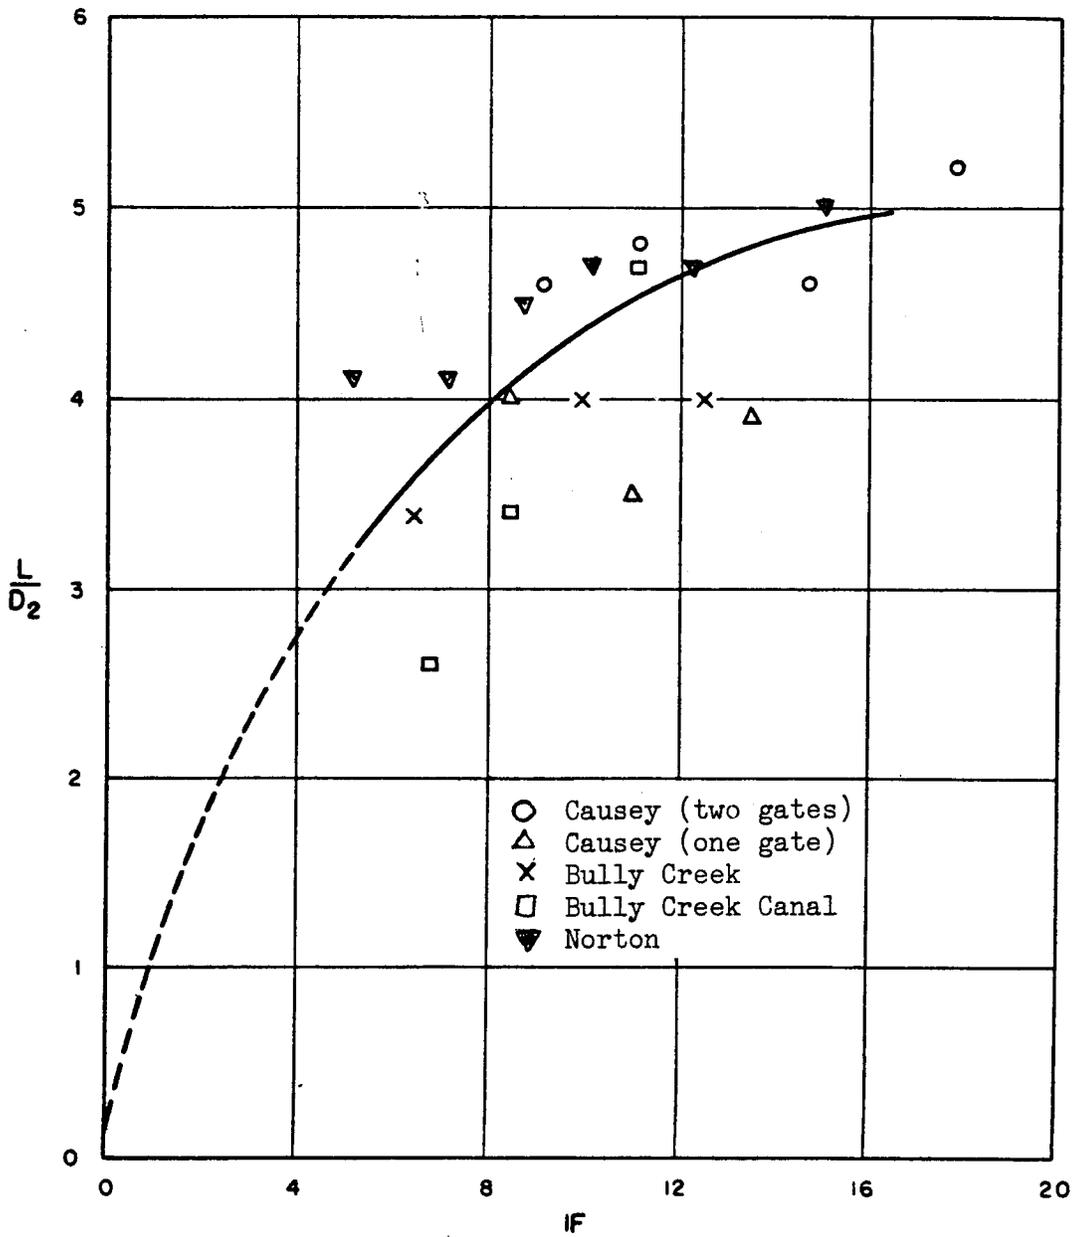
Figure 3. SLIDE GATE STILLING BASIN STUDIES

LENGTH OF HYDRAULIC JUMP -- HYDRAULIC JUMP BASIN

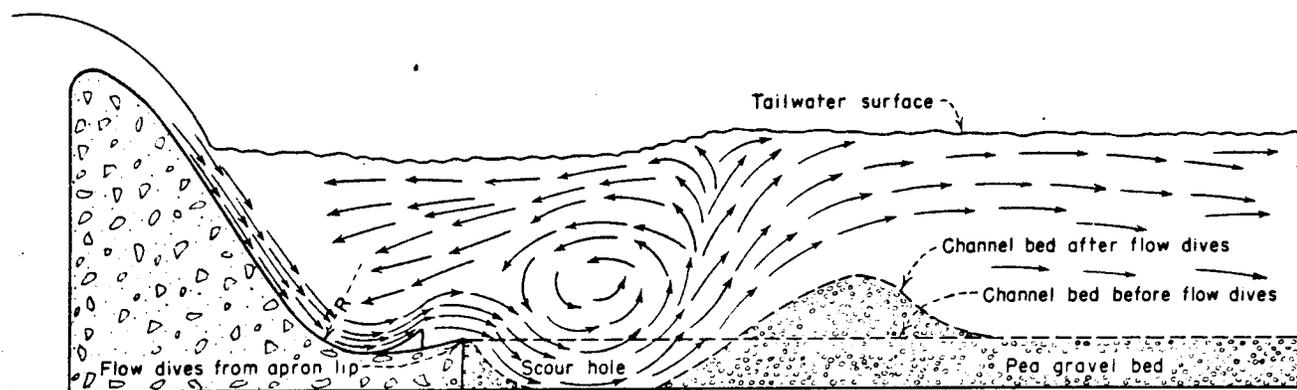
Note: The diving flow condition occurs with the slotted bucket only when the tailwater depth becomes too great.

FIGURE 4 —Diving flow condition—slotted bucket.

From a theoretical standpoint, I could not begin to identify adverse hydraulic conditions for a stilling basins. I have not worked that much with the theory, and even if I took more time I think it would be a dead end for me. However, I do have another thought which may have a theoretical aspect, and that is do we have a true hydraulic jump in these HHSO OW basins for many of their flow conditions? A hydraulic jump is a physical phenomenon of nature, fast supercritical flow changing to slower subcritical flow. Nature needs a given jump length for this intrinsic process to occur, and for a given inflow condition, the natural process works best with a downstream water depth ascribed the conjugate or sequent depth. Yet because of economy we alter the process, we force and constrain the jump to occur in a shorter length. Furthermore, because of field conditions beyond our control, I believe these basins seldom operate with the conjugate tailwater depth. Thus, we have a water pool that is agitated by a high velocity entrance jet and may be more similar to flow conditions of a slotted bucket energy dissipator, figure 4.

Possibly the above flow conditions are conducive to "ball milling" of abrasive debris, while a hydraulic jump has a better flushing process. This flushing process may be of a probability nature, whereby, there is churning of the debris but eventually it is caught in a downstream current and swept away from the jump.
