Department of the Interior  
Bureau of Reclamation

# OPERATION AND MAINTENANCE EQUIPMENT AND PROCEDURES

RELEASE NO. 29

July, August and September 1959

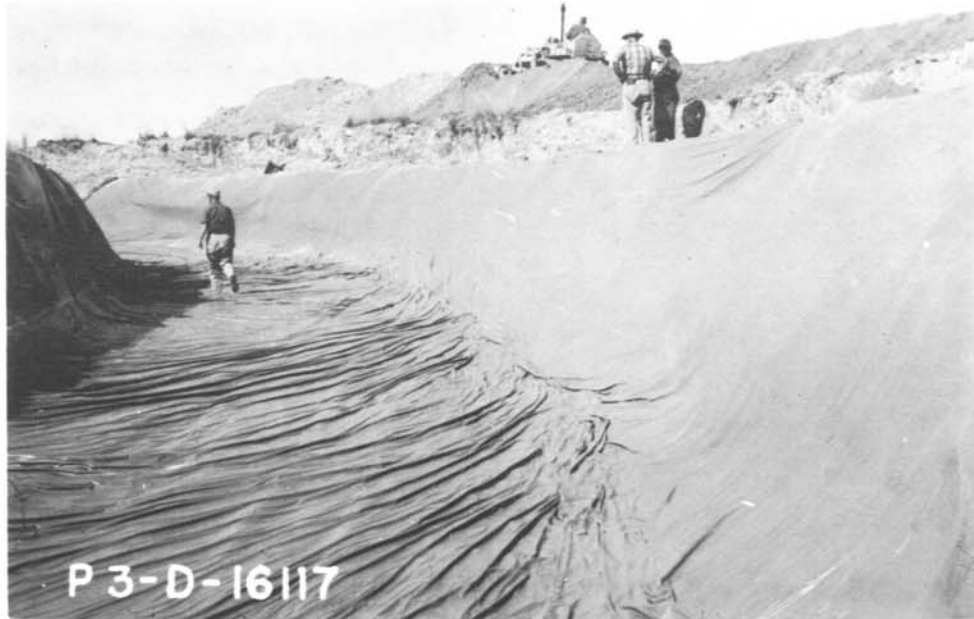
Two experimental installations of plastic film were made under the Bureau's Lower-cost Canal Lining Program this past spring (1959) as a part of the evaluation of plastics for such purposes. In one installation, as shown on the cover of this issue of the bulletin, the film was installed as a cutoff curtain in a trench excavated on the inside of the downhill bank of the canal prism. In the other installation, as shown below, the film was placed as a buried membrane.

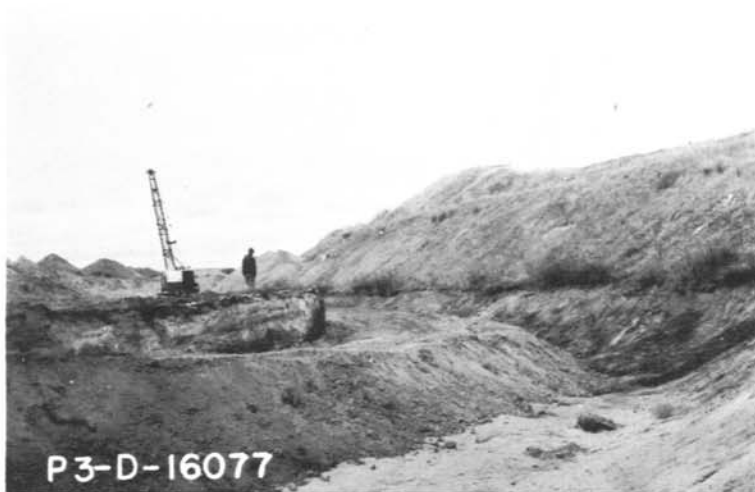
at the site of installation, is located on the side of a low hill, as shown at left, where the subgrade material generally is a sandy loam, but consists in some reaches largely of fine and coarse clean sands overlying a relatively impervious clay layer located approximately 14 feet below the bottom of the canal. High seepage through this section fostered the growth of willows

and tules below the canal and contributed to the general water-logging of adjacent irrigated farm lands.

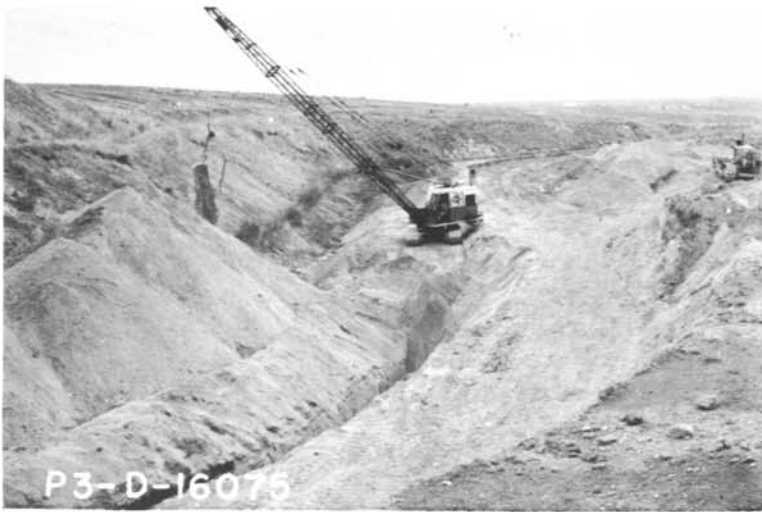
The top of the bench was 18 inches vertically above the operating water level of the canal and was used as the working level for a dragline with a 1-cubic yard bucket, as shown at left. The cutoff trench varied from 26 to 28 feet in depth, with the slope of the upper portion being about  $1/2$ :1, while the bottom portion was practically vertical.

Project forces constructed benches on the lower side of the canal with bulldozers, as shown in the photograph on the preceding page.

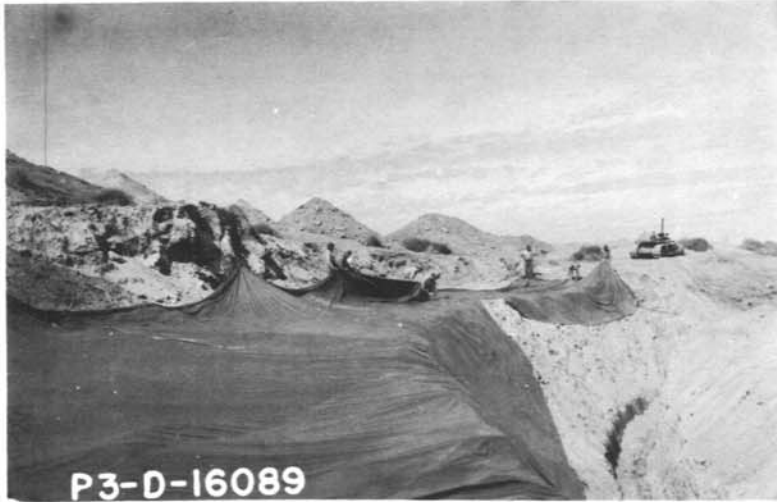
installation and unfold about one-half of the material upstream from that point first; later unfolding the remaining 200 feet in the downstream direction. Accordingly, after about half of the excavation had been completed, the film was spread on the upstream reach, as shown at left, by 8 men in a simple and rapid operation. It was then lowered into the trench gradually, until ap-

proximately  $1\frac{1}{2}$  feet of the sheet remained at the bench level. This allowed for ample material in the bottom of the trench on the clay layer.

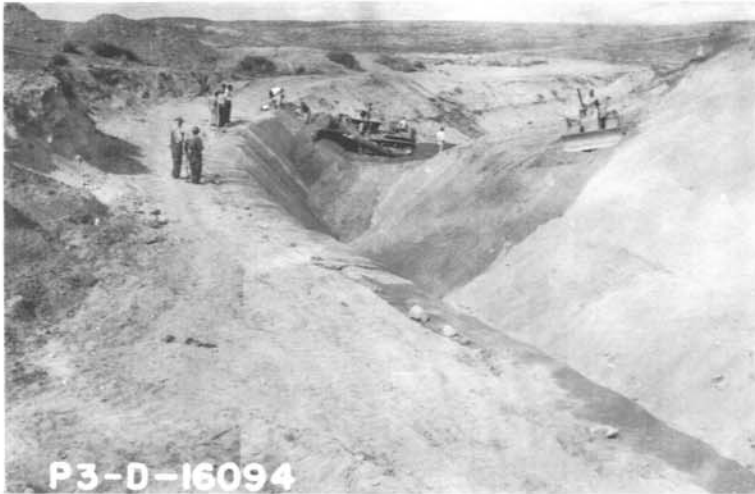
over a rough subgrade without injury, providing the backfilling operation is carefully done and the backfill material does not contain sharp rocks or cobbles.

The previously stockpiled material from the trench excavation on the uphill side of the canal was gradually dozed into the trench.

After the trench was completely filled, the cover for the film on the lower bank was worked up the slope, as shown in the upper photograph.

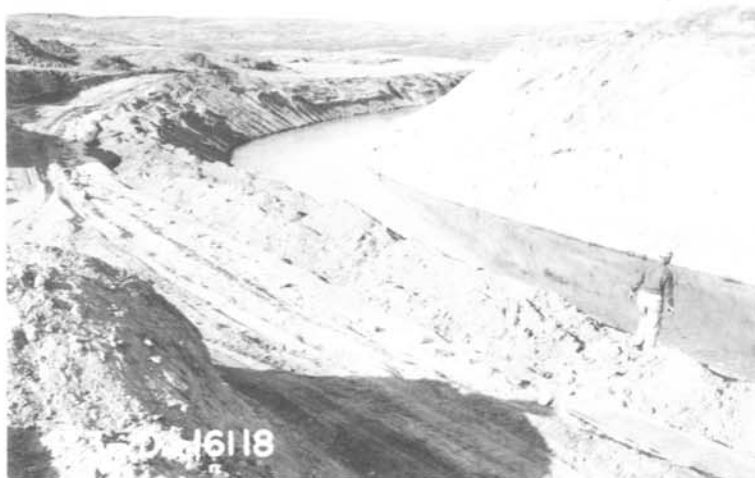
The entire job was accomplished in the period March 30, 1959, when excavation was started, through April 4, 1959, when the canal was placed in operation as shown in the lower photograph. It would seem the plastic has possibilities in emergency repairs

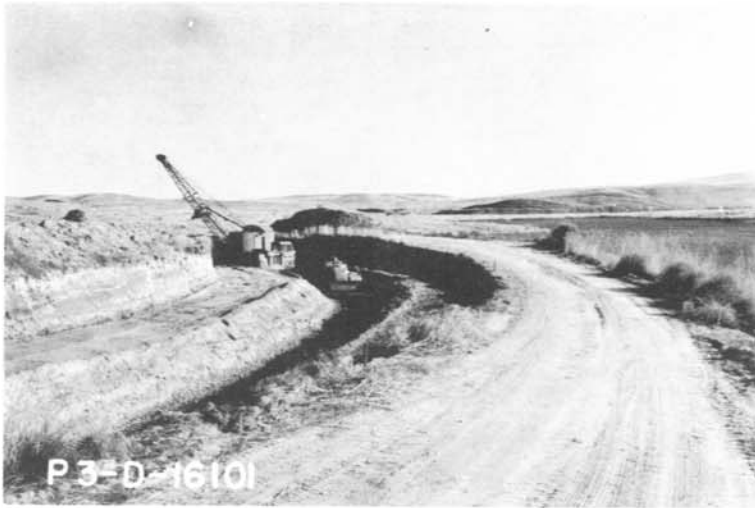
A similar method of benching used in the cutoff curtain installation was employed for the buried lining installation as shown at left. The benches, about 10 feet wide, were leveled by dozers 18 inches in elevation above maximum water elevation in the canal, allowing ample free-board. A dragline excavated the invert 2 feet below normal canal grade.

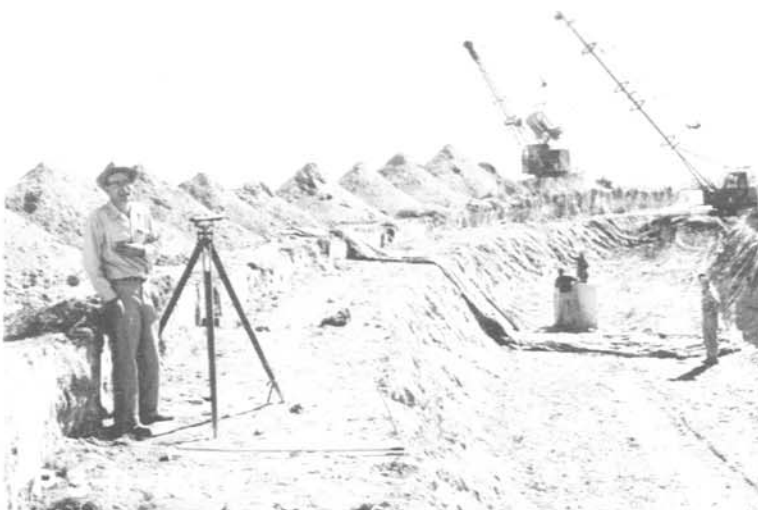
The plastic film, after removal from the shipping crate, was placed near the center of the reach to be lined and methods similar to that used in placing and handling the film for the cutoff curtain were followed. Since the installation was in a curved reach of the canal, some folding of the film was necessary on the inside of the curve.

The slopes of the canal were left essentially as excavated with the dragline. That is, no special trimming or rolling was performed although one pass with a motor patrol or grader, had there been one available having the mold board angled to trim the slope, would have produced a much better subgrade or base for the plastic at practically no cost. The sequence of operations is shown in the photographs below and on the following pages.

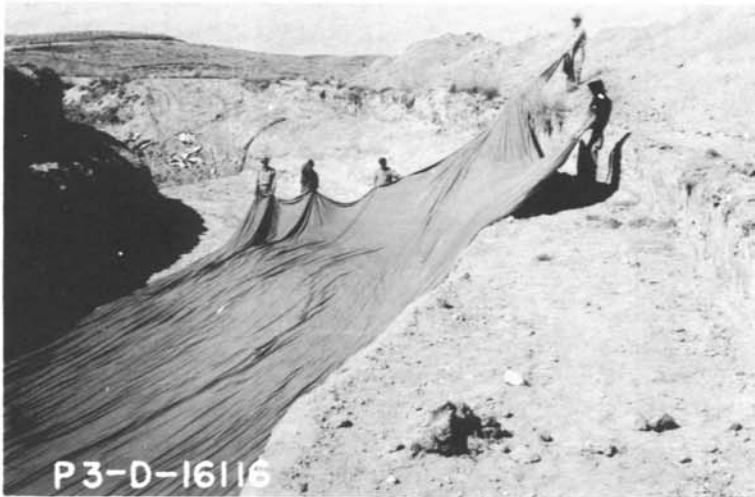
The lining material was placed rapidly and without difficulty, as shown below, with the air temperature at 34 to 35 degrees F. and with the wind velocity up to 15 miles per hour.

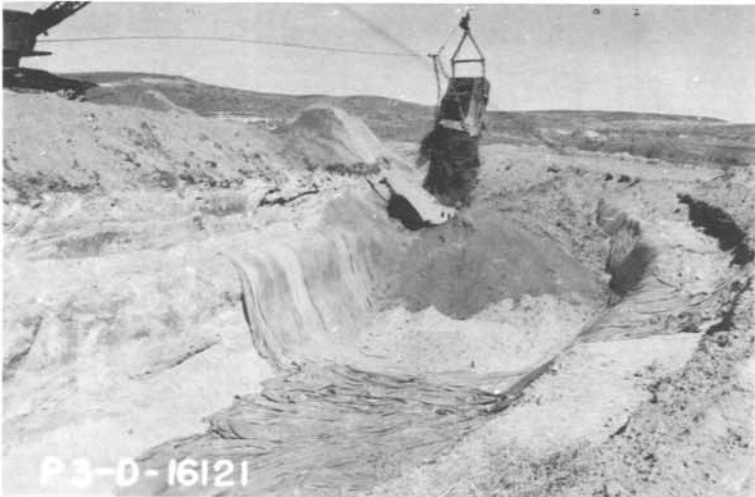
Material excavated from the canal was used to cover the plastic membrane. Placement of the cover was accomplished by both drag-

line and dozer. In the lower photograph the cover material is being deposited on the membrane in the bottom of the canal. The cover on the bottom was spread to a minimum thickness of 2 feet. Side slopes were then replaced to the original 1½:1, as shown in the photograph on the following page.

It should be pointed out, as will be evident from the photographs, that the side slopes as excavated for the lining were approximately 1/2:1 in lieu of the 2½:1 slopes used in previous installations of this kind. This was done purposely to reduce the amount of excavation necessary on the hillside location. One obvious advantage of placing the material over steeper side slopes is that the plastic membrane is buried far deeper at the toe of the slope than in the usual buried membrane installation, and therefore, less likely to become damaged during future cleaning operations with necessary heavy cleaning equipment.

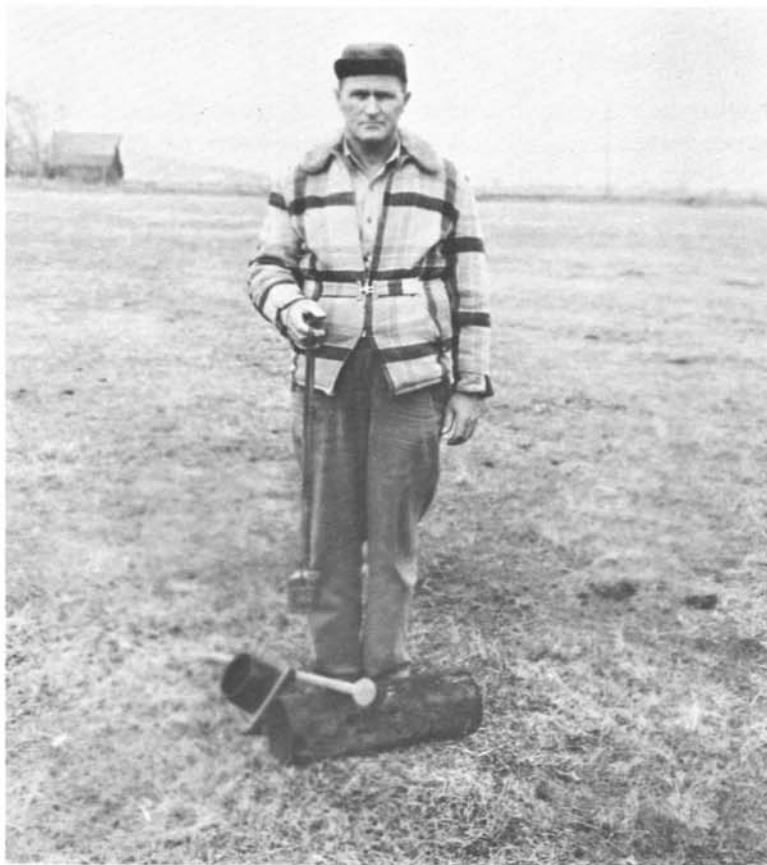
Burt Mitchell of the Klamath Project has suggested a method of burial and location that can eliminate the problems. He points out that land corner monuments can be buried in a capped pipe sleeve in cultivated areas to protect the marker from damage by farming operations; and that the buried monument can then be located by use of an aquameter, a device used in locating buried pipe lines.

The pipe, pipe cap and the bench-mark type monument are shown in the photograph above.

Mr. Mitchell holds an aquameter, which quickly locates buried markers.

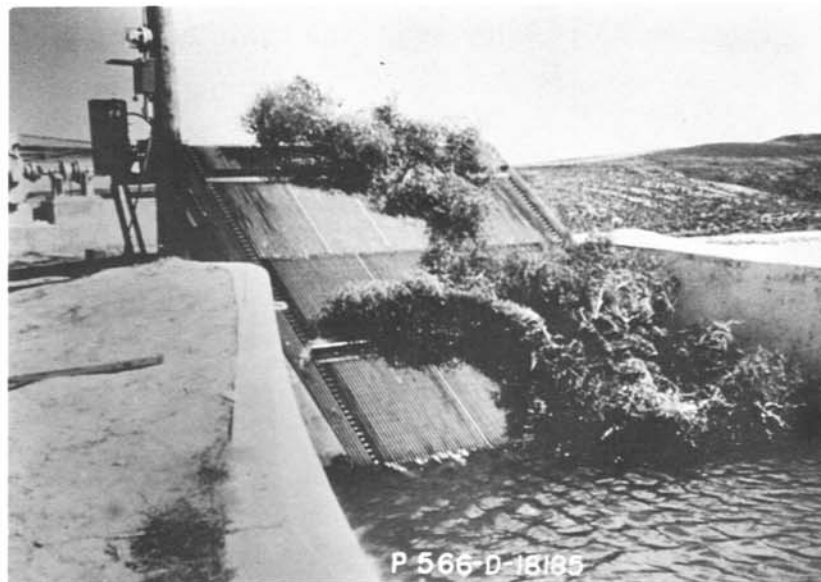
Mr. Nutley was discussing the weed removal problems encountered in his operation of the irrigation system, at an Irrigation Operator's Conference in Boise, Idaho, February 18 and 19, 1959, and the installation of an automatic weed rack is shown in the photograph below.

Angle-iron bars moving upward by sprocket-driven endless chains, carry weeds to a conveyor which in turn carry the weeds to a pit which is provided to trap and burn the weeds.
