WATER OPERATION AND MAINTENANCE

BULLETIN NO. 138

GUIDELINES FOR MANUAL MAINTENANCE MANAGEMENT SYSTEMS (MMS)
FOR WATER O&M PROJECTS

GUIDELINES
for
Manual Maintenance Management Systems (MMS)
for
Water O&M Projects

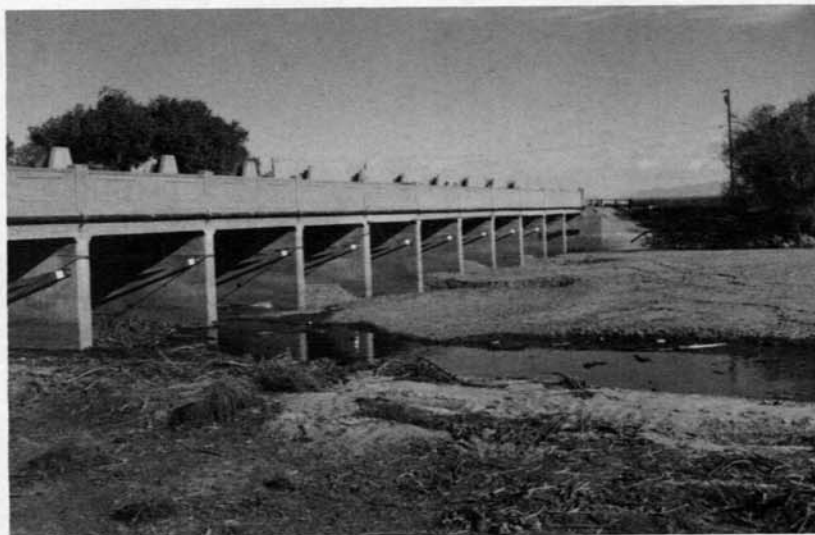
Cover photograph:

Downstream face of sluiceway bridge at Mesilla Diversion Dam, which is one of the example structures featured in the appendix.
