Water Operation and Maintenance Bulletin

No. 219

Identifying and Solving Problems with Embankment Dam
Conduits: Best Practices

Water Production for Emergency Response – Expeditionary
Unit Water Purifier Proven in Hurricane Duty

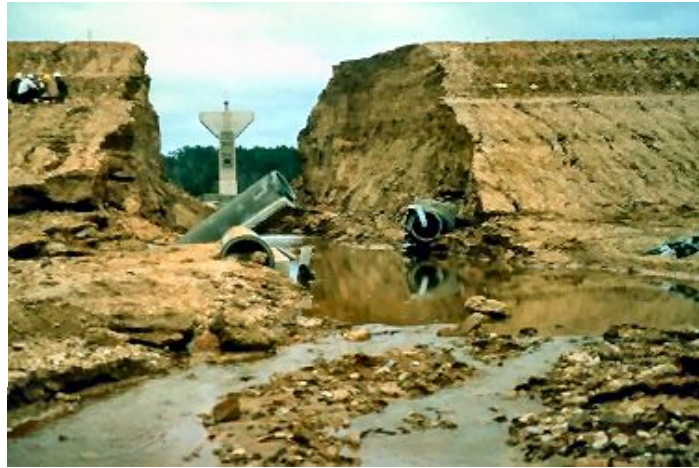
Failure of this embankment dam resulted from internal erosion of earthfill near an outlet works conduit. The embankment soil contained dispersive clay fines, and the dam's design included antiseep collars, but no filter diaphragm.

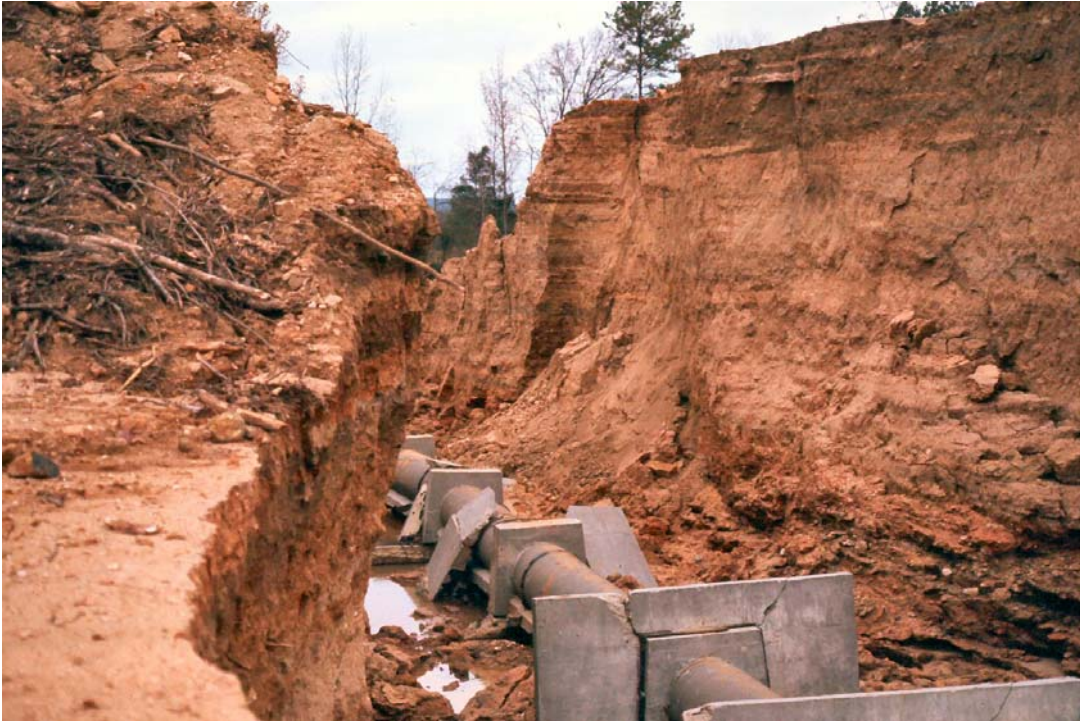
This embankment dam failed shortly after the reservoir was filled for the first time. Failure was attributed to internal erosion because of the short time required for seepage to develop and because the soils were not the type considered susceptible to backward erosion piping.

Cover photograph *This embankment dam failed shortly after the reservoir was filled for the first time. Failure was attributed to internal erosion because of the short time required for seepage to develop and because the soils were not the type considered susceptible to backward erosion piping.*

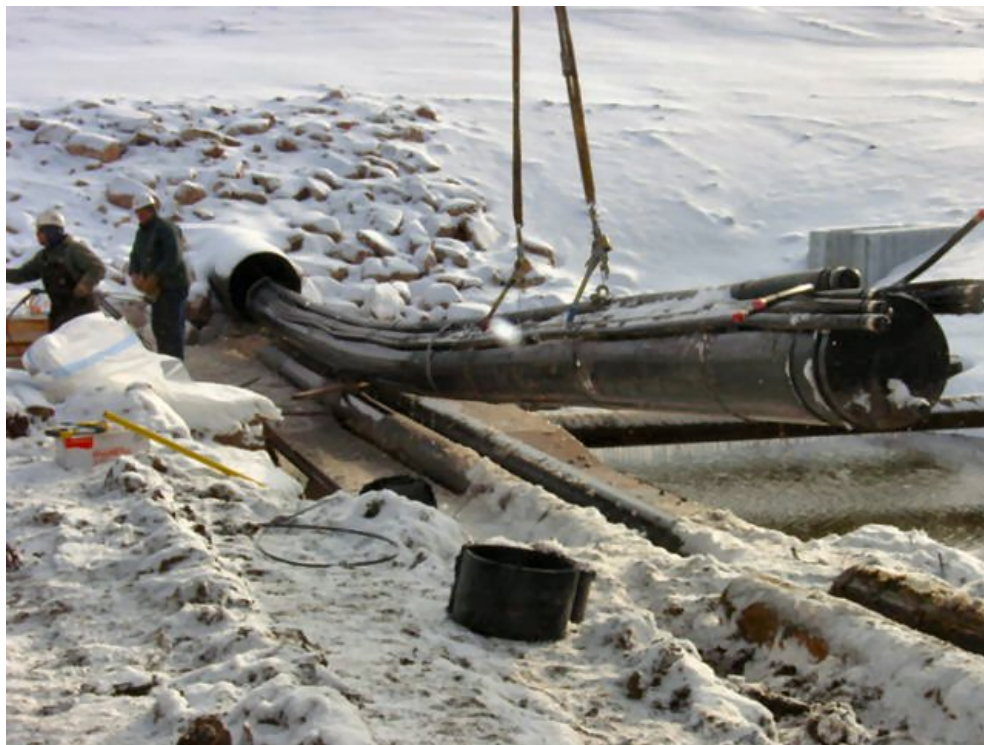
Sliplining of existing conduits is the most common renovation method. At this dam, a high-density polyethylene plastic slipliner is being inserted into an existing corrugated metal pipe outlet works conduit.

- *Renovation.* Renovation of the conduit using trenchless methods, rather than traditional removal and replacement, has become popular. Sliplining of existing conduits, which involves pulling or pushing a pipe of smaller diameter into the conduit and grouting the annulus, is the most common renovation method. Flexible plastic and steel pipe has been successfully used for sliplining.

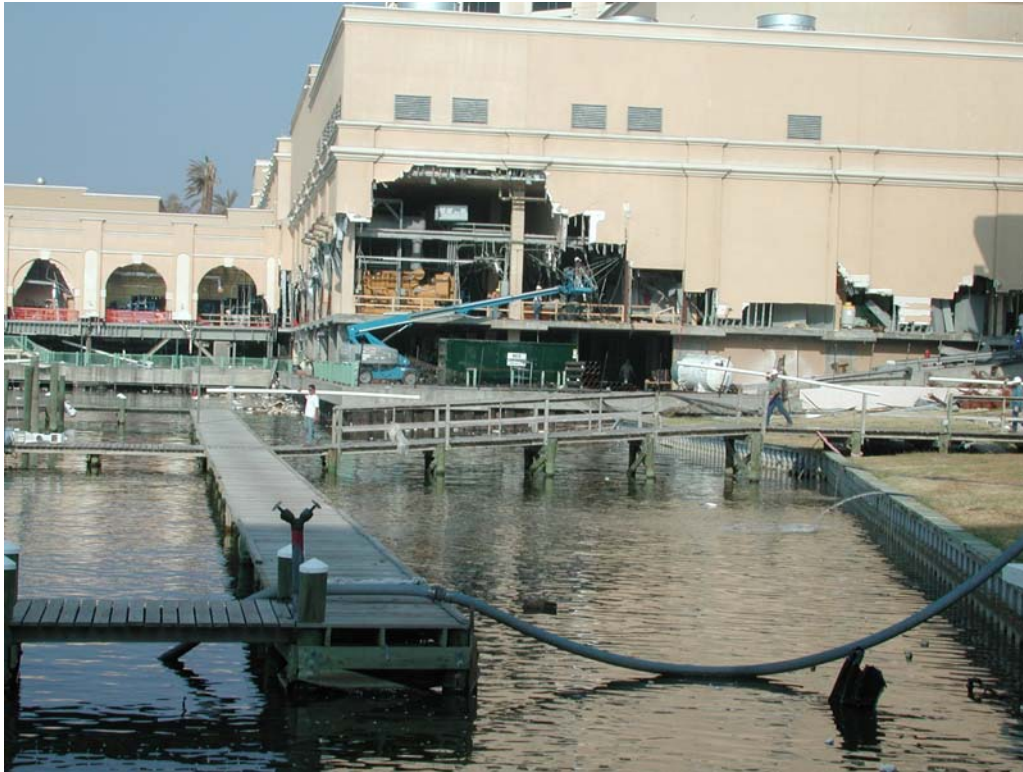
Figure 4.—Extending the intake to the end of the pier – plumbing donated by Ivey Mechanical.

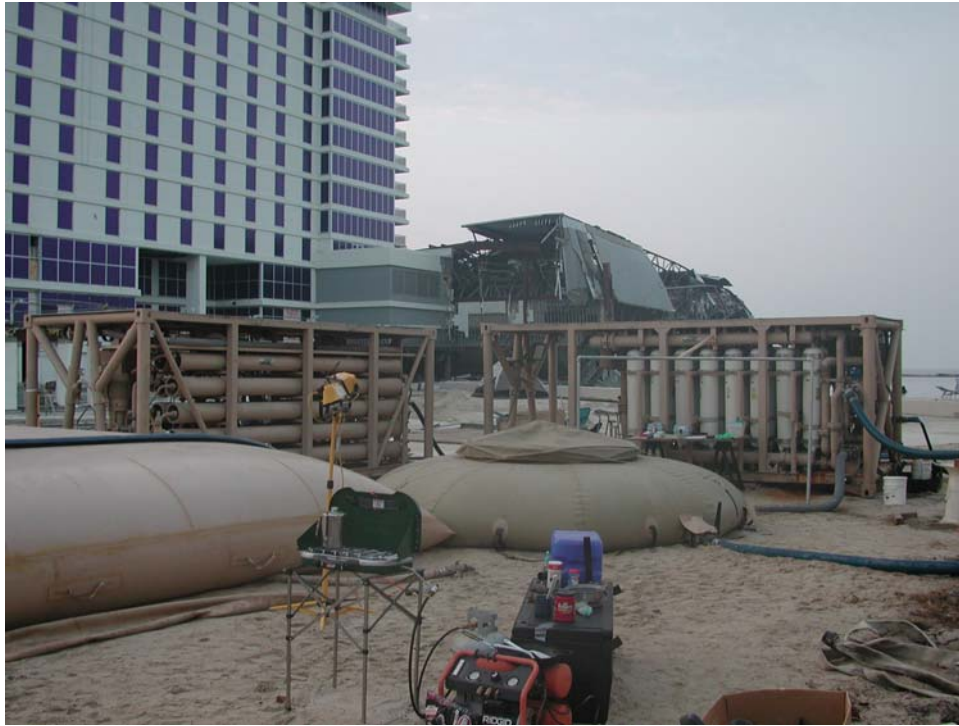
Figure 6.—Fully operational UF skid to the right, RO skid to the left, UF feed tank, and 20-kgal product storage tank and makeshift kitchen in the front.

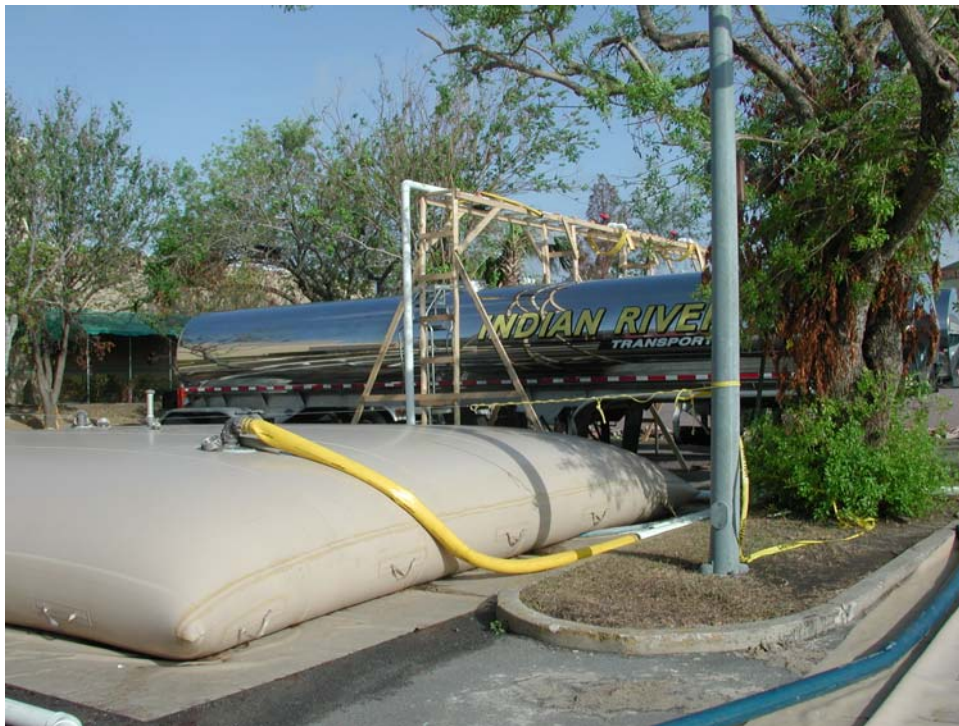
Figure 7.—Additional storage at the hospital – 3 6-kgal trucks and another 20-kgal bladder.

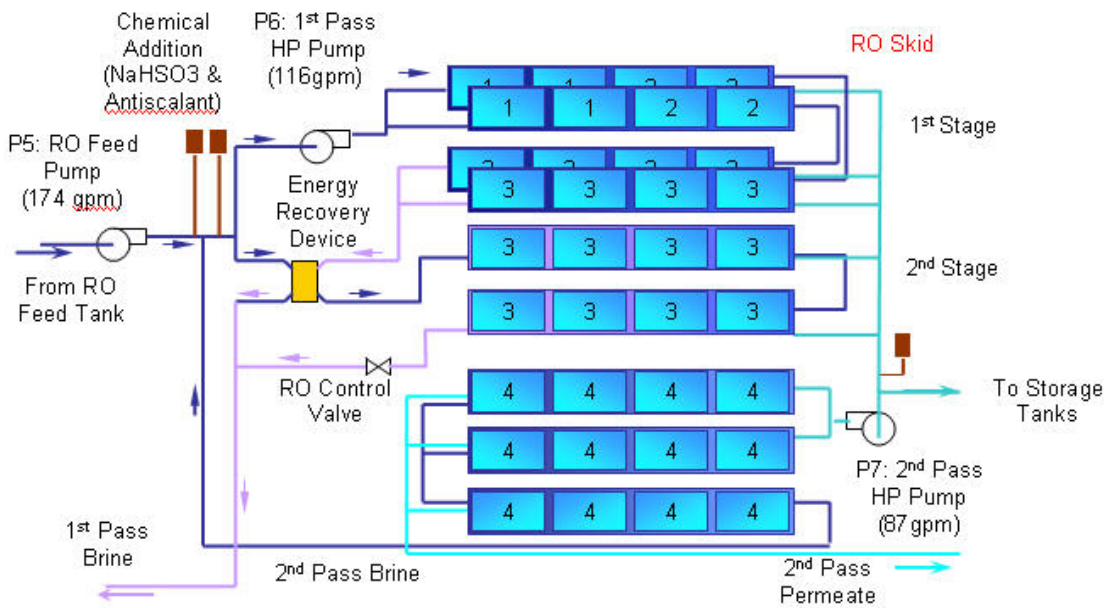
Figure 9.—RO system schematic with FilmTec Membranes: (1) SW30HR LE-400, (2) SW30XLE-400, (3) SW30HR-12000, and (4) BW30.
