# Intake Diversion Dam

## Fish Protection and Passage Concept Study Report II

Lower Yellowstone Project  
Yellowstone River, Montana

Bureau of Reclamation  
Technical Service Center  
Denver, Colorado

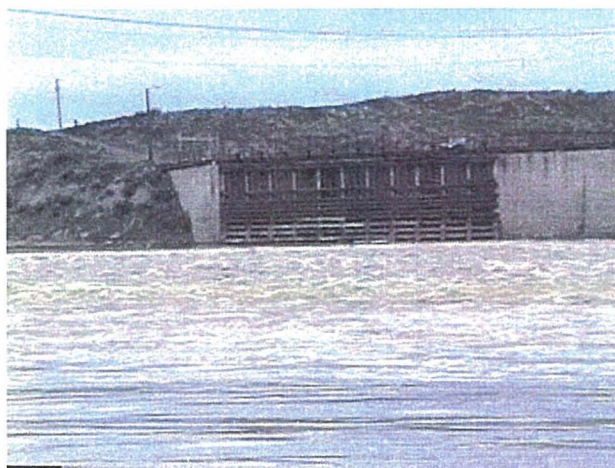
Figure 2 - View of Intake Dam and Main Canal Headworks.

The Main Canal diverts to the west side of the Yellowstone River at Intake and extends down the valley to the confluence of the Yellowstone and Missouri Rivers. The canal is 71.6 miles long, unlined, and has an initial capacity of about 1,400 ft<sup>3</sup>/s. The canal headworks is a concrete structure with 11 slide gates (Figure 2). There are no trashracks in front of the intake gates but there are horizontally spaced timbers (Appendix I). The canal was originally designed with a 30-foot-bottom-width and 1.5:1 side slopes. The canal is designed to convey its full capacity at a flow depth of about 10 feet and a velocity of 3.1 ft/s. The canal operates from late April through September of each year.
