Restoration of the Salton Sea

Volume 2: Embankment Designs and Optimization Study

Appendix 2D: Risk Analysis

**Prepared by:
Kleinfelder, Inc.
Golden, CO 80401
Project No. 71100**

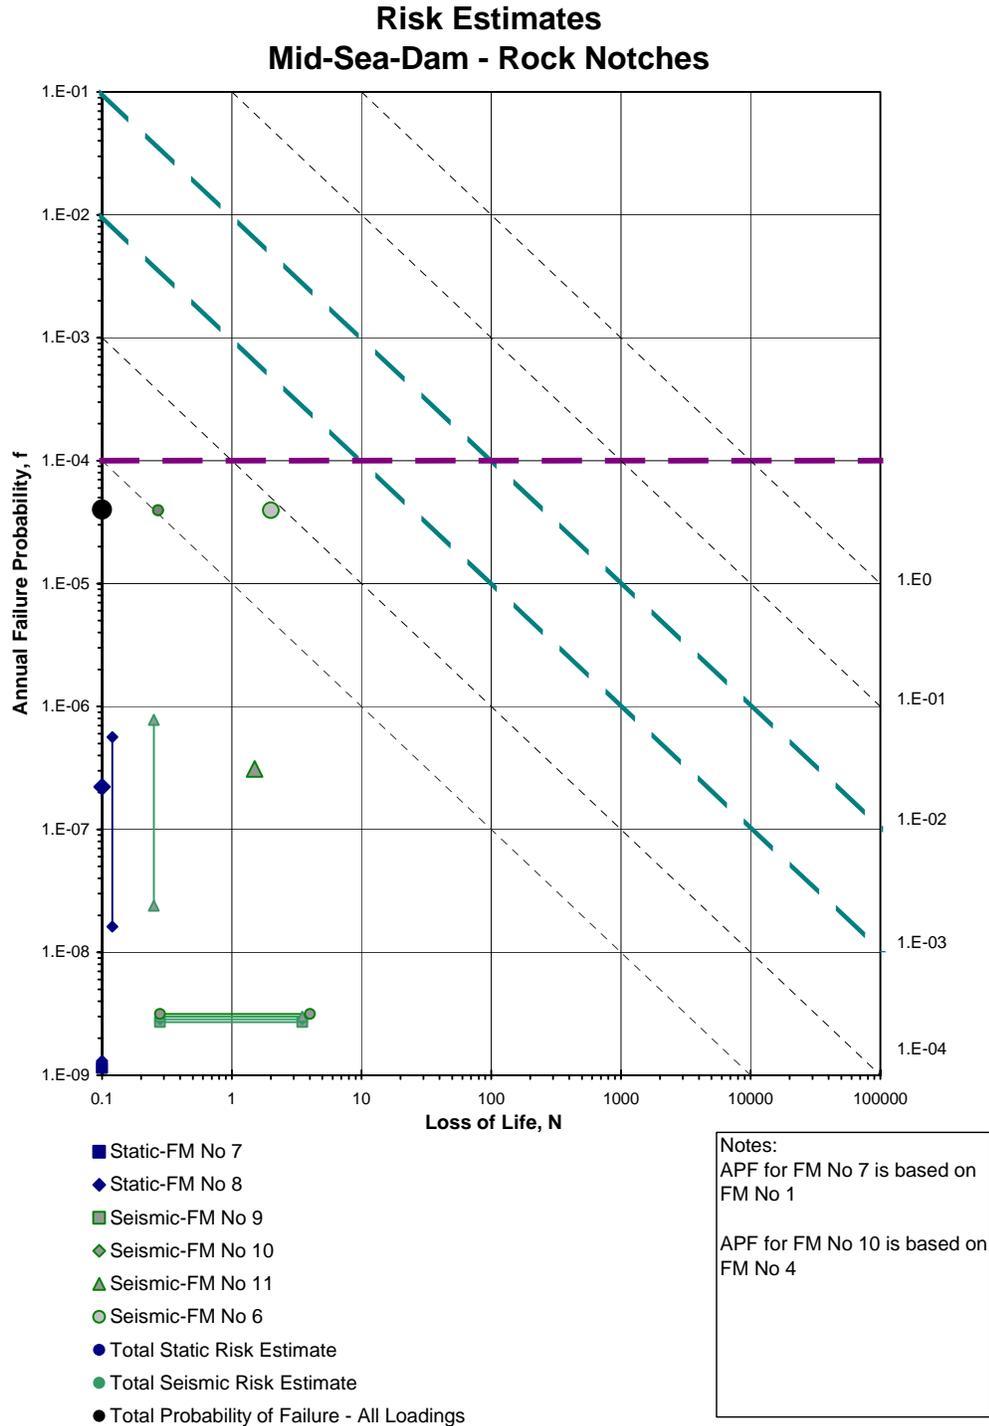
Figure D.2 f-N Chart Portraying Risks for Mid-Sea Dam – Rockfill Dam with Rock Notches and Maximum Seismic Filters

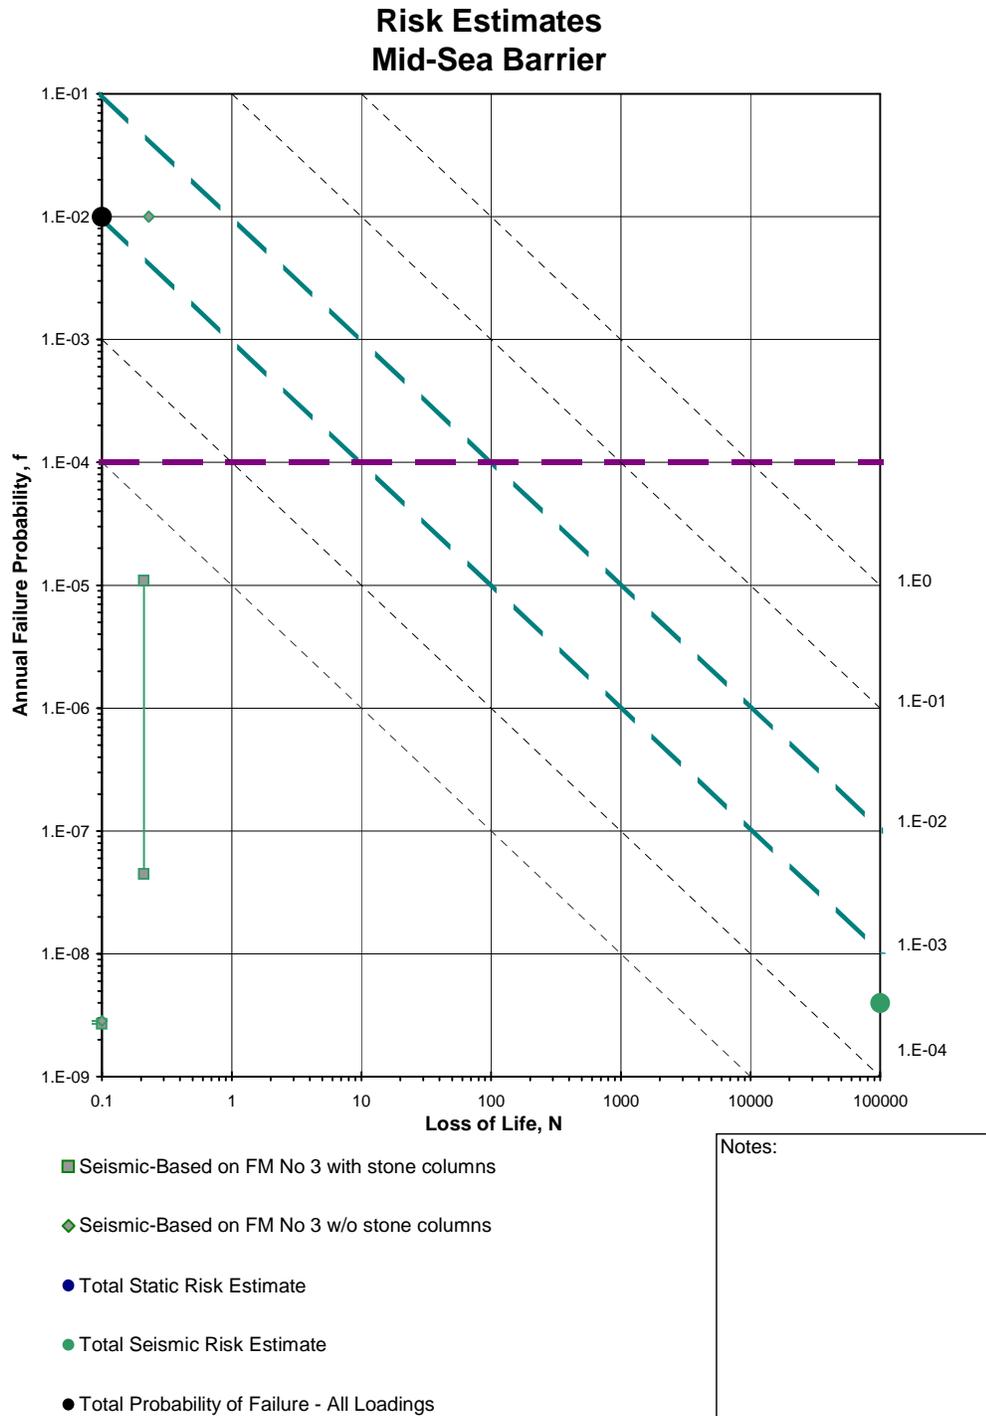
Figure D.3 f-N Chart Portraying Risks for Mid-Sea Barrier with and without Stone Columns

Based on Failure Mode	Failure Mode Description	Mean APF	LOL	Mean ALL
FM No. 3 (without stone columns)	Mid-Sea-Barrier, Seismic - Deformation and Overtopping of Embankment	>1.0E-02	0	0
FM No. 3 (with stone columns)	Mid-Sea-Barrier, Seismic - Deformation and Overtopping of Embankment	≤ 3.8E-06	0	0
Overall Risk (maximum risk for static and seismic FMs) Without Stone Columns		>1.0E-02	0	0
Overall Risk (maximum risk for static and seismic FMs) With Stone Columns		≤ 3.8E-06	0	0

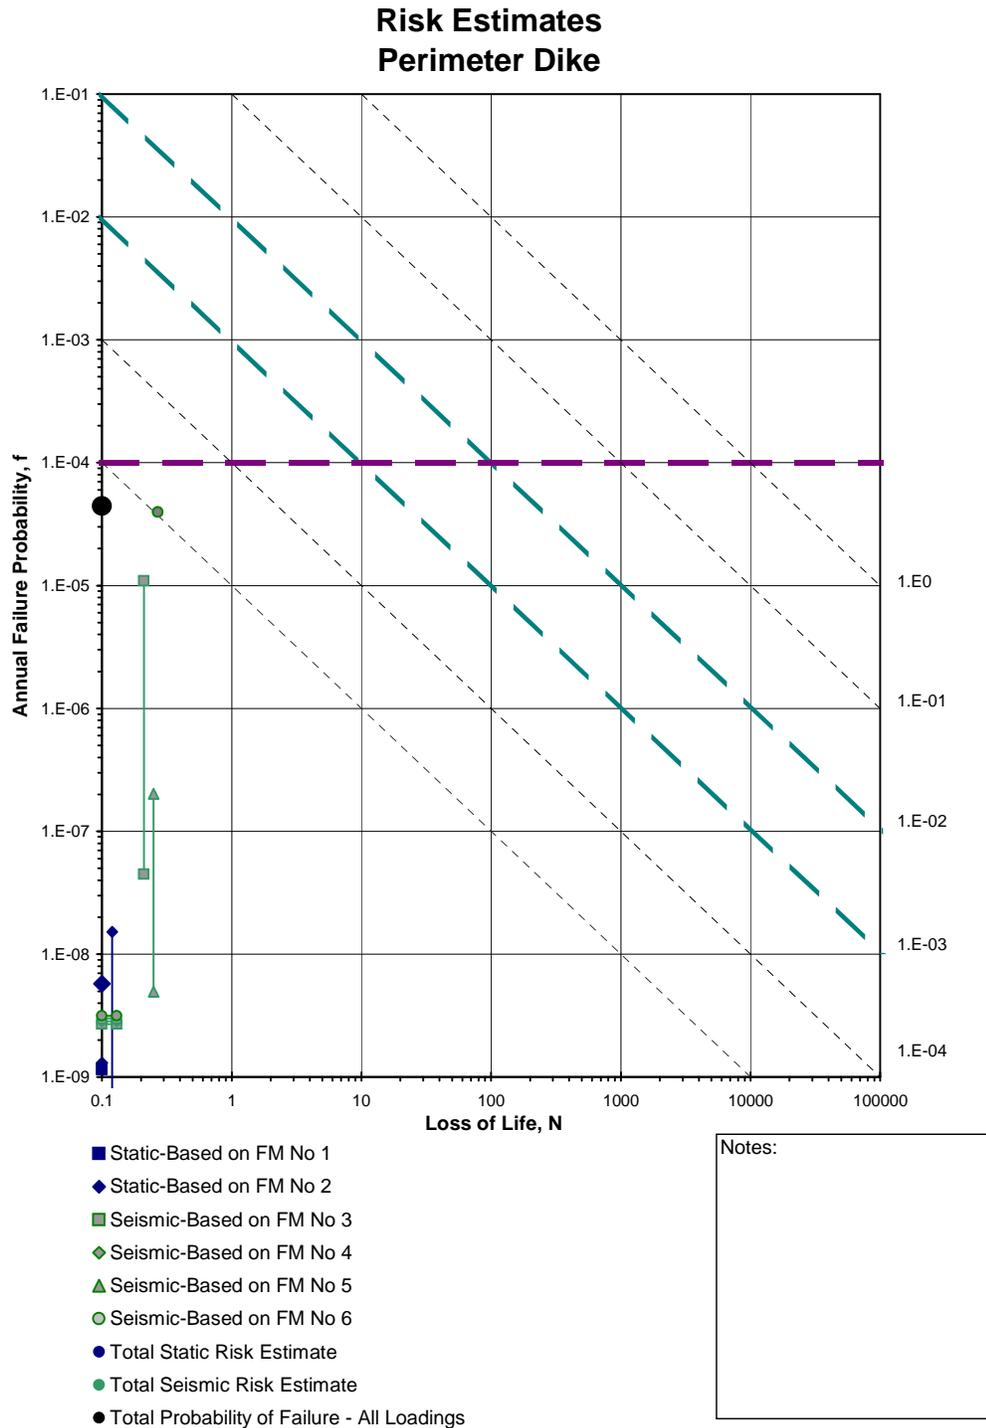
Figure D.4 f-N Chart Portraying Risks for Perimeter Dikes with Stone Columns

Based on Failure Mode	Failure Mode Description	Mean APF	LOL	Mean ALL
FM No. 1	Perimeter Dikes, Static - Internal Erosion (Piping) of Embankment	≤ 3.8E-11	0	0
FM No. 2	Perimeter Dikes, Static - Internal Erosion of Foundation Materials	6.1E-09	0	0
FM No. 3	Perimeter Dikes, Seismic - Deformation and Overtopping of Embankment	≤ 3.8E-06	0	0
FM No. 4	Perimeter Dikes, Seismic - Deformation and Internal Erosion of Embankment	≤ 3.1E-11	0	0
FM No. 5	Perimeter Dikes, Seismic - Deformation and Internal Erosion of Foundation Materials	≤ 8.0E-08	0	0
FM No. 6	Perimeter Dikes, Seismic - Liquefaction of Upper Stiff Lacustrine, Seismic Deformation and Overtopping of Embankment	≤4.0E-05	0	0
Overall Risk (maximum risk for static and seismic FMs)		≤4.0E-05	0	0

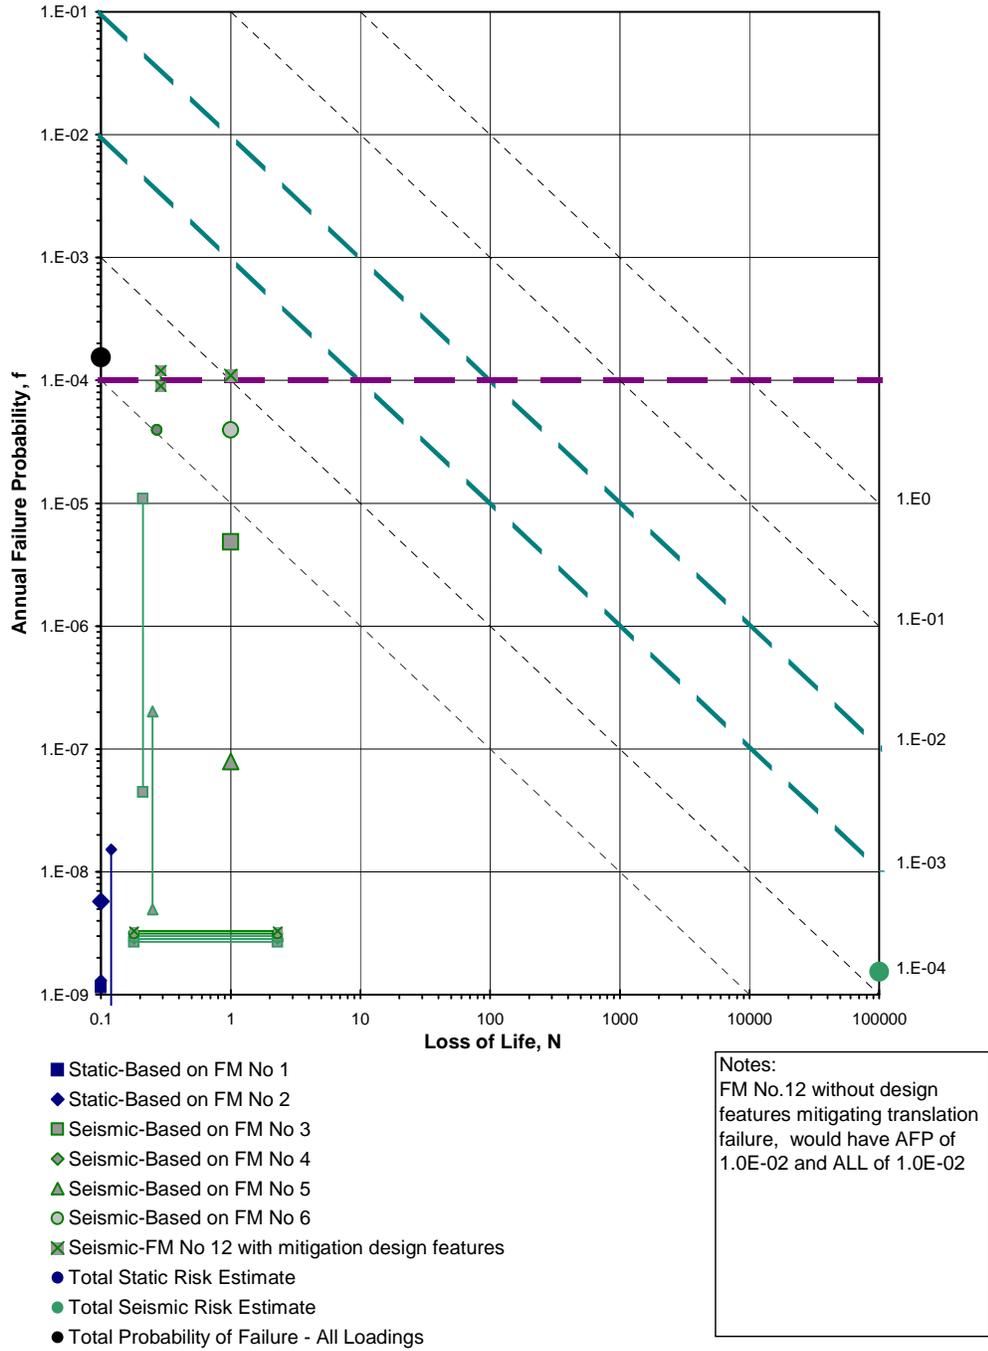
Risk Estimates South-Sea Dam

Figure D.5 f-N Chart Portraying Risks for South-Sea Dam with APF for FM Nos. 6 & 12

Based on Failure Mode	Failure Mode Description	Mean APF	LOL^(a)	Mean ALL
FM No. 1	South-Sea Dam, Static - Internal Erosion (Piping) of Embankment	$\leq 3.8E-11$	0	0
FM No. 2	South-Sea Dam, Static - Internal Erosion of Foundation Materials	$\leq 6.1E-09$	0	0
FM No. 3	South-Sea Dam, Seismic - Deformation and Overtopping of Embankment	$\leq 3.8E-06$	1	$\leq 3.8E-06$
FM No. 4	South-Sea Dam, Seismic - Deformation and Internal Erosion of Embankment	$\leq 3.1E-11$	1	$\leq 3.1E-11$
FM No. 5	South-Sea Dam, Seismic - Deformation and Internal Erosion of Foundation Materials	$\leq 8.0E-08$	1	$\leq 8.0E-08$
FM No. 6	South-Sea Dam, Seismic - Liquefaction of Upper Stiff Lacustrine, Seismic Deformation and Overtopping of Embankment	$\leq 4.0E-05$	1	$\leq 4.0E-05$
FM No. 12	South-Sea Dam, Seismic - Offset and Translation of Embankment (with translation mitigation design features)	1.0E-04	1	1.0E-04
FM No. 12	<i>South-Sea Dam, Seismic - Offset and Translation of Embankment (without translation mitigation design features)</i>	<i>1.1E-02</i>	<i>1</i>	<i>1.1E-02</i>

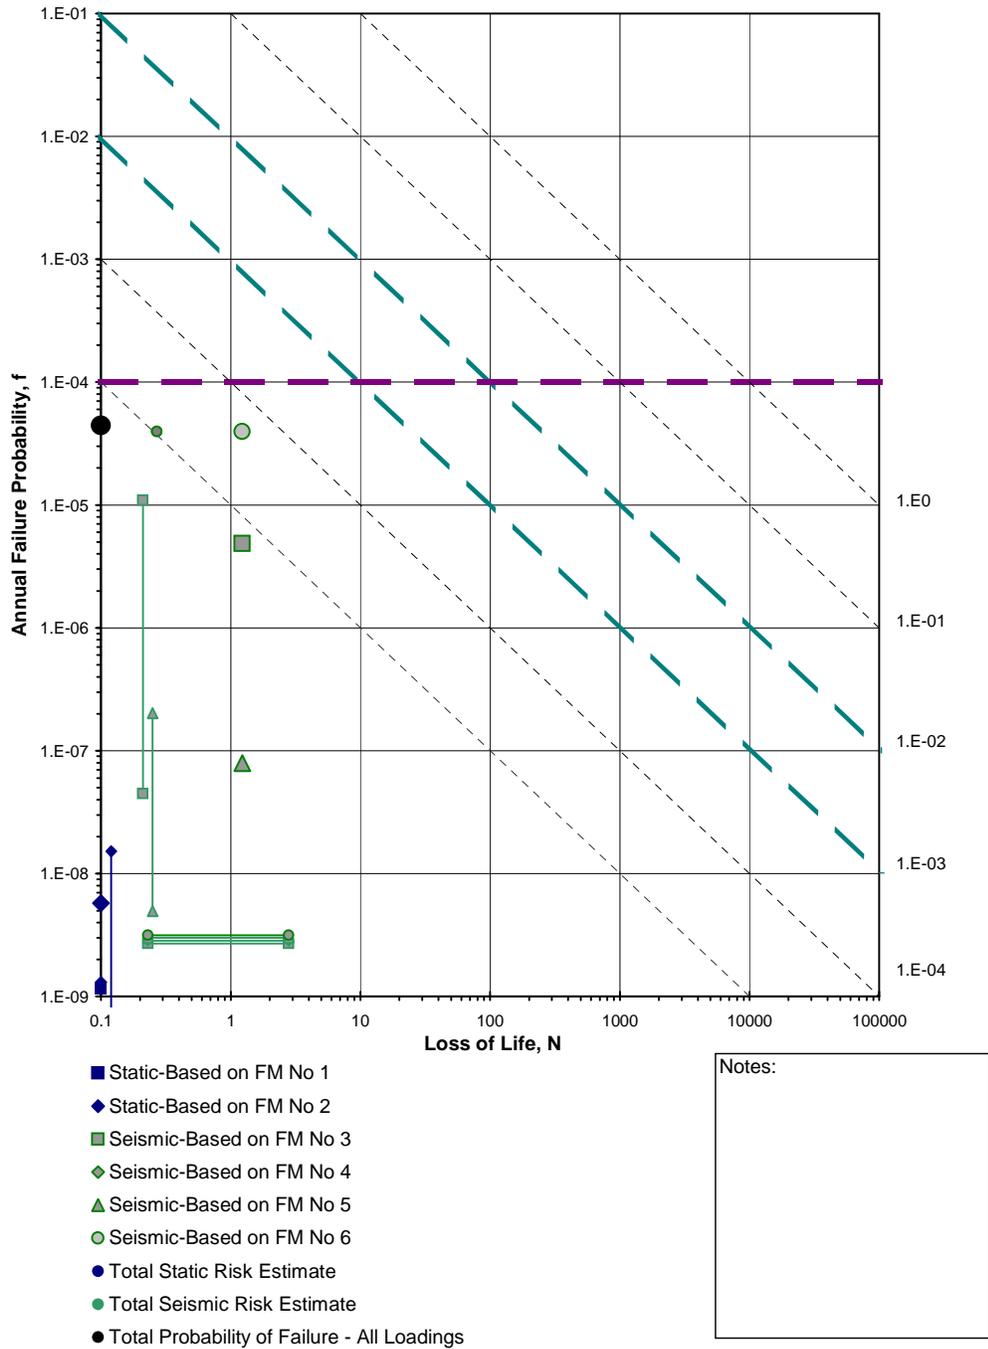
Risk Estimates North-Sea Dam

Figure D.6 f-N Chart Portraying Risks for North-Sea Dam with APF for FM No. 6

Based on Failure Mode	Failure Mode Description	Mean APF	LOL	Mean ALL
FM No. 1	North-Sea Dam, Static – Internal Erosion (Piping) of Embankment	≤ 3.8E-11	0	0
FM No. 2	North-Sea Dam, Static – Internal Erosion of Foundation Materials	≤ 6.1E-09	0	0
FM No. 3	North-Sea Dam, Seismic - Deformation and Overtopping of Embankment	≤ 3.8E-06	2	≤ 7.6E-06
FM No. 4	North-Sea Dam, Seismic - Deformation and Internal Erosion of Embankment	≤ 3.1E-11	2	≤ 6.2E-11
FM No. 5	North-Sea Dam, Seismic - Deformation and Internal Erosion of Foundation Materials	≤ 8.0E-08	2	≤ 1.6E-07
FM No. 6	North-Sea Dam, Seismic - Liquefaction of Upper Stiff Lacustrine, Seismic Deformation and Overtopping of Embankment	≤ 4.0E-05	2	≤ 8.0E-05
Overall Risk (maximum risk for static and seismic FMs)		≤ 4.0E-05	2	≤ 8.0E-05

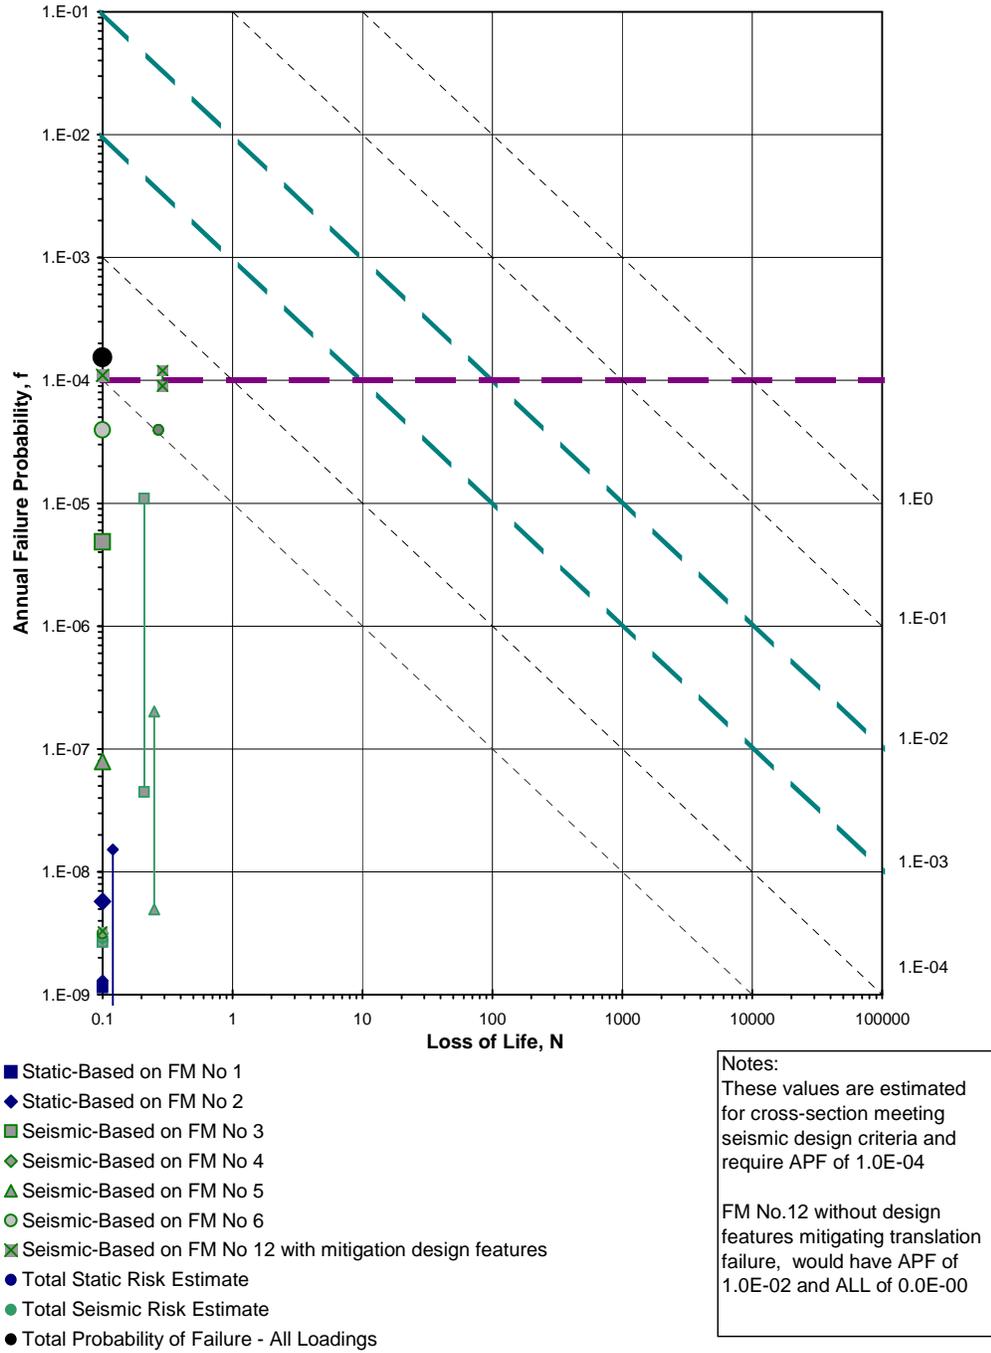
Risk Estimates Concentric Ring Dikes

Figure D.7 f-N Chart Portraying Risks for Concentric Lakes Dikes, Outer Two Lakes with APF for FM Nos. 6 & 12

Based on Failure Mode	Failure Mode Description	Mean APF	LOL ^(d)	Mean ALL
FM No. 1	Lakes Dikes, Static - Internal Erosion (Piping) of Embankment	$\leq 3.8E-11$ ^(a) $1.0E-02$ ^(b)	0	0
FM No. 2	Lakes Dikes, Static - Internal Erosion of Foundation Materials	$\leq 6.1E-09$ ^(a) $1.0E-02$ ^(b)	0	0
FM No. 3	Lakes Dikes, Seismic - Deformation and Overtopping of Embankment	$\leq 3.8E-06$ ^(a) $1.0E-02$ ^(b)	0	0
FM No. 4	Lakes Dikes, Seismic - Deformation and Internal Erosion of Embankment	$\leq 3.1E-11$ ^(a) $1.0E-03$ ^(b)	0	0
FM No. 5	Lakes Dikes, Seismic - Deformation and Internal Erosion of Foundation Materials	$\leq 8.0E-08$ ^(a)	0	0
FM No. 6	Lakes Dikes, Seismic - Liquefaction of Upper Stiff Lacustrine, Seismic Deformation and Overtopping of Embankment	$\leq 4.0E-05$ ^(a) $\leq 8.4E-03$ ^(b)	0	0
FM No. 12	South-Sea Dam, Seismic - Offset and Translation of Embankment (with translation mitigation design features)	$1.0E-04$ ^(c)	0	0

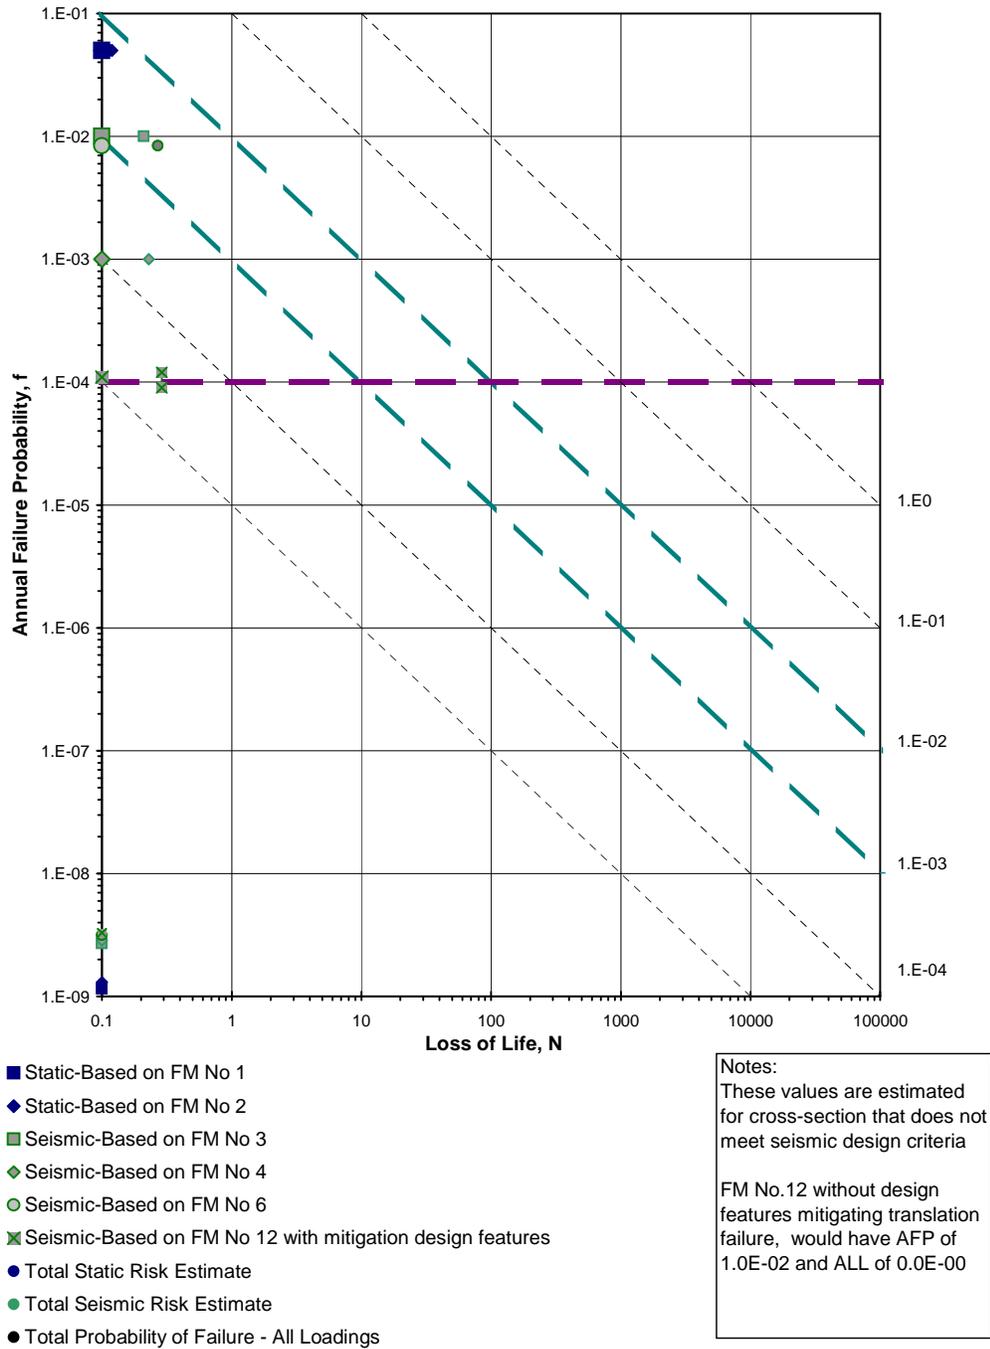
Risk Estimates Concentric Ring Dikes

Figure D.8 f-N Chart Portraying Risks for Concentric Lakes Dikes, Inner Lakes with APF for FM Nos. 6 & 12

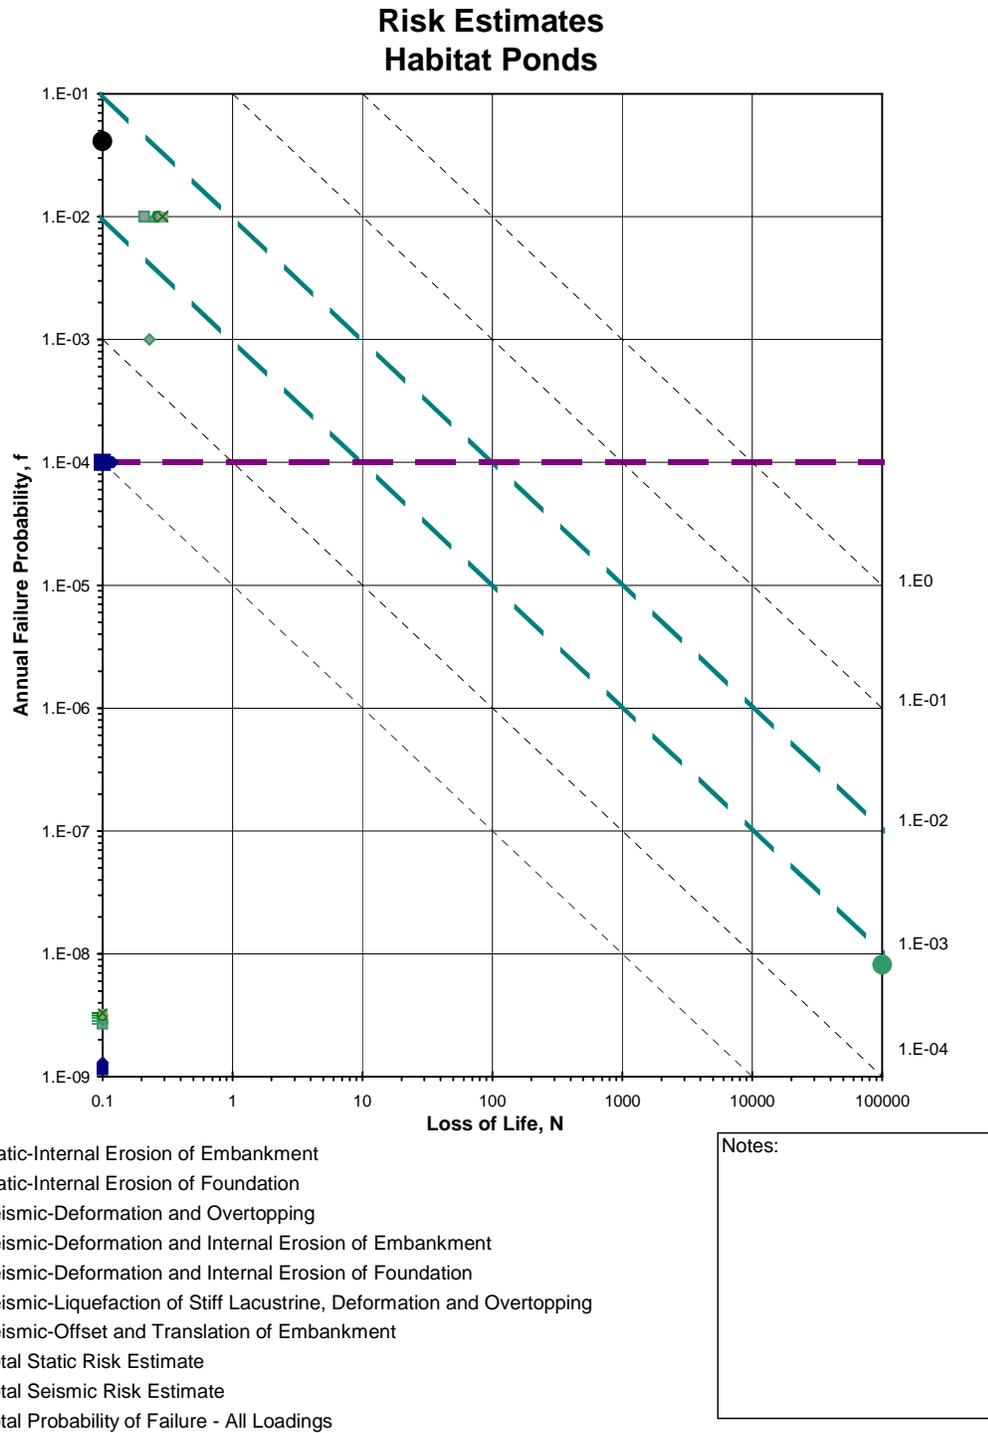
Figure D.9 f-N Chart Portraying Risks for Habitat Pond Embankments with APF for FM No. 12

Based on Failure Mode	Failure Mode Description	Mean APF	LOL ^(b)	Mean ALL
N/A ^(a)	Habitat Ponds, Static - Internal Erosion (Piping) of Embankment	1.0E-04	0	0
N/A ^(a)	Habitat Ponds, Static - Internal Erosion of Foundation Materials	1.0E-04	0	0
N/A ^(a)	Habitat Ponds, Seismic - Deformation and Overtopping of Embankment	1.0E-02	0	0
N/A ^(a)	Habitat Ponds, Seismic - Deformation and Internal Erosion of Embankment	1.0E-03	0	0
N/A ^(a)	Habitat Ponds, Seismic - Deformation and Internal Erosion of Foundation Materials	≤ 1.1E-02	0	0
N/A ^(a)	Habitat Ponds, Seismic - Liquefaction of Upper Stiff Lacustrine, Seismic Deformation and Overtopping of Embankment	≤ 1.1E-02	0	0
FM No. 12	Habitat Ponds, Seismic - Offset and Translation of Embankment	≤ 1.1E-02	0	0
Overall Risk (maximum risk for static and seismic FMs)		1.0E-02	0	0

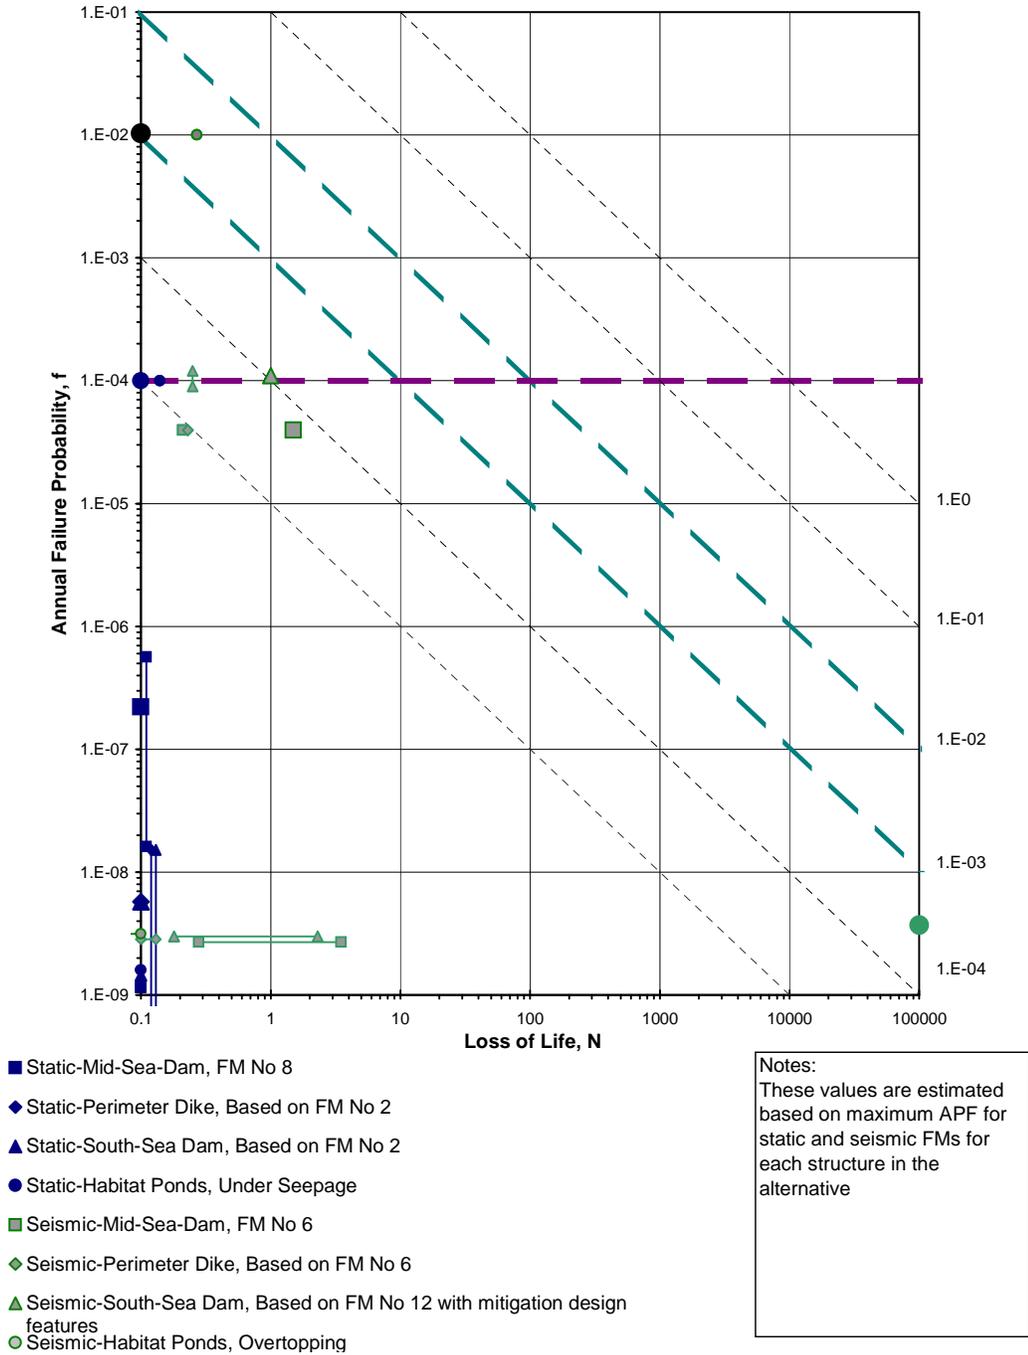
Risk Estimates Alternative No 1

Figure D.10 f-N Chart Portraying Risks for Alternative No. 1 with APF for Hypothetical FM Nos. 6 & 12

After the RET had evaluated the risks for all of the failure modes for each embankment structure, the team then compiled the risks for each structure to develop a “composite” risk for each alternative. The team considered that since all static and seismic loadings for each individual structure were not independent variables (i.e., each structure would experience the loading for the same particular event at the same time, rather than as separate and independent events), the risk of failure of an alternative could be described by the risk associated with failure of the “weakest link” in the system. Therefore, annual probability of failure and annual loss of life for each alternative was considered to be the highest value for static or seismic failures for each of the structures comprising an alternative. Using the assumptions that (a) potentially liquefiable layers in the stiff lacustrine materials are identified and improved and (b) translation mitigation design features are incorporated into the designs, the compiled results of these alternatives are summarized in Table 2D.39 below and on f-N charts on Figures D.10 through D.14 for each of the alternatives.

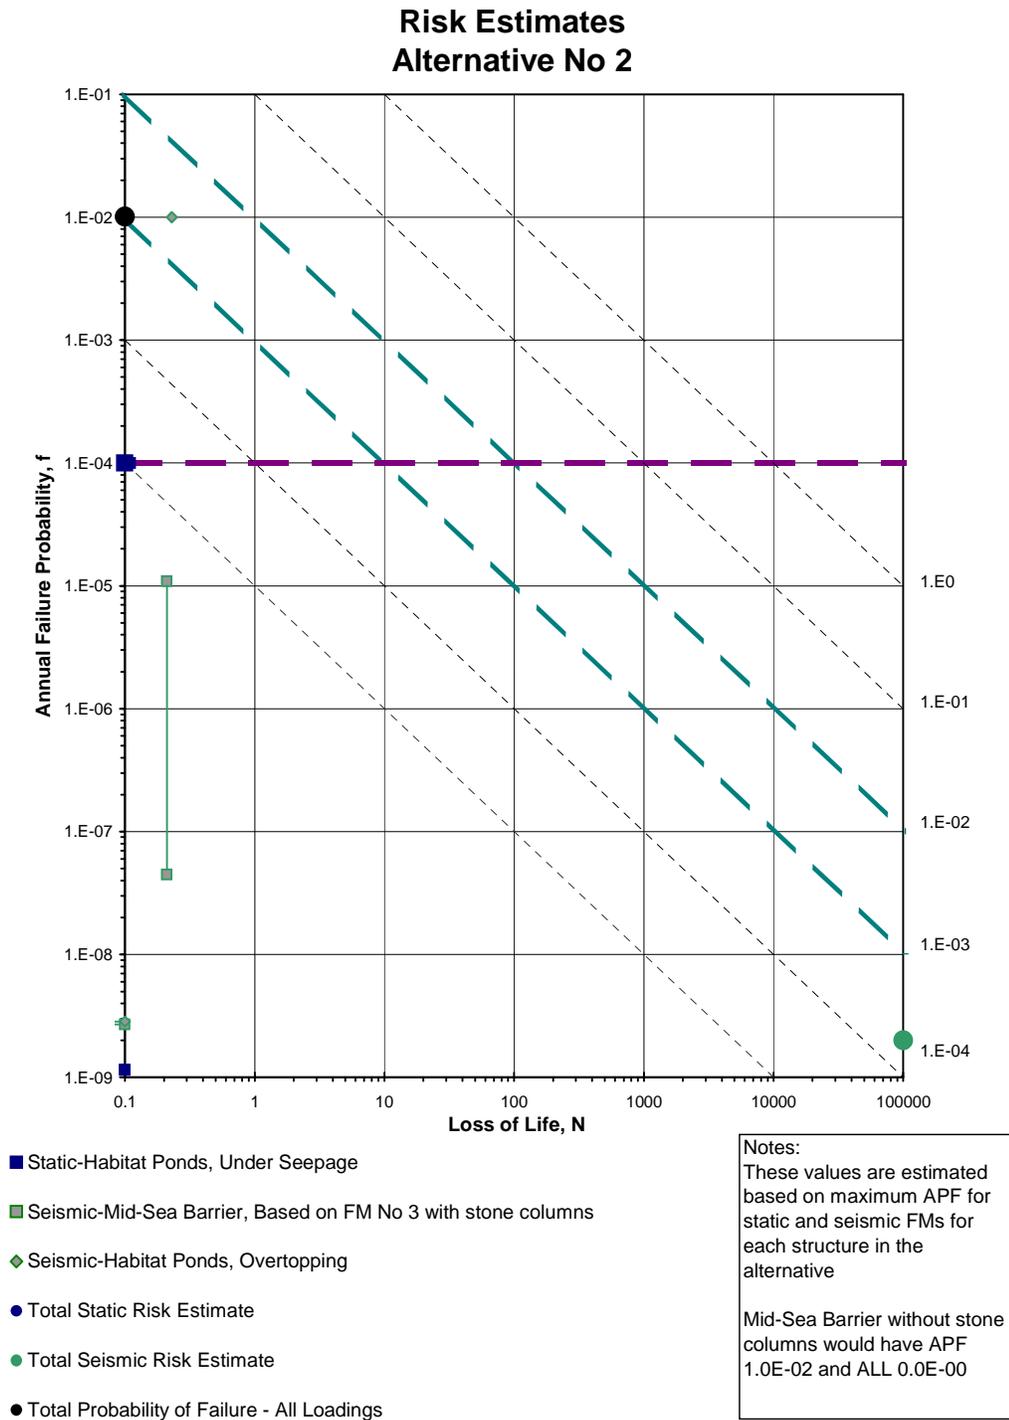
Figure D.11 f-N Chart Portraying Risks for Alternative No. 2

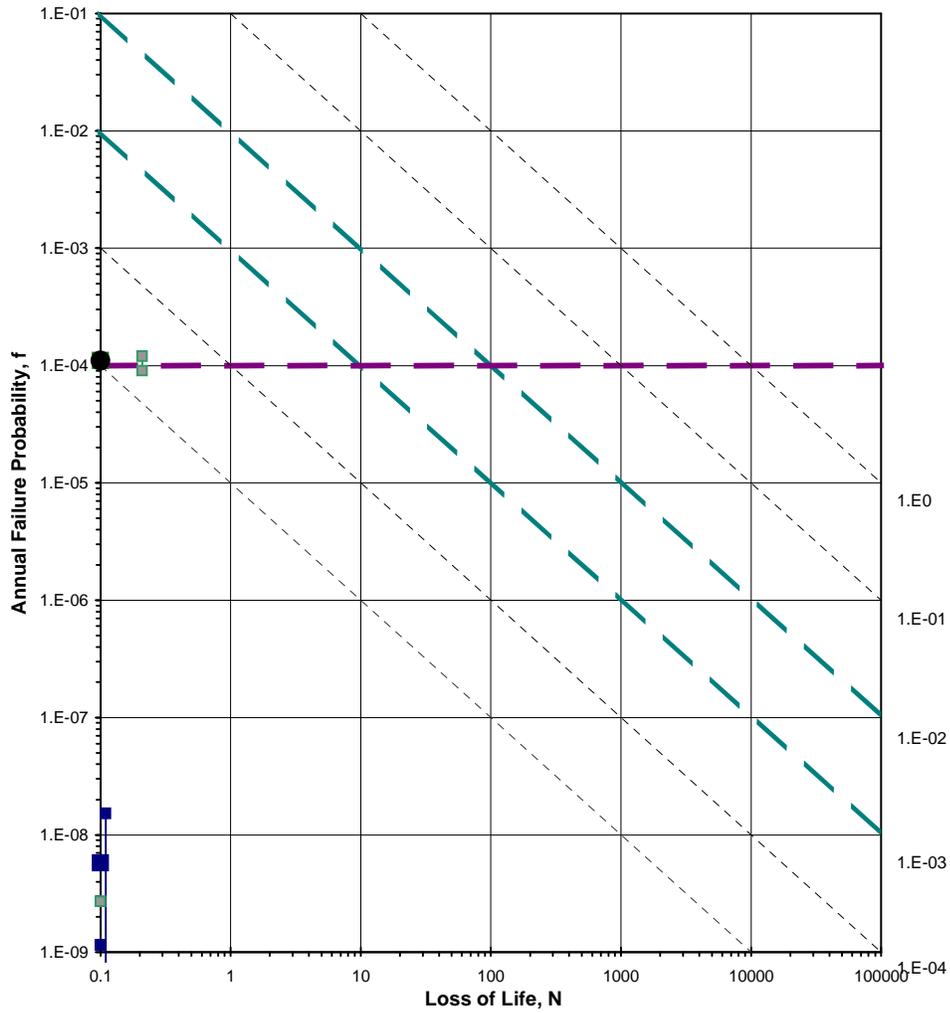
Risk Estimates Alternative No 3

- Static-Concentric Ring Dikes (outer rings), Underseepage
- Seismic-Concentric Ring Dikes (outer rings) with mitigation design features, Translation
- Total Static Risk Estimate
- Total Seismic Risk Estimate
- Total Probability of Failure - All Loadings

Notes:
 These values are estimated based on maximum APF for static and seismic FMs for each structure in the alternative

Outer Concentric Ring Embankment without design features mitigating translation failure, would have APF of 1.0E-02 (failure by translation) and ALL of 0.0E-00

Figure D.12 f-N Chart Portraying Risks for Alternative No. 3 for cross-section meeting seismic design criteria and improved to mitigate translation failure

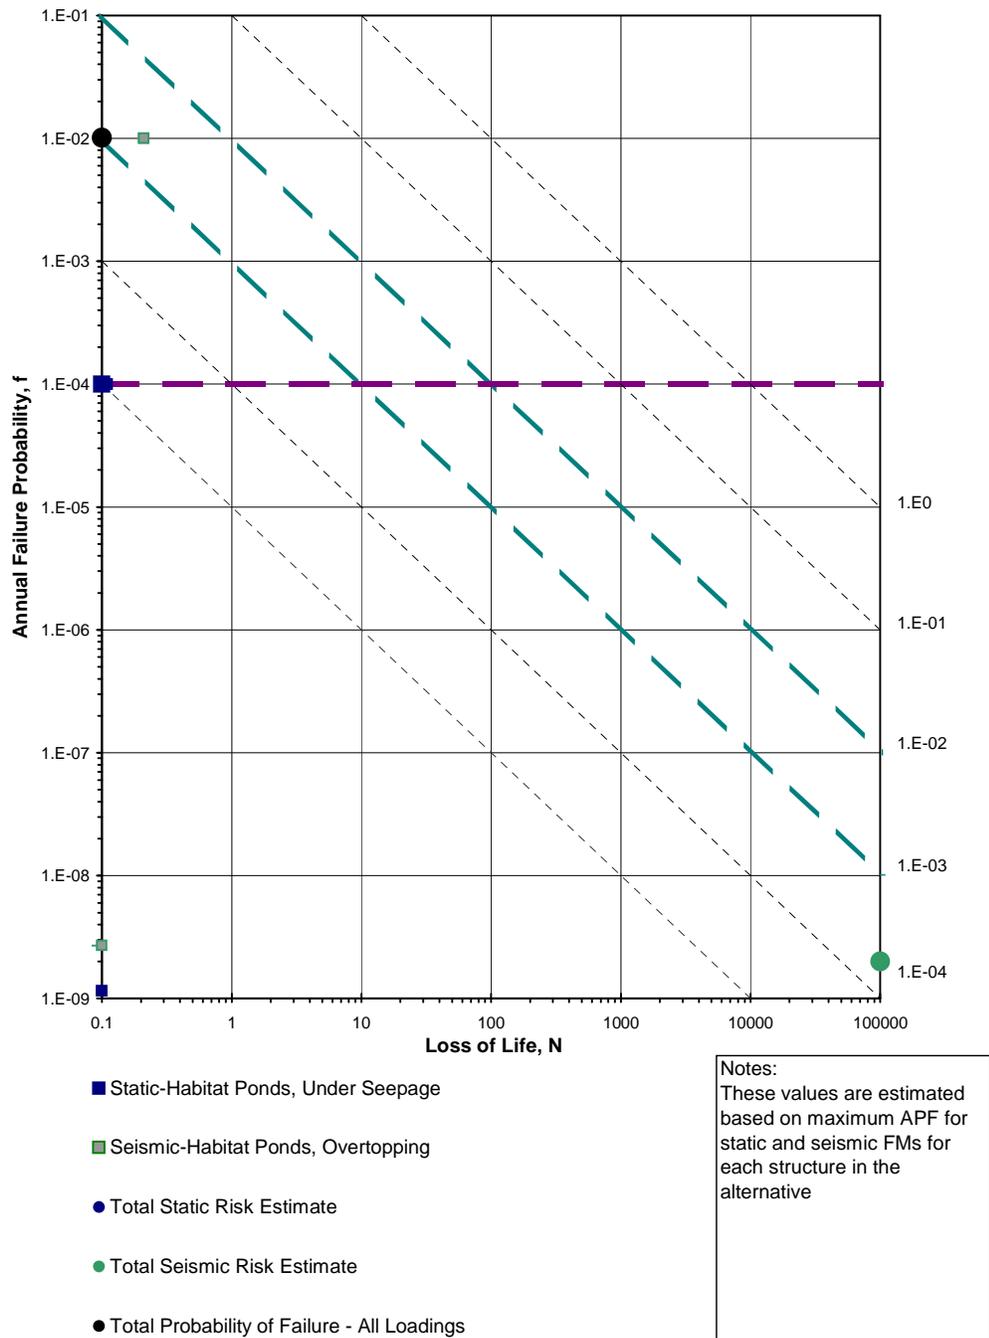
Risk Estimates Alternative No 5

Figure D.14 f-N Chart Portraying Risks for Alternative No. 5
