## Draft Environmental Assessment

### Bankline Stabilization and River Control above Palo Verde Dam

**Yuma Area Office  
Environmental Group  
Yuma, Arizona**

**June 2005**

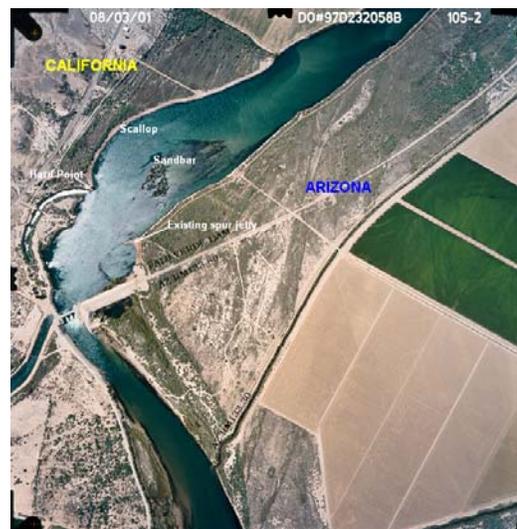
A large sandbar (approximately 450,000 cubic yards) has formed above the Dam and is deflecting the river flow against the California bankline causing extensive erosion and creating a large scallop approximately 3,500 ft long and 300 ft into the bankline (see photo inset).

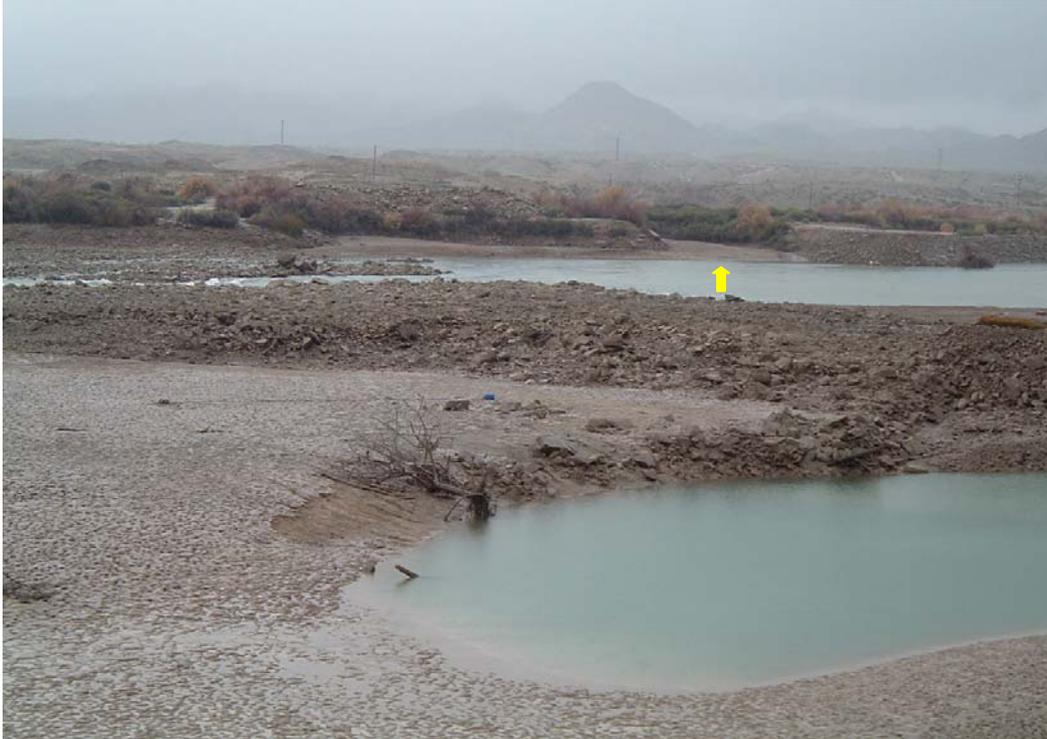
1. View west from AZ shore of Colorado River channel during annual low water. Rock (center) is old weir diversion that was replaced by present Palo Verde Diversion dam, located downstream (off photo-left). Channel bottom is predominantly sand. Foreground pool is eddy-carved from "AZ Spur". Yellow arrow is abandoned irrigation diversion canal intake (e.g. "Backwater" of Marsh 2004 study).

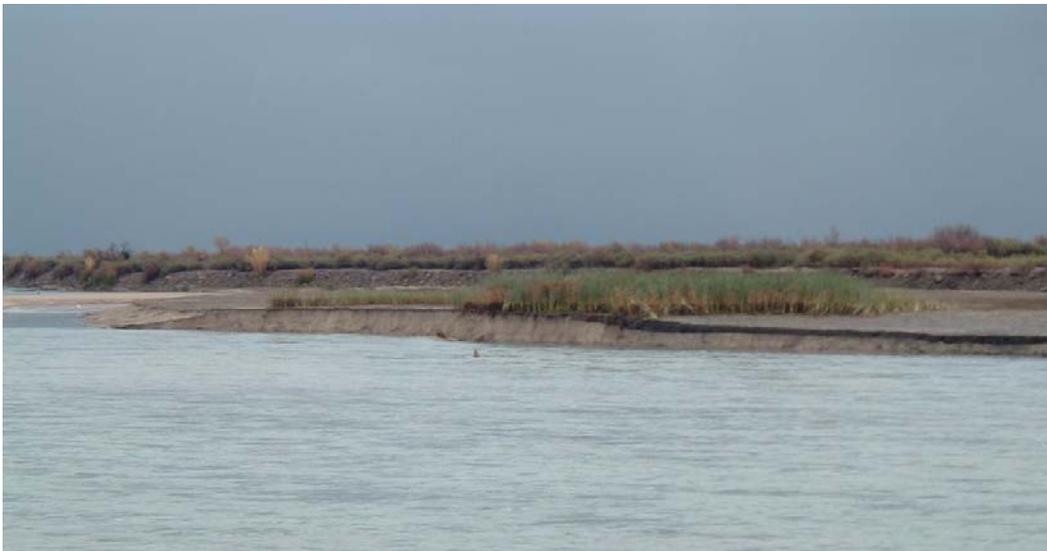
2. Pointbar in channel viewing toward AZ shore. Dark silt layer indicates low velocity flows near wetlands and ability of vegetation to trap sediment. Underlying unstratified sand layer indicates high velocity flow event that deposited sandbar. Exposed bank on bar is about 6 ft. high above water surface. Normally this area is flooded to obvious high water line.

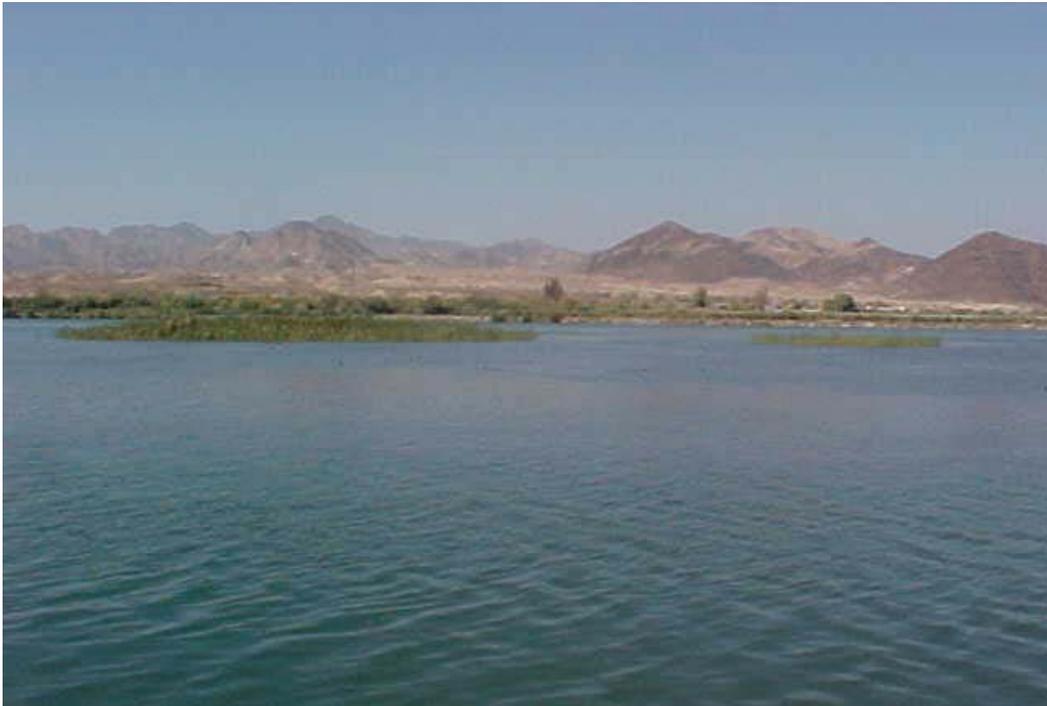
3. View of pointbar (same as 2. above) during normal highwater flows. Only the emergent vegetation is above water. Photograph date 25 Oct. 2005.

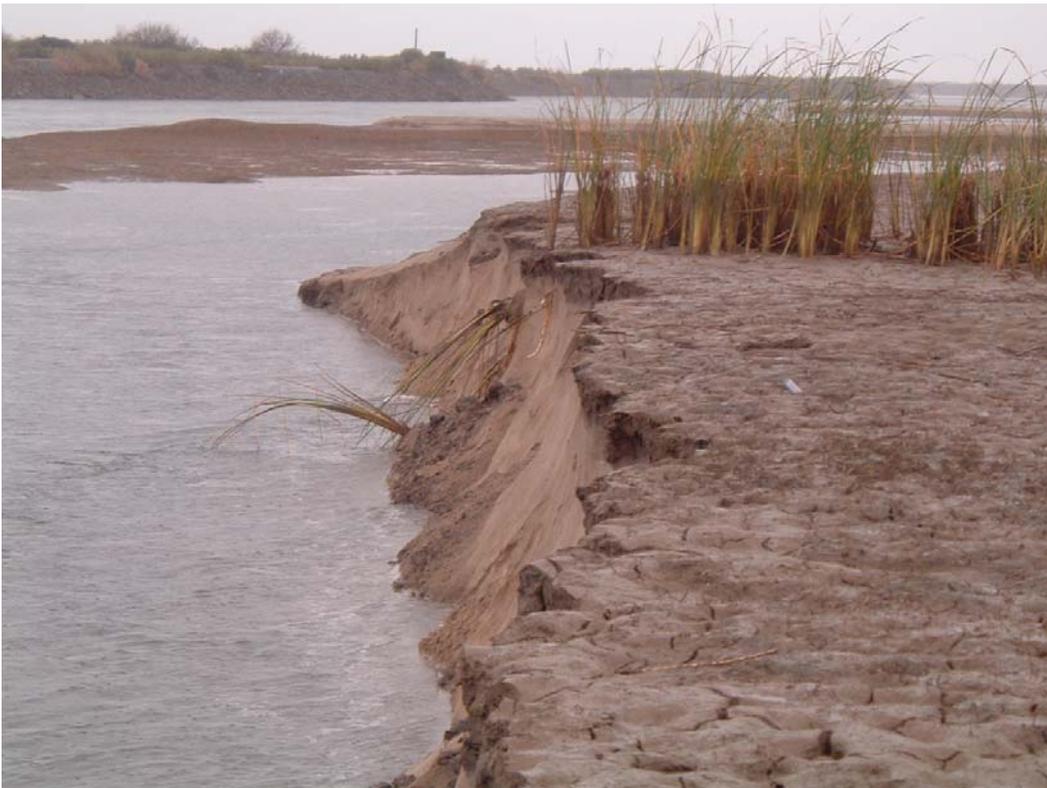
4. View upstream of channel and sandbar during low water, CA shore in distance. Dark silt layer overlays thick sand forming bar. Silt layer (ca. 1 ft. thick) indicates modest flows in shallows over sandbar and current attenuation by wetland plants. Note deeper main channel to left, about 6 ft. below sandbar elevation (annual low-water).

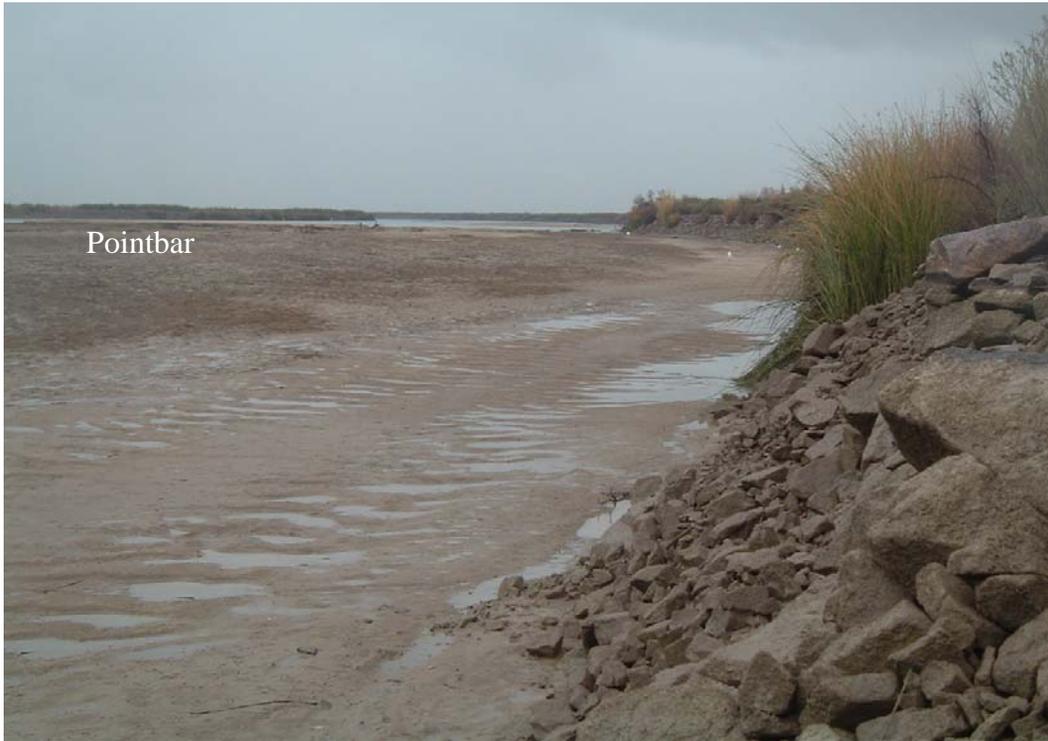
5. Viewing upstream along AZ shoreline (riprap), sandbar is center left. High velocity channel along shore is over bottom of scoured, coarse sand. Note lack of channel diversity and smooth river bed, indicative of high velocity flows. Steep rip-rapped banks are typical.

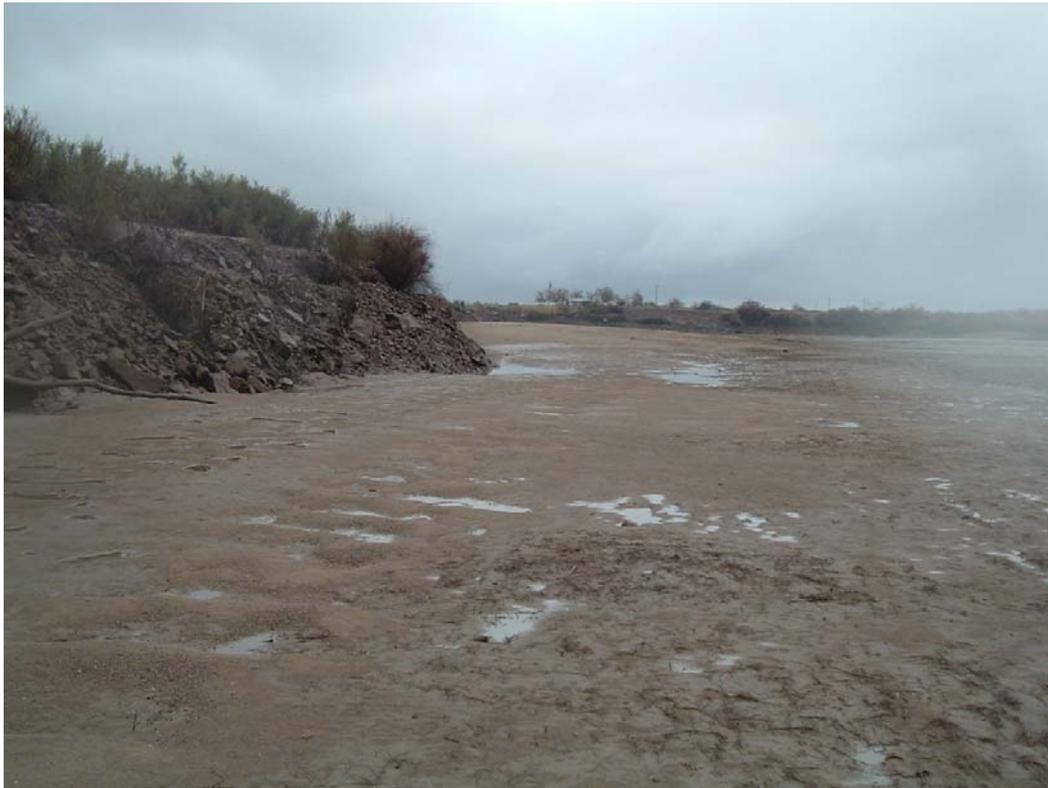
6. AZ shoreline view of channel bottom looking downstream toward Palo Verde Dam. This area normally under 8 to 10 ft. of water. Note flat, sandy bottom and steep rip-rapped shoreline.

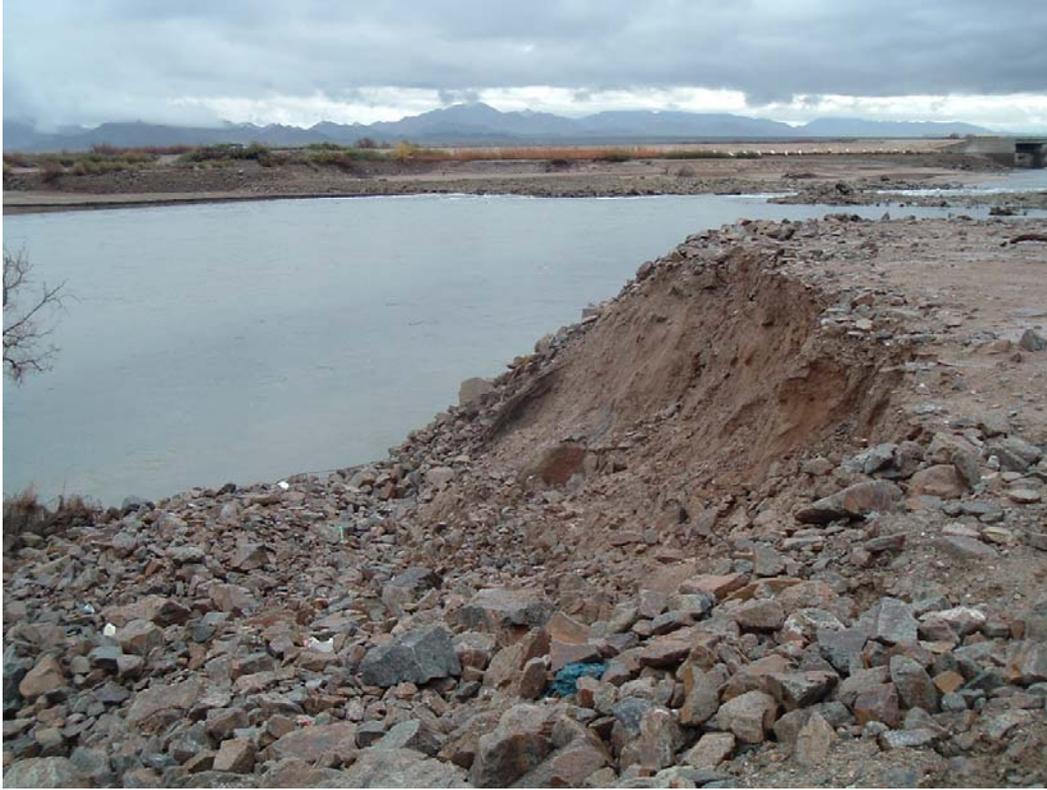
7. Slumped rip-rap on CA shoreline observed 1/4/2005, indicating steep banks and rapid erosion. Dam is visible in distance (upper right).

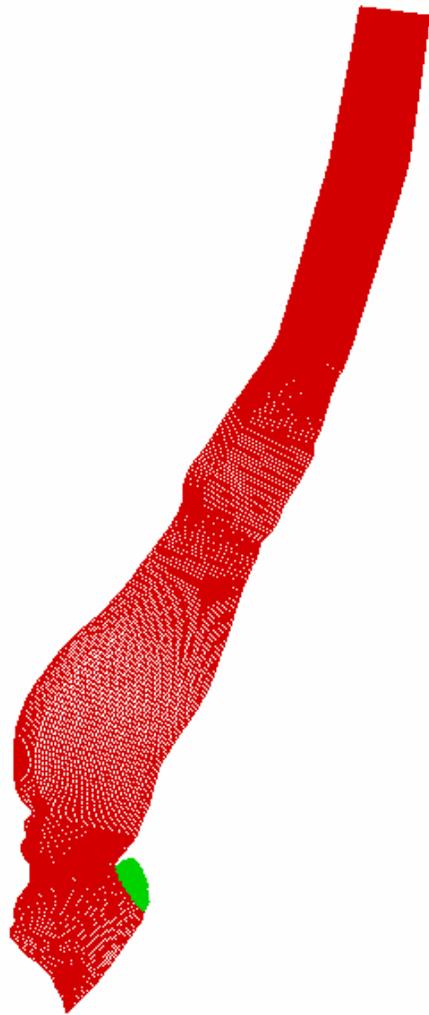
**(a) Mesh for Baseline Case**

**(b) Mesh for Case I**

**Figure 5. Plan Views of Meshes Used for the Present Study (different colors represent mesh blocks)**

Final meshes were developed for all scenarios. For cases under existing conditions (no training structure and jetties), the 3D mesh consists of 197,757 mesh points with 21 vertical points, while the mesh for cases with the training structure has 238,917 mesh points and 21 vertical points. The mesh distribution is not uniform in all directions - point density was increased around important areas such as structures and point bars. On average, mesh elements have a streamwise spacing of about 40 ft, a lateral width of around 15 ft, and a vertical depth up to 2 ft. Plan views of Baseline Case and Case I meshes are shown in Figure 5. The mesh system selection is based on extensive past experiences and is deemed adequate for obtaining accurate solutions for the present project.

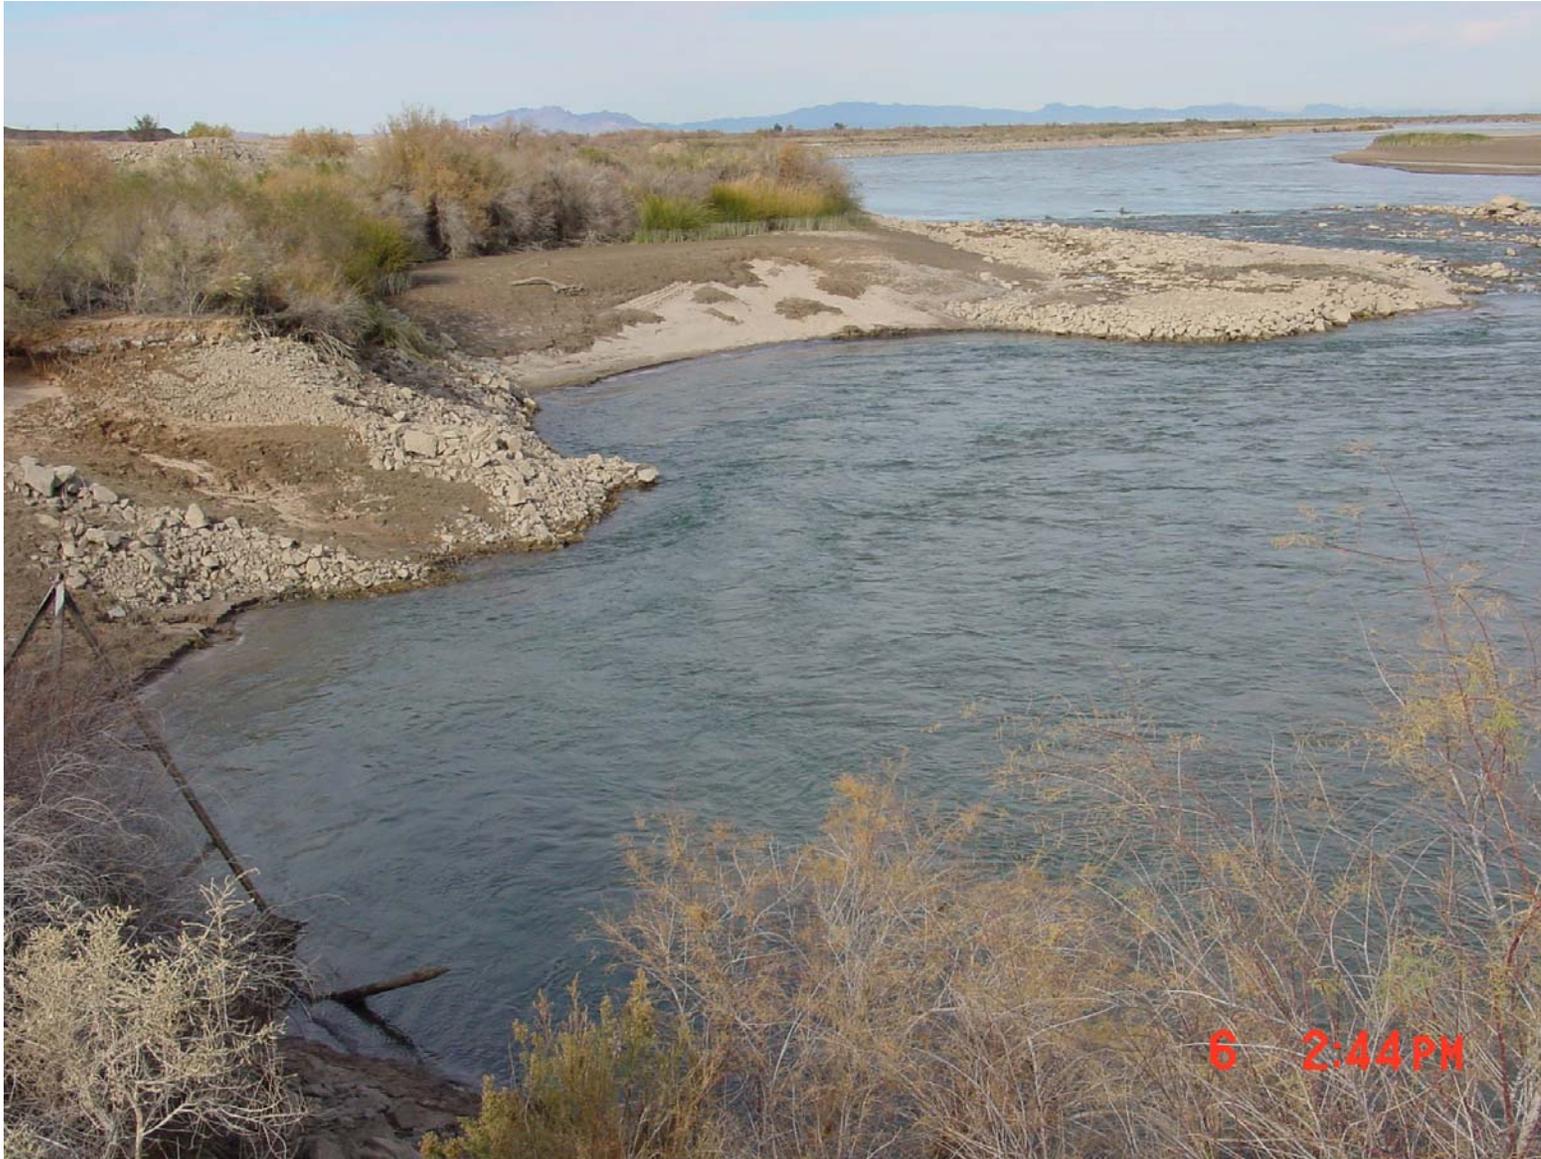
**Figure 21. Photo Showing the Current Bank and Riprap Conditions on the Right Bank in Front of the Intake**

Another eddy of concern (Eddy #2) is the one located on the right bank near the Diversion Dam intake. This eddy becomes stronger with the training structure in place (see Figs. 15 and 17), though the strength could be lowered with the point bar eroded. During the site trip, it was noticed that the existing riprap at this location is not in good shape (see Figure 21); it is recommended that this location be strengthened with new riprap because a stronger eddy may result in higher erosion potential.

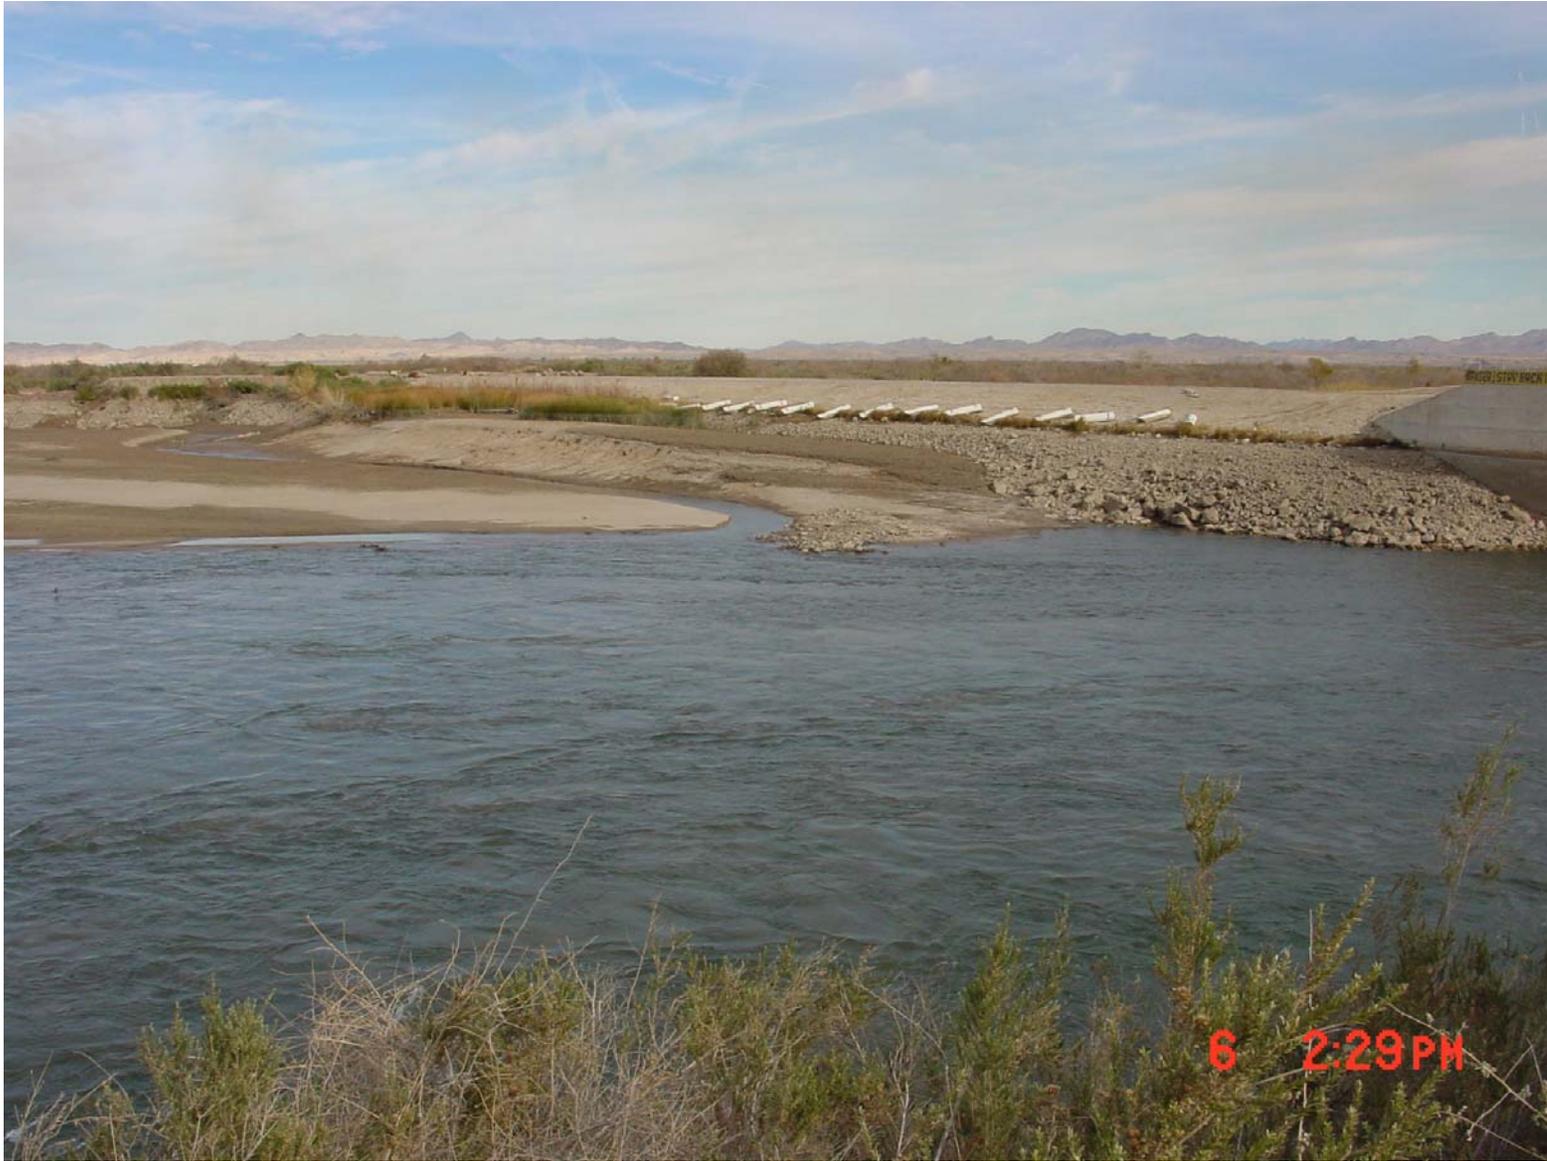
**Figure 22. Photo Showing the Current Condition of the Embankment at the Diversion Dam**
