**GEOTECHNICAL INPUT - EIR**  
**North Fork American River Trail Project**  
Placer County, California

BCI File No. 767.1  
February 2, 2006

Subject: **GEOTECHNICAL INPUT - EIR**  
North Fork American River Trail Project  
Placer County, California

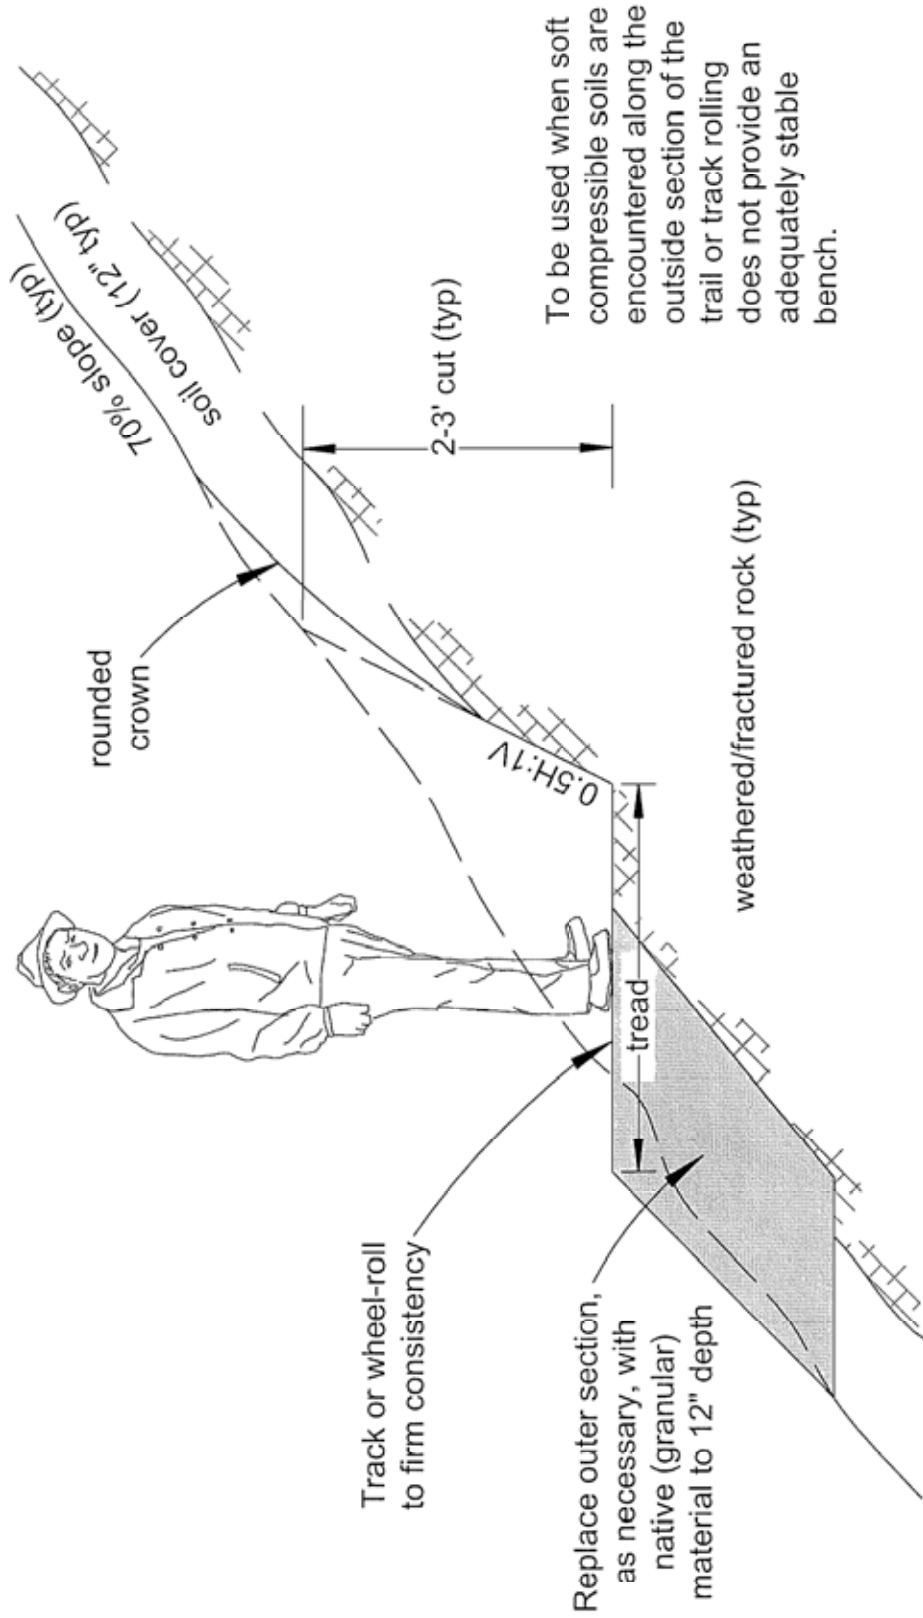
Section B

# **Schematic Section - Cut/Fill with Limited Replacement North Fork American River Trail**

Section B: Cut/Fill with Limited Replacement

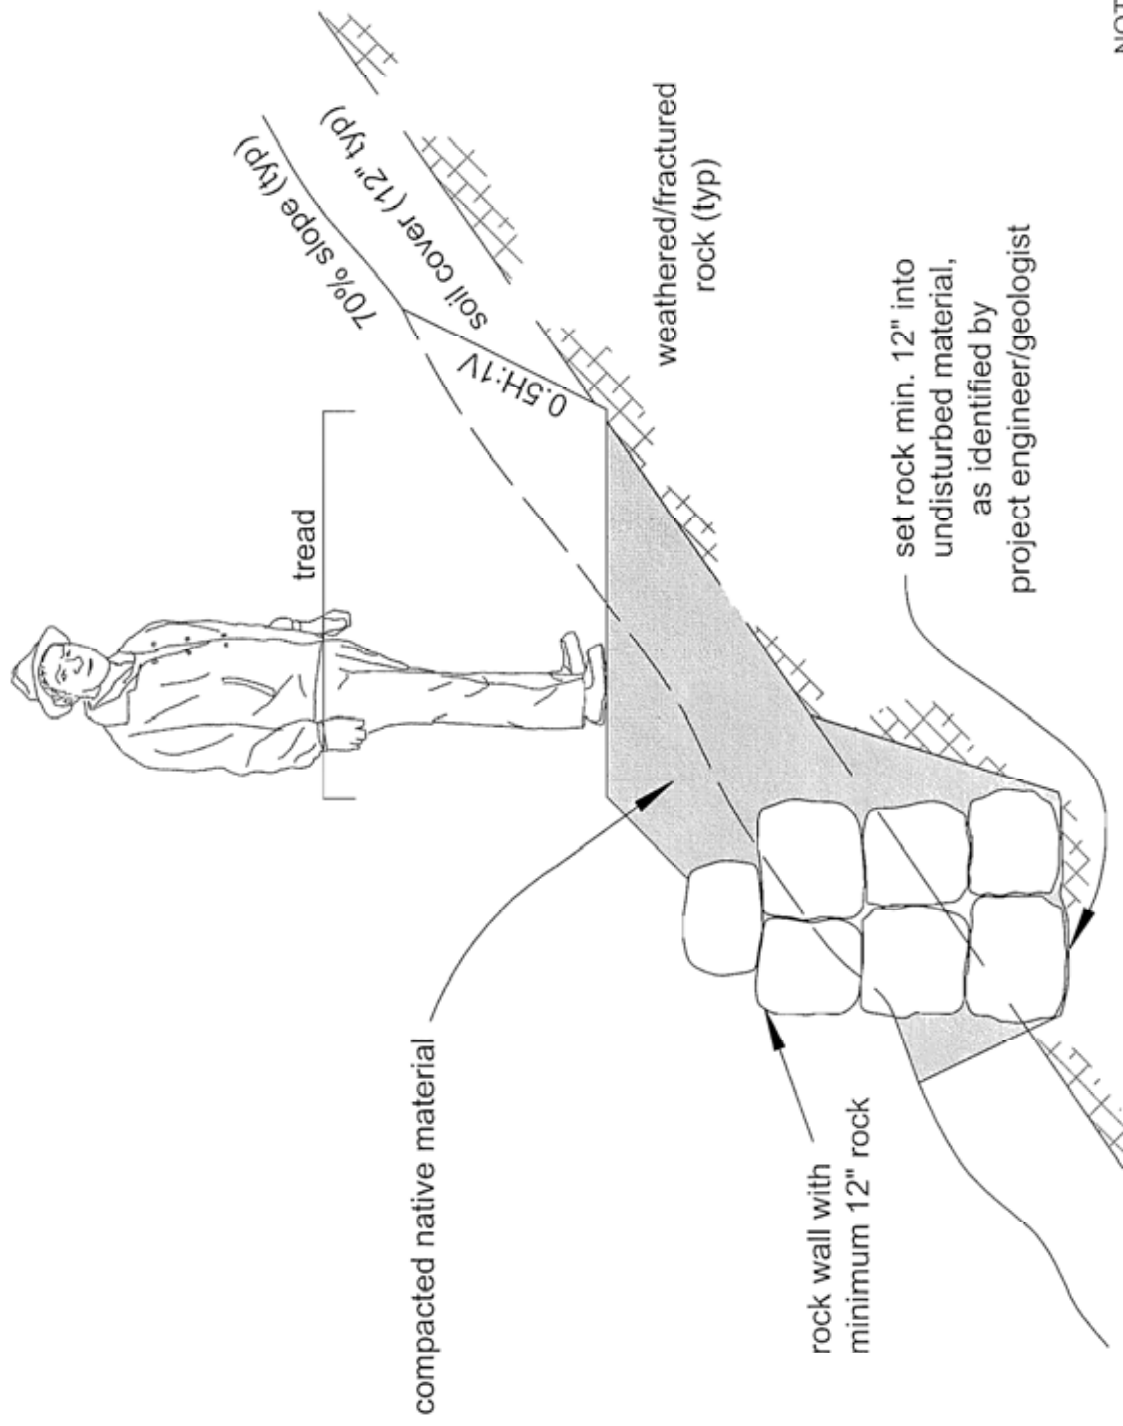
File No. 767.1  
July 2006  
Section D

# Schematic Section - Rock Wall North Fork American River Trail

**Section D: Rock Wall**

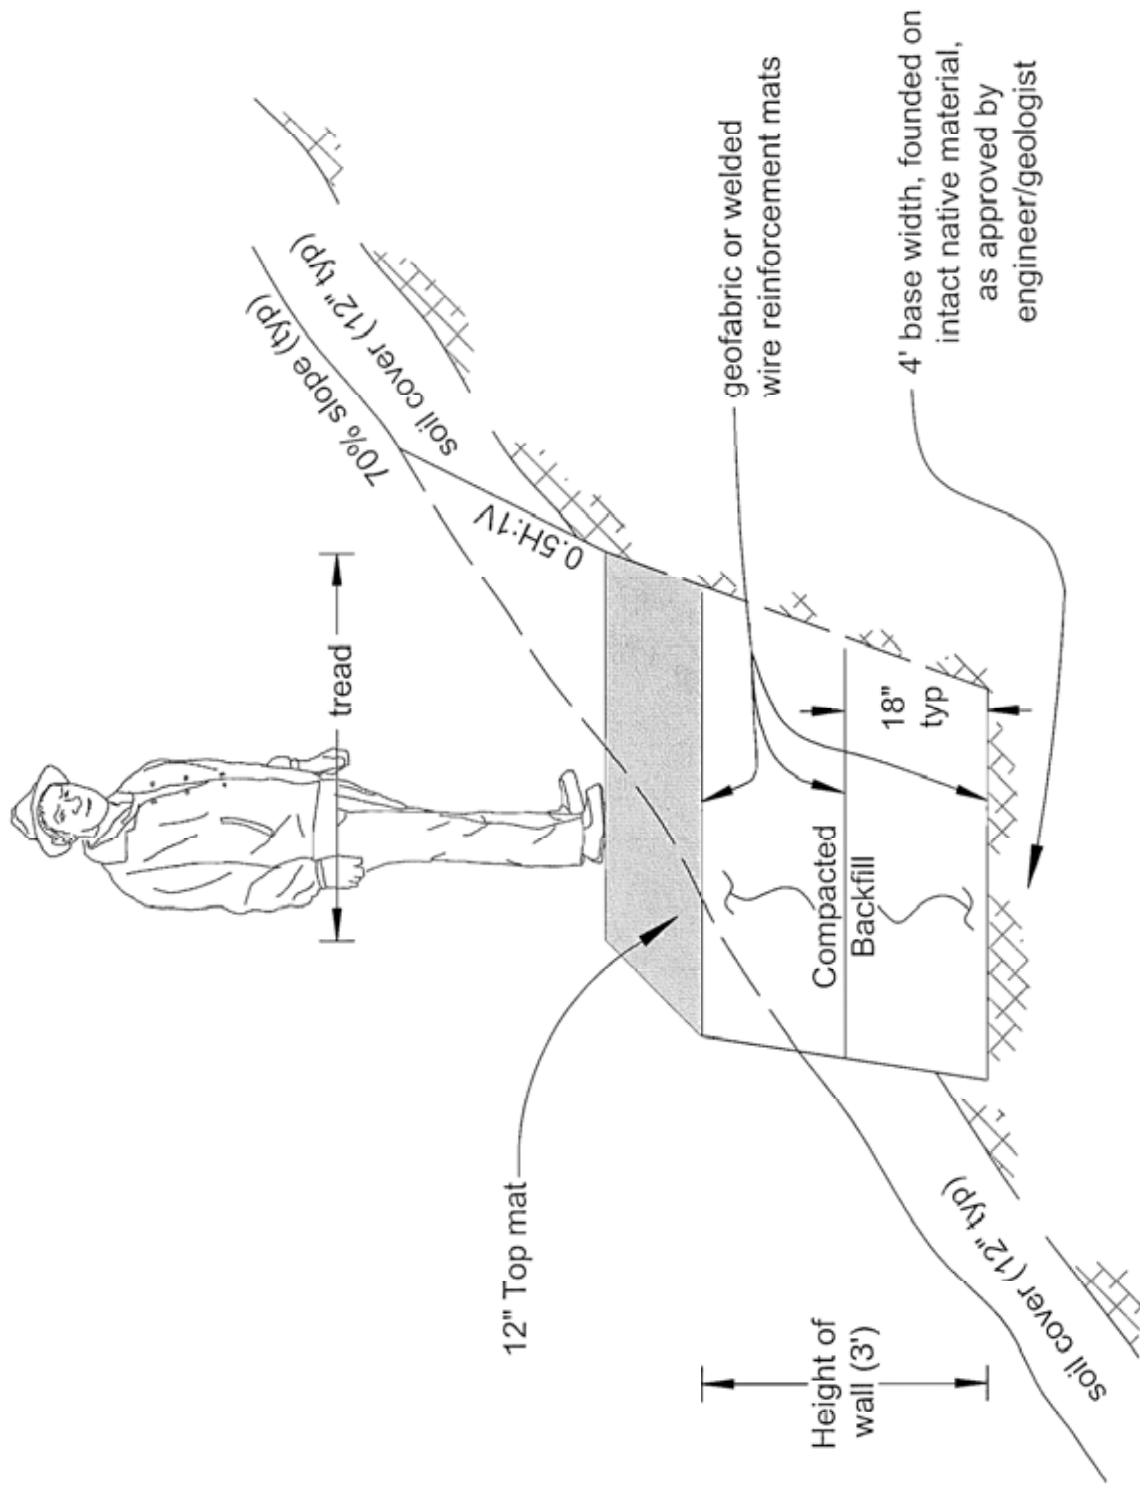
## Schematic Section - MSE Wall North Fork American River Trail

**Section E: MSE Wall**

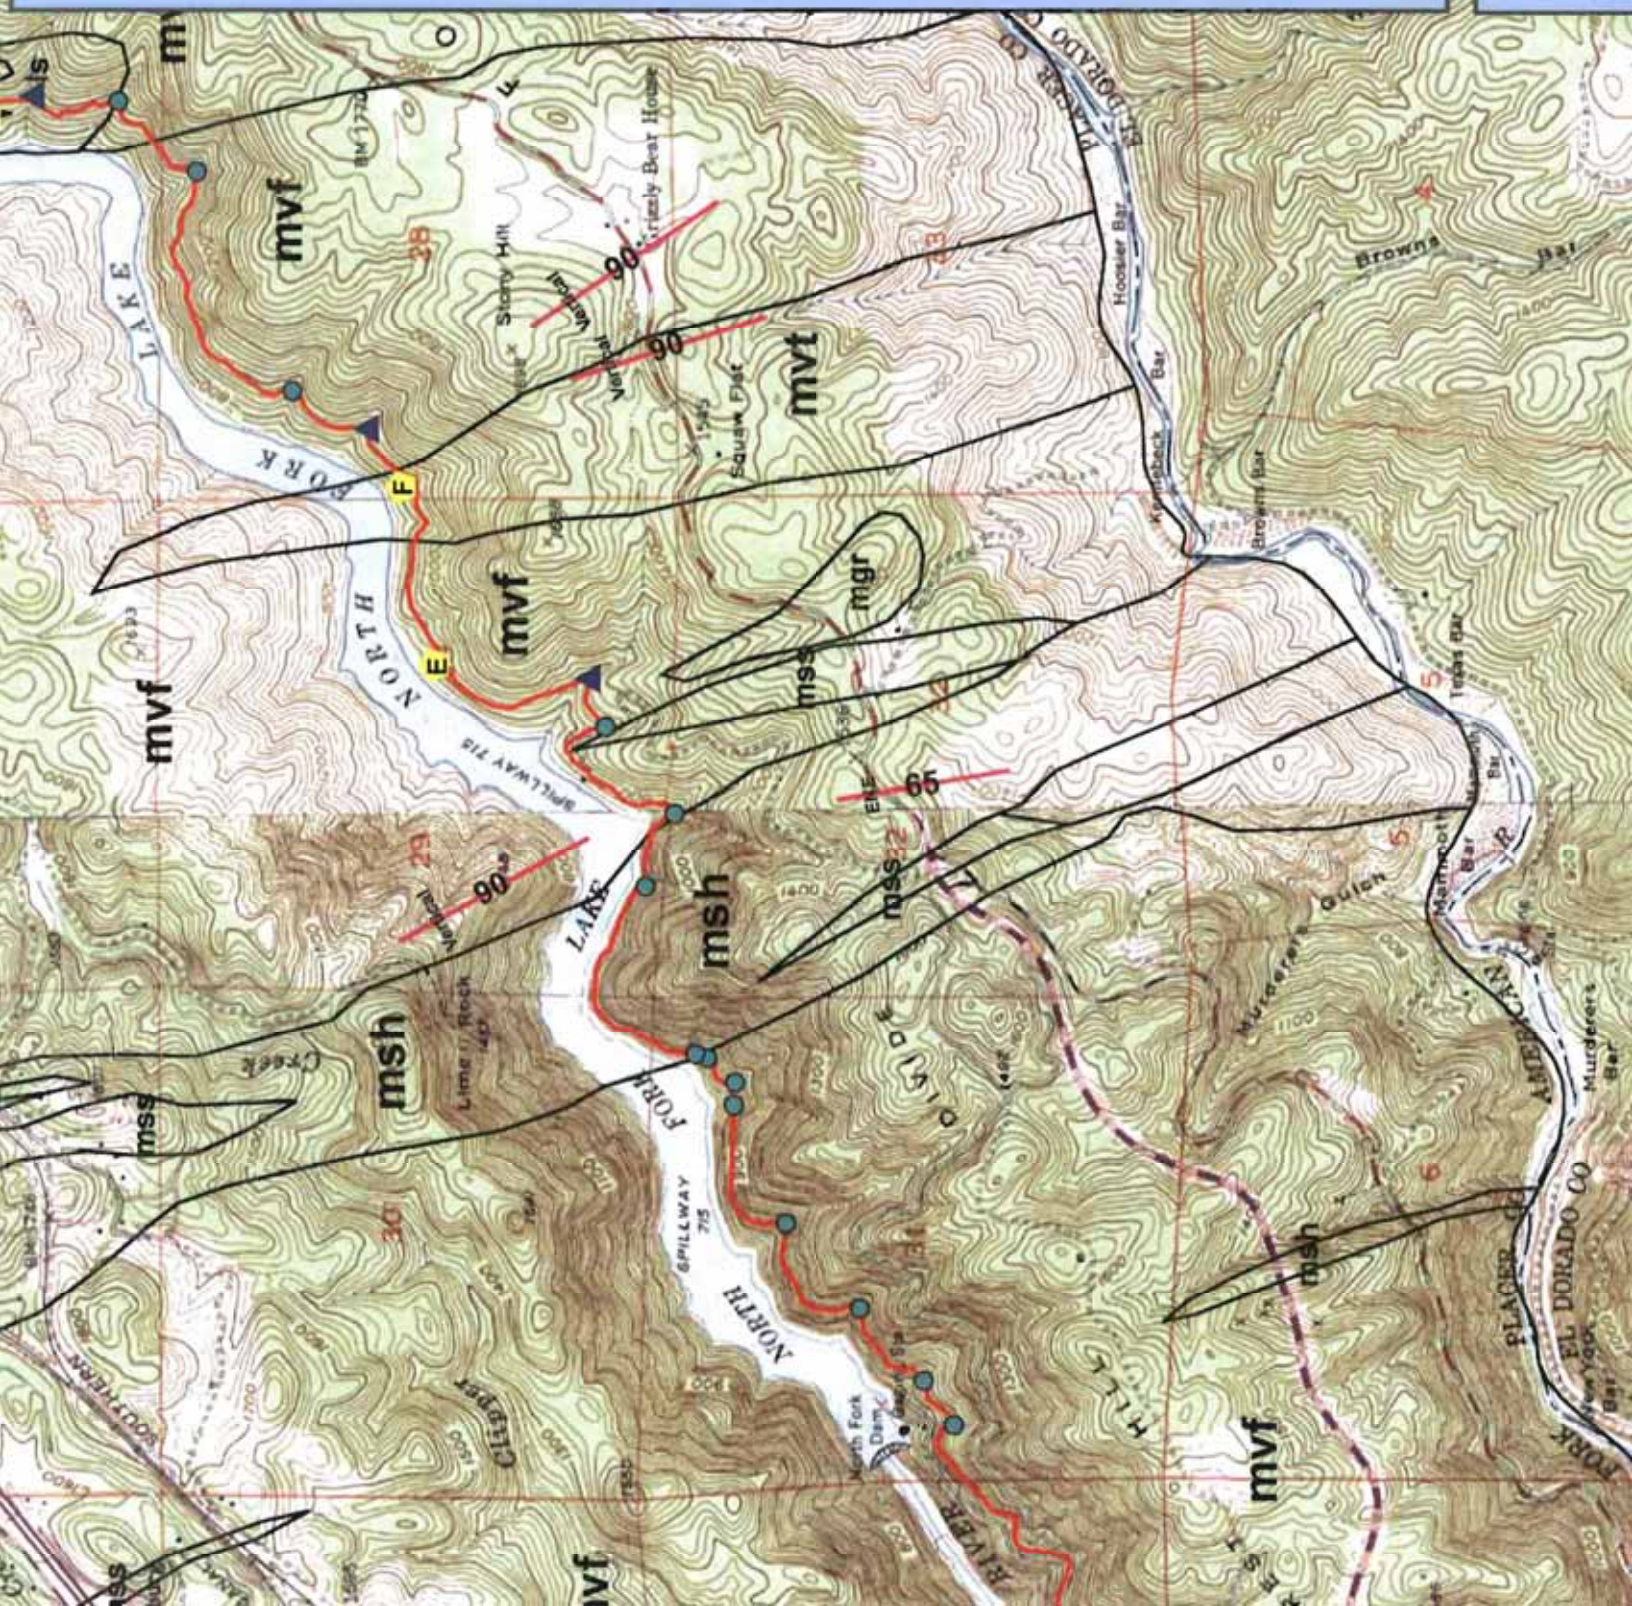
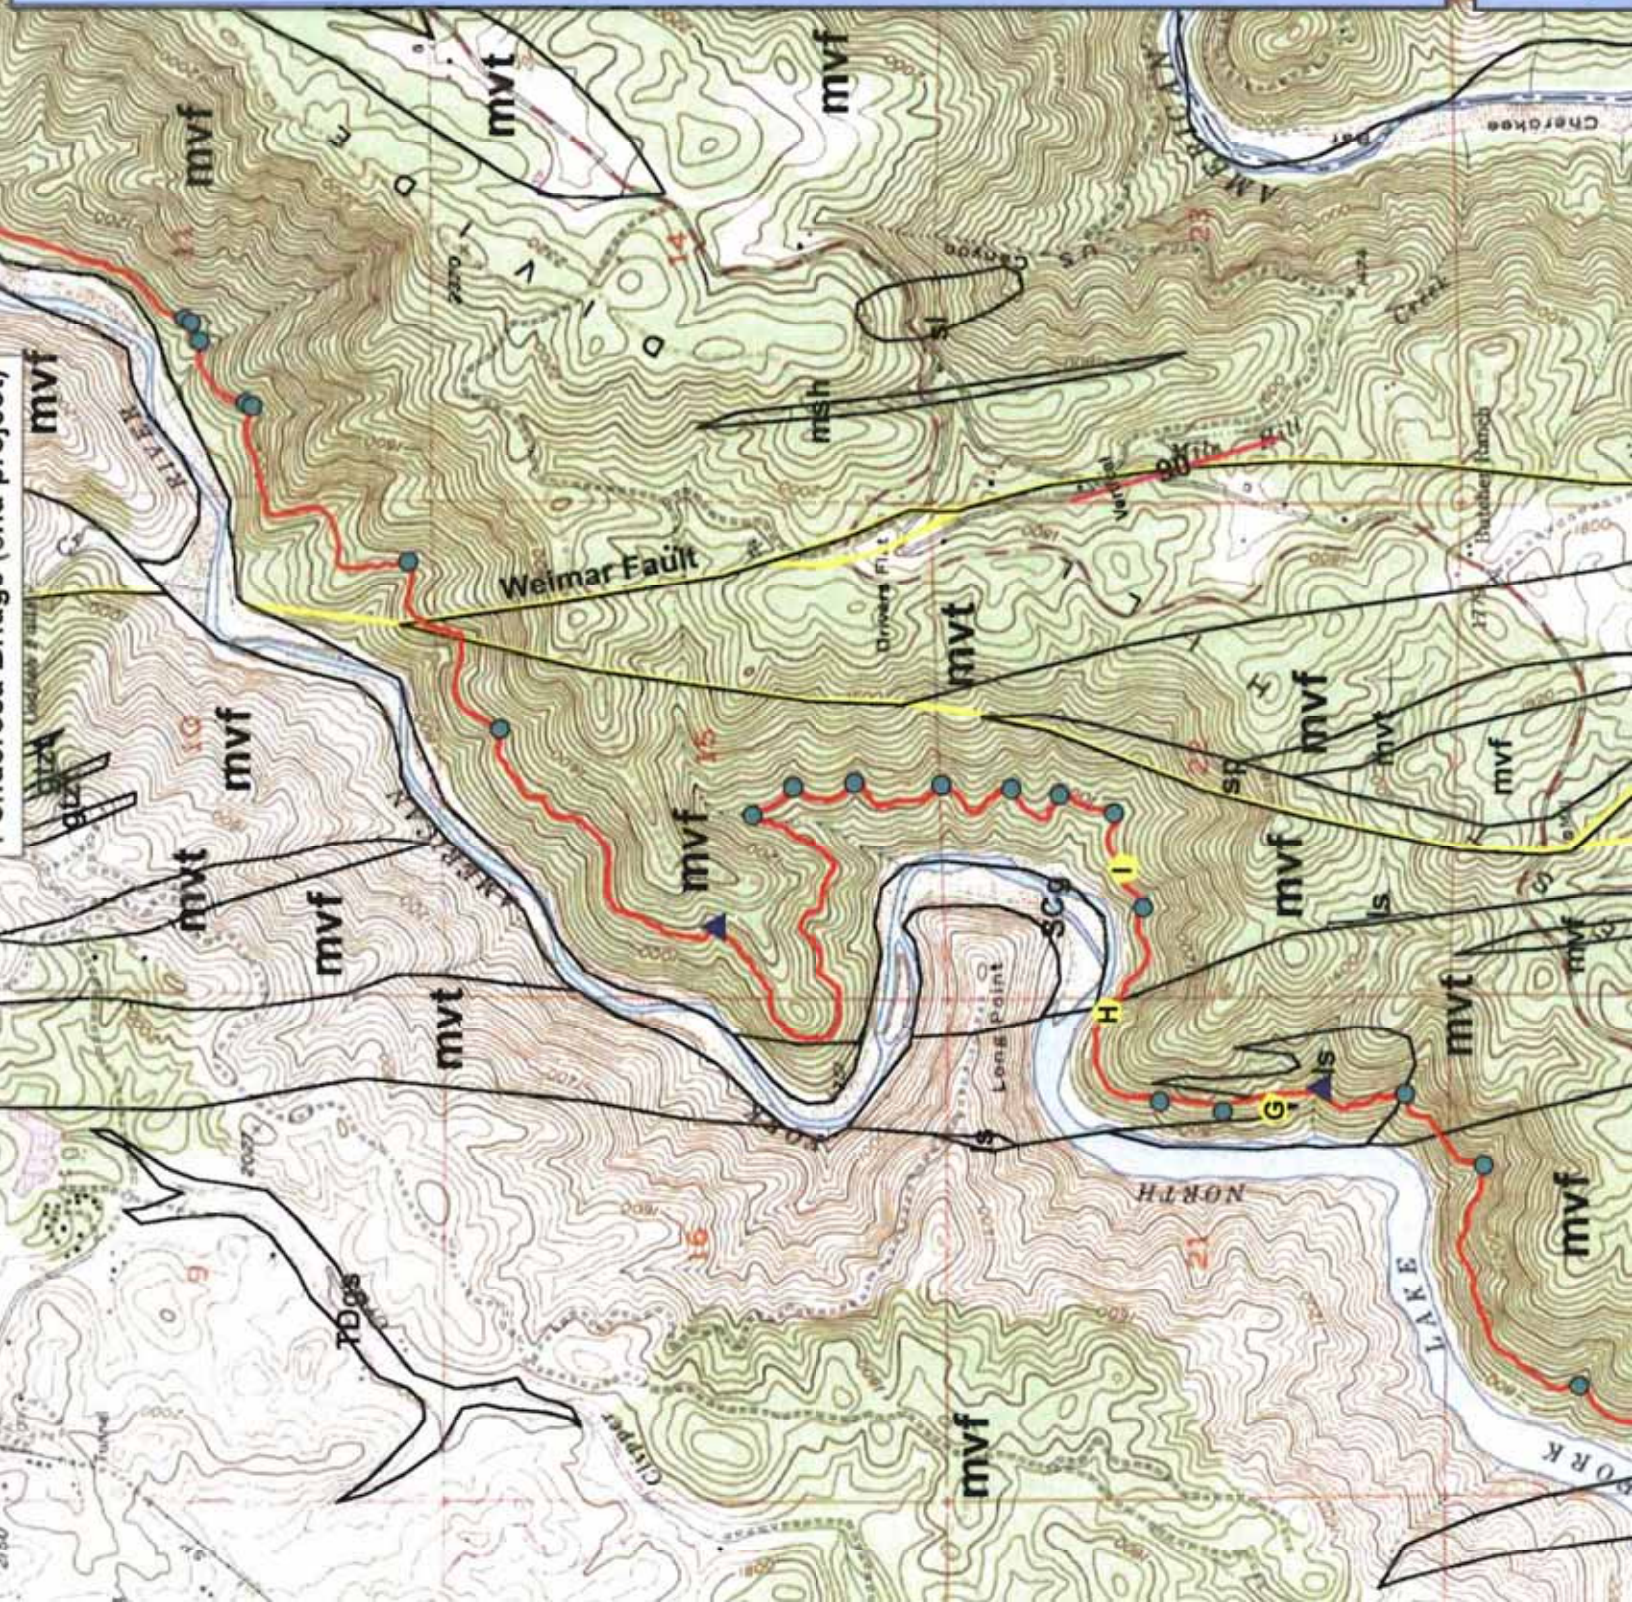
**Figure 2 – Geologic Map (2 Pages)**

- Trail
- Proposed Bridge Crossing
- Proposed Low Water Creek
- Areas Needing Special Attention
- Lithologic Contact
- Fault Contact
- Foliation
- SCg Stream Channel Deposit
- mvf Meta-volcanic, intensely fractured
- mvt Meta-volcanic Tuff, intensely weathered
- mss Meta-sandstone, bedded, coarse grained
- msh Meta-shale, Brit. evenly bedded. Limestone
- ls Limestone, resistant to weathering
- sp Serpentine, Vein, intensely fractured

Livingston (1974) maps the entire project area as predominately hard, fractured, metavolcanic flow rocks. This rock structure strikes generally north-northwest, with fracture/foliation planes dipping steeply northeast. Livingston maps lesser bands of northwesterly trending metavolcanic tuffs and meta-shale crossing sections of the trail alignment; these bands tend to be intensely weathered/foliated and, in general, less competent than the flow rock. Isolated limestone bodies, typically hard and massive, are also mapped within the metavolcanic flow rock.

We show the site geology, as mapped by Livingston, on Figure 2.

The Weimar Fault is mapped near the northeast portion of the project (Wagner, 1981, and Jennings, 1994). This fault, shown on Figure 2, is a Pre-Quaternary fault with no evidence of movement within the last 1.6 million years. Two other unnamed faults are mapped near the Weimar Fault, also shown to be Pre-Quaternary age.

Figures 2 and 3 show the locations of nine sites (identified as "A" through "I") noted during our field review that will require specific geotechnical input by BCI during construction. We discuss each of these sites briefly, below.

Four bridge crossings are proposed along the trail alignment, at locations shown on Figures 2 and 3. Each of these locations cross ephemeral drainages with relatively steep banks. Metamorphic rock is exposed at each site. We expect the structures to consist of 10-25 ft long, single-span, timber-stringer bridges, supported on timber or concrete sill abutments.

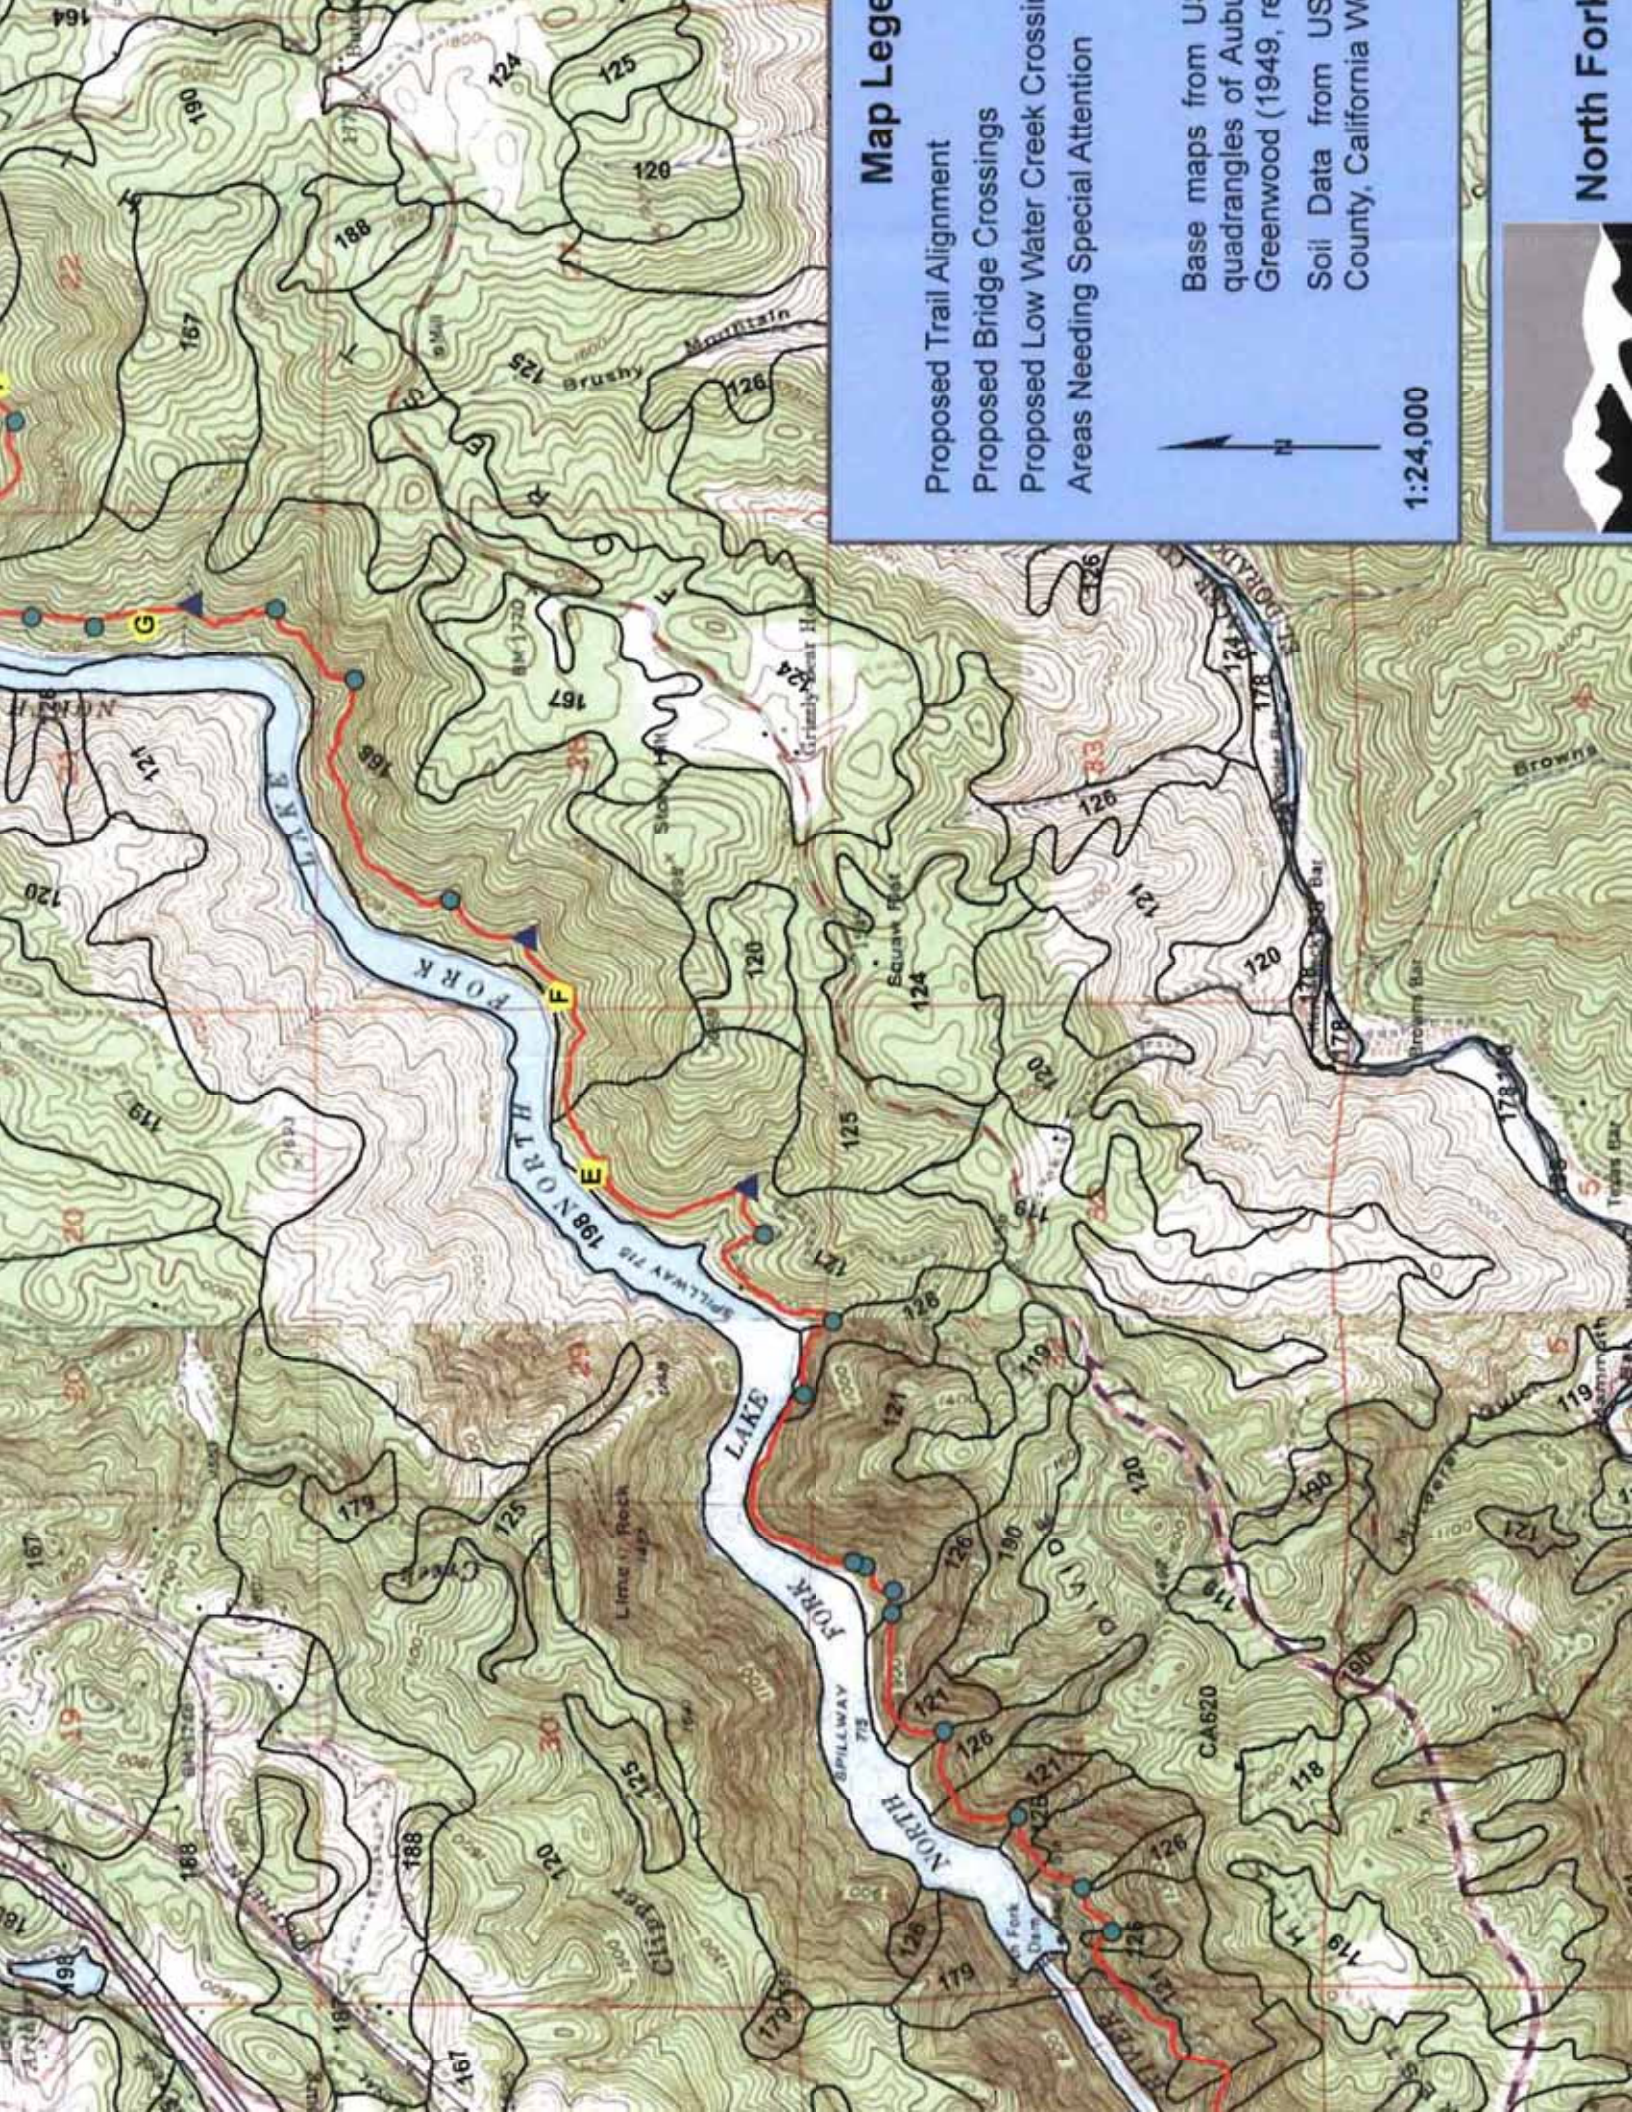
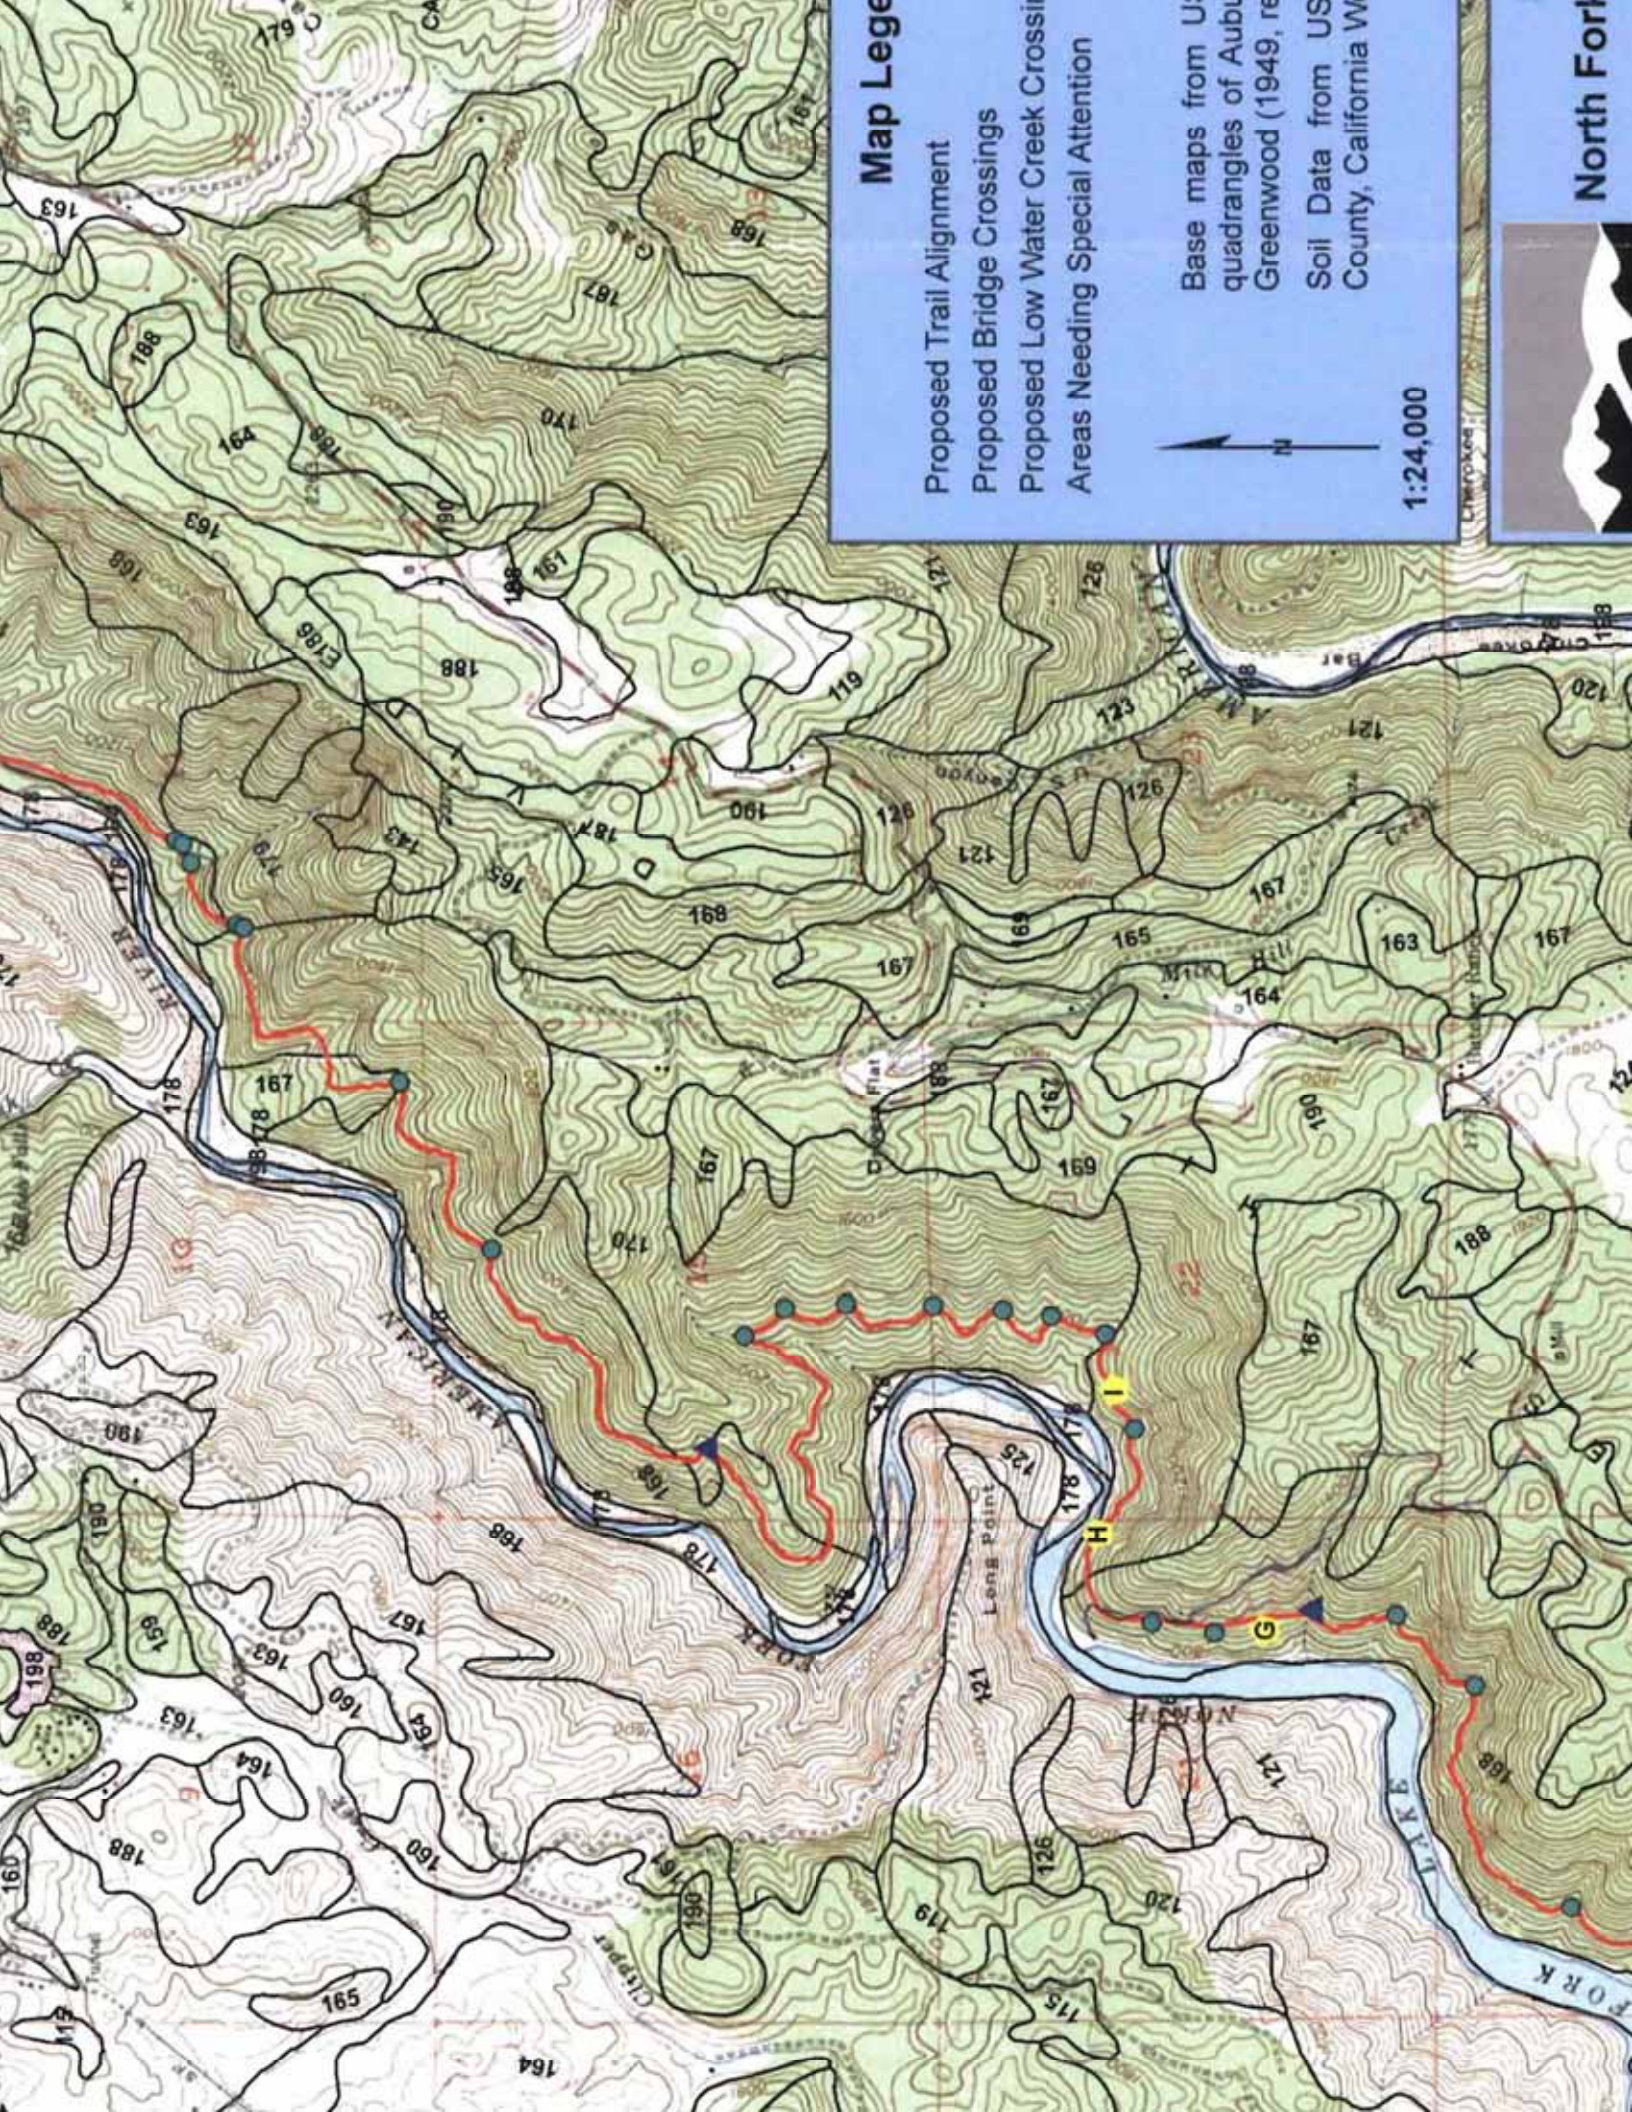
**Figure 3 – Soils Map (2 Pages)**

Proposed Trail Alignment  
Proposed Bridge Crossings  
Proposed Low Water Creek Crossings  
Areas Needing Special Attention

- Proposed Trail Alignment
- Proposed Bridge Crossings
- Proposed Low Water Creek Crossings
- Areas Needing Special Attention

According to the United States Department of Agriculture (USDA), Soil Survey of Placer County, Western Part (July 1980), the site is underlain by the soil types described below. We show the distribution of these soils on Figure 3.

*Auburn-Sobrante-Rock outcrop complex:* The Auburn soil unit is a shallow, residuum soil over fractured, vertically-tilted meta-basic bedrock, with rock outcrops. Typically 4 inches of silt loam over 16 inches of silt loam subsoil. Soil permeability is moderate, with very high erosion potential. The Sobrante soil unit is moderately deep, residuum soil over fractured, vertically-tilted meta-basic bedrock, with rock outcrops. Typically 7 inches of silt loam over 26 inches of silt loam and heavy loam with gravel. Soil permeability is moderate, with very high erosion potential. Rock is erosion resistant.

*Mariposa-Josephine complex:* The Mariposa part of the soil unit is a shallow, residuum soil over weathered/fractured schist and slate, with isolated rock outcrops. Typically 6 inches of gravelly loam over 22 inches of gravelly clay loam. Soil permeability is moderate, with moderate to high erosion potential. The Josephine is a deep, residuum soil over metamorphic rock, with isolated rock outcrops. Typically 11 inches of loam over 41 inches of clay loam and silty clay loam. The soil has slow permeability, with moderate to high erosion potential. Rock is erosion resistant.

*Mariposa-Rock outcrop complex:* Shallow, residuum soil over fractured, vertically-tilted schist and slate, with rock outcrops. Typically 6 inches of gravelly loam over 28 inches of gravelly loam subsoil. Soil cover is moderately permeable, with moderate to high erosion potential. Rock is erosion resistant.
