**GEOTECHNICAL INPUT - EIR**  
**North Fork American River Trail Project**  
Placer County, California

BCI File No. 767.1  
February 2, 2006

Subject: **GEOTECHNICAL INPUT - EIR**  
North Fork American River Trail Project  
Placer County, California

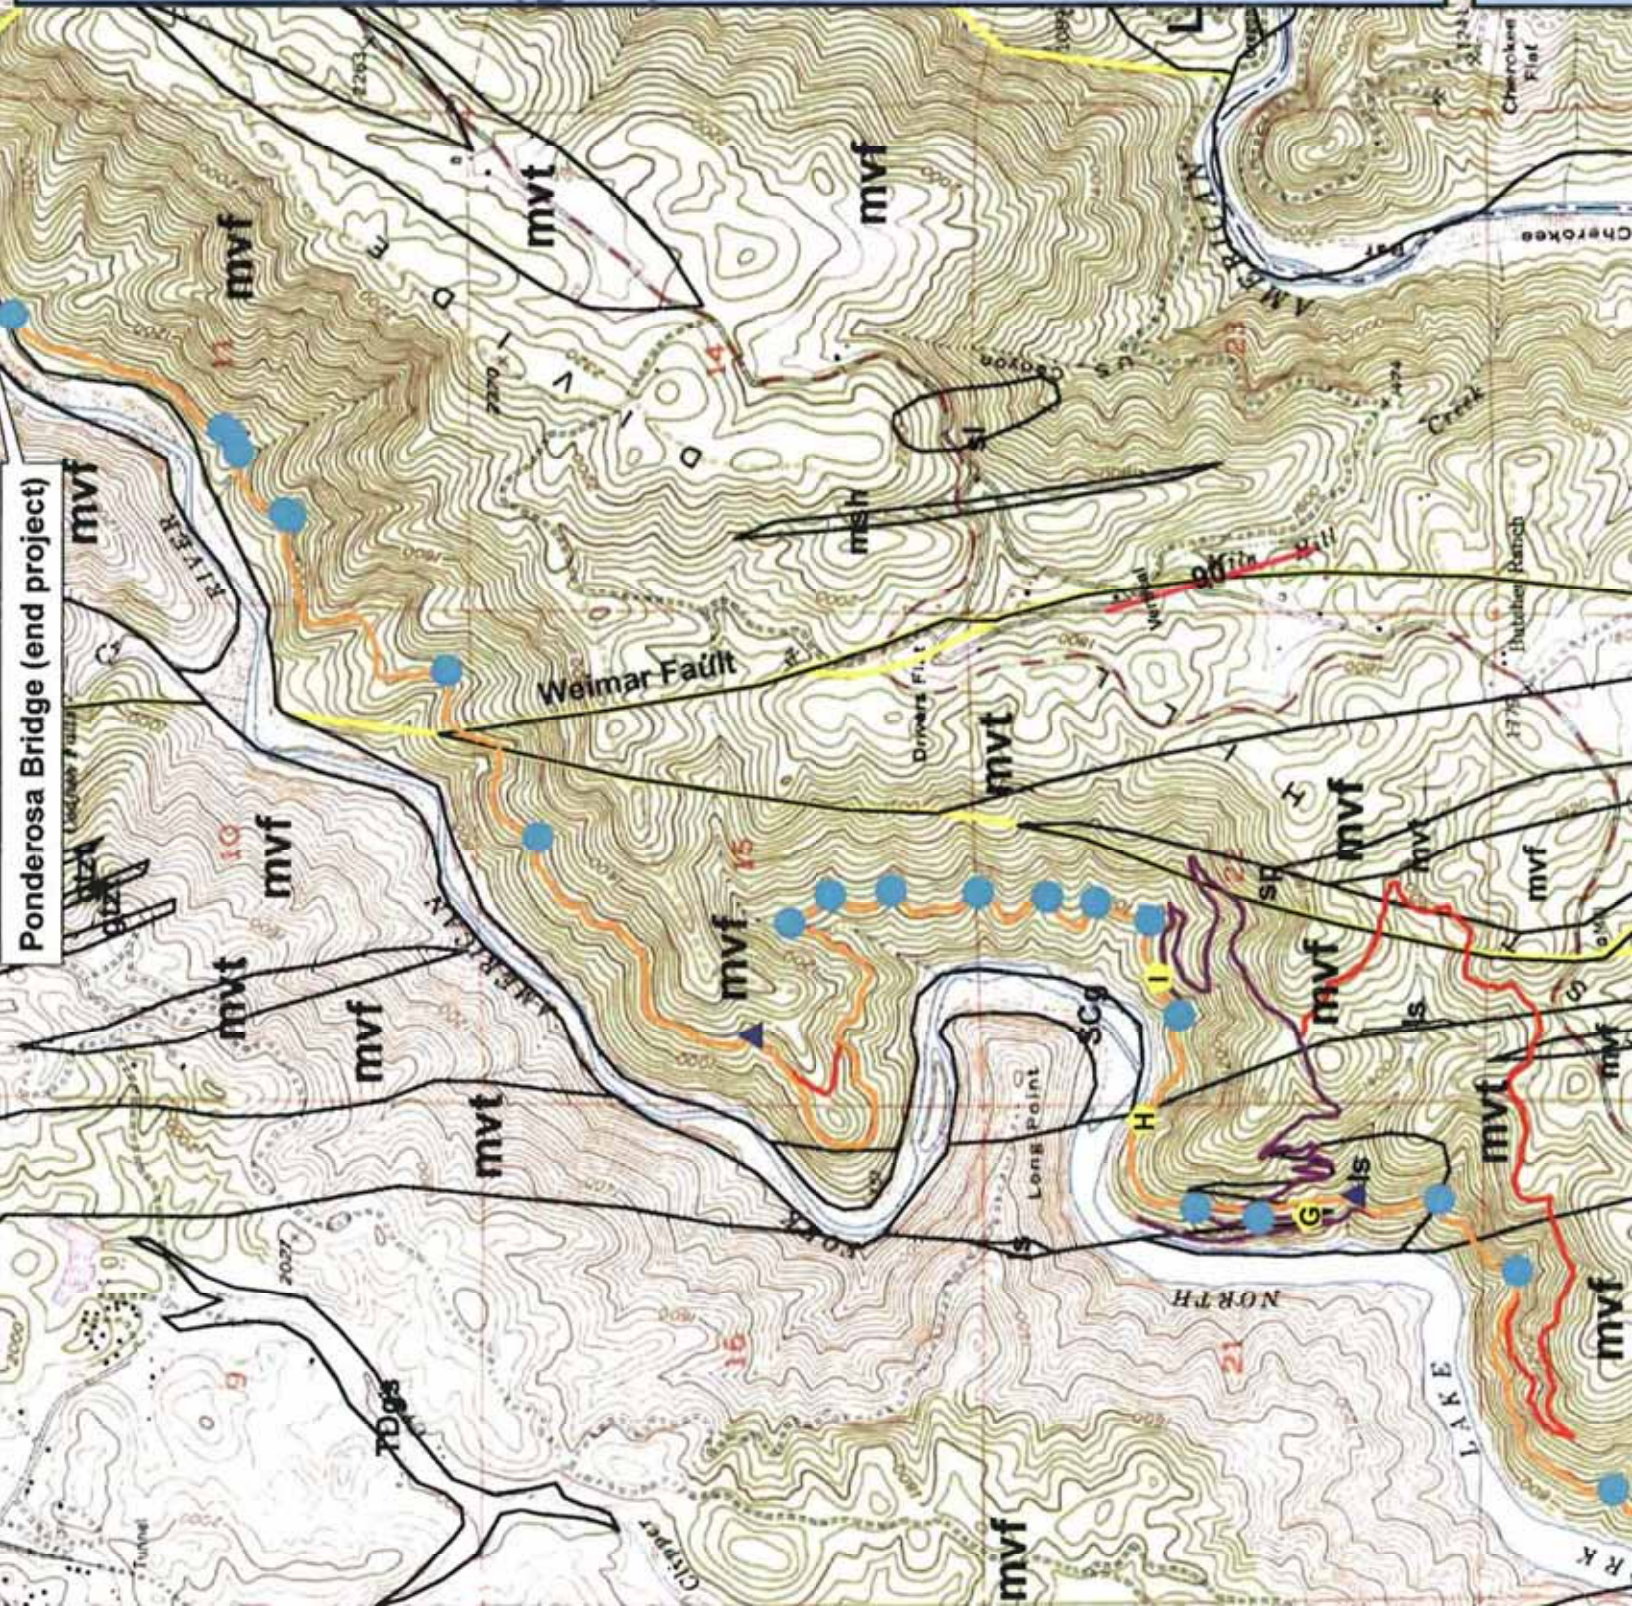
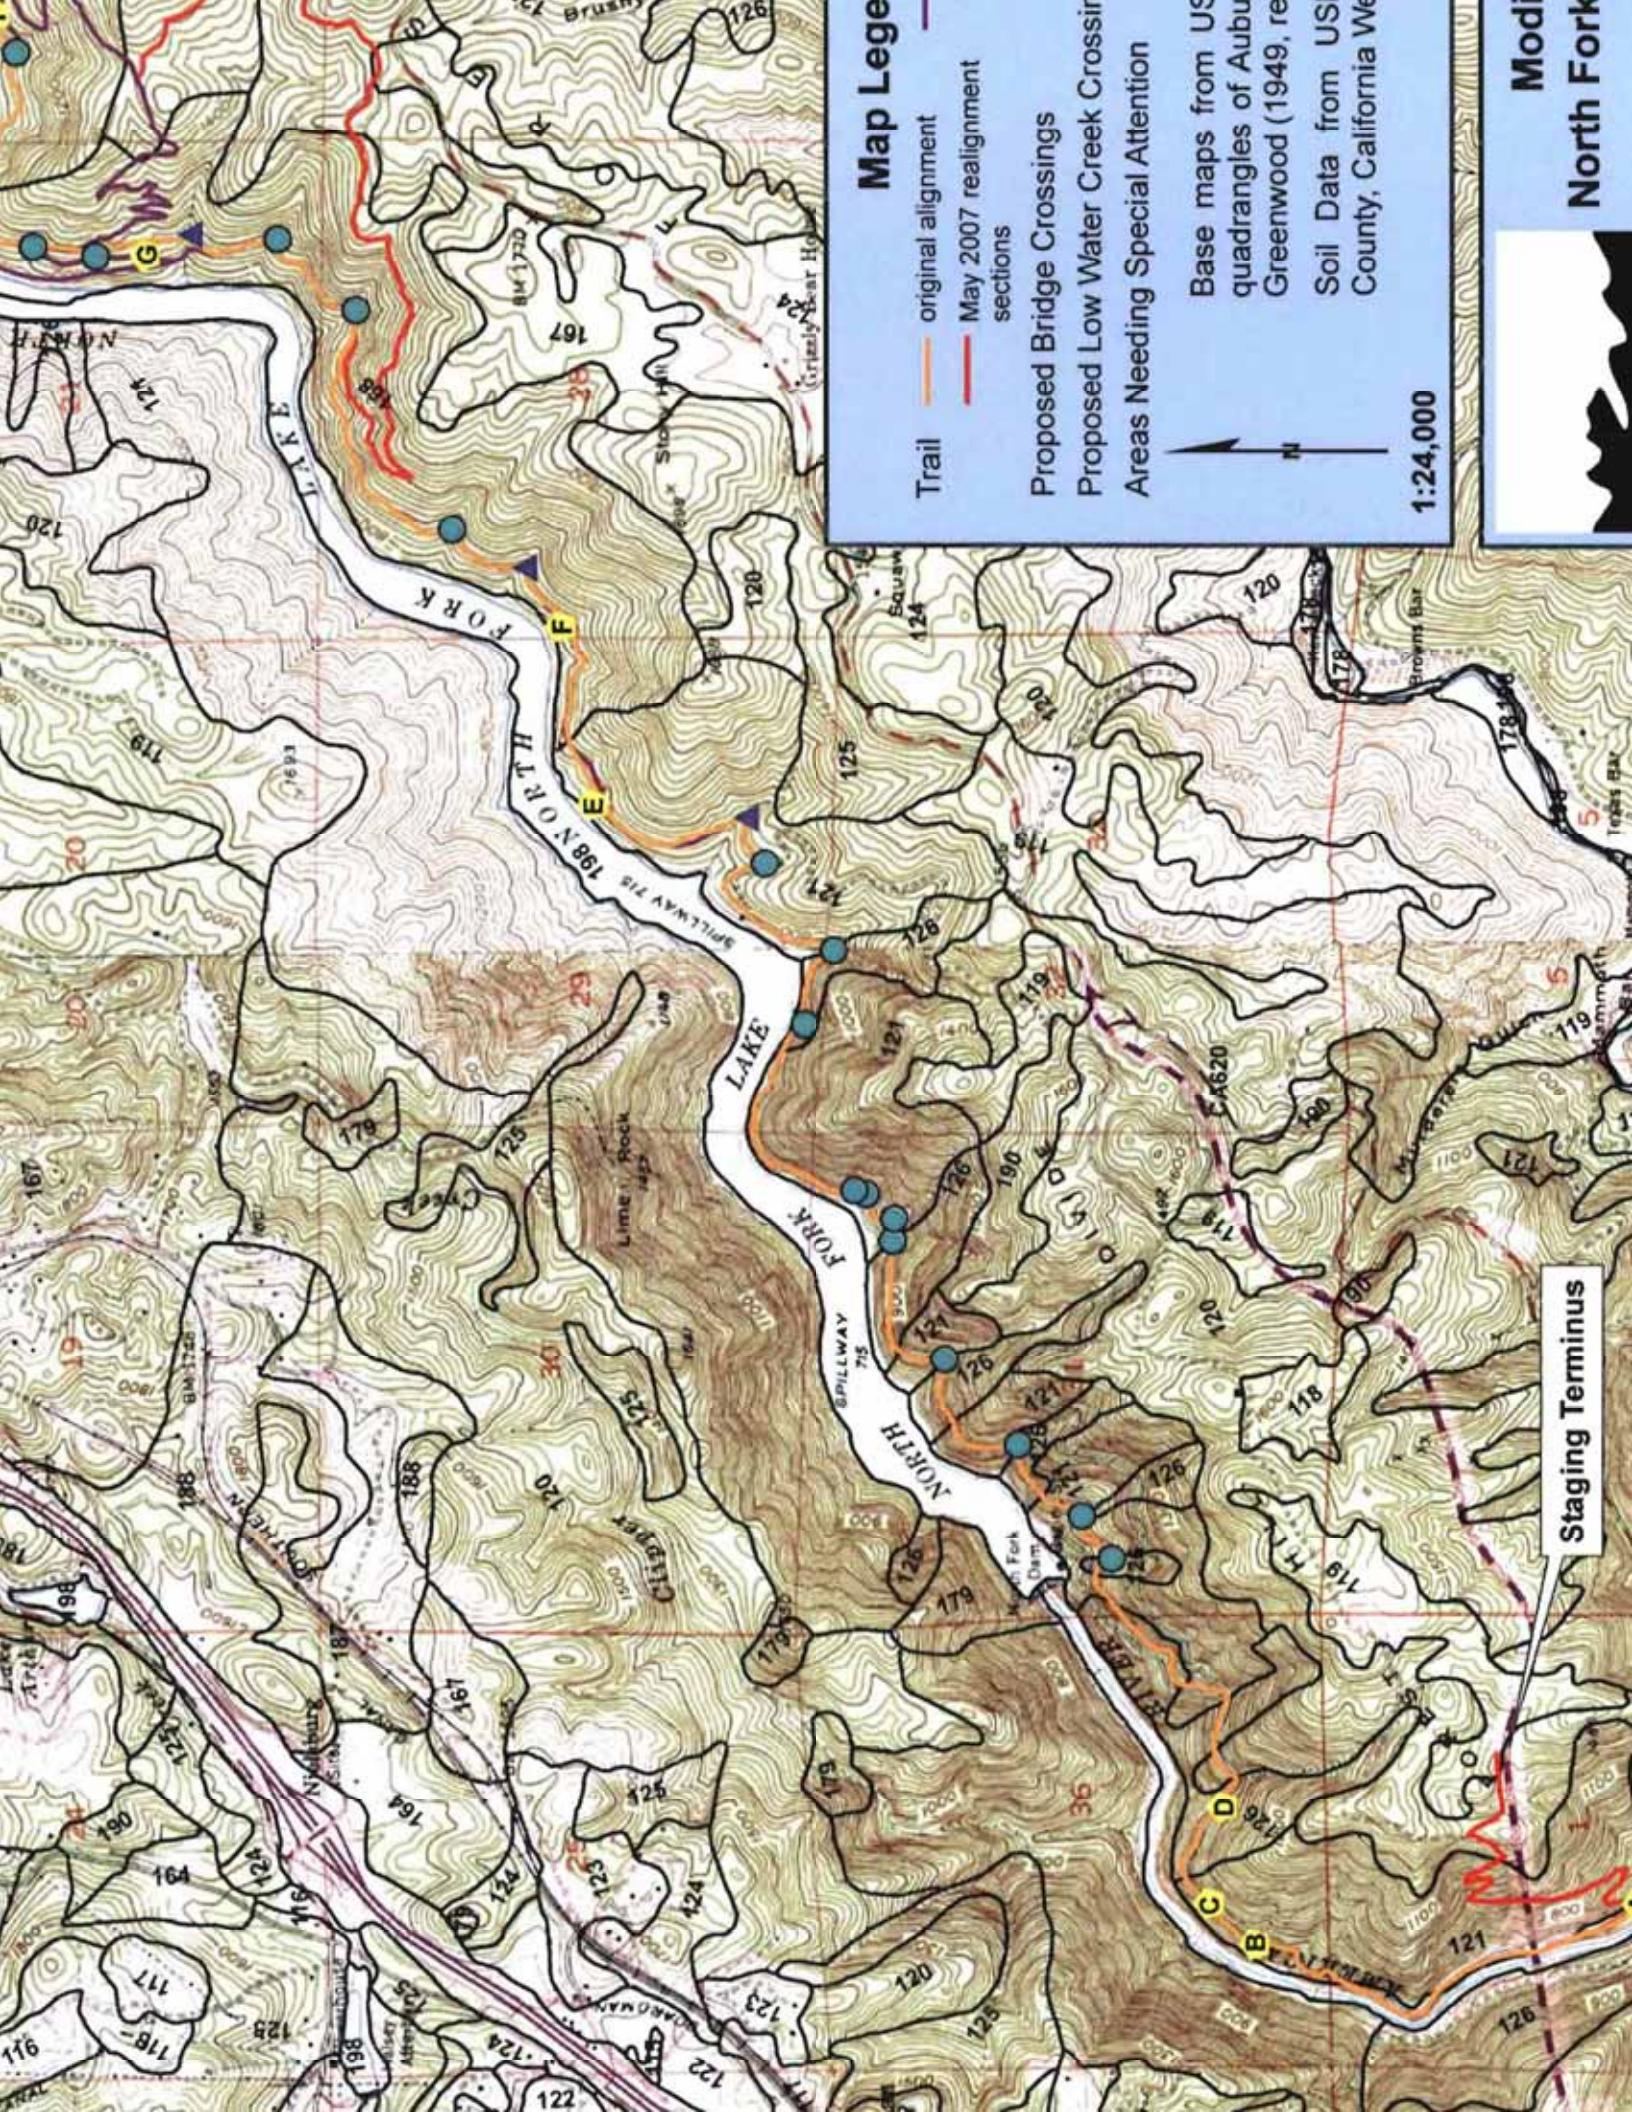
**MODIFIED**  
**North F**

- Trail  
— original alignment  
— May 2007 realignment sections

Attachment: Figure 2 - Modified Geologic Map (2 pages)  
Figure 3 - Modified Soils Map (2 pages)

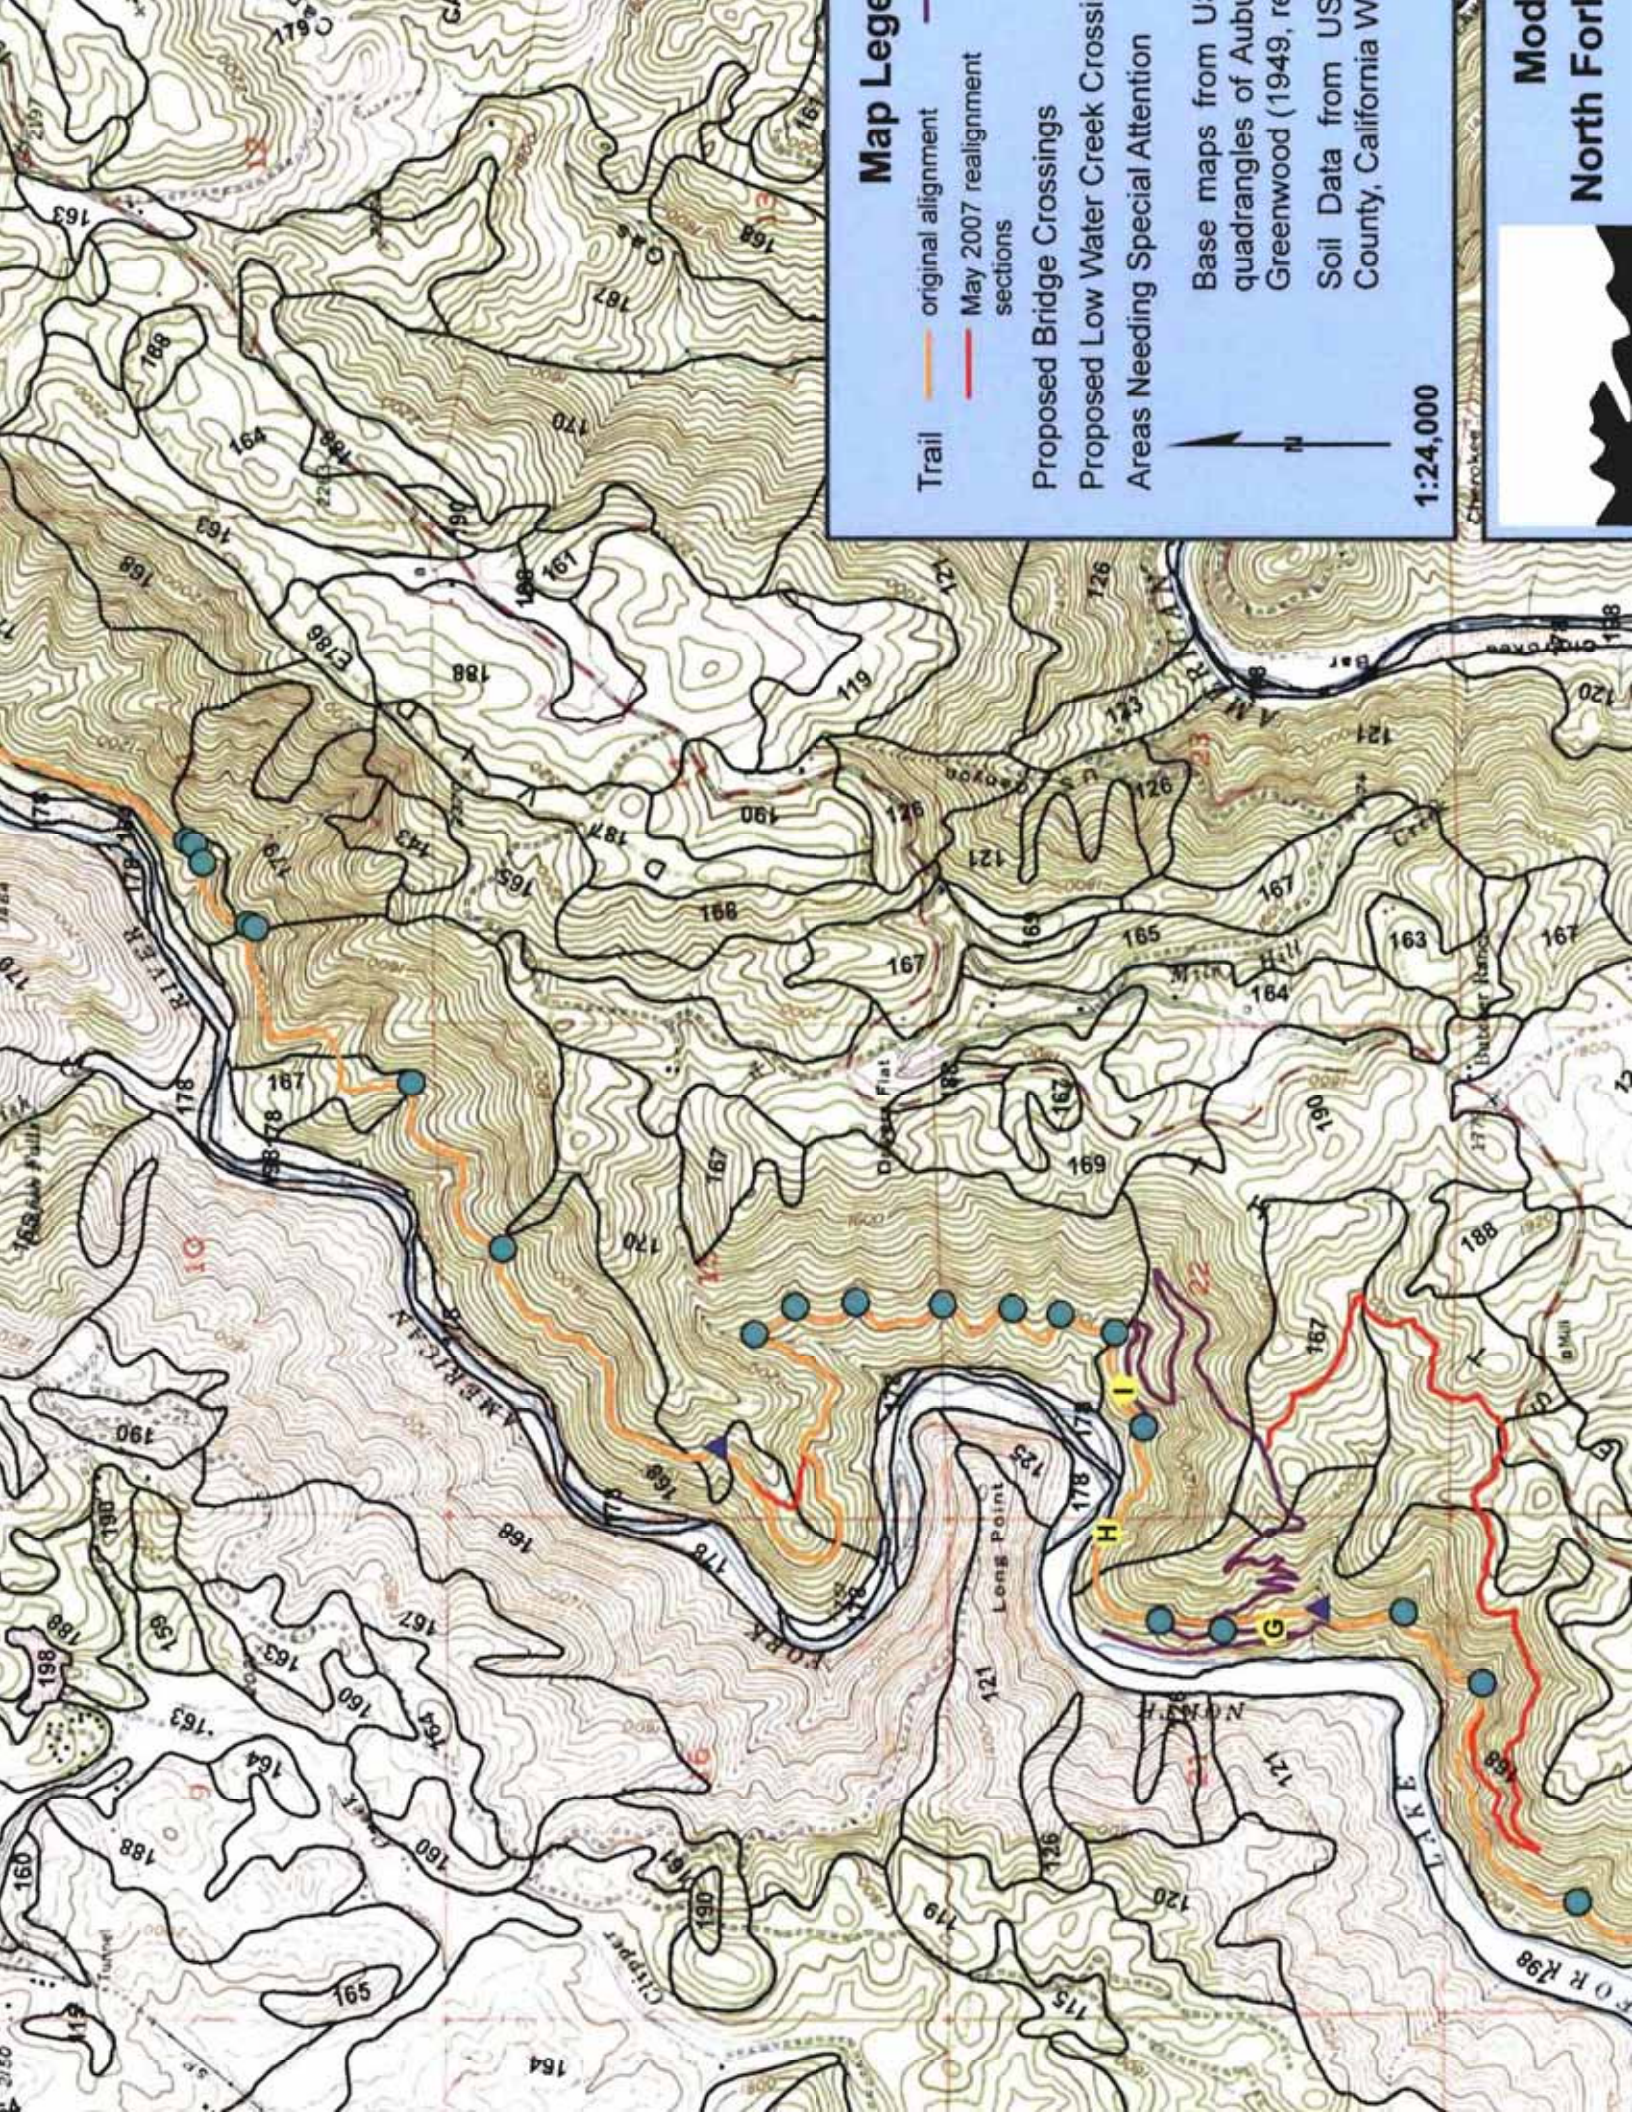
- Trail
- original alignment
- May 2007 realignment sections
