# **Clear Creek Dam Fish Passage Assessment**

**Second Annual Progress Report**

U.S. Fish and Wildlife Service
Mid-Columbia Fishery Resource Office
Yakima Sub-Office

May 5, 2014

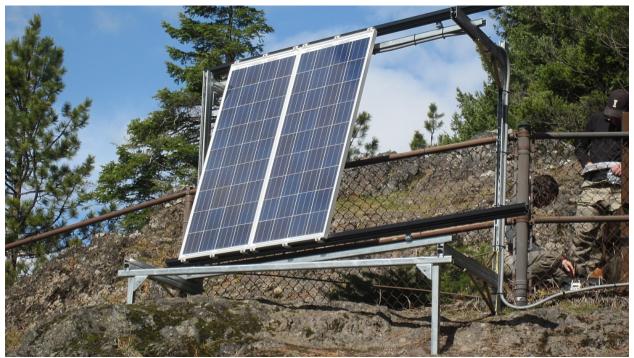
Figure 1. Solar panels installed to power the upper spillway and ladder antennae

As was described in the first annual report, two antennae were operating at the end of 2012. These were located at the top of the spillway channel (spanning the channel directly above the concrete weir on the spillway crest) and at the exit/entry portal of the pool-and-weir ladder. Both operated until the third week of December when weather conditions precluded access to the site and the batteries froze. Solar panels were installed at the site in March, 2013 (Figure 1) to charge the batteries which power these antennae and eliminate the need to exchange batteries. At the same time a new high-tension nylon rope with less stretch than the previous one was installed spanning the spillway weir and a turnbuckle was included at the right side anchor. This provided much greater tightening capability to prevent the loss of the antenna to high flows. Elevated mounting platforms for the tuning boxes for both the spillway and ladder antennae were also constructed to eliminate the possibility of submergence.

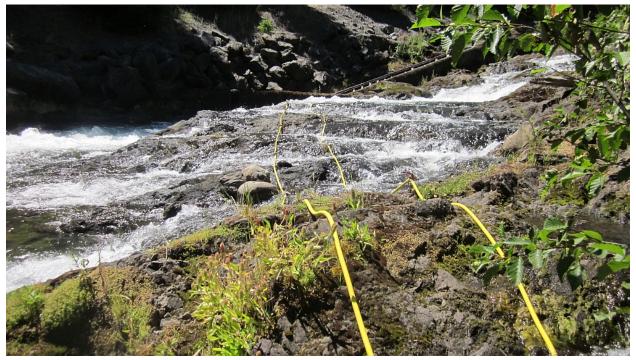
Figure 2. Antenna installed at the lower terminus of the spillway channel on July 9, 2013

A new antenna was installed spanning the spillway channel just above its lower terminus on July 9, 2013 (Figure 2). PIT tag detections at this lower spillway site will provide confirmation that any bull trout detected at the top of the spillway channel actually left Clear Lake. They will also provide data to determine when tagged fish attempted to ascend the channel and the success they had in doing so.

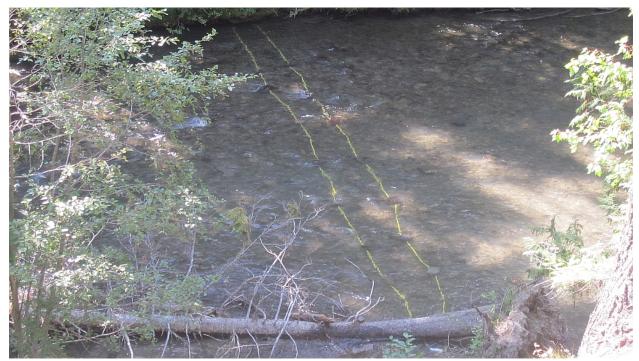
Figure 3. Antenna installed in the North Fork Tieton River on August 1, 2013

A new antenna was also installed in the NF Tieton River on August 1 (Figure 3). This channel-spanning antenna was located 0.75 mile upstream of Clear Lake. Detections at this site will reveal pre- and post-spawn migration timing (and residence time in the river), provide some

The NF Tieton and lower spillway antennae were constructed from General Cable Carol Super-VU Tron Supreme power cable, 12 gage with 4 strands. The North Fork antenna consisted of a single coil attached to the stream bed using rebar anchors in a flat-plate or pass over configuration. This antenna measured 20 meters (66 feet) long by about 1 meter (3 feet) wide. After dewatering the channel the lower spillway antenna was attached to the bedrock spillway using stainless steel anchor bolts with eye nuts attached. The antenna wire was run through the eyes and tied off for stability (Figure 4). This antenna was also in a flat-plate configuration measuring 16.3 meters (54 feet) long by about 0.6 meters (2 feet) wide. Both antennae operated on 12 volt DC current supplied by rechargeable deep-cycle batteries. Solar panels were mounted to recharge the batteries at the lower spillway site (Figure 5); The North Fork site lacked the necessary exposure for a solar configuration, thus the two six-volt batteries which powered the antenna were exchanged weekly. Antenna performance was evaluated periodically using test tags and through the use of timer tags, once installed, set to send a tag code to the reader every 31 minutes. Data was downloaded manually with a laptop computer and subsequently stored on Reclamation's Upper-Columbia Area Office network.

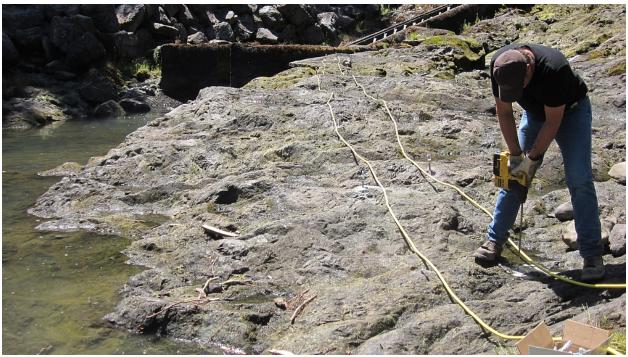
Figure 4. Installation of the lower spillway antenna on July 9, 2013

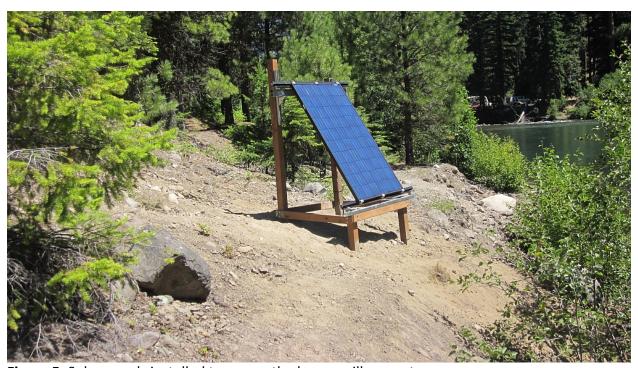
Figure 5. Solar panels installed to power the lower spillway antenna

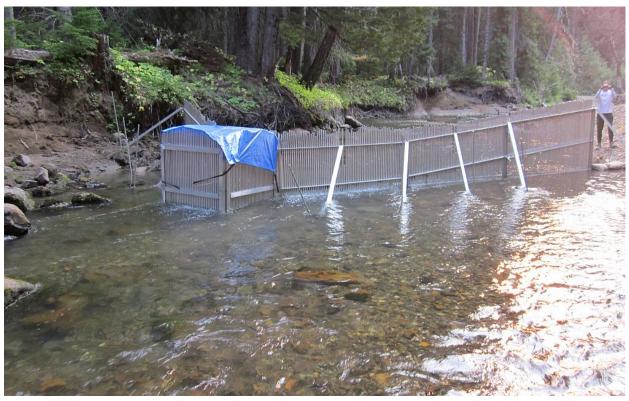
Figure 6. The picket-weir box trap use in 2012 on the North Fork Tieton River

The same picket-weir box trap that was used in 2012 was again utilized in 2013 but with some significant modifications. Having noted the escape of two bull trout from the capture box in 2012 and avoidance behavior (trap shyness) displayed by a few bull trout approaching the trap entrance, these modifications were deemed necessary. Figure 6 shows the trap configuration used in 2012. The trap box was directly connected to adjacent weir panels. The entrance to the trap (not pictured) was flat and perpendicular to the current with two wings extending into the trap where fish would pass through a vertical opening 4-5 inches wide. It was thought that trapped fish would be disinclined to go back through this opening but that turned out not to be the case on at least a couple of occasions. The entrance was modified so that a caged cone extended about three feet back from the entrance (Figure 7). This cone led to a 10-inch diameter opening to which a four-foot section of PVC pipe was attached. This pipe extended about two feet into the trap and was approximately six inches above the stream bed inside it. A burlap sleeve was then affixed to the end of the pipe to further dissuade captured fish from finding the opening. Finally, the entrance to the trap was painted flat black to minimize avoidance behavior. Figure 8 shows the trap entrance and the position of the trap relative to it. All modifications were done WDFW's Region 3 screen shop.

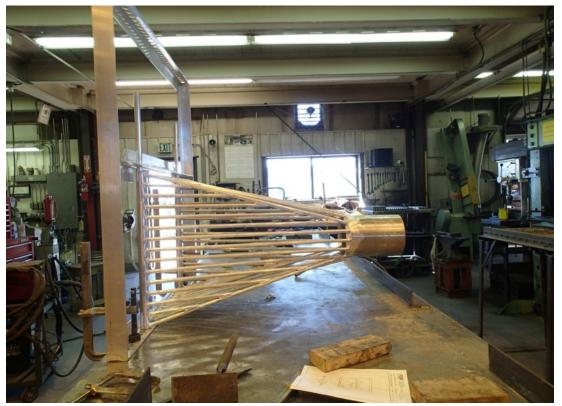
Figure 7. Modification to the entrance of the 2013 trap in WDFW's screen shop

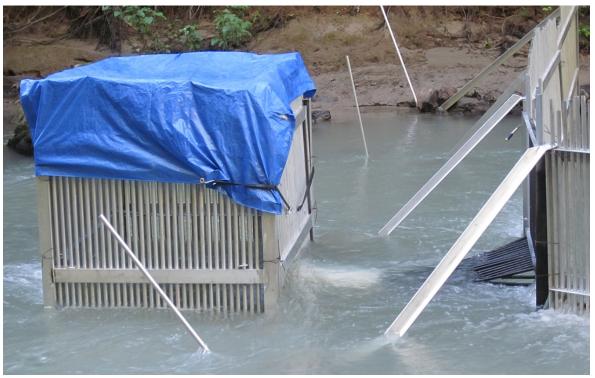
**Figure 8**. The modified configuration of the trap used in 2013. Note the modified entrance leading to the PVC pipe extending into the trap. The trap itself sits about five feet from the entrance.

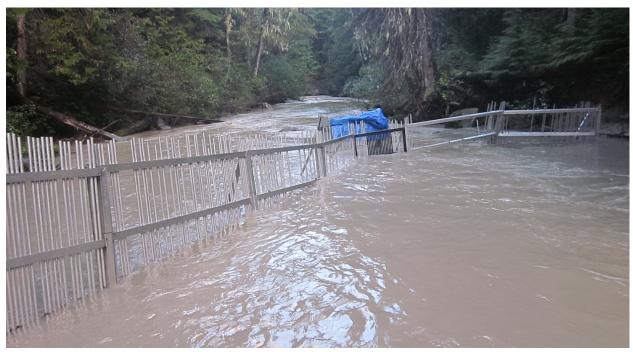
**Figure 9.** North Fork Tieton River fish trap after the high flow event on September 22, 2013 had partially collapsed the two weir panels on the right bank and weir pickets had been pulled to relieve pressure on the panels. The photo was taken the next day after the river had receded.

The trapping operation progressed without complications except for two notable exceptions. The first was the high flow event on September 22 when the river rose approximately 1.5 feet and partially collapsed the two eight-foot weir panels on the right bank (Figure 9). At 6:30 PM the crew worked quickly pulling pickets from the weir panels to reduce pressure on them. The structure incurred no further damage. At around 11:00 PM, after river stage had dropped about 12 inches, the partially collapsed panels were righted to the greatest extent possible and pickets were replaced in alternating holes in the weir panels. The trap was fishing again but with the possibility that fish could pass through the three-inch gap between alternating pickets. With intermittent rain still occurring throughout the day on September 23, all of the pickets were not replaced until the following morning. The panels on the right bank were also realigned

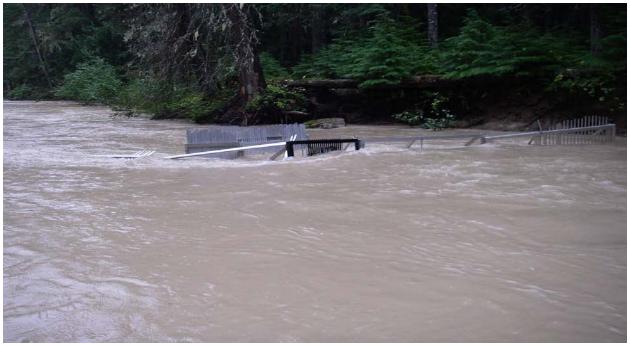
**Figure 10.** North Fork Tieton River fish trap during the high flow event which occurred at the end of September, 2013. This photo was taken the morning of September 29<sup>th</sup>. The left weir panels have already washed downstream. The remaining panels and the box were gone soon after. The river continued to rise.

The second high flow event began the afternoon of September 27 with a steadily rising river that seemed to level off by late night. However, heavy rains occurred the next day and by very early in the morning of September 29 the river was rising rapidly. Efforts to save the trap in the pre-dawn hours were halted because of dangerous conditions. A few hours later the trap began to disintegrate and washed downriver (Figure 10). Our trapping operation had come to a quick and decisive end. (Note: all of the weir and trap box components were recovered a few days later when the river had receded. Some had washed as much as 200 meters downstream).

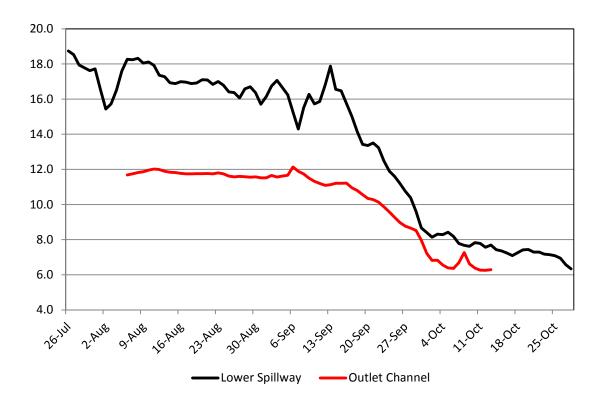
**Figure 11**. Average daily water temperatures (°C) for 2013 in the lower spillway and outlet channels of Clear Creek Dam on the North Fork Tieton River

Water temperatures at the top of the spillway (i.e. the ladder) and the bottom tracked closely and will not be differentiated here. On July 25 the mean daily temperature exceeded 18°C and for all but one day remained above 15°C (the temperature believed to limit bull trout distribution) until September 17 before beginning a steady decline (Figure 11). Temperature data for the outlet channel were a more limited because high releases from the dam had washed the data logger closer to the stream bank and it was left in the dry after October 13. By that time average water temperatures in both the outlet and spillway channels were fairly similar and below 8°C. This certainly was not the case through August and most of September when temperatures were much cooler in the outlet channel. The logger in the NF Tieton River only collected data for 19 days. It ran out of storage space on August 19 because it had mistakenly been set to record data every minute. The data that were collected showed average daily water temperatures ranging from 10-11.5°C.
