Clear Creek Dam Fish Passage Assessment

Second Annual Progress Report

**U.S. Fish and Wildlife Service
Mid-Columbia Fishery Resource Office
Yakima Sub-Office**

**U.S. Bureau of Reclamation
Columbia-Cascades Area Office**

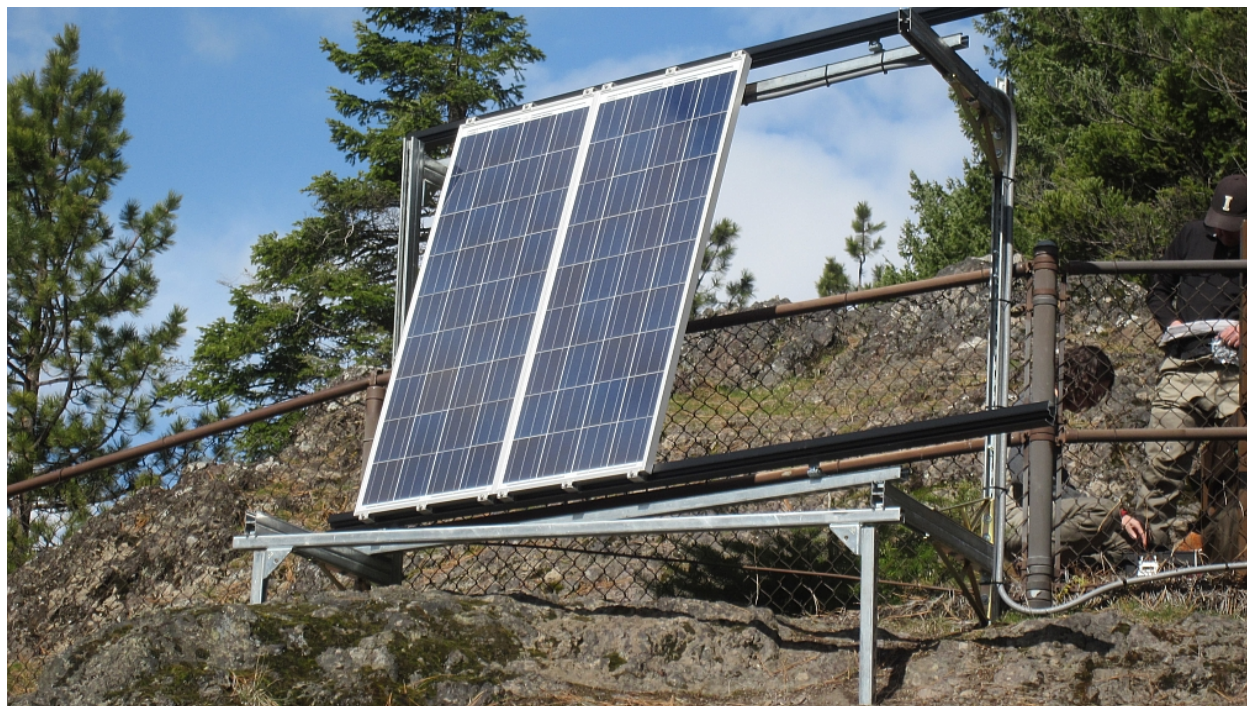
Figure 1. Solar panels installed to power the upper spillway and ladder antennae

After thinking this through, we believe what most likely occurred was that the new solar charging system for the upper spillway and ladder site created “noise” or interference with the PIT tag interrogation equipment which for some reason only affected the much larger spillway antenna. We briefly considered the possibility that natural solar “noise” was the source of the problem but this hypothesis was discarded. Solar noise can cause interference with RFID

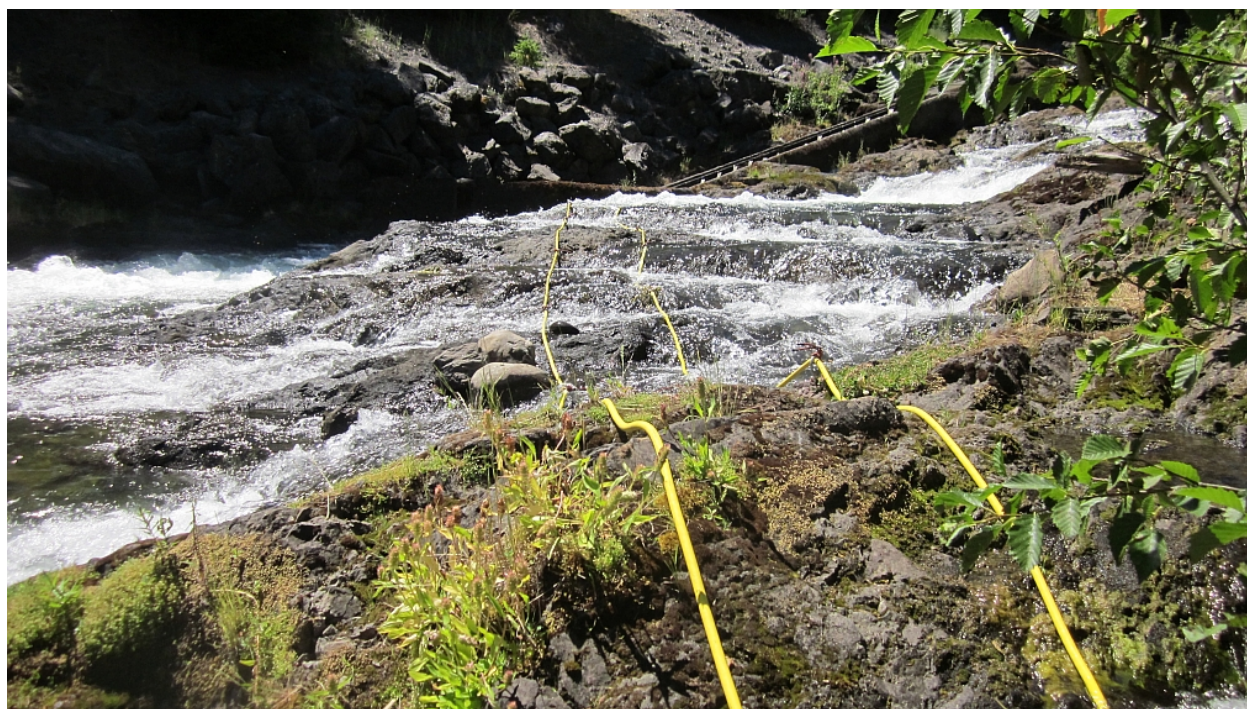
Figure 2. Antenna installed at the lower terminus of the spillway channel on July 9, 2013

A new antenna was installed spanning the spillway channel just above its lower terminus on July 9, 2013 (Figure 2). PIT tag detections at this lower spillway site will provide confirmation that any bull trout detected at the top of the spillway channel actually left Clear Lake. They will also provide data to determine when tagged fish attempted to ascend the channel and the success they had in doing so.

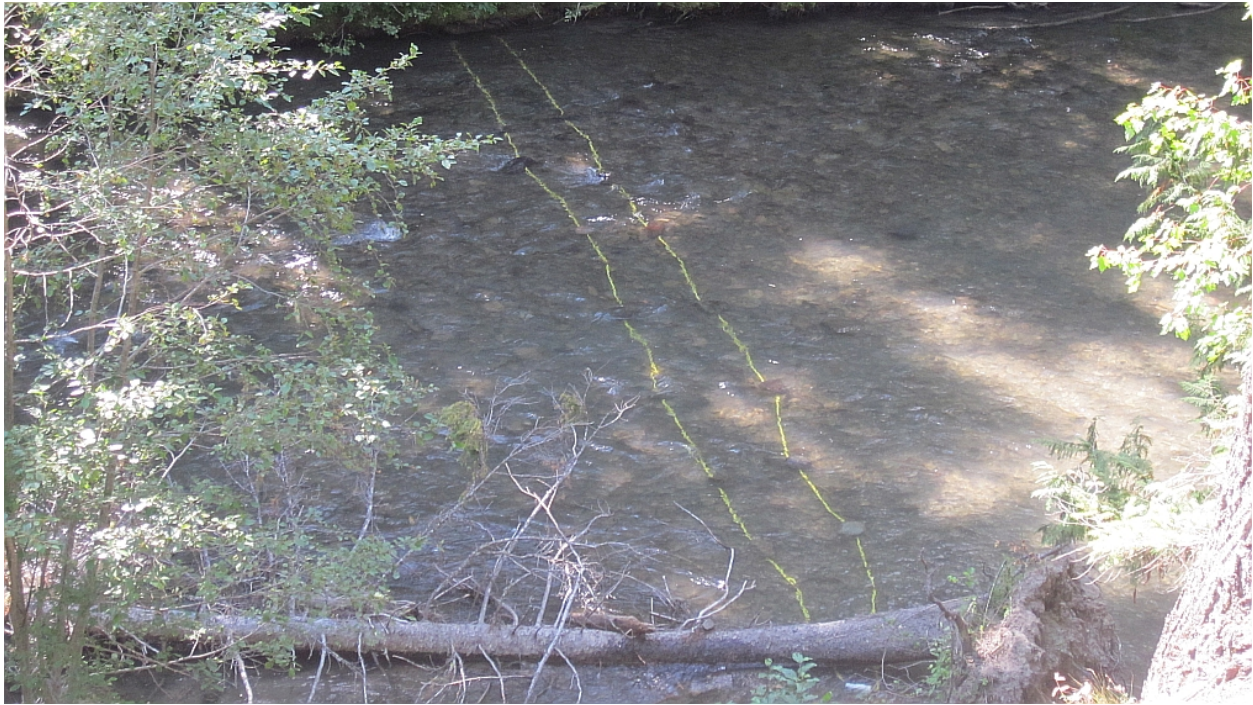
Figure 3. Antenna installed in the North Fork Tieton River on August 1, 2013

A new antenna was also installed in the NF Tieton River on August 1 (Figure 3). This channel-spanning antenna was located 0.75 mile upstream of Clear Lake. Detections at this site will reveal pre- and post-spawn migration timing (and residence time in the river), provide some

The NF Tieton and lower spillway antennae were constructed from General Cable Carol Super-VU Tron Supreme power cable, 12 gage with 4 strands. The North Fork antenna consisted of a single coil attached to the stream bed using rebar anchors in a flat-plate or pass over configuration. This antenna measured 20 meters (66 feet) long by about 1 meter (3 feet) wide. After dewatering the channel the lower spillway antenna was attached to the bedrock spillway using stainless steel anchor bolts with eye nuts attached. The antenna wire was run through the eyes and tied off for stability (Figure 4). This antenna was also in a flat-plate configuration measuring 16.3 meters (54 feet) long by about 0.6 meters (2 feet) wide. Both antennae operated on 12 volt DC current supplied by rechargeable deep-cycle batteries. Solar panels were mounted to recharge the batteries at the lower spillway site (Figure 5); The North Fork site lacked the necessary exposure for a solar configuration, thus the two six-volt batteries which powered the antenna were exchanged weekly. Antenna performance was evaluated periodically using test tags and through the use of timer tags, once installed, set to send a tag code to the reader every 31 minutes. Data was downloaded manually with a laptop computer and subsequently stored on Reclamation's Upper-Columbia Area Office network.

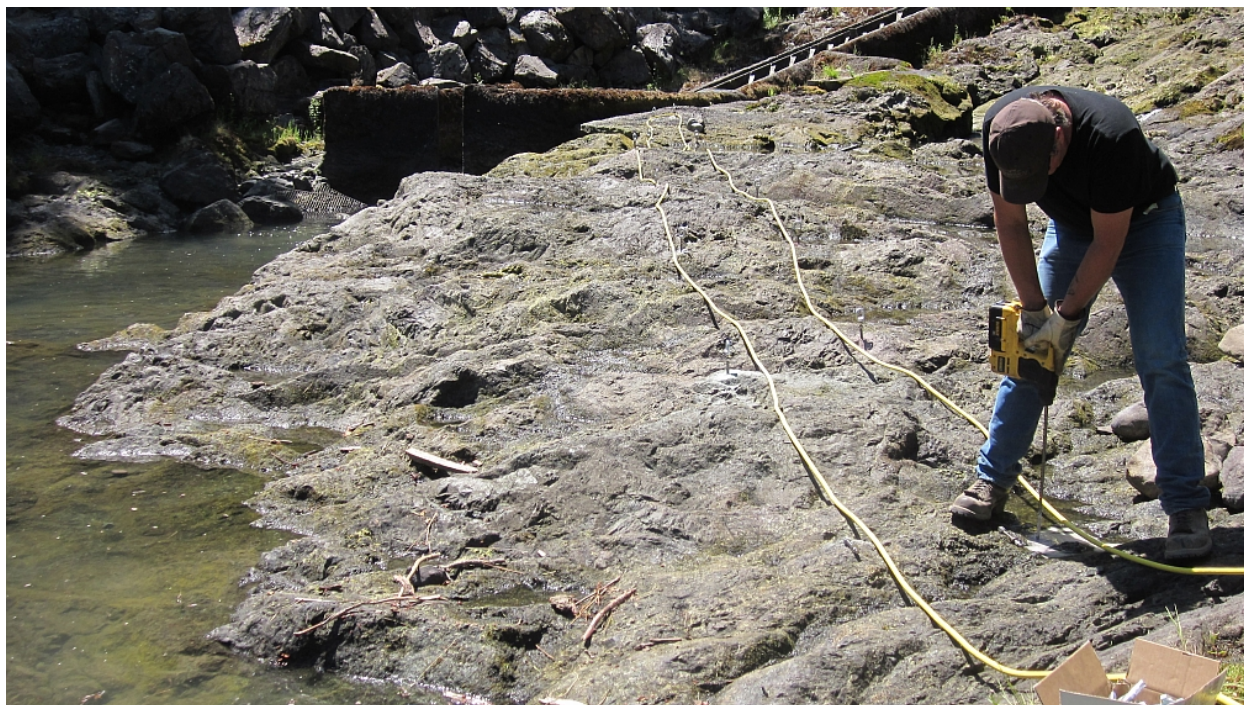
Figure 4. Installation of the lower spillway antenna on July 9, 2013

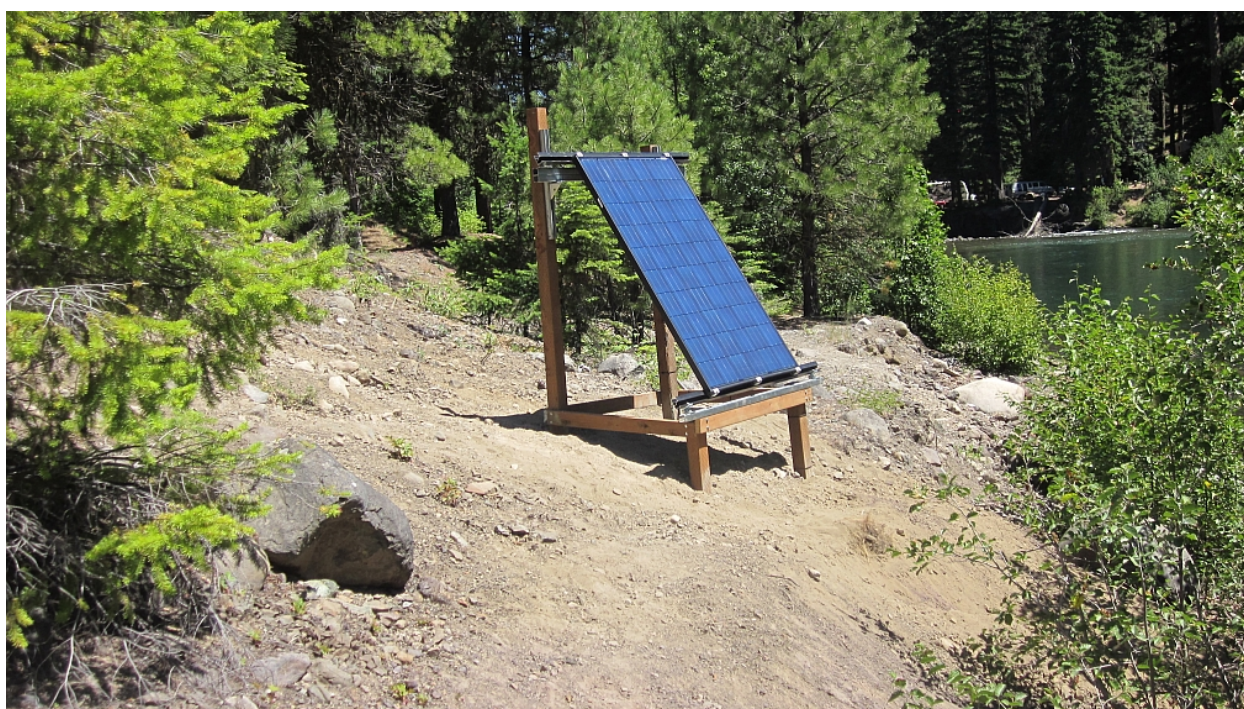
Figure 5. Solar panels installed to power the lower spillway antenna

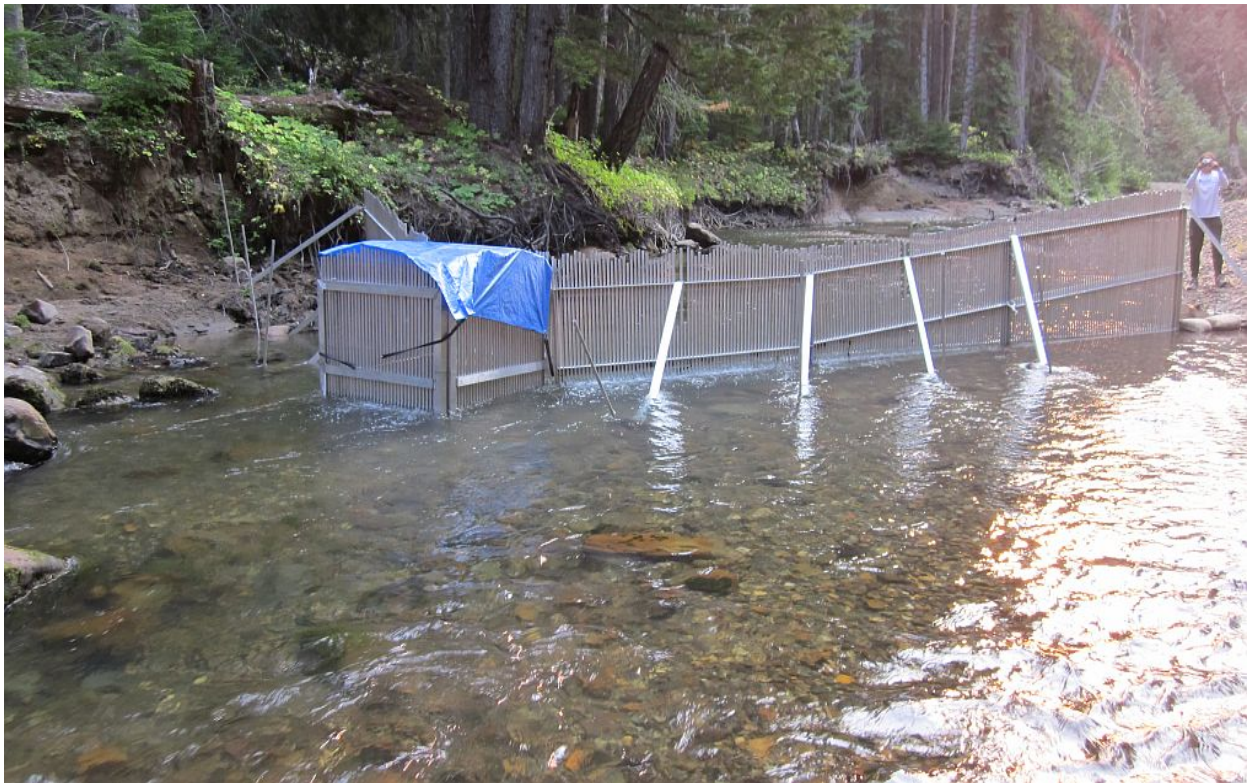
Figure 6. The picket-weir box trap use in 2012 on the North Fork Tieton River

The same picket-weir box trap that was used in 2012 was again utilized in 2013 but with some significant modifications. Having noted the escape of two bull trout from the capture box in 2012 and avoidance behavior (trap shyness) displayed by a few bull trout approaching the trap entrance, these modifications were deemed necessary. Figure 6 shows the trap configuration used in 2012. The trap box was directly connected to adjacent weir panels. The entrance to the trap (not pictured) was flat and perpendicular to the current with two wings extending into the trap where fish would pass through a vertical opening 4-5 inches wide. It was thought that trapped fish would be disinclined to go back through this opening but that turned out not to be the case on at least a couple of occasions. The entrance was modified so that a caged cone extended about three feet back from the entrance (Figure 7). This cone led to a 10-inch diameter opening to which a four-foot section of PVC pipe was attached. This pipe extended about two feet into the trap and was approximately six inches above the stream bed inside it. A burlap sleeve was then affixed to the end of the pipe to further dissuade captured fish from finding the opening. Finally, the entrance to the trap was painted flat black to minimize avoidance behavior. Figure 8 shows the trap entrance and the position of the trap relative to it. All modifications were done WDFW's Region 3 screen shop.

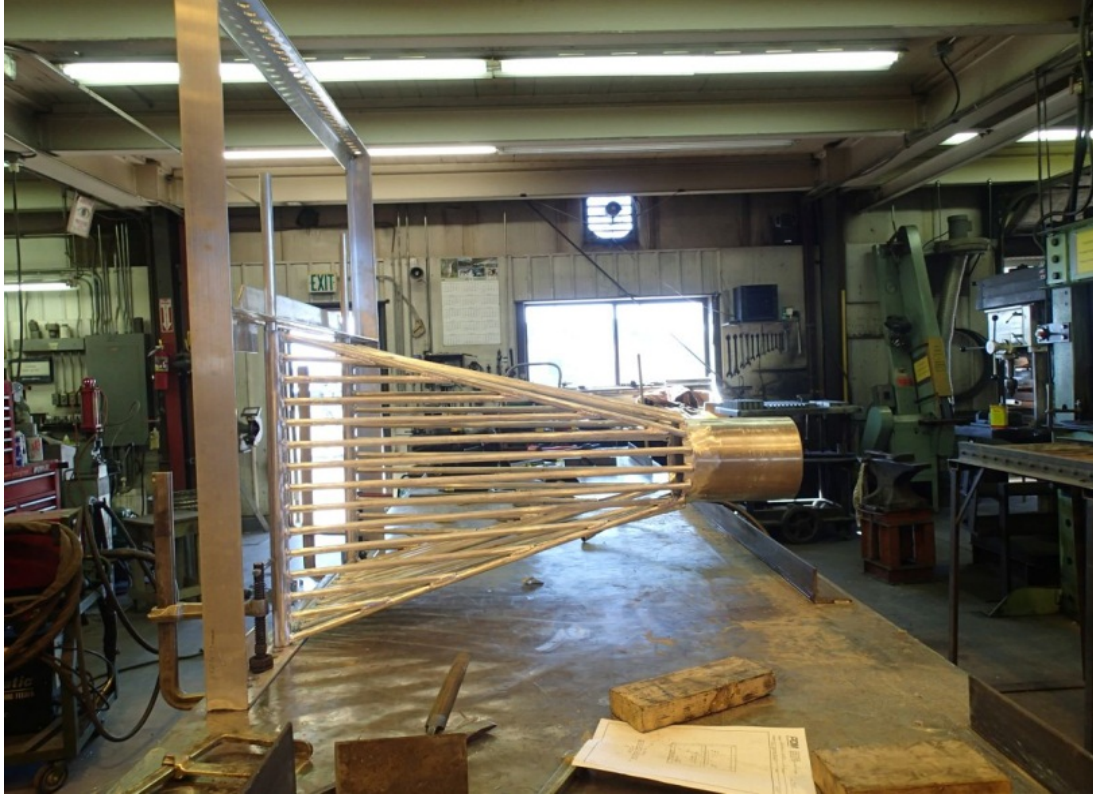
Figure 7. Modification to the entrance of the 2013 trap in WDFW's screen shop

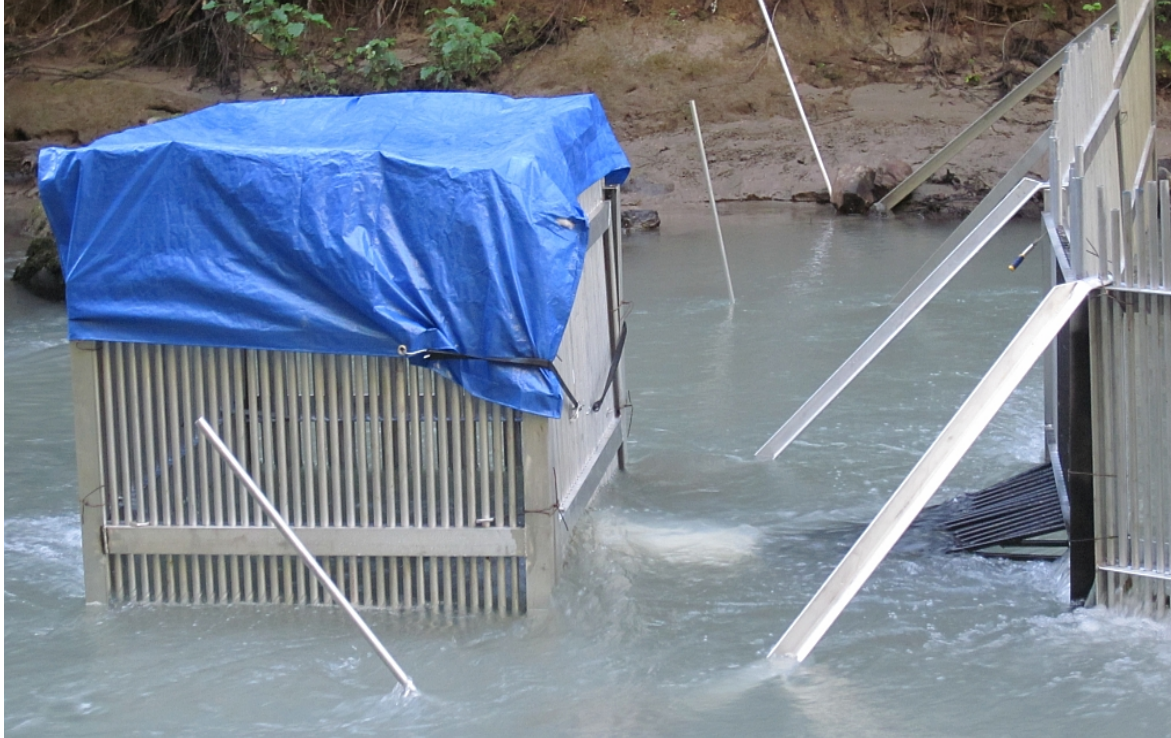
Figure 8. The modified configuration of the trap used in 2013. Note the modified entrance leading to the PVC pipe extending into the trap. The trap itself sits about five feet from the entrance.

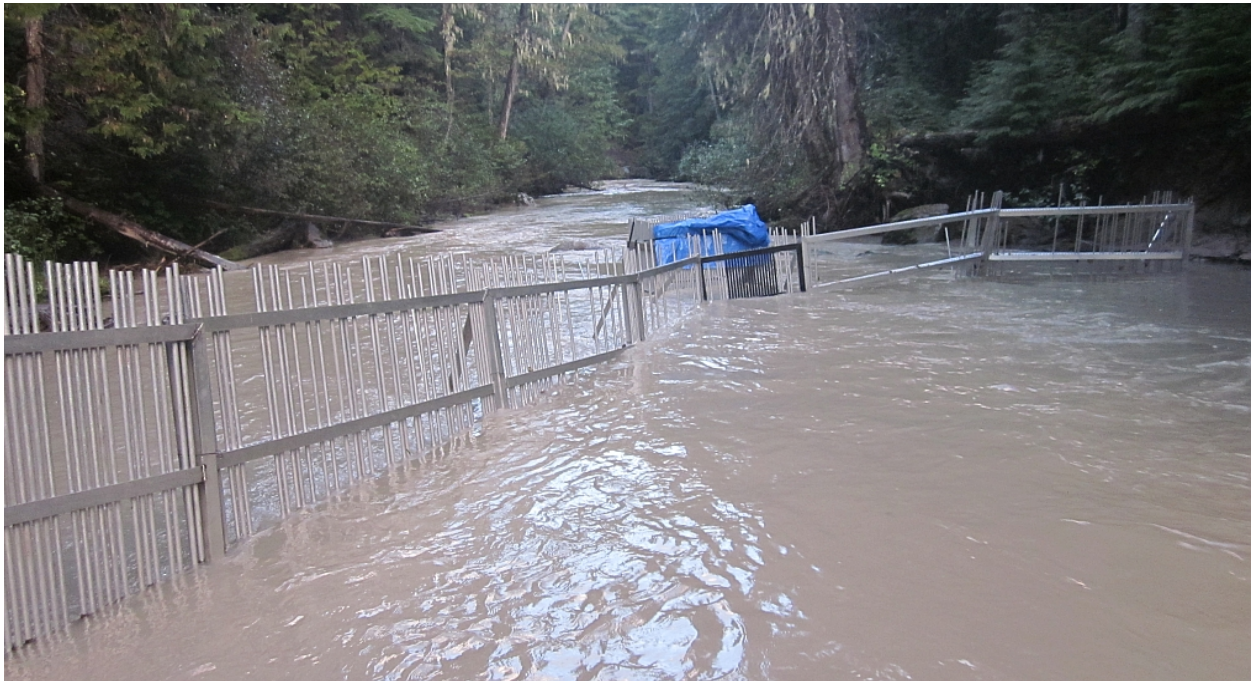
Figure 9. North Fork Tieton River fish trap after the high flow event on September 22, 2013 had partially collapsed the two weir panels on the right bank and weir pickets had been pulled to relieve pressure on the panels. The photo was taken the next day after the river had receded.

The trapping operation progressed without complications except for two notable exceptions. The first was the high flow event on September 22 when the river rose approximately 1.5 feet and partially collapsed the two eight-foot weir panels on the right bank (Figure 9). At 6:30 PM the crew worked quickly pulling pickets from the weir panels to reduce pressure on them. The structure incurred no further damage. At around 11:00 PM, after river stage had dropped about 12 inches, the partially collapsed panels were righted to the greatest extent possible and pickets were replaced in alternating holes in the weir panels. The trap was fishing again but with the possibility that fish could pass through the three-inch gap between alternating pickets. With intermittent rain still occurring throughout the day on September 23, all of the pickets were not replaced until the following morning. The panels on the right bank were also realigned

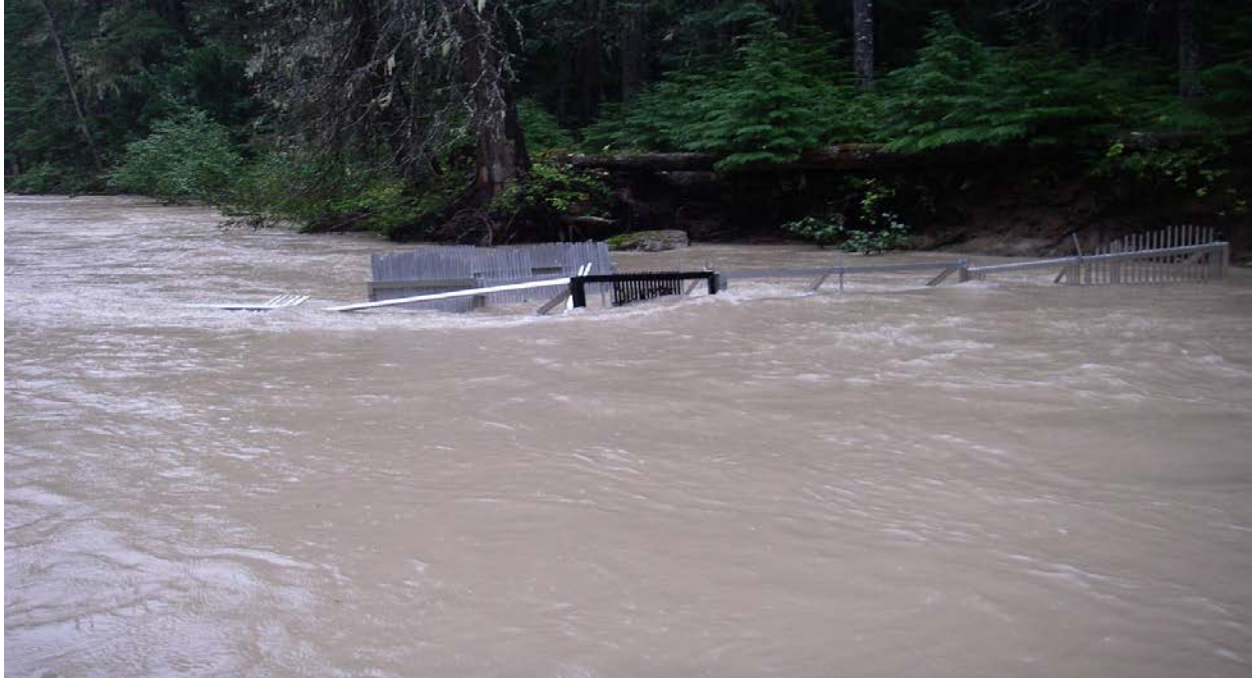
Figure 10. North Fork Tieton River fish trap during the high flow event which occurred at the end of September, 2013. This photo was taken the morning of September 29th. The left weir panels have already washed downstream. The remaining panels and the box were gone soon after. The river continued to rise.

The second high flow event began the afternoon of September 27 with a steadily rising river that seemed to level off by late night. However, heavy rains occurred the next day and by very early in the morning of September 29 the river was rising rapidly. Efforts to save the trap in the pre-dawn hours were halted because of dangerous conditions. A few hours later the trap began to disintegrate and washed downriver (Figure 10). Our trapping operation had come to a quick and decisive end. (Note: all of the weir and trap box components were recovered a few days later when the river had receded. Some had washed as much as 200 meters downstream).

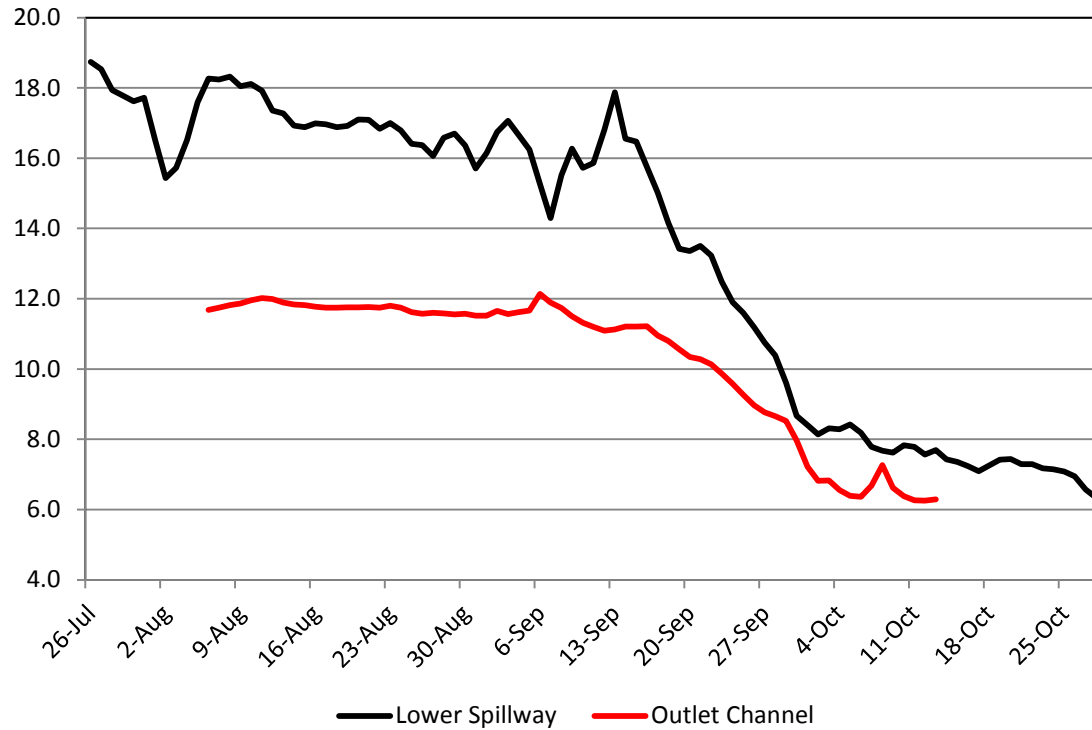
Figure 11. Average daily water temperatures (°C) for 2013 in the lower spillway and outlet channels of Clear Creek Dam on the North Fork Tieton River

Water temperatures at the top of the spillway (i.e. the ladder) and the bottom tracked closely and will not be differentiated here. On July 25 the mean daily temperature exceeded 18°C and for all but one day remained above 15°C (the temperature believed to limit bull trout distribution) until September 17 before beginning a steady decline (Figure 11). Temperature data for the outlet channel were a more limited because high releases from the dam had washed the data logger closer to the stream bank and it was left in the dry after October 13. By that time average water temperatures in both the outlet and spillway channels were fairly similar and below 8°C. This certainly was not the case through August and most of September when temperatures were much cooler in the outlet channel. The logger in the NF Tieton River only collected data for 19 days. It ran out of storage space on August 19 because it had mistakenly been set to record data every minute. The data that were collected showed average daily water temperatures ranging from 10-11.5°C.
