Yakima River Basin
Water Enhancement Project, Washington

Damsite and Structure Review Team Report

Bureau of Reclamation
Boise, Idaho
January 1984

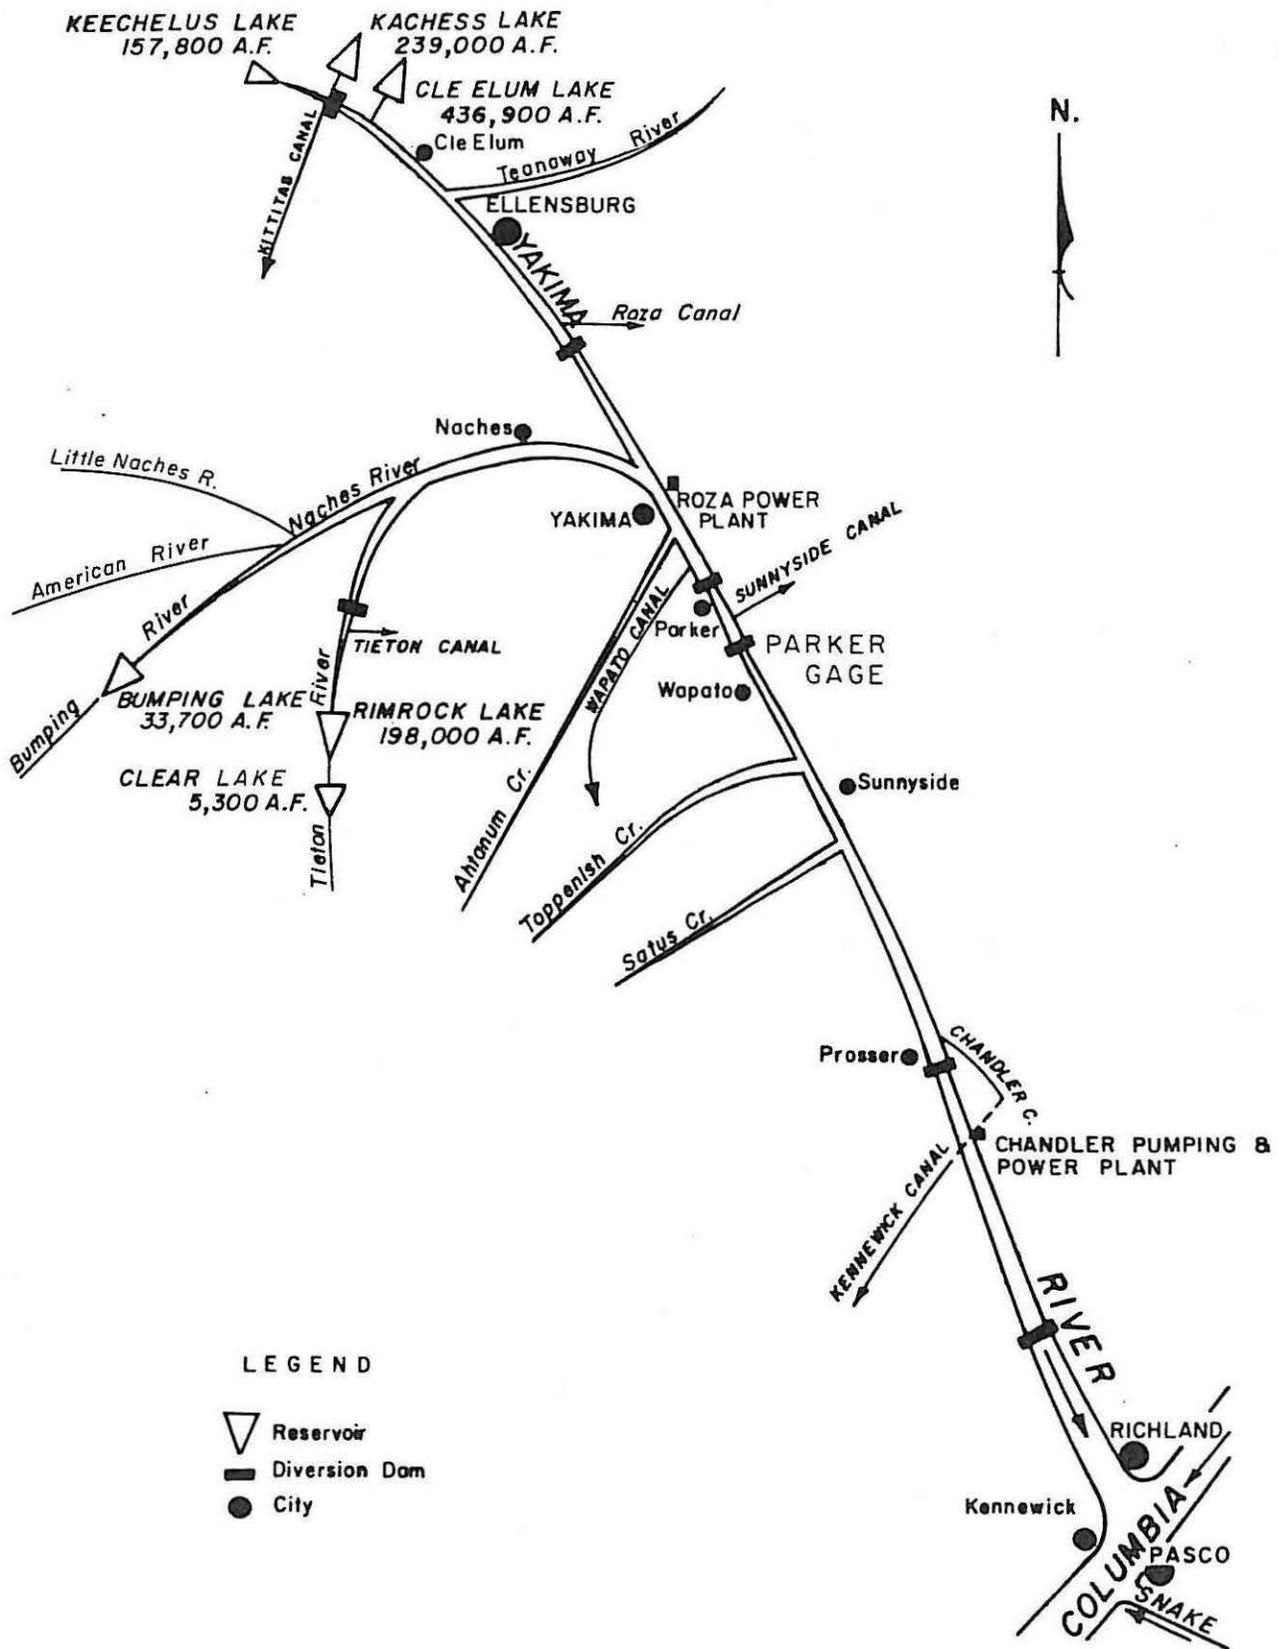
**SCHEMATIC
YAKIMA RIVER BASIN**

features include several diversion dams, two hydroelectric generating plants, canals, laterals, and pumping plants. The Yakima River basin schematic shows the major tributaries and diversions.

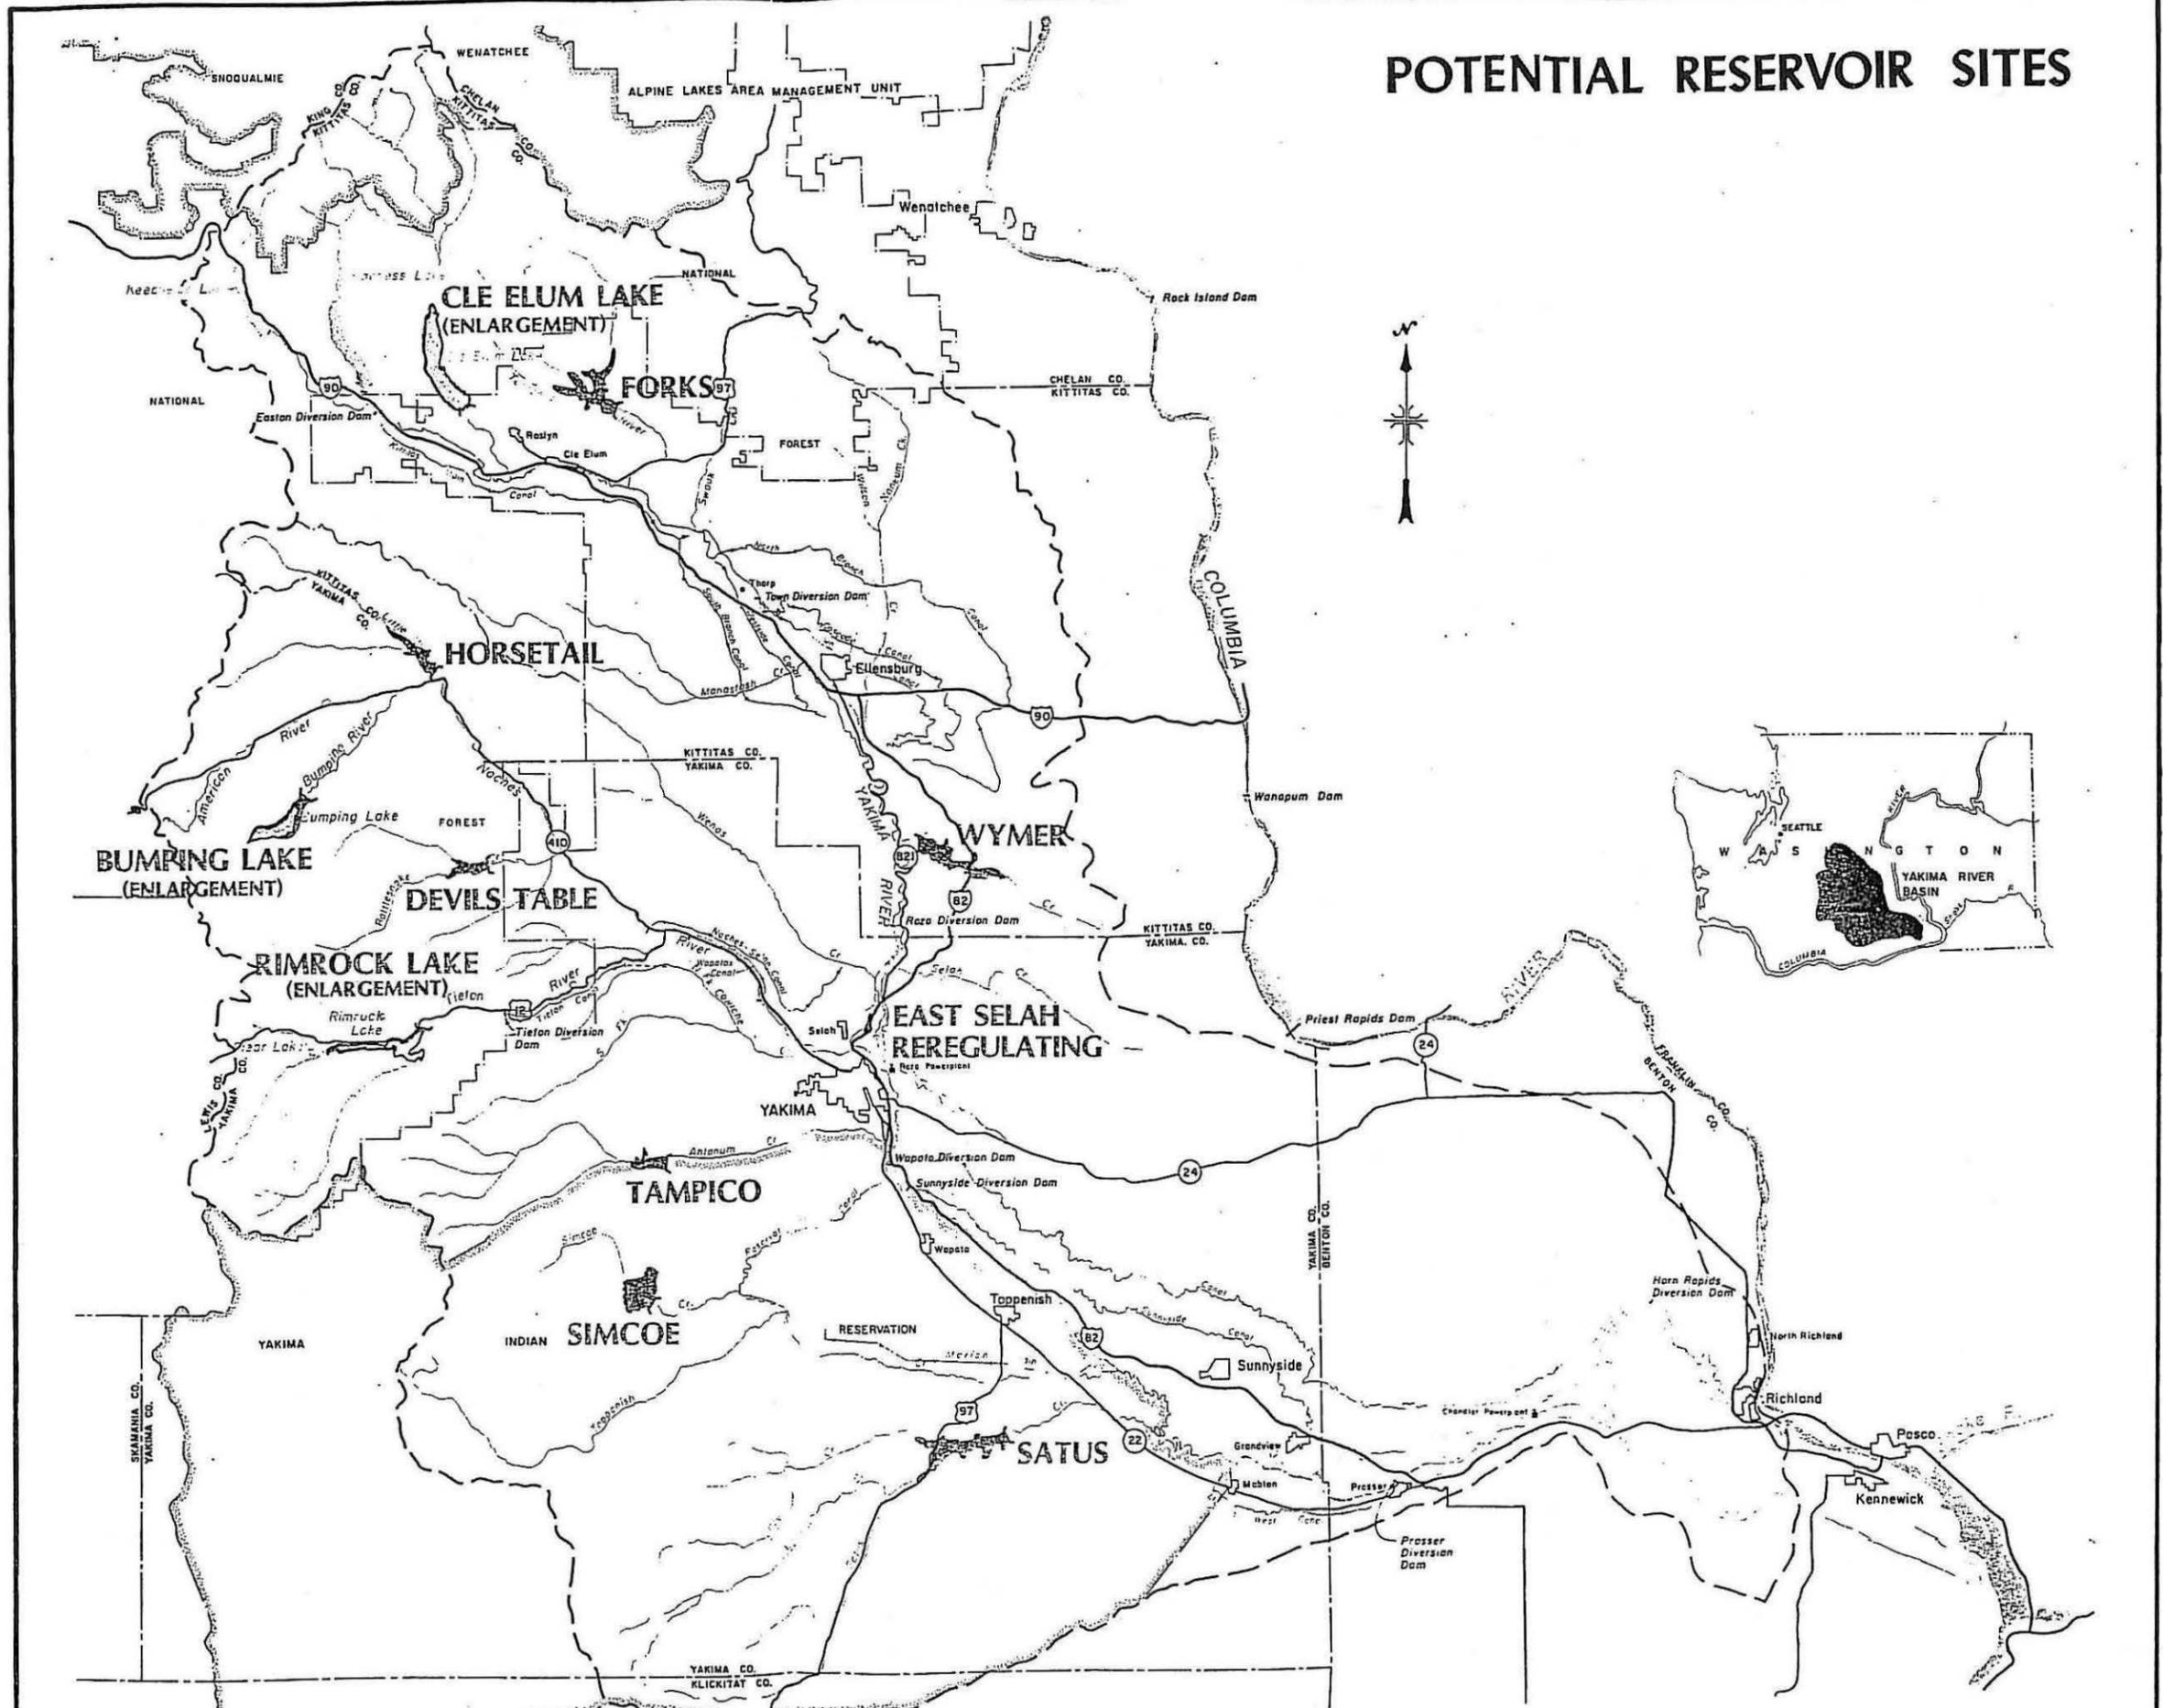
POTENTIAL RESERVOIR SITES

The 11 reservoir sites identified for further detailed study are scattered throughout the Yakima basin (see Potential Reservoir Sites map). Four sites (Bumping Lake and Rimrock Lake enlargements and Devil's Table and Horsetail Reservoirs) are located in the Naches River drainage, three sites (Cle Elum Lake Enlargement and Forks and Wymer Reservoirs) are located in the upper Yakima River drainage, three sites (Satus, Simcoe, and Tampico Reservoirs) are located on the Yakima Indian Reservation, and the single reregulating site is located near Yakima (see East Selah Reregulating Reservoir map). Hydroelectric generation facilities are included at all sites except East Selah reregulating, Satus, and Tampico. Hydrologic data including hydroelectric potential at the 11 reservoir sites are shown in table 5. Specific functions were not identified with individual reservoirs, as any reservoir added to the Yakima system would be operated as an integrated facility with the existing reservoir system to accomplish project objectives.

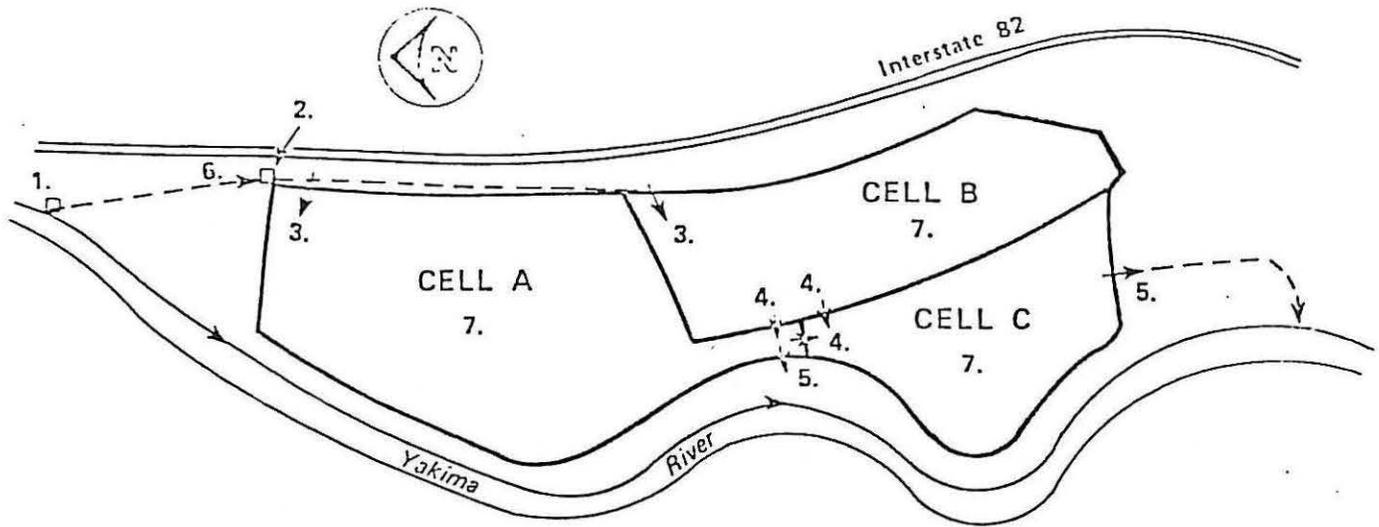
1. Fish Screen Structure. Traveling screens with automatic backwash and manual gates for ice protection.
2. Flood-Proofing Structure. Manual gate; open during irrigation season and closed during off-irrigation season.
3. Inlet Structure (2 each). Remotely operated radial gates modulated to control inflow to cells A and B.
4. Transfer Structure (3 each). Remotely operated slide gates modulated to control transfer of stored water from cell to cell. Cell B has to be transferred to Cell A or C for release to the river.
5. Outlet Structures (2 each). Remotely operated slide gates modulated to control release rates.
6. Inlet Canal Water Surface. Remotely monitored; indicator of river level and water available to direct into storage. Changes in water surface as inlet gates are opened also indicate inflow volumes.
7. Cell Water Surface Elevations (3 each). Remotely monitored.
