Using Self-Healing Concrete for Concrete Repairs on Aging Concrete Structures

Research and Development Office
Science and Technology Program
(Final Report) ST-2016-7064-1

U.S. Department of the Interior
Bureau of Reclamation
Research and Development Office

September 2016

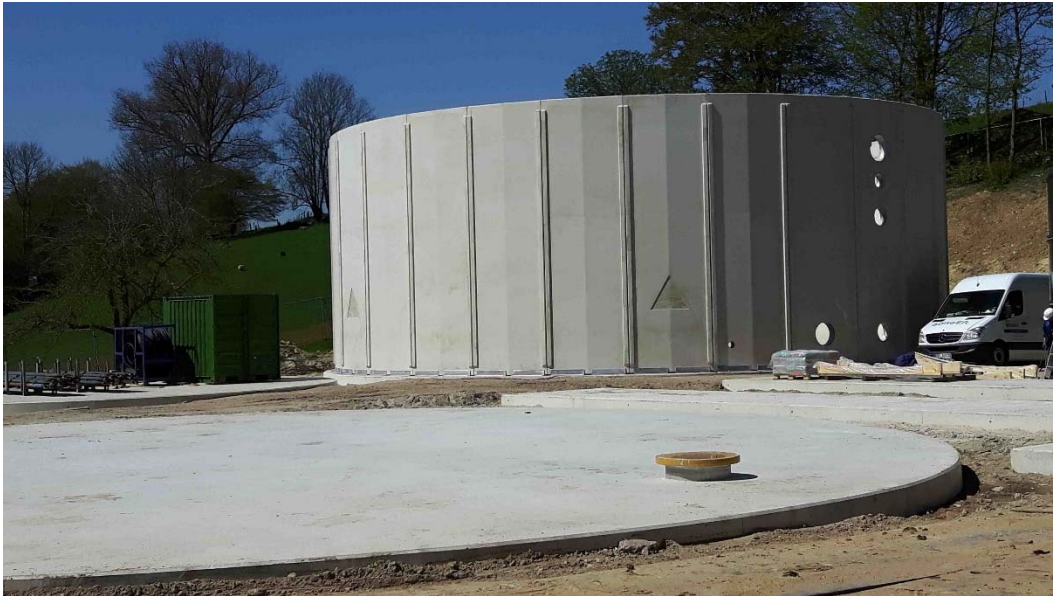
Figure 5. Concrete Wastewater Treatment Tank in Limburg, the Netherlands

In partnership with the Dutch company Verdygo a wastewater treatment tank in Limburg, the Netherlands will be constructed using self-healing concrete [9]. The tank is composed of steel reinforcement with prefabricated concrete elements with dimensions of 23 ft. X 5 ft. X 1 ft., (Figure 5). Full operation of the treatment tank will begin in the fall of 2016 [10].

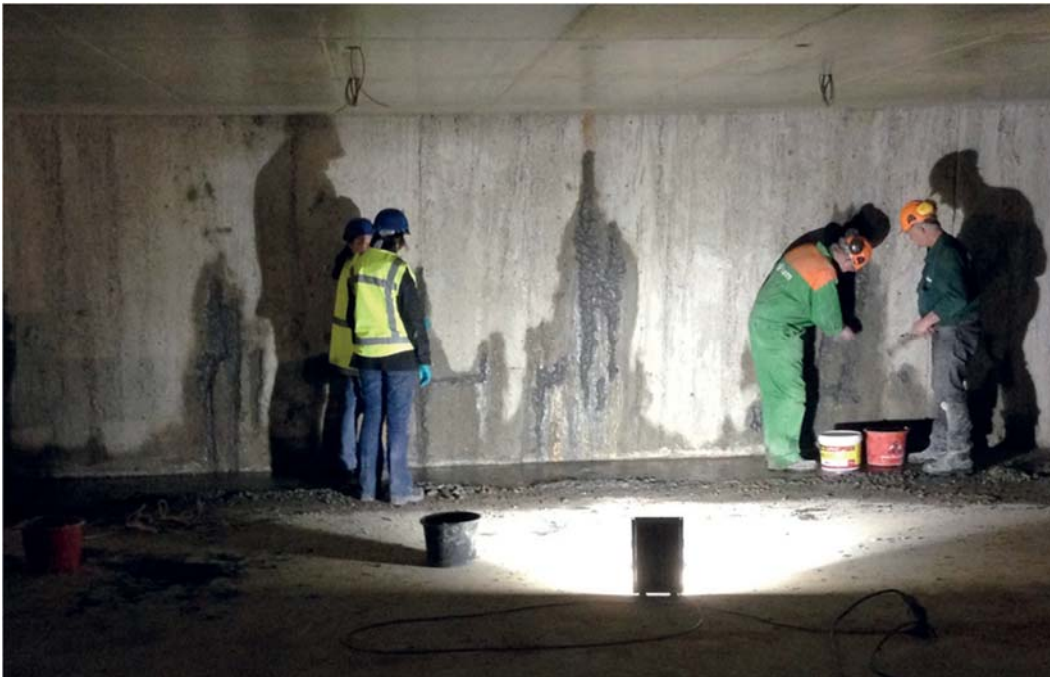
Figure 7. Groninger Forum Diaphragm wall repair with bacterial mortar

Prior to application, the cracks were cut to approximately 1.96-inch deep to provide a good bonding surface. A fast setting cement was then applied to the cracks to mitigate the water flow coming from the cracks. After the fast setting cement cured, the self-healing repair mortar was applied to the areas, (Figure 7). Due to the low-shrinkage properties of the mortar there was good adhesion with the underlying concrete. Fibers were also added to the mortar to provide added tensile stress to the repair areas and reduce micro-cracking. After ten weeks of application the areas were assessed and the existing cracks appeared to be watertight [13].

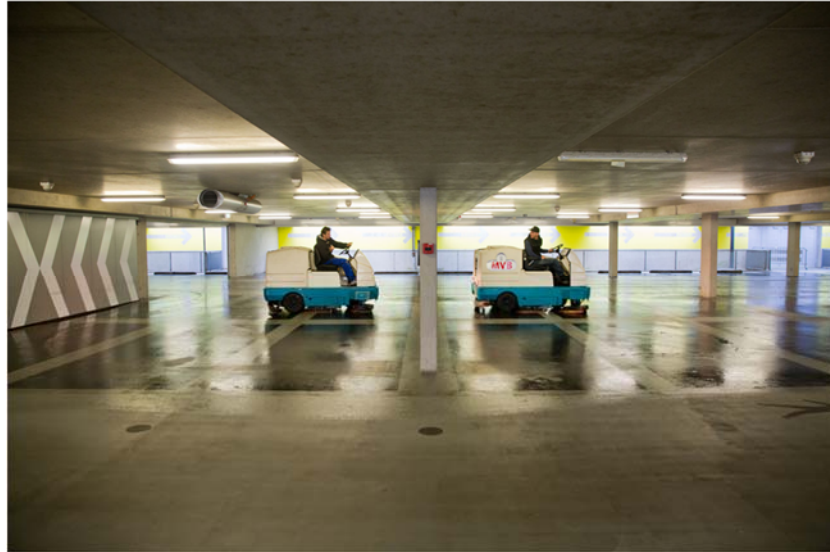
Figure 8. Application of bacterial liquid with scrubbing machines

bacterial liquid repair system that would cover a total of 129,167 ft². The first phase took place in October of 2014 and the second phase in March of 2015. Both floor areas consisted of an equal surface area of 64,584 ft² [15]. The liquid repair system was chosen for its ability to be applied externally with low-pressure in contrast to conventional injections that could cause damage to the existing polymer topcoat [14]. Each phase received a different application, for the first 64,584 ft² the bacterial liquid solution was applied through the use of scrubbing machines (Figure 8). For the second phase the bacterial liquid solution was distributed using hand-carried high pressure spraying devices (Figure 9) [14].

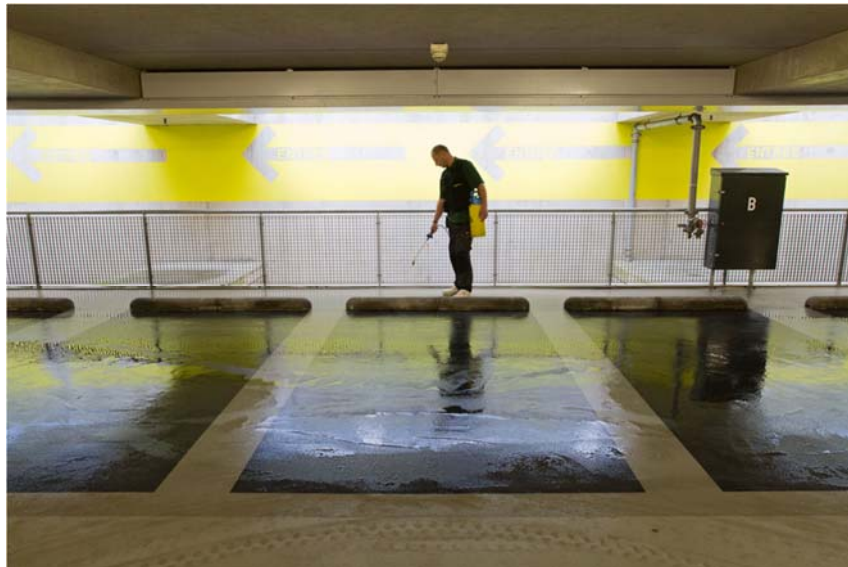
Figure 9. Application of bacterial liquid with hand-carried spraying device

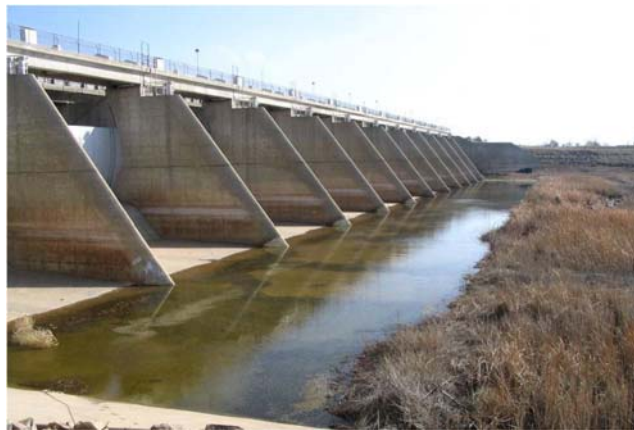
Figure 10. View of approach area of spillway. The soil berm trapped water on the apron, leading to deterioration of the concrete.

The invert of the excavated inlet channel upstream of the inlet apron is approximately 1 foot higher than the inlet apron invert which creates a grassy berm upstream of the spillway. As a result, water which is located on top of the inlet apron (either from receding reservoir levels or precipitation) becomes trapped and remains ponded in this area (Figure 10) [16].

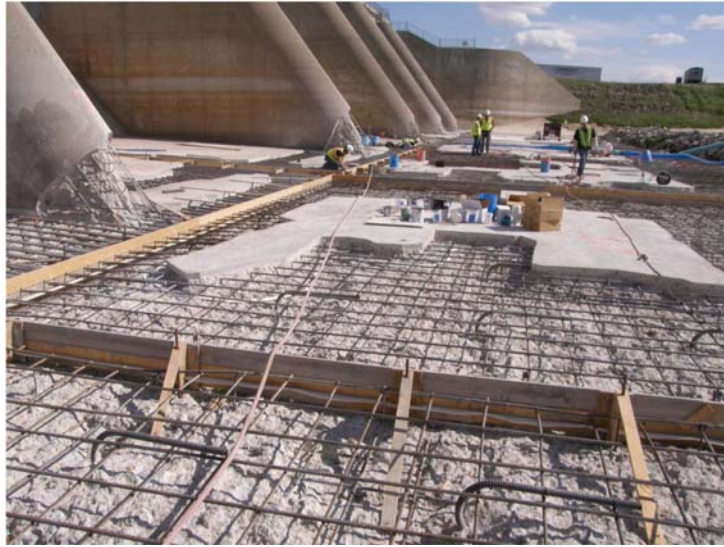
Figure 13. Example of concrete removal with some original concrete remaining

The repair consisted of removing deteriorated concrete using hydro demolition methods and then placing new concrete back to the existing lines and grades. In most areas, damaged concrete was removed to a depth of about 6-inches, leaving about 12-inches of the original concrete. In some areas, due to the poor quality of the concrete, it was excavated down to the foundation. In addition, for some areas, no concrete was removed, so full depth areas of existing concrete were left in place (Figure 13) [16].

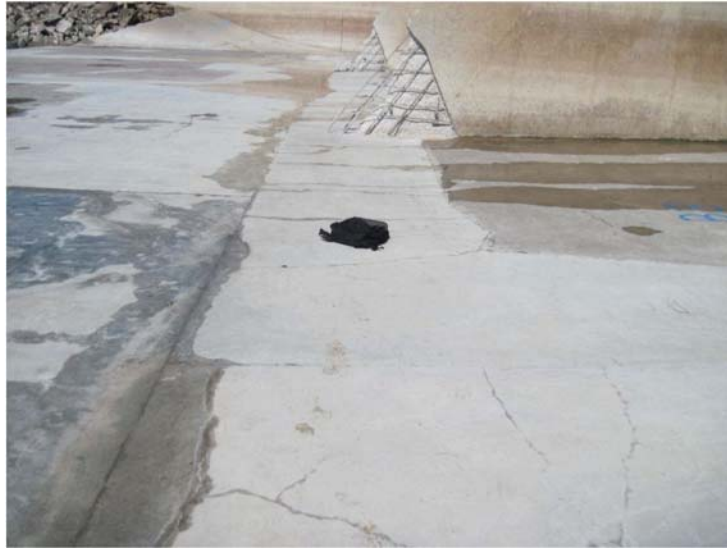
Figure 14. View of shrinkage cracking first observed within one to two weeks of concrete placement.

After initial placements were performed in the late summer and fall of 2010, restrained shrinkage cracking was observed in the new concrete (Figure 14). The occurrence of this cracking was not unanticipated, but the number and size was disconcerting [16].

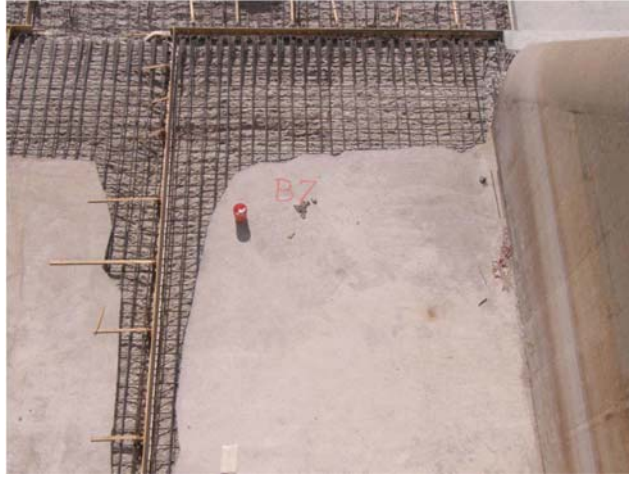
Figure 15. Bay 7 ready for trial concrete placement using concrete containing the Premier Magnesia additive.

including one bay area placement (B7, Figure 15) and one approach slab placement (S10, Figure 16) [16].

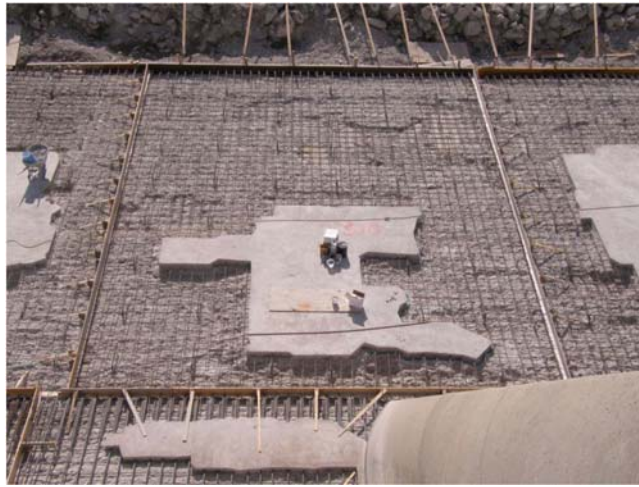
Figure 16. Slab 10 ready for trial concrete placement using concrete containing the Premier Magnesia additive.

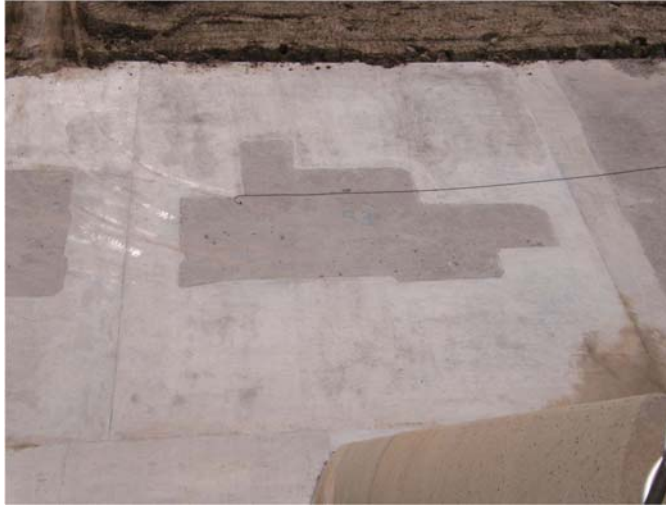
Figure 17. Slab 3 placement made with concrete without the Premier Magnesia additive.

For comparison crack mapping, two similar areas with about the same shape were selected to map cracks (B3, Figure 17 and S3 Figure 18). One bay area placement (B8 and 9, Figures 19, shown after concrete placement) was added to the trial since material was available and the contractor had time to place additional concrete. A total of approximately 100 cubic yards of concrete were placed in three separate placements. The first placement was about 70 cubic yards, and the second and third were about 15 yards each [16].

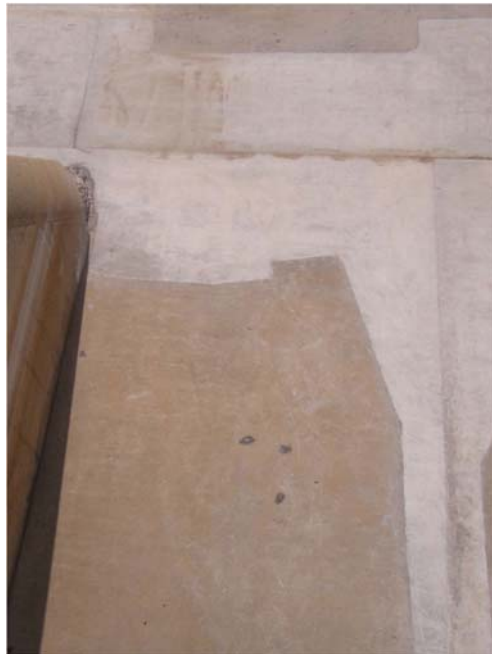
Figure 18. Bay 7 placement made with concrete without Premier Magnesia additive.

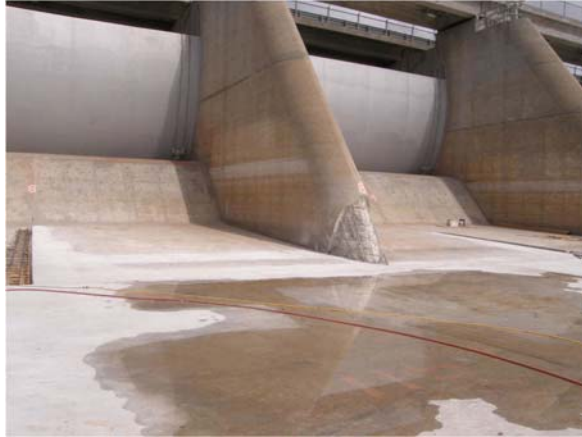
Figure 19. Placement B8/9 made with concrete containing the Premier Magnesia additive.

Results of the trial indicated that the Premier Magnesia product had significantly less cracking. One large test placement saw cracking reduced about 90% over the comparable placement made the previous fall. Overall, about 110 cubic yards of concrete were placed with the Premier Magnesia product. The first placement was about 70 cubic yards, and the second and third were about 15 yards each [16].

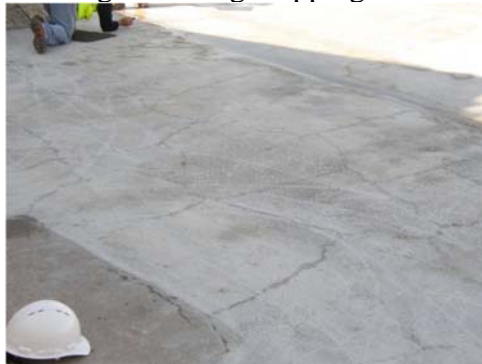
Typical shrinkage cracking mapping and measurement

Figure 20. Typical shrinkage cracking mapping and measurement.

Materials Engineering Research Laboratory personnel traveled to the site just prior to the placements to map cracks from comparable placements made the fall before (Figures 20 and 21). The following day MERL personnel observed the concrete placements of concrete containing the Premier additive. In addition, executives from Premier and personnel from their laboratory were on site during the trial placements. Their lab ensured that the Premier additives were added properly and that concrete met the specified fresh properties before it was placed [16].

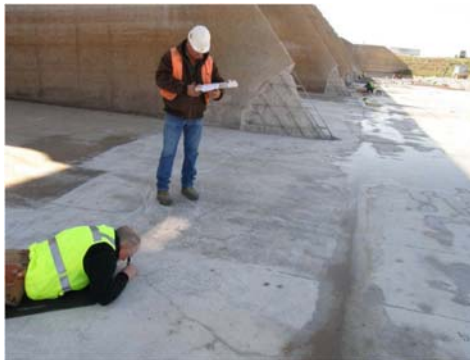
Figure 21. Measuring crack openings.

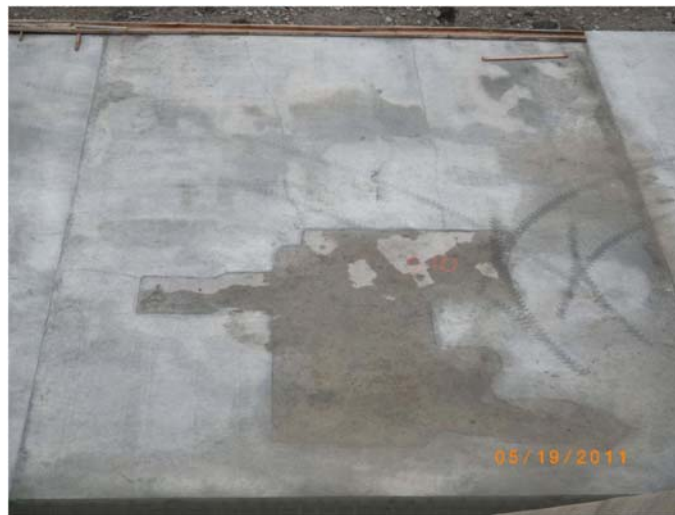
Figure 22. Slab 10 repair made with the trial concrete

Three weeks later, personnel from MERL and executives from Premier returned to the site to examine the trial concrete placements. Only the placement for slab 10 (S10) showed any cracking (Figure 22), and that was significantly less than cracking observed in the comparison slab.

The cracking in S10 was measured and documented in a drawing. The next day, construction activities at the site were halted due to flooding (Figure 23), and were resumed several months later [16].

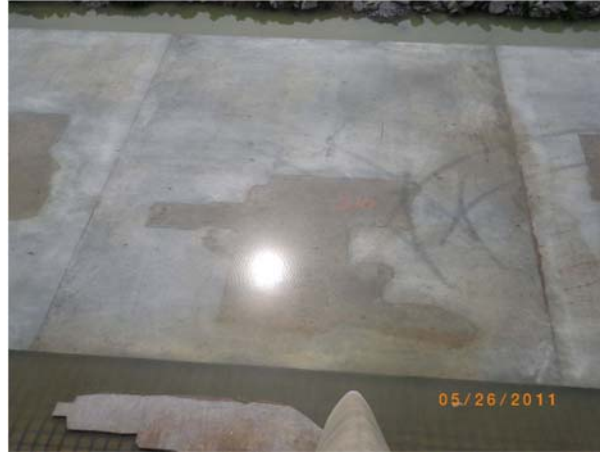
Figure 23. Approach apron under water after flooding

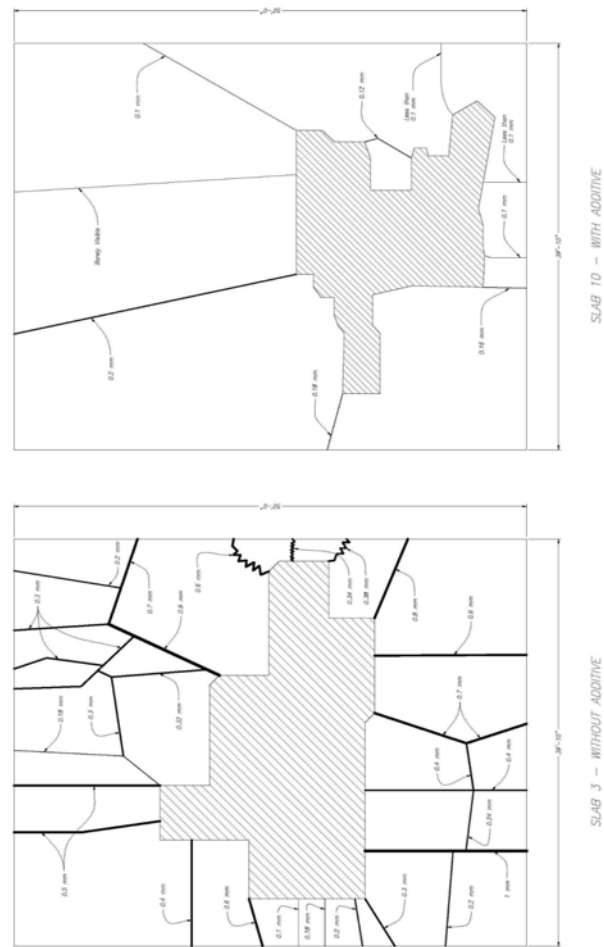
Figure 25. Comparison of slab placements for concrete placements made with and without the shrinkage reducing additive.

Figures 24 and 25 are drawings showing the approximate crack locations and widths of the observed cracks. Since the placement for Bay 8/9 was not in the original plan, a comparable placement form last year was not evaluated. However, there was no cracking observed in that placement. Results show that cracking was either greatly reduced or completely eliminated when cracking was compared between concrete with and without additive. In addition, surface areas of open cracks were estimated from crack length and opening data. Table 3 shows those comparisons [16].
