Durability Testing of Fiberglass Pipe for Reclamation Pipelines

**Research and Development Office
Science and Technology Program
Final Report ST-2018-9777-02, 8540-2018-52**

Research and Development Office
Science and Technology Program
Interim Report ST-2016-9777-01

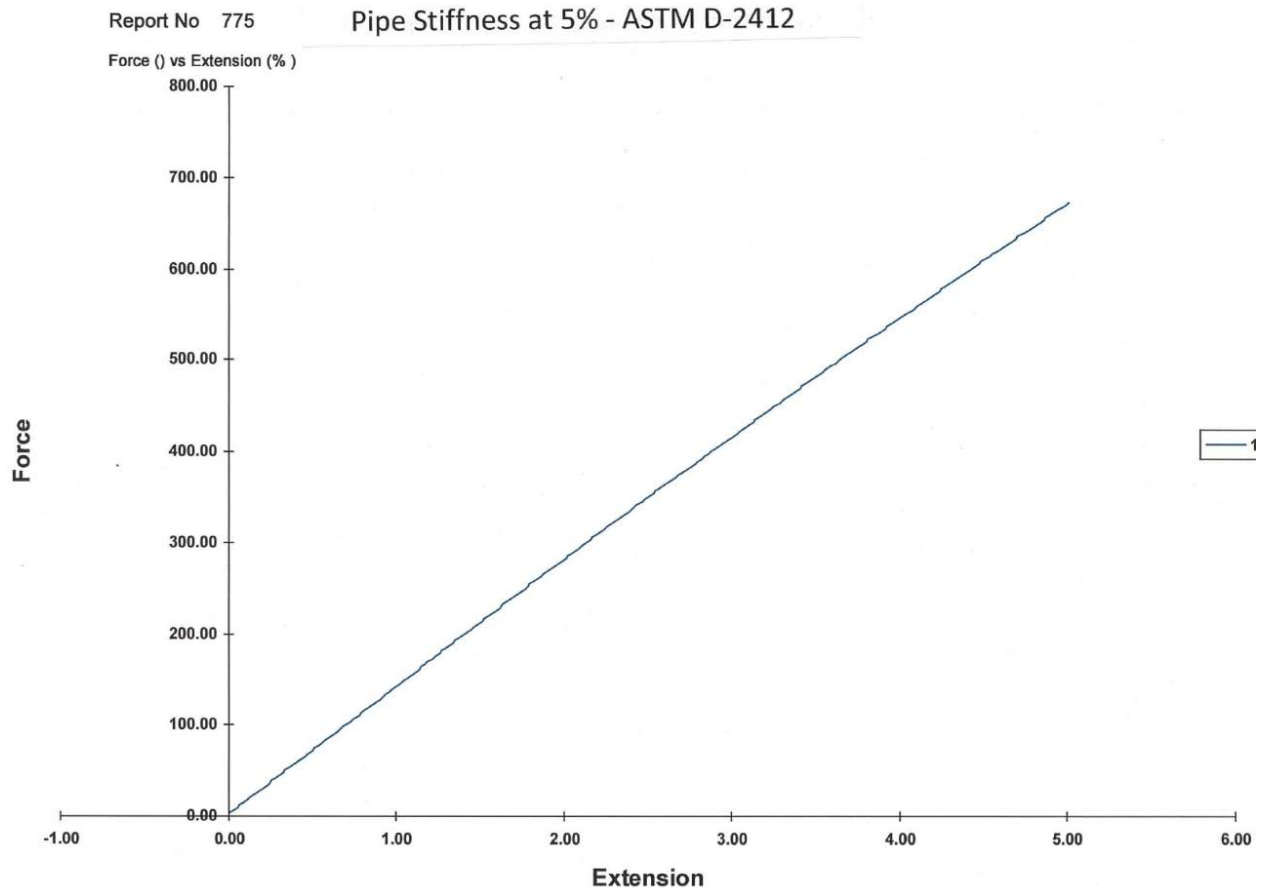
Pipe Diameter (inches)	Length (inches)	Force at 5% (psi)	Pipe Stiffness at 5% (psi)
Flowtite	25.1	11.75	672	45.58

Figure 2 - Pipe stiffness testing results from Reclamation's laboratory.

Reclamation evaluated pipe stiffness of a short section of 25-inch diameter RPM pipe manufactured by Flowtite. The tested pipe had stiffness of 0.31 MPa (45 psi) at 5% deflection (see Table 1 and Figure 2). This stiffness value represents a significant improvement over stiffness values of pipe made during the 1970s, when values on the order of 0.07 MPa were typical. The observed enhanced performance can be attributed to Flowtite's use of continuous fibers in combination with chopped fibers which give additional axial support.

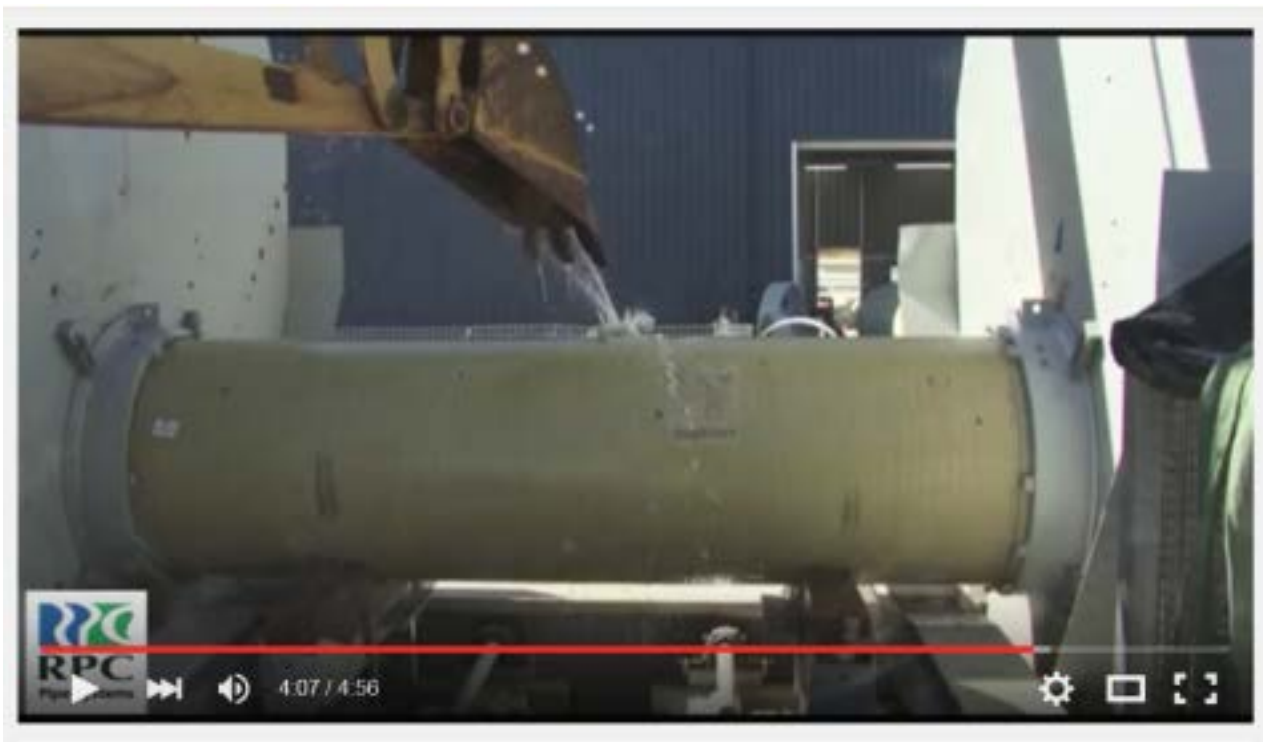
Figure 2 – Screenshot of Backhoe Impacting RPM Pipe

1. Flowtite video (www.youtube.com/watch?v=G2Z_S2rhTU) [15] shows a backhoe bucket repeatedly impacting a 30-inch fiberglass pipe pressurized to 232 psi (1600 kPa). After about a dozen blows, the impacts from the backhoe cause structural damage to the pipe wall and the pipe begins to leak significantly at the impact site. The pipe leaks but does not fail catastrophically. The impact demonstration is impressive, but not readily quantifiable.

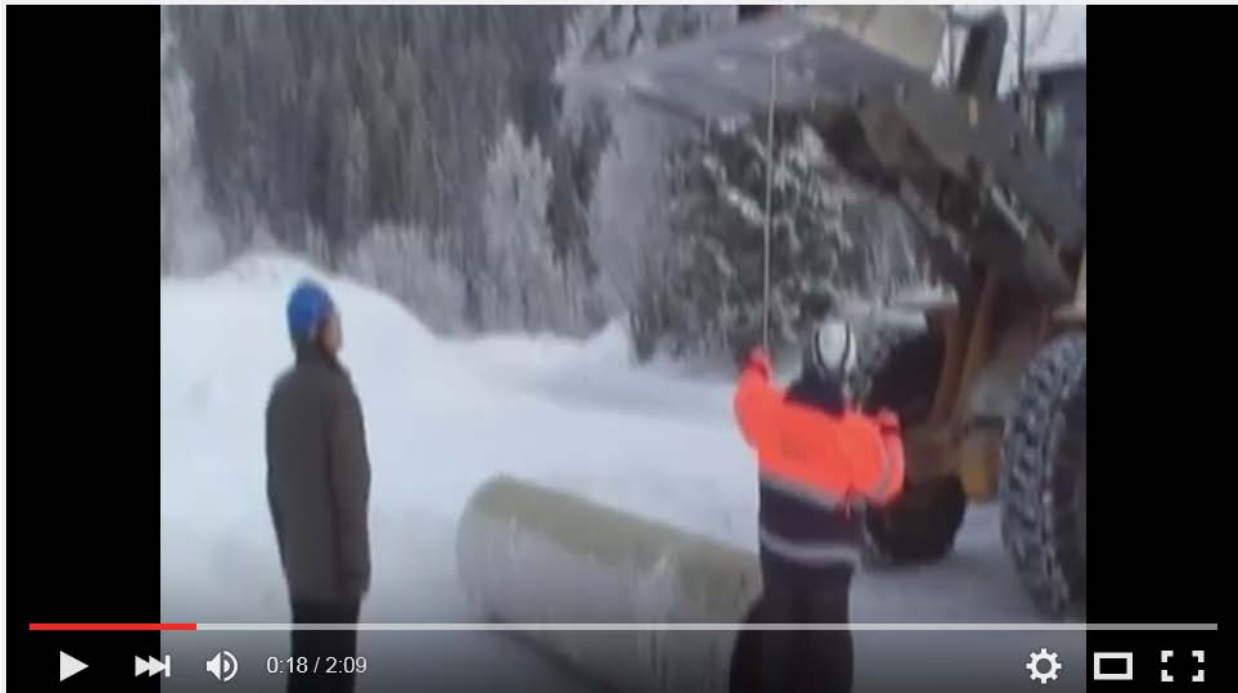
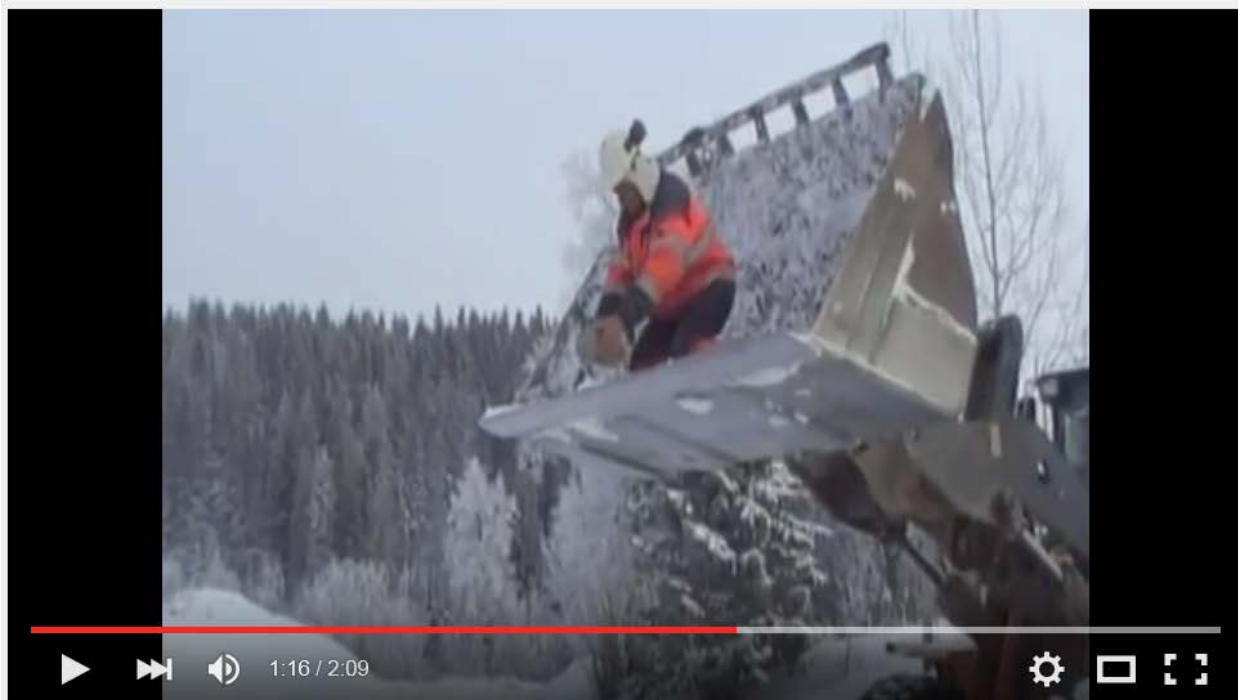
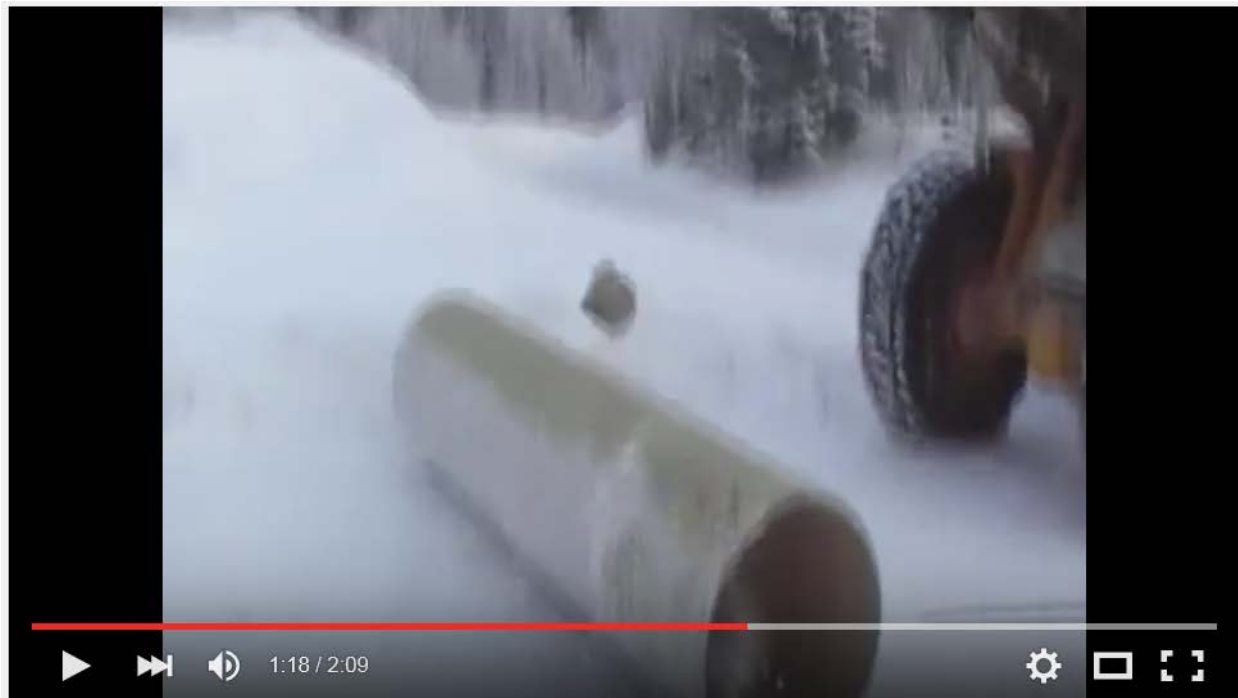
Figure 3 – Screenshot of Rock Dropped onto the RPM Pipe.

2. Flowtite video www.youtube.com/watch?v=C6EypeARCC4 [16] shows a 28.6 lb (13 kg) rock dropped from a height of 6.6 feet (2 meters) onto the crown of an unrestrained section of Flowtite pipe on a jobsite in Sweden during the winter months. Impact energy calculates to 190 ft-lb. The same pipe is later burst tested at the factory (see below).

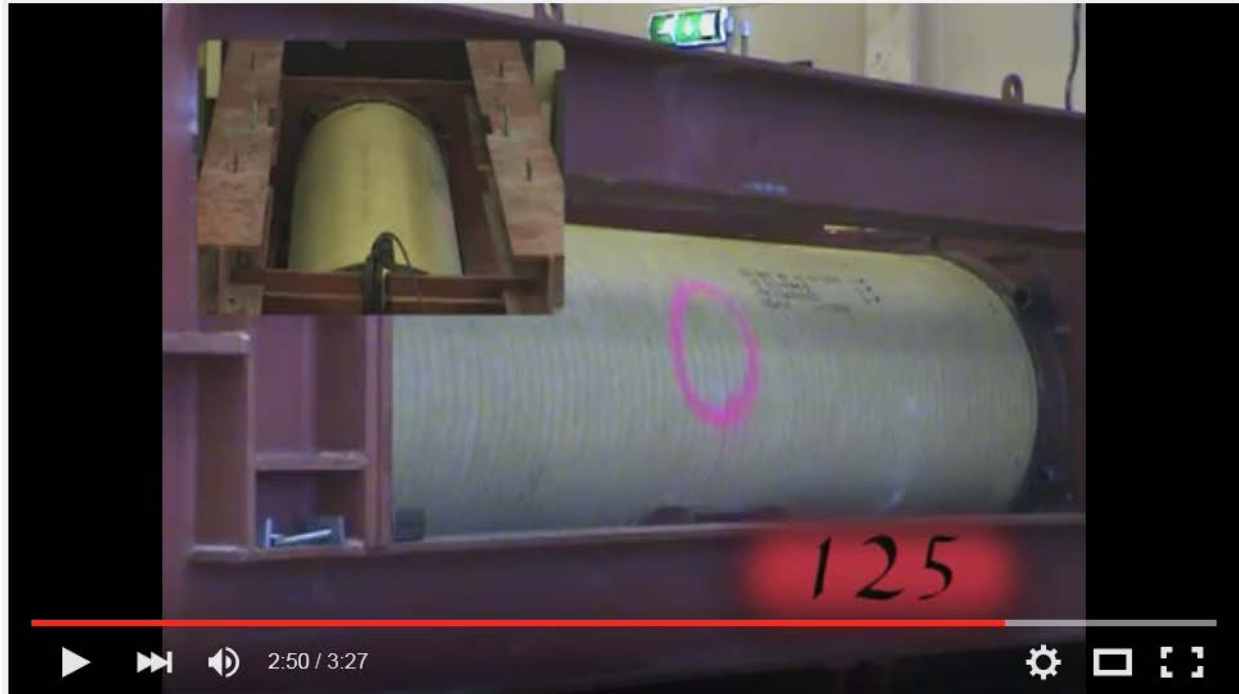
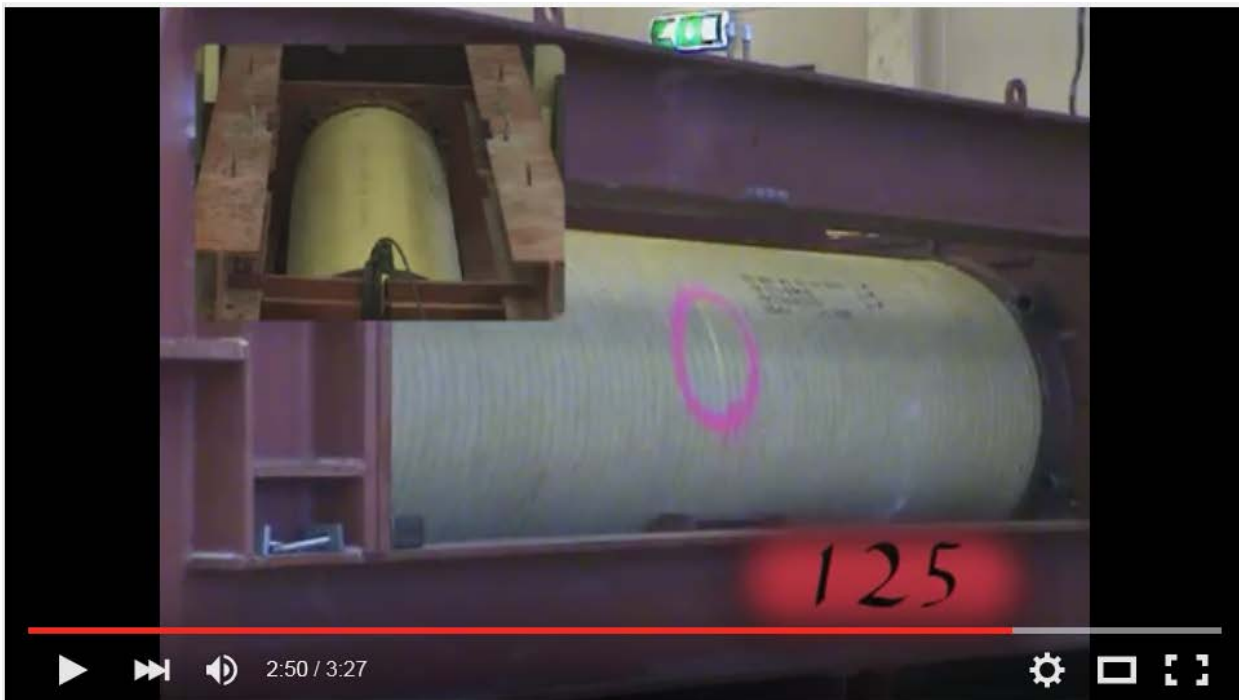
Figure 4 – A split-second prior to failure, a crack appears at the location of the rock impact.

3. After the field impact (190 ft-lb), the pipe is factory burst tested and fails catastrophically www.youtube.com/watch?v=eLj7Ukzt8ck [17] at a pressure of 1812 psi (125 bars). The 32-inch pipe is rated for 232 psi (16 bars) operating pressure. The burst pressure test is 7.8 times the rated pressure. The original FS for burst of an undamaged pipe is somewhere between 8 and 10 (based on conversations with the pipe manufacturer).

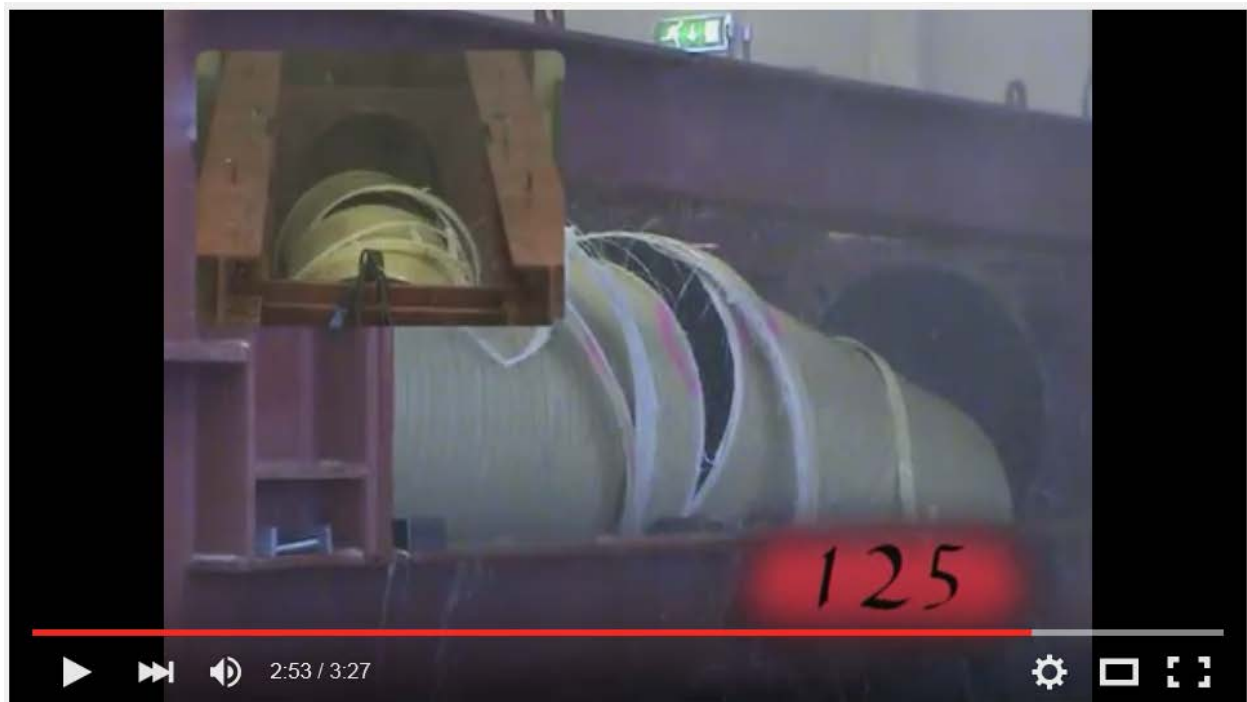
Figure 5 – Pipe failure is catastrophic at 1812 psi (125 bars).

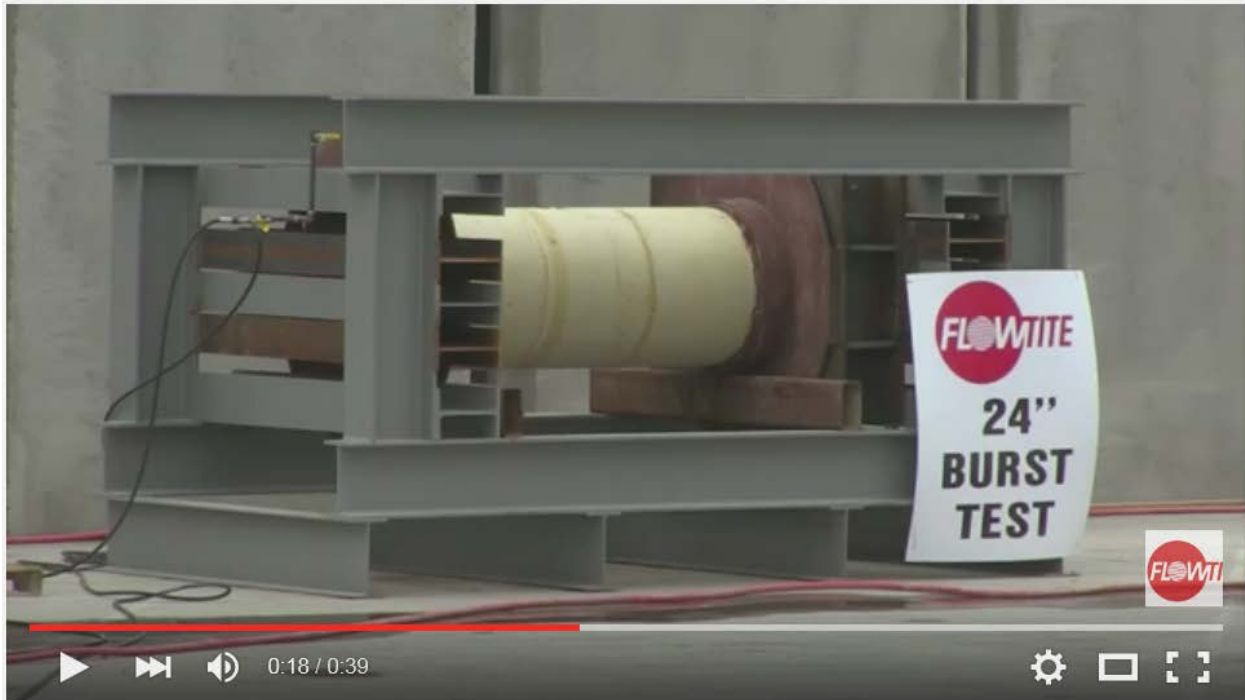
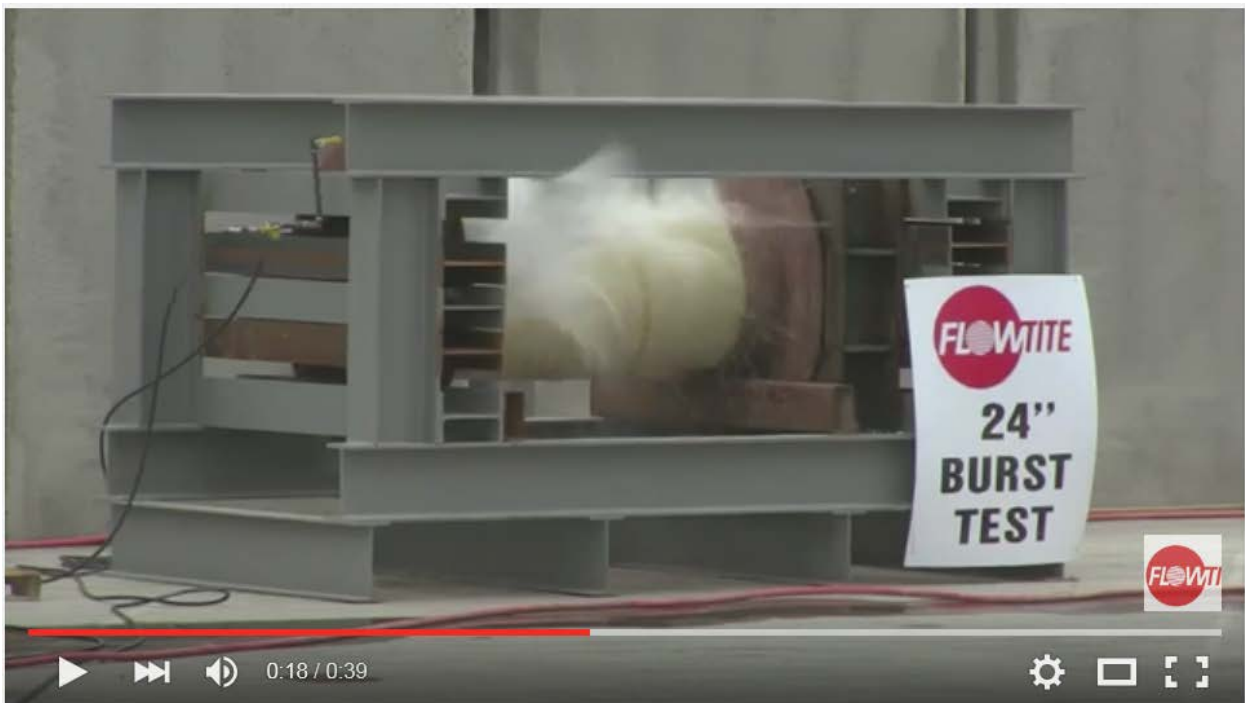
Figure 6 –Laboratory burst test on 24-inch RPM Pipe. Failure initiates at left end cap.

4. Flowtite video www.youtube.com/watch?v=nQ4xSn4A0iw [18] shows a burst of 1375 psi on a 150 psi 24-inch FRP Flowtite pipe, demonstrating a ratio of 9.2 (1375/150) between quick burst and rated pipe pressure. In the video, the failure appears to initiate at the left-hand seal, suggesting the true burst strength is higher than the demonstrated 1375 psi.

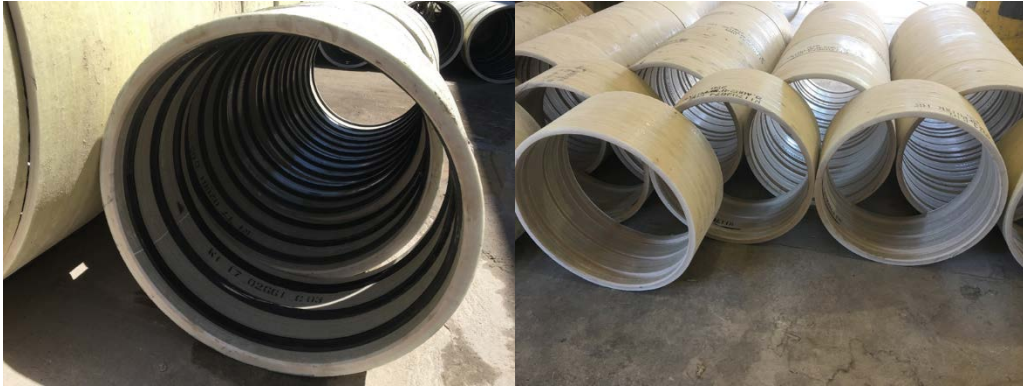
Figure A-1.—GFRP pipe couplings/fittings with gaskets for sealing

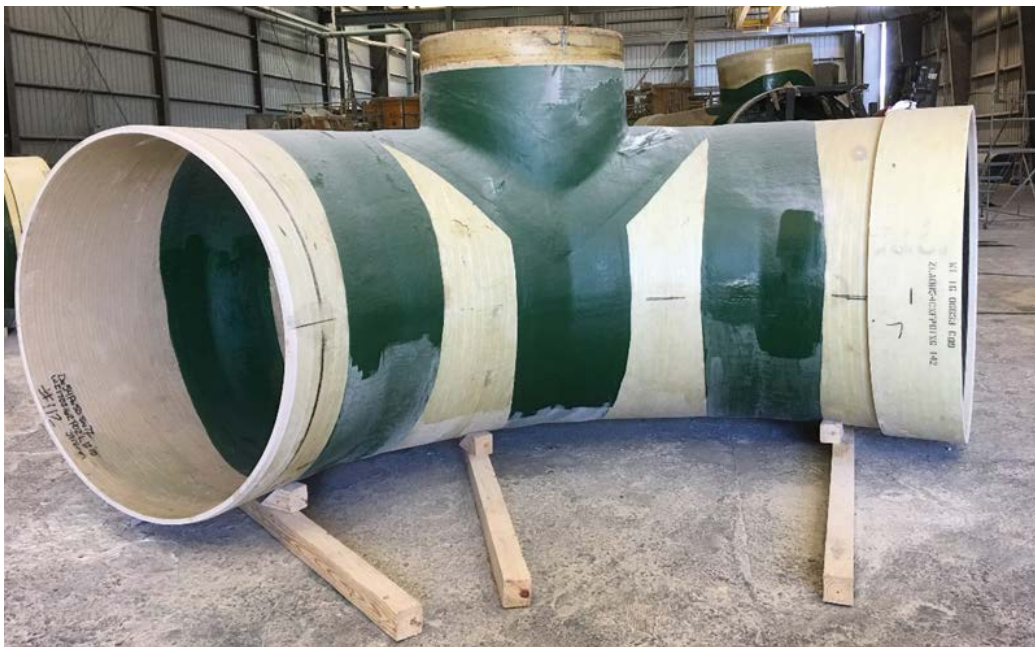
Figure A-2.—GFRP tee connector

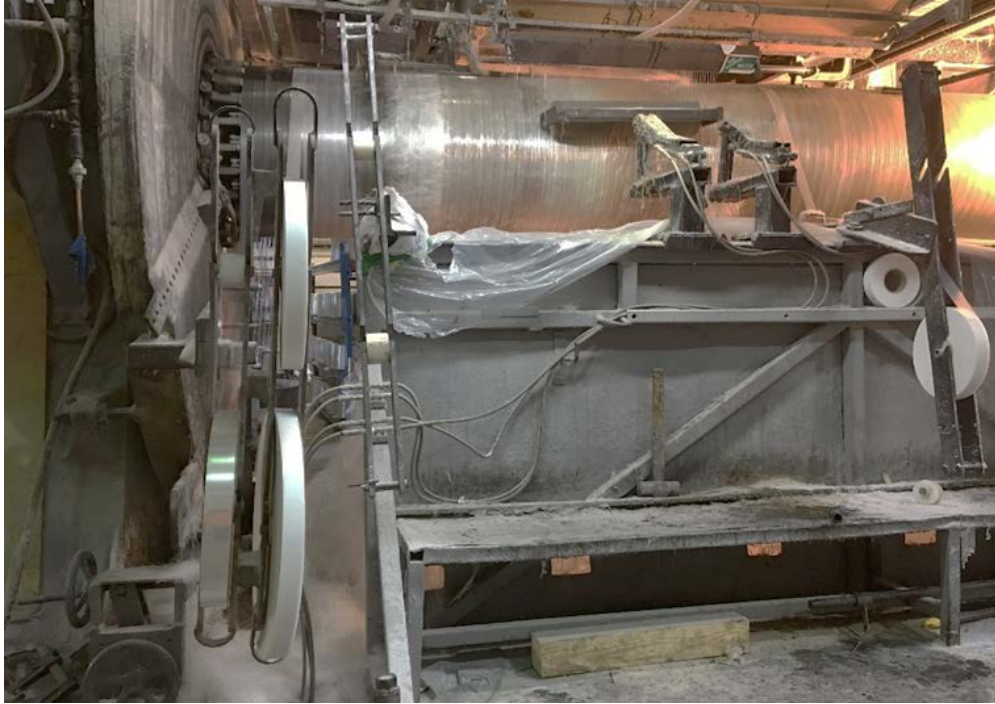
Figure A-3.—Flowtite filament wound manufacturing process

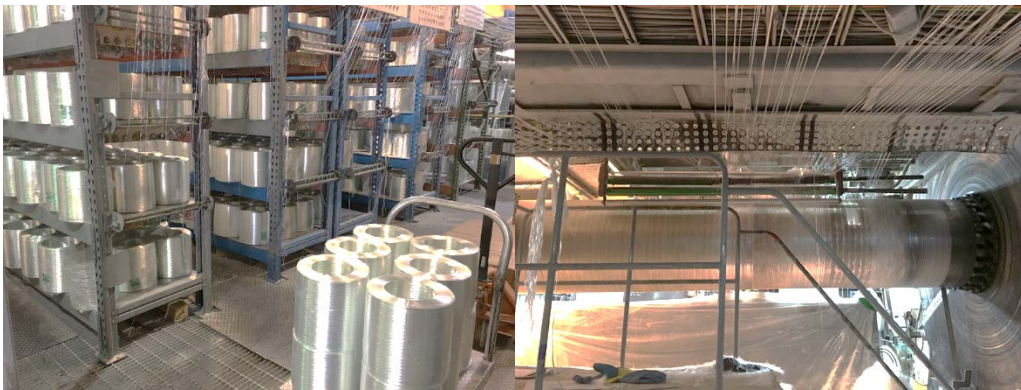
Figure A-4.—Continuous fiberglass thread woven and wrapped over Mylar

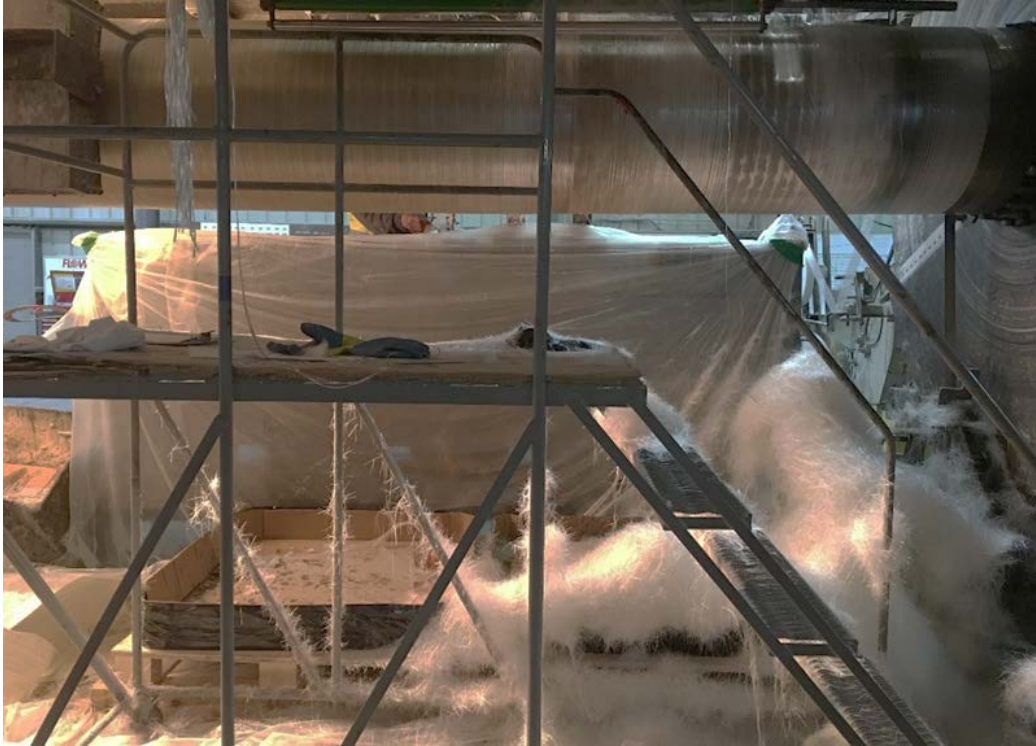
Figure A-5.—Chopped glass fiber waste

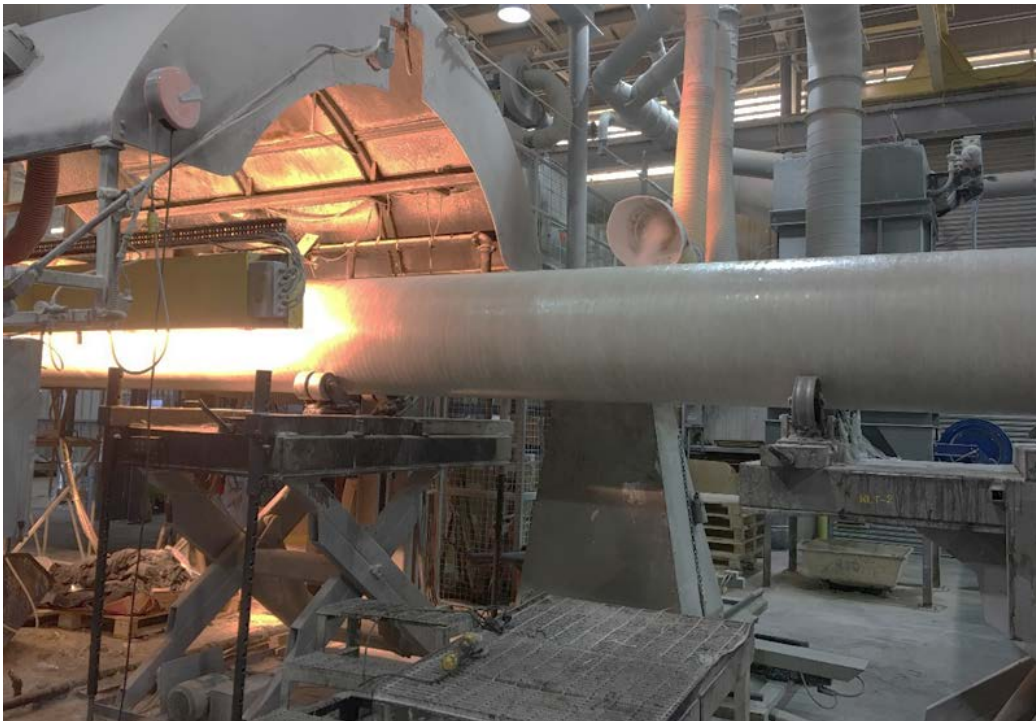
Figure A-6.—Heating system to cure resin

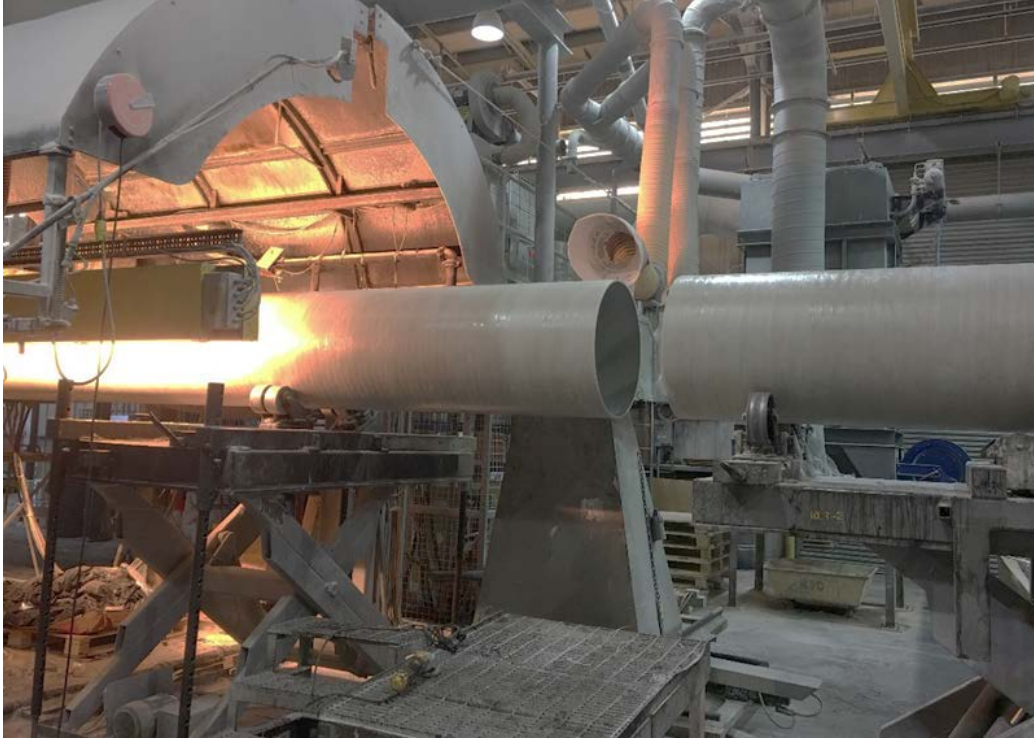
Figure A-7—Cutting pipe to the required length

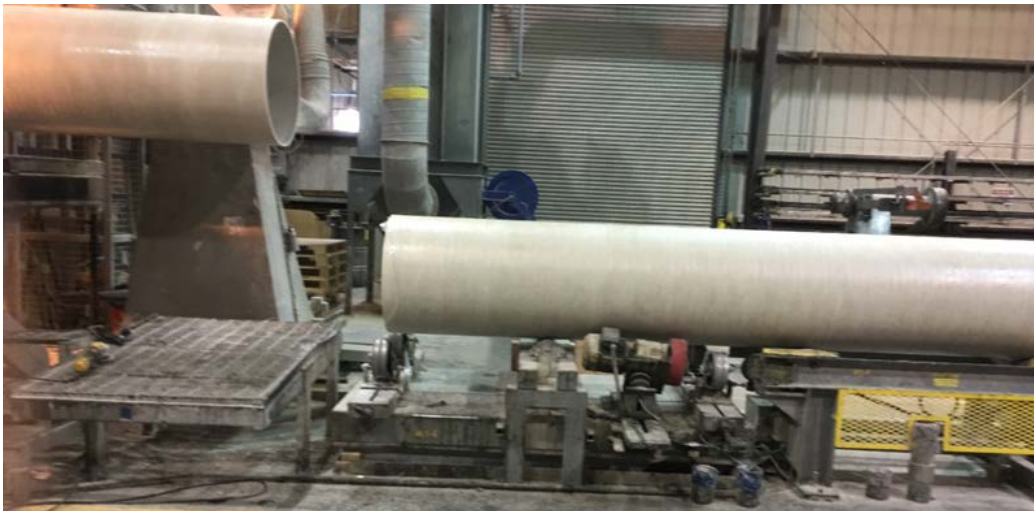
Figure A-8.—Lowering the pipe for testing

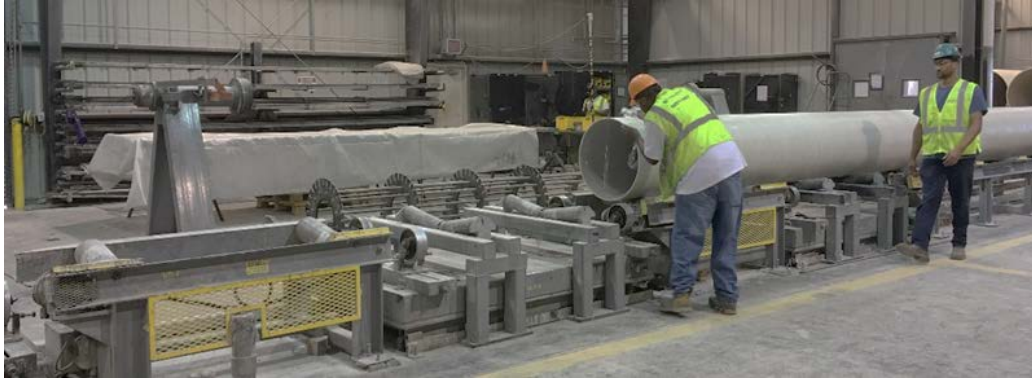
Figure A-9.—Checking the pipe and removing Mylar

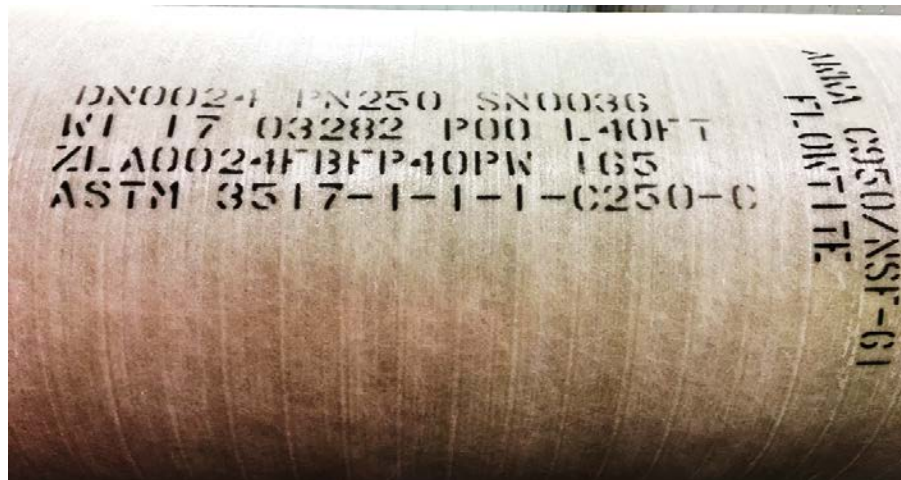
Figure A-10.—Stamping the pipe identification
(diameter (24 inch or 61 cm), pressure (250 psi or 2 MPa), and stiffness
(36 psi or 0.25 MPa))

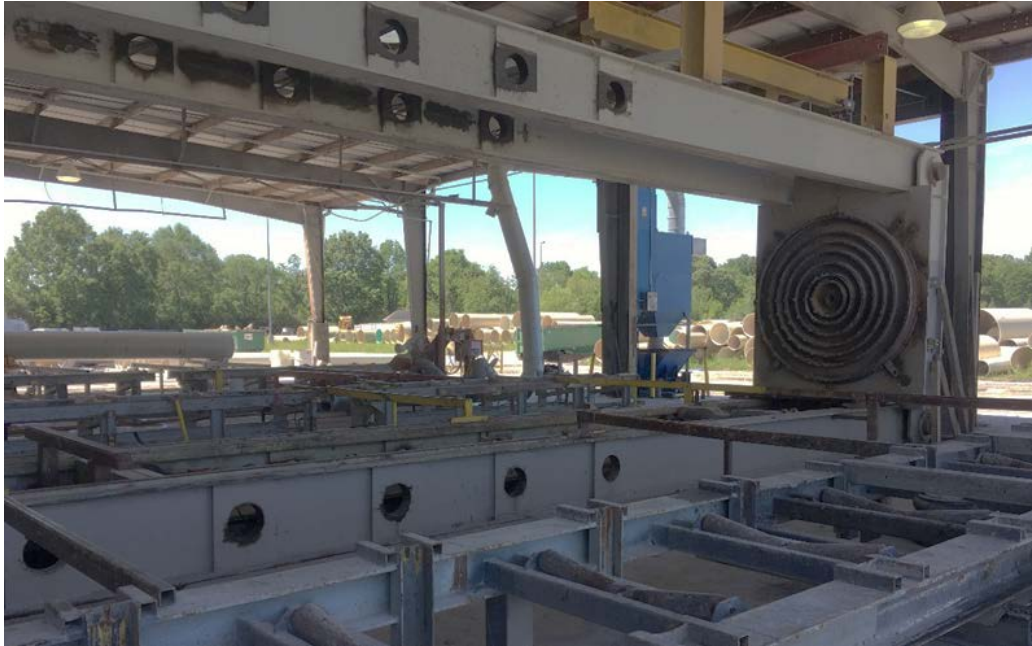
Figure A-11.—Hydro-tester station

After the pipe fabrication, the pipe sections move to a calibration station: the ends are calibrated/adjusted to fit in the Flowtite couplings. Pipe sections are then forwarded to the hydro-tester station (figure A-11) for pressure testing with water. All pipe sections are tested to twice the rated pressure and held for two minutes. The setup for hydro-testing the GFRP pipe is similar to steel pipe hydro-testing. The pipe fails if it loses pressure.

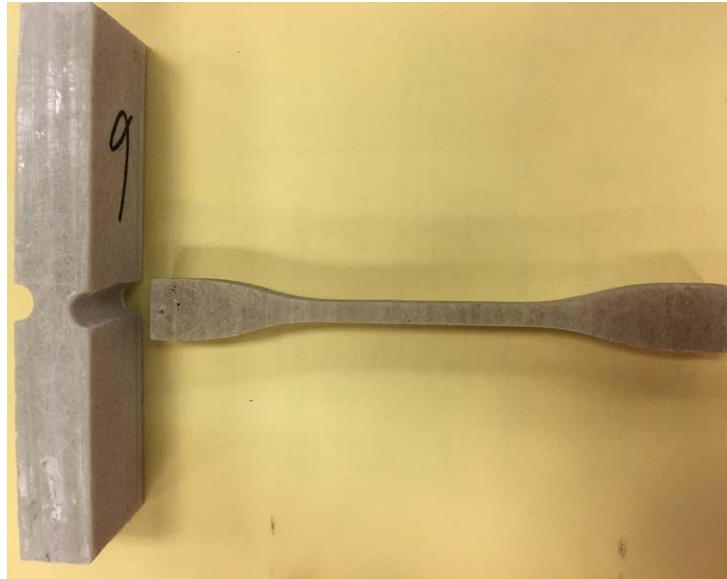
Figure A-12.—Samples for mechanical testing

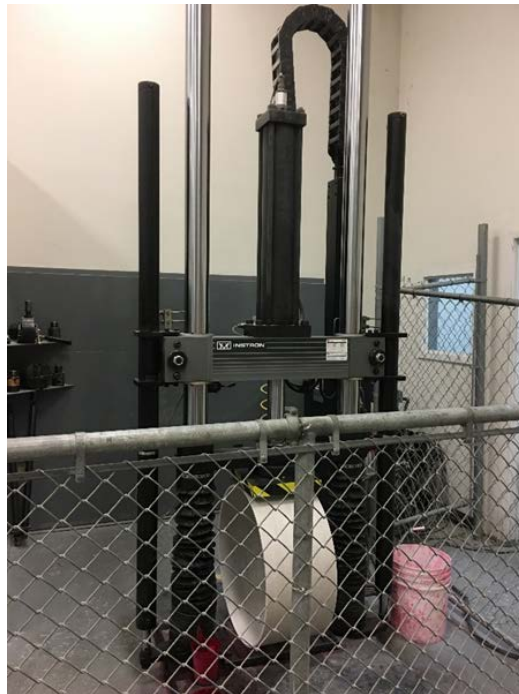
Figure A-13.— Mechanical properties tester (29,000 N load at 5% deflection)

Stiffness tester: ASTM 2412: pipe sample deflects until breaks (figure A-13, test observed).

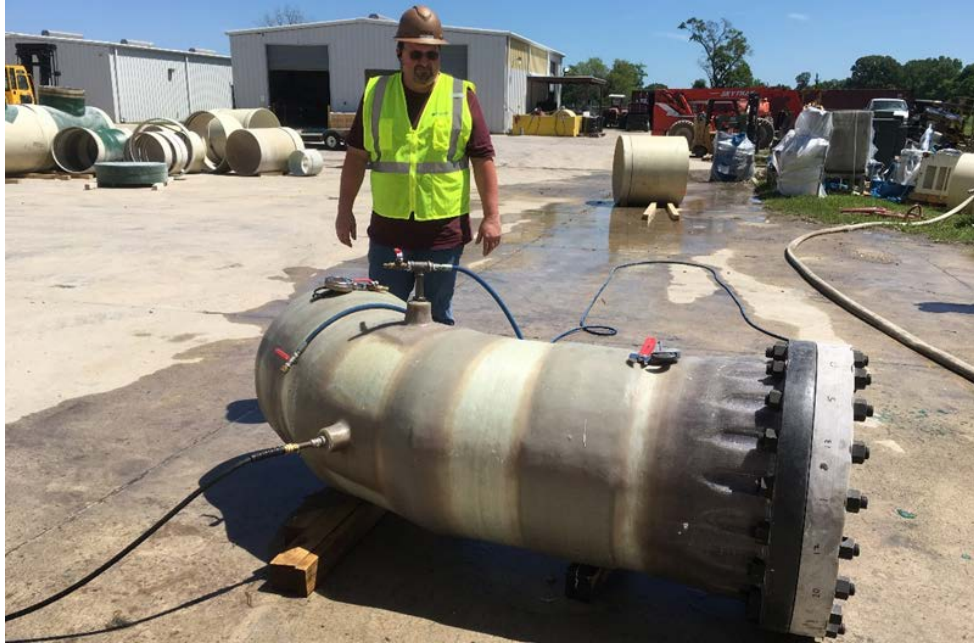
Figure A-14.—pressure testing of the fittings

The fittings were tested similar to pipe at twice the pressure rating and held for a period of two minutes to ten minutes (figure A-14).

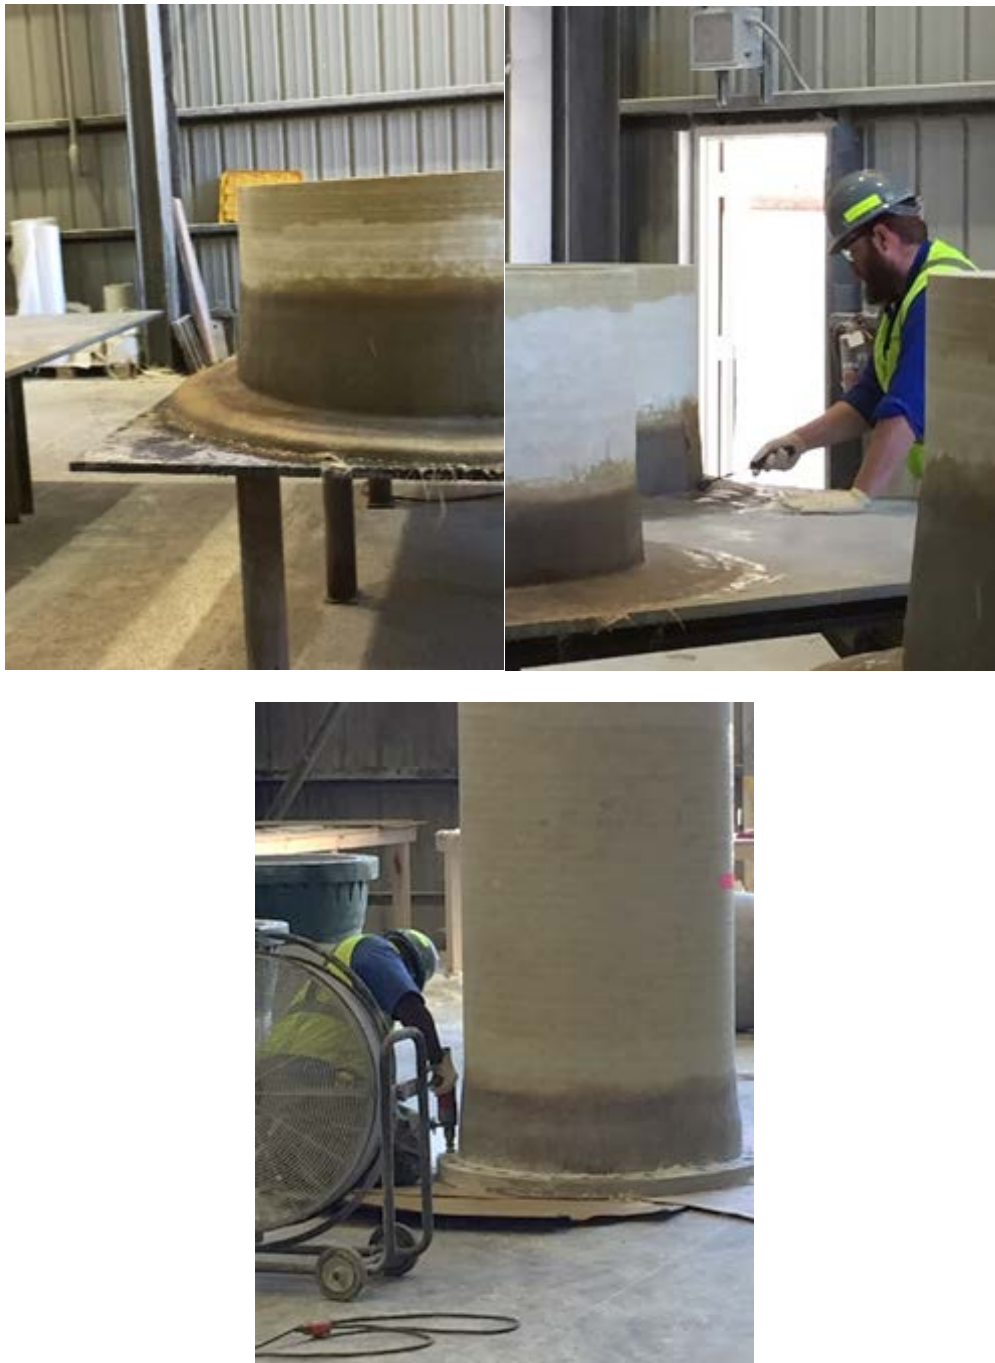
Figure A-15.—Fabrication process of flanges

As mentioned earlier, flanges are fabricated by hand (figure A-15). The pipe section is placed on a table. Sections of woven fiberglass cloths (figure A-16) approximately 20 cm × 30 cm are layered on a separate table and coated with resin. They are then formed to the pipe to create a flange. This process is time intensive and takes about 2 days (2 to 3 shifts per day) to complete one flange. The flange bolt holes are then drilled by hand.

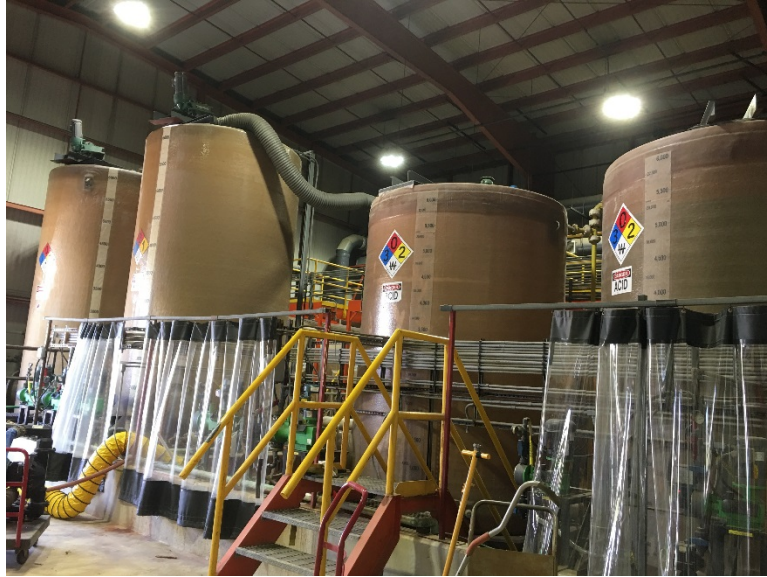
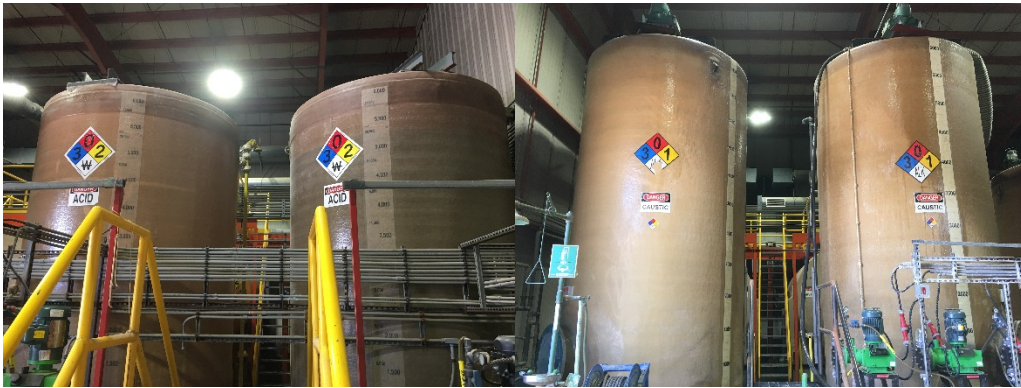
Figure B-1.—Acid and caustic tanks used for water treatment with their manufacturing information

Inspection was performed on both acid and caustic tanks (figures B-1 and B-2). These tanks are used for chemical treatment and cleaning water. Visual inspection was a reliable and easy method to detect blisters, air pockets, voids, and delamination in FRP tanks. Digital tap hammer could also be used as a tool for detecting delamination by change in the sound.

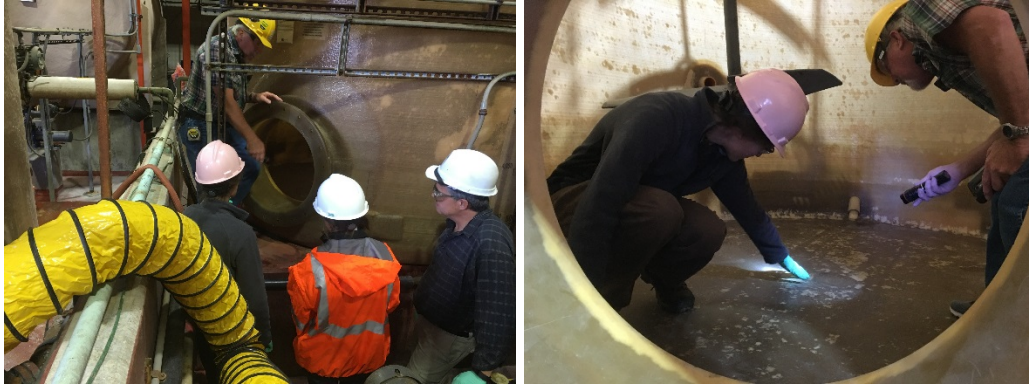
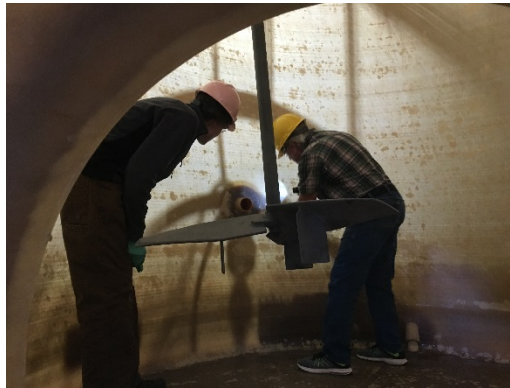
Figure B-2.—Visual inspection of the acid tank interior
