Scoping Report: Public Safety of Low-Head Hydraulic Structures

Research and Development Office
Science and Technology Program
Final Report ST-2017-1799-01

U.S. Department of the Interior
Bureau of Reclamation
Research and Development Office

September 2017

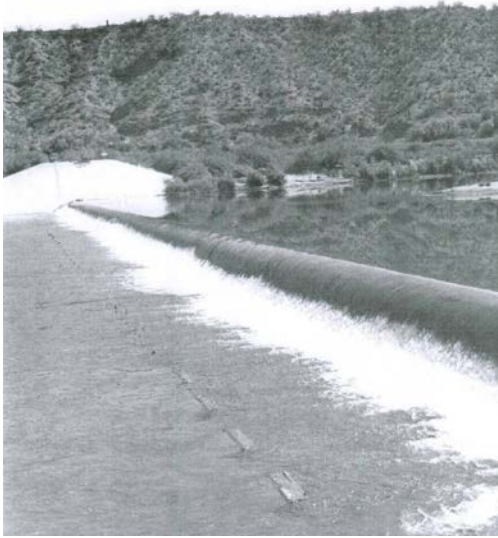
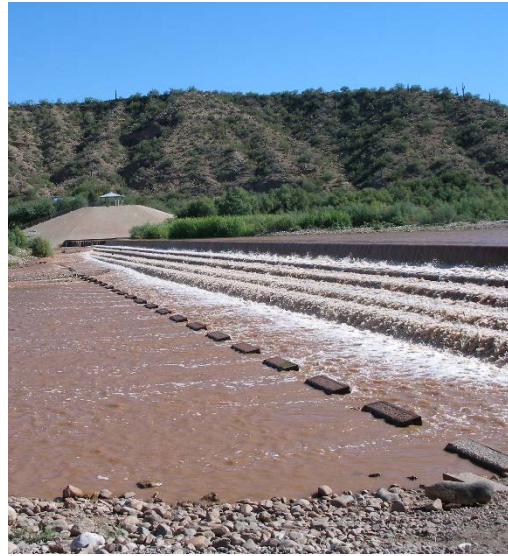
Figure 3. – Reclamation's Roosevelt Diversion Dam at the Power Canal upstream of Roosevelt Dam in the original design (left) and safer design retrofitted in 1989 (right).

The Power Canal Diversion Dam was modified in 1989 to improve recreational safety while maintaining the fish barrier effect of the original weir (Figure 3). The original 7.25-ft-high ogee-shaped weir was retrofitted with steps on the downstream face of the spillway in 1989 to improve safety issues. A 1:35 Froude-scaled physical hydraulic model of Roosevelt Diversion Dam showed that a combination of a 3.25-ft step at the dam crest elevation followed by a series of 1-ft steps with differing tread length provided the best hydraulic conditions for recreational safety while preserving the fish barrier characteristics to prevent migration of non-native fish into the Salt River (Dodge 1989).

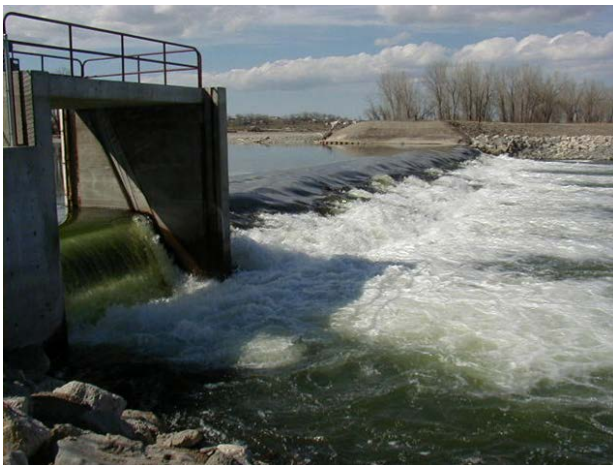
Figure 4. Huntley Diversion Dam was modified to enhance public safety during rehabilitation after the 1997 spring flood.

Constructed in 1933, the original design of Reclamation's Huntley Diversion Dam on the Yellowstone River included a concrete gravity structure with a structural height of 10 to 11 ft and a crest length of about 250 ft. The structure was used to meet agricultural and municipal water demands for the Huntley Project and it was transferred to the Huntley Project Irrigation District for operation and maintenance. After the record spring runoff of 1997, Huntley Diversion Dam was modified to repair the dam, but also provide fish passage and enhance public safety (Figure 4). Along with a left abutment fish passage channel, heavy riprap was placed at a 4H:1V slope from the crest of the dam to the river bottom with a natural rock basin at the toe of the riprap slope. The top 6 inches of the riprap was grouted (Womack & Associates, Inc. 1999).
