Flow Deflectors to Reduce Abrasion Damage in Stilling Basins – 40 Year Progress Report

Research and Development Office
Science and Technology Program
ST-2018-8143-01

Hydraulic Laboratory Report HL-2019-02

April 2019

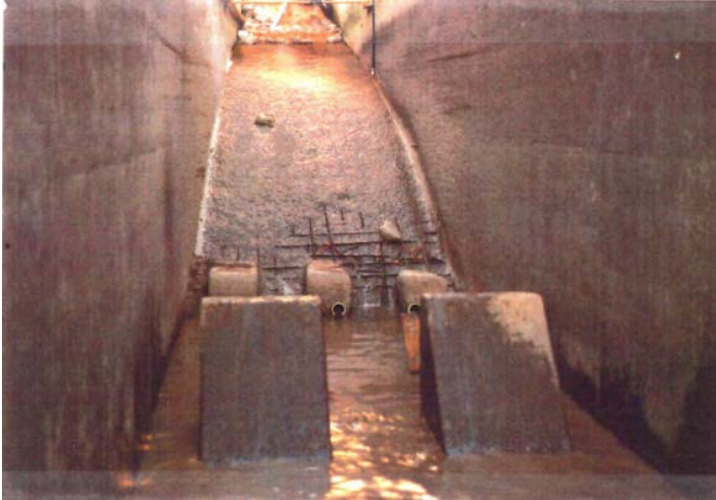
Figure 4. — Inspection photo from Taylor Draw Dam outlet works stilling basin, 1987.

A 1:10 scale physical hydraulic model of the Taylor Draw Dam outlet works stilling basin was tested in Reclamation's Hydraulics Laboratory to determine the cause of concrete damage and develop modifications to prevent future damage (Dodge 1992). The model showed that the flow exiting the outlet gate lifted off of the chute floor and concentrated to one side near the water surface. The concentrated surface flow produced return flow over the downstream basin sill. The separation of the outlet flow from the incoming chute floor was a more severe problem than the general separation of flow from the stilling basin floor seen by Zeigler in the Mason model. A vortex generated from a bifurcation upstream from the gate caused these flow conditions. The return flow brought rocks as large as 9 inches in diameter into the basin. The churning and tumbling rocks severely abraded the concrete, even across the toe of the chute at the upstream end of the basin (Figure 4; Resource Consultants, Inc. 1991).
