Final Report ST-2019-8284-01

Cracked Embankment Erosion Test

December 2019

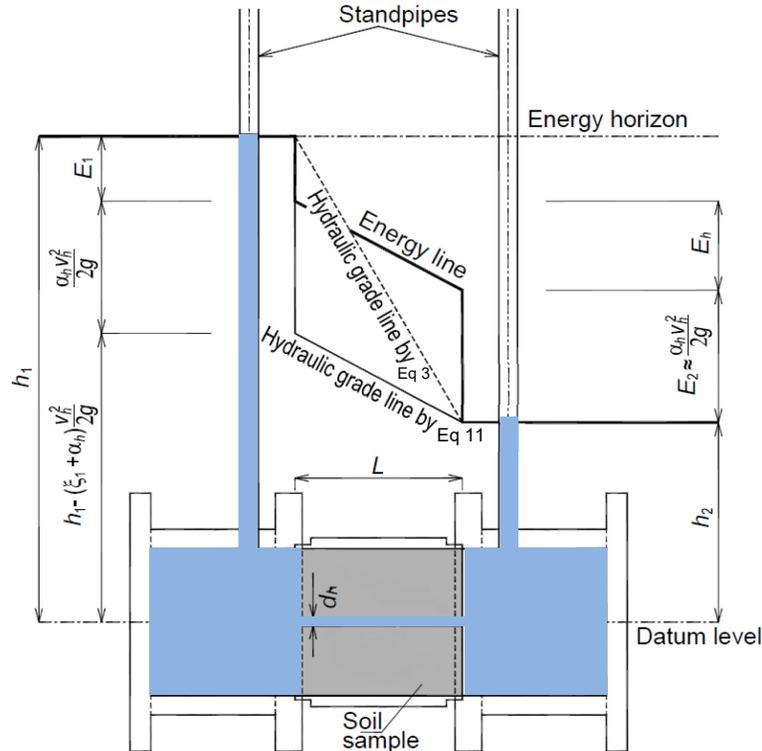
Figure 1. – Schematic of the Hole Erosion Test (from [8]). Hydraulic gradient across the hole was traditionally calculated using equation 3. Equation 11, described by Riha and Jandora [8], updates the equation to account for additional head loss as the flow enters the specimen.

The HET measures erodibility of a soil by directing flow through a hole drilled through the center of a specimen. The specimen is prepared in a 4-inch standard Proctor mold, drilled with a 1/4" hole and then loaded into the apparatus for testing. A schematic of the apparatus is shown in Figure 1.

Accounting for entry losses when calculating the average gradient, has the largest impact on the calculation of τ_c [8]. Typically, the gradient is assumed to be linear across the sample, as shown by the dashed hydraulic grade line in Figure 1. Detailed modeling of the specimen was completed using computation fluid dynamic software. The research found that entry losses and the increase in velocity head have a significant impact in calculating τ_c [8].

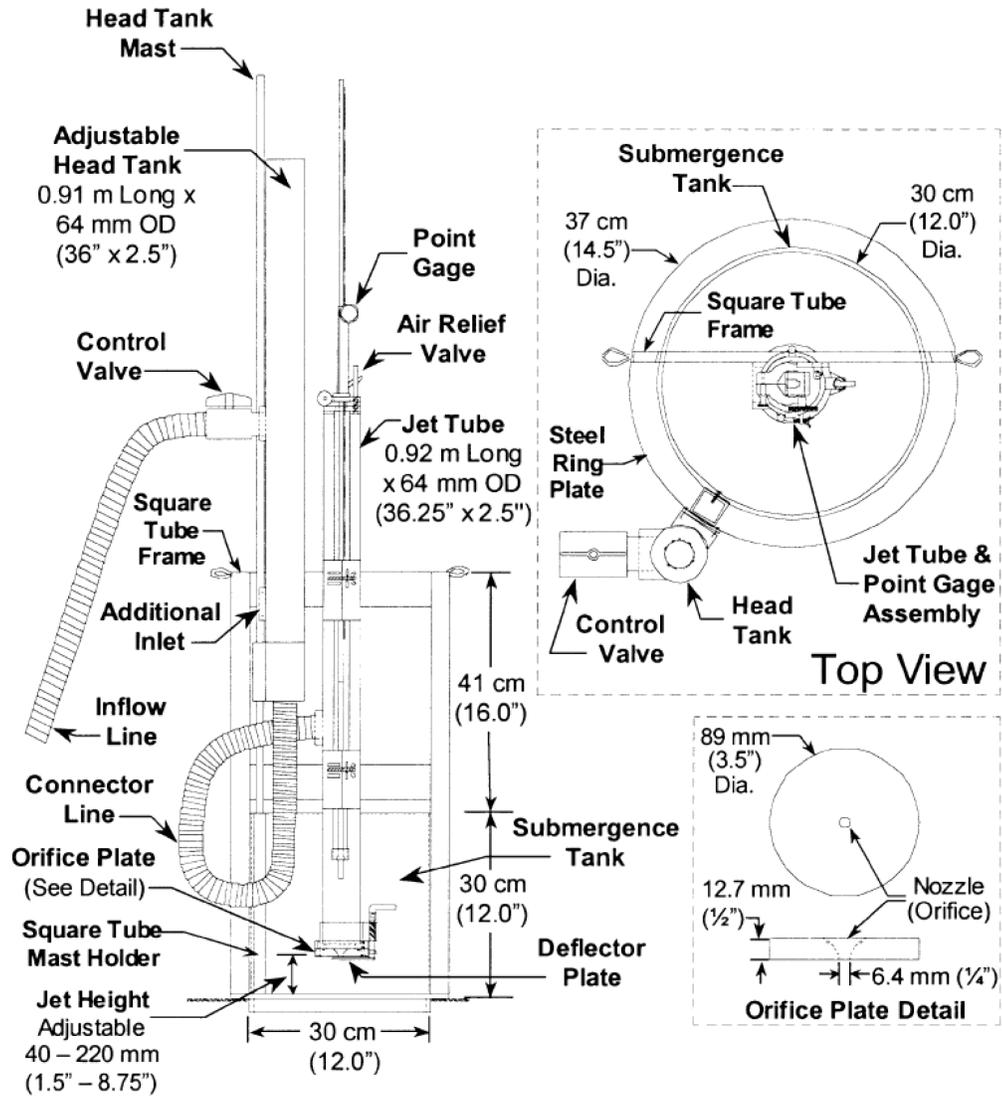
Figure 2. - Schematic of the JET apparatus (from [9])

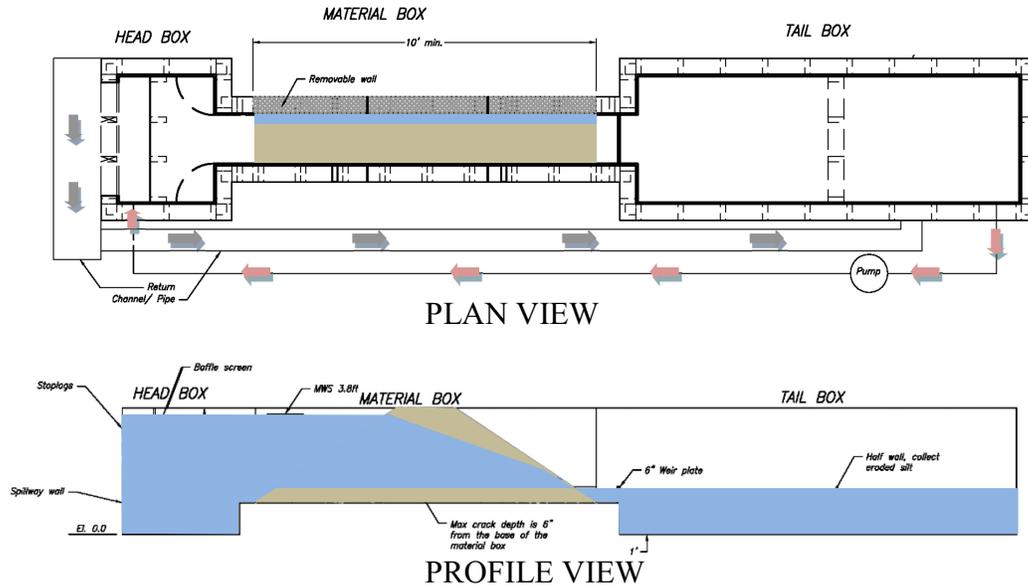
Figure 3. - CEET apparatus plan and profile.

Some of these questions were easier to answer than others. After much consultation with Reclamation's Hydrologic and Geotechnical Laboratory experts, including resident carpenters, the team derived a plan for the CEET apparatus. The apparatus was developed to model the upper three feet of an embankment, canal, or levee with a crack along the outside edge of the embankment. Given the variation in how long erosion may take to initiate, the system for supplying water to the upstream side of the embankment was designed to reach an elevation, then spill into another section and be recirculated. Plan, profile, section, and details of the testing apparatus are included in Appendix A. Some of the details have changed, but Appendix A shows the design concepts used by the carpenters to build the system. The CEET apparatus has three primary components; head box, material box, and tail box. The configuration of all three components is shown in Figure 3.

The first removable wall was designed to protrude into the embankment (i.e. the wall has something attached to it that will be the shape of the flaw). The second removable wall was flat, allowing a crack to form where the protrusion from the first removable wall had been. This second removable wall was transparent, allowing for monitoring of the erosion during the test. Forming the crack in this manner allowed the flaw to have a known approximate initial volume and width, and to be consistent between tests. In Figure 3 the crack is highlighted in blue on the plan view between the brown material and removable water.

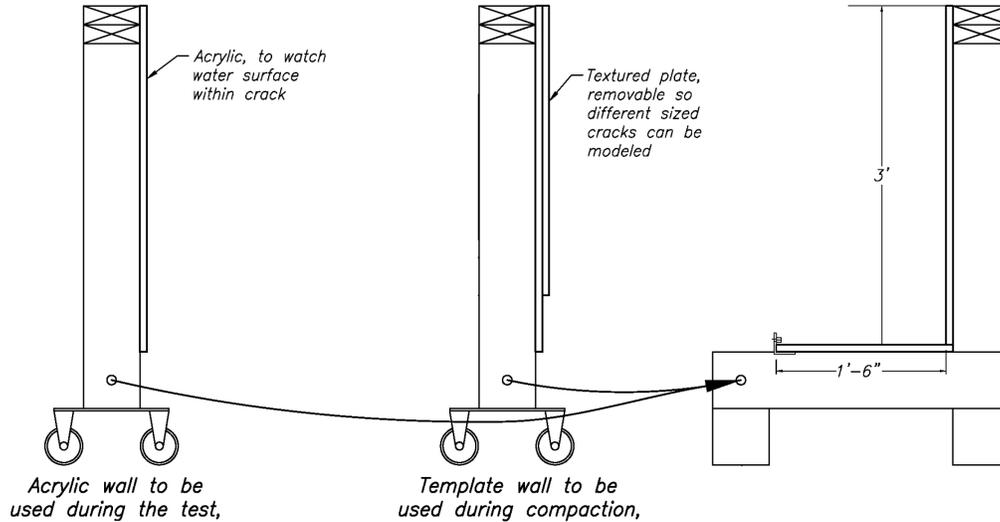
Figure 4. - Section through material box, showing removable wall system.

The material box was designed to hold an embankment that was approximately 3.0 feet tall, 12.0 feet long (at the base), and 1.5 feet wide. The material box was designed with a removable wall on one side. Two different removable walls were designed to fit into the same place, see Figure 4.

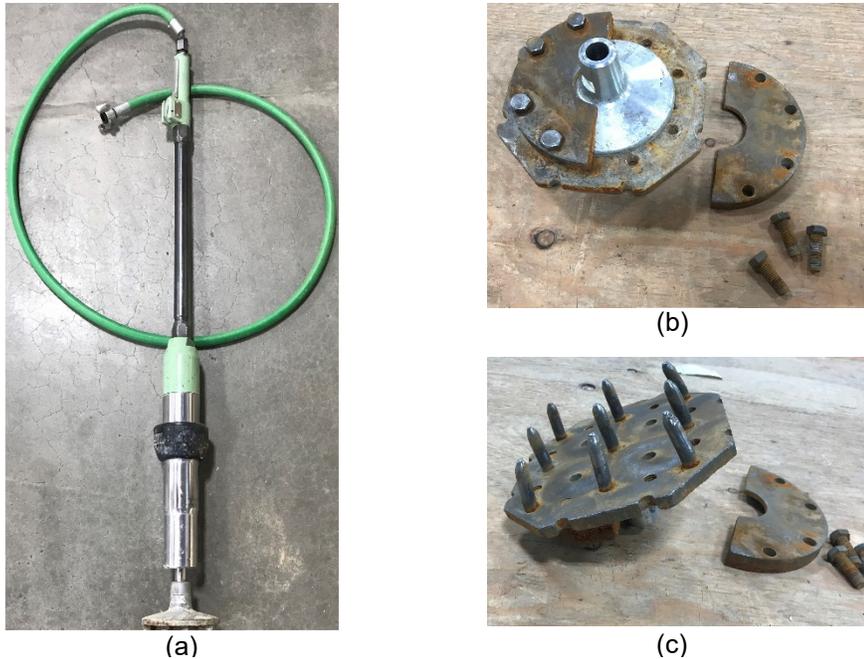
Figure 5. – (a) Sullair backfill tamper with standard flat plate attachment, (b) top of spike-foot attachment that fits over the standard plate, (c) bottom of spike-foot attachment.

9 additional JETS were completed on Highland Clay material. However, instead of compacting the material using standard Proctor methods, the material was compacted in a large steel box using the same pneumatic tamper shown in Figure 5. The steel box was designed to withstand the energy from the pneumatic tamper and to be rotatable with a removable wall so JETs could be completed on the top and side of the compacted material, see Figure 18. The steel box is approximately 18-inches wide by 30-inches long by 18-inches deep.

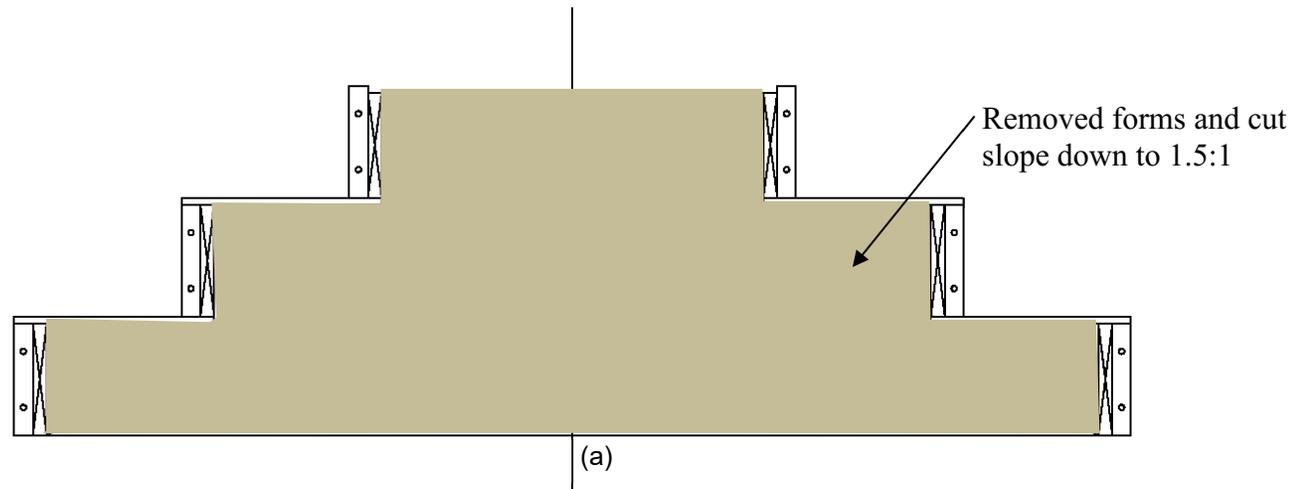
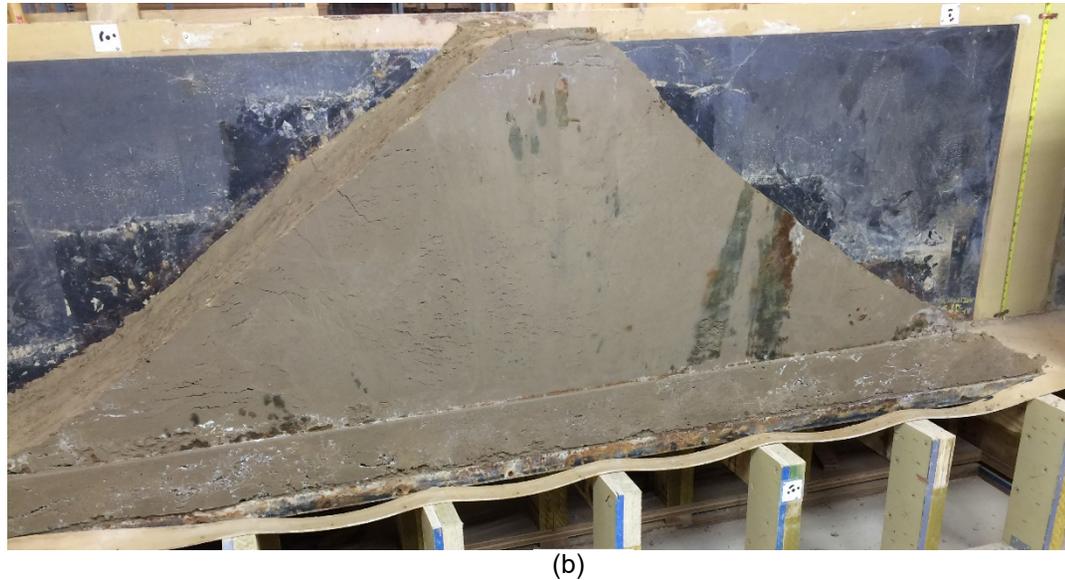
Figure 6. – (a) Schematic of stepped embankment construction, (b) final embankment configuration (picture taken from Test 4). Note, schematic only shows three steps, in actual construction 4 steps were required. Also, figure b shows the embankment after removal of the compaction wall.

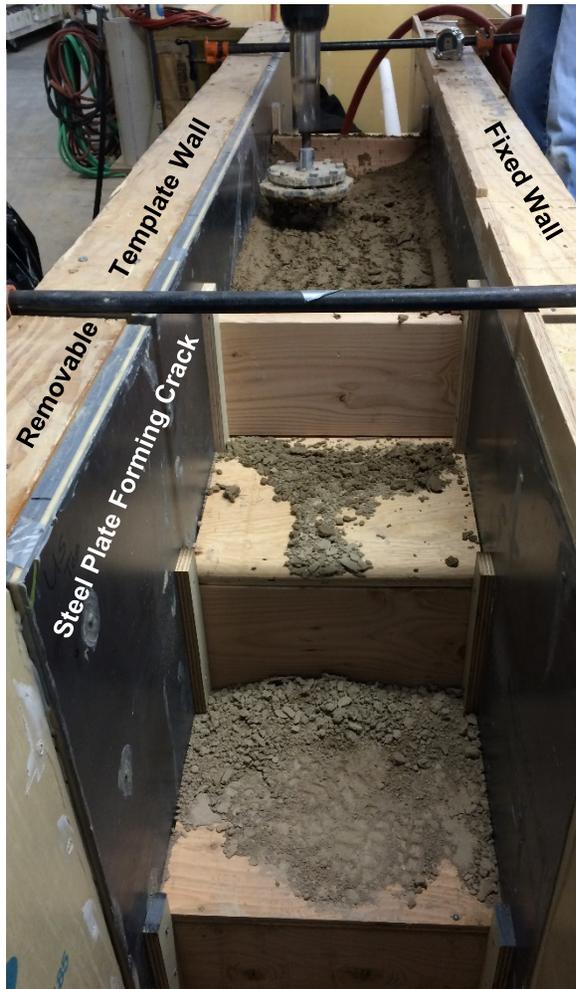
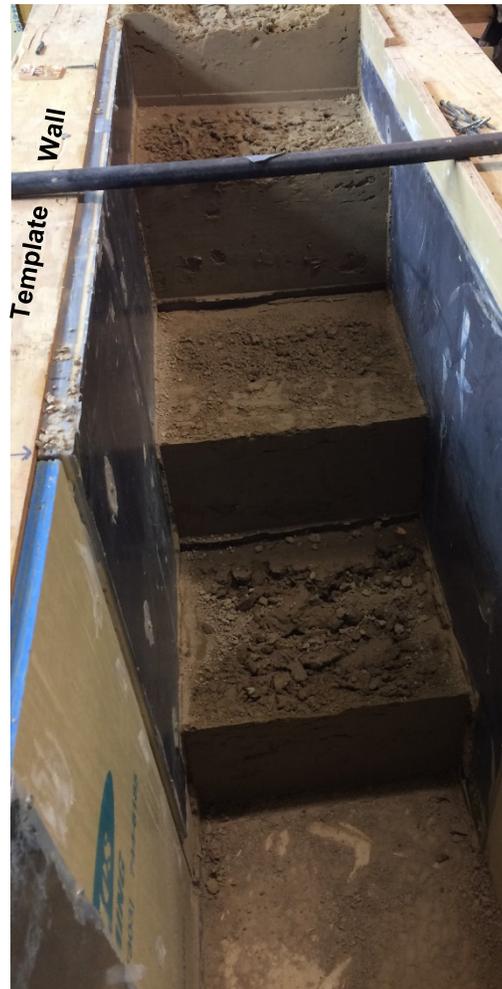
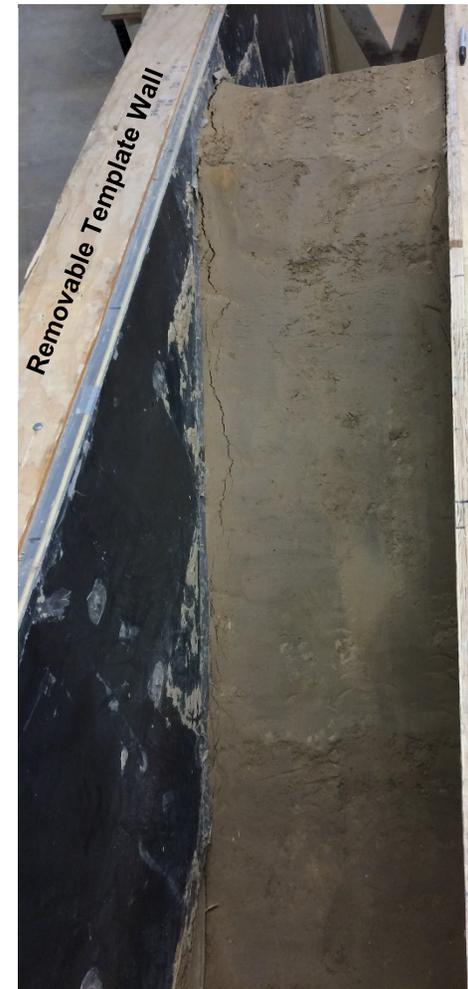
Figure 7. – (a) compaction of embankment in step three of four, (b) stepped embankment after removal of forms, (c) embankment after cutting off the steps to create smooth 1.5H:1V slopes. Pictures are taken from Test 2.

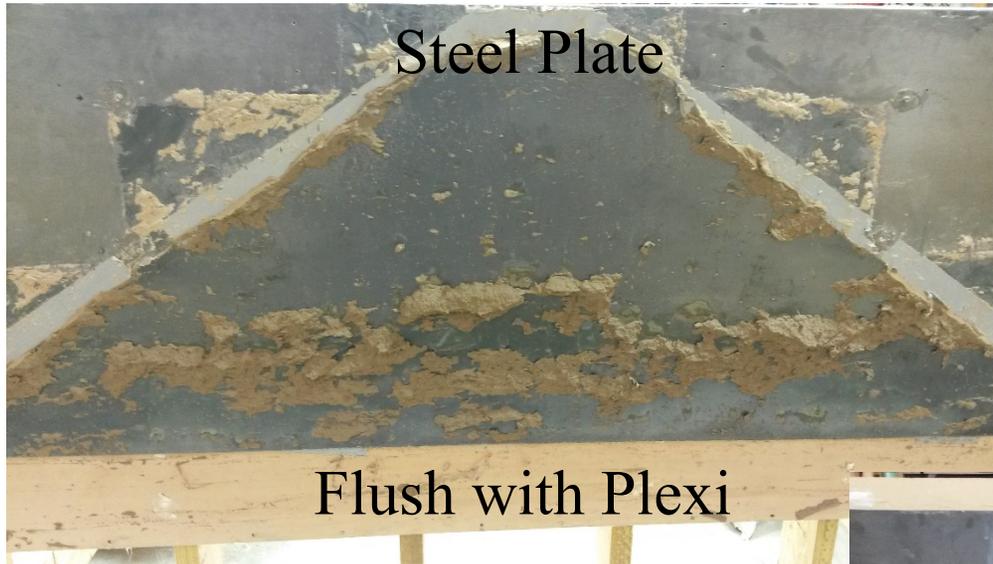
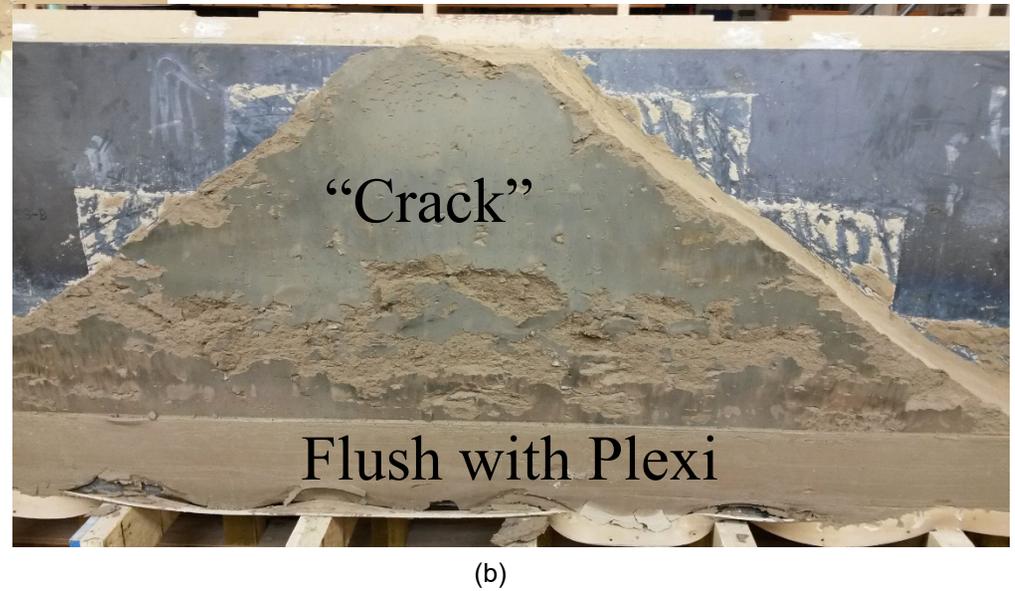
Figure 8. – (a) Image of the template wall showing soil stuck to the steel plate used to form the wall, (b) Embankment showing where soil was removed and how embankment was disturbed. Photos were taken from trial test 2.

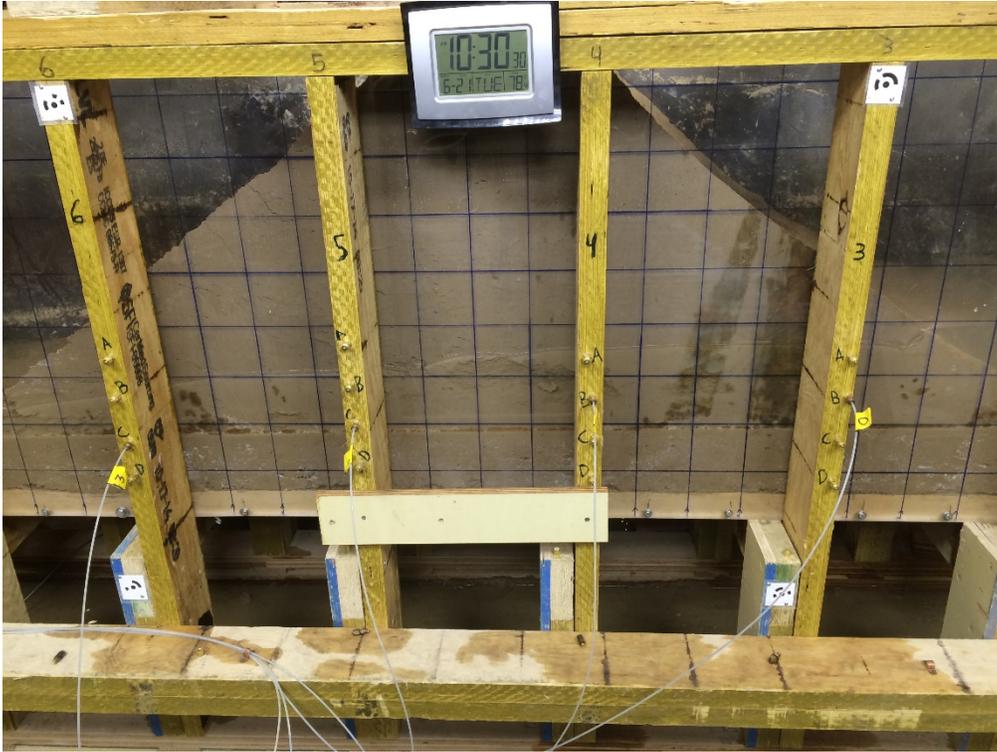
Figure 9. – Apparatus with acrylic glass testing wall installed. Note, grid on acrylic glass is 4-inches by 4-inches.

After compaction of the embankment, the template wall was removed and replaced with the acrylic testing wall. Figure 9 shows the testing apparatus with the acrylic wall installed. The testing wall was constructed from 0.75-inch plexiglass/acrylic. The crack was the 0.375-inch gap between the embankment and acrylic. This gap or crack formed between the wall and embankment is shown in Figure 10. Once the testing wall was in place, the perimeter of the wall was sealed to the apparatus by bolting the removable testing wall to the apparatus. Rubber gaskets and silicone were placed between the removable wall and apparatus to ensure a tight seal. At this point, the embankment was ready to be tested and the reservoir could be filled.

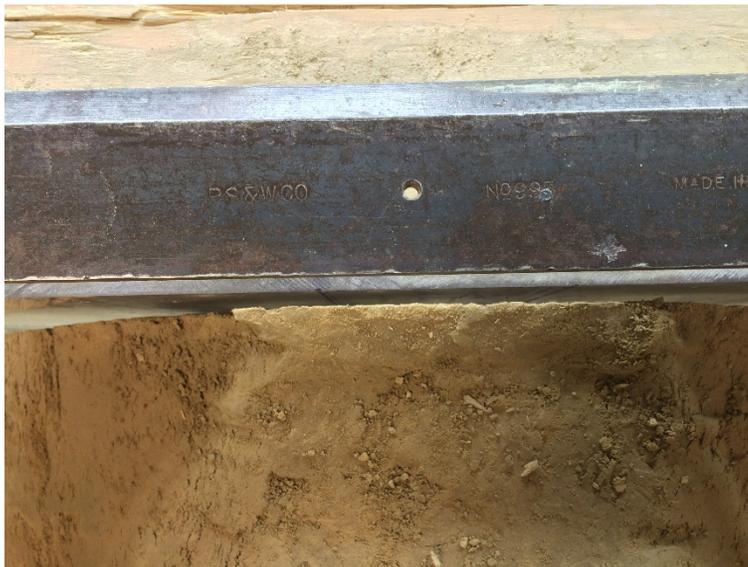
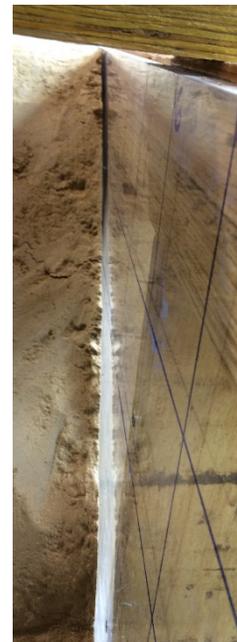
Figure 10. – (a) view of the crack from above the embankment looking down (b) view of the crack from the upstream slope looking towards the reservoir.

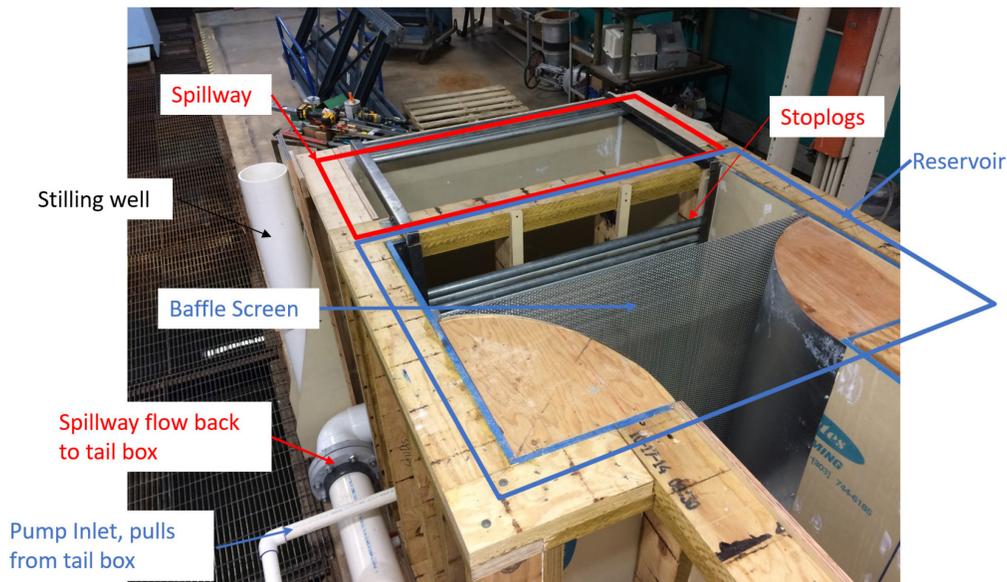
Figure 11. – Image of the head box detailing the different components.

After the acrylic wall is bolted and sealed to the apparatus, the tail box is filled with water. As previously mentioned, the reservoir is supplied by a pump moving water from the downstream tail box to the upstream head box. Figure 11 shows the different components within the head box. The pump has a maximum capacity of 280 gallons per minute (gpm) and the initial 0.375-inch crack only allows 3.5 gpm. The limited flow rate through the crack results in excess water flowing into the spillway and back to the tail box. Reservoir height is controlled by stoplogs in the spillway, adding stoplogs increases the reservoir height and removing logs lowers the reservoir. Directing flow over the spillway allowed the crack width to widen and flow through the crack to increase without a significant change in reservoir elevation. At the beginning of each test when flows through the crack were limited, flow from the pump was throttled using a ball valve. The throttle valve was only fully opened when flow through the crack increased significantly due to the eroding pipe.

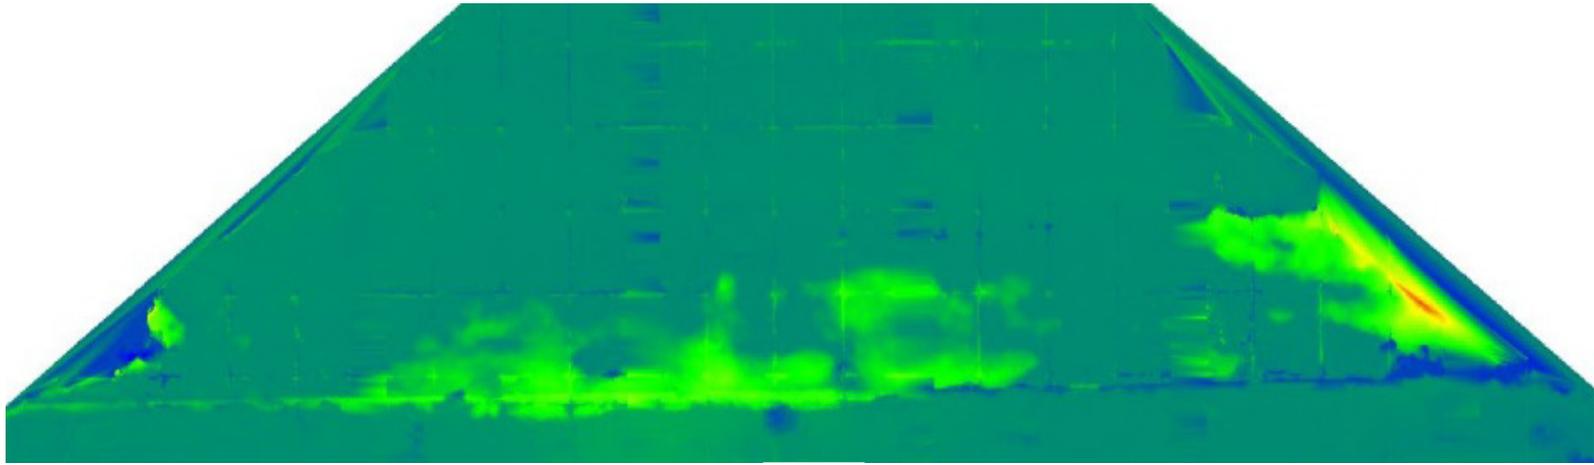
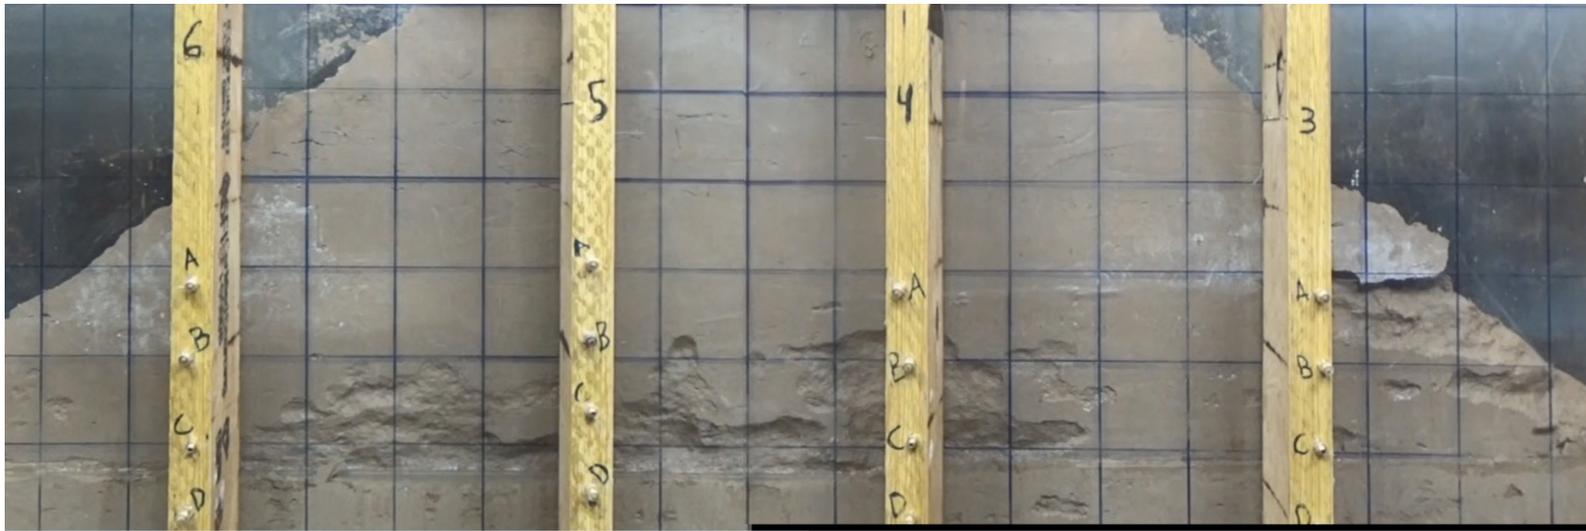
Figure 12. – (a) eroded surface constructed from photogrammetry (b) picture of the actual eroded surface. Note the removal of the structural members and the slight grid shown on the photogrammetry surface.

local hydraulic shear stress requires not only knowing the local change in velocity head, pressure head, and elevation head but also the average crack width. As seen in Figure 12, the crack width can vary greatly between post/ports. Furthermore, the average velocities and pressures measured at the post do not match the velocities and pressures within the eroded areas where the crack is wider. For this reason, calculating local hydraulic shear stress between posts became very difficult, further discussion on the difficulties is provided in the result and uncertainty sections below.

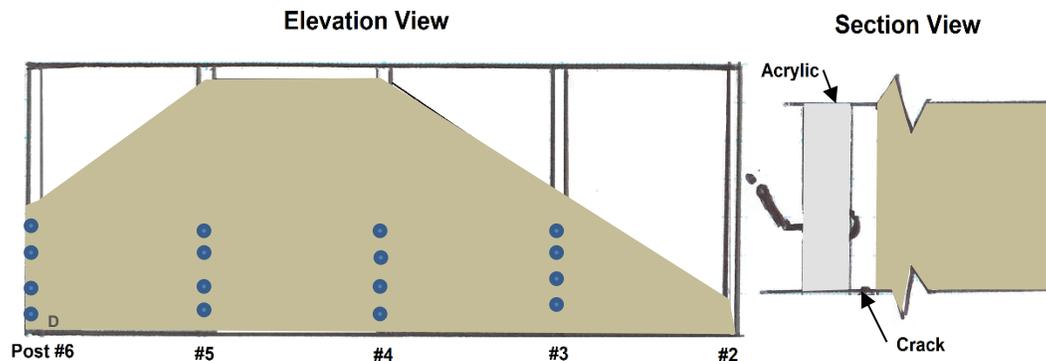
Figure 13. – Schematic used when calculating local gradient between ports. Note, total head within the tube is assumed to be equal to total head in crack.

The transducers were connected to ports that penetrated through the acrylic wall into the crack, as shown in Figure 14. The ports on the exterior of the material box were connected to porous stone located inside the crack flush with the acrylic wall. Four ports could be connected at one time. A total of twenty ports were installed, four ports were installed in each post, as shown in Figure 13.

Knowing the pressure head, velocity head, and elevation head at several locations within the crack allowed for the calculation of head loss and estimation of the local gradients. As shown in Figure 13, pressure ports were inserted in every post, velocity was measured in between every post, and all critical components were surveyed to measure relative distance and elevation change. This meant an average pressure, velocity and elevation could be measured at each post and the change in these values from post to post could be used to calculate head loss.

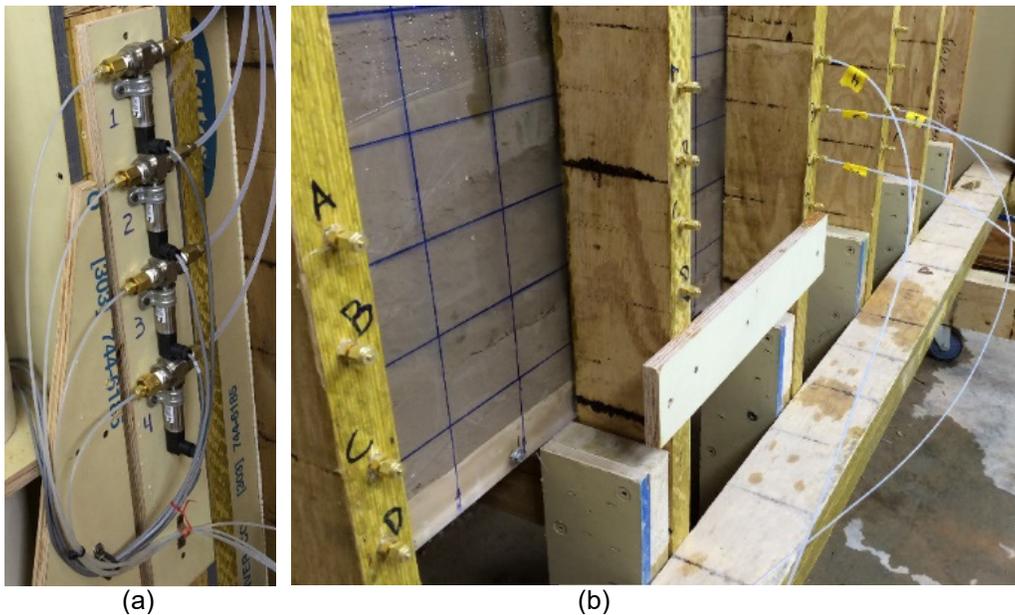
Figure 14. – (a) pressure transducers (b) ports connected to porous stone reading the pressure head within the crack.

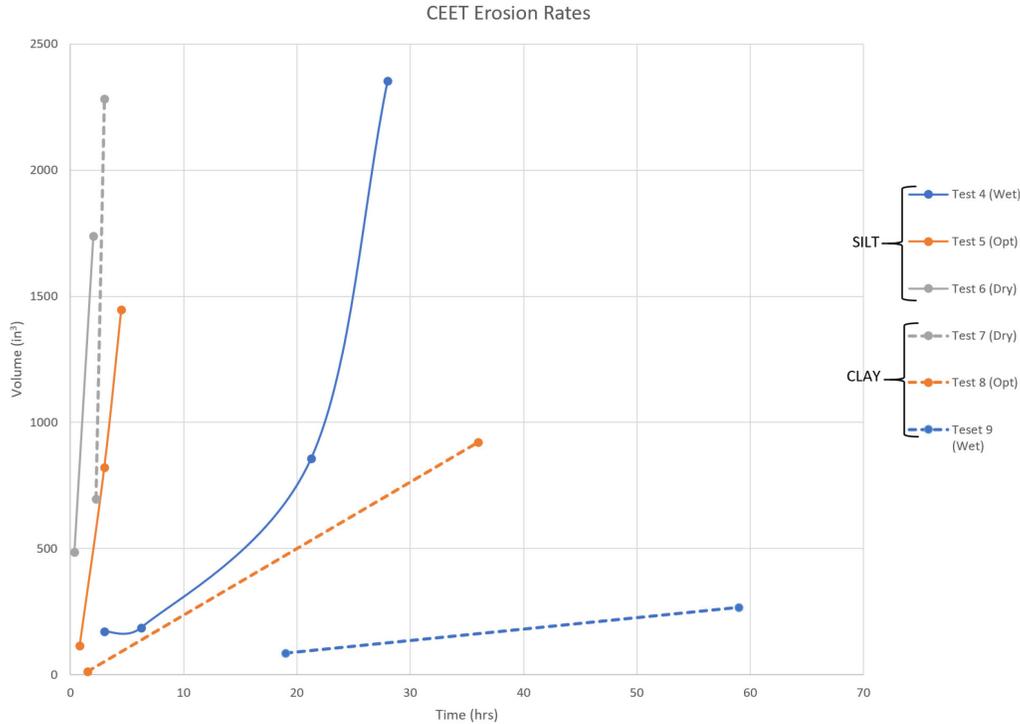
Figure 15. – Erosion rate of cracked embankment erosion tests. Note, final erosion volumes measured in Tests 8 and 9 occurred after gradient was increased.

Each of these tests were completed on the same size of embankment using methods previously discussed with a 0.375-inch wide crack and the reservoir 8-inches above the bottom of the crack. The average gradient across the embankment was 0.11 and average hydraulic shear stress was 0.11 psf (5 pa). Note this hydraulic shear stress is calculated at the beginning of the test, prior to any erosion. The amount of erosion varied significantly between tests. Erosion rates were calculated using the volume of eroded material calculated from photogrammetry and the length of time between erosion measurements. Average erosion rates for each test are shown in Table 4 and Figure 15.

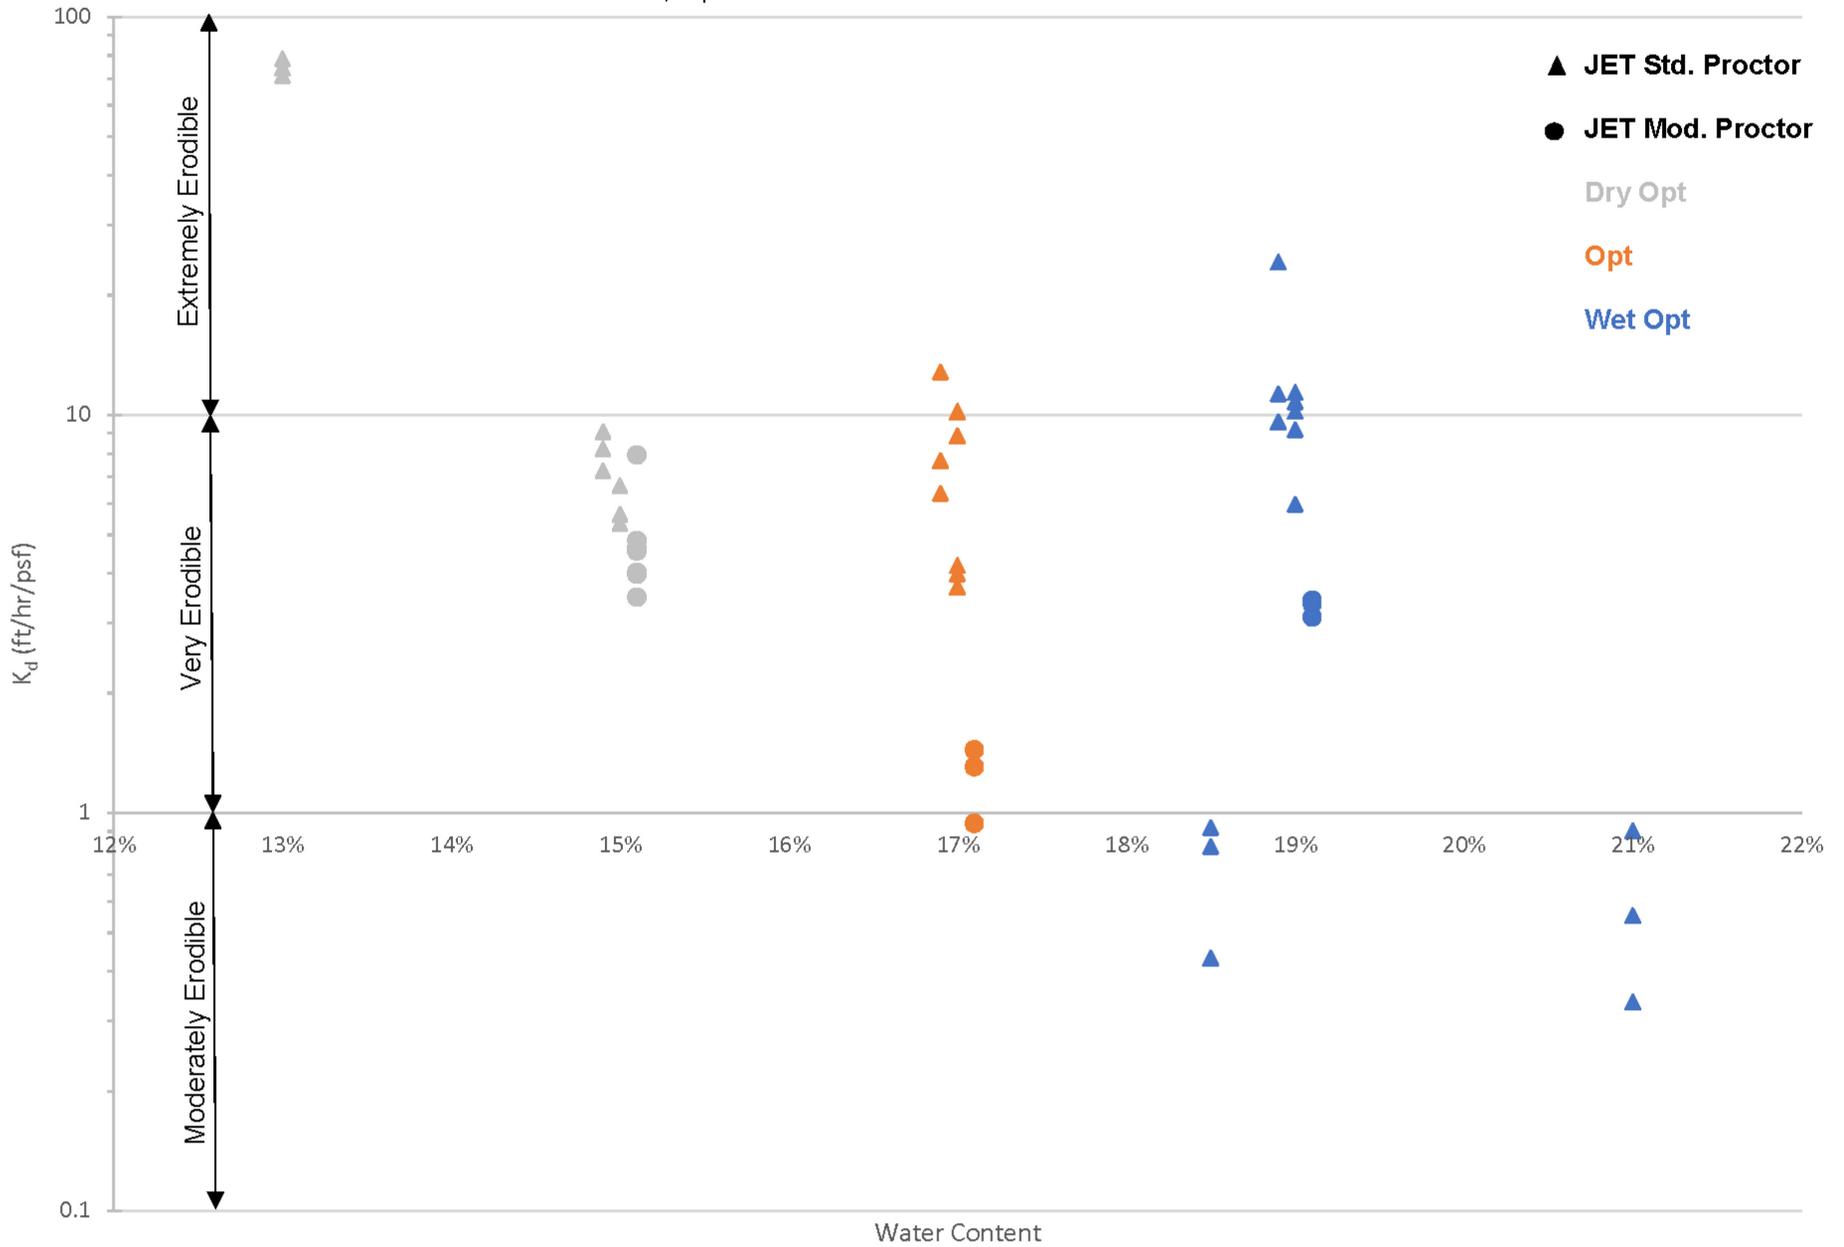
Bonny Silt K_d vs Water Content

Note, Optimum Water Content is 17%

Figure 16. – Bonny Silt JET and HET results.

Overall, Bonny Silt can be classified as moderately erodible (at 4% wet of optimum) to extremely erodible (at 4% dry of optimum). This means erodibility spans three orders of magnitude. Samples within 2% of optimum are classified as very erodible. JET results for Bonny Silt are also reported graphically in Figure 16. The plot shows how the data is clustered and/or scattered.

The average k_d for all 47 Bonny Silt JETs was 10.4, which would classify the material as extremely erodible. Taking an average k_d is not an accurate estimate of the soil's erodibility. Only 25 percent of the samples have a k_d greater than 10, and the average k_d is skewed by a few samples with k_d greater than 70. Using Figure 16, a majority of tests plot in very erodible and the soil could be best summarized as very erodible.

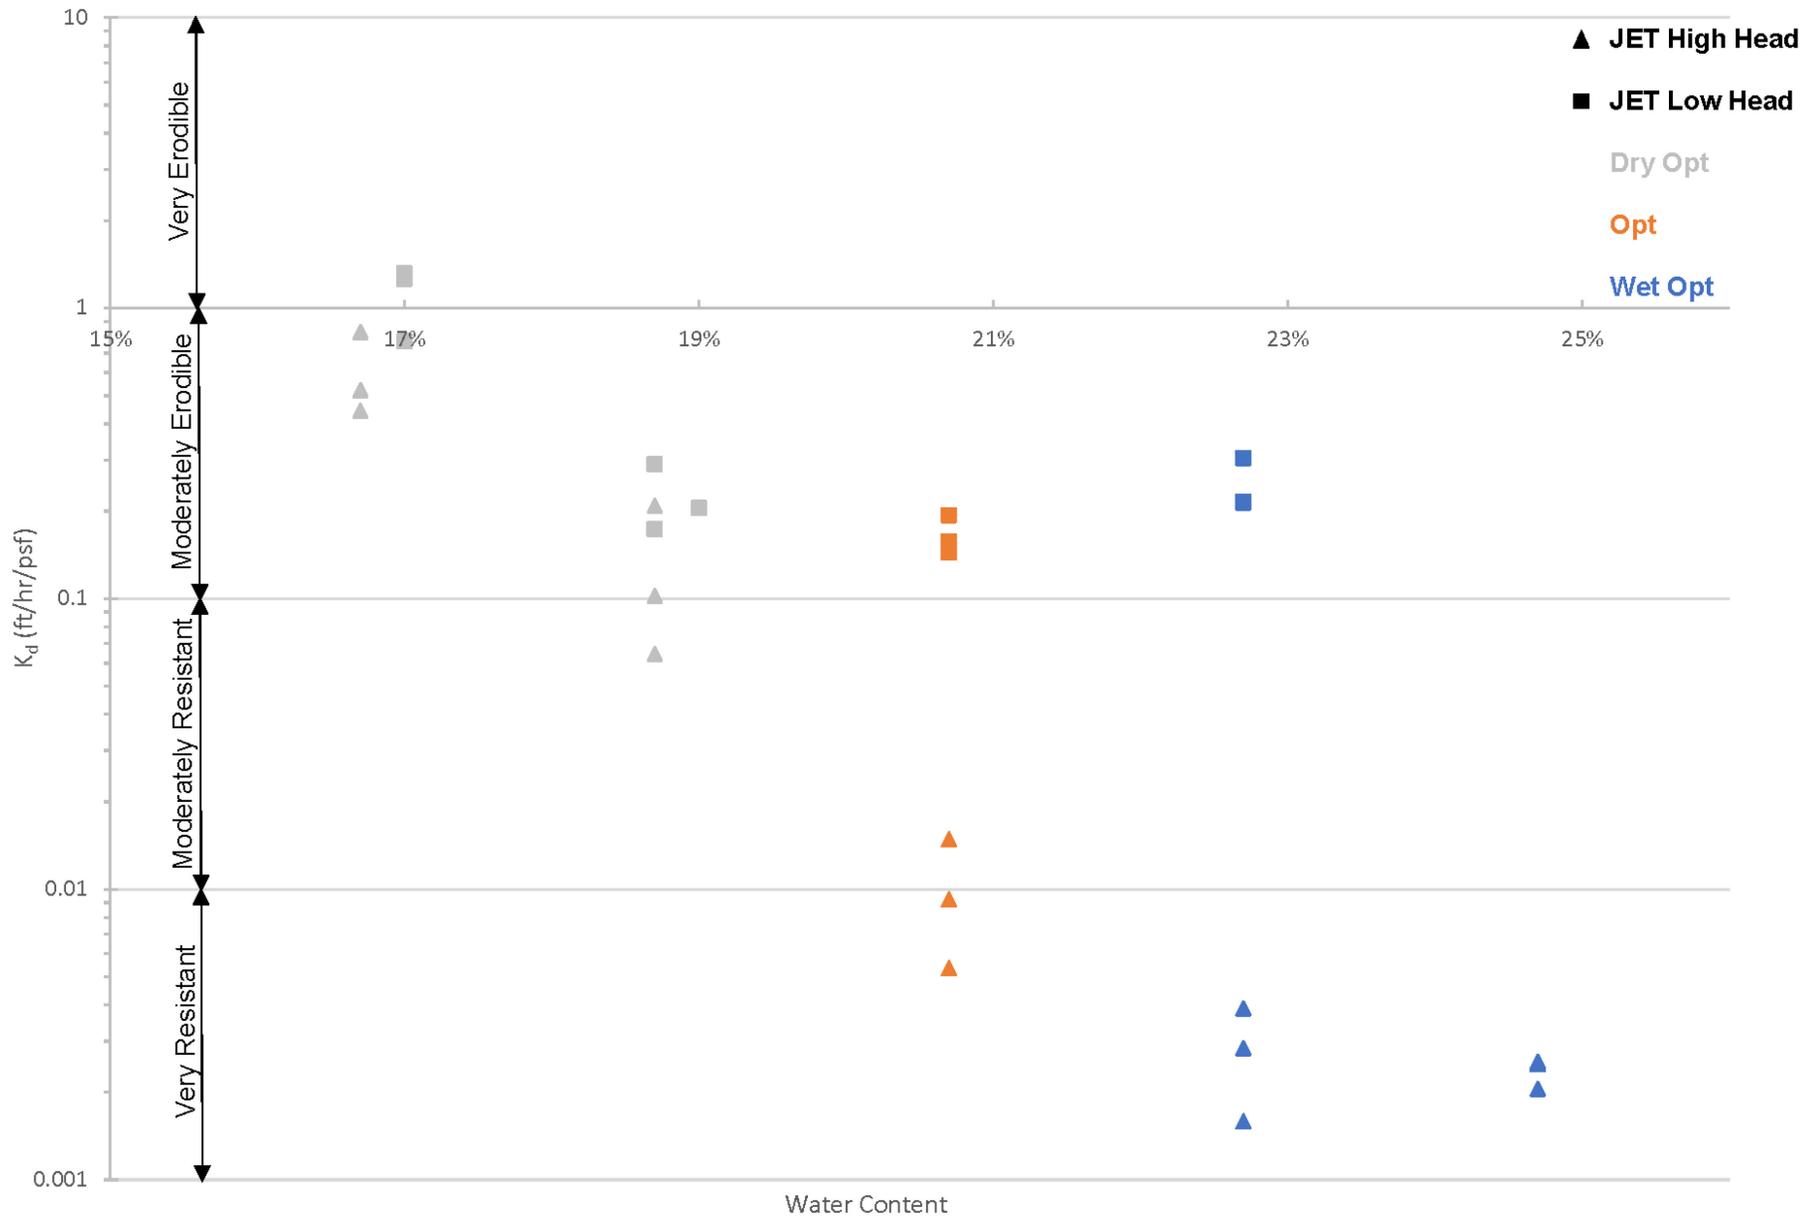
Highland Clay K_d vs Water Content

Note, Optimum Water Content is 20.7%

Figure 17. – Highland Clay JET results.

Overall, Highland Clay can be classified as very resistant (at 0 to 4% wet of optimum) to moderately erodible (at 0 to 4% dry of optimum). Highland Clay erodibility also spans three orders of magnitude. JET results for Highland Clay are reported graphically in Figure 17. The plot shows how the data is clustered and/or scattered.

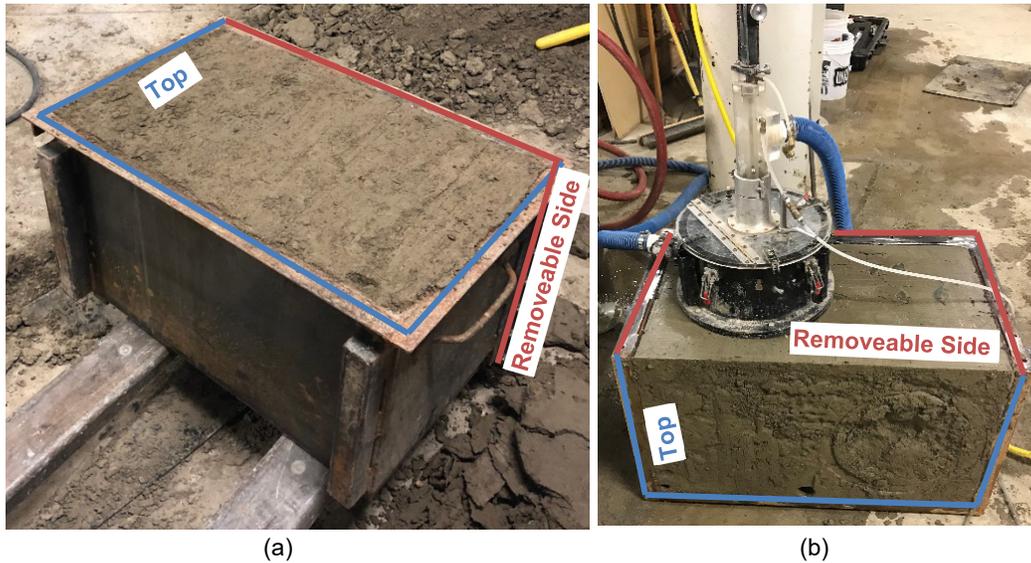
Figure 18. – (a) Steel compaction box shortly after filling. JET was completed on the top before rotating and completing a JET on the side (b).

This method then tested the surface that was compacted, as well as the side perpendicular to the direction of compaction. It was expected that the “side” testing was more similar to the large-scale testing. Only Highland Clay was used in the steel box.
