Final Report ST-2019-8284-01

Cracked Embankment Erosion Test

December 2019

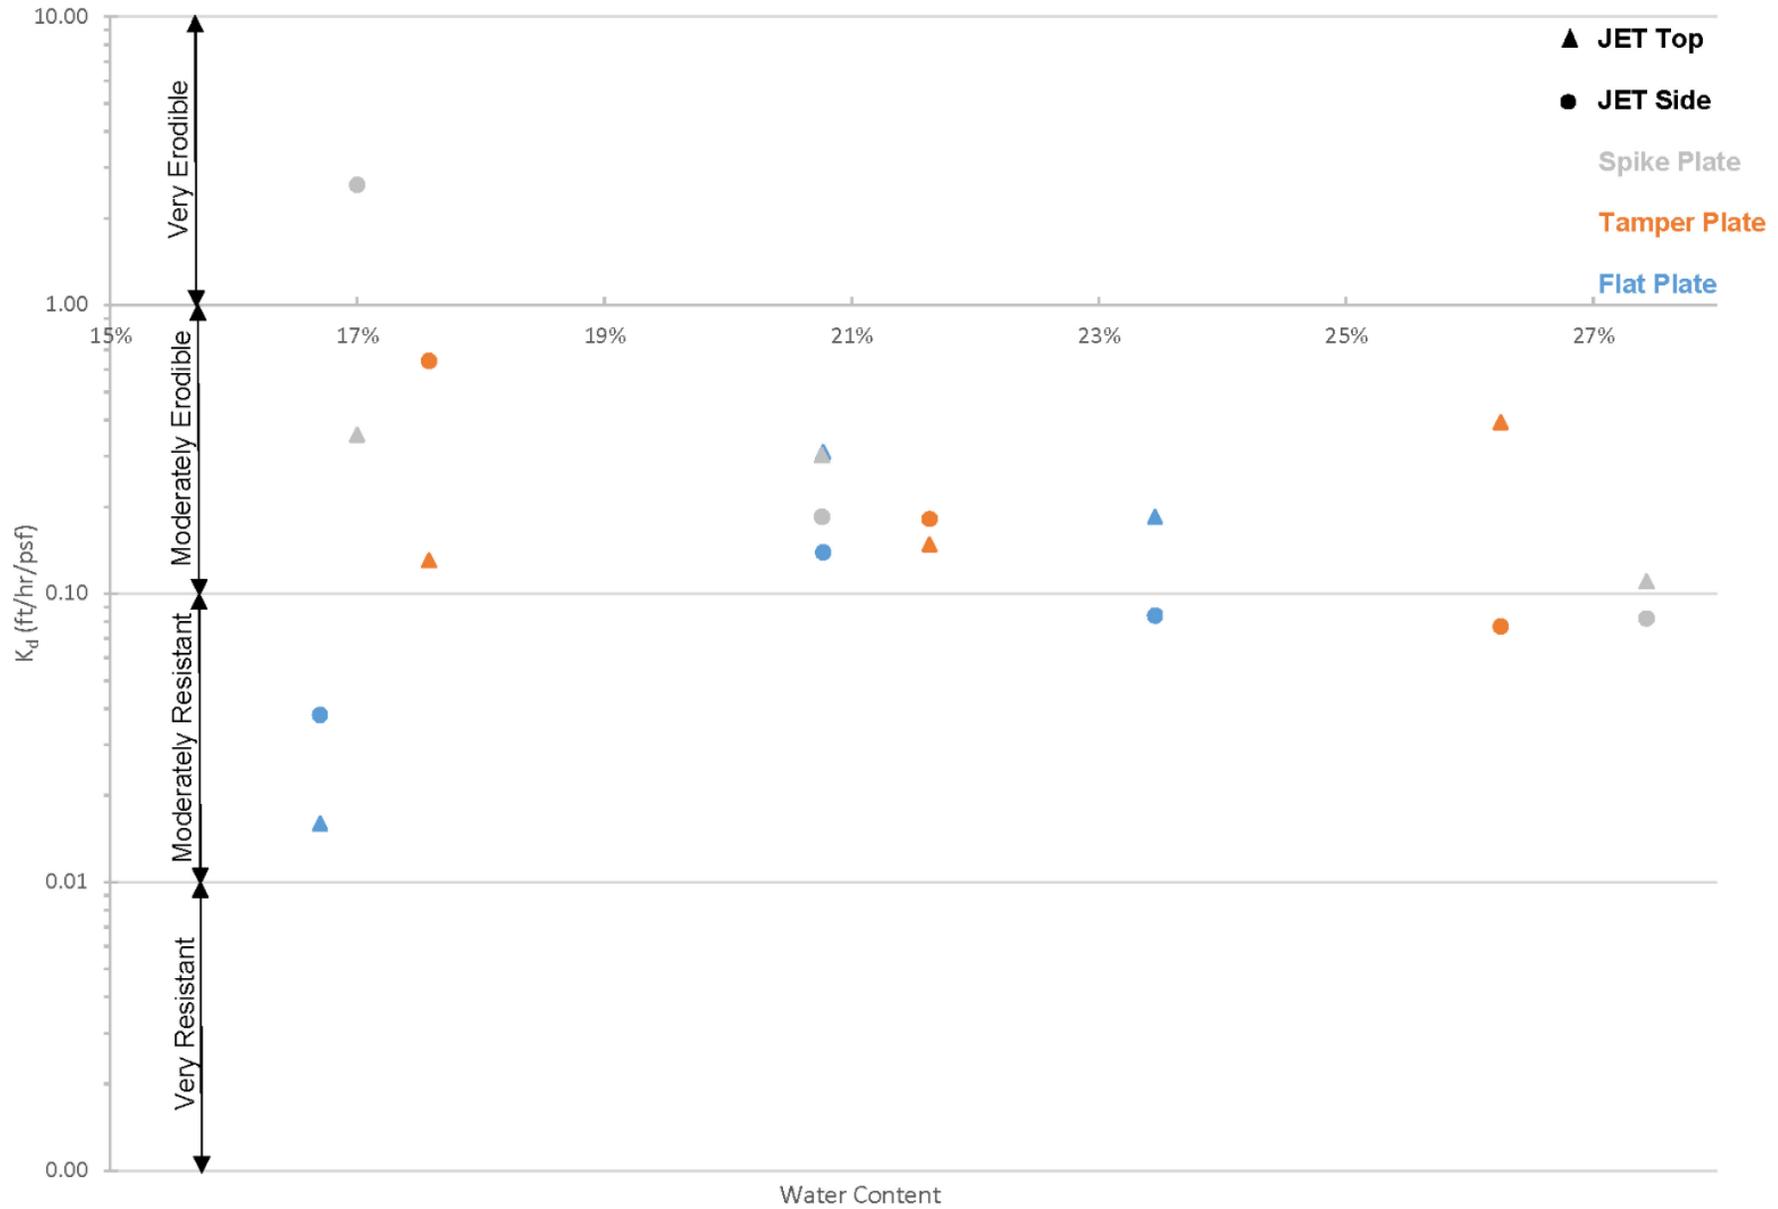
Highland Clay K_d vs Water Content

Note, Optimum Water Content is 20.7%

Figure 19. – Steel box JET results.

Three different ranges of water contents (optimum, >2% wet, >2% dry) and 3 different compaction techniques (flat plate, spiked plate, and tamper plate) made up all 9 steel box tests. Each compaction technique used the pneumatic tamper with a different plate. The flat plate was approximately 6-inches in diameter with a smooth base (the standard plate noted in Figure 5b), the spike plate is shown in Figure 5b and 5c, the tamper plate was the flat plate with 0.5-inch wide by 0.5-inch thick cubes welded on bottom. Two of three compaction plates (spiked and tamper plates) were designed to simulate compaction techniques found in the field and to provide better compaction than the standard Proctor method; the flat plate was used as a comparison to the standard Proctor compaction method. Results from all 9 steel box tests are included in Table 9 and Figure 19.

Overall, JETs completed on the steel box had a relatively narrow range in k_d when compared over a wide range of water contents. Variability in k_d was less for the steel box than for Proctor samples. Less variability in k_d could be due to more energy put into compacting the steel box. Meaning, water content at the time of compaction has less of an impact on soil structure because more energy was used during placement. However, variability for the dry of optimum materials was still high. Dry of optimum flat plate tests had a lower k_d than optimum and wet of optimum tests, this was unexpected and could not be explained. Note, a different operator was used for the dry of optimum flat plate test. Even though the same apparatus and procedures were followed this could be a source of the variability.

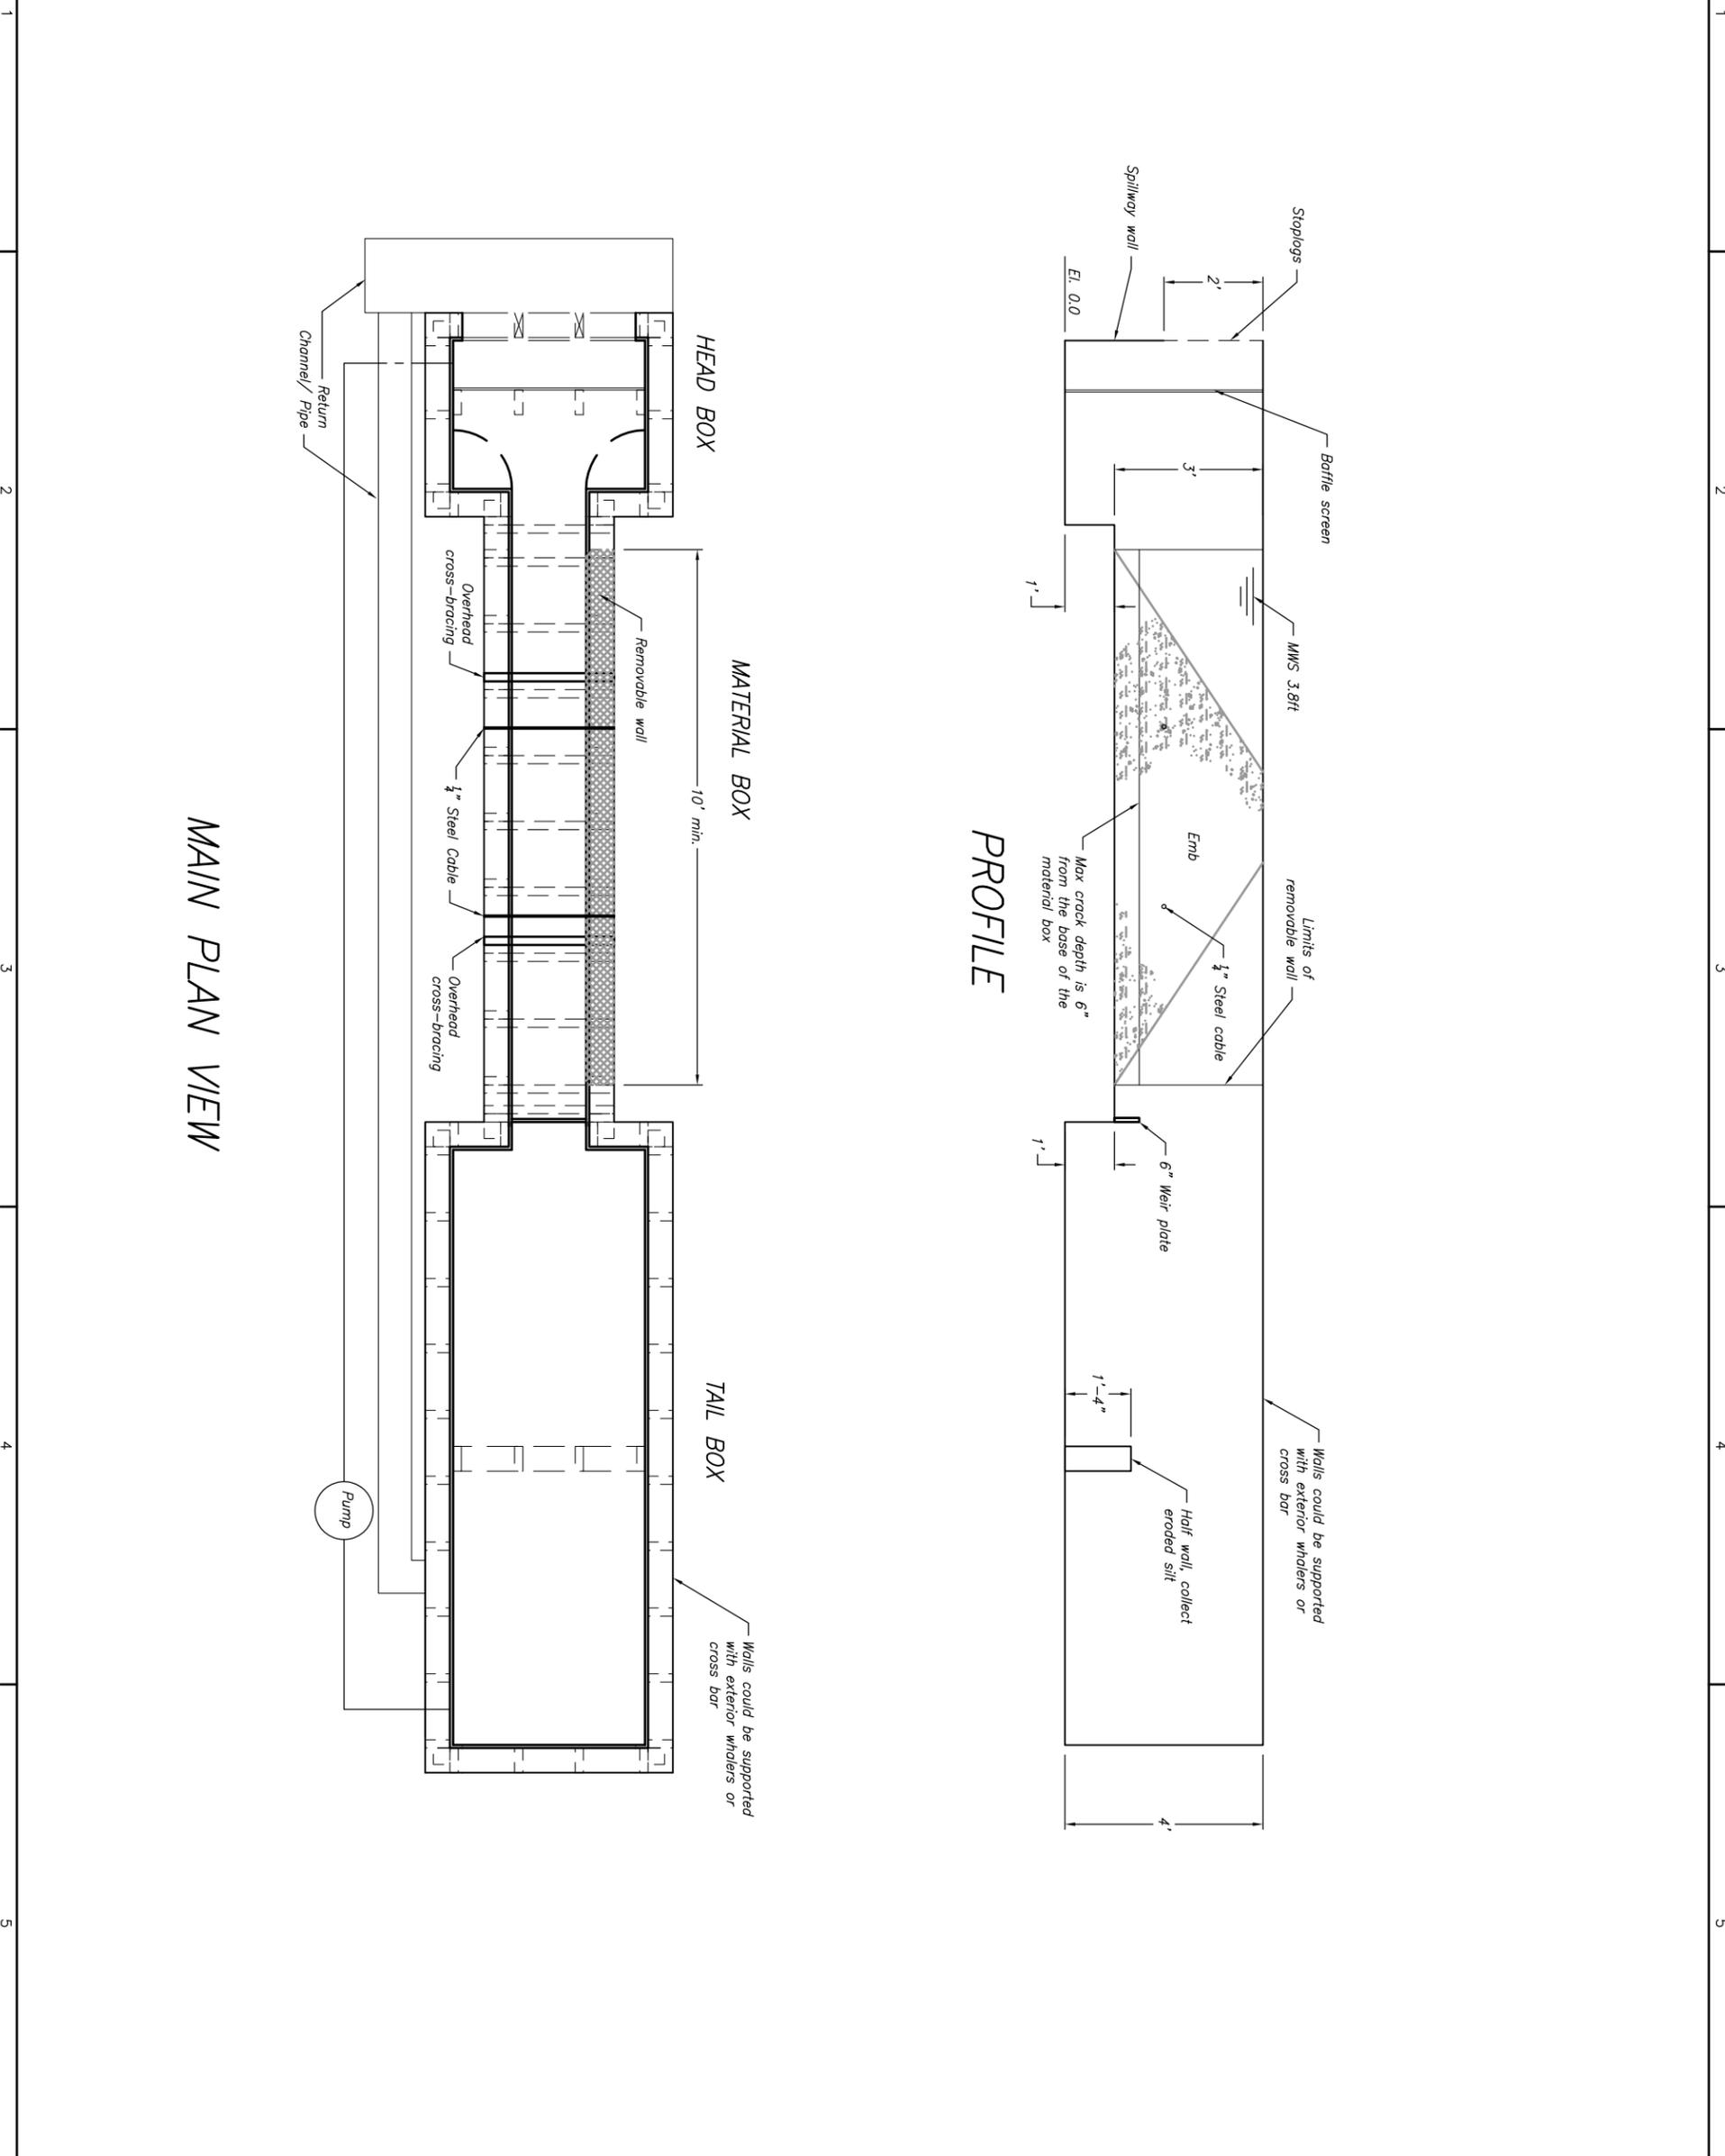
MAIN PLAN VIEW

**CREST EMBANKMENT EROSION TEST
PROPOSED MODEL**

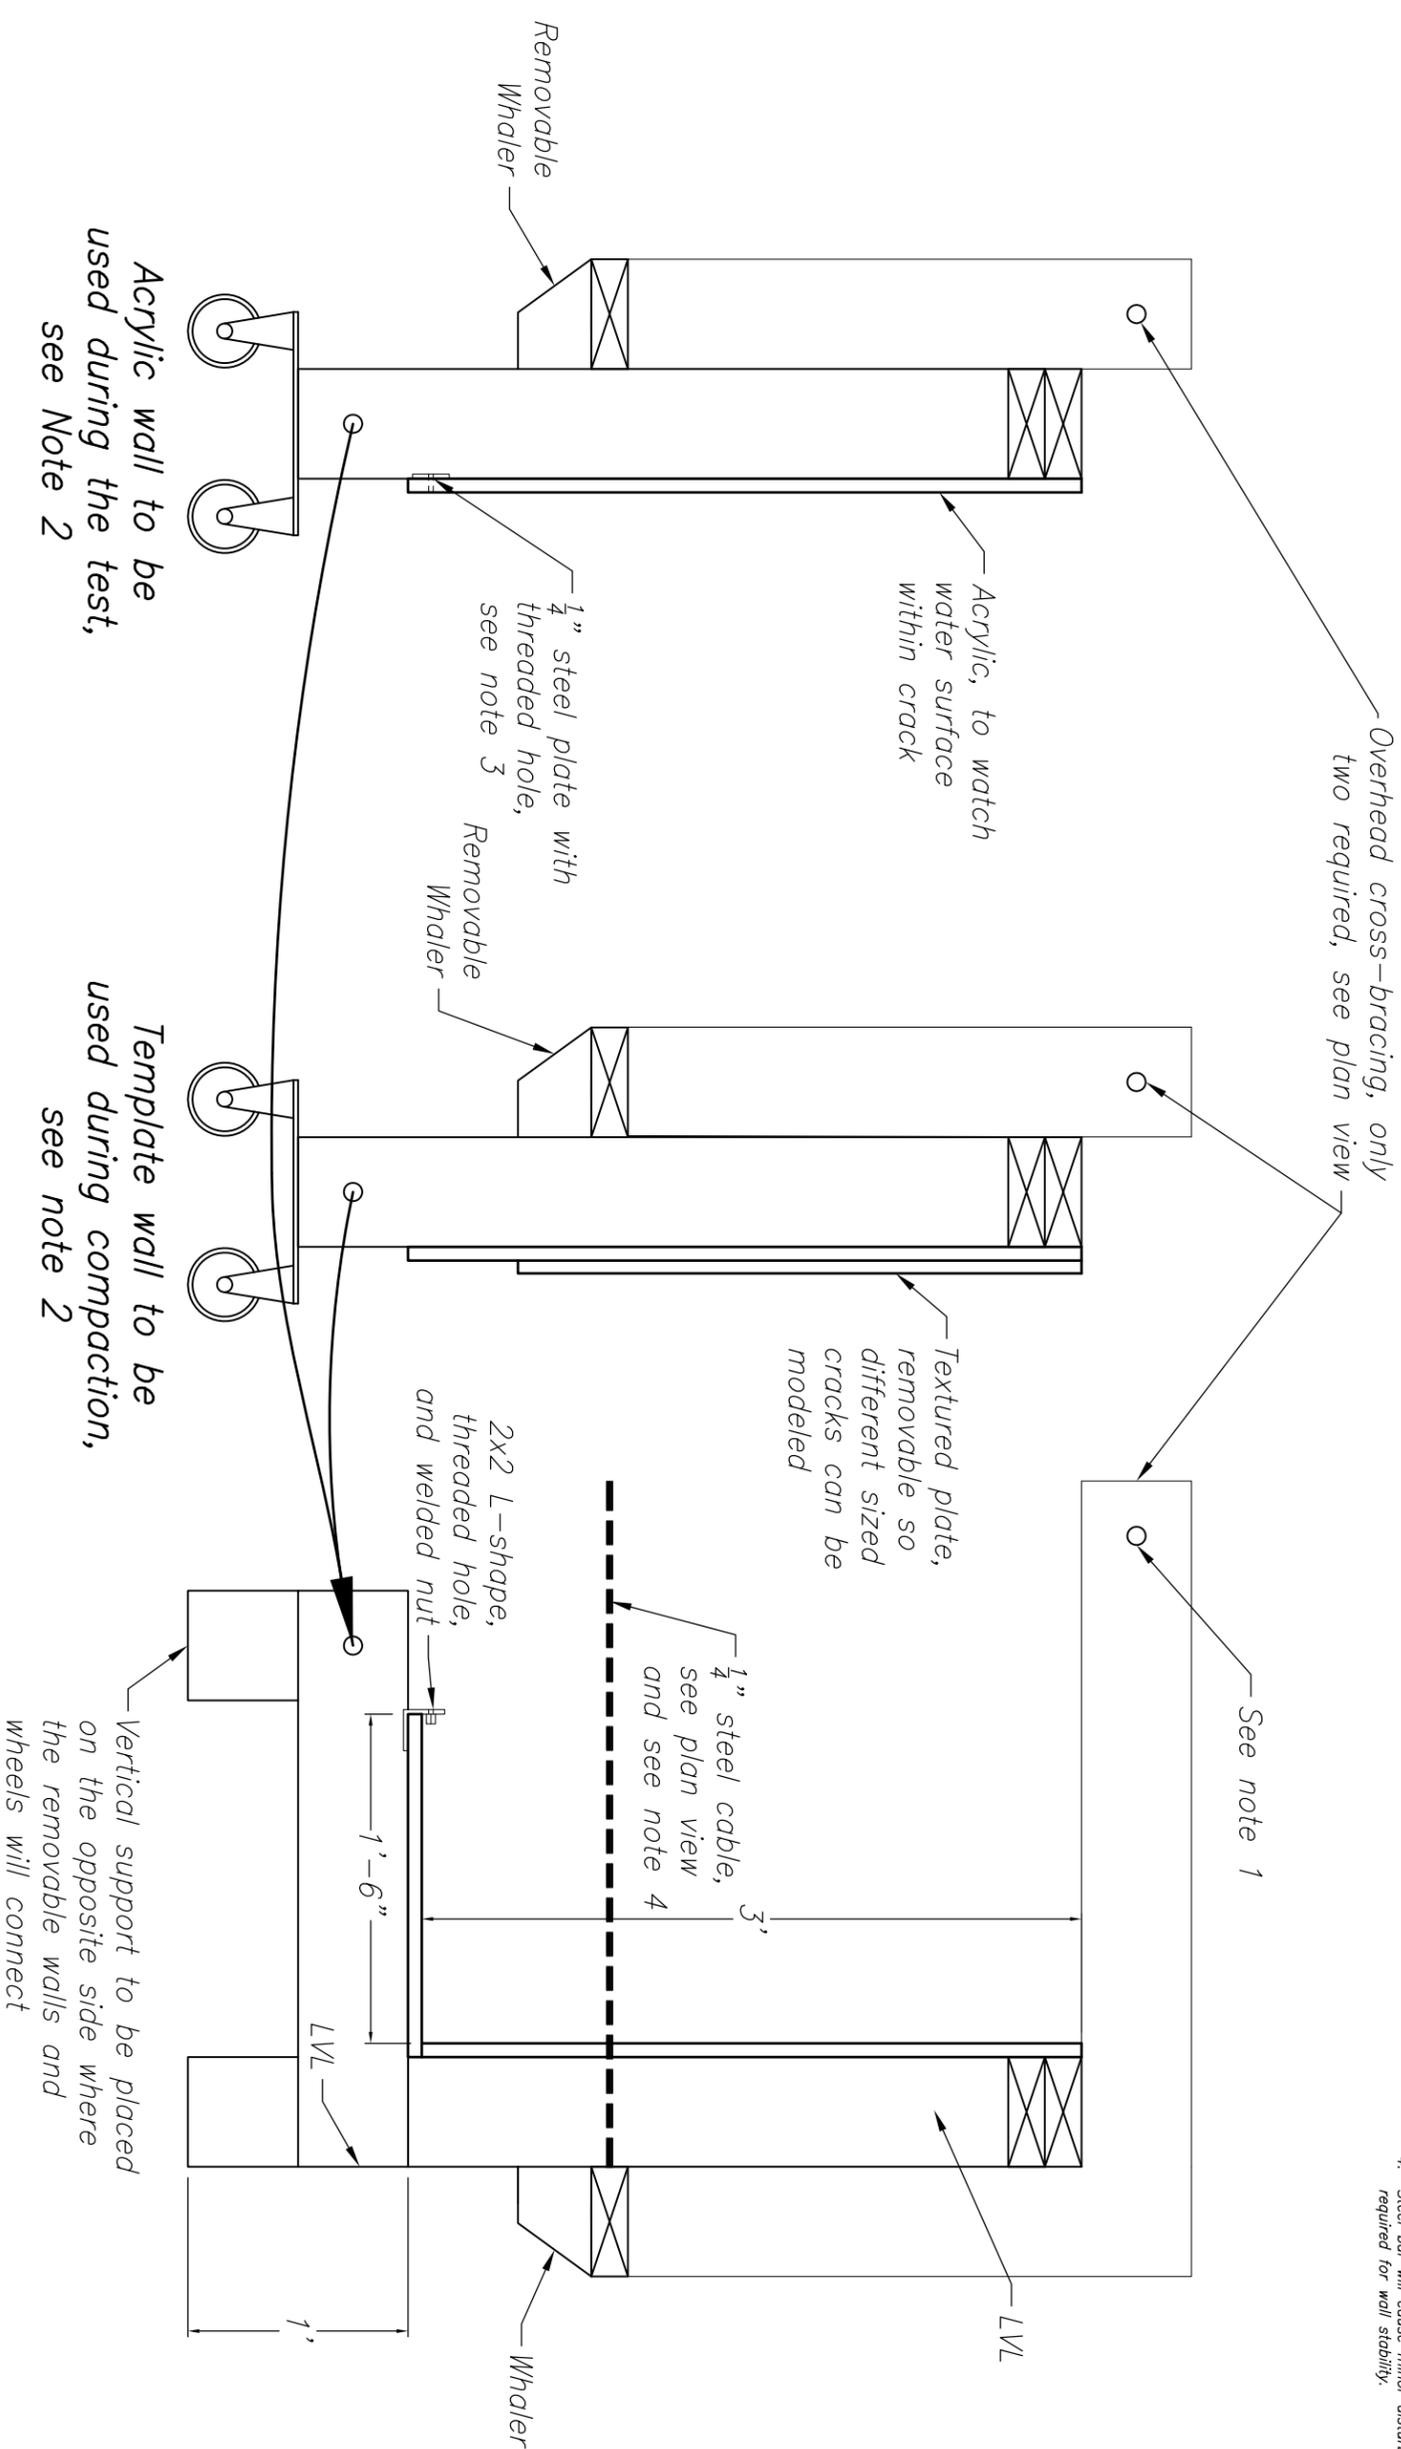
SECTION VIEW

Acrylic wall to be used during the test, see Note 2

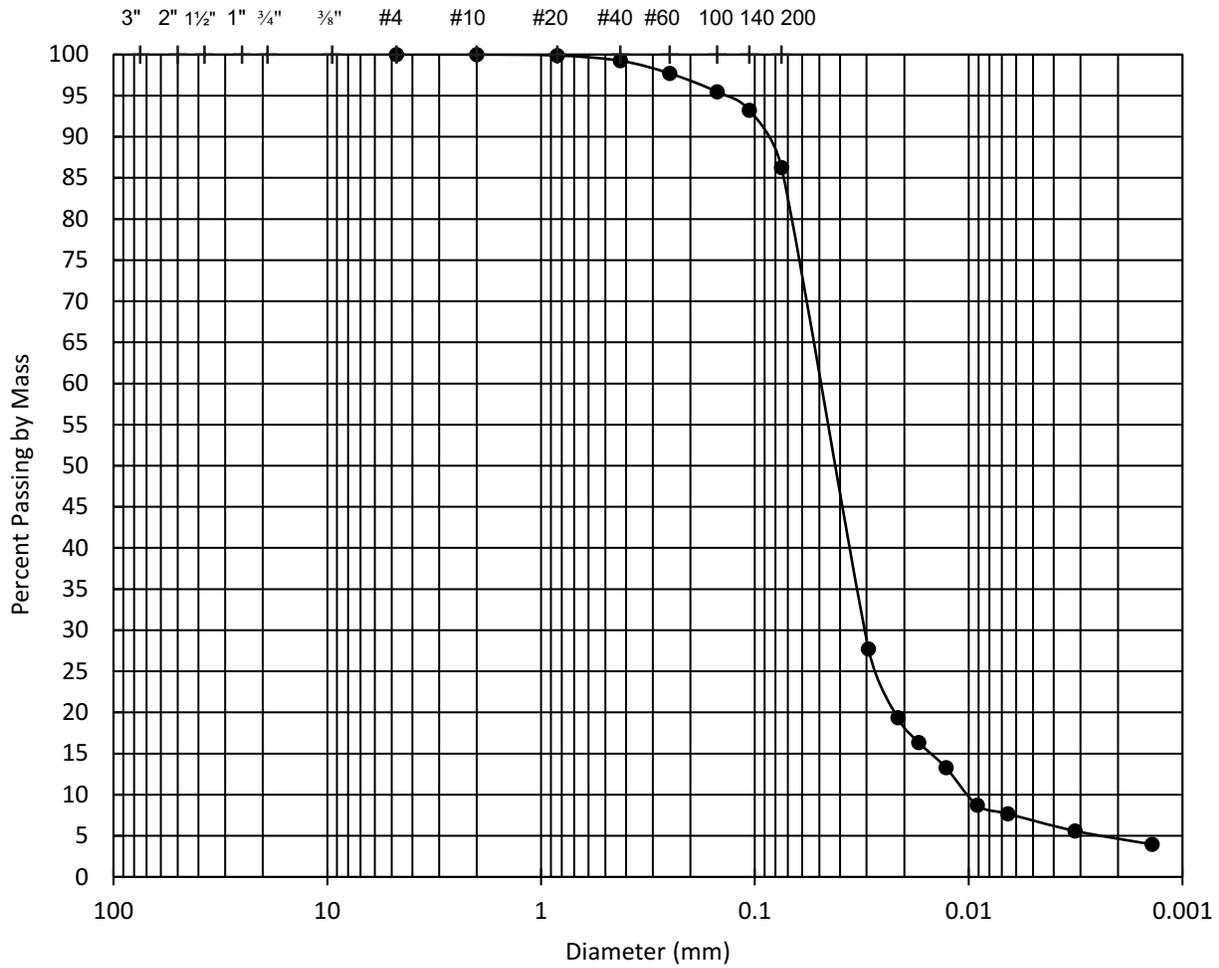
**PARTICLE SIZE DISTRIBUTION
ASTM D6913**

Cobbles (%)	Gravel (%)		Sand (%)			Fines (%)	
			13.7			86.3	
	Coarse	Fine	Coarse	Medium	Fine	Silt	Clay
				0.8	13.0	79.5	6.7

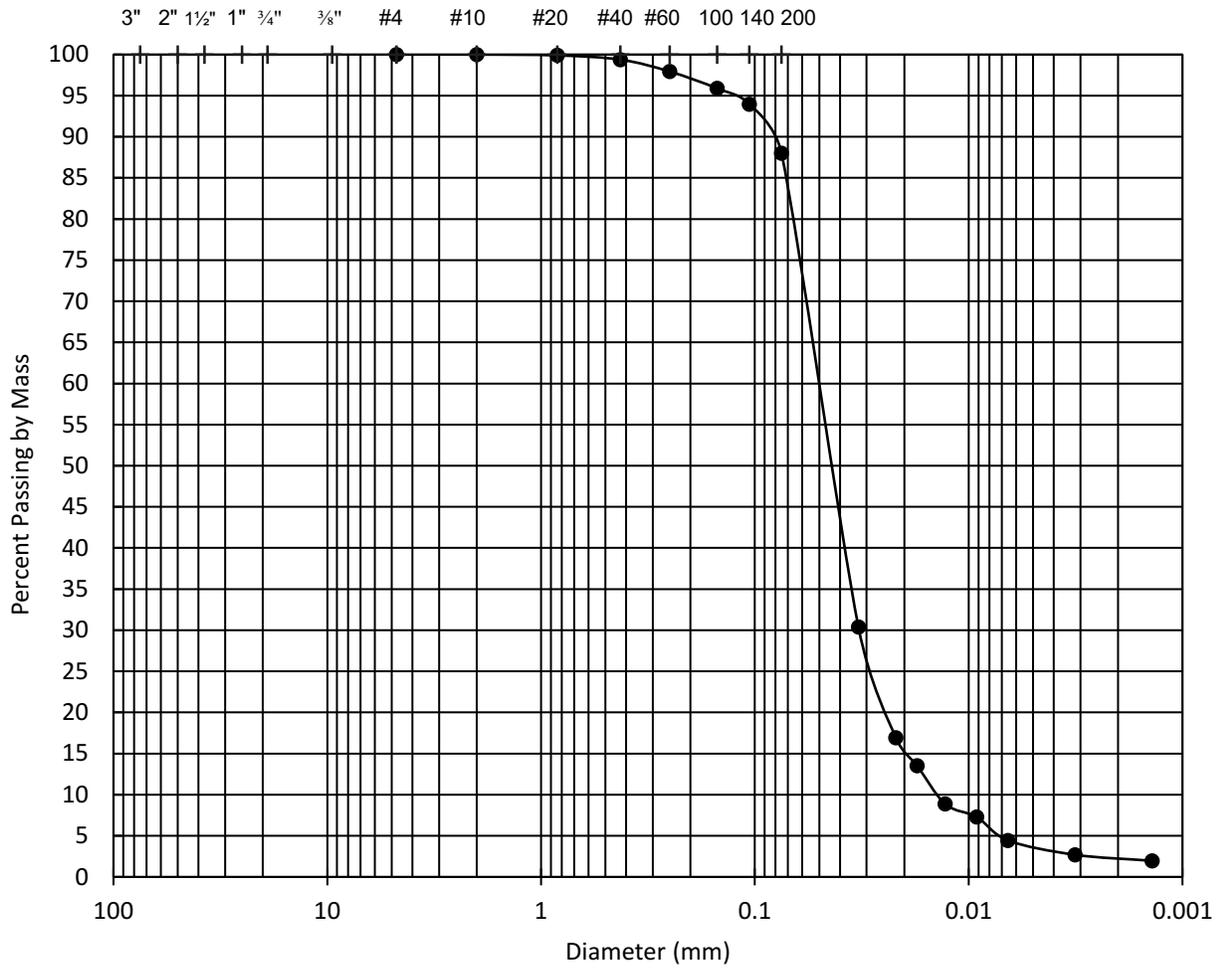
PARTICLE SIZE DISTRIBUTION ASTM D6913

Cobbles (%)	Gravel (%)		Sand (%)			Fines (%)	
			12.0			88.0	
	Coarse	Fine	Coarse	Medium	Fine	Silt	Clay
				0.6	11.4	84.3	3.6

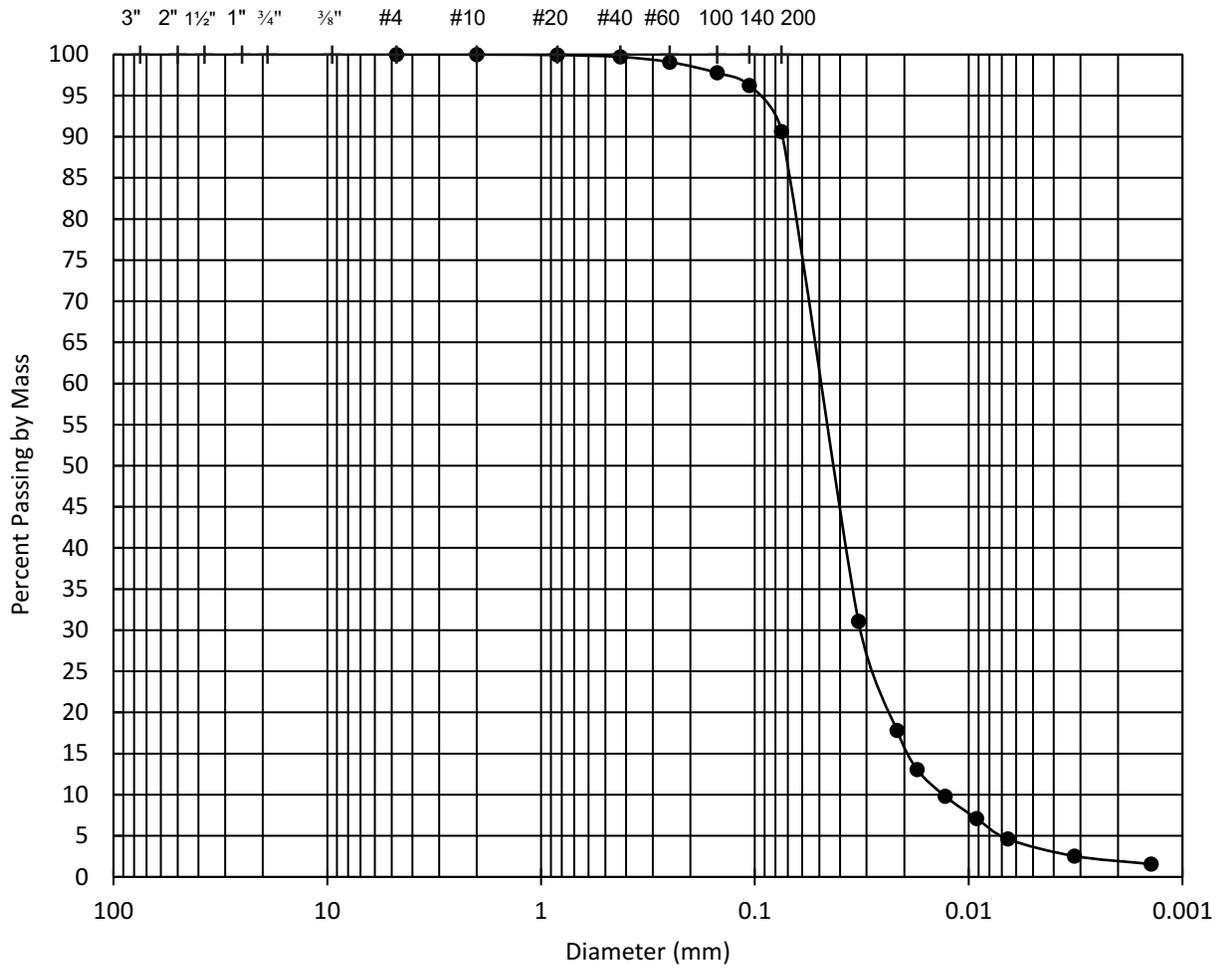
PARTICLE SIZE DISTRIBUTION ASTM D6913

Cobbles (%)	Gravel (%)		Sand (%)			Fines (%)	
			9.4			90.6	
	Coarse	Fine	Coarse	Medium	Fine	Silt	Clay
				0.3	9.1	87.0	3.6

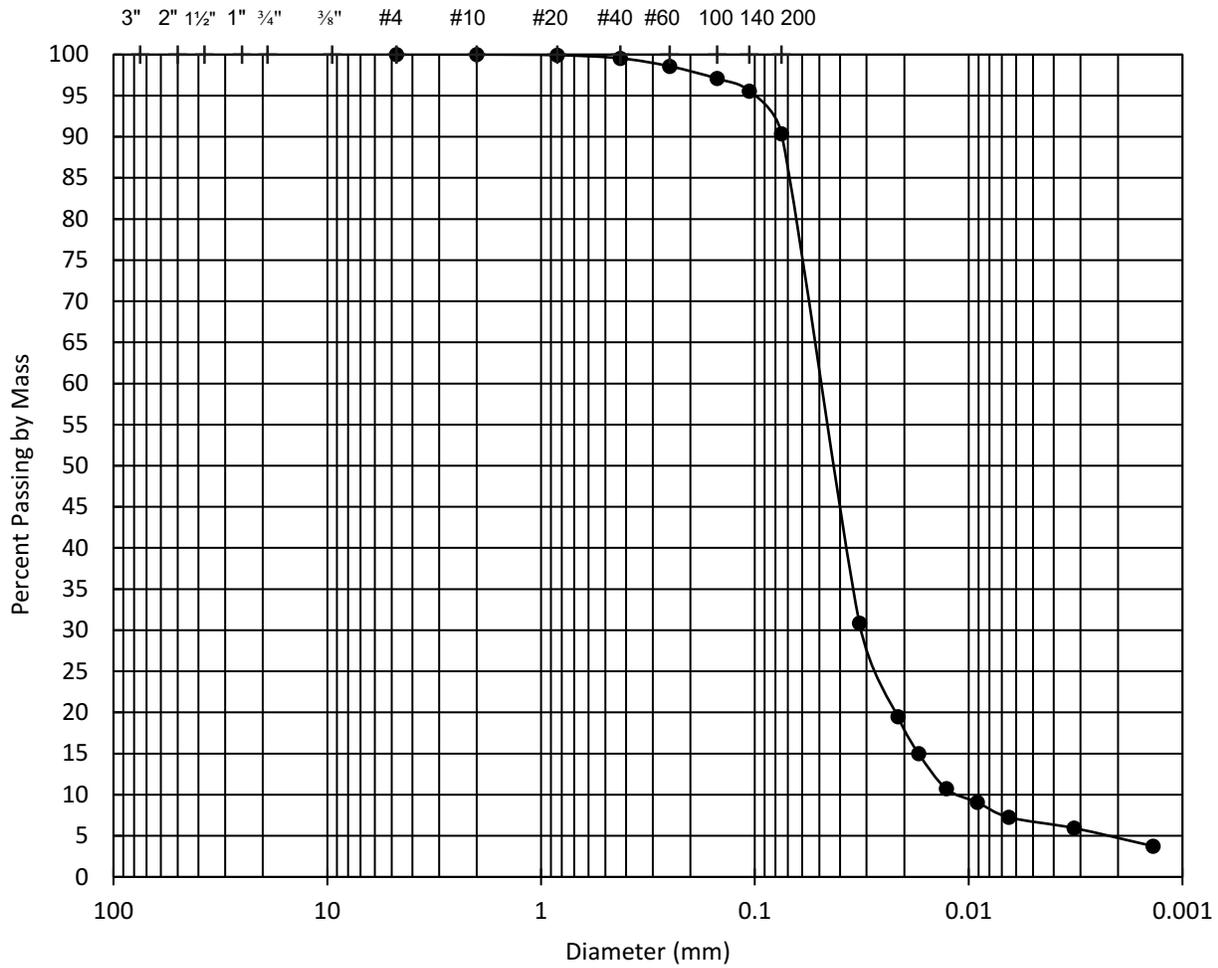
**PARTICLE SIZE DISTRIBUTION
ASTM D6913**

Cobbles (%)	Gravel (%)		Sand (%)			Fines (%)	
			9.6			90.4	
	Coarse	Fine	Coarse	Medium	Fine	Silt	Clay
				0.5	9.2	83.7	6.7

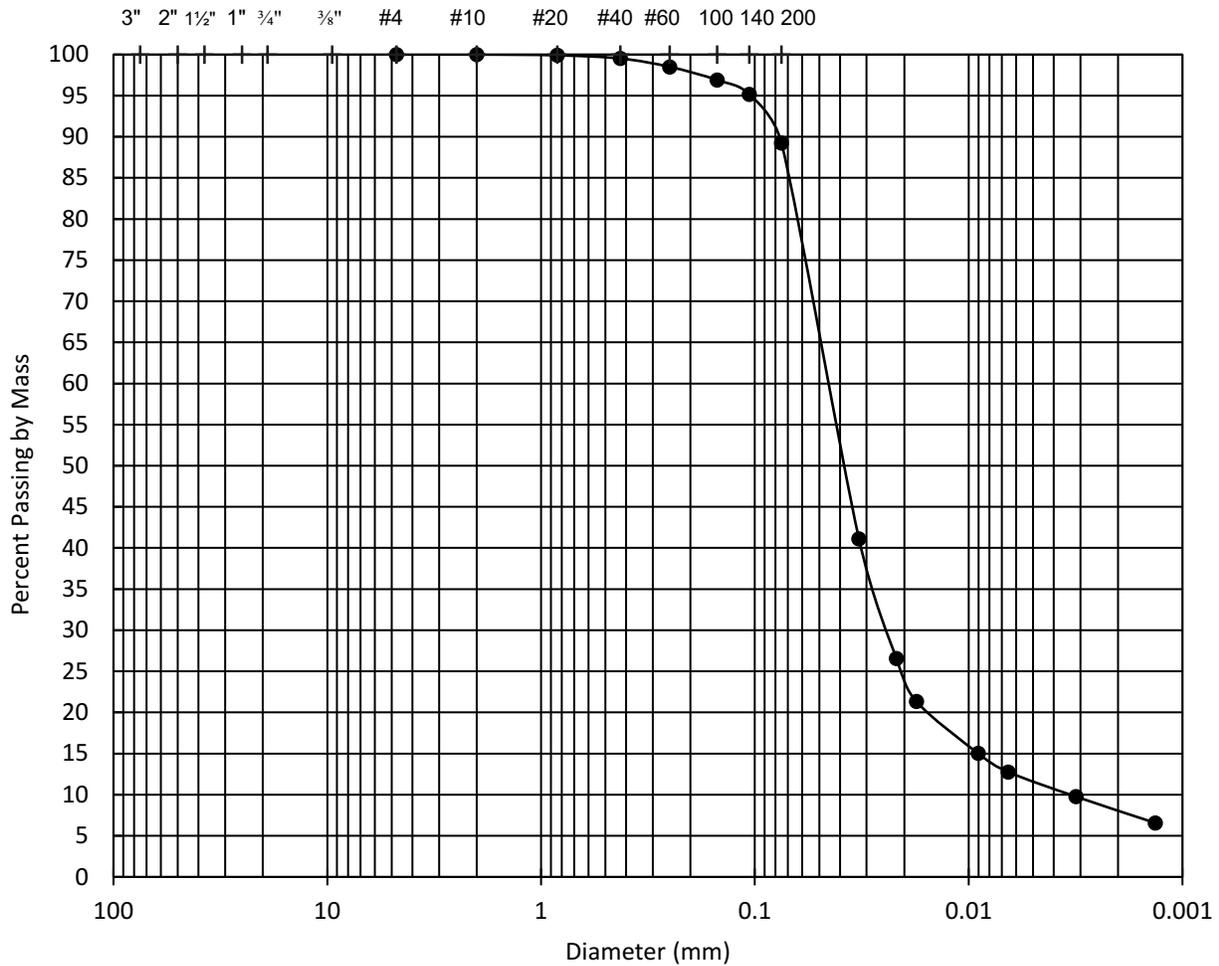
**PARTICLE SIZE DISTRIBUTION
ASTM D422 & D6913**

Cobbles (%)	Gravel (%)		Sand (%)			Fines (%)	
			10.8			89.2	
	Coarse	Fine	Coarse	Medium	Fine	Silt	Clay
				0.5	10.3	77.8	11.4

Project No.: 15121002
 Project Name: Bonny Silt
 Sample: Composite 1-4

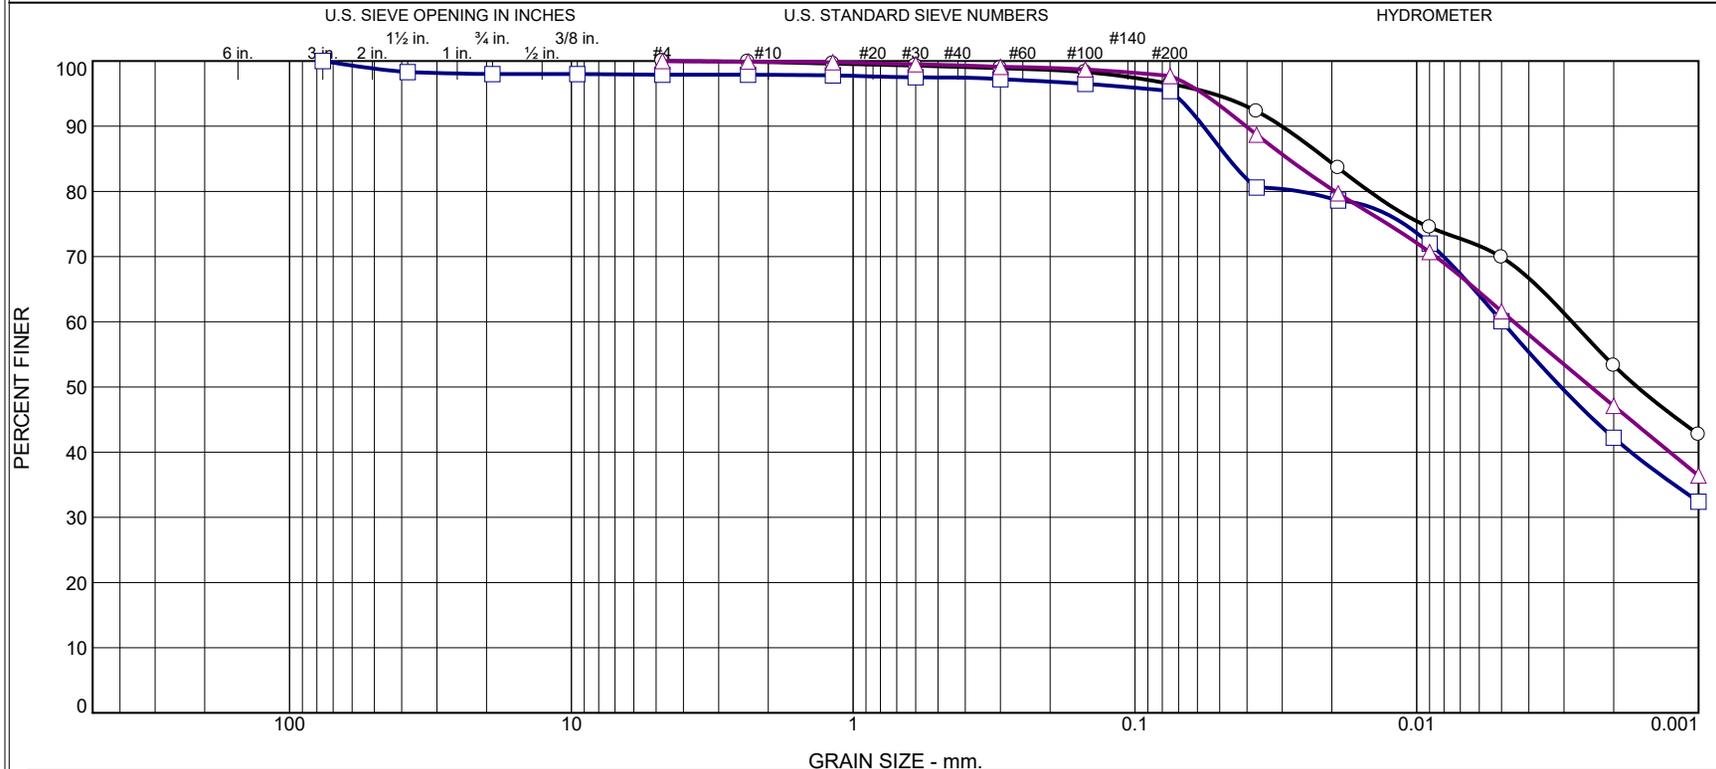
Particle Size Distribution Report

% Cobbles	% Gravel		% Sand			% Fines	
		Coarse	Fine	Coarse	Medium	Fine	Silt	Clay
○	0.0	0.0	0.0	0.2	0.7	2.6	43.2	53.3
□	0.0	2.0	0.1	0.0	0.4	2.1	53.2	42.2
△	0.0	0.0	0.0	0.1	0.6	1.6	50.6	47.1

Source	Sample #	Depth/Elev.	Date Sampled	USCS	Material Description	NM %	LL	PL
Highland Clay	Clod		12-2-2016	CH	CH - Fat Clay, "Clod" Sample		53	25
Highland Clay	Composite			CH	CH/CL - Borderline Fat to Lean Clay, Composite of both trucks.		50	23
Highland Clay	Loose		12-2-2016	CL	CL - Lean Clay, "Loose" sample		48	26

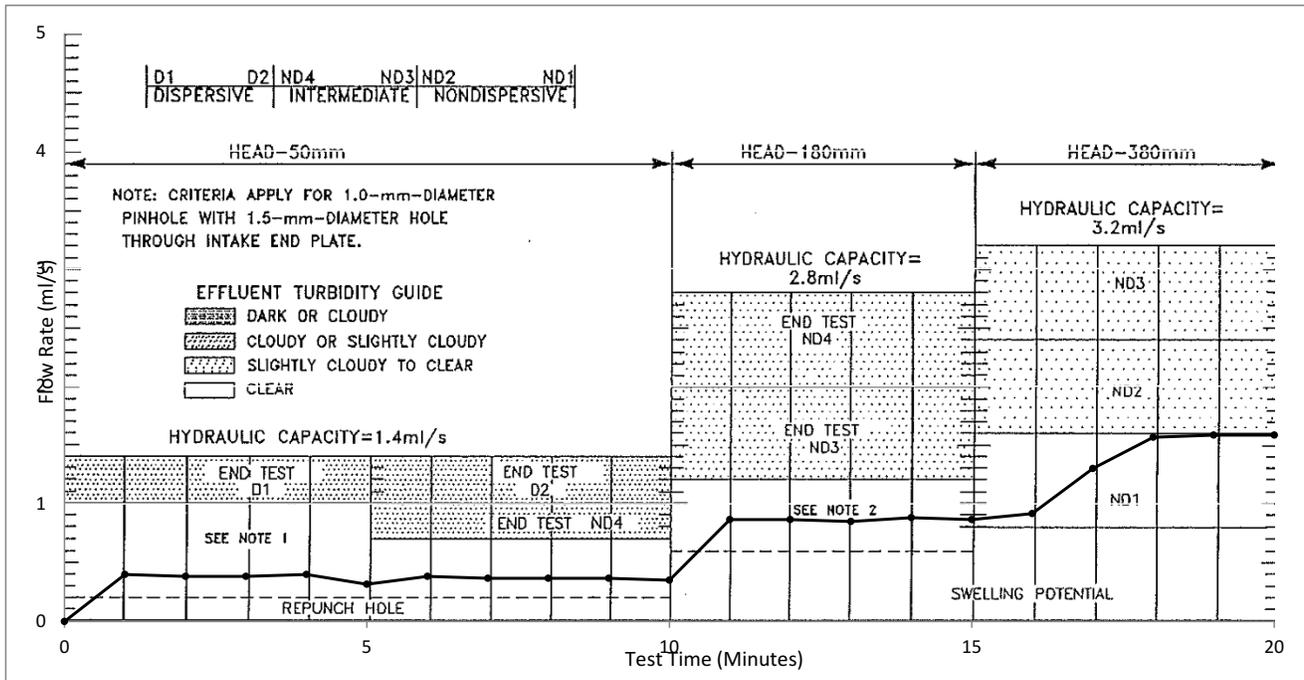
PINHOLE TEST - DISPERSIVE VERSUS FLOW RATE

Note 1: Flow rate < 1.0 ml/s continue test at 50mm head for 5 more minutes.

Note 2: Flow rate of 0.6 to 1.2 ml/s increase head and continue test.

Sample Number	Placement Conditions		Dispersive Grade Classification
	Dry Density	Water Content	
Crack Box Specimen	105.3 pcf	21.22%	ND2

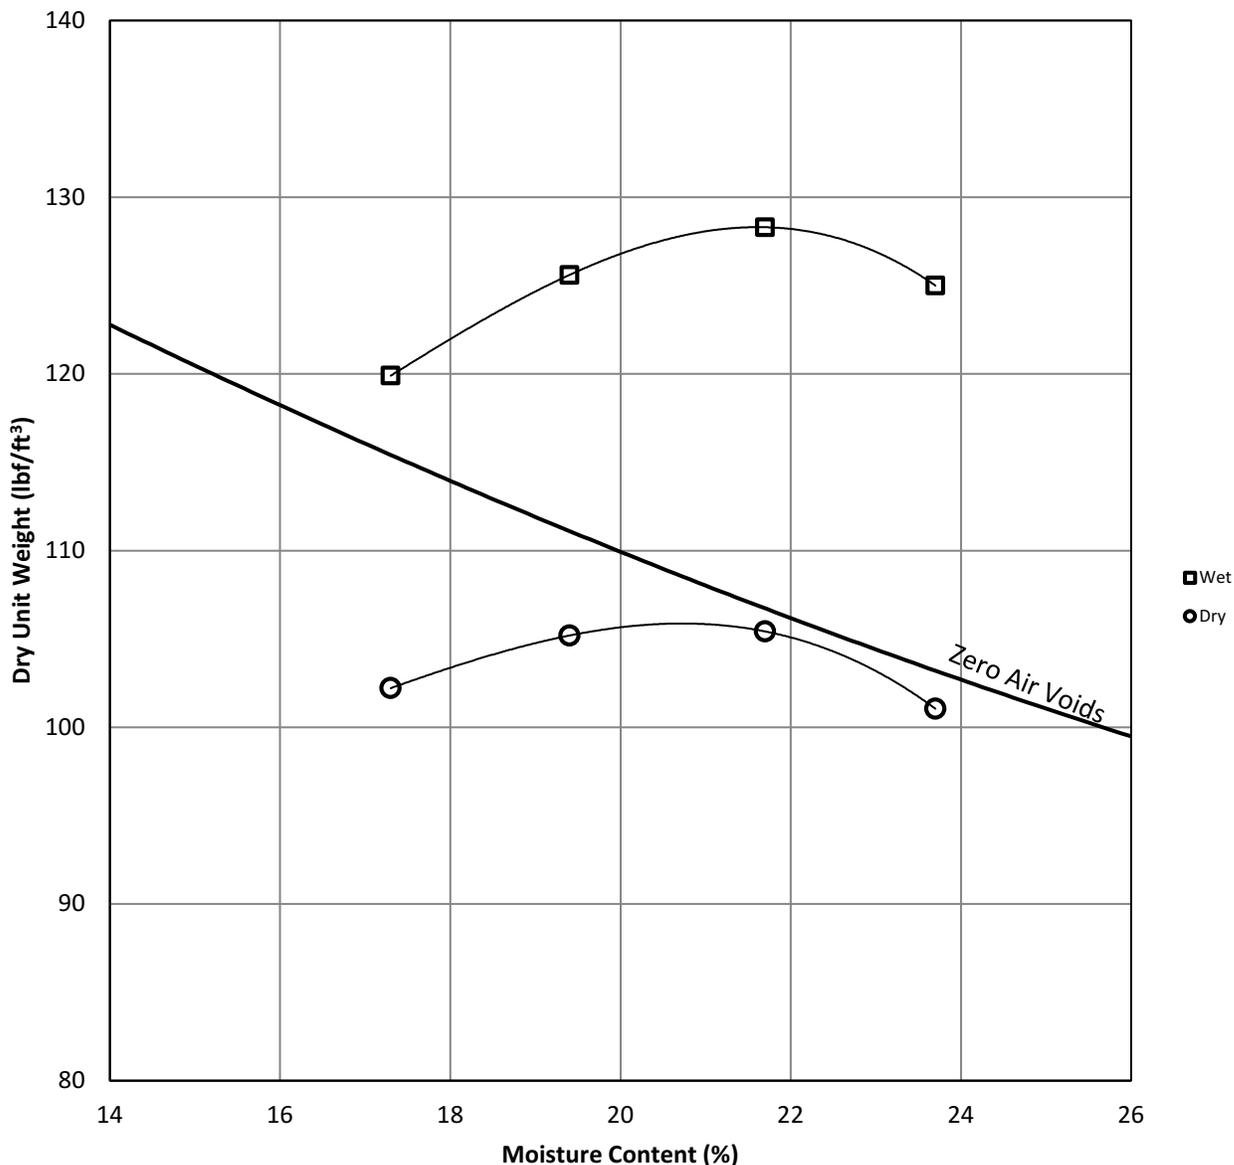
Project CEET
Feature NA
Location Bldg 56 Stockpile
Depth (ft) NA
Sample No. Clay

Specific Gravity
Minus No. 4 2.72
Plus No. 4
Bulk
Apparent
Absorption (%)

Compaction
Percent larger than tested 2.1
Maximum Dry Unit Weight (lb/ft³) 106.0
Optimum Moisture Content (%) 20.7
Degree of saturation @ opt (%) 93.8

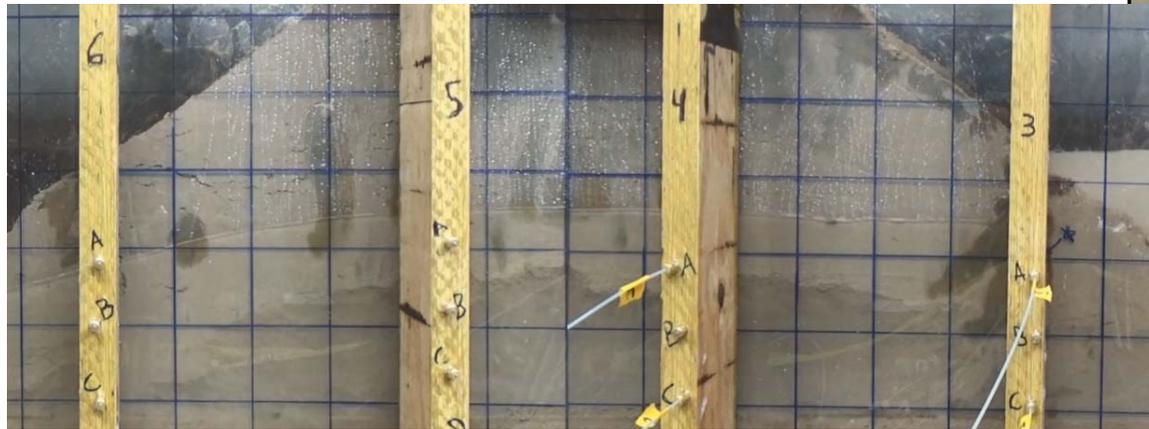
Test 3 Bonny Silt 95%comp, 18.7%MC

- **Bonny Silt**
 - Test 3 added steel, pressure gauges, had a varying reservoir

- Tests 1 through 3 are considered trials and were not used in the results

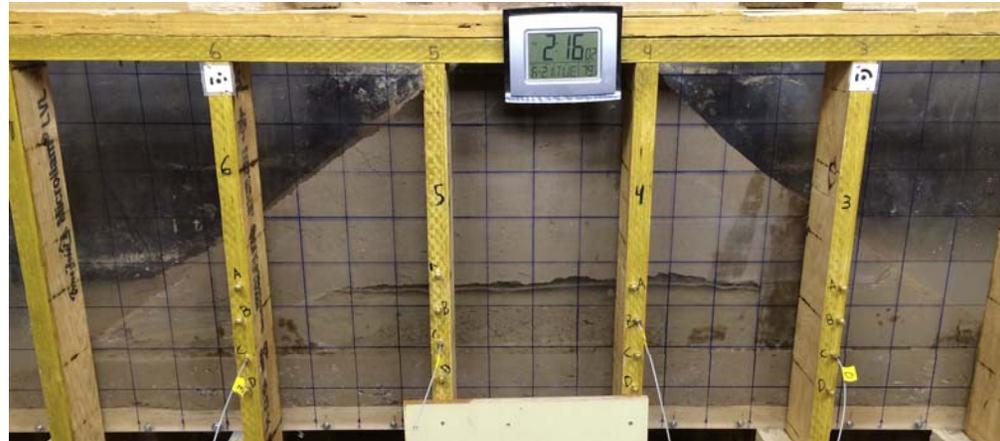
• Observations during Test 4

- Erosion started approximately 50 minutes after water entered the crack, behind post 4.
- Lowly spread upstream and downstream.
- Clods deposited in crack.
- Lowering of water for photogrammetry disturbed clods.
- After 12 hours the clods were slowly removed from the system.
 - Roof began collapsing after 12 to 16 hours, very large clods collapsed and were carried downstream.
- Reservoir remained constant at 8 inches above the bottom of the crack. Except when lowered for photogrammetry

- Compacted to 93%, placed at 2% wet of optimum
- Global Gradient ~ 0.08 , $P(\text{Erosion}) = 0.3$ to 1.0
- Erosion Started after 50 minutes
 - 172 in³ eroded after 3 hours
 - 186 in³ eroded after 6.25 hours
 - 856 in³ eroded after 21.25 hours
 - 2354 in³ eroded after 28 hours
 - Average erosion rate = 53 in³/hour

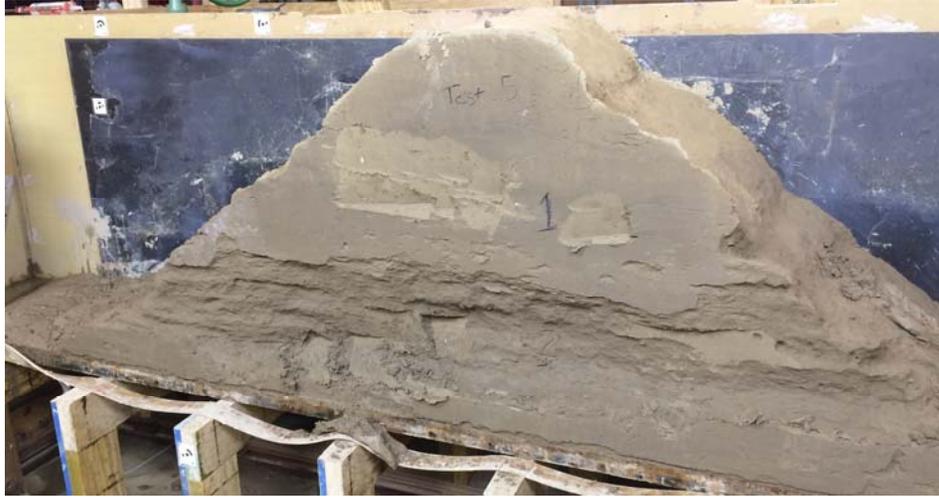
- **Compacted to 101%, placed at optimum**
- **Global Gradient ~ 0.08 , $P(\text{Erosion}) = 0.3$ to 1.0**
- **Erosion Started after 5 minutes**
 - 116 in^3 eroded after 0.83 hours
 - 820 in^3 eroded after 3.0 hours
 - 1448 in^3 eroded after 4.5 hours
 - Average erosion rate = $245 \text{ in}^3/\text{hour}$

• Observations during Test 5

- Erosion started immediately where the water entered the crack.
- After 45 minutes erosion began between posts 6, 5, and 4 moving upstream towards the reservoir.
- Clods were smaller than Test 4 and did NOT deposit in crack.
- Erosion path was downward not just horizontal.
- No large collapse like when roof collapsed in Test 4.
- Reservoir remained constant at 8 inches above the bottom of the crack. Except when lowered for photogrammetry

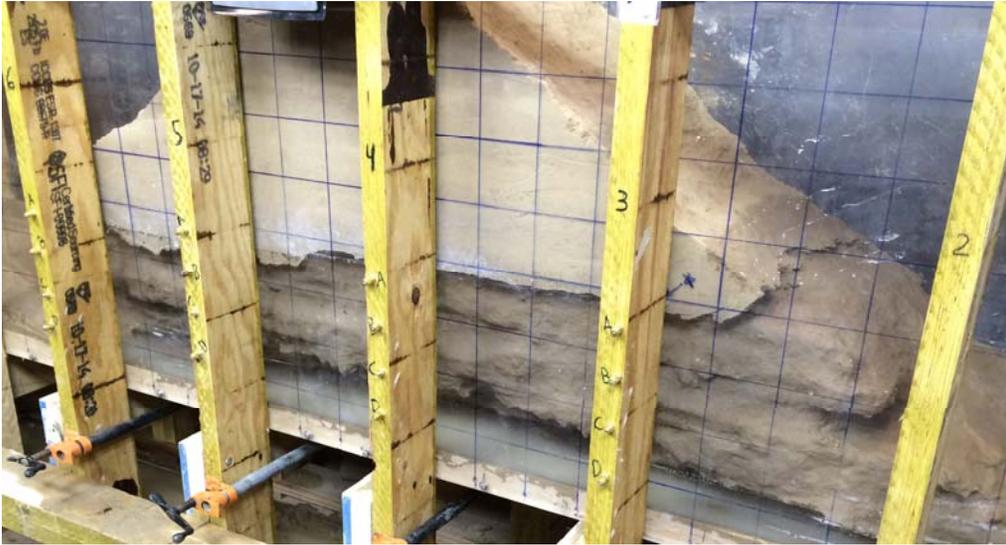
• Observations during Test 6

- Erosion started immediately where the water entered the crack.
- Erosion began at the base of the crack between posts 5 and 4.
- Clods were very small, material appeared explosive.
- Pipe formed from upstream to downstream in less than 20 minutes (note 485 in³ in 0.3 hours!)
- Erosion was downwards and into the embankment. Extended more than 12 inches into the embankment

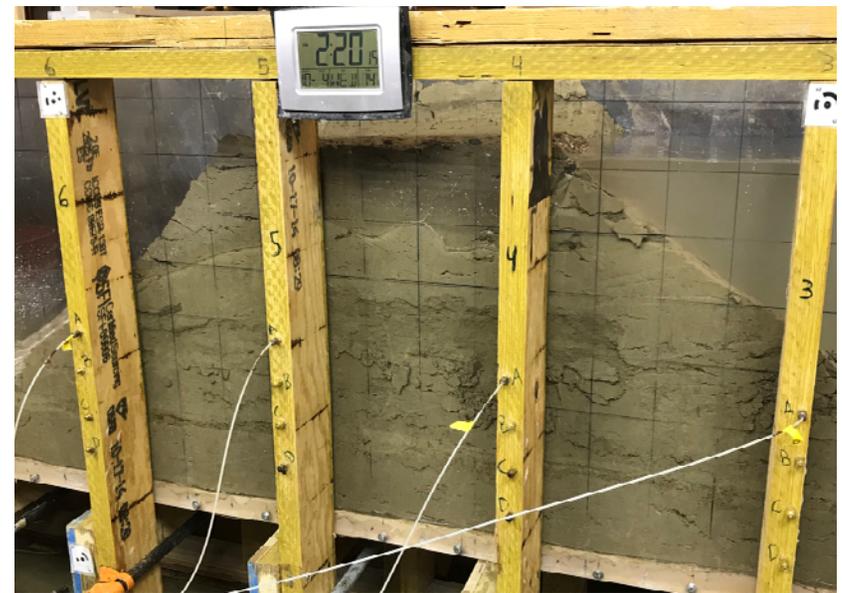
Test 9 Highland Clay 91%comp, 23.5%MC

- **Global Gradient ~ 0.08**
- **Foster and Fell Tables**
 - $P(\text{Erosion}) = 0.03 \text{ to } 0.4$
