Final Report ST-2019-8284-01

Cracked Embankment Erosion Test

December 2019

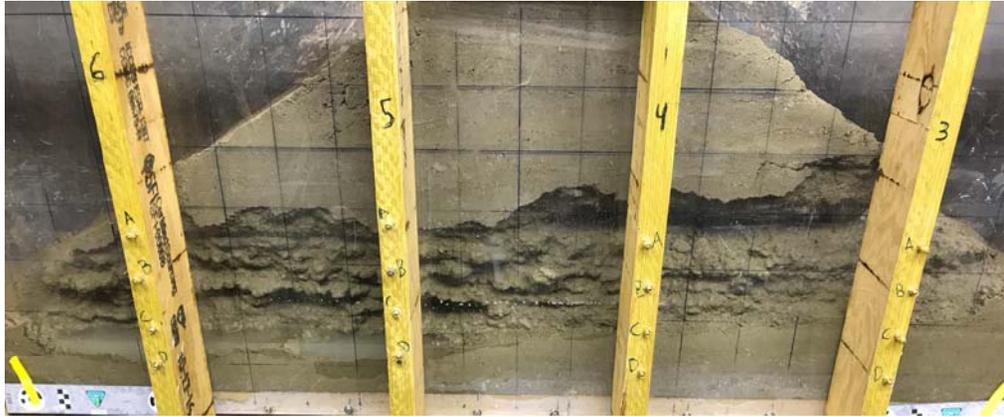
• Observations during Test 7

- Erosion started immediately where the water entered the crack.
- Erosion began anywhere water encountered the material. Erosion was continuous from US to DS didn't just occur at one location
- Clods were very small, material appeared explosive.
- Clods deposited in crack even though they were small.
- A few large Clods between posts 5 and 6 caused average gradient to flatten.
 - Large clods were eventually washed out. Along with smaller clods deposited in channel.

- Compacted to 102%, placed at 3.7% dry of optimum
- Global Gradient ~ 0.08 , $P(\text{Erosion}) = 0.03$ to 0.4
- Erosion started after immediately (explosive)
 - 696 in^3 eroded after 2.25 hours
 - 2282 in^3 eroded after 3.0 hours
 - Average erosion rate = $535 \text{ in}^3/\text{hour}$

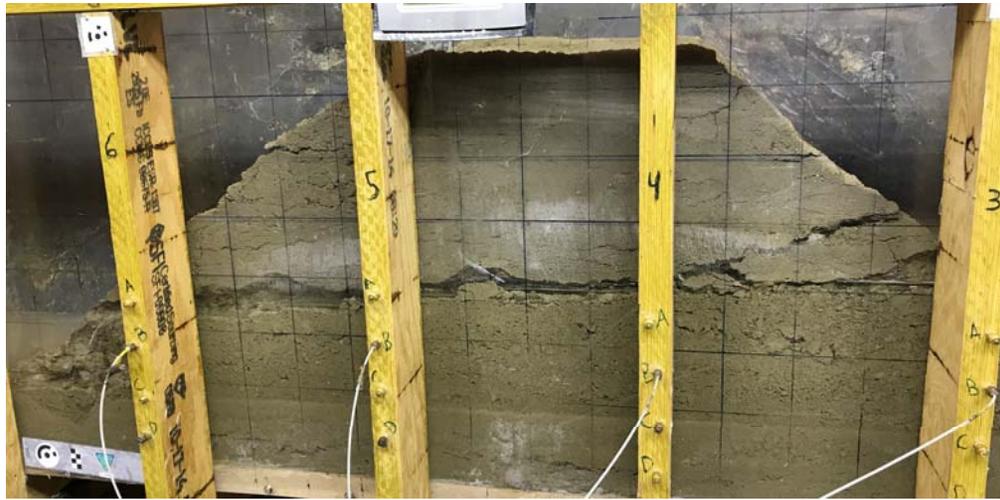
• Observations during Test 8

- Erosion started quickly.
- Erosion began between posts 6 and 3. Erosion was continuous from US to DS didn't just occur at one location
- Clods were small and large.
- Clods deposited in crack.
- Enough clods deposit in the crack that the gradient became flat and after ~40 hours almost no flow past through the crack.
 - Considered the crack to be self-healed at this point and the reservoir was increased flushing out clods from the crack.
- Reservoir was increased to the full height after 48hrs for 45 minutes. Note that the last eroded volume measurement is largely influenced by the high erosion rates that occurred at the higher reservoir.

- **Compacted to 96%, placed at 0.5% dry of optimum**
- **Global Gradient ~0.08, P(Erosion) = 0.03 to 0.4, Reservoir Increased after Self healing**
- **Erosion Started after 2 minutes**
 - 12 in³ eroded after 1.5 hours
 - 921 in³ eroded after 43 hours
 - Average erosion rate = 17 in³/hour
 - **NOTE**
 - Flow less than 1 gpm after 20 hours. Lost reservoir 35 hours into test
 - Reservoir raised after 38 hrs of water flowing through crack. Gradient increased to 0.2
