Subject: Report of Findings, Laboratory Evaluation of Concrete Thin Repair Materials –
Yellowtail Dam Spillway Tunnel Repairs - Yellowtail Unit, Lower Bighorn Division, Pick-Sloan
Missouri Basin Program, Montana

Materials Engineering and Research Laboratory Report No. MERL-2009-36

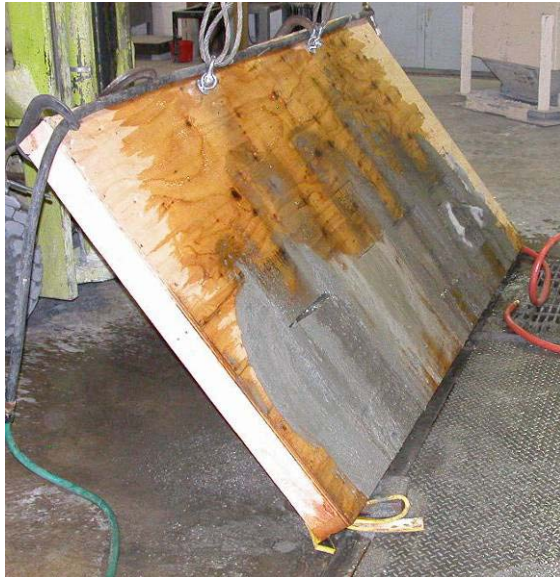
This test was developed to model placing the repair material on a wet, sloped concrete surface. The test used a platform that had cutouts designed such that the repair material would be placed in a cavity where the top edge was 1-inch deep, the bottom edge was ¼-inch deep and was 12-inches square. The platform was angled 55 degrees and a small stream of water running down over the repair areas. A picture of the test setup is shown below.

Figure 1. The testing apparatus shortly after all the materials were cast on the concrete substrates.

1. Place 12 in. by 12 in. by 3-in. thick concrete base slabs in wood frame angled to match spillway surface.
2. Adjust slab in frame such that the top of the slab is recessed about one inch from the wood surface and the bottom of the slab is recessed about 1/4-inch deep.
3. Moisten slab surface just prior to repair material placement.
4. Adjust drip hose so there is slight water flow down the wood frames surface and onto the concrete slab.
5. Place repair material on conditioned base slab. Finish flush to wood frame surface.
6. Document placement performance.

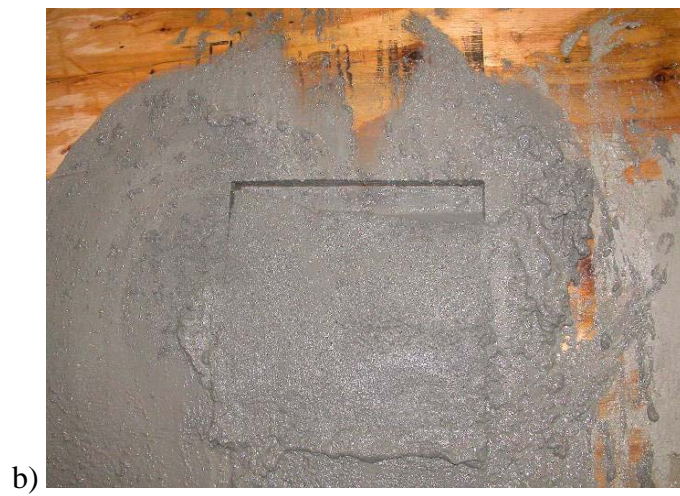
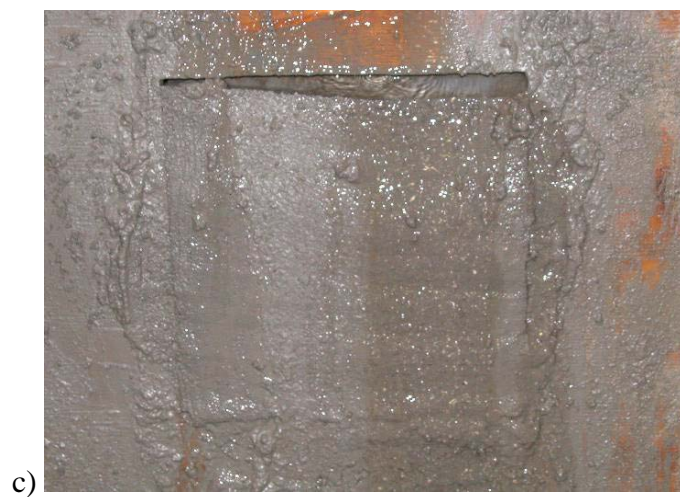
This material initially sagged after placement. When held in place with a wooden float, the material was able to bond and setup. After it was held in place the top edge still sagged down over an inch.

Figure 2. The Sika material a) sagging away after initial application, b) after being held in place for a short time, and c) after about 2 hours.

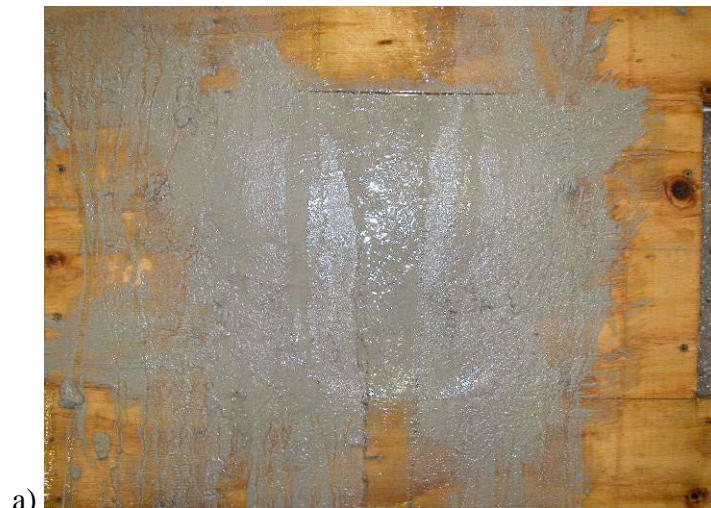
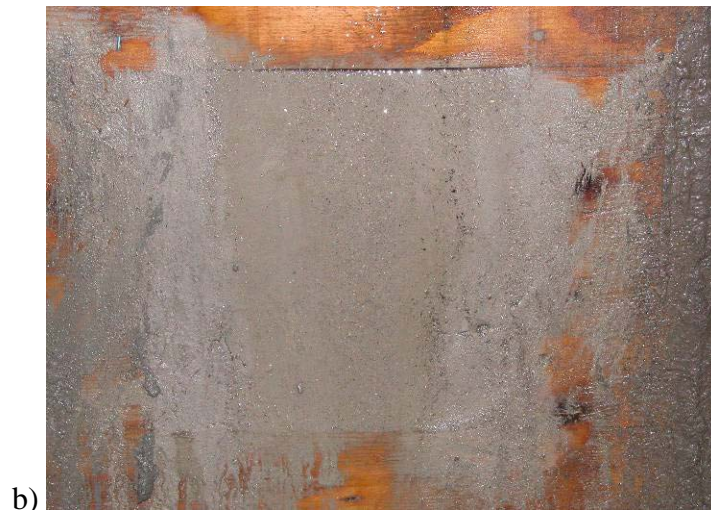
This material setup and performed the best in this test. The top edge sagged down very little, but it never had to be held in place. There was a small amount of initial washout on the surface.

Figure 3. The ConproSet material a) after initial application and b) after about 2 hours.

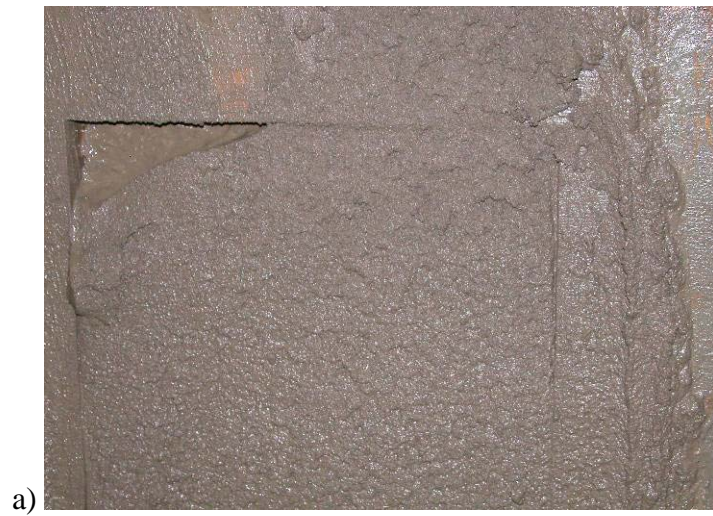
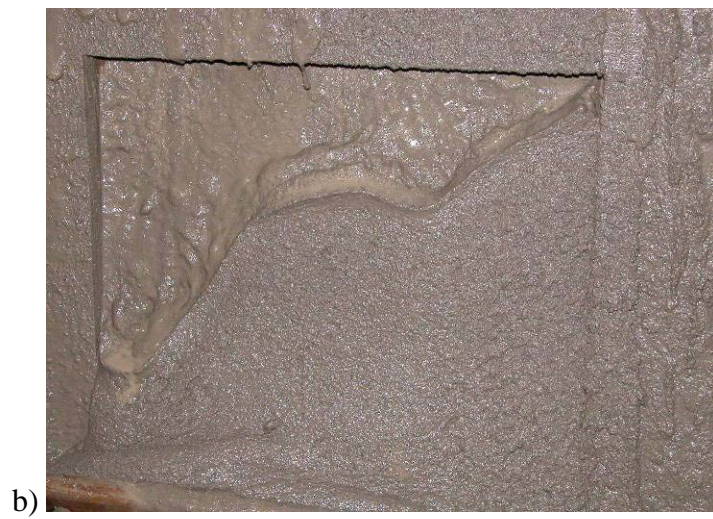
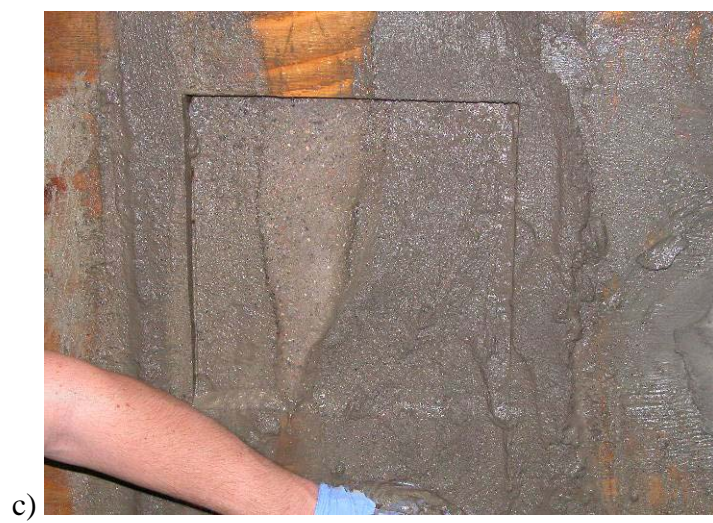
This material didn't bond or hold its structure. It sagged and ran down the slab as soon as it was applied and water came in contact with it. Trying to hold it in place with the float was not effective.

Figure 4. The BASF material a) when applied to the substrate, b) immediately sagging after the application, and c) completely sagged off a short time later.

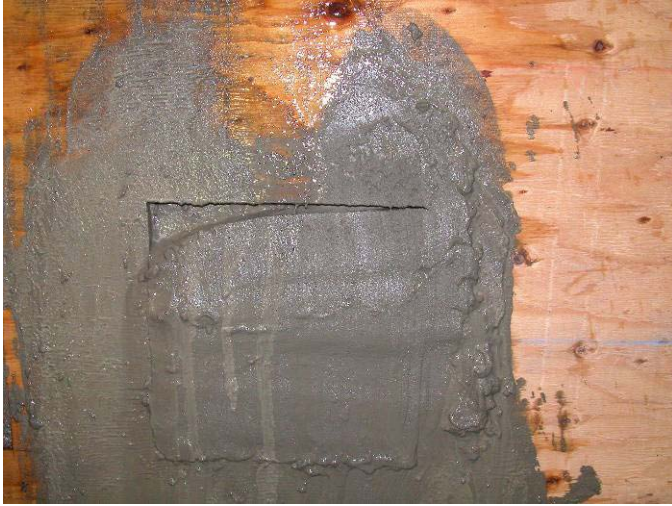
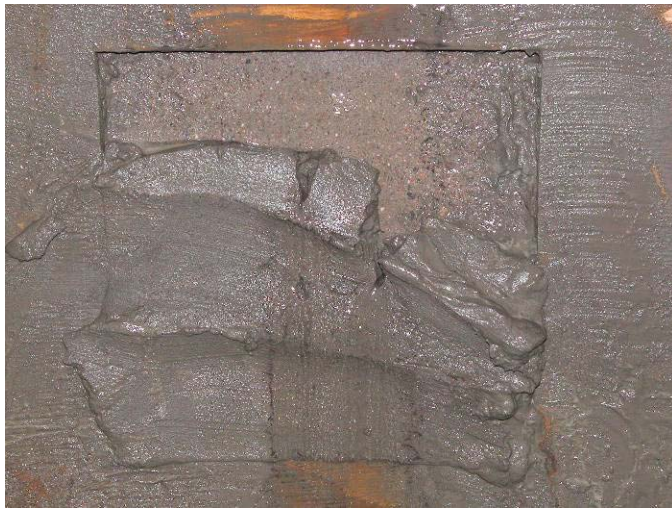
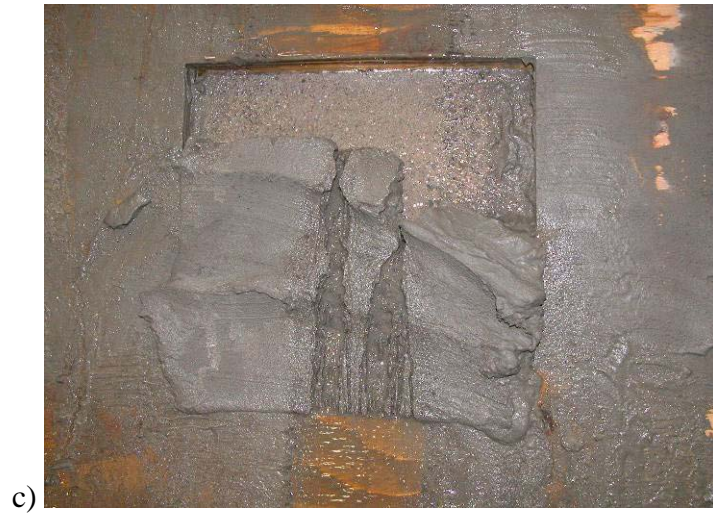
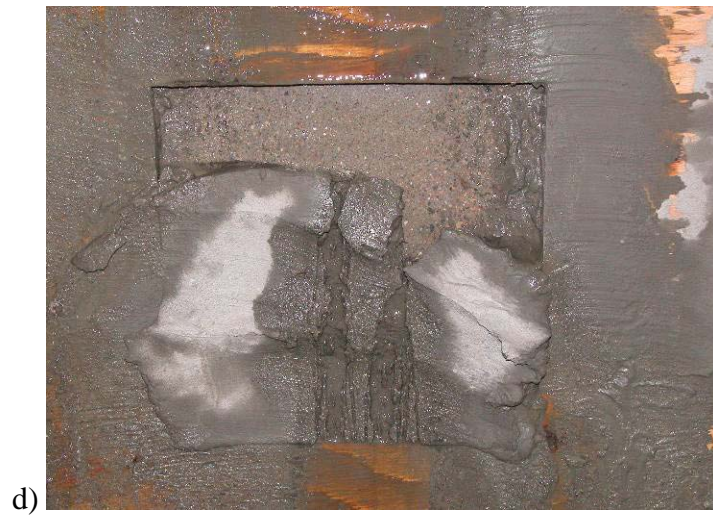
This material sagged and didn't bond to the substrate. When held in place it still sagged after slightly setting up. When water ran down it after the structure setup, the slow stream of water eroded a path in the surface.

Figure 5. The Five-star material a) during application, b) sagging away after approximately one minute, c) the starting of erosion, and d) setting up.
