## **D-3 FLOOD OVERTOPPING FAILURE OF DAMS AND LEVEES**

## Chapter D-3 Flood Overtopping Failure of Dams and Levees

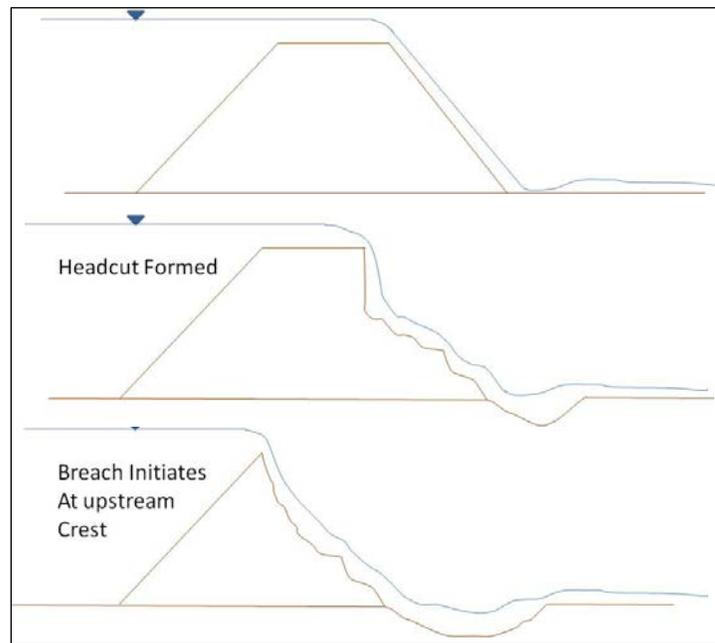
Figure D-3-1 shows the progression of dam failure that initiates at the toe of the dam. Once erosion initiates at the toe of the dam, a headcut forms at the toe and then advances upstream until the crest of the dam is breached (Wahl 1998). As discussed in “chapter D-1, Erosion of Rock and Soil,” the program WinDAM C (U.S. Department of Agriculture-Natural Resources Conservation Service [USDA-NRCS 2016]) initiates the headcut near the downstream edge of the crest to be conservative. Note that the breach does not initiate until the upstream crest begins to erode.

**Figure D-3-1.—Dam overtopping failure progression for embankment dam.**

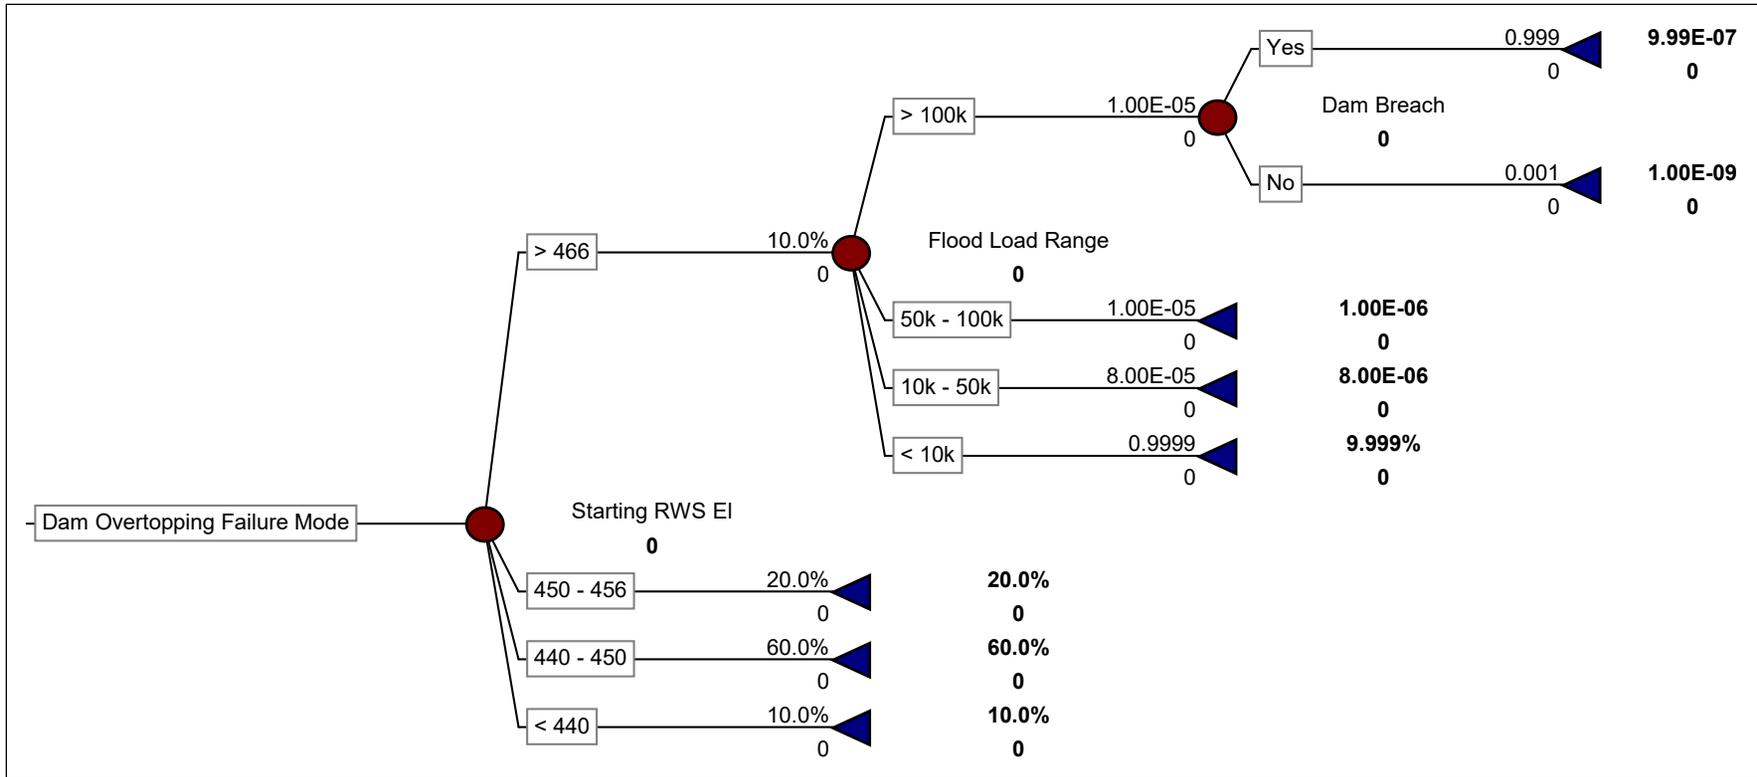
Figure D-3-2.—Example event tree for flood overtopping failure of an embankment dam.

An example event tree described in this section is relatively simple, and is typical of what would be considered for an overtopping potential failure mode. Each branch consists of five events –the pool loading, vegetation or riprap removal, headcut initiation, headcut or erosion advancing, and finally breach. In cases where debris plugging, gate failure, or wave overtopping is a concern, additional events can be added to account for the likelihood of these conditions developing. The erosion and breaching process can be subdivided into a sequence of necessary steps:

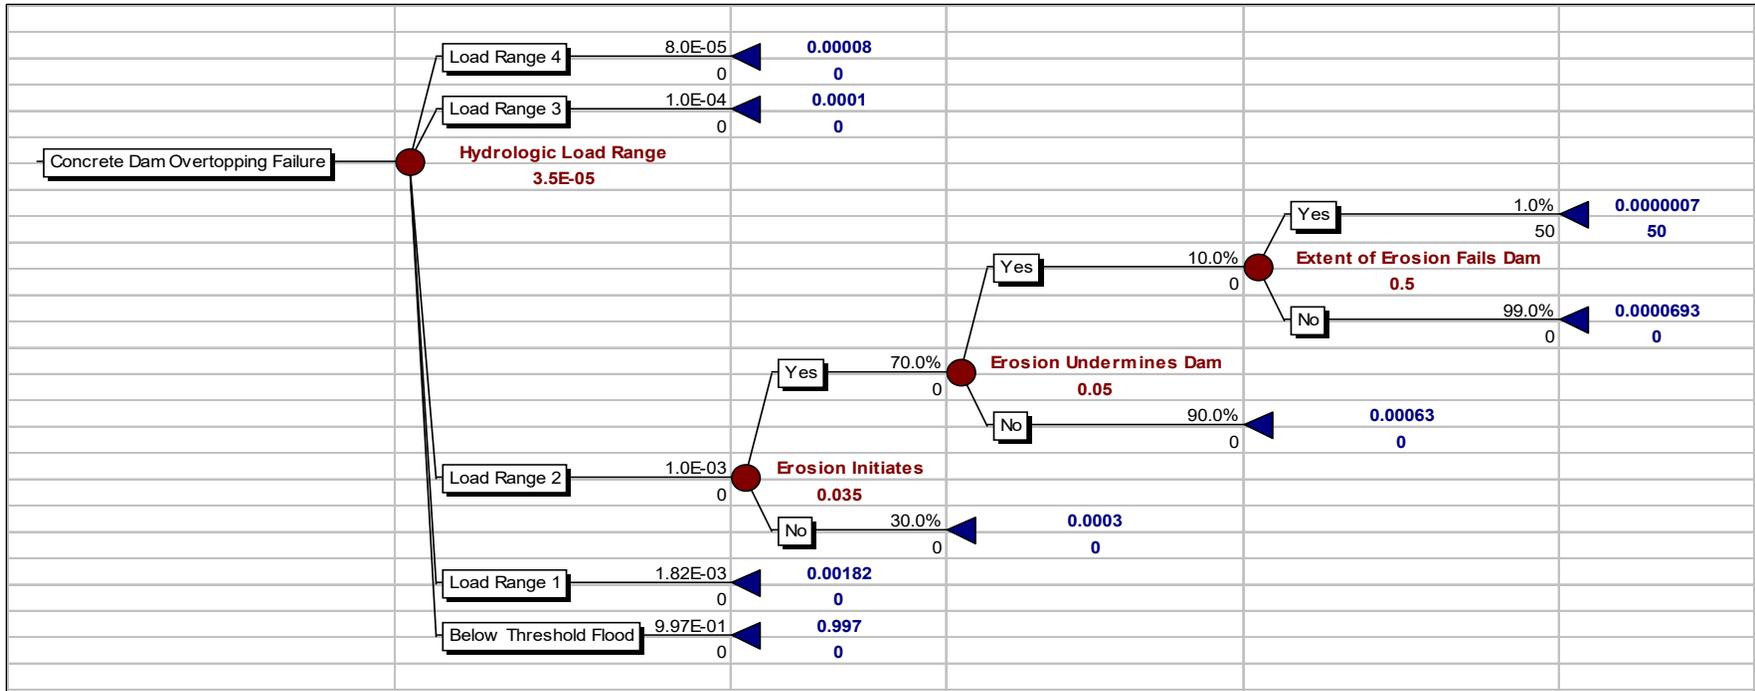
Figure D-3-3.—Example event tree for flood overtopping failure of a concrete dam.
