D-7 FOUNDATION RISKS FOR CONCRETE DAMS

D-7.1 Key Concepts

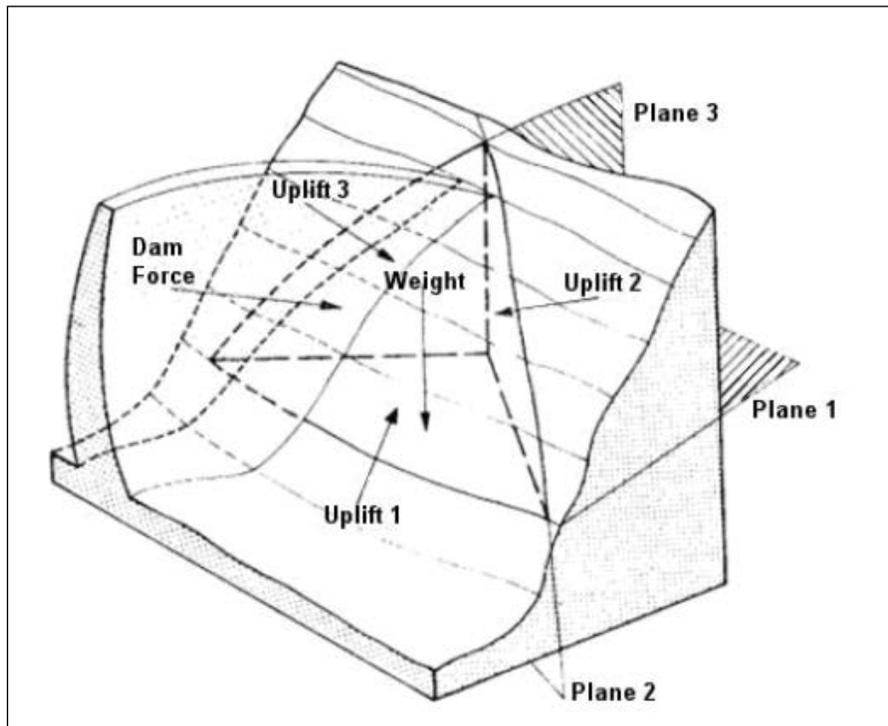
Figure D-7-1.—Example of potentially unstable foundation wedge (adapted from Londe 1973).

Perhaps the most critical area for evaluating the foundation of a concrete dam has to do with sliding along geologic discontinuities within the abutment or foundation of a dam. Planes or intersections of planes that daylight downstream and form wedges upon which the dam rests should be identified and evaluated for sliding stability. Figure D-7-1 shows schematically how such a wedge might form, and the forces acting on such a wedge. In this case it is likely the wedge would tend to slide along the intersection of Plane 1 and Plane 2 under the applied loads.

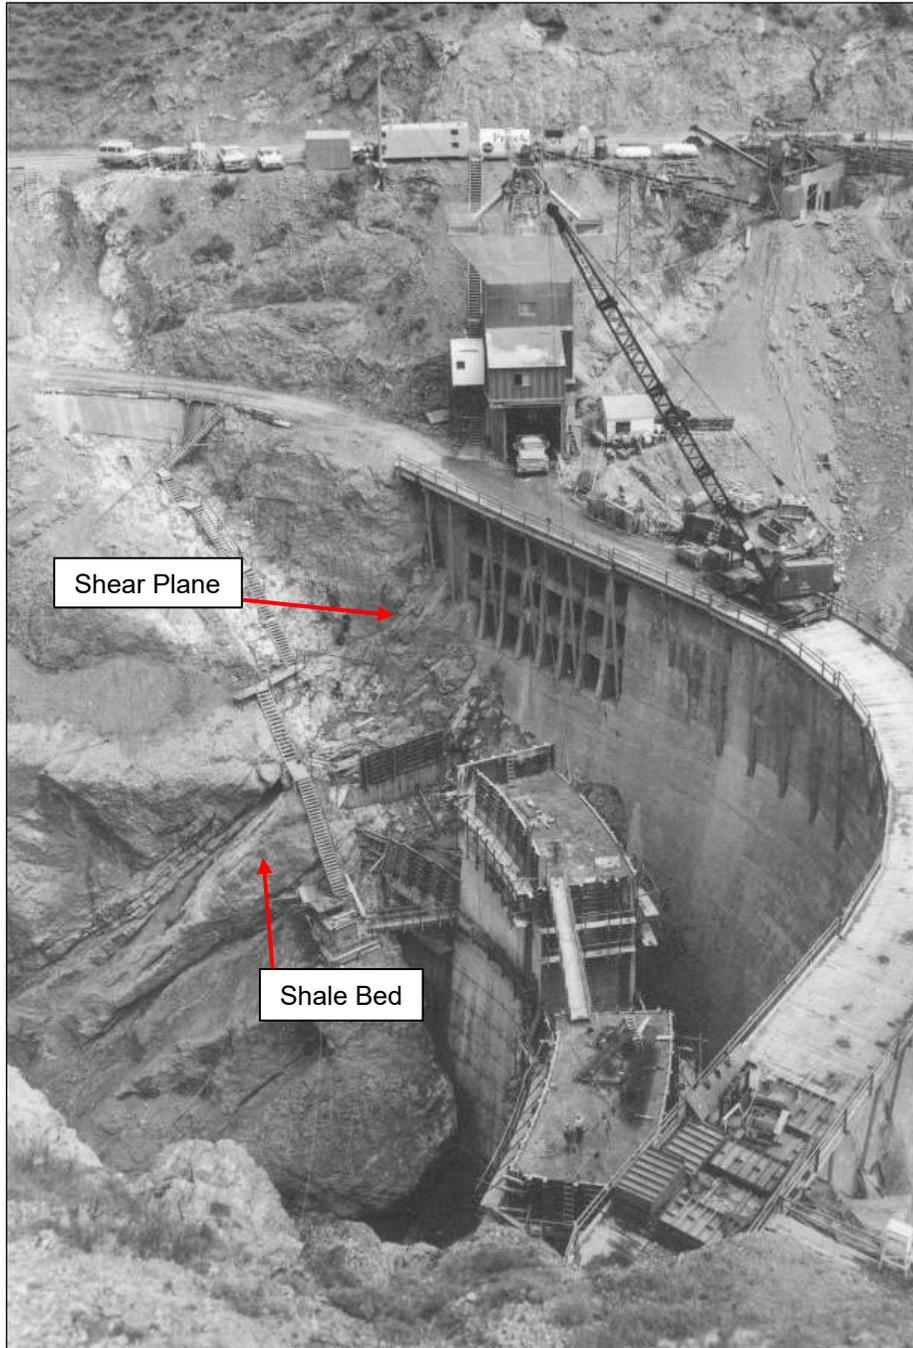
Figure D-7-2.—Construction photo showing major discontinuities (note new arch dam being constructed immediately downstream of an existing arch dam).

for daylighting discontinuities that could influence stability. Critical low angle planes may not be visible in the foundation. Construction photographs can be invaluable in identifying discontinuities in this area, as well as in the excavation footprint, as shown on figure D-7-2.

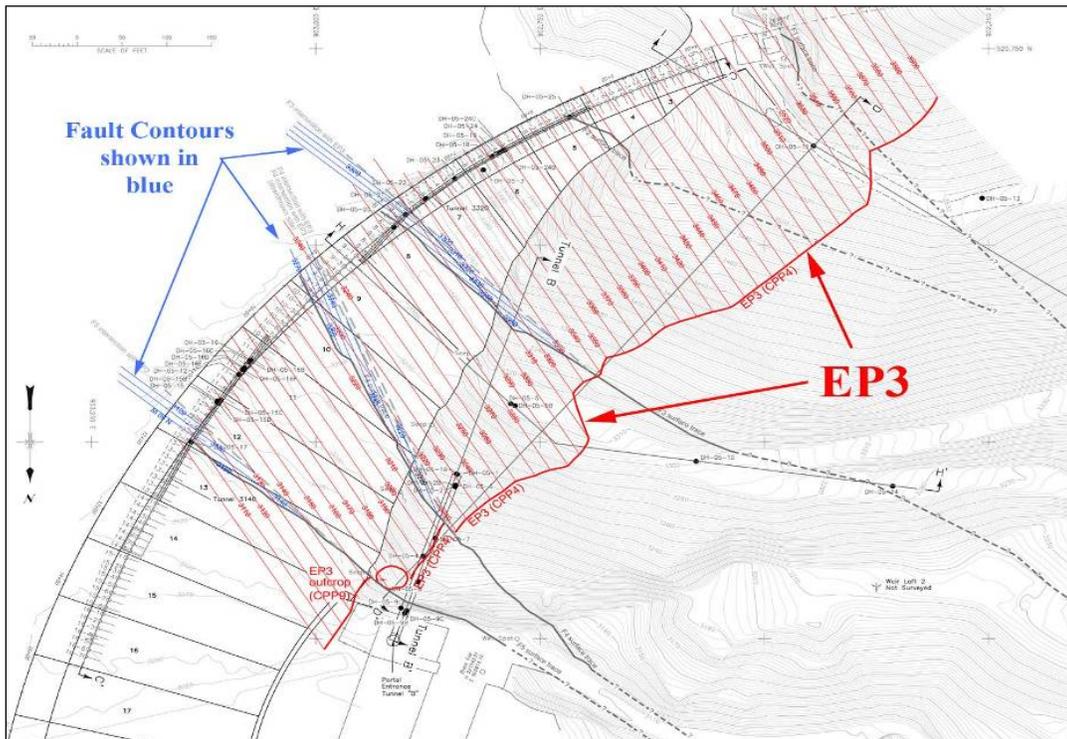
Figure D-7-3.—Structural contours on major discontinuities.

Major discontinuities that are continuous relative to the foundation dimensions and potentially weak in shear (or that can release in tension near the upstream wedge boundary) should be identified, and their location, orientation, and characteristics should be defined. It is important to portray the geologic information on plan maps, cross sections, profiles, and structural contour maps so that the geometry is well understood, and appropriate evaluations and calculations can be made. Figure D-7-3 shows example structural contours on prominent clay-coated bedding plane partings and faults. For this project, a difference in several degrees of bedding strike had a large influence on calculated stability. Information from many different sources was combined to develop structural contours for each fault and prominent “EP (Engineering Plane) bedding plane.” These planes represented potential sliding surfaces that included multiple bedding planes that aligned across faults. Data available included: preconstruction exploration; construction mapping of the foundation and adits; construction photographs of the foundation; and post construction drilling and borehole geophysics performed in the existing drain holes. EP3 was identified as the critical potential slide plane based on its close proximity to the dam foundation contact, and its extent from fault 1 at the upstream end of the dam down to fault 4 toward the bottom of the abutment. EP3 daylights downstream along with its intersections with several faults on the abutment.

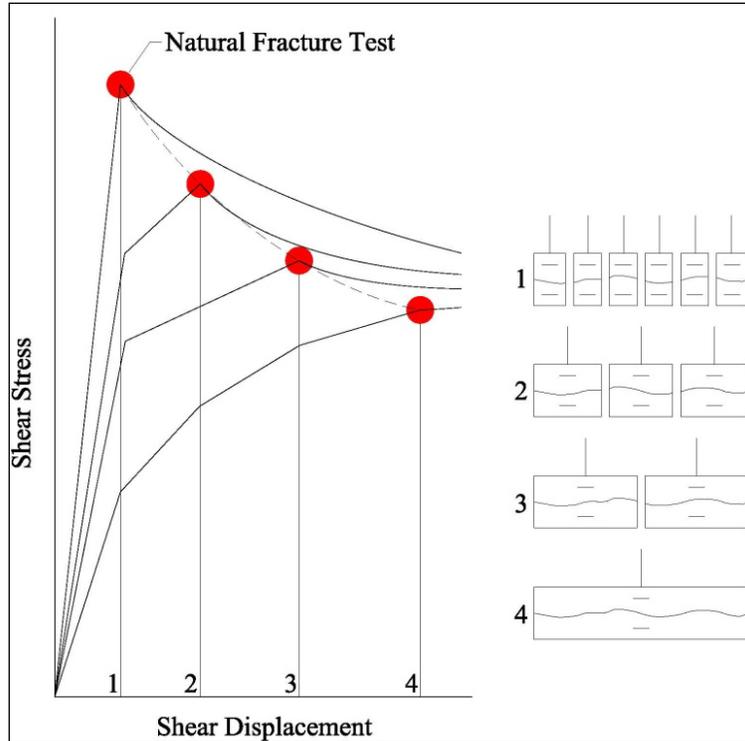
Figure D-7-4.—Scale effects from testing natural joints (adapted from Bandis et al 1983).

Bandis et al (1983) performed direct shear tests on samples of natural fractures as shown on figure D-7-4. They started by testing a large specimen, then proceeded to cut it into smaller and smaller specimens. On average, the strengths increased as the specimens became smaller. This indicates that the small-scale

asperities are not mobilized when shearing large scale joints, and testing of small scale rough joint specimens can therefore overpredict the strength. Some have proposed testing saw cuts to overcome this issue and estimate a basic friction angle for a given rock type. However, this leads to more uncertainty as most saw blades can polish the surface smoother than the individual rock grains leading to conservative estimates of the basic friction angle. Attempts to artificially roughen a saw cut surface can result in significant variation and uncertainty as well, and any alteration along the joint surfaces is not taken into account with such an approach. A better approach to determining the basic friction angle seems to include subtracting the specimen dilation by measuring the normal and shear displacement during testing. The slope of the normal displacement versus shear displacement curve at the point of sliding is the dilatancy angle. Figure D-7-5 shows the relevant plots from a direct shear test.

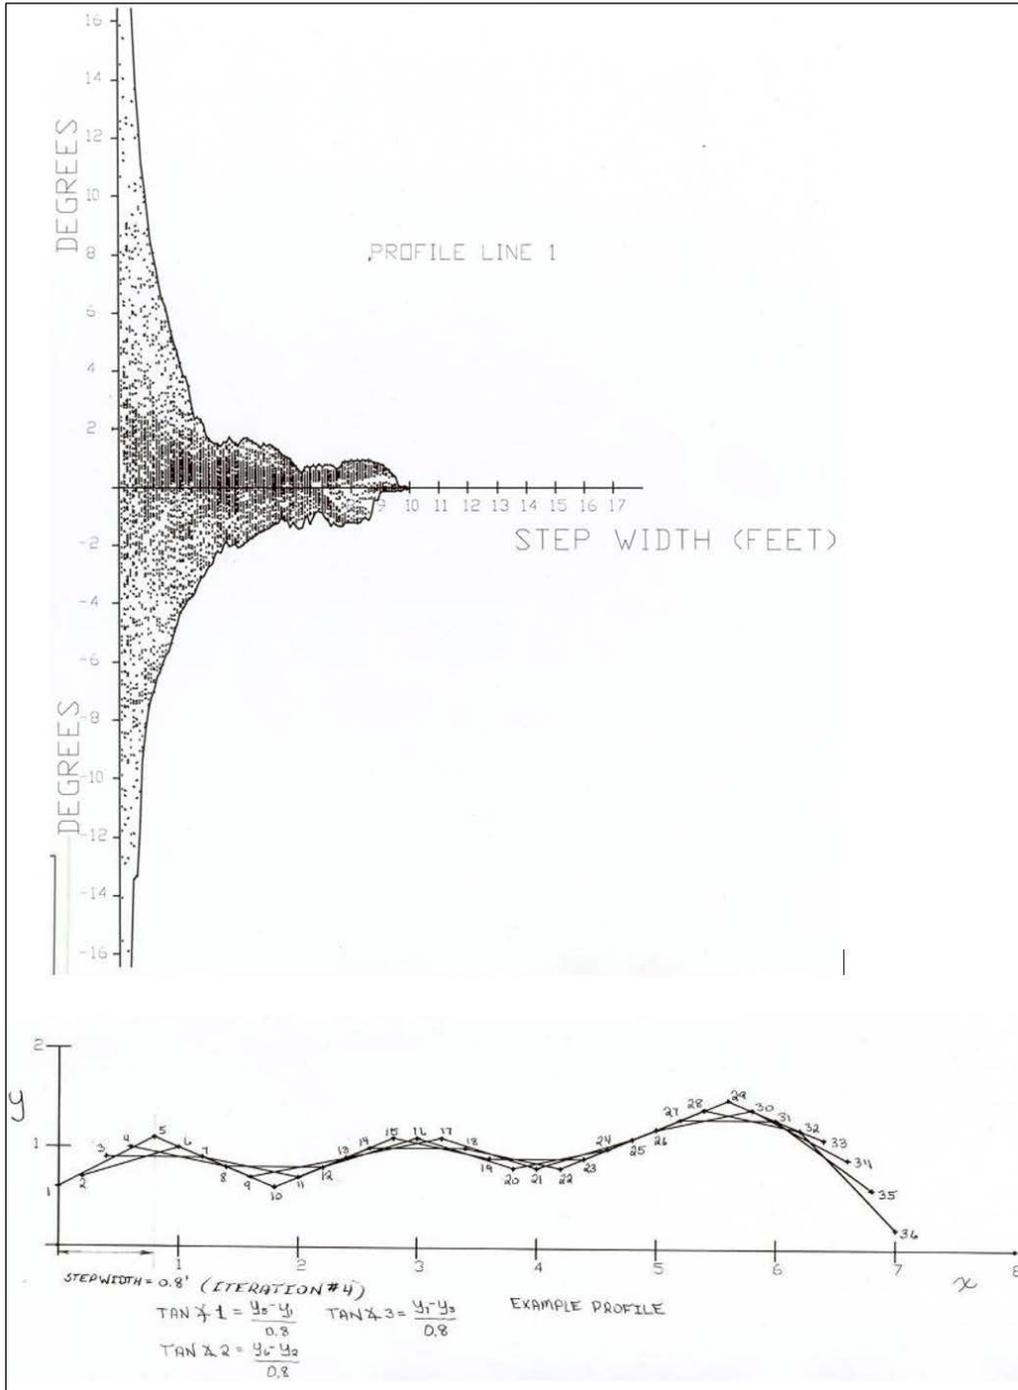
Figure D-7-6.—Waviness angle analysis (after Rengers 1970).

The scatter in the corrected data should be reduced over that obtained from the raw test data. Once a basic friction angle has been established, the large-scale asperity angles or undulations can be added to obtain an estimate of effective in situ friction angle. This typically requires some field measurements. Photogrammetry models (see “chapter A-2, Geologic Information Required for Dam and Levee Risk Assessment” for geological information needed for a risk analysis) of large discontinuity surfaces can be useful for making these measurements. Typically, angles are measured along a large-scale discontinuity profile using increasing step width (constructed as consecutive segments along the profile). The asperity angles are plotted as a function of step width as shown on

figure D-7-6. The asperity angle may converge to a steady state value, or a value that corresponds to 1 to 2 percent of the in situ sliding plane length has sometimes been selected to represent the waviness angle to be added to the basic friction angle. For probabilistic analyses, ranges or distributions in both the basic friction angle and waviness angle should be considered.

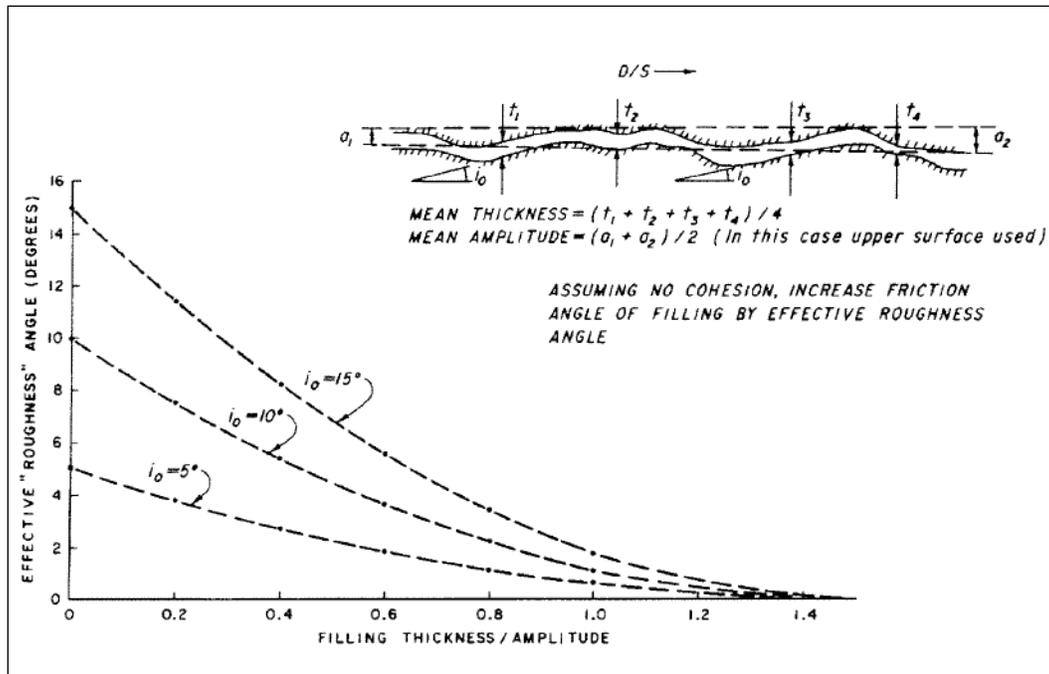
Figure D-7-7.—Effective waviness angle for filled discontinuities (adapted from Ladanyi and Archambault 1977).

In some cases, a critical sliding plane will be filled with softer infilling material, and the strength of the filling material will have a major effect on its shear strength. It can also affect the roughness or waviness component of the shear strength as the filling material compresses during shearing. To account for this, Ladanyi and Archambault (1977) have proposed some relationships that are plotted on figure D-7-7. An effective roughness angle can be estimated based on the ratio of the Filling Thickness/Rock Wall Amplitude. Again, ranges or distributions should be considered when performing probabilistic analyses.

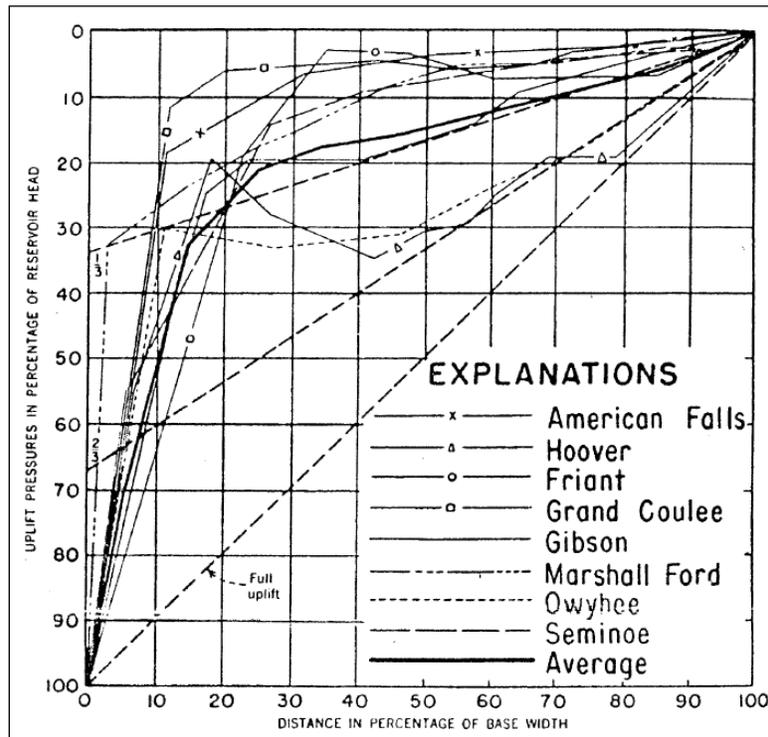
Figure D-7-9.—Uplift measurements at concrete dams.

A line of drains is typically installed as a defensive measure in a concrete dam foundation. If functioning, the drains can dramatically reduce the foundation water pressures, which would be reflected in the water pressure contours. Measurements just below the foundation contact of several large concrete dams show that the pressures downstream of a line of functioning drains are greatly reduced by the drainage, as shown on figure D-7-9. It can be noted that the original measurements made at Hoover Dam and Owyhee Dam did not show as much pressure reduction. However, additional deeper drains were drilled, and the pressures were brought down. In that regard, it is necessary that the drains penetrate the major zone of seepage. Typically drains at about 40 percent of the hydraulic height into the foundation are adequate for this purpose. Shallower drains can also be effective if the major zone of seepage is more shallow, but it may be necessary to measure foundation pressures at depth to verify this. It is important to clean and maintain the drains in operating conditions for an adequate defensive measure.

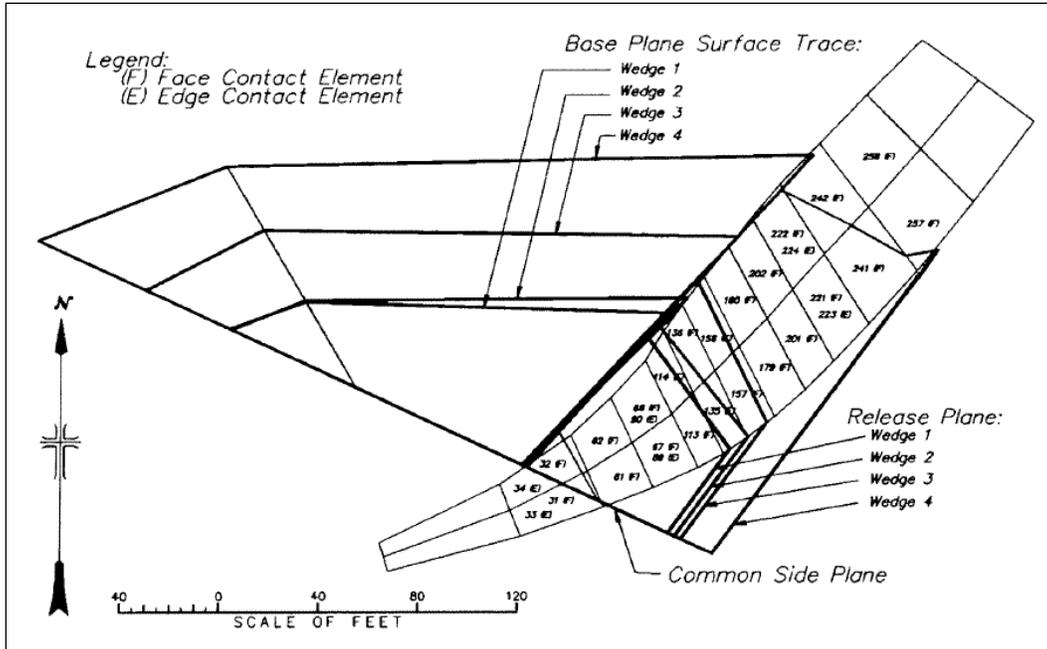
Figure D-7-10.—Finite element mesh superimposed on nested foundation wedges.

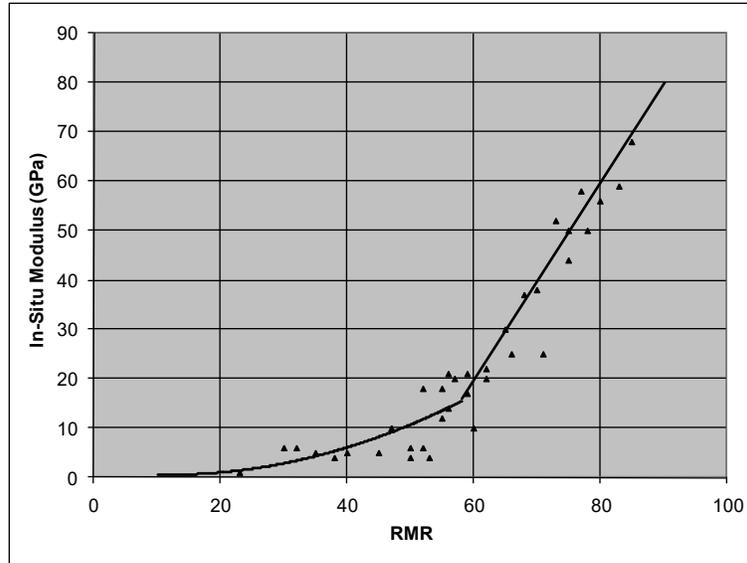
Figure D-7-11.—Correlation between rock mass modulus and RMR (adapted from Bieniawski 1989).

The easiest way to estimate rock mass modulus for a concrete dam foundation involves the use of empirical correlations developed from large scale in situ jacking test results and rock mechanics index properties. One such relationship is shown on figure D-7-11, which correlates in situ modulus with rock mass rating (RMR) developed by Bieniawski (1989). RMR is a rock mass quality index that rates the rock mass according to: (1) the intact rock strength (typically from lab testing or point load testing), (2) rock quality designation (RQD), (3) joint spacing, and (4) the condition of the joints (continuity, weathering, infilling, roughness) (Scott 1982). A separate evaluation would be required for each major rock unit within the foundation of the dam and the effects on dam response evaluated.

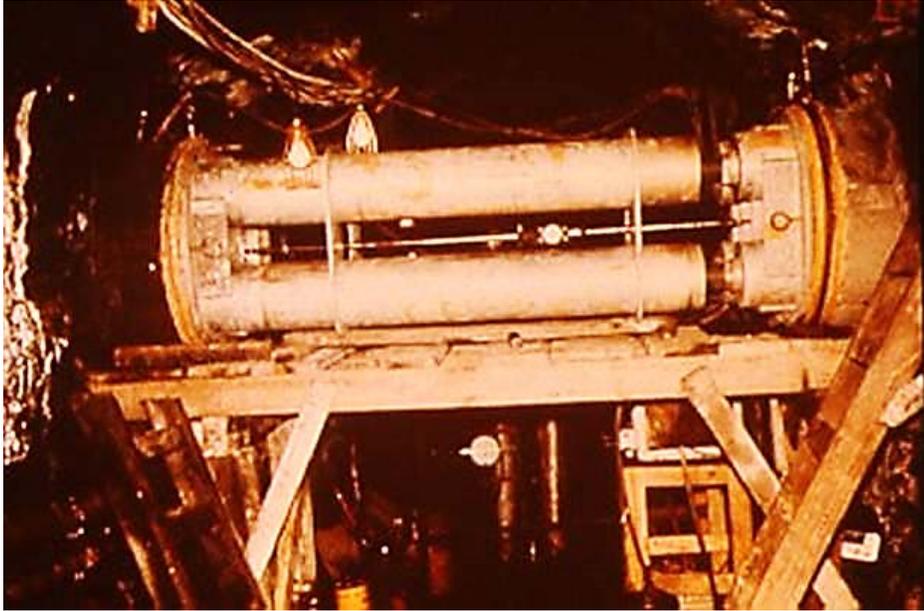
Figure D-7-12.—In situ uniaxial jacking test setup.

The most direct way to estimate foundation rock mass modulus is to measure it using large scale jacking tests, such as that shown on figure D-7-12. Loading is

applied to the rock mass through large jacks or flat jacks, typically across an excavated tunnel or adit, and the deformation of the rock mass is measured at the rock surface and at depth beneath the loaded surface using multiple position borehole extensometer. The load and deformation data are then used to back calculate a modulus value for the given loading geometry. Limited equipment and expertise currently exist in the United States to perform this type of testing, and additional development may be needed to use this testing method in the future.

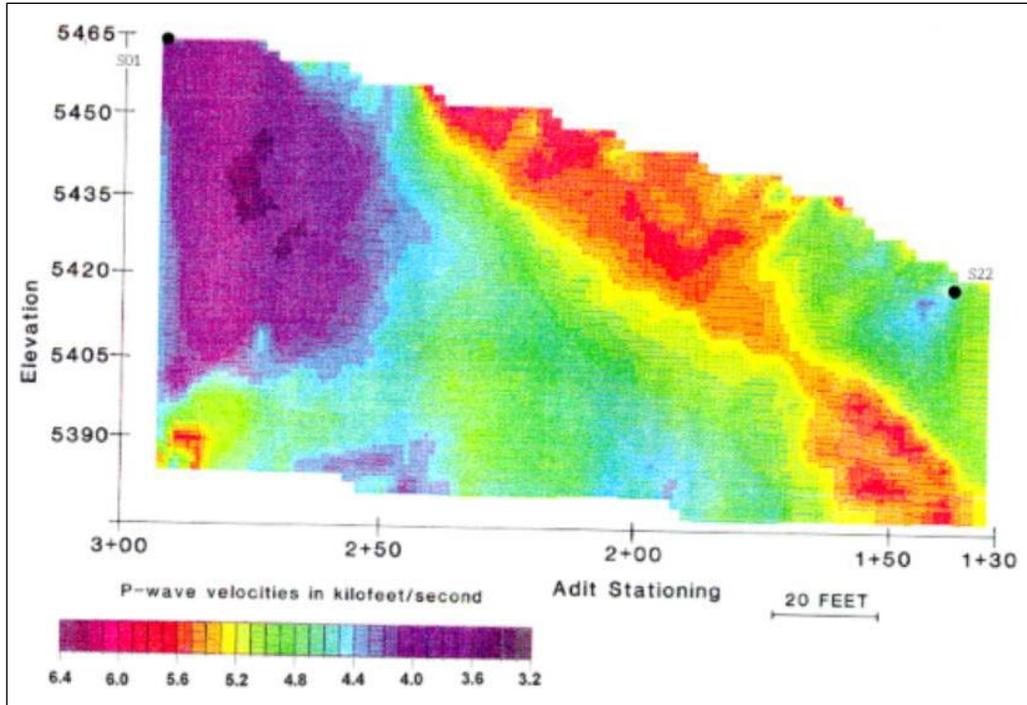
Figure D-7-13.—Seismic tomography developed between adit and ground surface.

Even though such a jacking test measures a relatively large volume of rock, it is small compared to the volume of a dam foundation. Therefore, a means of relating the jacking test results to the varying geologic conditions within the dam foundation must be established. One such method is seismic tomography. P-wave and/or S-wave velocities are measured over multiple overlapping ray paths between a series of source and receiver locations. The tomographic reconstruction process then gives a picture of the variation in velocity throughout the tested section. Figure D-7-13 shows a P-wave tomography developed for a dam abutment. Receivers were placed in the roof of an exploratory adit, and sources were set off along a line on the abutment (ray paths between sources and receivers can also be developed between boreholes). As can be seen, there are zones of relatively large velocity contrast that may be important to the structural response and foundation loading.

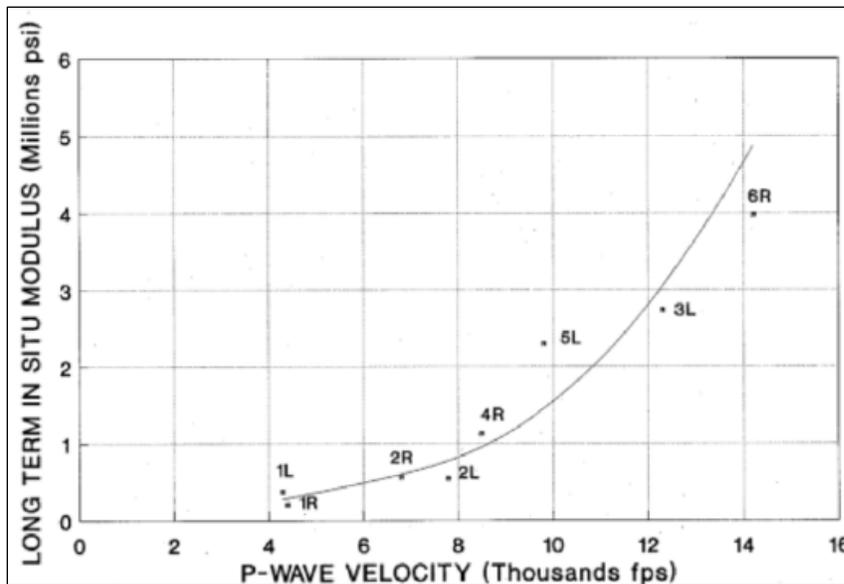
Figure D-7-14.—Correlation of P-wave velocity with in situ modulus.

A number of in situ jacking tests were performed in the exploratory adit to correlate the P-wave velocities with modulus. The correlation was quite good, as shown on figure D-7-14. Using this relationship, modulus values could be assigned to various velocity zones within the foundation, based on the seismic tomograms.

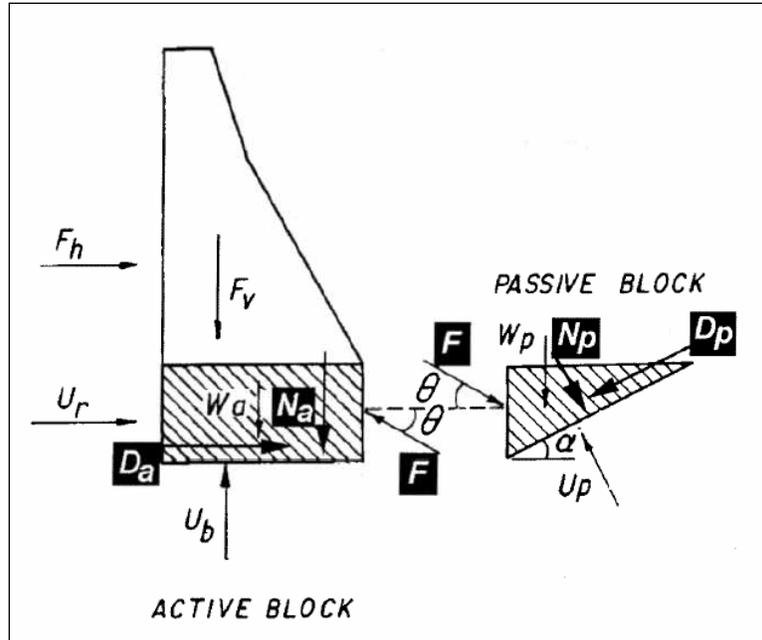
Figure D-7-15.—Typical two-wedge sliding analysis.

Figure D-7-15 shows a two-wedge sliding analysis typically performed for concrete gravity dams, especially when founded on horizontally bedded sedimentary rock. The traditional 2-D analysis usually involves a passive wedge downstream of the dam. Although this type of analysis can be found in many guidance documents, it can be misused. For one thing, unless the passive wedge is very thin, the intact rock material is very weak, or there is an adversely oriented discontinuity or joint set passing through the passive wedge, it is unlikely that shearing will occur through the passive rock mass. In addition, in order for the passive wedge to move, shearing must occur along the boundary between the active and passive wedge. Unless there is a near vertical joint or discontinuity in this location, this may be unlikely. Finally, the calculated factor of safety is

typically sensitive to the inclination angle assumed for the interwedge force, F . At the limit of equilibrium this should approach the friction angle of the interwedge plane. It is usually taken as horizontal which may be conservative in many cases.

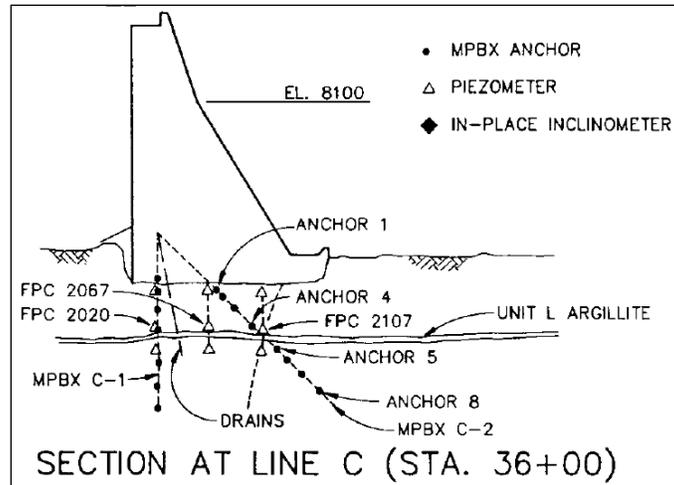
Figure D-7-16.—Instrumentation and geologic section.

Some deformation is typically needed to mobilize the passive wedge. If there are deformable discontinuities in the rock mass downstream, that deformation may lead to cracking of the concrete. Consider the roller-compacted concrete (RCC) gravity dam shown on figure D-7-16, which is founded on a Cambrian quartzose sandstone foundation. In the abutments and beneath the main dam, interbeds of gray argillite, a lower strength material in between shale and slate, are present. Figure D-7-16 shows a typical instrumentation layout at Line C in the spillway area. Note that there is a weak layer, the Unit L argillite, within the otherwise hard quartzose sandstone. A passive wedge is present downstream of the dam above the Unit L layer. Of note are the vertical and angled multi-point borehole extensometers (MPBXs) passing from the gallery through the dam and into the foundation, with anchors above and below the Unit L layer. Piezometers are also installed above and below the Unit L layer and upstream and downstream from the line of drains. Not shown are the vertical inclinometers passing through the dam and into the foundation through the Unit L layer at sections outside the spillway.

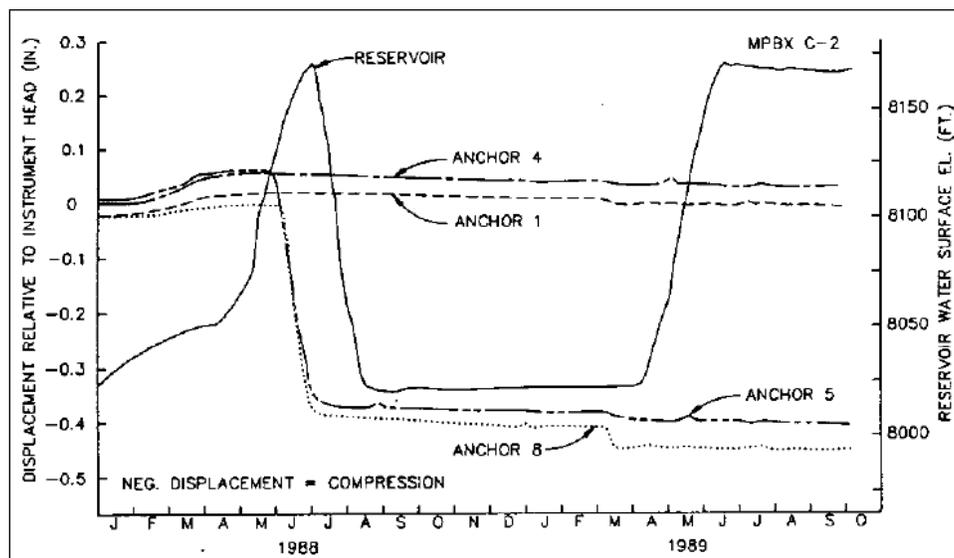
Figure D-7-17.—Angled MBPX response.

Figure D-7-17 shows the response of the angled MBPX at line C during the first reservoir filling. As the reservoir went up, the anchors below the Unit L argillite layer began to deviate while those above did not. This meant that there was relative movement between the lower anchors and the anchor head, but not between the upper anchors and the anchor head. This suggested that the wedge above the Unit L was moving with respect to the rock below the Unit L. In addition, an inclinometer at a nearby location showed a distinct offset in its profile across the Unit L argillite layer. The piezometers showed relatively high pressures in the upstream and middle area of the foundation.

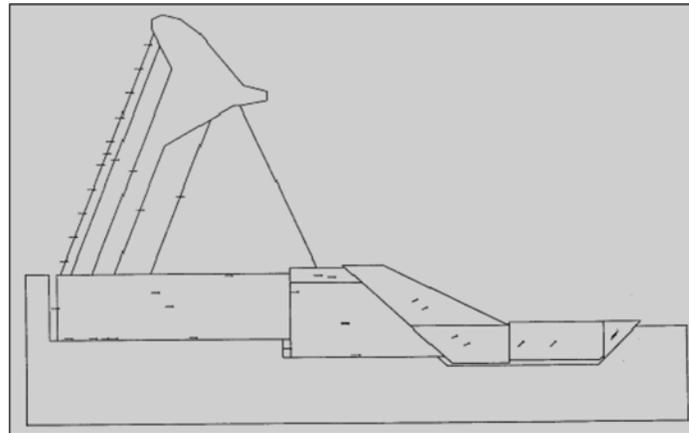
Figure D-7-18.—DDA of multi-wedge system.

A better approach to performing analysis of multi-wedge systems is to use a distinct element code such as Universal Distinct Element Code (UDEC) or a Discontinuous Deformation Analysis code (DDA), as shown on figure D-7-18. This type of analysis accounts for the interwedge forces and angles more appropriately. But again, the failure planes must be realistically possible.

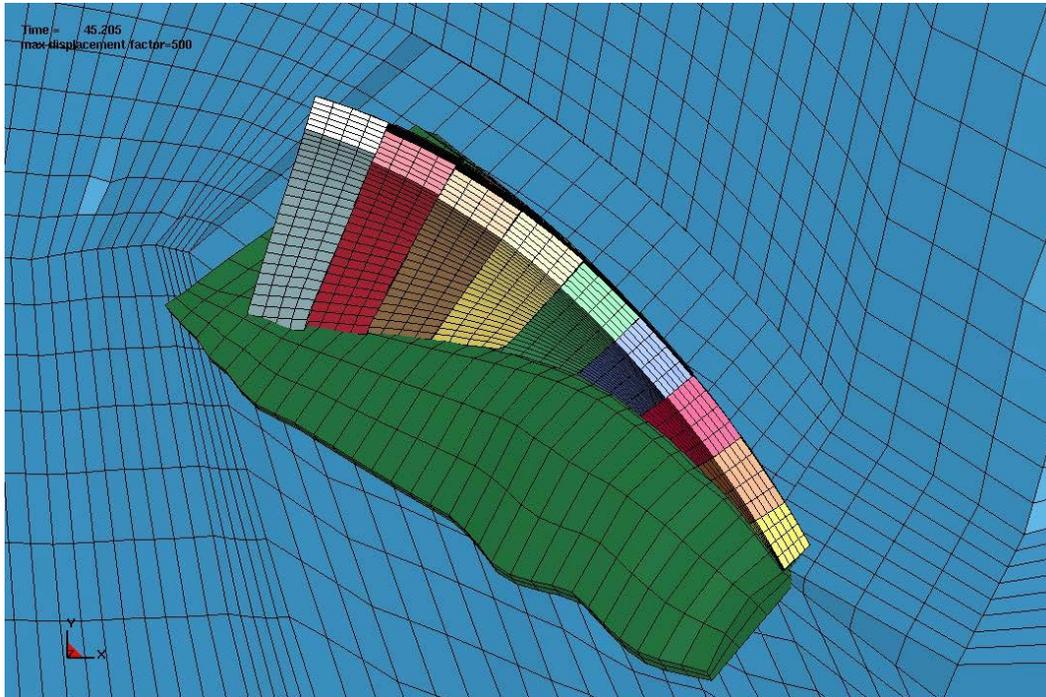
Figure D-7-19.—Nonlinear coupled dam-foundation analysis.

as shown on figure D-7-19. This allows for stress redistribution and allows interaction between the dam and foundation. In addition, if the dam is very thick and it is thought that the potential for foundation wedge movement might be controlled by contraction joints within the dam, this type of analysis can be helpful in demonstrating this type of behavior. However, these types of analyses are complicated, time consuming and expensive, and mistakes in model development can be made. Therefore, it is essential to thoroughly test the model to make sure it is performing correctly and giving reasonable results.

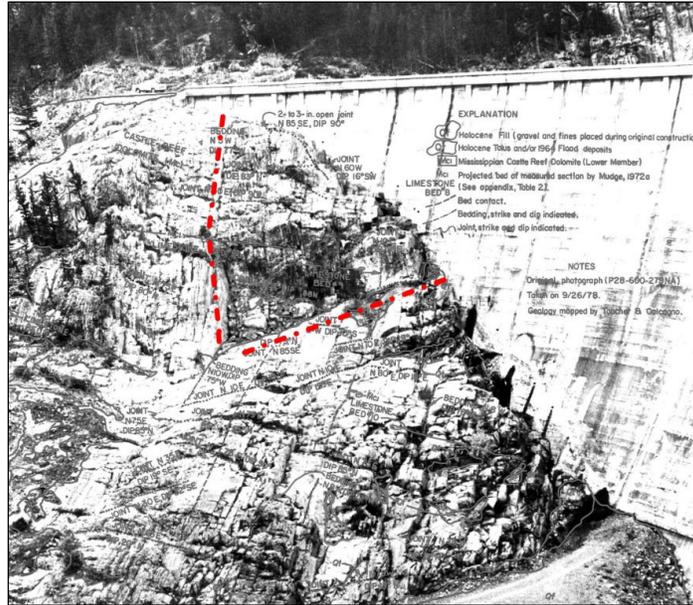
Figure D-7-20.—Photo showing right abutment wedge.

- A large potentially unstable foundation wedge is well defined (figure D-7-20). *Geologic mapping of the hard-dolomitic limestone in the downstream right abutment shows a continuous high angle bedding plane parting angled toward the channel from upstream to downstream forming a continuous side plane boundary. A continuous low angle joint can be observed in the downstream abutment, and construction photos indicate it traverses completely across the dam foundation forming the wedge base plane. Continuous high angle joints were mapped in the upstream reservoir area, capable of forming back release surfaces for the wedge.*

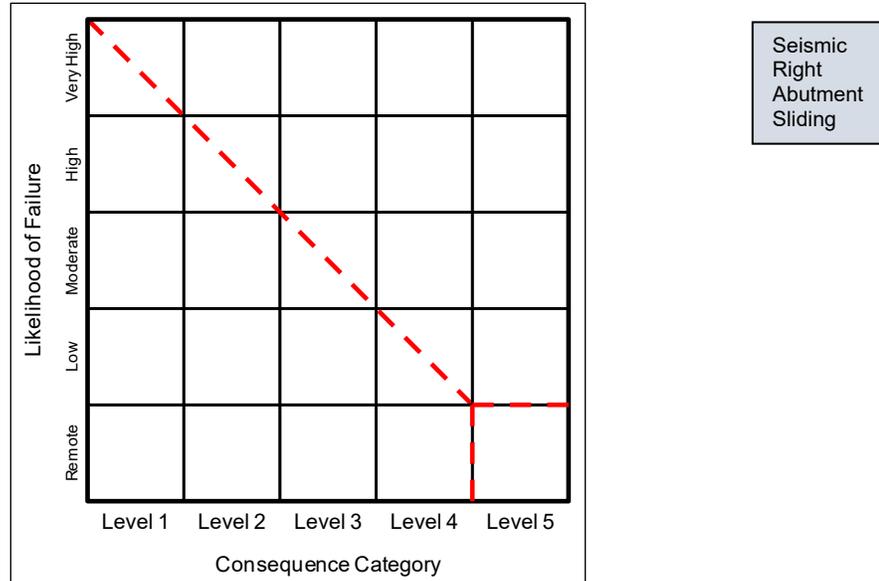
Figure D-7-21.—Risk matrix.

This semi-quantitative evaluation plots on the risk matrix as shown on figure D-7-21. Based on the fact that the risks plot with high confidence in an area on the matrix where they may justify action, a quantitative

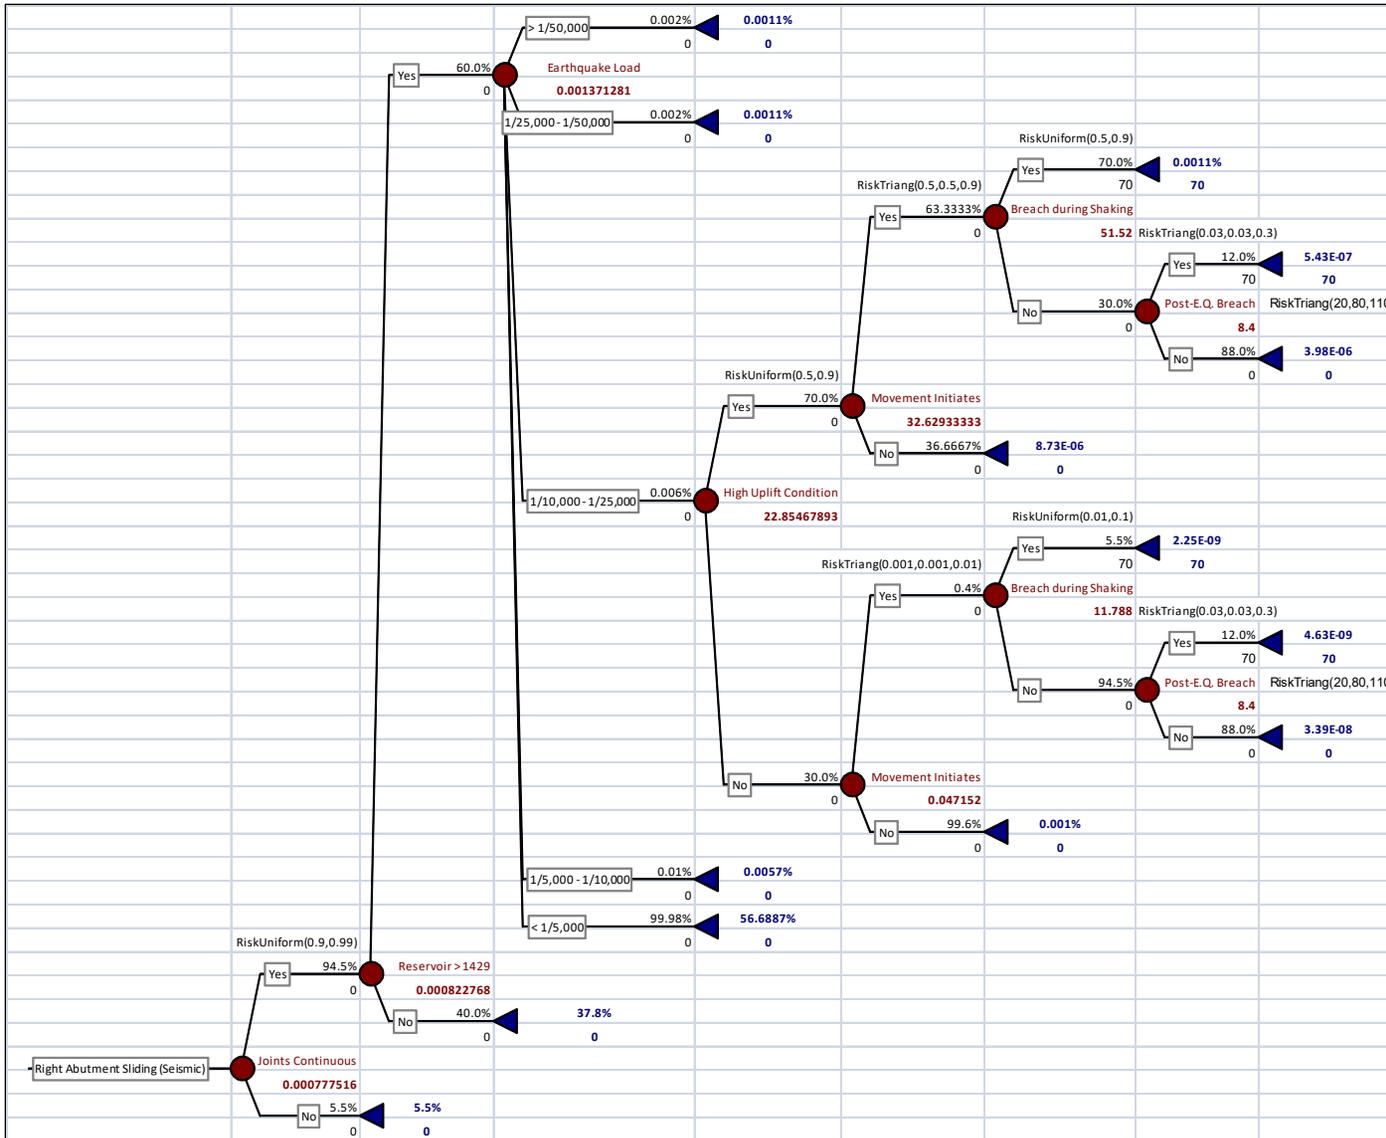
Figure D-7-22.—Example event tree.

analysis of risk for this PFM can be justified. Given the detailed description of the PFM, an event tree can be constructed as shown on figure D-7-22. Only one seismic load branch (1/10,000 to 1/25,000 annual exceedance probability) is constructed all the way through the event tree for illustration purposes. The conditional failure probability branches following the load branch must be duplicated for all load ranges above the threshold load value. The probability of failure is dependent on not only the earthquake loading level, but also the reservoir level at the time the earthquake hits. If several reservoir and earthquake levels were represented in the tree, it would be extremely large. To simplify the evaluation, only one reservoir load range was included, chosen to represent loadings which were significant to the abutment wedge and at levels that would produce significant consequences if failure occurred. The event tree was developed after a credible foundation wedge had been defined based on a detailed evaluation, and the primary geologic uncertainty is the joint continuity. Uncertainties related to joint orientation, strength, and water forces for a given uplift condition do not necessarily follow linearly, are interrelated, and all affect the stability. These were handled in external kinematic stability analyses as discussed below.

Monte-Carlo simulation results developed from the event tree shown on figure D-7-22 are depicted in the scatter-plot shown on figure D-7-24, where each

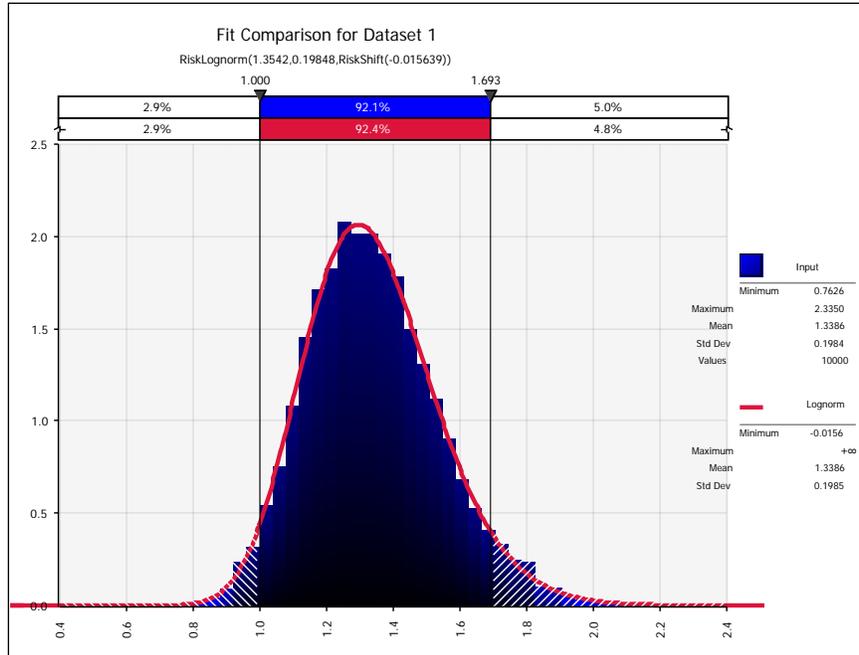
Figure D-7-23.—Output from Monte Carlo simulation (horizontal axis is factor of safety).

The weight of the wedge was varied in the analysis using a uniform distribution (equally likely between lower and upper input values) considering reasonable variations in unit weight and wedge volume. The water forces are also uncertain, but for post-earthquake conditions it was assumed the joints opened sufficiently to generate full hydrostatic loading on the back-release joint, varying linearly to the “daylight” trace of the side and base plane joints downstream. The post-earthquake thrust from the arch dam, although uncertain, was taken as constant for a high reservoir elevation, based on finite element structural analyses simulating post-earthquake conditions to the extent possible. The results of 10,000 iterations in terms of sliding factor of safety are shown on figure D-7-23. As can be seen, approximately 2.9 percent of the calculated factors of safety were less than 1.0 (i.e. probability of $FS < 1.0 = 0.029$).

output safety factor distribution. For this, the @Risk program prints out a list of ranking coefficients. Those input distributions with the highest positive or negative ranking coefficients affect the results most. The coefficients for this analysis are shown in table D-7-2.

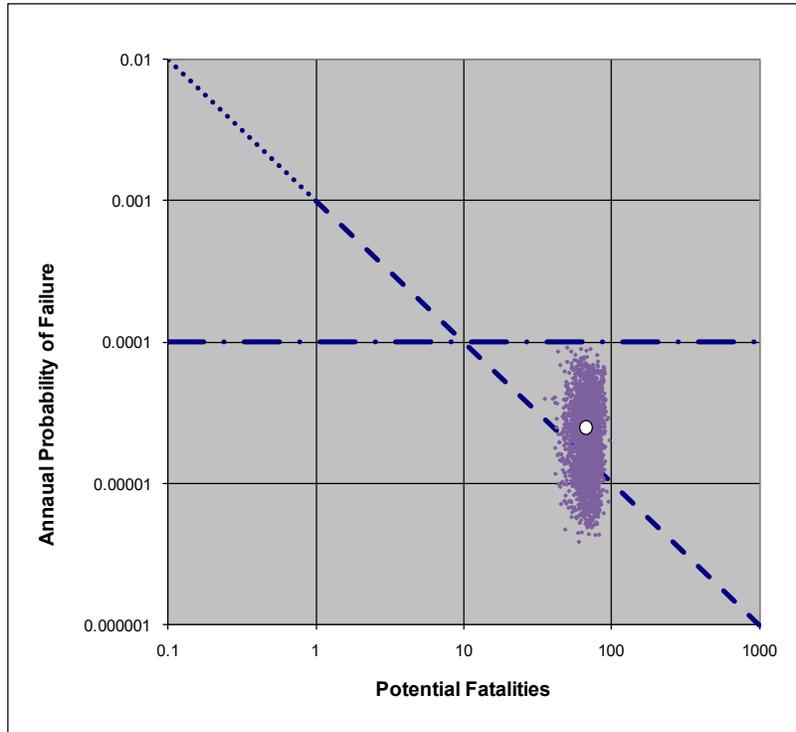
Figure D-7-24.—Scatter plot from event tree Monte-Carlo analysis.

point represents a single combination of possible values chosen from each variable's probability distribution. The mean (shown by the large open circle) represents the 'expected value' of the risk estimates (where the weighted consequences are typically calculated as the annualized life loss divided by the annualized failure probability). The outlying points represent situations where more extreme values are chosen from each variable's probability distribution.
