G-2 Failure GATES OTHER THAN RADIAL GATE

G-2.1 Key Concepts

G-2.2 Description of Gate Types and Potential Failure Modes

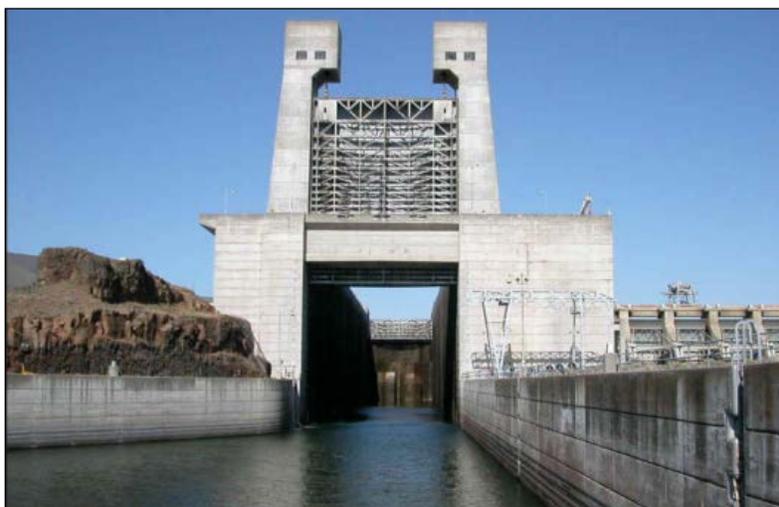
Figure G-2-7.—Overhead vertical lift gate.

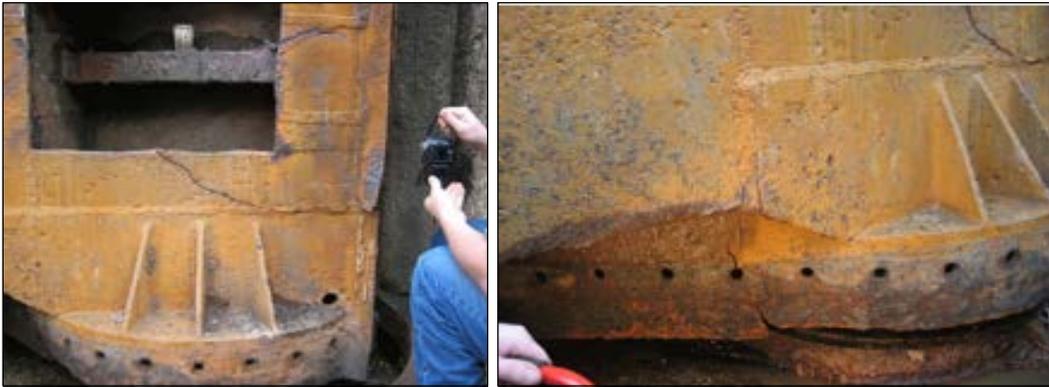
Figure G-2-10.—Cracking in main chamber miter gates, Greenup Lock and Dam (USACE 2010a).

Cracking has also been found in the flanges where the pintle casting is connected or in the pintle socket casting itself. Cracking in the flanges can cause excessive movement of the pintle, which could result in problems during operation of the gates. Cracking of the pintle socket casting is usually caused by worn or improper adjustment of quoin blocks resulting in loss of contact with the wall quoin. This results in additional load on the pintle, which can lead to cracking of the pintle or failure of the bolts at the girder connection (USACE 2010b). Figure G-2-10 shows cracking around the pintle casting discovered at Greenup Locks and Dam in September 2003.

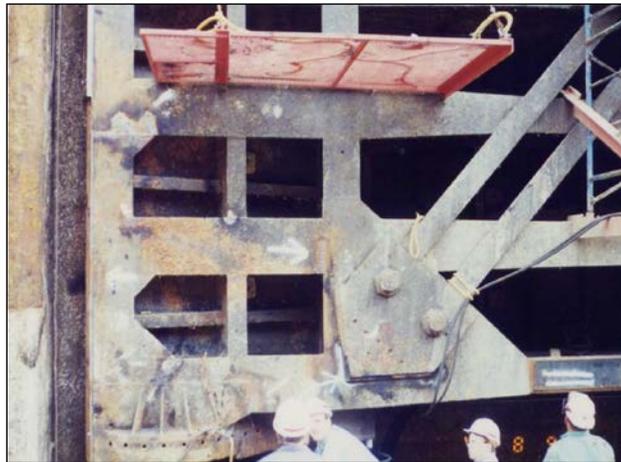
Figure G-2-13.—Fatigue cracking in girder flange at diagonal anchor plate, Markland Lock and Dam (USACE 2010b).

A dewatering was scheduled for the main chamber at Markland Locks and Dam, Pennsylvania, in 1994 to perform major maintenance including jacking the miter gates and replacing the pintle and seals. Once the lock was dewatered and the gates were inspected, severe cracking was found in some of the welds of the horizontal girders as shown on figure G-2-13. In particular, the heaviest cracking occurred near the pintle area on the lower girders. It was determined that the extensive cracking was fatigue-related and additional finite element analysis was done to help determine the cause for the extensive cracking. Through the additional analysis, it was determined that the cracking was due to residual tensile stresses present near the girder welds. When welding occurs during original construction, large stresses are developed in the members near the weld joints. During operation of the gate, the members are subjected to compression loads, causing a stress reversal at these locations. Since the gates were considered to be in critical condition, immediate repairs were made to the gate during the dewatering. This included gouging out the cracks and rewelding. To evaluate the performance of the repairs, another dewatering was scheduled in 1996. It was found that the cracks had re-initiated at the same locations where they had been repaired during the 1994 dewatering. Other modifications were made to the gate during the dewatering of 1996 including adding structural plates, etc., but the condition of the gate was still considered critical. Louisville District Operations and Engineering Divisions instituted a 2-3 year dewatering interval to continue to monitor the gates until the gates were replaced (USACE 1999a).

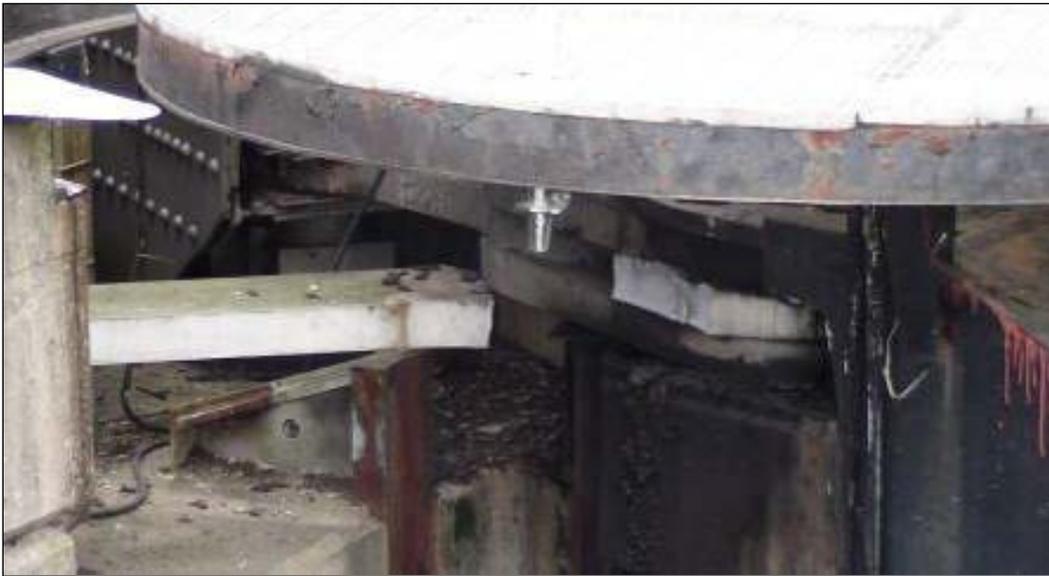
Figure G-2-14.—Failed Anchor Arm, Greenup Lock and Dam (USACE 2010a).

The emergency closure of Greenup Locks and Dam, Kentucky, main chamber took place from Wednesday, January 27 through Monday, February 22, 2010. The closure resulted from a sudden fatigue failure of the miter anchor arm on the main chamber downstream middle wall gate leaf as shown on figure G-2-14. The gate was being properly operated during a routine up bound lockage. No operator error occurred. The failure initiated at the root of a fillet weld connecting the miter anchor arm to the top connecting link and propagated through the entire cross section of the miter anchor arm. The weld was shown on the original contract drawings and had been identified during Periodic Inspection No. 8 performed in July 2008 as a poor weld detail for a tension member. Visual inspection of the root of the weld and base material subsequent to failure indicates the crack had initiated prior to the failure as evidenced by corrosion in the crack. The crack was not visible during prior inspections due to limited accessibility, paint and over spill of lubricating grease for the gudgeon pin.

The gate came to rest on the concrete sill in a near vertical position supported by the pintle, strut arm and the remaining non fractured but damaged recess anchor arm. Emergency repairs were performed on January 29, 2010 by welding a splice plate to the fractured anchor arm and other gate stabilization efforts were completed to prevent more damage to the gate. The miter gate was removed and a detailed structural inspection was performed on the gate and anchorage. Dive inspections were performed on the gate sill and pintle. Anchor wedge assemblies, anchor arms, connector plates, gudgeon and link pins were replaced and the gate was reinstalled on February 21, 2010. A final inspection was done on February 22, 2010 and the main lock chamber was reopened for traffic (USACE 2010a).

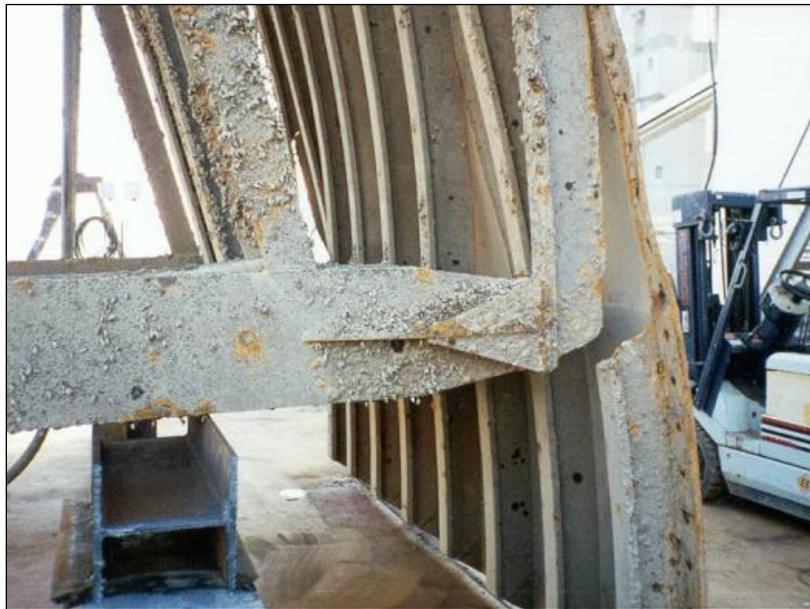
Figure G-2-15.—Failed culvert valve, Cannelton Locks and Dam.

The lower river wall emptying culvert valve for the main chamber at Cannelton Locks and Dam, Indiana and Kentucky, was reported to be inoperable on September 10, 1999. The valve emergency bulkheads were set by lock personnel, but extensive leakage prohibited immediate dewatering of the valve chamber. The Louisville Repair Station arrived at the site early in the week of October 4 and were able to get the bulkheads set and the chamber pumped down so that the valve could be inspected and removed for repairs. The initial inspection was performed on Wednesday, October 6, 1999. The valve was inspected in-situ in the valve chamber. The valve was bound against the sidewalls and had a slight twist in a clockwise direction as viewed facing downstream. The skin plate and vertical rib beams were torn away from the lower girder as shown on figure G-2-15. The fillet welds that attached the rib beams to the lower girder had failed. The second and third vertical rib beams were fractured completely through the flange and extended through the web, and proceeded to tear the stem of the T-beam away from the skin plate. These beams had also broken loose from the upper girder. The end vertical rib beam nearest the Kentucky side suffered a fractured web. The downstream flanges of both of these girders experienced warping when the rib beams tore away. The culvert valve was removed and inspected more closely and it was found that the main valve body was considered structurally sound and deemed capable of service. The failure of the valve may be attributed to fatigue of the welds which connect the rib T-beams to the lower girder beam of the main valve frame. Cannelton's 1,200 foot chamber has experienced a significant number of open/close cycles in its 30 year career; this is categorized as low cycle fatigue loading. In addition to the low cycle static loading imparted by differential hydraulic head, the valve also experienced high cycle fatigue due to turbulent flow conditions (USACE 1999b).

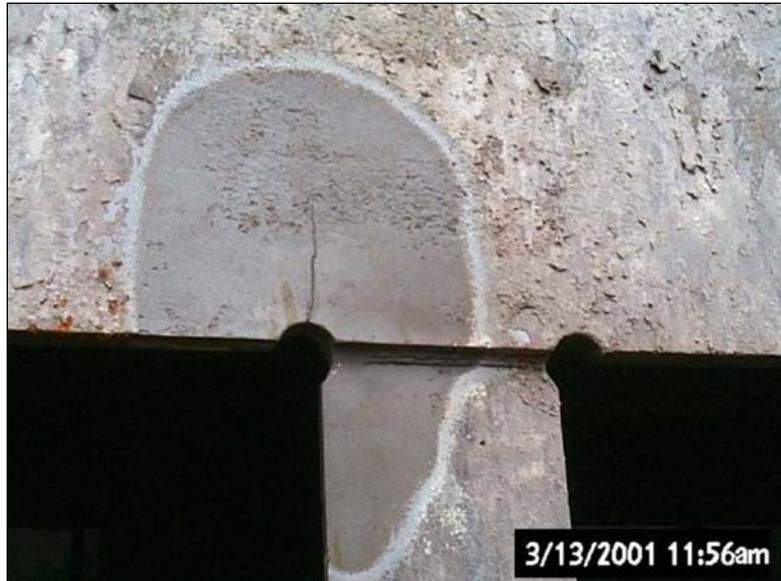
Figure G-2-17.—Fatigue cracking in the tension tie, vertical lift gate, John Day Locks and Dam (Hanson and Chambers 2001).

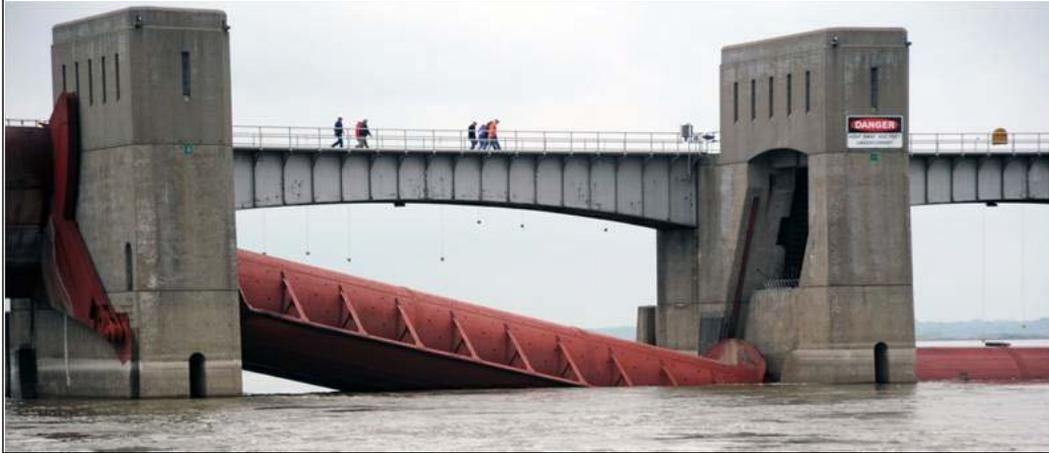
Figure G-2-18.—Damaged roller gate, Mississippi River Lock and Dam 25 (USACE 2011).

The gate came to rest at an angle with the cog/hoist end up into the bottom of the machinery house as shown on figure G-2-18. Emergency repairs began immediately by installing emergency stoplogs to stop flow. Damage was severe enough that engineers decided the gate had to be completely removed in order to implement complete repairs. Removing the gate required multiple attempts with various rigging arrangements. The clear distance from pier to pier is 100 feet; with a gate length of 109 feet, the gate would not clear the pier house. This was the first time a roller gate had ever been removed from a USACE dam. The gate was repaired on a special work barge. During repairs it was discovered that over six feet of mud had accumulated inside the roller gate body; this was removed. Because both side shields were damaged during the failure, each had to be removed and replaced with new custom fabricated replacements, as well as the chain lug plates. To facilitate re-installation, approximately 30 feet of the apron had to be temporarily removed. The fully repaired gate was successfully reinstalled by the summer of 2010 (USACE 2011).
