IV-2. Flood Overtopping Failure of Dams and Levees

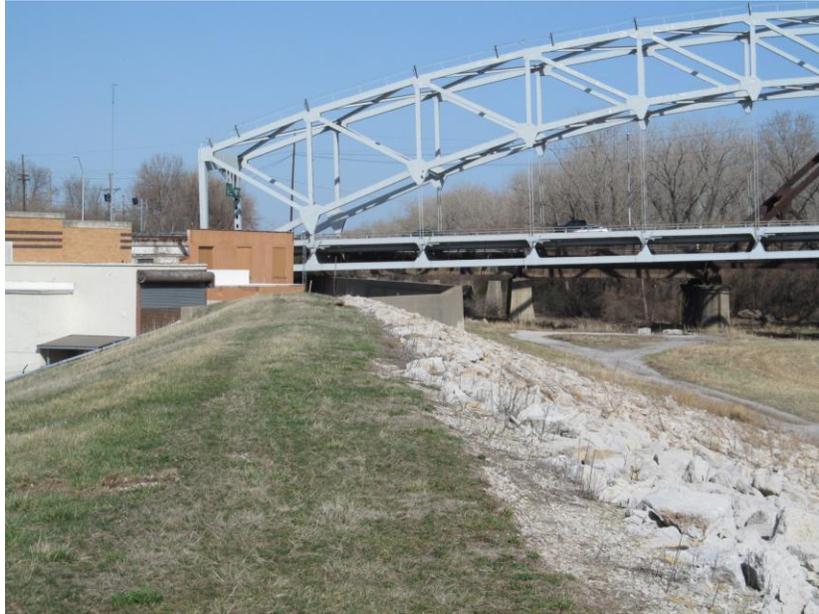
Riverine levee crest near transition to floodwall, which is visible below bridge. The river under normal flow conditions is located about 300 feet to the right of the embankment.

List factors that affect the overtopping erosion for a riverine levee, a hurricane (coastal) levee, a water conservation area levee (Florida):
