IV-5. Foundation Risks for Concrete Dams

Foundation Sliding Stability

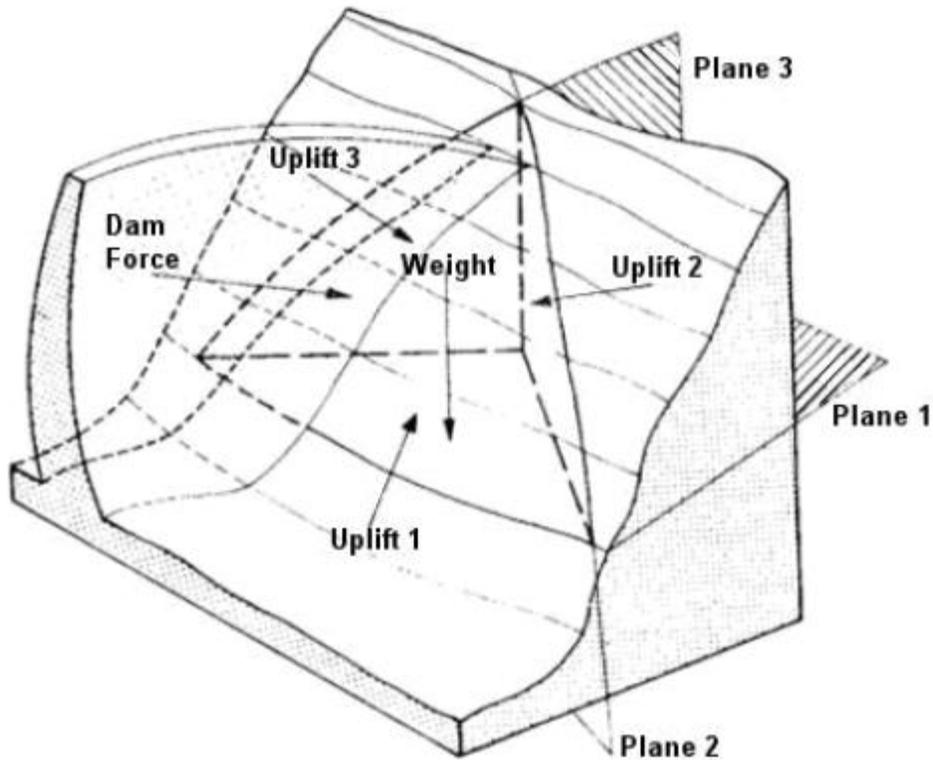
Figure IV-5-1. Example of Potentially Unstable Foundation Wedge (adapted from Londe, 1973)

Perhaps the most critical area for evaluating the foundation of a concrete dam has to do with sliding along geologic discontinuities within the abutment or foundation of a dam. Planes or intersections of planes that daylight downstream and form wedges upon which the dam rests should be identified and evaluated for sliding stability. Figure IV-5-1 shows schematically how such a wedge might form, and the forces acting on such a wedge. In this case it is likely the wedge would tend to slide along the intersection of Plane 1 and Plane 2 under the applied loads.

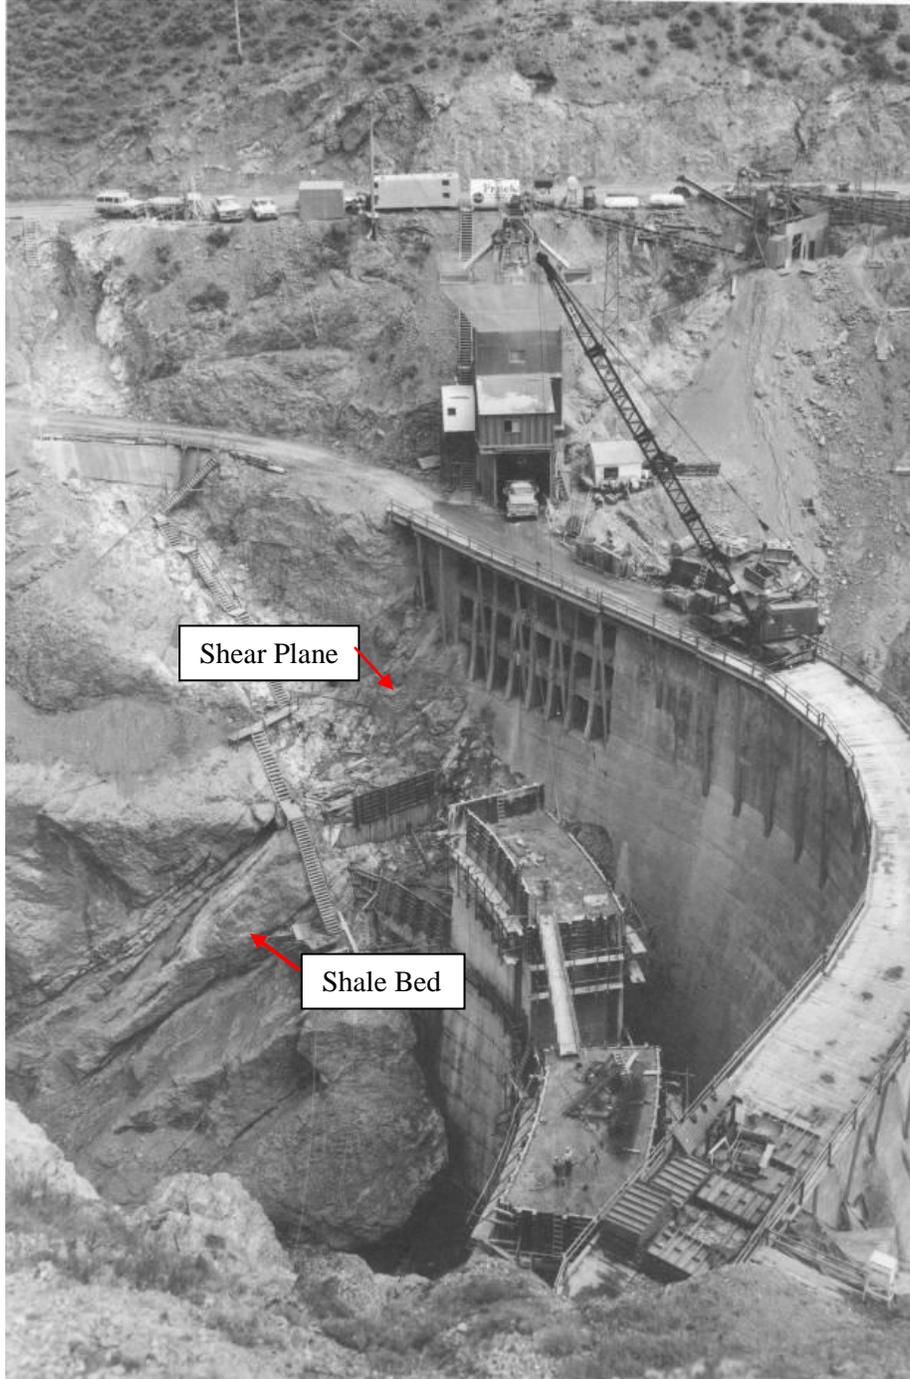
Figure IV-5-2. Construction Photo Showing Major Discontinuities (note new arch dam being constructed immediately downstream of an existing arch dam)

One step in identifying potentially unstable foundation wedges requires carefully searching available foundation maps, construction photographs, drill hole data, LiDAR analysis, and/or lineation mapping for characterizing discontinuities important to stability, particularly continuous low angle base planes that may daylight (i.e. intersect with the downstream topography in a manner that allows movement) downstream along with continuous side planes. The search should continue downstream of the foundation contact where discontinuities may be visible or were mapped. In the past, it was common to map the foundation in detail; however the areas downstream of the abutments were not always exposed and were often unmapped. This is a very important area to investigate, looking for daylighting discontinuities that could influence stability. Critical low angle planes may not be visible in the foundation. Construction photographs can be invaluable in identifying discontinuities in this area, as well as in the excavation footprint, as shown in Figure IV-5-2.

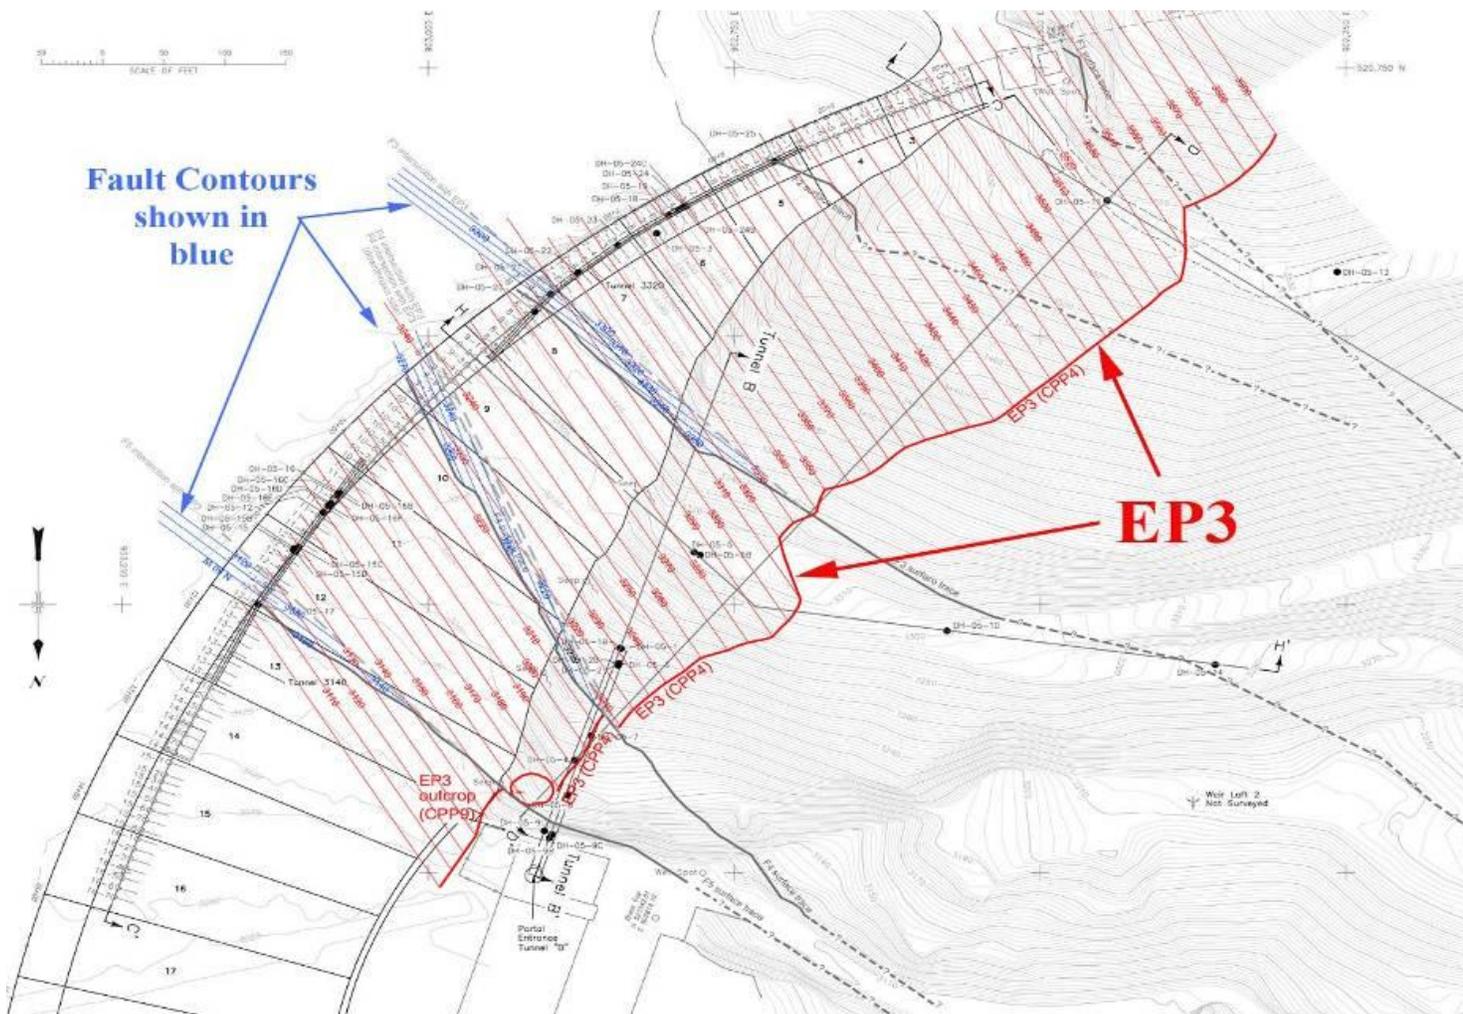
Figure IV-5-3. Structural Contours on Major Discontinuities

and appropriate evaluations and calculations can be made. Figure IV-5-3 shows example structural contours on prominent clay-coated bedding plane partings and faults. For this project, a difference in several degrees of bedding strike had a large influence on calculated stability. Information from many different sources was combined to develop structural contours for each fault and prominent “EP (Engineering Plane) bedding plane”. These planes represented potential sliding surfaces that included multiple bedding planes that aligned across faults. Data available included: preconstruction exploration; construction mapping of the foundation and adits; construction photographs of the foundation; and post construction drilling and borehole geophysics performed in the existing drain holes. EP3 was identified as the critical potential slide plane based on its close proximity to the dam foundation contact, and its extent from fault 1 at the upstream end of the dam down to fault 4 towards the bottom of the abutment. EP3 daylights downstream along with its intersections with several faults on the abutment.

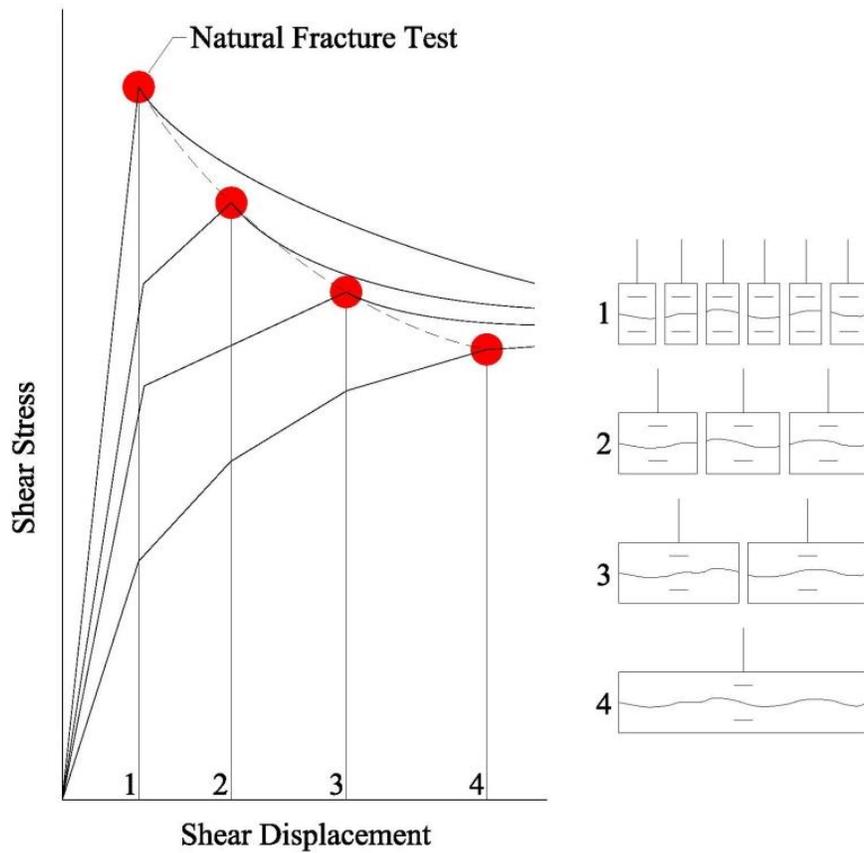
Figure IV-5-4. Scale Effects from Testing Natural Joints (adapted from Bandis et al, 1983)

Bandis et al (1983) performed direct shear tests on samples of natural fractures as shown in Figure IV-5-4. They started by testing a large specimen, then proceeded to cut it into smaller and smaller specimens. On average, the strengths increased as the specimens became smaller. This indicates that the small scale asperities are not mobilized when shearing large scale joints, and testing of small scale rough joint specimens can therefore overpredict the strength. Some have proposed testing saw cuts to overcome this issue and estimate a basic friction angle for a given rock type. However, this leads to more uncertainty as most saw blades can polish the surface smoother than the individual rock grains leading to conservative estimates of the basic friction angle. Attempts to artificially roughen a saw cut surface can result in significant variation and uncertainty as well, and any alteration along the joint surfaces is not taken into account with such an approach. A better approach to determining the basic friction angle seems to include subtracting the specimen dilation by measuring the normal and shear displacement during testing. The slope of the normal displacement vs. shear displacement curve at the point of sliding is the dilatency angle. Figure IV-5-5 shows the relevant plots from a direct shear test.

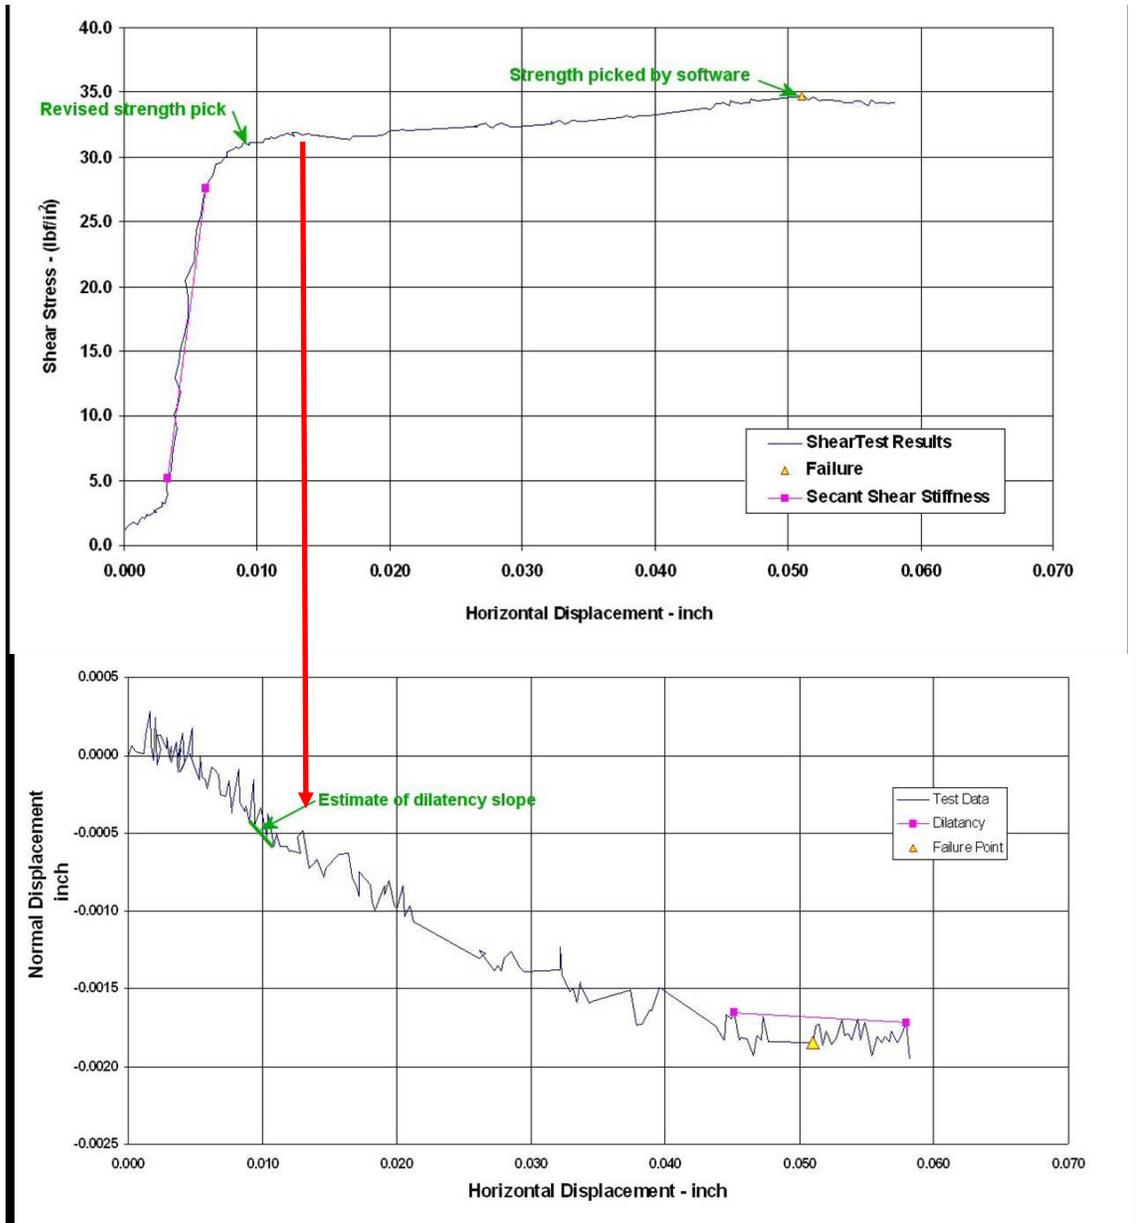
Figure IV-5-5. Direct Shear Test Plots

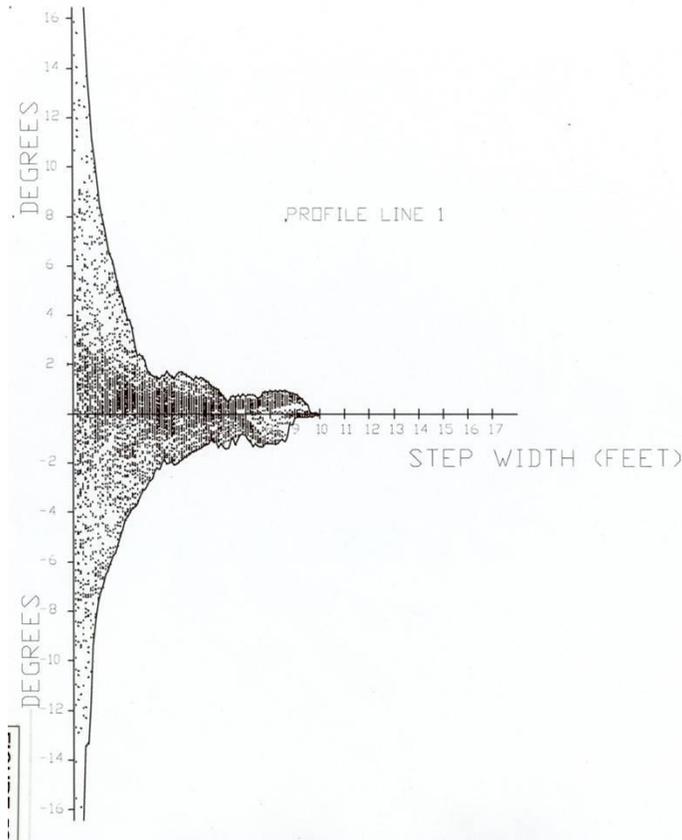
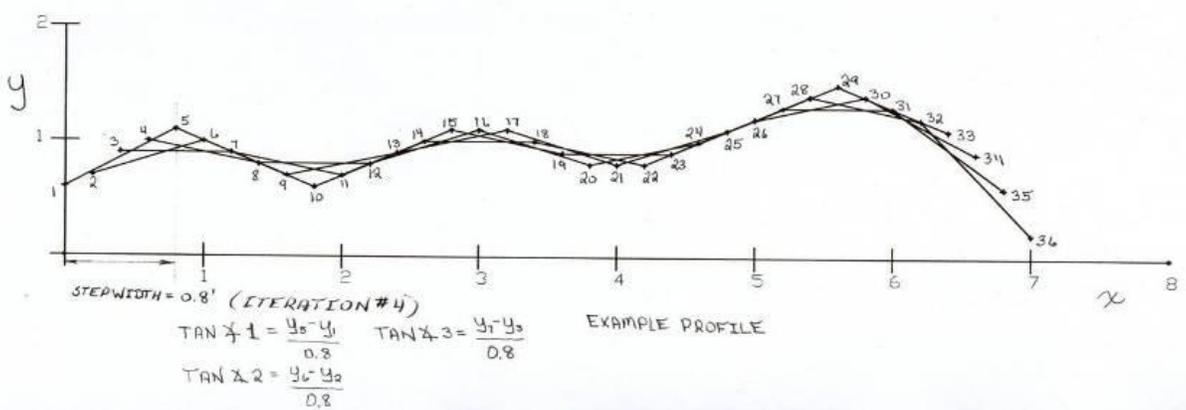
Figure IV-5-6. Waviness Angle Analysis (after Rengers, 1970)

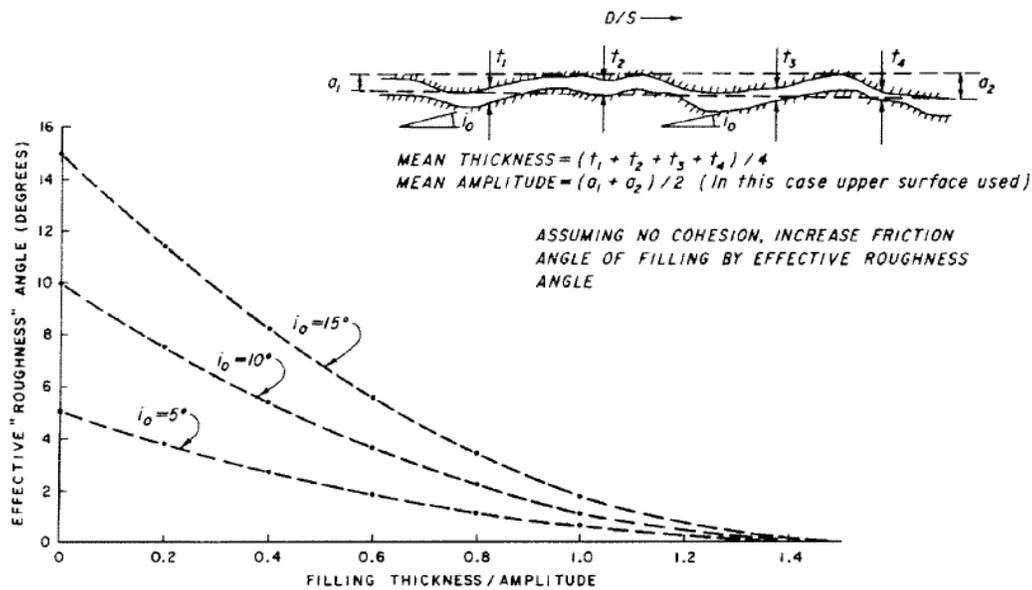
Figure IV-5-7. Effective Waviness Angle for Filled Discontinuities (adapted from Ladanyi and Archambault, 1977)

In some cases a critical sliding plane will be filled with softer infilling material, and the strength of the filling material will have a major effect on its shear strength. It can also affect the roughness or waviness component of the shear strength as the filling material compresses during shearing. To account for this, Ladanyi and Archambault (1977) have proposed some relationships that are plotted in Figure IV-5-7. An effective roughness angle can be estimated based on the ratio of the Filling Thickness/Rock Wall Amplitude. Again, ranges or distributions should be considered when performing probabilistic analyses.

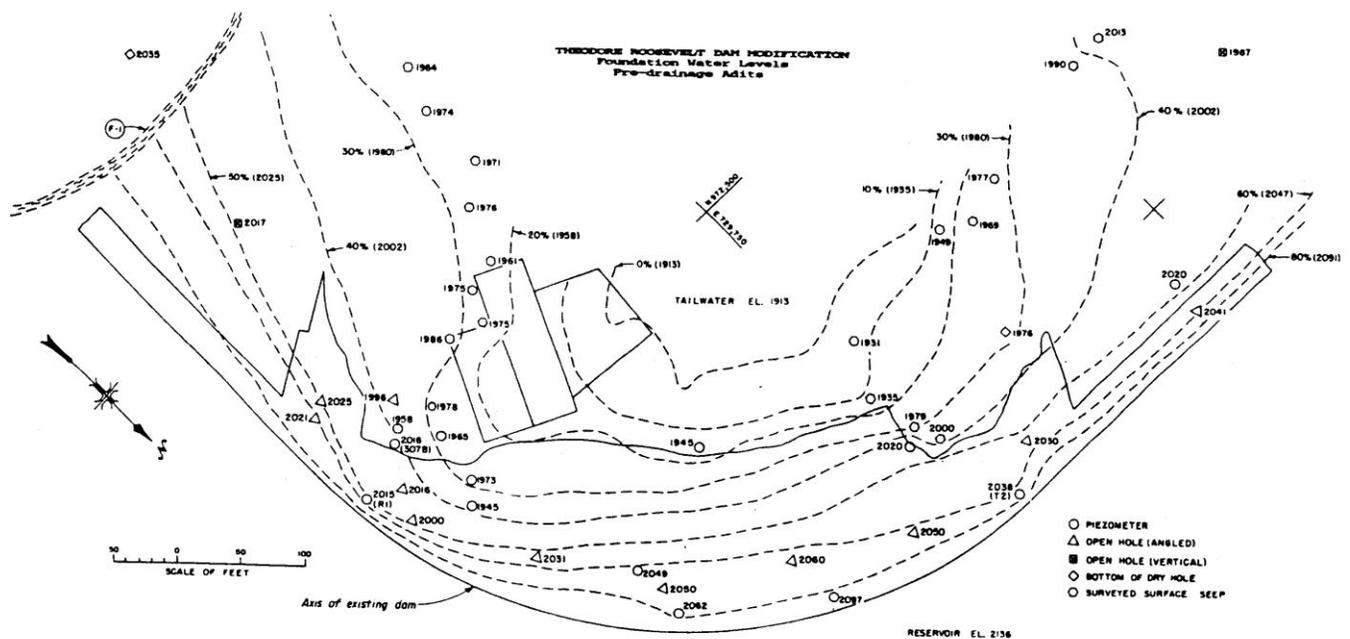
Figure IV-5-8. Foundation Water Pressure Contour Map

Despite the advancements in seepage modeling that are available, experience suggests that it is difficult to model flow through jointed rock and accurately predict foundation water pressures. Therefore, typically foundation pressures are measured at key points using piezometers installed in areas of water conduits. If enough piezometers are installed, water pressure contour maps can be generated as shown in Figure IV-5-8.

The water pressure contour map, and structural contour map of the foundation wedge planes can be used to estimate water pressures and total water force acting normal to the planes. Sufficient piezometer data may not be available, in which case interpretations of the groundwater contours and elevations may need to be predicted or inferred based on modeling or rules-of-thumb. The intersection of the phreatic surface with the wedge planes must be determined unless the wedge planes are fully submerged. Then, using the water pressure contours, the plane is divided into areas across which the variation in water pressure is generally uniform. The pressures at each corner of these areas are calculated by subtracting the elevation of the point on the plane from the elevation of the water pressure contour directly above it. The average pressure multiplied by the area gives a force, and the summation of all such forces gives a total force on the plane.

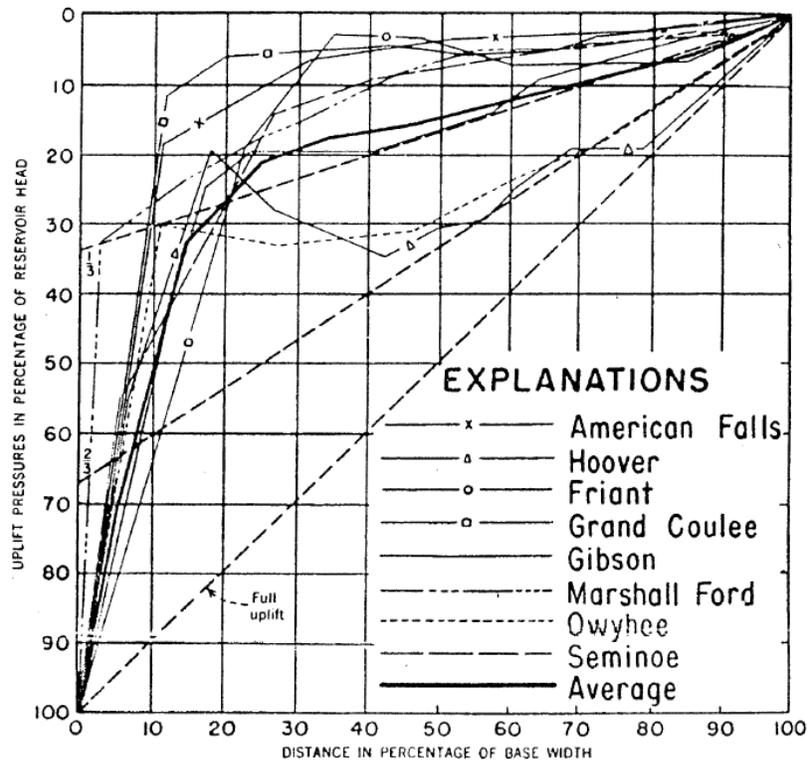
Figure IV-5-9. Uplift Measurements at Concrete Dams

A line of drains is typically installed as a defensive measure in a concrete dam foundation. If functioning, the drains can dramatically reduce the foundation water pressures, which would be reflected in the water pressure contours. Measurements just below the foundation contact of several large concrete dams show that the pressures downstream of a line of functioning drains are greatly reduced by the drainage, as shown in Figure IV-5-9. It can be noted that the original measurements made at Hoover Dam and Owyhee Dam did not show as much pressure reduction. However, additional deeper drains were drilled and the pressures were brought down. In that regard, it is necessary that the drains penetrate the major zone of seepage. Typically drains at about 40 percent of the hydraulic height into the foundation are adequate for this purpose. Shallower drains can also be effective if the major zone of seepage is more shallow, but it may be necessary to measure foundation pressures at depth to verify this. It is important to clean and maintain the drains in operating conditions for an adequate defensive measure.

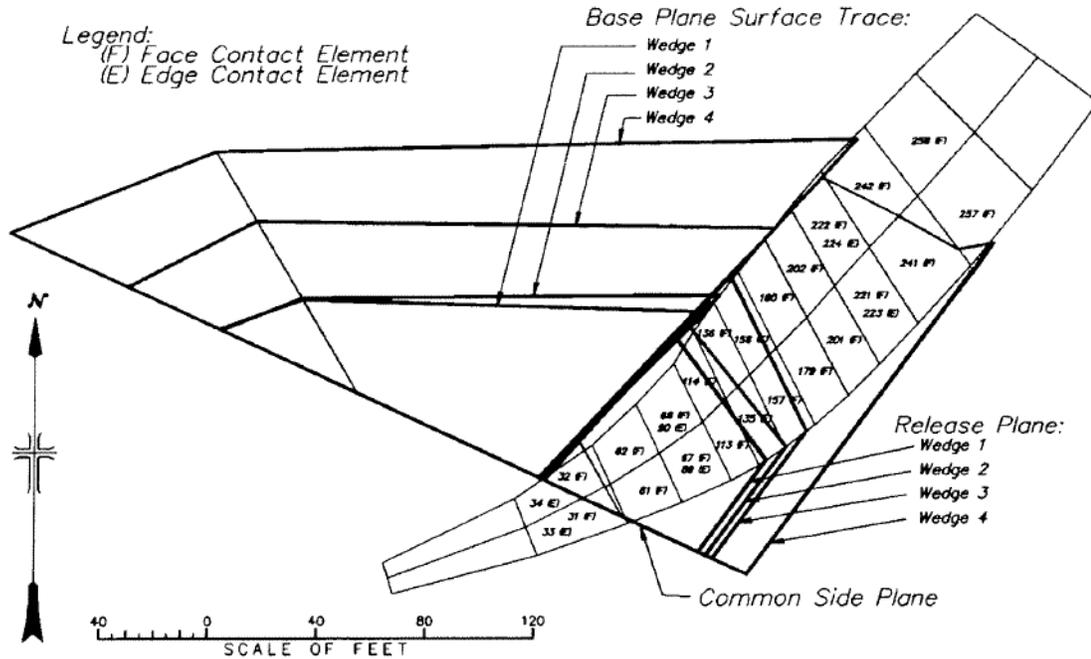
Figure IV-5-10. Finite Element Mesh Superimposed on Nested Foundation Wedges

forces from elements contacting the wedge, as shown in Figure IV-5-10, are used to estimate the external loading. Forces can be time-varying for seismic analyses.

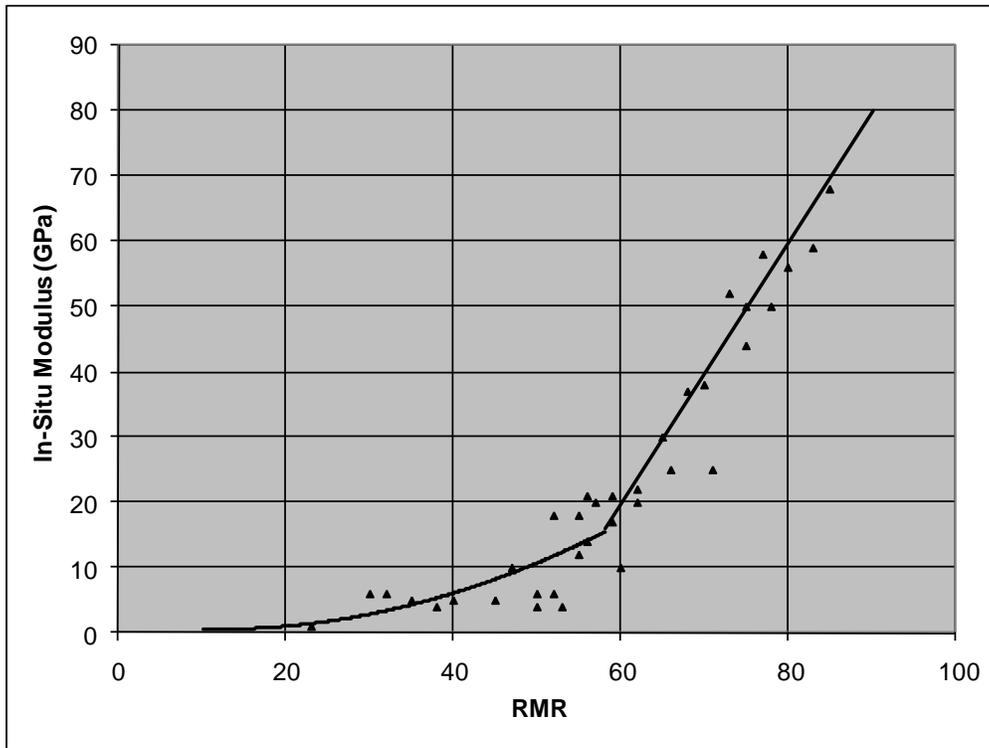
Figure IV-5-11. Correlation between Rock Mass Modulus and RMR (adapted from Bieniawski, 1989)

The easiest way to estimate rock mass modulus for a concrete dam foundation involves the use of empirical correlations developed from large scale in-situ jacking test results and rock mechanics index properties. One such relationship is shown in Figure IV-5-11, which correlates in situ modulus with Rock Mass Rating (RMR) developed by Bieniawski. RMR is a rock mass quality index that rates the rock mass according to (1) the intact rock strength (typically from lab testing or point load testing), (2) rock quality designation (RQD), (3) joint spacing, and (4) the condition of the joints (continuity,

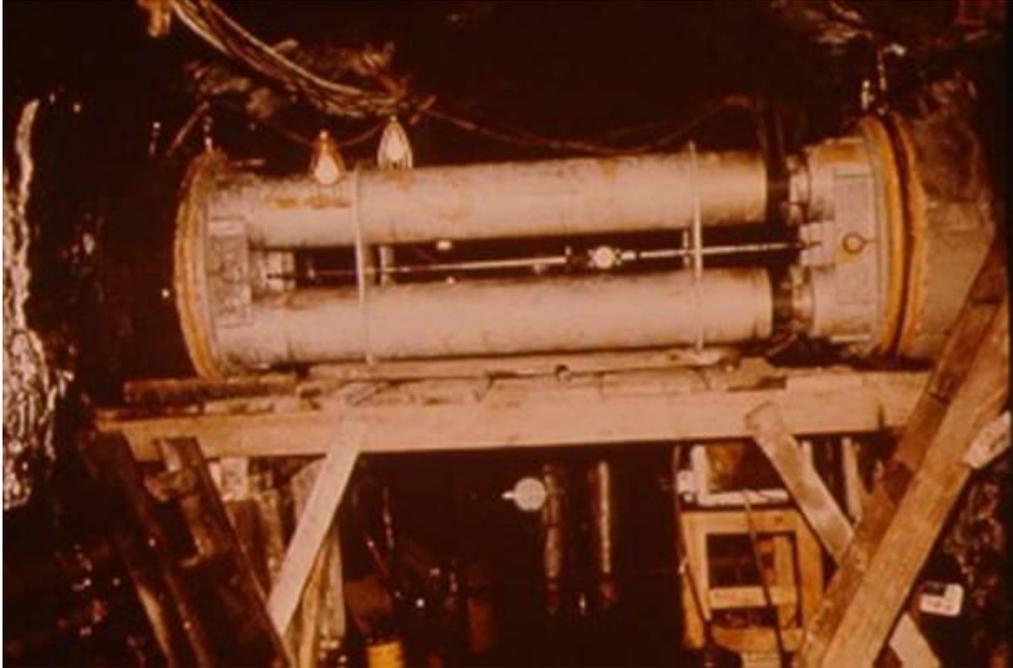
Figure IV-5-12. In Situ Uniaxial Jacking Test Setup

The most direct way to estimate foundation rock mass modulus is to measure it using large scale jacking tests, such as that shown in Figure IV-5-12. Loading is applied to the rock mass through large jacks or flat jacks, typically across an excavated tunnel or adit, and the deformation of the rock mass is measured at the rock surface and at depth beneath the loaded surface using multiple position borehole extensometer. The load and

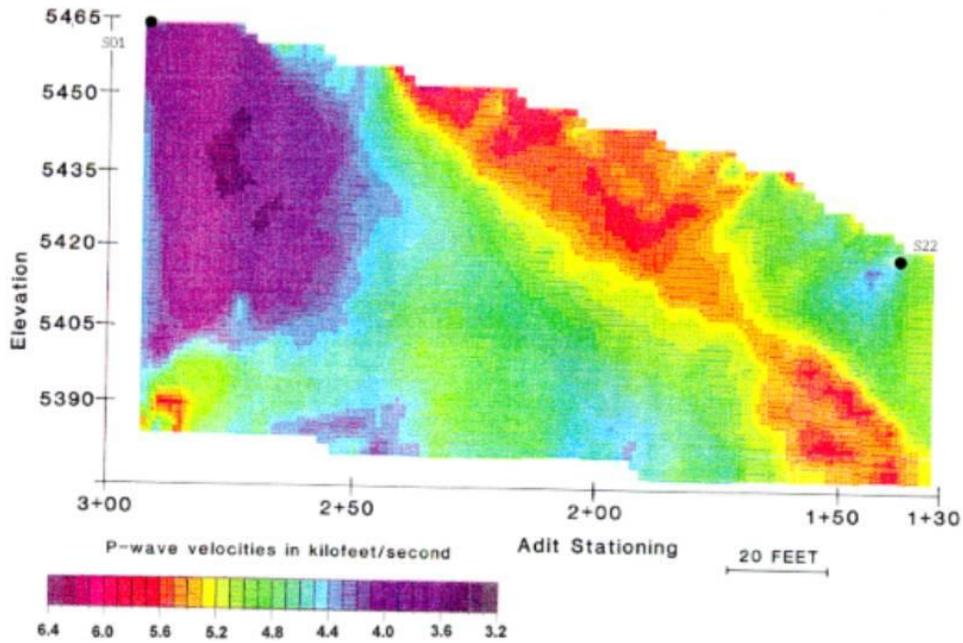
Figure A3. Seismic Velocity Tomogram Developed between Ground Surface and Adit.
 Note: 1000 ft/s = 305 m/s.

Figure IV-5-13. Seismic Tomograph developed between Adit and Ground Surface

Even though such a jacking test measures a relatively large volume of rock, it is small compared to the volume of a dam foundation. Therefore, a means of relating the jacking test results to the varying geologic conditions within the dam foundation must be established. One such method is seismic tomography. P-wave and/or S-wave velocities are measured over multiple overlapping ray paths between a series of source and receiver locations. The tomographic reconstruction process then gives a picture of the variation in velocity throughout the tested section, similar to a CaT scan. Figure IV-5-13 shows a P-wave tomography developed for a dam abutment. Receivers were placed in the roof of an exploratory adit, and sources were set off along a line on the abutment (ray paths between sources and receivers can also be developed between boreholes). As can be seen, there are zones of relatively large velocity contrast that may be important to the structural response and foundation loading.

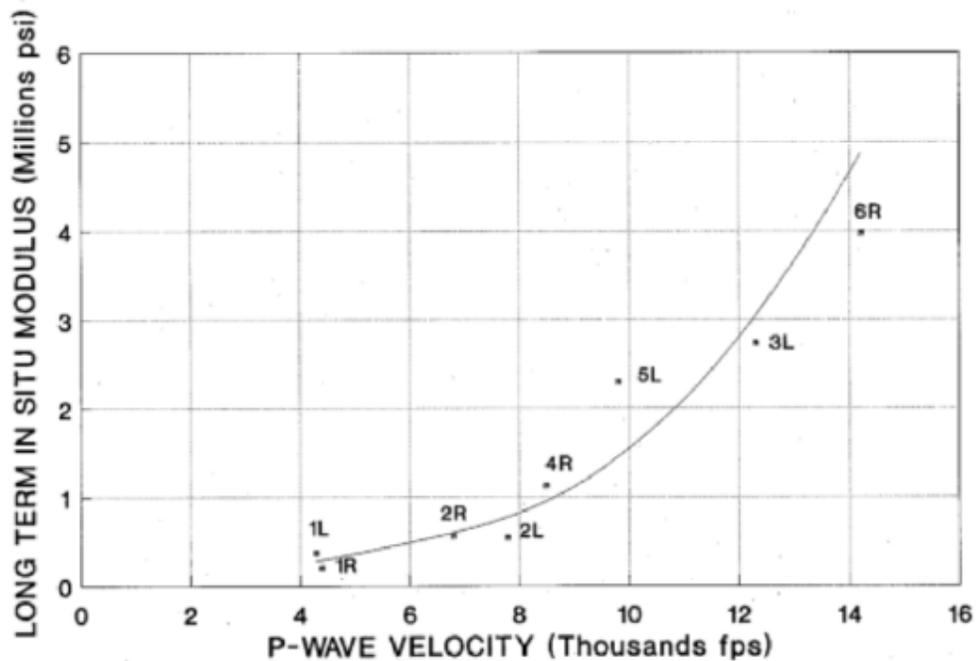
Figure IV-5-14. Correlation of P-wave Velocity with In Situ Modulus

A number of in-situ jacking tests were performed in the exploratory adit to correlate the P-wave velocities with modulus. The correlation was quite good, as shown in Figure IV-5-14. Using this relationship, modulus values could be assigned to various velocity zones within the foundation, based on the seismic tomograms.

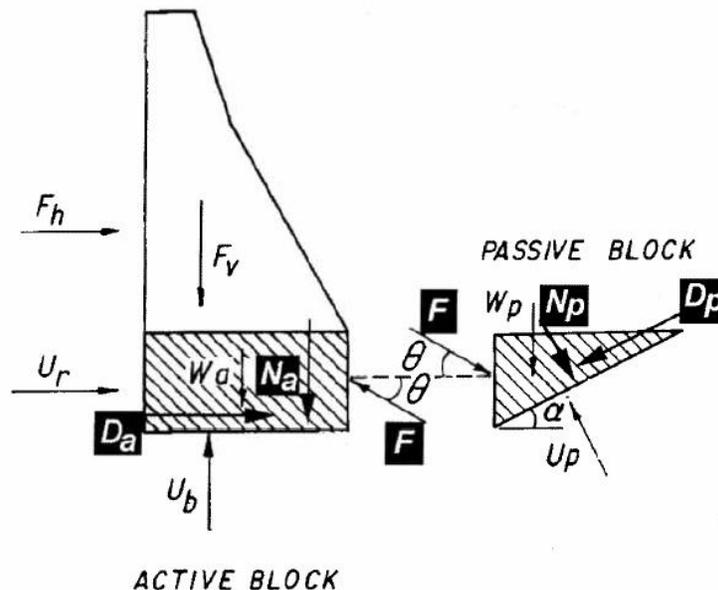
Figure IV-5-15. Typical Two Wedge Sliding Analysis

Figure IV-4-15 shows a two-wedge sliding analysis typically performed for concrete gravity dams, especially when founded on horizontally bedded sedimentary rock. The traditional 2-D analysis usually involves a passive wedge downstream of the dam. Although this type of analysis can be found in many guidance documents, it can be misused. For one thing, unless the passive wedge is very thin, the intact rock material is very weak, or there is an adversely oriented discontinuity or joint set passing through the passive wedge, it is unlikely that shearing will occur through the passive rock mass. In addition, in order for the passive wedge to move, shearing must occur along the boundary between the active and passive wedge. Unless there is a near vertical joint or discontinuity in this location, this may be unlikely. Finally, the calculated factor of safety is typically sensitive to the inclination angle assumed for the interwedge force, F . At the limit of equilibrium this should approach the friction angle of the interwedge plane. It is usually taken as horizontal which may be conservative in many cases.

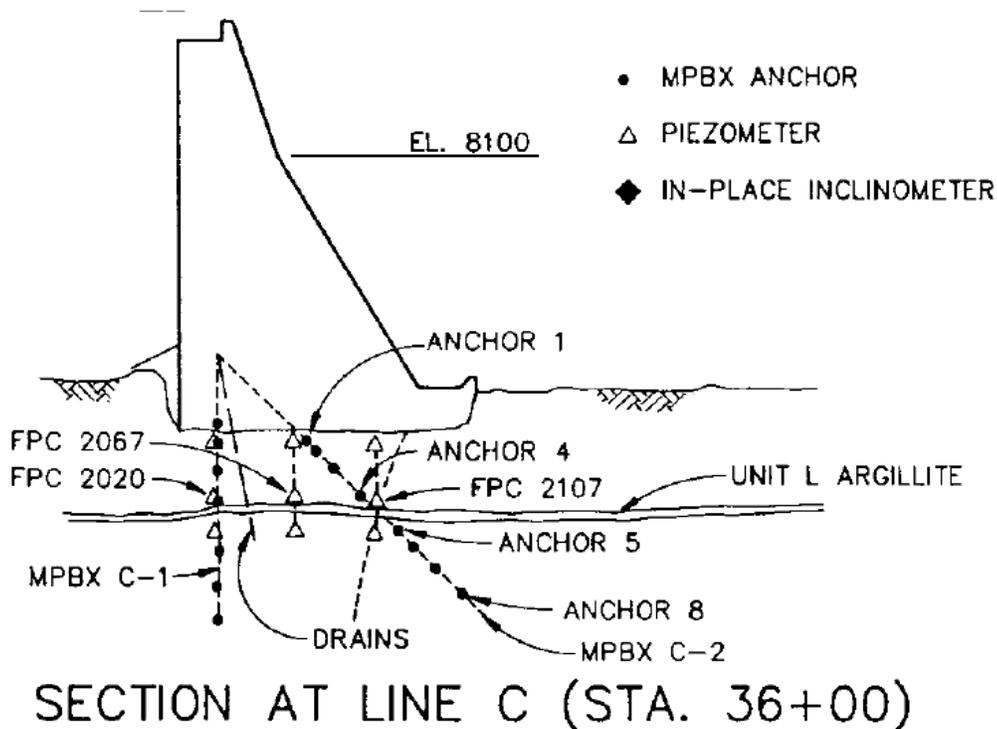
Figure IV-5-16. Instrumentation and Geologic Section

Some deformation is typically needed to mobilize the passive wedge. If there are deformable discontinuities in the rock mass downstream, that deformation may lead to cracking of the concrete. Consider the roller-compacted concrete (RCC) gravity dam shown in Figure IV-5-16. The dam is founded on a Cambrian quartzose sandstone foundation. In the abutments and beneath the main dam, interbeds of gray argillite, a lower strength material in between shale and slate, are present. Figure IV-5-16 shows a typical instrumentation layout at Line C in the spillway area. Note that there is a weak layer, the Unit L argillite, within the otherwise hard quartzose sandstone. A passive wedge is present downstream of the dam above the Unit L layer. Of note are the vertical and angled MPBX's passing from the gallery through the dam and into the foundation, with anchors above and below the Unit L layer. Piezometers are also installed above and below the Unit L layer, and upstream and downstream of the line of drains. Not shown are the vertical inclinometers passing through the dam and into the foundation through the Unit L layer at sections outside the spillway.

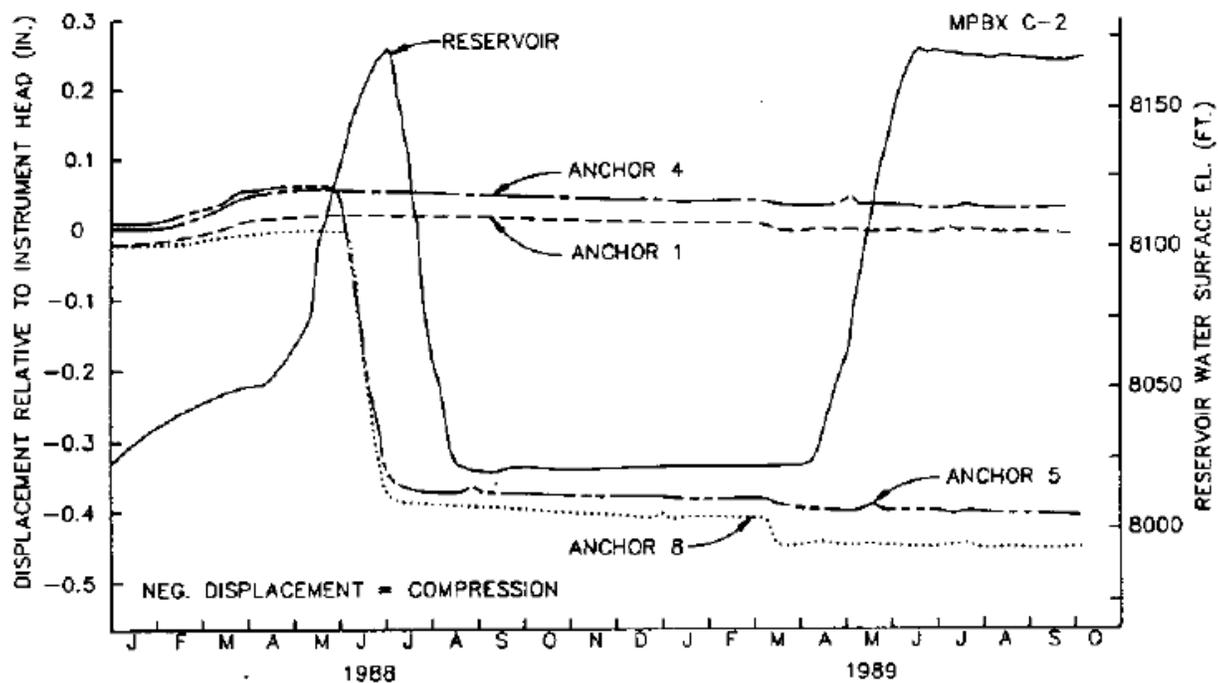
Figure IV-5-17. Angled MPBX Response

Figure IV-5-17 shows the response of the angled MBPX at line C during the first reservoir filling. As the reservoir went up, the anchors below the Unit L argillite layer began to deviate while those above did not. This meant that there was relative movement between the lower anchors and the anchor head, but not between the upper anchors and the anchor head. This suggested that the wedge above the Unit L was moving with respect to the rock below the Unit L. In addition, an inclinometer at a nearby location showed a distinct offset in its profile across the Unit L argillite layer. The piezometers showed relatively high pressures in the upstream and middle area of the foundation.

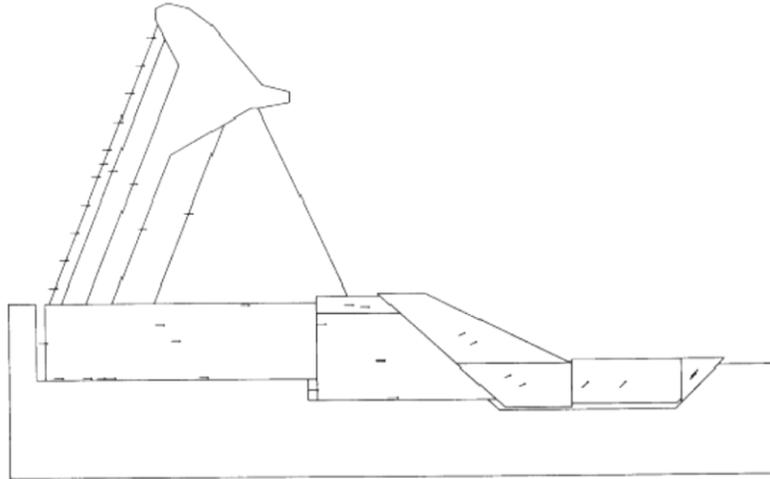
Figure IV-5-18. DDA Analysis of Multi-Wedge System

A better approach to performing analysis of multi-wedge systems is to use a distinct element code such as Universal Distinct Element Code (UDEC) or a Discontinuous Deformation Analysis code (DDA), as shown in Figure IV-5-18. This type of analysis accounts for the interwedge forces and angles more appropriately. But again, the failure planes must be realistically possible.

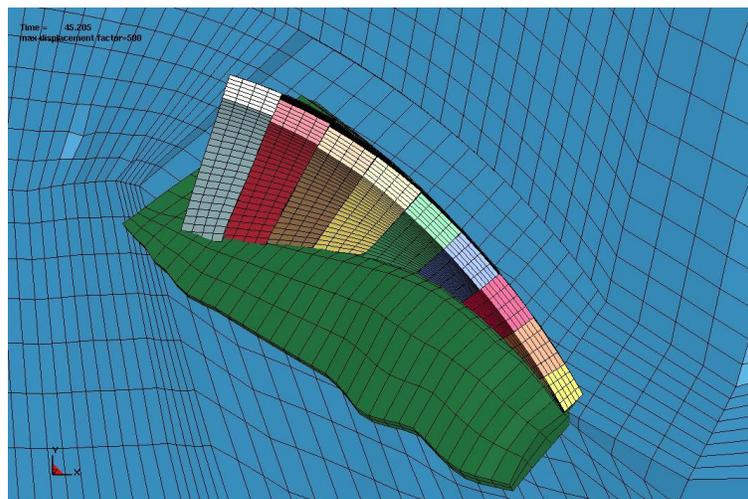
An uncoupled evaluation of foundation wedges with external dam loading is typically performed using stereographic vector analysis or rigid block analysis techniques. If these types of analyses indicate high risks, or large dynamic foundation wedge displacements, it may be useful to perform a nonlinear coupled analysis whereby the dam and foundation wedge are included in the same model, as shown in Figure IV-5-19. This allows for stress redistribution and allows interaction between the dam and foundation. In addition, if the dam is very thick and it is thought that the potential for foundation wedge movement might be controlled by contraction joints within the dam, this type of analysis can be helpful in demonstrating this type of behavior. However, these types of analyses are complicated, time consuming and expensive, and mistakes in model development can be made. Therefore, it is essential to thoroughly test the model to make sure it is performing correctly and giving reasonable results.

Figure IV-5-19. Nonlinear Coupled Dam-Foundation Analysis

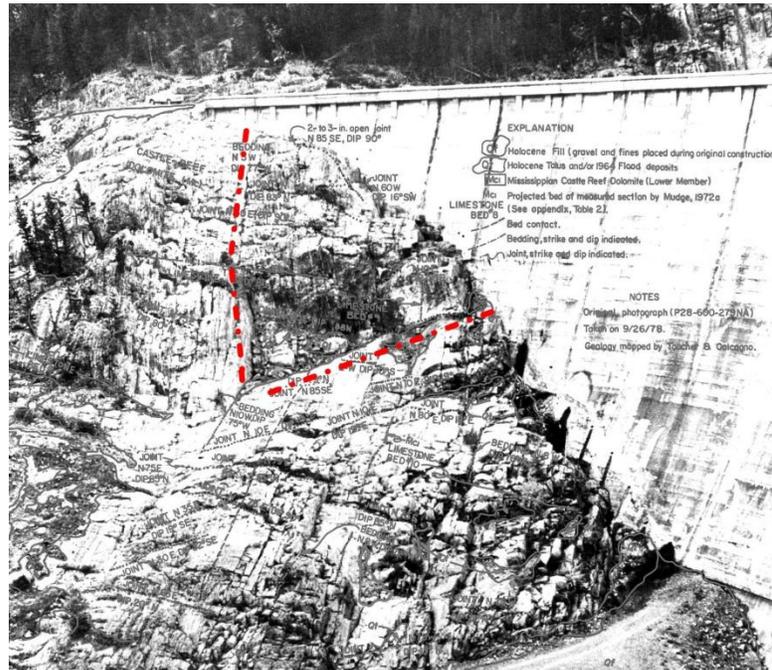
Figure IV-5-20. Photo Showing Right Abutment Wedge

- A large potentially unstable foundation wedge is well defined (*see Figure IV-V-20*). *Geologic mapping of the hard dolomitic limestone in the downstream right abutment shows a continuous high angle bedding plane parting angled toward the channel from upstream to downstream forming a continuous side plane boundary. A continuous low angle joint can be observed in the downstream abutment, and construction photos indicate it traverses completely across the dam foundation forming the wedge base plane. Continuous high angle joints were mapped in the upstream reservoir area, capable of forming back release surfaces for the wedge.*

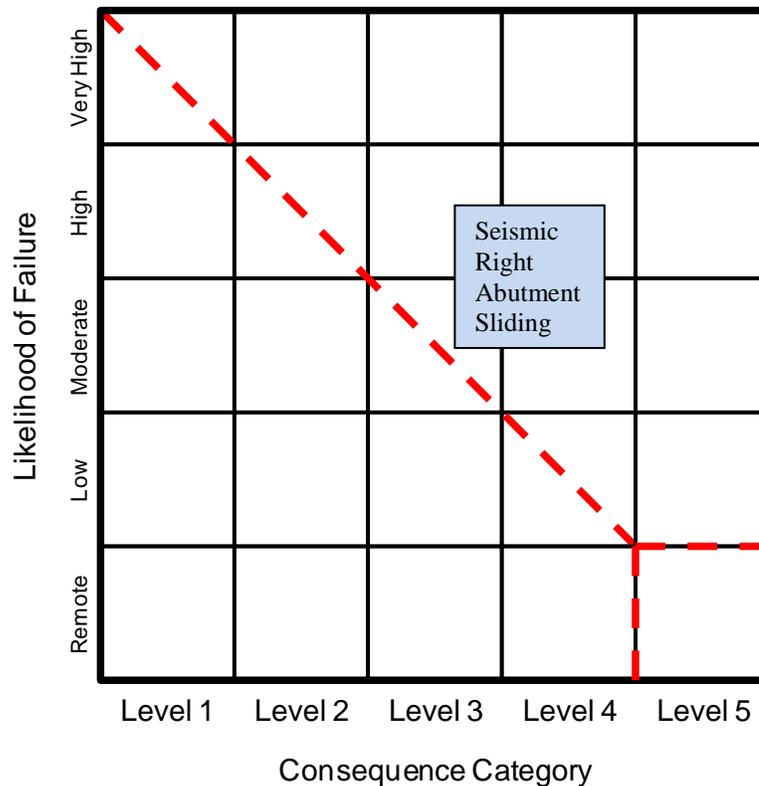
Figure IV-5-21. Risk Matrix

This semi-quantitative evaluation plots on the risk matrix as shown in Figure IV-5-21. Based on the fact that the risks plot with high confidence in an area on the matrix where they may justify action, a quantitative analysis of risk for this potential failure mode can be justified. Given the detailed description of the potential failure mode, an event tree can be constructed as shown in Figure IV-5-22. Only one seismic load branch (1/10,000 to 1/25,000 annual exceedance probability) is constructed all the way through the event tree for illustration purposes. The conditional failure probability branches following the load branch must be duplicated for all load ranges above the threshold load value. The probability of failure is dependent on not only the earthquake loading level, but also the reservoir level at the time the earthquake hits. If several reservoir and earthquake levels were represented in the tree, it would be extremely large. To simplify the evaluation, only one reservoir load range was included, chosen to represent loadings which were significant to the abutment wedge and at levels that would produce significant consequences if failure occurred. The event tree was developed after a credible foundation wedge had been defined based on a detailed evaluation, and the primary geologic uncertainty is the joint continuity. Uncertainties related to joint orientation, strength, and water forces for a given uplift condition do not necessarily follow linearly, are interrelated, and all affect the stability. These were handled in external kinematic stability analyses as discussed below.

Comparing Figure IV-5-24 with Figure IV-5-21 indicates that the risks are estimated to be slightly lower from the detailed quantitative risk analysis in comparison to the semi-quantitative screening. Although the consequences category was a reasonable reflection of the detailed evaluation, the likelihood category was about half an order of magnitude higher than the quantitative estimates.

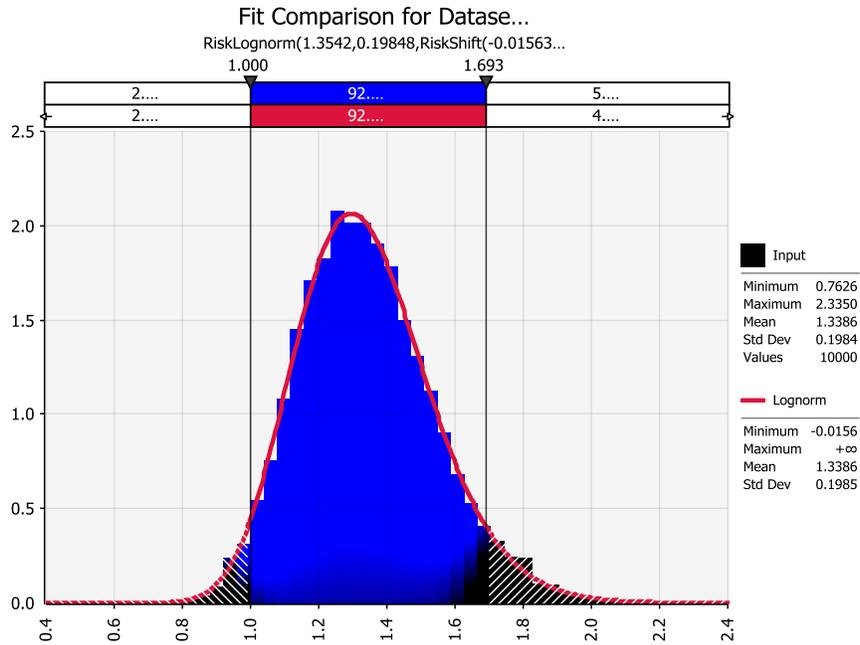
Figure IV-5-23. Output from Monte Carlo Simulation (horizontal axis is factor of safety)

The weight of the wedge was varied in the analysis using a uniform distribution (equally likely between lower and upper input values) considering reasonable variations in unit weight and wedge volume. The water forces are also uncertain, but for post-earthquake conditions it was assumed the joints opened sufficiently to generate full hydrostatic loading on the back release joint, varying linearly to the “daylight” trace of the side and base plane joints downstream. The post-earthquake thrust from the arch dam, although uncertain, was taken as constant for a high reservoir elevation, based on finite element structural analyses simulating post-earthquake conditions to the extent possible. The results of 10,000 iterations in terms of sliding factor of safety are shown in Figure IV-5-23. As can be seen, approximately 2.9 percent of the calculated factors of safety were less than 1.0 (i.e. probability of $FS < 1.0 = 0.029$).

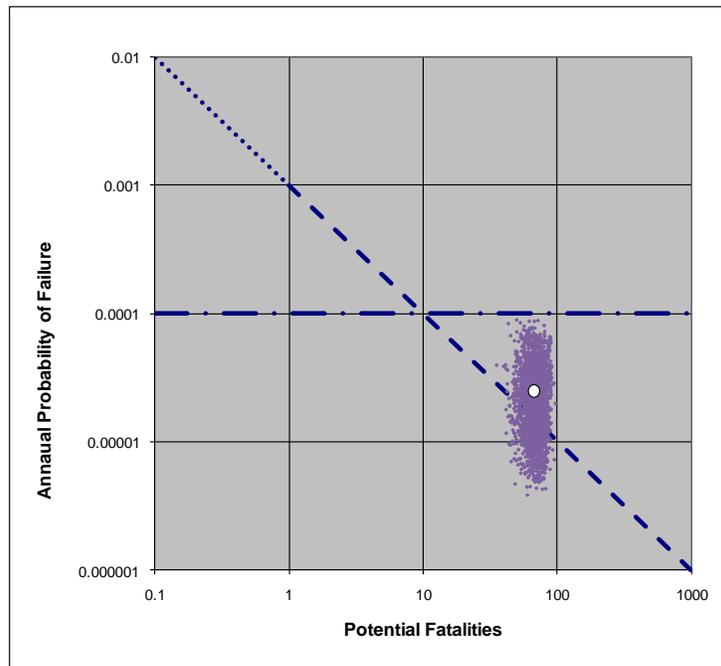
Monte-Carlo simulation results developed from the event tree shown in Figure IV-5-22 are depicted in the scatter-plot shown in Figure IV-5-24, where each point represents a single combination of possible values chosen from each variable's probability distribution. The mean (shown by the large open circle) represents the 'expected value' of the risk estimates (where the weighted consequences are typically calculated as the annualized life loss divided by the annualized failure probability). The outlying points represent situations where more extreme values are chosen from each variable's probability distribution. The likelihood of and extent to which the variation in results exceed the risk guidelines (in this case Reclamation's guidelines shown) can be an important input to the decision process.

Figure IV-5-24. Scatter Plot from Event Tree Monte-Carlo Analysis
