# Risk Assessments for Gates Other Than Radial Gates

Best Practices in Dam and Levee Safety Risk Analyses

Chapter G-2

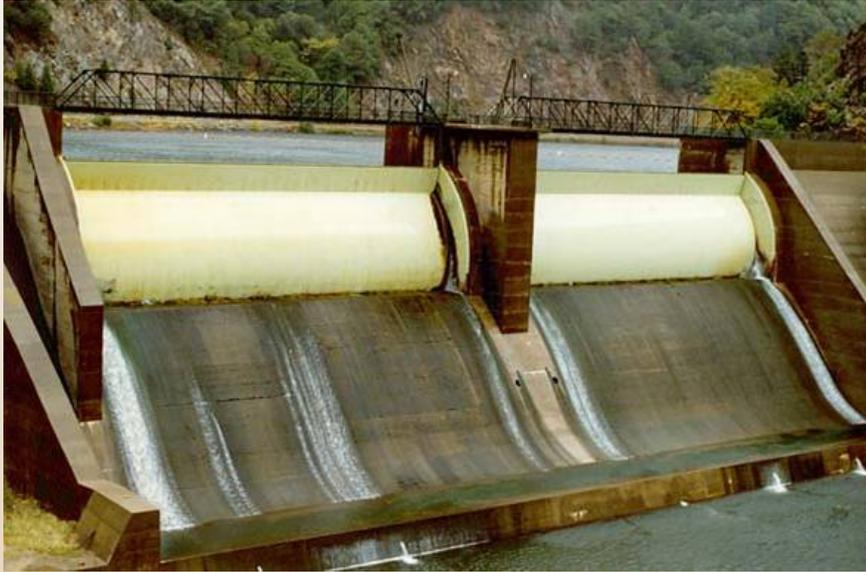
# Cresta Dam (PG&E) Drum Gate Incident

- Dam is in Feather River Canyon, CA.
- Owned/operated by PG&E for generation of electric power.
- Two 28-ft diameter by 124-ft long drum gates.
- Summer mid-afternoon in 1997.
- Left side drum gate dropped uncontrollably
- EAP initiated due to dropping reservoir/rising tailwater alarm
- 20-30 minutes to drop completely
- D/S water level rose from 1.6' to 15' in 40 min.
- Maximum downstream discharge ~ 15,100 cfs
- No fatalities

- Failure of drum gate drain line prevented removal of water from inside of gate
- Allowed water into gate through faulty check valve ultimately resulting in the forces acting to lower the gate overcoming the forces acting to raise the gate
- Exacerbating Conditions:
  - Excessive seal leakage
  - Impaired inlet capacity

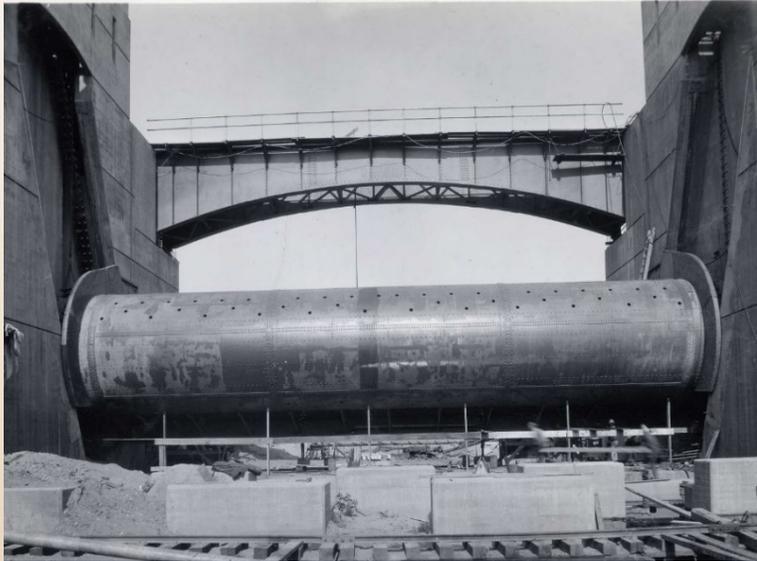
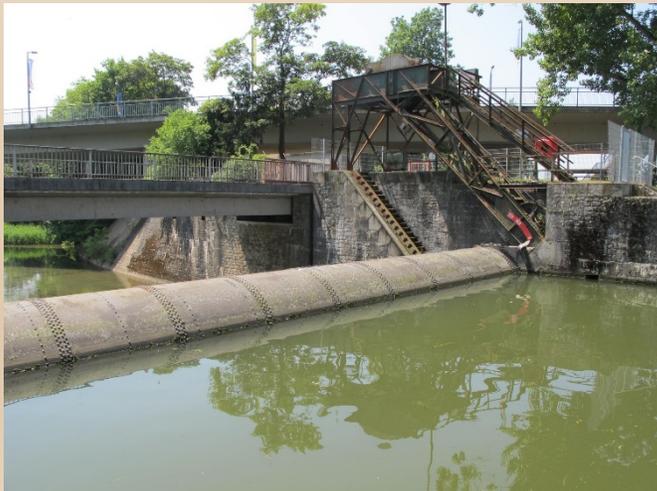
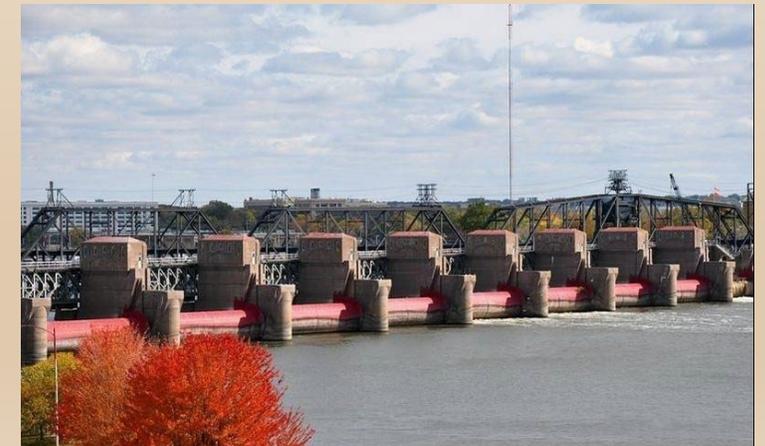
# ROLLER GATES

- Simply supported, but internally redundant structures
- Used in older, lower head navigation locks with wide pier to pier distance.
- Steel cylinder, usually riveted.
- Despite no ice loading or seismic considerations in design, these gates have a long history of robust performance on the Mississippi River for low head structures
- Hoisted by chains from one end only – simplifying O&M
- Used to pass ice over the top.
- Significant vibration during lowering of gate has changed operation of dam at certain locations.
- Fatigue cracking has been seen at end frames and at welded details used for repairs or strengthening.

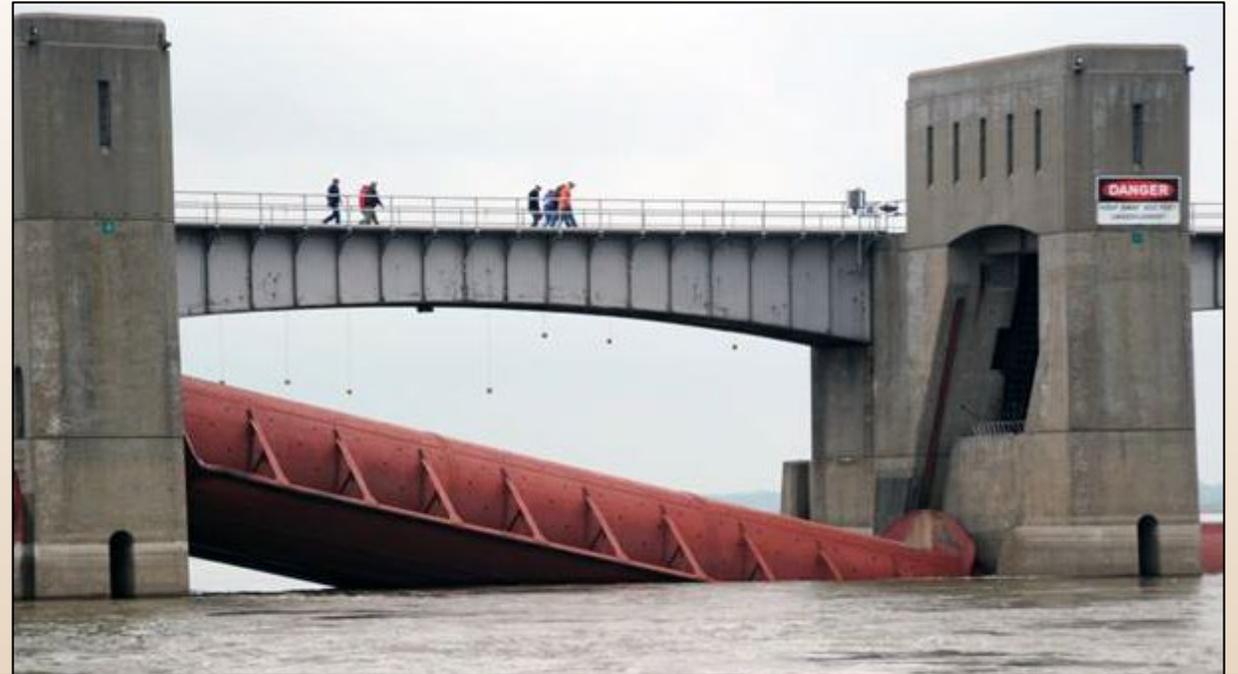
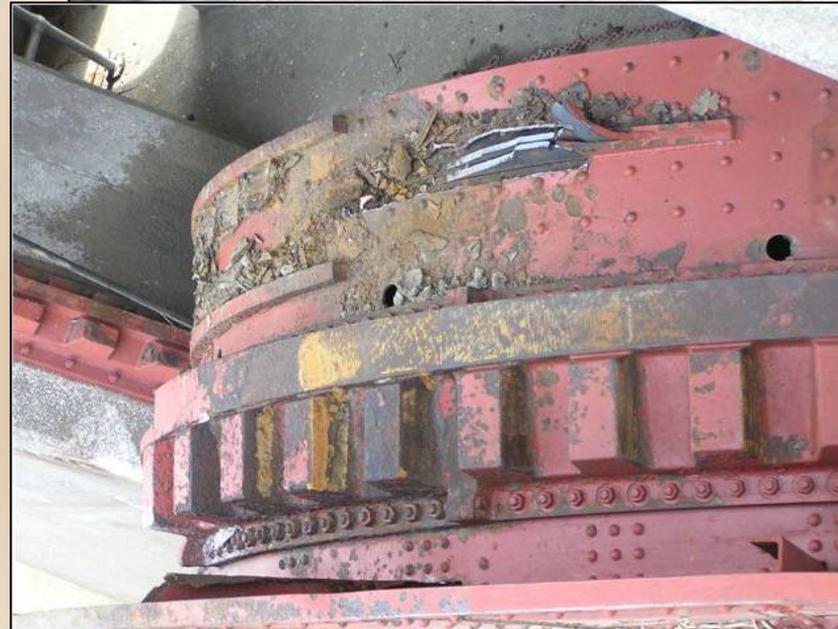
- L&D 25 on the Mississippi River
- April 2010
- Failure of a limit switch that resulted in a roller gate over traveling and coming off the rack.
- The hoist chain failed, the gate fell and became racked.
- The operator, after starting gate movement, walked away and went to operate another gate.
- If the operator had not walked away they would have been able to notice that the gate had over traveled before it came off the rack
- USACE Operations removed the damaged gate and completed repairs.

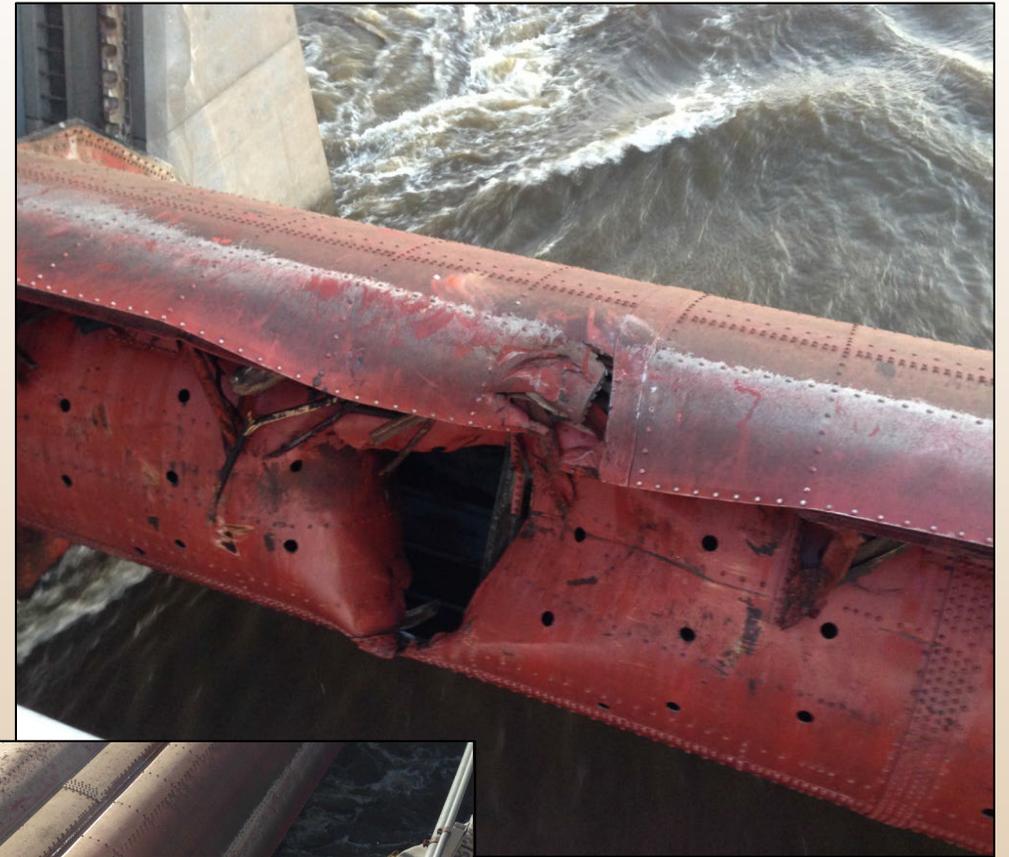
- There have been numerous barge collisions with the roller gates on L&D #3 on Mississippi River
- None have resulted in a loss of pool.
- Concrete-filled barge that impacted Gate 5 on L&D #14 on Mississippi River, July 2014
- Pool was not lost, and gate alignment was not compromised.
- Repairs completed by USACE Operations personnel

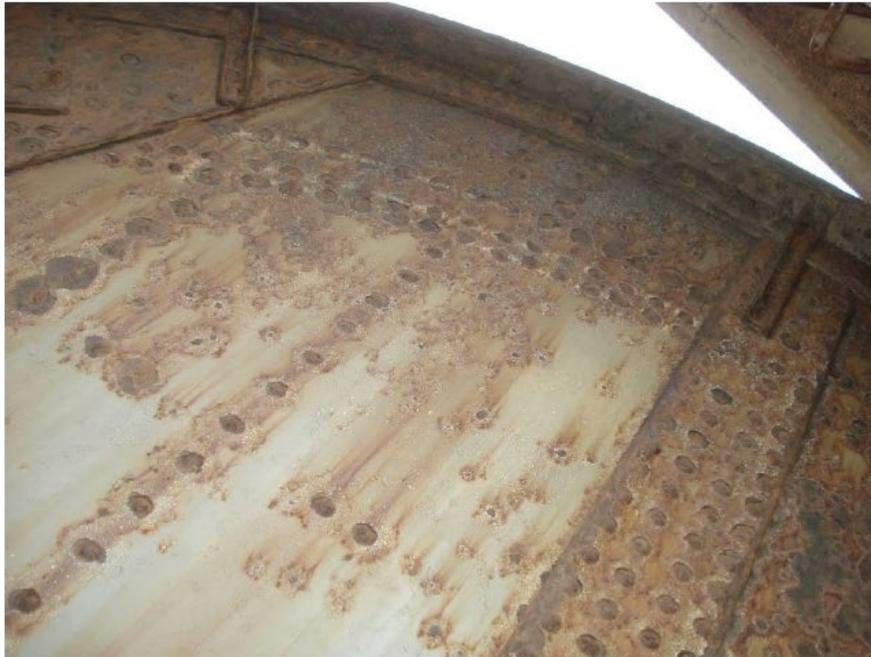
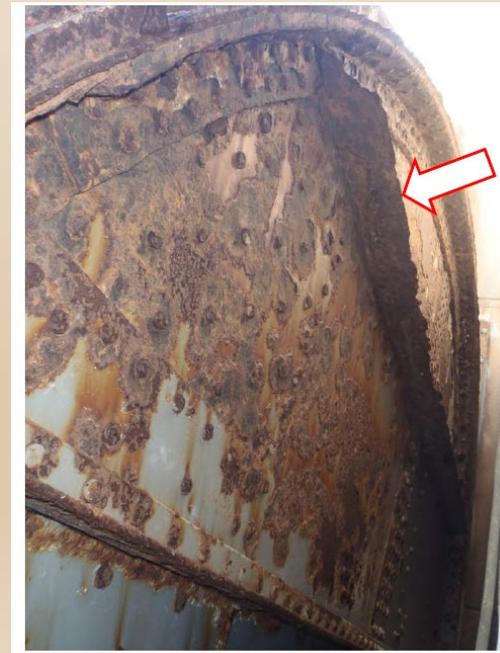
- Corrosion leading to advanced section loss to main load carrying members plus total loss of many rivet heads could lead to sudden catastrophic failure of gate
- Photos from Winfield L&D

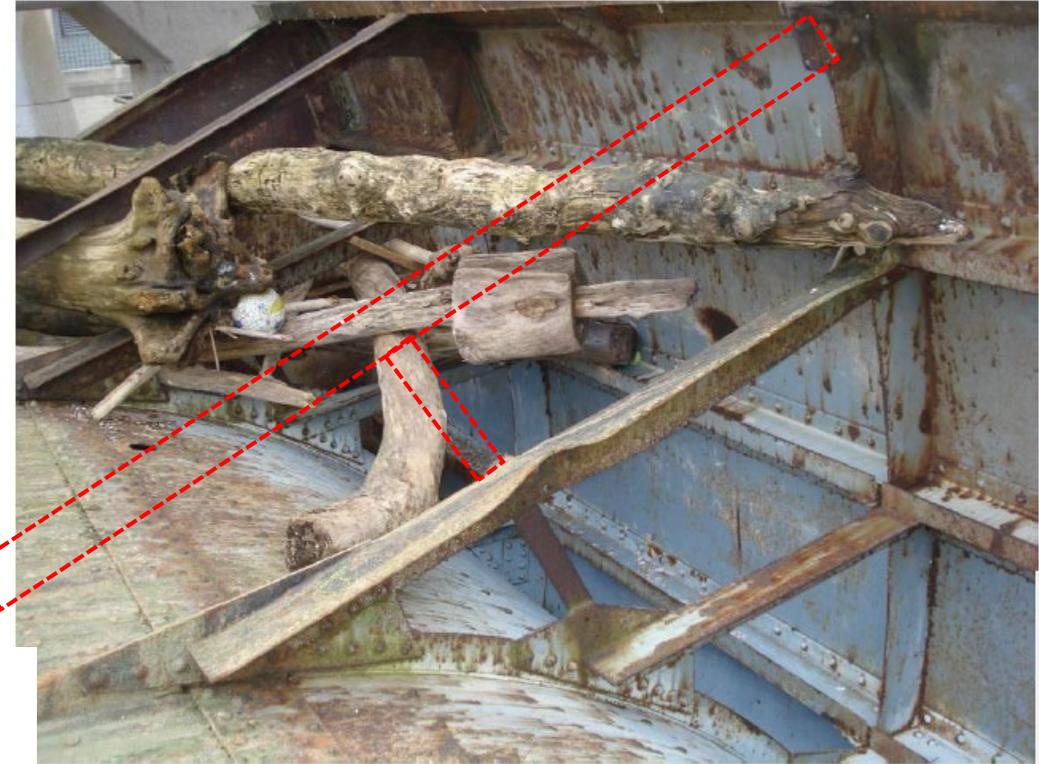
- Damage from debris to apron bracing could lead to collapse of apron and loss of pool – note missing bracing
- Damage to end shields allows debris to foul hoist; gate jams
- Photos from Winfield L&D

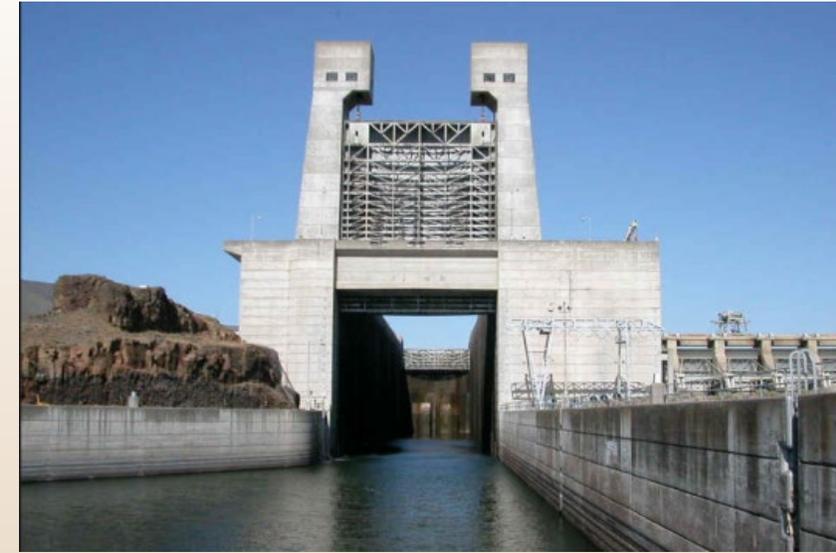
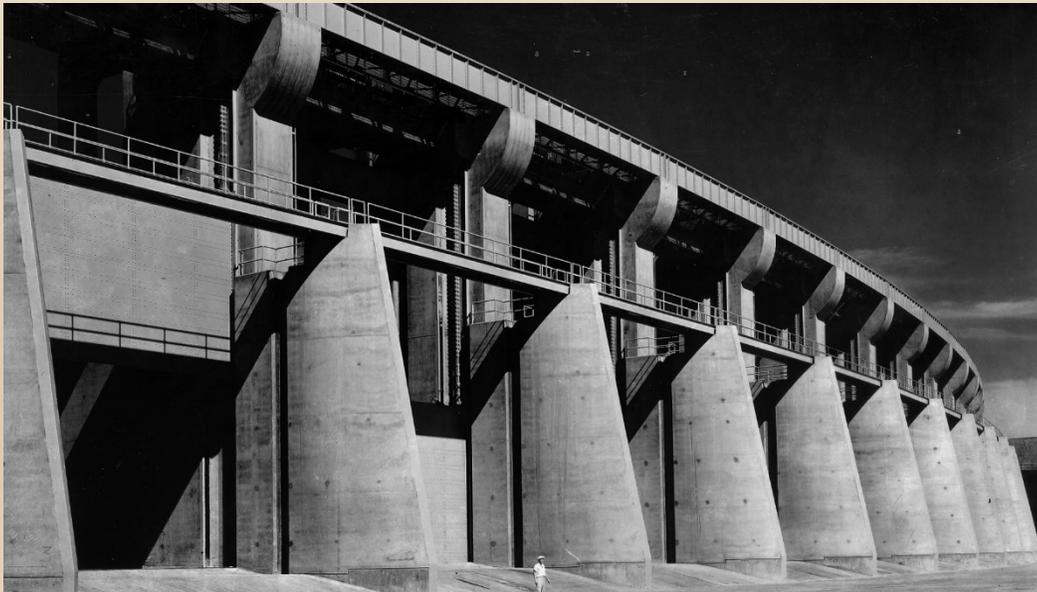
# Vertical Lift Gates

- Used both in Navigation and FRM dams.
- For Navigation dams, used in lock chamber and as part of the moveable dam.
- Slide gates or fixed-wheel gates not as susceptible to failure – more robust and loaded in bending (ductile behavior)
- But may have massive hoist house and counter weights that should be evaluated under seismic loading

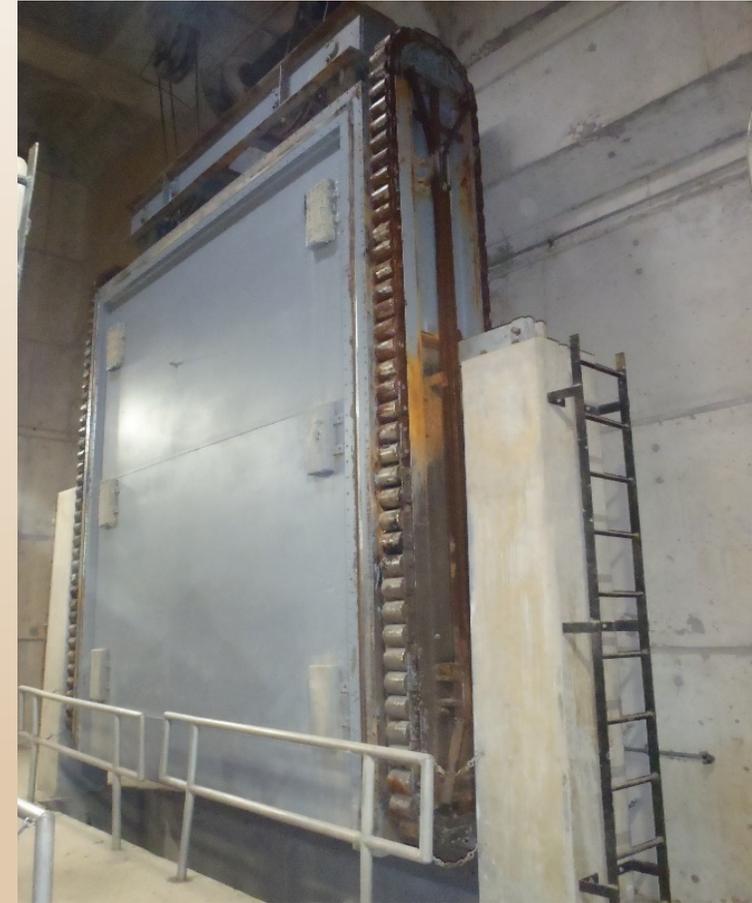
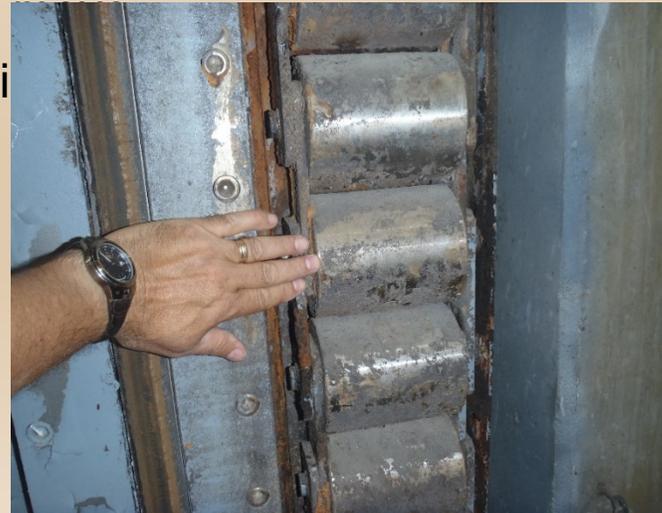
# Vertical Lift “Tractor” or “Caterpillar” Gates

- Tractor/Caterpillar Gates are roller-mounted vertical lift gates supported along either side by a continuous series of stainless or carbon steel rollers.
- Otherwise, their construction and function is very similar to that of Wheeled Vertical Lift Gates.
- Serve functionally as service gates, spillway gates, emergency gates and powerhouse closure gates
- Caterpillar Gates are sometimes called Coaster or Tractor gates.
- There are historical problems with the design, leading to decreased reliability.
  - 1. Roller pins or links break, causing chain to separate.
  - 2. Rollers or links corrode and chain does not
  - 3. No way to grease or lubricate chain roller pi
- Found in FRM dams.
- Approximately 288 in USACE inventory

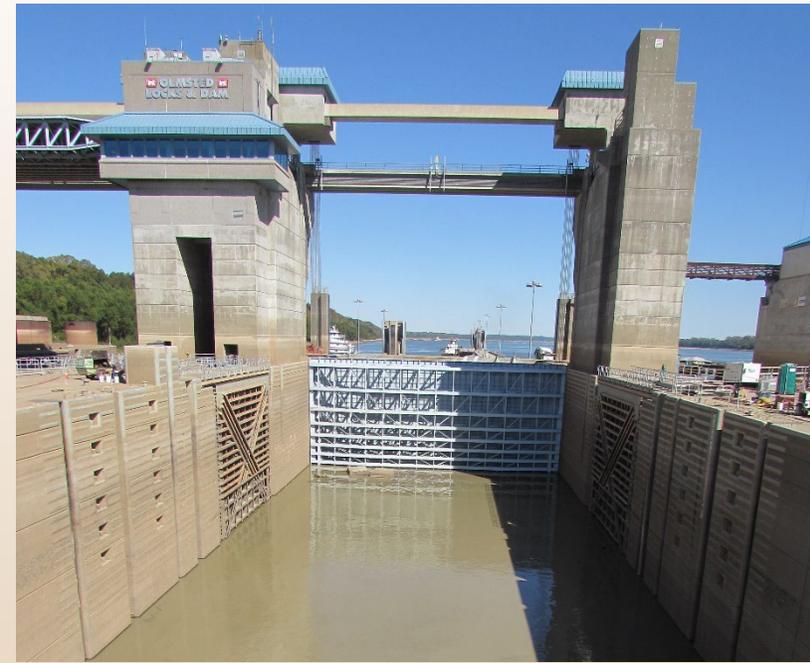
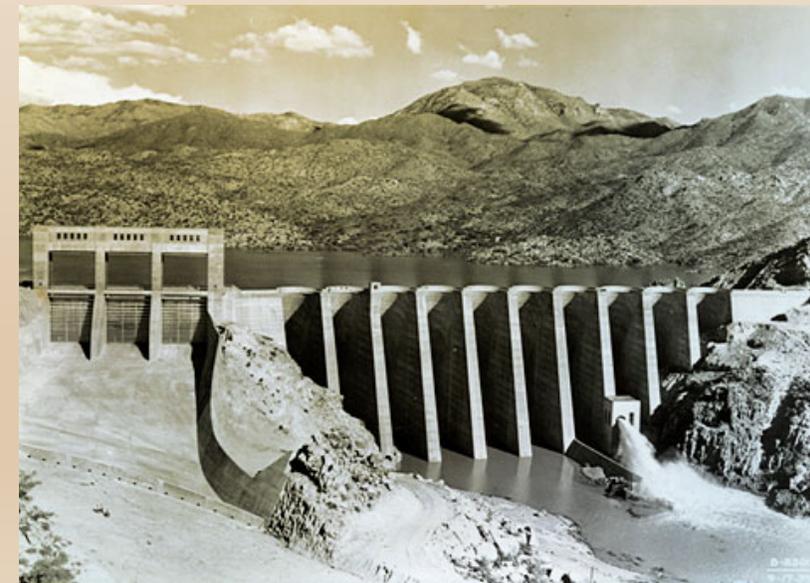
# Possible Event Tree for Hoist Houses Seismic Loading

**Hoist houses are typically massive structures carrying suspended massive gates - seismic loading is most obvious PFM.**

- ↪ Reservoir is at high elevation and vertical lift gate is in fully lowered position, not suspended from hoist house
- ↪ Strong earthquake occurs in weak axis direction
- ↪ Hoist House piers begin cracking as weight of hoist house oscillates
- ↪ Piers fail in moment/shear
- ↪ Hoist houses and piers collapse onto vertical lift gate
- ↪ Vertical lift gate is heavily damaged
- ↪ Rainfall event raises reservoir, gate cannot be operated
- ↪ With spillway unusable, the reservoir rises and overtops dam
- ↪ Dam breaches

**A similar event tree can be developed for the case where the vertical lift gate(s) is(are) suspended.**

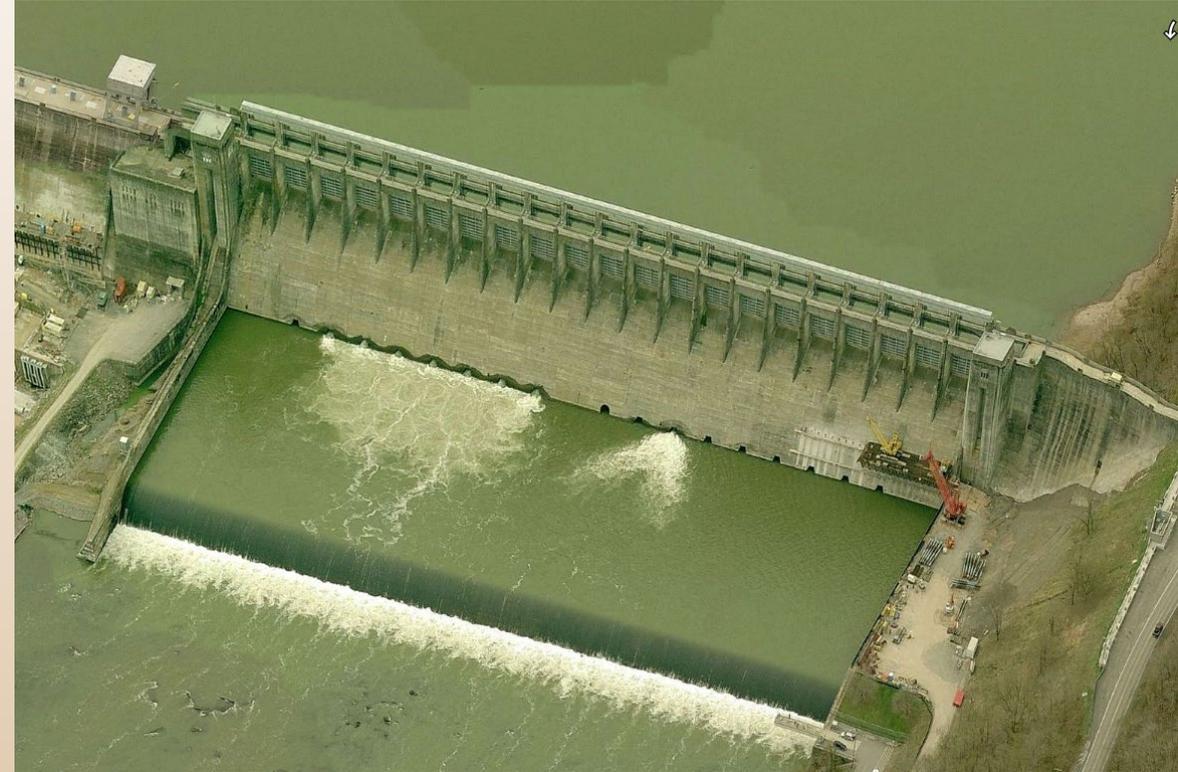
# Dams with Multiple Vertical Lift Gates

- Similar to Tainter gates on dams, the likelihood of losing pool as the result of the loss of one gate is lower if the dam has multiple gates. The more gates are on the spillway, the lower the likelihood.
- The likelihood of overtopping as the result of the loss of one gate is lower if the dam has multiple gates. The more gates are on the spillway, the lower the likelihood.
- Pascal's Triangle can be employed to estimate likelihood of multiple gate failures

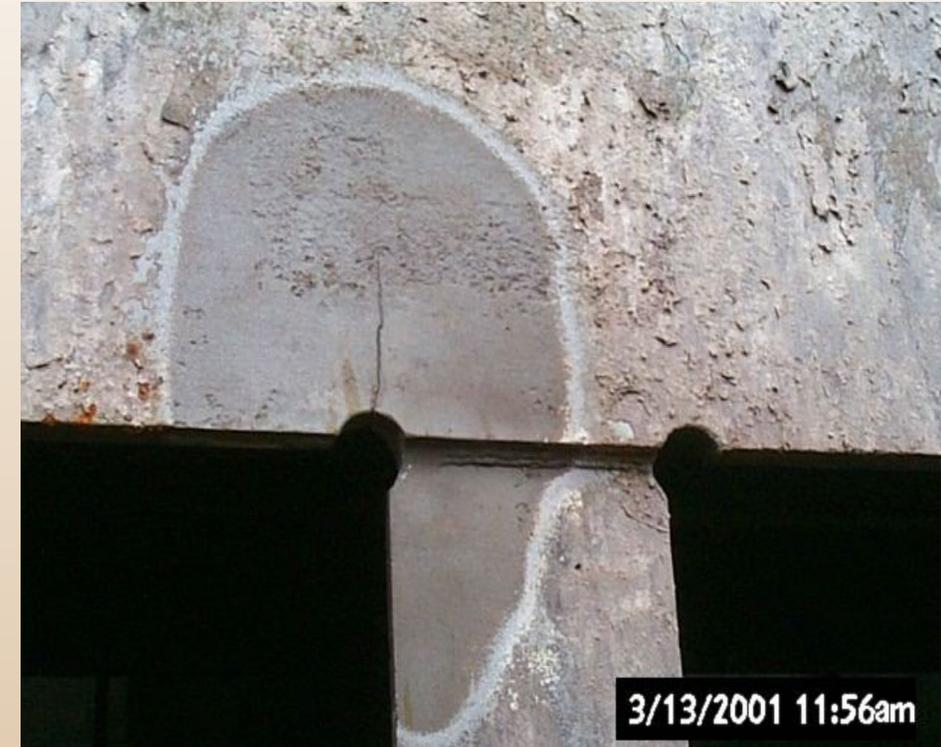
# Fatigue Cracking of Vertical Lift Gates

- Fatigue cracking found in vertical lift gates at John Day and Ice Harbor Locks and Dam
- Both had similar design and age.
- Cracking first found at Ice Harbor in 1980 and John Day in 1982.
- Cracking in tension tie at welded connections.
- FEM showed cracking due to exceeded fatigue limit due to cyclic loading.
- Ice Harbor gates replaced in 1996 due to excessive cracking and maintenance. 2 month shut down and cost of \$6.5M.
- John Day gates replaced in 2011 for \$12M.

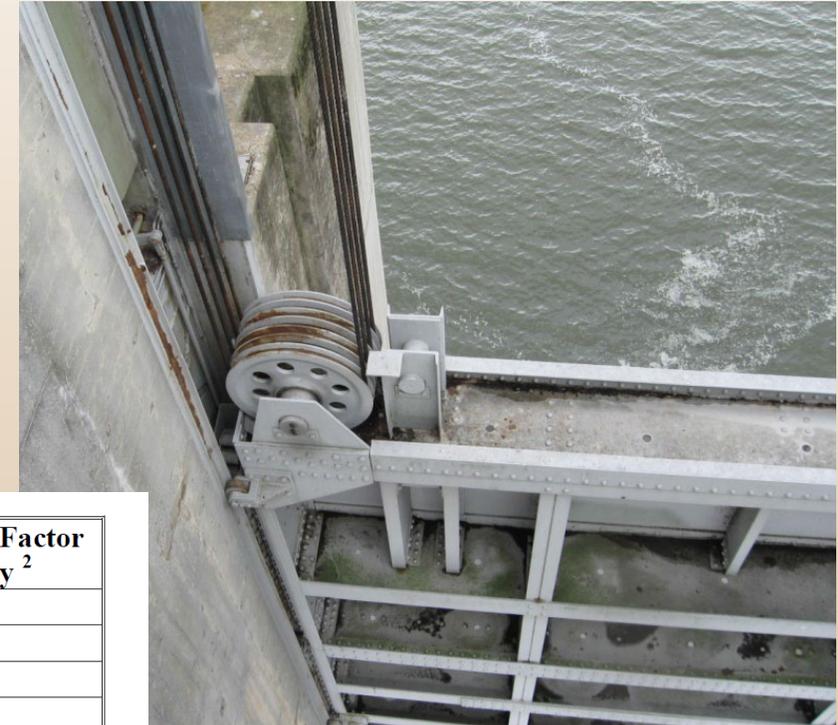
# Hoist-Induced Failure of Vertical Lift Gate

- For Bluestone Dam, analysis was performed of hoisting loads on the Hoist Assembly Pin Plate Connection
- Each crest gate weighs 113,000 pounds
- Uninhibited rolling resistance associated with the roller chain assemblies of approx. 2.5% of maximum water load (26,000 lbs.)
- Side seal friction of 175 lb/ft (11,000 lbs.)
- The above assumptions equate to a total normal running load of 150,000 lbs, for which the gate was designed.

Load Condition	Force (lbs)	Pin Plate Factor of Safety <sup>1</sup>	Hoist Rope Factor of Safety <sup>2</sup>
Normal Running Load	150,000	2.6	6.05
Hoist Design Load	195,000	2.0	4.66
Hoist Stall Load	487,500	0.8	1.86
Overstress Load	387,800	1.0	2.34
Hoist Rope Failure	487,500 (on one connection)	0.4 <sup>3</sup>	0.93 <sup>3</sup>

Based on the above factors of safety, the potential exists for the hoist assembly pin plate connection to fail at loads greater than the overstress load of 387,000 lbs.

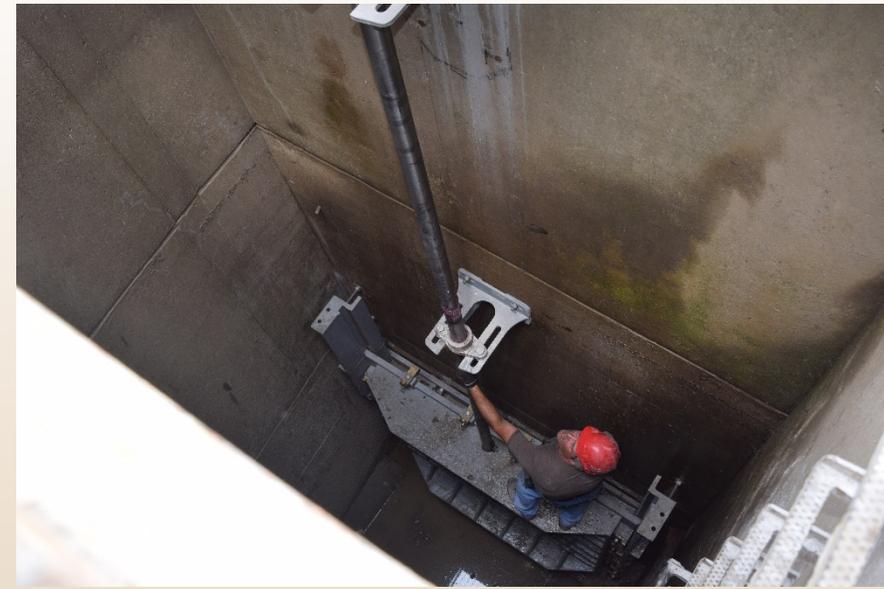
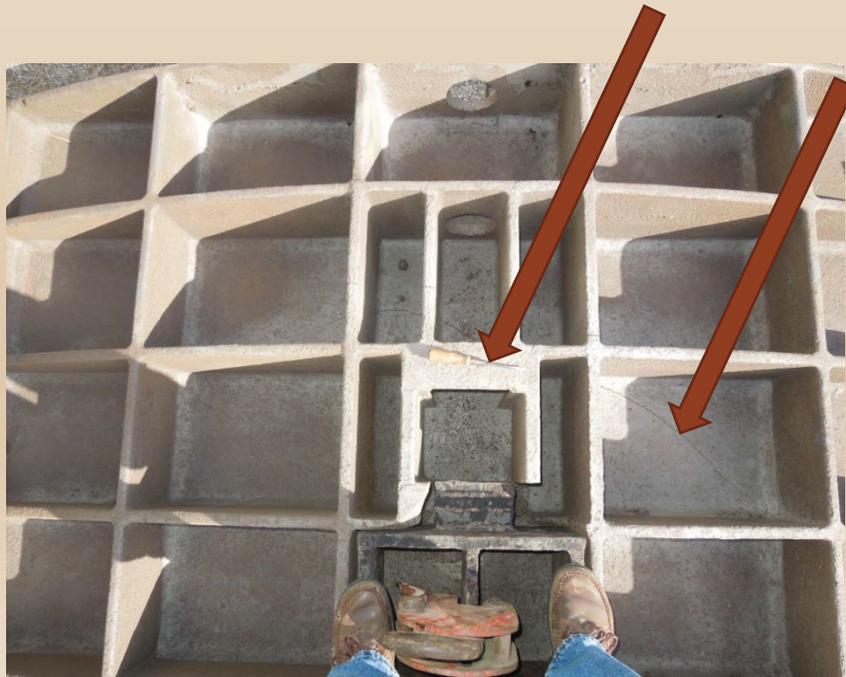
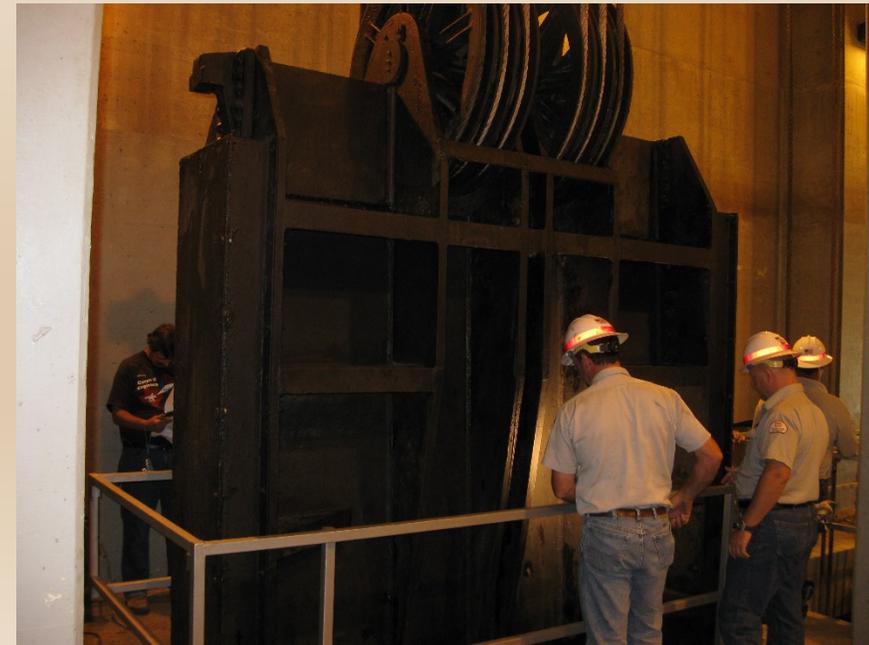
# Sluice Gates

- Used both in Levees and FRM dams.
- For levees, used in gatewells to prevent backflow during floods.
- Generally cast steel (ductile) or cast iron (non-ductile behavior)
- Generally operated with steel stems but also may be hoisted with wire ropes

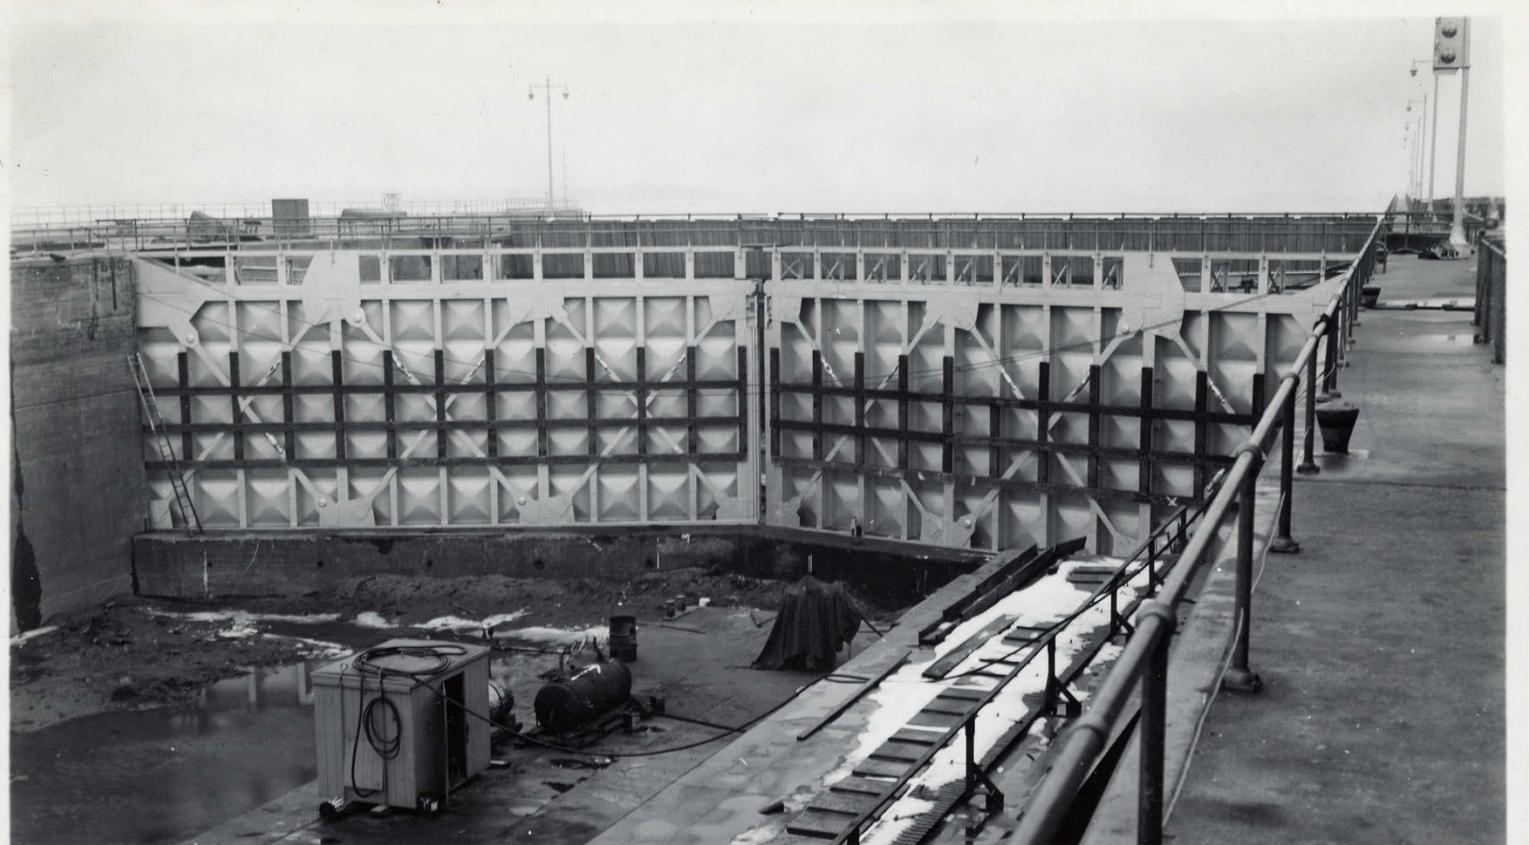
# Vertically Framed Miter Gates

- Loads are transferred from skin plate to vertical girders.
- Load is distributed equally between the top horizontal girder and at each vertical girder's contact point with the concrete gate sill. Horizontal loads do not collect at the pintle.
- Photo from Mississippi River L&D 16 (1951)

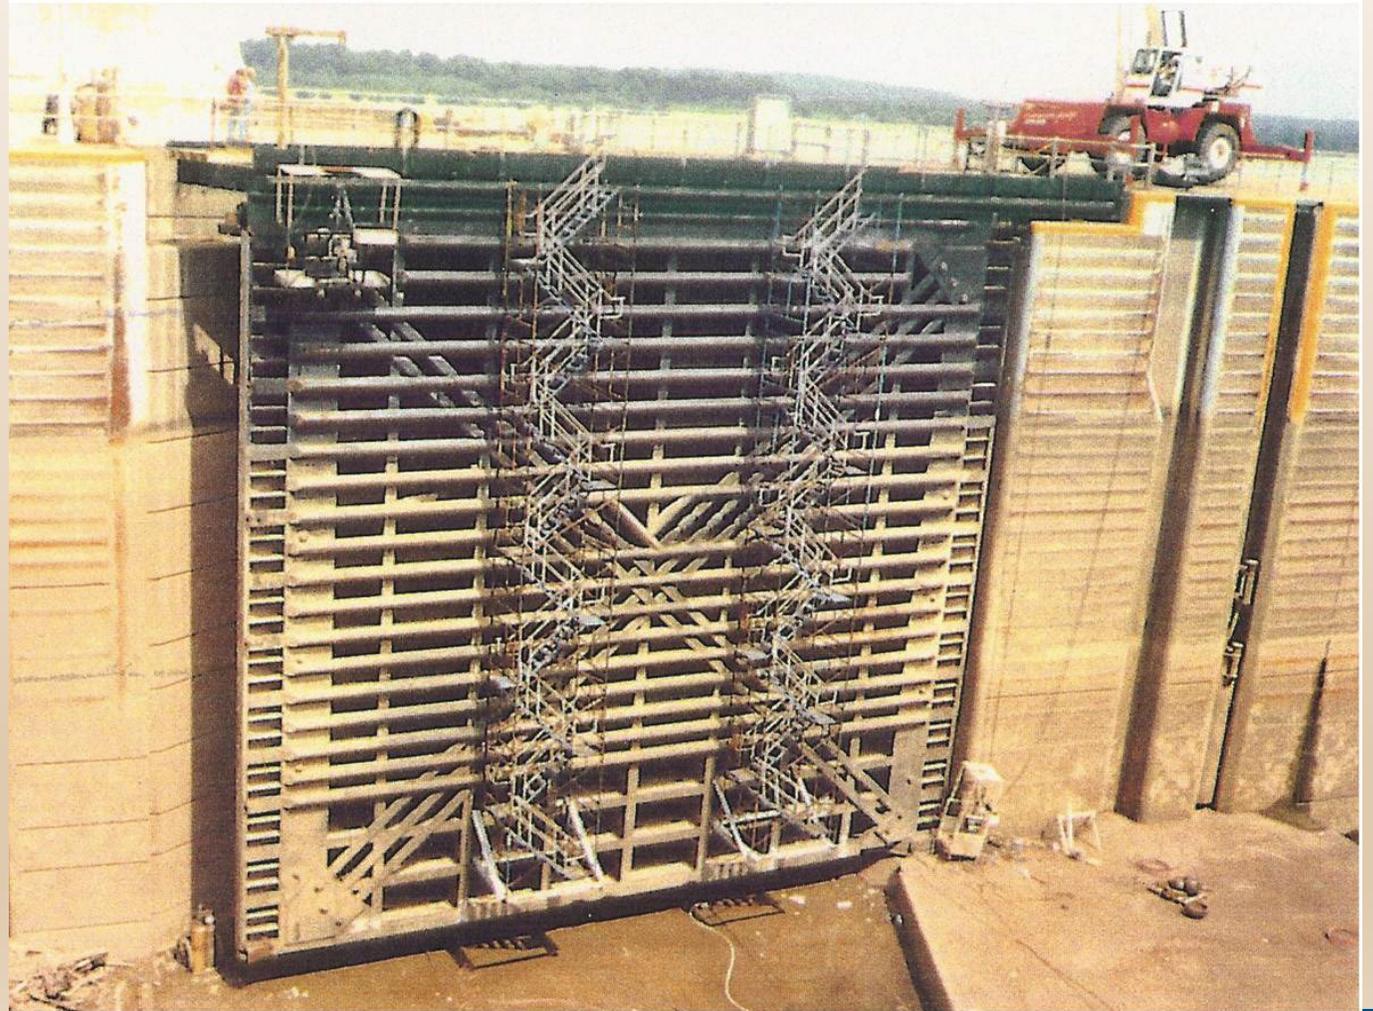
# Horizontally Framed Miter Gates

- Hydrostatic loads are transferred from skin plate to vertical intercostals and from there to horizontal girders.
- The load from the horizontal girders is distributed to the quoin and miter posts.
- Horizontal loads collect at the quoin and miter contact blocks.
- Quoin block transfers horizontal loads to the lock walls from top to bottom.
- Miter blocks transfer horizontal loads to the other gate leaf's miter block.
- Horizontal loads should not be collected by the pintle (bottom) or the gudgeon pin (top).
- Photo from Cannelton L&D (Ohio River), 1980's

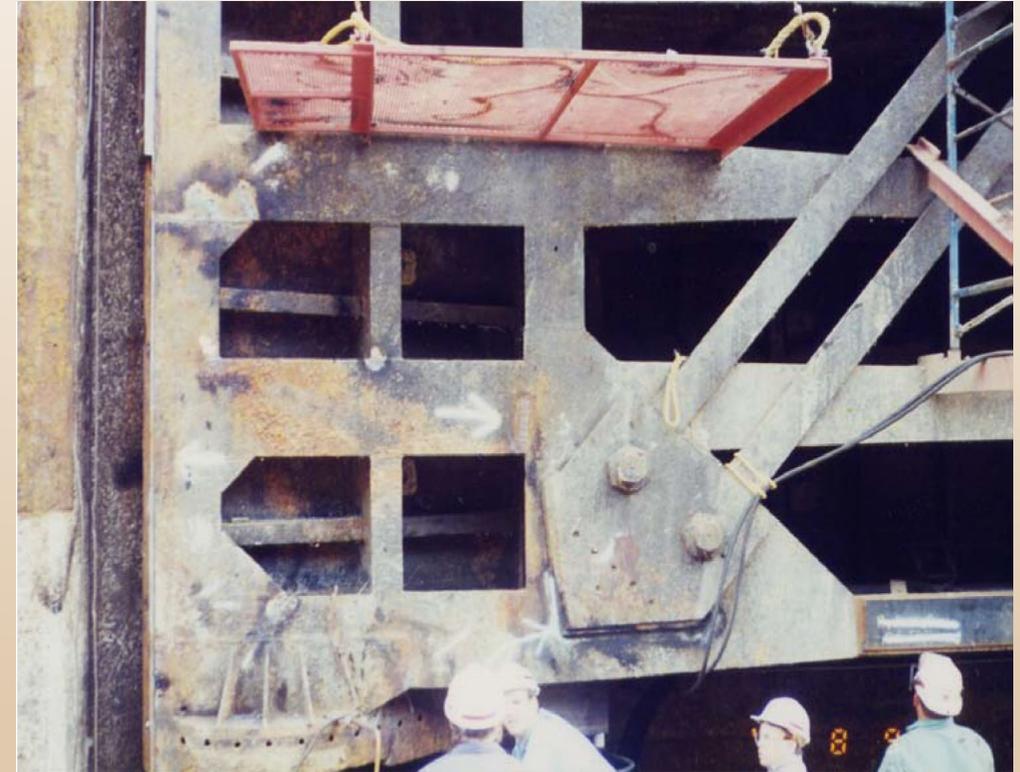
# Fatigue Cracking of Miter Gates Markland Lock and Dam

- Severe cracking found at welded connections of horizontal girders in 1994.
- Gates considered to be in critical conditions and immediate repairs were done.
- Dewatering
- Gate was replaced in 2011 with a cost of \$12M.
- Ice Harbor had a similar design. Gates were replaced in 1996 with a two month outage and \$6.5M cost.

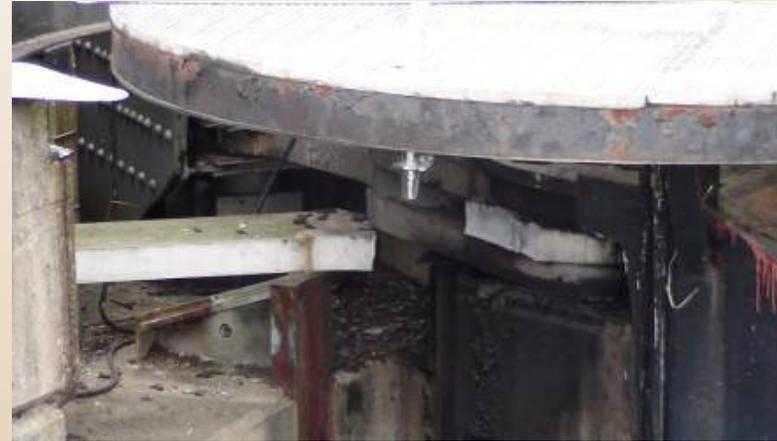
# Failure of Miter Gate Anchor Arm Greenup Lock and Dam

- Sudden failure of anchor arm of main chamber miter gate caused a 26 day emergency closure.
- The failure initiated at the root of a fillet weld connecting the miter anchor arm to the top connecting link and propagated through the entire cross section of the miter anchor arm.
- The crack was not visible during prior inspections due to limited accessibility, paint and over spill of lubricating grease for the gudgeon pin.
- Gate fell on the sill in a vertical position.

- Anchor wedge assemblies, anchor arms, connector plates, gudgeon and link pins were replaced and the gate was reinstalled on February 21, 2010. February 22, 2010 the main lock chamber was reopened for traffic

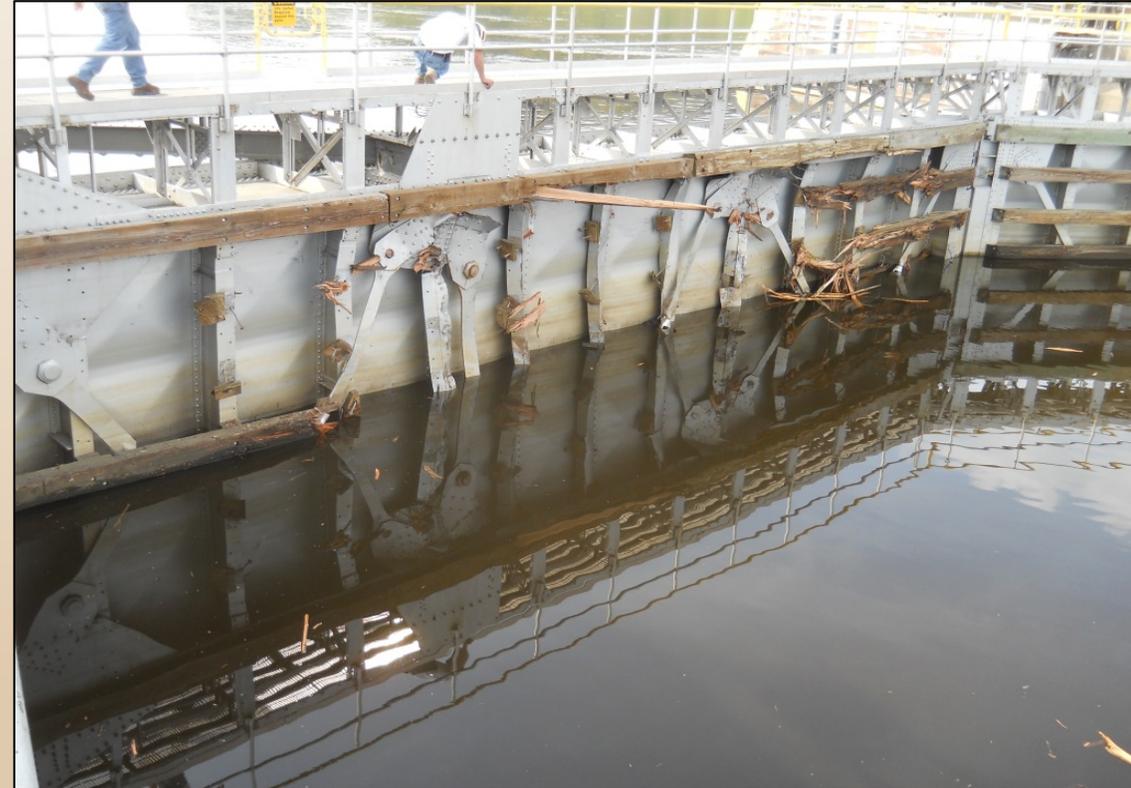
# Barge Impact Damage to Miter Gate Leaf Mississippi River L&D 5A

- Tow Impacts Upstream Landwall Gate while it was in the recessed position on 16 May 2013 at noon; Flows were High (Outdraft); there was < half a foot difference between upper and lower pool
- Initial Lock Closure/Inspection was conducted within 2 hours
- Initial Above the Waterline Inspection Complete by 1800 hours 16 May 2013
- Operations locks through remaining tows
- MVR's *Quad Cities* (crane barge) arrives and swaps out damaged gate with temporary replacement gate 23 May 2013
- Gate Swap is accomplished during a 24 hour lock closure
