Operational Related Risks

Best Practices in Dam and Levee Risk Analysis

Part H – Other Risks

Chapter H-1

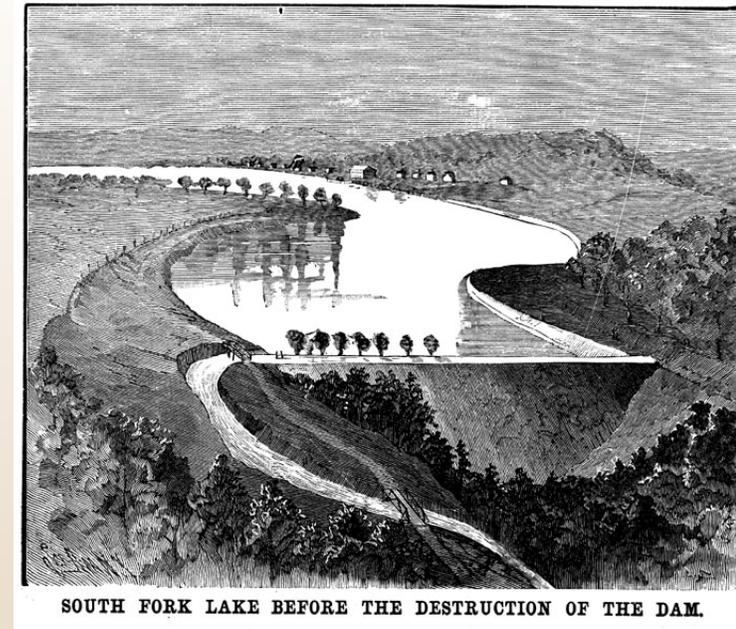
- Failed in 1862 - collapse of stone outlet conduit, reconstructed but outlet filled in
- Spillway:
 - Ungated overflow
 - 99 feet wide
 - Bridge across spillway with supports at 6-1/2 foot spacing
 - Iron Screens were placed across the spillway to prevent fish from escaping reduced spillway capacity by 40%
- Dam crest lowered to widen roadway so that carriages could pass
- No camber, center portion of dam crest lower

SOUTH FORK LAKE BEFORE THE DESTRUCTION OF THE DAM.

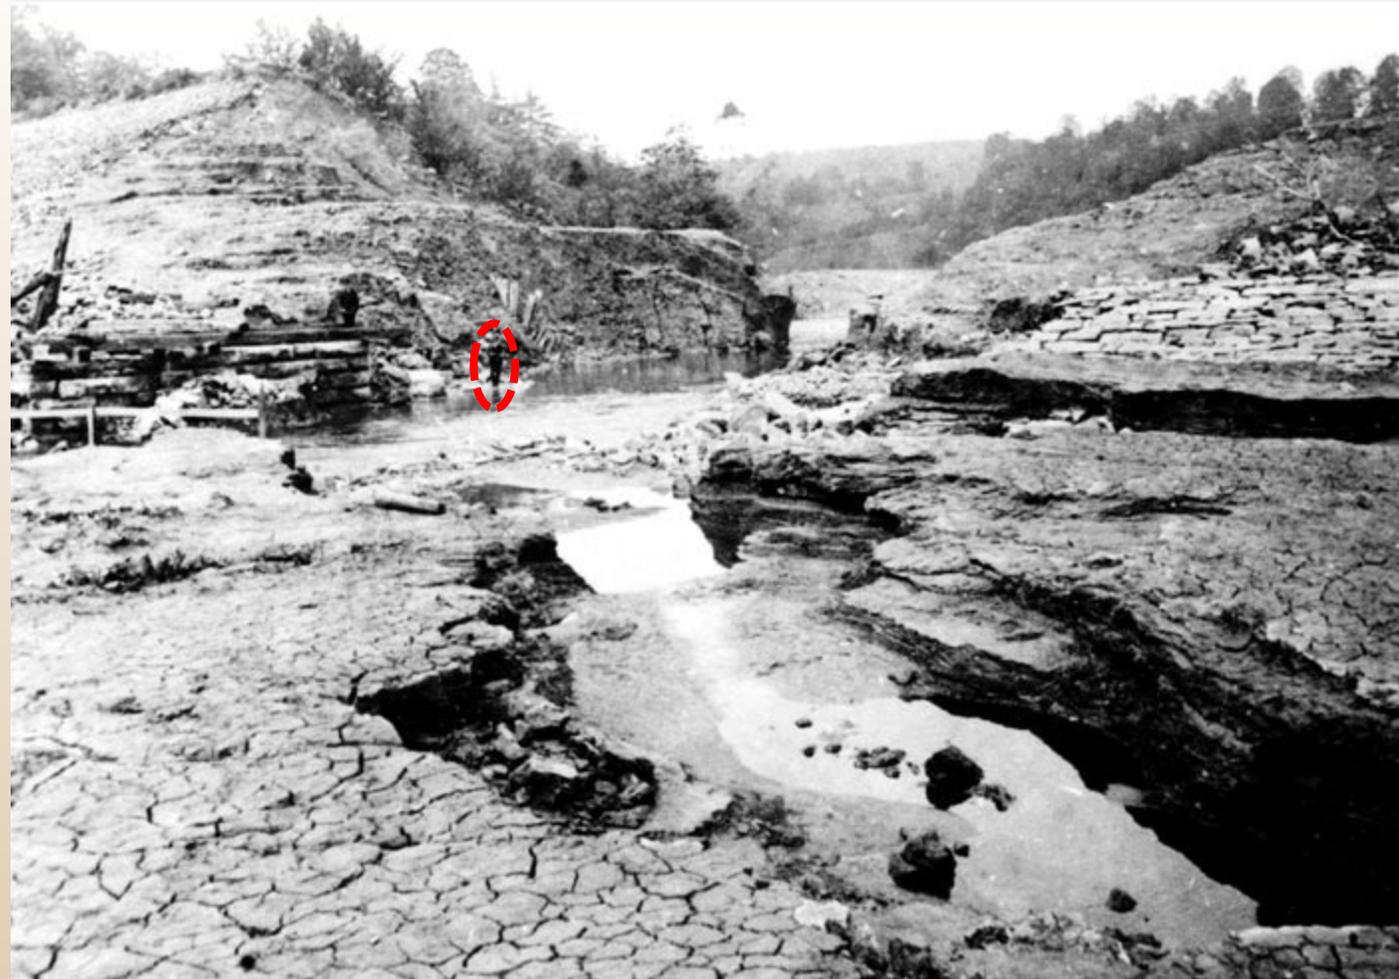
South Fork Dam

- Heavy rains in May of 1889
- Inflow greater than spillway capacity and fish screens became plugged with debris
- Dam overtopped and failed

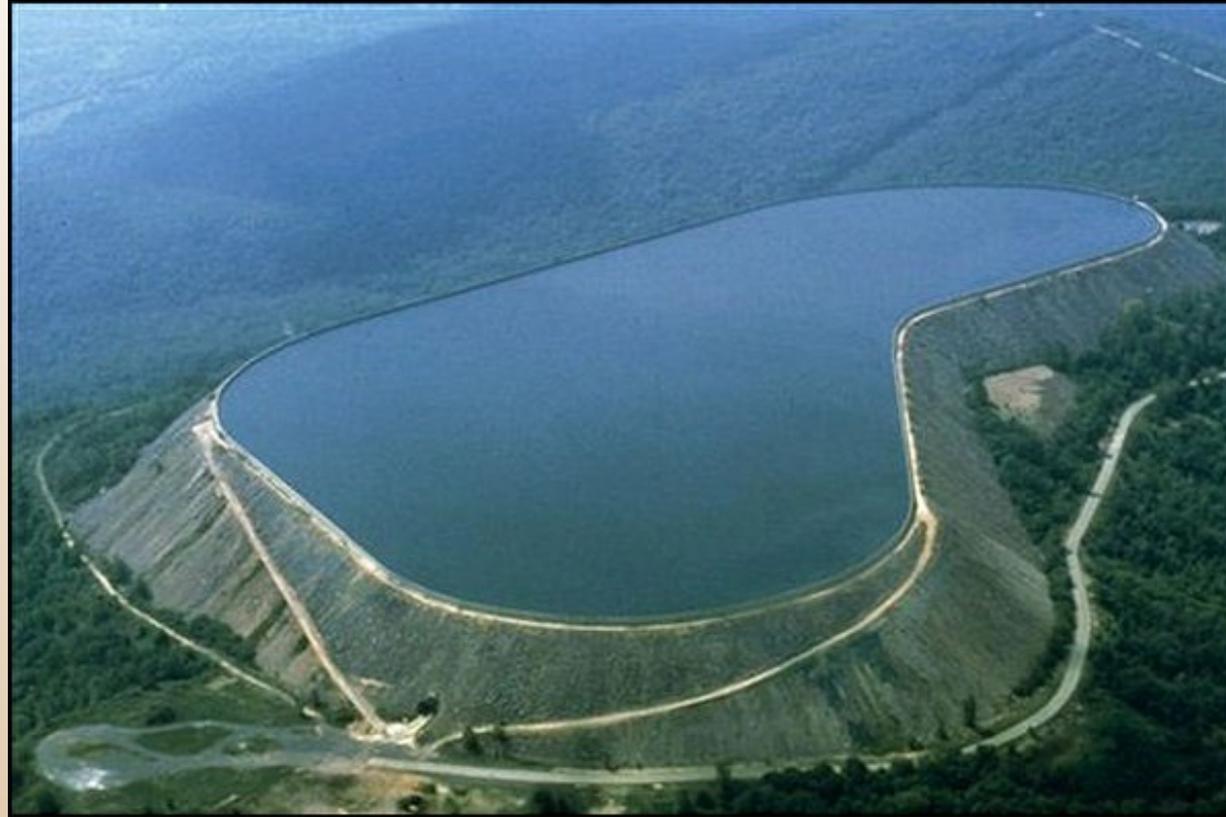
Taum Sauk

- Concrete-faced earthfill “ring-dike” structure
- Upper reservoir of pumped-storage project
- Water routinely stored on 10-foot high parapet

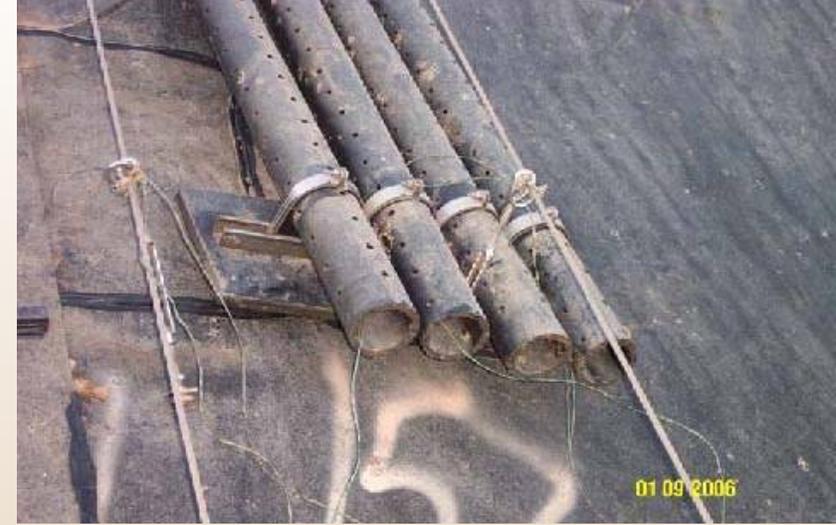
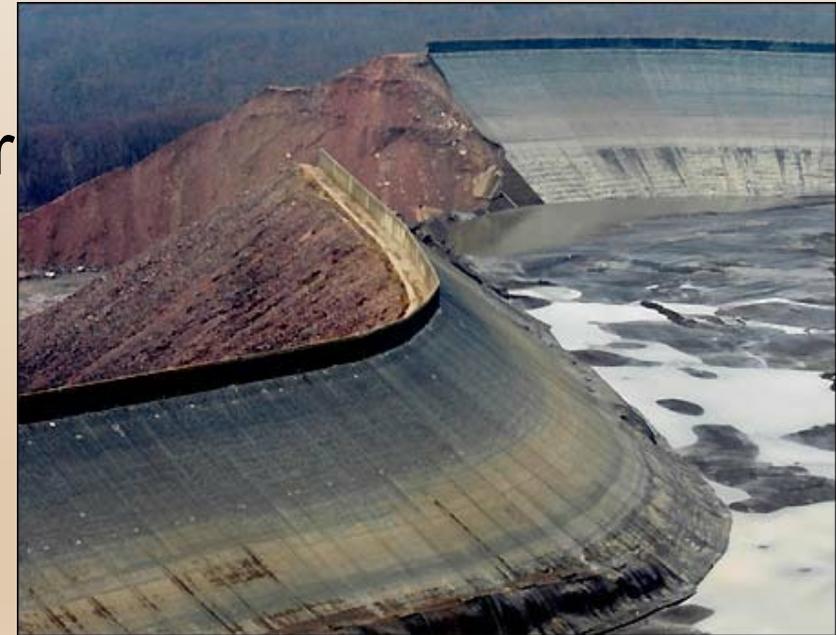
Taum Sauk

- Membrane liner installed in 2004
- Reservoir level instrumentation could not be reinstalled properly due to liner warranty issues
- Instruments were loose and not reading reservoir level properly
- Resetting of reservoir sensors did not account for settlement of embankment
- Alarms wired so high level and high-high level sensors both needed to trigger for alarm
- Over-pumping was not detected and dam overtopped and failed

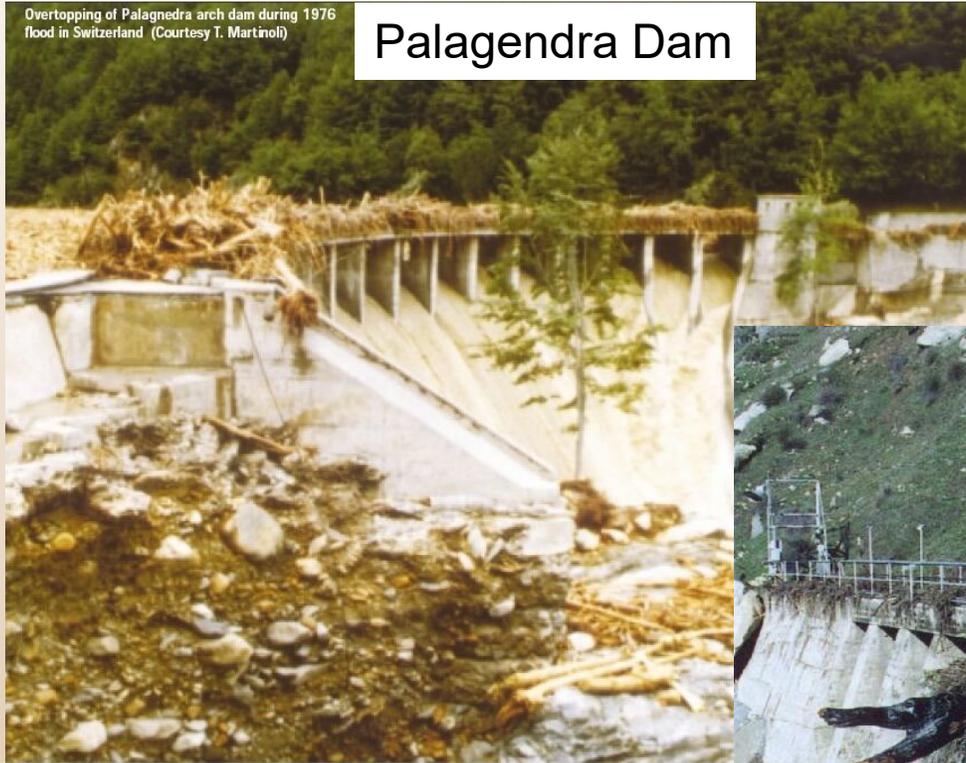
Palagnedra Dam

Overtopping of Palagnedra arch dam during 1976 flood in Switzerland (Courtesy T. Martinoli)

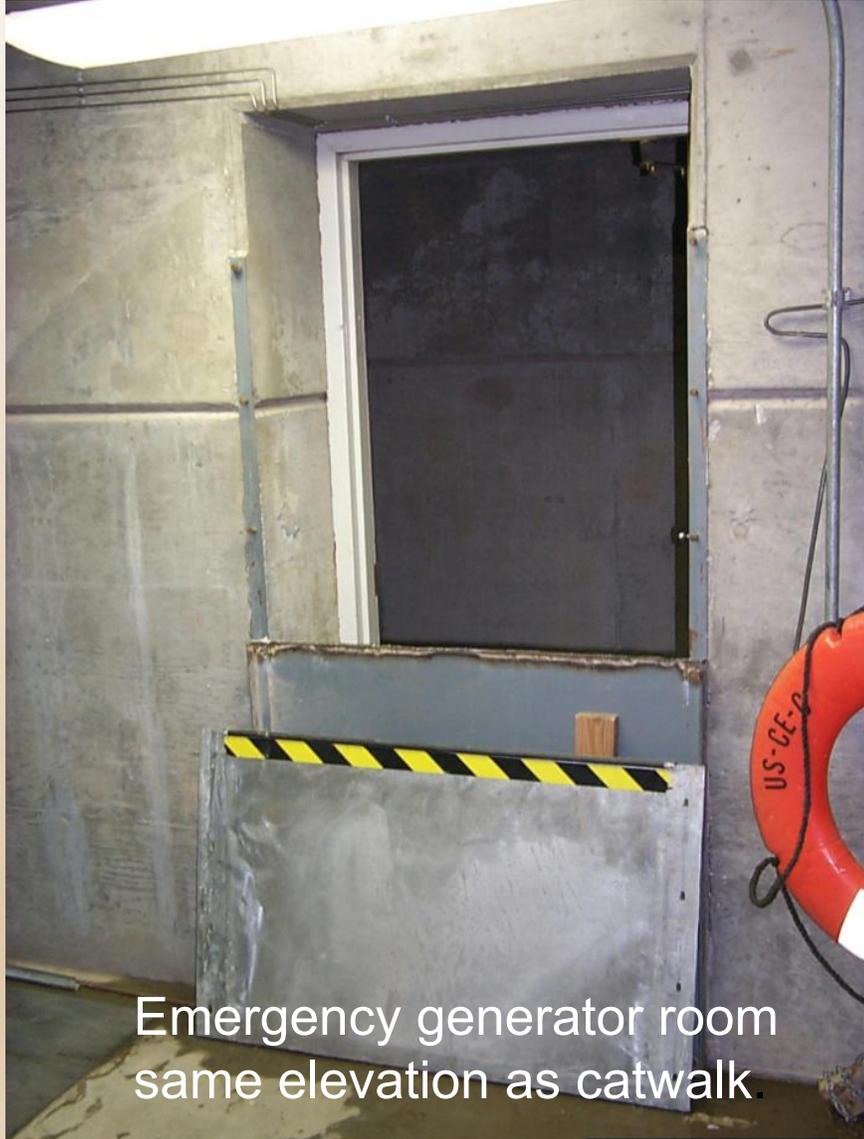
Spillway Operating Deck and Generator Floods

Emergency generator room
same elevation as catwalk.

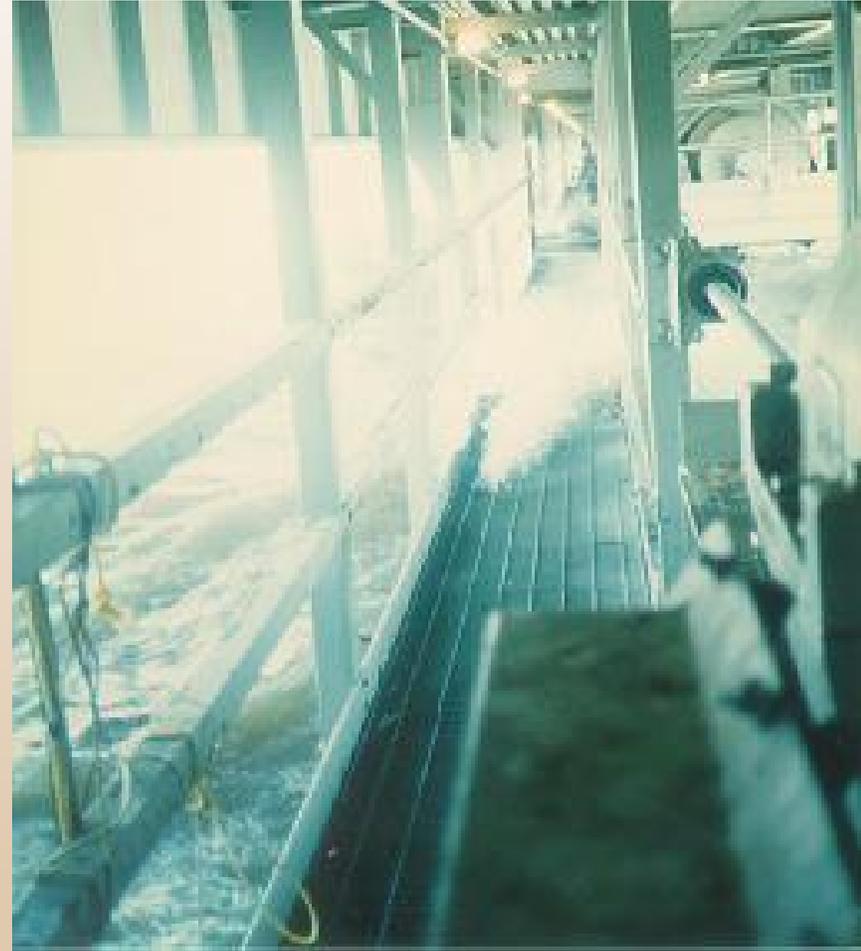
Catwalk almost inundated
during flood – gates must be
operated from catwalk

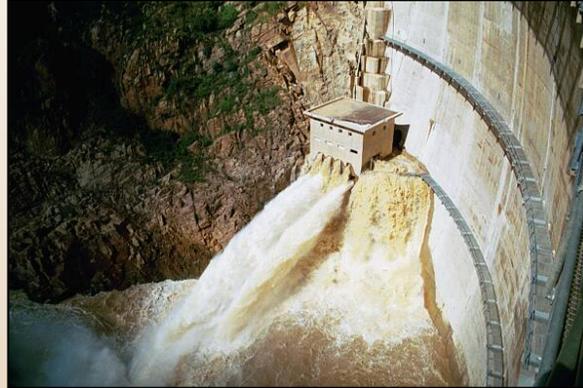
- Valve failure

- Control valve left in open position leading to fully opened gate
 - Control valve not equipped with spring loaded lever
- Software error in SCADA syst. causes gate to open unexpectedly

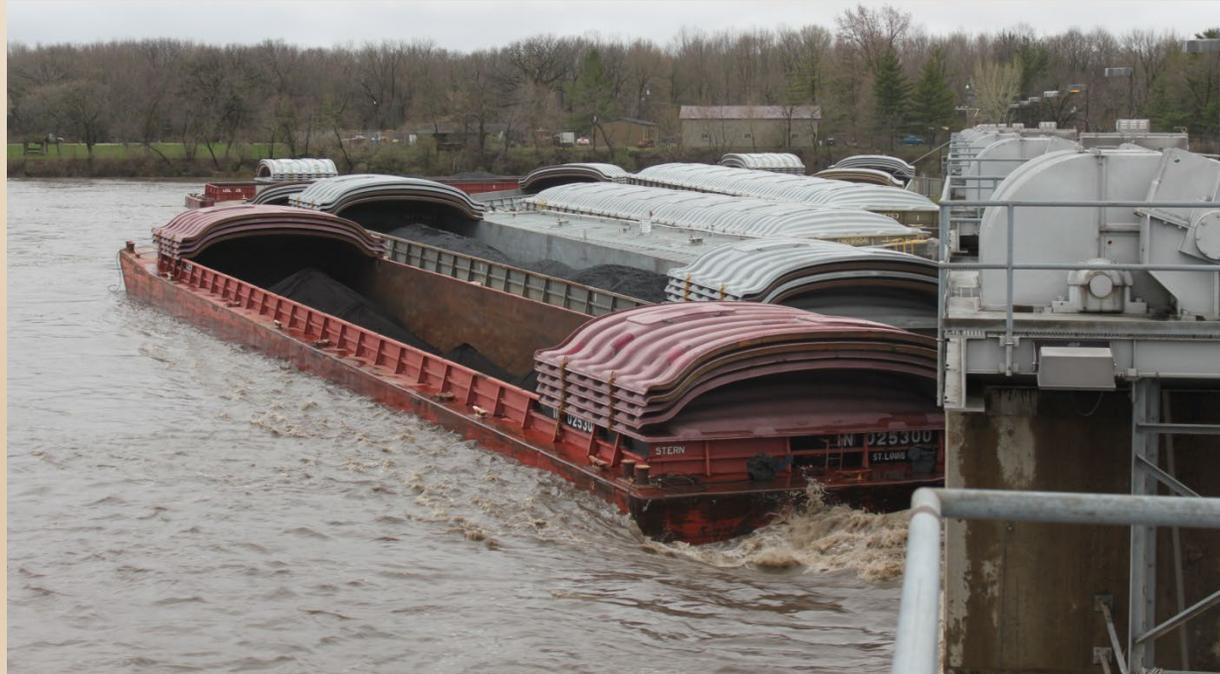
Marseilles Damage Summary

- Main Dam
 - Six barges break free and three sink.
 - Gates 2 through 6 impacted by barges leaving Gates 2 and 3 inoperable
 - Pier 2 trunnion anchorage destroyed
 - Decreased spillway capacity led to erosion at dam around boiler house
- Earth Dike (Note: this structure is upstream of the main dam)
 - Erosion of earth section
 - Widespread residential flooding

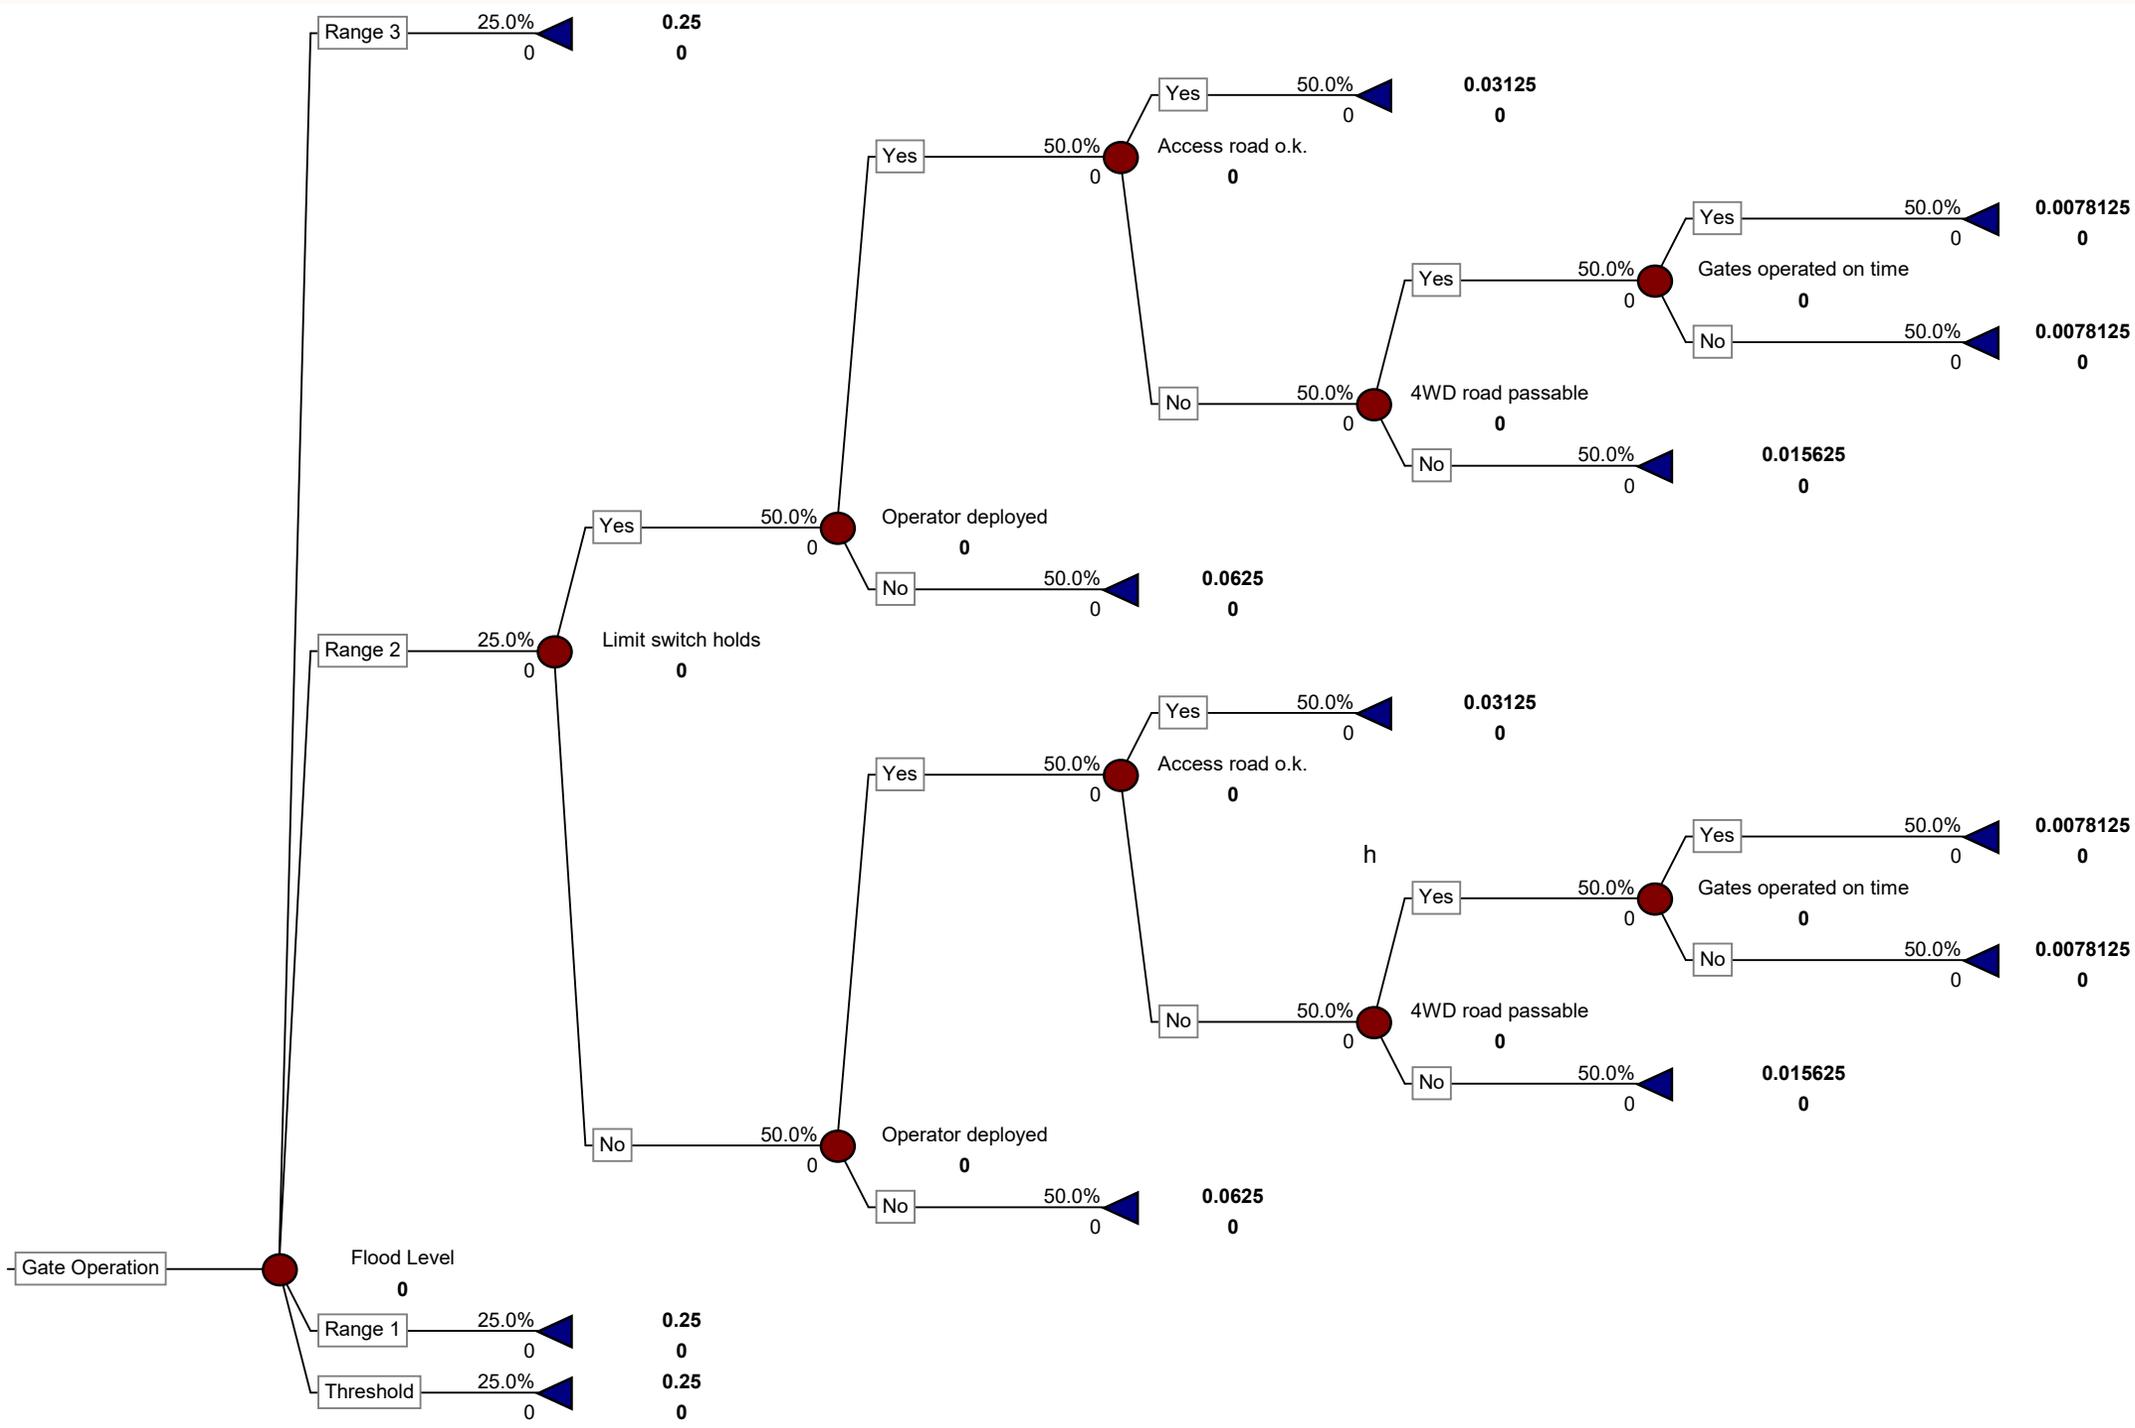
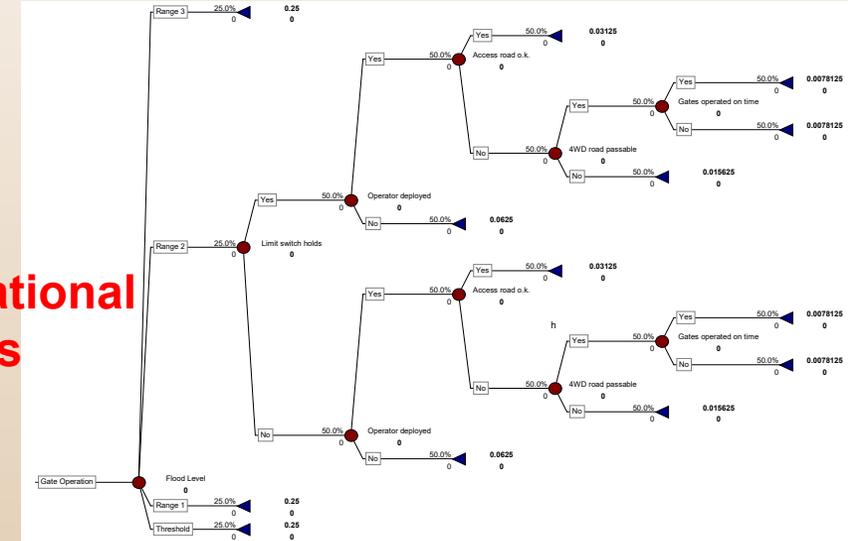
Typical Portion of Event Tree

- ↳ Reservoir loading (partition)
 - ↳ Initiation - Limit Switch Fails
 - ↳ Operator Deployed
 - ↳ Main Access Road Impassable
 - ↳ Secondary (4WD) Road Impassable
 - ↳ Gates Not Operated on Time
 - ↳ Embankment Dam overtops
 - ↳ Erosion Initiates
 - ↳ Crest breaches
 - ↳ Dam breaches (uncontrolled release of reservoir)
