Technical Memorandum No. MERL-2012-11

## Coatings for Mussel Control — Three Years of Laboratory and Field Testing

U.S. Department of the Interior  
Bureau of Reclamation  
Technical Service Center  
Denver, Colorado

March 2012

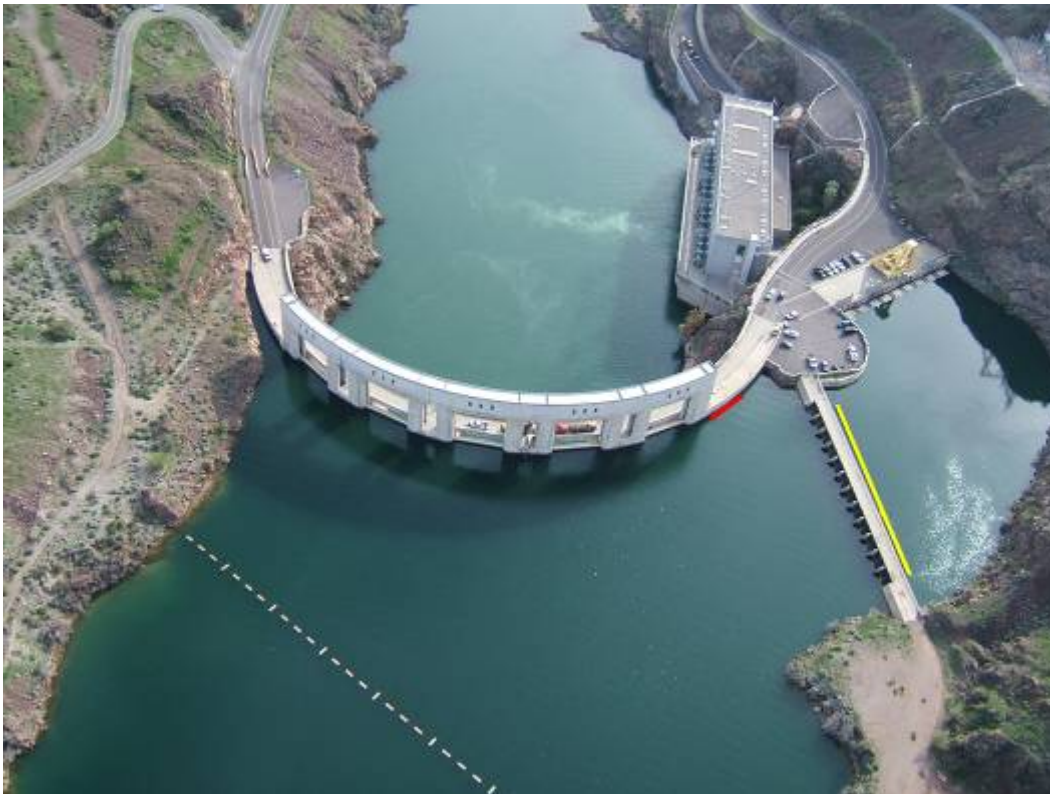
**Figure 1.—Aerial photo of Parker Dam. The red line indicates the location the panels were placed, and the yellow line indicates where grates were placed.**

Parker Dam was selected as the field test site to evaluate coatings in static (non-flowing) and dynamic (flowing) exposure conditions (shown in figure 1). The mussels at this location reproduce almost year round and have a very high growth rate. For each coating system tested, three 1-foot-square steel plates were used in static exposure and were tied off by a nylon rope and lowered into the water to approximately 50 feet (ft) depth near the face of the dam. For the dynamic conditions, one 18-inch by 24-inch coated floor grate with 1-inch

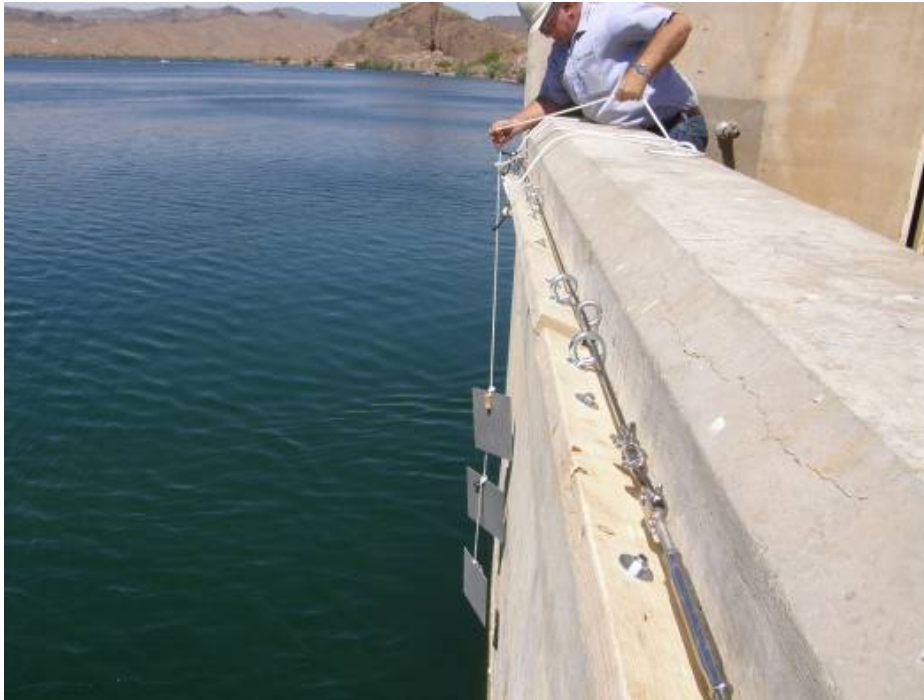
Figure 2.—Coated steel plates placed in static exposure from the face of Parker Dam.

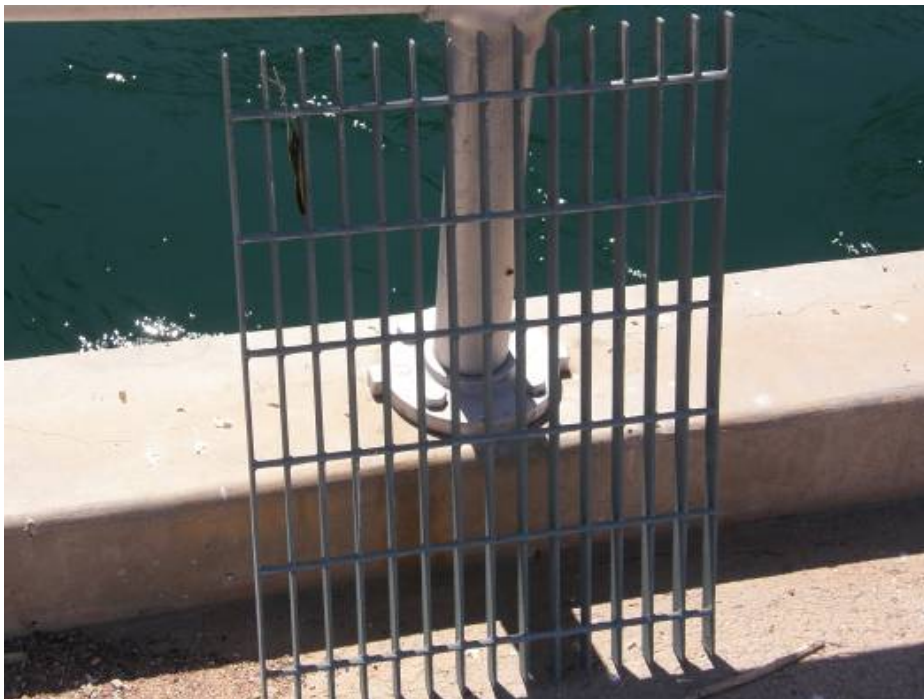
Figure 3.—Coated floor grate before being hung from the forebay trashrack structure at Parker Dam.

The coated plates were 12 inches by 12 inches by 3/16 inches thick. The plates were prepared according to SSPC SP1 solvent cleaning and abrasive blast cleaning to a SSPC SP10/ NACE 2 near white metal blast with a 3.0 mil surface profile [2, 3]. All coatings were applied in accordance with the coating manufacturer's recommendations and in some cases samples were shipped to the coating manufacture for application. Figure 2 shows a set of coated plates being lowered into the water. The substrates were prepared and coated in the same manner as the plates. Figure 3 shows a coated floor grate prior to being lowered into the water.

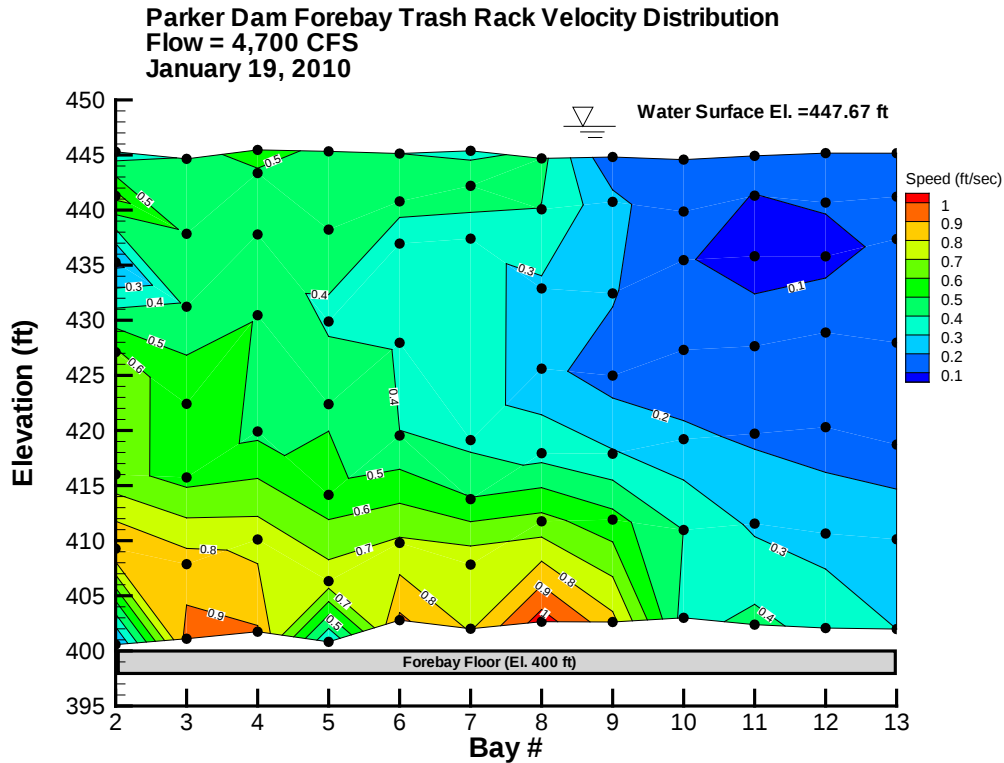
Figure 5.—Isovel plot of the velocity magnitudes passing through trashrack bays 2 to 13. The test grates were located near elevation 410 ft.

The coated floor grates are approximately 40 ft below the water surface at elevation 410 ft. Figure 5 shows measured velocities during the lowest flow rate of 4,700 ft<sup>3</sup>/s, figure 6 shows velocities at 9,800 ft<sup>3</sup>/s, and figure 7 shows velocities at 15,000 ft<sup>3</sup>/sec. The variability in measurement elevation was caused by strong currents moving the probe downstream and upward in the water column. At elevation 415 ft, the velocities varied from 0.3 ft/s to 0.6 ft/s when only one unit was operating. At 15,000 ft<sup>3</sup>/s, the velocities were 1.5 ft/s to 2.0 ft/s. In general, velocities were largest on the south end of the trashrack structure (nearest the dam) and increased with depth. The velocity measurements at the dam face, where the static plates are located, were recorded at varying depths.

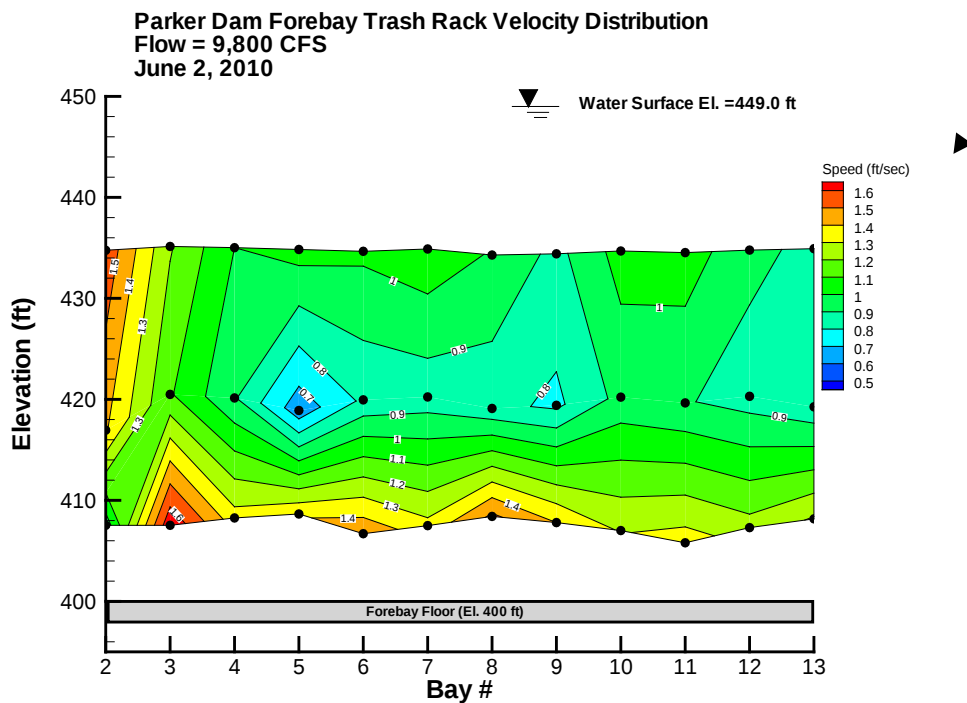
Figure 6.—Isovel plot of the velocity magnitude passing through trashrack bays 2 to 13. Units 3 and 4 were discharging 9,800 ft<sup>3</sup>/s during the measurements.

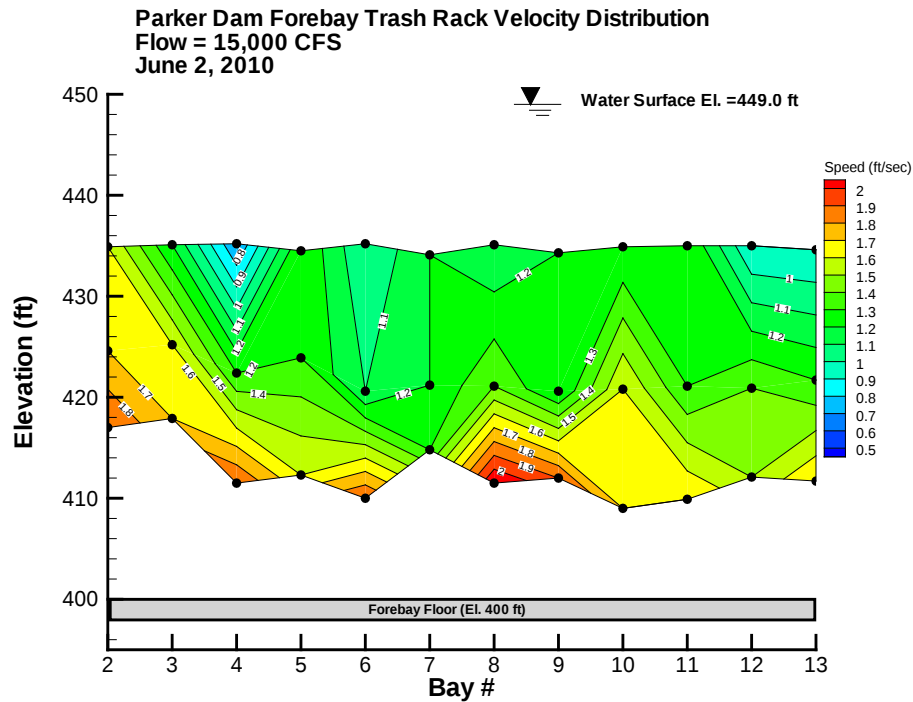
Figure 7.—Isovel plot of the velocity magnitude passing through trashrack bays 2 to 13. Units 1, 3, and 4 were discharging 15,000 ft<sup>3</sup>/s during the measurements.

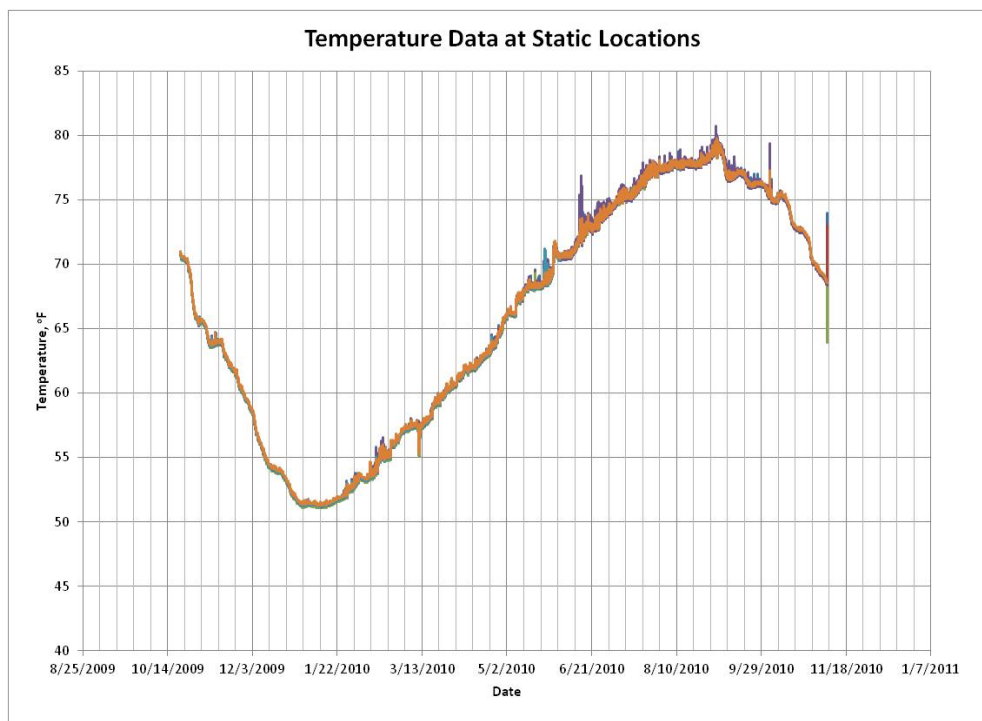
Figure 8.—Temperature data at elevation 410 ft, 30–40 ft below the water surface.

Temperature data were recorded on several test substrates from October 20, 2009, through October 2010, at 15-minute intervals. Figure 8 shows temperature data at elevation 410 ft, 40 ft below the water surface. Quagga mussels are capable of reproducing as low as 48°F. Temperature data shows that at this facility the water temperatures would allow the quagga mussels to reproduce year round.

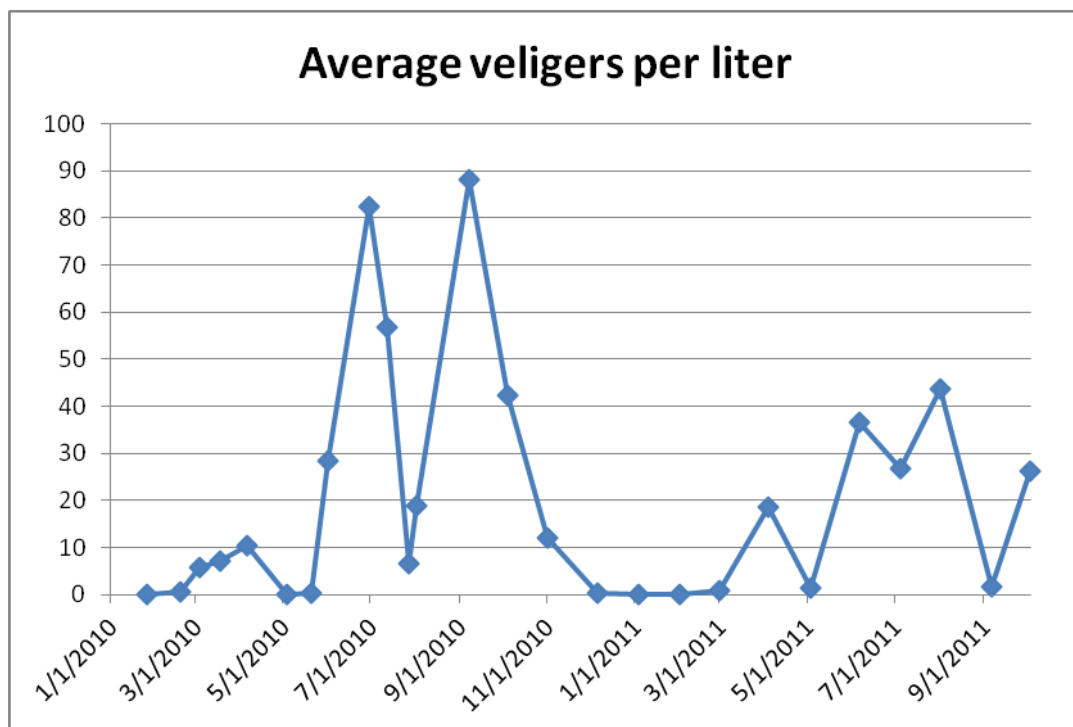
Figure 9.—Average number of veligers per liter of water from January 2010 through October 2011.

Results of the veliger sampling program indicate that the majority of mussel reproduction appears to occur in the warmer months between March and November. Comparing the veliger counts to water temperatures shows the mussels appear to have greater reproduction rates when water temperatures are above 58 °F.

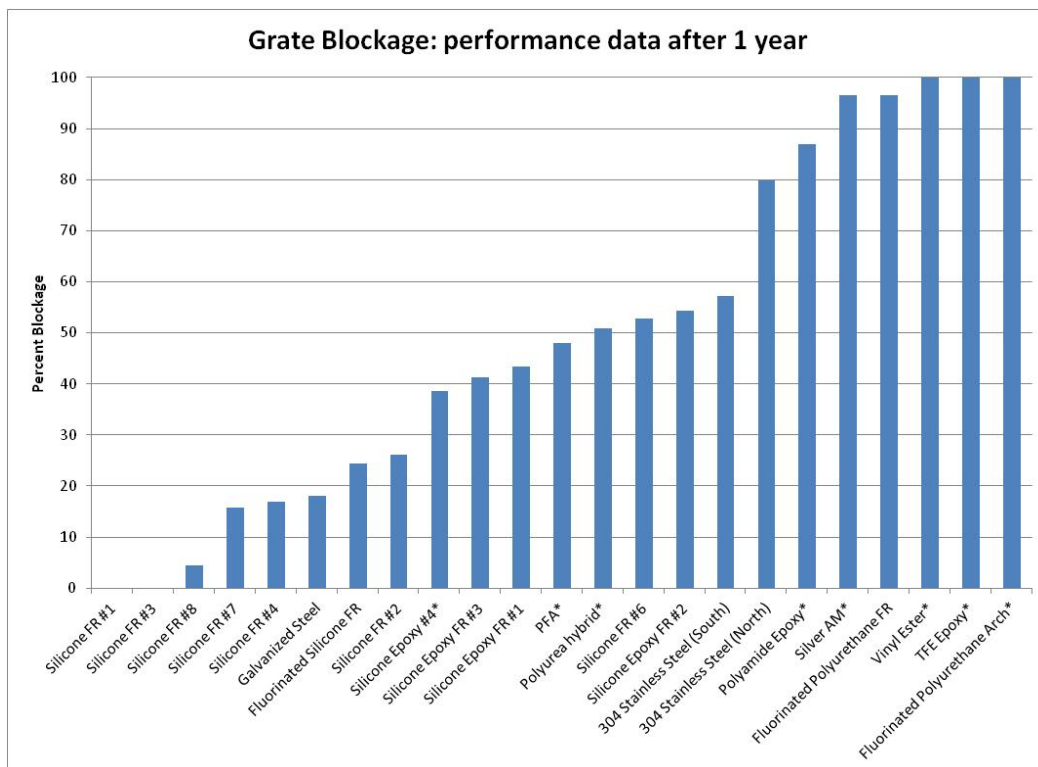
Figure 12.—Performance data for grates after 1 year of exposure.

Figure 11 shows the maximum force to remove individual mussels from the coated surfaces. The force gauge instrument was very sensitive, but all readings below 0.02 pound were assigned a zero force due to increased possibility for human error. Figures 12 and 13 show blockage after 1 and 2 years, respectively.

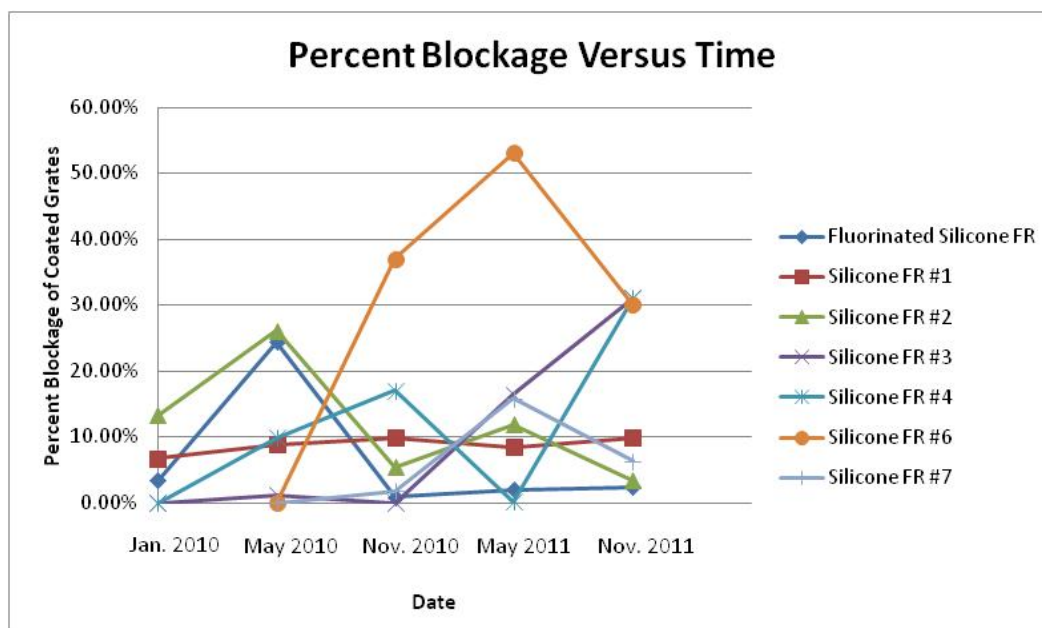
Figure 14.—Percent blockage of the silicone foul release coatings seasonal variation.

accumulation of algae, slime, and bryozoans. Quagga mussels do not attach to the silicone surfaces. For some foul release coatings, there was a decrease in percent blockage of the grate from season to season as seen in figure 14. The silicone and fluorinated silicone foul release coatings showed releases once fouling had built up enough for drag forces to exceed the bond strength and peel the fouling off the surface. Another possible explanation is that during the summer months flow rates and hence velocities are higher due to an increased power demand (peaking power) and water demand for irrigation which subjects the fouling to larger shear forces. During fall inspections, there was significantly less fouling on the silicone and fluorinated silicone foul release coatings than during the spring inspections. The velocity range during the summer months (or when all units are operating) was between 1.8 and 2.4 ft/s. The sloughing off has only been documented with the silicone and fluorinated silicone foul release systems.

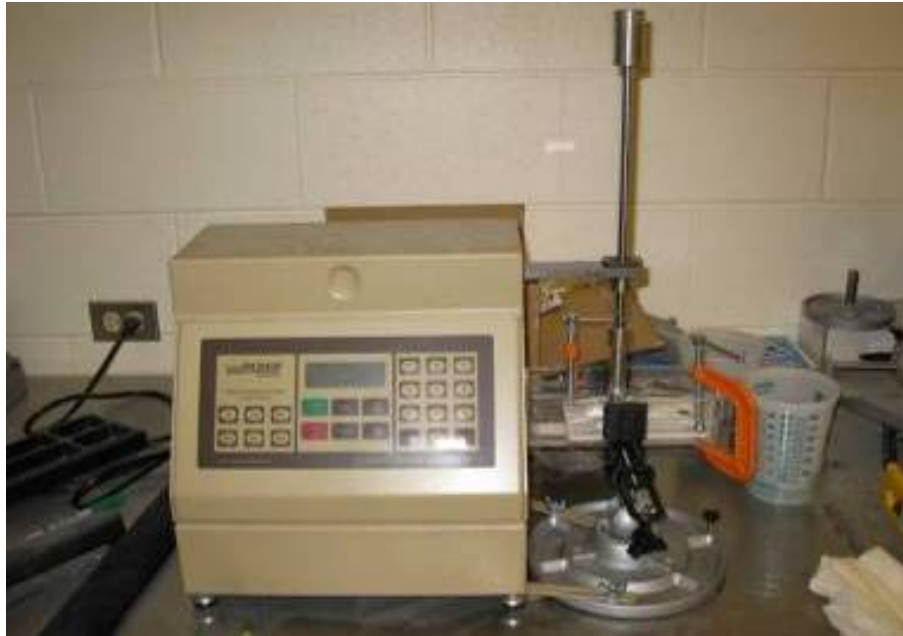
**Figure 19.—Abrasion test setup.**

Abrasion testing was performed using a reciprocating Linear Taber Abraser test machine (Model 5750) equipped with an extra course abrasive bristle brush purchased from Ace Hardware. A 3 x 6-inch panel was submerged in 10 ounces of filtered water in an acrylic tub and held in place by two C-clamps as shown in figure 19. Weights were placed on a splined shaft connected to the brush to control the normal force exerted on the coated surface. The brush was cycled

back and forth 1,500 times at a speed of 75 cycles per second, creating a wear track on the coating. The test panel was then removed from the solution and allowed to dry overnight. Following drying, the coating was weighed to determine material loss due to abrasion. This process was repeated to achieve a total of 4,500 cycles. Three wear tracks were created using three different weight levels: 0, 500, and 1,000 gram weights were added to the splined shaft (4,500 cycles per track). The weight of the splined shaft assembly was approximately 380 grams.

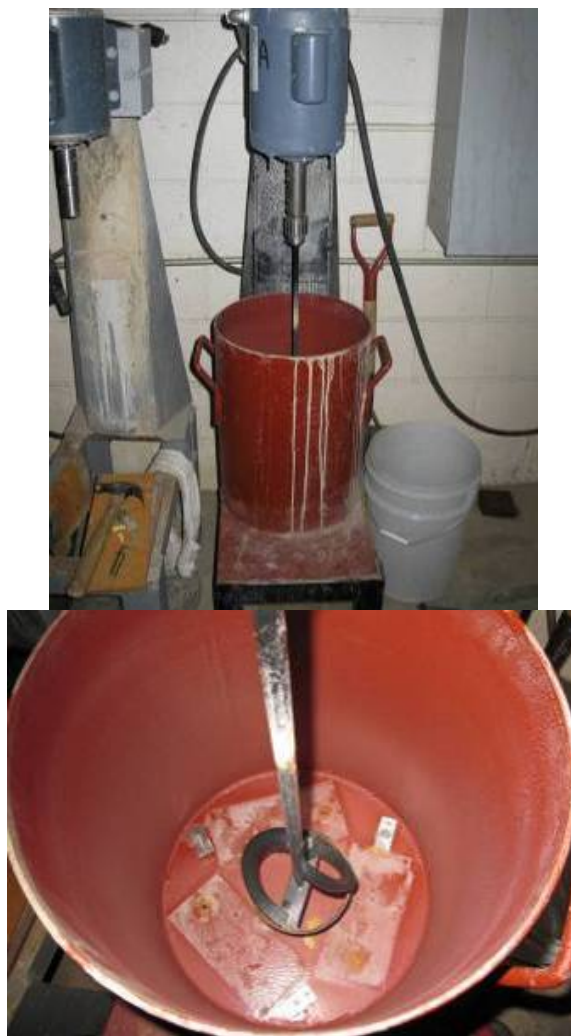
Figure 20.—Erosion test configuration.

Reclamation's erosion test for coatings is based on ASTM C1138 [12], an erosion resistance test for concrete that involves circulating steel ball bearings in water. Three coated 3- x 6-inch samples were fastened to the base of an 11.5-inch internal diameter cylindrical tank as shown in figure 20. The tank was then filled with approximately 5 gallons of water and 900 grams of sieved sand (#16 - #20). A vertically oriented motor was connected to a helical paint stirring rod. Clearance between the rod and tank bottom was 3-3/8 inches. The tank was then sealed and the slurry was agitated vigorously at 1,140 rpm for 48 hours. The samples were then removed, dried, and weighed.

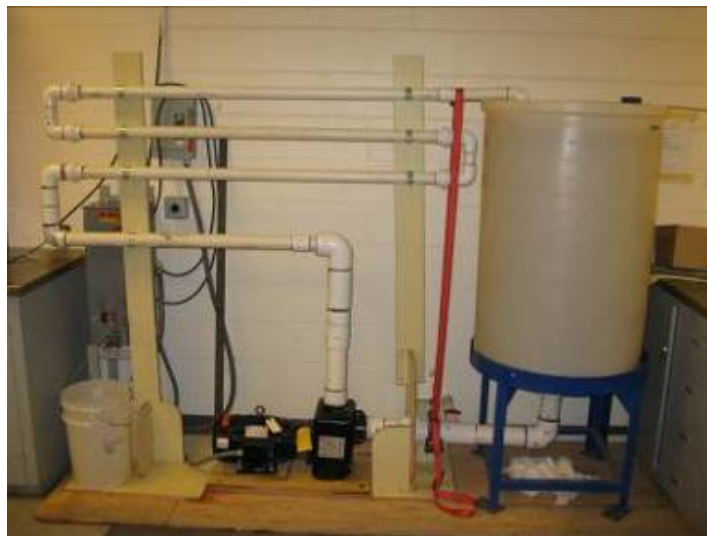
**Figure 21.—High flow water test set up. Samples are placed inside 1.5-inch PVC pipe.**

A high flow rate test using deionized water was conducted using a reservoir tank, polyvinyl chloride (PVC) piping, and a 7.5-horsepower pump as shown in figure 21 to produce flow rates of 95 gallons per minute. Details of the test configuration are presented in table 1.

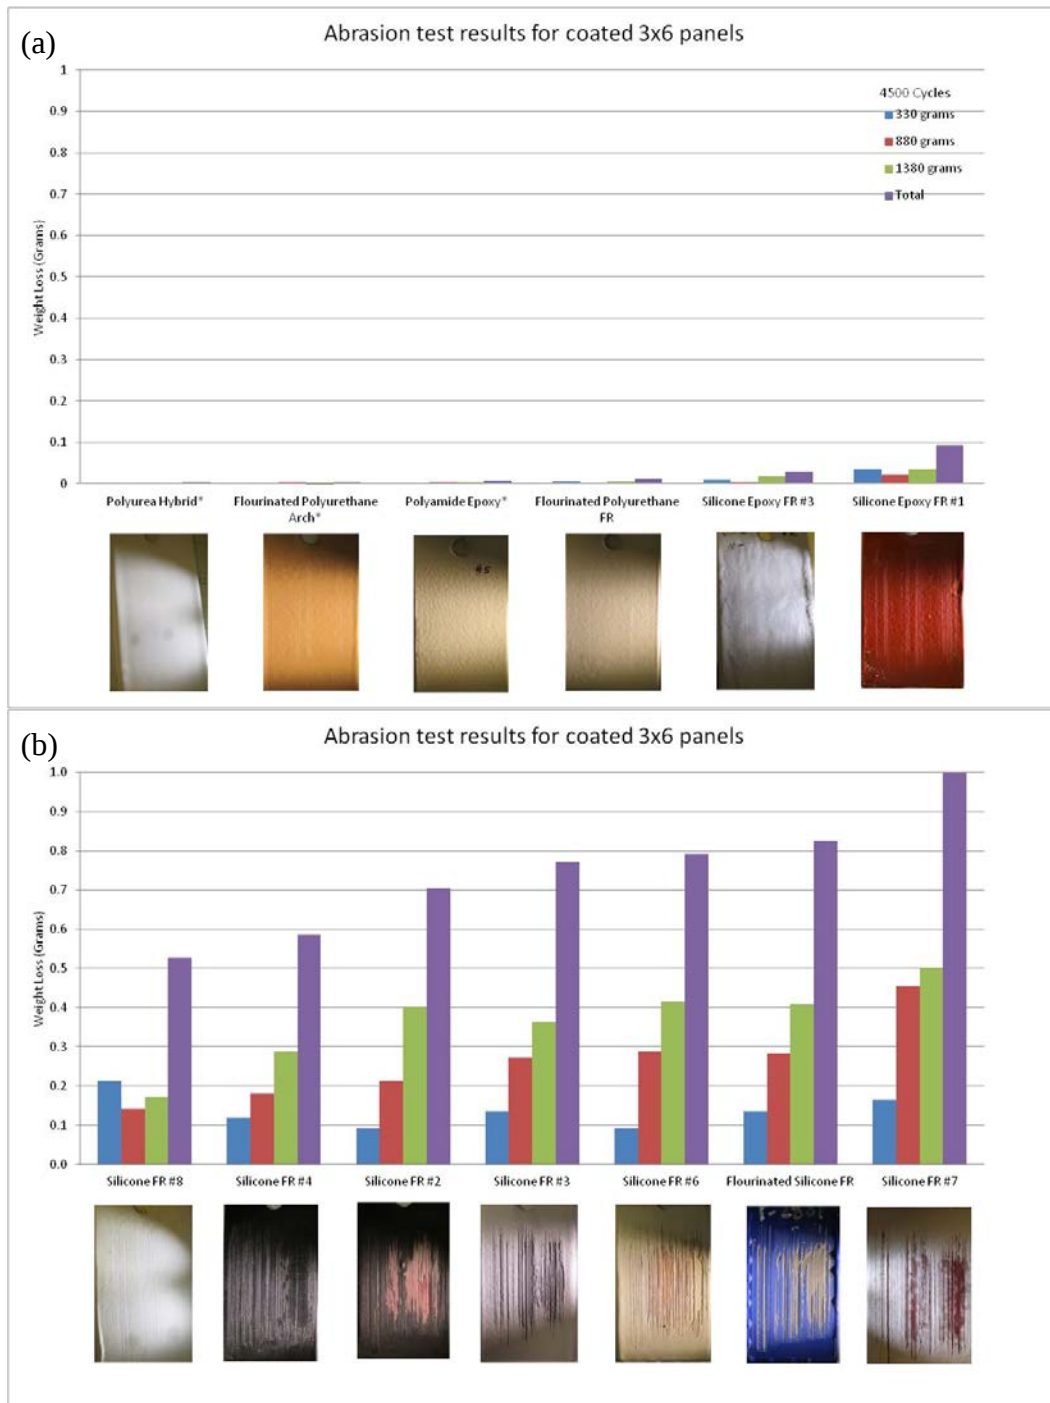
Figure 22.—Abrasion test results for (a) control samples and durable foul release coatings and (b) silicone foul release coatings.

In general, the harder coatings were far more durable than the softer coatings. However, one notable exception was the polyurethane-urea hybrid control sample, which was both soft and durable. The abrasion test results for the more durable coatings are given in figure 22a; results for silicone-based coatings are shown in figure 22b.
