# HYDRAULIC MODEL STUDIES OF STEWART MOUNTAIN DAM SPILLWAY

*Hydraulics Branch  
Division of General Research  
Engineering and Research Center  
Bureau of Reclamation*

*July 1975  
GR-6-75*

**GR-6-75**

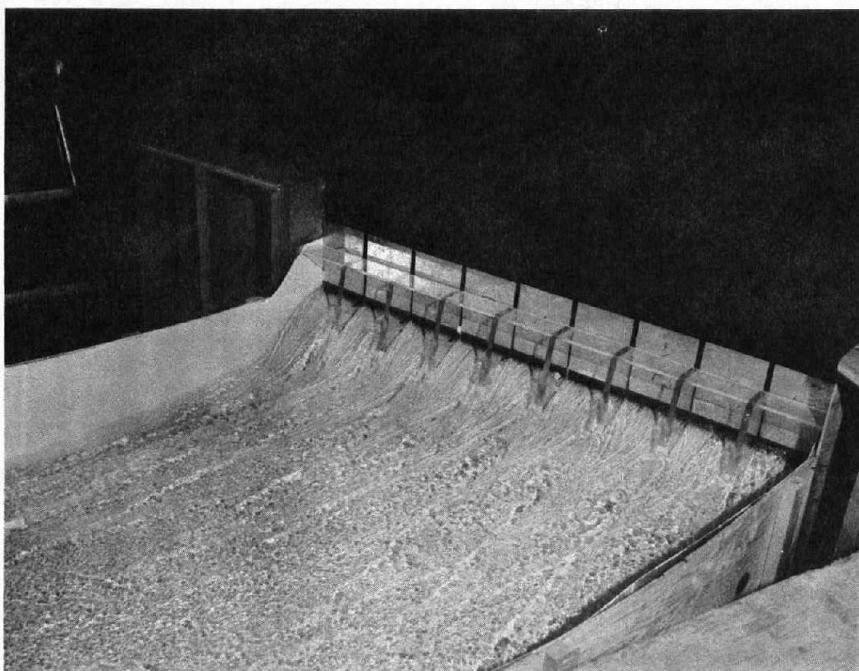
Figure 6. Hydraulic model. Photos P25-D-75889 and P25-D-75890.

Photographs of the model are shown in figure 6. The slide gates were constructed from sheet metal, the piers were made of plastic, the spillway of a sand and epoxy concrete placed on a sheet metal frame, the box and dam of wood, and the topography of layered styrofoam. Use of the styrofoam in the topography construction had several advantages over previously used wood and concrete construction. It allowed considerably more detail to be placed in the topography. Detail was important in this particular study because of the concern with flow conditions over the poor rock zones and the need for detailed descriptions of the flow patterns. In addition, sections of the topography could be removed with a knife or saw and reattached with glue or wood screws. For this study, where many modifications were made to the topography, this ease of modification was essential. The styrofoam also allowed the placement of piezometers in the topography and, consequently, the direct measurement of impact pressures.

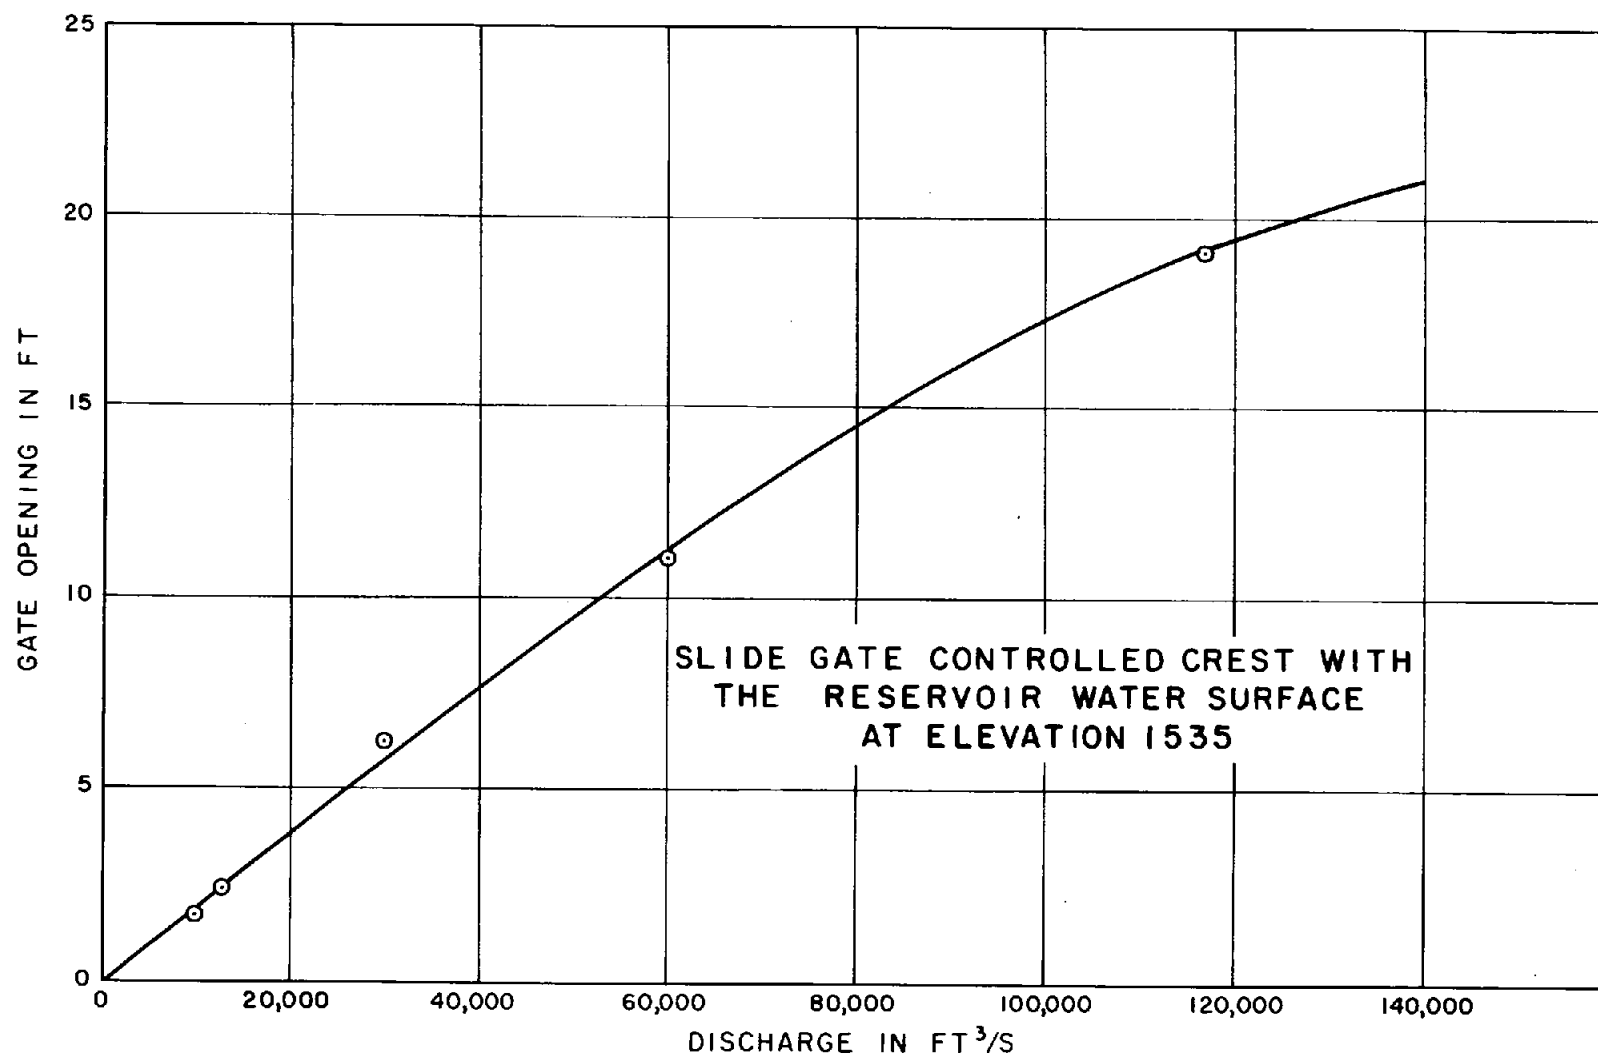
Figure 8. Spillway calibration.

The first step in the model study was calibration of the spillway crest. Because the spillway is assumed to operate with the reservoir water surface at maximum elevation and with all gates open equally, the calibration became an exercise in determining the correct gate opening to pass each discharge. The curve obtained is shown in figure 8.

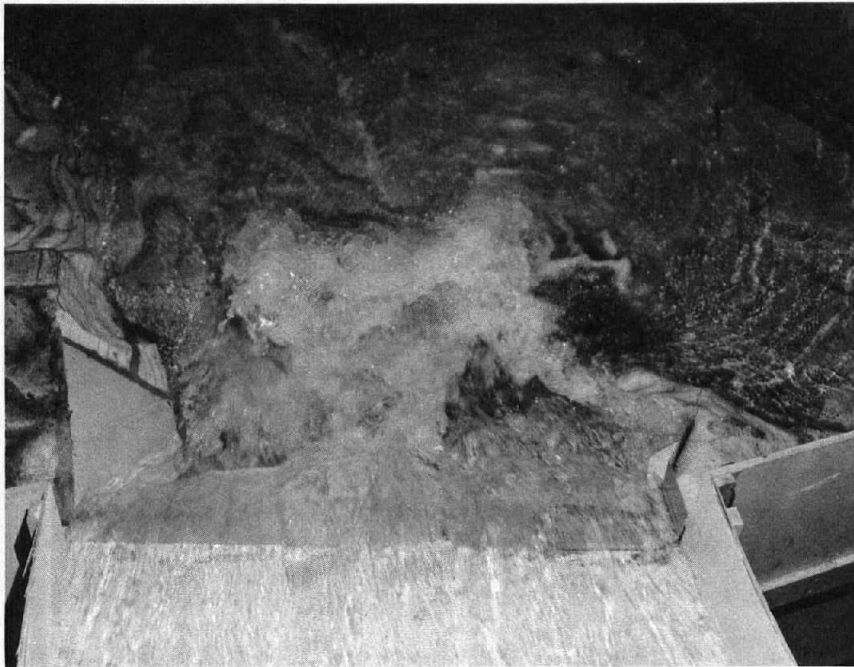
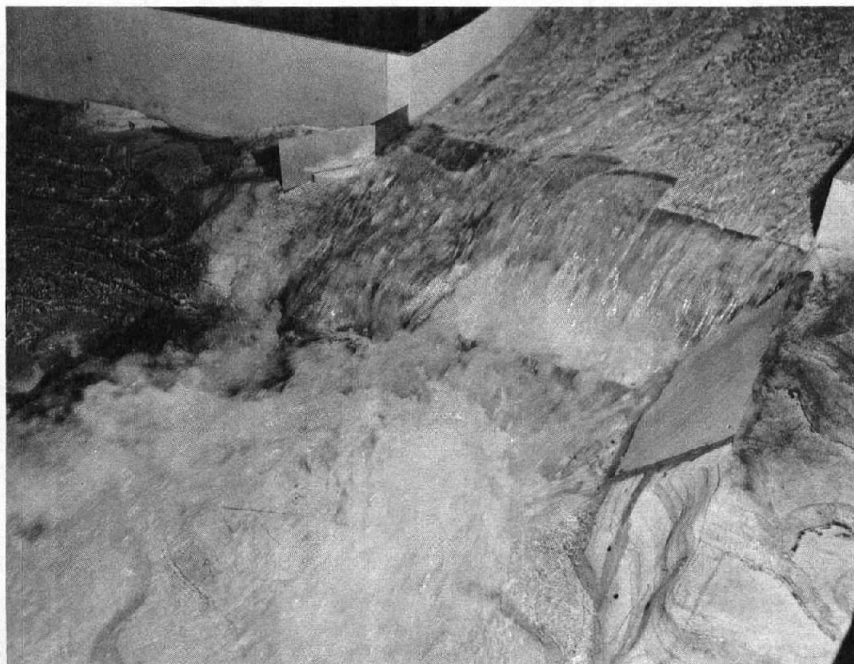
Figure 10. Operating toothed flip. Photos P25-D-75891 and P25-D-75892.

A second modification was the placement of a flip structure at or near the end of the chute. Two basic flip structure configurations were considered. Performance of the flips were evaluated visually and no physical measurements of the flow conditions were made. One configuration (fig. 9) consisted of a series of wedge-shaped blocks that were oriented so that the flow was deflected farther downstream and to the right. Generally, for the blocks to significantly deflect the flow to the right, their height and size must be quite large (5 feet (1.52 m) high and 10 to 15 feet (3.0 to 4.6 m) long or longer). Even with this size blocks, moderate and large discharges climbed the blocks and passed downstream with only a small deflection (fig. 10). Discharges above 20,000 ft<sup>3</sup>/s (566 m<sup>3</sup>/s) had too much mass, velocity, and total momentum to be easily turned. The smaller discharges were turned through greater angles, but because their trajectory lengths were short, displacement of the flow to the right was still relatively small. The second configuration considered was a solid triangular sill that ran the complete length of the

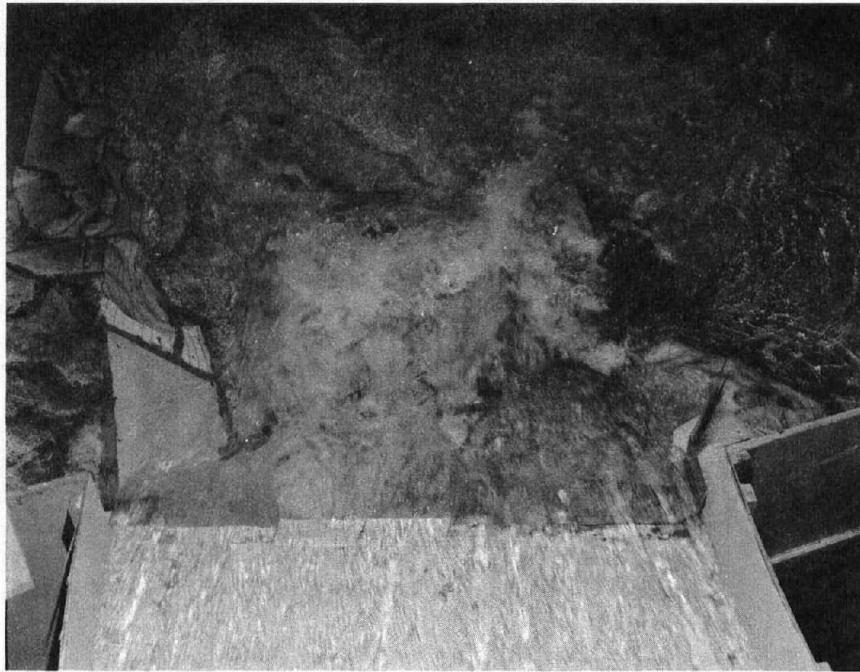
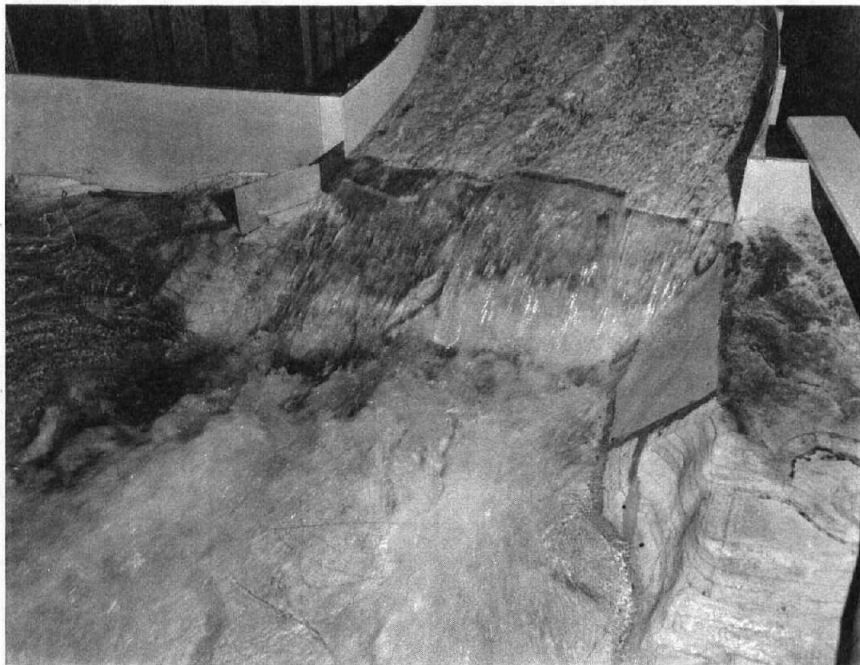
Figure 11. Operating solid flip. Photos P25-D-75893 and P25-D-75894.

chute lip (fig. 9). This configuration did not deflect the flow to the right (fig. 11), but both the toothed and solid flip structures do throw the flow farther downstream. This resulted in the impact zones being moved farther away from the chute structure for any given discharge. Shifts in the location of the impact zone generally ranged between 10 and 20 feet (3.0 and 6.1 m) and did not significantly improve the flow conditions. Because an entire range of discharges was considered in the model test, the flow still impacted over the same surfaces. It should also be noted that because the elevation drop from the chute lip to the rock is basically fixed, the vertical component of the velocity that results from the drop is also relatively constant. The angle of impingement is, in most cases, somewhat steeper but not greatly changed by the flip structure. The result with either flip configuration is flow patterns that are similar to patterns observed without the flip structures. The impact and flow velocity conditions across the poor quality rock were not significantly improved.

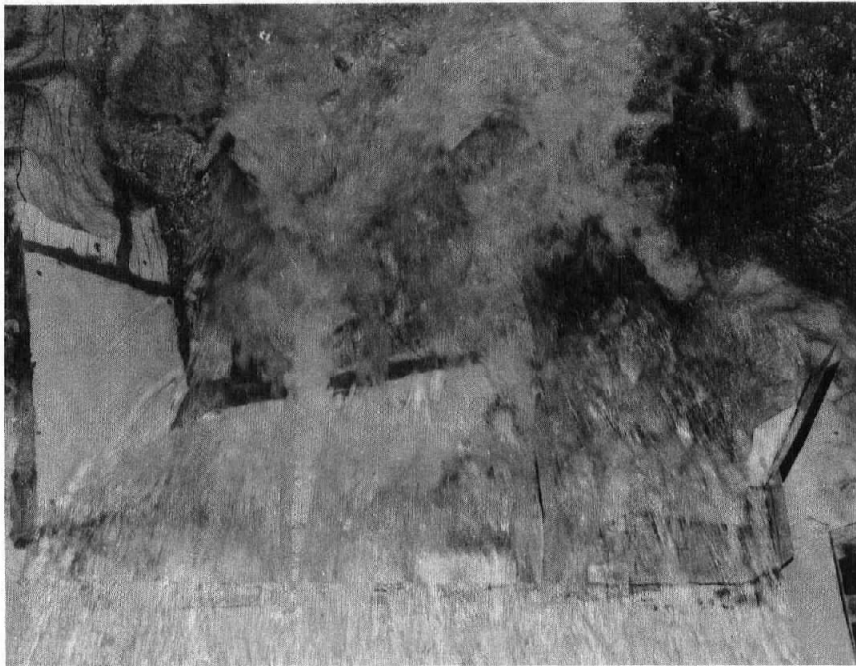
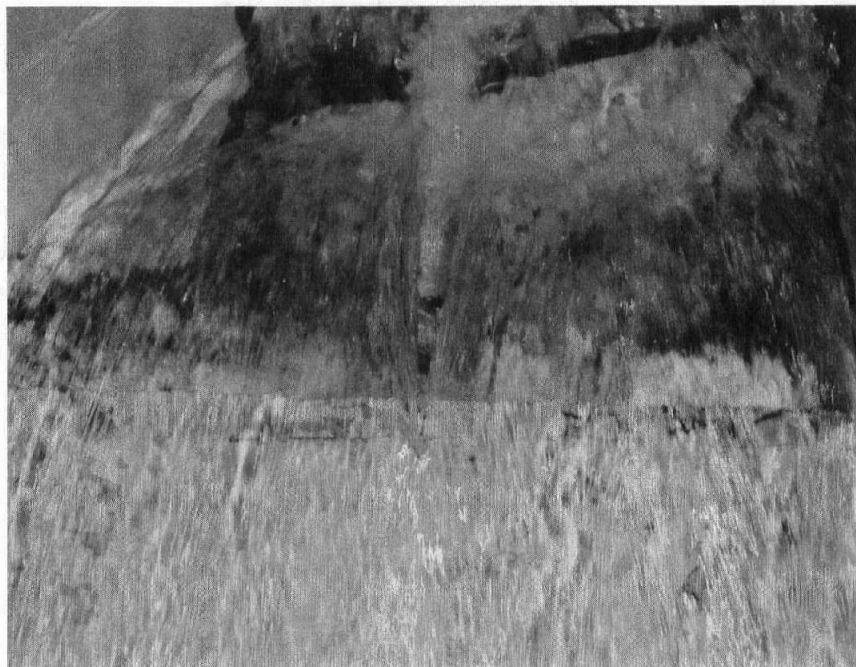
Figure 18. Splitter piers operating. Photos P25-D-75896 and P25-D-75897.

flow could be divided by a lead pier (similar to pier (e)) and that a second smaller pier at the chute lip could be used to divide the shallow flows in the wake. The second pier would be subject to much smaller forces than the lead pier. Piers (b), (c), (f), and (g) as well as intermediate-shaped piers between (c) and (g) were based on this concept. All these designs were suitable for discharges between 25,000 and 60,000 ft<sup>3</sup>/s (708 and 1,700 m<sup>3</sup>/s). At discharges below 25,000 ft<sup>3</sup>/s (708 m<sup>3</sup>/s), the superelevation of the chute caused the flow to approach the piers from the side. This action increased as the discharge decreased for observed flows down to about 8,000 ft<sup>3</sup>/s (227 m<sup>3</sup>/s). The resulting crossflow and fins resealed the opening for piers (b), (c), and (f). Pier (g), however, was suitable for these conditions as well as at discharges up to 140,000 ft<sup>3</sup>/s (3,960 m<sup>3</sup>/s) (fig. 18). The maximum velocities past the piers were approximately 60 ft/s (18.3 m/s). Two piers located at the third points across the chute were considered adequate.

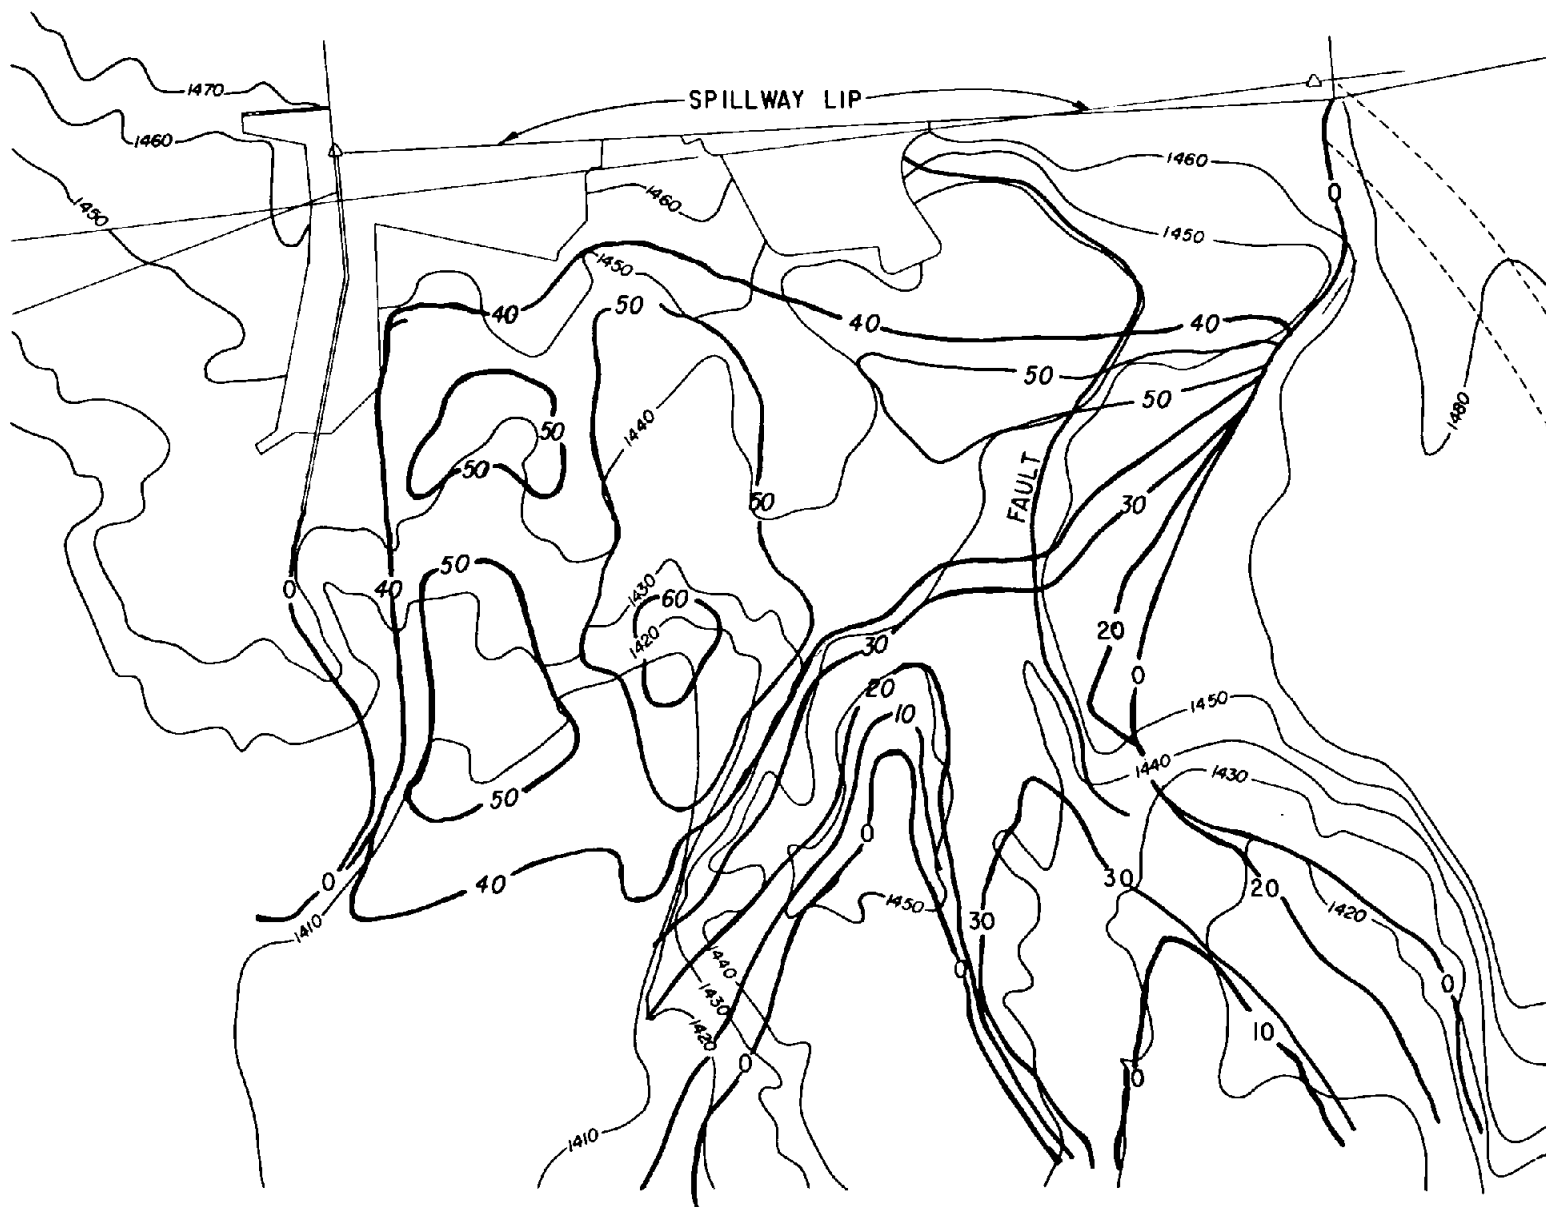
Figure A-4. Velocity contours for a discharge of 30,000 ft<sup>3</sup>/s (initial model topography).

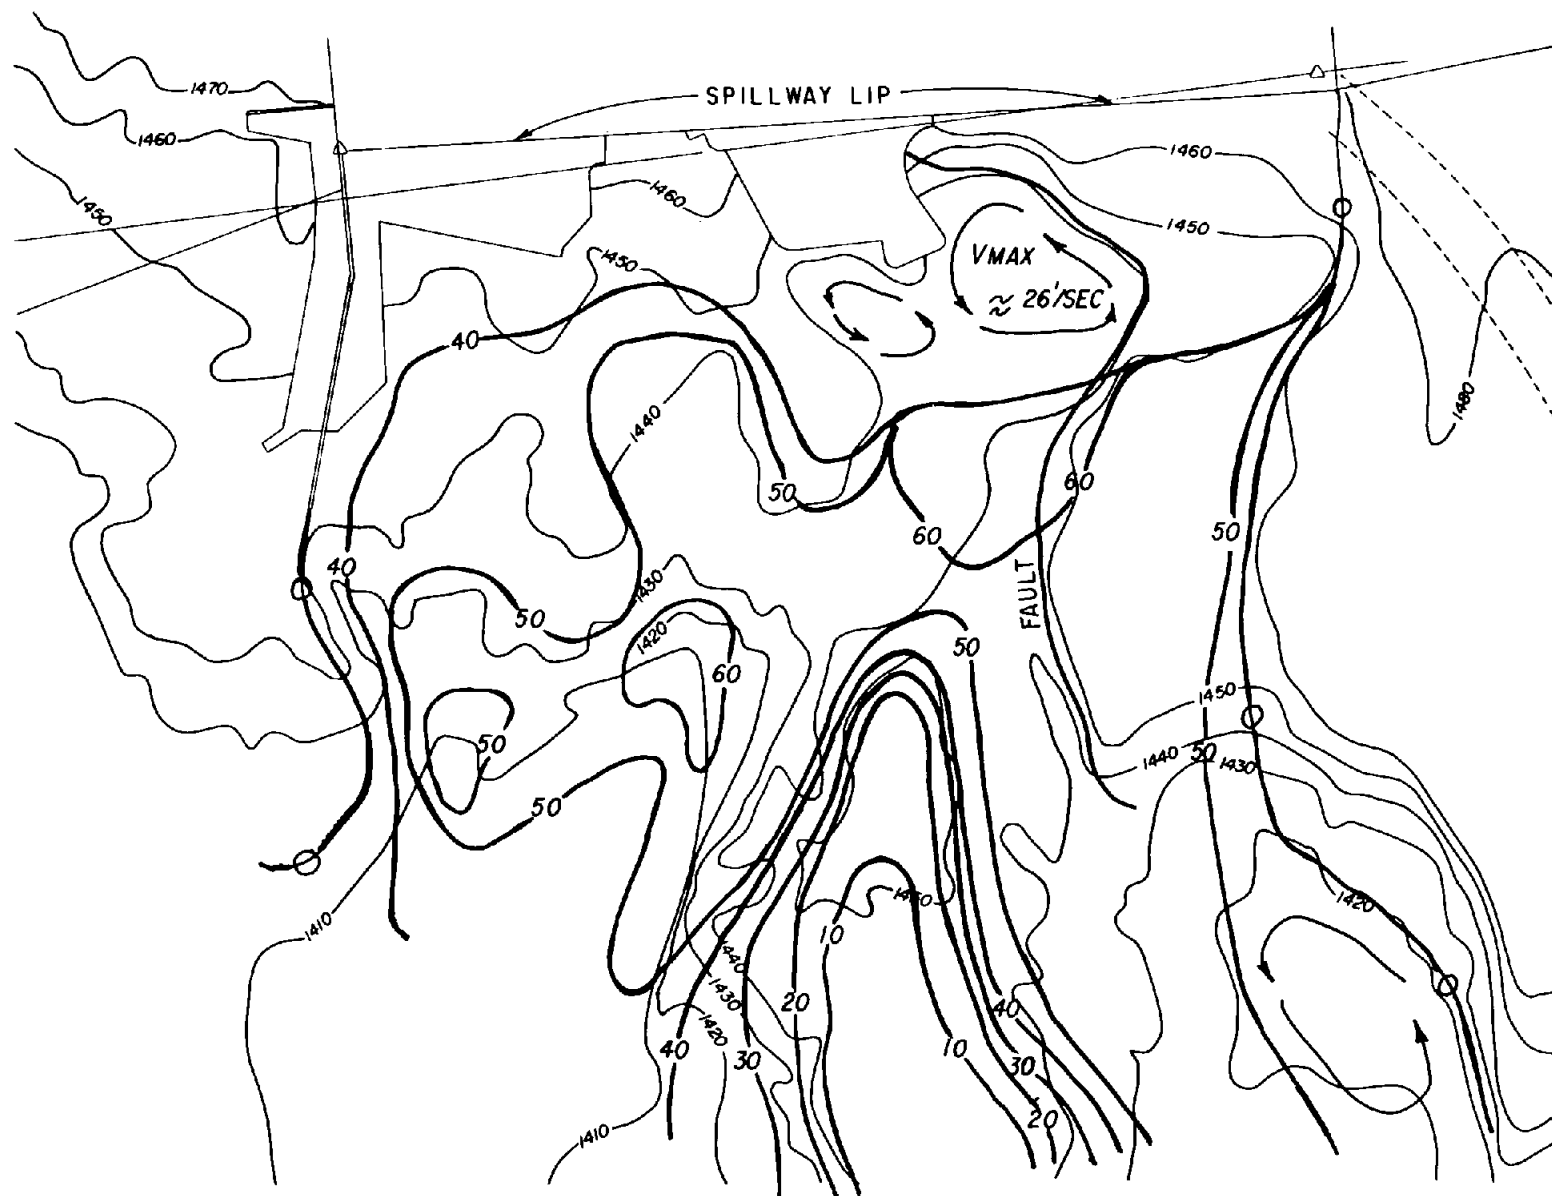
Figure A-6. Velocity contours for a discharge of 60,000 ft<sup>3</sup>/s (initial model topography).

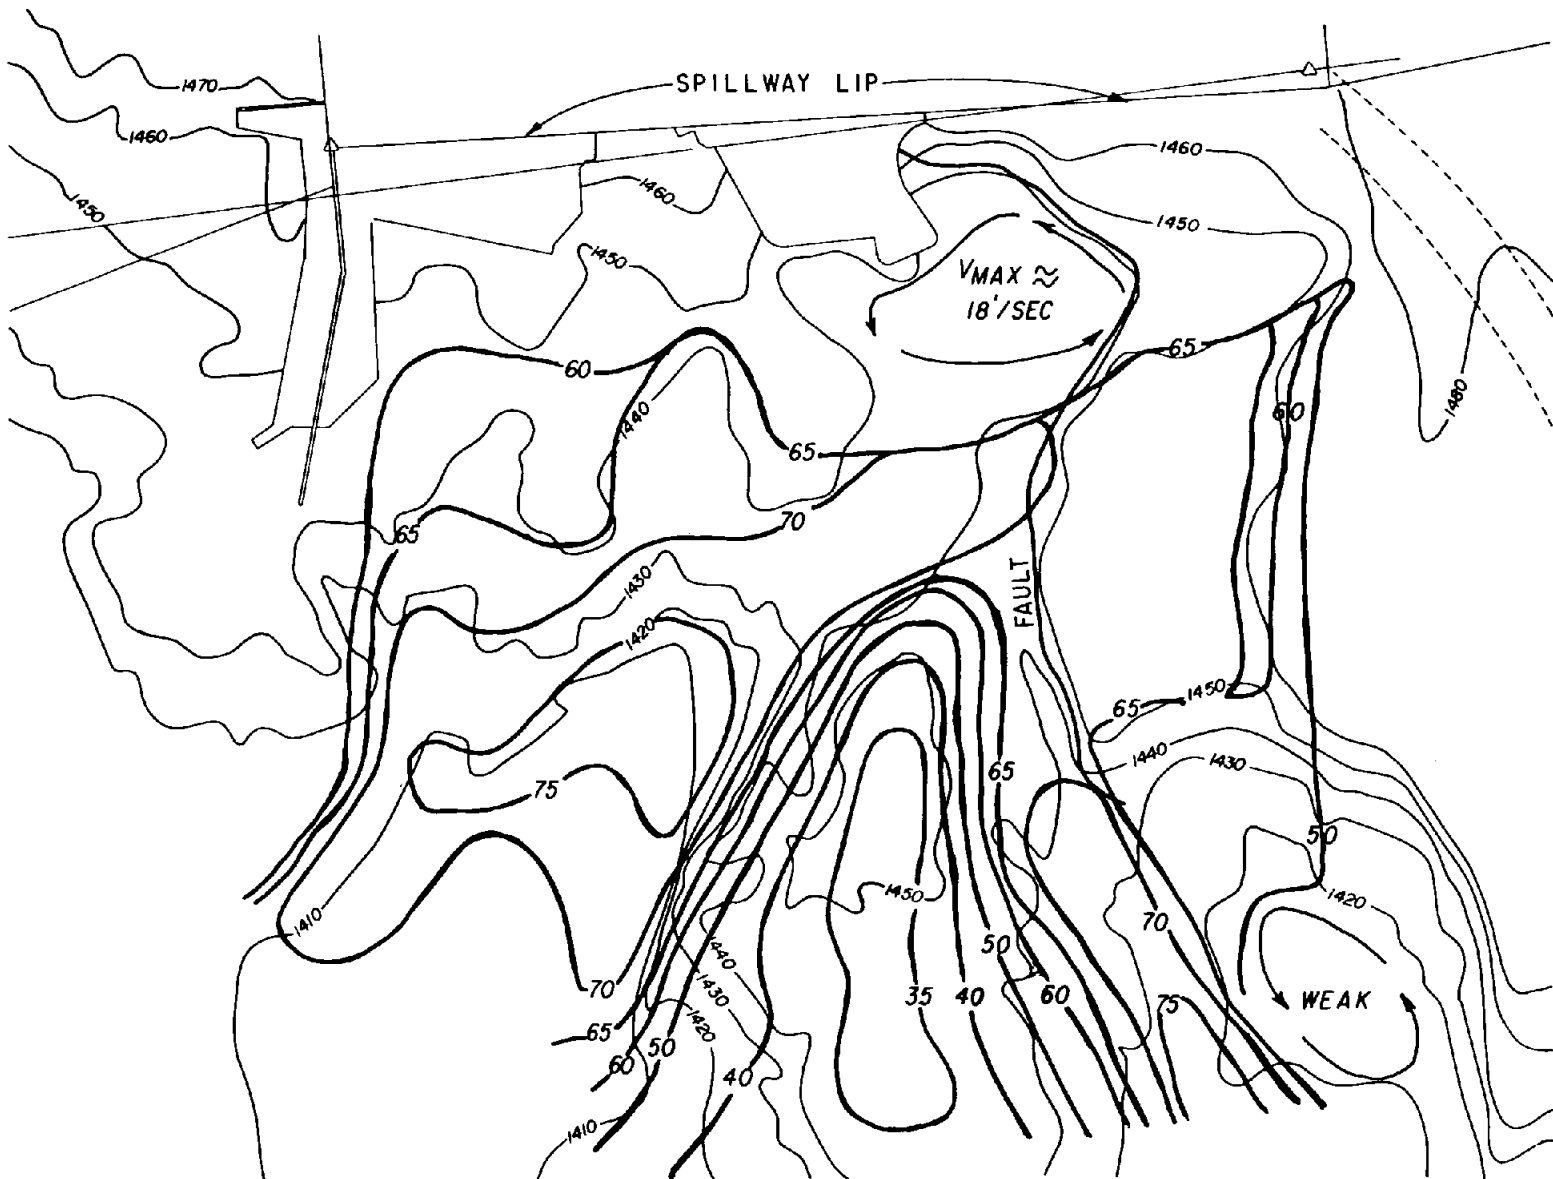
Figure A-8. Velocity contours for a discharge of 140,000 ft<sup>3</sup>/s (initial model topography).
