HYDRAULIC MODEL STUDY OF BRANTLEY DAM SPILLWAY

*May 1987
Engineering and Research Center*

U.S. Department of the Interior
Bureau of Reclamation
Division of Research and
Laboratory Services
Hydraulics Branch

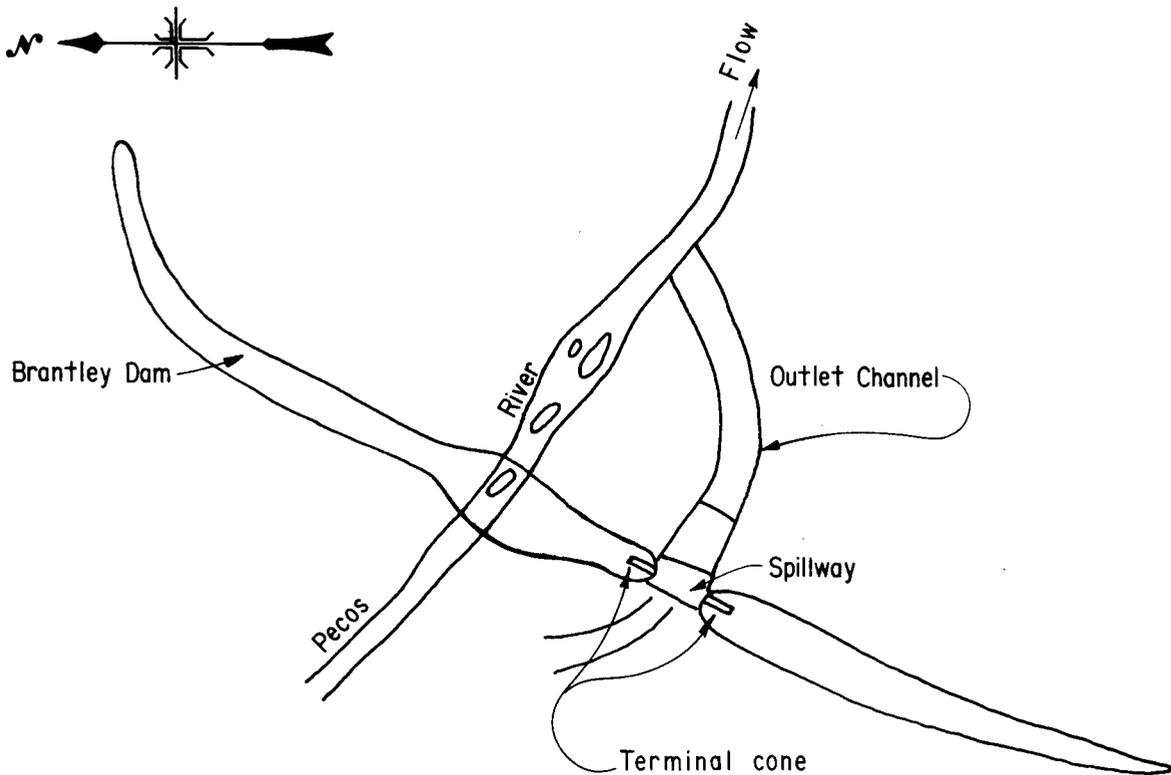
(b) General plan.

Figure 1. – Location of Brantley Dam.

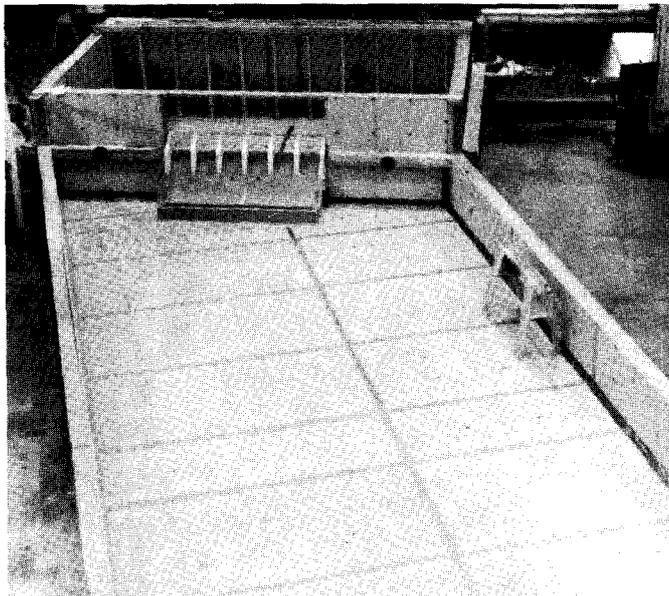
(a) Model headbox and tailbox. P801-D-81129.

Figure 2. – The model.

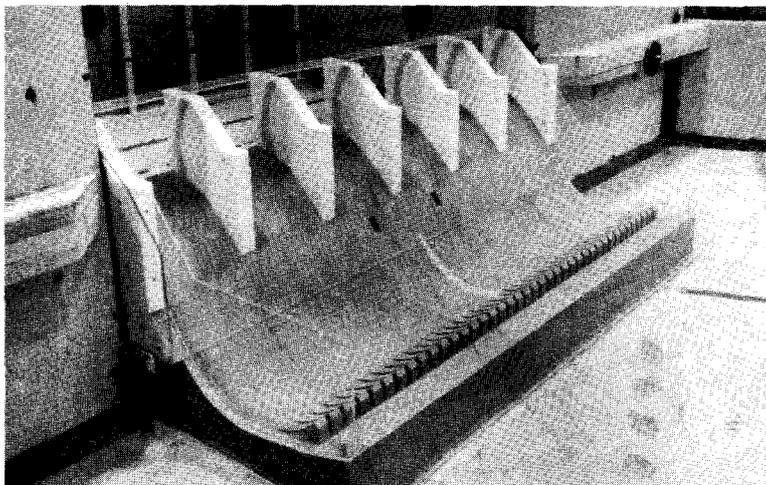
(b) Model spillway with slotted bucket energy dissipator. P801-D-81130.

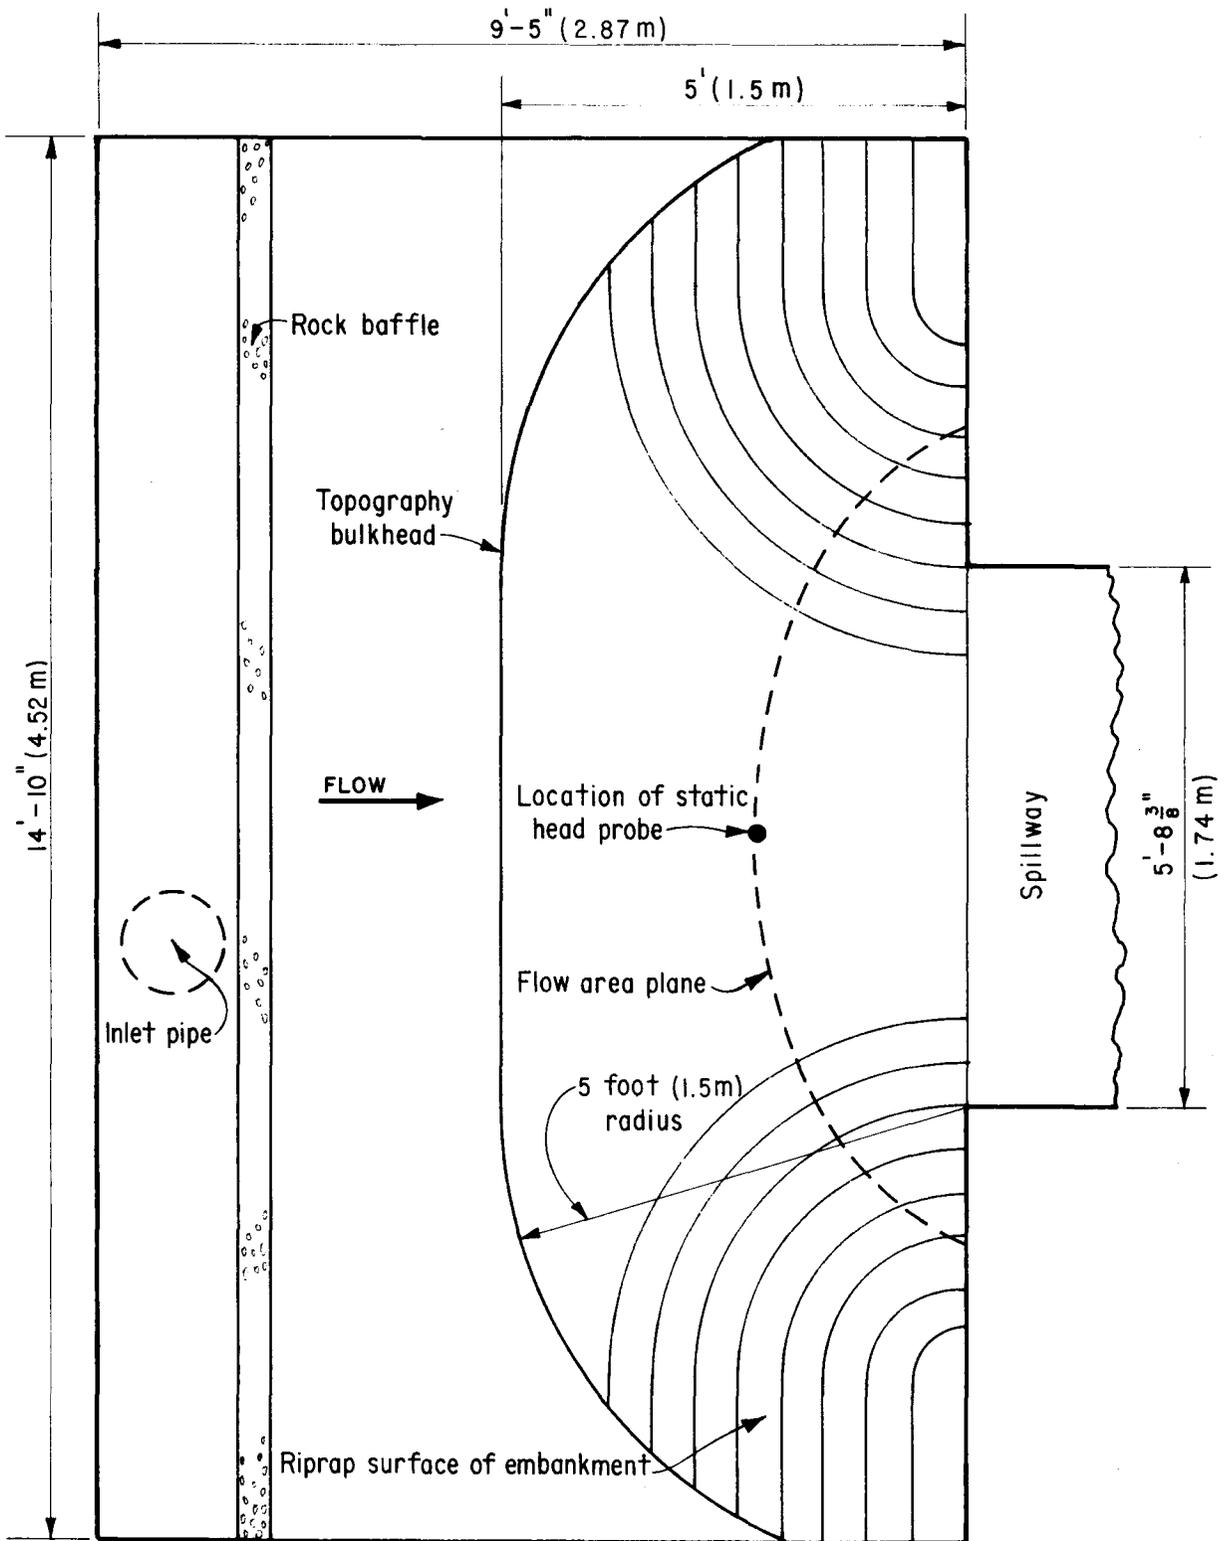
Figure 3. – Model headbox.

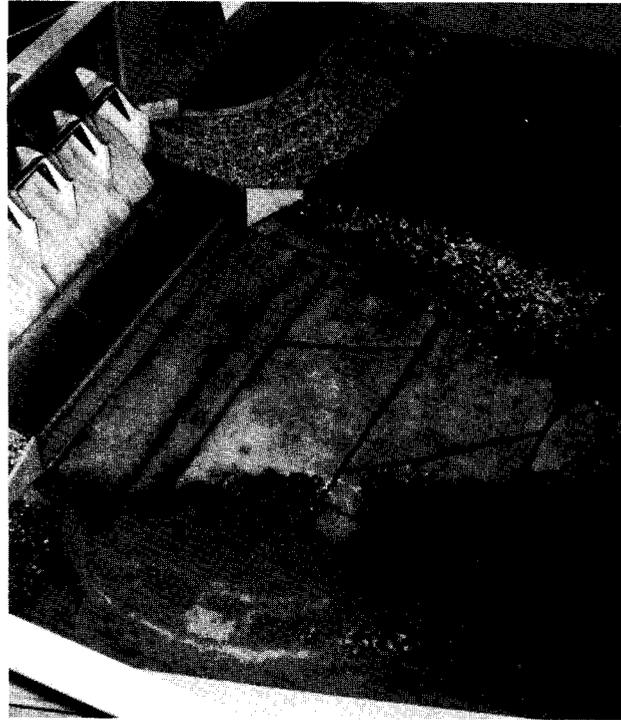
Figure 4. – Topography in model tailbox after erosion test No. 1. P801-D-81131

The initial erosion test was made with the preliminary design configuration using 3-foot (0.9-m) riprap on each side of the tailwater channel, from the wingwall, 400 feet (122 m) downstream to the outlet channel. A 324,000-ft³/s (9175-m³/s) flood flow rapidly destroyed the tailwater channel and outlet channel and endangered the terminal cone of the embankment dam near the spillway. The erodible bed was flushed off the concrete mortar downstream from the spillway tailwater channel, figure 4.

This erosion test provided information for the recommended design. The tailwater elevation was above the riprapped side slope and sand eroded from behind the riprap, which caused riprap failure (note each side of tailwater channel on fig. 4). Either the riprapped side slope should extend above the water surface or additional riprap should be placed on the flat surface above the side slope to prevent erosion of the material from back of the riprap. Much of the riprapped side slope did not rest on bedrock, but was on the erodible material. Flow velocities readily eroded this material, undermining the riprap. Therefore, the riprapped side slope should rest on bedrock to prevent this type of failure. Flow velocities removed the sand from the bedrock for a considerable distance downstream from the spillway. Protecting the flood plain from erosion would be prohibitively expensive; however, the flood plain erosion had a compensating effect in that the larger flow area reduced velocities. The economical design for the spillway tailwater channel and spillway outlet channel appeared to be one that would allow erosion of the downstream flood plain and also provide riprapped berms to protect the terminal cone of the zoned earthfill dam.

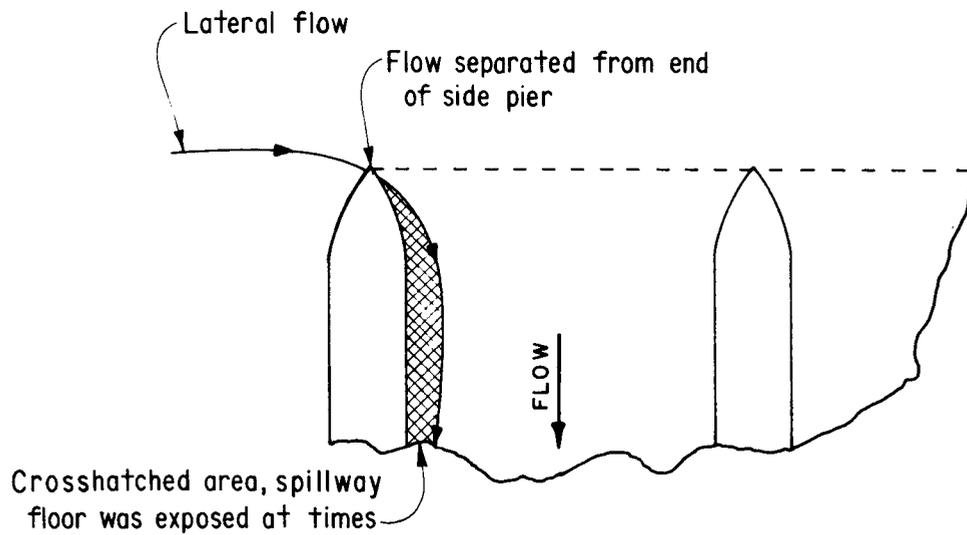
Figure 5. – Schematic of side pier flow separation.

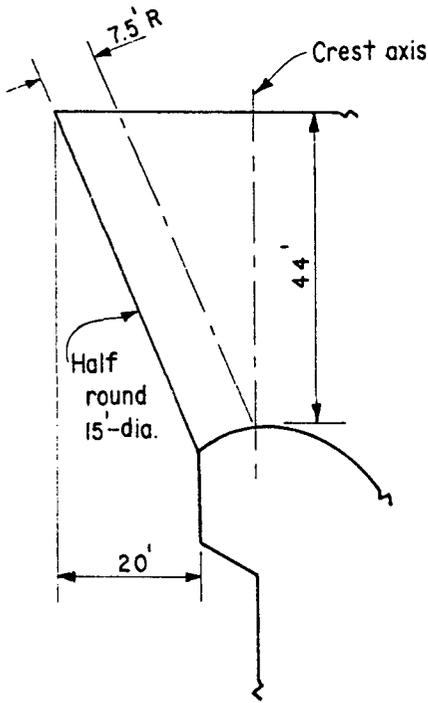
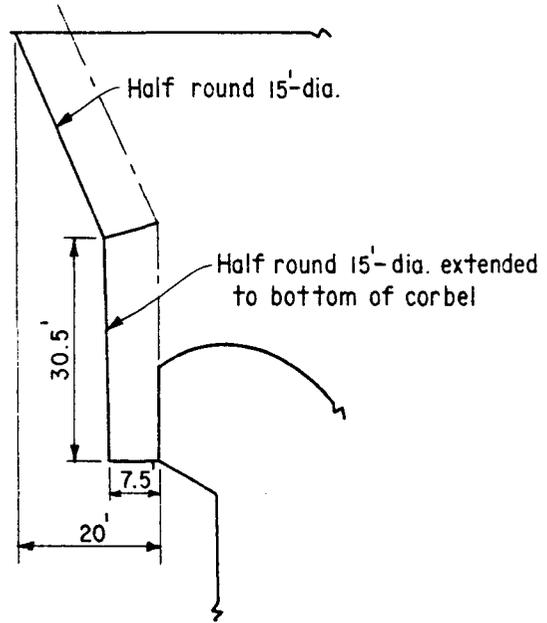
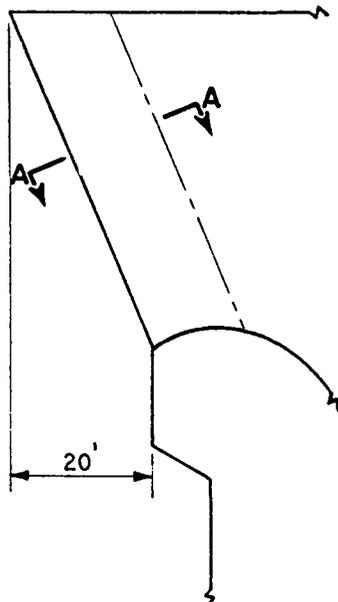
MODIFICATION No. 1

MODIFICATION No. 2

MODIFICATION No. 3

Figure 6. - Side pier modifications.

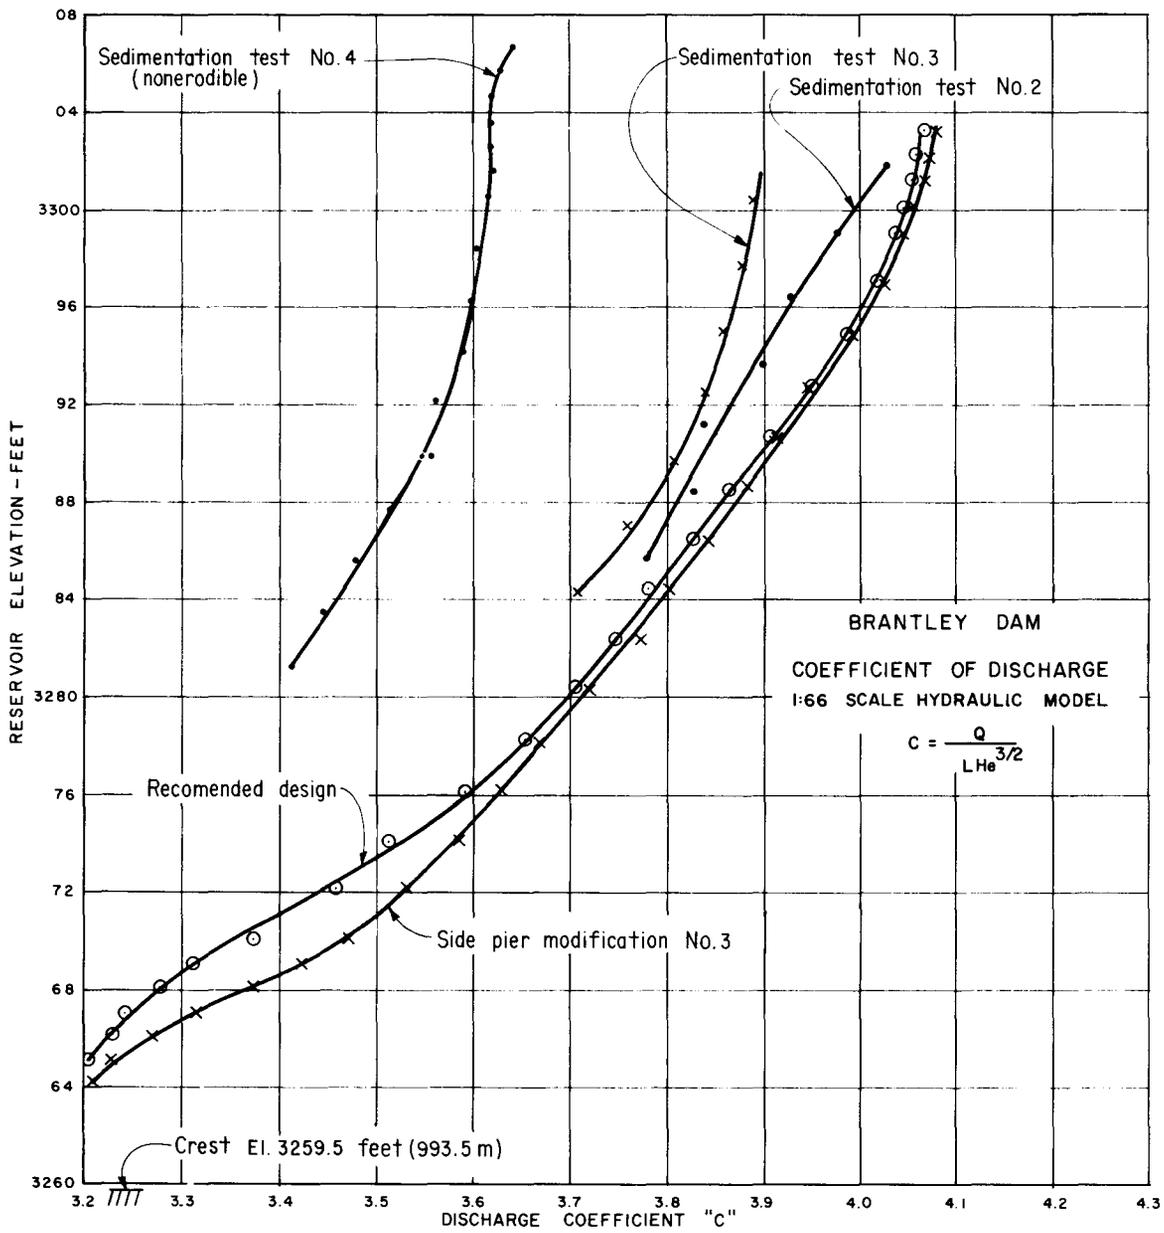
Figure 8. - Coefficient of discharge.

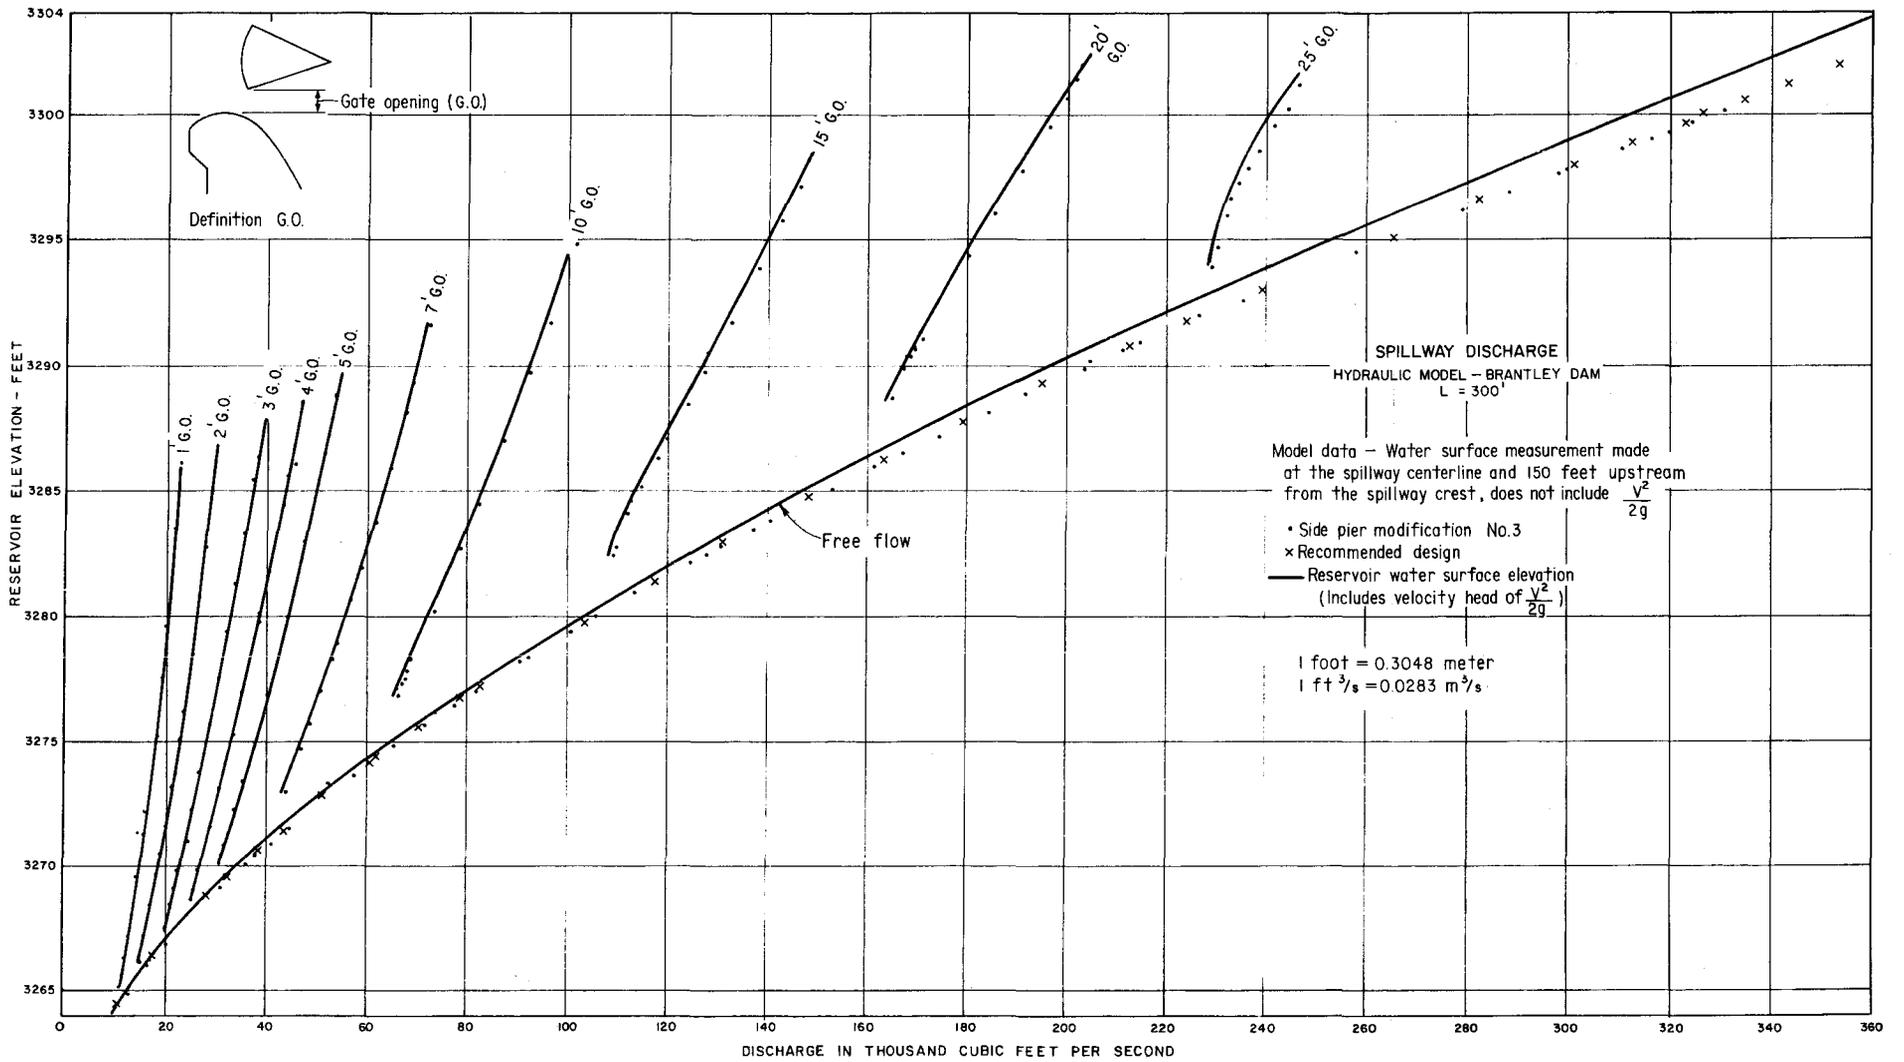
Figure 9. - Spillway discharge.

Model tests were made with different gate openings to obtain discharge ratings, figure 9. Note that the G.O. (gate opening) is defined as "the vertical distance from the crest to the bottom of the gate."

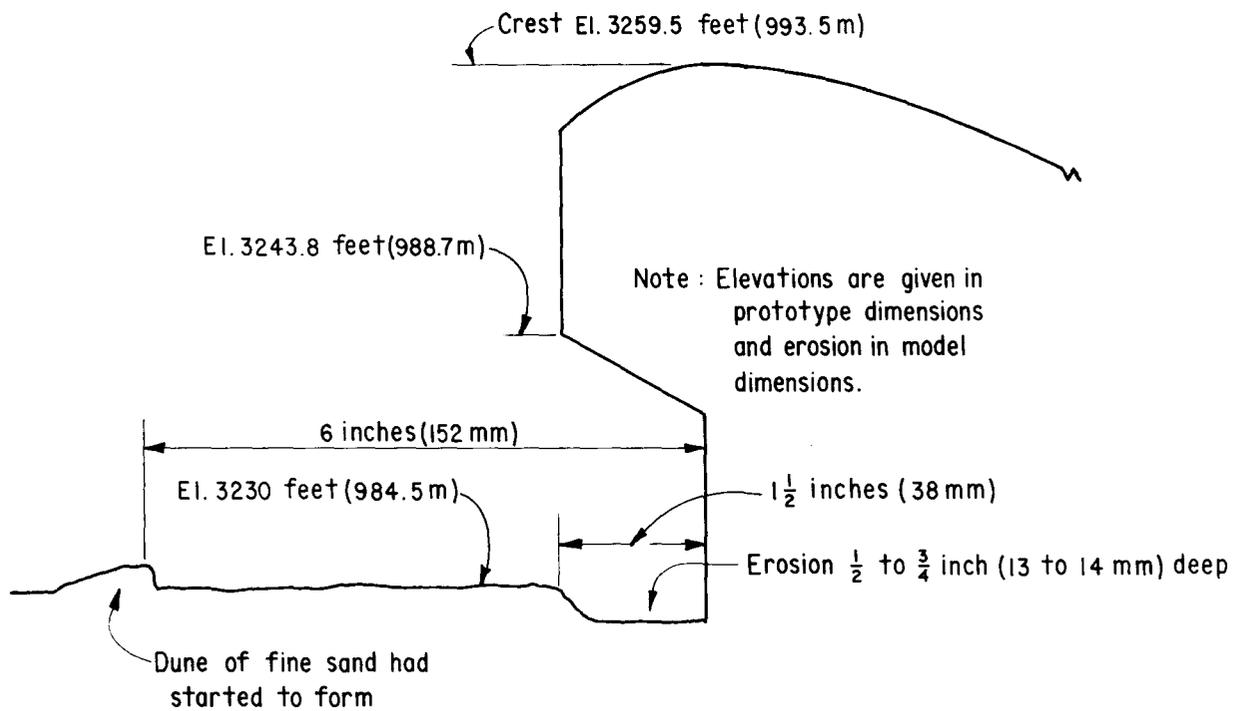
Figure 10. – Sediment test No. 1.

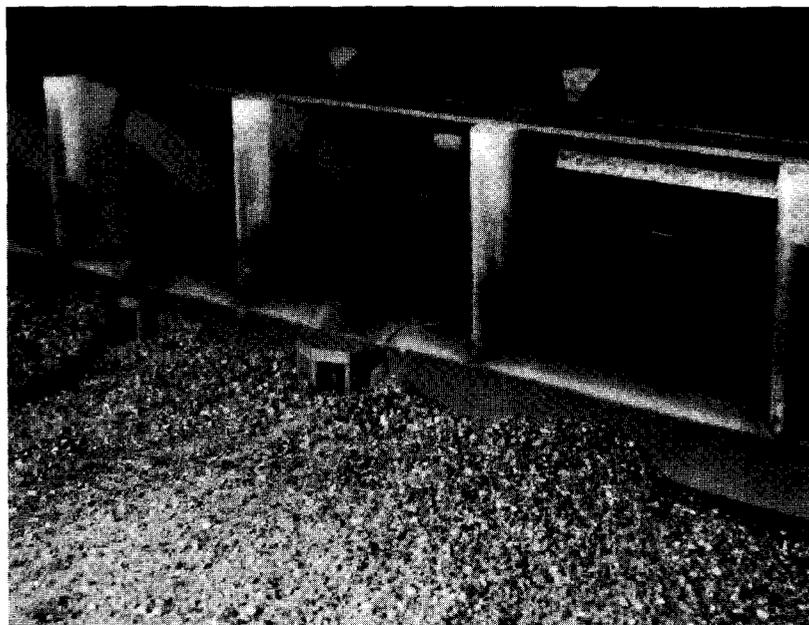
Figure 11. – Sediment test No. 2. P801-D-81132.

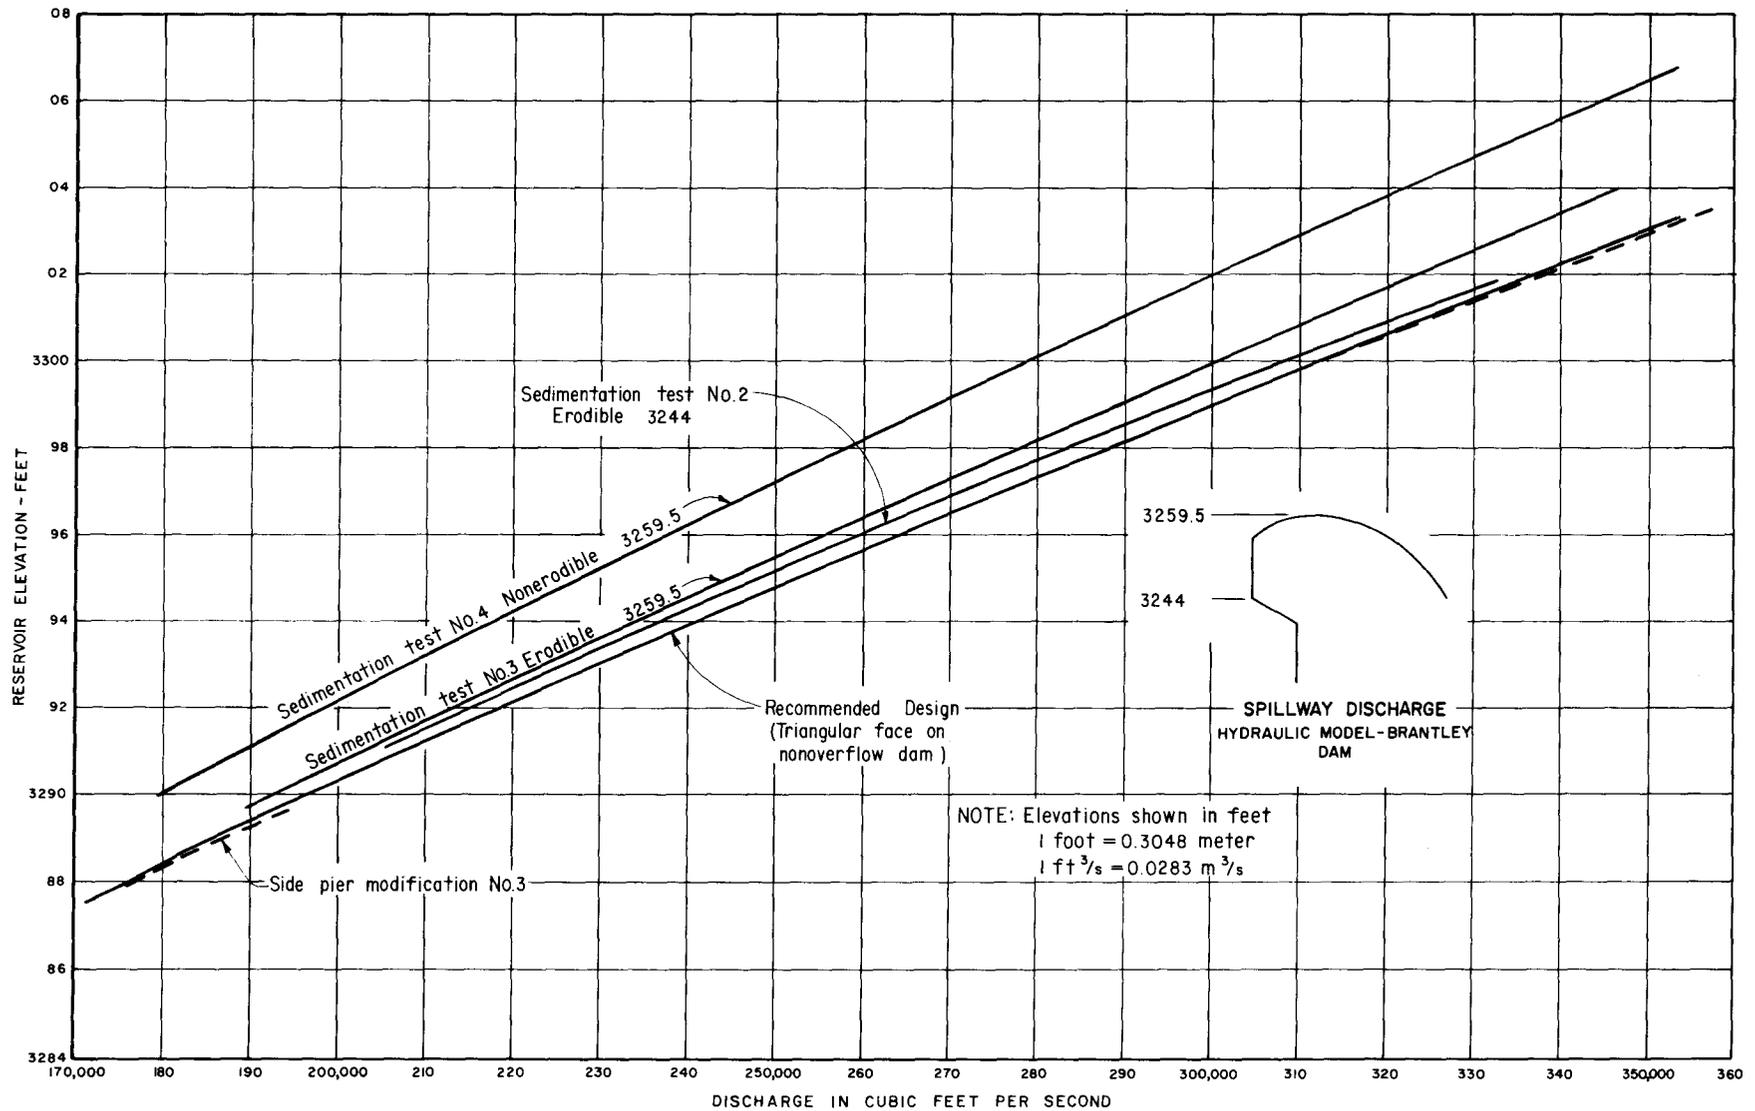
Figure 12. - Effect of reservoir sedimentation on spillway discharge.

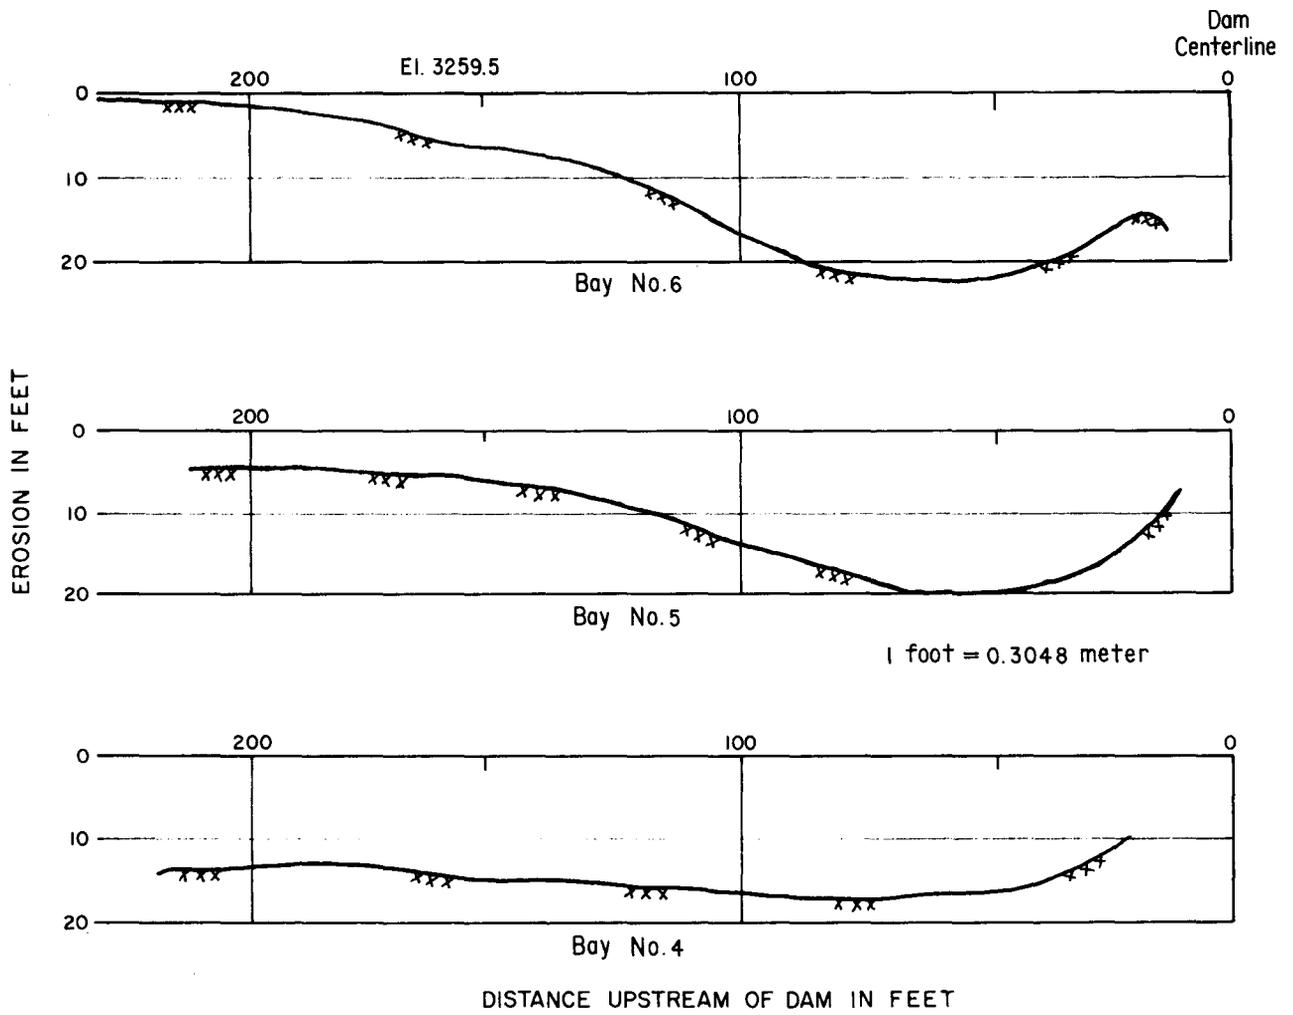
Figure 13. - Erosion for sediment test No. 3.

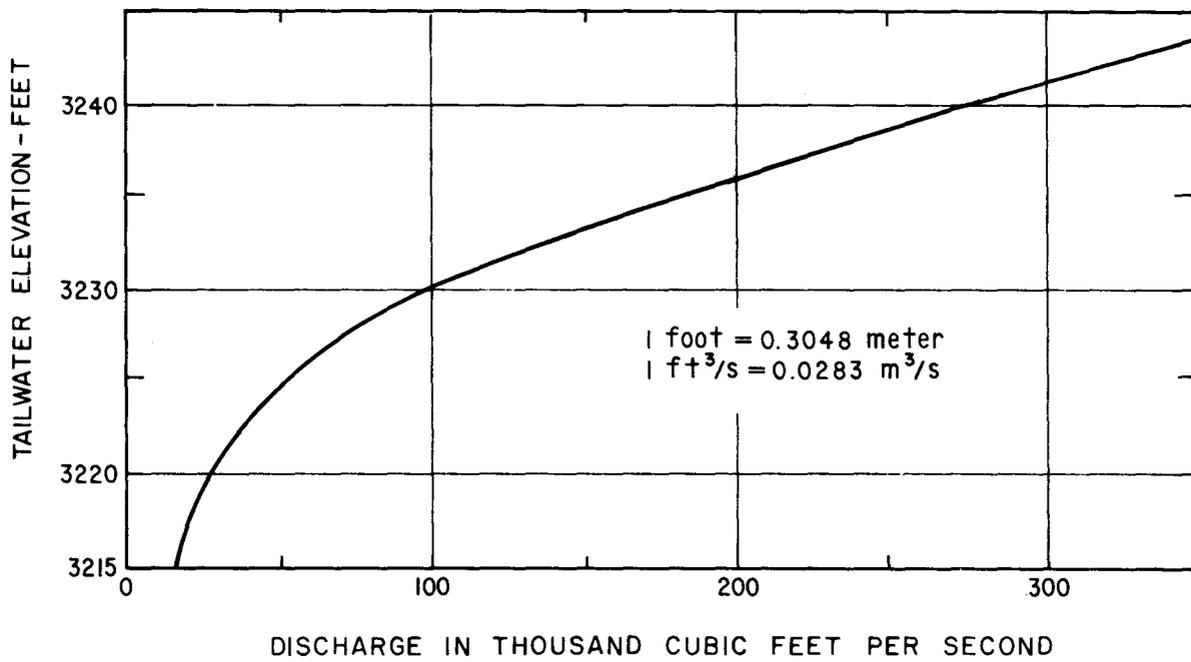
Figure 14. - Discharge - tailwater elevation.

The top elevation of the slotted bucket side walls was 3238.5 feet (987.1 m). At high discharges, water will flow over the side walls into the slotted bucket (tailwater curve, fig. 14). Note the water level in back of left wingwall of slotted bucket, figures 15(c) and 16(a).

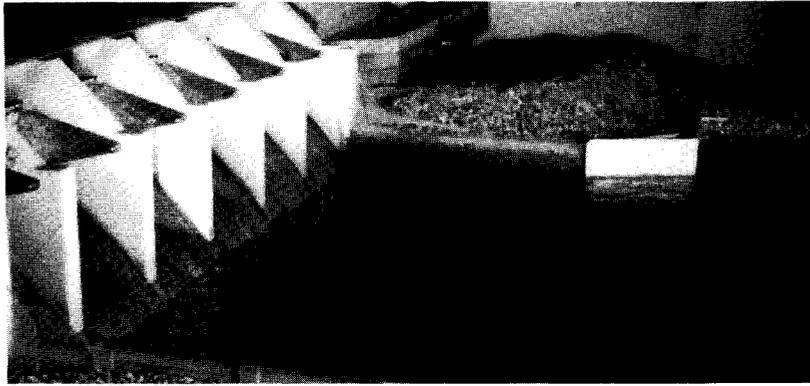
(a) Tailwater El. 3225 feet (983.0 m), $Q = 30,000 \text{ ft}^3/\text{s}$ ($850 \text{ m}^3/\text{s}$). P801-D-81133.

Figure 15. – Slotted bucket flows.

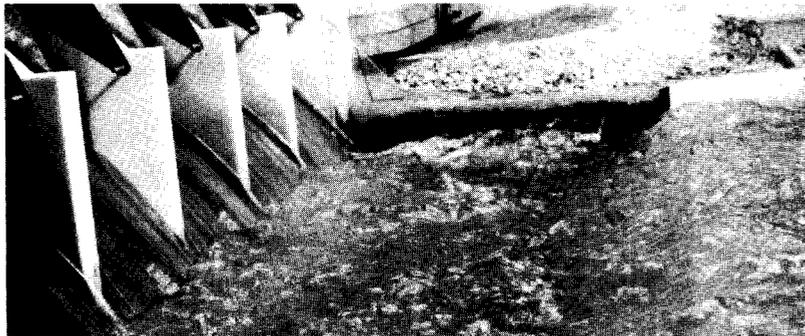
(b) Tailwater El. 3230 feet (984.5 m), $Q = 100,000 \text{ ft}^3/\text{s}$ ($2832 \text{ m}^3/\text{s}$). P801-D-81134.

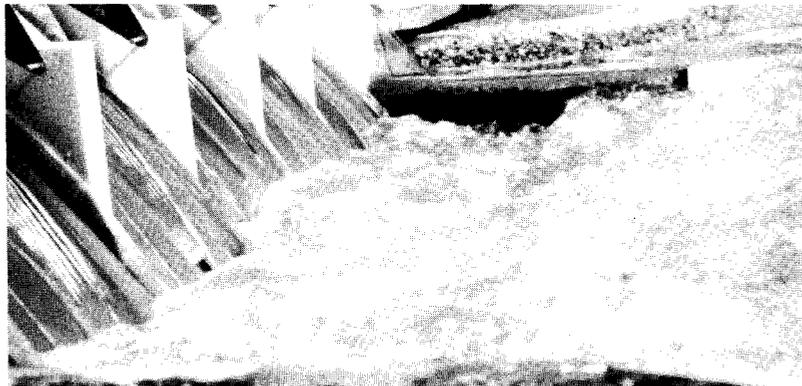
(c) Tailwater El. 3239 feet (987.2 m), $Q = 250,000 \text{ ft}^3/\text{s}$ ($7079 \text{ m}^3/\text{s}$). P801-D-81135.

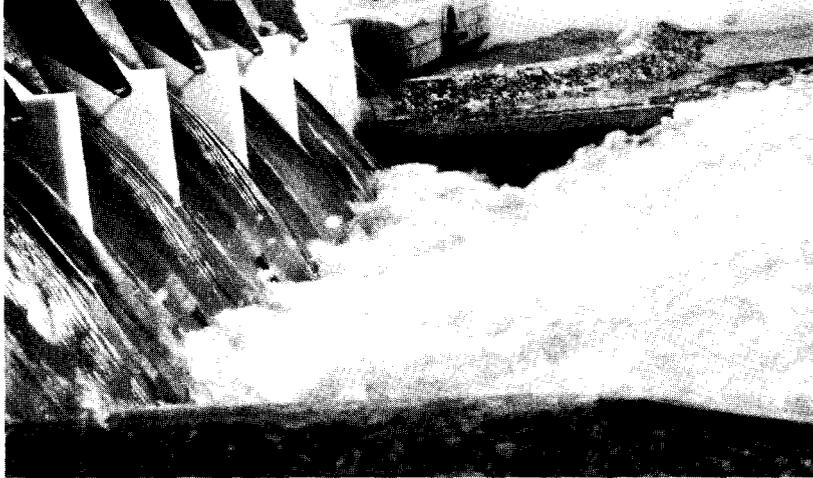
(a) Tailwater El. 3243 feet (988.5 m), $Q = 342,000 \text{ ft}^3/\text{s}$ ($9684 \text{ m}^3/\text{s}$). P801-D-81136.

Figure 16. – Slotted bucket flows at maximum discharges.

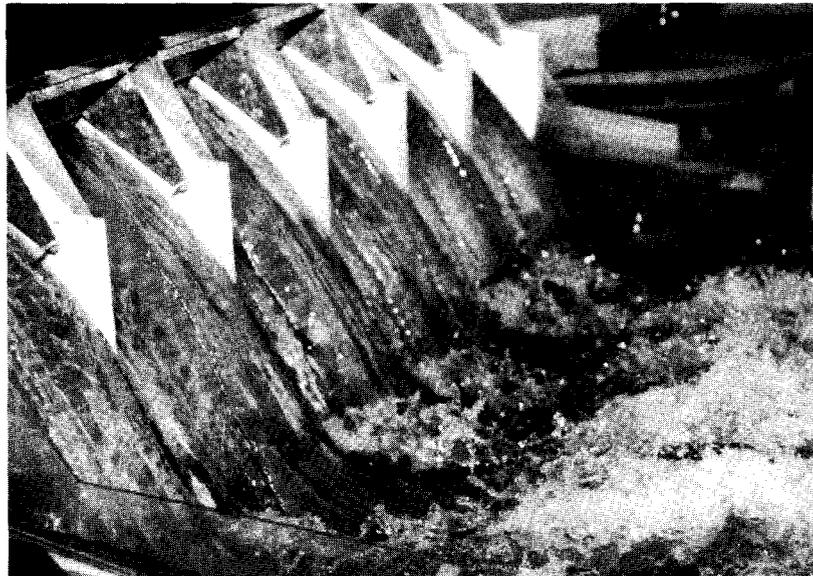
(b) "Sweepout", tailwater El. 3233 feet (985.4 m), $Q = 345,000 \text{ ft}^3/\text{s}$ ($9769 \text{ m}^3/\text{s}$). P801-D-81137.

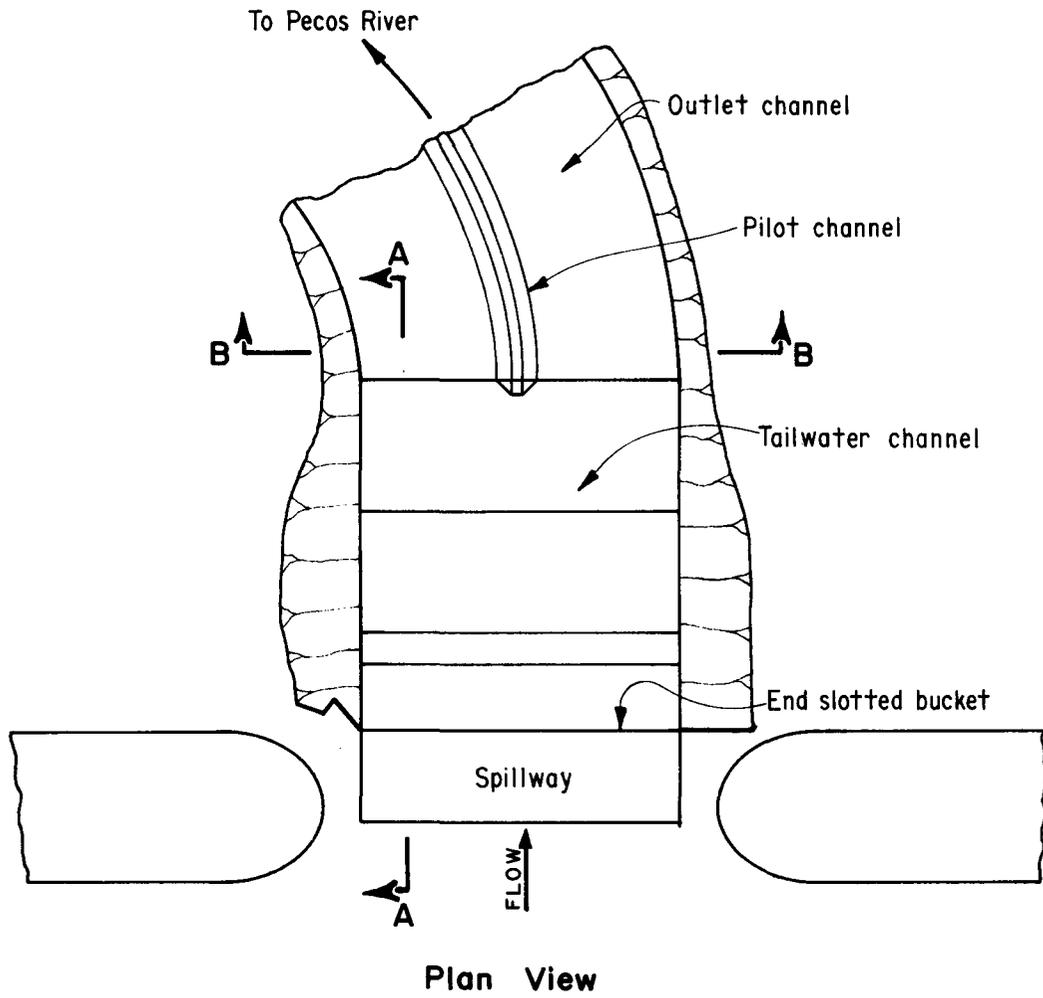
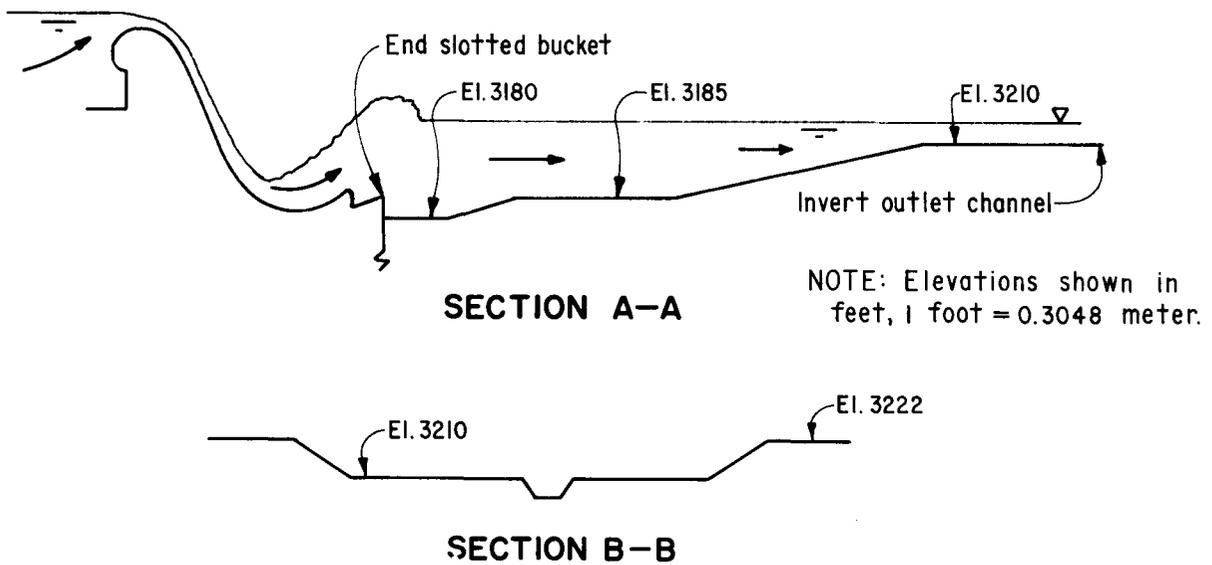
Figure 17. - Schematic of spillway tailwater channel and outlet channel - preliminary design.

Figure 17 is a schematic of the preliminary design spillway tailwater channel and outlet channel. The tailwater channel is located between the slotted bucket energy dissipator and the outlet channel. The elevation of the tailwater channel changes in the transition from the end of the bucket to the dual trapezoidal channels of the outlet channel, figure 17 section A-A. The pilot channel will handle outlet works flows up to 500 ft³/s (14.2 m³/s), and the larger trapezoidal channel will handle spillway flows up to about 30,000 ft³/s (850 m³/s). For discharges greater than 30,000 to 40,000 ft³/s (850 to 1133 m³/s), the water progressively spreads out over the flood plain. At 100,000-ft³/s (2832 m³/s) discharge, the water extends 1.5 miles (2.4 km) widthwise across the

The shapes of the wingwalls were developed from the model tests. For the preliminary design (fig. 17), the right wingwall was straight and at about a 90° angle from the stilling basin side wall. The left wingwall was at a 45° angle and then had a dog-leg farther out from the stilling basin side wall. Observations of model flow conditions indicated better performance with the left wingwall; i.e., smaller and less intense eddy action at the left side of the spillway tailwater channel. A 130-foot (39.6-m) long wingwall at a 45° angle was also tried on the right side; however, the left side still had better flow conditions. Next, the wingwall (recommended design as shown on fig. 18) was placed at the right side of the stilling basin. This configuration produced less intense eddy action than the two previous wingwalls.

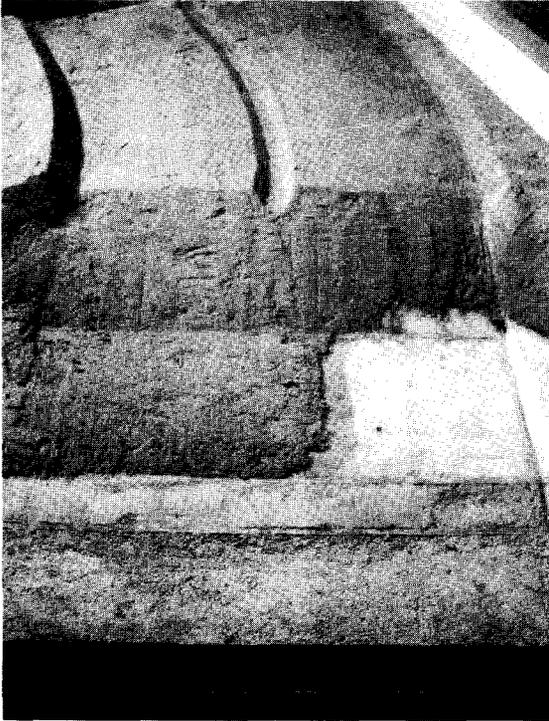
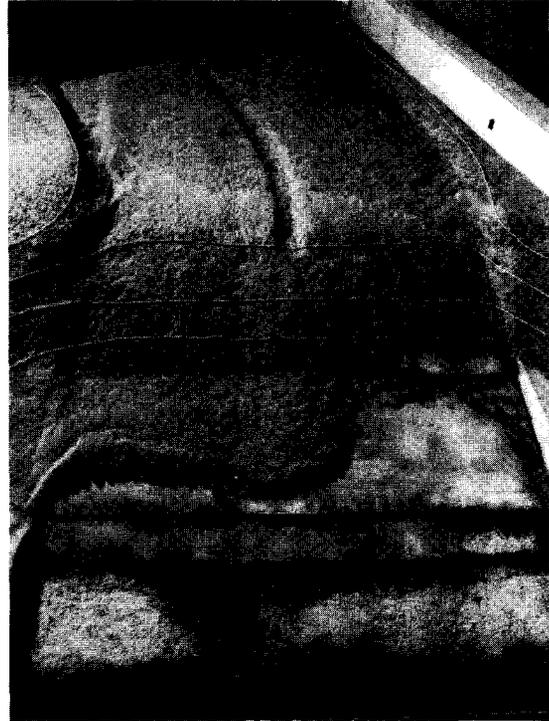
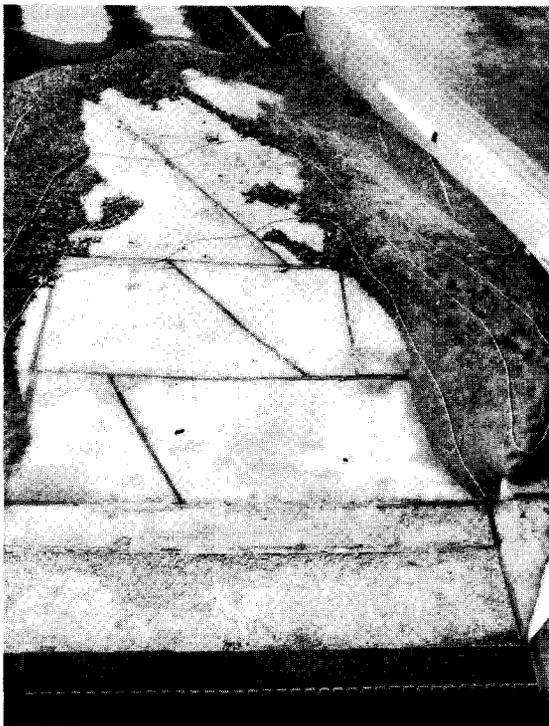
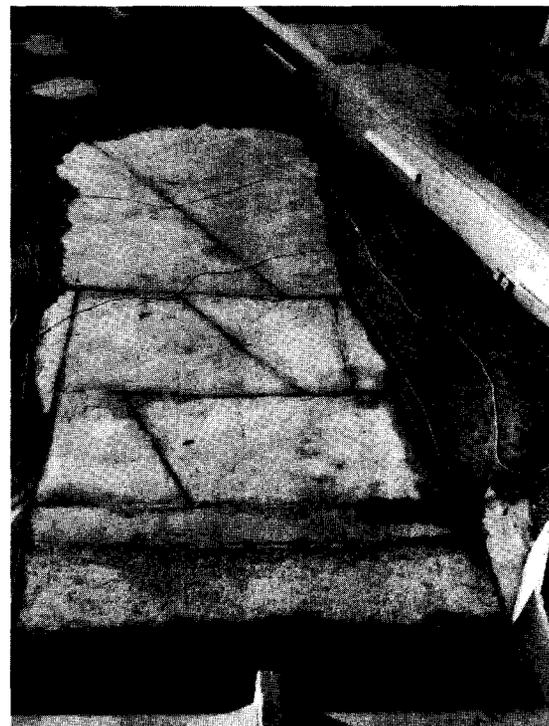
(a) Before. P801-D-81138.

(b) After 50,000 ft³/s (1416 m³/s). P801-D-81139.

(c) After 186,000 ft³/s (5267 m³/s). P801-D-81140.

(d) After 238,000 ft³/s (6739 m³/s). P801-D-81141.

Figure 19. – Erosion tests.

erosion occurred; and at 50,000 ft³/s (1416 m³/s), slight erosion occurred along the spillway tailwater channel invert at the upstream edge of the 3185-foot (971-m) elevation. At 186,000 ft³/s (5267 m³/s), considerable erosion occurred; and sand was flushed off the bedrock surface almost to the end of the tailbox topography. The area of exposed bedrock slightly increased widthwise for the 238,000- and 342,000-ft³/s (6739- and 9684-m³/s) discharges, and reached the end of the installed topography. Bedrock would probably have been exposed further than 800 feet (244 m) from the spillway if it had been installed in the model. Erosion tests are shown on figures 19 and 20(a).

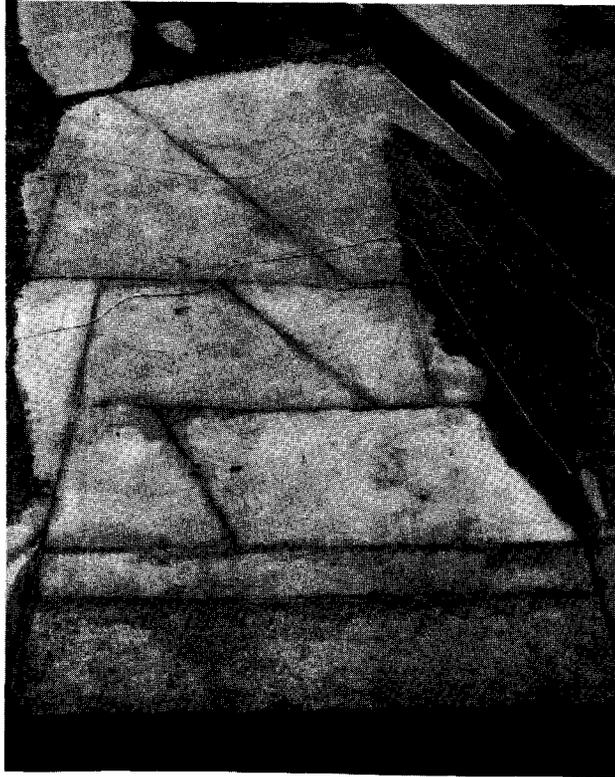
(a) After 342,000 ft³/s (9684 m³/s). P801-D-81142.

Figure 20. – Erosion tests at maximum discharge.

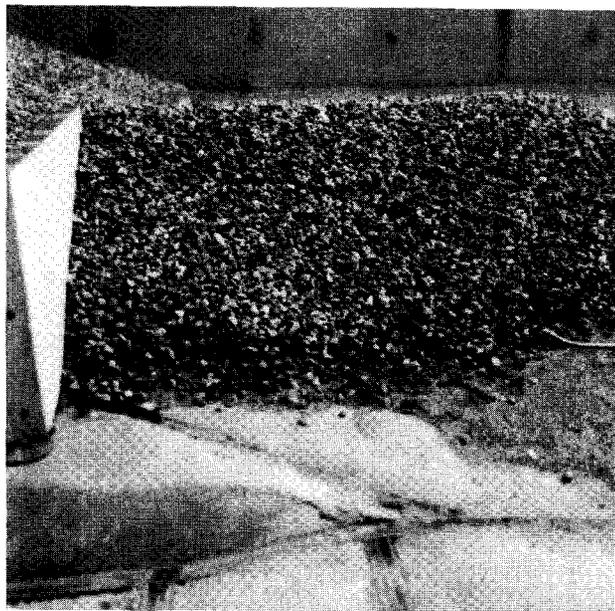
(b) Left berm after 342,000 ft³/s (9684 m³/s). P801-D-81143.

A greater depth of sand was eroded from the downstream vicinity of the right berm than from the left berm. This erosion difference was probably affected by proximity of the model tailbox side wall (fig. 18). Thus, for judgment of berm design, more weight should be given to occurrences at the left berm. Adjacent to the left berm, the exposed mortar extended 80 feet (24.4 m) downstream from the wingwall, figure 20(b). Proceeding further downstream, less sand eroded from the berm.

Gravel on the concrete mortar did not appear as stable as the gravel on the berm as it readily flushed off the bedrock surface, see figure 20(b). Possibly, less force is needed to roll a stone along a relatively smooth surface than to dislodge a somewhat embedded stone. An area more susceptible to this movement is where the berm riprap rests on the bedrock. Additional riprap protection is therefore recommended for this location, figure 21. A remedial measure is needed to prevent stones from rolling, possibly by embedding the first layer of stones in a concrete pad or a key trench that restrains stone movement.
