HYDRAULIC MODEL STUDY OF BRANTLEY DAM SPILLWAY

*May 1987
Engineering and Research Center*

U.S. Department of the Interior
Bureau of Reclamation
Division of Research and
Laboratory Services
Hydraulics Branch

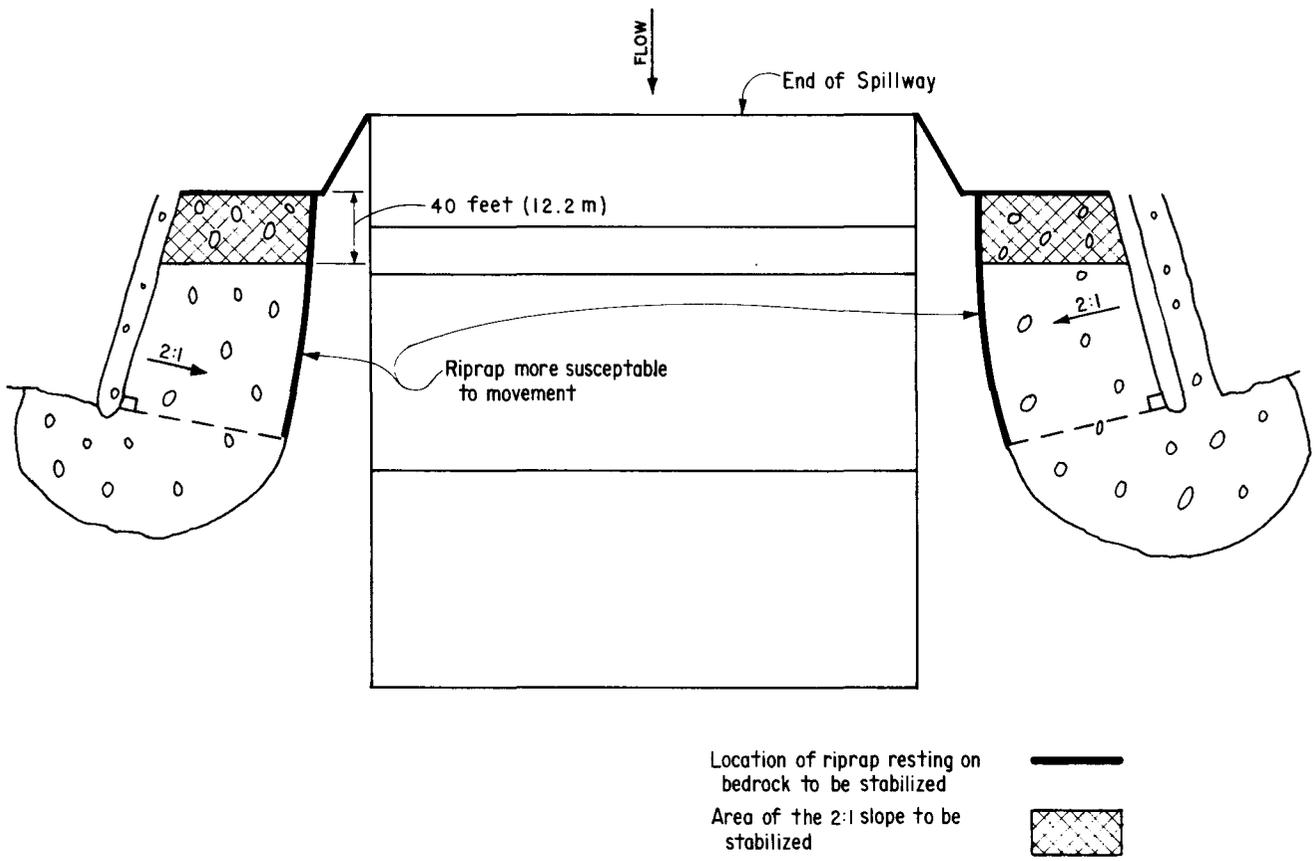
Figure 21. – Riprap stabilization for berms of the spillway tailwater channel.

the model operating at 342,000-ft³/s flow revealed occasional rock movement. Additional riprap protection is recommended for the sloping portion of each berm for a 40-foot (12.2-m) distance downstream of the wingwall, figure 21. Either 3-foot riprap or stabilization of the 2-foot riprap with concrete or shotcrete should be sufficient. The objective of using concrete or shotcrete would be to adhere individual stones together, making a larger mass to resist movement by the flowing water.

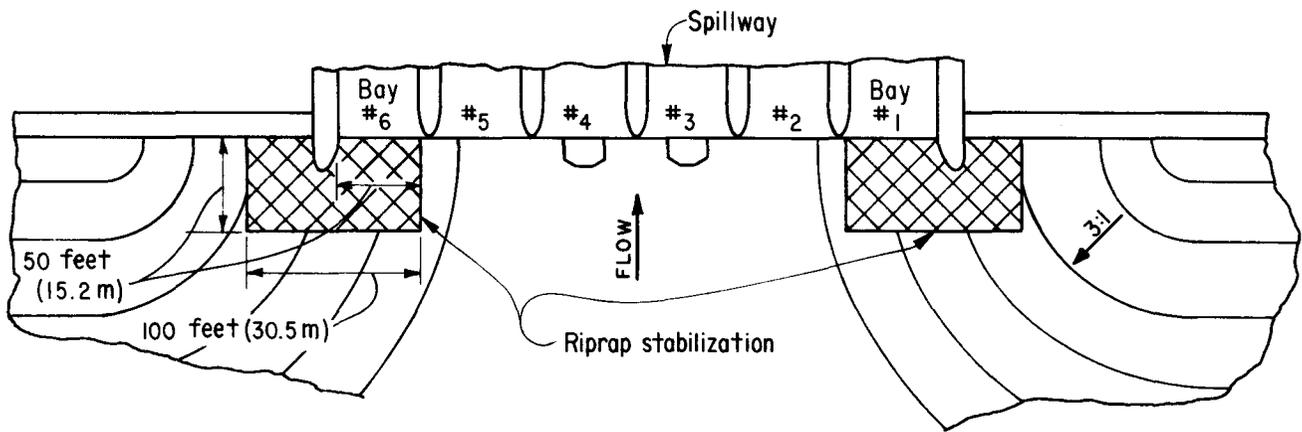
(a) Area needing stabilization.

Figure 22. – Riprap stabilization upstream of spillway.

Riprap eroded immediately upstream from the spillway in the vicinity of each side pier. Additional testing was done to determine whether the riprap rolled down the embankment or was carried over the spillway. Model gravel painted orange was placed in the eroded areas, and the model was operated at a 342,000-ft³/s (9684-m³/s) discharge. The orange gravel was found downstream of the spillway tailwater channel, proving that the eroded riprap was carried over the spillway. The upstream area requiring riprap stabilization is shown on figure 22. This area is believed to be more critical to dam safety than the downstream areas. A high degree of stabilization is recommended.

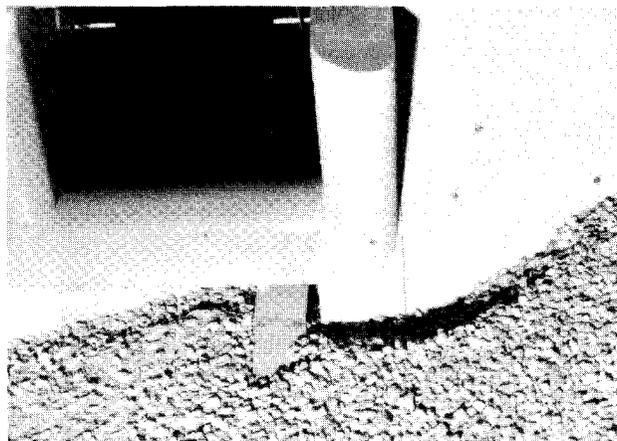
(b) Erosion of model riprap. P801-D-81144.

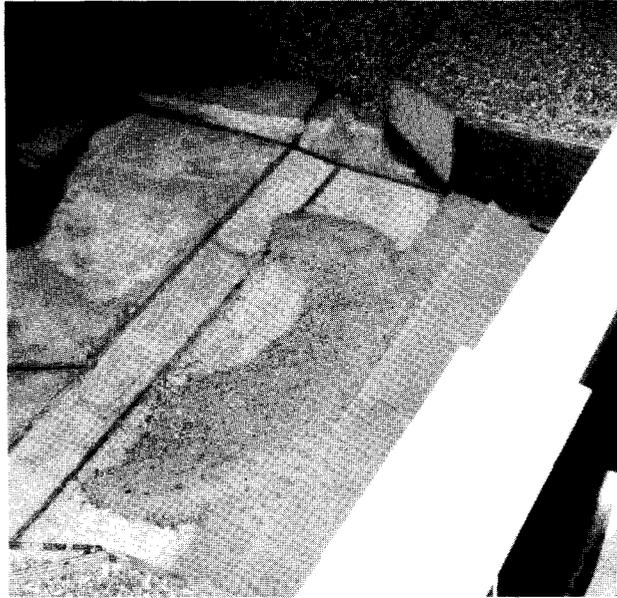
(a) After operation of gates No. 1 and 6. P801-D-81145.

Figure 23. – Erosion with two-gate operation.

Model tests were made with a 3-foot (0.9-m) gate opening to ensure sand movement. Two different operation modes were tried: (1) opening the two inside gates (Nos. 3 and 4), and (2) opening the two outside gates (Nos. 1 and 6). The gates are numbered from right to left, looking downstream (fig. 22). Less sand entered the basin with flow through the inside gates, figure 23(b). Thus, recommended operation is to start with the inside gates, and a maximum gate opening of 1 foot (0.3 m). If practical, an even smaller gate opening would be better. If higher discharges are required, open additional gates proceeding outward, starting with gates 2 and 5 and then gates 1 and 6.
