Hydraulic Laboratory Report HL-2006-01

Hydraulic Model Study of the American River Pumping Station, Phase II Redesign

February 2006

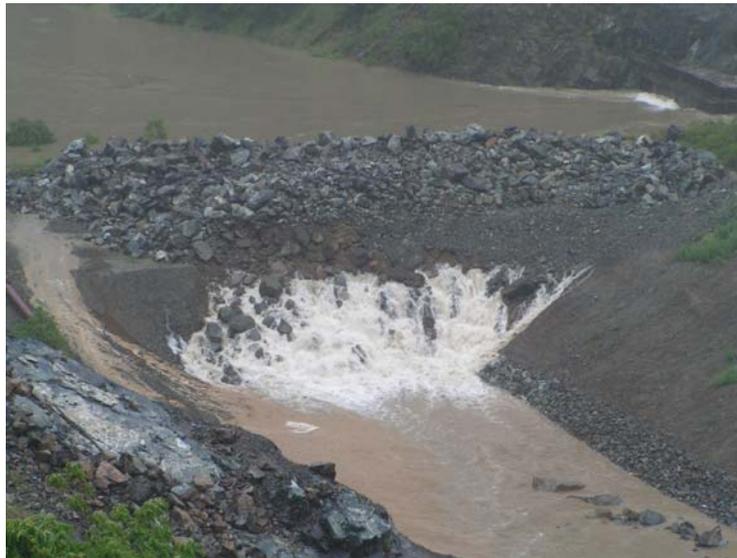
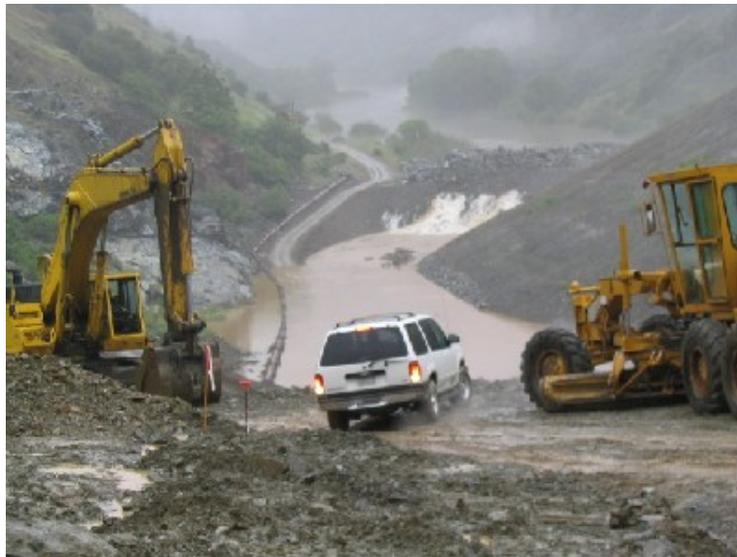
Figure 4. – These figures are looking upstream at the American River section upstream from the proposed pumping station intake in the river during a high flow event in May 2005. The existing cofferdam remnant in the river forms the diversion dam. The diversion tunnel entrance area is out-of-sight to the right behind the cofferdam. The toe of the current 2:1 sloping cofferdam has been protected with riprap. Notice the large bend in the river upstream from the cofferdam toe and the narrow river section formed by the 2:1 sloping cofferdam.

An earth cofferdam across the river and diversion tunnel are being used to divert the river around the new screened pumping station intake during construction. Figure 4 shows the diversion dam, the diversion tunnel area on the right looking upstream, and the toe of the current remaining cofferdam running parallel to the river, during a May 2005 high flow event.

The first investigations in the model looked at the proposed fill placement over the closed diversion tunnel, figure 5. The diversion dam shown in figure 4 was removed to simulate the final river geometry. Baseline upstream river channel investigations were carried out for the 10-year flow event of 72,000 ft³/s. Observations with dye tracings, velocity data, still photographs, and video were used to investigate the flow patterns through the upstream river section. Flow conditions were documented from where the flow entered the model (Sta. 114), through the diversion tunnel area, and past the cofferdam to about Sta. 104+00. Data obtained from the baseline evaluation was used to determine if the fill provided acceptable approach flow to the downstream cofferdam. The 3:1 sloping cofferdam begins at Sta. 108+00 along the downstream white line with the toe of the 3:1 slope shown in orange in figure 5.

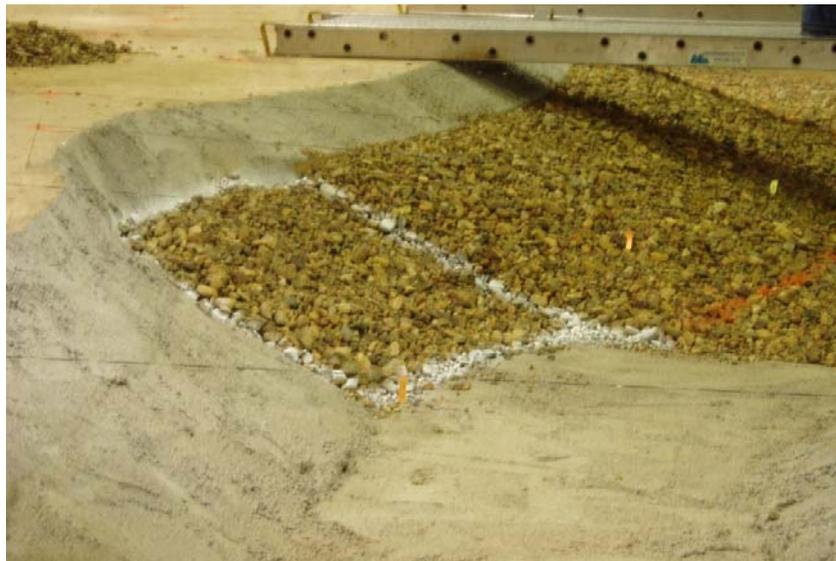
Figure 5. - Original diversion tunnel fill geometry. The fill area is outlined in white paint. The toe of the 3:1 cofferdam slope at El. 491 is shown in orange paint.

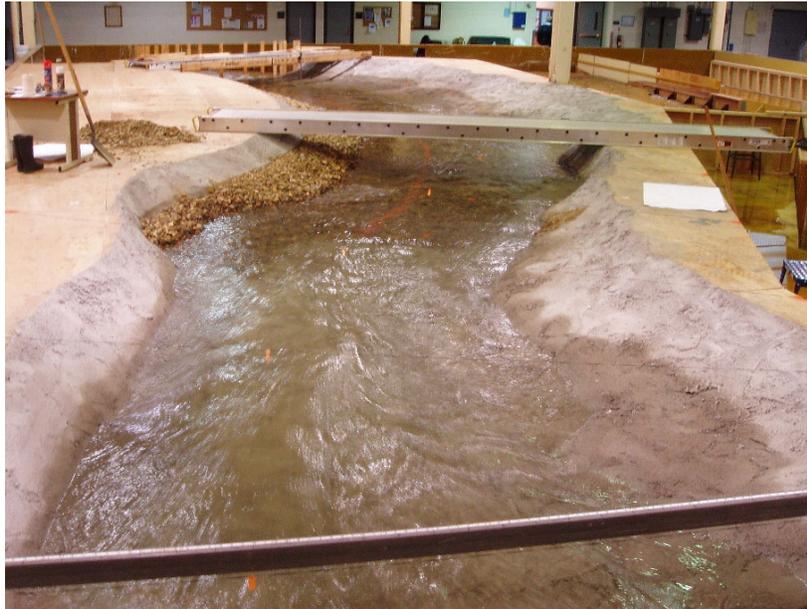
Figure 6. - Overall view (looking downstream) of the American River model operating under the 10-year event of 72,000 ft³/s with the initial

1. Proposed channel widening adjacent to the cofferdam:
 - a. Model tests of the 10 year and 50 year floods showed that the 140 ft wide channel with a 3:1 cofferdam slope provided a smooth transition from the upstream river to the reach containing the PCWA pumping plant intake structure.
 - i. Figure 6 shows the upstream extent of the cofferdam and the diversion tunnel fill cover material redirect the main river flow toward the opposite bank. Downstream from Sta. 106+00 the flow is concentrated to the outside of the right hand bend as it approaches the pump intake structure.
 - ii. Figures 7-10 give the results of extensive 2D baseline velocity measurements gathered to document initial flow conditions for comparison as diversion tunnel fill geometries were investigated.

The river upstream from the diversion tunnel is aligned relatively straight. Downstream, the river must curve around the sloping toe of the cofferdam. Figure 6 shows that the cofferdam remnant creates a long sweeping bend. The tunnel fill and upstream extent of the cofferdam turn the flow toward the right bank. Once the flow passes Sta. 106+00 it is generally realigned with the bend and concentrated more to the right side of the river channel.

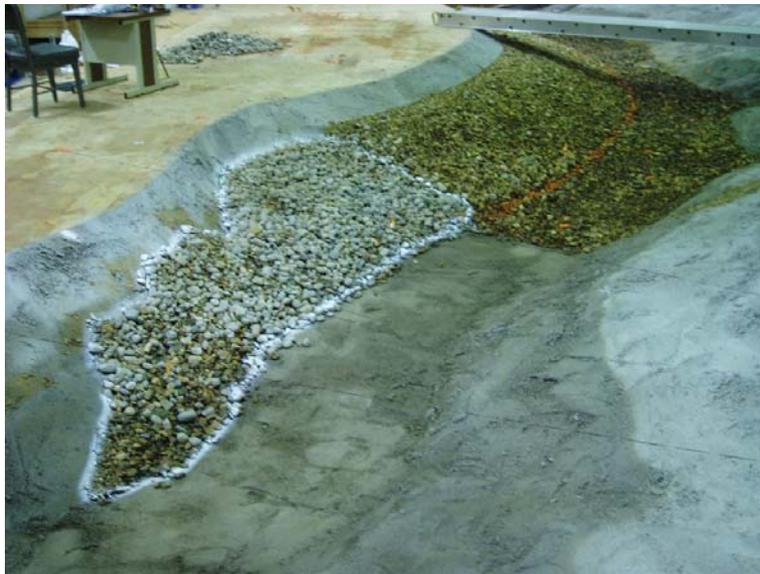
Figure 11. - Fill extended upstream from the diversion tunnel to about Sta. 112+00.

Figure 11 shows the fill added to Sta. 112+00 along the left bank upstream from the tunnel entrance. During changes to the fill volumes and geometry spot checks of the velocity were made and compared with the values from the initial velocity mapping. The velocity measurements along with flow visualization techniques and constructability led to the determination of the final fill geometry. While the

options that added fill aided in redirecting the flow from the cofferdam slope and toe, they also reduced the flow area in the channel and generally increased the flow velocities at stations 108+00, 106+00, and 104+00.

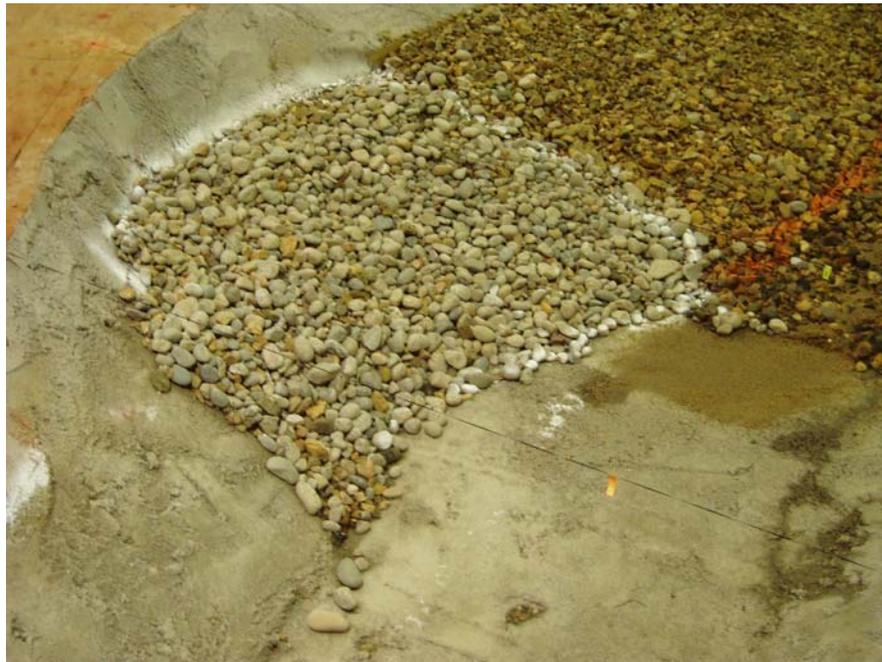
Figure 12. - Final diversion tunnel fill geometry outlined in white and extending to the toe of the cofferdam. The slope of the fill varies from about 1.7:1 at the upstream end to match the existing topography to 3:1 at the downstream end to match the cofferdam slope.

2. Diversion tunnel fill geometry investigations:
 - a. The recommended tunnel fill geometry will improve redirecting the flow away from the cofferdam and reduce fill quantities and placement issues. The final tunnel fill geometry is shown on figures 12 and 13.

The final geometry of the fill over the diversion tunnel is shown on figures 12 and 13. The fill for the diversion tunnel area extended about 176 ft upstream from Sta. 108+00 and the beginning of the remaining cofferdam. The toe of the fill follows the general line of the cofferdam toe upstream to about Sta. 109+44.5 then breaks back to match the steeper slope of the topography at about Sta. 109+76. The slope of the fill varied from 3:1 where it met the cofferdam slope and steepened to about 1.7:1 to meet the topography at the upstream end. The model floor was at prototype El. 485 in this area and the toe of the fill is shown at that elevation. The fill extended up to El. 540 or the top of the cofferdam 3:1 slope.

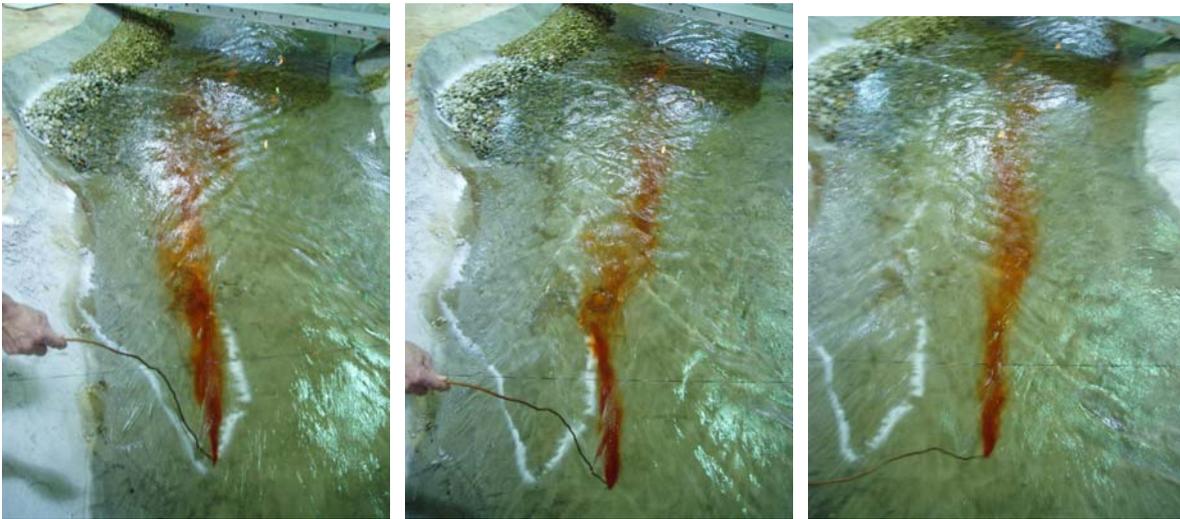
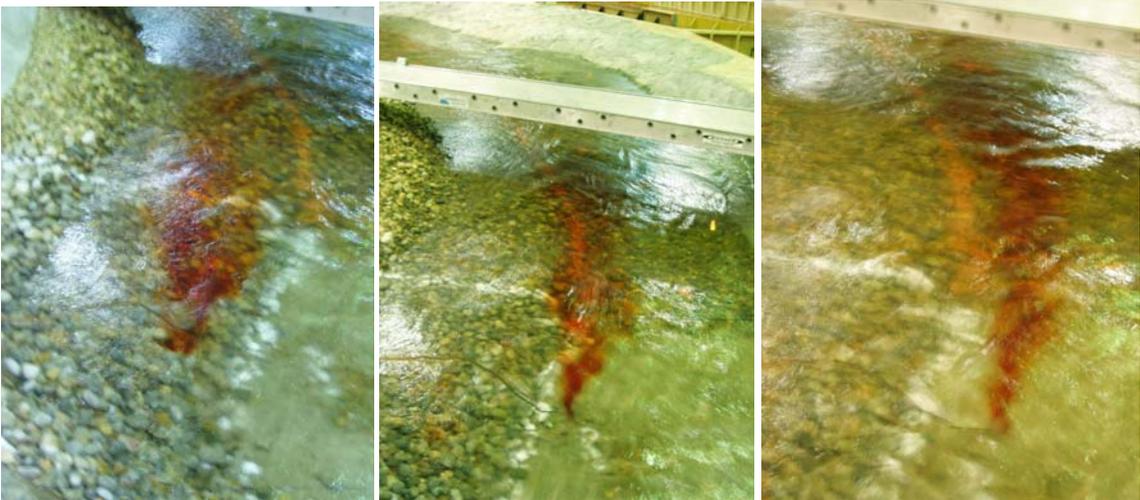
Dye tracing for the 10-year event at Sta. 112+00 for the final diversion tunnel fill geometry.

Dye tracing for the 10-year event at Sta. 110+00 for the final diversion tunnel fill geometry.

Figure 14. Dye tracing for the 10 yr event at Sta. 109+00 for the final diversion tunnel fill geometry. Photos are at the toe of the left bank, 18 and 36 ft out from the bank across the channel to the right.

Figure 14 shows the dye tracings for the final fill geometry in consecutive order from upstream to downstream and from the toe along the left bank across the invert toward the right bank under the 10-year event of 72,000 ft³/s. Dye was released as close as possible to each station and at the toe of the left bank, about 18 ft and 36 ft out from the left bank across the channel. Dye was injected near the bottom of the river invert in all cases. (The white paint that extends upstream in figure 14 is from previous fill investigations.)

The dye tracings showed that the plume is much more concentrated at the upstream stations and disperses as it travels closer to the cofferdam, indicating that the velocity is reduced. In addition, the plume seems to begin following the cofferdam curvature at Sta. 109 about 100 ft upstream from the beginning of the 3:1 cofferdam slope.

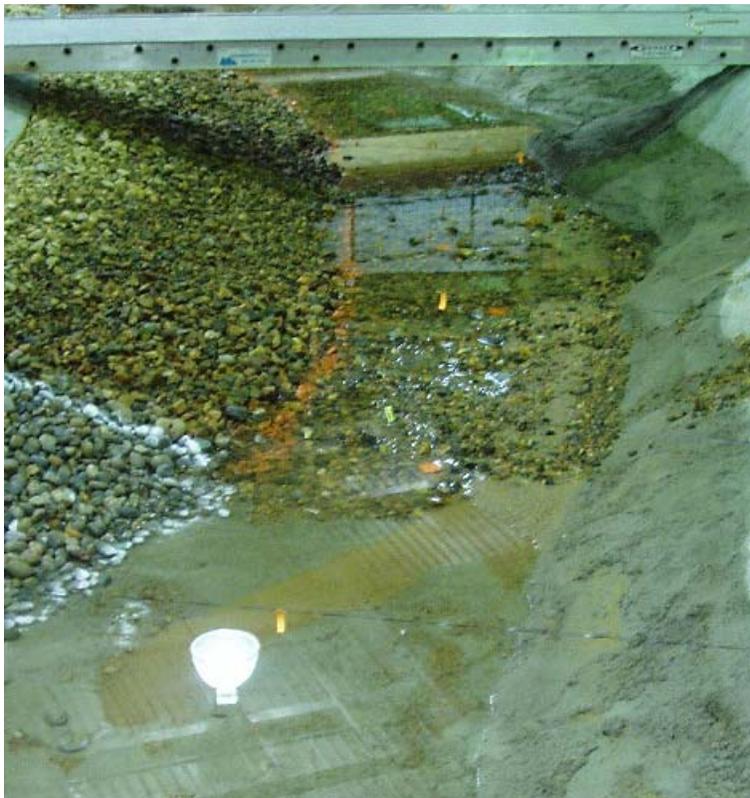
Figure 18. - Overall view of the sediment deposition with the final tunnel fill geometry after passing 72,000 ft³/s prior to installing the screened pumping plant intake downstream.

- c. Sand, simulating coarse bed material in the prototype traveled along the right side of the invert under the 10-year event as shown on figure 18. The invert material itself did not move under this flow rate.

Figure 18 shows the overall deposition pattern after operation with the final tunnel fill geometry. The material traveled downstream along the invert scouring along the toe of the tunnel fill. The material formed a dune diagonally across the river from left to right where the material entered the rock invert at Sta. 108 to the right side of the channel, figure 19. The higher velocity flow then stays along the right side of the channel until the rock outcropping at about Sta. 104+00 forced some of the flow to travel back across the river towards the cofferdam. Figure 20 shows the result of the higher velocity flow along the river centerline with deposition along the toe of the cofferdam (outlined in orange paint) at about Sta. 102.

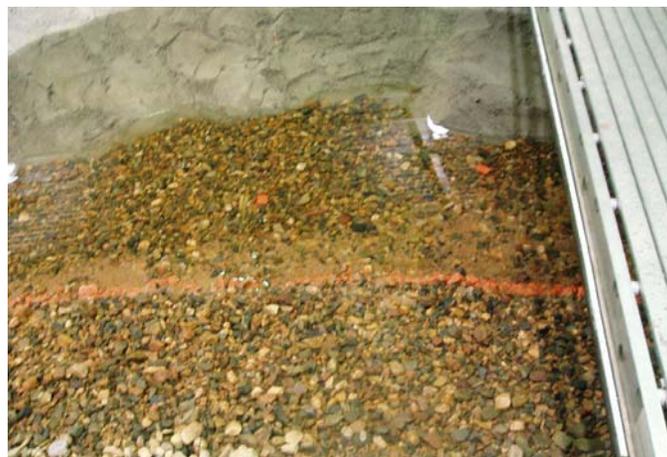
Figure 20. - Close up view of the sediment deposition at about Sta. 102+00 after the 72,000 ft³/s event.

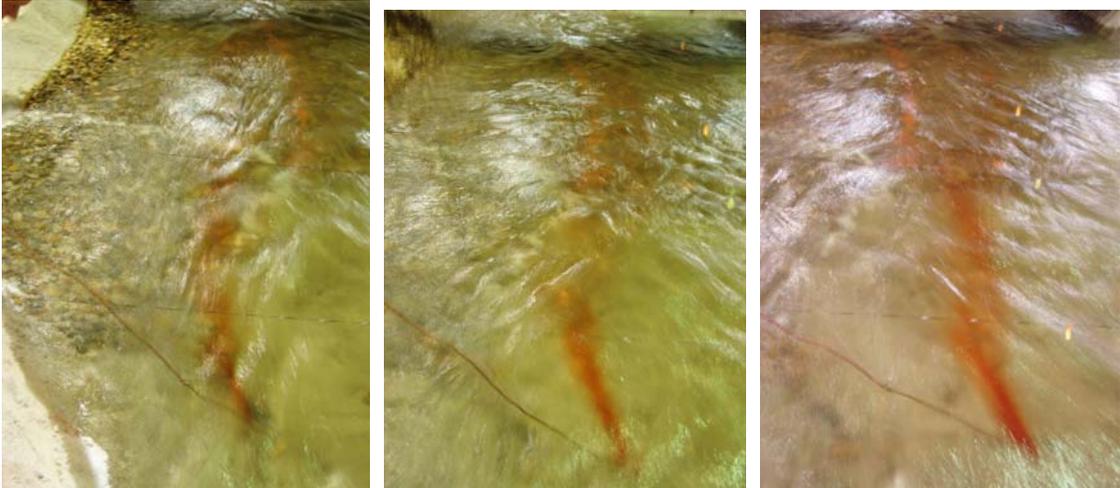
Dye tracings for the final fill geometry at Sta. 112+00 from the left bank toe across the invert for the 50-year flow event of 160,000 ft³/s.

Dye tracings for the final fill geometry at Sta. 110+00 from the left bank toe across the invert for the 50-year flow event of 160,000 ft³/s.

Figure 21. - Dye tracings for the final fill geometry at Sta. 109+00 from the left bank toe across the invert towards the right bank for the 50-year flow event of 160,000 ft³/s.

The same dye and velocity data were gathered for the 50-year event of 160,000 ft³/s as for the 10-year event. The dye tracings are shown on figure 21, with the dye injected at the bottom of the river channel. The tracings were again from upstream to downstream along the left bank across the invert toward the right bank. The results for this higher flow rate were very similar to those from the smaller flow of 72,000 ft³/s. The same trends were observed, except the higher velocities did not allow the plume to be tracked as far downstream. The dye

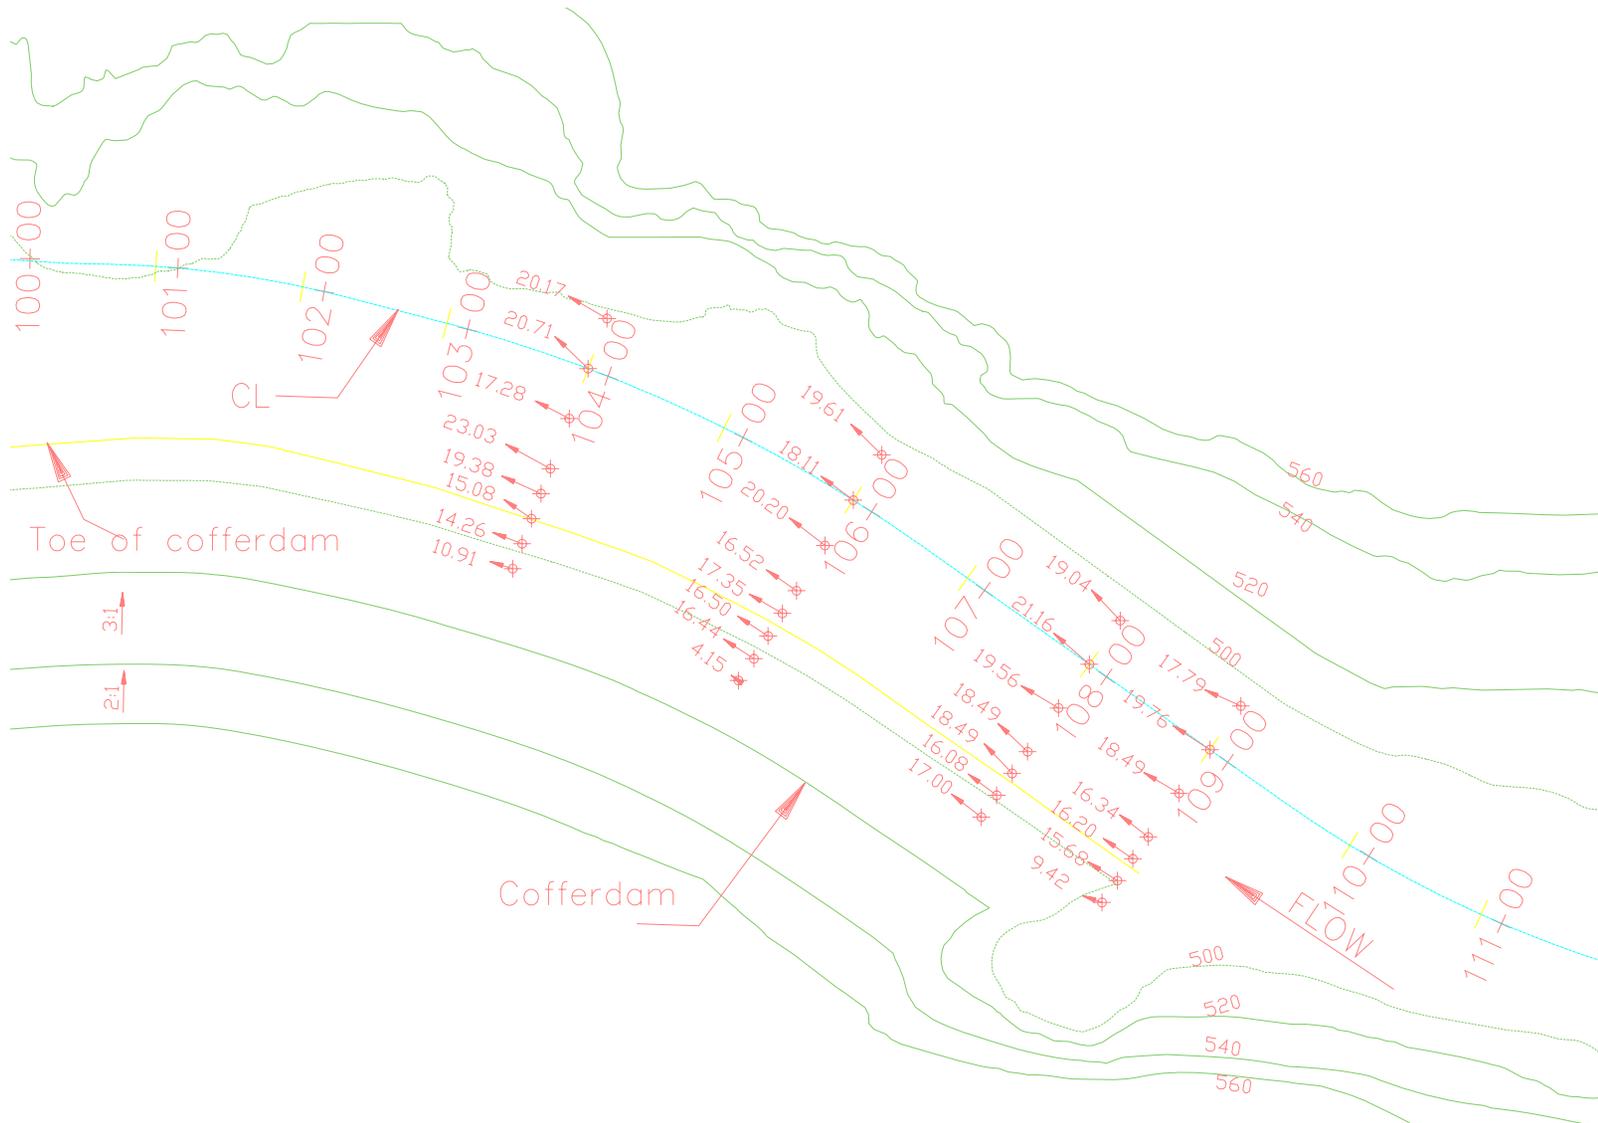
Figure 22. - Plan view of the bottom velocity vectors and magnitudes for the final tunnel fill geometry for the 50-yr event of 160,000 ft³/s.

The velocities were gathered near the bottom to provide information regarding erosion potential of the river channel and the riprap that will be placed on the cofferdam slope. Table 3 shows the velocities near the bottom of the channel for the final upstream fill configuration under the flow of 160,000 ft³/s. Figure 22 shows a plan view of the velocity magnitudes and vectors for the 50-year event. Figures 23 and 24 show a comparison of the velocities across the river stations for both the 10 and 50-year events. It can be seen that the higher flow produces generally higher velocities as expected, but velocity trends are very similar. The only difference seems to be generally higher proportional velocities near the cofferdam than across the river channel.

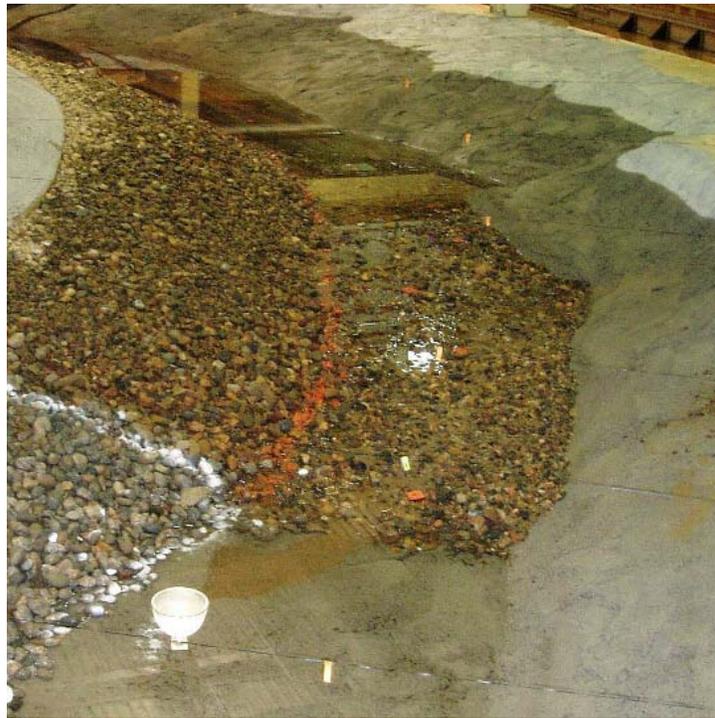
Figure 25. - Overall view of the sediment deposition after the 160,000 ft³/s event prior to intake installation.

Upon completion of the flow observations, sediment travel was investigated again under the same model configuration with the 50-year event flow rate of 160,000 ft³/s. Five-gallon buckets of sand, representing 2-2.25 inch bed load material in the prototype, were gradually poured into the model at about Sta. 114+00. The sand quickly moved downstream, mostly along the centerline or slightly left of centerline to just upstream from Sta. 108+00, figure 25. The sand formed a berm at this location that then entered the cofferdam area along the centerline of the invert. From the centerline the material then moved left toward the cofferdam toe as it traveled downstream. This pattern was intensified as the sand moved downstream to the topography protrusion at about Sta. 102 where the sand was pushed far left and up on the cofferdam as the flow was redirected by the topography, figure 26. Material appeared to pass through the center of the river channel more than occurred under the 10-year flow.

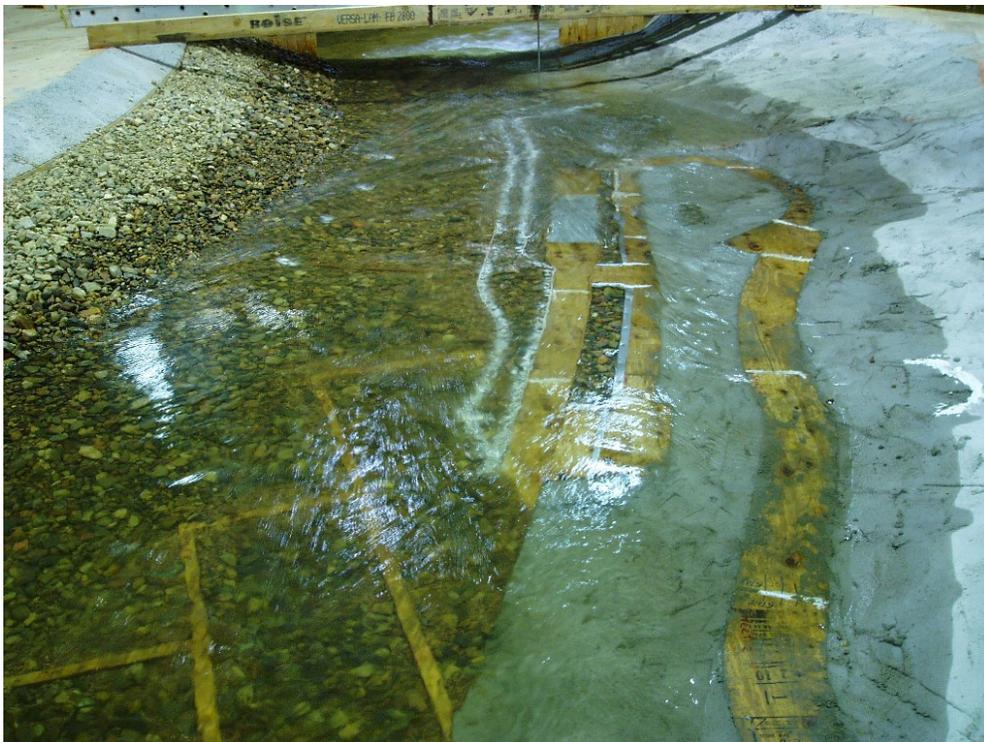
Figure 29. - Flow through the initial intake and main channel geometry for the 5-yr event of 45,000 ft³/s.

Figure 29 shows the overall flow condition for the initial intake and main channel geometries operating under the 5-yr event of 45,000 ft³/s. The tailwater was set to El. 511.78 at Sta. 94+00 to match the HEC-RAS model results. Dye tracings showed similar flow patterns to the 1.5-year flow event. Flow conditions upstream from the intake show the angled sediment basins to be effective in redirecting the bottom flow away from the intake. The influence of the bend in the river is seen with the flow up in the water column staying near the right side of the channel and entering the intake area.

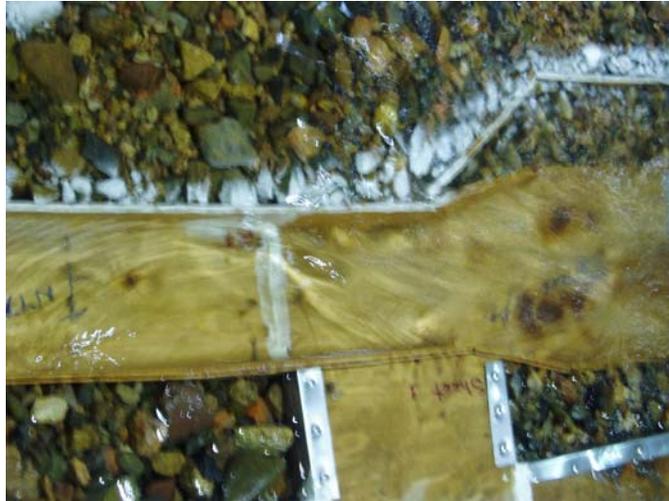
Figure 30. - Close up of the intake channel upstream of and on the screened intake for the 5 yr event of 45,000 ft³/s.

Figure 30 shows flow passing over the divider berm into the intake channel and the formation of a standing wave just upstream from the intake screen.

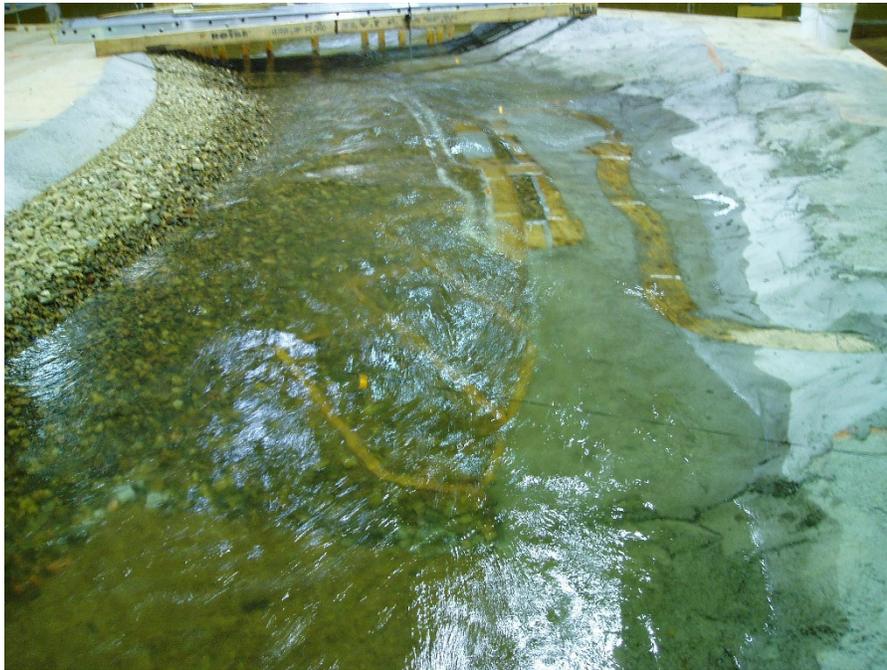
Figure 31. - Overall view of the initial intake and main channel design operating under the 10-year flow event of 72,000 ft³/s. Notice that the upper access road is submerged and there is a poorly formed hydraulic jump over the topography adjacent to the screened intake.

- c. Supercritical flow occurred across the screened pumping station intake structure under all flow rates. Cross waves occurred over the screened intake due to the short expansion section upstream from the screened area of the design. The location of the wave front varied with flow rate but was present over a portion of the screen at all times. Various flow conditions over the screened intake are shown on figures 41, 45, 49, 56, and 59.

Figure 31 shows the overall flow conditions for the initial pumping station intake and main channel areas for the 10-year event of 72,000 ft³/s. The tailwater was set to El. 517.36 at Sta. 94+00 to match that of the HEC-RAS model. The flow conditions continued to be similar to the smaller flows with more submergence of the intake and divider berm and higher velocities overall in the channel. Dye tracings indicated that flow near the bottom was redirected to the main channel on the left by the two upstream vanes. Flows off the bottom and near the surface still followed the bend and entered the intake area or flowed over the right bank topography and access roads from the two upstream vanes. Higher overall velocities in the channel; however, made the third basin or the one closest to the intake channel less effective, with even some dye near the bottom entering the intake.

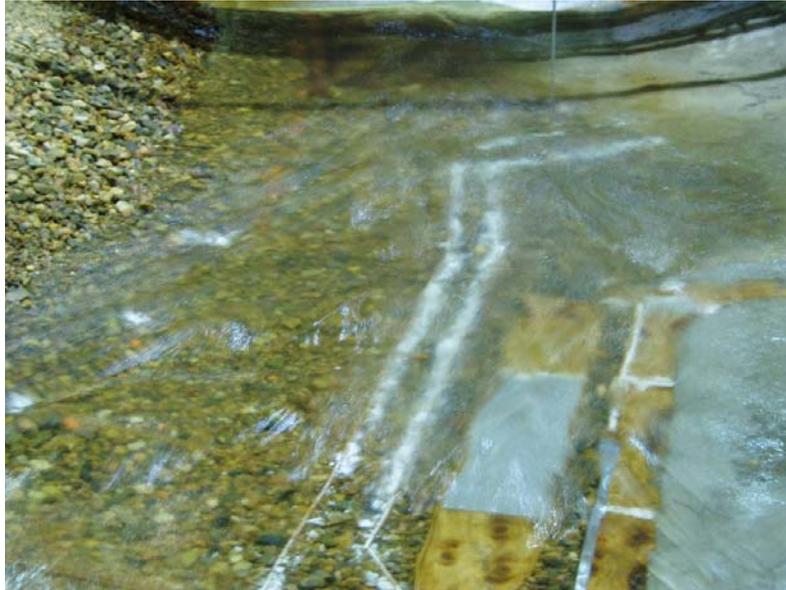
Figure 32. - The top photo shows the 10-year event of $72,000 \text{ ft}^3/\text{s}$ flowing through the initial intake and main channel. A wave forms over the screened intake. The bottom photo shows the formation of a hydraulic jump over the topography on the right bank.

Flow converged over the screen from both the main channel and the right bank. Figure 32 shows two views of flow over the intake area. Supercritical flow occurs over the screened intake area with a wave forming over the screen. In addition, flow over the right bank forms a jump over the low spot in the topography on the bank (figure 32, bottom photo) then releases downstream over the end of the intake area and into the dissipation pool. The flow exited from the intake and dissipation pool then met with the main channel flow and flowed toward the left of the channel centerline to the end of the model. A recirculating eddy still existed in the pool to the right downstream from the access road cut.

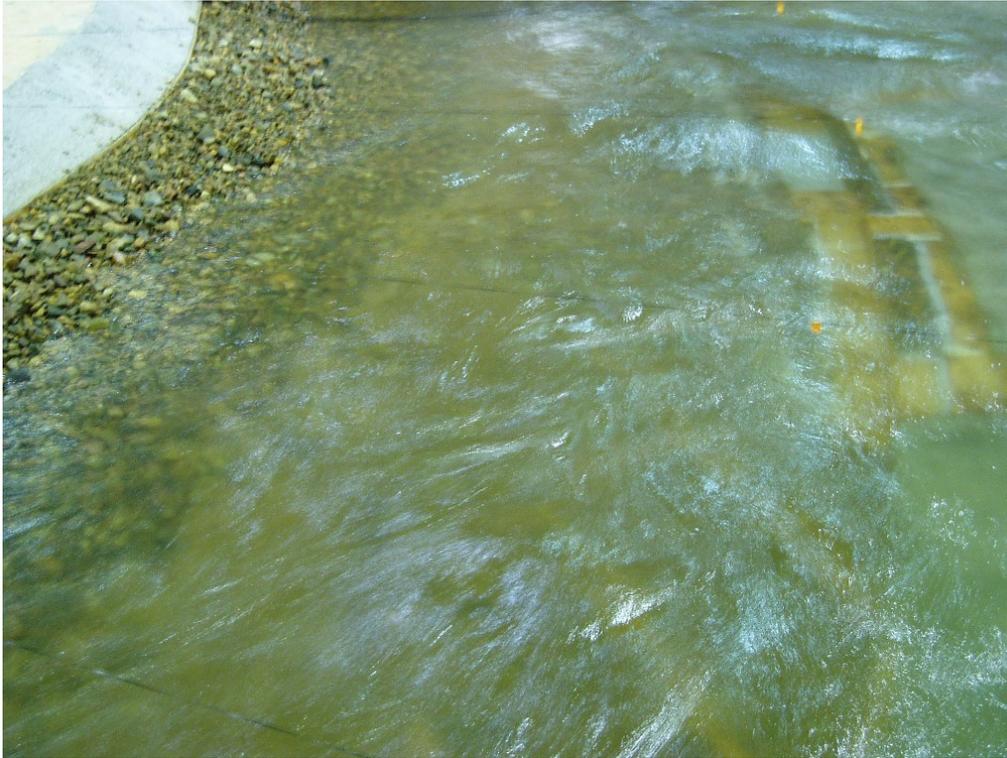
Figure 35. - Flow conditions in the initial screened pumping station intake and adjacent main channel operating under the 50-year flood event of 160,000 ft³/s.

Finally, the model was operated for the 50-yr event of 160,000 ft³/s with the initial screened pumping station intake and main channel geometry. The tailwater was set to El. 531.7 at Sta. 94+00 to match that of the HEC-RAS model. Figure 35 shows the river channel with the intake and main channel areas fully submerged.

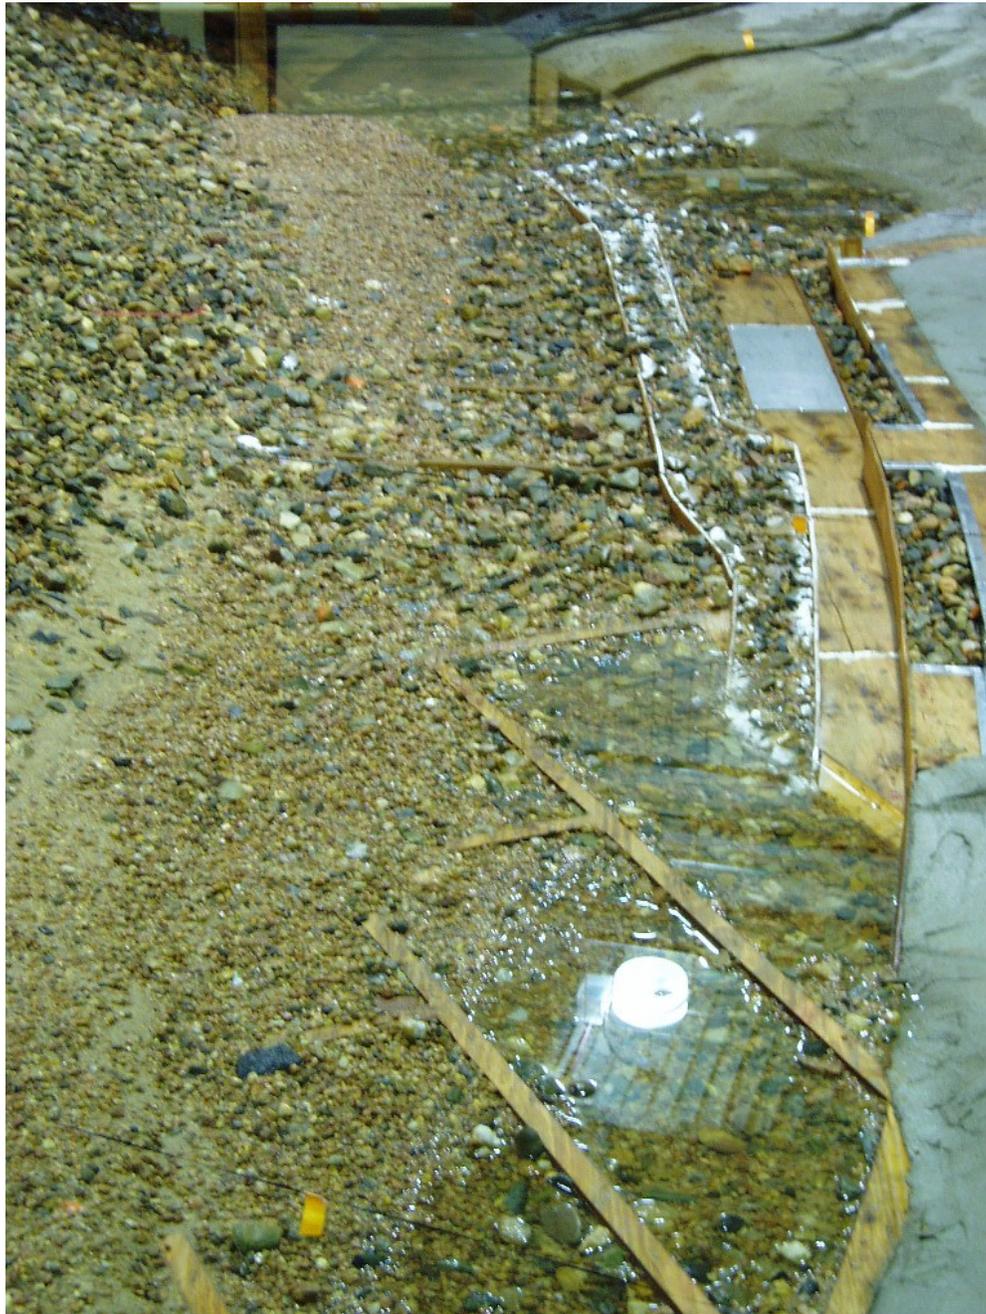
Figure 37. - Overall view of the sediment basins, intake area and adjacent main channel after operating under the 50-year event of 160,000 ft³/s.

Figure 37 shows the result of deposition in the main channel area. Primarily, the fine-grained sand added to the model relatively quickly moved downstream entirely through the system. Some deposited up high on the cofferdam slope. Most of the material, particularly that deposited at the downstream end of the model, is the slightly larger material washed from the upstream channel invert.

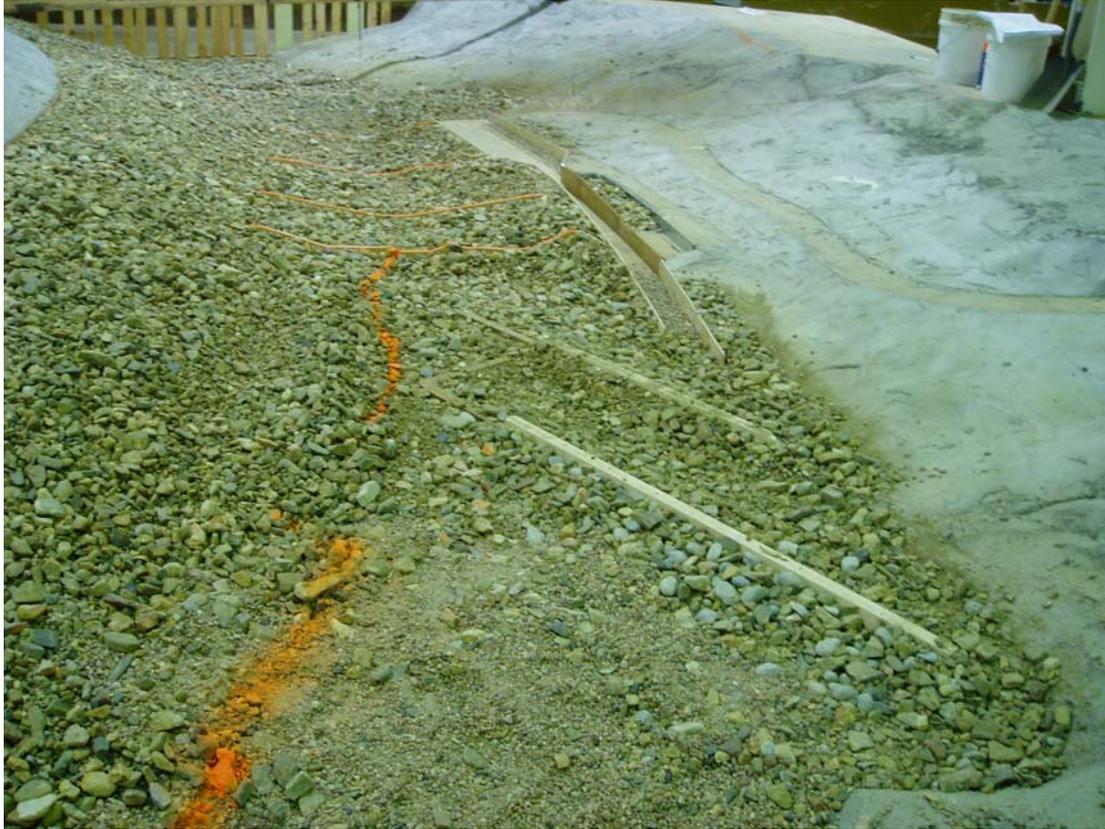
Figure 39. - Overall view of the final screened intake channel and main channel modifications per the June 2005 specifications. The location of the emergency intake structure and access roads were not changed in the model. The entrance to the screened area was lengthened and the screened area was widened. The main channel area was constructed of templates (painted orange in the photo) and included the crest control locations for the kayak pools and adjacent topography.

The model is shown in the dry with the modifications made on figure 39. The model topography on the bank above the intake structure was not reconstructed to expedite the schedule. This meant that the right bank access roads became inundated by the tailwater sooner than will in the prototype under small flows. The templates used to construct the main channel topography are shown at Stas. 99+18, 98+45, 97+43, 96+36, and 94+64 on figures 38 and 39 and represented locations very near to the crests or controls for the first four pools. The pools were modeled by making small depressions below the template crests.

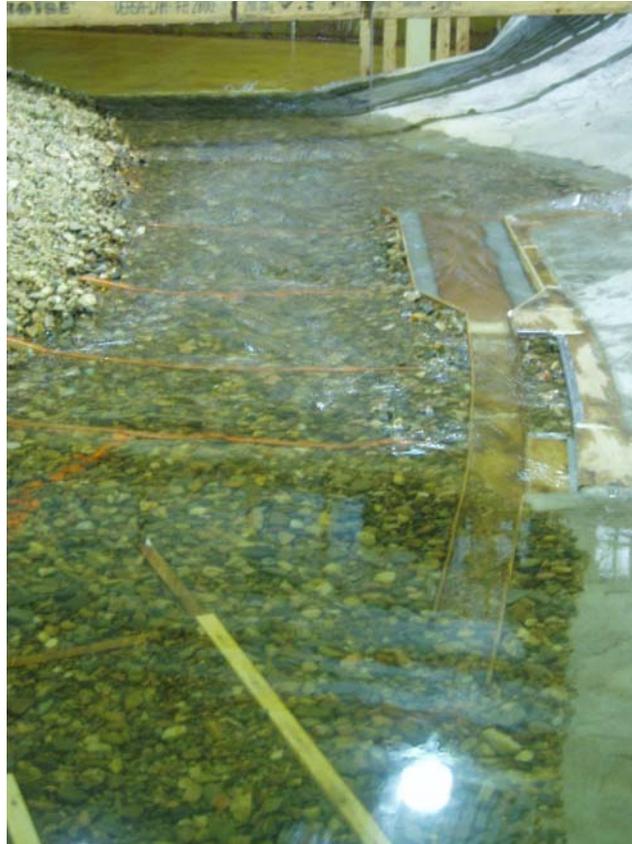
Figure 40. - Overall view of the intake structure and main channel passing the final 1.5 year event flow rate of $11,900 \text{ ft}^3/\text{s}$.

channel splits some of the flow directing a portion into the intake channel. Flow enters the intake channel along the left and right walls until about Sta. 98+45 when the wall height of the upstream intake channel exceeded the upstream flow depth for this discharge. With the previous hydrology and channel designs, flow came over the berm dividing the intake from the main channel. The current divider berm design successfully separated the flow between the main channel and the screened intake area. An overall view of the model operating under the 1.5-year event of $11,900 \text{ ft}^3/\text{s}$ is shown on figure 40.

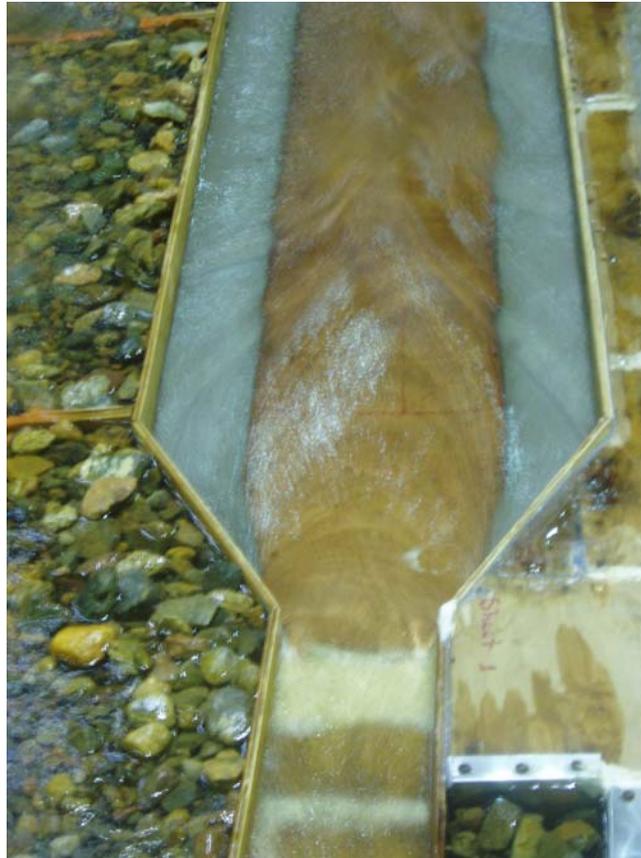
Figure 41. - Close up of the flow through the approach channel to the screen area and the wave over the screen area during operation under 11,900 ft³/s.

The flow in the intake channel went through critical depth at the location where the channel widened and spread to the width of the section. Cross waves formed at the end of the expansion and met over the screened area about two-thirds of the way down the screen area with supercritical flow over the length of the area, figure 41. The width of the channel and the tailwater also influenced the formation of a wave over the screened area.

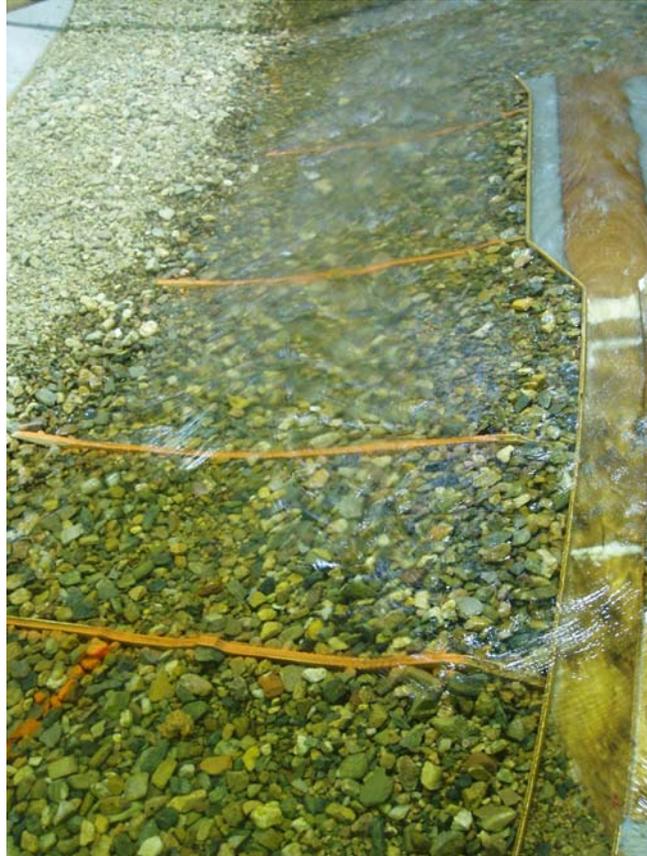
As mentioned, the model scale was not large enough to provide much detail regarding the crests and pools designed for kayaking in the main channel. The crest of the control section into the main channel was entirely submerged under the flow from the 1.5 year event, except for the rounded riprap knob between the main channel and the intake channel. The flow then concentrated through then crest section formed by the template at Sta. 98+45 and came together forming a wave in the pool below the crest. Figure 42 shows the standing waves extended downstream following the center of the main channel, figure 42.

Figure 42. - View of the main channel kayak pools and the adjacent intake channel under the 1.5-year flow event of 11,900 ft³/s.

- e. Control occurred farther upstream in the main channel with this design. Flow was supercritical through the main channel crests and pools over the full flow range, figures 42, 47, 50, 55, and 58. The flow followed a very similar path to the previous design through the main channel until near the end of the model where the flow released more to the right due to the orientation of the channel geometry.

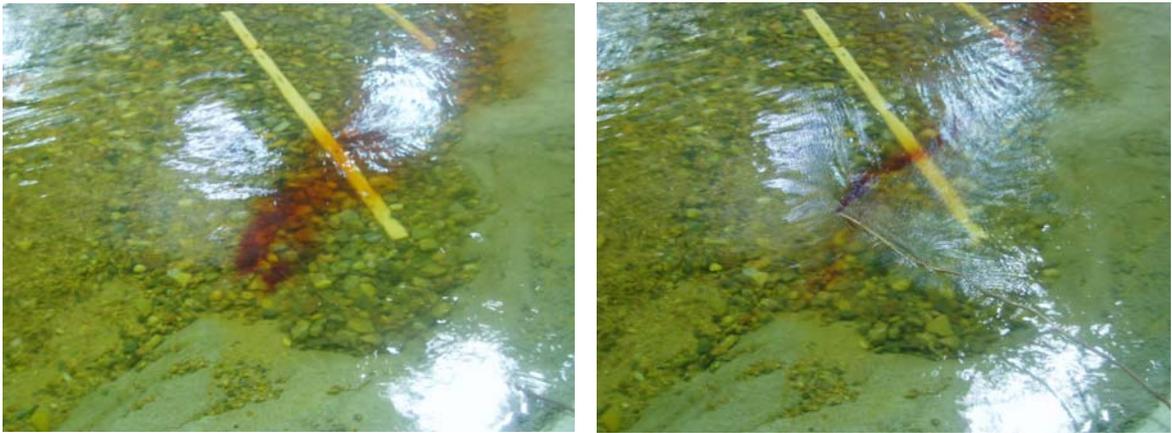
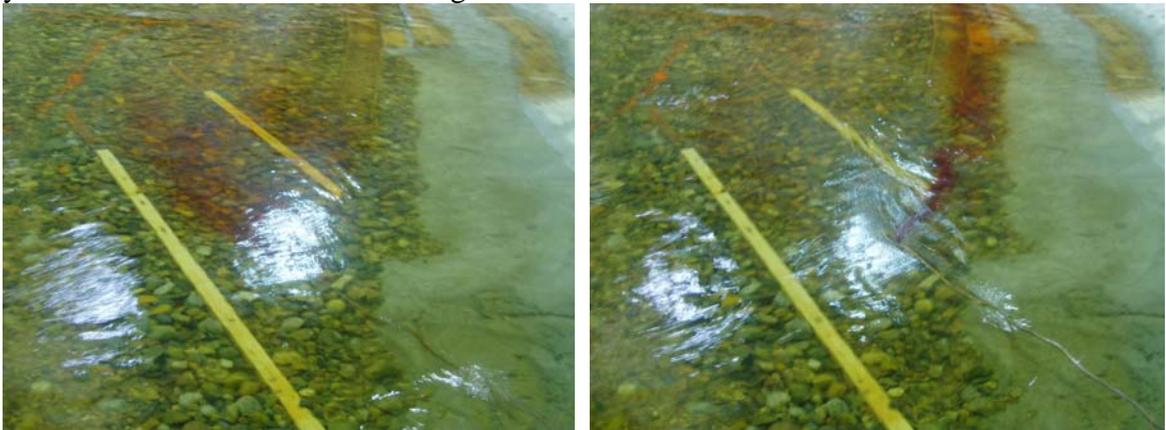
outside of the bend near through the flow depth to the surface. The flow characteristics upstream and downstream of the first vane are shown on figure 43. When dye was injected upstream of the entrance to the intake, the performance was somewhat better than in the previous design. The dye near the bottom dispersed left somewhat which did not occur before. The projection of the vanes higher into the flow is probably the reason for this improvement.

Dye injected on the bottom (left) and top (right) upstream from the first vane under the 5 year flow event for the current design.

Figure 43. - Dye injected on the bottom (left) and top (right) between the upstream and downstream vanes for the 5-year flow event of 11,900 ft³/s for the current design.

- b. Dye investigations indicated that the sediment vanes and basins remained effective when the vanes were raised 4 ft above the channel invert to El. 495, rather than basins formed by excavation to El. 487, figure 43.

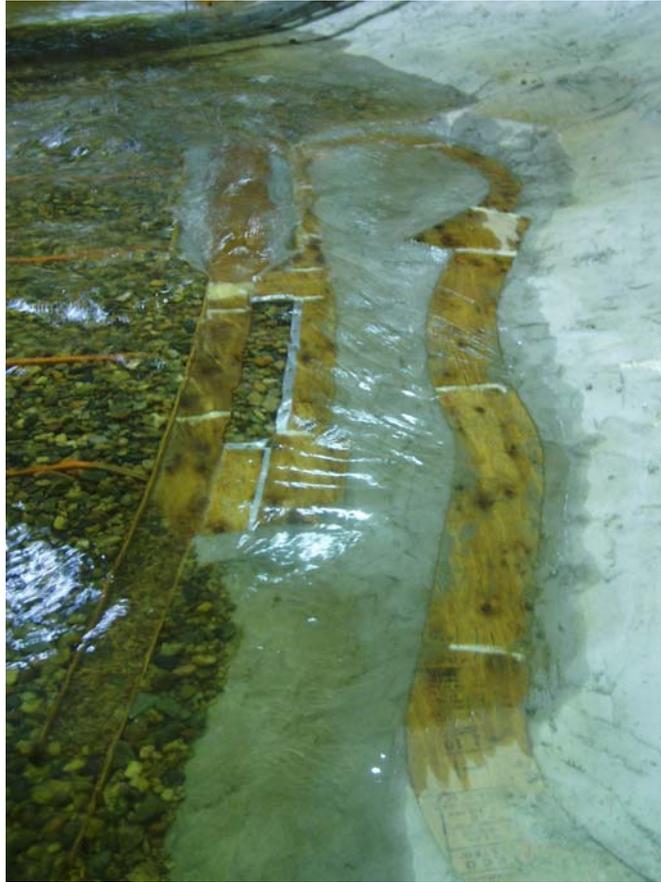
The entire intake structure was submerged by the depth of the flow in the river upstream, figure 44. Water flowed over the access roads beginning at the bottom of the curve at about El. 514, but the location of the intake vault on the bank was dry. Water over the access roads flowed down the right bank and into the intake

structure. Water in the main channel flowed parallel to the intake channel and then flowed over the divider berm into the area of the expanded screen width.

Figure 44. -- Overall view of the intake structure and access road area for the 5-year event of 42,000 ft³/s. Note the screened intake area is entirely submerged with flow entering from both the main channel and from the right bank, although the access roads are not entirely submerged.

Figures 44 and 47 show flow in the main channel over the crests and pools formed for the kayak reach of the current design. In general, the wave front had moved further downstream than the location under the 5-year event. The flow concentrated in the center of the channel and plunged over the third crest at about Sta. 97+43, into the pool below. Waves continued downstream as the flow followed the center of the main channel.

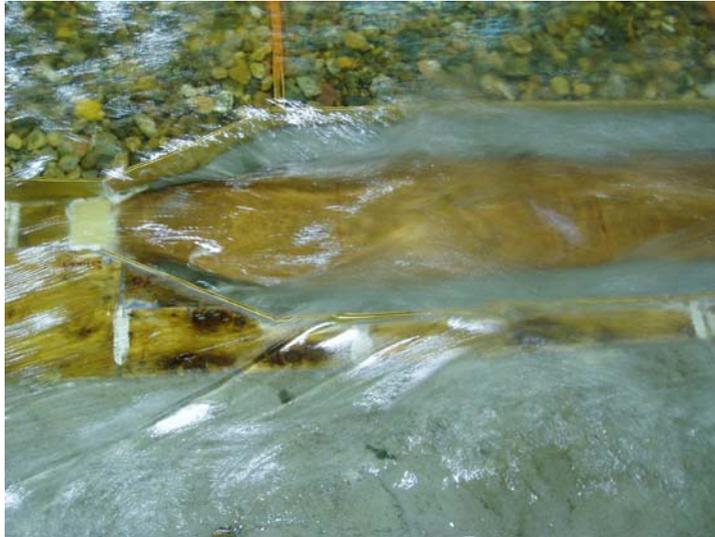
Figure 45 shows a large standing wave was located over the upper portion of the screen area with supercritical flow throughout the remaining downstream screen area. Flow over the upper topography also flowed along the road adjacent to the screened intake area and formed a wave at the downstream end of the structure where the flow from over the topography and that exiting the intake met. Flow recirculated over the flatter topography below the intake vault and access road up to about El. 504 as shown in figure 46.

Figure 45. - Close up of the current screened intake operating under the 5-year event showing flow entering both sides of the expanded section upstream from the screen. A wave is formed over the screen where the flows met.
