Hydraulic Laboratory Report HL-2006-01

Hydraulic Model Study of the American River Pumping Station, Phase II Redesign

February 2006

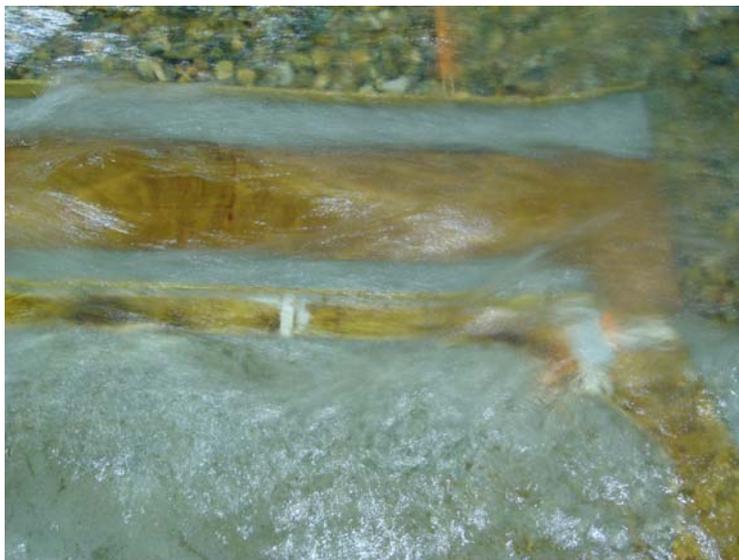
Figure 46. - Downstream end of the intake operating under the 5-year event with a wave shown on the right side of the structure where flow over the topography met flow exiting the structure. Flow recirculated over the topography in the bottom of the photograph.

- d. The screened pumping station intake channel, and right bank including the access roads were submerged to varying degrees for all flow rates tested above the 1.5-year event, figures 46, 49, 56, and 59.

Figure 45 shows a large standing wave was located over the upper portion of the screen area with supercritical flow throughout the remaining downstream screen area. Flow over the upper topography also flowed along the road adjacent to the screened intake area and formed a wave at the downstream end of the structure where the flow from over the topography and that exiting the intake met. Flow recirculated over the flatter topography below the intake vault and access road up to about El. 504 as shown in figure 46.

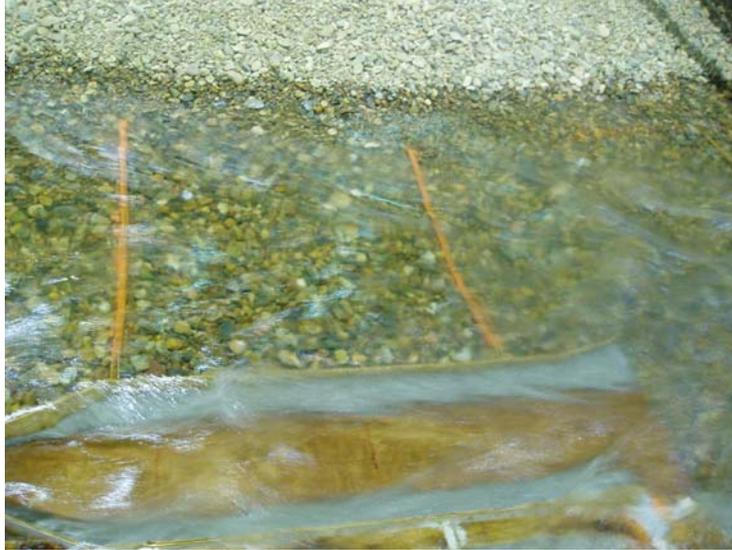
Figures 44 and 47 show flow in the main channel over the crests and pools formed for the kayak reach of the current design. In general, the wave front had moved further downstream than the location under the 5-year event. The flow concentrated in the center of the channel and plunged over the third crest at about Sta. 97+43, into the pool below. Waves continued downstream as the flow followed the center of the main channel.

Figure 47. - Flow through the main channel (looking across the channel from the right bank) showing where the flow concentrated and the wave front was formed between Stas. 97+43 and 96+36.

- e. Control occurred farther upstream in the main channel with this design. Flow was supercritical through the main channel crests and pools over the full flow range, figures 42, 47, 50, 55, and 58. The flow followed a very similar path to the previous design through the main channel until near the end of the model where the flow released more to the right due to the orientation of the channel geometry.

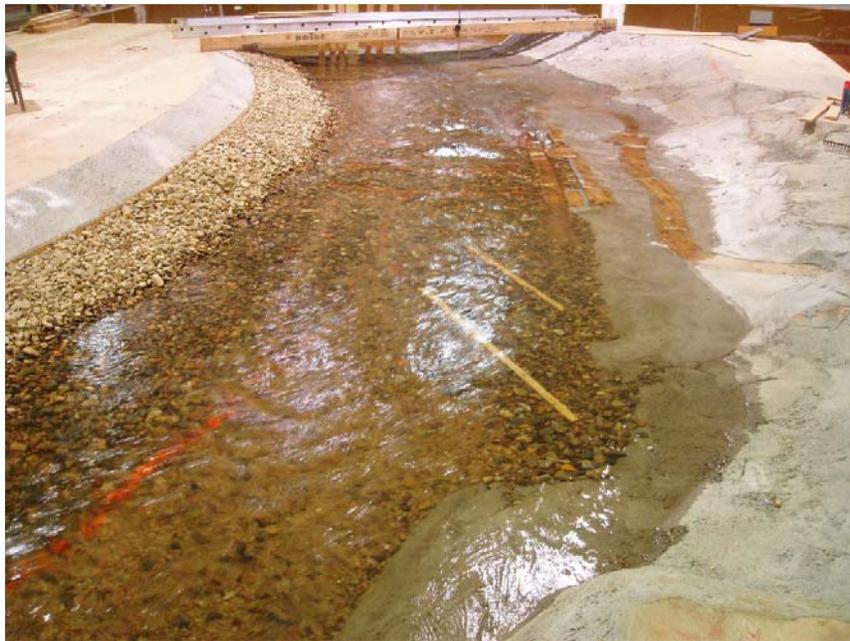
The tailwater was set to El. 515.78 at Sta. 94+00 for the 10-year flow event of 63,000 ft³/s. The new 10-year event was 9,000 ft³/s lower than that previously tested. The upstream water surface was measured at El. 521.43 ft. at Sta. 114+00. Flow conditions for this event were similar to those for the previous flow rate and design, just less submergence and velocity, although figure 48 shows there was still submergence of the access roads, intake area, and main channel.

Figure 48. - Overall view of the final intake and main channel geometry operating under the 10 year event of 63,000 ft³/s. Notice all the structures, main channel pools, and access roads are fully submerged.

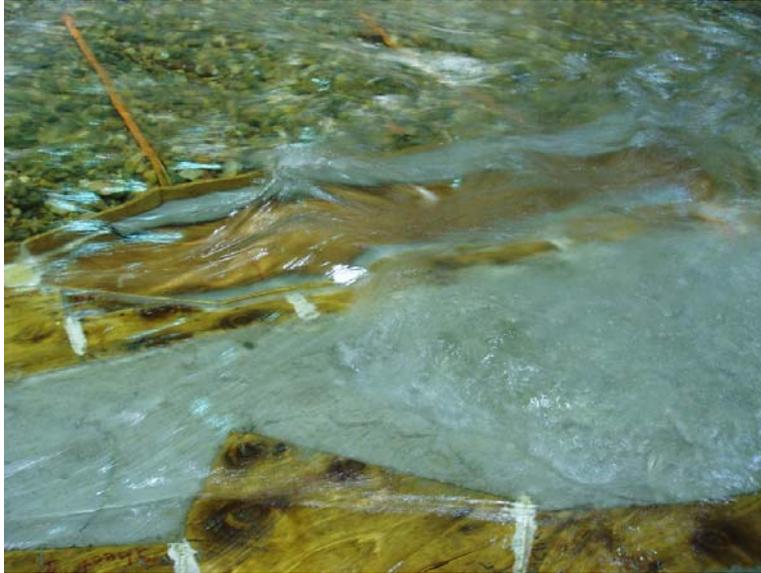
The access road conveyed water down the bank through the intake vault area where a hydraulic jump formed over the topography. Flow continued to recirculate over the curved portion of the lower access road. Water from the bank entered the screened intake further downstream than for the 5-year event. A standing wave formed over the screen but slightly further downstream with the higher discharge. A rooster tail developed on the left side of the wave over the screen caused by flow entering from the main channel, figure 49. The wave at the end of the structure was less pronounced and the flow remained supercritical with the greater flow volume sweeping the flow further downstream.

Figure 49. - Flow over the topography to the right of the intake and over the screened area of the intake for the current geometry under the 10-year event. Notice the pronounced wave over the screen with the rooster tail on the left side. Also, note the hydraulic jump and recirculation of flow over the lower portion of the topography and the lower access road.

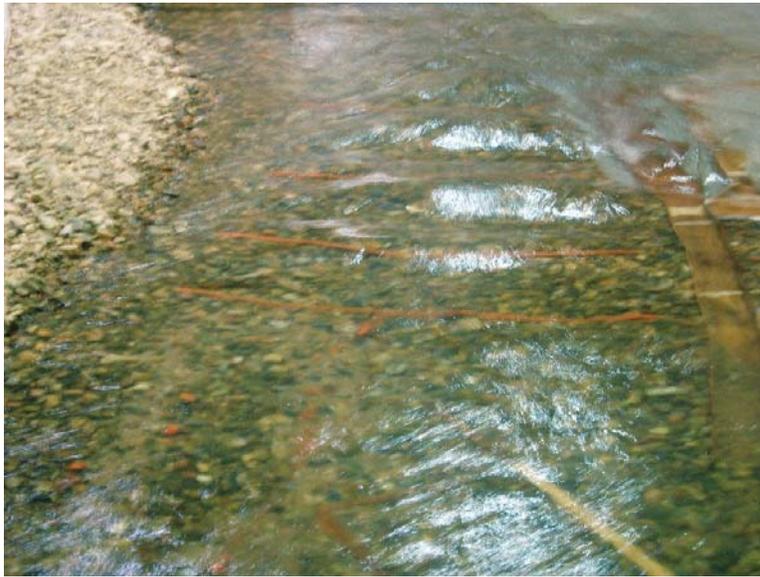
Flow through the main channel is also shown in figure 50 with the flow supercritical through all sections parallel to the intake channel. Flow in the main channel separated from the cofferdam beginning between Stas. 98+45 and 97+43. The flow concentrated in the low spots in the channel downstream of Sta. 96+36 and followed the right side of the main channel. A large wave formed past the end of the intake structure to the left of the flow exiting the intake structure.

Figure 50. - Flow through the main channel showing the wave near the end of the channel while operating under the 10-year event of 63,000 ft³/s for the current design.

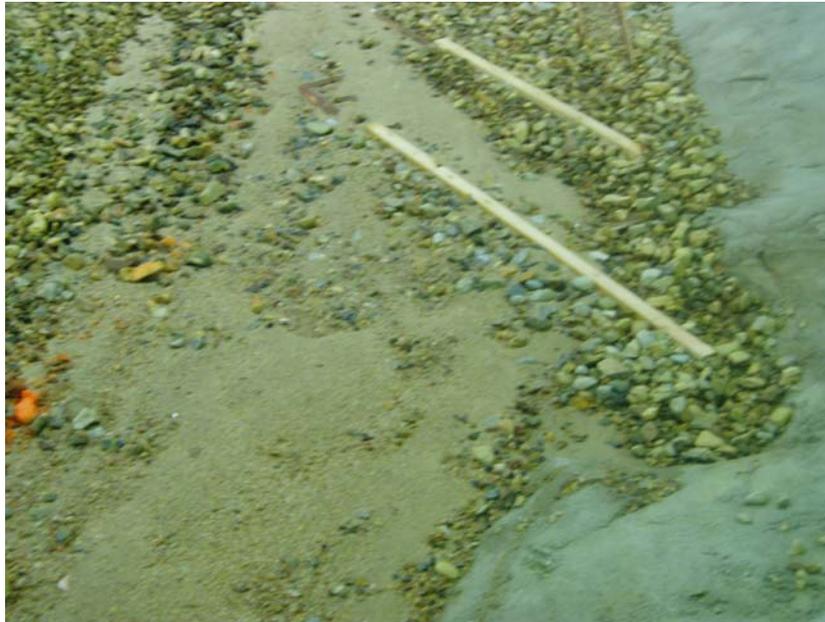
Most of the sediment that traveled over the vane entered the settling basin about 69 ft from the right end of the vane, figure 51, and traveled along the bottom of the basin toward the main channel. The point of topography upstream from the first vane directed the flow and sediment. The vane must be anchored to the rock with minimal excavation or shaping needed in the lea of the rock point.

Even though an entire cubic yard of material was fed into the model, no material passed over the second vane and into the settling basin as it had in the previous design. In addition, the flat surface formed into the cofferdam for a kayak take out area collected sand as seen in the upper left corner of figure 51.

Figure 51. - Deposition pattern at the sediment vanes, upstream of the main channel control section and over the kayak take out area, for the current design after the 10-year event of 63,000 ft³s.

flow rate for the revised 10-year event was much smaller; therefore, less material was mobilized. The material that did move was largely diverted by the sediment vanes toward the main channel, figures 51 and 52. The 100-year event corresponded to the previous 50-year event and showed almost identical bed load movement and deposition patterns with scour of the upstream channel occurring and the majority of the material passing through the main channel.

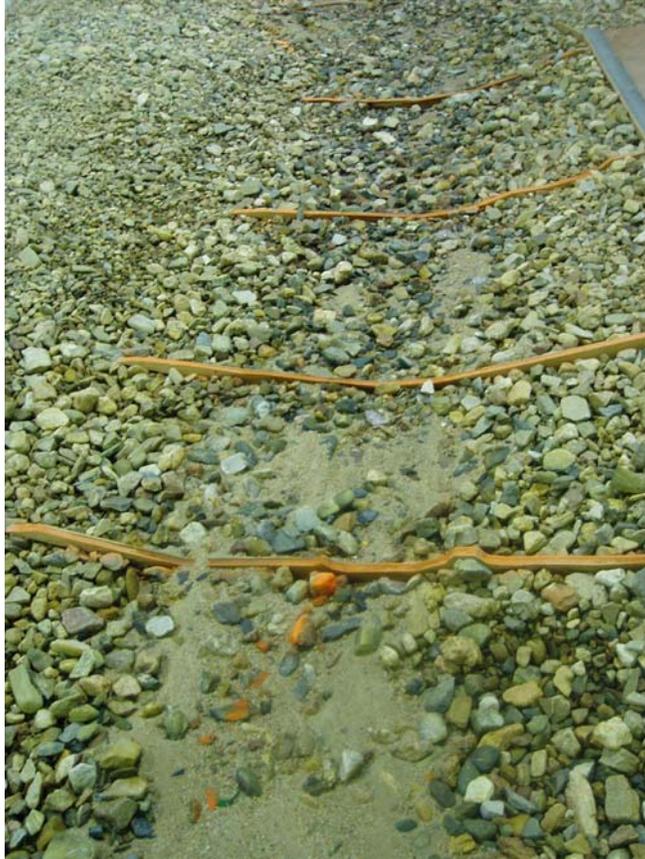
The main channel after the sediment testing is shown on figure 52. Sediment primarily entered the channel to the left of the centerline of the control section where a trail of deposition occurred. Sediment deposited upstream from the control, in the main pool downstream, and in the area to the left of the main pool. Material then passed through the next crest section primarily through the centerline of the channel and deposited in the pool.

Figure 52. - Sediment deposition in the current main channel design after testing the 10-year event. Note the sediment primarily entered the channel to the left of the centerline, deposited in the main pool and traveled

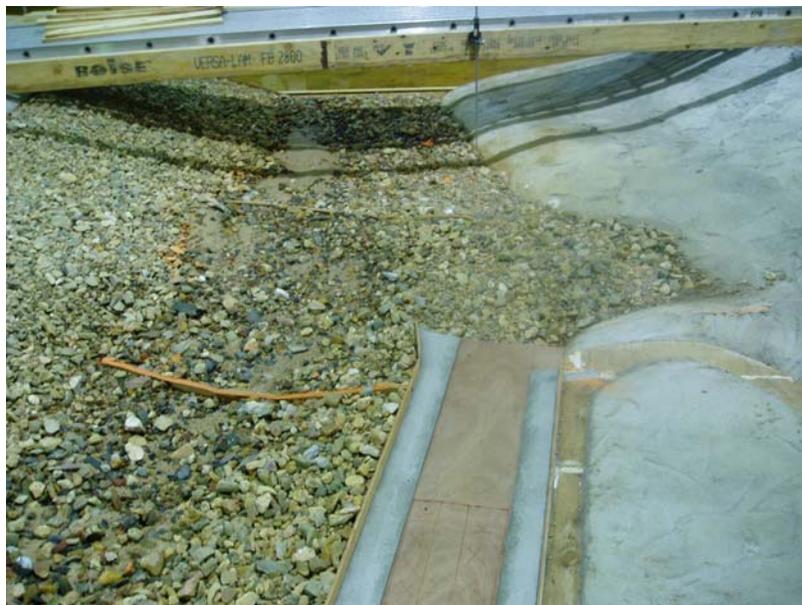
The deposition pattern further downstream at the end of the main channel after the 10-year event is shown in figure 53. At the end of the main channel, sediment deposited to the left of the channel centerline. The centerline of the channel was swept clear by the combined flows from the main and intake channels.

Figure 53. - Final sediment deposition pattern at the downstream end of the main channel after testing the 10-year event of 63,000 ft³/s. Note that sediment deposited to the left of the main channel near the end of the model by Sta. 94+00.

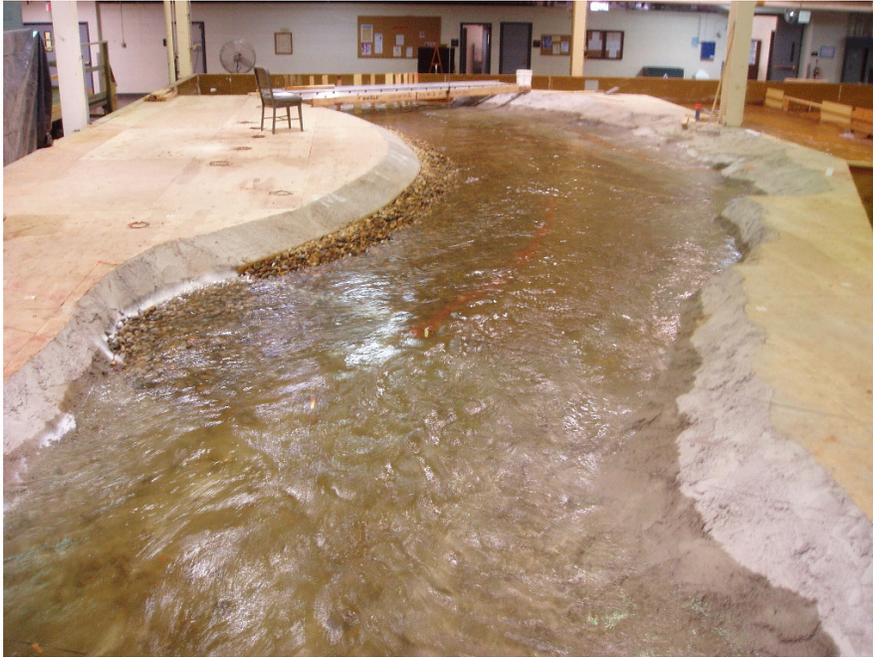
The tailwater was set to El. 526.13 at Sta. 94+00 for the 50-year flow event of 128,000 ft³/s. This was 32,000 ft³/s lower than that previously tested. The upstream water surface was measured at El. 531.12 ft. at Sta. 114+00. Flow conditions for this event were similar to those for the 10-year event flow rate, but with more submergence of the structures and higher velocities, figure 54.

Figure 54. - Overall view of the model operating under the new 50-yr event of 128,000 ft³/s showing the diversion tunnel fill area, and the general flow conditions in the river.

Figure 54 shows a portion of the upstream river channel through the diversion tunnel fill area. Flow still appeared to separate from the cofferdam at about Sta. 106+00 and swing toward the outside of the bend where the intake channel was located. Fines in the invert beginning at Sta. 108+00 began moving slightly under this flow event.

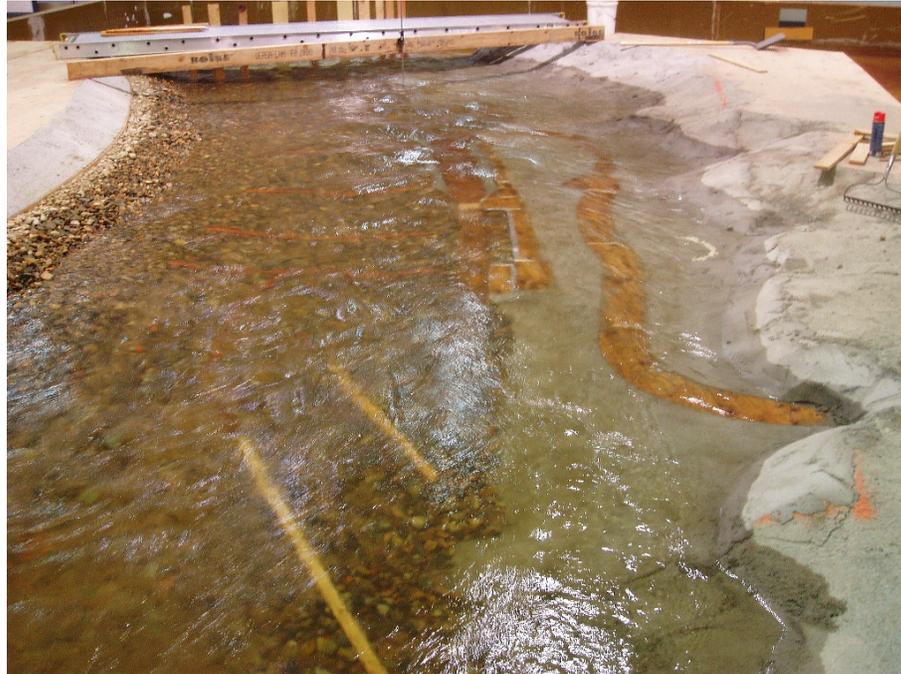
Figure 55 shows the submergence of the intake area with supercritical flow through the entire river section. Figure 56 shows a close up view of the flow sweeping over the right bank access road area and the wave pattern over the screened intake area.

Figure 55. - The intake and main channel area operating under the 50-year event of 128,000 ft³/s showing the submergence of the structures.

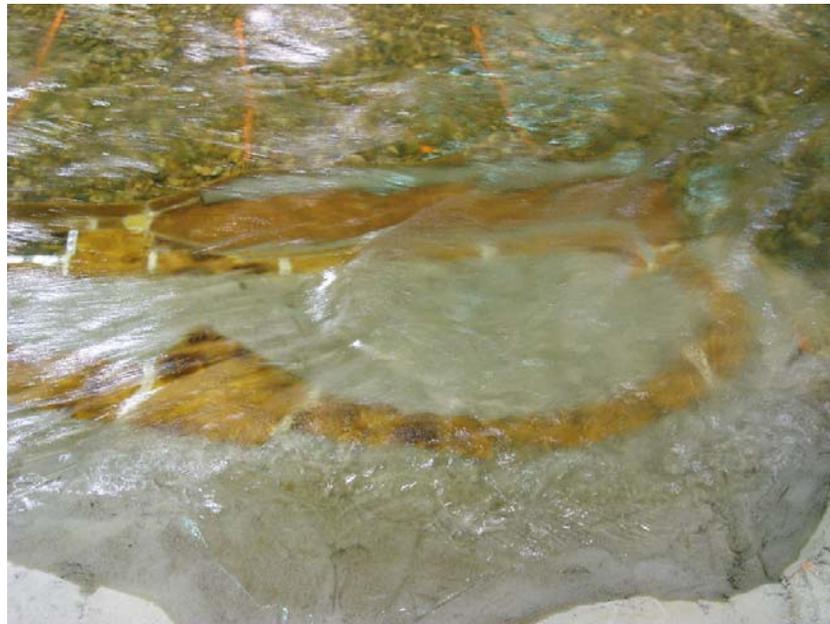
Figure 56. - Side view of the main channel, screened intake area and right bank with the roadway submerged under the flow of 128,000 ft³/s representing the 50-year event.

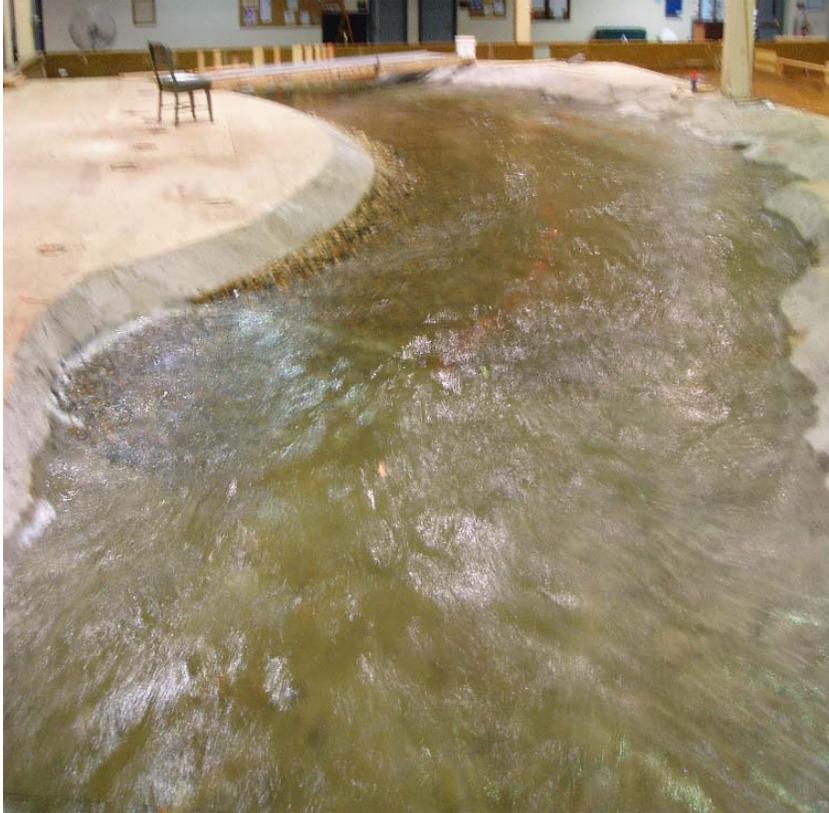
The 100-year event flow rate of 164,000 ft³/s was almost identical to the previous 50-year event of 160,000 ft³/s. Basically, the return period doubled for this higher flow event. Figures 57-59 show that the flow conditions that occurred were almost identical to those discussed under the 50-year event from the previous intake and main channel geometry. Material from the invert at Sta. 108+00 eroded to the fixed floor of the model and the erosion was migrating downstream.

Figure 57. - Overall view of the river from the diversion tunnel location through the main channel and intake for the new 100-year event of 164,000 ft³/s.

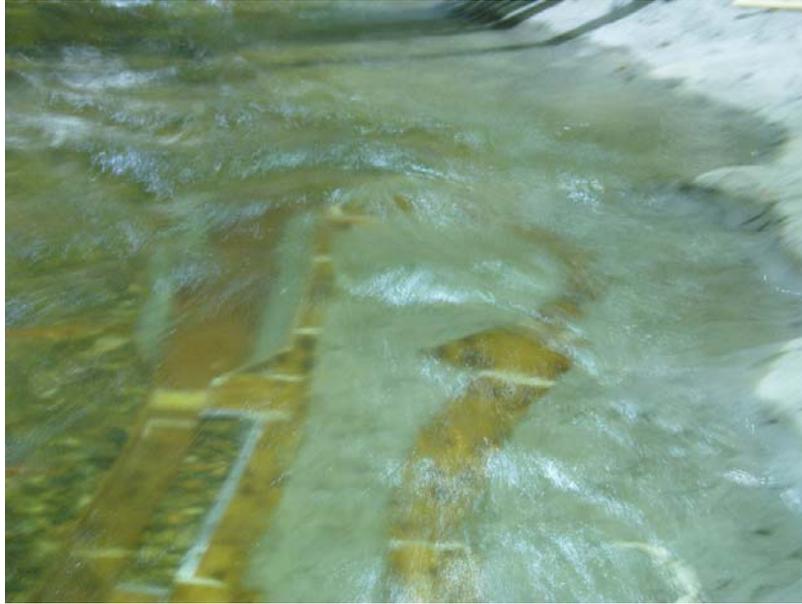
Flow over the bank submerged all the access roads and supercritical flow existed over the bank and intake. Flow in the main channel was also supercritical with waves extending to the end of the model. Material was removed by the flow from the end of the model upstream to about Sta. 93+00.

Figure 58. - View of the intake area and right bank with standing waves over the submerged intake and bank under the 100-year event of 164,000 ft³/s. The adjacent main channel was also fully submerged with standing waves at the downstream end of the channel.

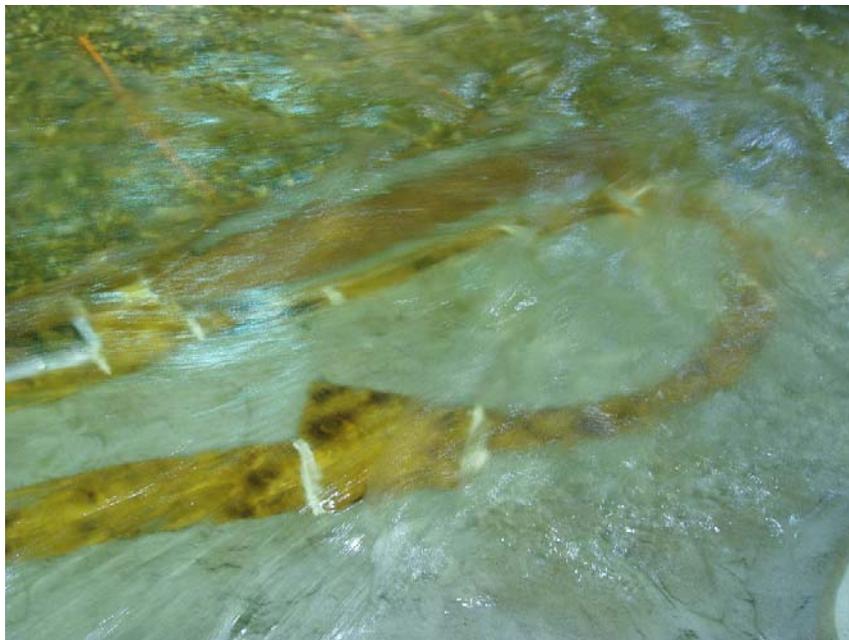
Figure 59. - The right bank and intake area submerged by the 100-year event with supercritical flow and standing waves occurring.
