Hydraulic Laboratory Report HL-2006-05

## Hydraulic Model Study of Gwinnett County Georgia Y15 Dam Overtopping Protection

August 2006

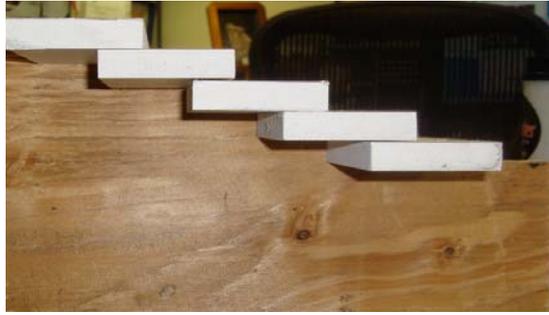
Figure 2. - View of the PVC sheet material cut into strips and mounted on a sample template.

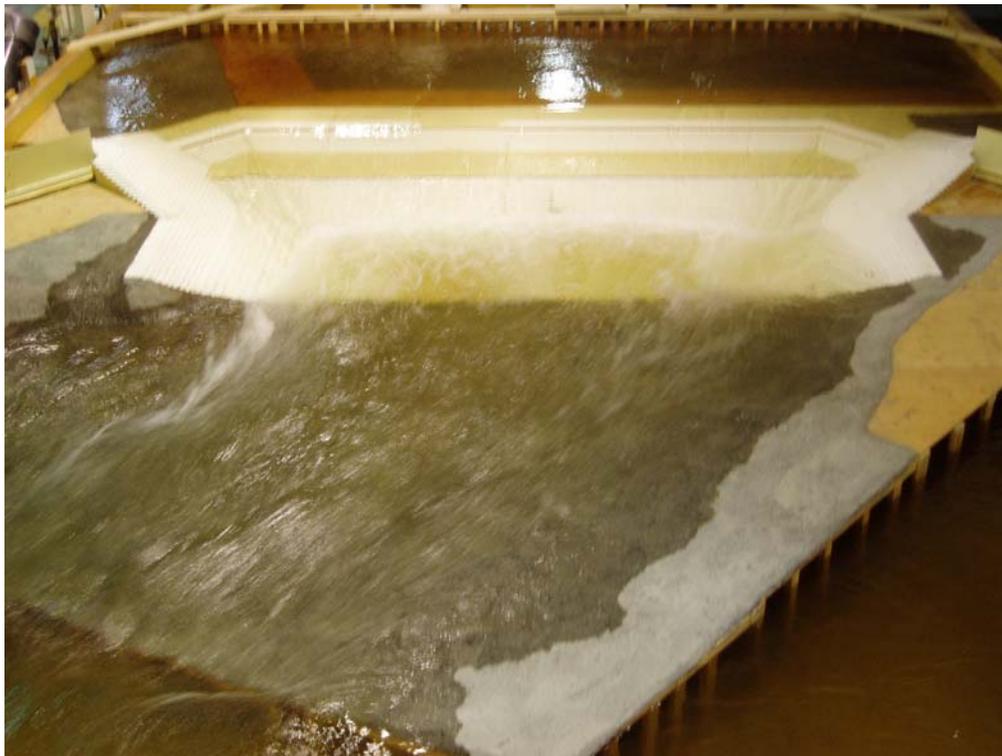
Figure 3. - Overall view of the 1:24 scale hydraulic model of the Y15 dam stepped overtopping protection.

In addition to the overtopping protection, a short section of the upstream embankment topography, and about 250 ft of the downstream river channel below the stilling basin were included. The downstream river channel is composed of minimal alluvial cover over good quality rock. Non erodible topography was modeled. The RCC will be covered with soil and seeded after construction, which, was of no concern in the model. An overall view of the 1:24 scale model as originally constructed is shown on figure 3.

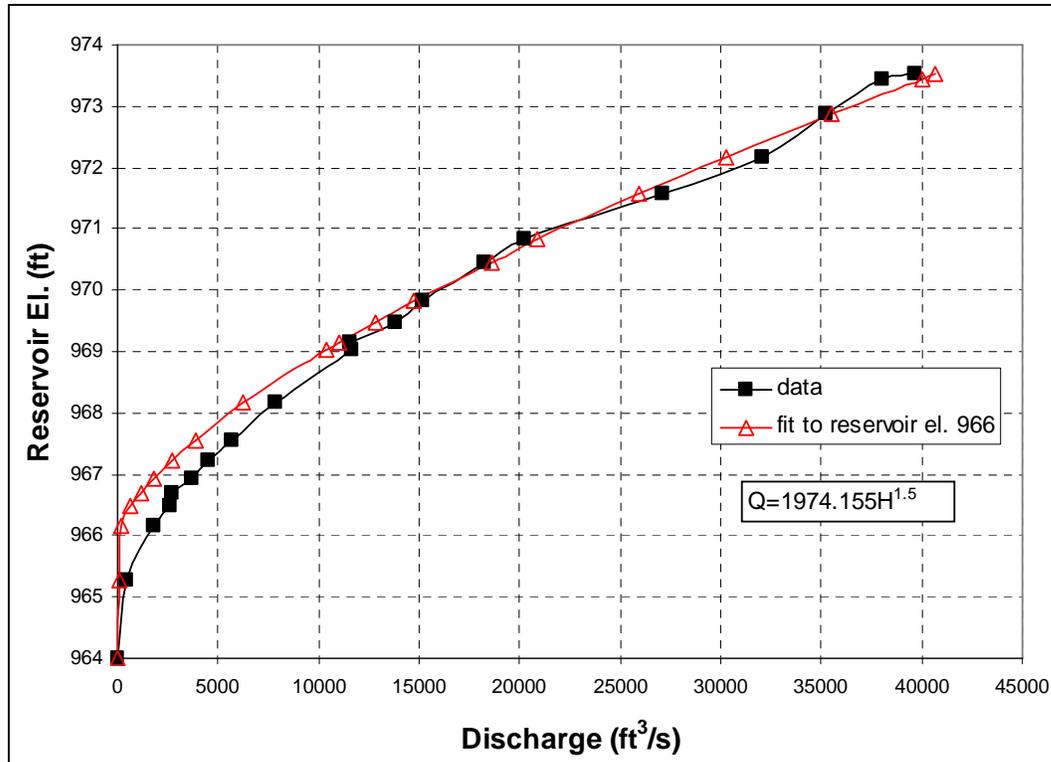
Figure 4. - Rating curve for Y15 overtopping protection with a curve fit to the free flow weir equation. The head was referenced to El. 966. The design discharge is passed below the top of the dam. The fit to the curve in the low flow range is not particularly good because of the relative amount of flow through the low flow notch compared to the total flow over the main crest.

- The broad crest with ends angled downstream and low flow section produced a discharge of 44,335 ft<sup>3</sup>/s under the maximum reservoir head of 7.96 ft above crest El. 966 as per the equation fit to the measured values, figure 4.

The rating data in table 2 and the curve on figure 4 show that the PMP flow condition is passed under the expected reservoir elevation and the flood will not overtop the remaining portion of the dam. The head was referenced to the main crest at El. 966. The maximum reservoir elevation necessary to pass the overtopping flow PMP of 37,926 ft<sup>3</sup>/s, plus the principal spillway flow of 120 ft<sup>3</sup>/s, was computed to be El. 973.96 under a head of 7.96 ft above crest El. 966.

Figure 4 also shows the data fit to the weir equation equal to:

$$Q = 1974.155 \times H^{1.5}$$

where the head value is referenced to El. 966 of the main crest. The equation fit was not performed for the low flow and head values below El. 966. The actual flow through the low flow notch at El. 964 had an impact on the fit to the rating curve, particularly in the lower portion of the curve. The fit with the weir equation improved as the amount of flow through the notch became relatively less with increasing total flow. The discharge equation produces a flow rate of 44,335 ft<sup>3</sup>/s over the crest under a reservoir head of 7.96 ft. This flow is quite a bit more than the predicted discharge under the PMP event.

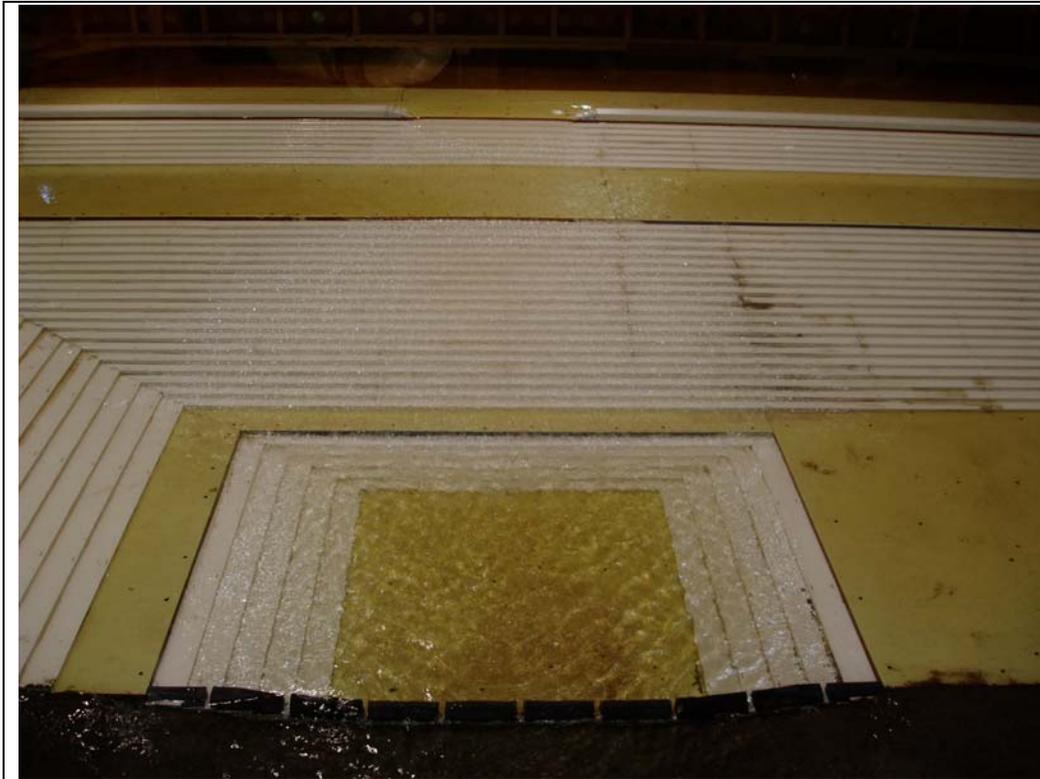
Figure 5. - Flow through the low notch section designed to pass the 100-year event.

Flow through the low notch section at El. 964, 2 ft below the main crest elevation, is shown operating on figure 5. The 45-ft-long notch was not centered on the crest length but along the centerline of the existing principal spillway. The flow through the notch was very small with the scale used in the model and an attempt to exactly determine the flow capacity of the notch prior to spilling over the main crest was not made. The 100-yr event was computed to be 581 ft³/s including 120 ft³/s through the principal spillway. A discharge of 483 ft³/s was measured through the low flow notch at El. 965.28; therefore, it seemed that the expected flow rate could be passed through the notch without concern. Figure 5 shows that the flow through the notch spreads significantly along the flat bench.

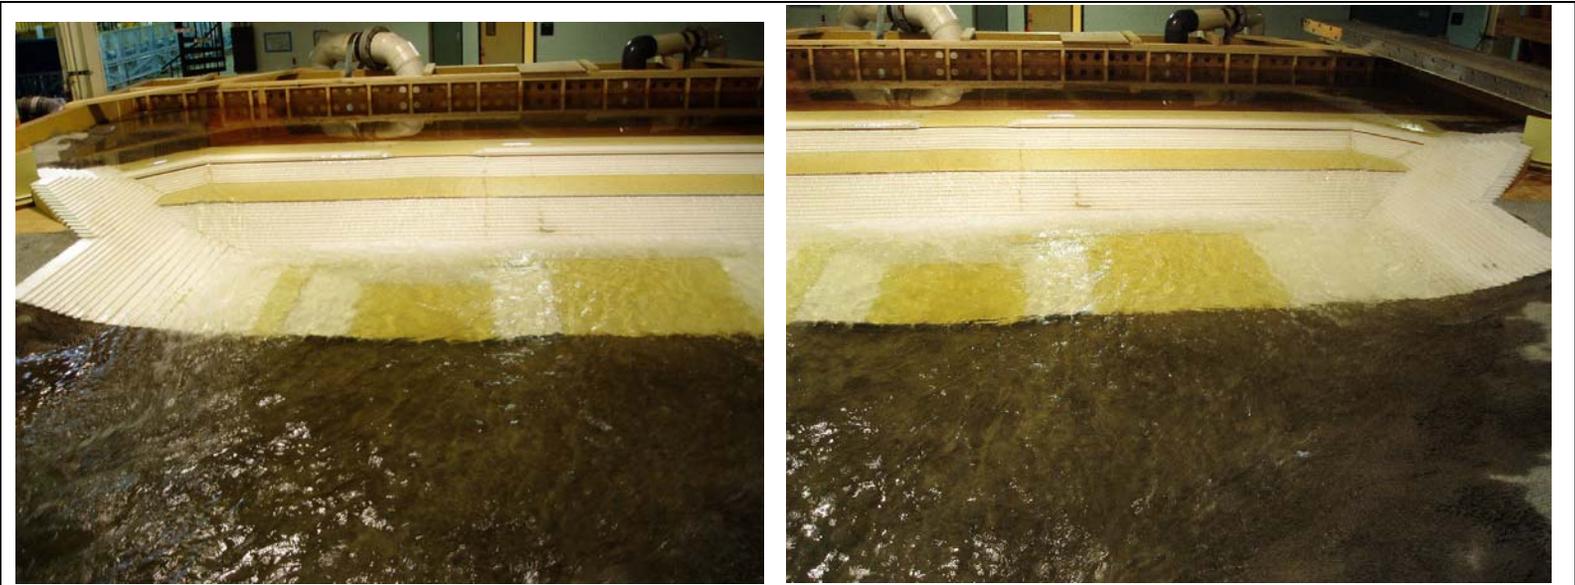
Figure 6. - One-quarter PMP event, looking downstream, operating over the initial design and the tailwater with culverts.

The flow conditions for the initial overtopping design are shown in figures 6 through 14 for the 1/4 to PMP events.

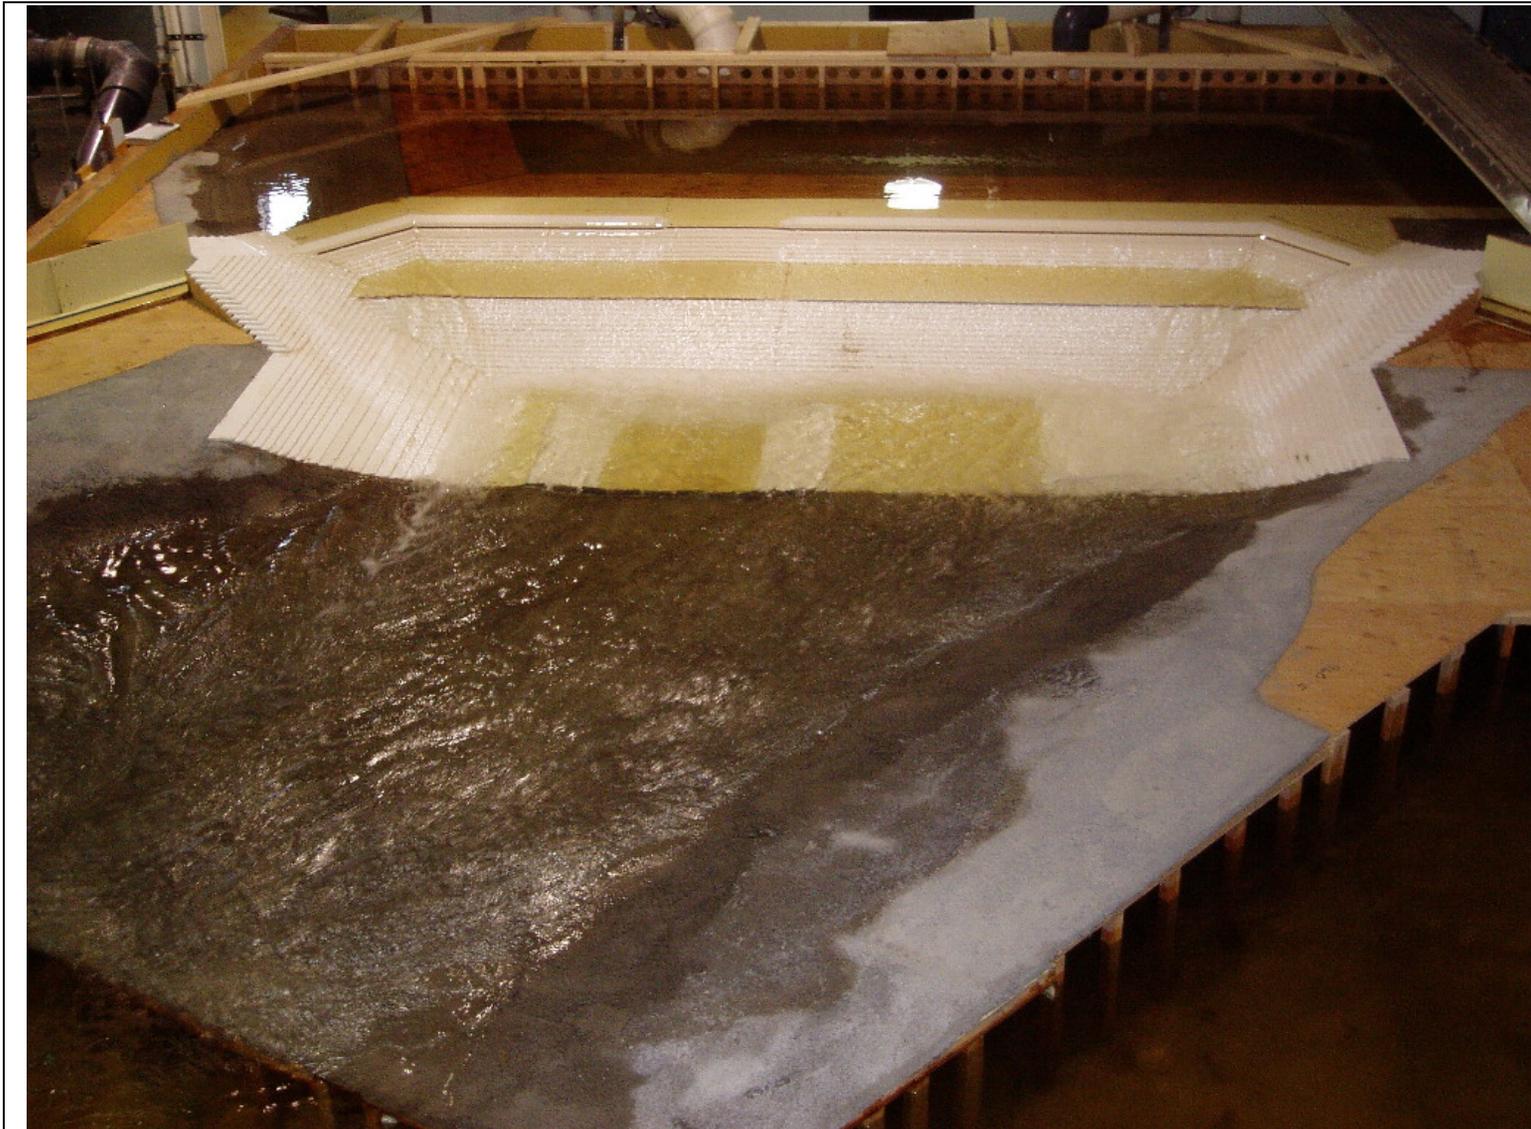
Figure 7. - One-half PMP AMC II event operating over the initial design and the tailwater without culverts

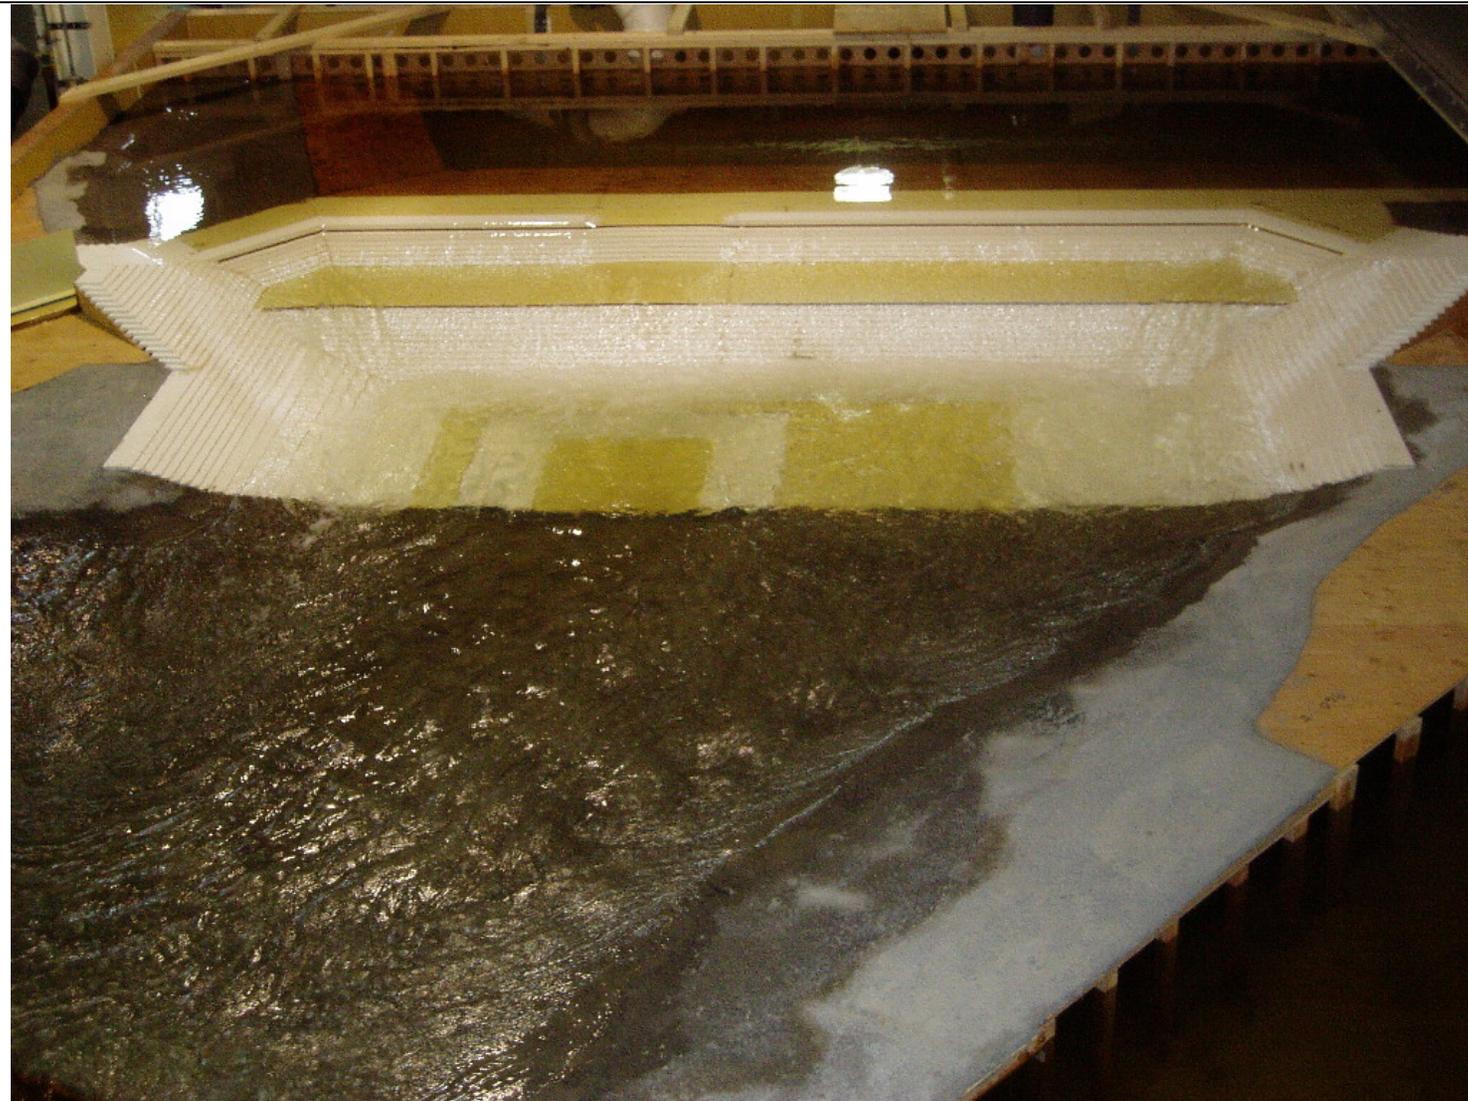
Figure 8. - One-half PMP AMC II event operating over the initial design and the tailwater with culverts.

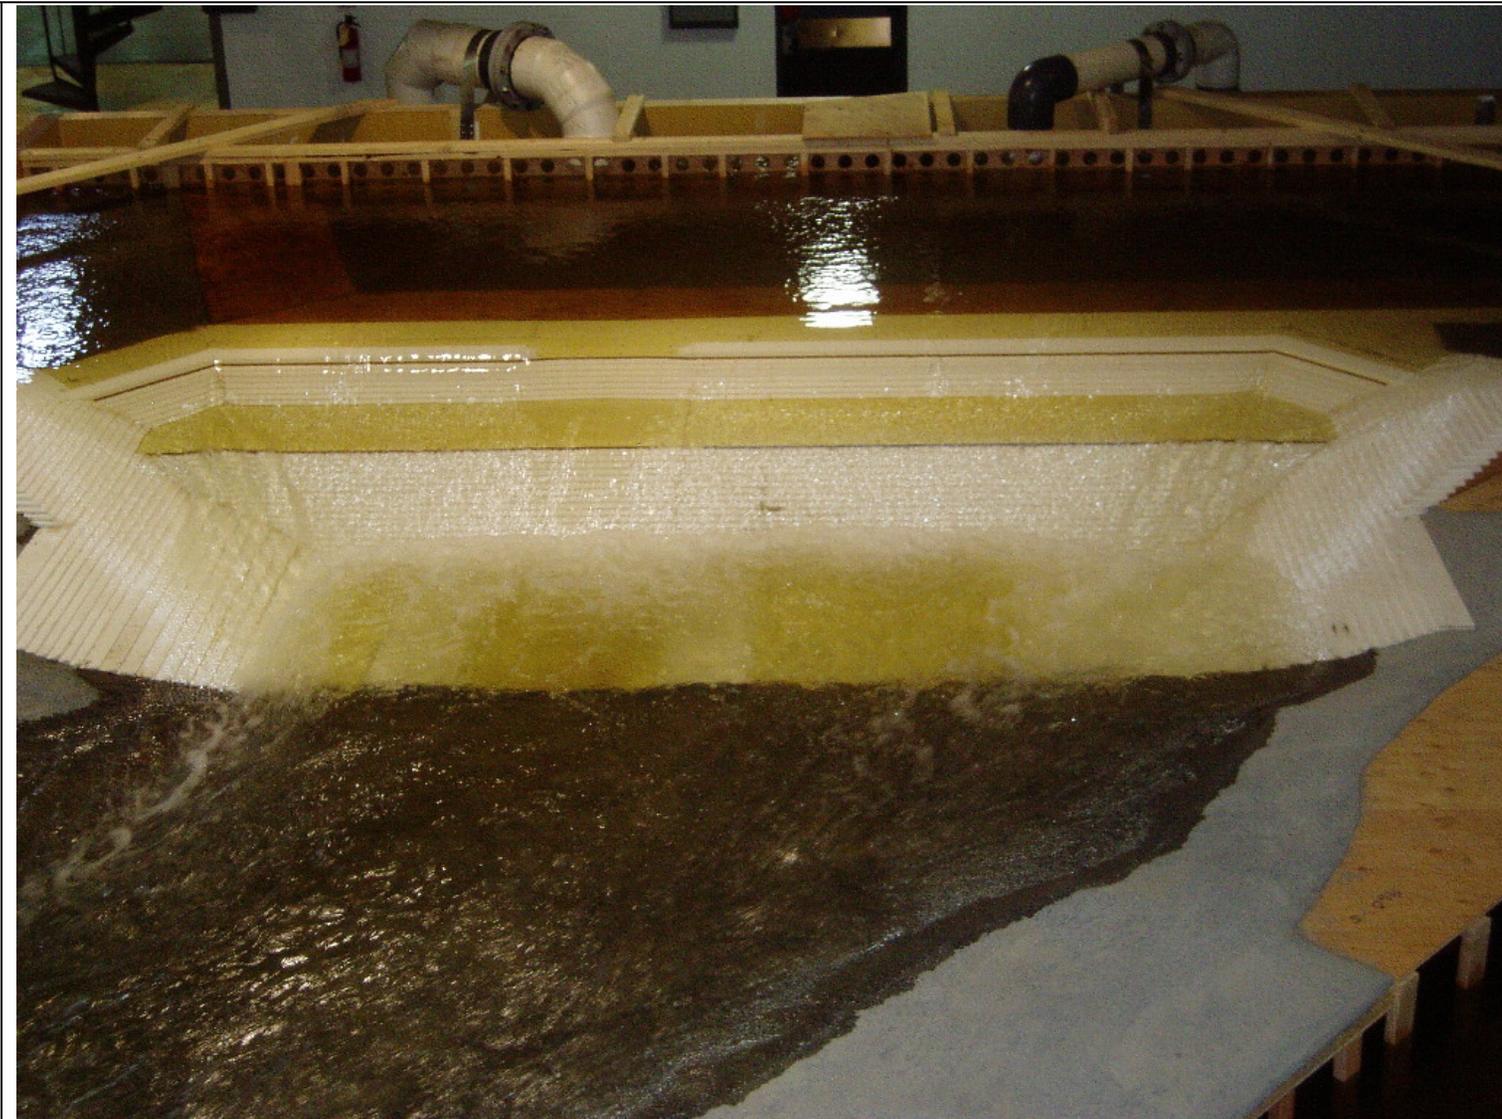
Figure 9. - One-half PMP AMC III event operating over the initial design and tailwater without the culverts.

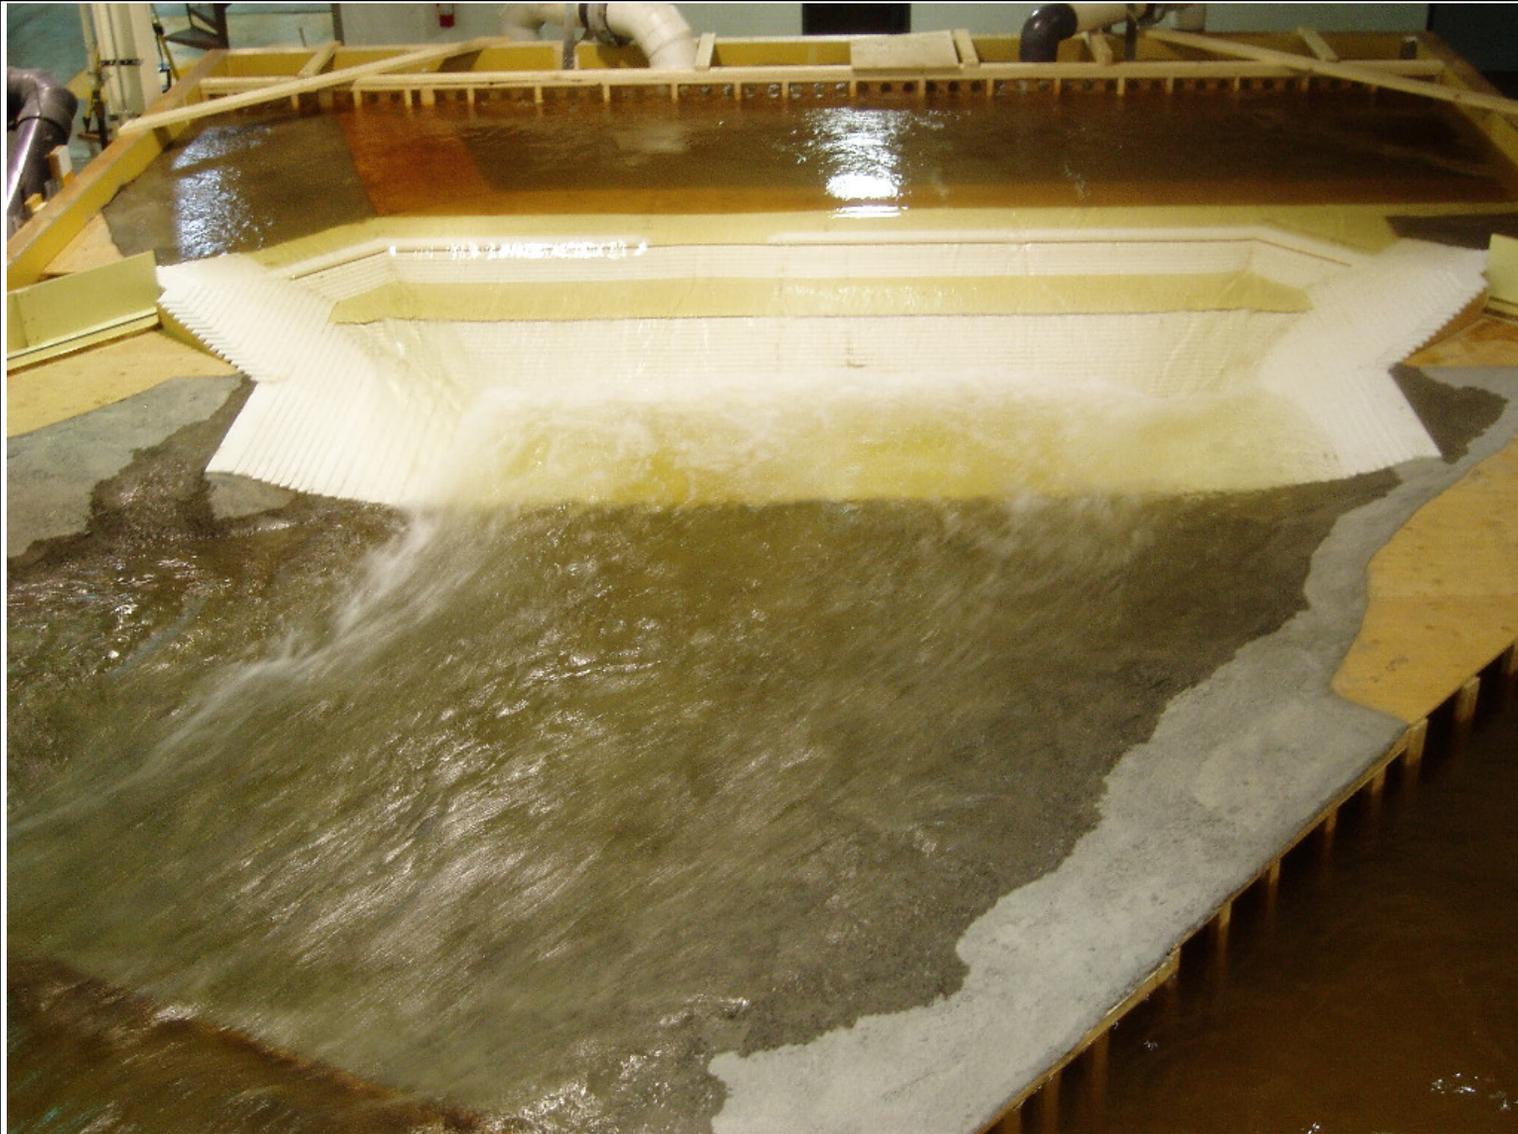
Figure 10. – One-half PMP AMC III event operating over the initial design and tailwater with culverts.

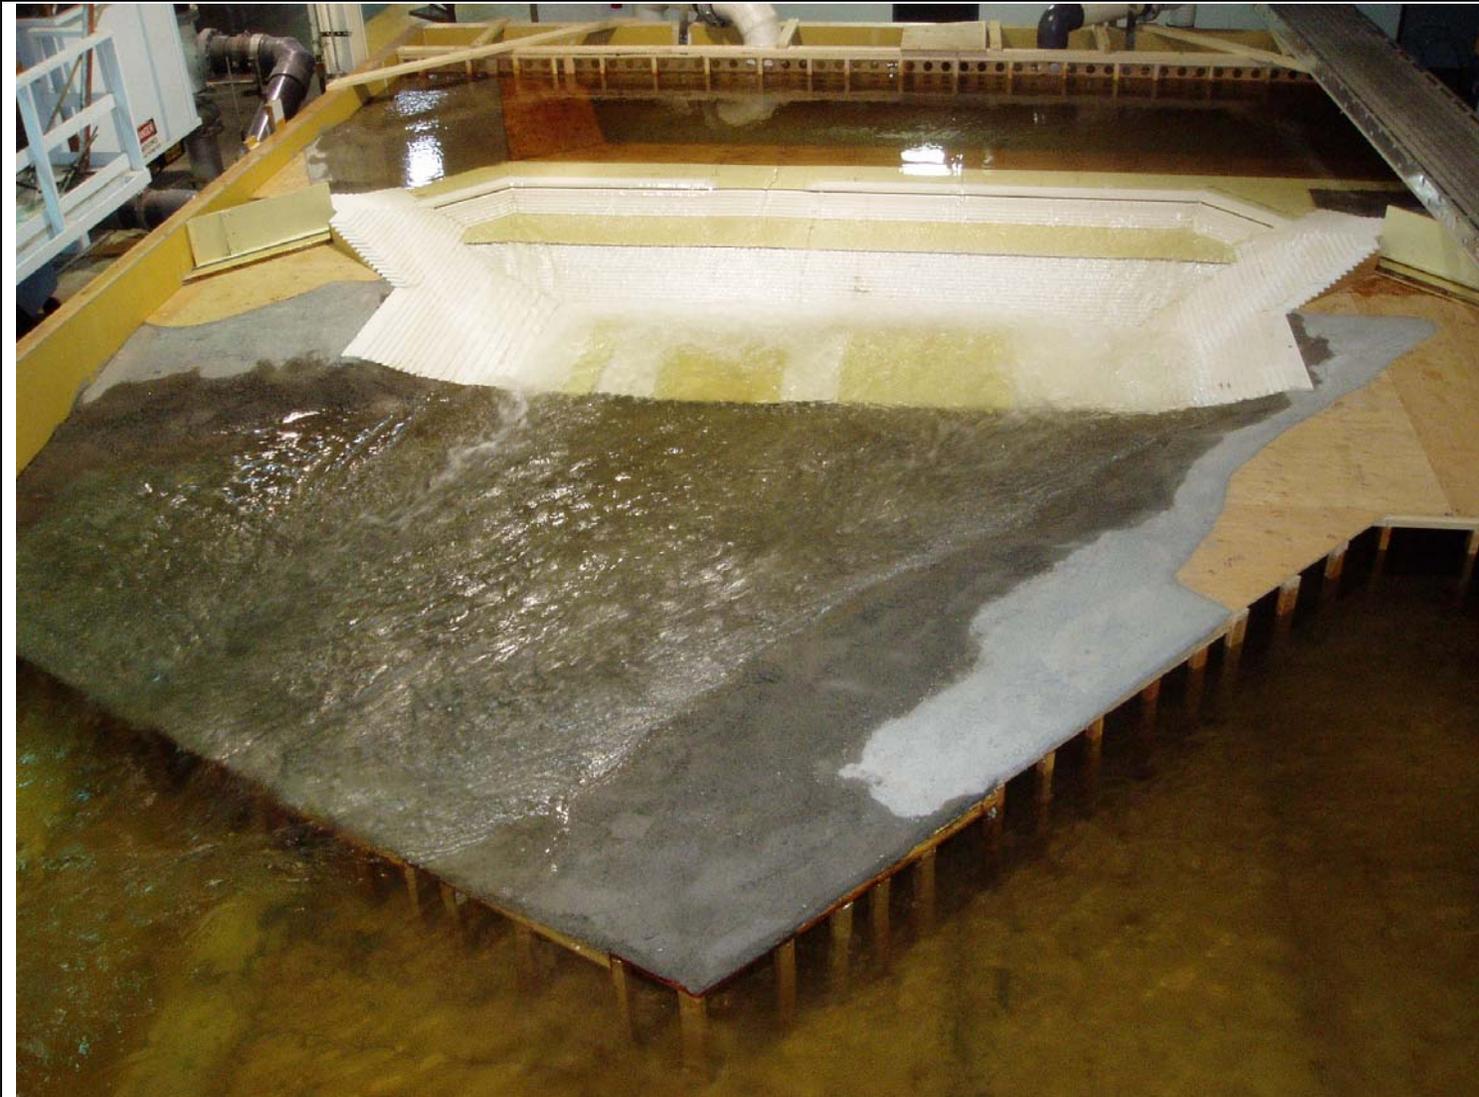
Figure 11. - Two-thirds PMP event operating over the initial design and tailwater without the culverts.

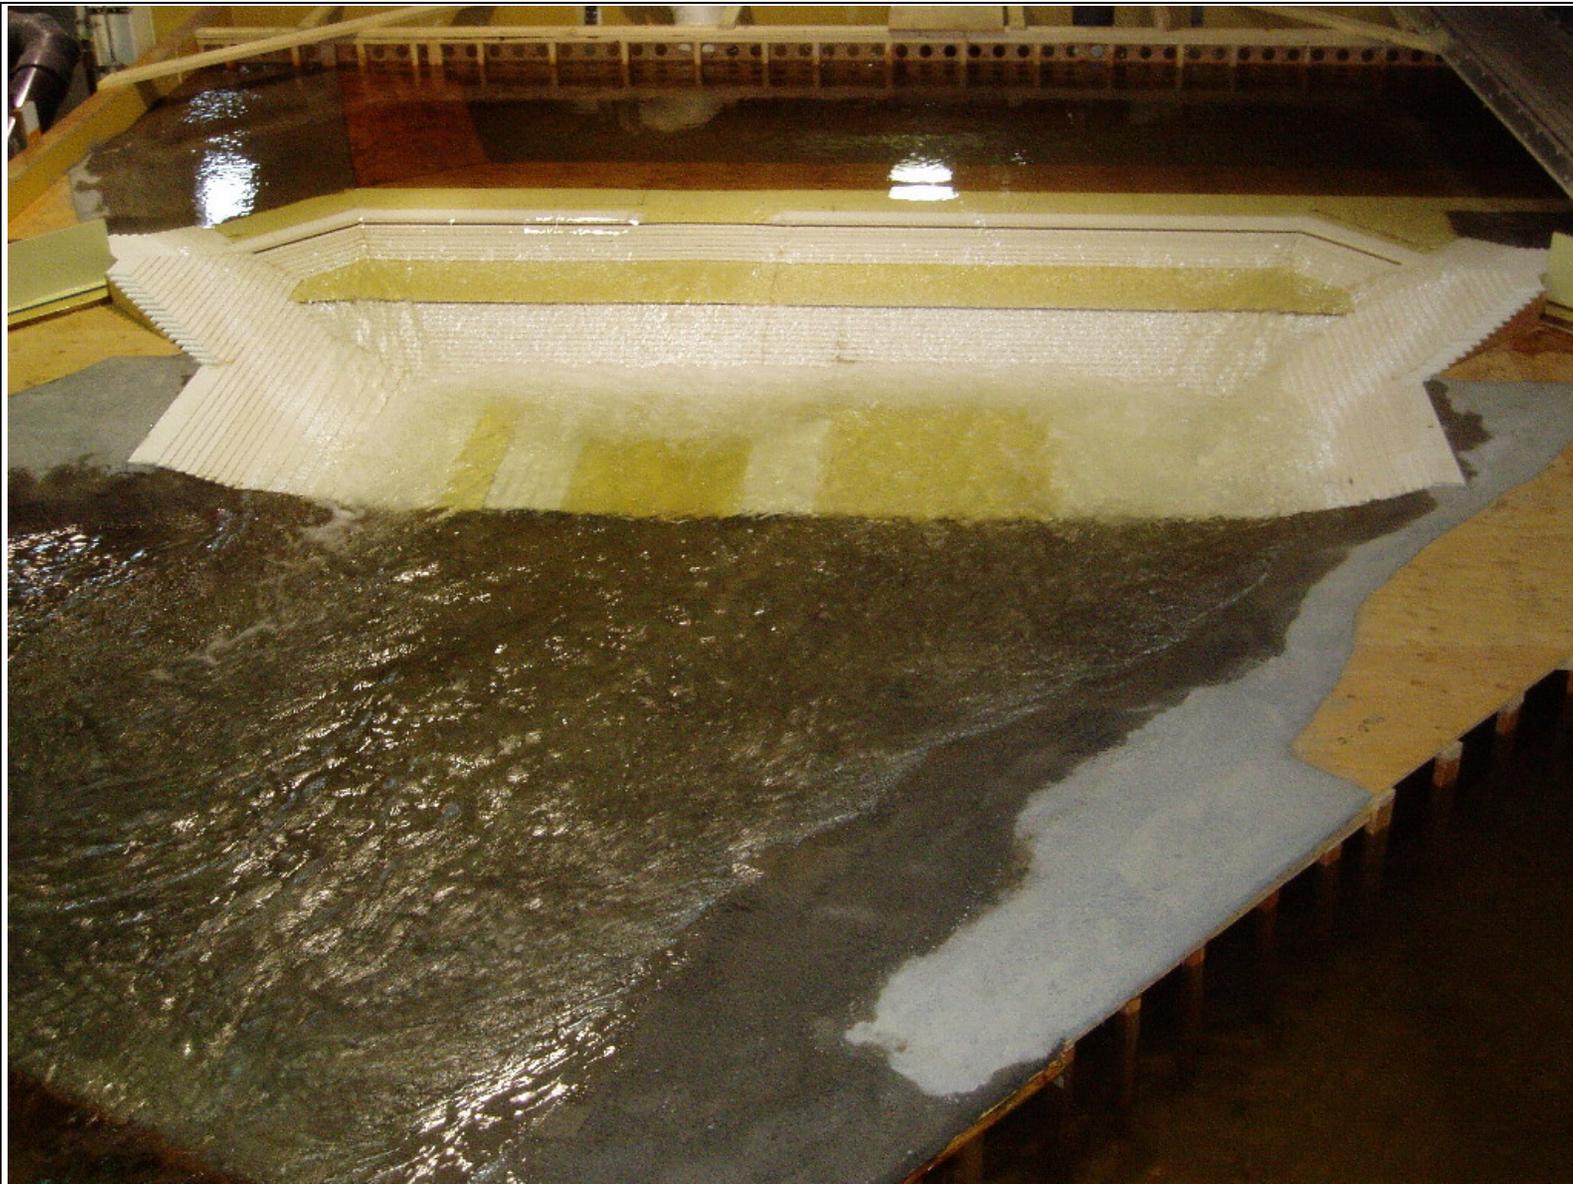
Figure 12. - Two-thirds PMP event operating over the initial design and the tailwater with the culverts.

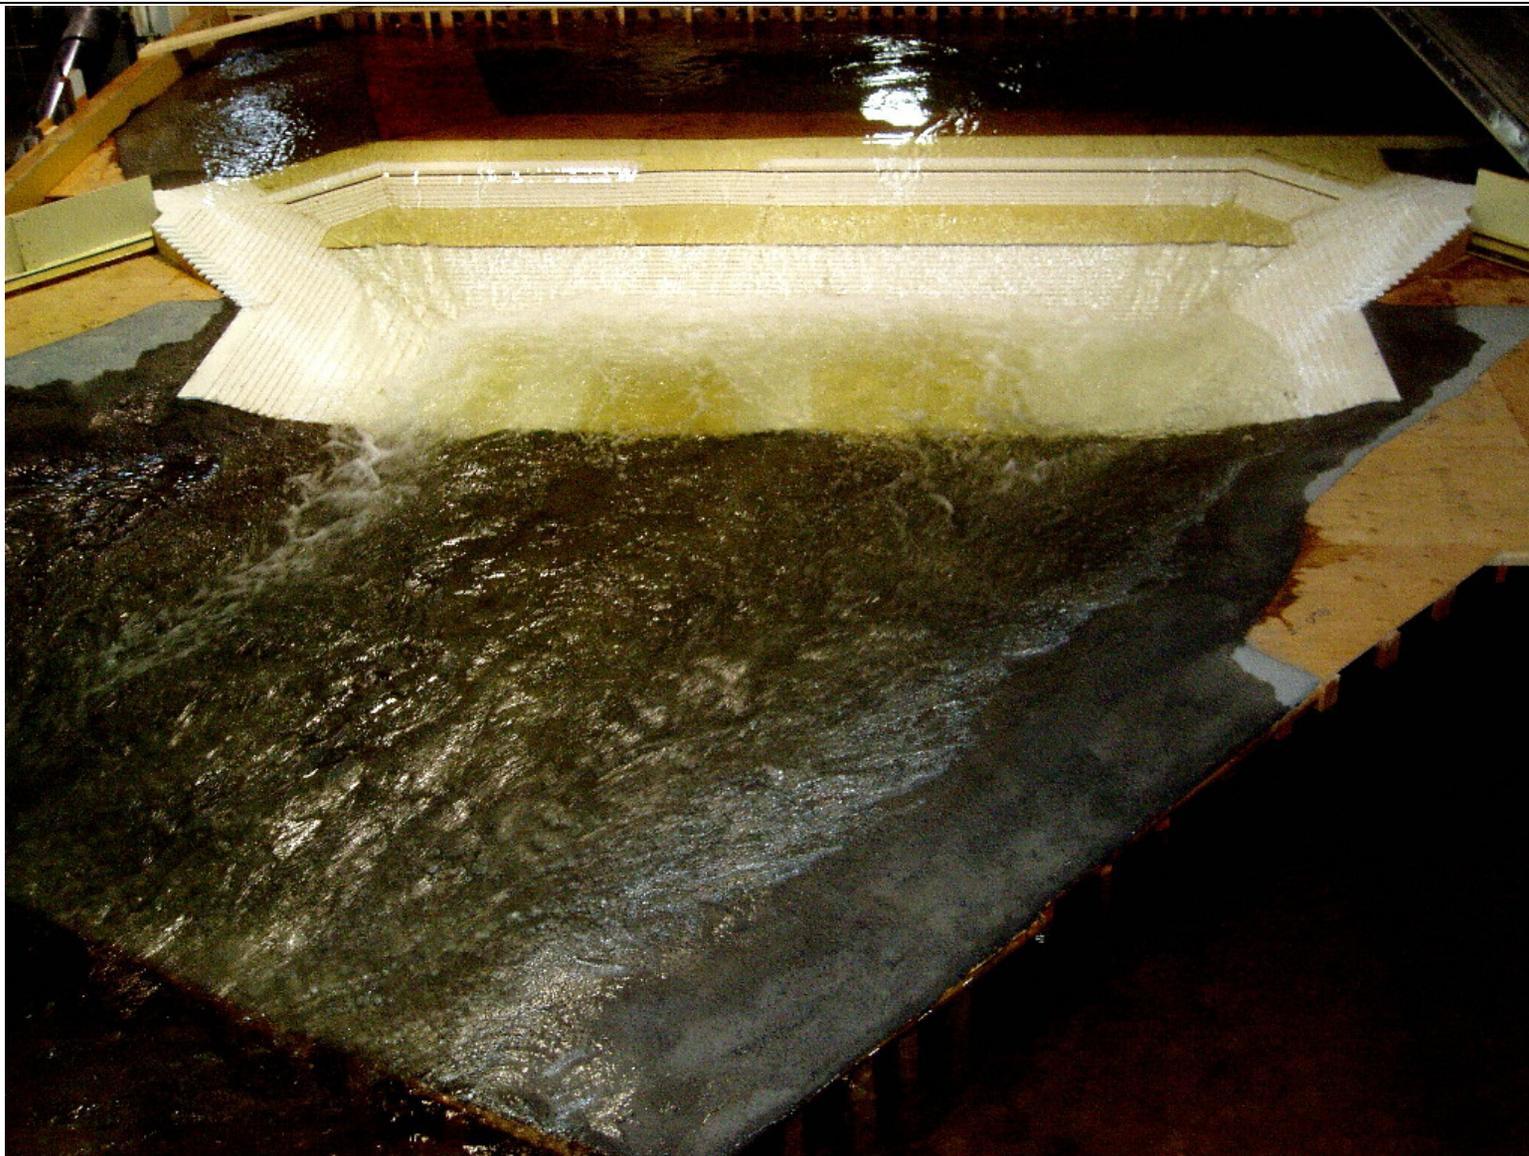
Figure 13. - Full PMP event with the initial design operating under a tailwater without the culverts.

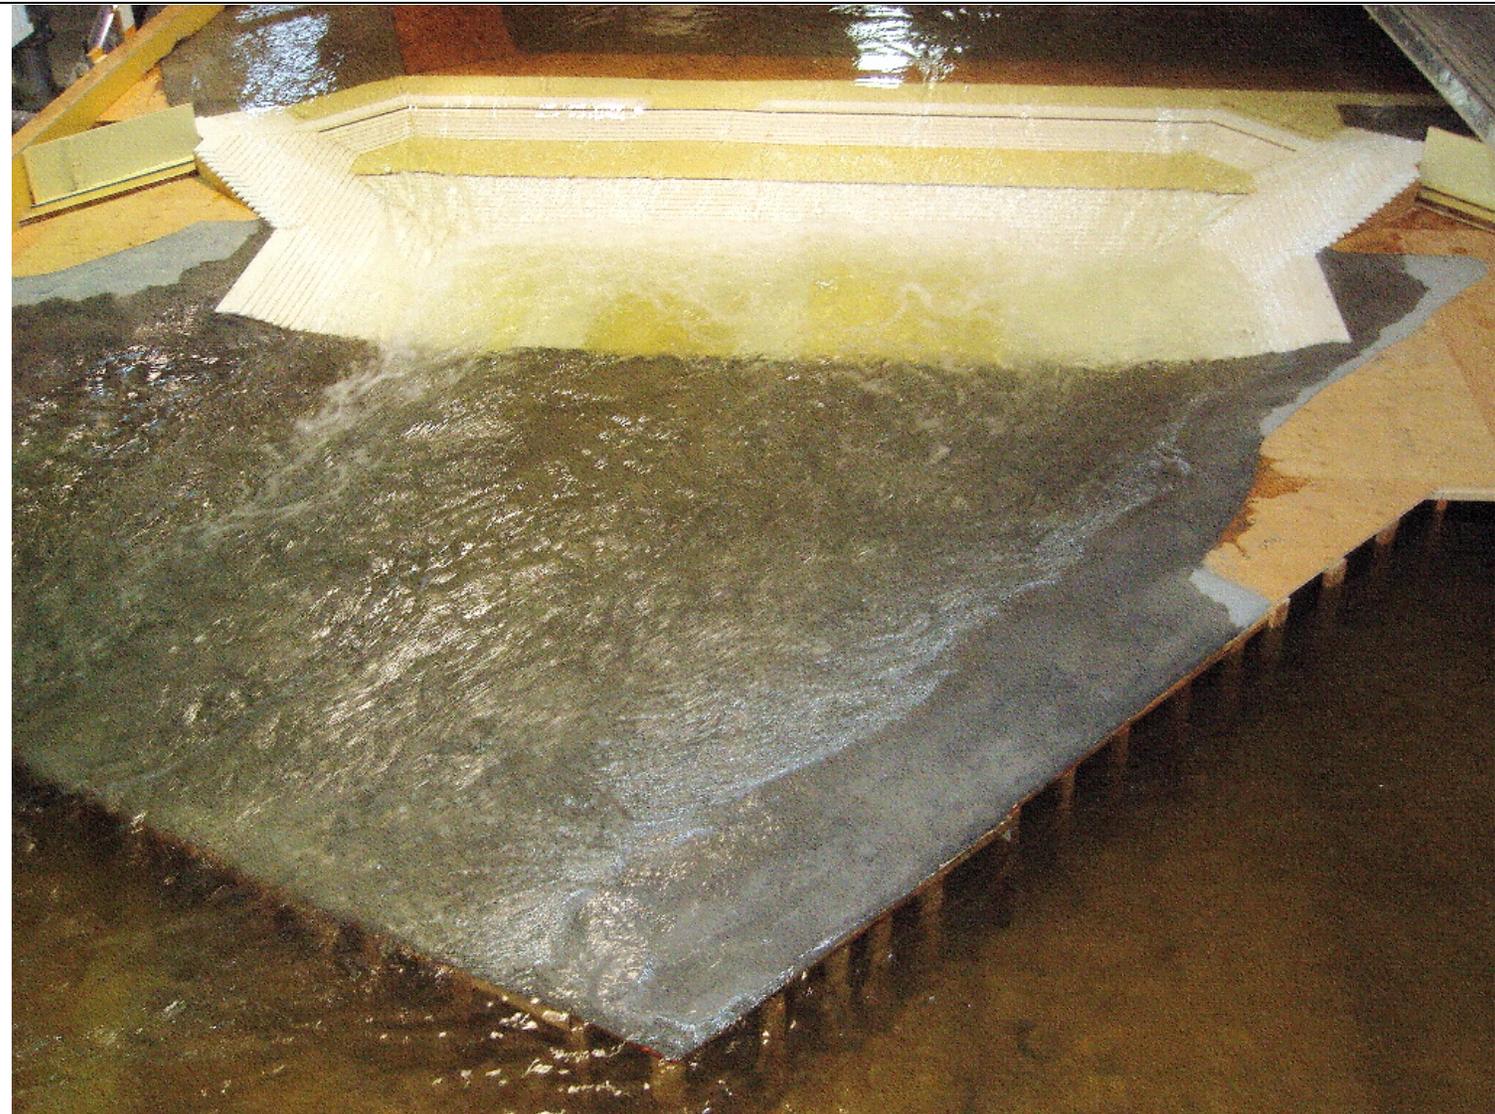
Figure 14. - Full PMP with the initial design operating under the tailwater with the culverts.

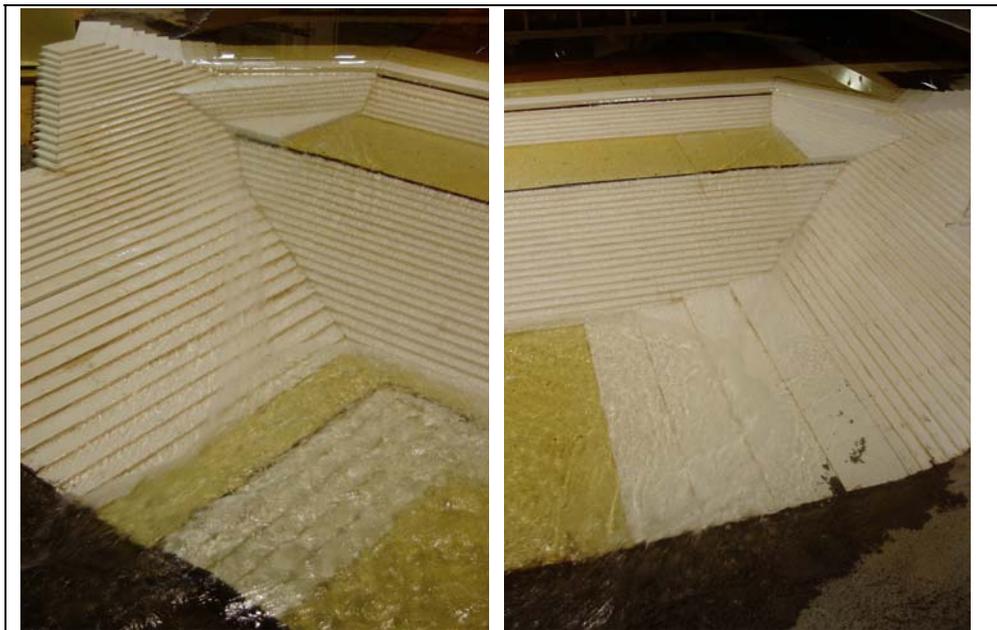
Figure 15. - Initial investigations with fillets below the angled crest sections on the upper flat bench. Left photo is the right fillet looking upstream.

While the angled portions of the crest were designed to reduce run out on the side walls, they produced additional flow concentrations in the groin areas when joining with the flow from the straight crest and the restriction of the sloping side walls. Initial investigations tried to redirect the flow concentrations inward towards the middle of the structure to spread the flow. Figure 15 shows the right and left fillets installed below the angled crests that were the initial attempt to reduce the flow concentrations. This geometry did not redirect the flow significantly and other options were investigated.

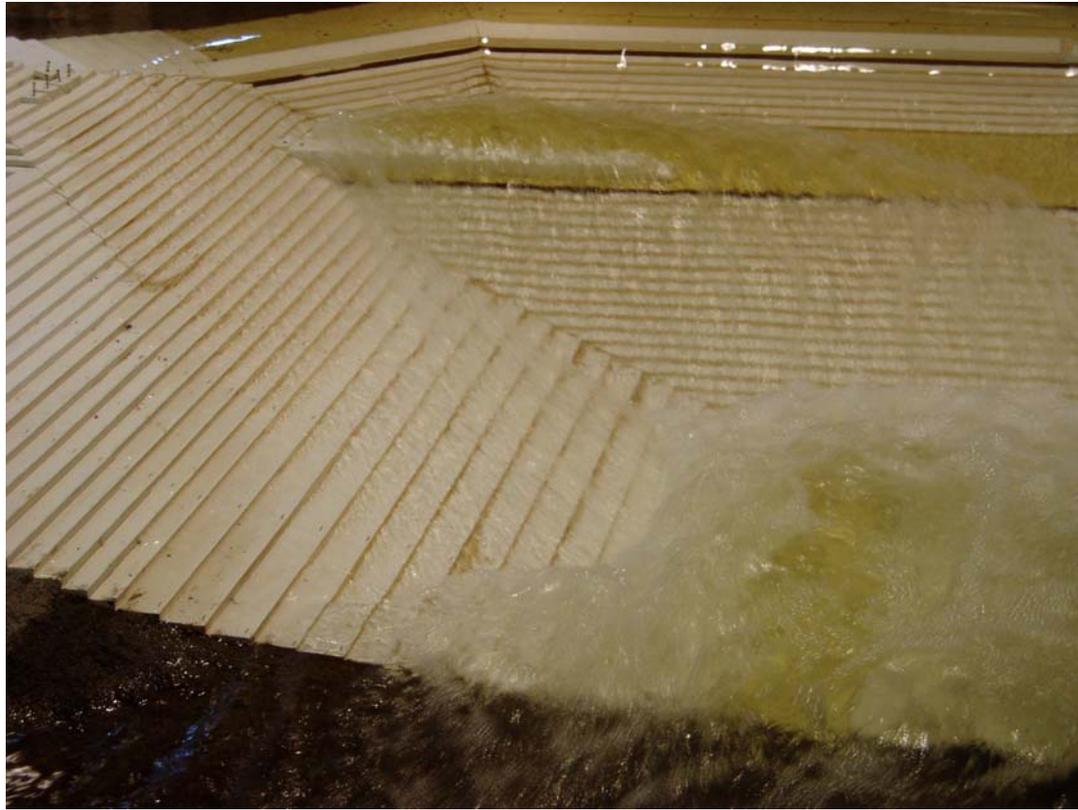
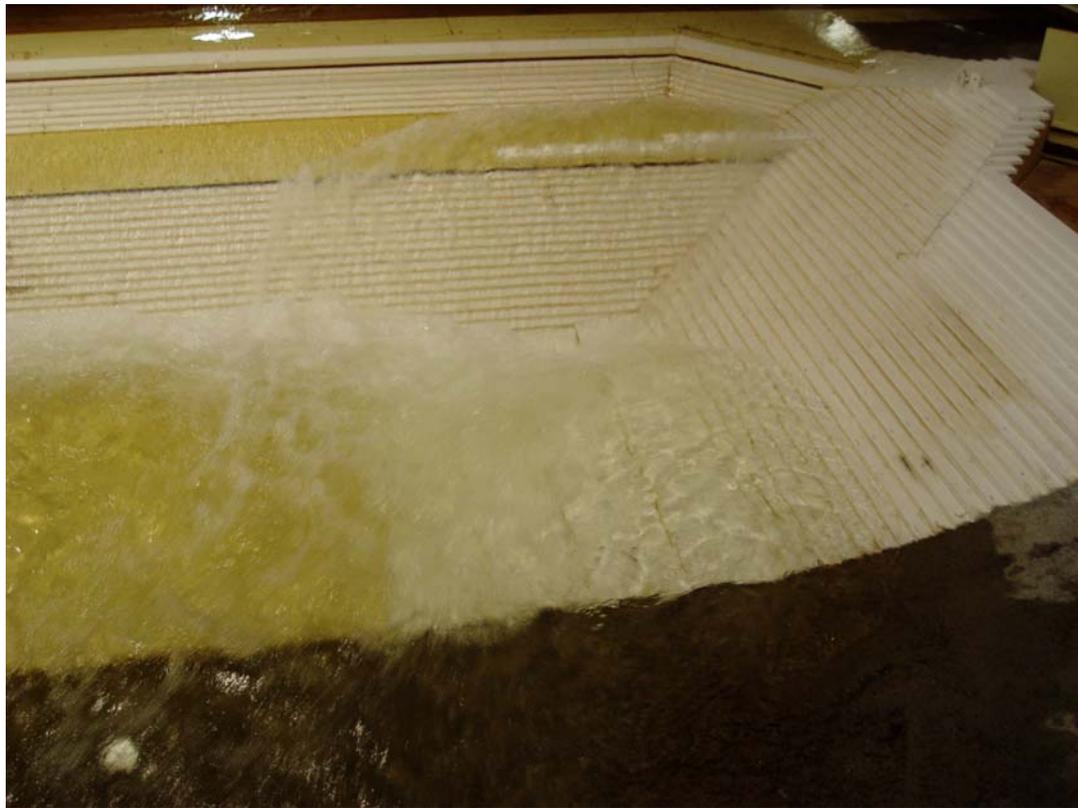
Figure 16. - Sill investigations with the partial 4-ft-high fillet shown operating under the PMP event.

- Construct high sills at the downstream end of the flat bench to divert more of the flow to the middle of the structure.
  - During the client visit 4-ft-high sills were investigated briefly. Figure 16 shows the flow conditions associated with the partial 4-ft-high sill located on the left or right side of the structure operating under the PMP. The sill worked quite well and led to the final recommended geometry. Further investigation also led to the conclusion that the sills would need to be considerably higher than a 3 or 4-ft-high sill to substantially improve the downstream flow conditions and this would be unacceptable from an aesthetics and construction standpoint.

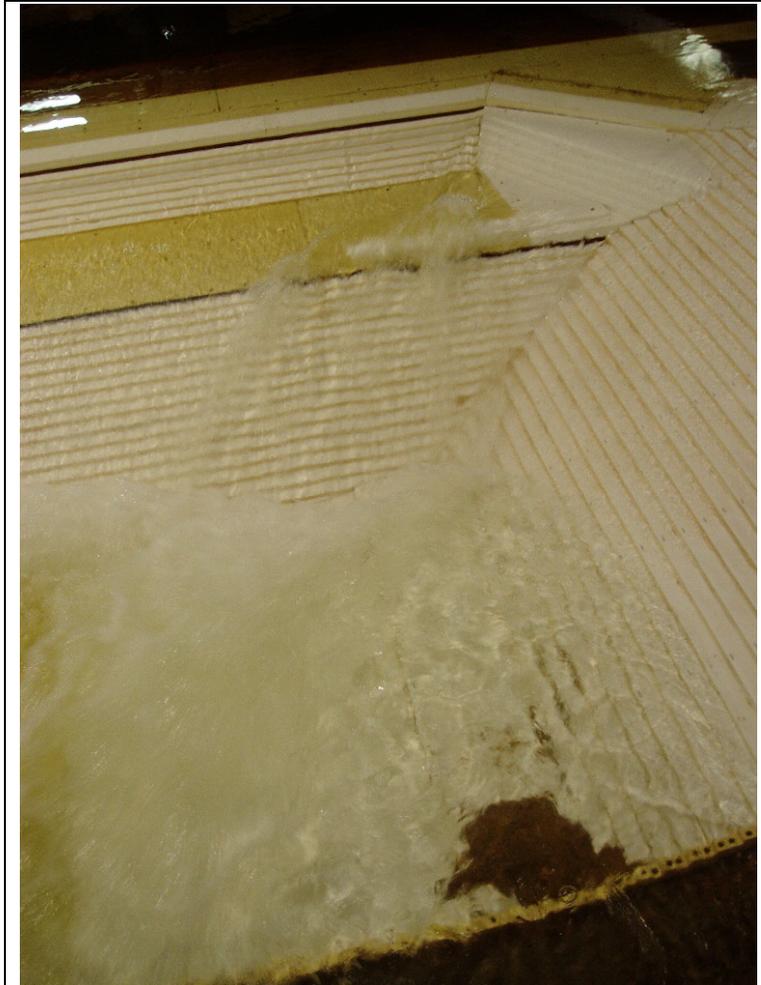
Figure 17. - Recommended 3-ft-high sill with the previously tested fillet installed first extending the influence of the sill out toward the middle of the structure operating under the PMP and tailwater without the culverts.

- Construct a fillet with the recommended sill on the upper bench. This option is shown on figure 17 and shows minimal improvement while operating under the PMP event.
