Hydraulic Laboratory Report HL-2006-05

## Hydraulic Model Study of Gwinnett County Georgia Y15 Dam Overtopping Protection

August 2006

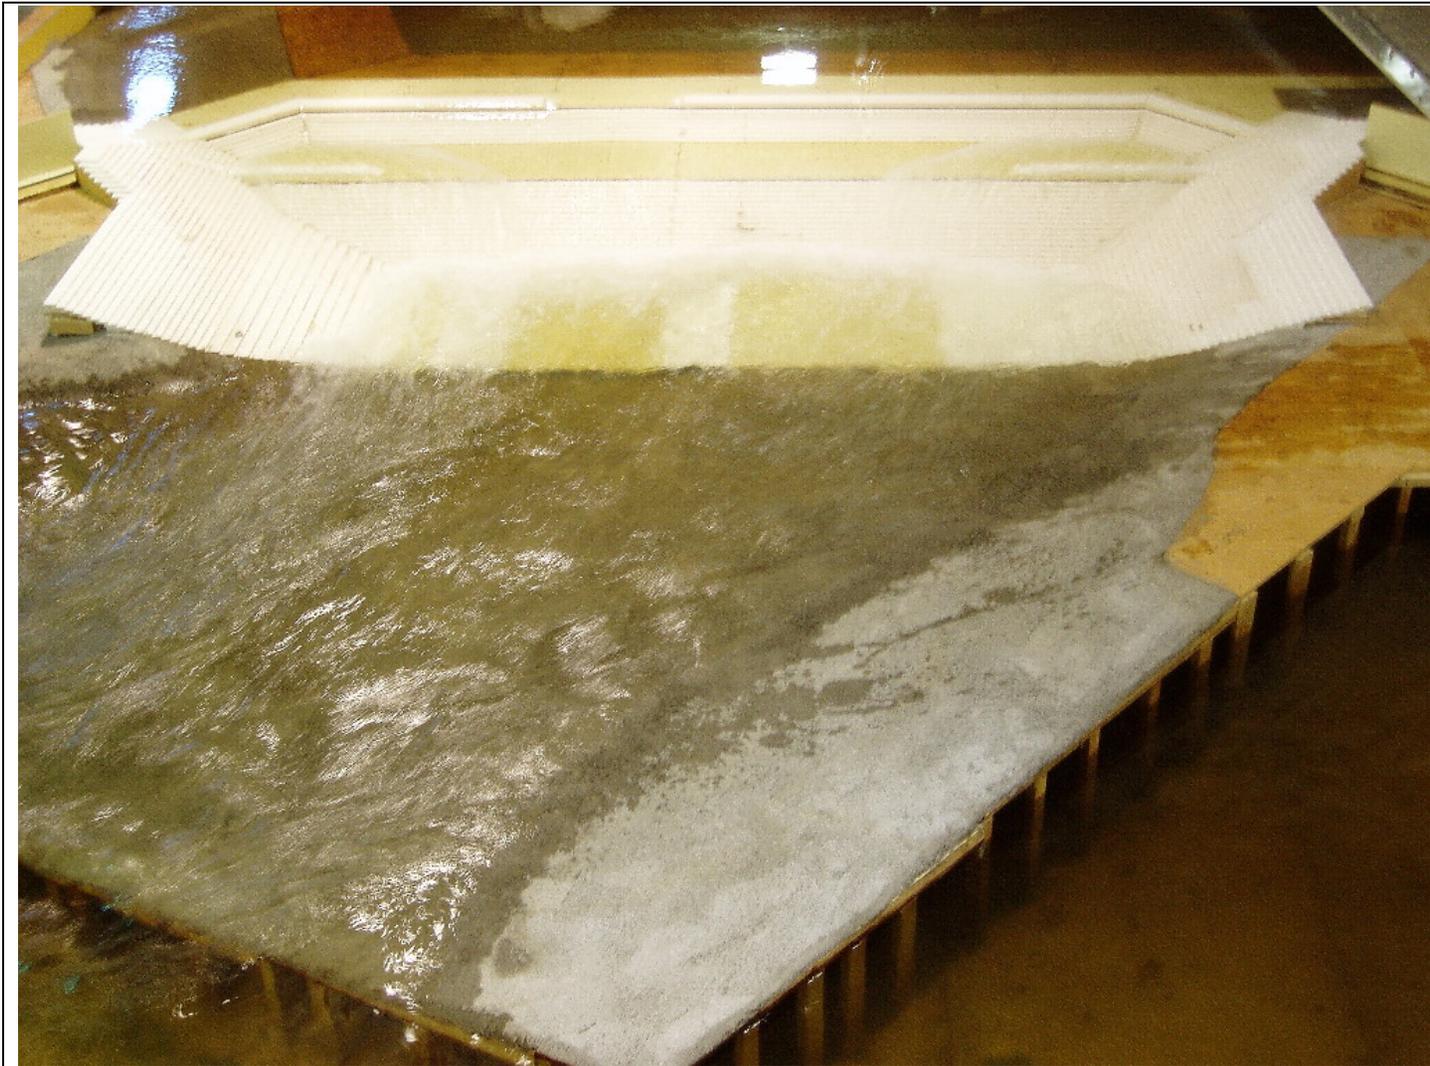
Figure 19. - Operation under the two-thirds PMP with the recommended sills on the flat upper bench and the tailwater without the culverts.

Figures 19-21 show the recommended sill geometry operating under the 2/3 and full PMP events operating under the tailwater without the culverts. A hydraulic jump forms on the bench behind the sills during flow rates up to the 2/3 PMP event. The jump sweeps out as the flow rate increases to the PMP with the 3-ft-high sill. The higher 4-ft-sill maintained the jump upstream during the PMP, but did not appear to spread the flow significantly better. As mentioned earlier, with aesthetic issues and the need for a much higher sill to spread significantly more water, the 3-ft-high sill was recommended. Velocities measured for the 3-ft-high sill did not seem excessive, as discussed in the next section.

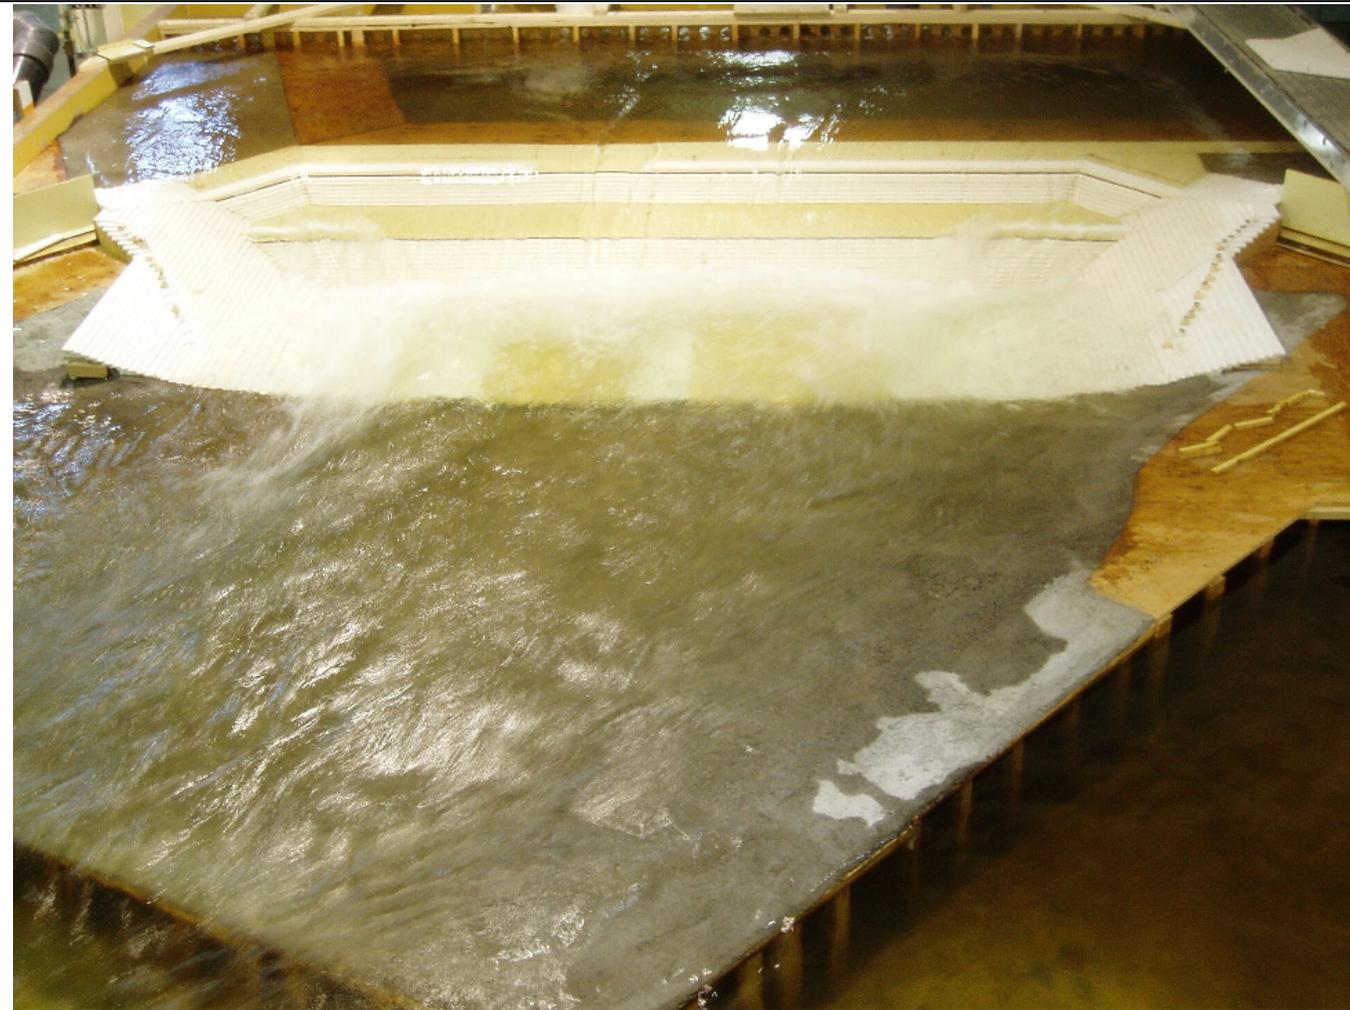
Figure 20. - PMP flow rate over the RCC protection with the recommended sills installed on the upper bench and the tailwater without the culverts.

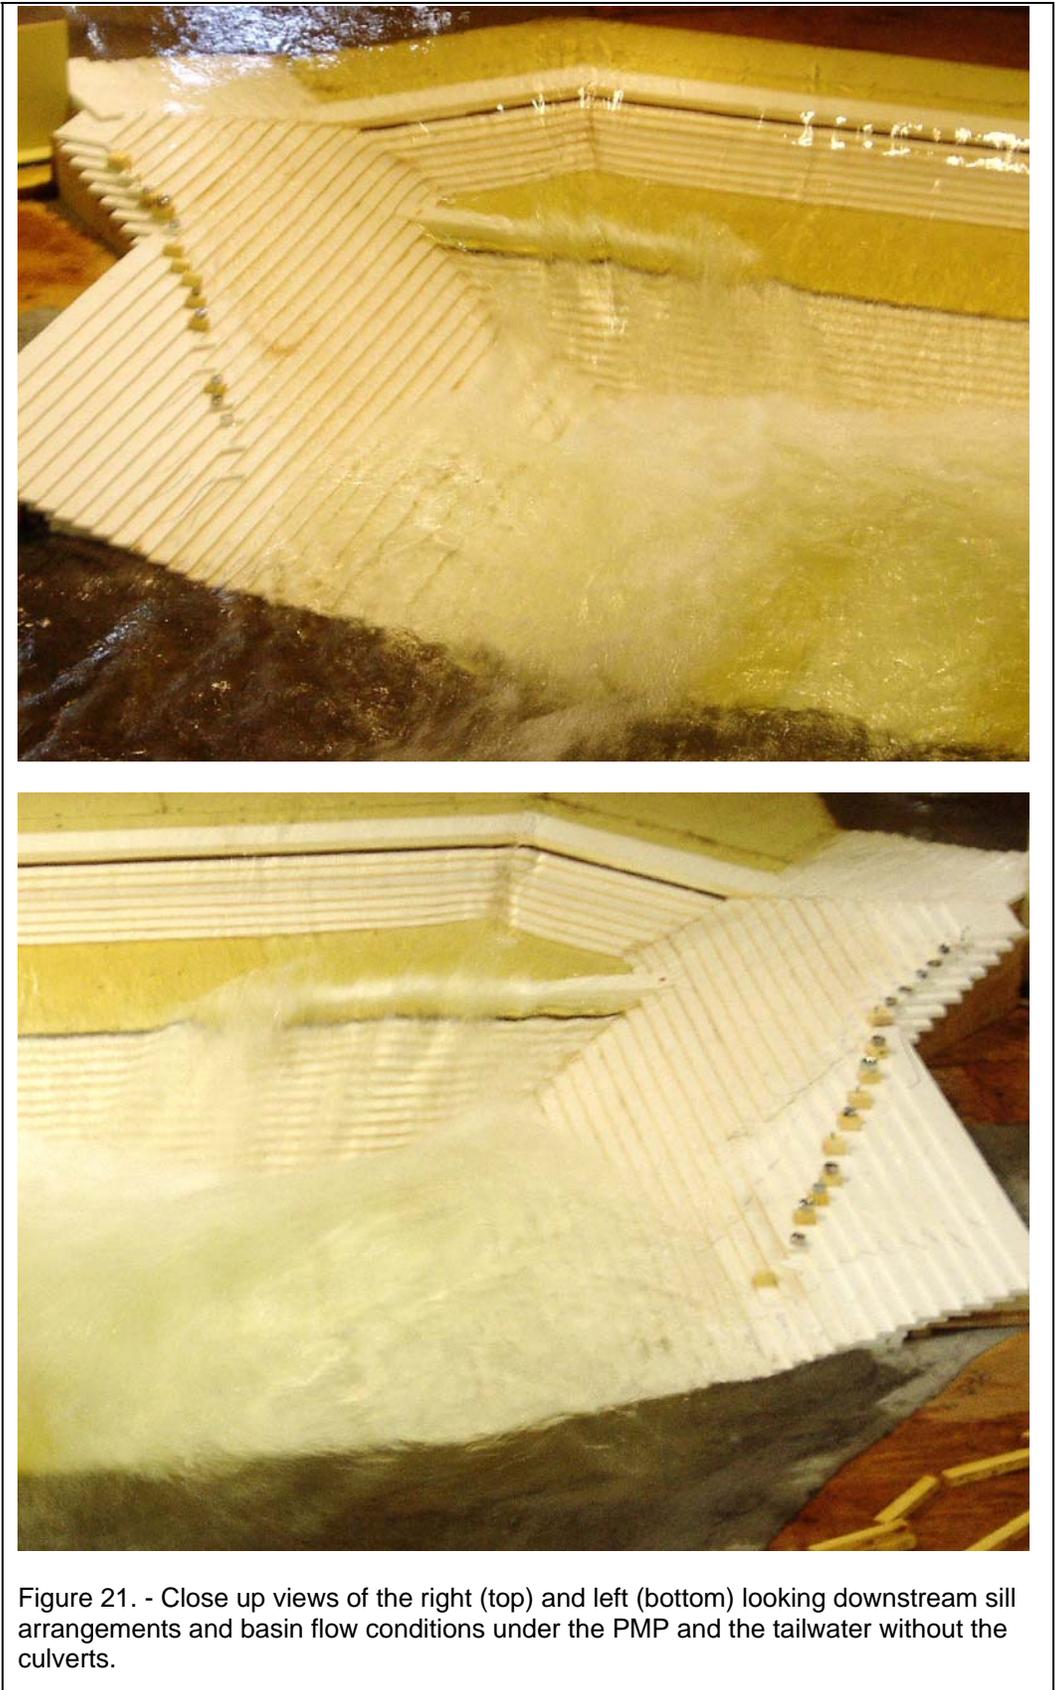
Figure 21. - Close up views of the right (top) and left (bottom) looking downstream sill arrangements and basin flow conditions under the PMP and the tailwater without the culverts.

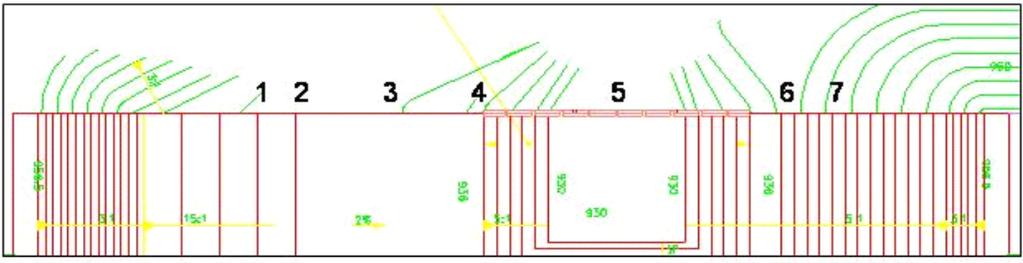
Plan view of the end of the Y15 structure showing the levels of the basins and the locations for the velocity measurements at the end of the RCC protection.

Velocities were measured at seven locations just downstream from the end of the structure with the recommended 3-ft-high sills installed on the upper flat bench. The velocities were first measured with the basin end sills only located below the principal spillway basin as in the initial design. Upon completion of these initial measurements, a 2-ft-high end sill was installed along the entire end of the structure and flow conditions documented and velocities measured. The locations were chosen to measure velocities where the flow concentrations were exiting the structure and where the flow exited the approximate center of the various basin elevations. Velocities were measured for the two-thirds PMP and PMP events under the tailwater elevations expected with and without the downstream culverts washed out during the floods at El. 949.81 and 955.09, respectively. Velocities were measured with a hand-held Swiffer propeller meter at 0.6 depth due to the shallow flow depths in the model. Table 3 shows a schematic of the measurement locations below the structure protection with the prototype velocity magnitudes.

Maximum velocities were measured under the PMP event. Velocities of about 21-22 ft/s occurred at locations 6 and 7 from the flow concentration exiting the right side of the structure. On the left side of the basin the velocities reached 17 -18 ft/s at locations 1 and 2. The flow conditions appeared to be very similar with or without a 2-ft-high end sill located across the entire structure. With very shallow depths the velocities were slightly higher with the end sill due to the location of the measurement and the lesser flow depth over the sill. Under the 2/3 PMP, the flow seemed to dive downstream from the end sill where the flow exited the right side of the basin. The end sills will reduce recirculation of material into the basins until the zone downstream from the sill fills with material. There was not any noticeable improvement in the velocities or the flow conditions by adding the end sill in the locations of the concentrated jets exiting the structure.

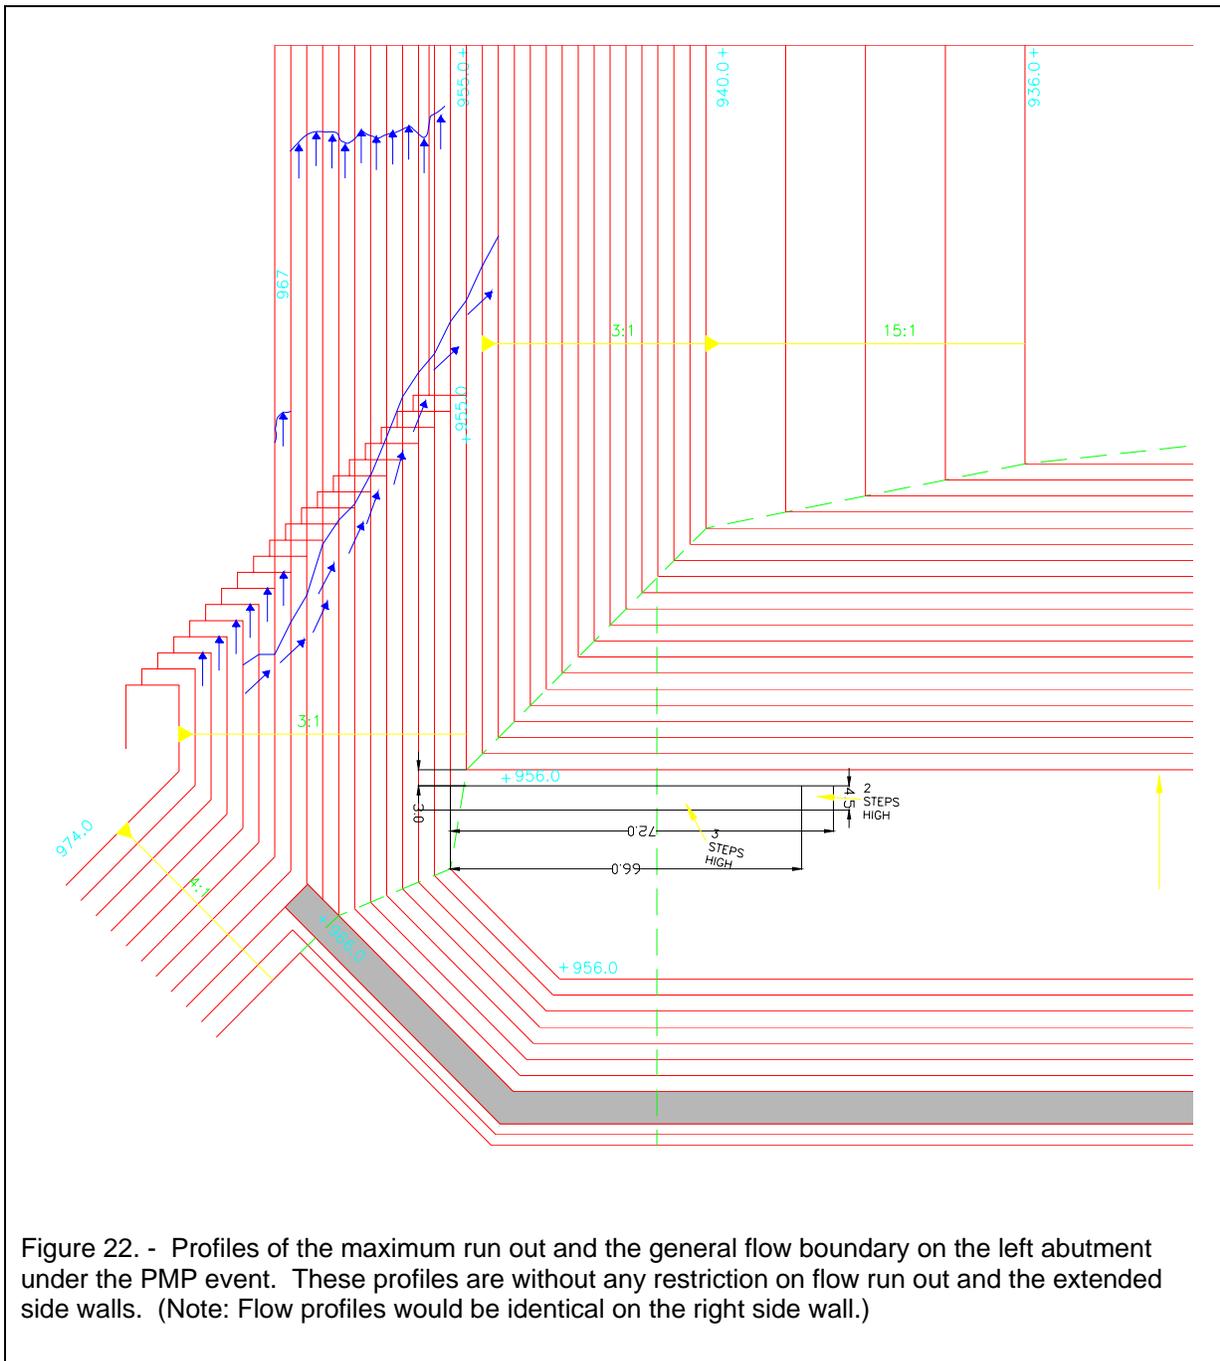
Figure 22 shows the plan view of two flow lines under the PMP event. The flow arrows on the upper portion of the protection show that the flow will run out over the end of the protection from the reservoir water surface at the crest. The run out will continue over the extended wall area also until about 16 to 20 ft from the downstream end of the structure. The profile for where the majority of the flow travels was then marked and measured producing the more upstream profile. Figure 23 shows the PMP flow event with the water flowing down the left side wall with the profiles marked. Flow profiles on the right side wall were identical.

- The extent of the protection would need to be increased throughout the entire height of the structure to contain the run out under the PMP without a mechanism to prevent the flow (figure 22).

Figures 22, 23, and 24 show the plan views of the run out experienced over the stepped side walls, and two methods for containing the run out as investigated in the model under the PMP flow condition.

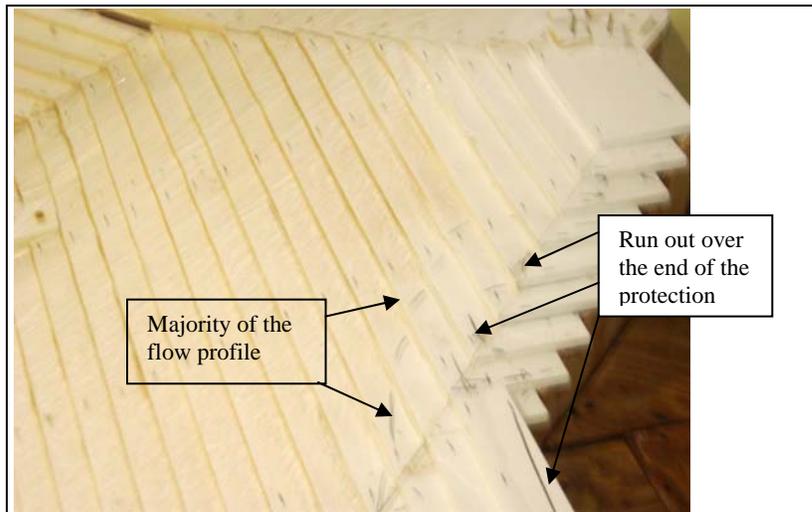
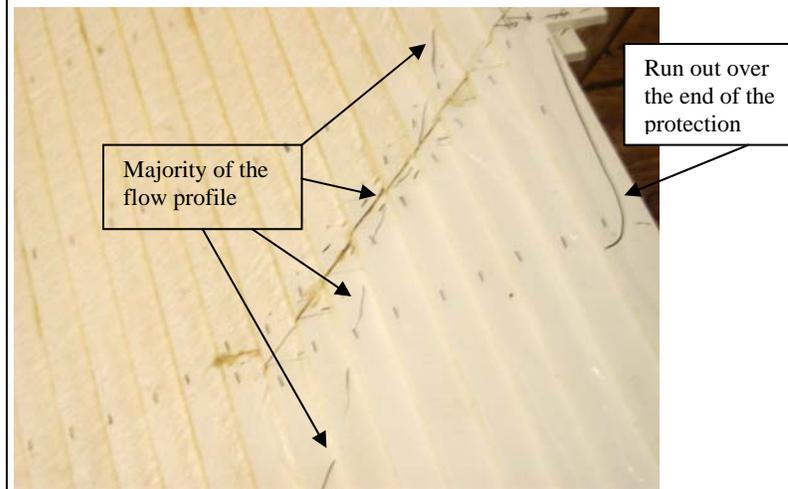
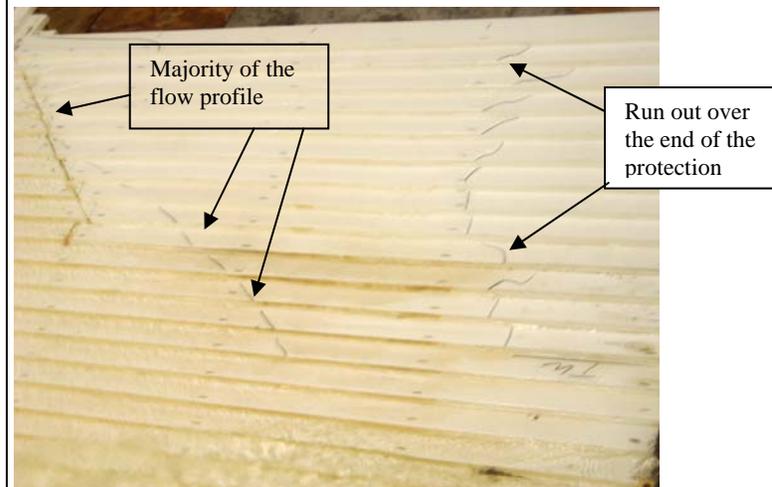
Upper left side wall majority flow profile and run out flow.

Flow profile of the majority of the flow over the left side wall.

Flow profile of the majority of the flow and the downstream end of maximum run out.

Figure 23. - Three views of the maximum run out marked with arrows and the main flow marked with dashed lines under the PMP.

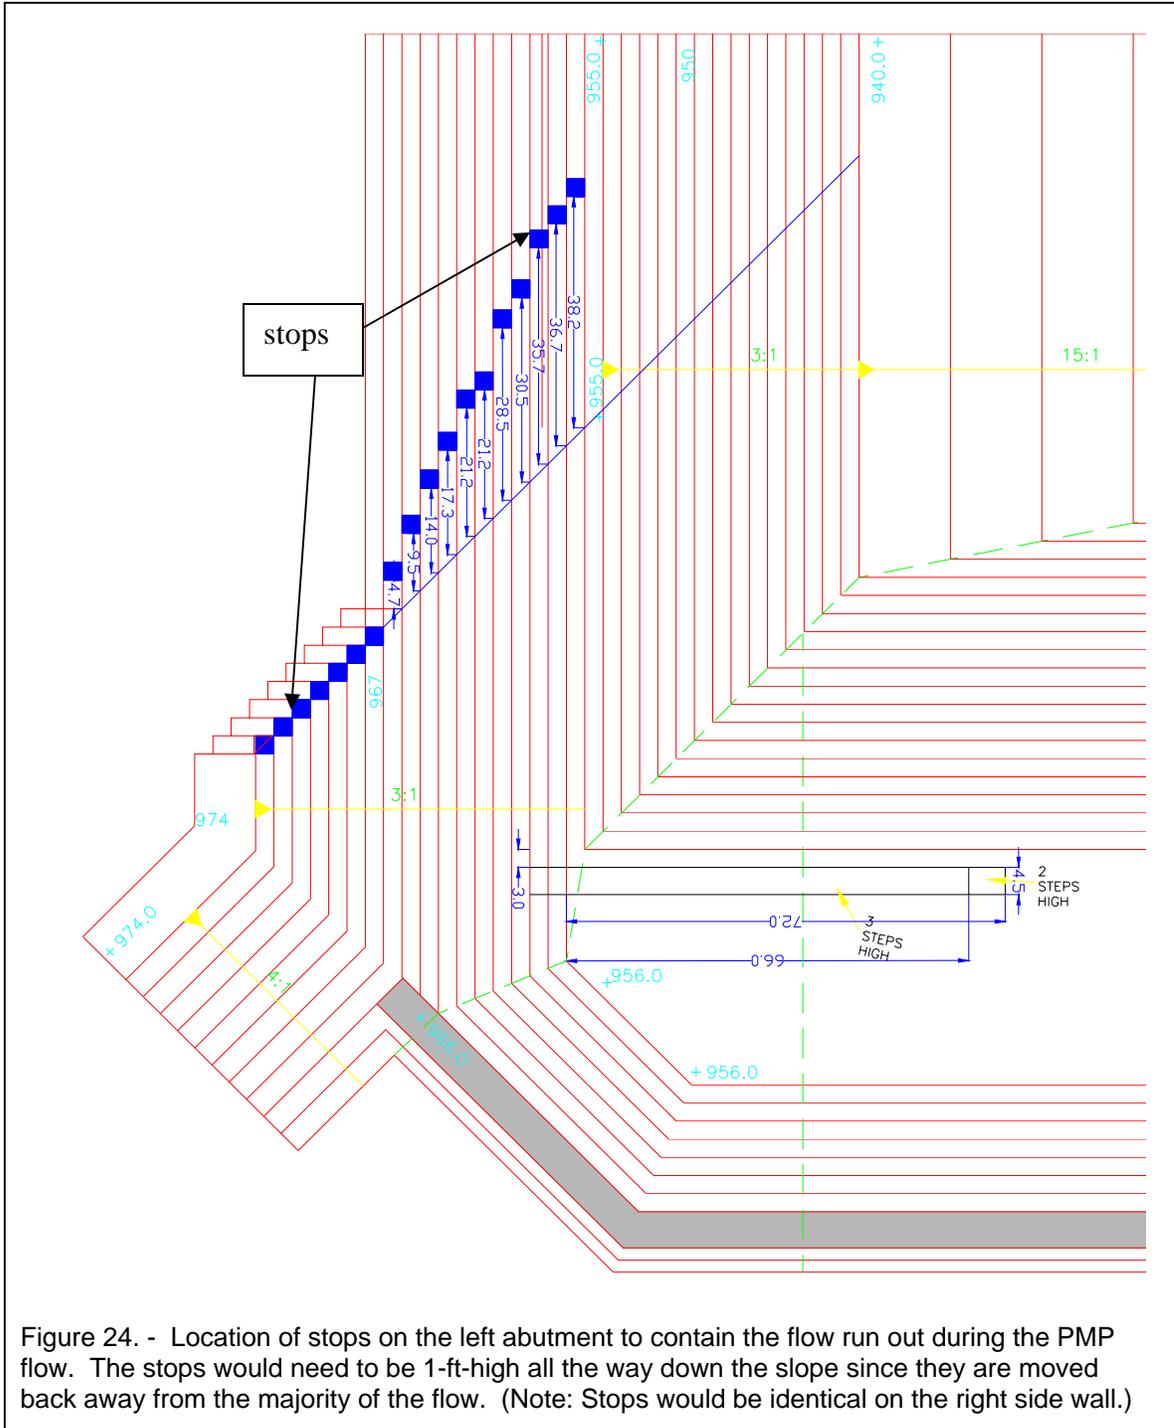
Figure 24. - Location of stops on the left abutment to contain the flow run out during the PMP flow. The stops would need to be 1-ft-high all the way down the slope since they are moved back away from the majority of the flow. (Note: Stops would be identical on the right side wall.)

- Stops can be used to contain the flow along the upper portion of the wall at the break point in the RCC lift turn around, then out on the lower portion at the locations shown in figures 24 and 25. This would still require extension of the RCC on the lower portion of the wall to the location of the stops on the lower portion.

Figure 24 shows the stops to contain run out of the PMP flow event. Dimensions are given from the break line for the turn on each RCC lift. The stops are located on the extension of the RCC protection, but are only 1 ft high. Figure 25 shows the PMP flow event with the stops located on the left and right side walls above the tailwater. This option would contain the flow above El. 967 and require extension of the side walls between El. 967 and the original elevation of 955.

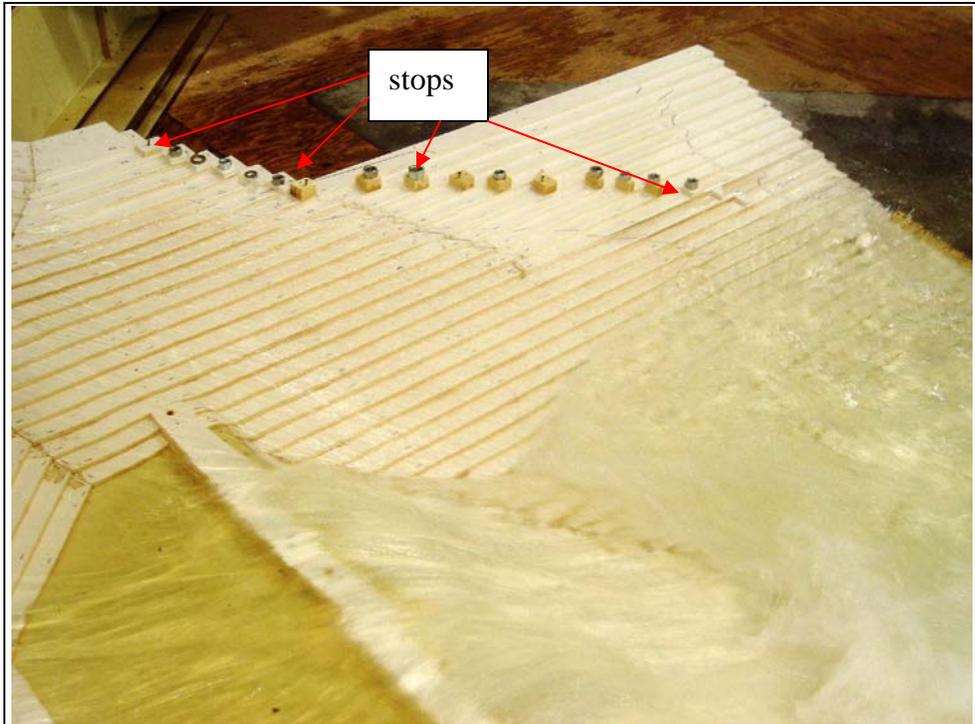
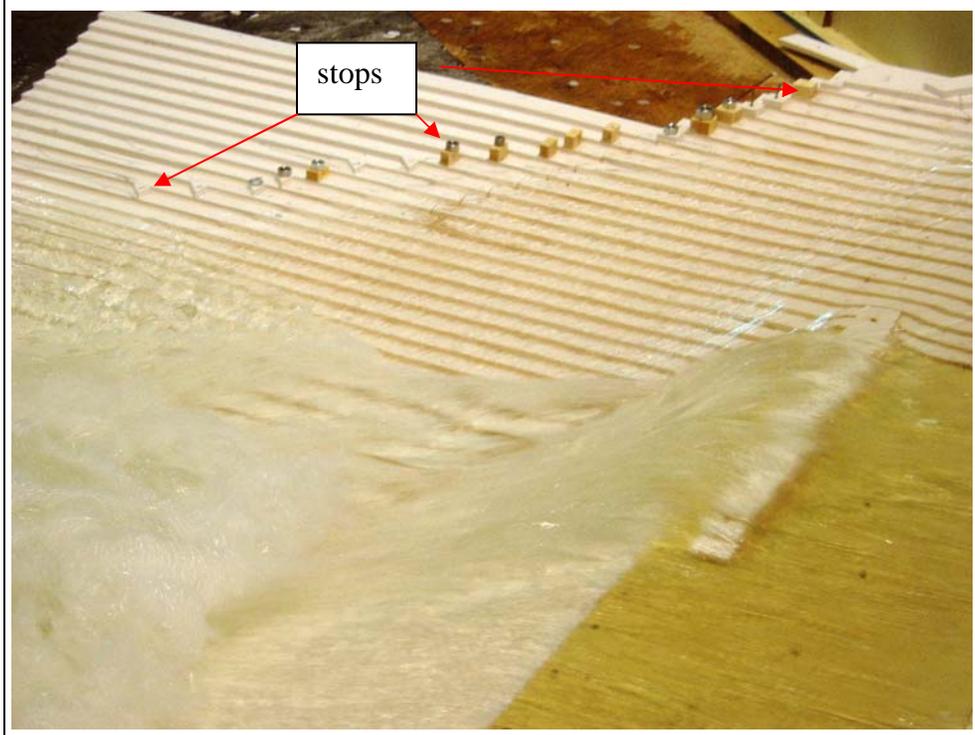
Figure 25. - Left (top) and right (bottom) side wall stops shown with operation under the PMP. (Note: The nuts over the blocks are only weights.)

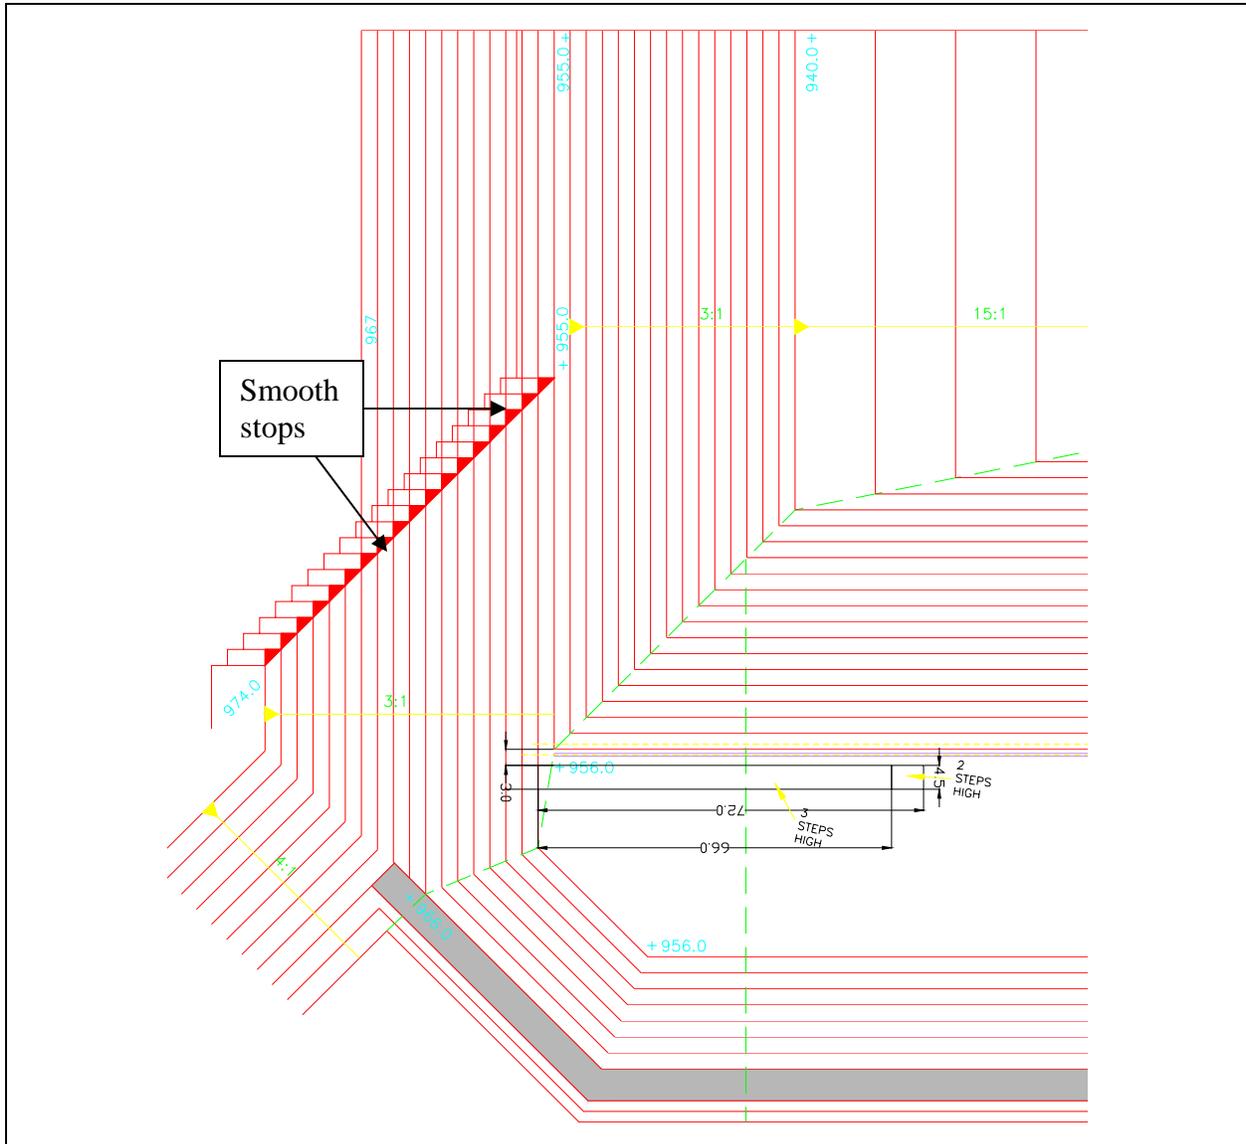
Figure 26. - Location of the smooth surface of stops on the left abutment along the break line for the RCC protection under the PMP event. The face of the stops forms a smooth surface next to the water but the back shape may be of any shape. The stops are 1-ft-high from the top to El. 966 and 2-ft-high from El. 966 to the tailwater. They may overlap from step to step to be wider than the step run for an extra factor of safety or constructability. (Note: Stops would be identical on the right side wall.)

- Figures 26, 27, and 28 show the containment stops forming a smooth wall-like surface along the break point in the RCC lift turn around. Use of these steps would require no additional extension of the side wall protection. They were modeled at 1-ft-high from the top down to El. 966 and 2-ft-high below that to the tailwater. Another option would be to start forming the stops from the bottom up and over widen the placement providing an overlap on each step run to prevent water from potentially passing at each stop edge.

Figures 26, 27, and 28 show the containment stops forming a smooth wall-like surface along the break point in the RCC lift turn around. They would require no additional extension of the side wall protection. They were modeled at 1-ft-high from the top down to El. 966 and 2-ft-high below that to the tailwater. Another option would be to start forming them from the bottom up and overlap them providing a continuous wall instead of a break where water could potentially pass at each stop edge as shown in the schematic on figure 27. In addition, the downstream edges of each stop would not need to be formed. The back side of the stops could be any shape. Figure 28 shows this wall stop arrangement operating under the PMP event.
