Hydraulic Laboratory Report HL-2009-01

## Hydraulic Model Study of Arthur R. Bowman Dam Total Dissolved Gas Deflector

May 2009

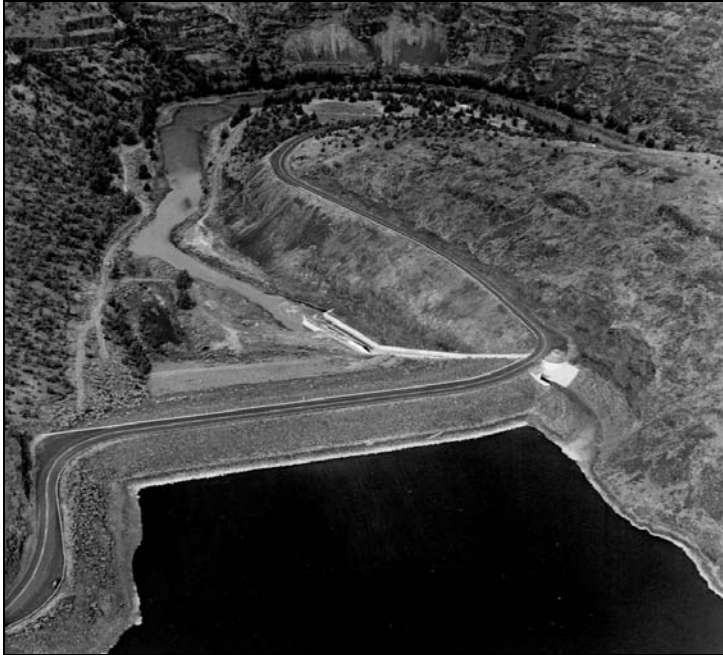
Figure 2. Aerial view of A.R. Bowman Dam looking downstream with the spillway on the right abutment.

Arthur R. Bowman Dam (formerly Prineville Dam) is an earthfill structure on the Crooked River about 20 miles upstream from Prineville, Oregon (figure 1). This Bureau of Reclamation (Reclamation) dam has a height of 245 ft, a crest length of 800 ft, and a volume of 1,424,000 cubic yards of material. Prineville Reservoir has an active capacity of 152,800 acre-feet and a surface area of 3,030 acres at the spillway crest elevation 3234.8 ft (United States Department of the Interior, 1981). Figure 2 shows an aerial view of A.R. Bowman Dam.

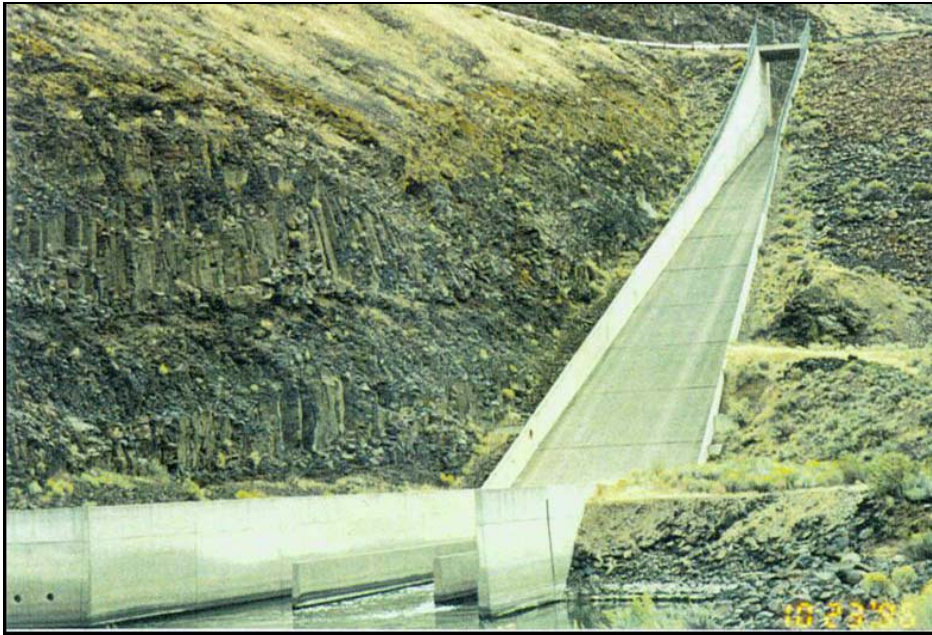
Figure 3. A.R. Bowman prototype spillway structure.

wells in the headbox and tailbox. Vertical slats at the downstream end of the model were used to adjust the tailwater elevation in the model. Figures 3 and 4 compare the prototype and model structures.

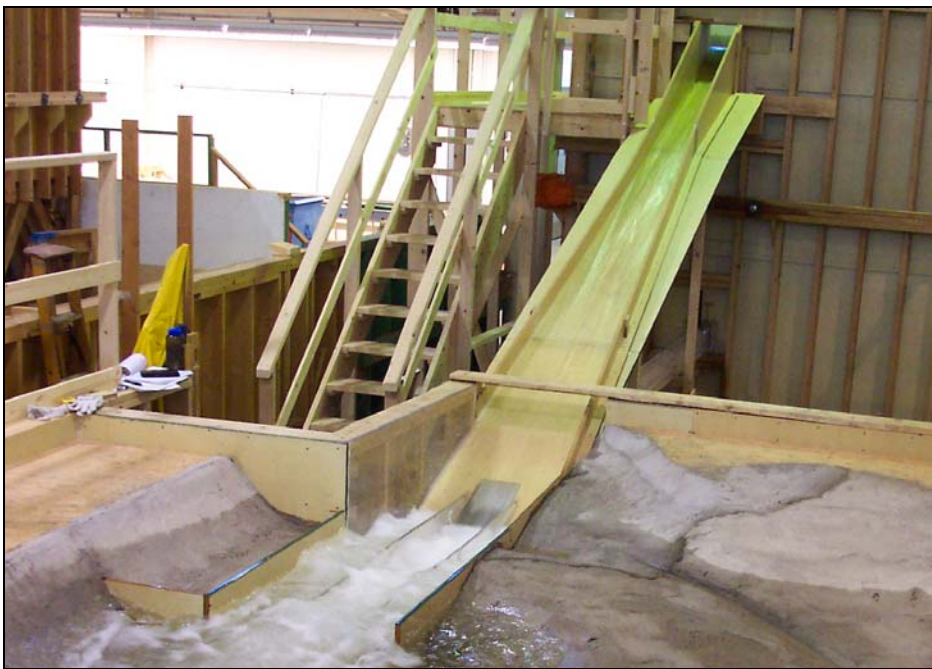
Figure 4. A.R. Bowman model spillway structure.

The lateral extent of the model included about 1/3 of the length of the dam on the left side. Concrete topography was installed 240 ft upstream of the dam crest in the headbox and 650 ft downstream of the toe of the dam in the tailbox. Inflow to the hydraulic model was measured by the calibrated laboratory Venturi system. Reservoir and tailwater elevations were measured with point gages inside stilling

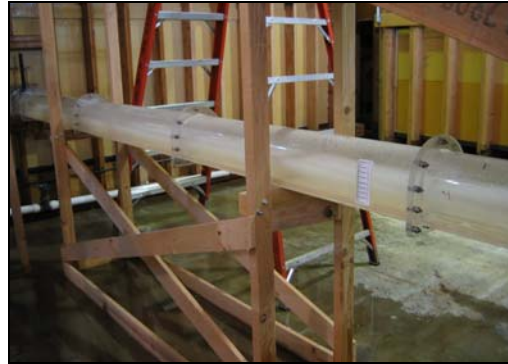
Figure 7. Outlet works tunnel.

Upstream features included the concrete approach channel, high-density polyurethane foam spillway crest, sheet metal curved inlet structures, and a plywood roadway (figure 5). The marine-grade plywood spillway chute flared from 20 ft wide at the spillway crest to 54 ft in the stilling basin (figure 6). The horseshoe-shaped outlet works tunnel, two 4 ft by 6 ft slide gates, and the transition chamber were constructed of clear acrylic (figure 7). A clear acrylic viewing area was installed next to the transition chamber in order to observe flow patterns in the region where the outlet works daylight onto the spillway face. Stilling basin details included chute blocks, a dentated endsill, and two splitter walls (figure 8).

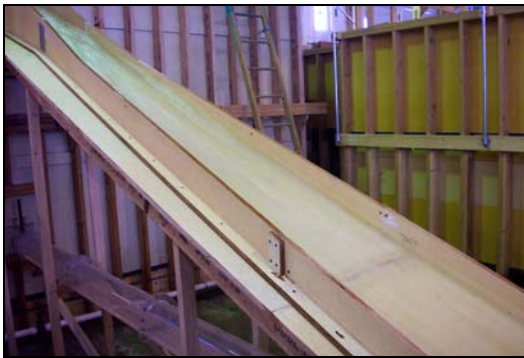
Figure 6. Spillway chute.

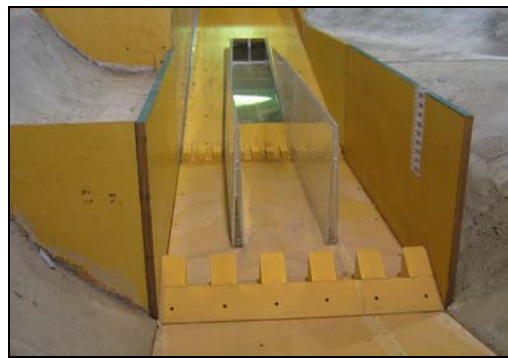
Figure 8. Stilling basin configuration.

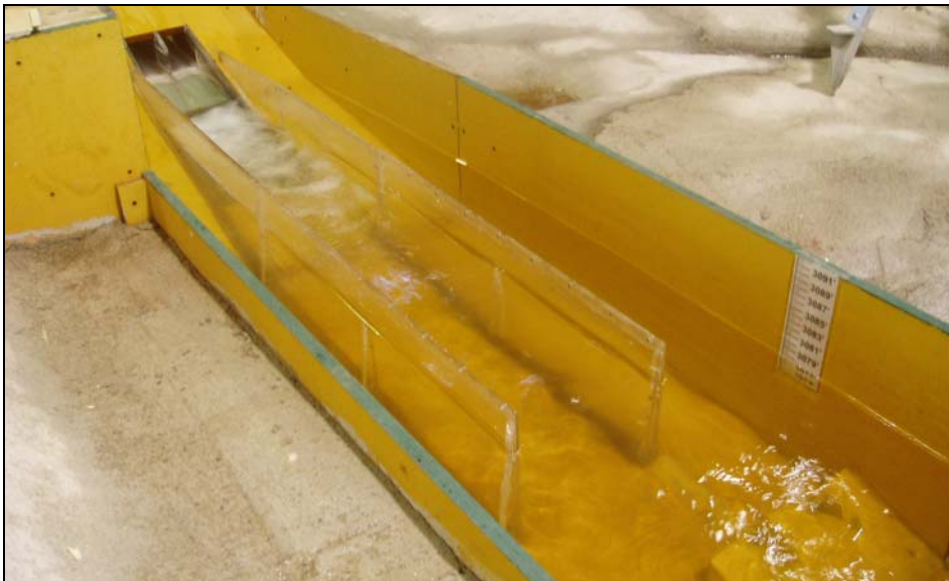
Figure 14. Surface view with no deflector installed and existing stilling basin geometry. At a discharge of 700 ft<sup>3</sup>/s, plunging flow was observed.

Outlet works flows of 700, 1,000, 2,000, and 3,000 ft<sup>3</sup>/s were tested in the model to document baseline flow conditions without a deflector installed (figures 13-20). As the discharge increased, the bubbles plunged deeper into the basin.

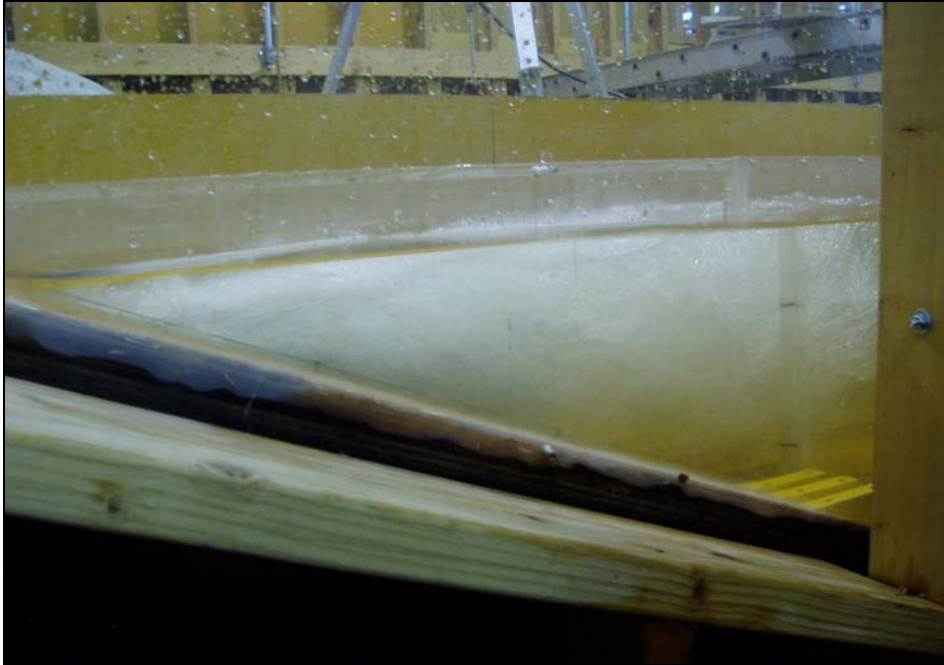
Figure 15. Side view with no deflector installed and existing stilling basin geometry. At a discharge of  $1,000 \text{ ft}^3/\text{s}$ , plunging flow was observed.

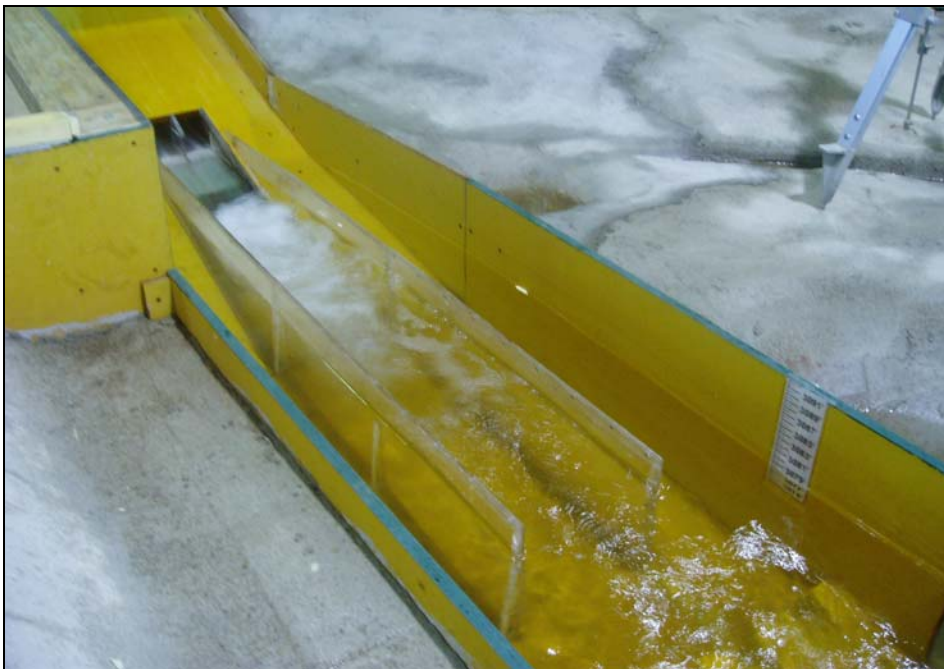
Figure 16. Surface view with no deflector installed and existing stilling basin geometry. At a discharge of  $1,000 \text{ ft}^3/\text{s}$ , plunging flow was observed.

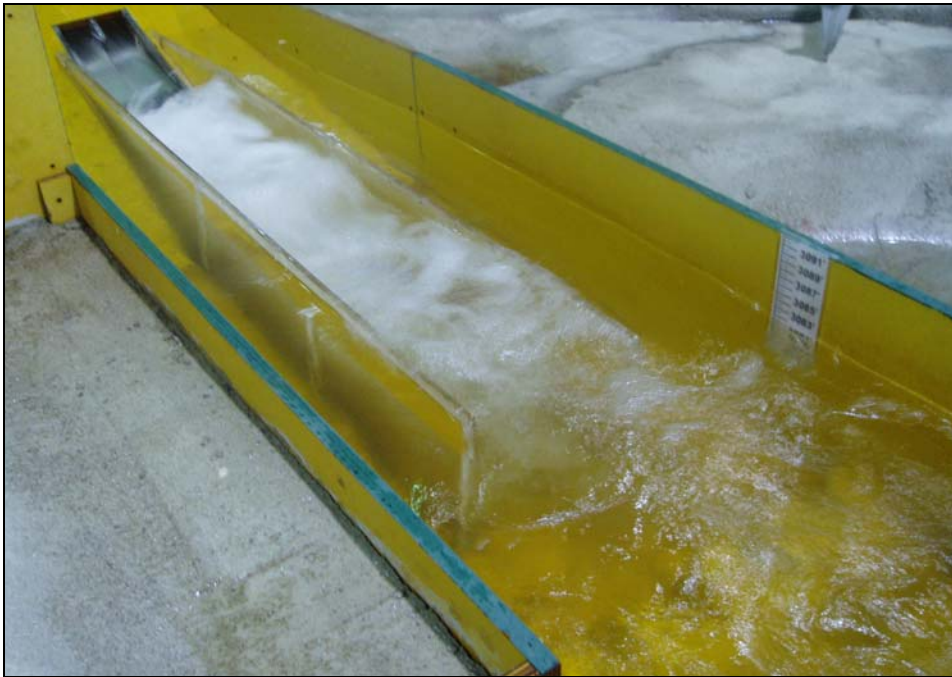
Figure 18. Surface view with no deflector installed and existing stilling basin geometry. At a discharge of 2,000 ft<sup>3</sup>/s, plunging flow was observed.

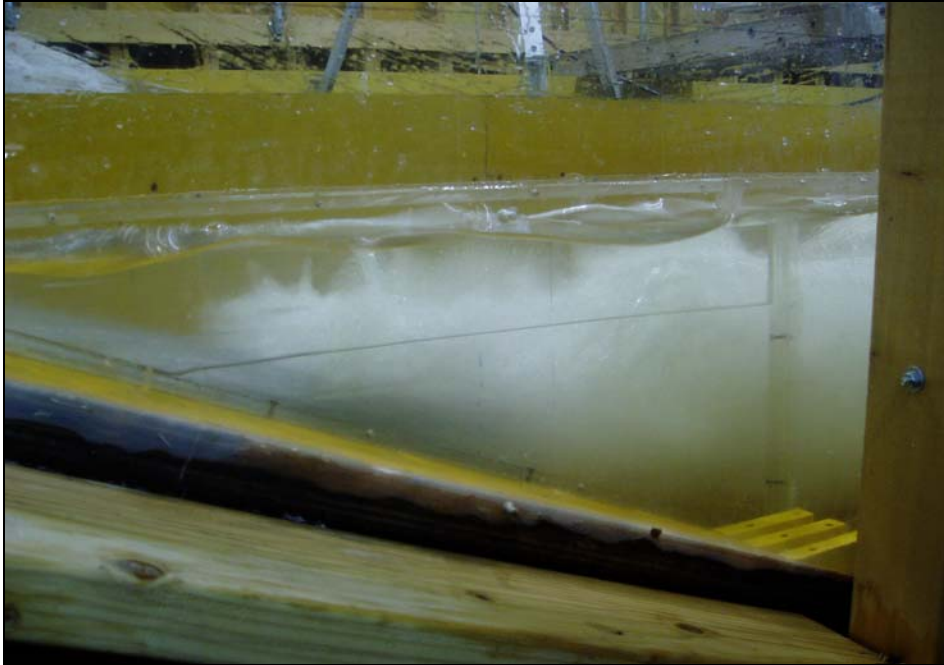
Figure 19. Side view with no deflector installed and existing stilling basin geometry. At a discharge of  $3,000 \text{ ft}^3/\text{s}$ , plunging flow was observed.

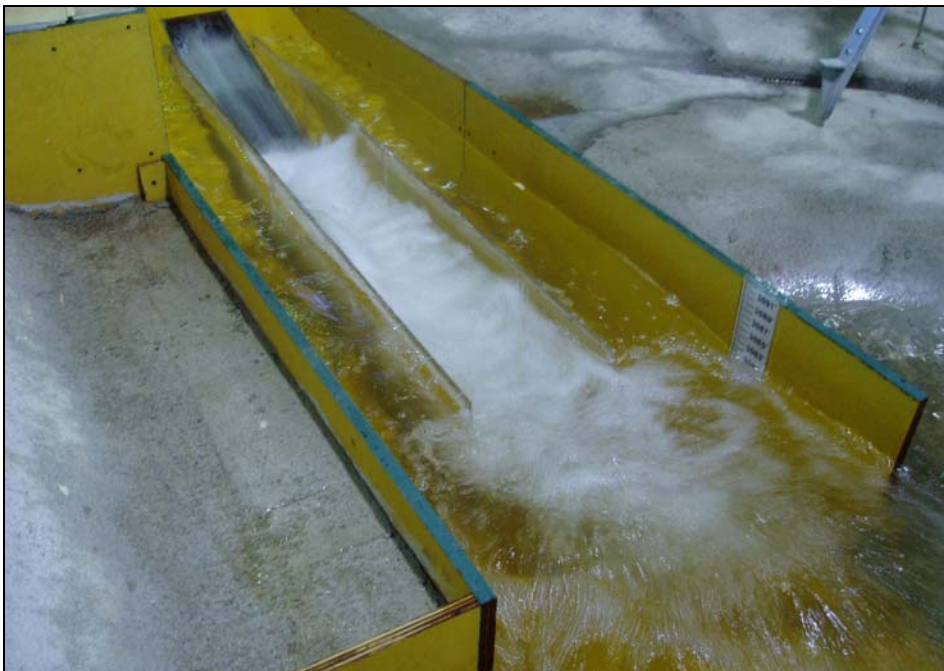
Figure 20. Surface view with no deflector installed and existing stilling basin geometry. At a discharge of  $3,000 \text{ ft}^3/\text{s}$ , plunging flow was observed.

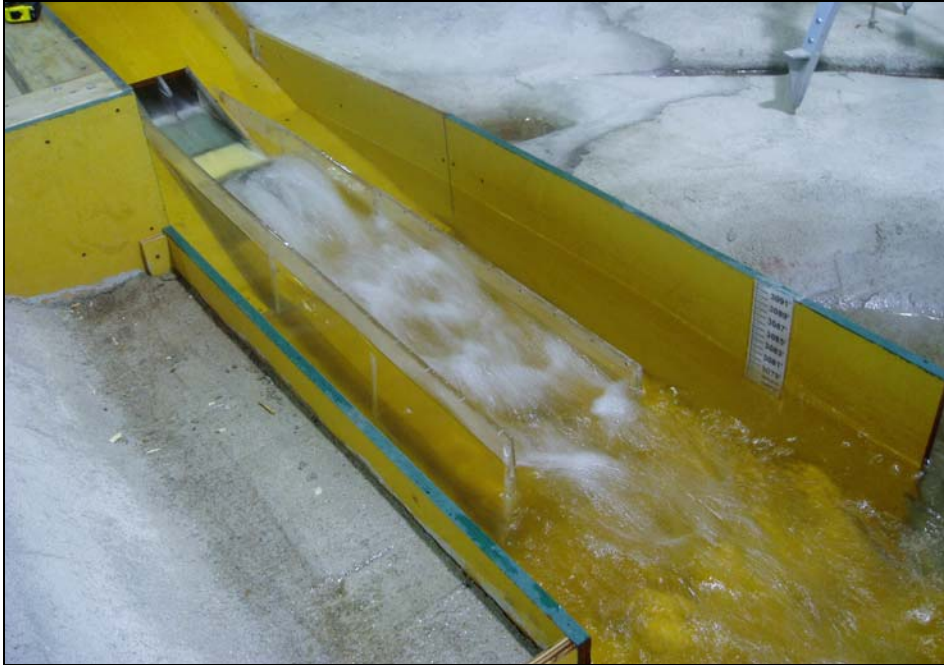
Figure 22. Surface view with a 12.5-ft-long deflector installed at 3073.3 ft and existing stilling basin geometry. At a discharge of  $1,000 \text{ ft}^3/\text{s}$ , undular flow was observed.

A 12.5-ft-long deflector was initially installed at elevation 3073.3 ft, because submergence values for discharges from 500 to 3,000  $\text{ft}^3/\text{s}$  were in the “skimming flow” range in Cain’s model study (Cain, 1996). In the model, undular flow conditions occurred with a small initial wave and a replunging zone for discharges from 700 to 1,000  $\text{ft}^3/\text{s}$  (figures 21 and 22). Undular flow limits the amount of TDG reduction due to air entrainment in the replunging zone. From 2,000 to 3,000  $\text{ft}^3/\text{s}$ , the outlet works jet plunged deep into the basin, indicating that the submergence was too low. Based upon measurements of bubble plunge depths, there was no noticeable improvement in performance between the baseline condition without a deflector and the plunging flow condition with a 12.5-ft-long deflector installed at elevation 3073.3 (figures 23 and 24).

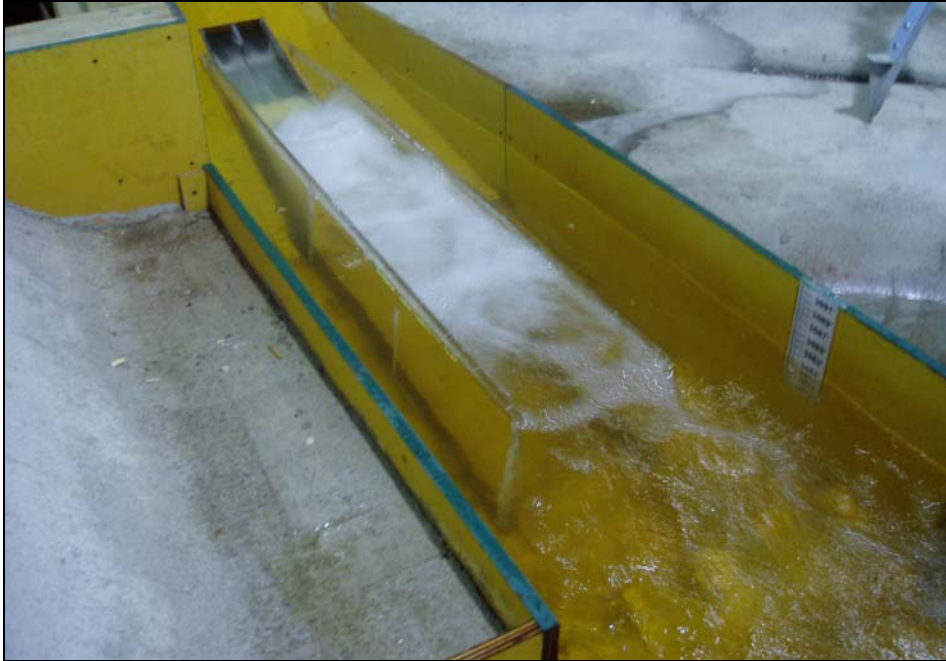
Figure 24. Surface view with a 12.5-ft-long deflector installed at 3073.3 ft and existing stilling basin geometry. At a discharge of 2,000 ft<sup>3</sup>/s, plunging flow was observed.

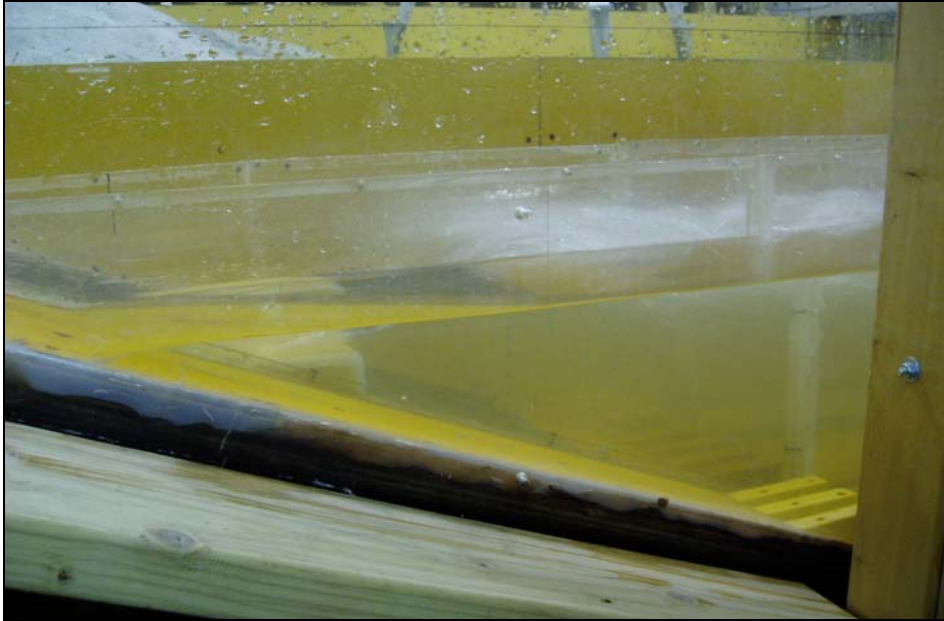
Figure 25. Side view with a 12.5-ft-long deflector installed at 3071.5 ft and existing stilling basin geometry. At a discharge of  $700 \text{ ft}^3/\text{s}$ , mild undular flow was observed.

The 12.5-ft-long deflector was lowered to elevation 3071.5 ft to increase the submergence. For discharges of 700-1,000 ft<sup>3</sup>/s, undular flow conditions were produced with a small initial wave and a replunging zone (figures 25-28). Undular flow conditions were stronger at 2,000 ft<sup>3</sup>/s (figures 29 and 30). During a release of 3,000 ft<sup>3</sup>/s, plunging flow occurred. There was no true skimming condition at any discharge.

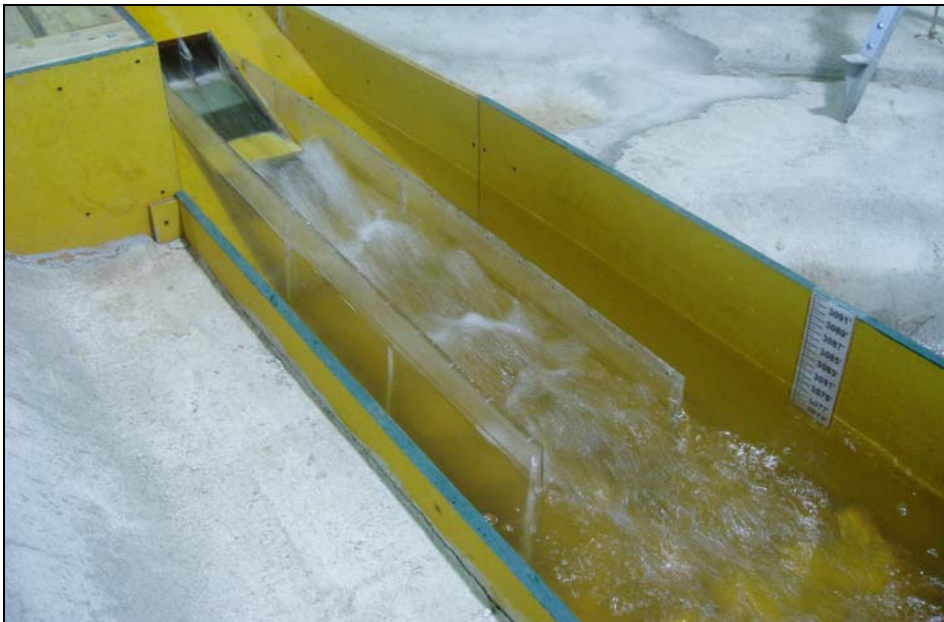
Figure 26. Surface view with a 12.5-ft-long deflector installed at 3071.5 ft and existing stilling basin geometry. At a discharge of  $700 \text{ ft}^3/\text{s}$ , mild undular flow was observed.

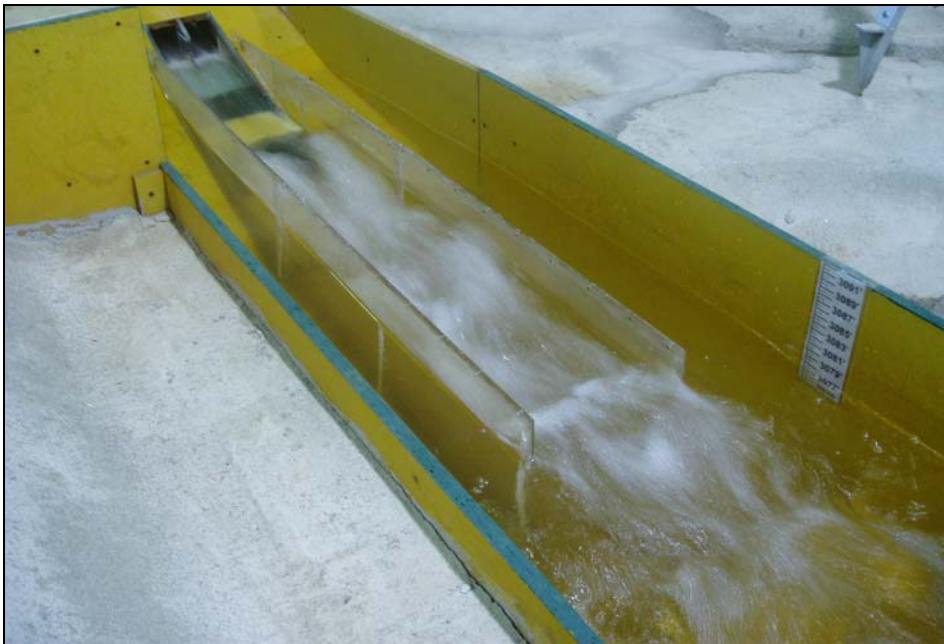
Figure 28. Surface view with a 12.5-ft-long deflector installed at 3071.5 ft and existing stilling basin geometry. At a discharge of 1,000 ft<sup>3</sup>/s, mild undular flow was observed.

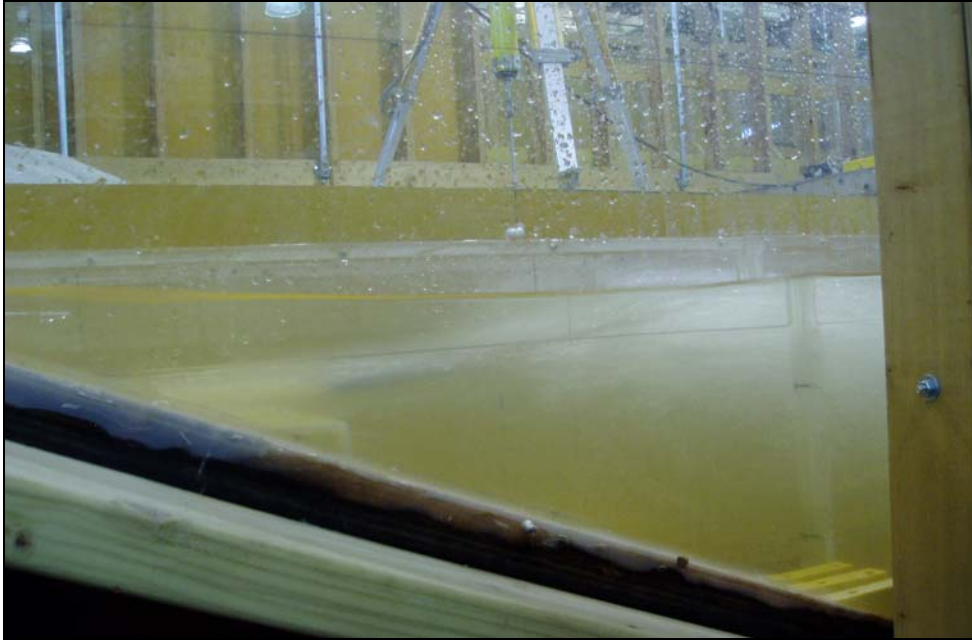
Figure 29. Side view with a 12.5-ft-long deflector installed at 3071.5 ft and existing stilling basin geometry. At a discharge of 2,000 ft<sup>3</sup>/s, undular flow was observed.

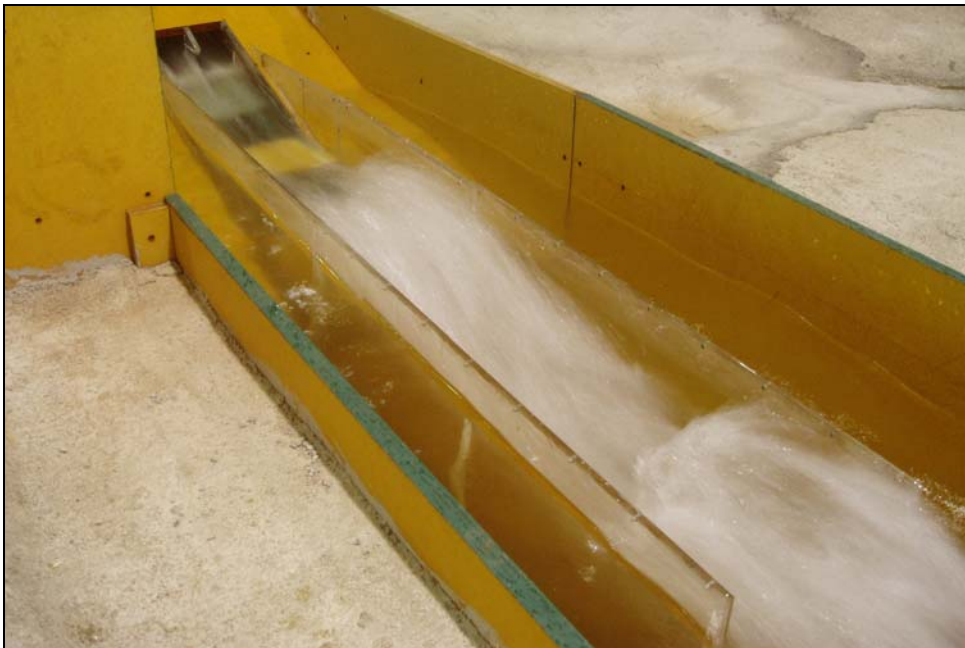
Figure 30. Surface view with a 12.5-ft-long deflector installed at 3071.5 ft and existing stilling basin geometry. At a discharge of 2,000 ft<sup>3</sup>/s, undular flow was observed.

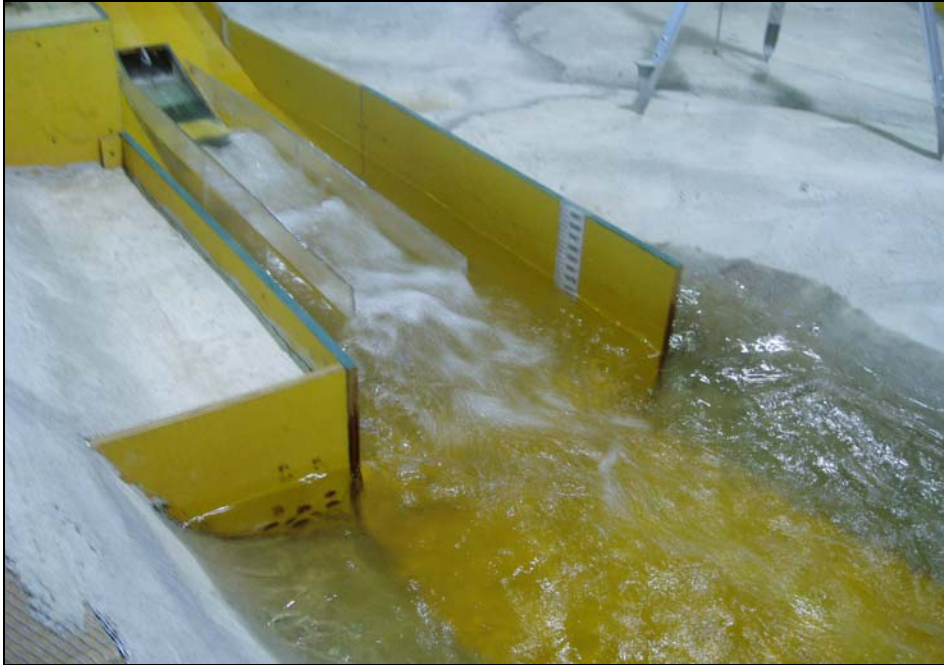
Figure 32. Surface view with a 20-ft-long deflector installed at 3070.3 ft and existing stilling basin geometry. At a discharge of  $1,000 \text{ ft}^3/\text{s}$ , undular flow was observed.

To improve flow conditions at  $3,000 \text{ ft}^3/\text{s}$ , the deflector was moved down to elevation 3070.3 ft. The horizontal length of the deflector was increased from 12.5 ft to 20.0 ft in an attempt to provide additional support for the jet. The increased submergence at deflector elevation 3070.3 ft produced strong undulation in the water surface for discharges of 1,000 and  $2,000 \text{ ft}^3/\text{s}$  (figures 31-34). During a  $3,000 \text{ ft}^3/\text{s}$  release, the flow was unstable, meaning that the performance varied from plunging flow to undular flow with a disturbance in the water surface or a slight variation in the tailwater elevation (figures 35 and 36). Because the basin conditions were unfavorable at low flows and unstable at high flows, deflector elevation 3070.3 ft was not considered further.

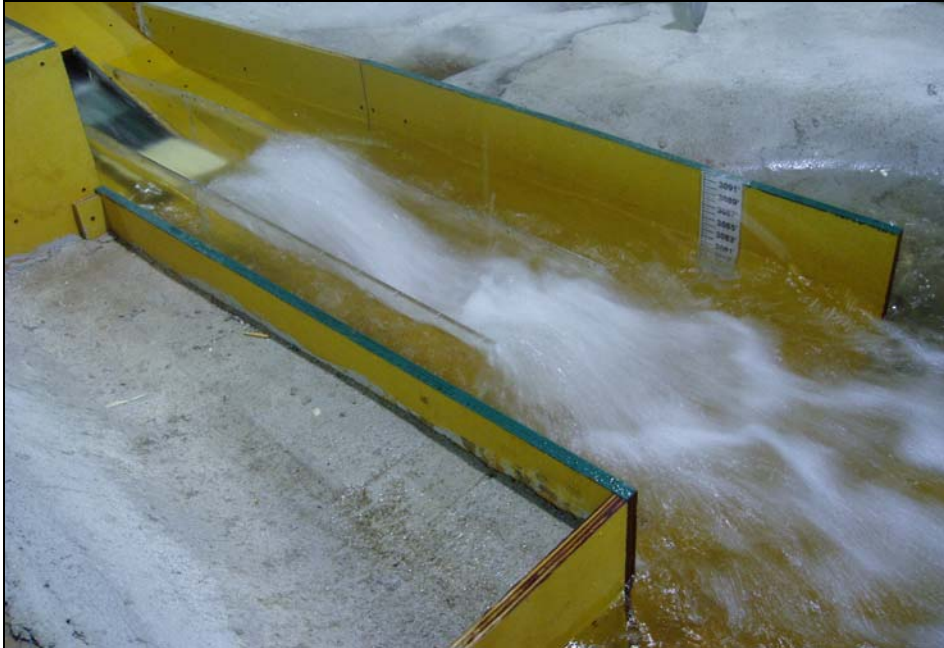
Figure 34. Surface view with a 20-ft-long deflector installed at 3070.3 ft and existing stilling basin geometry. At a discharge of  $2,000 \text{ ft}^3/\text{s}$ , strong undular flow was observed.

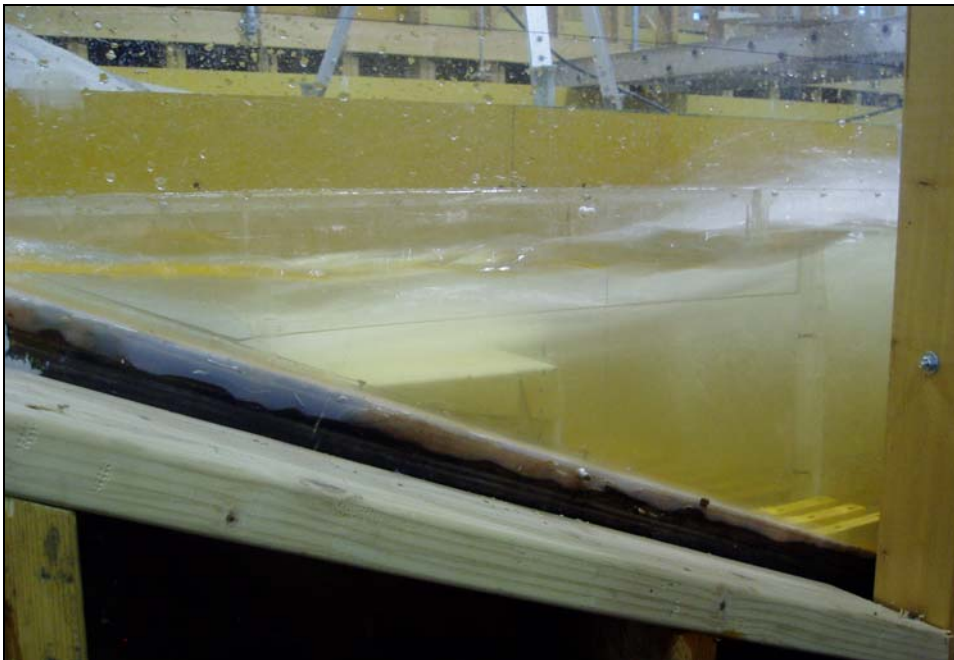
Figure 35. Unstable undular flow at  $3,000 \text{ ft}^3/\text{s}$  with a 20-ft-long deflector installed at elevation 3070.3 ft. Existing stilling basin geometry.

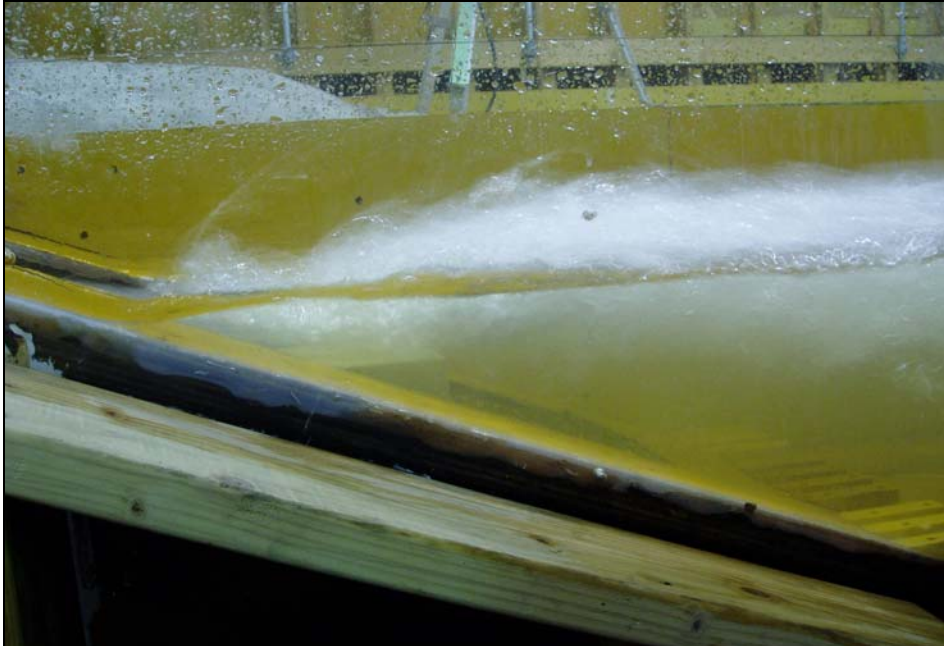
Figure 37. Deflector installed at 3071.5 ft with splitter walls fully removed. At a discharge of 2,000 ft<sup>3</sup>/s, undular flow was observed.

The splitter walls in the basin were removed and the deflector was placed at three trial elevations. The deflector was first installed at elevation 3071.5 ft, because this configuration produced the best flow conditions with the existing stilling basin geometry. When the walls were fully removed, a small undular wave occurred, indicating that the deflector had too much submergence (figure 37).

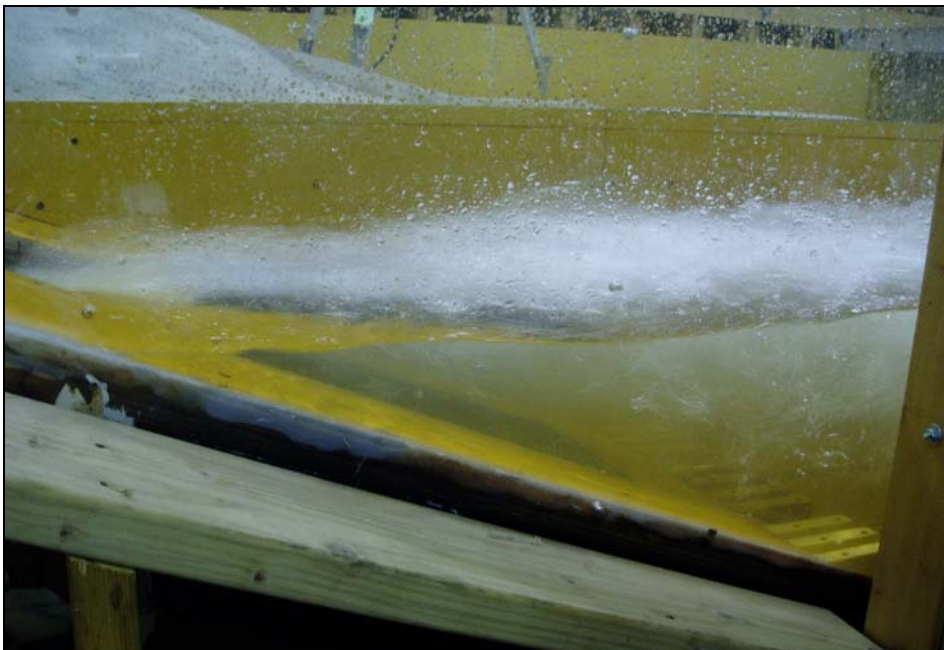
Figure 38. Deflector installed at 3075.3 ft with splitter walls fully removed. At a discharge of 2,000 ft<sup>3</sup>/s, some plunging bubbles were observed.

At elevation 3075.3 ft, the deflector did not have enough submergence. At this elevation, the jet skimmed across the water surface, but bubbles were still entrained deep in the stilling basin (figure 38).

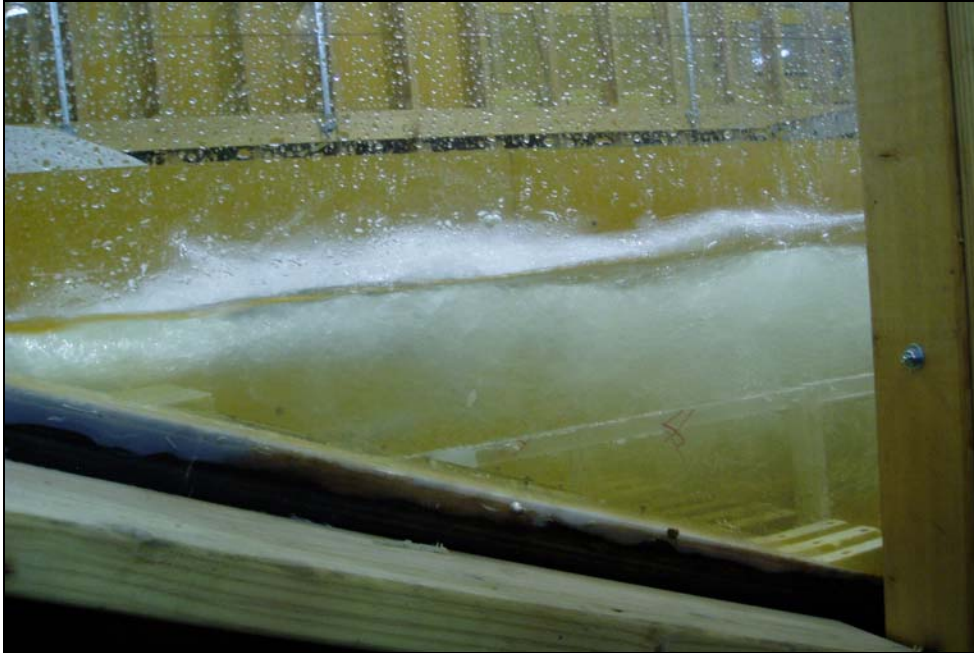
Figure 45. Deflector installed at 3073.3 ft with splitter walls reduced by 15 ft. At a discharge of 2,000 ft<sup>3</sup>/s, skimming flow occurred on the surface, but some bubbles were observed deep in the basin.

The splitter walls were reduced by an additional 3 ft to elevation 3067.5 ft and the deflector remained at elevation 3073.3 ft. During a  $2,000 \text{ ft}^3/\text{s}$  release, skimming flow was produced on the surface, but some bubbles still plunged near the floor of the basin (figure 45). Dye tests showed some interaction between the bays but the flow continued to plunge in the center bay. Dye injected in the side bays moved upstream. Although this condition did produce some improvement in flow conditions, fully removing the splitter walls provided the best opportunity for reduction of TDG levels downstream.

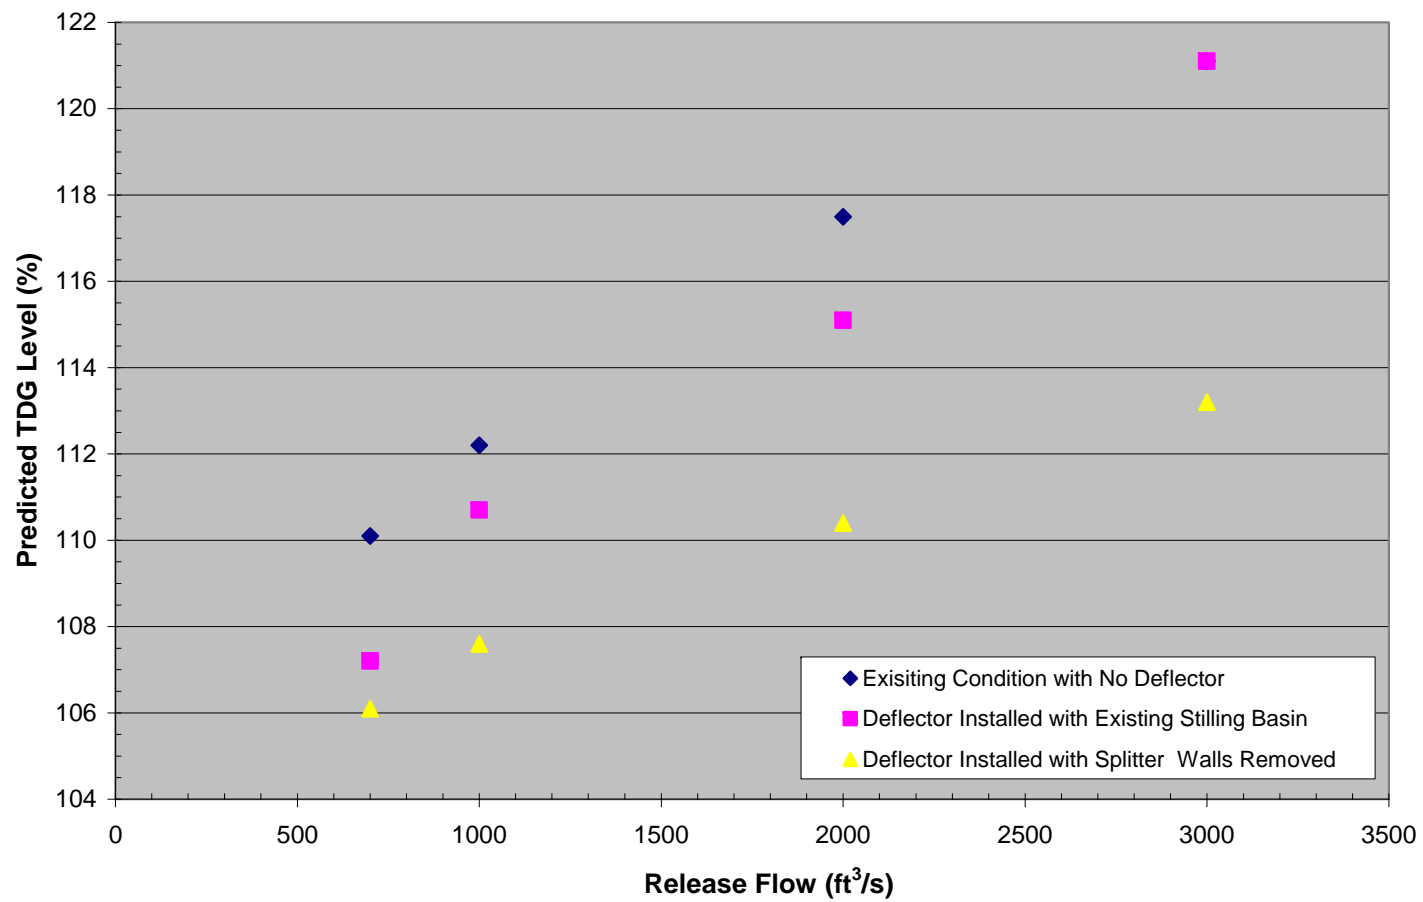
Figure 46. Graphical depiction of predicted TDG levels based on model observations of bubble plunge depths.

Model observations of bubble plunge depths under the best deflector elevations with and without splitter walls are shown in Table 1. Predicted TDG levels based on the bubble plunge depths were calculated by using the methods outlined in “Prediction of Dissolved Gas at Hydraulic Structures (Johnson, 1975). These predicted values are shown in Table 2 and Figure 46. Unpublished field measurements collected by Reclamation from 2006-2007 report a TDG level in the upstream reservoir of 104 percent. The saturation concentration of nitrogen was based on the average temperature of 6.6 degrees C in the field tests. The k and t parameters were back-calculated from the field data and used in subsequent TDG concentration predictions. Because the stilling basin at A.R. Bowman Dam is relatively shallow, the benefit of gas abatement alternatives is reduced because not as much reduction in plunge depth can be achieved.

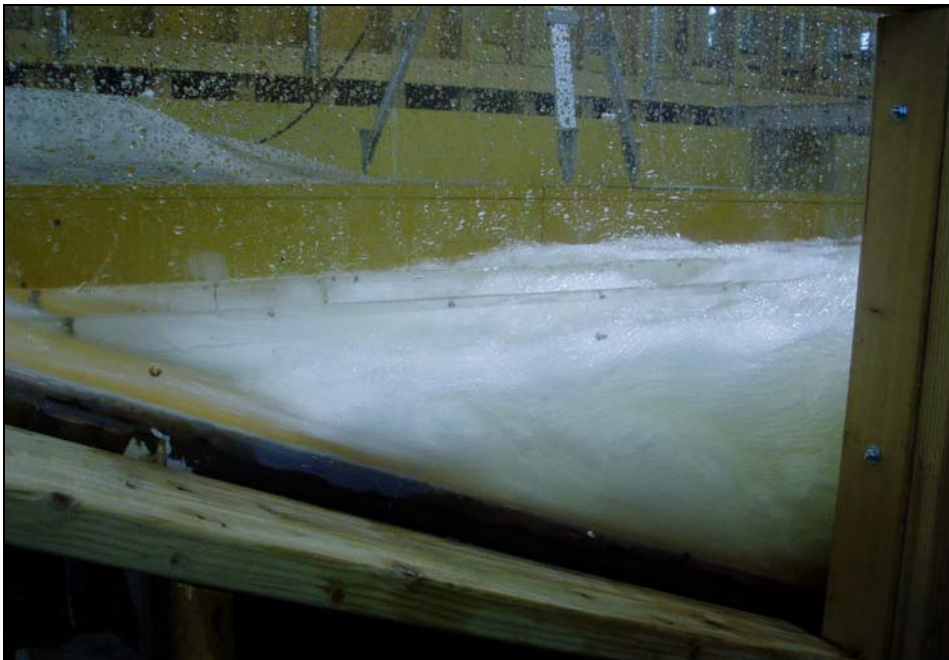
Figure 47. Condition 1: Side view with no deflector and existing stilling basin geometry at a discharge of 4,000 ft<sup>3</sup>/s.

Photographs of all spillway flow tests are shown in figures 47-63. Detailed model observations are provided in the appendix.

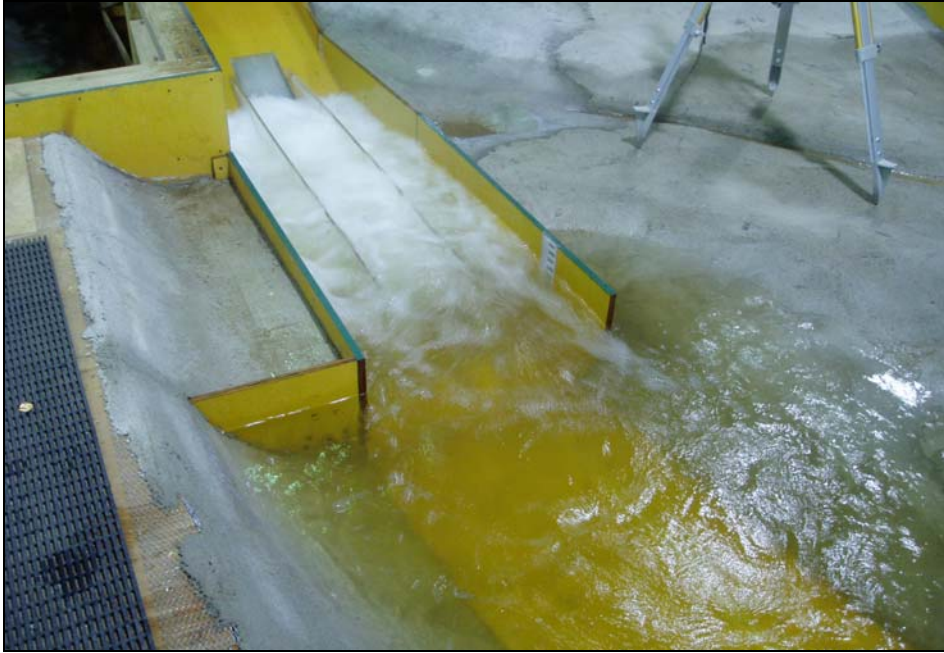
Figure 48. Condition 1: Surface view with no deflector and existing stilling basin geometry at a discharge of  $4,000 \text{ ft}^3/\text{s}$ .

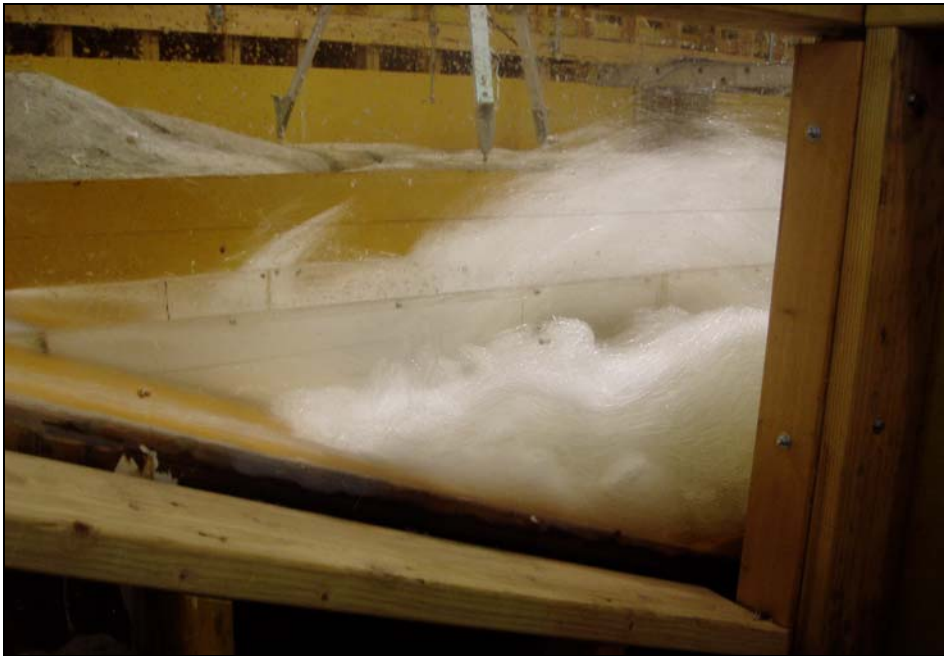
Figure 49. Condition 2: Side view with deflector installed and existing stilling basin geometry (deflector elevation  $3071.5 \text{ ft}$ ). Release flow was  $4,000 \text{ ft}^3/\text{s}$ .

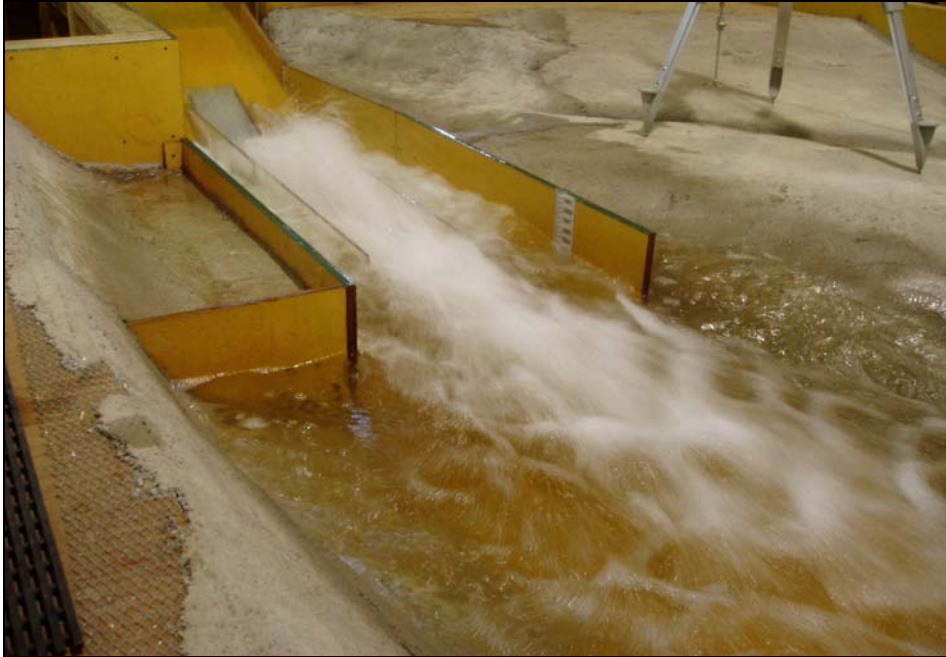
Figure 50. Condition 2: Surface view with deflector installed and existing stilling basin geometry (deflector elevation 3071.5 ft). Release flow was 4,000 ft<sup>3</sup>/s.

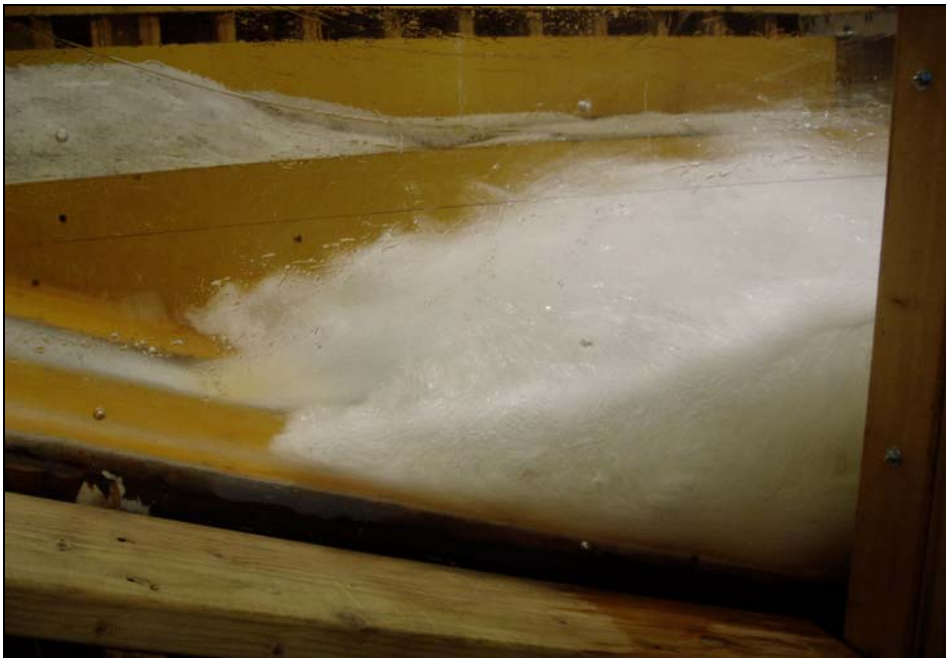
Figure 51. Condition 3: Side view with deflector installed and splitter walls completely removed (deflector elevation 3073.3 ft). Release flow was 4,000 ft<sup>3</sup>/s.

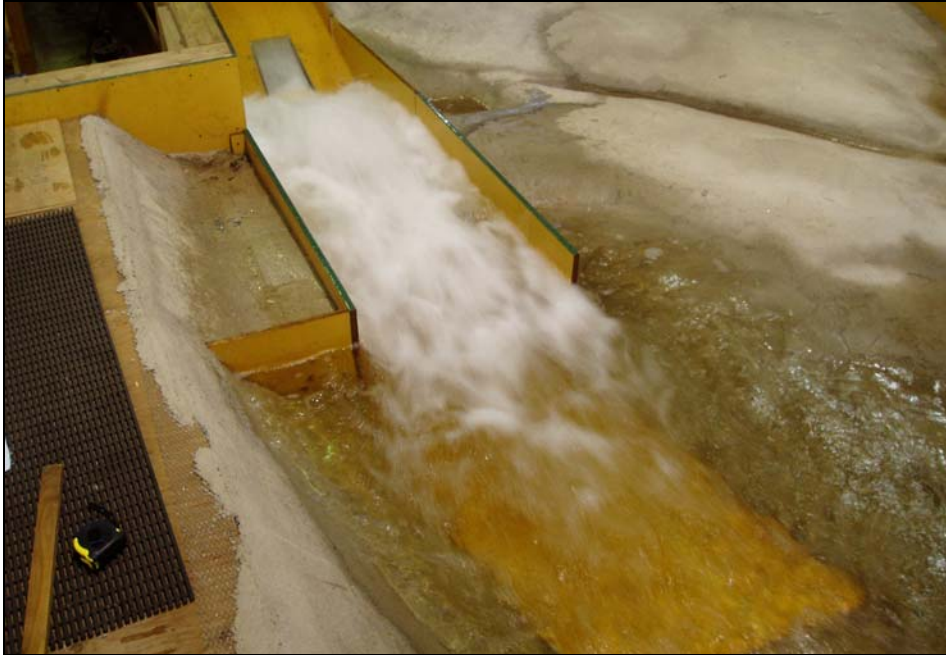
Figure 52. Condition 3: Surface view with deflector installed and splitter walls completely removed (deflector elevation 3073.3 ft). Release flow was 4,000 ft<sup>3</sup>/s.

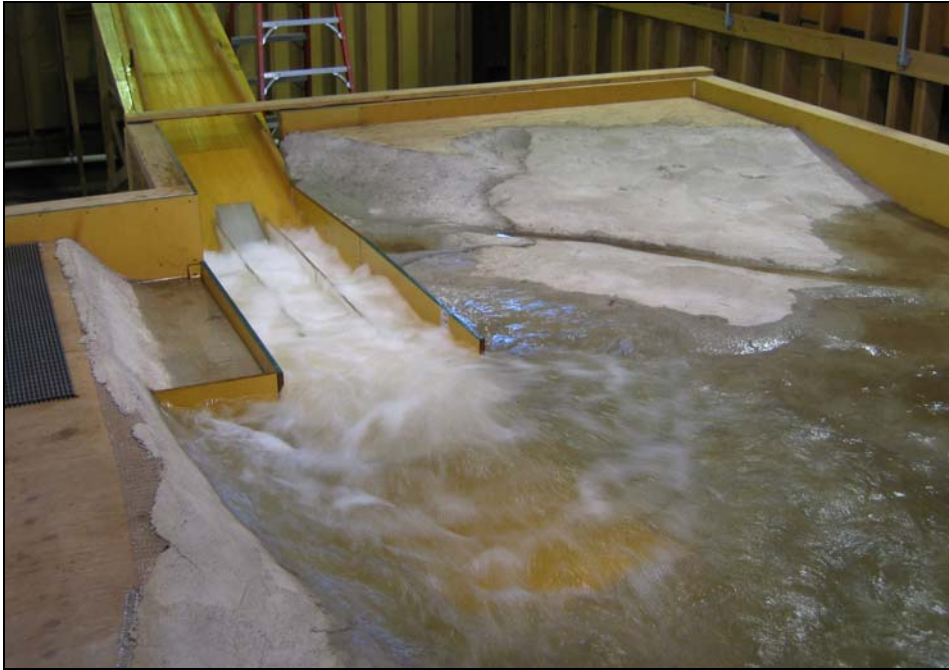
Figure 53. Condition 1: Surface view with no deflector and existing stilling basin geometry at a discharge of 8,120 ft<sup>3</sup>/s.
