Hydraulic Laboratory Report HL-2009-01

## Hydraulic Model Study of Arthur R. Bowman Dam Total Dissolved Gas Deflector

May 2009

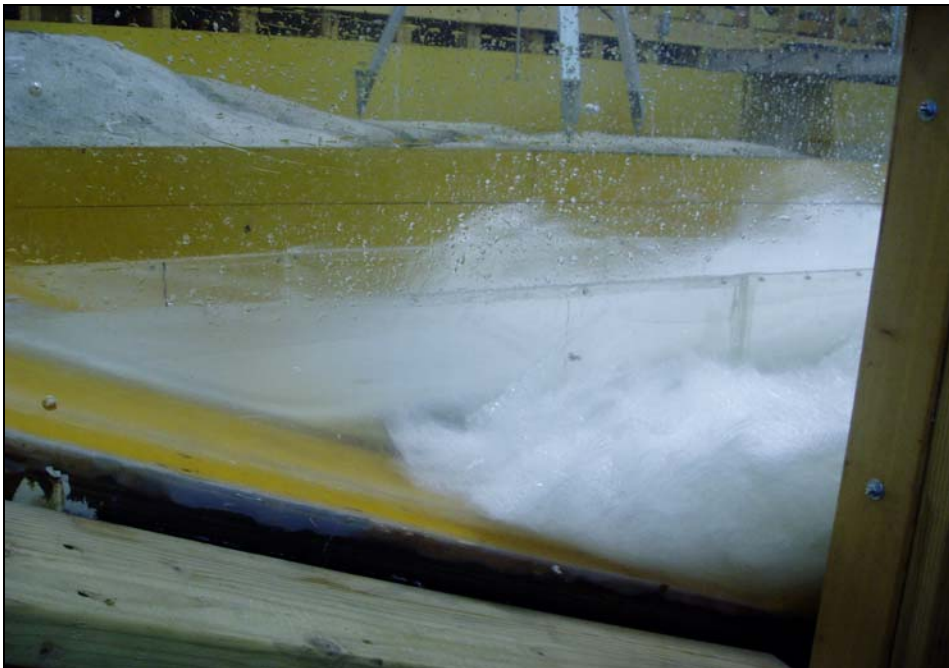
Figure 54. Condition 2: Side view with deflector installed and existing stilling basin geometry (deflector elevation 3071.5 ft). Release flow was 8,120 ft<sup>3</sup>/s.

Photographs of all spillway flow tests are shown in figures 47-63. Detailed model observations are provided in the appendix.

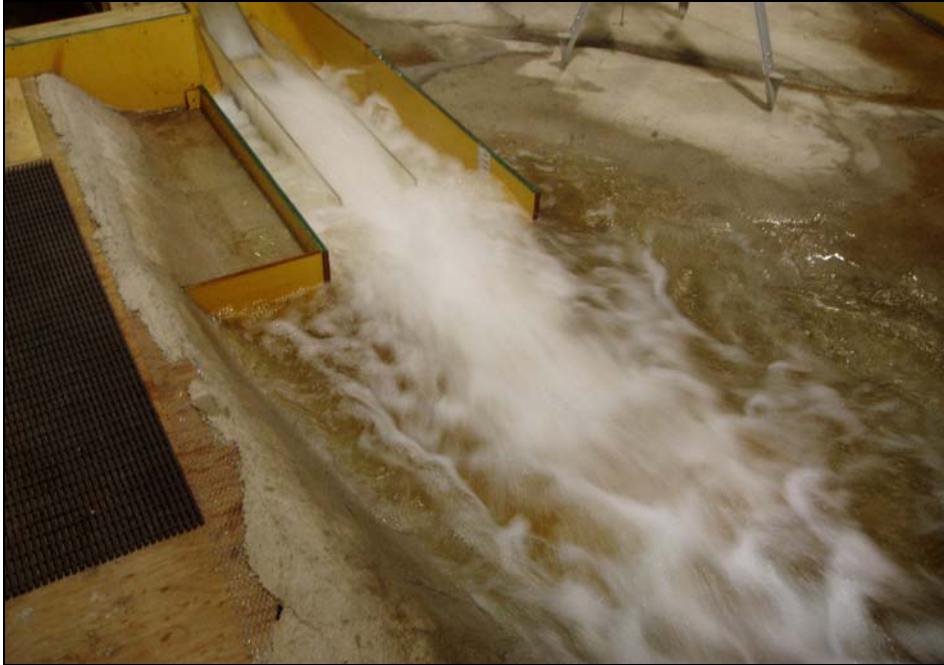
Figure 55. Condition 2: Surface view with deflector installed and existing stilling basin geometry (deflector elevation 3071.5 ft). Release flow was 8,120 ft<sup>3</sup>/s.

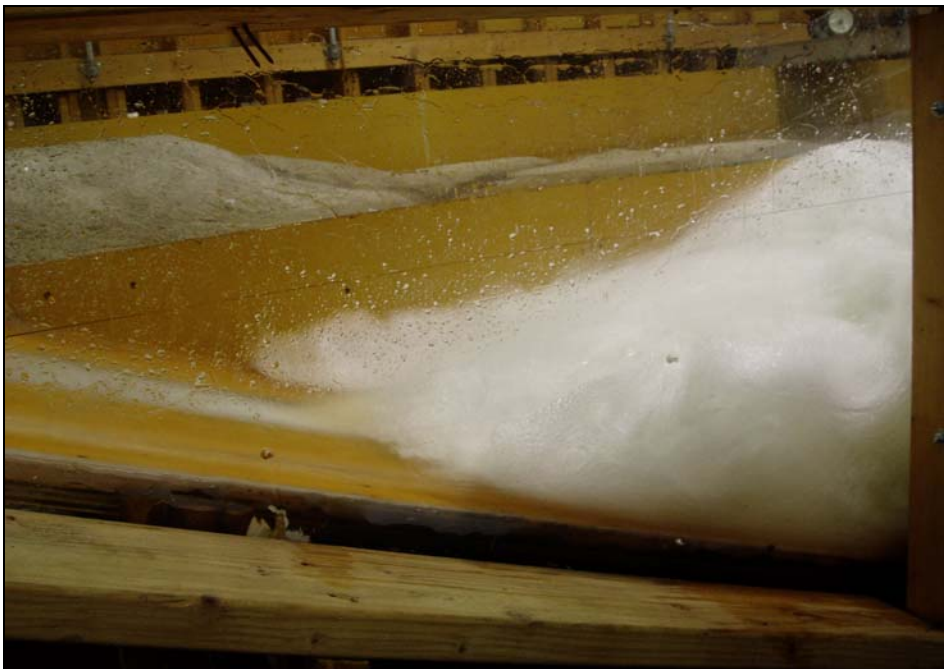
Figure 56. Condition 3: Side view with deflector installed and splitter walls completely removed (deflector elevation 3073.3 ft). Release flow was 8,120 ft<sup>3</sup>/s.

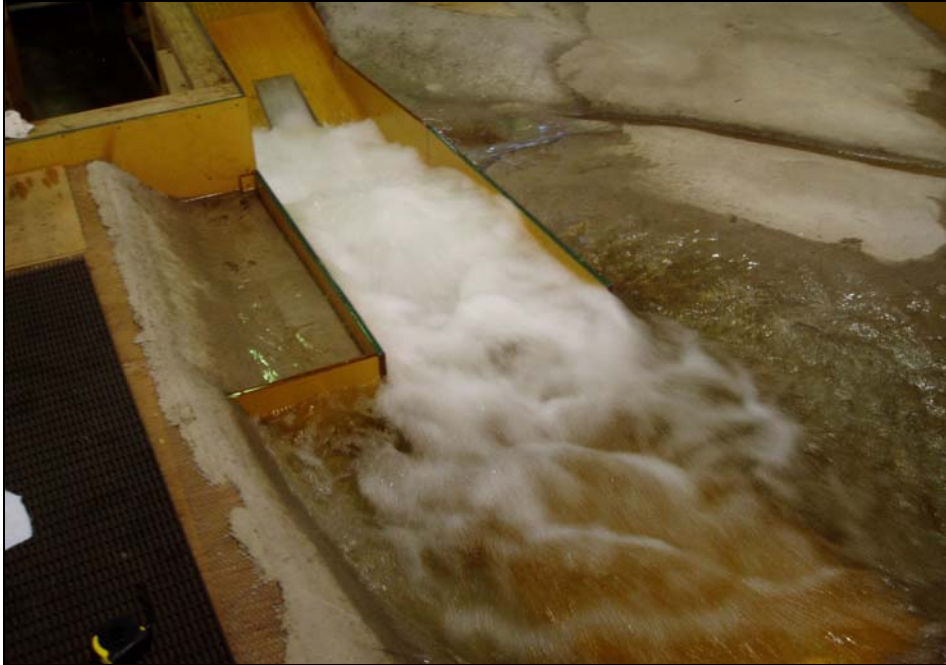
Figure 57. Condition 3: Surface view with deflector installed and splitter walls completely removed (deflector elevation 3073.3 ft). Release flow was 8,120 ft<sup>3</sup>/s.

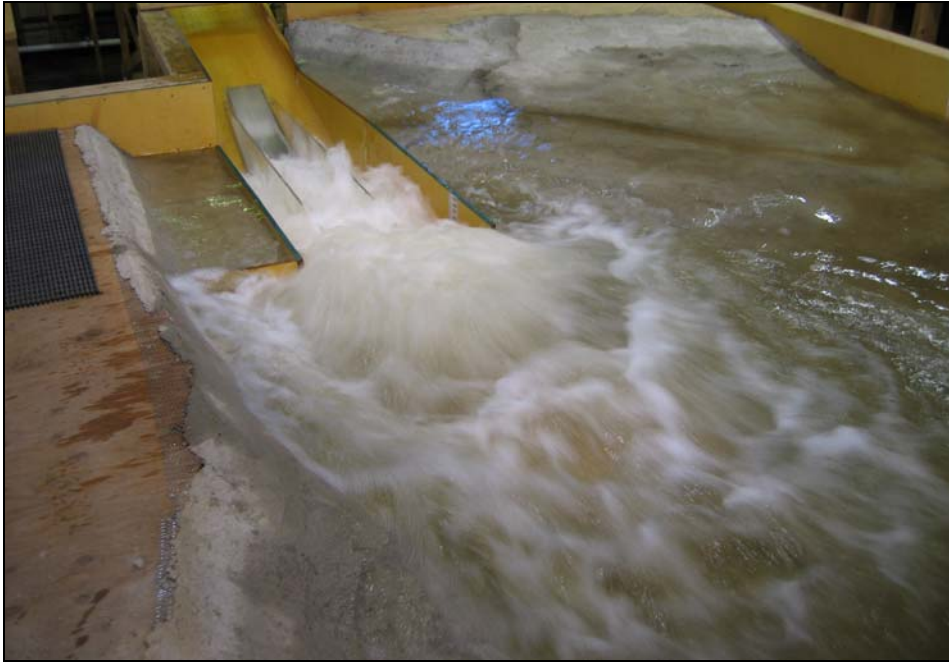
Figure 58. Condition 1: Surface view with no deflector and existing stilling basin geometry at a discharge of 14,965 ft<sup>3</sup>/s.

Flows greater than the design discharge of 8,120 ft<sup>3</sup>/s swept out of the basin for all three test conditions, regardless of whether a deflector was installed. At a discharge of 14,965 ft<sup>3</sup>/s, a large turbulent boil in the exit channel was produced for all three tested conditions, however the boil was larger and more energetic with a deflector installed. During condition 3 with the splitter walls removed, a large nonuniform boil attached to the right basin sidewall and boiled over the right sidewall.

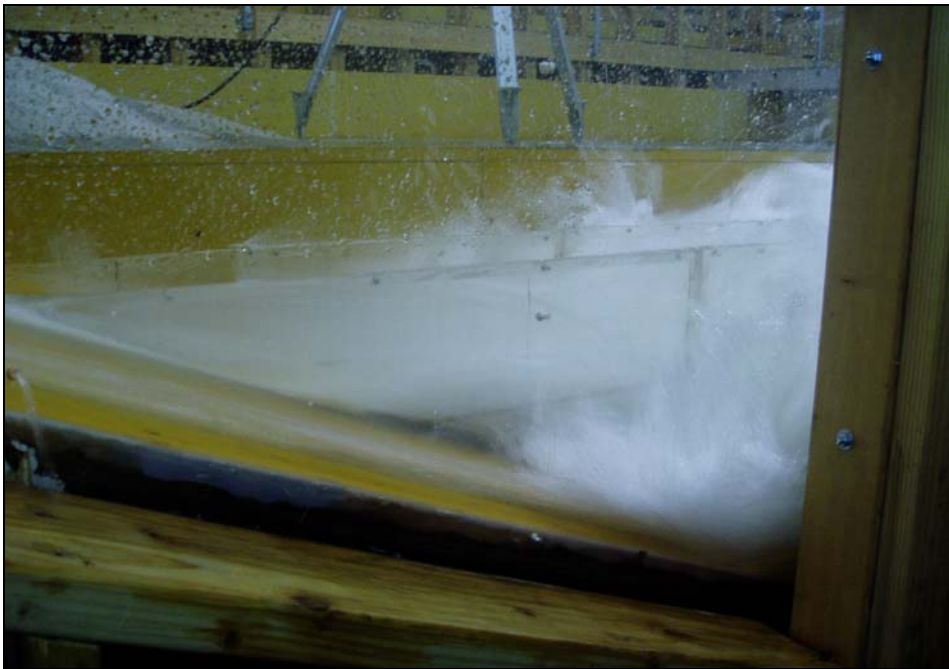
Figure 59. Condition 2: Side view with deflector installed and existing stilling basin geometry (deflector elevation 3071.5 ft). Release flow was 14,965 ft<sup>3</sup>/s.

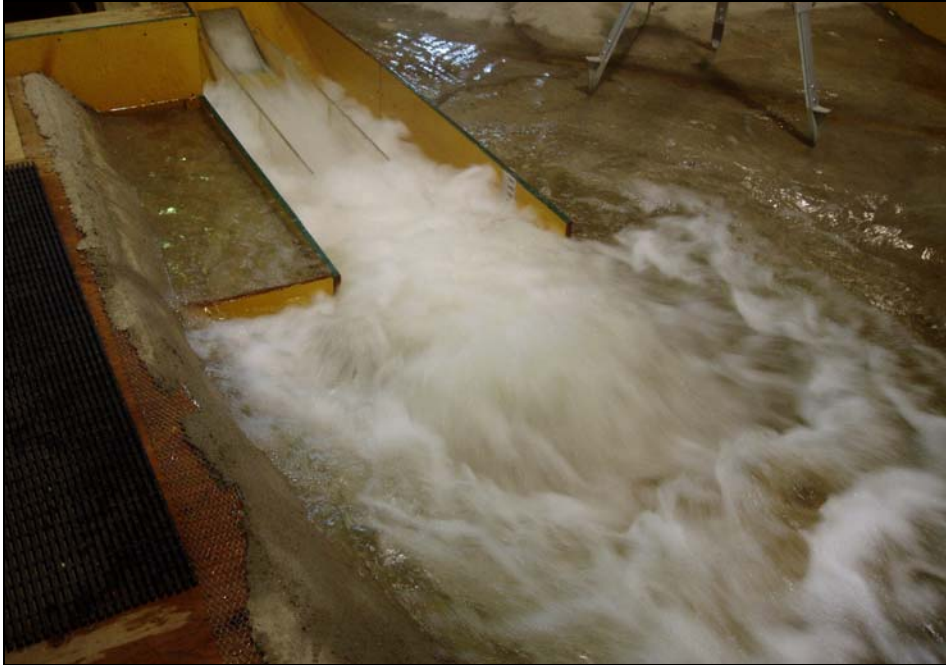
Figure 60. Condition 2: Surface view with deflector installed and existing stilling basin geometry (deflector elevation 3071.5 ft). Release flow was 14,965 ft<sup>3</sup>/s.

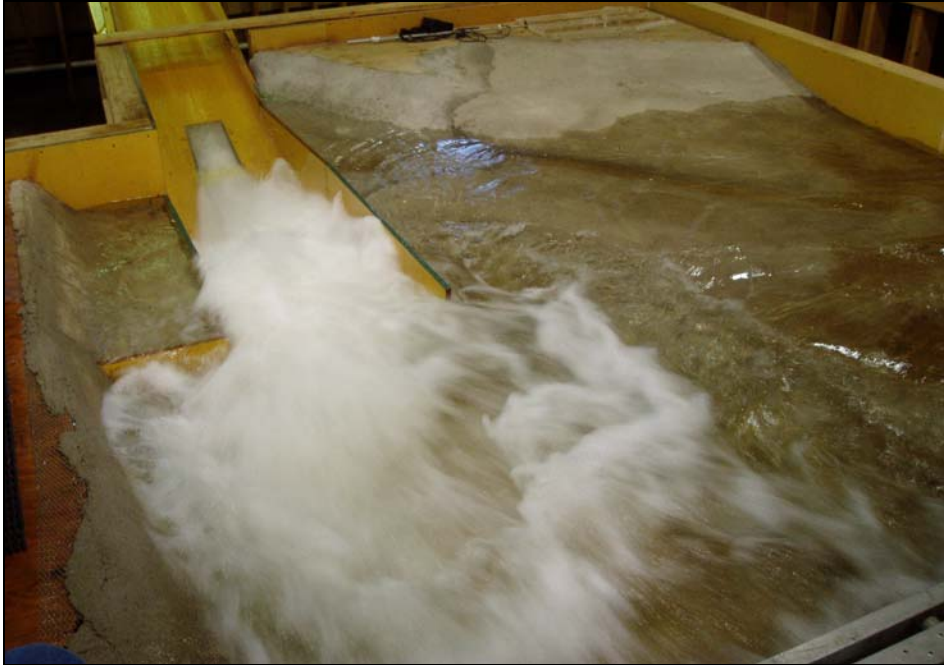
Figure 62. Condition 3: Surface view with deflector installed and splitter walls completely removed (deflector elevation 3073.3 ft). Release flow was 14,965 ft<sup>3</sup>/s. Note the uneven flow distribution in the stilling basin. Flow moves over right stilling basin wall and up the right bankline.
