Hydraulic Laboratory Report HL-2012-04

Guernsey Dam South Spillway Hydraulic Model Study

September 2012

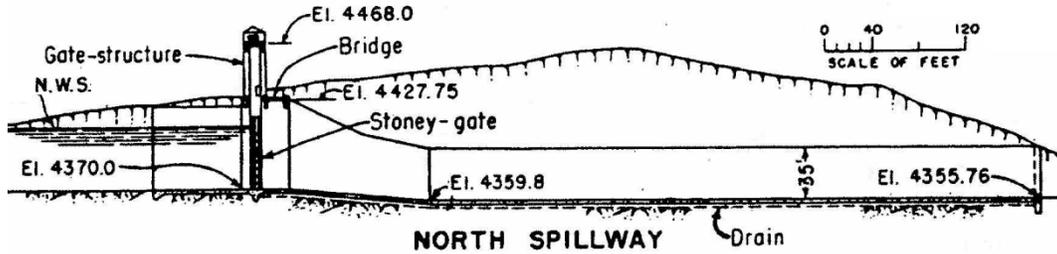
Figure 2. North Spillway. Note this drawing does not indicate the 8 in. concrete overlay that was placed on the spillway invert in 1983.

Guernsey Dam was originally equipped with two spillways. The north spillway is controlled by a 50 ft by 50 ft Stoney gate (vertical sluice gate) (Figure 2). The invert of the north spillway was originally built at elevation 4370 ft, but in 1983 an 8 in. concrete overlay raised the invert to its current elevation of 4370.67 ft. The south spillway (Figure 3) is controlled by two 64 ft by 14.5 ft drum gates. Downstream from the gates, a warped concrete structure referred to as “the bathtub” transitions into a 31-ft-diameter vertical shaft leading to an elbow and then a horizontal, horseshoe-shaped tunnel that is approximately 30 ft in diameter and 723 ft long with a constant invert elevation of 4319 ft. The south spillway

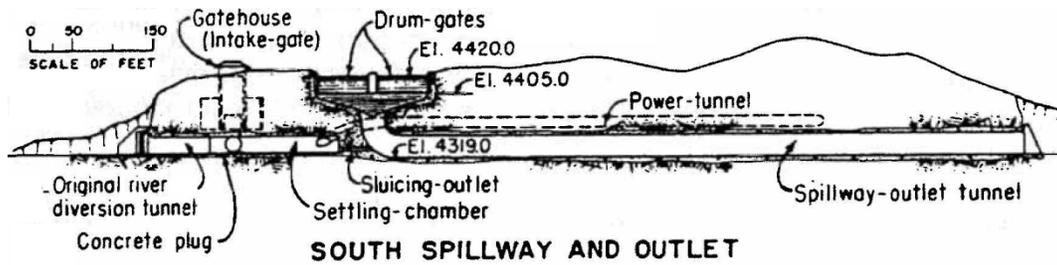
Figure 3. South Spillway and Outlet.

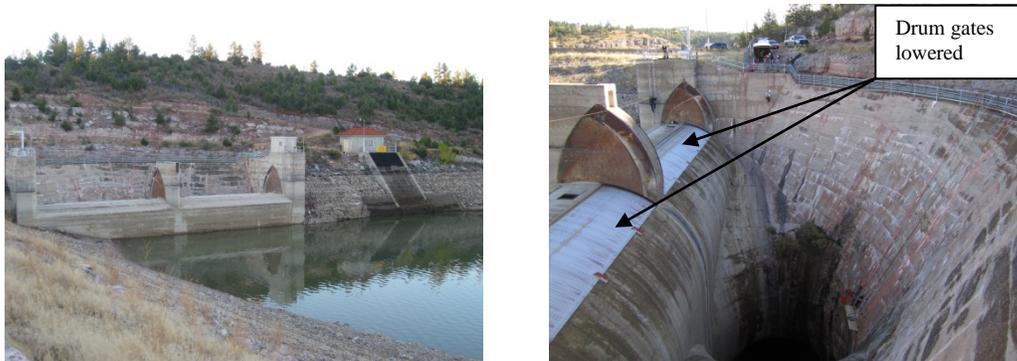
Figure 4. Guernsey Dam south spillway. The left photo is taken from the dam crest looking at the entrance to the left and right spill bays. The right photo is taken from the right wall of the spillway, looking into the transition section and the vertical shaft.

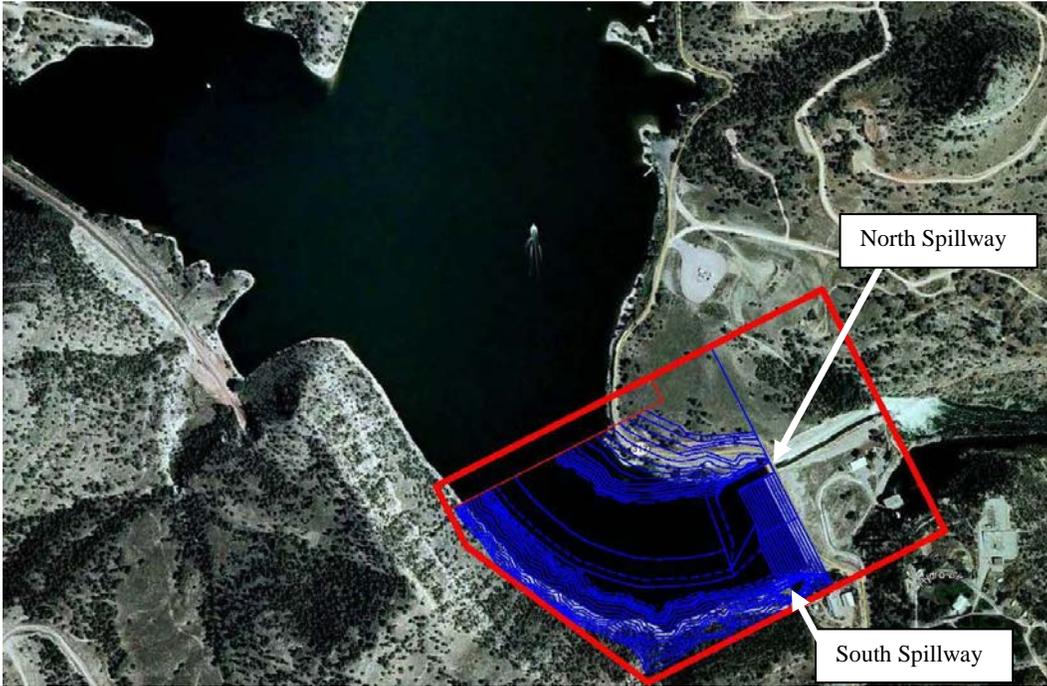
Figure 5. Aerial photo of Guernsey Dam and part of Guernsey reservoir. The physical model boundaries are outlined in red.

Figure 5 shows a plan view of Guernsey Dam, the two spillways, and the reservoir immediately upstream from the dam. The outline of the area included in the physical model is also shown. Flow approaching the dam and spillways must negotiate a sharp left-hand curve; a significant part of this curved approach is included in the modeled area. The river bed just upstream from the dam was originally at elevation 4330 ft, but the reservoir experienced a lot of sediment accumulation before Glendo Dam was completed in 1958. A photograph taken at low WSEL in September 2010 shows a large sediment deposit at an elevation of approximately 4380 ft (Figure 6). On a regular basis the north spillway is used to sluice the reservoir to carry fine sediments downstream with the intent to line the irrigation canals and maintain reservoir storage. Due to the expedited nature of this project there was not time to obtain current bathymetry. Therefore, topography was constructed from the original dam construction drawings from the

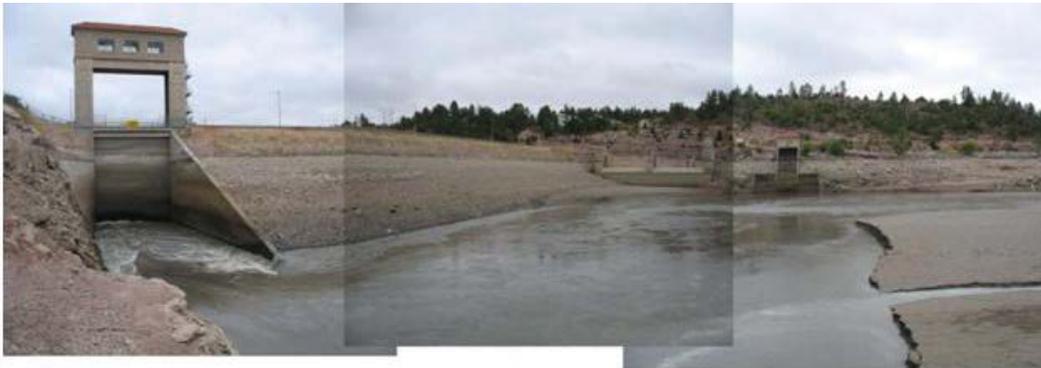
Figure 6. A collage of photos showing Guernsey Dam, the north and south spillways (far left and middle, respectively), and the accumulated sediment berm. The photos were taken on September 18, 2010. The reservoir WSEL was 4379.3 ft while discharging 5066 ft³/s. The powerplant intake is visible to the right of the south spillway.

The size and location of the reservoir sediment deposits were estimated and incorporated into the physical model. Based on observations by personnel familiar with the project, the sediment deposit seen in Figure 6 extends far up into the reservoir. At low flow there is a channel on the river right side that leads to the powerhouse penstock intake and then cuts across the face of the dam to the

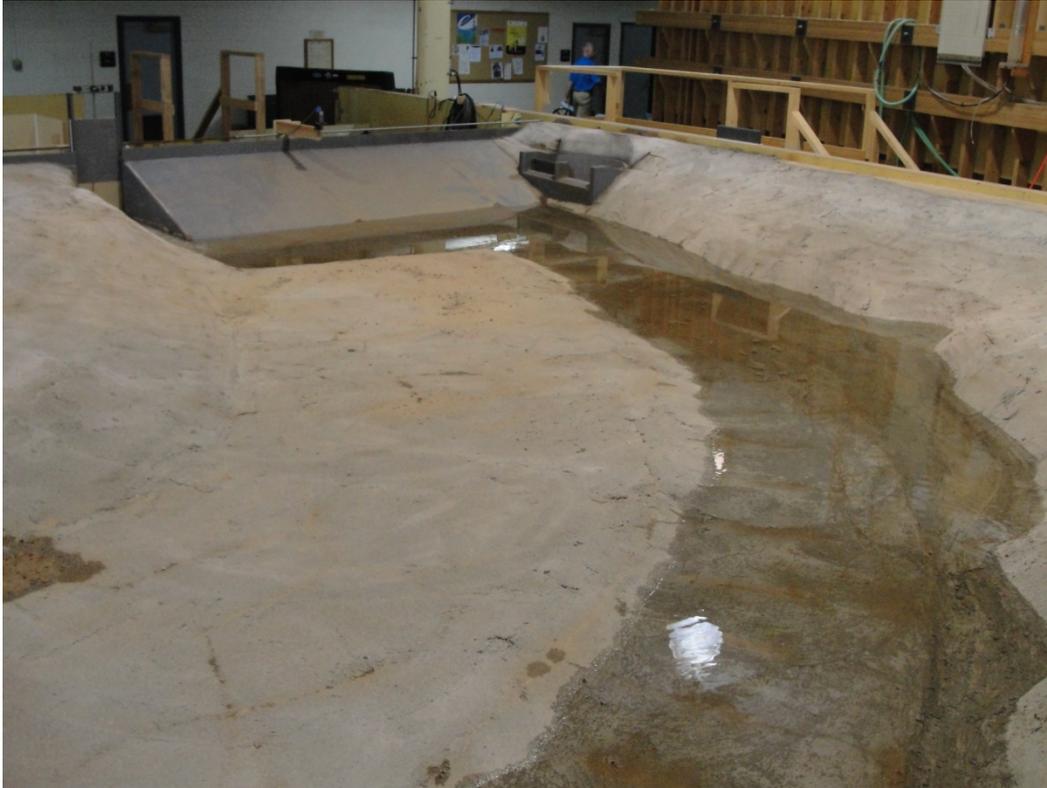
Figure 7. Guernsey Dam hydraulic model showing the modeled reservoir, north spillway (left) and south spillway (right). The picture shows how the model represents the sediment deposits on the river left side of the reservoir (see Figure 6). Water flows down the river right side of the reservoir, across the face of the dam, and through the north spillway.

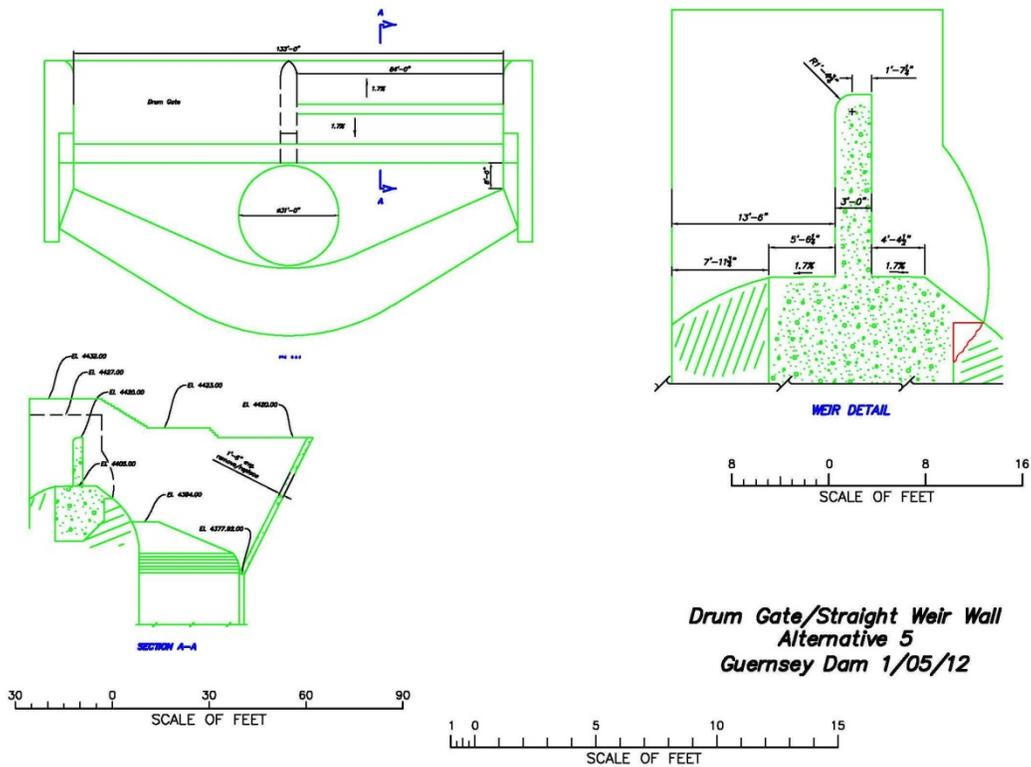
Figure 8. Drawing details of weir for Guernsey Dam south spillway.

All simulations involving drum gates modeled the gate in the fully open (lowered) position. The model was built to allow interchangeable pieces representing the drum gate and the weir to be moved in and out of place for different model configurations. The weir was built to allow the placement of the weir to be “forward” (closer to the reservoir), “back” (farther from the reservoir and closer to the drop shaft), or at any intermediate position (Figure 10). In the “middle” position the front of the weir is 13.5 ft from the front edge of the structure. The weir is 3 ft thick with a radius on the upstream edge of 2.3 ft (Figure 8).

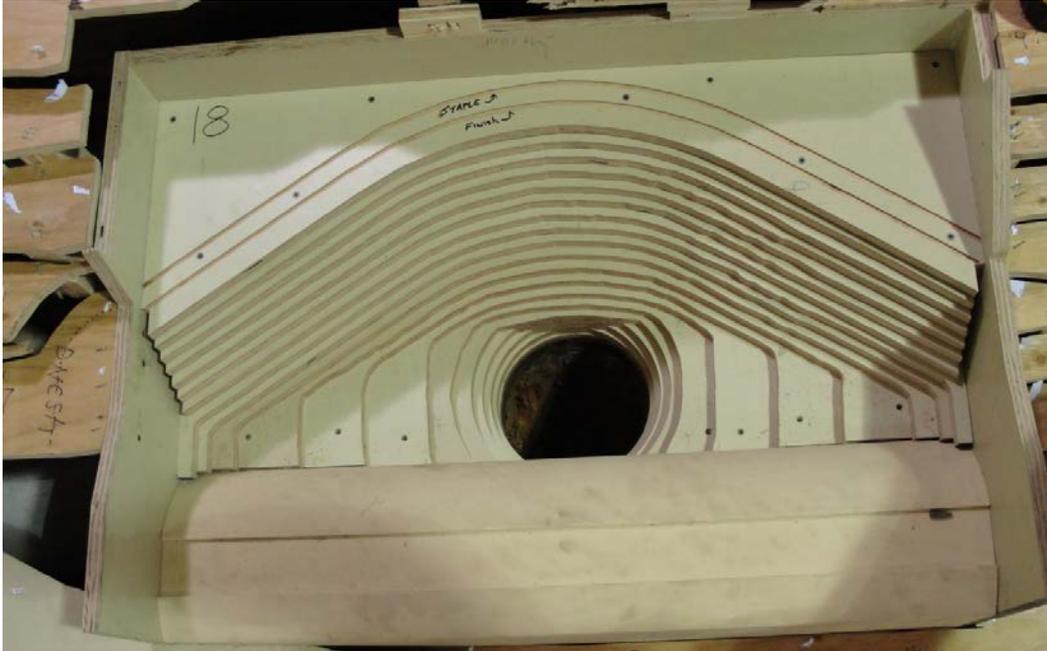
Figure 9. Guernsey Dam model, south spillway, topography lines from the DTM were transferred to plywood and then cut out to shape the spillway basin.

Construction of the bathtub area of the spillway was accomplished using a digital terrain model (DTM) of this part of the structure. The DTM was created from photos taken in the field, using CalibCam and 3D Analyst photogrammetric analysis software from ADAM Technology Software. The original purpose for creating the DTM was to evaluate the condition of the concrete, but it also proved very useful for physical model construction. The DTM of the spillway was scaled down to the model size, and topography lines at intervals of the thickness of marine grade plywood were created using AutoCAD Civil 3D. The topography lines were then transferred to the plywood and the spillway shape was cut and formed (Figure 9). An auto body repair filler material was used to “fill in” the steps between the contours (Figure 10). The spillway piers and crest were machined from high-density polyurethane foam.

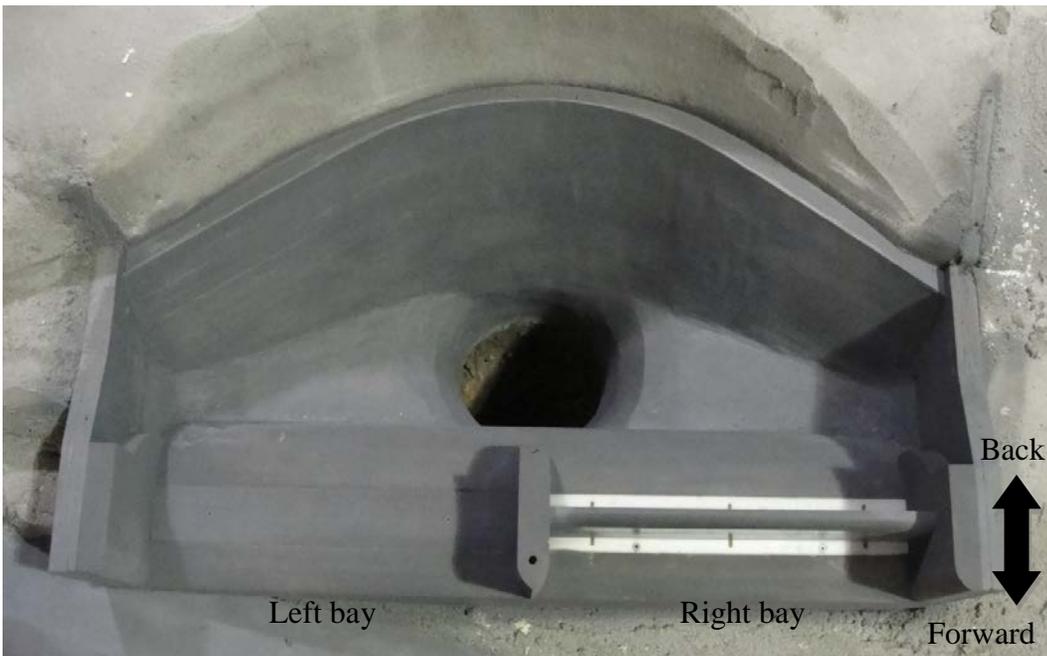
Figure 10. Guernsey Dam model, south spillway. An auto body repair material was used to create a smooth surface from the plywood templates. The left bay is modeling the drum gate in the open or lowered position. In the right bay the drum gate has been removed and the concrete weir is being modeled. In this picture the weir is placed in a mid-position (forward vs. back).

Six drum gate/weir configurations were analyzed in the model under differing flow conditions. Variations of the weir/drum gate location (left bay or right bay) and positions within the bay are described below. Spillway bays are identified as right hand or left hand, referenced to a viewpoint that looks downstream into the spillway structure. The left hand bay is closest to the dam face and is on the east end of the spillway intake structure. The placement of the weir within the bay is described as forward or back, with back indicating closer to the back wall of the bathtub area and drop shaft. Figure 10 helps to illustrate this terminology.

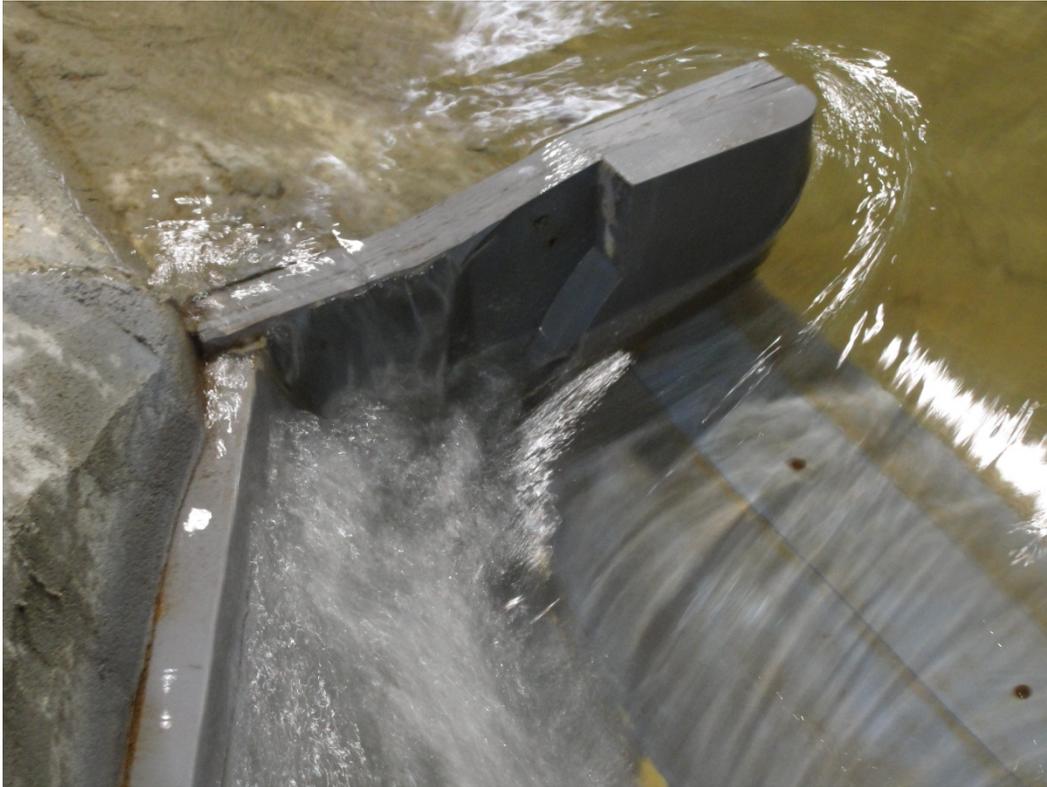
Figure 11. South Spillway, reservoir WSEL at 4426 ft with water flowing over the side of the spillway basin. The reinforcing concrete walls are not being modeled in this photo. Compare with Figure 12.

The structural design team was concerned about the loading associated with flow of water entering the spillway basin over the side walls, (Figure 11). This flow condition occurs when the reservoir level exceeds 4423 ft. To provide additional strength, the designers proposed thickening both sidewalls as shown in Figure 12. The thickened walls were included in most of the model testing to ensure that they would not introduce undesirable hydraulic conditions.

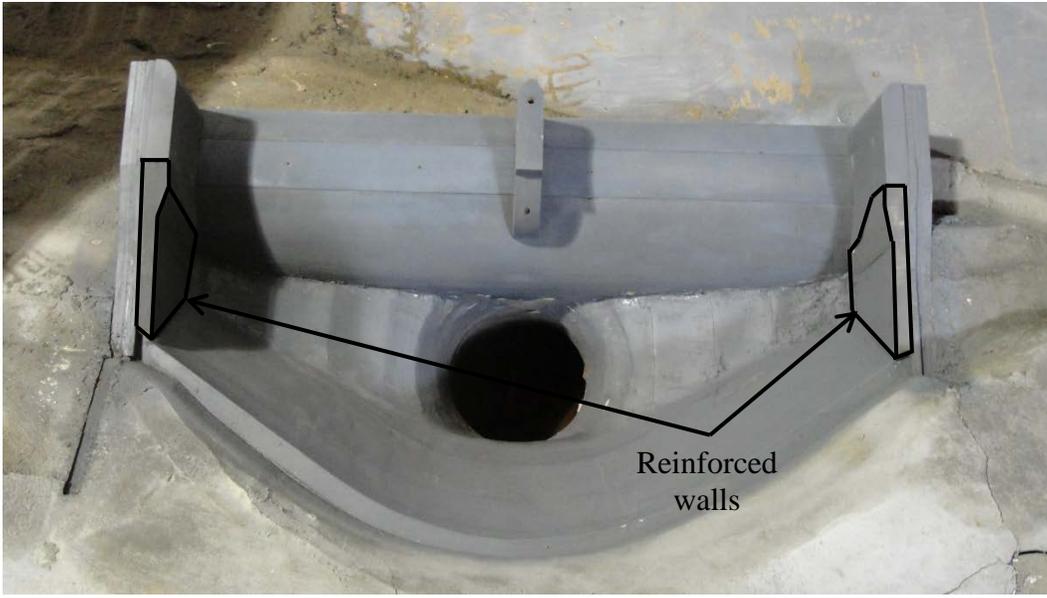
Figure 12. South Spillway basin with the reinforced walls (outlined in black) added to the sides of the spillway.

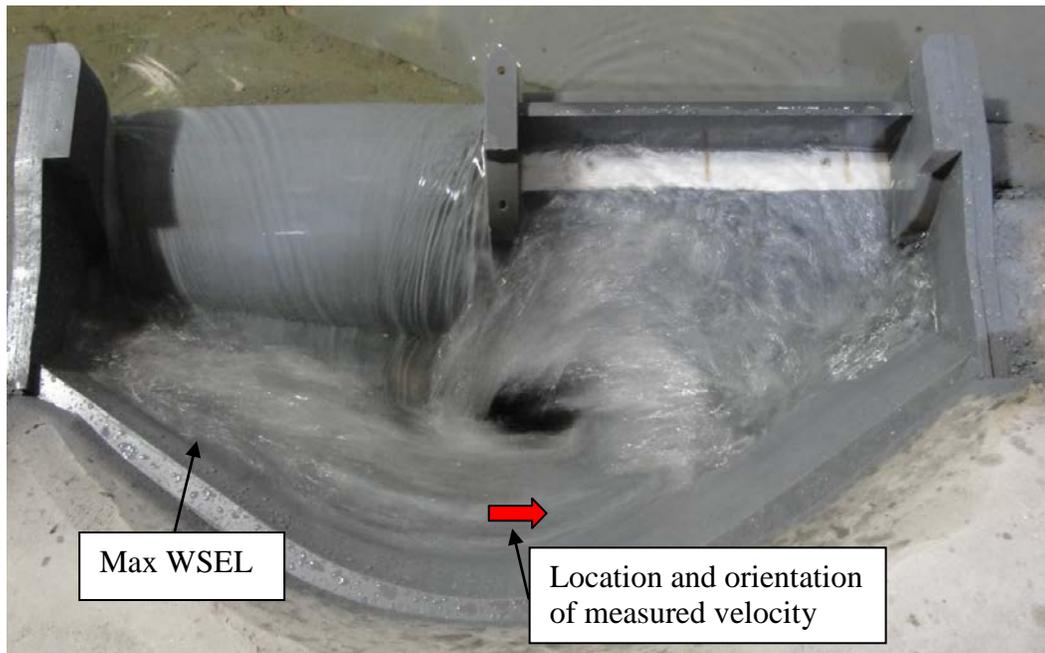
Figure 13. Guernsey south spillway showing the location and orientation of measured velocities and the maximum WSEL. Often the maximum WSEL was not in the center of the spillway, as shown in this photo.

Velocity measurements were made with a Swoffer 3000 hand-held current meter. This meter has a 50 mm diameter horizontal axis propeller and an accuracy of $\pm 1\%$ of the measured velocity. When the south spillway was configured with one drum gate and a weir wall in the other bay, flow in the bathtub area was unsymmetrical with strong circulation, and water traveled along the back wall of the spillway with significant velocity. The location and orientation of the

measured velocity are shown in Figure 13. In this figure the drum gate is in the right bay so the direction of velocity along the back wall of the spillway is from right to left looking into the intake. In configurations where the drum gate was in the left bay the velocity along the back wall was in the opposite direction. Velocity measurements were always taken in the center of the spillway in the direction of water travel. The meter was placed into the current deep enough that the propeller was submerged and did not impact the back wall. The maximum WSEL on the back wall of the spillway was also measured by marking the maximum level and measuring to reference elevations in the structure.

Figure 20 shows the discharge vs. back wall velocity and discharge vs. the back wall maximum WSEL with a drum gate in the right hand bay and a weir in the left hand bay. See Figure 13 for the location and direction of the velocity measurements. The general trends shown in Figure 20 are typical of each flow configuration.

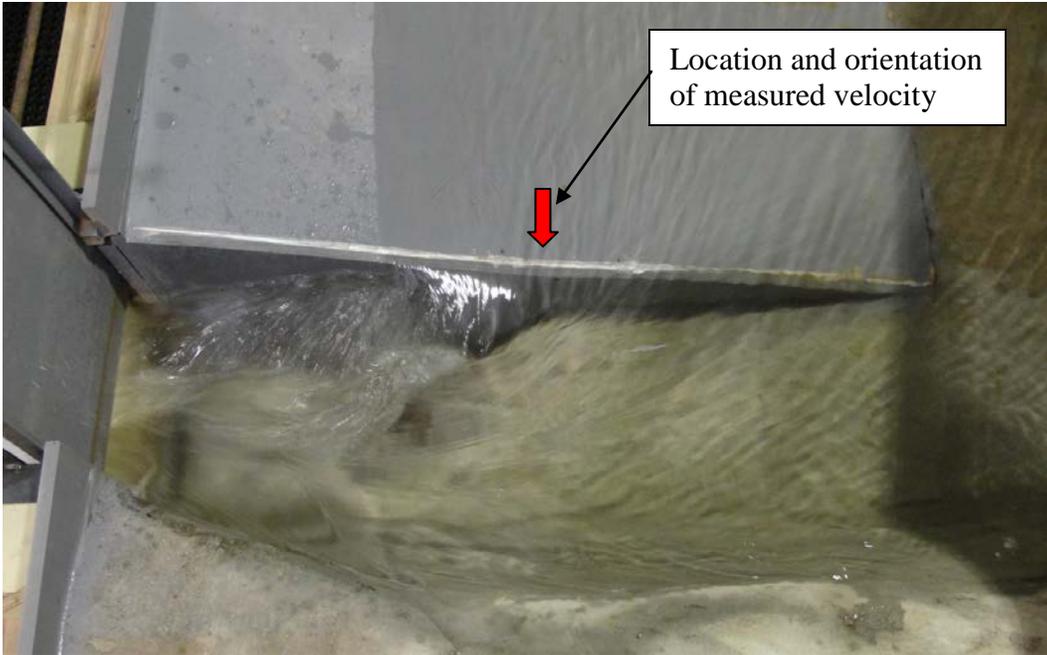
Figure 14. Guernsey Dam north spillway, showing the location and orientation of velocity measurements. The gray area at the top of the photo is the upstream dam face. The open Stoney gate is at the left.

There have been reports that riprap on the face of the dam near the north spillway has been washed away in past flow events. Velocity measurements in this area were also collected with the meter's propeller submerged and without impacting the face of the dam as shown in Figure 14.

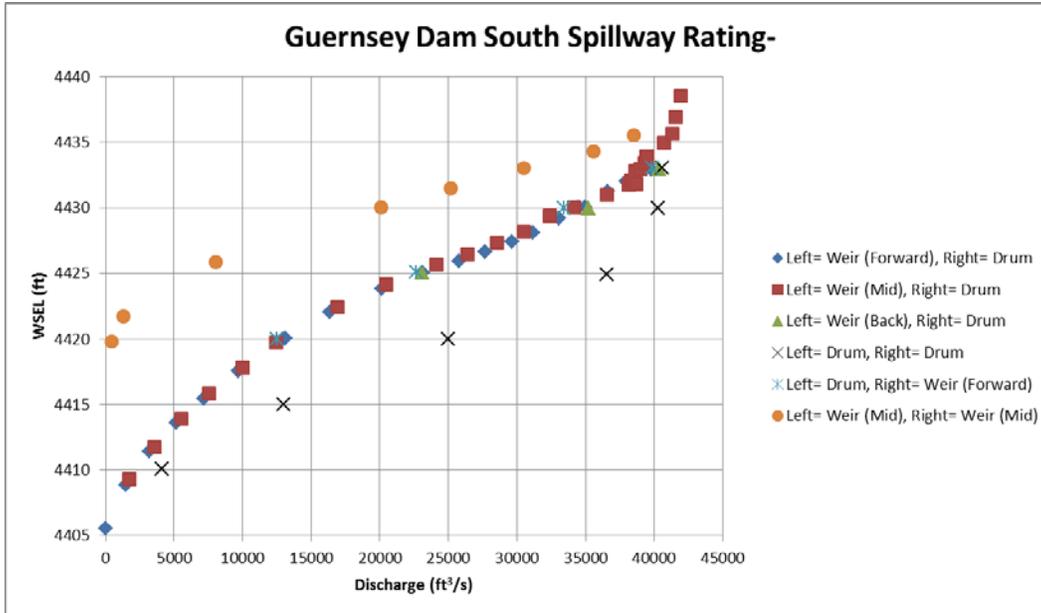
Figure 15. Stage vs. discharge ratings for each configuration tested in the south spillway.

Stage vs. discharge plots were developed and compared to determine the efficiency of each configuration (Figure 15). Hydraulic conditions in the bathtub transition area were also analyzed.

Configurations with two weirs and two drum gates were also modeled. As expected, the configuration with two drum gates has the highest capacity, while 2 weirs at an elevation of 4420 ft has the lowest capacity (Figure 15). However, these configurations either do not satisfy the economic goals of the modification (two drum gates) or do not meet the discharge capacity requirements (two weirs). They were modeled for the purpose of comparing flow conditions and spillway discharge limits.

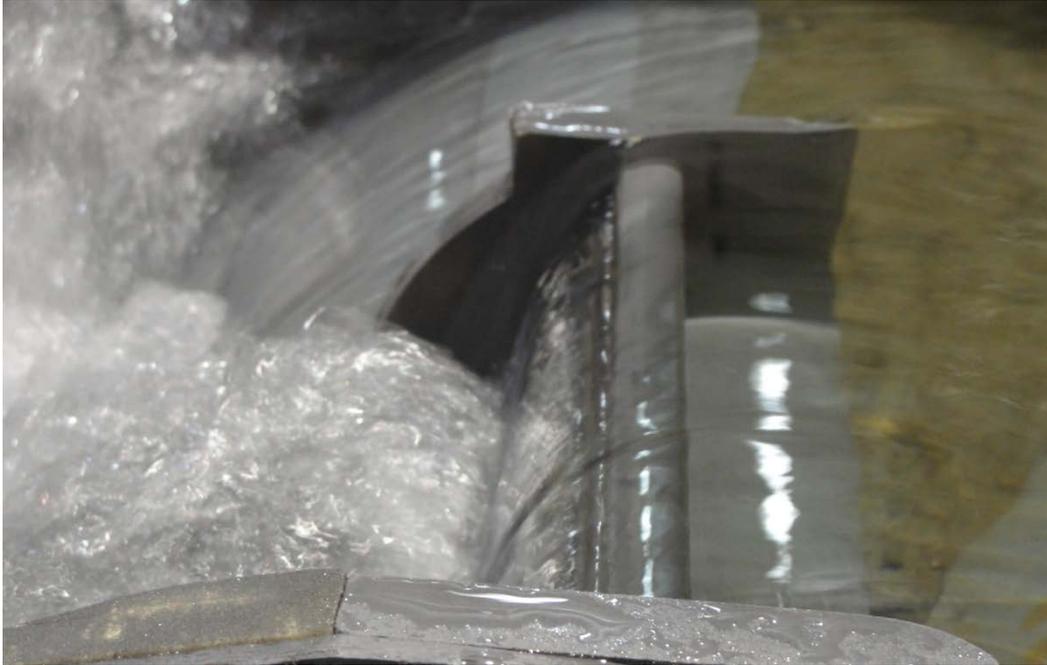
Figure 16. South spillway discharge of 23,200 ft³/s at a reservoir WSEL of 4425 ft. The weir is in the left hand bay in the forward position.

Overall, the placement of the weir forward or back had little impact on the spillway efficiency. When the weir was in the forward or middle position and was not submerged, as in Figure 16, the nappe was not continuously aerated and tended to be pulled down toward the back side of the weir. When the weir was in the back position the nappe was sometimes disrupted by water coming around the upstream side of the middle pier. This caused the nappe to oscillate between aerated and not aerated. This oscillation may produce vibrations when the weir is in the back position. If there is a compelling reason to place the weir in the back position, this oscillation should be investigated further. No other large differences in flow conditions were observed. Due to the lack of hydraulic benefits or negative effects, these minor hydraulic differences should not be the primary influence of the placement of the concrete weir in either the forward or back position.

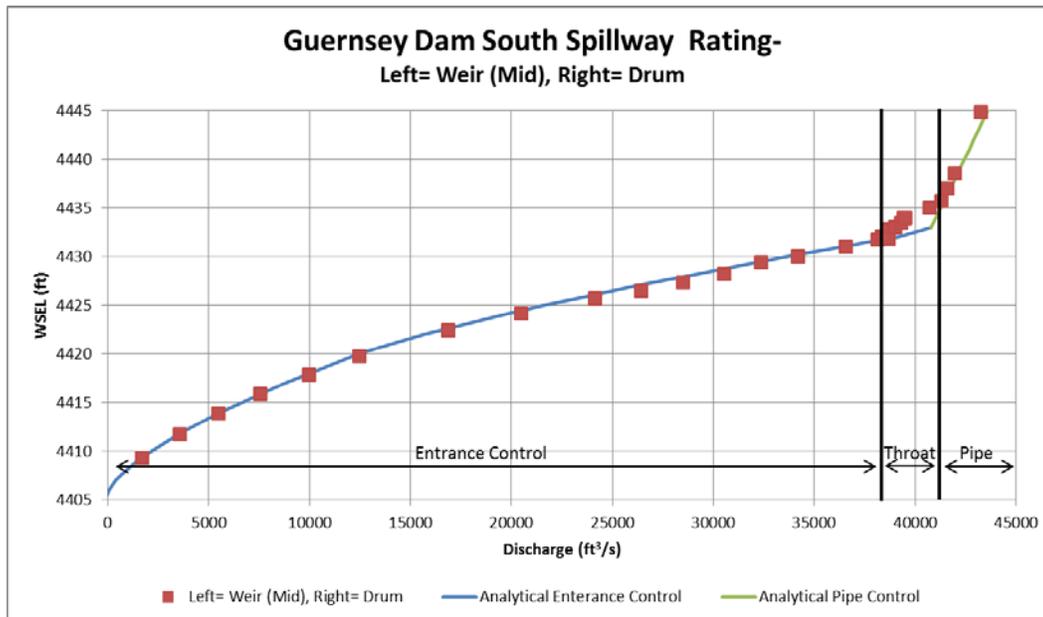
Figure 17. Stage vs. discharge rating in the south spillway with the weir in the middle position of the left bay and the drum gate fully open in the right bay. The physical model is compared with the analytical discharge estimates.

Figure 17 shows the stage vs. discharge relationship for configuration 2, the weir in the left bay in the middle position and the drum gate in the right hand bay. The plot also indicates shifts from entrance to throat to pipe control. As discussed in the model setup section, only 75% of the tunnel was modeled. In the model, the tunnel was backpressured to simulate analytical estimates of stage vs. discharge at the tunnel exit during pipe control.

Figure 17 also shows the analytical estimates of the discharge curve. However, the analytical solution shows that pipe control is more limiting than throat control and therefore control jumps directly from entrance control to pipe control as the discharge increases. Model data collected at flow rates between the zones of entrance control and pipe control suggest that the spillway is either shifting to throat control, or at this flow condition the vortex that forms in the drop shaft inlet (e.g., see Figure 13) is decreasing the spillway efficiency (Humphreys 1970). In this range, discharge through the spillway was unstable. Discharge would randomly increase or decrease over time (Figure 17).

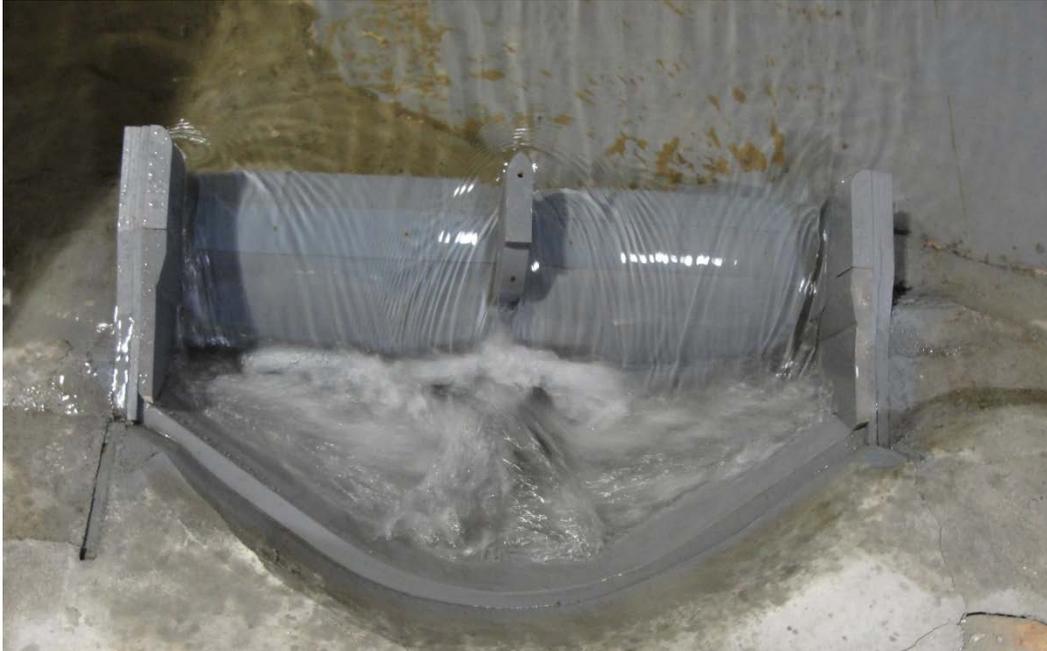
Figure 18. South spillway discharge of 25,000 ft³/s at a reservoir WSEL of 4420 ft, modeling two drum gates. Note the symmetric flow conditions in the spillway.

In the south spillway structure the bays and transition area are symmetric and exhibit better hydraulic conditions when flow entering the spillway is symmetric, i.e. both drum gates open the same amount. In this case, water passes through the bays and circles around to the center of the bathtub, impacts on itself, and goes down into the tunnel (Figure 18). The replacement of just one drum gate with a weir having a much higher crest elevation leads to extremely unsymmetrical flow conditions. Thus, in the configurations where flow through one bay was much greater than the other, a large vortex formed as water raced around the back of the spillway bathtub (Figure 19).

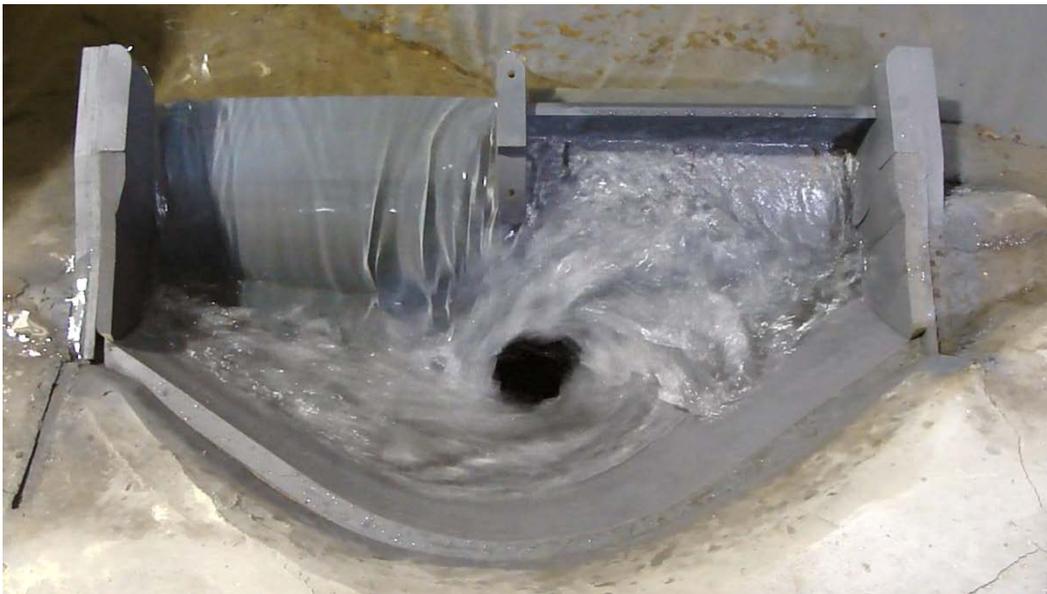
Figure 19. South spillway discharge of 13,100 ft³/s at a reservoir WSEL of 4420 ft. The configuration here is the fixed weir at the forward position in the left bay (looking downstream into spillway) and the drum gate in the right bay, Notice the large vortex in the center of the spillway.

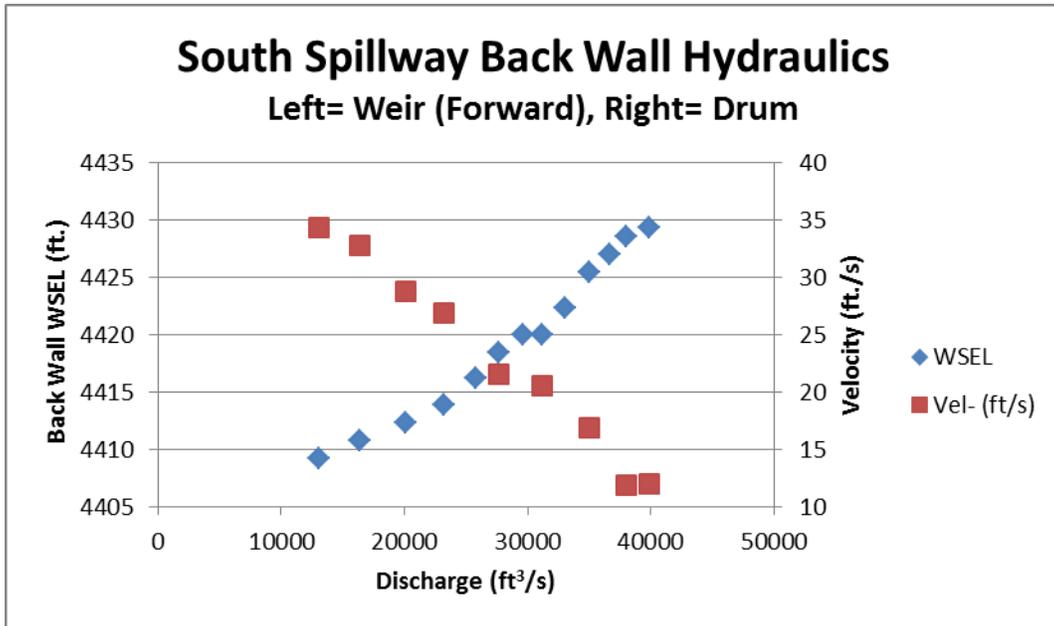
Figure 20. South spillway back wall hydraulic conditions, left bay = weir (forward), right bay = drum gate.

For the various configurations that led to unsymmetrical flow, the velocity on the back wall of the spillway ranged from 11.8 ft/s to 34.3 ft/s over the range of discharges tested. The highest velocities were observed at low discharges. As the discharge increased, the gradual shift toward throat and eventually tunnel control caused the water level in the bathtub area to increase, thus reducing velocities along the back wall.

- Due to unsymmetrical flow conditions, velocities along the back wall of the south spillway can be as high as 34 ft/s. The highest velocities occurred at low discharges around 13,000 ft³/s.

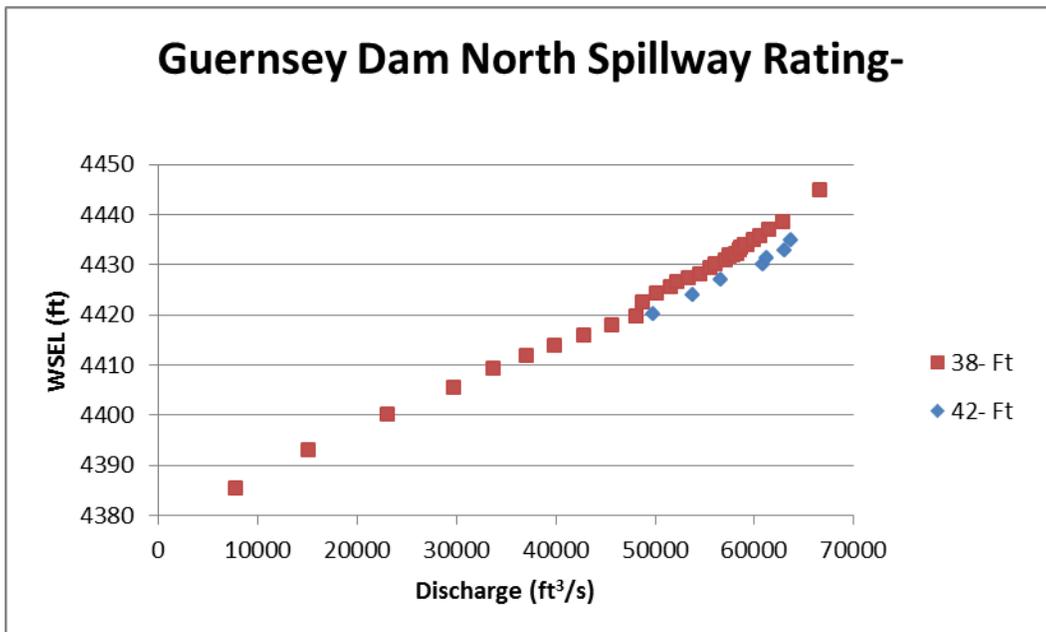
The current limit switch settings and standard operating procedures for the north spillway limit the Stoney gate to an opening of 38 ft as shown by the gate position indicator (Koenig 2010), which is not adjusted to account for the effects of the 8 inch crest overlay. Drawing 20-D-476 indicated the maximum gate opening is 42 ft above elevation 4370.0 ft which is 4412.0 ft. The spillway crest elevation with the new overlay is now 4370.67 ft, for an opening of 41.33 ft. In the physical model study, the north spillway gate was set to both 38 ft and 42 ft openings as would be read on the gate position indicator. The actual openings are 37.33 ft and 41.33 ft, respectively. Figure 21 compares the discharge curve for a 38-ft and 42-ft opening.

Figure 21. North Spillway discharge vs. elevation rating curve with the Stoney gate open 38 ft and 42 ft, according to the gate indicator (37.33 ft and 41.33 ft actual)

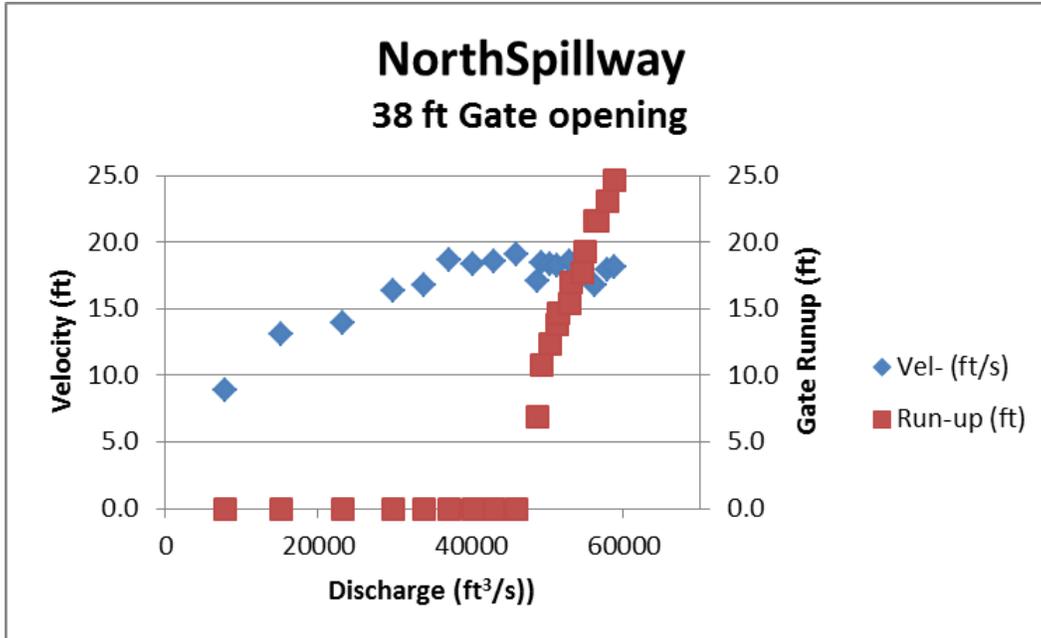
When the north spillway is discharging, some water travels along the face of the embankment and then pours over the concrete wall into the spillway entrance. It has been reported that some riprap on the embankment has been washed away. In the model, velocities along the face of the embankment were measured over the range of discharges tested. See Figure 14 for the location and orientation of the velocity measurements. Figure 22 shows the velocity along the embankment vs. discharge through the spillway. In general, the larger discharges exhibited larger

velocities. For discharges between 40,000 ft³/s and 60,000 ft³/s velocity measurements ranged from 17 ft/s to 19 ft/s. Figure 22 also shows the depth of water against the Stoney gate. The depth was measured from the bottom of the gate to the maximum water surface against the gate.

Figure 22. Velocity along the embankment face near the north spillway entrance and the depth of water above the lower lip of the Stoney gate (elev. 4408.0).

- Velocities along the face of the embankment approaching the north spillway inlet can be as high as 19 ft/s for large discharges through the north spillway (near 60,000 ft³/s).

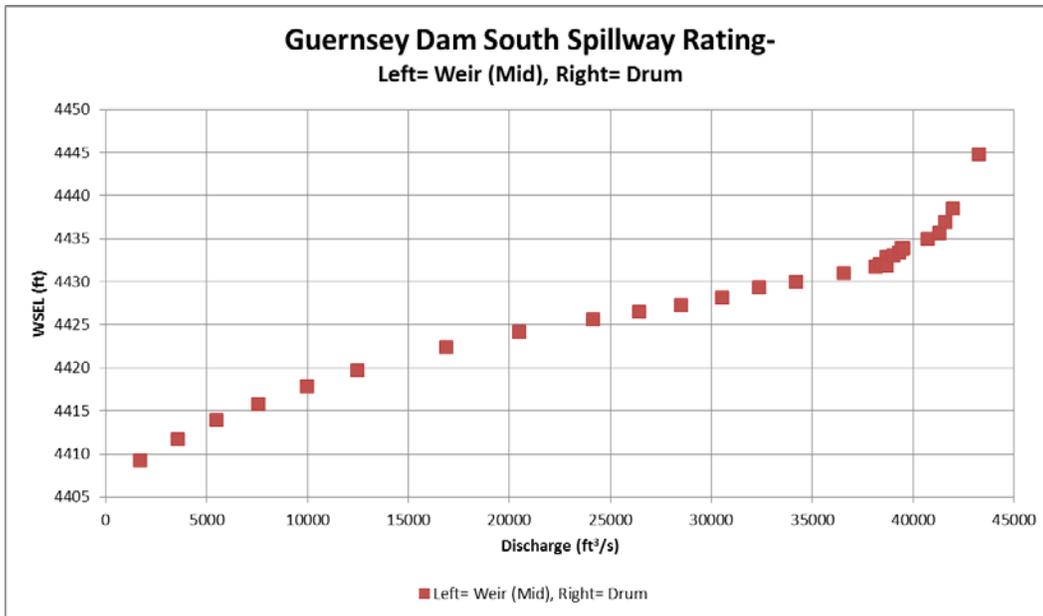
Figure 23. Guernsey Dam south spillway rating curve for the configuration with the weir in the left hand bay in the middle position, and the drum gate in the right hand bay.

- These findings have been used by the design team during the development of the design and specifications for the dam modifications. The spillway ratings for the preferred alternative, with the weir in the left bay in the middle position, and the drum gate in the right hand bay are given in Figure 23 through Figure 25 and Table 1.

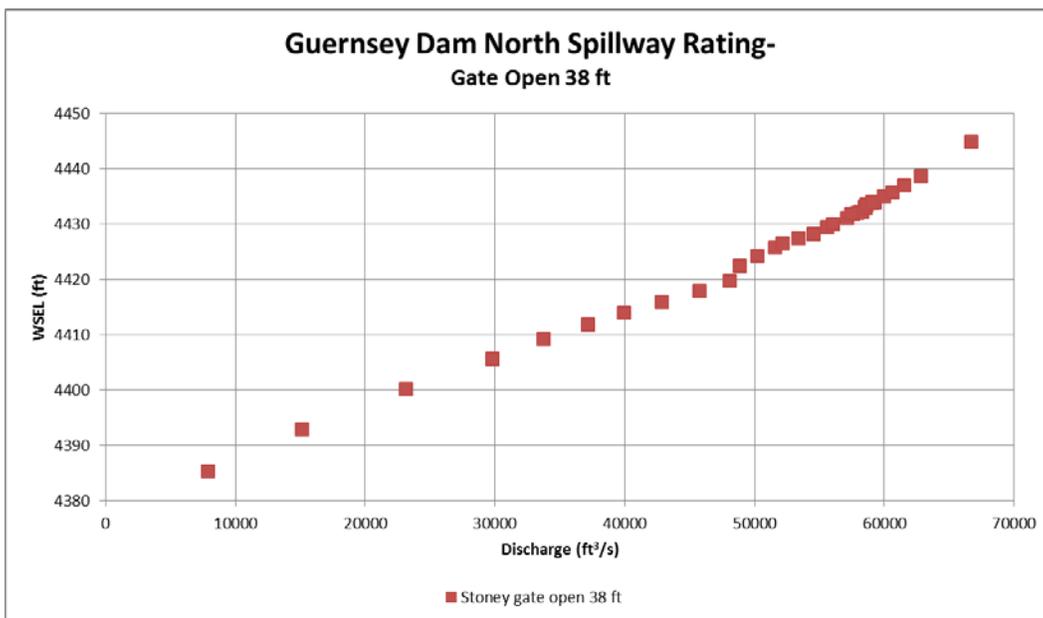
Figure 24. Guernsey Dam north spillway rating curve with the Stoney gate open 38 ft.

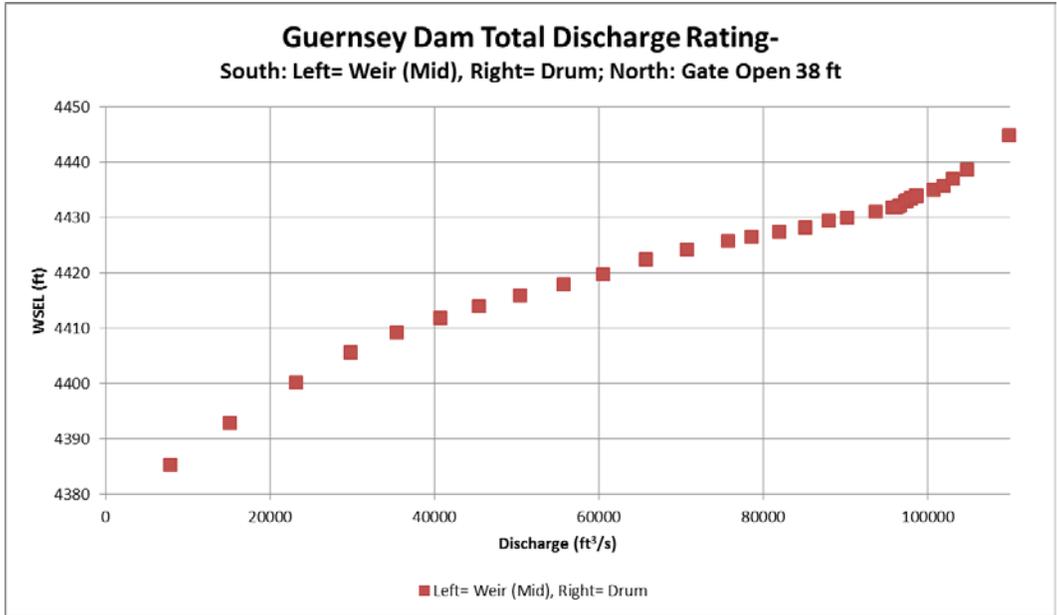
Figure 25. Guernsey Dam total discharge rating curve for the south spillway configuration with the weir in the left hand bay in the middle position, and the drum gate in the right hand bay, and the Stoney gate open 38 ft.
