Hydraulic Laboratory Report HL-2018-07

Paonia Outlet Tunnel Blowback Model Study

December 2018

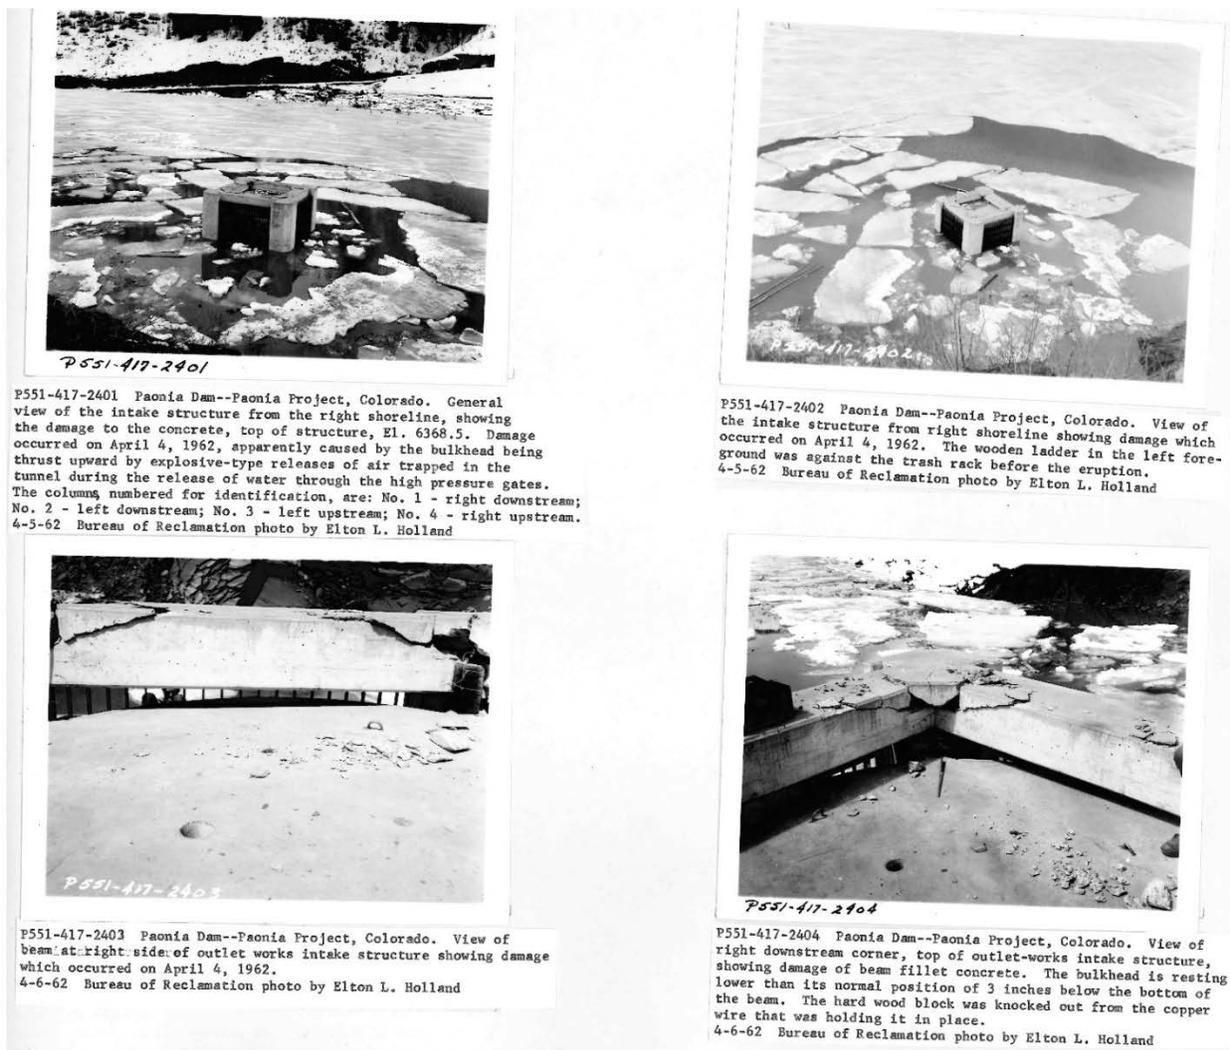
Figure 1. Four historical photos of existing blowback that occurred April 4, 1962 at Paonia outlet tunnel.

The outlet works at Paonia Dam are currently undergoing design for rehabilitation of the emergency and regulating gates. The project is also facing challenging sediment management issues that have impacted operations. One proposed solution to improve sediment management includes changes in operations to allow releases through the outlet works at low reservoir elevations during which the crest at the intake may be controlling. Since initial filling of the reservoir, the outlet works has been under an operating restriction limiting discharges to 200 ft³/s or less for reservoir levels below El. 6373 ft and 30 ft³/s or less for reservoir levels below El. 6362 ft. These restrictions have been in place to prevent potential blowback damage to the intake structure. Blowback damage was first documenting in 1962, when explosive blowback damaged the exiting trashrack structure as shown in Figure 1.

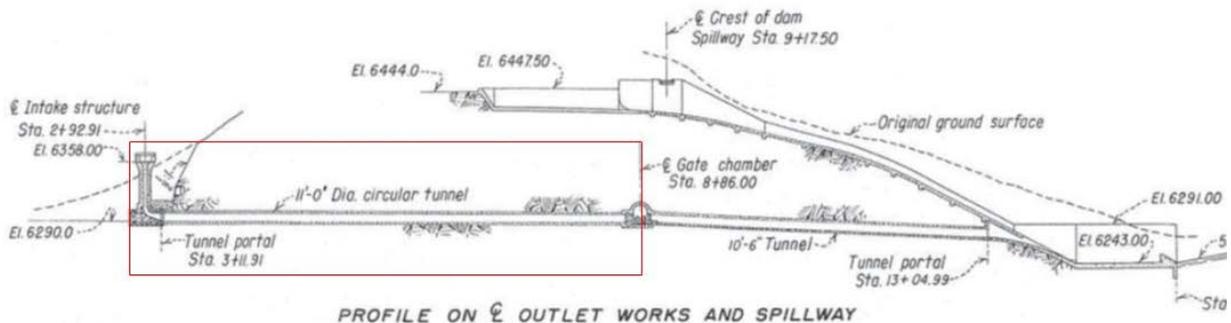
Figure 2. Profile of Paonia outlet works along the centerline of the outlet tunnel and spillway (the red box highlights the features that were modeled).

A 1:11.1 scale physical hydraulic model was constructed at Reclamation’s Hydraulics Laboratory in Denver, Colorado. All hydraulic and structural components from the reservoir through the outlet works control gates were modeled (Figure 1) including the trashrack structure (Figure 2), inlet (Figure 3), vertical 6-ft-diameter conduit (Figure 4), transitional expansion elbow (Figure 6 and Figure 7), horizontal 11-ft-diameter tunnel (Figure 5) and the outlet gates transition section (Figure 6 and Figure 7). Gates were simulated using a single wood slide gate that could operate from the fully open to the fully closed position (Figure 10 and Figure 11).

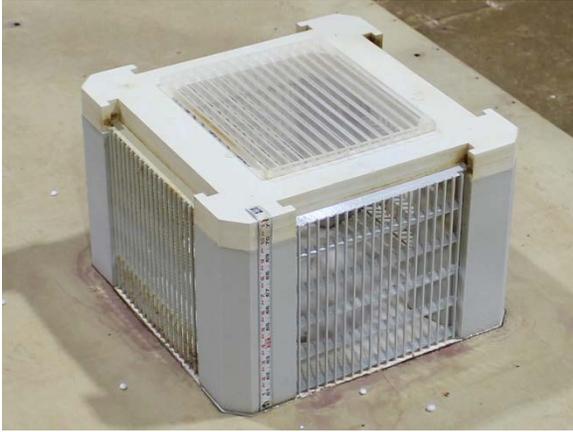
Figure 3. Paonia outlet works trash rack structure.

The model was constructed from several different materials. The intake and trashrack structure were printed on a 3D printer and glued together with plastic epoxy. The vertical shaft was constructed of clear acrylic pipe. The transitional expansion elbow was machined from 2 pieces of clear acrylic and then bolted together. The horizontal outlet conduit was constructed of 12-inch-diameter clear PVC. The outlet gate transition and bifurcation were printed on a 3D printer and then fastened to the horizontal conduit with screws and silicone to make a water tight union.

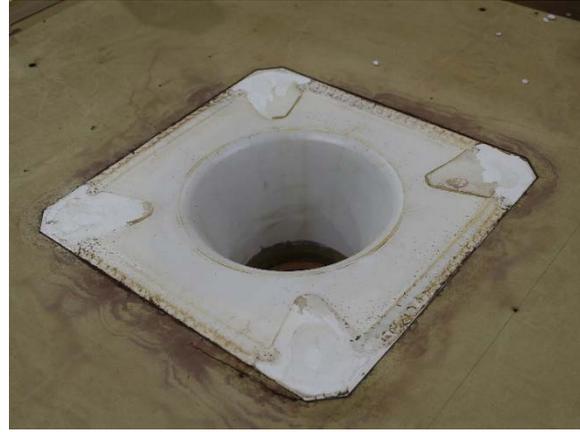
Figure 4. Paonia inlet without trashrack structure in place.

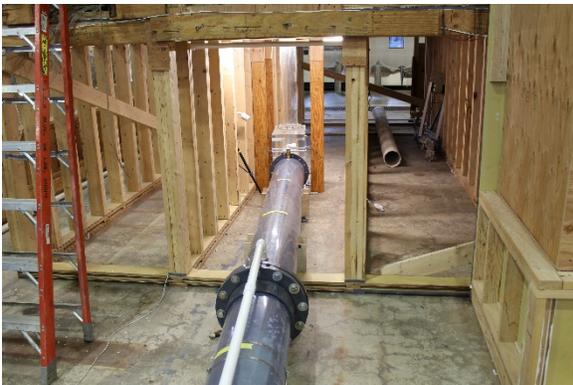
Figure 5. Vertical shaft and horizontal outlet conduit.

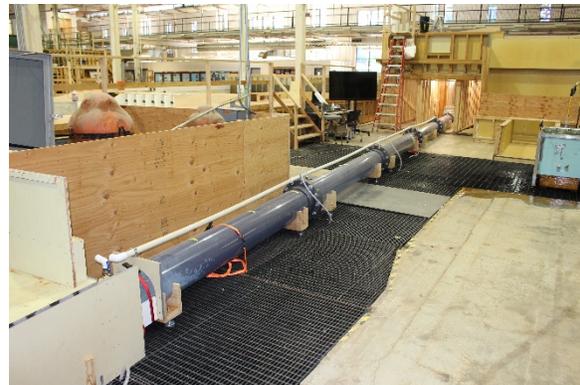
Figure 6. Horizontal outlet conduit.

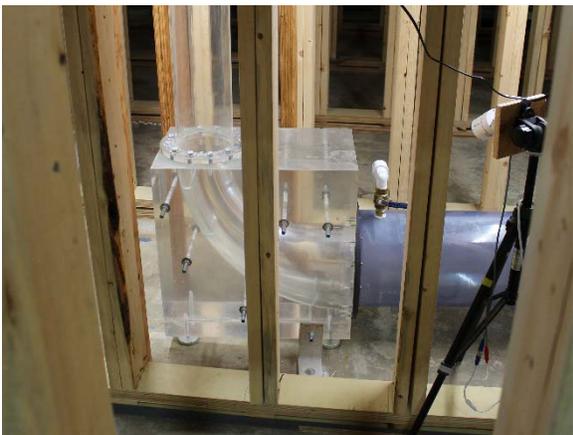
Figure 7. Transitional expansion elbow.

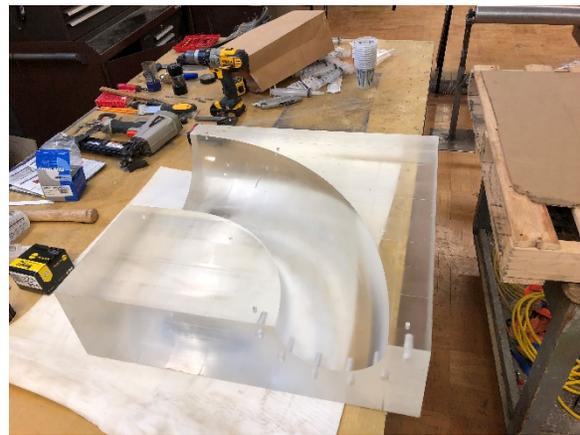
Figure 8. One half of the transitional expansion elbow.

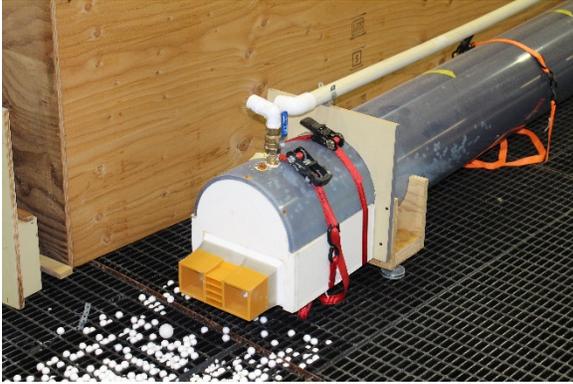
Figure 9. Outlet works gate chamber.

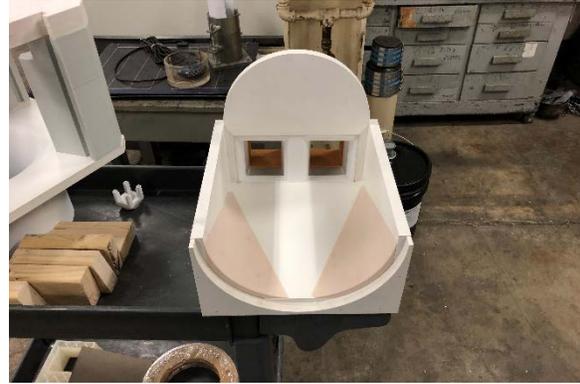
Figure 10. Outlet works gate chamber without the conduit installed.

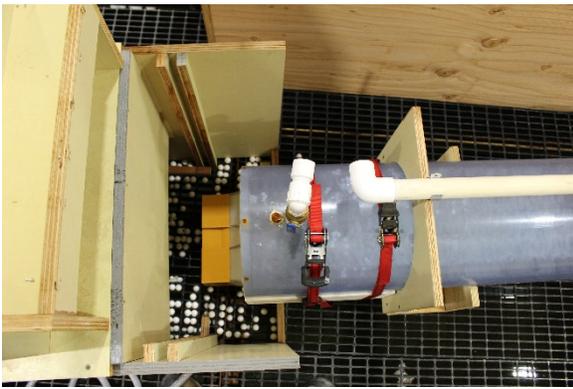
Figure 11. Outlet works gate chamber with tailbox.

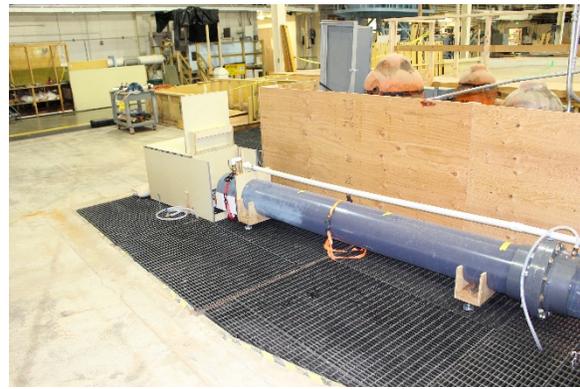
Figure 12. Outlet works gate chamber and tailbox with the slide gate installed in the open position.

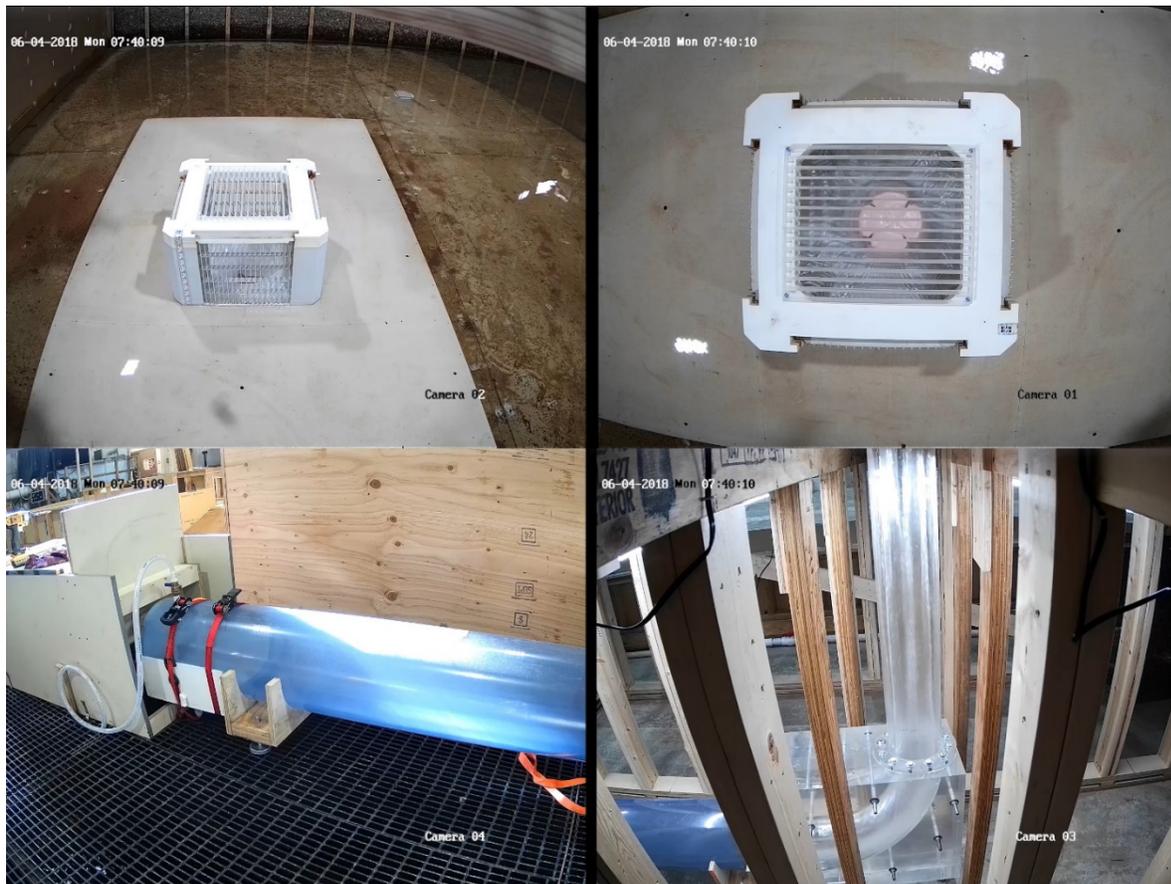
- Camera 01: Upstream reservoir looking straight down into the intake structure.
- Camera 02: Upstream reservoir oblique view of the intake structure.
- Camera 03: Horizontal tunnel and transitional elbow viewed from the side.
- Camera 04: Gate chamber and downstream piping section viewed from the side.

Figure 13. Security camera footage collage showing the 4 camera angles for which video was acquired.

A video surveillance system was used to record discharge events simultaneously from 4 different camera angles (Figure 12):

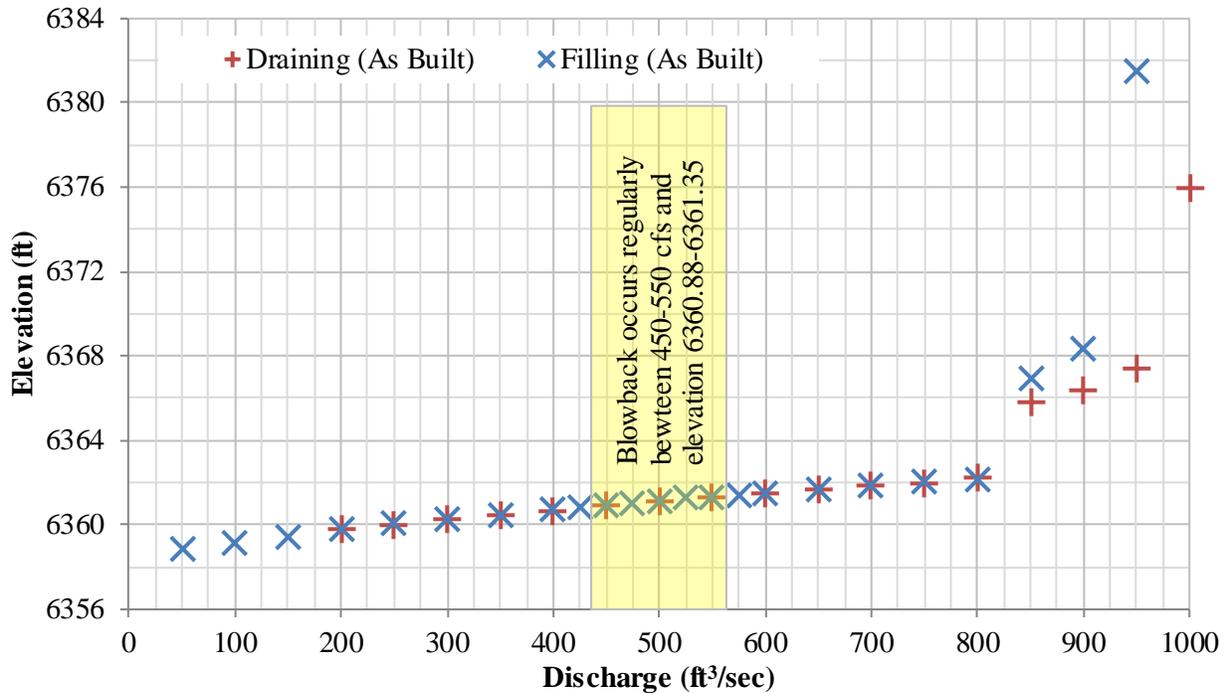
Figure 14. Paonia outlet tunnel rating curves for the as-built configuration with blowback area identified.

Rating curves were generated for reservoir filling and draining conditions. During the data collection visual observations were made to determine what flowrates had issues regarding blowback at the intake structure. Surveillance camera footage was recorded for each flowrate with time stamp information to allow comparisons of all four camera angles. One of the main objectives during this study was to identify flowrates and water surface elevations that create blowback. Figure 13 shows the filling and draining rating curves for the as-built conditions with the outlet regulating gates fully open. Varying degrees of blowback were identified at discharges between 450 and 550 ft³/sec with water surface elevations between 6360.88 and 6361.35 ft. In this range blowback was repeatable and would vary from slight (minor surface bulges) to extreme (complete burst of air spraying water several model feet in the air). Although blowback did not occur at regularly timed intervals, it was always present in the indicated discharge and water surface elevation range.

Video analysis showed that a complex interaction between the intake transition from submerged to unsubmerged discharges would result in small surges of water in the outlet tunnel. These surges would cause discharges at the gate chamber to temporarily seal any air from exiting the outlet tunnel through the regulating gate chamber. This momentary seal would force air to accumulate upstream from the gate chamber, travel up the horizontal conduit and eventually be forced out of the vertical shaft resulting in blowback at the intake structure. The degree of surging at the gate chamber would affect the degree to which the blowback occurred.

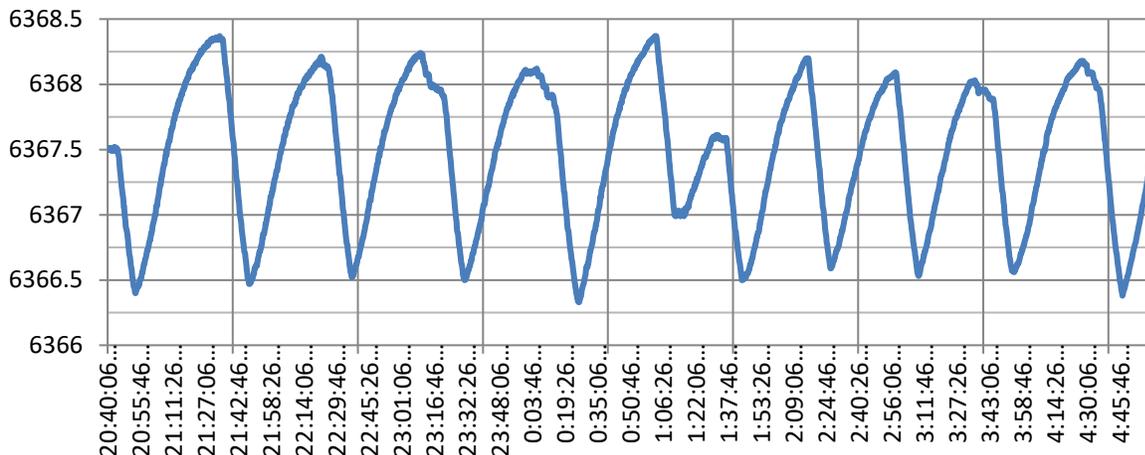
Figure 15. Oscillating reservoir water surface elevation for 900 ft³/sec discharge logged over an 8 hour interval.

Discharges above 800 ft³/sec (prototype) were different during the draining and filling reservoir ratings due to an oscillating water surface in the model caused by control shifts within the tunnel. This is typical for discharge control transition zones. Video documentation revealed that with a constant inflow the reservoir would never reach a stable water surface elevation because the control in the model would shift from inlet control (intake or transition elbow) to outlet control (gate chamber) and back again. Figure 14 provides the model water surface elevations (prototype scale) logged over an extended period to show the oscillating water surface with a constant inflow of 900 ft³/sec. Similar plots could be produced for each flowrate tested above 800 ft³/sec. Regardless of whether the reservoir was draining or filling, the same results were present above 800 ft³/sec. As a result, the curves for the filling and draining reservoir cases were established by recording the maximum and minimum water surface elevation the reservoir reached during an 8 hour period. The size of the model headbox representing the reservoir is much smaller in volume than the existing prototype reservoir, so the timing of oscillations will be much different in the prototype from that seen in the model. With a larger prototype reservoir, the oscillations in the water surface would likely be realized as an unstable discharge from the outlet works that would change unexpectedly depending on how long it takes to fill the reservoir to the point where the control shifts.

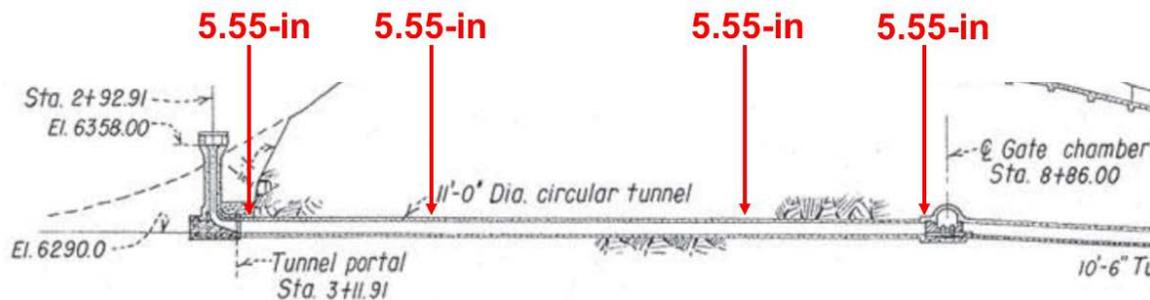
Figure 16. Locations for four 5.55-in air vents installed on the Paonia outlet tunnel model.

To reduce the blowback potential and dampen the effects of the control shift causing an unstable water surface for discharges above 800 ft³/sec, four ½-in model (5.55-in prototype), air vents were installed at the locations shown in Figure 15. Half-inch model vents were selected based on a recommendation from the design team that 6-in prototype vents were likely the best choice from a construction standpoint. These vents were installed by drilling and tapping ½-in holes on the crown of the pipe and allowing the vent to discharge just beyond the crown through a ½-in ball

valve threaded into the pipe but not protruding into the flow path. Model discharges between 450 and 550 ft³/sec were tested with each of the air vents opened individually while the others remained closed. Blowback was reduced in all cases but was still present regardless of which air vent was open. Additional tests were run leaving all four air vents opened which prevented the blowback across most flowrates. When the discharges were changing rapidly blowback still occurred, especially when the reservoir was filling rapidly. Discharge entering the outlet tunnel would impact the gate chamber and rapidly fill the tunnel conduit, trapping air at the crown of the horizontal conduit. As the tunnel would fill with water, the trapped air would move upstream toward the intake structure. With the four air vents opened, air would escape from each vent until the pipe was full at the vented location, at which point water would be released through each vent. The air-water interface and hydraulic jump in the pipe would transition further upstream and the farthest upstream vent located at the transitional elbow became the last available vent to release the air before blowback occurred (farthest left vent shown in Figure 15). It was noted that the ½-in vent at this location was not large enough to always prevent the blowback. Due to the transitioning interface of the hydraulic jump, the upstream air vent (at the transitional elbow) operated over a wider range of discharges.

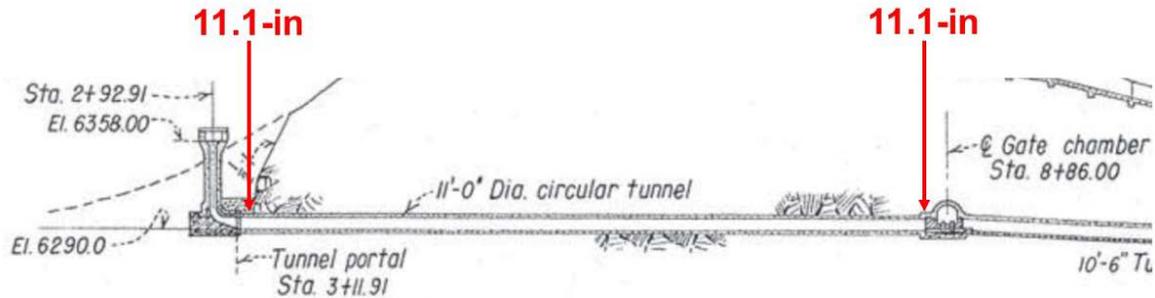
Figure 17. Locations for two 11.1-in air vents installed on the Paonia outlet tunnel model.

The air vents were modified based on the preceding findings to include a 1-in (model) vent at the crown of the horizontal conduit near the transitional elbow and just upstream of the gate chamber as shown in Figure 16. These vents were installed to determine if a single 12-in prototype vent could be used to evacuate enough air to protect the intake structure from blowback at all discharges and elevations, including rapid filling and draining. The 1-in ball valves were threaded into the crown of the pipe so that they did not protrude into the flow path. Air was discharged just above the crown of the pipe. Observations indicated that either vent location was sufficient to prevent blowback at any flowrate, but only the vent at the transitional elbow relieved the blowback caused by a rapid filling of the reservoir. The air vent near the gate chamber would seal off as soon as a hydraulic jump formed in the 11-ft-diameter horizontal conduit, making the air vent at the transitional elbow the best location for an air vent to be installed.

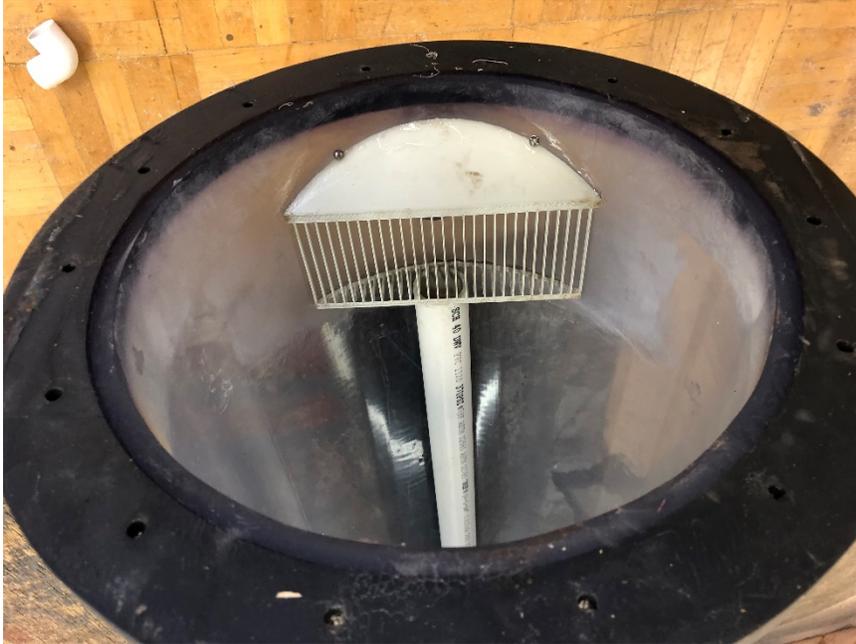
Figure 18. Trashrack and air collection chamber with the 1.25-in (model) PVC vent pipe attached. The conduit is rotated 180 degrees for visualization purposes.

The three venting options were presented to the design team to determine which would be best suited for implementation. The team determined that installing the vent by attaching a conduit on the inside of the 11-ft-diameter (prototype) tunnel would be the best option. To keep debris from entering while allowing the air to be collected in one spot, a small deflector was designed and installed (Figure 17). The 1.25-in (model) vent was run inside the horizontal tunnel for a distance of about 10 ft (model) and then passed through the tunnel wall and run the remainder of the distance to the gate chamber on the outside of the tunnel (Figure 18) to see if the orientation of the conduit entrance would impact its effectiveness. The trashrack and vent on the interior of the pipe was successful at removing air for all discharges tested, including rapid filling and draining. Scaling up the 1.25-in (model) vent conduit results in an air vent with an inside diameter of 13.875 inches (prototype). Further increasing the air vent size would be expected to increase effectiveness.

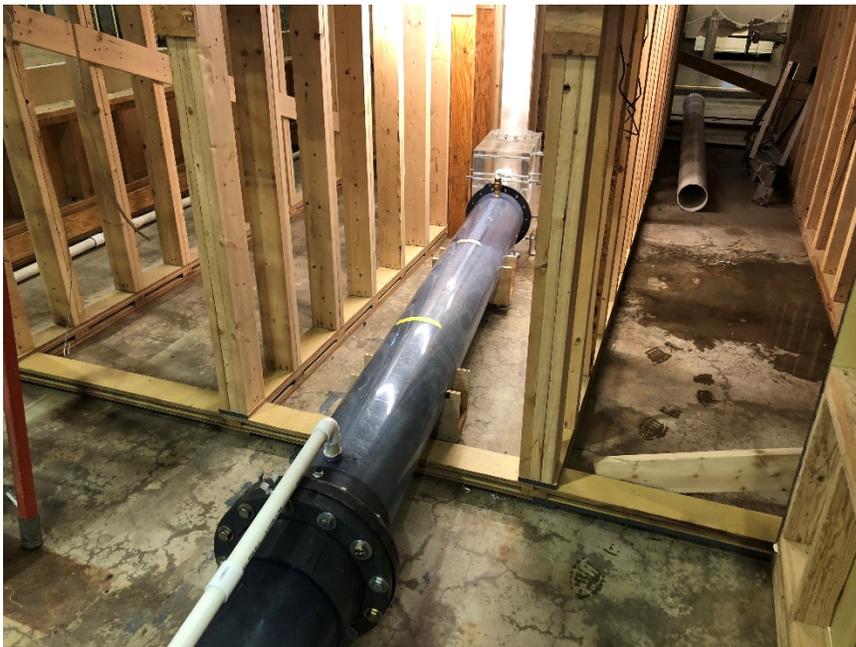
Figure 19. 1.25-in (model) air vent installed at the crown of the tunnel for one section of pipe and then exiting the pipe and continuing downstream to the gate chamber.

All three options were investigated in the physical model. A length of conduit was installed to simulate the vertically drilled pipe, and results showed good performance with effective venting over the full range of testing. A vertical vent pipe with a curved end was then held inside the 6-ft-diameter (prototype) vertical section and resulting venting was also successful. The addition of the vent pipe to the inside of the vertical conduit resulted in natural venting around the installed pipe also. The third option of installing the vent line inside the 11-ft-diameter tunnel was investigated by connecting 1-in (model) PVC pipe from the ball valve vent along the top of the modeled horizontal conduit to the location of the gate chamber. The PVC pipe was not installed inside the model conduit due to the complicated construction that would have been involved. When attached to the full length of conduit necessary to route the vent out of the gate chamber, the vent was unable to expel the necessary air due to the additional losses in the conduit. The vent size was then increased to 1.25 inches (model) which resulted in the vent operating as intended.

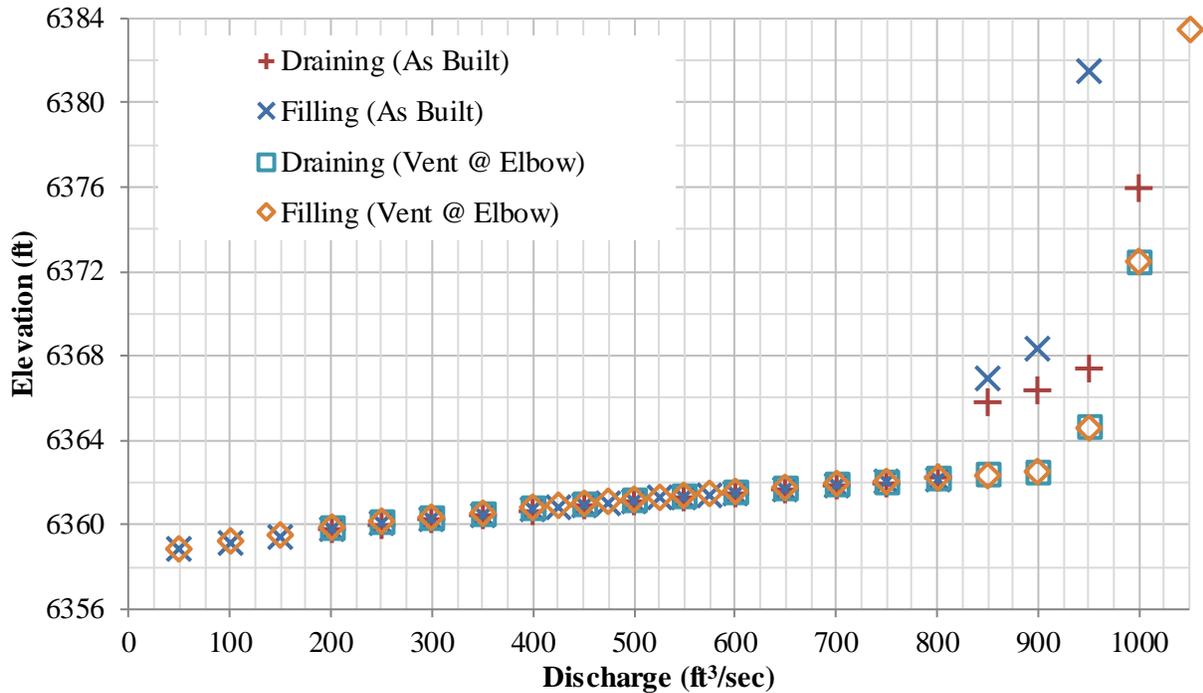
Figure 20. Paonia outlet tunnel rating curves for the as built and the vented configuration.

Figure 19 contains rating curves for both the filling and draining reservoir conditions. With the trashrack and vent installed at the crown of the 11-ft-diameter (prototype) horizontal conduit near the transitional elbow, the vent was effective in relieving blowback. Based on model study results, it is expected that installing a 16-in-diameter vent will protect the outlet works from blowback. A few quick tests were performed with floating debris added into the model. The trashrack structure
