NUREG/CR-7261

Hydraulic Laboratory
Report HL-2019-01

EROSION TESTING OF ZONED ROCKFILL EMBANKMENTS

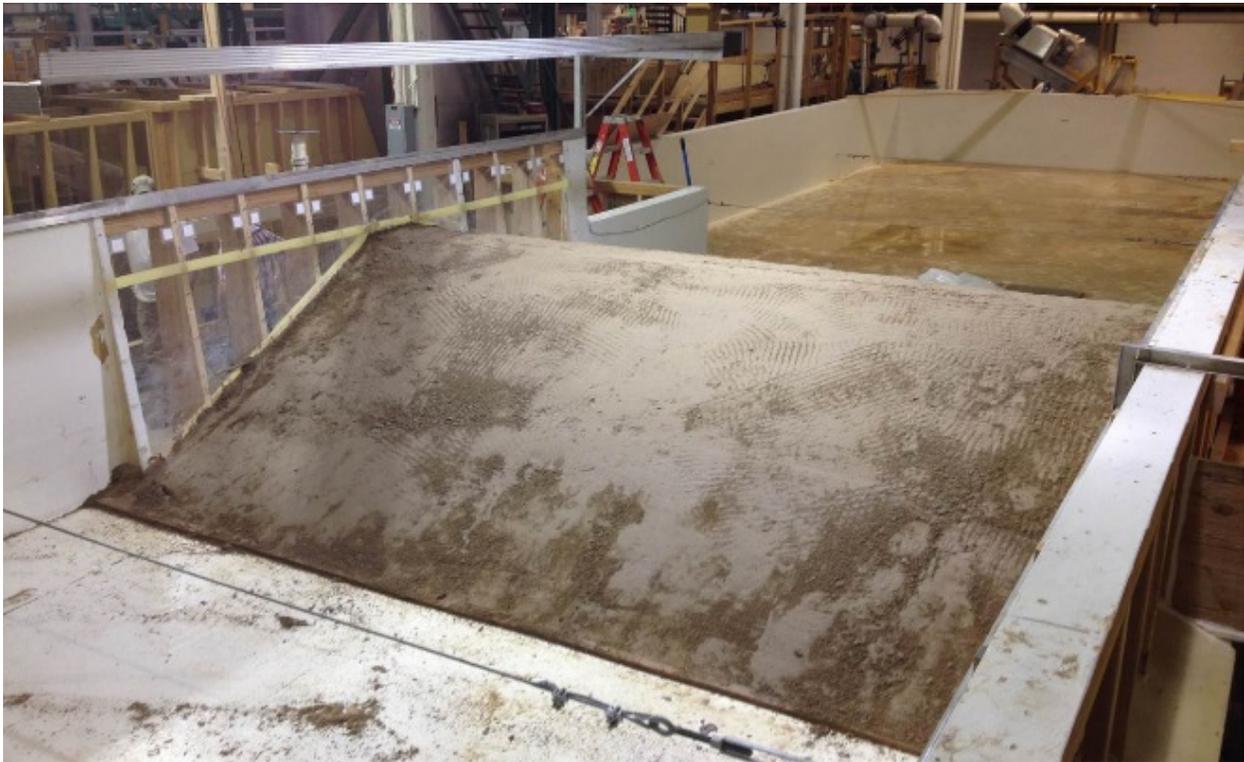
Figure 2-1 Embankment breach test facility viewed from the upstream end of the headbox, overlooking the homogeneous CL-ML embankment (Dam Safety-funded first test).

The dam breach test facility consisted of a 12.44-ft-base-width (3.79-m), 3-ft-high (0.91-m) embankment test section in a 27-ft-long (8.23 m) headbox that was elevated 2 ft (0.61 m) above a large tailbox (approx. 42 ft long by 22 ft wide, 12.8 m by 6.7 m) intended to capture the flow released during a breach test (Figure 2-1). Capturing the full flow volume allowed sediment to be retained and settled out in the tailbox before water was returned to the lab sump, minimizing the effect on other laboratory operations. However, the finite volume of the tailbox limited the total testing time once a breach had enlarged significantly; for the initial test of the homogeneous silty clay dam the test time was only about 48 minutes. For the tests of the zoned rockfill dams, the decision was made to extend the testing time and allow turbid water to return to the lab sump through a spillway section provided in the tailbox.

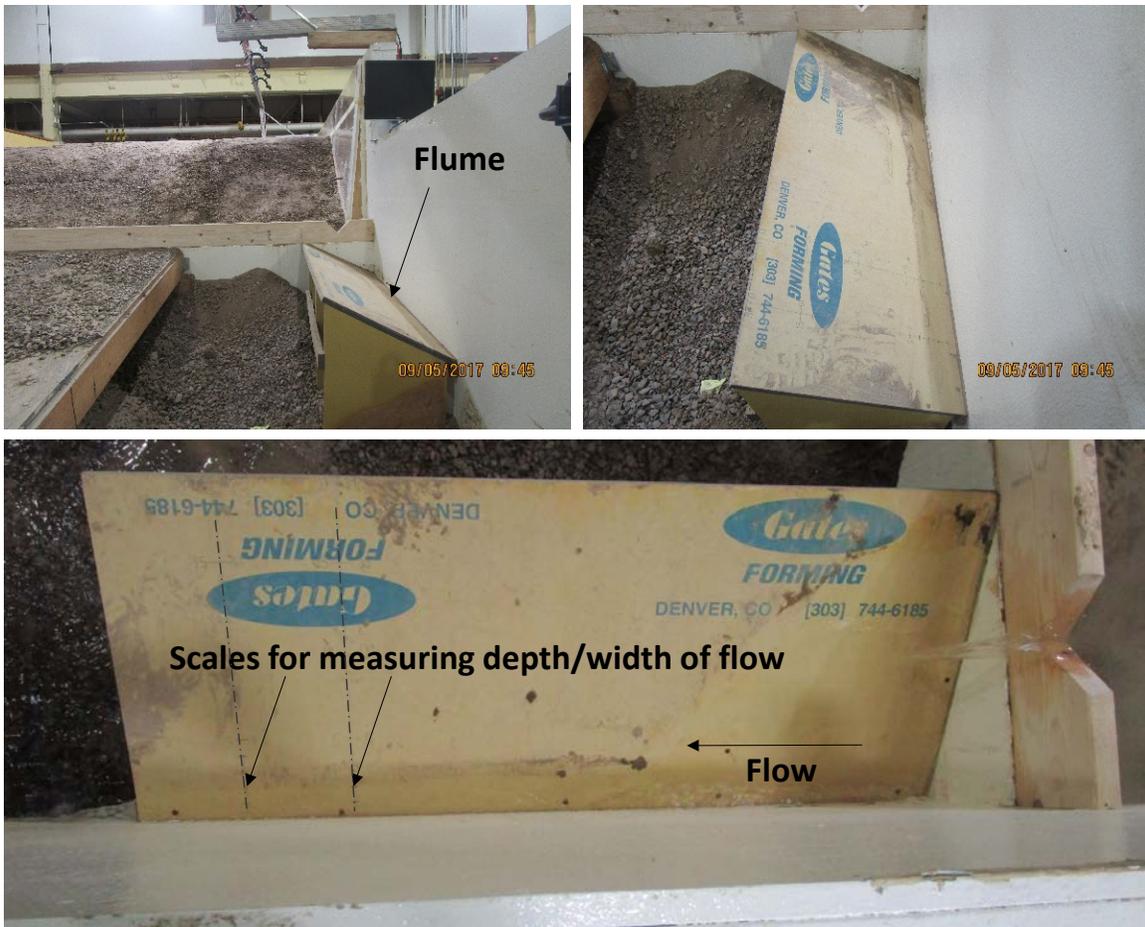
Figure 2-2 Supercritical flume downstream from left edge of embankment. The bottom photo is taken from directly overhead and shows the scales used to indicate the depth and width of flow, which were correlated to flow rate through in-place calibration.

It was anticipated that the accuracy of flows calculated through the embankment breach during the early stages of the two internal erosion tests would be poor, because the net flow would be a very small fraction of the total flow provided into the model and the flow spilled over the adjustable weir, and thus the difference (i.e., flow through the breach) would be lost in the uncertainty of the flow measurements. To overcome this, the test facility was fitted with a small supercritical flume (Figure 2-2) adapted from the concept described by Smith et al. (1981) for measuring sediment laden runoff from natural watersheds. The flume consisted of a triangular trough with a 2h:1v side slope and a 3% slope in the flow direction, attached to the sidewall of the model box just downstream from the toe of the embankment at the left abutment. In addition, prior to the internal erosion test of the zoned embankment, a small triangular notch was cut in a 2x6-inch wood stoplog added just downstream from the toe of the dam to provide a small amount of tailwater and ensure that initial flows were directed to the flume. This flume was calibrated in place with clear water prior to construction of any of the embankments, so that the flow depth and visually observed width of the water surface could be related to the flow rate. It was anticipated that this flume might be useful up to flow rates approaching 100 gallons per minute (gpm), or 6.3 L/s.

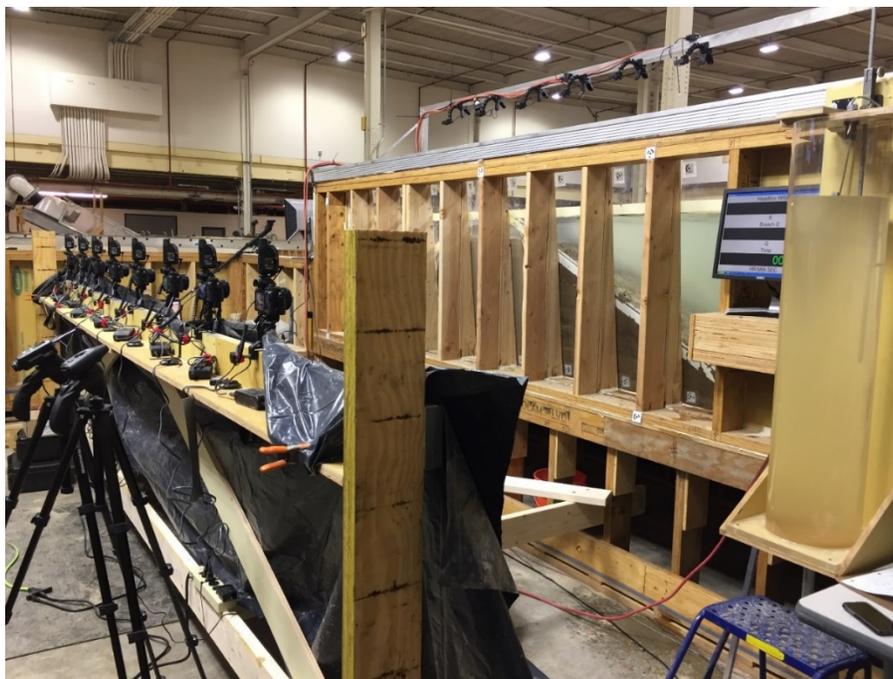
Figure 2-3 Camera equipment used during the test included six GoPro cameras deployed above the embankment and eight DSLR cameras viewing the left abutment through the acrylic wall.

Two arrays of still photo cameras were used to record images of the erosion taking place at the left abutment of the embankment test section and on the upstream and downstream surfaces of the embankments (Figure 2-3). Eight digital single lens reflex (DSLR) cameras were set up to take overlapping photos through the acrylic abutment wall, and 6 GoPro video/still cameras were positioned overhead to obtain overlapping photos of the surface of the left end of the embankment. Each camera's field of view included photogrammetry targets to enable subsequent image analysis. Picture rates were adjusted as needed during the various tests, with intervals varying from 10 seconds up to 5 minutes. Following the completion of the tests, images were processed to create time-lapse imagery and models of the erosion progress.

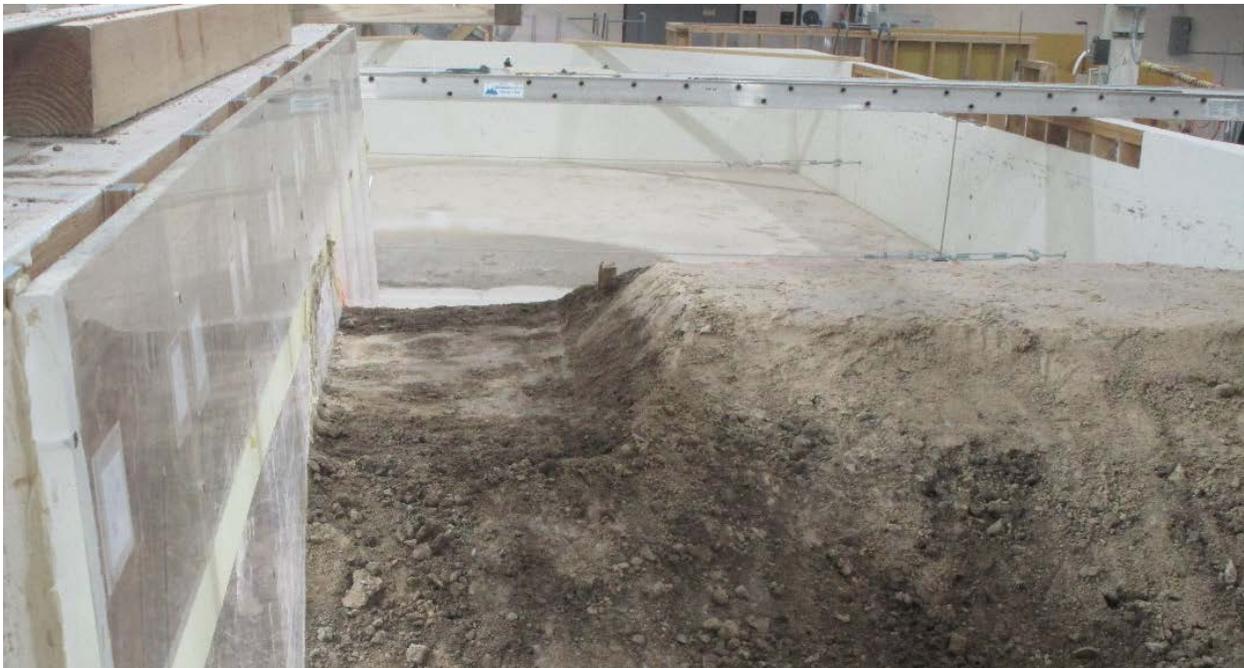
Figure 2-7 Pilot channel in zoned embankment prior to overtopping test.

For the overtopping test, a pilot channel was cut at the left abutment after the embankment was finished (Figure 2-7). The pilot channel was excavated to a depth of 5 inches (13 cm) and a base width of 15 inches (38 cm) with a 1:1 side slope on the embankment side. The invert of the pilot channel had segments of the core zone and the gravel zones exposed within it.

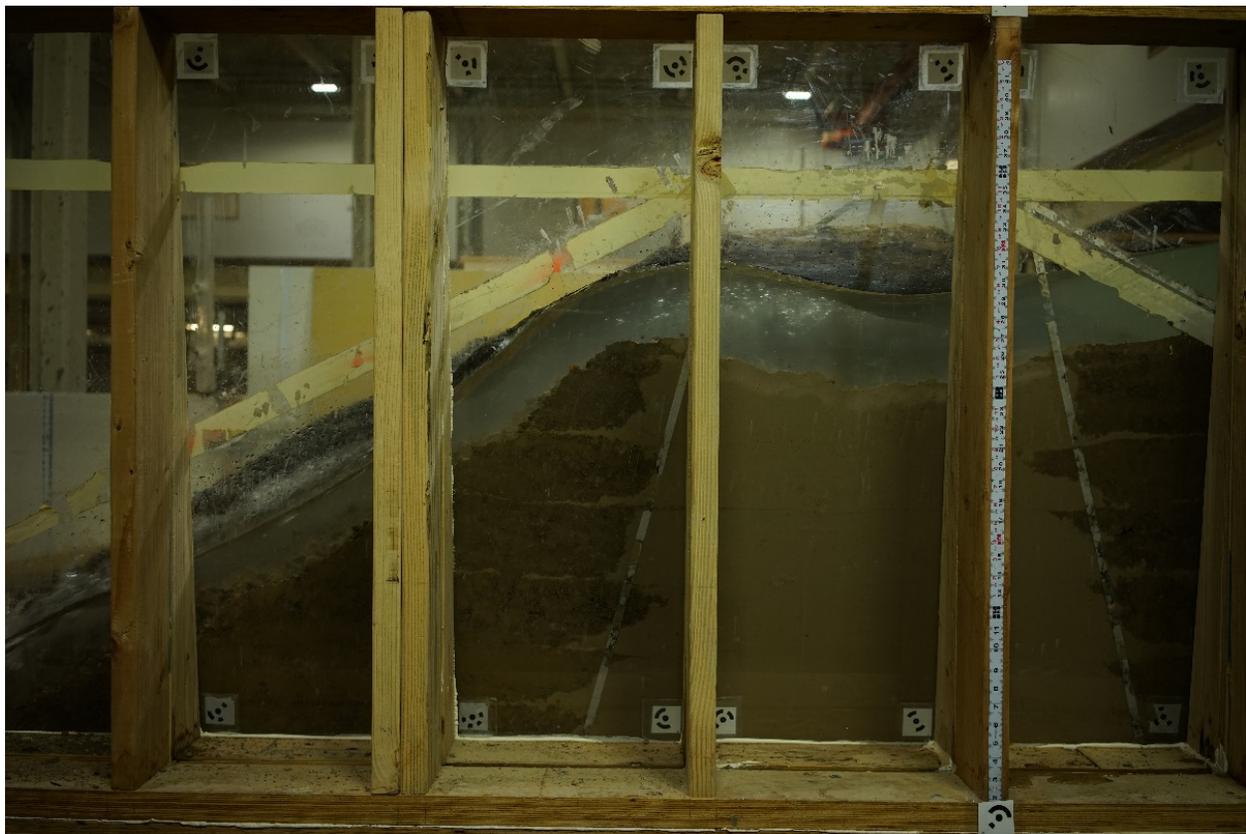
Figure 4-1 Erosion of top surface of core zone after about 6 minutes of flow on the second day of testing.

The erosion mechanism observed throughout the test was a combination of surface erosion of both the downstream slope and the crest of the core zone. At times the crest of the core actually eroded to levels significantly below the upstream edge of the gravel zone, especially at the start of the second day when there was rapid downward erosion of the top of the core, which had become saturated overnight by water standing in small depressions on the surface (see Figure 4-1). Although the core seemed less erosion resistant than the gravel zones, it was protected from more rapid erosion by the presence of the downstream gravel zone that prevented direct hydraulic attack against the downstream edge of the core.

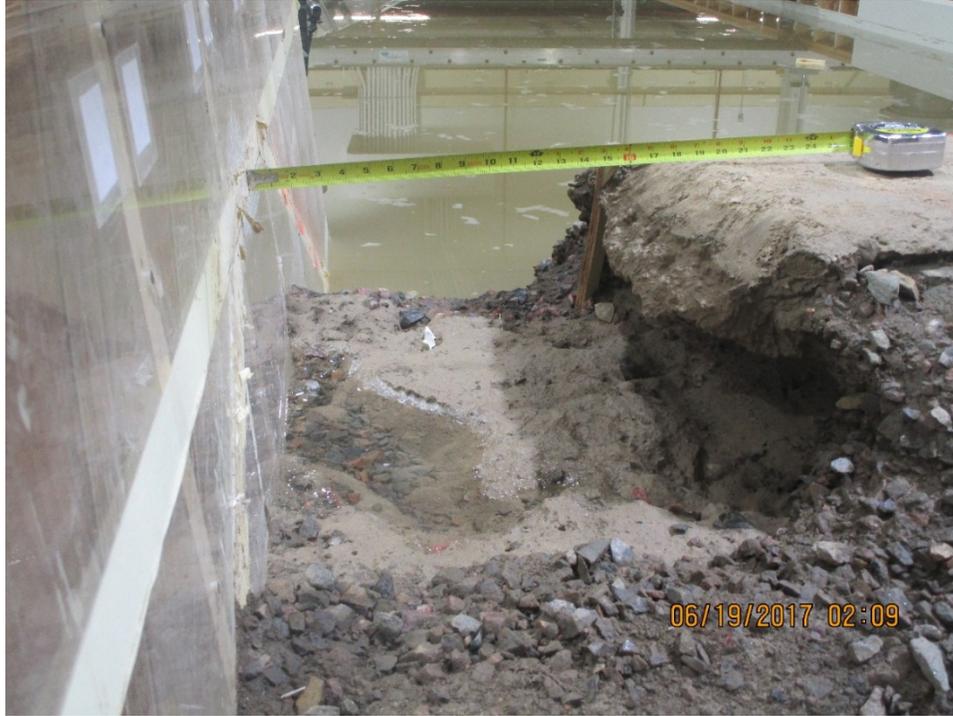
Figure 4-2 Breach pilot channel at the end of the first day of testing. Note the embedded wood stake that appeared to restrict lateral erosion.

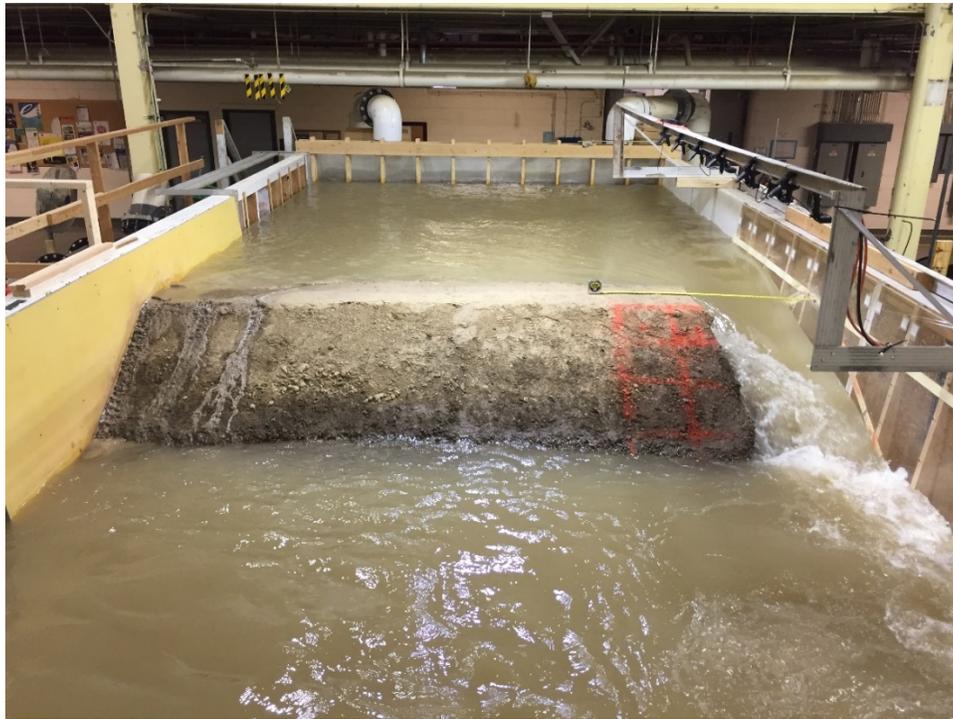
Figure 4-3 Flow conditions through the breach channel near the end of the zoned embankment overtopping test (t=2 hr 56 min).

The widening of the pilot channel appeared to some degree to be driven by flow contraction taking place at the entrance of the pilot channel and then the creation of horizontal recirculation zones immediately downstream from the pilot channel entrance. These horizontal eddies worked on the soil at the edges of the pilot channel, causing the pilot channel to widen, often at a rate that exceeded the deepening of the pilot channel. As the test progressed, an overhang began to form, with soil above the water surface hanging over areas that had eroded and widened. Eventually this overhanging soil broke off like a cantilevered beam and fell into the channel. Widening of the channel downstream from the crest was significant in the first 33 minutes of flow on the first day of testing, with the channel growing from about 15 to 24 inches wide (38 to 61 cm). Widening of the pilot channel during the first day was restricted somewhat by a wood stake that was embedded in the downstream edge of the embankment crest during construction (to hold a board separating zones as soil was initially placed) and accidentally left in place (Figure 4-2). This stake was removed before flow was resumed on the second day. As a result, the pilot channel width grew more rapidly for a short time during the second day of testing, but overall the width of the downstream channel grew slowly during the second day. Figure 4-3 shows the flow conditions just before the test was ended.

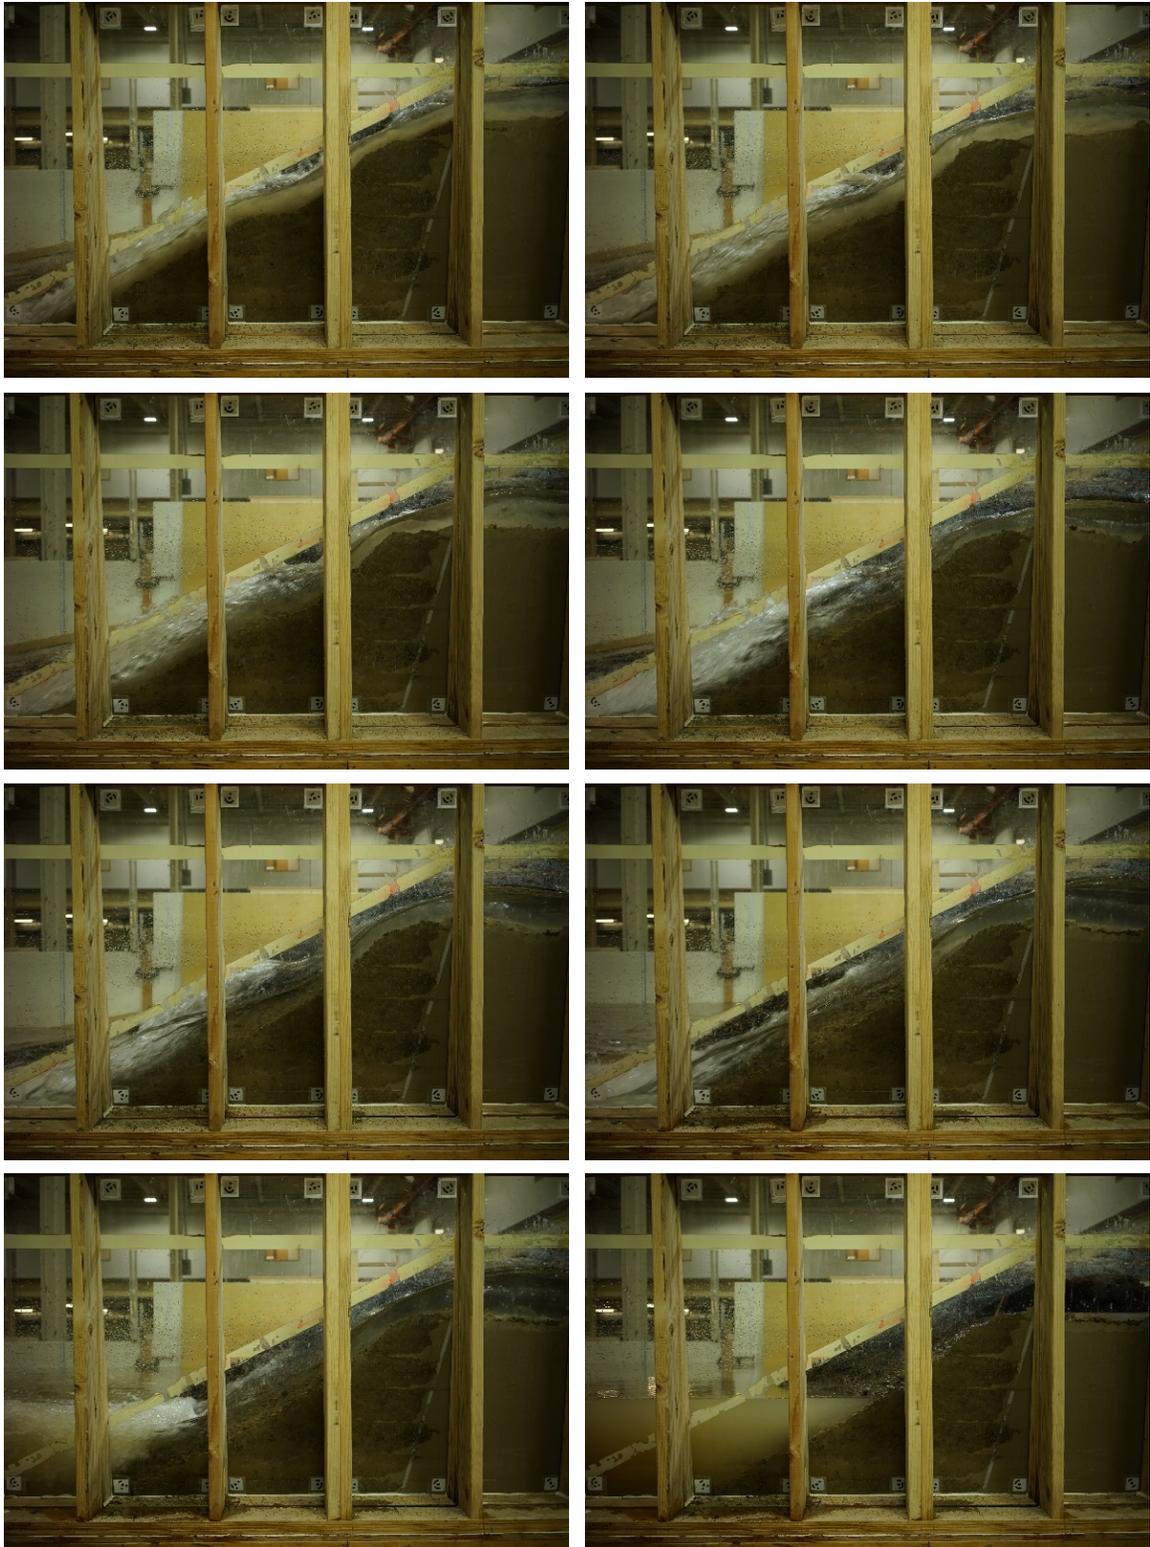
Figure 4-5 Photos of breach channel downward erosion progress on the first day of the zoned embankment overtopping test. Elapsed times (mm:ss) in the photos from left-to-right, top-to-bottom are: 3:20, 5:20, 7:20, 14:20, 19:20, 26:20, 33:20, and 33:20 (after flow was stopped).

Table 4-1 provides a summary of the data obtained from the photos shown in Figure 4-5 and Figure 4-6 from the first 3 hours of testing and the resulting k_d values. The k_d value at the end of each incremental time period was computed using the observed erosion during the preceding time interval and the average shear stress during that interval. Figure 4-7 shows the results graphically. The rate of erosion was rapid during the first 5 minutes of the test, but slowed dramatically thereafter. This was likely due to difficulty obtaining good compaction at the edge of the placement where there was no way to confine the soil. The highly erodible layer was about 6 inches (15 cm) thick. After the first few minutes, the flow depth was more difficult to determine from the photos due to turbulence, splashing, and aeration of the surface of the flow.

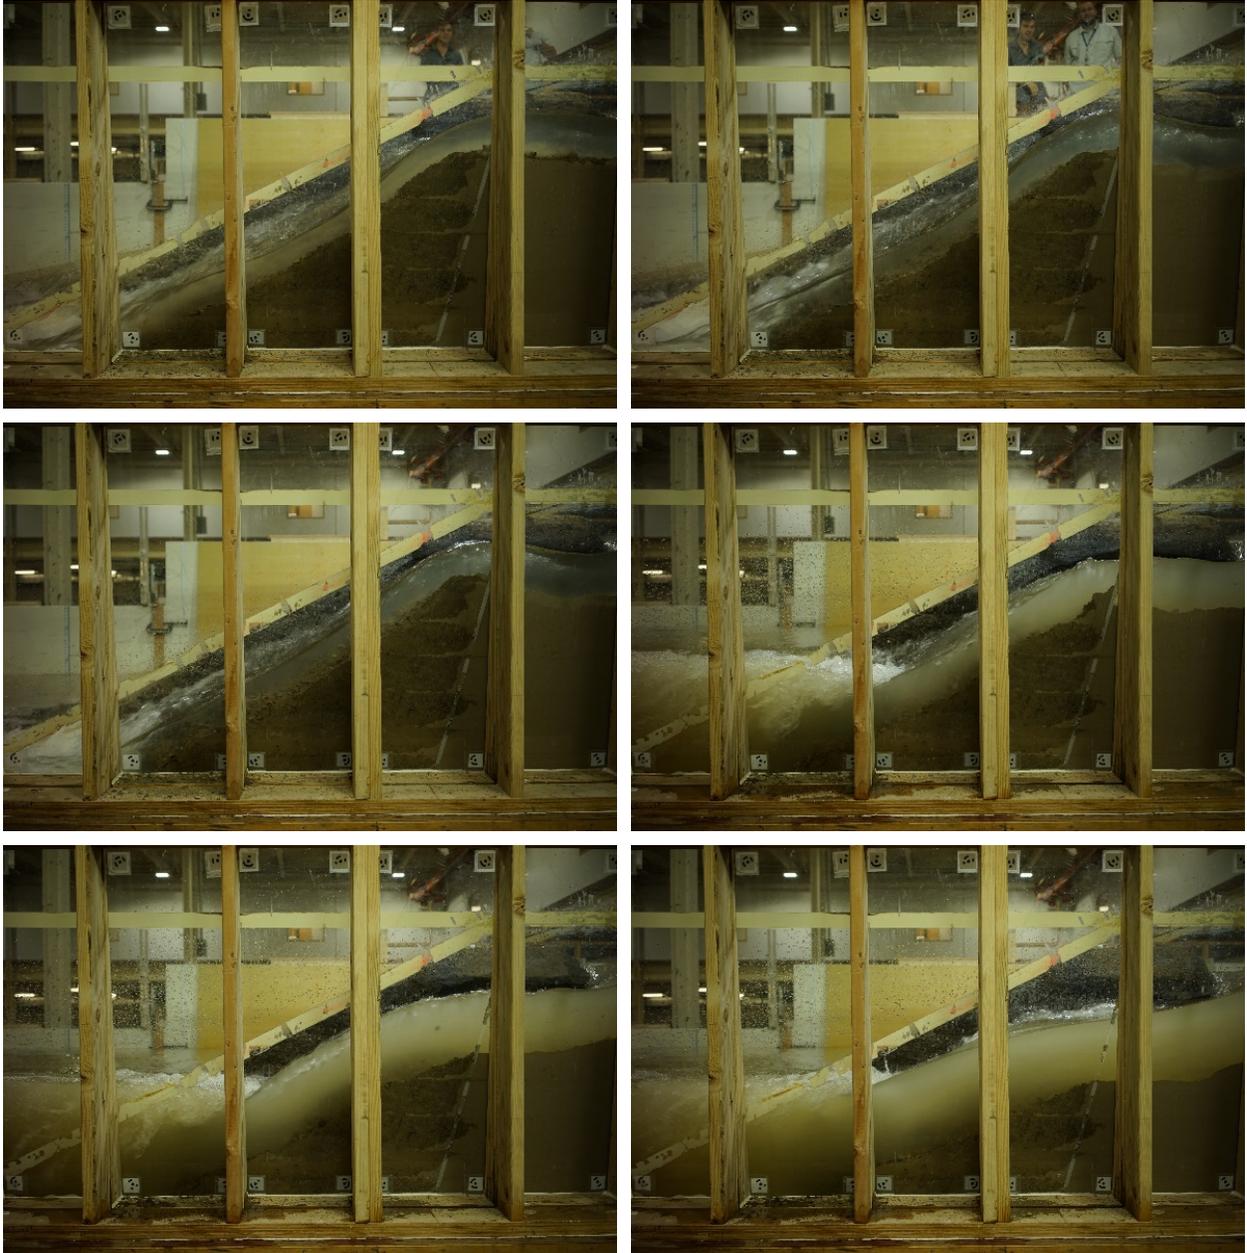
Figure 4-6 Photos of breach channel downward erosion progress on the second day of the zoned embankment overtopping test. Total elapsed times in minutes in the photos from left-to-right, top-to-bottom are: 34.5, 37, 47, 77, 120, 180.

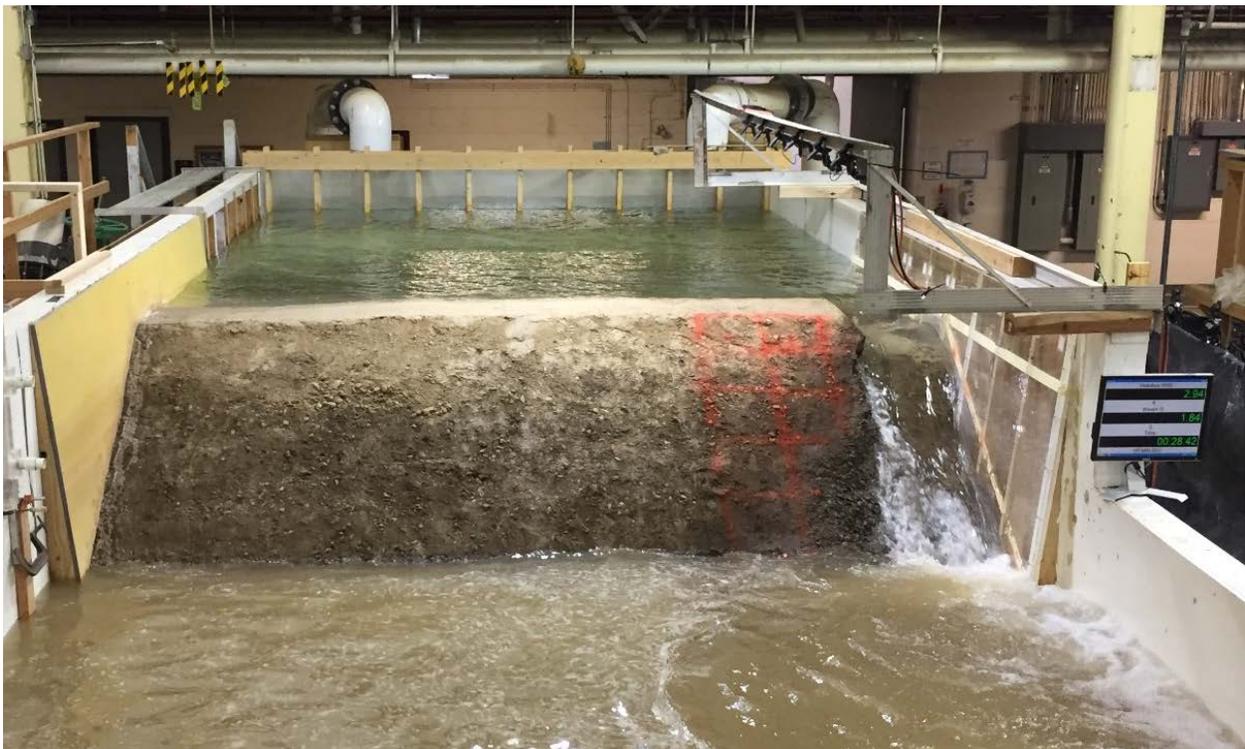
Figure 4-8 Downstream view of the breach channel 28 minutes after the start of overtopping flow. Vertical lines on the embankment face are at 1 ft (30.5 cm) intervals. Horizontal lines are at 0.5 ft (15.3 cm) elevation intervals.

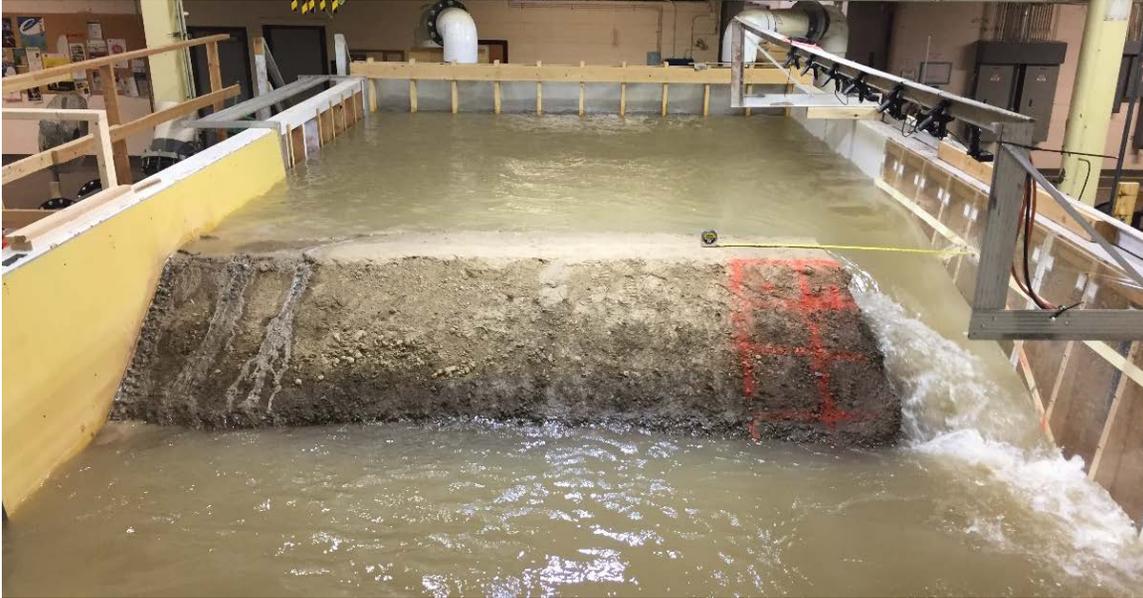
Figure 4-9 Downstream view of embankment near the end of the second day of testing, after a total elapsed test time of 5 hours, 8 minutes.

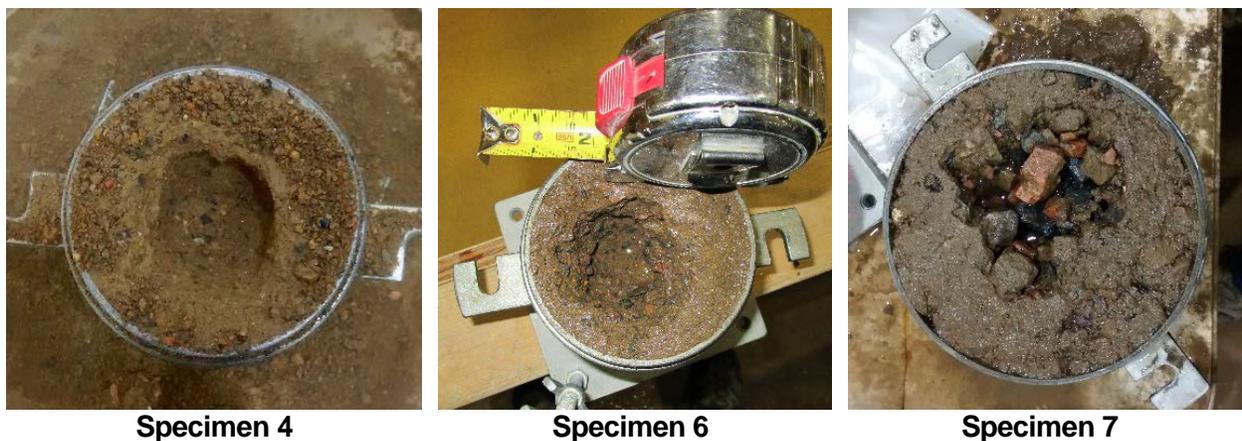
Figure 4-10 Selected JET specimens after testing.

value and greater than optimum. Specimen 6 provides a good comparison to specimen 3, with the water content and density values for the minus No. 4 material matching closely. The JET results show the k_d value to be lower by a factor of two (greater erosion resistance), but the critical shear stress values are similar, so the effect of the greater gravel content and larger maximum particle size appears to be minor. (It must be kept in mind that these are single tests and erodibility is inherently variable.) Finally, specimen 7 showed less erosion resistance when the specimen had the full gravel content. The observations of this test suggest that it was difficult to achieve sample uniformity and good compaction of the coarse gravel in the small soil mold (even though a 6-inch mold was used because of the larger gravel), and that scale effects (jet nozzle diameter vs. maximum particle size) were probably invalidating the test at this point. Segregation of material and nonuniformity of the specimen seemed likely (see Figure 4-10). In contrast, the tests of the minus 3/8-inch specimens seemed to proceed well and probably gave a valid indication of soil erodibility. This may represent an approximate upper limit on gravel size for use of this size JET device.

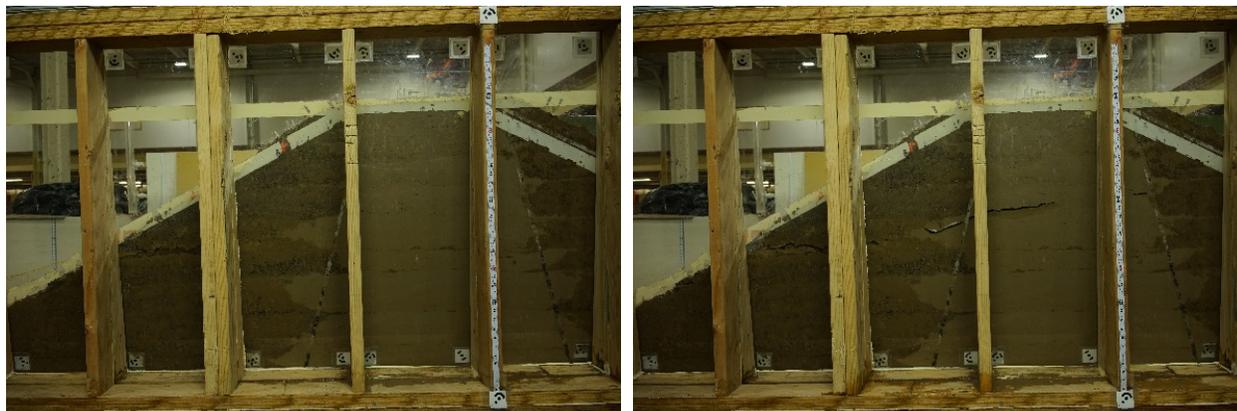
Figure 5-2 Pipe beginning to develop through embankment after removal of rebar on second day of testing. Elapsed times since the restart on the second day are 1 min (left) and 103 minutes (right). In the first photo the pipe is only visible in the downstream gravel zone. In the right hand photo, the color variation in the portion of the pipe within the core zone indicates redeposition of soil in the bottom of the pipe as erosion occurs from the roof.

removed. The initial process was consistent with what is typically described as concentrated leak erosion (USBR and USACE 2015). Figure 5-2 shows the upstream progress of erosion. The photos also show that there was not a perfect delineation of the zone boundaries as each lift was placed, but the straying of materials across the zone boundaries did not seem to affect the tests.

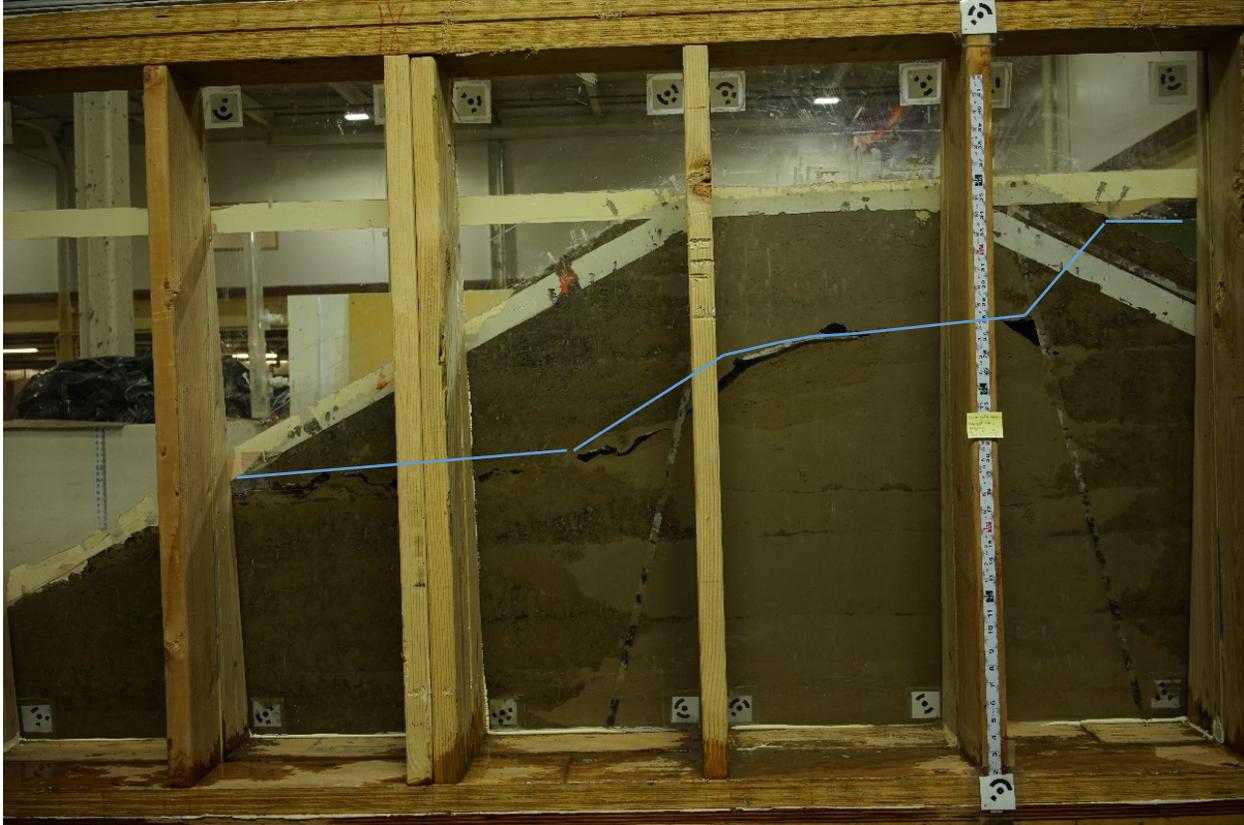
Figure 5-3 Development of stepped profile of erosion channel. An approximate hydraulic grade line for the flow is sketched over the photo in blue. As the roof of the channel collapsed and the bed migrated upward, most of the core zone began to experience open-channel, rather than pressurized flow.

Figure 5-3 shows that as the pipe continued to migrate upward, the erosion channel developed into a sequence of stepped pipes, with large losses of head occurring through the gravel zones and a low hydraulic gradient through most of the core of the embankment. In fact, flow through most of the void being created in the core appears to have a free surface, as evidenced by foam on the water surface. Near the downstream end of the core, there appears to be pressurized flow again in a steep portion of the pipe approximately paralleling the interface between the core and downstream gravel zones.

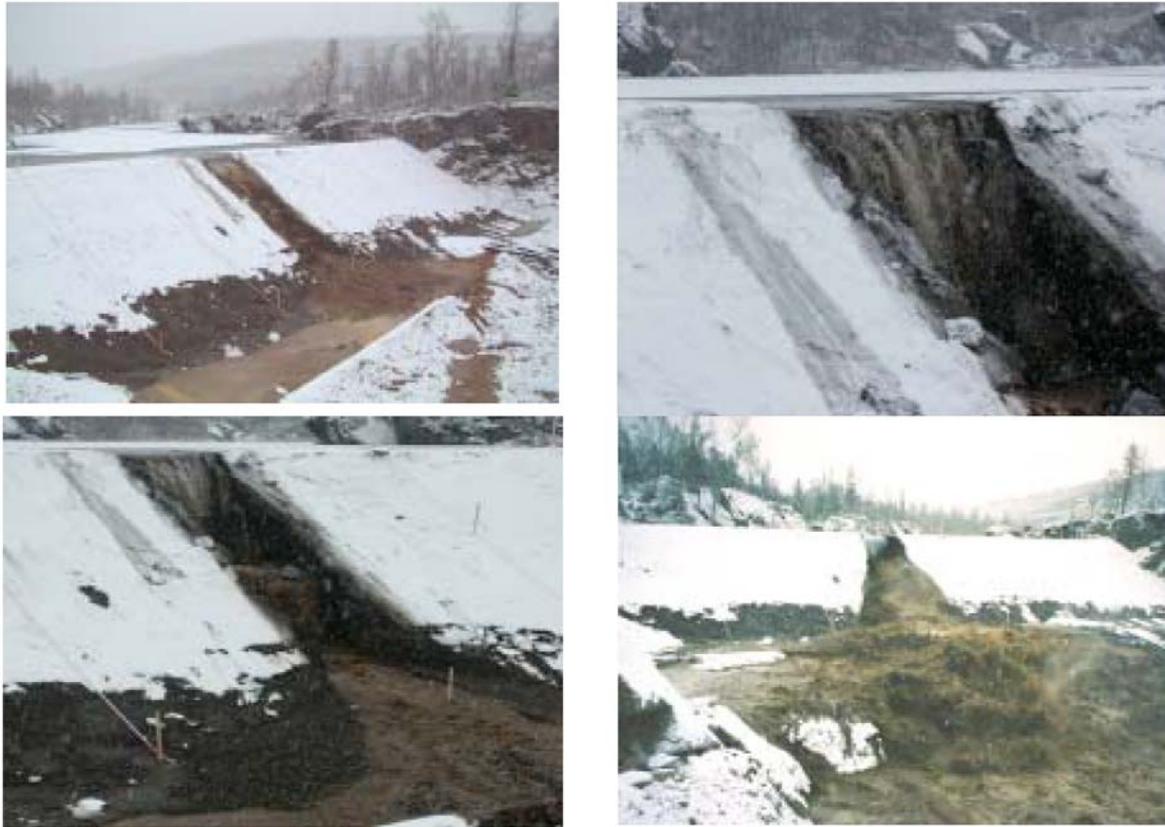
Figure 6-2 Headcut development during IMPACT test of homogeneous gravel dam, 2-2002 (from IMPACT WP2 Technical Report: Section 4).

The test of the homogeneous gravel dam took place in mid-October, with freezing temperatures the night before the test. Photos from the test in Figure 6-2 clearly show a headcut mode of erosion. It has been suggested that the embankment itself may have been partially frozen and that this may have been responsible for the headcutting behavior, but it seems doubtful that interior portions of the embankment would have been frozen. Instead, it seems more likely that the well-graded nature of the gravel, combined with the non-zero cohesion and some capillary tension created enough apparent cohesion to allow the soil to stand at a steep slope. Once established, this geometry prevented direct attack of the flow on the downstream slope, so a headcut mode of erosion occurred, with the crucial erosion taking place at the toe of the slope.

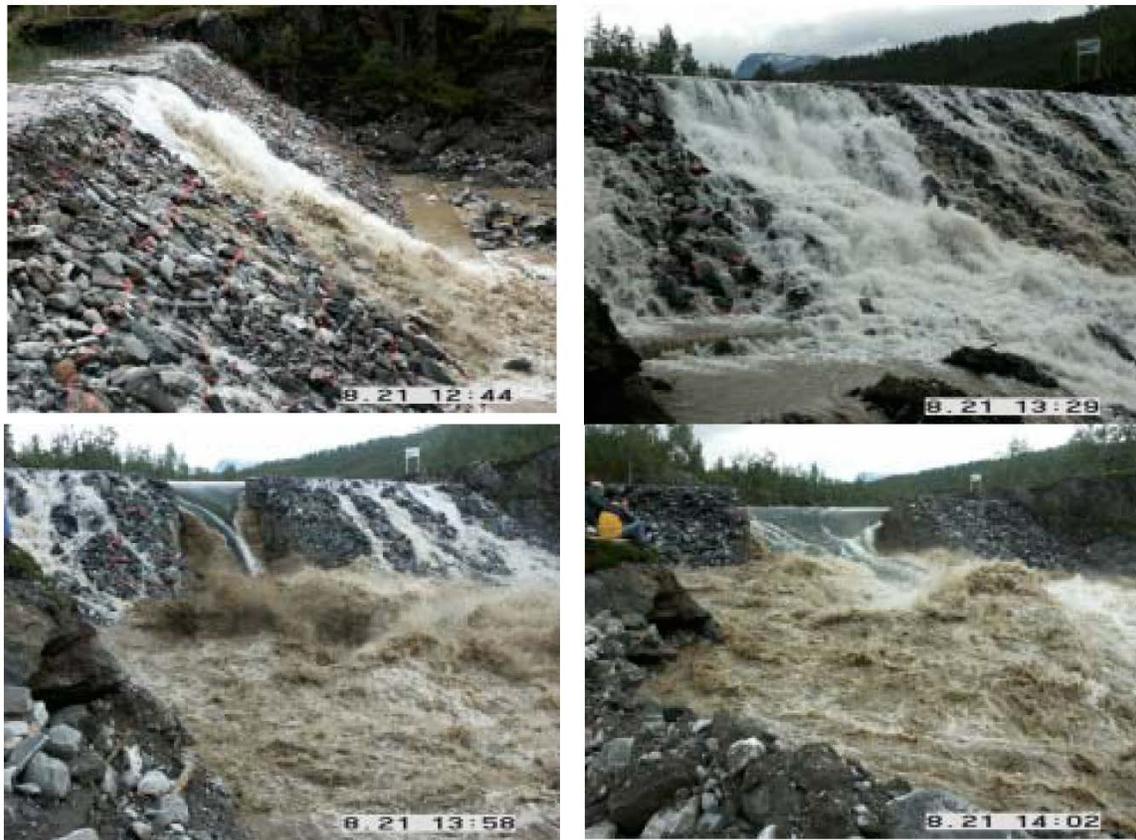
Figure 6-5 Headcut development during IMPACT test of zoned gravel dam, 1-2003 (from IMPACT WP2 Technical Report: Section 4).

IMPACT test 1-2003 was an overtopping test of a 5.9-m high, zoned embankment dam with a downstream rockfill zone of broadly-graded gravel (tunnel spoil), a central moraine core, and an upstream zone of uniformly graded gravel (Figure 6-3). Gradation curves for zones 1 and 2 are shown in Figure 6-4. Neither soil is well-graded, with the moraine material having a C_c value of about 0.53 and the rockfill zone having a C_c of 9.0. Although Figure 6-3 describes the pilot channel as 0.24 m deep and 6.5 m wide, it is also described as 0.2 m deep and 8 m wide in the IMPACT WP2 Technical Report, and 0.25 m deep and 8 m wide by Vaskinn et al. (undated). The latter report details the breaching process and reports that the core of the dam was overtopped for about 2 hours, then the notch was overtopped for 1.5 hrs, and finally the notch and full dam crest were overtopped for 1 hr before failure occurred. Estimated unit discharge through the notch was about 5.4 ft³/s/ft (0.5 m³/s/m) during the last hour, or about 1.5 ft (0.45 m) of overtopping head on the notch. In this test, erosion seemed to take a form that appears in Figure 6-5 to have both headcut and surface erosion characteristics, with a series of small headcuts, but not a tendency toward forming a single large headcut. Failure took place once the erosion broke through the upstream edge of the crest, and development of the full breach occurred quickly in about 10 minutes.
