Hydraulic Laboratory Report HL-2019-04

Physical Hydraulic Model Study of Debris Management Alternatives for Hogback Diversion Dam

U.S. Department of the Interior
Bureau of Reclamation
Technical Service Center
Hydraulic Investigations and Laboratory Services Group
Denver, Colorado

August 2019

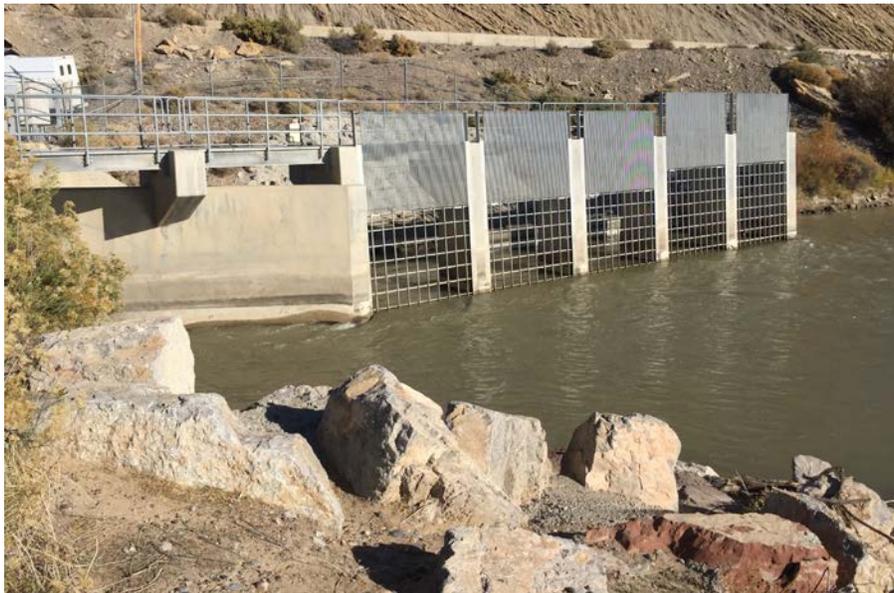
Figure 1. Photo of Hogback Diversion Dam intake structure from left bank of San Juan River, with lower bars of trashrack panels removed to reduce the debris caught along the bars.

The Hogback Diversion Dam is located on the San Juan River in San Juan County, New Mexico roughly 18 miles west of Farmington, NM. It was originally constructed by the Federal government with Civilian Conservation Corps crews in the 1930's to create a small impoundment and permanent intake facility for the Shiprock Irrigation District canal. This site was selected due to its location where the San Juan River penetrates the Hogback rock formation which reduces the likelihood of channel migration. In 2002 the original boulder and cobble overflow weir was fortified with grouted riprap and sheet pile. In addition, a new trashrack structure was added to reduce the amount of debris entering the canal. Also included with this revision was a fish weir and sluicing structure located approximately 2000 feet downstream. Figure 1-3 show the intake structure that was constructed in 2002 from the left bank and two plan view images with project features identified.

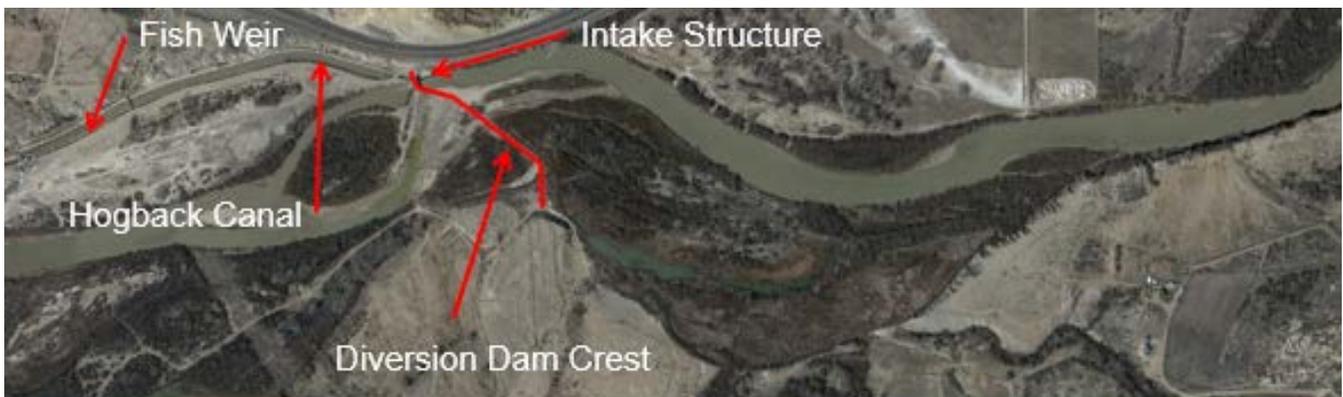
Figure 2. Plan view of Hogback Diversion Dam and vicinity.

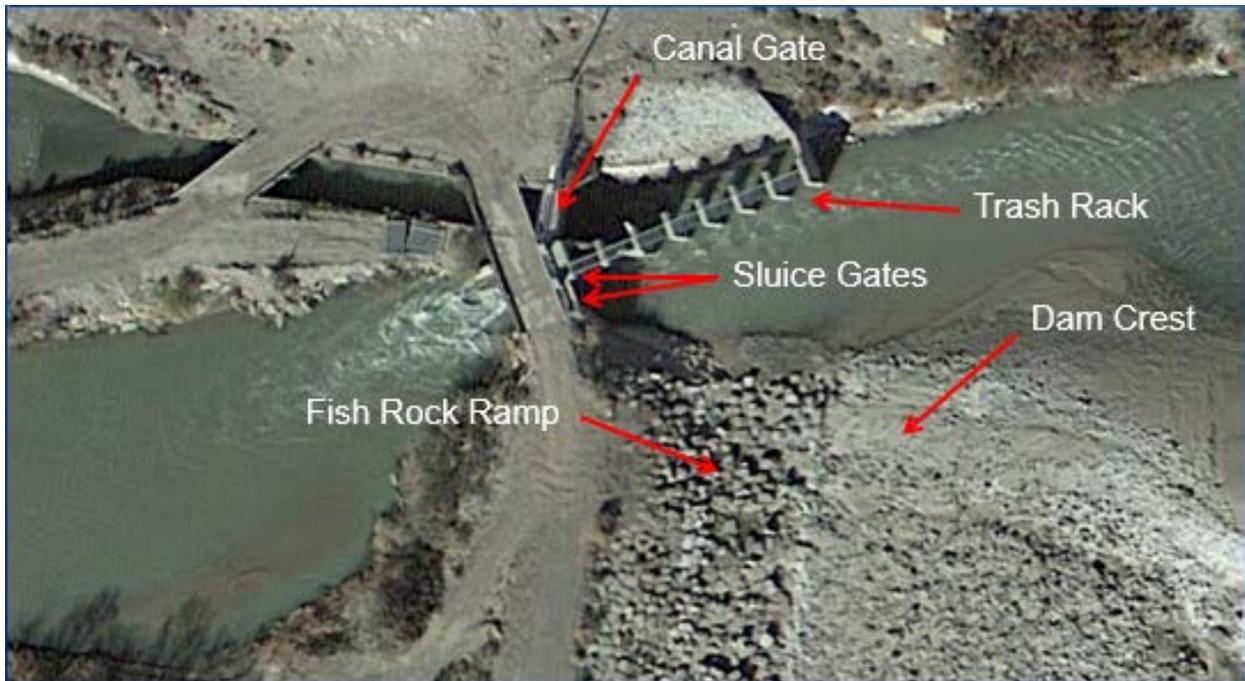
Figure 3. Plan view of the Hogback Intake structure with features labeled.

The diversion structure consists of a 16-foot wide by 4-foot high canal head gate protected upstream by the five-bay trashrack structure. Adjacent to the trashrack structure are two sluice gates, each 10-foot wide by 7-foot high. The bottom sill of the canal head gate is 4 feet higher than the bottom sill of the sluice gates to reduce the amount of bed load sediment that enters the canal. The canal is operated for irrigation from March to October and is controlled by the canal gate opening. More water is usually diverted through the headworks than is delivered downstream to the Hogback Canal. The excess diverted flow is used to sluice sediment and return fish into the river through sluicing dual leaf gates located beyond the fish weir.

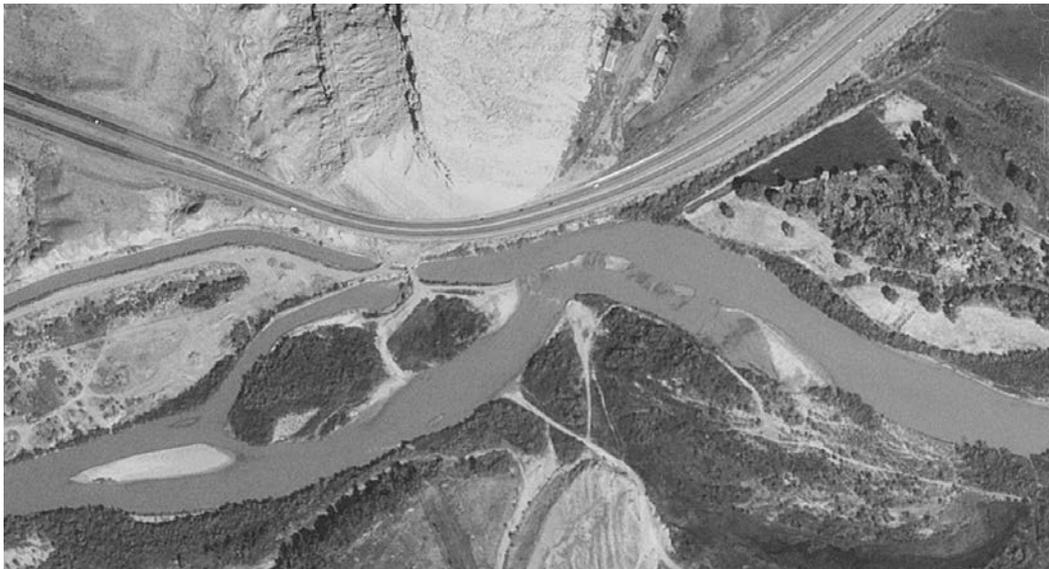
Figure 4. USGS satellite image of San Juan River at the Hogback Canal Intake, 1997.

Prior to the modifications at Hogback Diversion Dam, the low flow channel of the San Juan River was migrating away from the intake structure. The channel shift jeopardized the future ability to provide reliable irrigation diversion as shown below in Figure 4. Following the fortification of the diversion dam, the main channel of the San Juan River was constrained to follow the right bank road embankment, as shown in Figure 2, and reduced its ability to spread during low to moderate flows. Sand bed channels such as the San Juan maintain a stable energy balance by their dynamic ability to meander during moderate flows resulting in continuous channel migration throughout the floodplain. The reduction in the river's ability to meander has resulted in a more stable river channel which has allowed vegetation to colonize the large overbank area upstream of the diversion dam.

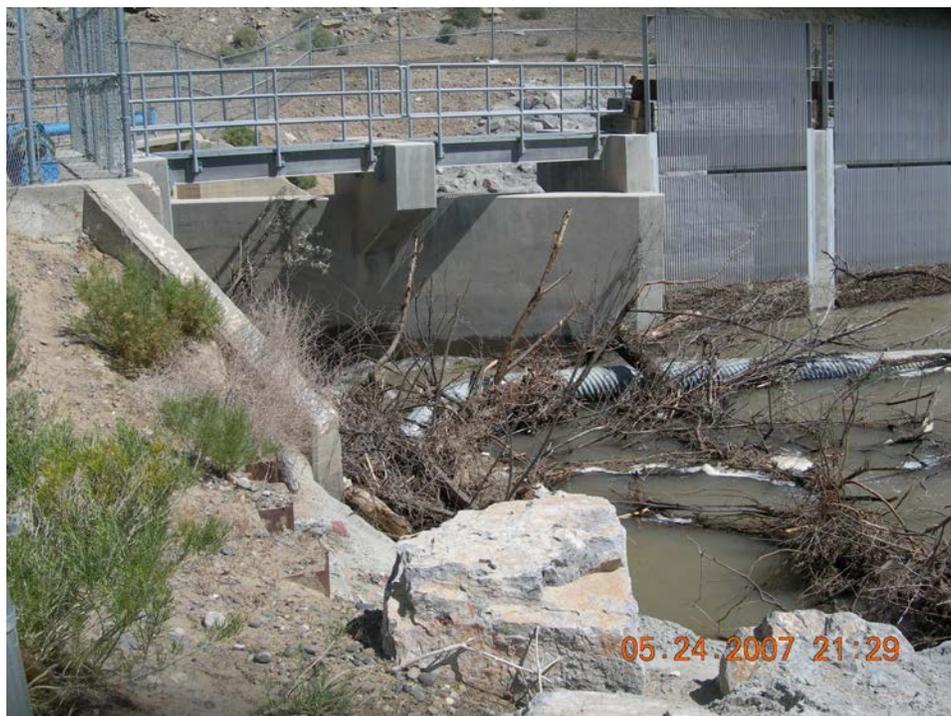
Figure 5. Debris following a peak flow of 9,000 cfs in May 2007. The log boom was damaged in this event due to the high amount of debris coming down the river.

This debris concentration has resulted in operational challenges to the operators and has resulted in expenses in terms of staff time and damage to the intake structure as shown in Figure 5 and Figure 6. Debris removal at the structure of smaller pieces is accomplished by manually dislodging debris

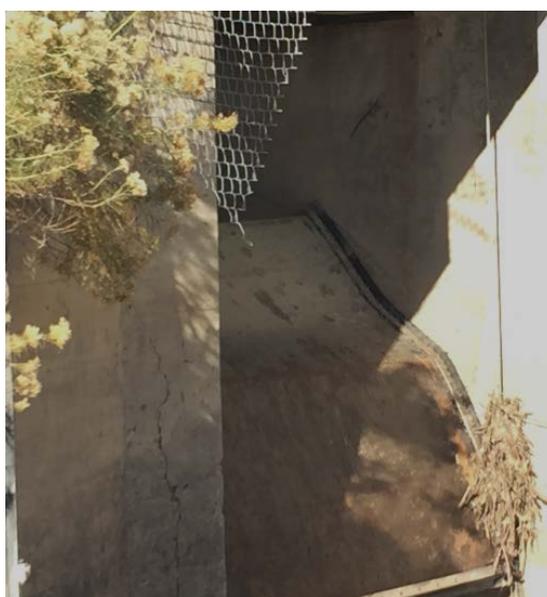
Figure 6. Photograph of damaged sluice gate skin plate due to debris strike.

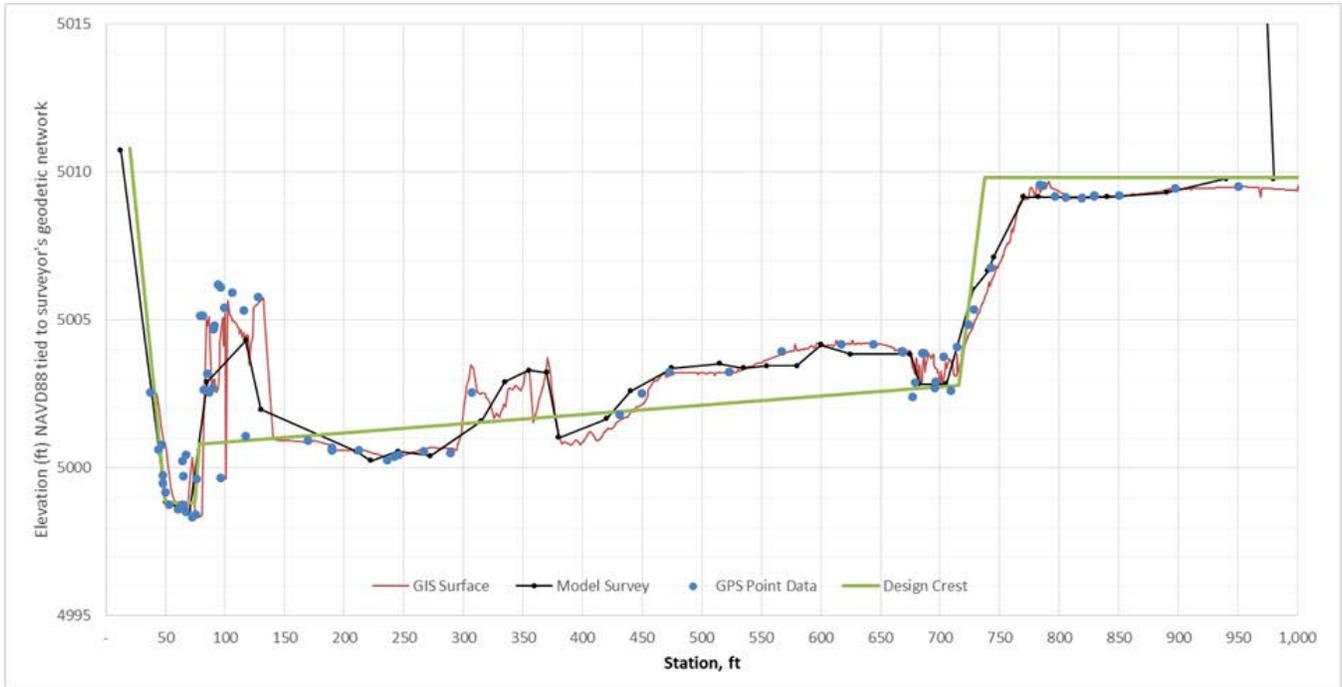
Figure 7. Crest profile as looking upstream (fish rock ramp notch on the left, moving south to the high ground tie in on the right) showing the design elevations, point survey data from 2017, a GIS surface created from all the survey points and elevations adjusted to prototype from the physical model survey.

During the diversion dam design phase, a crest elevation was selected to allow high flows to pass with a slight concentration towards the intake structure. However, a recent survey indicated that the crest elevation is much more variable than originally designed. The current varied elevation is likely due to sediment aggradation and effects of velocity sheltering from the overbank vegetation in some areas and flow concentration in other areas. This has led to a general increase in flows near the intake structure, and an associated increased debris load. Figure 7 shows the diversion dam design crest elevation along with point and surface data from a 2017 dam crest survey, as well as elevation data from a survey of the physical model dam crest.

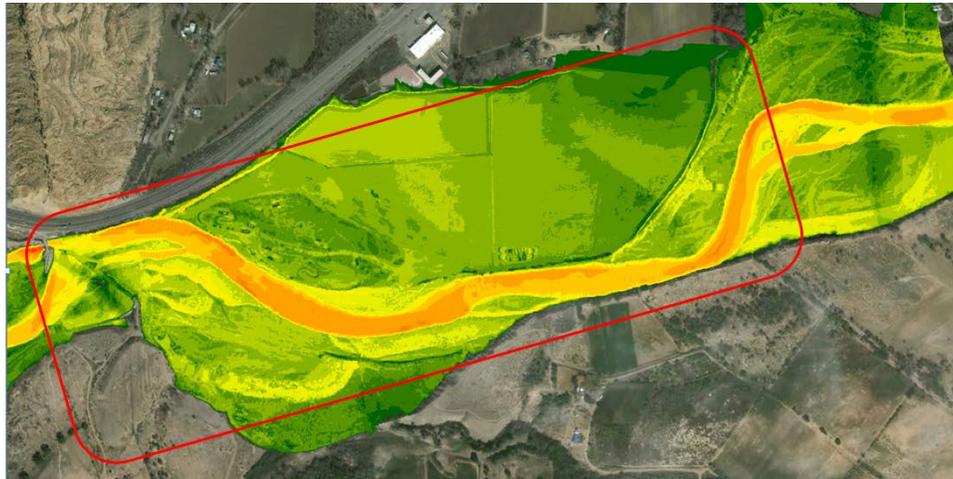
Figure 8. 1:60 scale physical model of the Hogback Diversion Dam, upstream San Juan River Channel and overbank area. The red line is the model extent. The background image shows flow depths during a 20,000 cfs flow event.

To be able to model debris transport in the river a large area of the river upstream of the Hogback Diversion Dam was needed. Due to the magnitude of area involved and space constraints in the laboratory, the model scale selected was 1:60 (model: prototype) geometric scale which included roughly one mile of river and overbank area upstream of the diversion dam. The entire diversion dam crest and the Hogback intake structure (including sluice gates, canal gate and trashrack piers) were also included within the extent of the model. While sediment is continually transported throughout the San Juan River channel, it was decided to construct the model with a non-mobile bed that represented conditions established by 2013 Light Detection and Ranging (LiDAR) and 2017 bathymetric surveys. Figure 8 shows the model extent overlaid with an aerial image and a flow depth raster created from United States Army Corps Hydrologic Engineering Center's River Analysis System (HEC-RAS) hydraulic modeling.

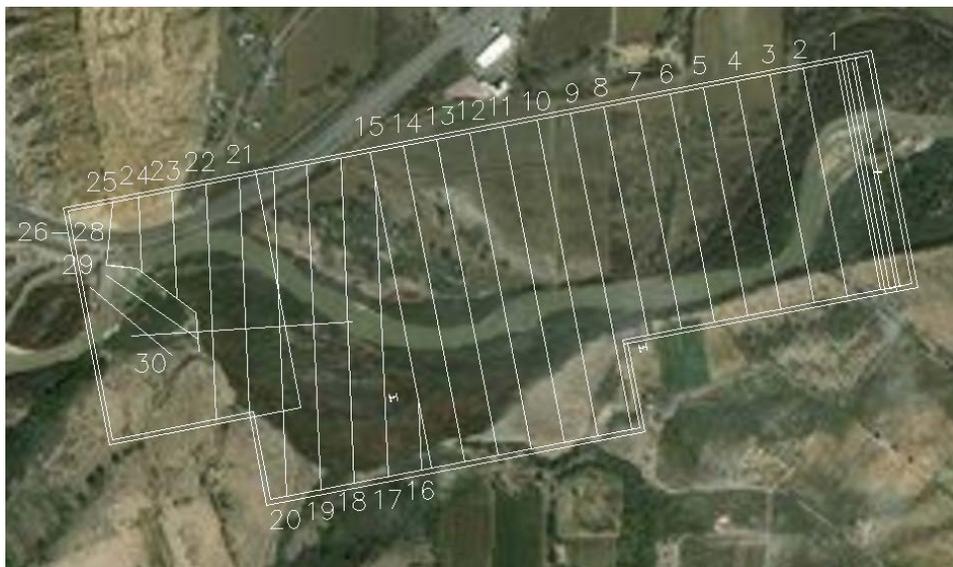
Figure 9. Model cross section layout.

Model topography was based on LiDAR data obtained from GeoDigital who performed the calibrated LiDAR data products acquisition in November 2013, and was supplemented with information from a 2017 GPS survey of the entire crest length as well as boat-based bathymetry of the San Juan River channel performed by the Sedimentation and River Hydraulics group of Reclamation's Technical Service Center (TSC). The digital terrain model was imported into AutoCAD and converted into contours that were used to lay out cross sections for the physical model. These cross sections were constructed using a template skeleton created from air injected Polyvinyl chloride (PVC) which was impervious to shrink and swell from moisture. This provided a stable elevation basis for the model topography. Figure 9 shows a plan view of the physical model extent and location of the cross sections.

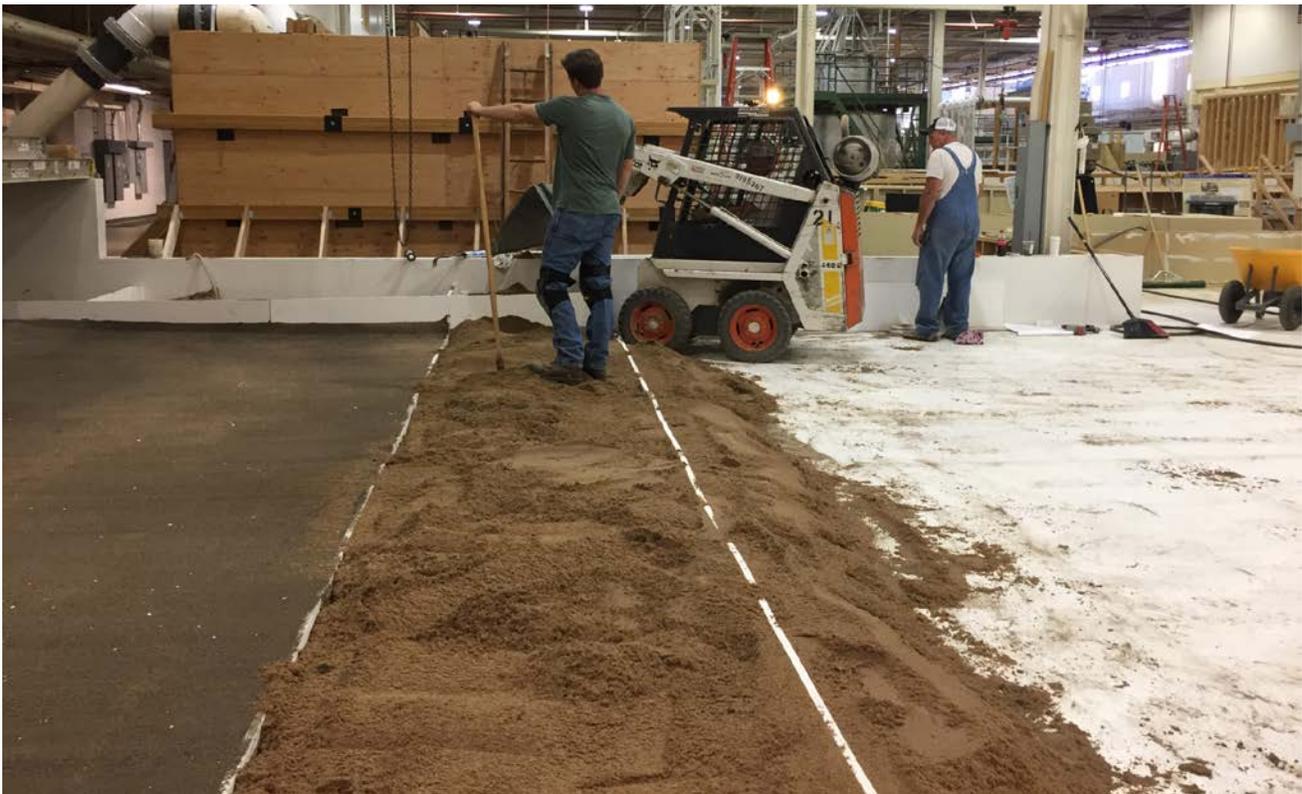
Figure 10. Model construction using PVC templates with concrete sand backfill and a mix of Portland cement and sand for a stabilized bed surface. The section to the left in the photograph has been stabilized with Portland cement, while the center section has just been filled with concrete sand. Both sides of the templates were filled with material to prevent deflection of the template during compaction.

The PVC templates were cut with a water jet which allowed accurate representation of the elevation changes in the topography and were installed using an index location incorporated into the water jet CAD file that allowed consistent survey markers across all the individual template sections. Once each template was installed, the area between templates (typically four feet) was backfilled with moistened concrete sand and compacted. To create the stable bed surface for the model, the top one inch was filled with a roughly 80:20% concrete sand to Portland cement mix. To ensure elevation control for the top one inch, the PVC templates were cut with a removable top section that allowed adjacent material to be screeded level to the top of the PVC and stabilized by curing the cement with water. Once cured, the top piece of the PVC was removed, and material was placed into this void and screeded level with the adjacent stabilized topography. To prevent underflow between cross sections, alternating PVC templates were sealed to the model floor. A photograph of model construction is shown in Figure 10.

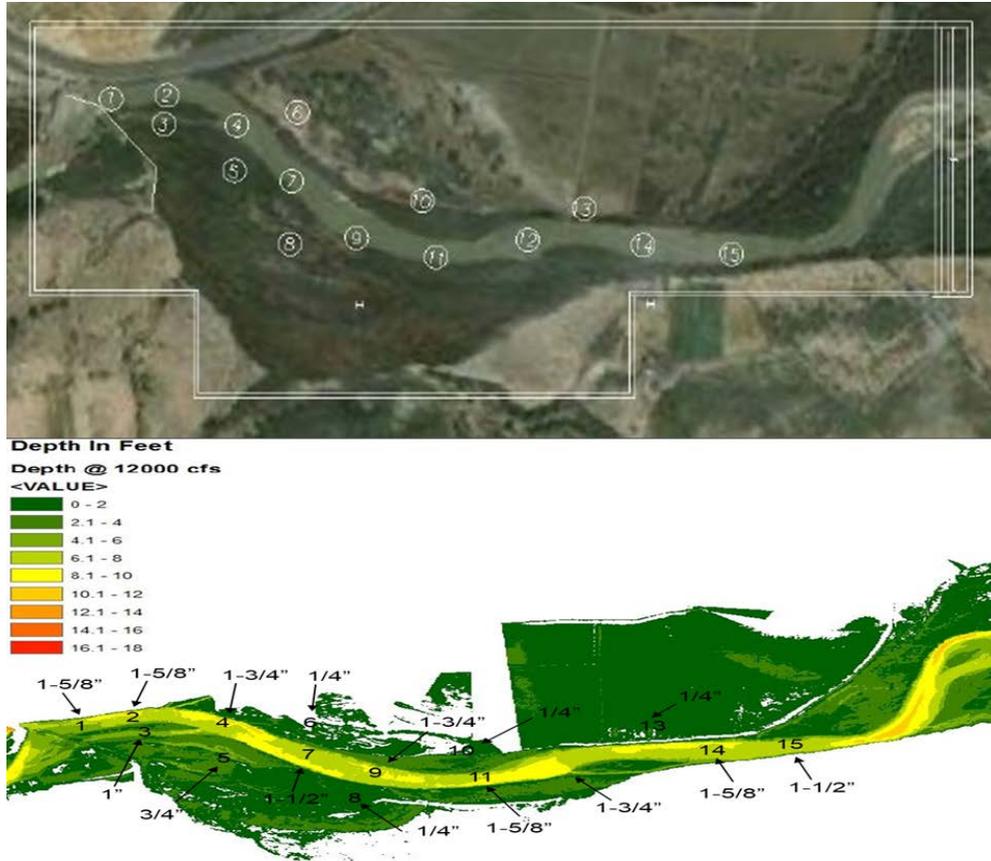
Figure 11. Physical model data verification points (upper image) and HEC-RAS inundation maps for river flow of 12,000 cfs with physical model flow depth measurements shown in inches.

Following construction, the physical model was validated by comparing reference flow depths with the HEC-RAS hydraulic model. To achieve this, 15 depth marker points were identified to compare flow depths between the physical model and the HEC-RAS model. Nine of these points were located within the main flow channel, and six points were in overbank areas. These depth markers were compared for all flows tested in the model. Figure 11 shows the location of these markers and the recorded model depth in inches overlain the HEC-RAS raster for one of the four test flow rates. Table 1 includes the measured physical model flow depths in inches, those physical measurements converted to prototype flow depths in feet, and the flow depth range as estimated by HEC-RAS in feet.

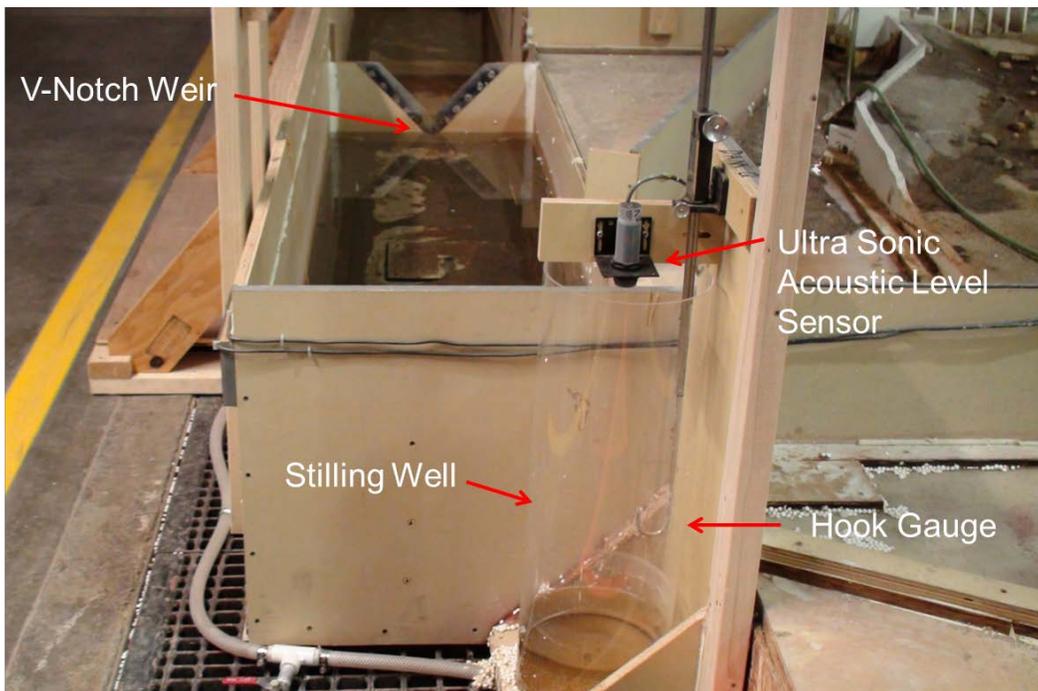
Figure 12. Photograph of physical model flow measurement.

Due to the porous topography that potentially could result in seepage losses through the physical model, all flow measurement was situated downstream of the Hogback Intake Structure. The model was designed with two separate flow measurement locations; one location for the combined flow passing over the diversion dam and through the sluice gates and the other location for flows passing into the Hogback Canal. Flow measurement locations utilized v-notch weirs connected to stilling wells, each outfitted with a combination of an ultra-sonic acoustic level sensor for automated reading, and a manual hook-type point gage reading for reference. Due to the sensitivity of the model flow scaling at a 1:60 scale, low flows were also calibrated with manual flow measurement. A photograph of the downstream flow measurement is found in Figure 12. DASYLab V13.0.0 was utilized for automated data acquisition which included the flow measurements of the v-notch weirs as well as the water surface elevation (WSE) in front of the trashrack. Flows to the model were supplied by a Variable Frequency Drive pump with a submerged intake plumbed into the sub-floor reservoir at the hydraulic laboratory.

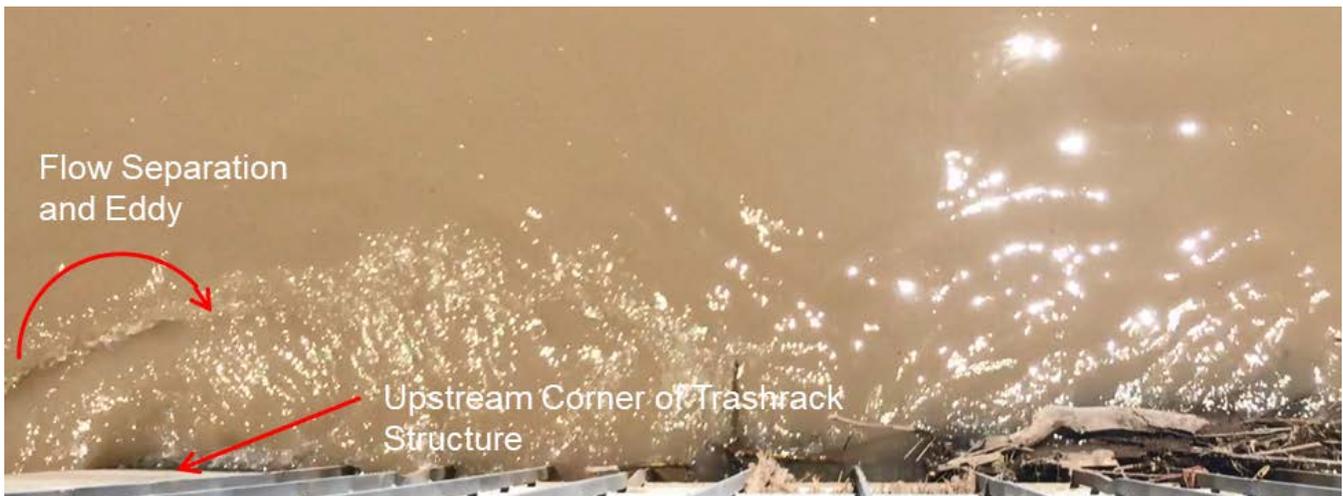
Figure 13. Screen capture from flow video of the prototype recorded at 600 cfs showing flow separation and eddy at the upstream corner of the trashrack structure, viewed from top.

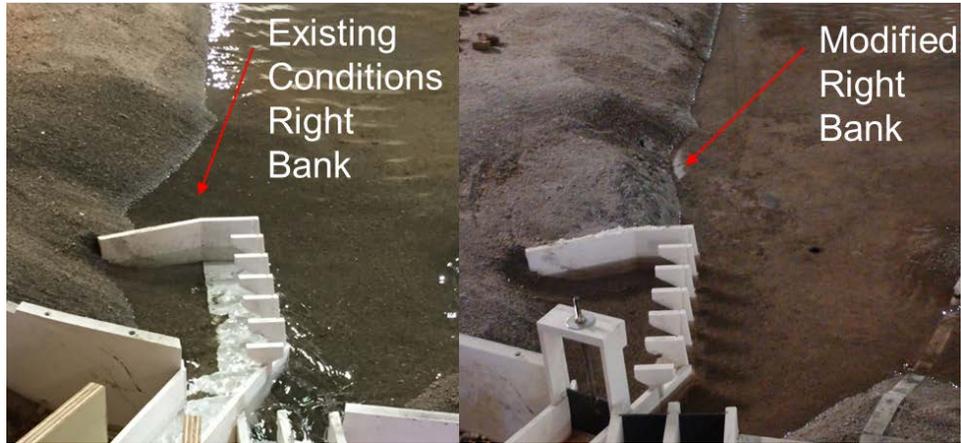
Figure 14. Photographs of physical model showing the right bank at the upstream corner of the trashrack for existing conditions (left image) and modified to smooth flows (right image).

To compare alternatives, the initial set of data collection from the physical model was performed on the existing conditions topography and without the use of any alternatives. Following the evaluation of existing conditions, one minor change to the model topography was performed. During shakedown testing, it was observed that the sudden river channel contraction that occurs when flows encounter the upstream wall of the trashrack structure produced a very large eddy that increased both flows and velocities entering the most upstream bay of the trashrack. This can also be observed at the prototype when looking at how the flow is forced around the 90-degree corner of the concrete structure as shown below in Figure 13. To remedy this, the right bank immediately upstream of the trashrack structure was filled with the sand & cement mix to create a smoother flow transition. Images of existing and modified upstream right bank can be found in Figure 14.

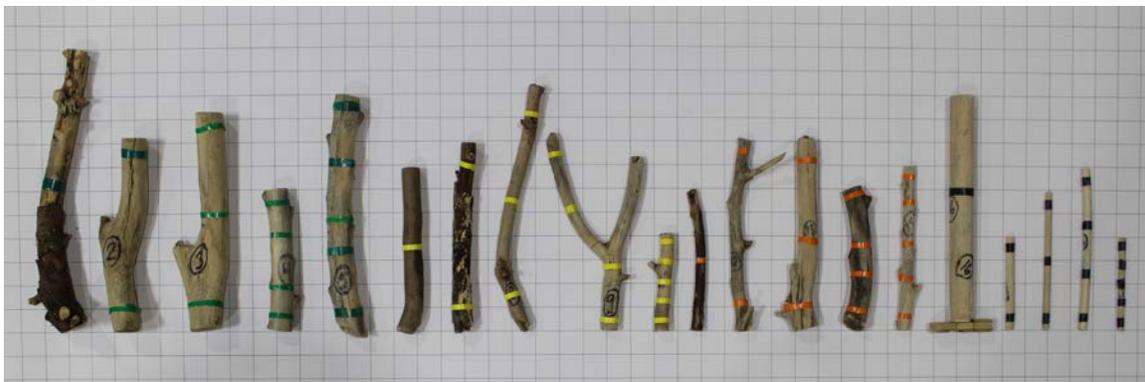
Figure 15. Debris pieces used for physical model tests in ascending order from left to right. The background is a 1-inch square grid.

For consistency among all tested conditions 20 pieces of debris were selected and used for each model test. Debris pieces were chosen to be representative in size of large cottonwoods and other mature tree species along the San Juan River, but had reduced branch complexity due to availability. Details of the debris pieces used for the physical model tests can be found below in Figure 15 and Table 3. Bands of colored tape were added to the test debris pieces to assist in identification of individual pieces during deposit and post deposit flow surge videos. One important consideration for the physical model tests was the ability to perform numerous iterations of where debris was deposited for a given flow and gate configuration. Due to the extensive test matrix (56 tests), and the duration required to stabilize flow in the model for steady state tests combined with the flow surging to represent flood conditions, only one iteration of each test was performed. Repeating tests would be expected to provide different results for debris accumulation locations, but the flow velocity vectors and hydraulic conditions created by each iteration would be repeatable. Therefore it is unlikely that repeated iterations would have changed the relative ranking of alternative performance.

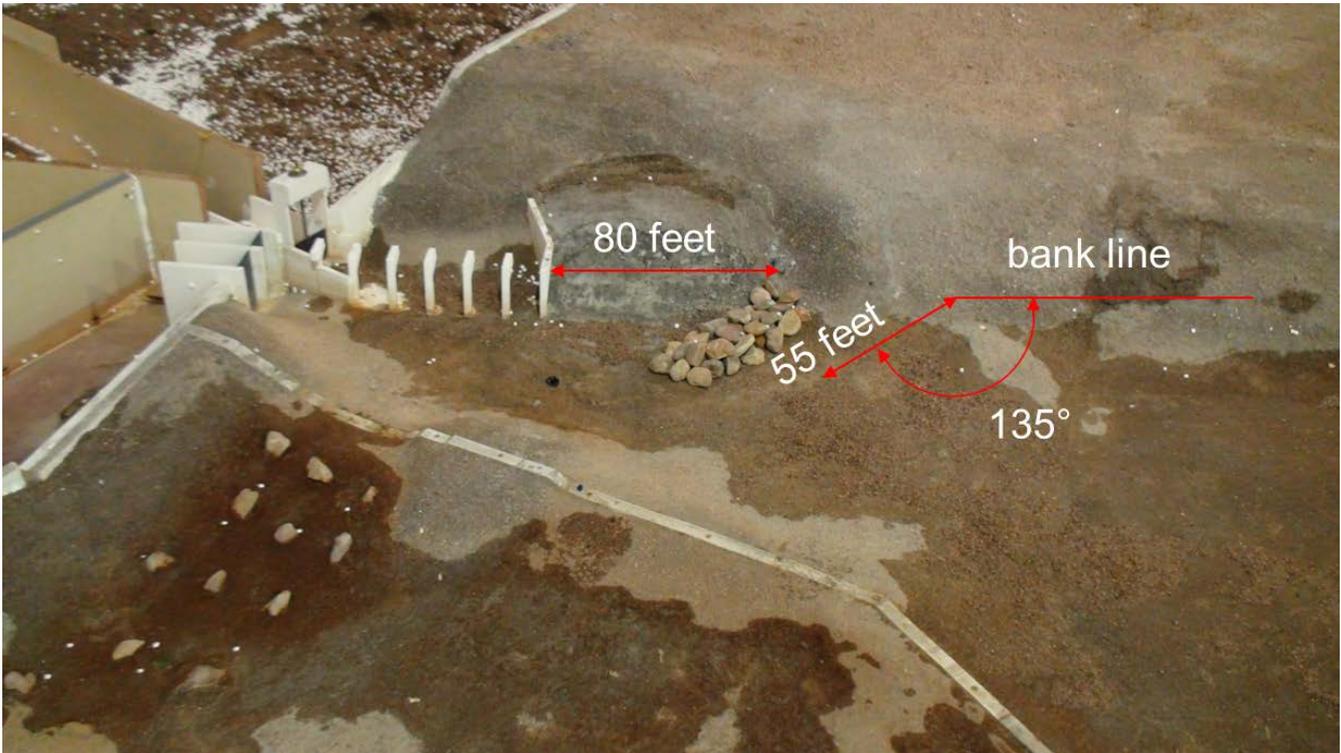
Figure 16. Photograph of Rock Structure 1 from downstream of the diversion dam.

RS1, shown in Figure 16, was located along the right bank of the river with the centerline of the bank tie in 80 feet upstream from the corner of the intake structure concrete wall. It was 55 feet in length and oriented downstream approximately 135° from bank tangent.

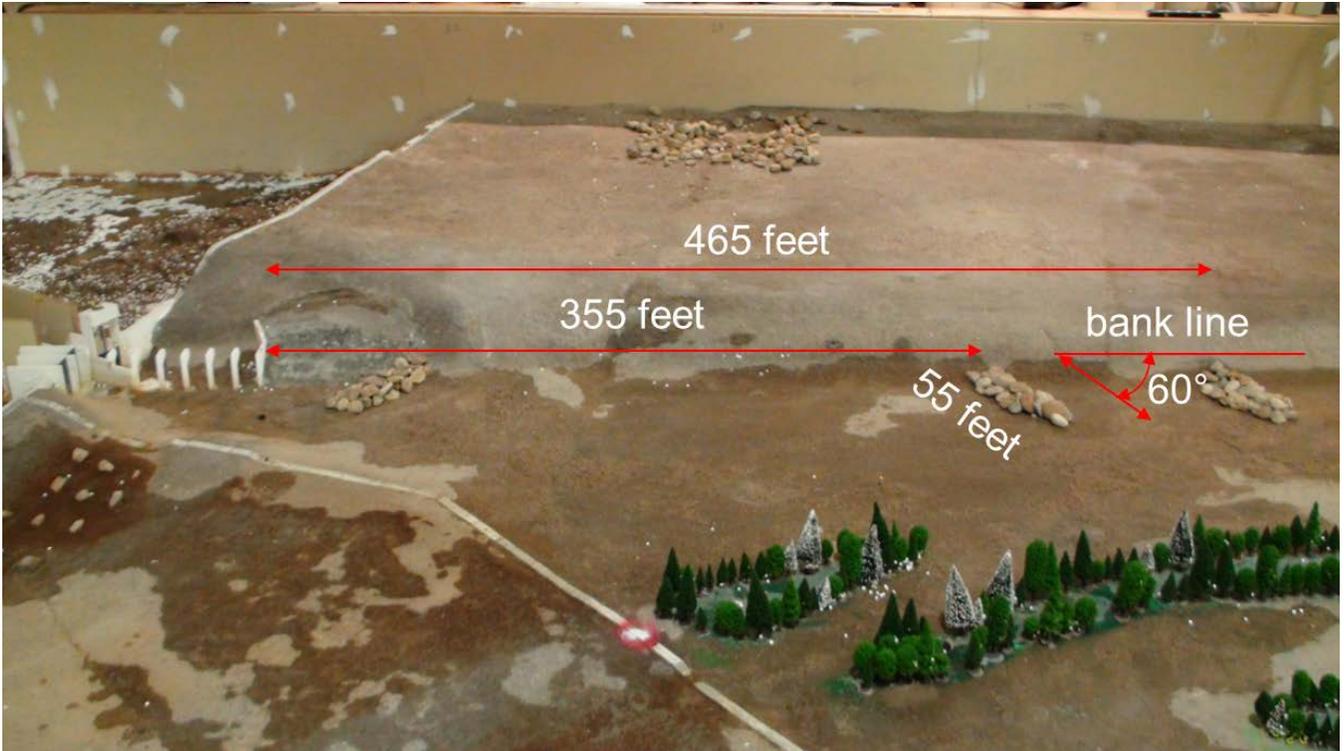
Figure 17. Photograph of Rock Structure 2 viewed from downstream of diversion dam.

RS2 was a combination of three structures as shown in Figure 17. RS2 incorporated RS1 with two additional structures tied into the right bank line upstream at 355 feet and 465 feet from the corner of the trashrack structure. The upstream structures were also 55 feet in length but were oriented upstream into the river flow each at angles of 60° from bank tangent.

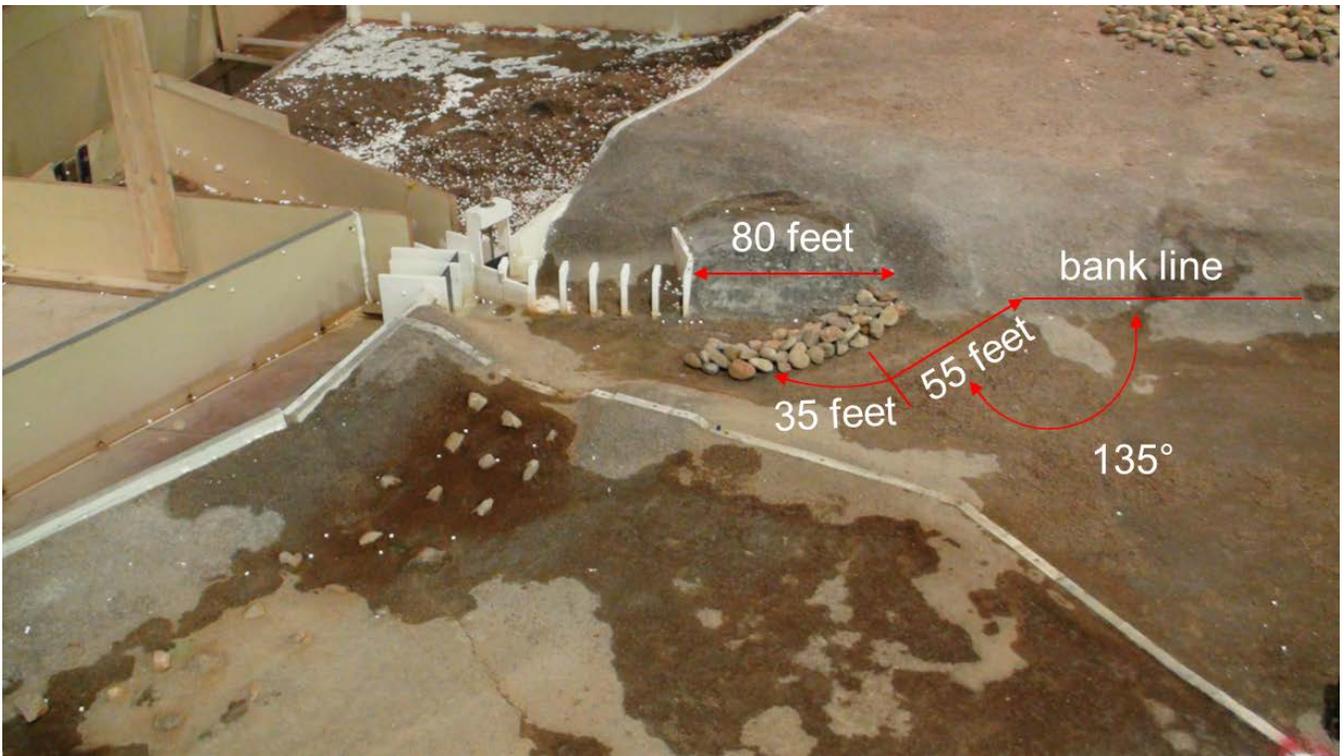
Figure 18. Photograph of Rock Structure 3 viewed from downstream of the diversion dam.

RS3 was a 90-foot-long structure constructed by adding 35 feet of material to the end of RS1 in an arc shape with the edge pointed toward the tie in point of the dam at the right abutment, it is shown in Figure 18.

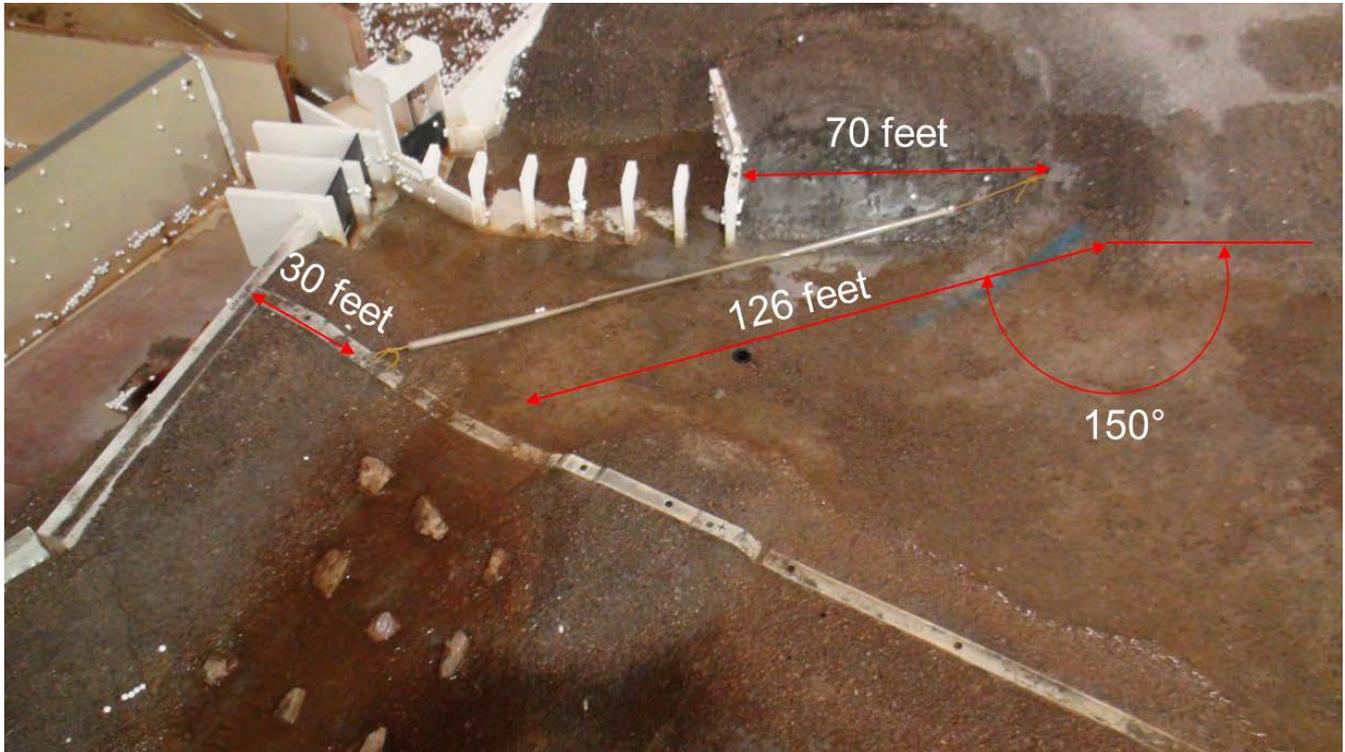
Figure 19. Photograph of LB1 viewed from downstream of the diversion dam.

LB1 was a 126-foot-long boom that spanned the river's width from 70 feet upstream of the intake structure on the right bank to right side of the fish rock ramp, when viewed from upstream shown in Figure 19. The downstream connection point was located 30 feet from the top of the slope on the right most extent of the dam crest. The orientation of the log boom was angled approximately 150° from the right bank line. It consisted of three 42-foot sections of boom, $2\frac{1}{2}$ inch diameter, connected to a cable that extended past the boom 24 feet on the upstream and 9 feet on the downstream end. In the model the log boom was made of three sections of ($\frac{3}{8}$ " OD) plastic tubing that were fitted over nylon string and injected with expanding foam to assist with buoyancy.

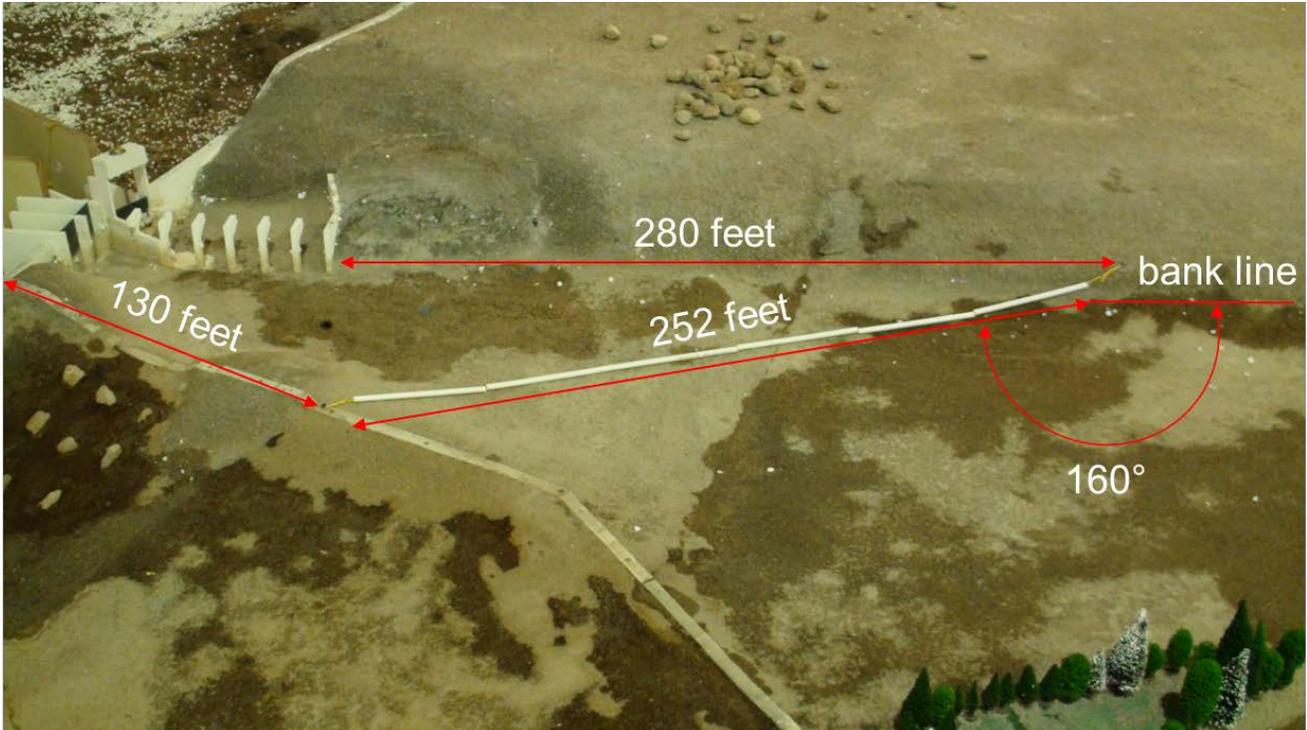
Figure 20. Photograph of LB2 viewed from downstream of the diversion dam.

LB2 was a 252-foot-long boom that spanned from the right bank upstream of the intake structure (viewed from upstream) to the dam crest on the left side of the fish rock ramp shown in Figure 20. The orientation of the log boom was angled approximately 160° from the right bank line. The boom consisted of six 42-foot sections attached with a cable that extended past the boom 24 feet on the upstream and 9 feet on the downstream end. The upstream connection point was on the right bank 280 feet upstream of the intake structure. The downstream connection point was located on the dam crest, 130 feet from the top of the slope at the right most extent, when viewed from upstream. In the model the log boom was made of six sections of ($\frac{3}{8}$ " OD) plastic tubing that were fitted over nylon string and injected with expanding foam to assist with buoyancy.

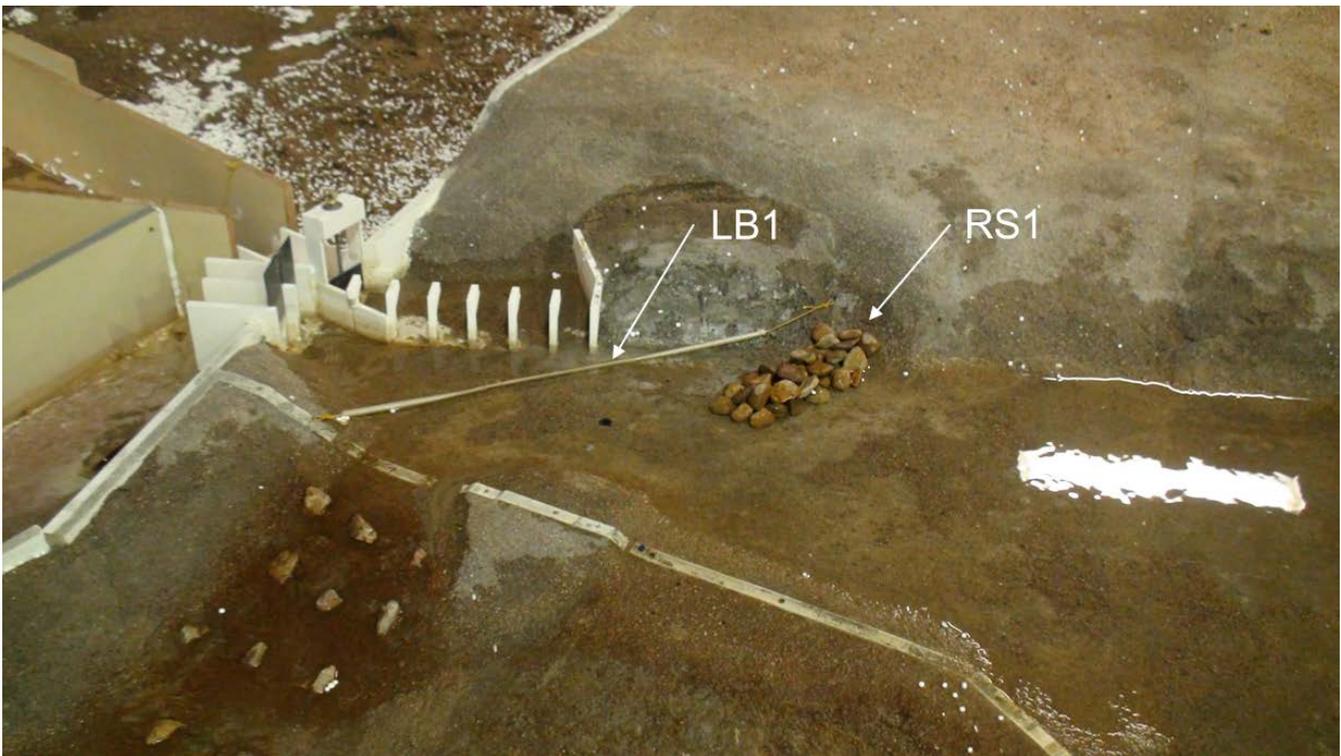
Figure 21. Photograph of RS1LB1 viewed from downstream of the diversion dam.

RS1LB1 was a combination of alternatives RS1 and LB1 which were the best performing individual rock structure and log boom alternatives. The combination is shown in Figure 21.

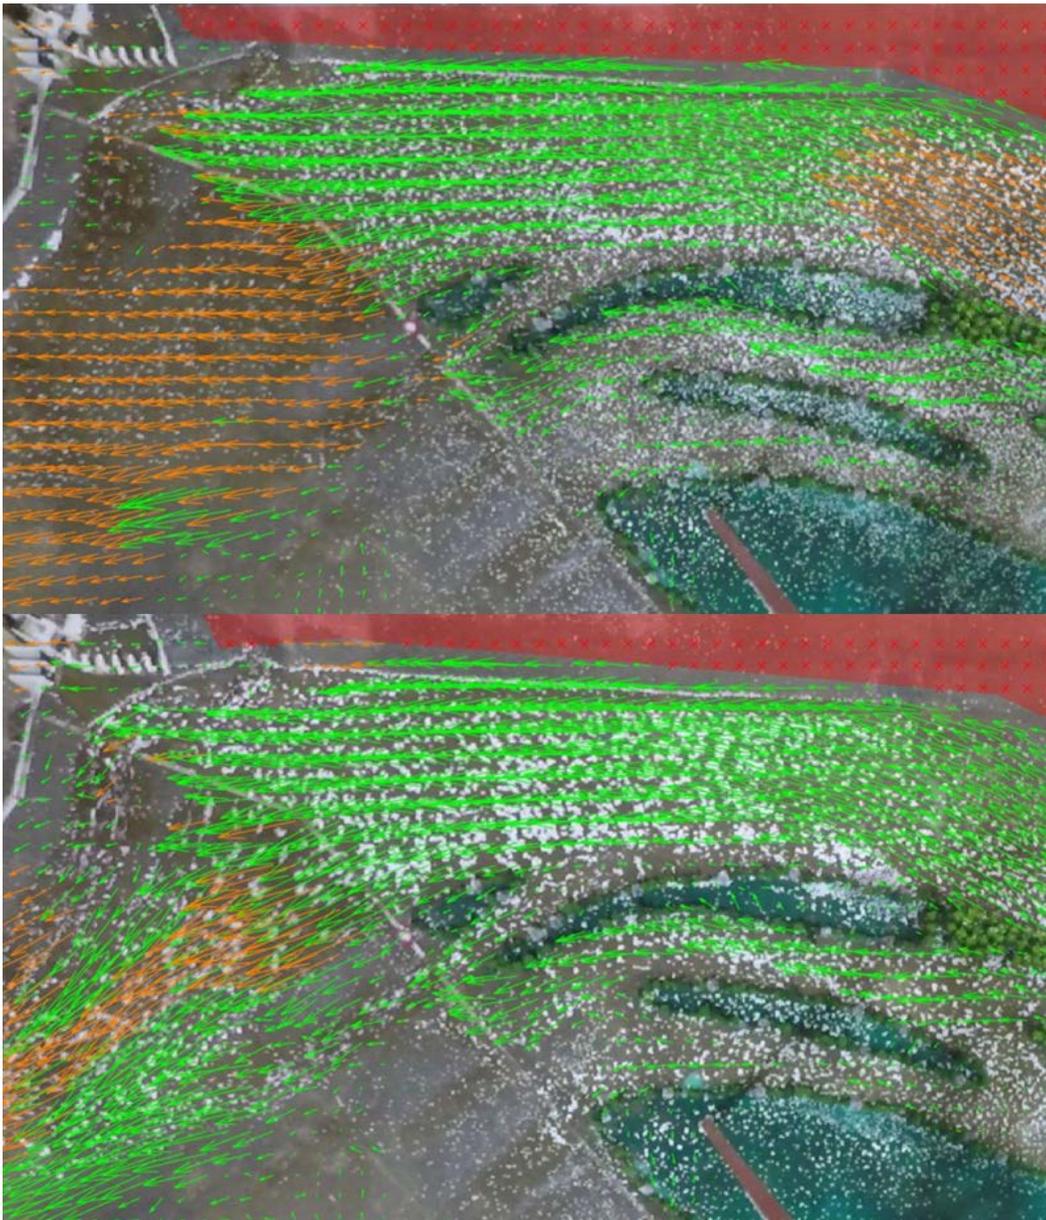
Figure 22. PIV velocity vectors for the RS1LB1 at 5,000 cfs for sluice gates open (top) and canal gate open with sluice gates closed (bottom).

Data recorded during physical model tests to compare the alternatives included Particle Image Velocimetry (PIV) that used video recorded while seed material was introduced into the model. Rectification of Image Velocity Results (RIVeR, V2.2) was used to extract paired images from 10 seconds of trimmed video. PIVlab V1.41 was used to create average surface velocity vectors of individual particle movements from the paired extracted images. This process was repeated for all flow conditions in the test matrix. Examples of PIV output images are shown in Figure 22 for RS1LB1 at 5,000 cfs for both the sluice gates open and closed. All other PIV images can be found in Appendix A. The orange vectors indicate that more than half of the original vectors at that spot were interpolated while the green vectors show individual particle movement.

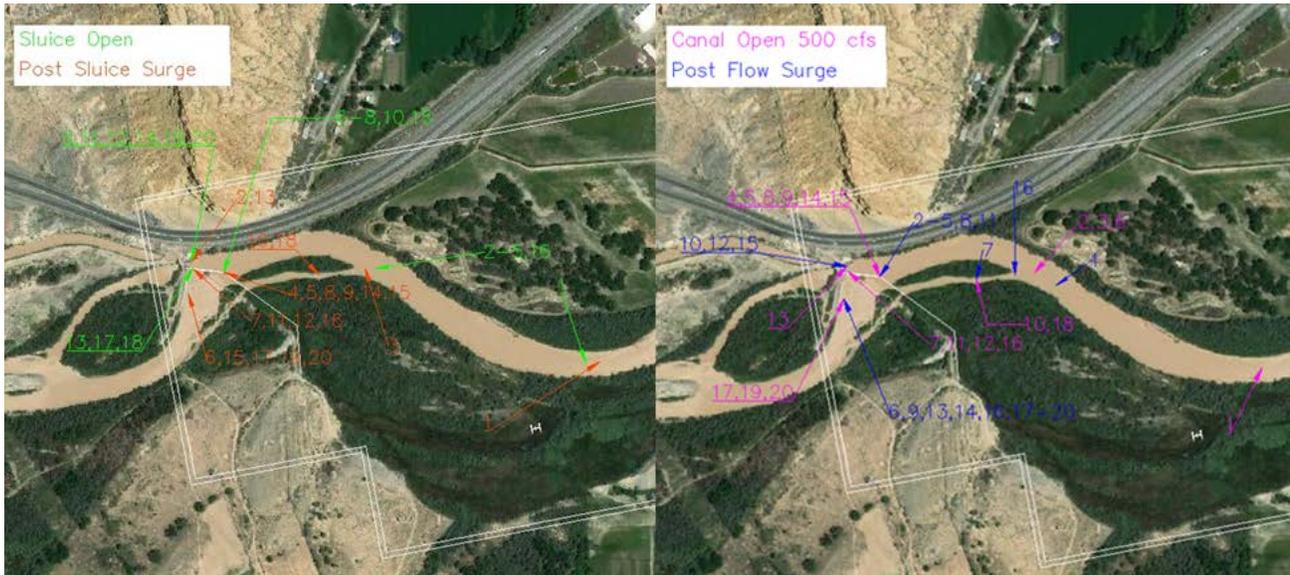
Figure 23. Debris capture locations for RS1LB1 at 5,000 cfs with sluice gates open and canal gate closed (left) and sluice gates closed and canal gate open to pass 500 cfs(right). The two text colors indicate debris deposit locations with steady flow (green and fuchsia) and following the flow surge (orange and blue).

To assess where debris was deposited in the physical model tests, debris capture locations were recorded following each model test combination of flow and gate configuration. In addition to the steady state flow deposition, the debris locations were also recorded following the flow surge to simulate how captured debris at lower river flows would mobilize when high flows were encountered. Figure 23 shows debris capture locations for RS1LB1 at 5,000 cfs for both the sluice open and closed. Debris capture locations for all other alternatives and flow conditions are included in Appendix A.
