Hydraulic Laboratory Report HL-2019-04

Physical Hydraulic Model Study of Debris Management Alternatives for Hogback Diversion Dam

U.S. Department of the Interior
Bureau of Reclamation
Technical Service Center
Hydraulic Investigations and Laboratory Services Group
Denver, Colorado

August 2019

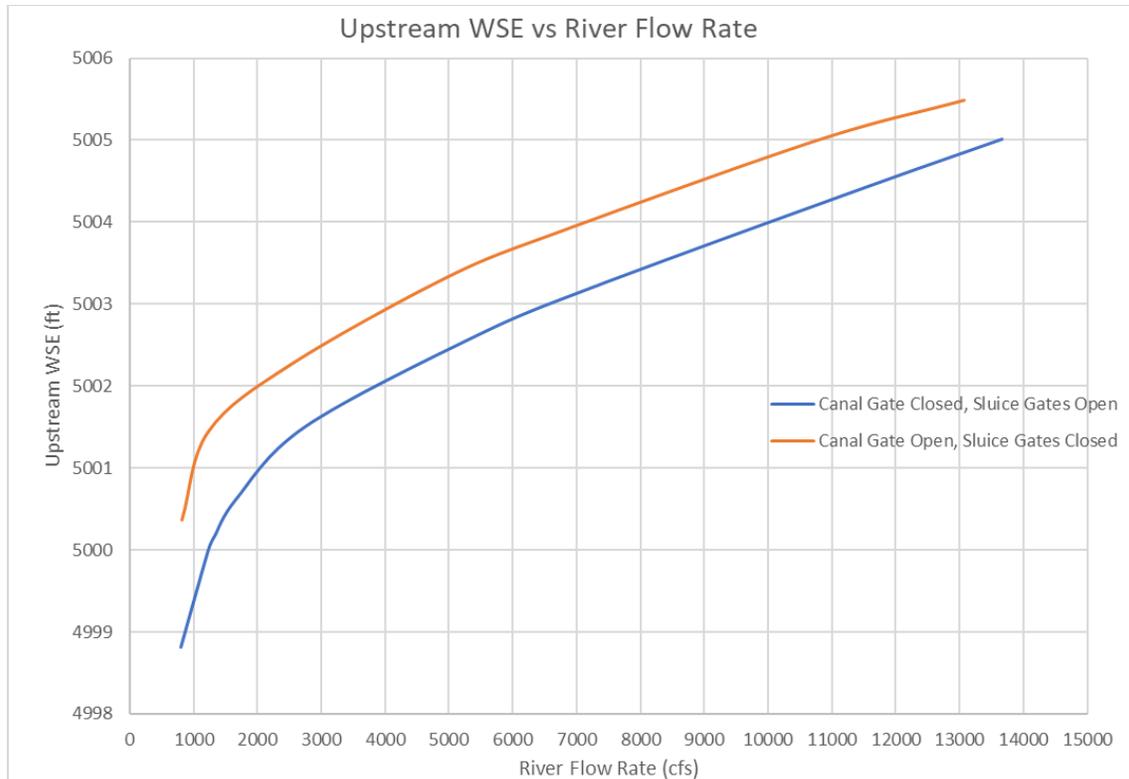
Figure 24. Rating curve for the San Juan River water surface elevation in front of the Hogback Intake trashrack structure.

The only quantitative data collected in the model was a rating curve of the river WSE in front of the trashrack structure, shown in Figure 24. Two curves were created, one for river WSE when the canal gate was closed and sluice gates open, and one for when the canal gate was open and sluice gates were closed. Data points taken with the canal gate open were based on a canal diversion flow of 250, 400, 500, and 600 cfs with river flow rates at 800, 2,500, 5,000, and 12,000 cfs, respectively.

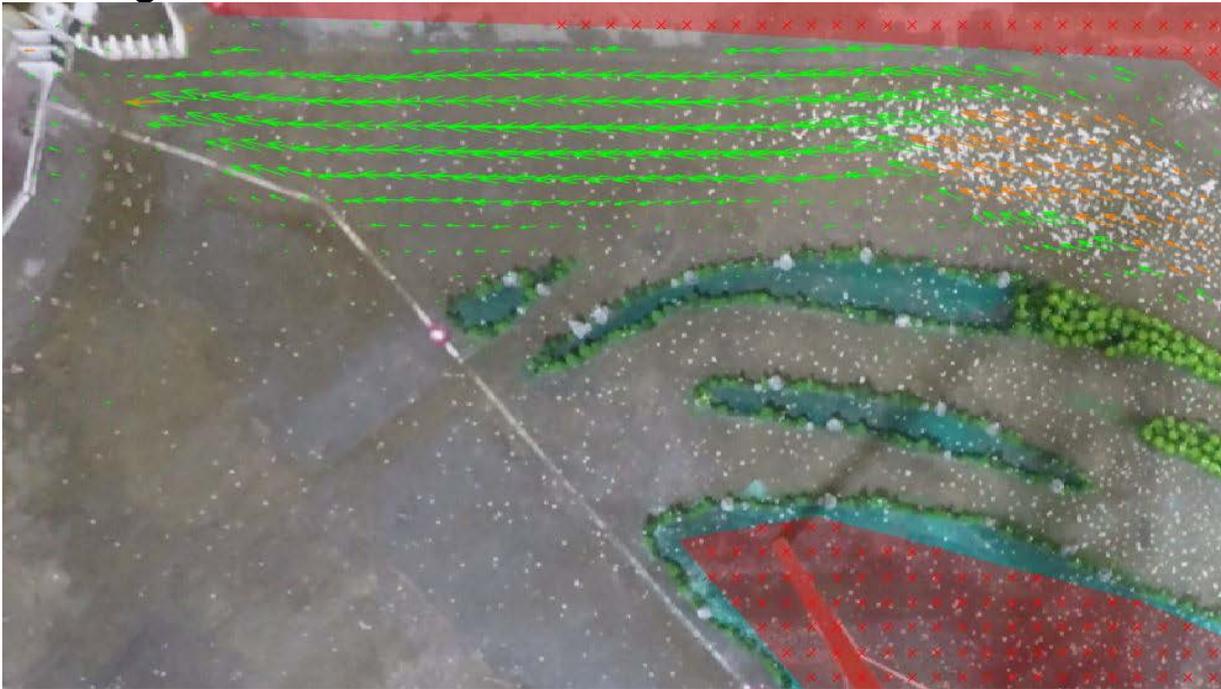
Image of LSPIV mean velocity vectors of the river modeled at the existing condition with River Q 800 cfs, Dam Q 550 cfs, Canal Q 250 cfs, and sluice gates closed.

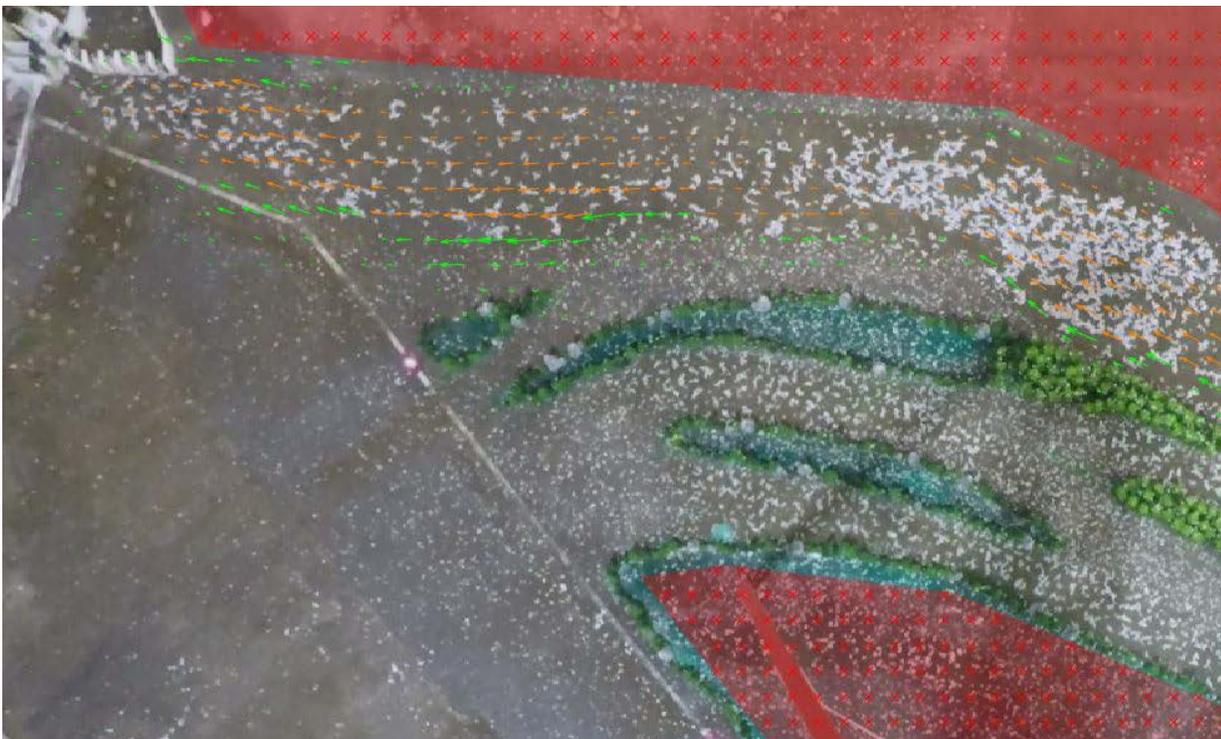
Image of LSPIV mean velocity vectors of the river modeled at the existing condition with River Q 800 cfs, Dam Q 800 cfs, Canal Q 0 cfs, and sluice gates open.

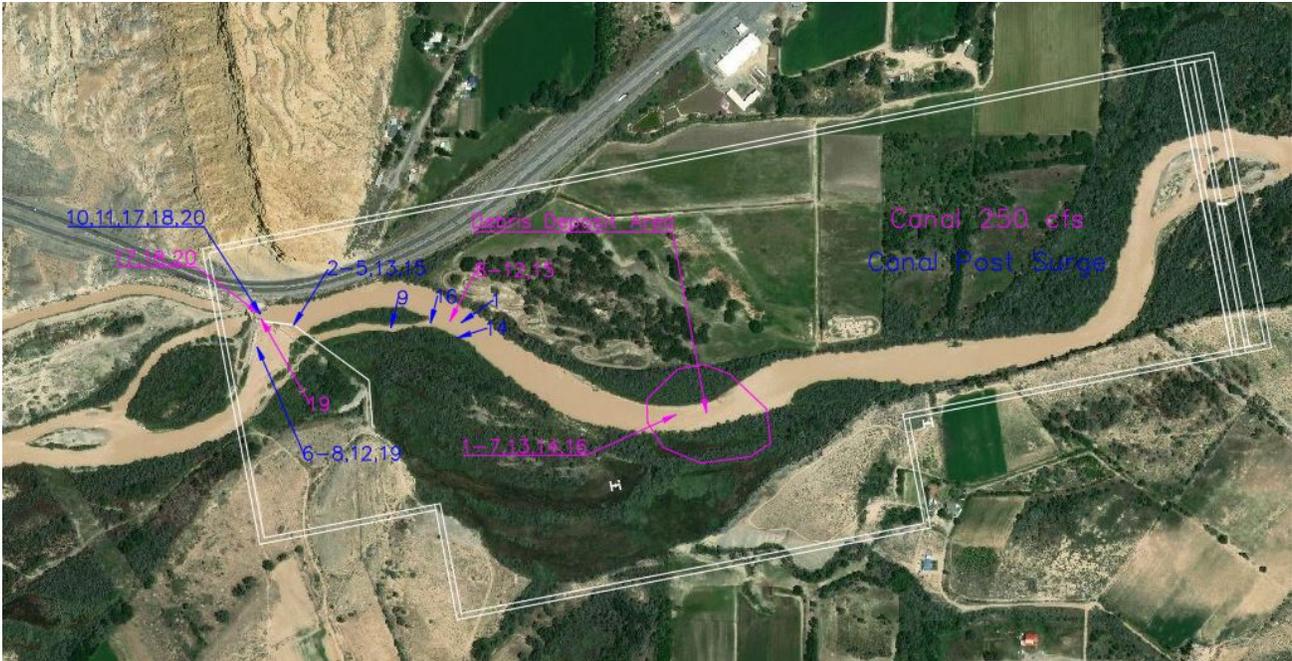
Image of debris capture location of the river modeled at the existing condition with River Q 800 cfs and Canal Q 250 cfs, with sluice gates closed.

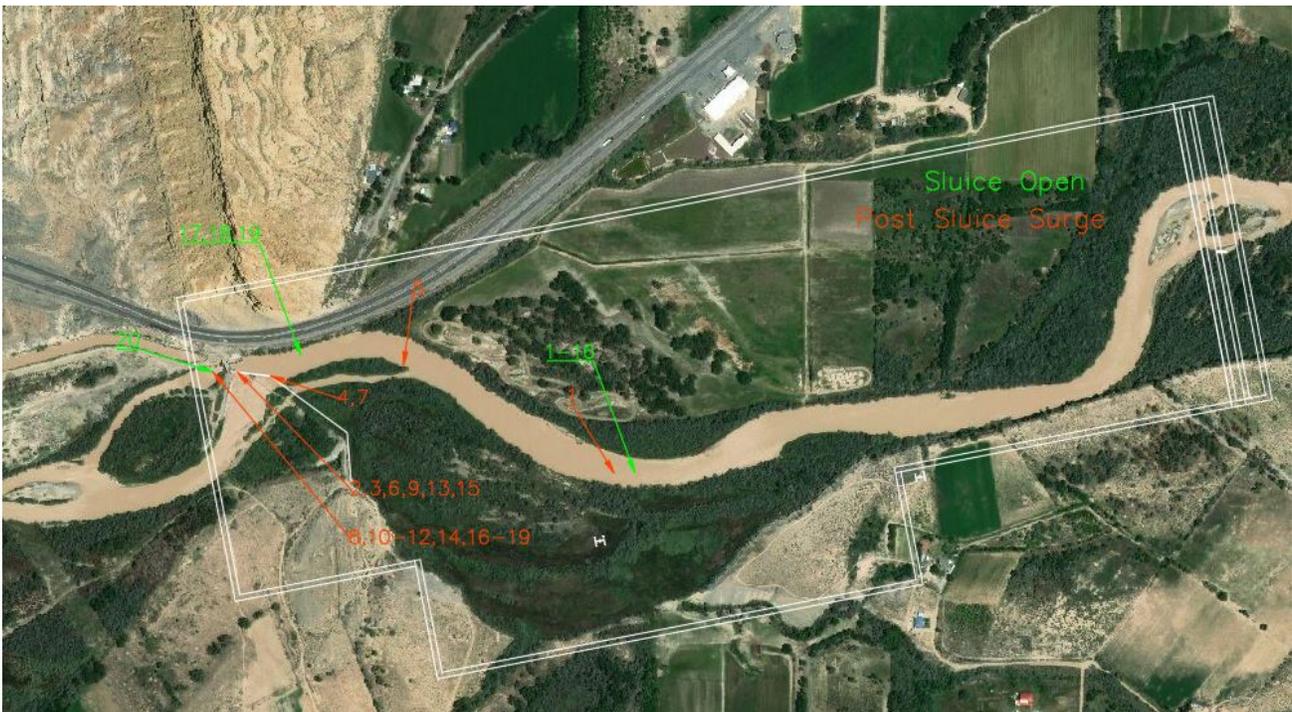
Image of debris capture location of the river modeled at the existing condition with River Q 800 cfs and Canal Q 0 cfs, with sluice gates open.

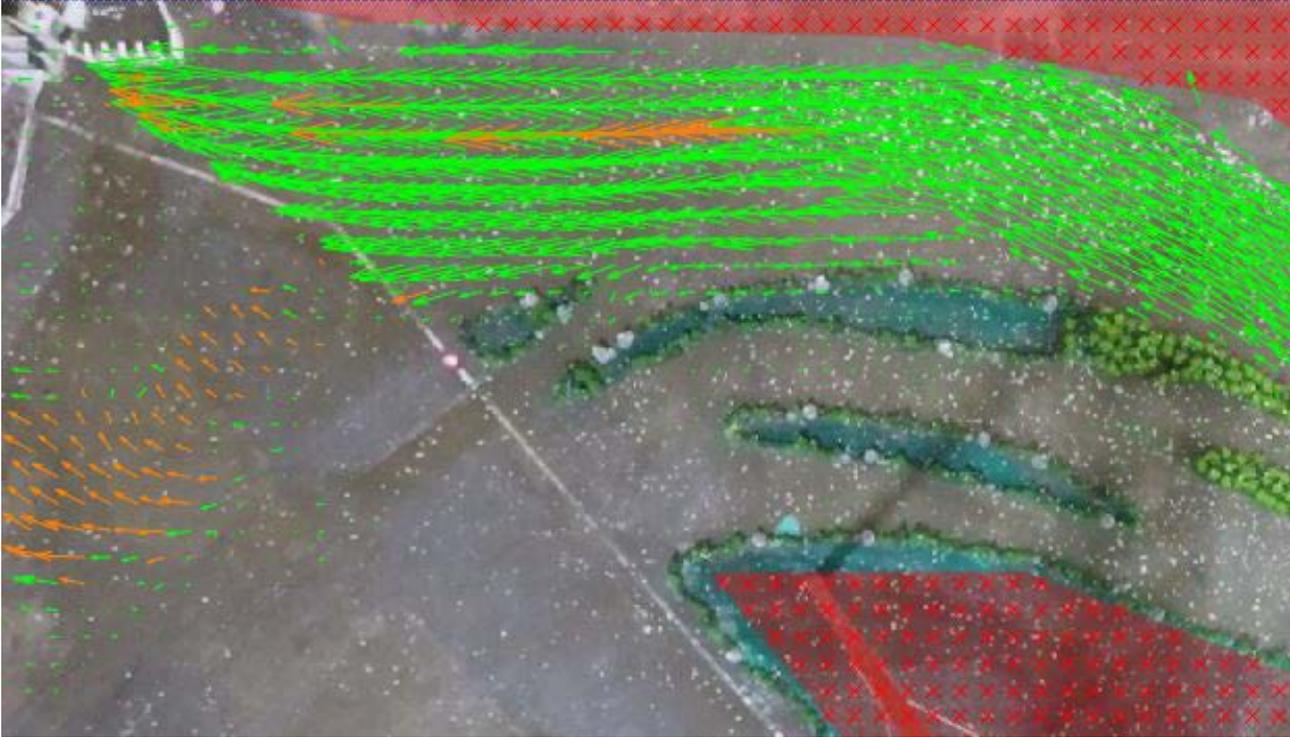
Image of LSPIV mean velocity vectors of the river modeled at the existing condition with River Q 2,500 cfs, Dam Q 2,500 cfs, Canal Q 0 cfs, with sluice gates open.

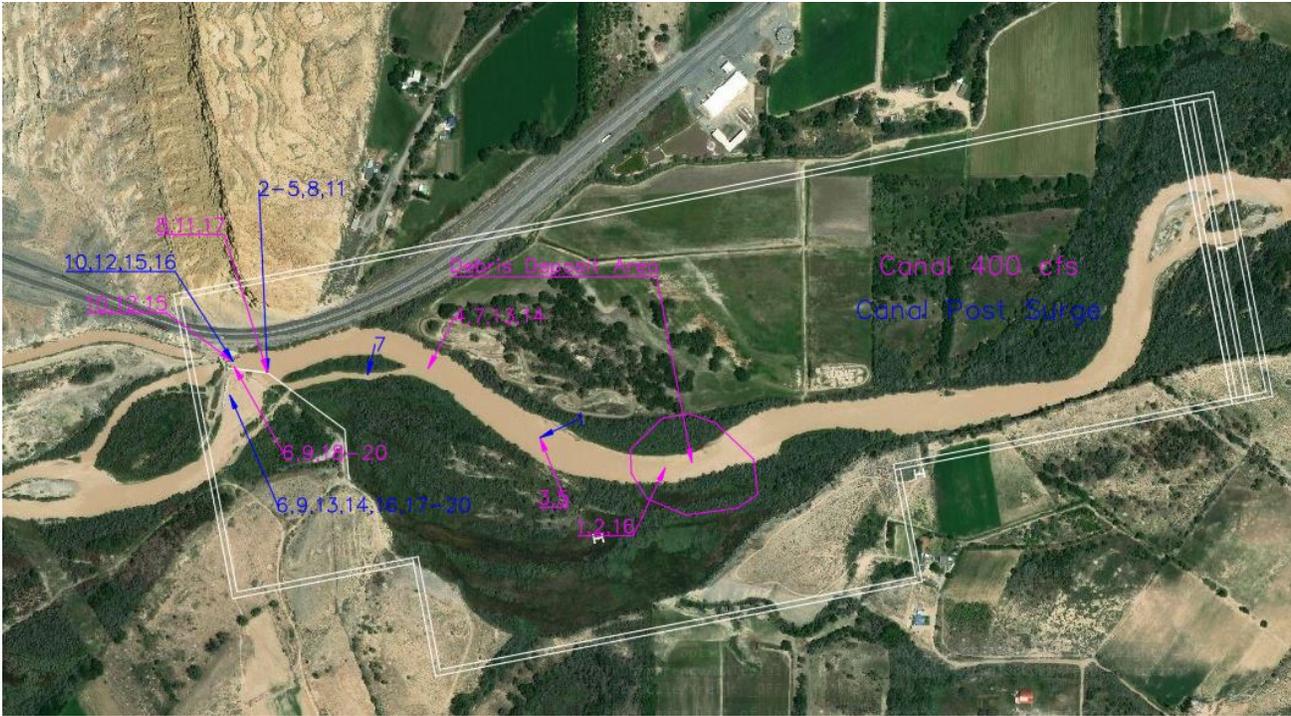
Image of debris capture location of the river modeled at the existing condition with River Q 2500 cfs and Canal Q 400 cfs, with sluice gates closed.

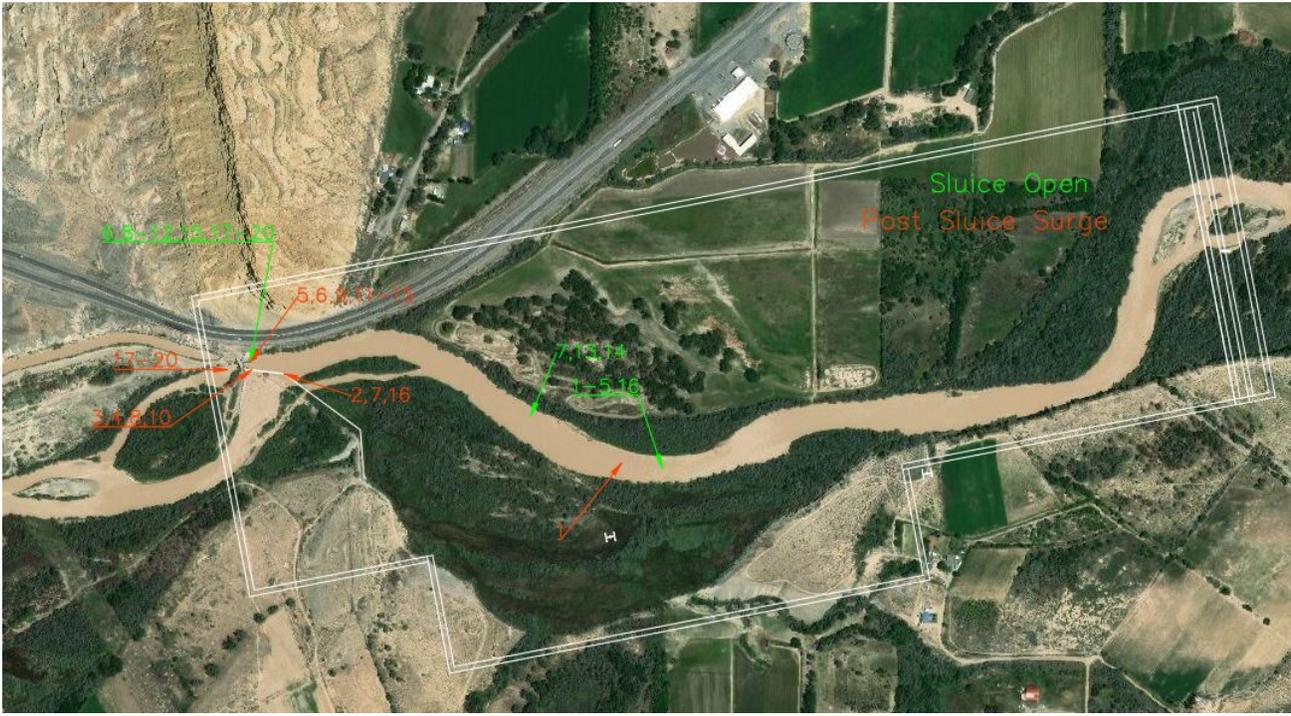
Image of debris capture location of the river modeled at the existing condition with River Q 2500 cfs and Canal Q 0 cfs, with sluice gates open.

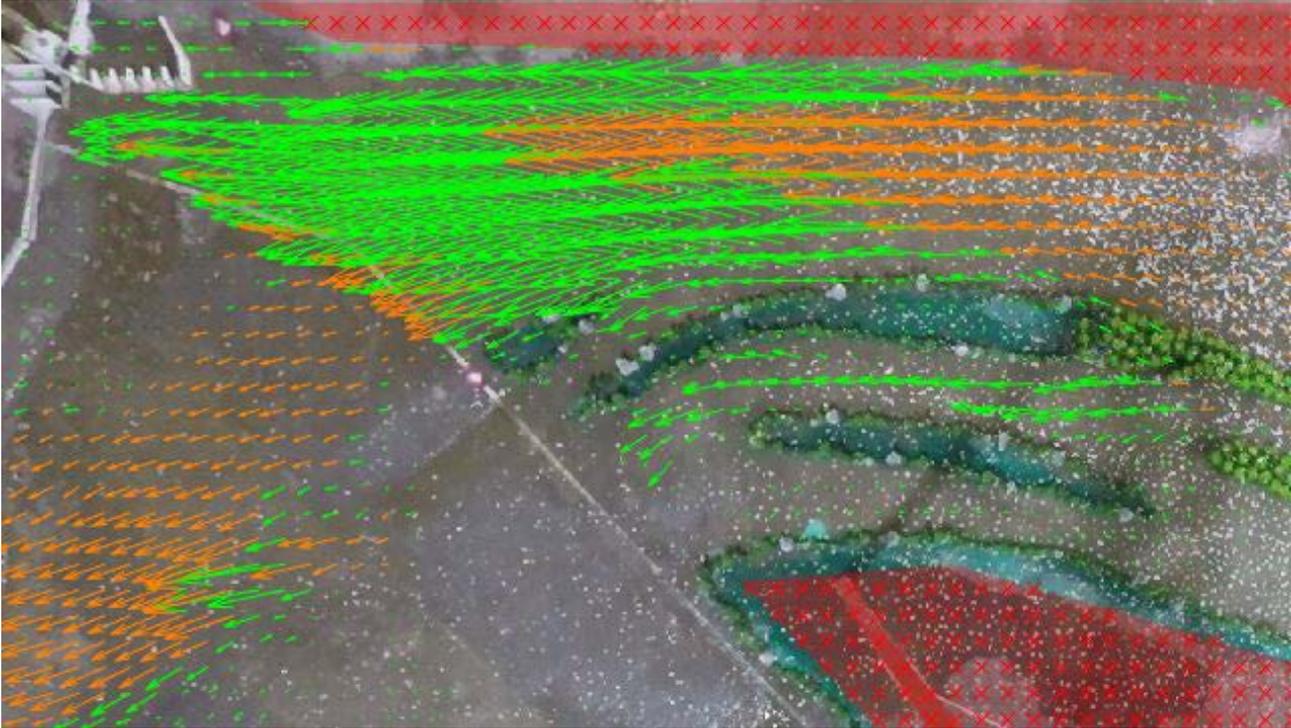
Image of LSPIV mean velocity vectors of the river modeled at the existing condition with River Q 5,000 cfs, Dam Q 4500 cfs, Canal Q 500 cfs, and sluice gates closed.

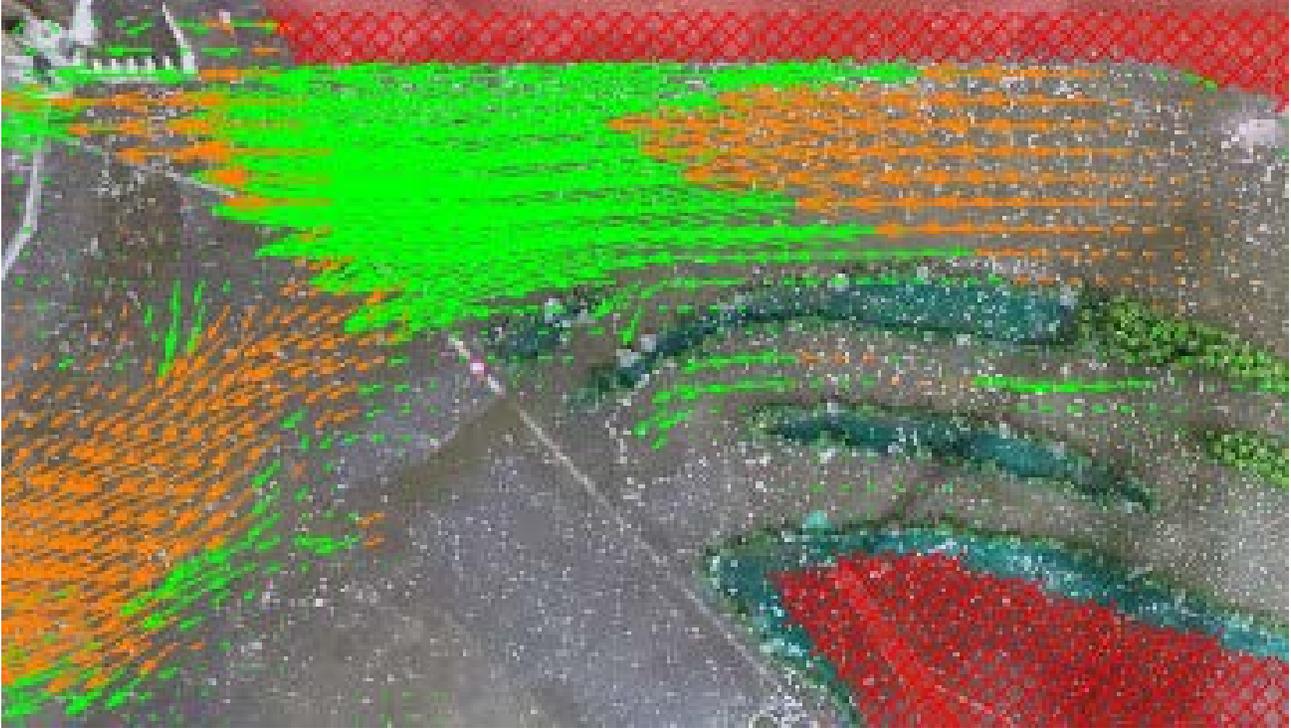
Image of LSPIV mean velocity vectors of the river modeled at the existing condition with River Q 5,000 cfs, Dam Q 5,000 cfs, Canal Q 0 cfs, with sluice gates open.

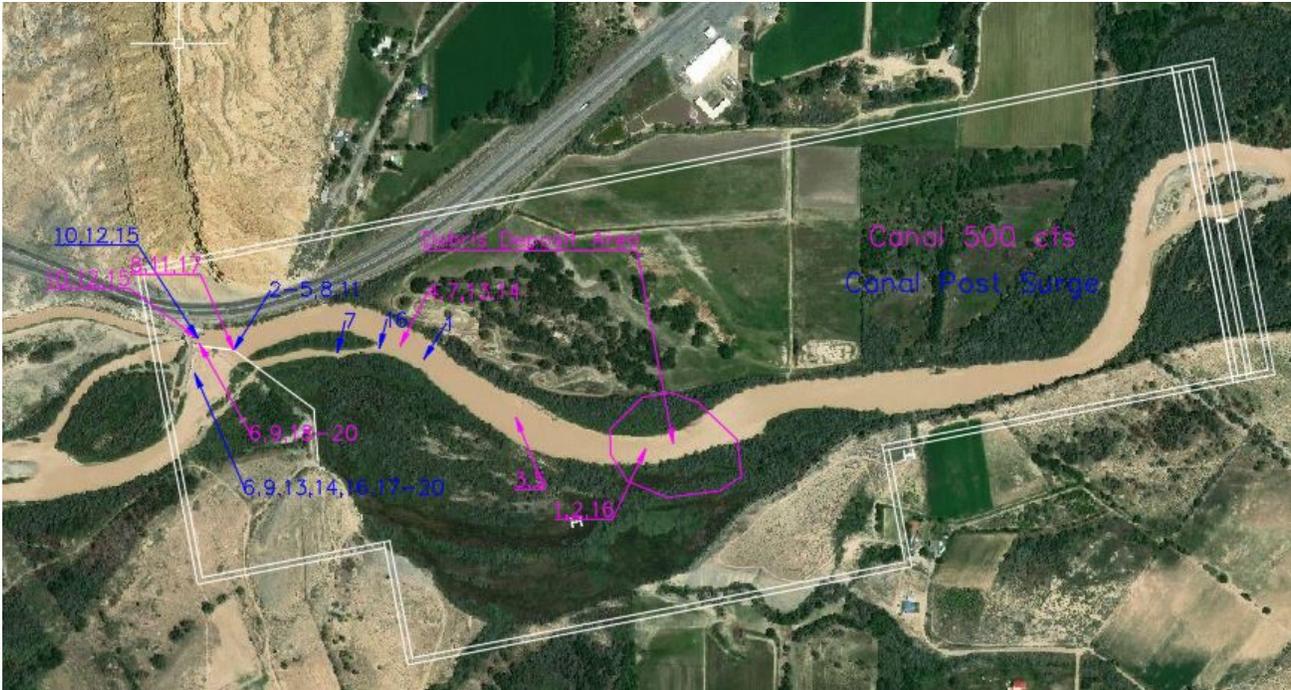
Image of debris capture location of the river modeled at the existing condition with River Q 5000 cfs and Canal Q 500 cfs, with sluice gates closed.

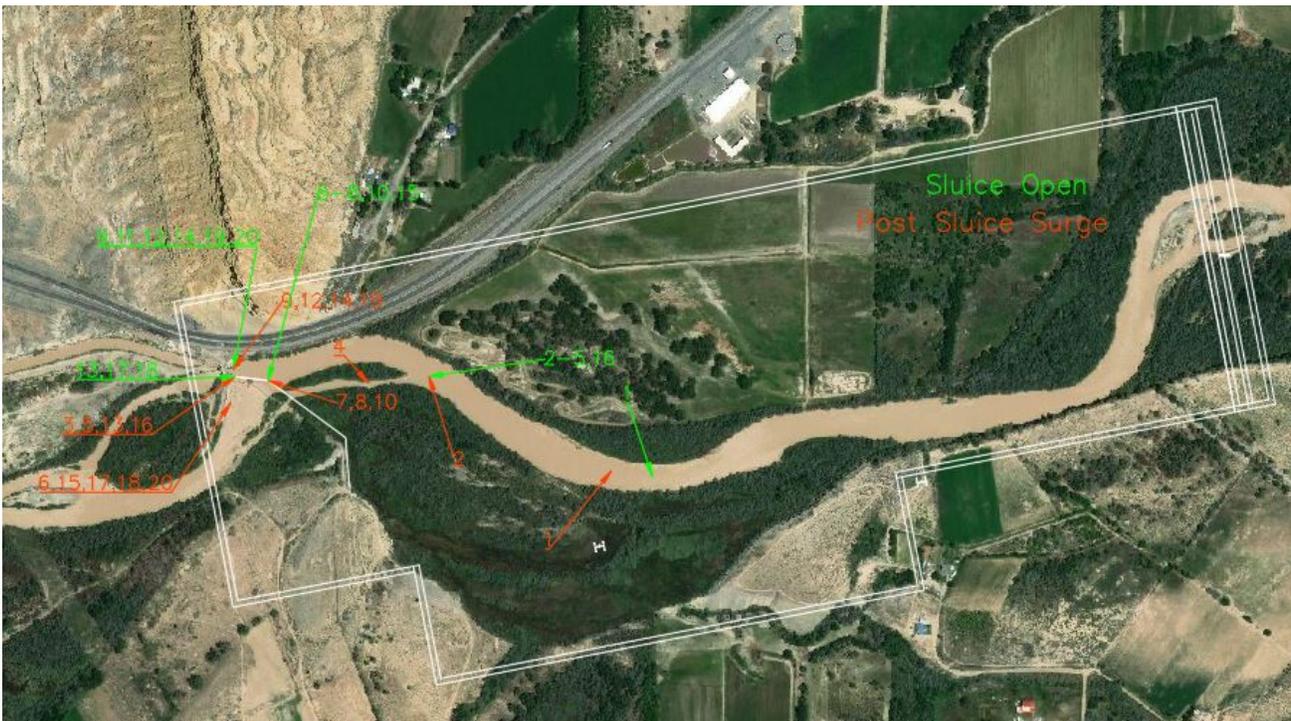
Image of debris capture location of the river modeled at the existing condition with River Q 5000 cfs and Canal Q 0 cfs, with sluice gates open.

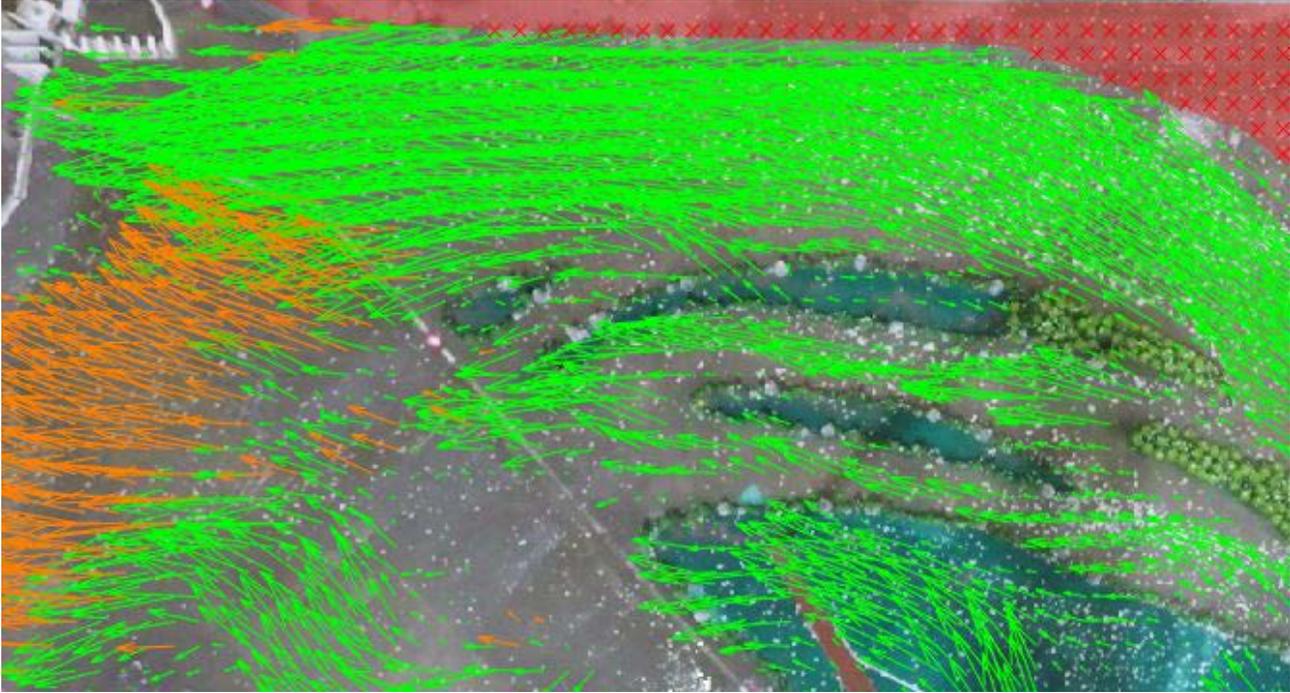
Image of LSPIV mean velocity vector of the river modeled at the existing condition with River Q 12,000 cfs, Dam Q 11400 cfs, Canal Q 600 cfs, with sluice gates closed.

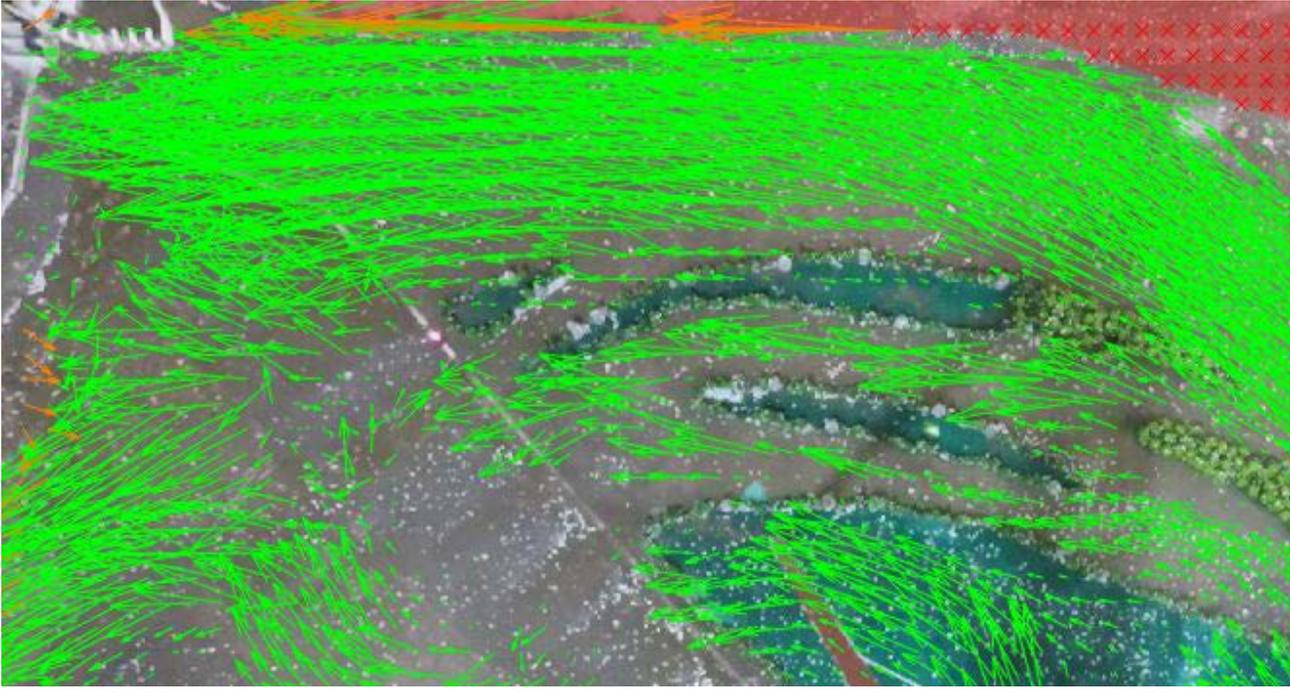
Image of LSPIV mean velocity vector of the river modeled at the existing condition with River Q 12,000 cfs, Dam Q 12,000 cfs, Canal Q 0 cfs, with sluice gates open.

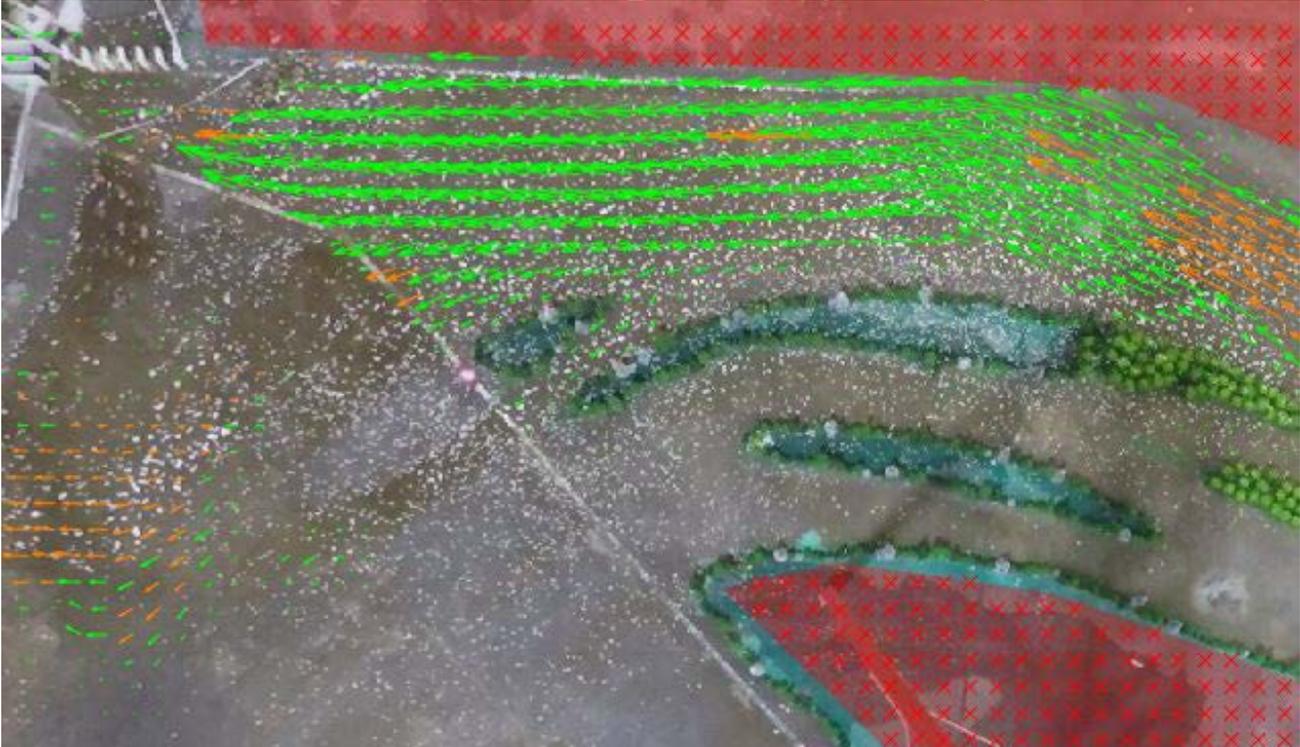
Image of RS1LB1 with LSPIV mean velocity vector at River Q 800 cfs, Dam Q 550 cfs, Canal Q 250 cfs, with sluice gates closed.

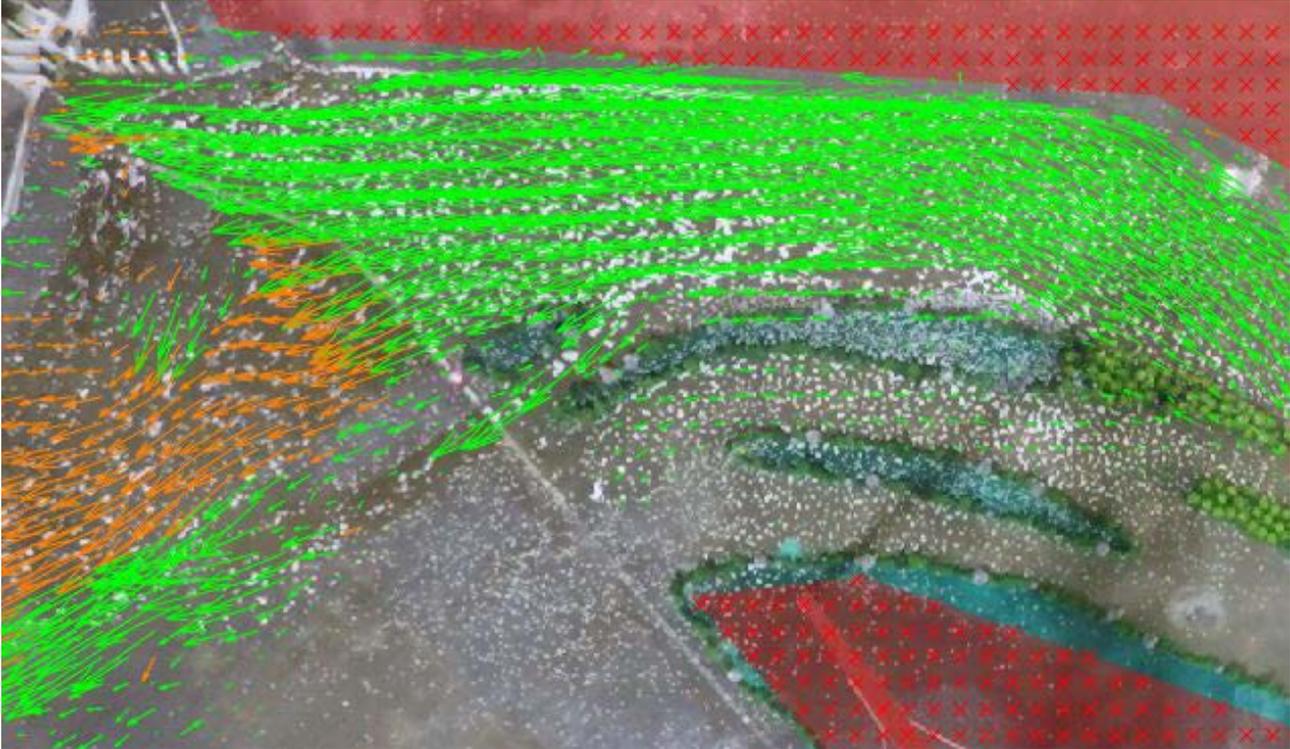
Image of RS1LB1 with LSPIV mean velocity vector at River Q 2,500 cfs, Dam Q 2100 cfs, Canal Q 400 cfs, with sluice gates closed.

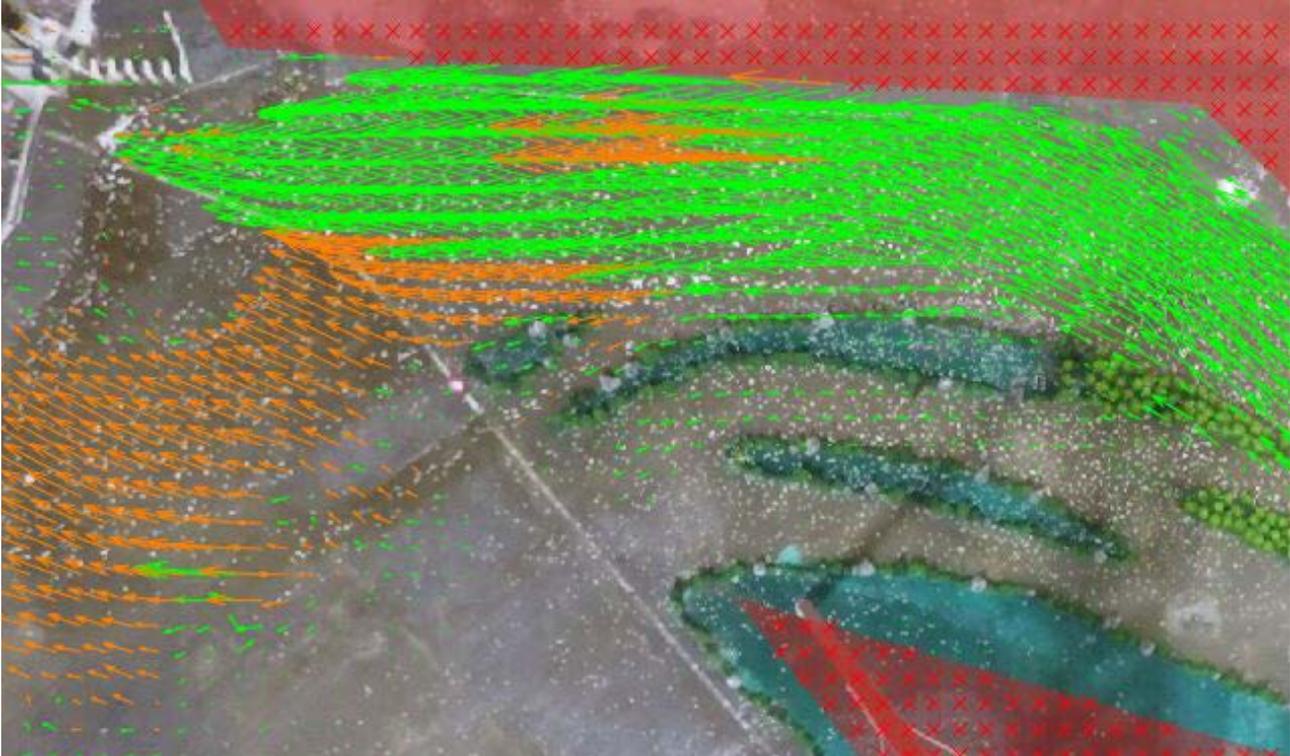
Image of RS1LB1 with LSPIV mean velocity vector at River Q 2,500 cfs, Dam Q 2,500 cfs, Canal Q 0 cfs, with sluice gates open.

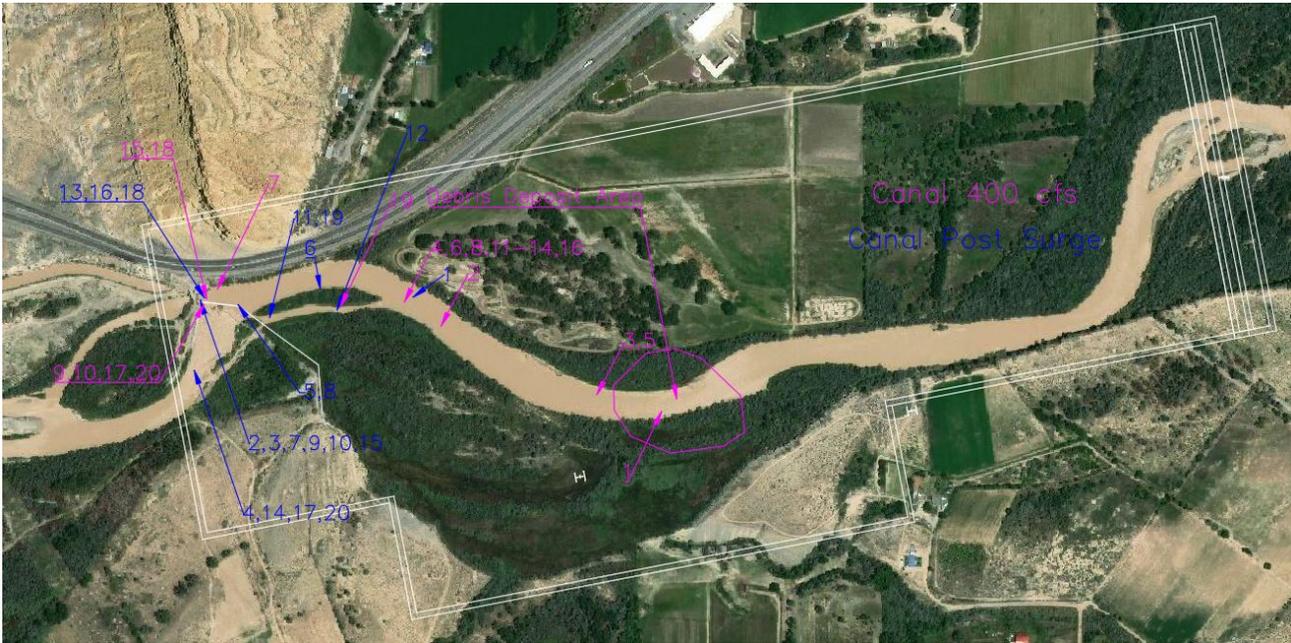
Image of debris capture location of the river modeled at the RS1LB1 condition with River Q 2500 cfs and Canal Q 400 cfs, with sluice gates closed.

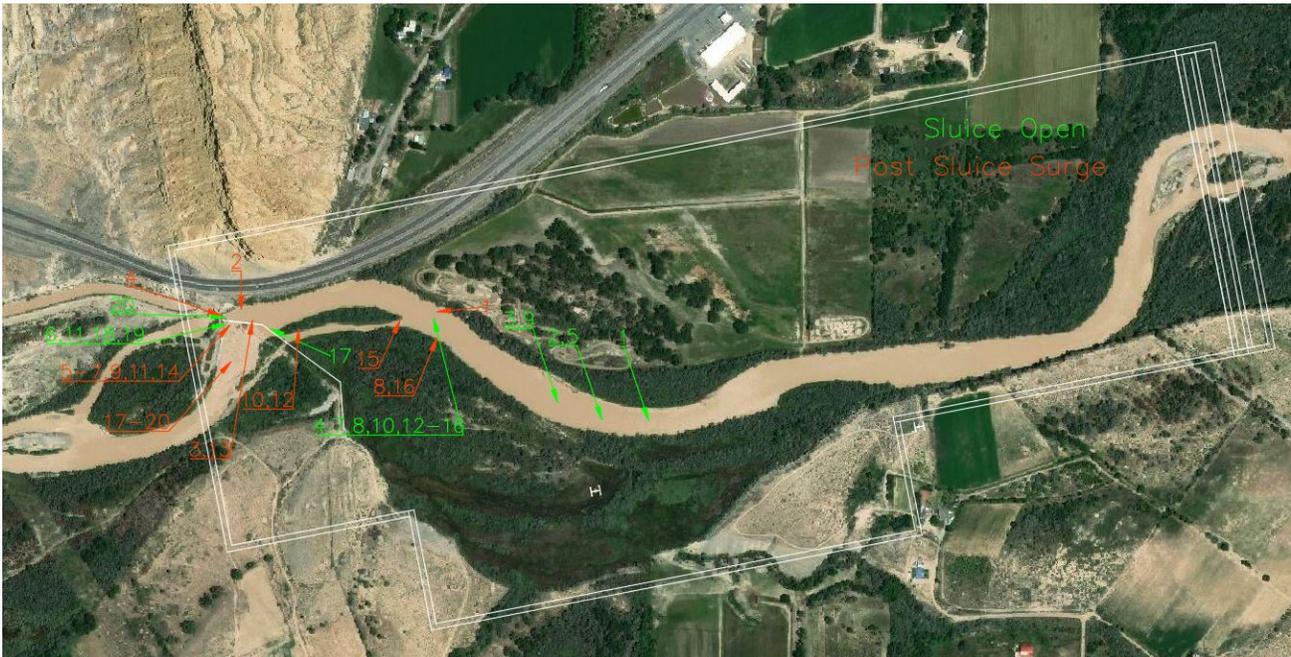
Image of debris capture location of the river modeled at the RS1LB1 condition with River Q 2500 cfs and Canal Q 0 cfs, with sluice gates open.

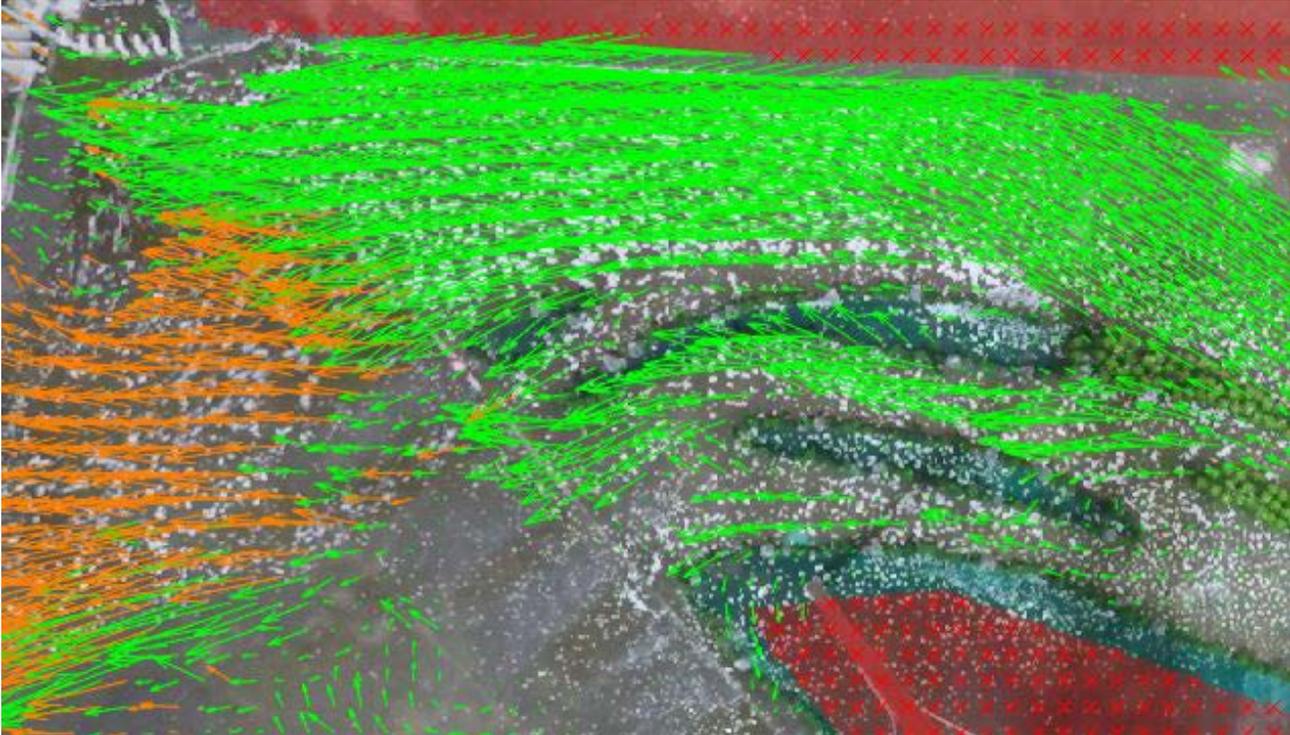
Image of RS1LB1 with LSPIV mean velocity vector at River Q 5,000 cfs, Dam Q 4500 cfs, Canal Q 500 cfs, with sluice gates closed.

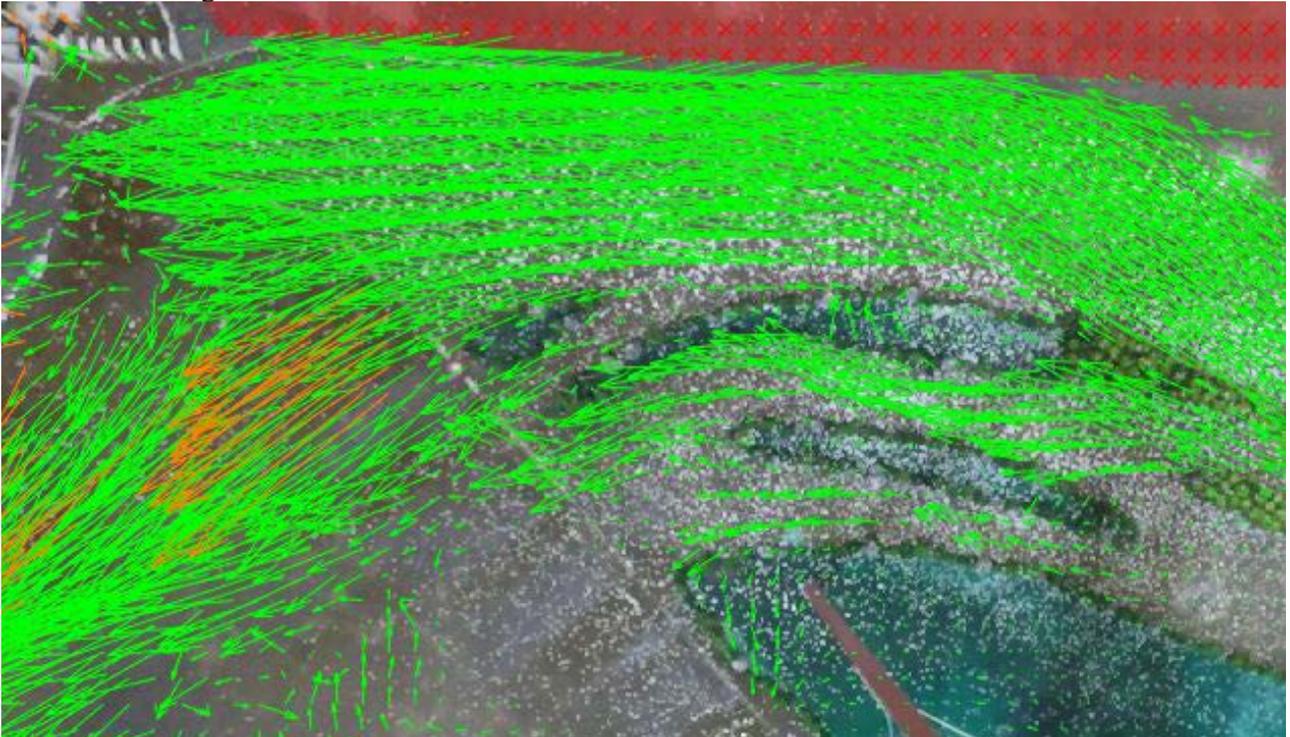
Image of RS1LB1 with LSPIV mean velocity vector at River Q 5,000 cfs, Dam Q 5,000 cfs, Canal Q 0 cfs, with sluice gates open.

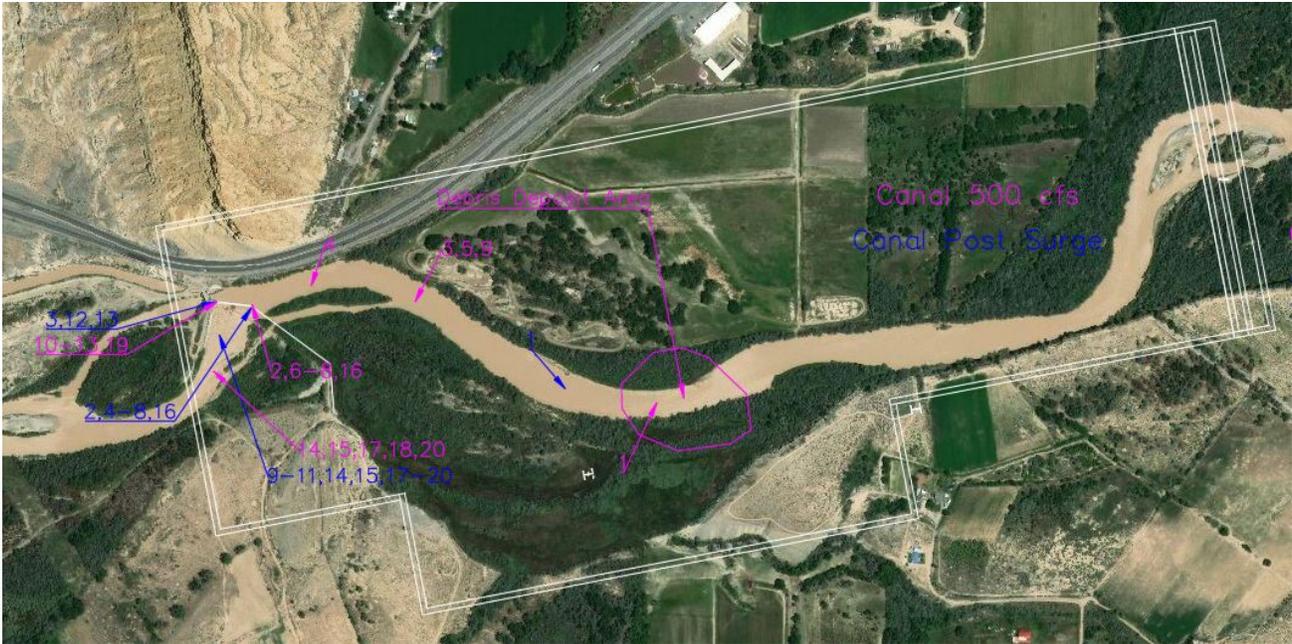
Image of debris capture location of the river modeled at the RS1LB1 condition with River Q 5000 cfs and Canal Q 500 cfs, with sluice gates closed.

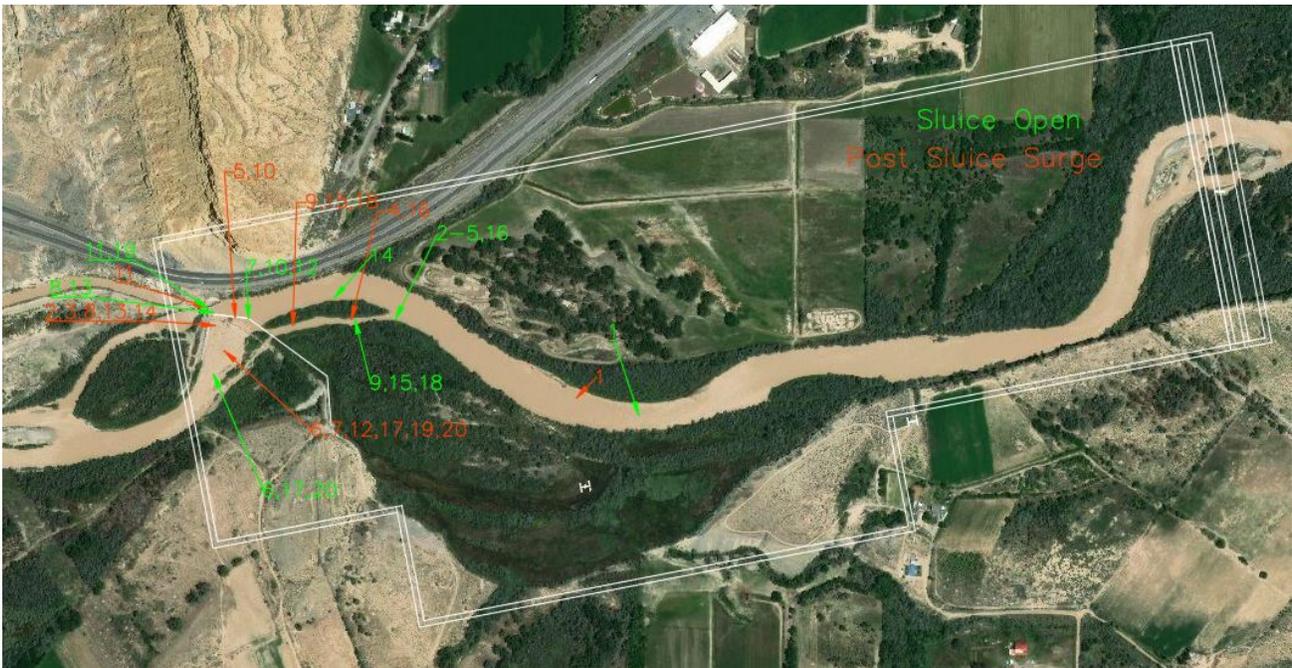
Image of debris capture location of the river modeled at the RS1LB1 condition with River Q 5000 cfs and Canal Q 0 cfs, with sluice gates open.

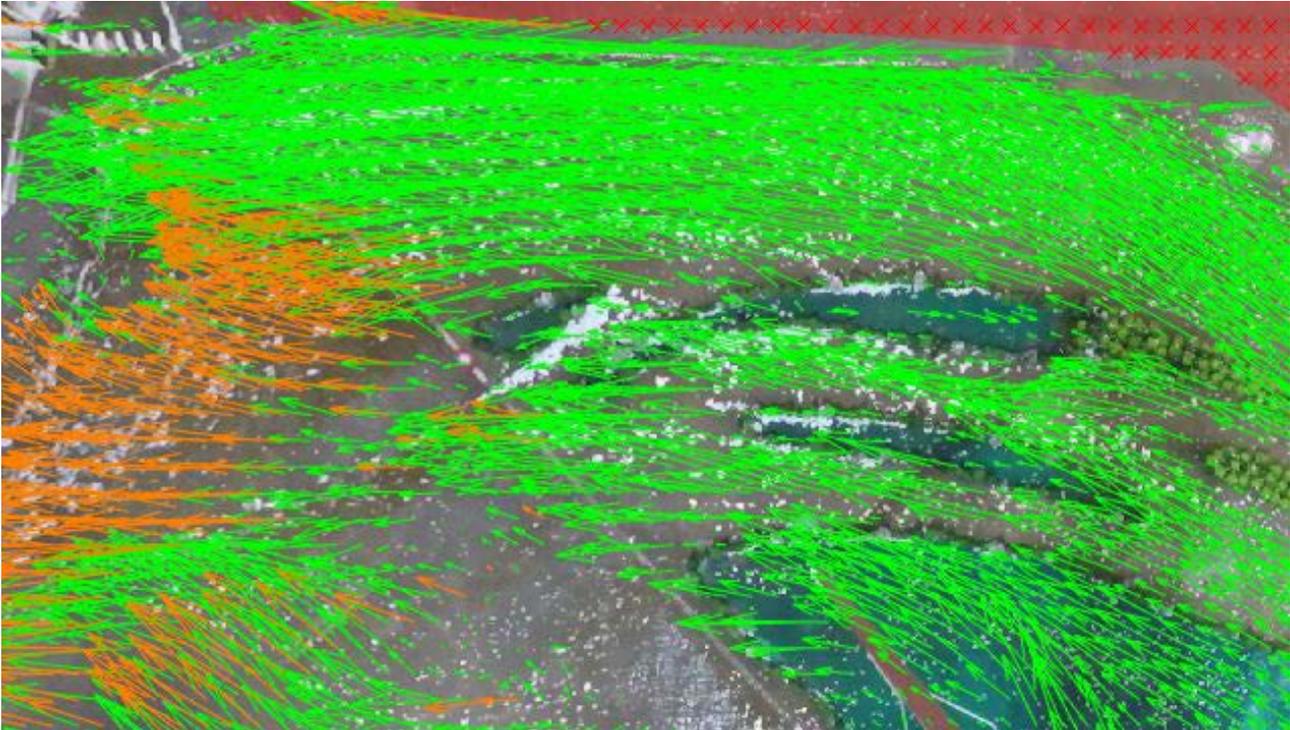
Image of RS1LB1 with LSPIV mean velocity vector at River Q 12,000 cfs, Dam Q 11400 cfs, Canal Q 600 cfs, with sluice gates closed.
