Hydraulic Laboratory Report HL-2019-04

Physical Hydraulic Model Study of Debris Management Alternatives for Hogback Diversion Dam

U.S. Department of the Interior
Bureau of Reclamation
Technical Service Center
Hydraulic Investigations and Laboratory Services Group
Denver, Colorado

August 2019

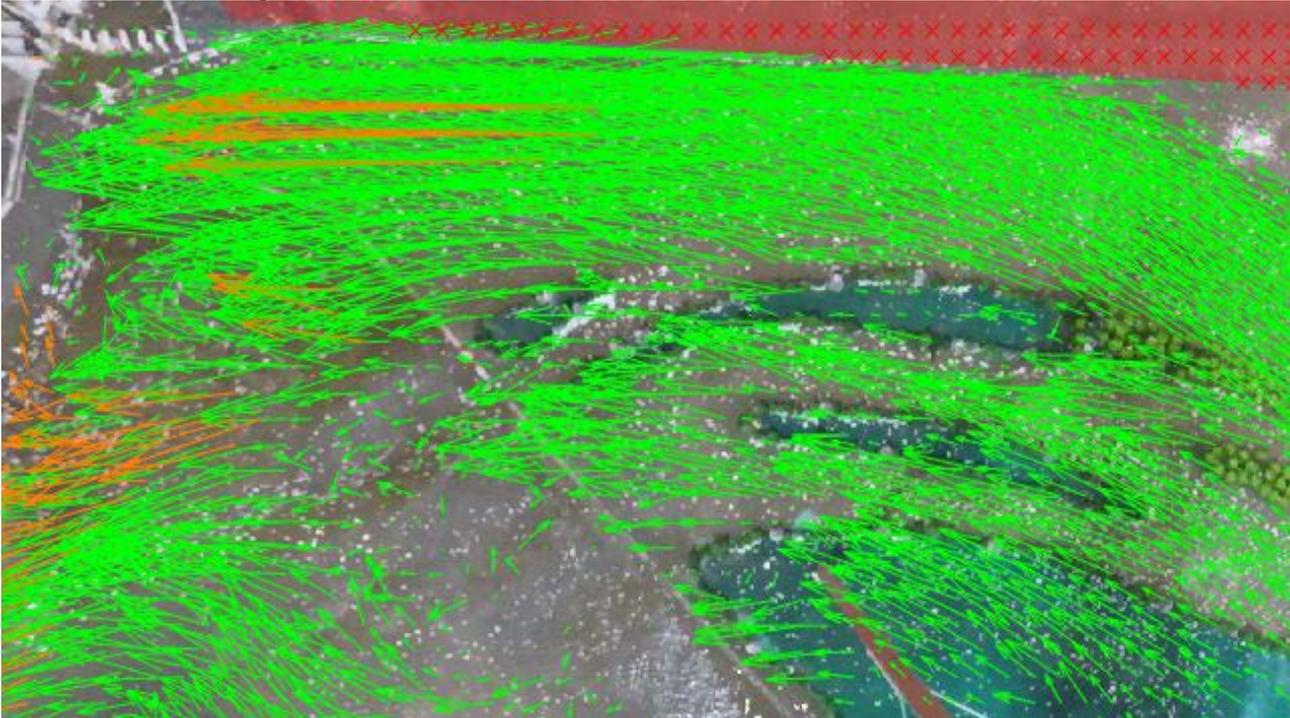
Image of RS1LB1 with LSPIV mean velocity vector at River Q 12,000 cfs, Dam Q 12,000 cfs, Canal Q 0 cfs, with sluice gates open.

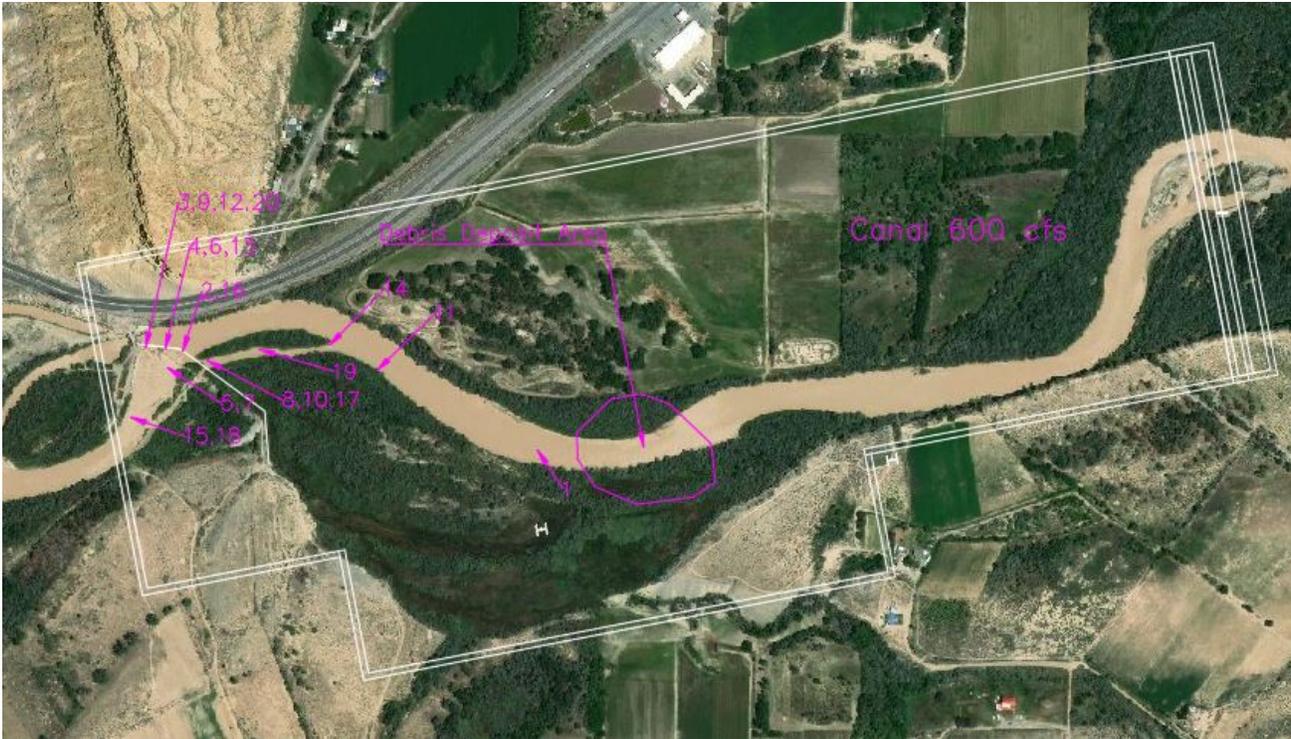
Image of debris capture location of the river modeled at the RS1LB1 condition with River Q 12000 cfs and Canal Q 600 cfs, with sluice gates closed.

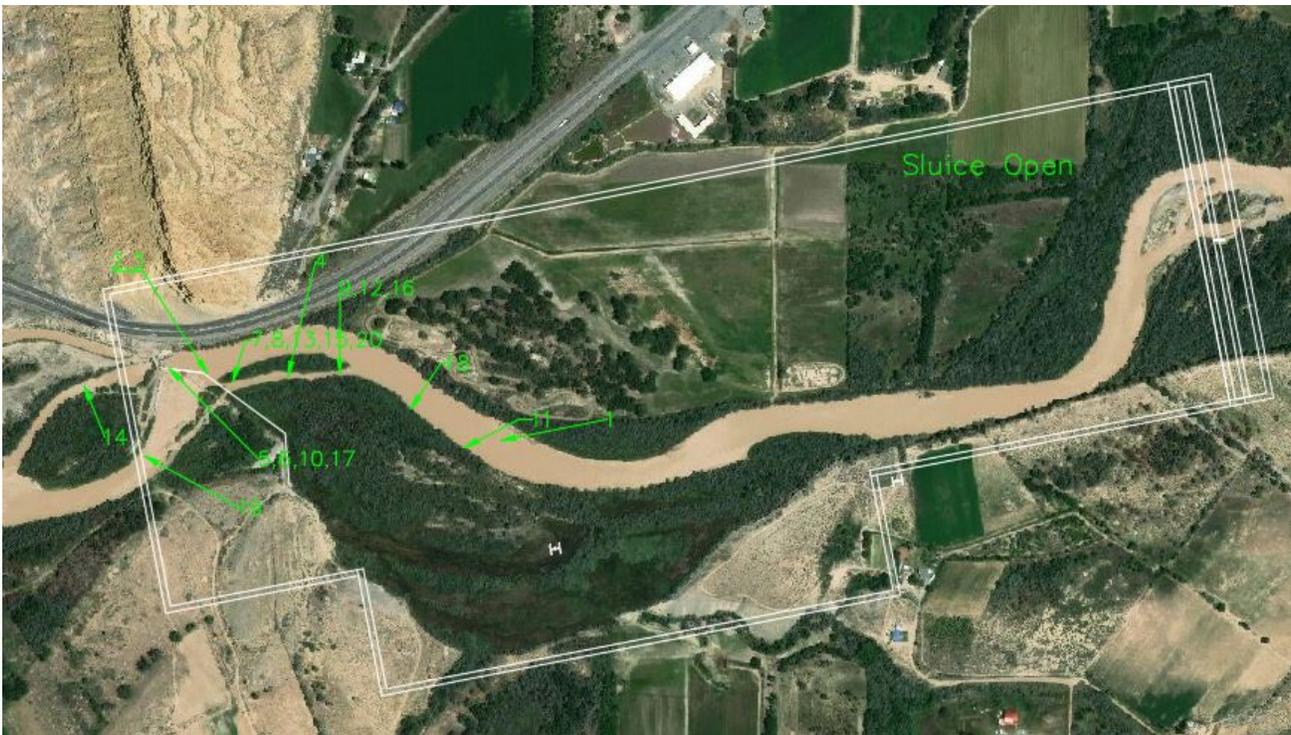
Image of debris capture location of the river modeled at the RS1LB1 condition with River Q 12000 cfs and Canal Q 0 cfs, with sluice gates open.

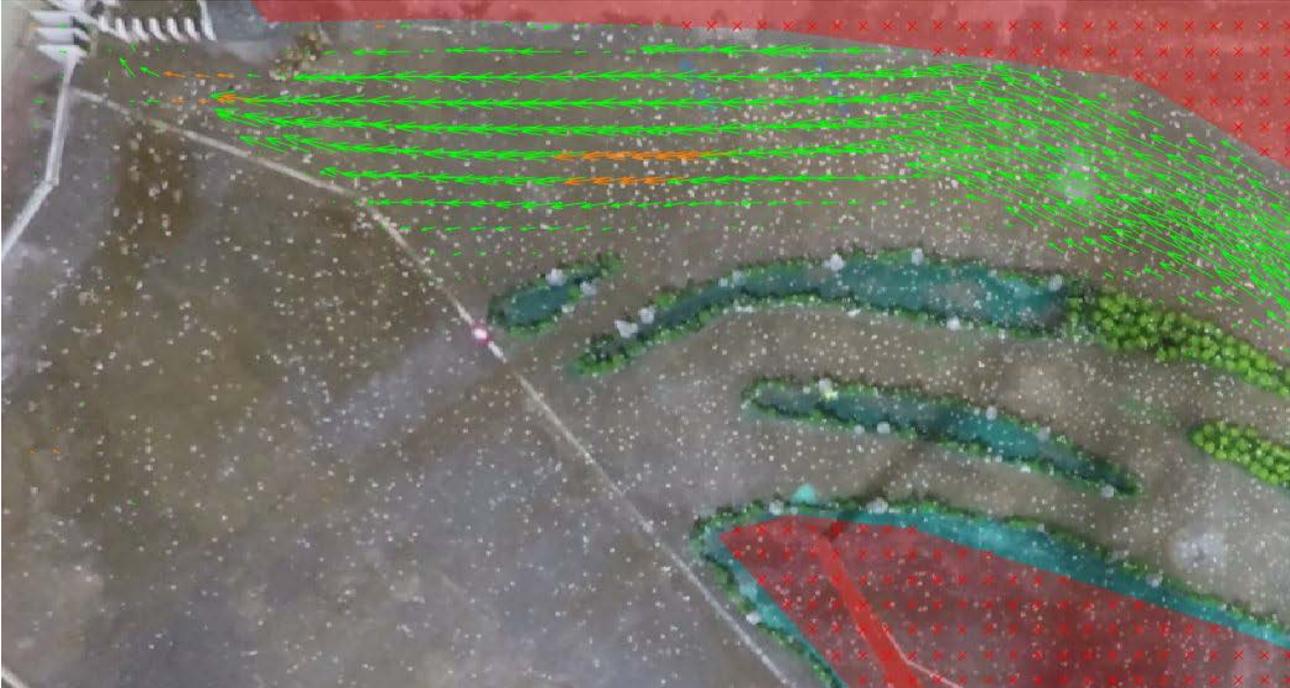
Image of RS1 with LSPIV mean velocity vector at River Q 800 cfs, Dam Q 650 cfs, Canal Q 250 cfs, with sluice gates closed.

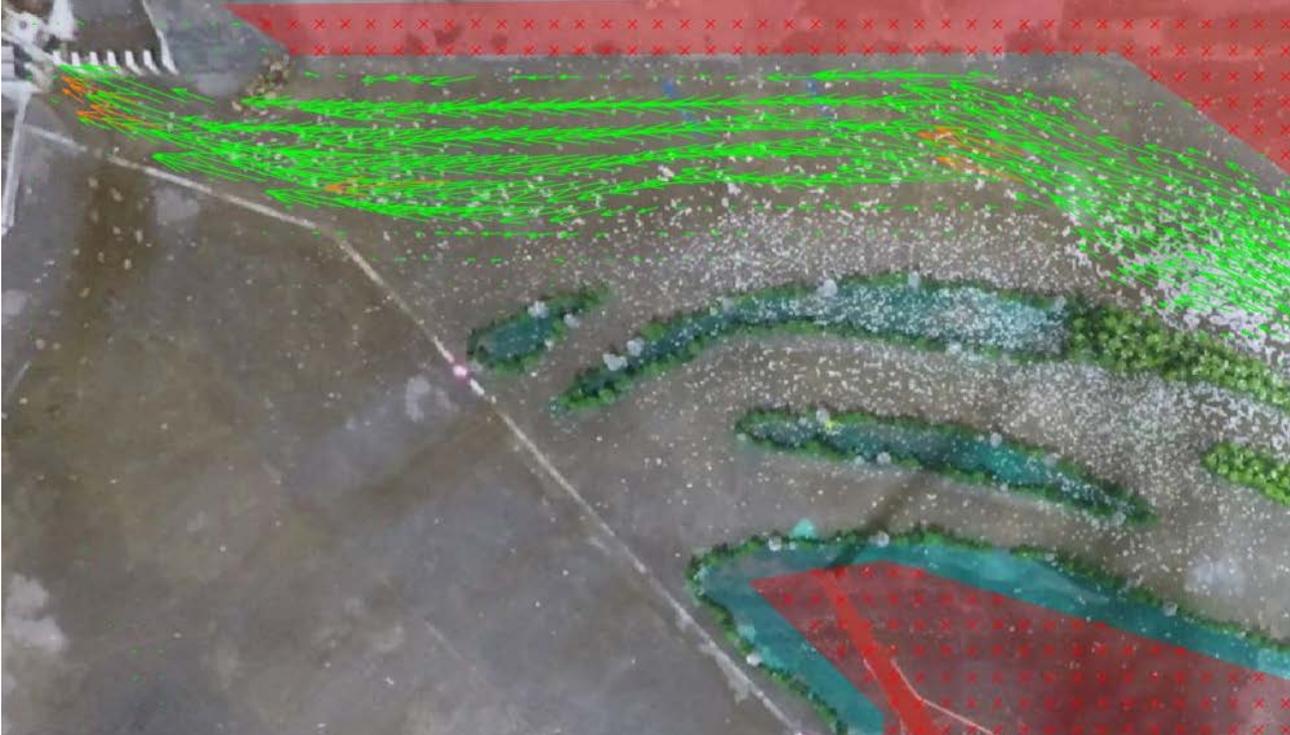
Image of RS1 with LSPIV mean velocity vector at River Q 800 cfs, Dam Q 800 cfs, Canal Q 0 cfs, with sluice gates open.

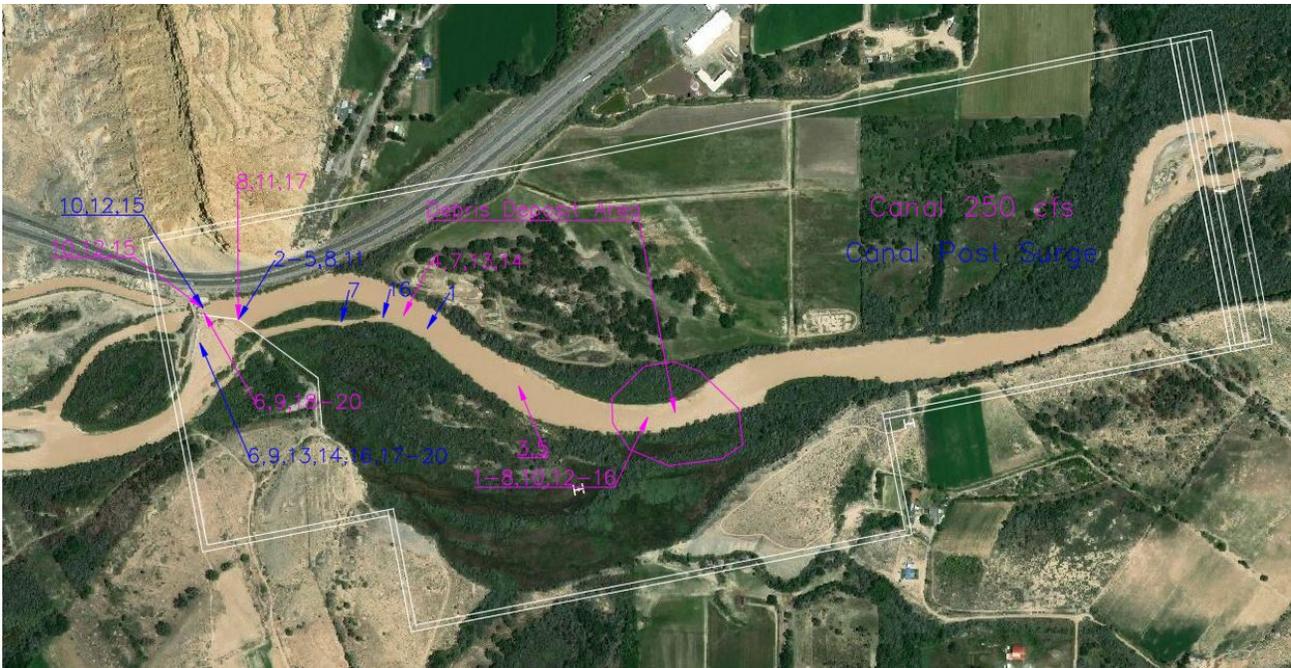
Image of debris capture location of the river modeled at the RS1 condition with River Q 800 cfs and Canal Q 250 cfs, with sluice gates closed.

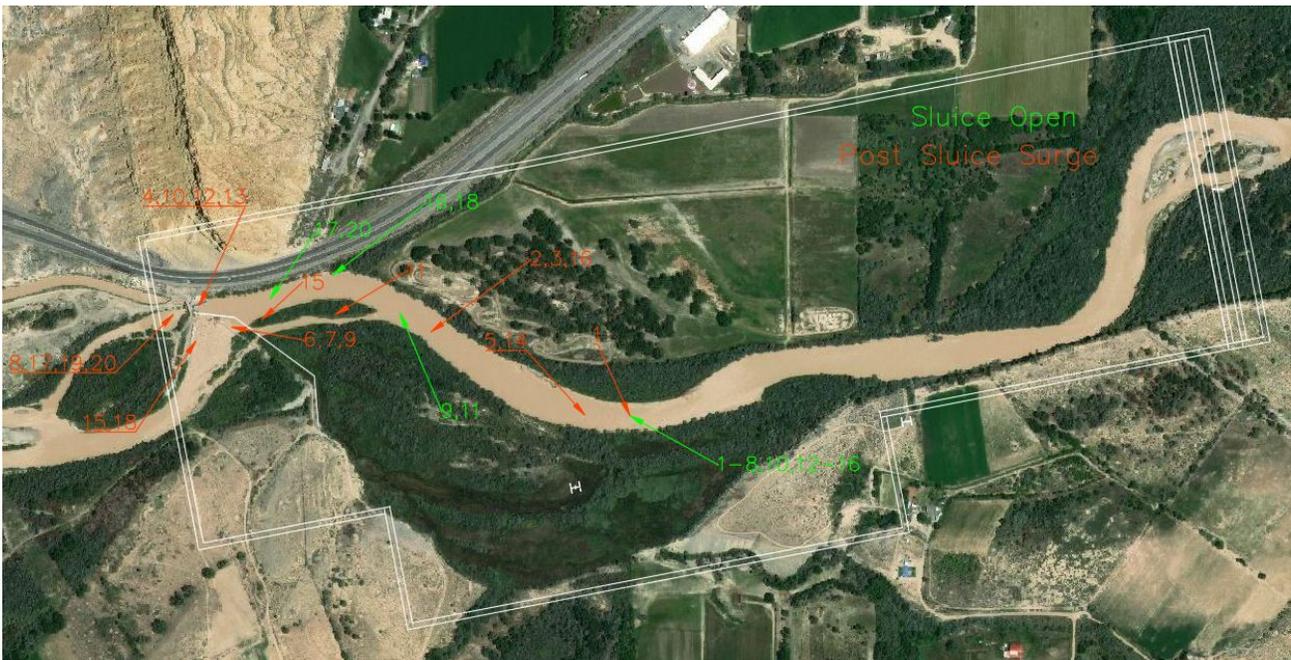
Image of debris capture location of the river modeled at the RS1 condition with River Q 800 cfs and Canal Q 0 cfs, with sluice gates open.

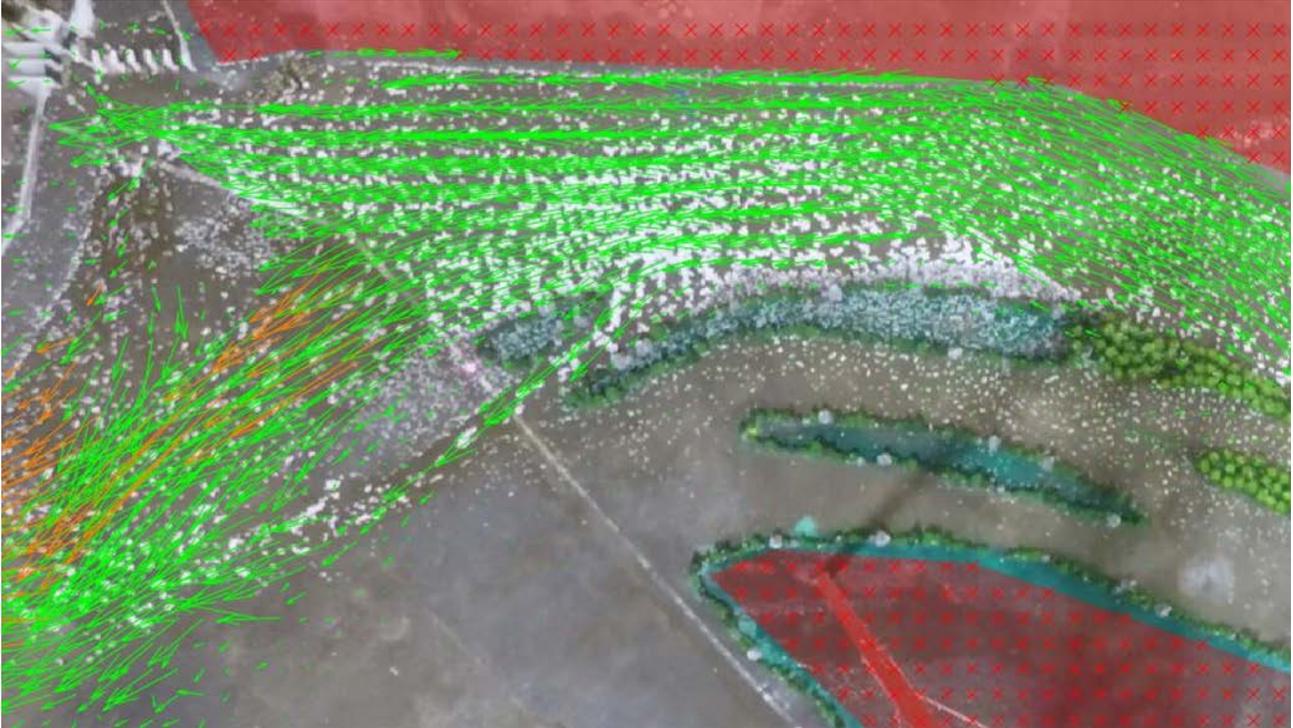
Image of RS1 with LSPIV mean velocity vector at River Q 2,500 cfs, Dam Q 2100 cfs, Canal Q 400 cfs, with sluice gates closed. Notice recirculation behind trashrack and velocities exiting upstream end of trashrack.

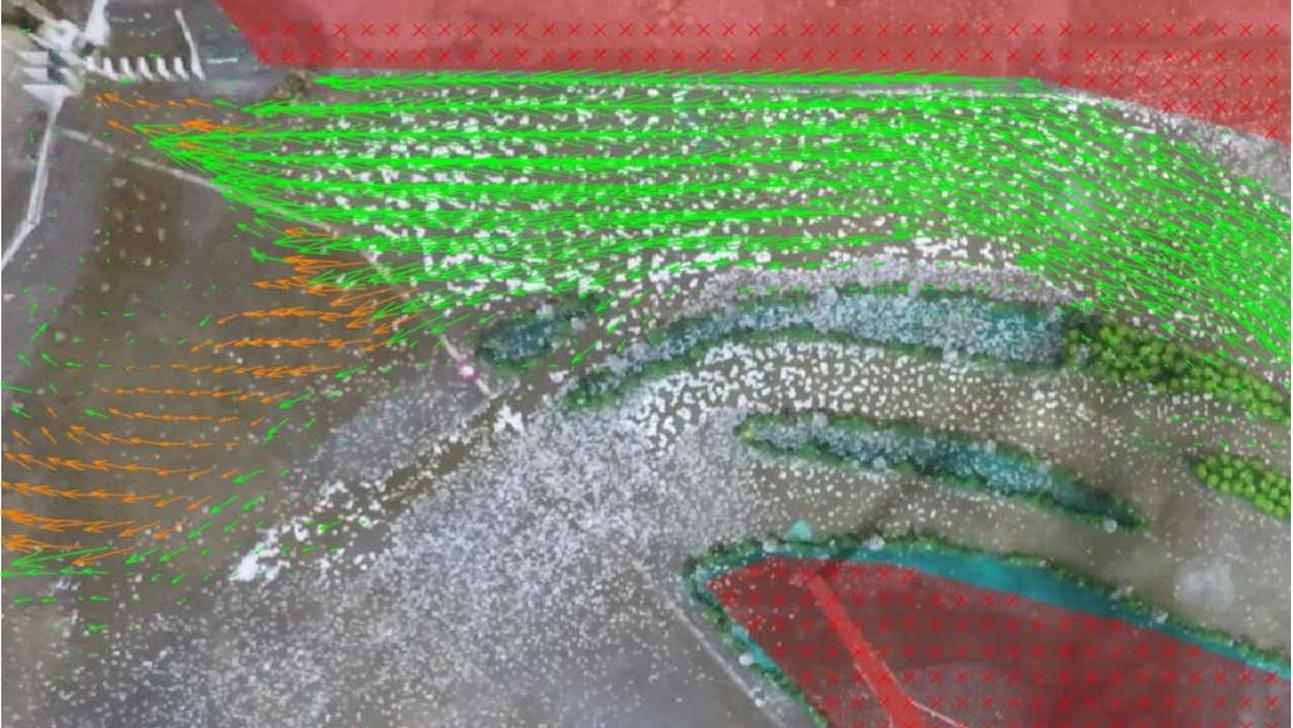
Image of RS1 with LSPIV mean velocity vector at River Q 2,500 cfs, Dam Q 2,500 cfs, Canal Q 0 cfs, with sluice gates open.

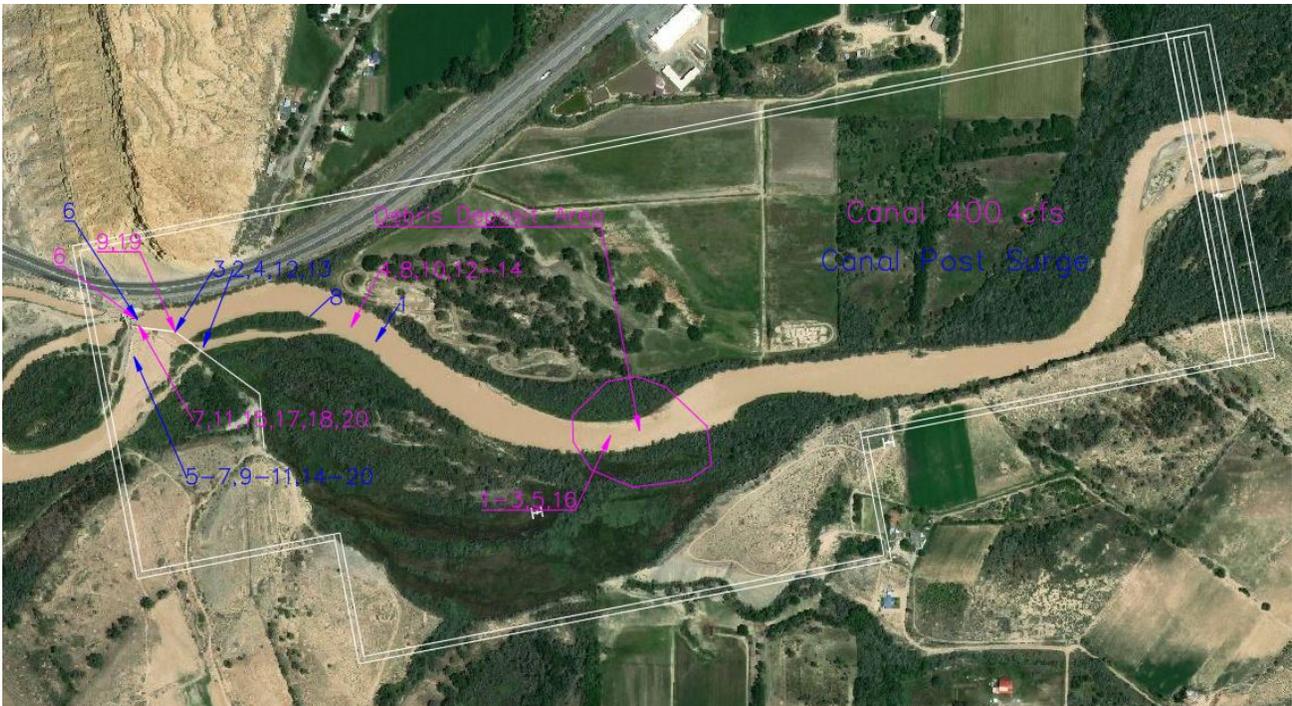
Image of debris capture location of the river modeled at the RS1 condition with River Q 2500 cfs and Canal Q 400 cfs, with sluice gates closed.

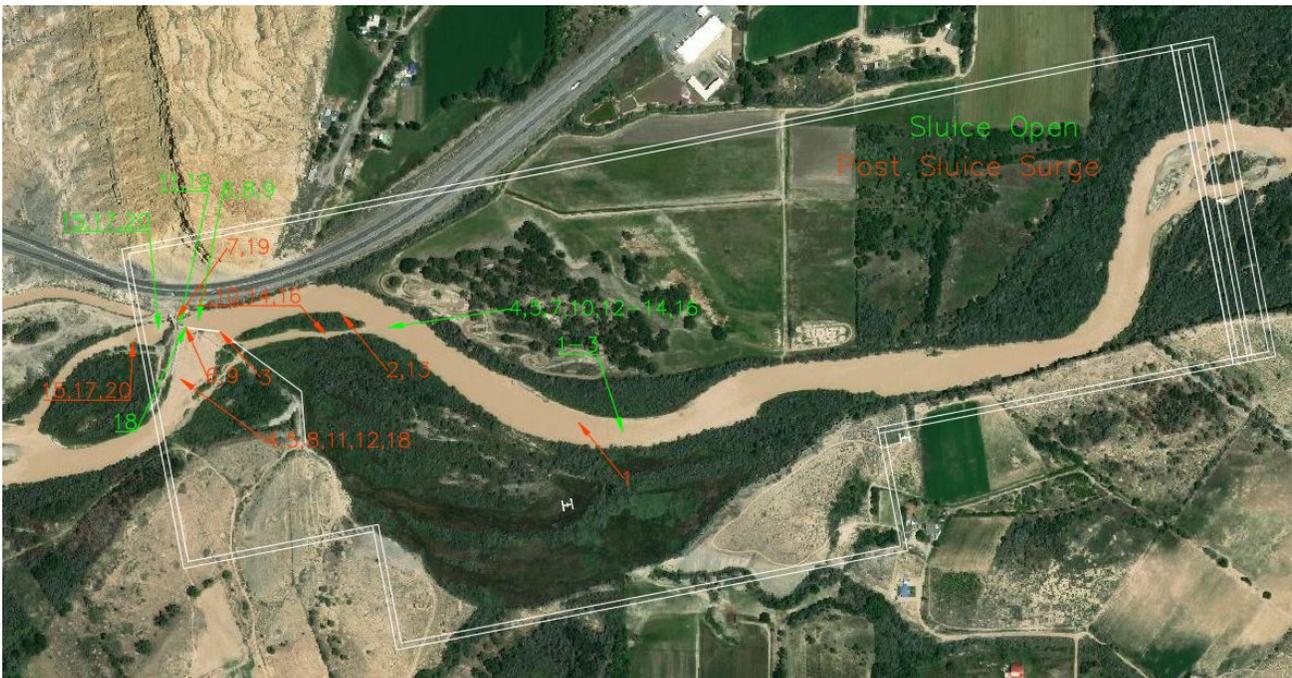
Image of debris capture location of the river modeled at the RS1 condition with River Q 2500 cfs and Canal Q 0 cfs, with sluice gates open.

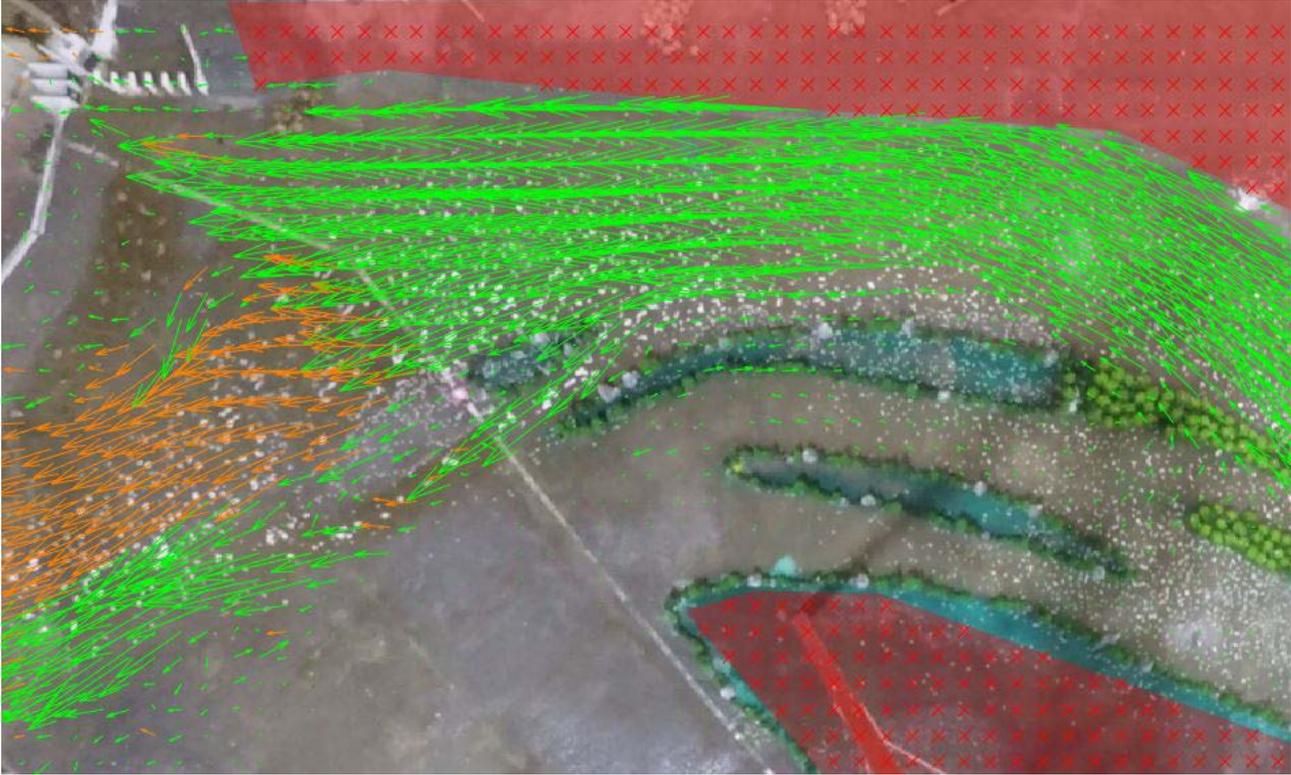
Image of RS1 with LSPIV mean velocity vector at River Q 5,000 cfs, Dam Q 4500 cfs, Canal Q 500 cfs, with sluice gates closed.

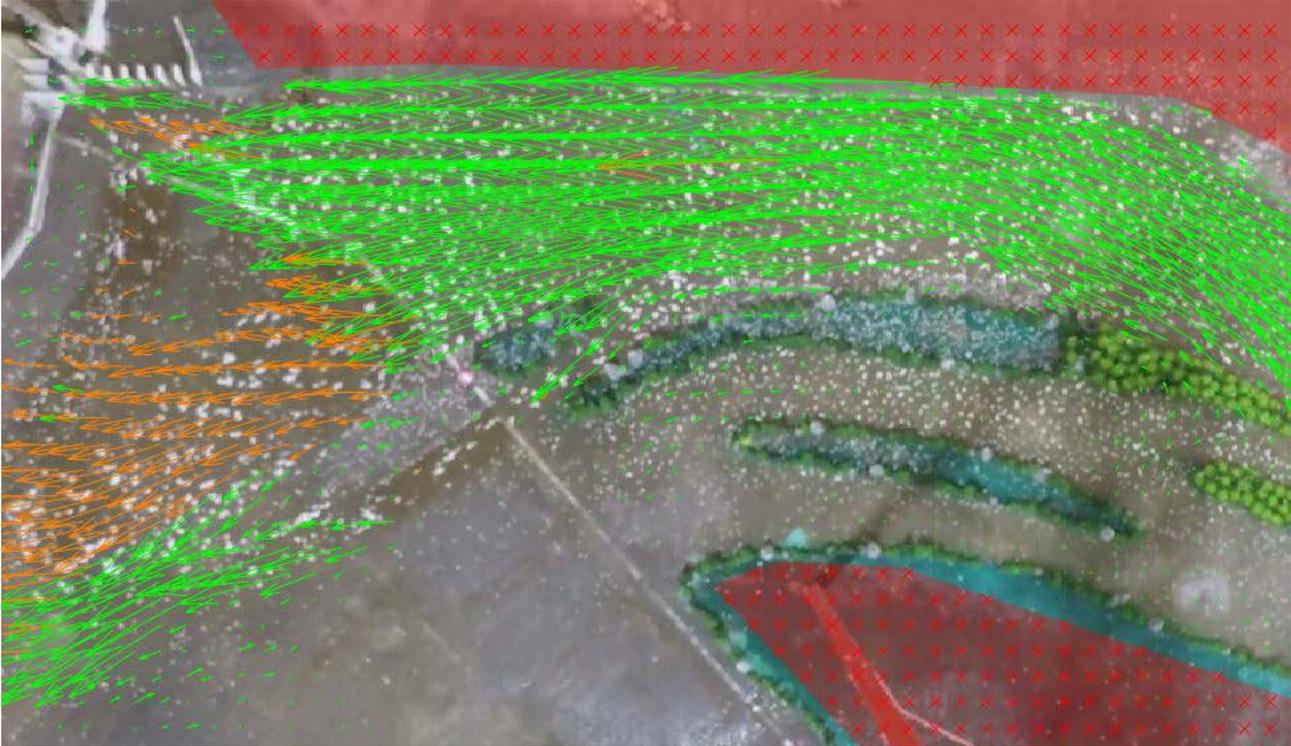
Image of RS1 with LSPIV mean velocity vector at River Q 5,000 cfs, Dam Q 5,000 cfs, Canal Q 0 cfs, with sluice gates open.

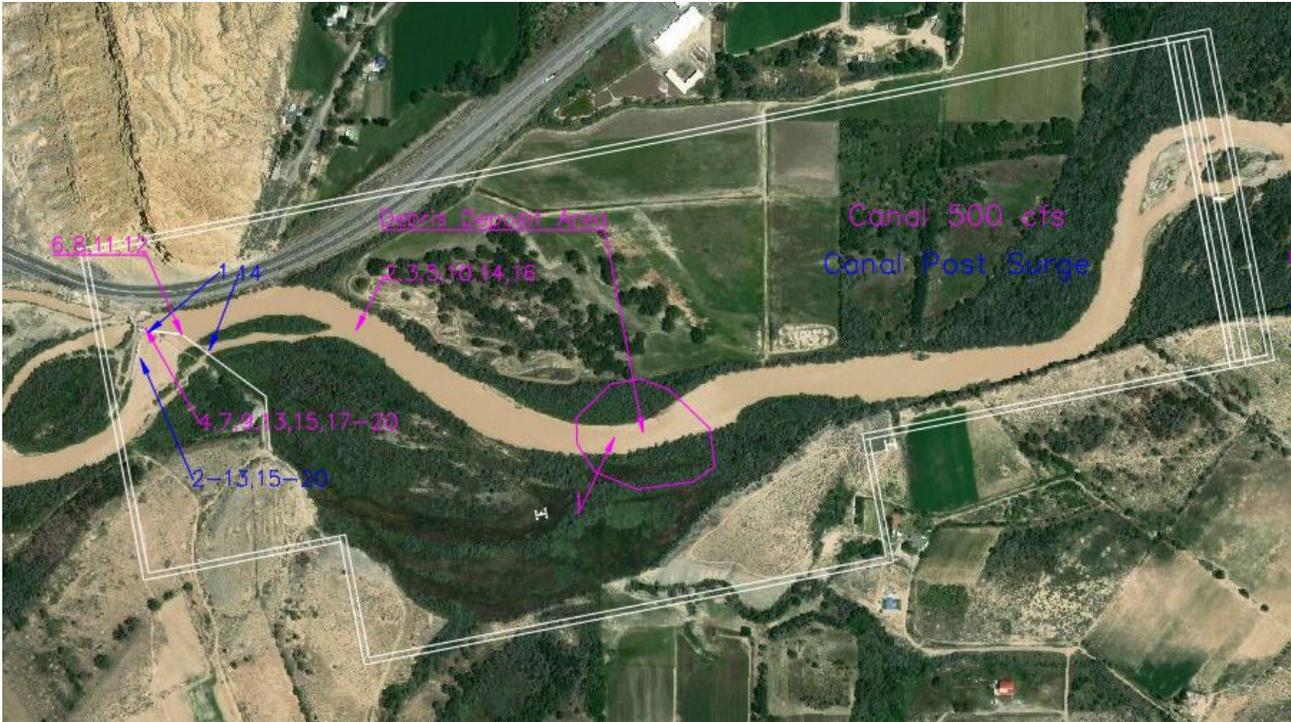
Image of debris capture location of the river modeled at the RS1 condition with River Q 5000 cfs and Canal Q 500 cfs, with sluice gates closed.

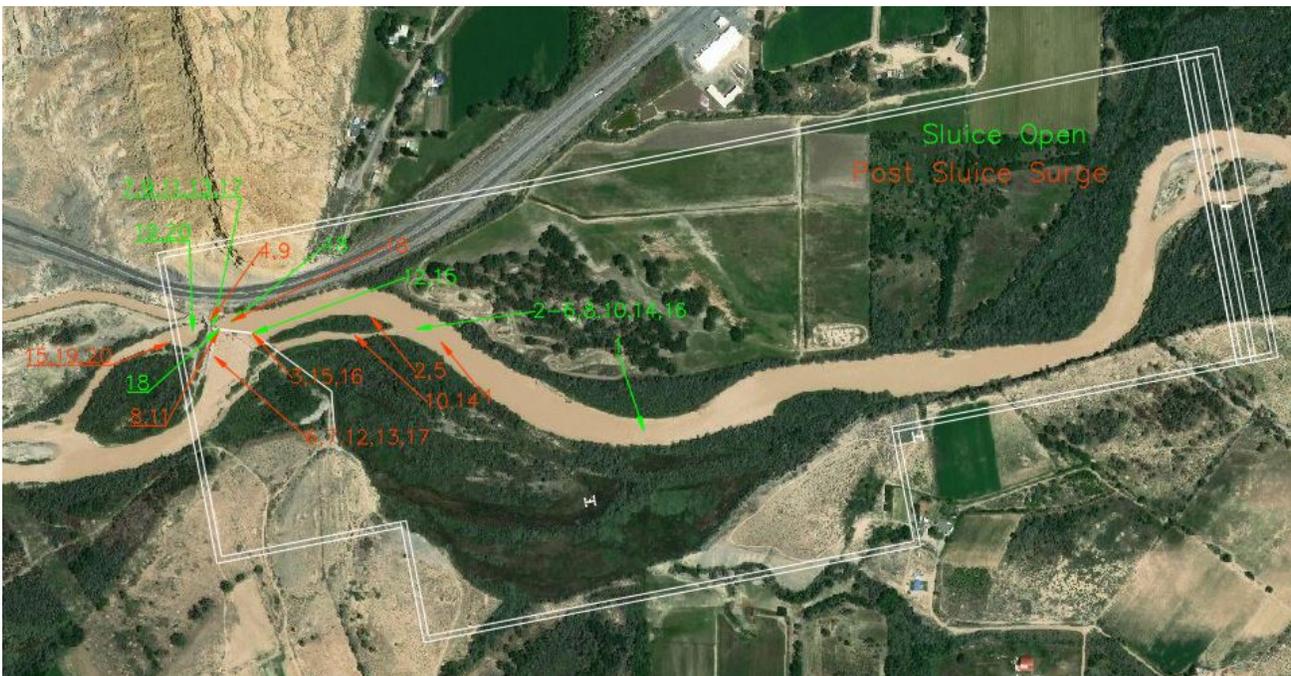
Image of debris capture location of the river modeled at the RS1 condition with River Q 5000 cfs and Canal Q 0 cfs, with sluice gates open.

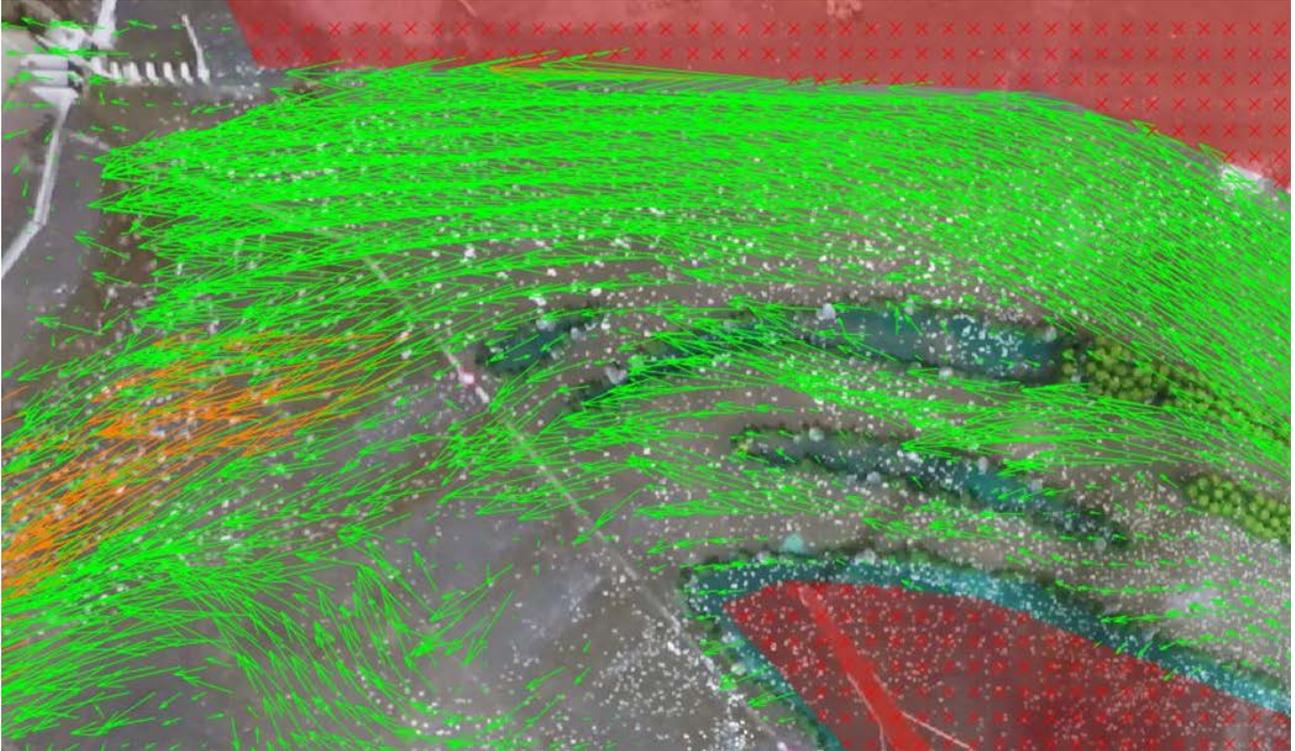
Image of RS1 with LSPIV mean velocity vector at River Q 12,000 cfs, Dam Q 11400 cfs, Canal Q 600 cfs, with sluice gates closed.

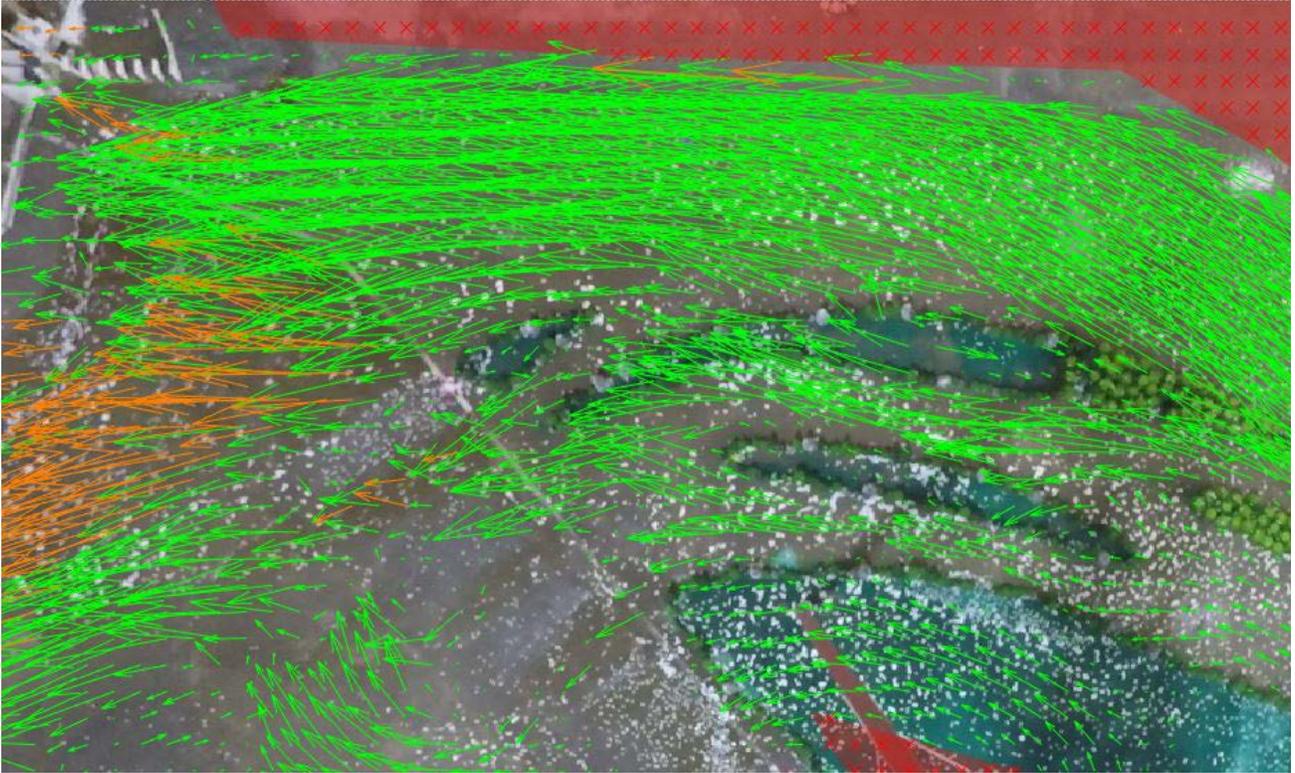
Image of RS1 with LSPIV mean velocity vector at River Q 12,000 cfs, Dam Q 12,000 cfs, Canal Q 0 cfs, with sluice gates open.

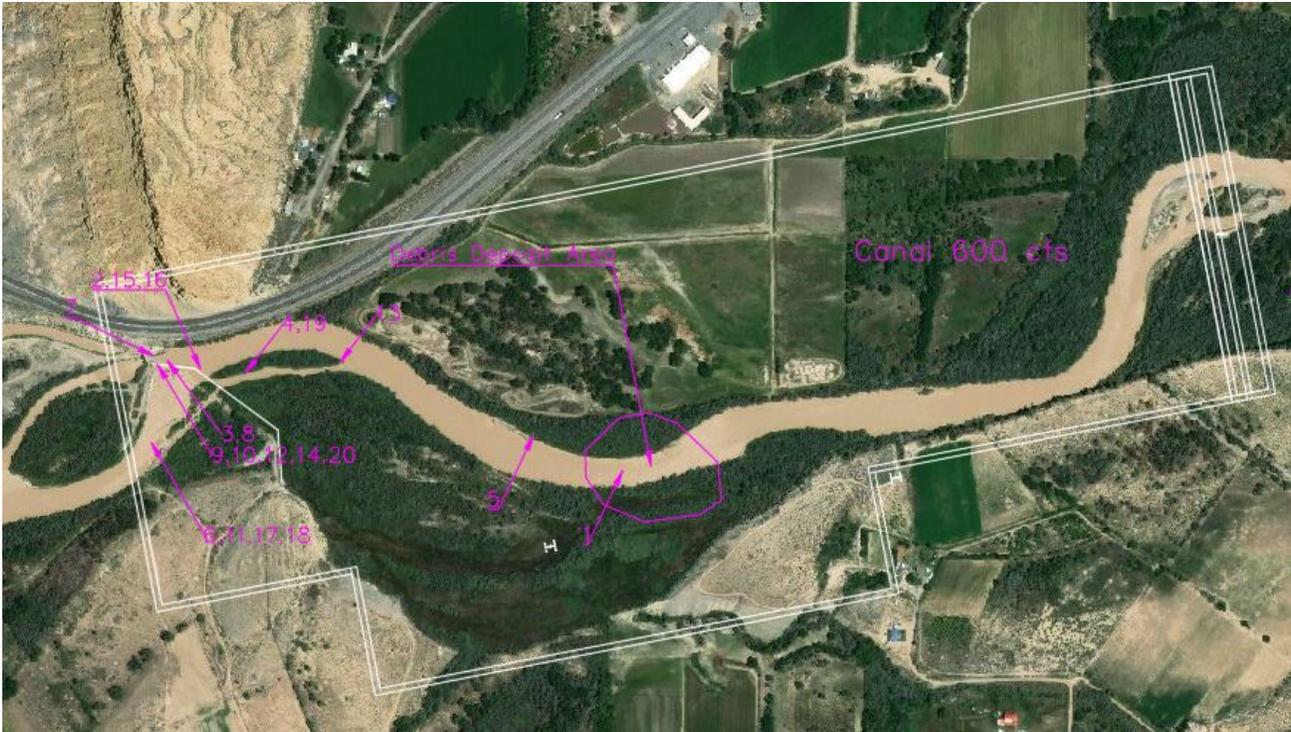
Image of debris capture location of the river modeled at the RS1 condition with River Q 12000 cfs and Canal Q 600 cfs, with sluice gates closed.

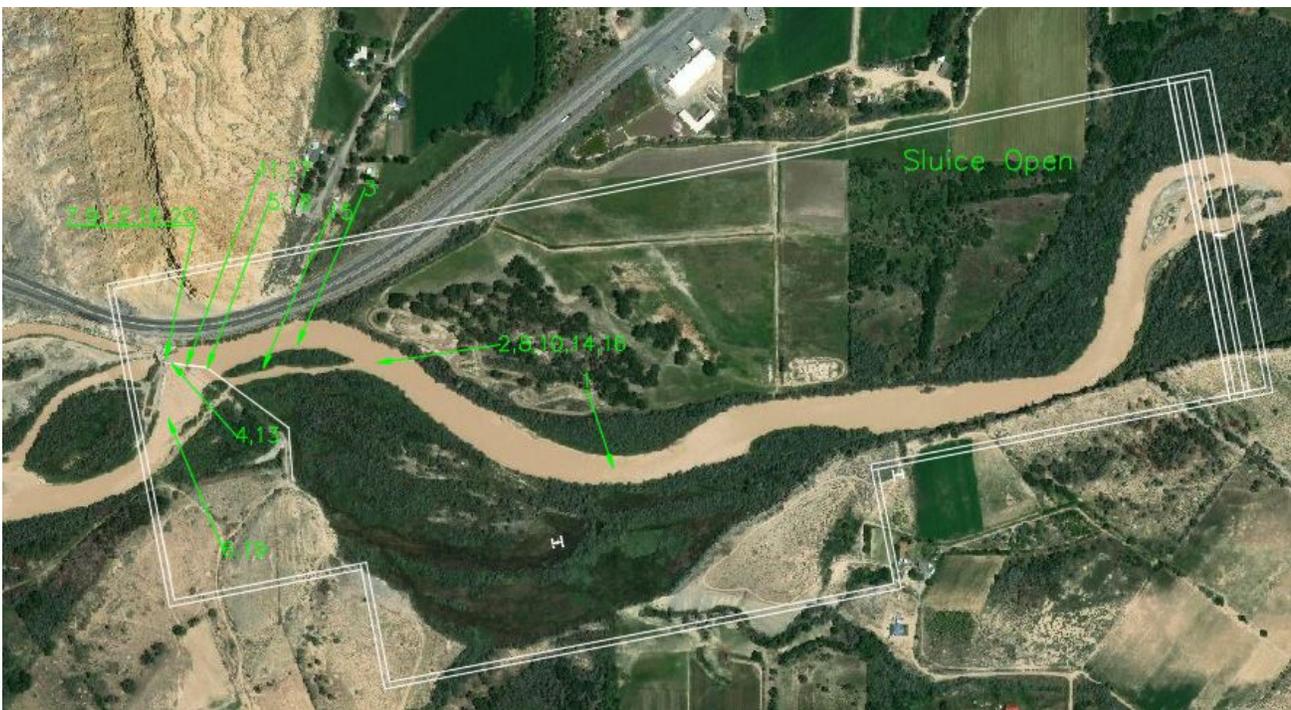
Image of debris capture location of the river modeled at the RS1 condition with River Q 12000 cfs and Canal Q 0 cfs, with sluice gates open.

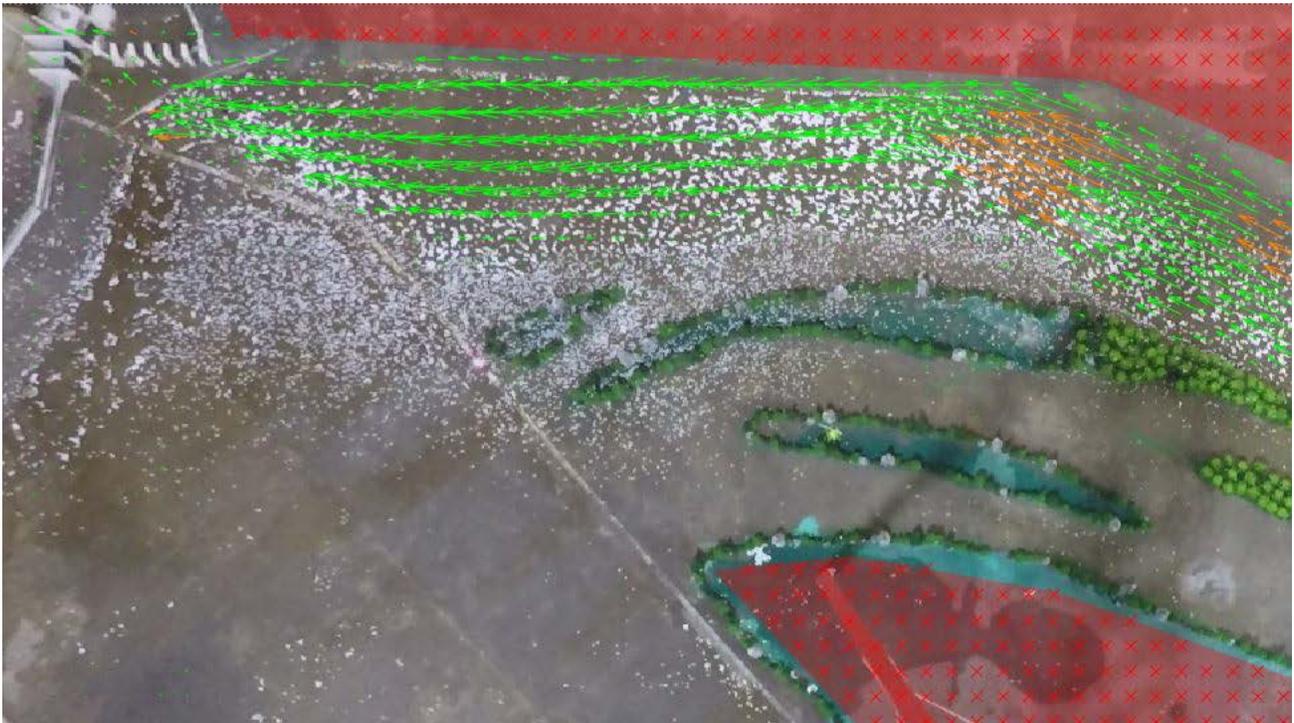
Image of LB1 with LSPIV mean velocity vector at River Q 800 cfs, Dam Q 550 cfs, Canal Q 250 cfs, with sluice gates closed.

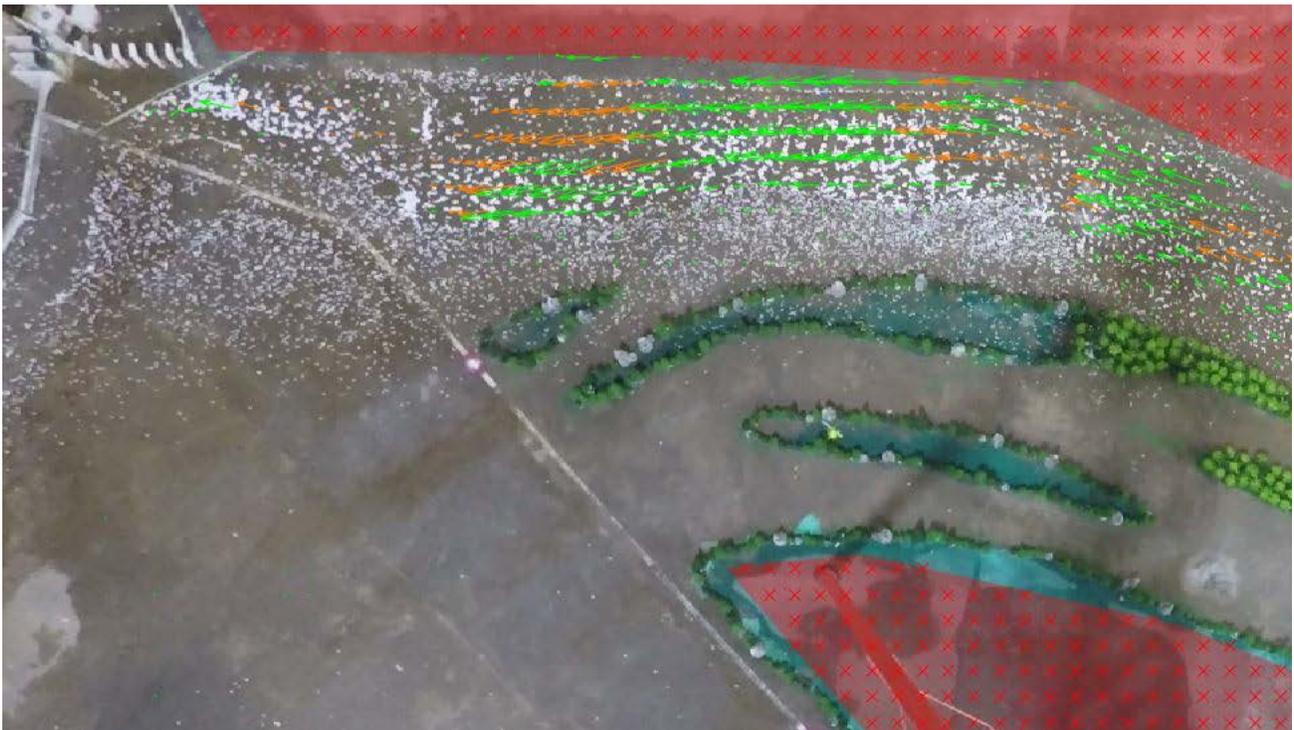
Image of LB1 with LSPIV mean velocity vector at River Q 800 cfs, Dam Q 800 cfs, Canal Q 0 cfs, with sluice gates open.

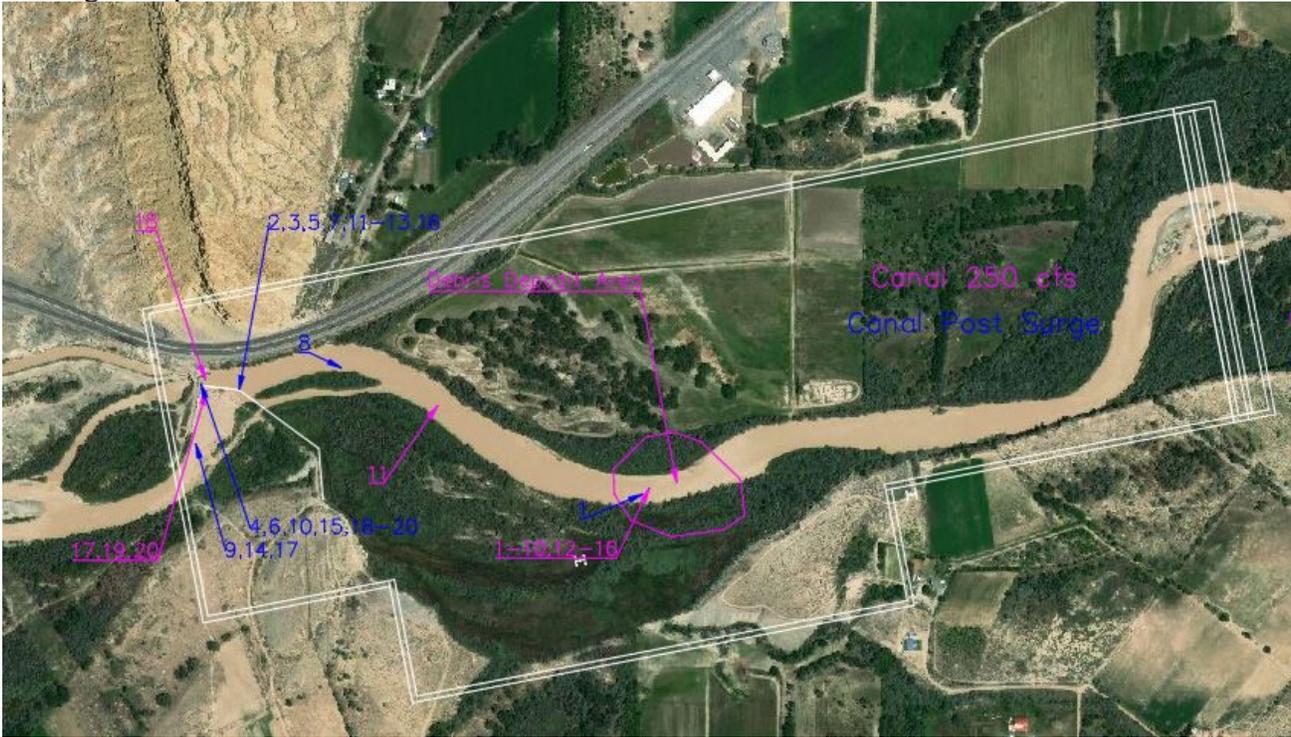
Image of debris capture location of the river modeled at the LB1 condition with River Q 800 cfs and Canal Q 250 cfs, with sluice gates closed.

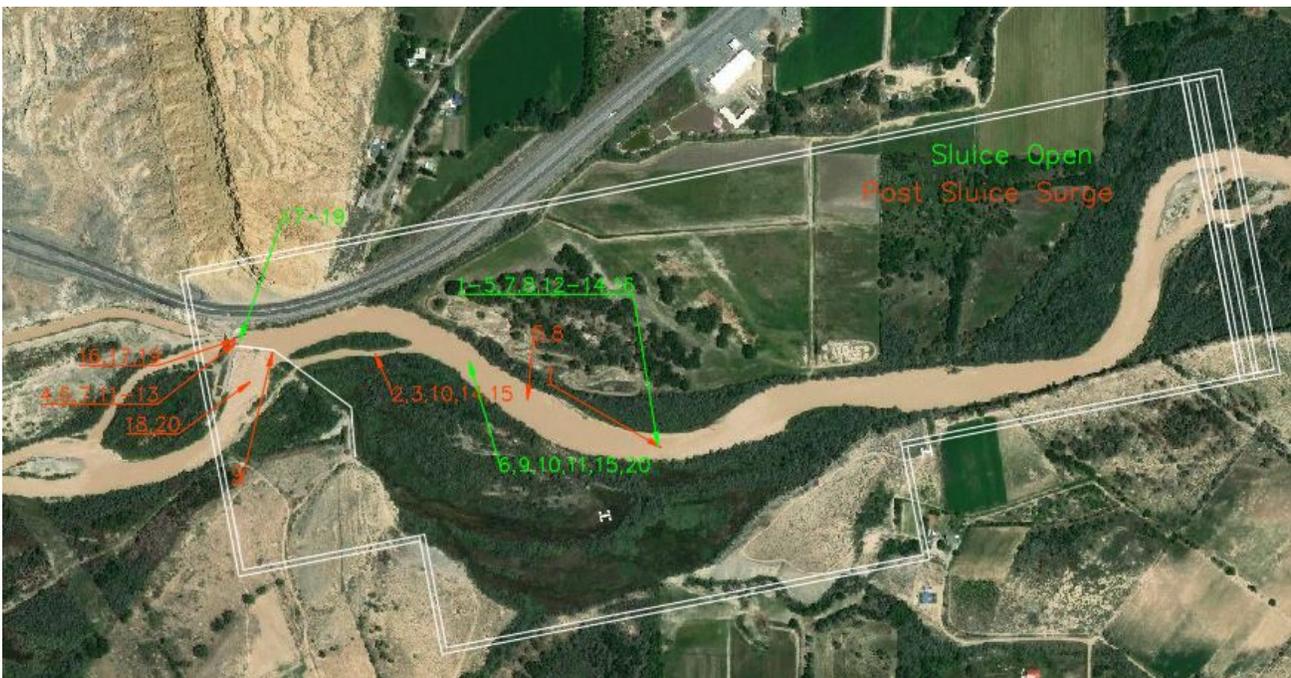
Image of debris capture location of the river modeled at the LB1 condition with River Q 800 cfs and Canal Q 0 cfs, with sluice gates open.

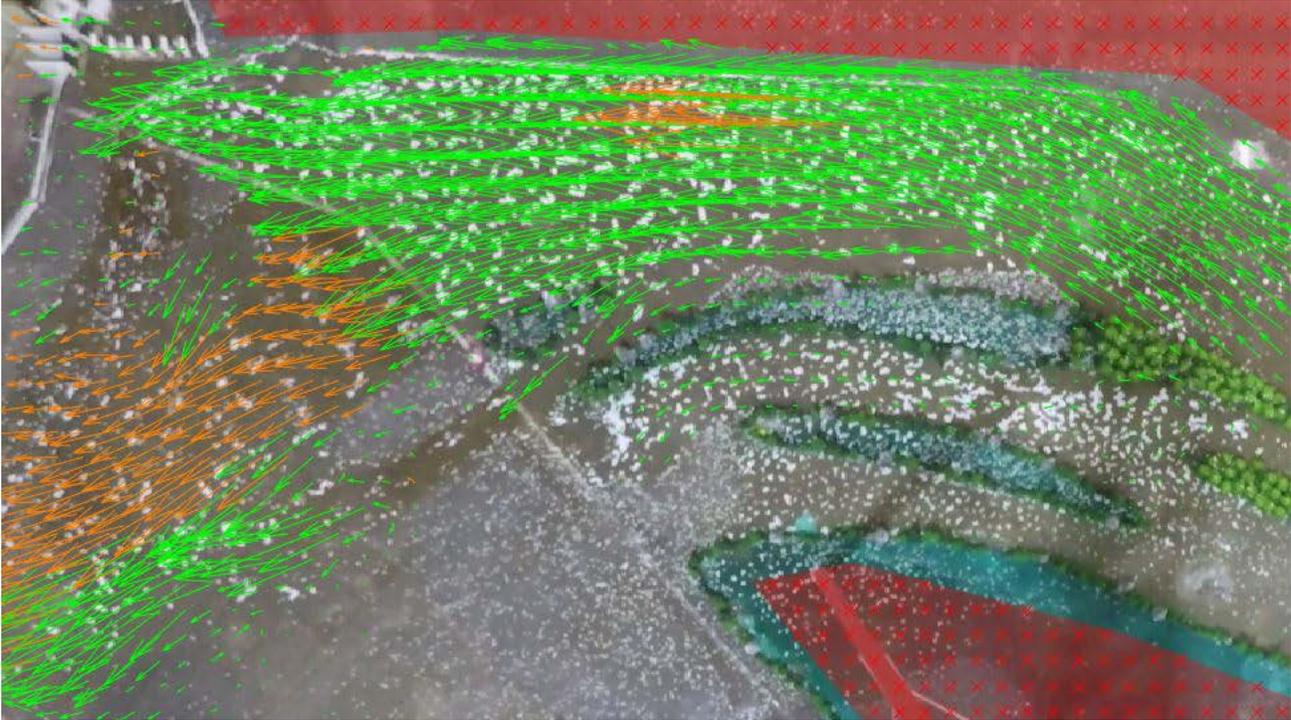
Image of LB1 with LSPIV mean velocity vector at River Q 2,500 cfs, Dam Q 2100 cfs, Canal Q 400 cfs, with sluice gates closed.
