Hydraulic Laboratory Report HL-2019-04

Physical Hydraulic Model Study of Debris Management Alternatives for Hogback Diversion Dam

U.S. Department of the Interior
Bureau of Reclamation
Technical Service Center
Hydraulic Investigations and Laboratory Services Group
Denver, Colorado

August 2019

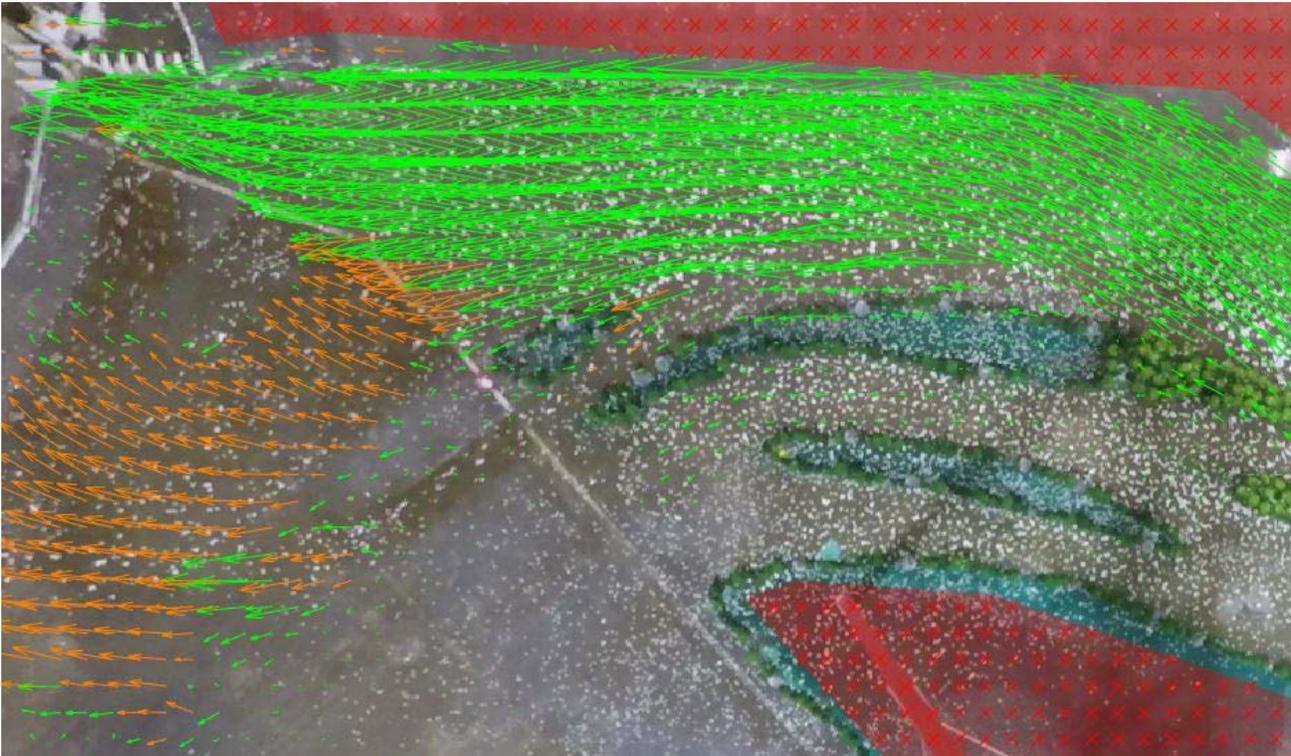
Image of LB1 with LSPIV mean velocity vector at River Q 2,500 cfs, Dam Q 2,500 cfs, Canal Q 0 cfs, with sluice gates open.

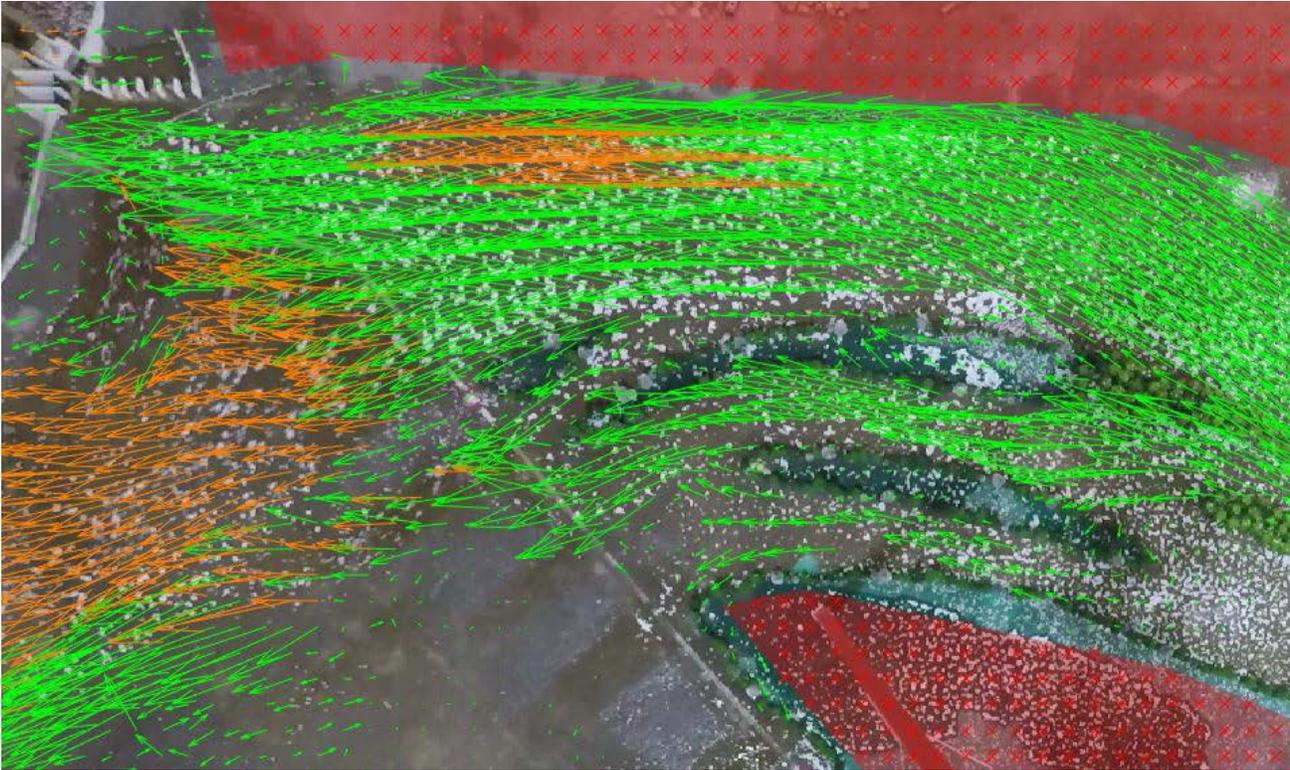
Image of LB1 with LSPIV mean velocity vector at River Q 5,000 cfs, Dam Q 4500 cfs, Canal Q 500 cfs, with sluice gates closed.

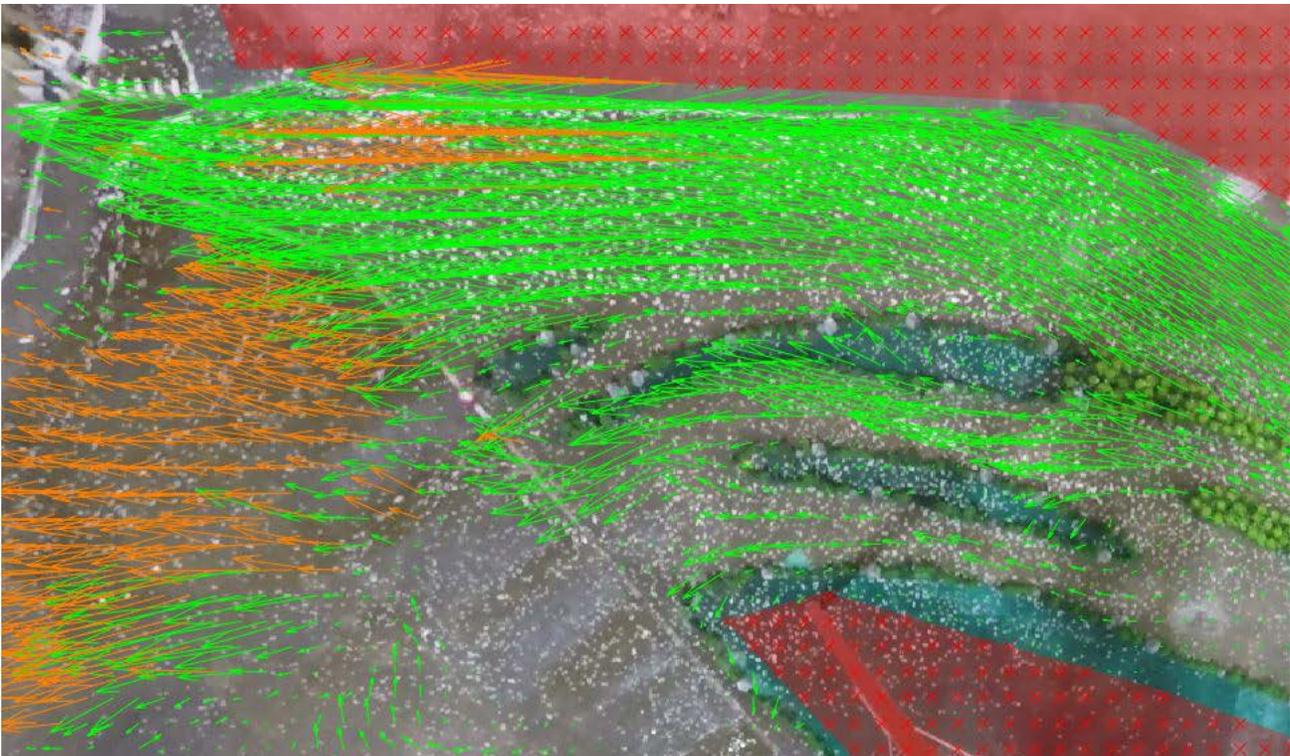
Image of LB1 with LSPIV mean velocity vector at River Q 5,000 cfs, Dam Q 5,000 cfs, Canal Q 0 cfs, with sluice gates open.

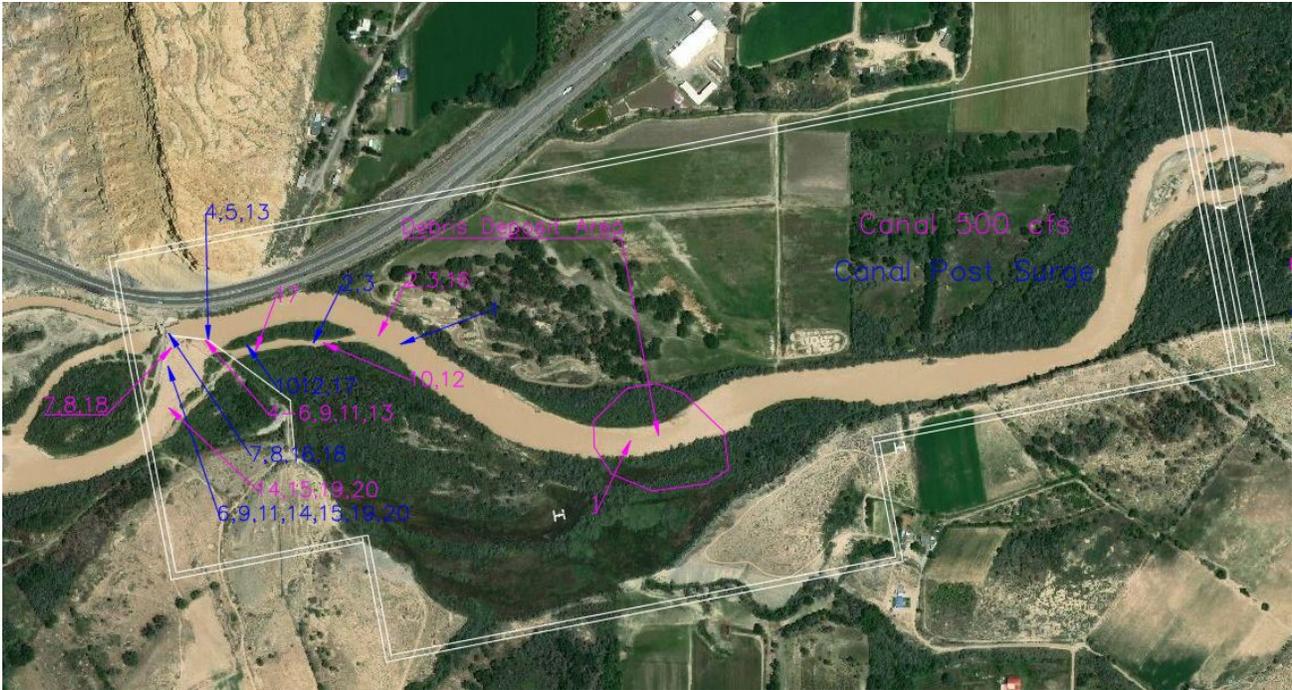
Image of debris capture location of the river modeled at the LB1 condition with River Q 5000 cfs and Canal Q 500 cfs, with sluice gates closed.

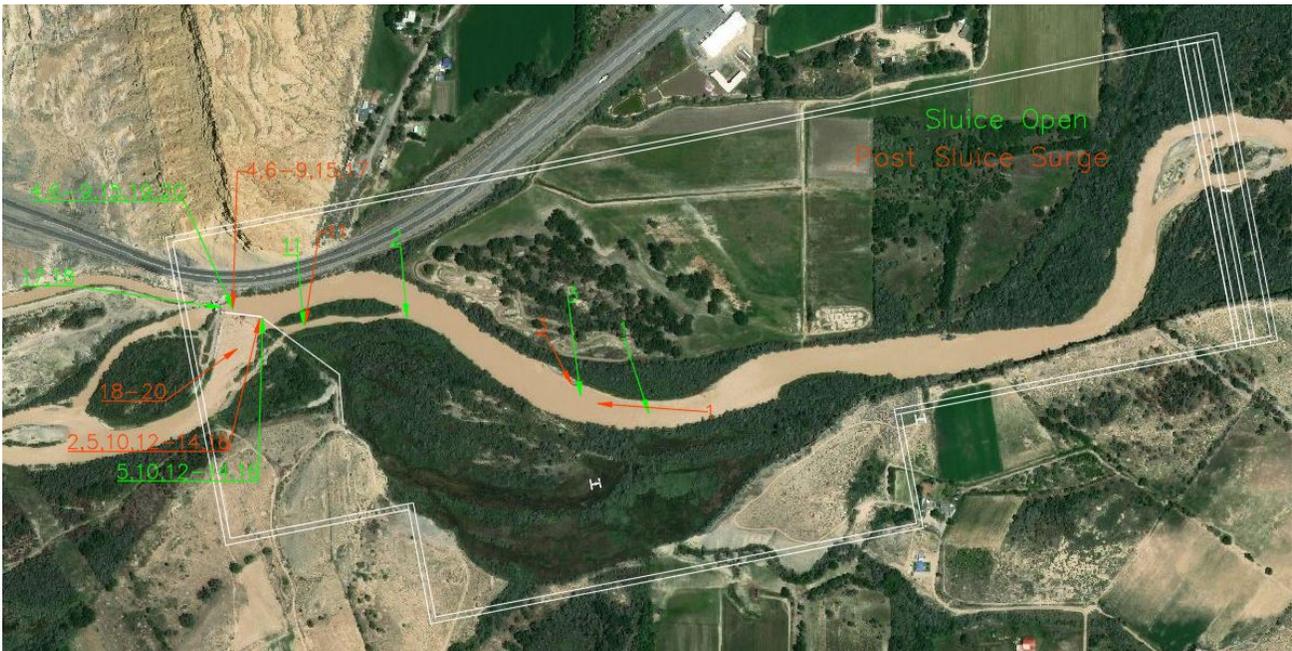
Image of debris capture location of the river modeled at the LB1 condition with River Q 5000 cfs and Canal Q 0 cfs, with sluice gates open.

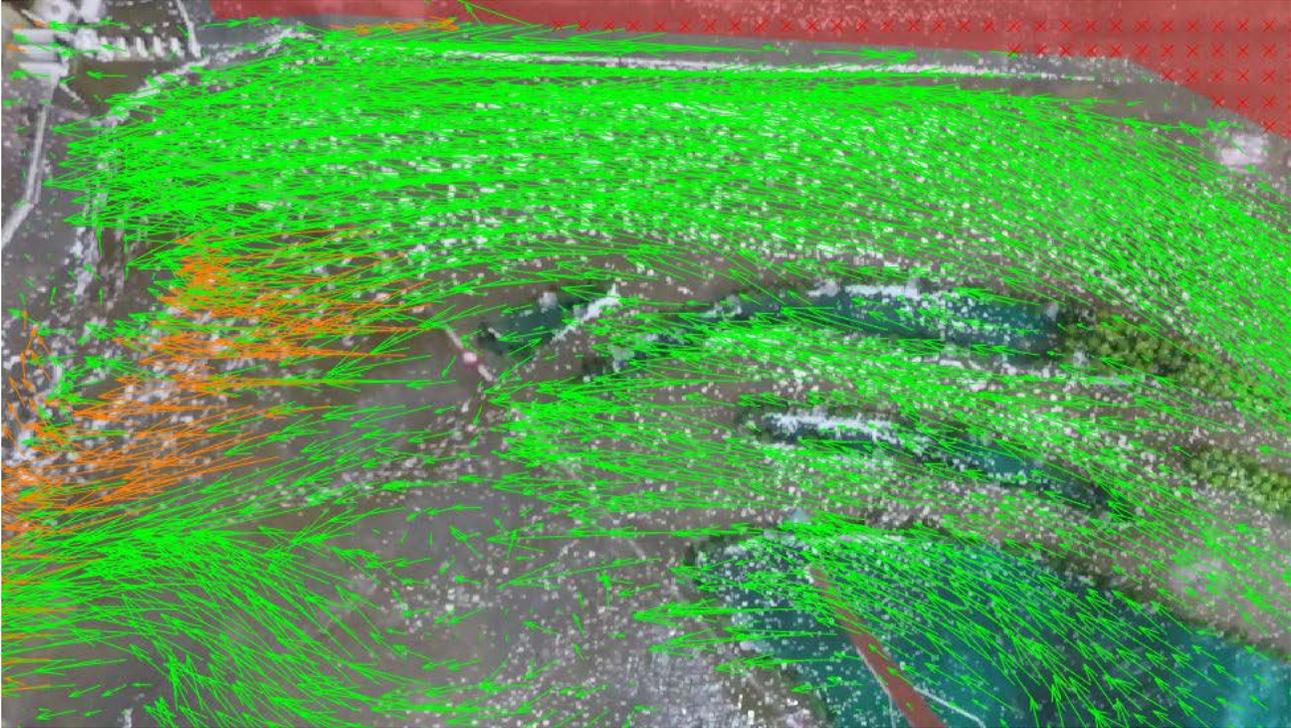
Image of LB1 with LSPIV mean velocity vector at River Q 12,000 cfs, Dam Q 11400 cfs, Canal Q 600 cfs, with sluice gates closed.

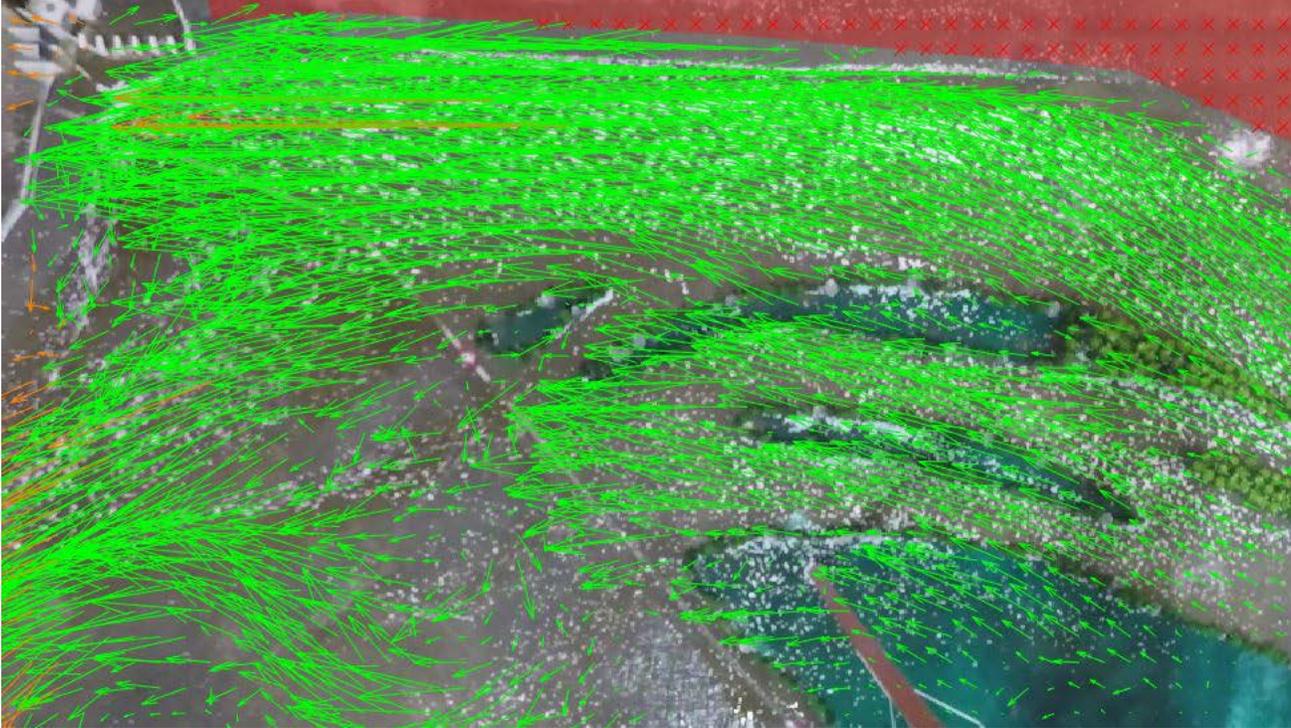
Image of LB1 with LSPIV mean velocity vector at River Q 12,000 cfs, Dam Q 12,000 cfs, Canal Q 0 cfs, with sluice gates open.

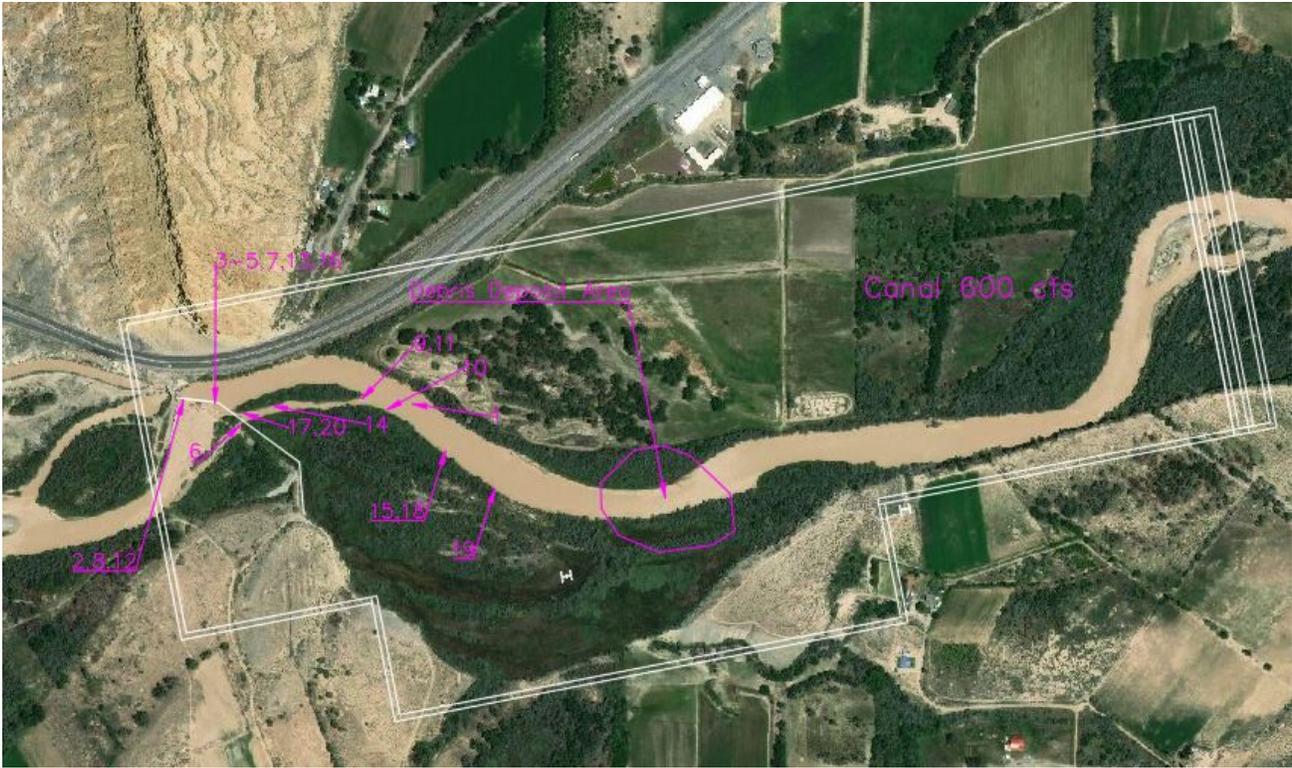
Image of debris capture location of the river modeled at the LB1 condition with River Q 12000 cfs and Canal Q 600 cfs, with sluice gates closed.

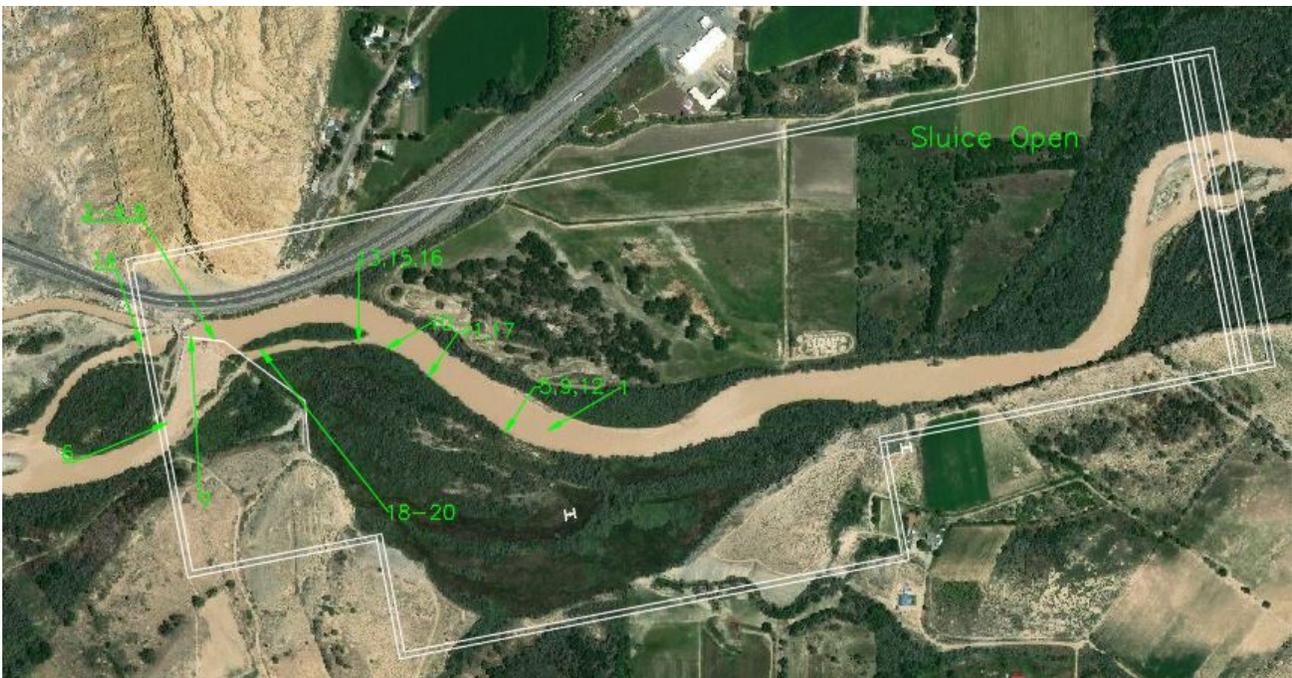
Image of debris capture location of the river modeled at the LB1 condition with River Q 12000 cfs and Canal Q 0 cfs, with sluice gates open.

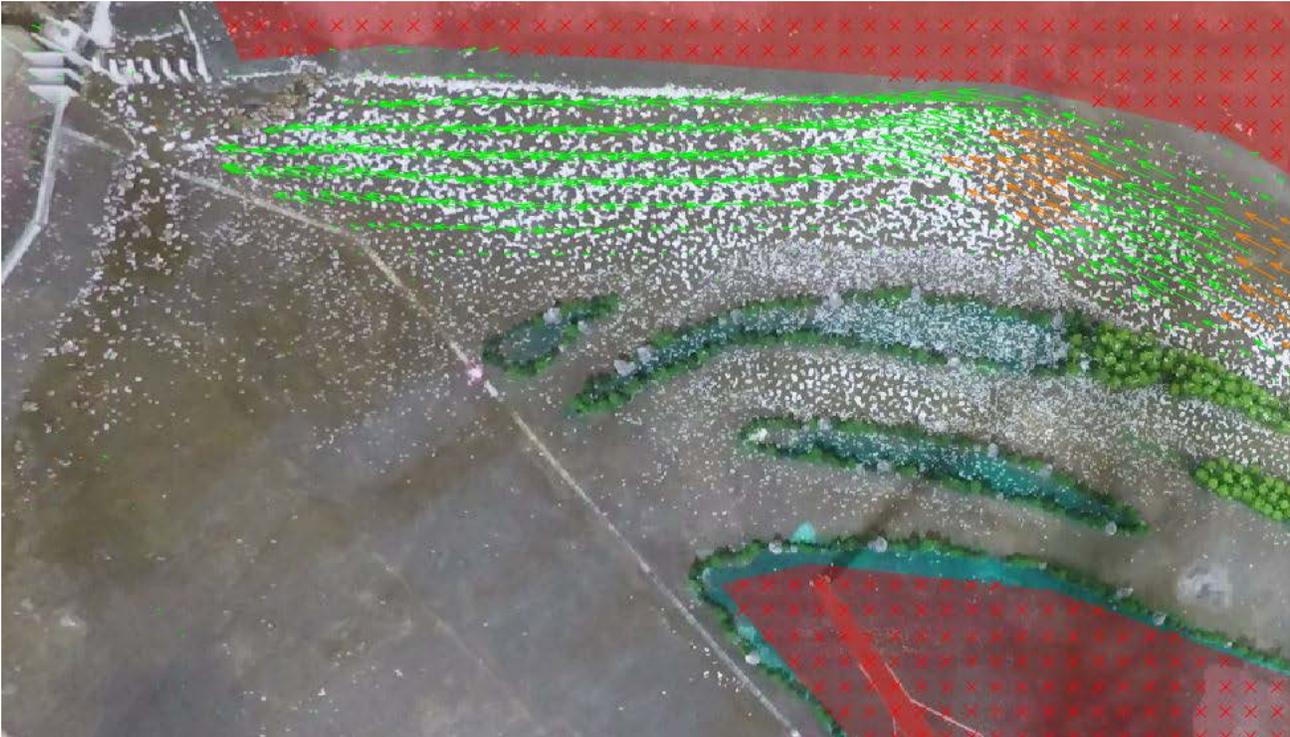
Image of RS3 with LSPIV mean velocity vector at River Q 800 cfs, Dam Q 600 cfs, Canal Q 200 cfs, with sluice gates closed.

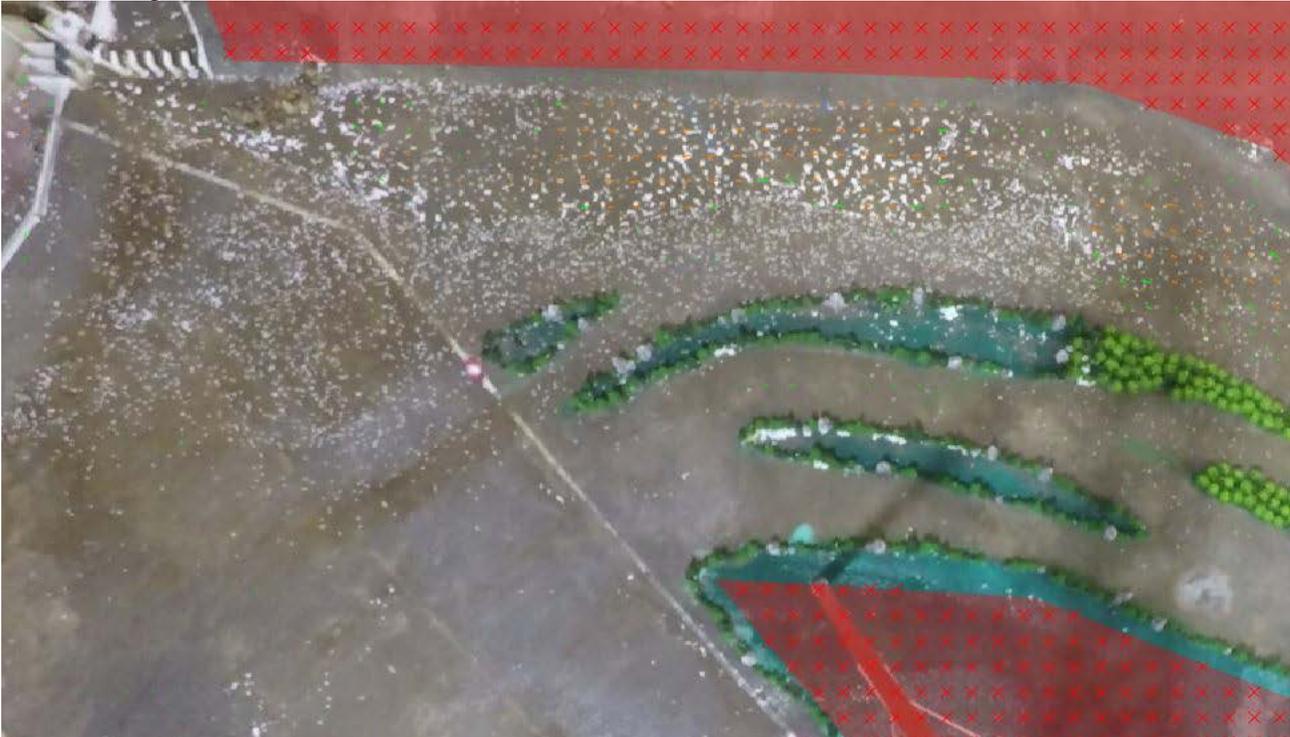
Image of RS3 with LSPIV mean velocity vector at River Q 800 cfs, Dam Q 800 cfs, Canal Q 0 cfs, with sluice gates open.

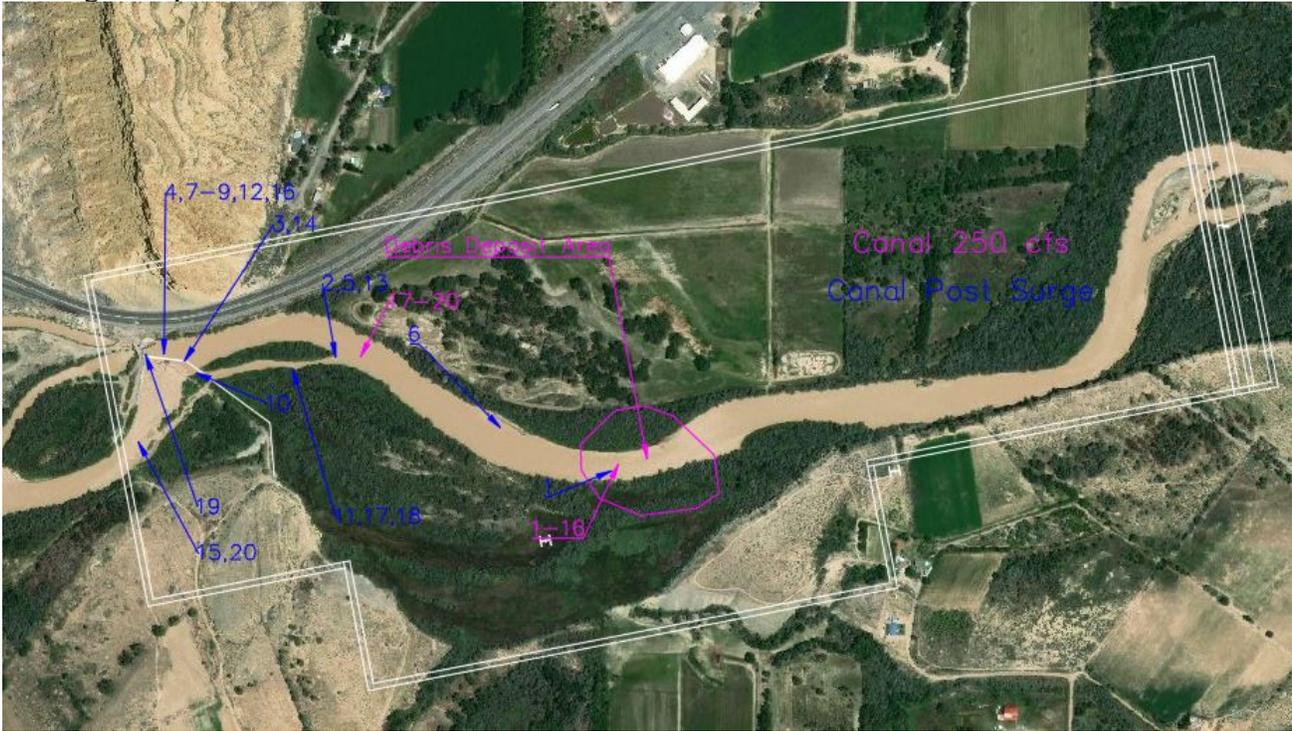
Image of debris capture location of the river modeled at the RS3 condition with River Q 800 cfs and Canal Q 250 cfs, with sluice gates closed.

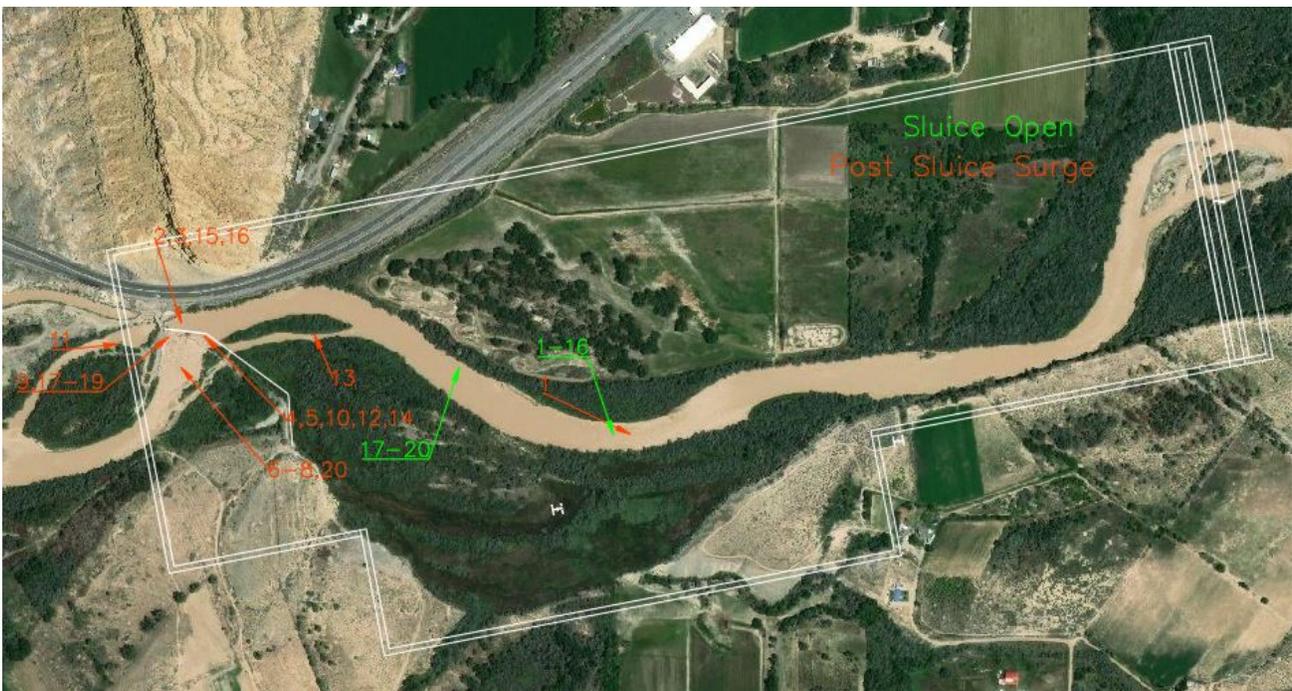
Image of debris capture location of the river modeled at the RS3 condition with River Q 800 cfs and Canal Q 0 cfs, with sluice gates open.

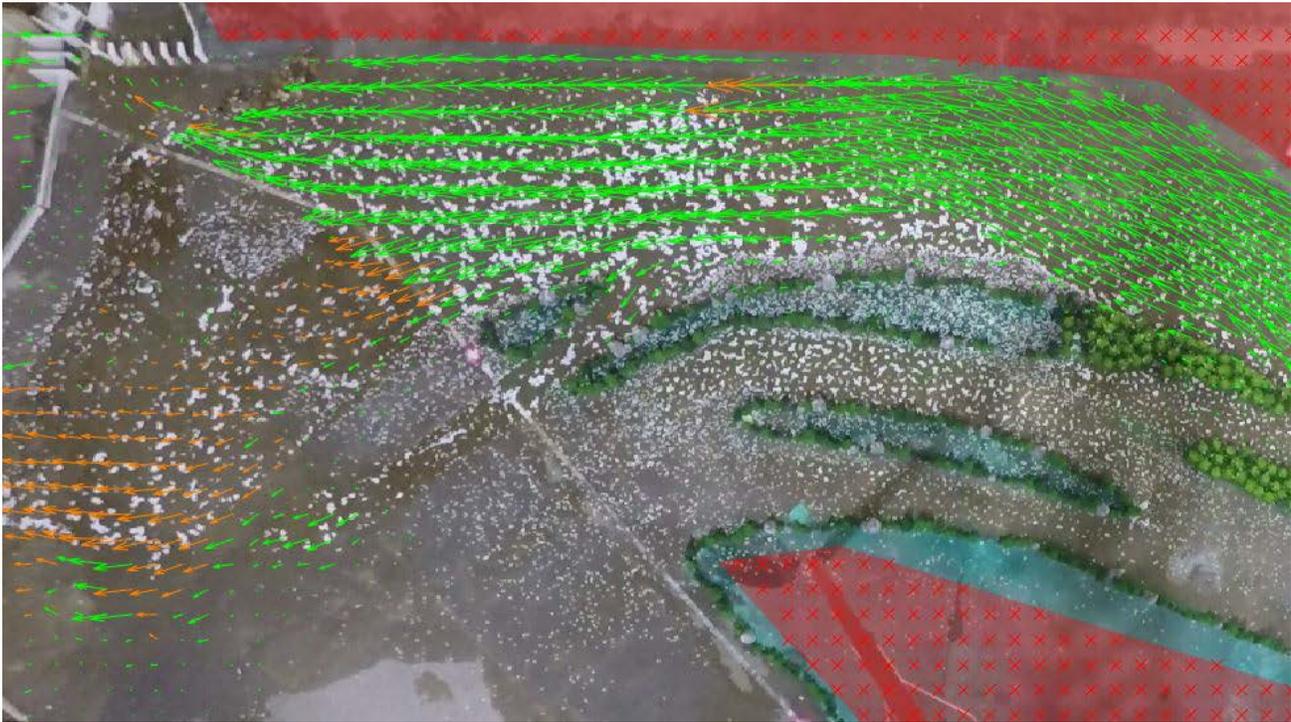
Image of RS3 with LSPIV mean velocity vector at River Q 2,500 cfs, Dam Q 2100 cfs, Canal Q 400 cfs, with sluice gates closed.

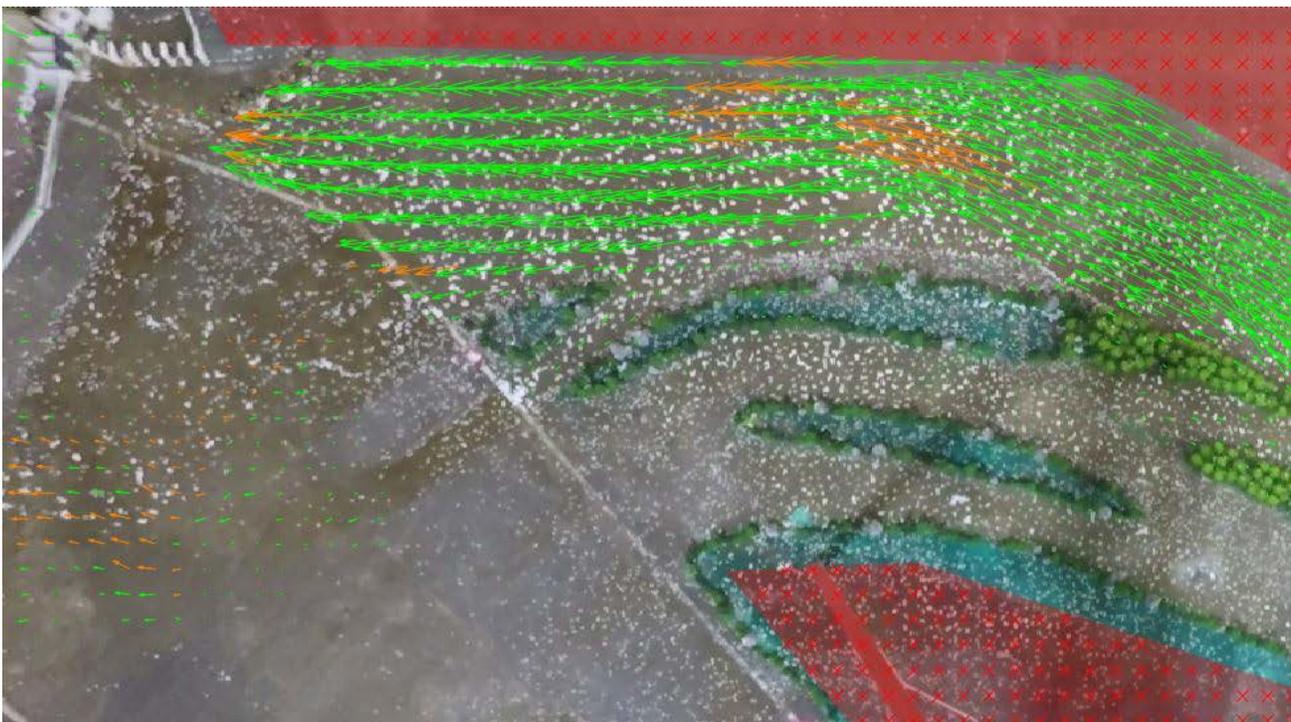
Image of RS3 with LSPIV mean velocity vector at River Q 2,500 cfs, Dam Q 2,500 cfs, Canal Q 0 cfs, with sluice gates open.

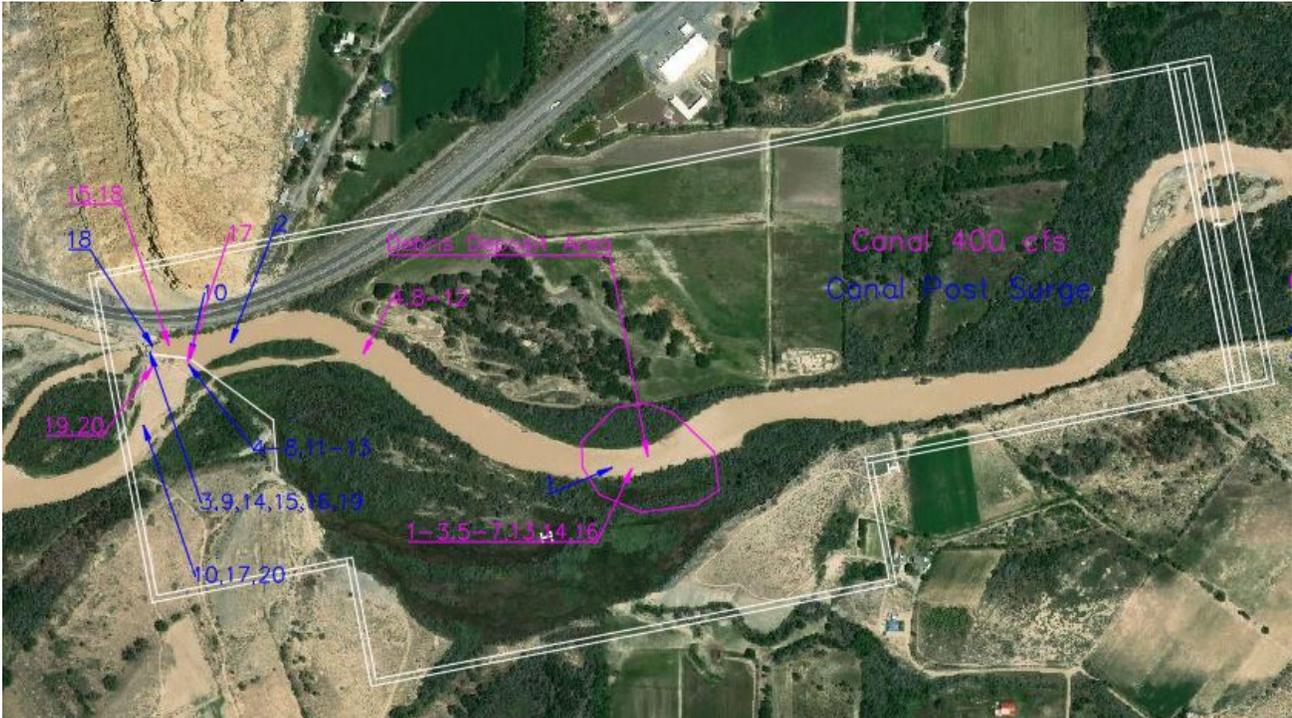
Image of debris capture location of the river modeled at the RS3 condition with River Q 2500 cfs and Canal Q 400 cfs, with sluice gates closed.

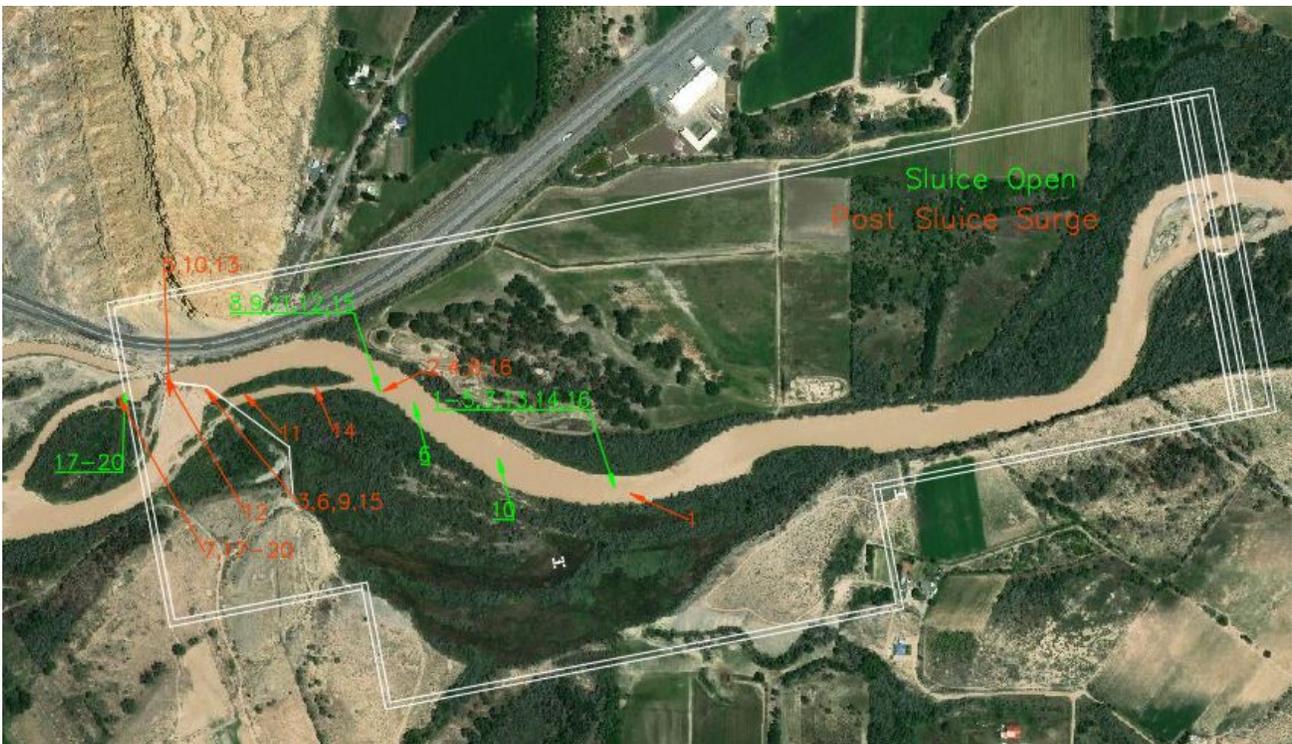
Image of debris capture location of the river modeled at the RS3 condition with River Q 2500 cfs and Canal Q 0 cfs, with sluice gates open.

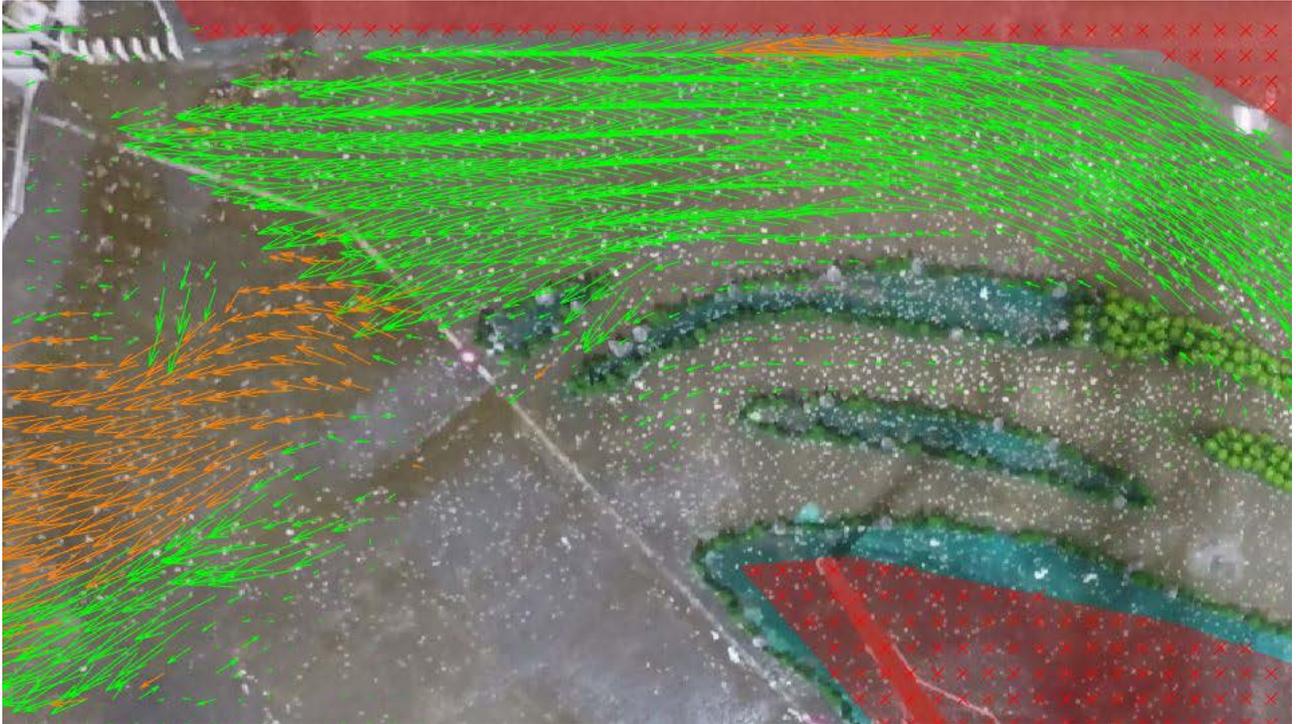
Image of RS3 with LSPIV mean velocity vector at River Q 5,000 cfs, Dam Q 4500 cfs, Canal Q 500 cfs, with sluice gates closed.

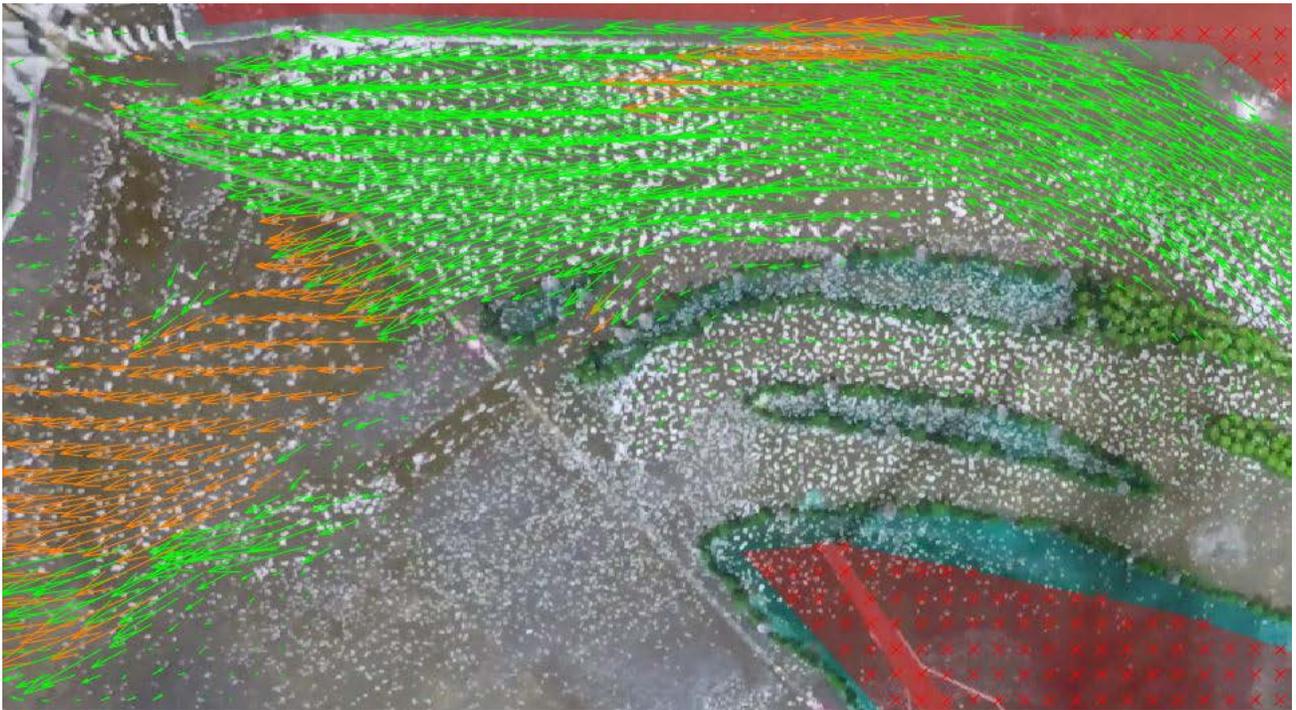
Image of RS3 with LSPIV mean velocity vector at River Q 5,000 cfs, Dam Q 5,000 cfs, Canal Q 0 cfs, with sluice gates open.

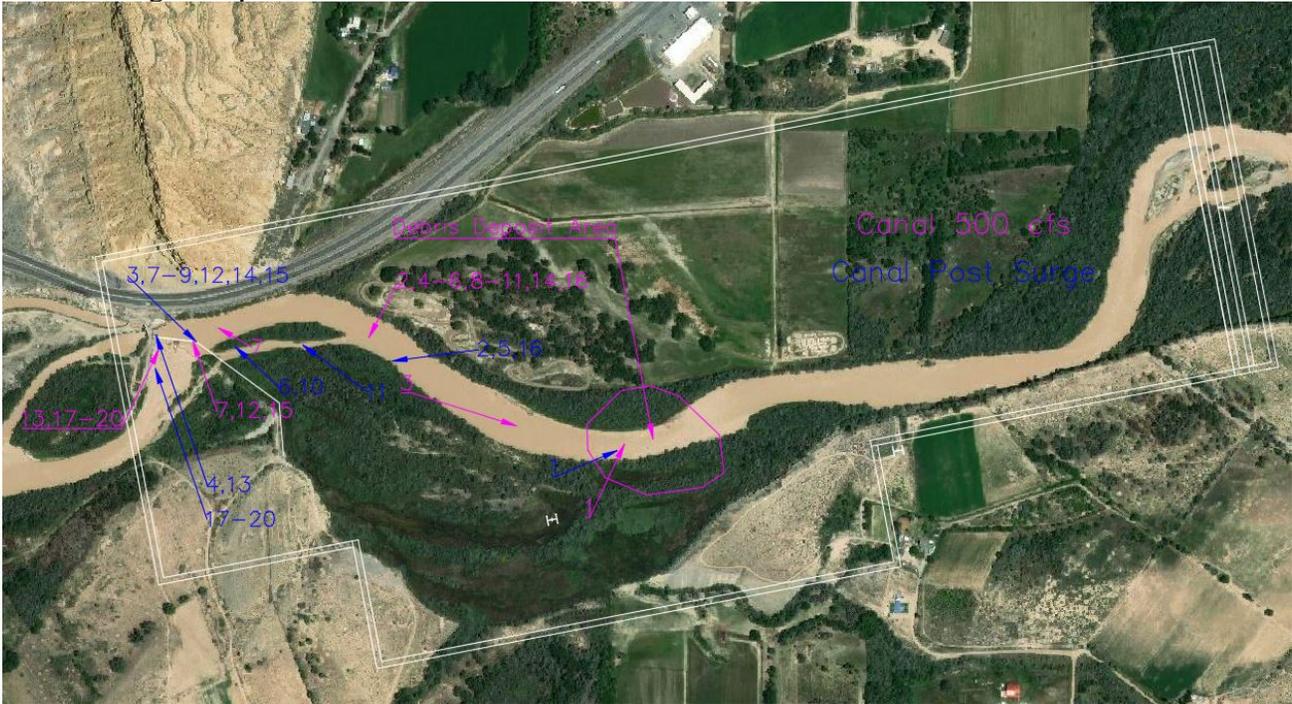
Image of debris capture location of the river modeled at the RS3 condition with River Q 5000 cfs and Canal Q 500 cfs, with sluice gates closed.

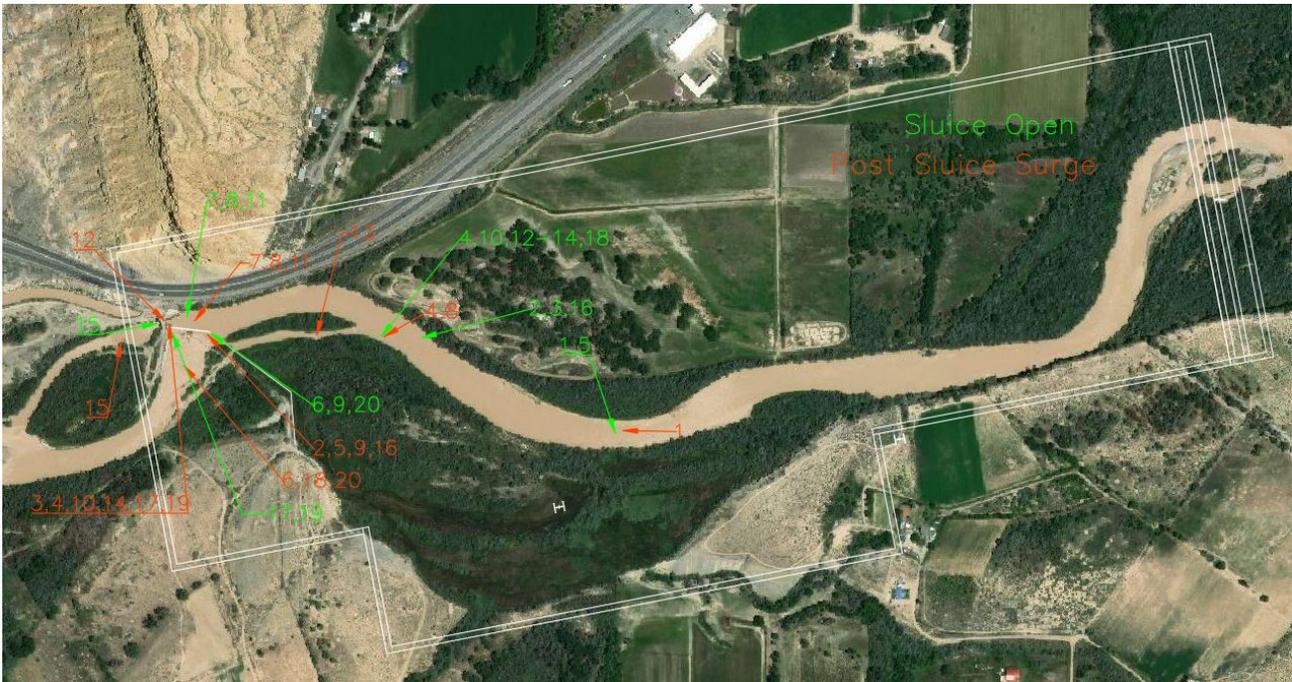
Image of debris capture location of the river modeled at the RS3 condition with River Q 5000 cfs and Canal Q 0 cfs, with sluice gates open.

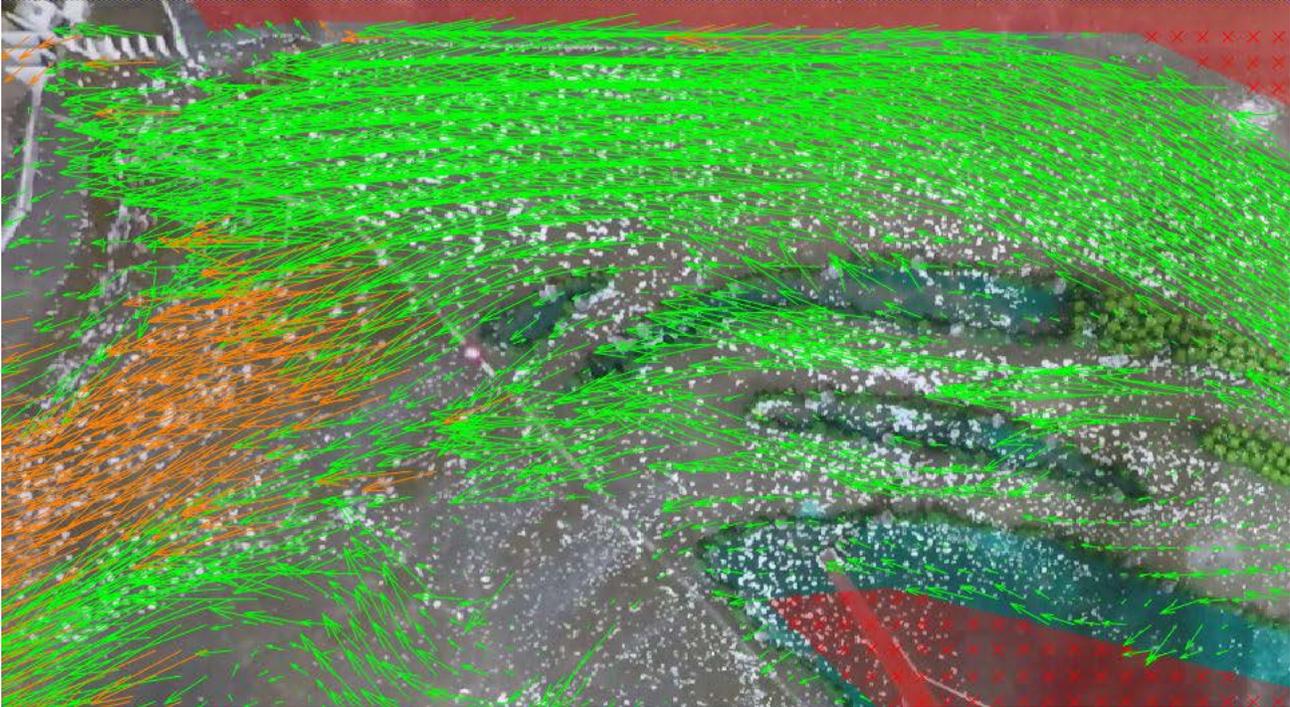
Image of RS3 with LSPIV mean velocity vector at River Q 12,000 cfs, Dam Q 11400 cfs, Canal Q 600 cfs, with sluice gates closed.

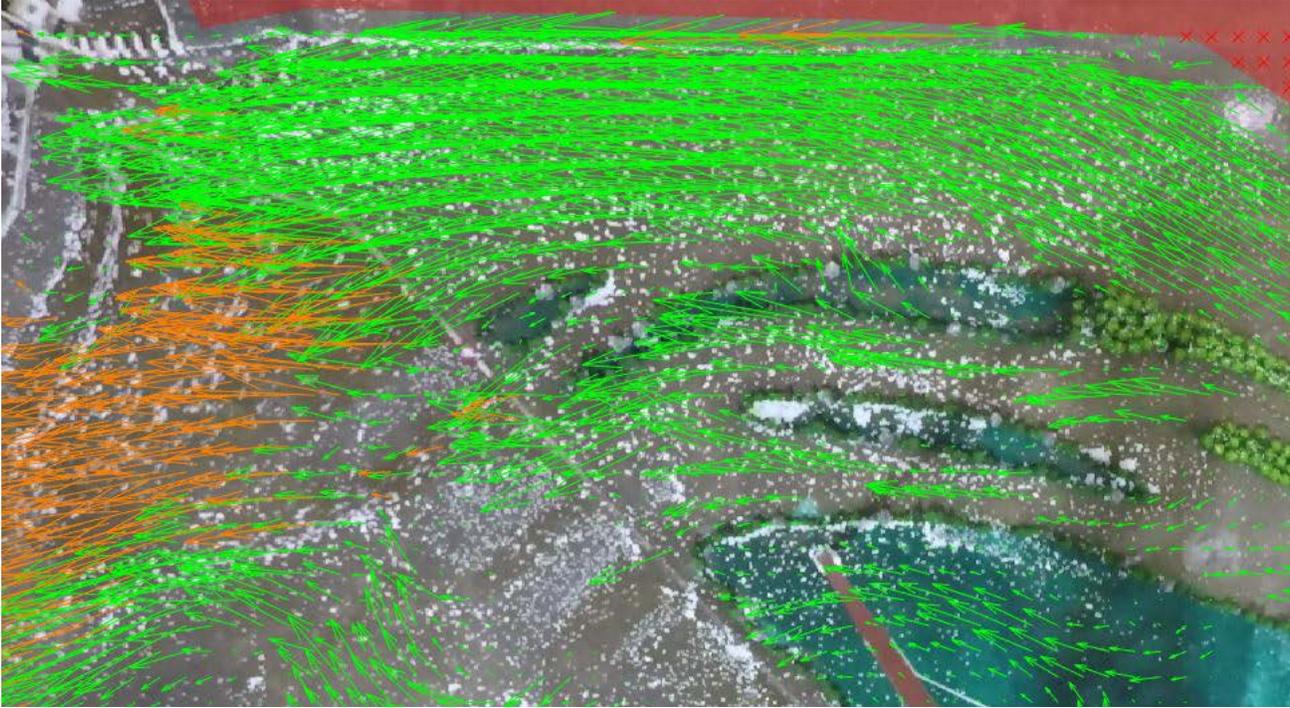
Image of RS3 with LSPIV mean velocity vector at River Q 12,000 cfs, Dam Q 12,000 cfs, Canal Q 0 cfs, with sluice gates open.

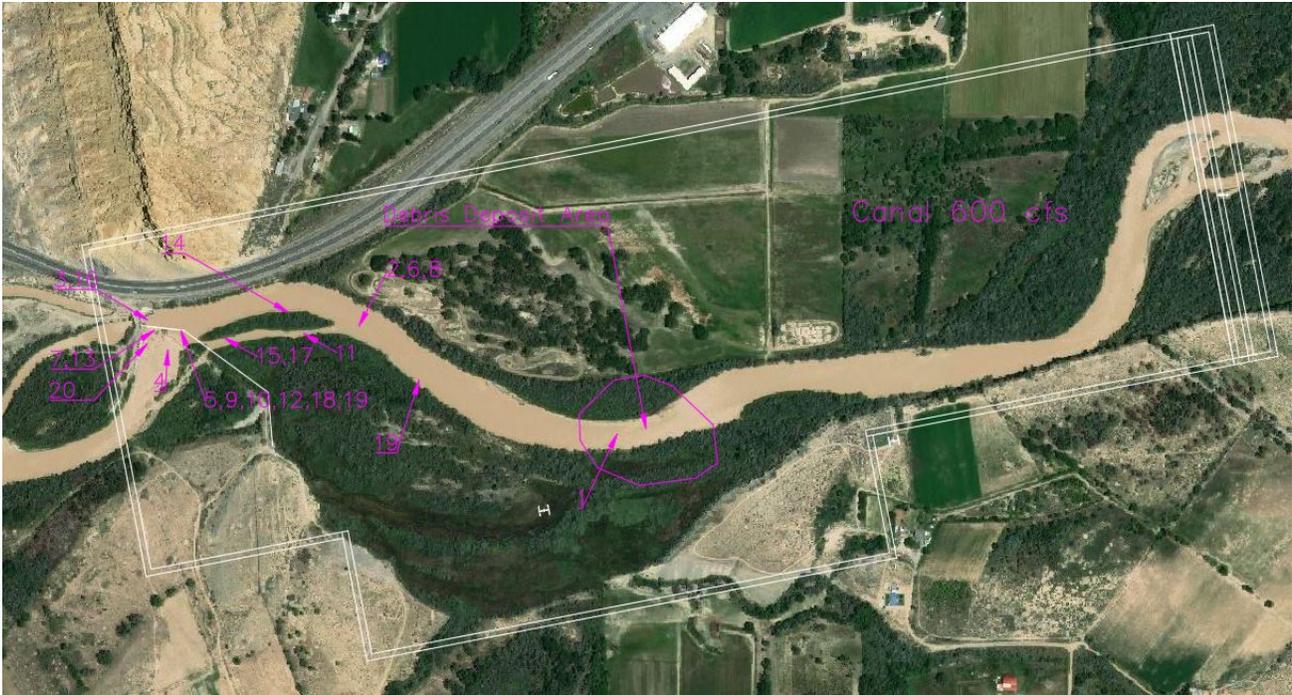
Image of debris capture location of the river modeled at the RS3 condition with River Q 12000 cfs and Canal Q 600 cfs, with sluice gates closed.
