Hydraulic Laboratory Report HL-2019-04

Physical Hydraulic Model Study of Debris Management Alternatives for Hogback Diversion Dam

U.S. Department of the Interior
Bureau of Reclamation
Technical Service Center
Hydraulic Investigations and Laboratory Services Group
Denver, Colorado

August 2019

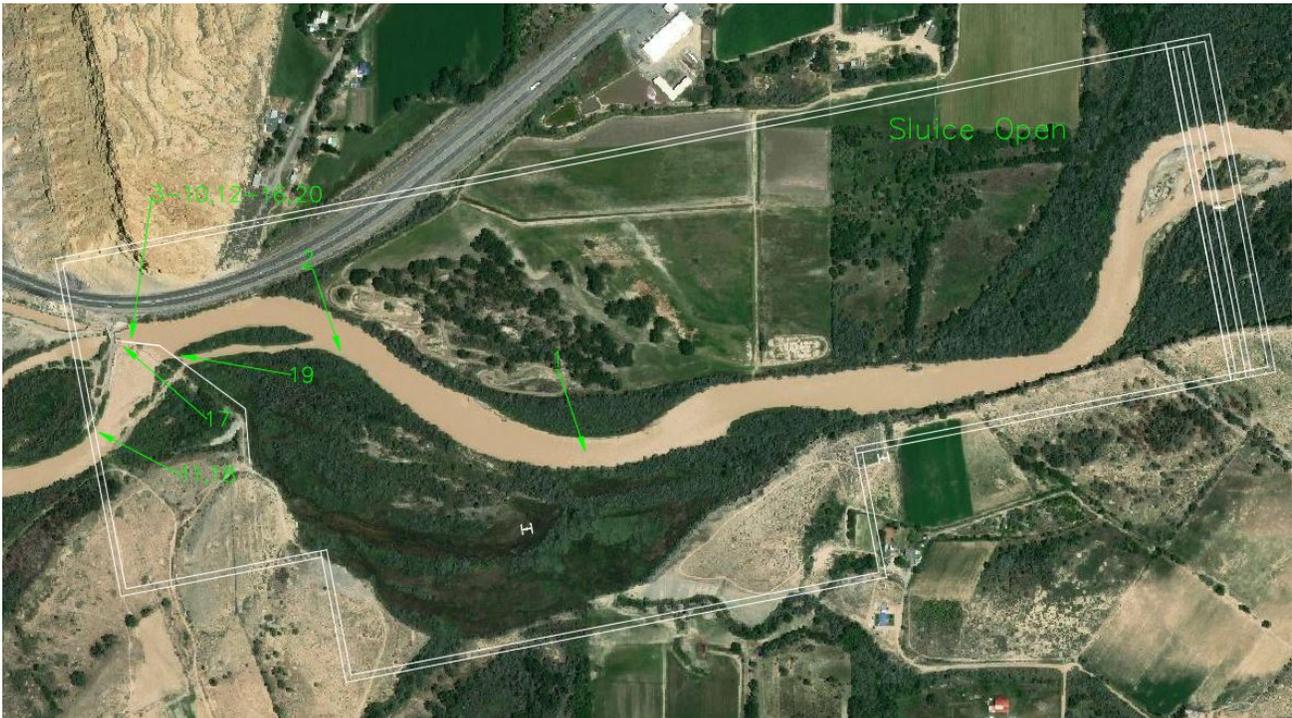
Image of debris capture location of the river modeled at the RS3 condition with River Q 12000 cfs and Canal Q 0 cfs, with sluice gates open.

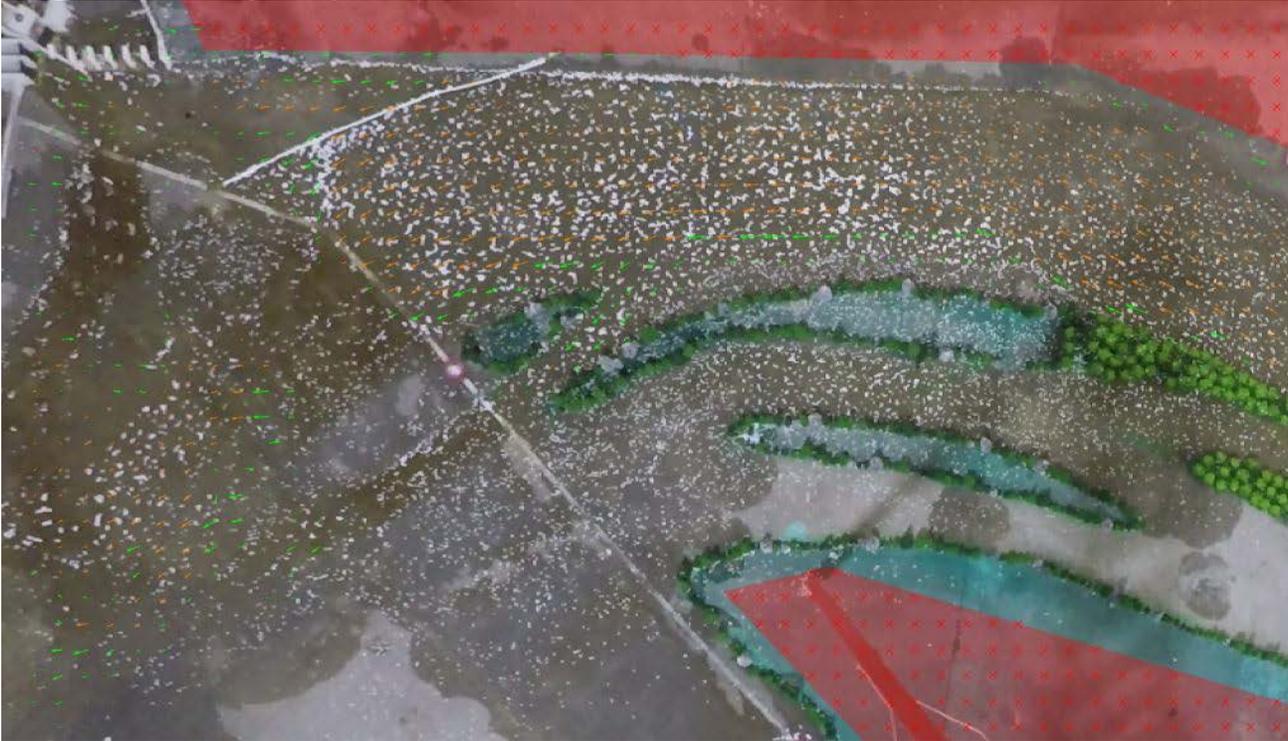
Image of LB2 with LSPIV mean velocity vector at River Q 800 cfs, Dam Q 550 cfs, Canal Q 250 cfs, with sluice gates closed.

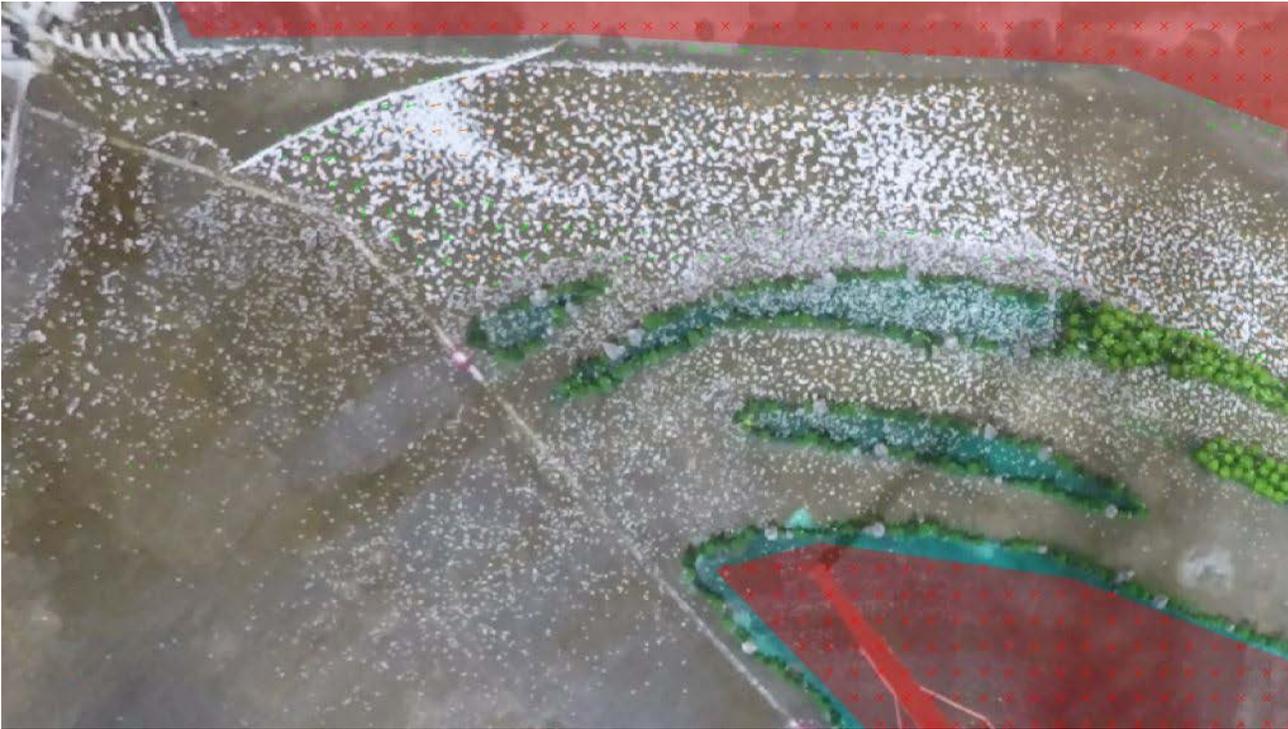
Image of LB2 with LSPIV mean velocity vector at River Q 800 cfs, Dam Q 800 cfs, Canal Q 0 cfs, with sluice gates open.

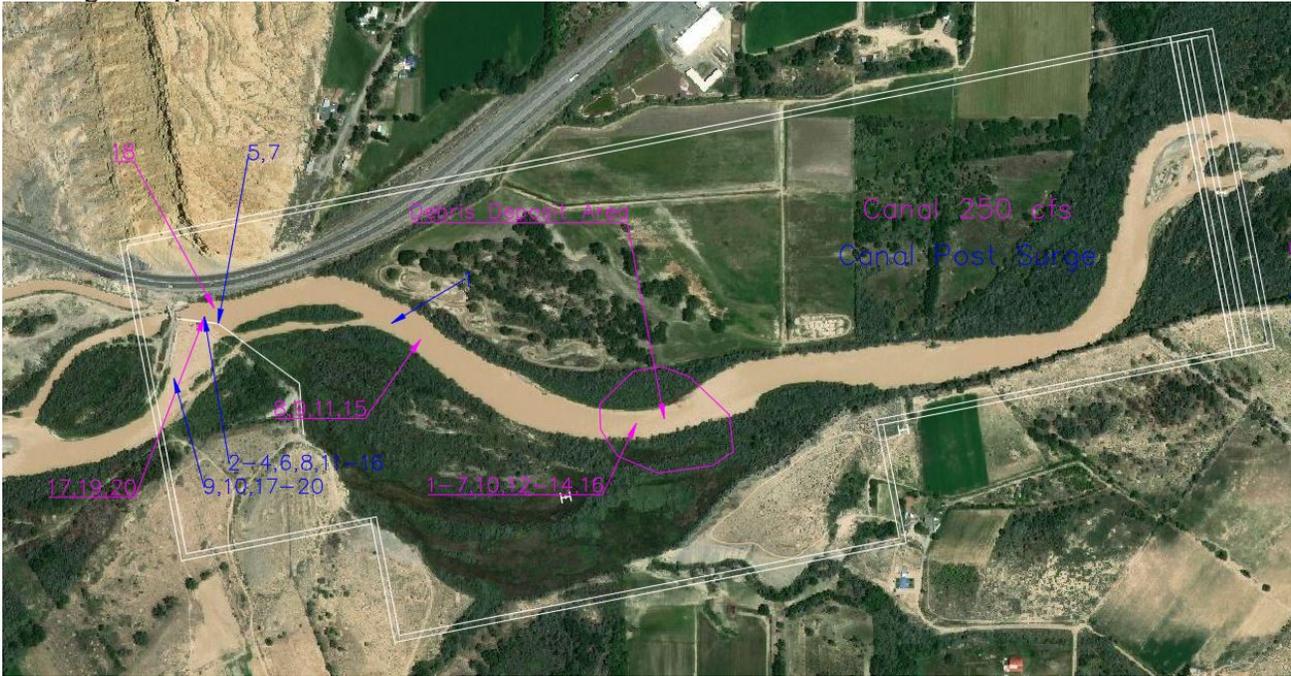
Image of debris capture location of the river modeled at the LB2 condition with River Q 800 cfs and Canal Q 250 cfs, with sluice gates closed.

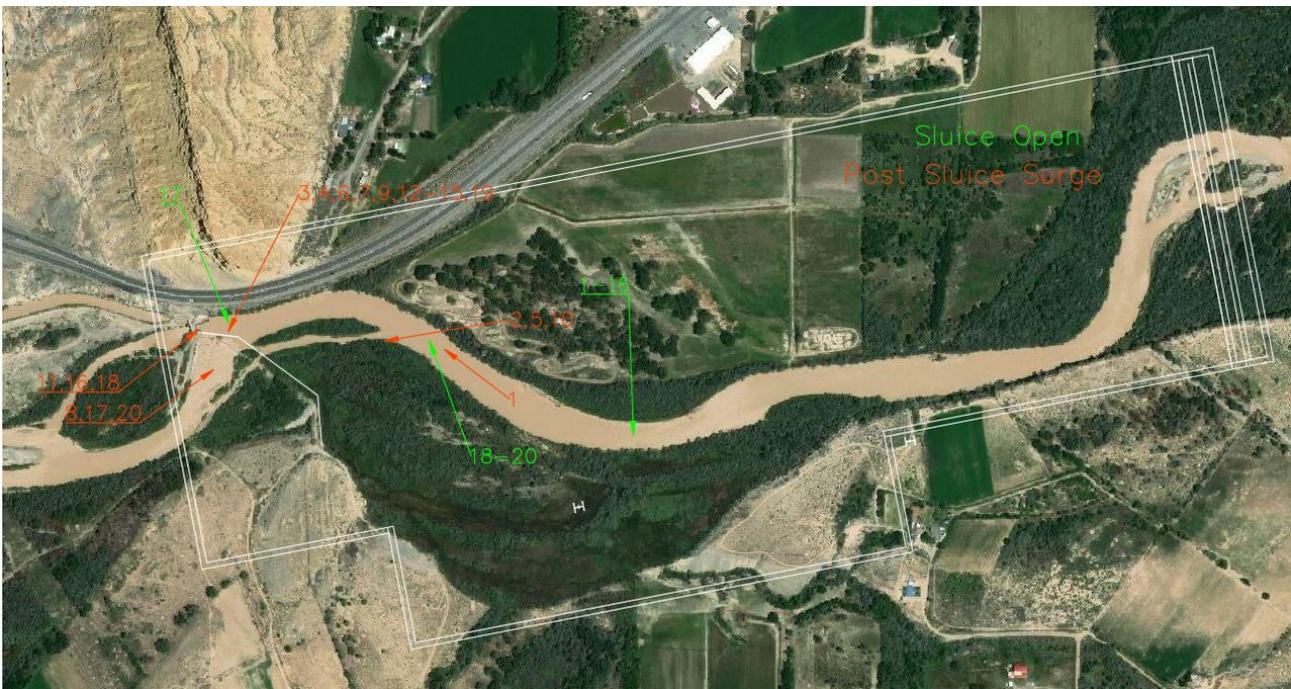
Image of debris capture location of the river modeled at the LB2 condition with River Q 800 cfs and Canal Q 0 cfs, with sluice gates open.

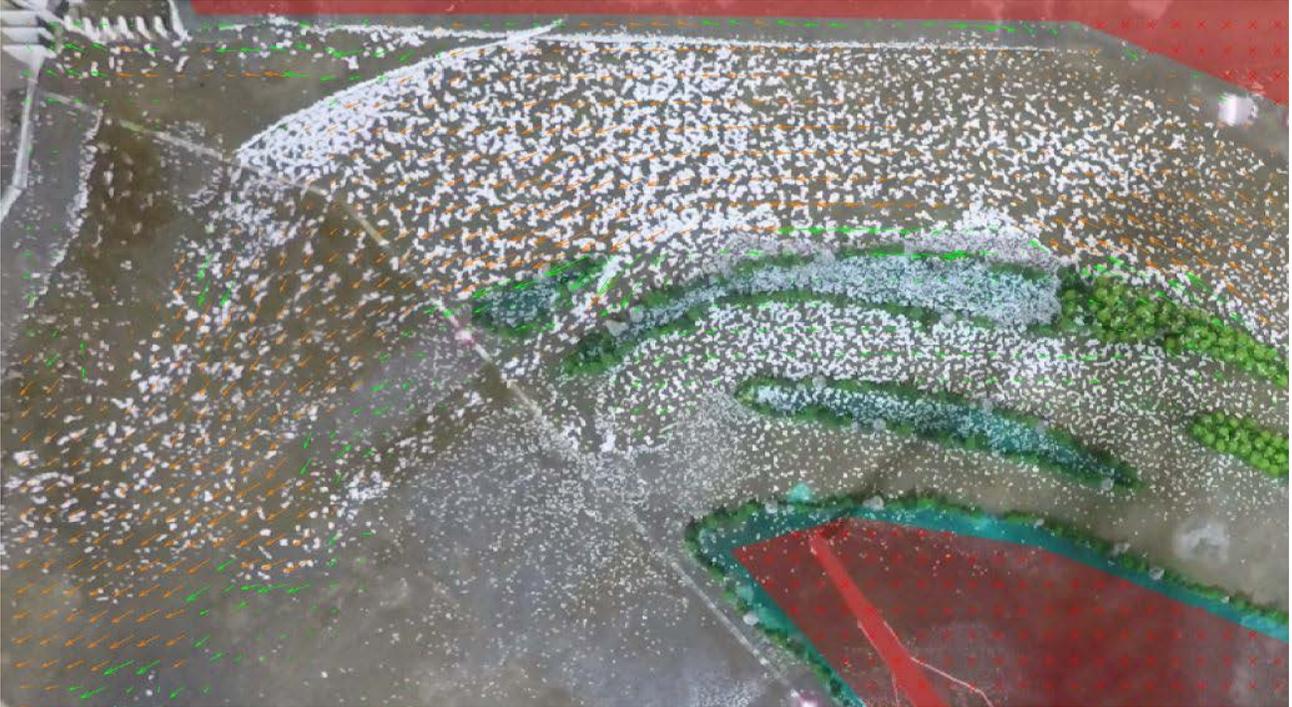
Image of LB2 with LSPIV mean velocity vector at River Q 2,500 cfs, Dam Q 2100 cfs, Canal Q 400 cfs, with sluice gates closed.

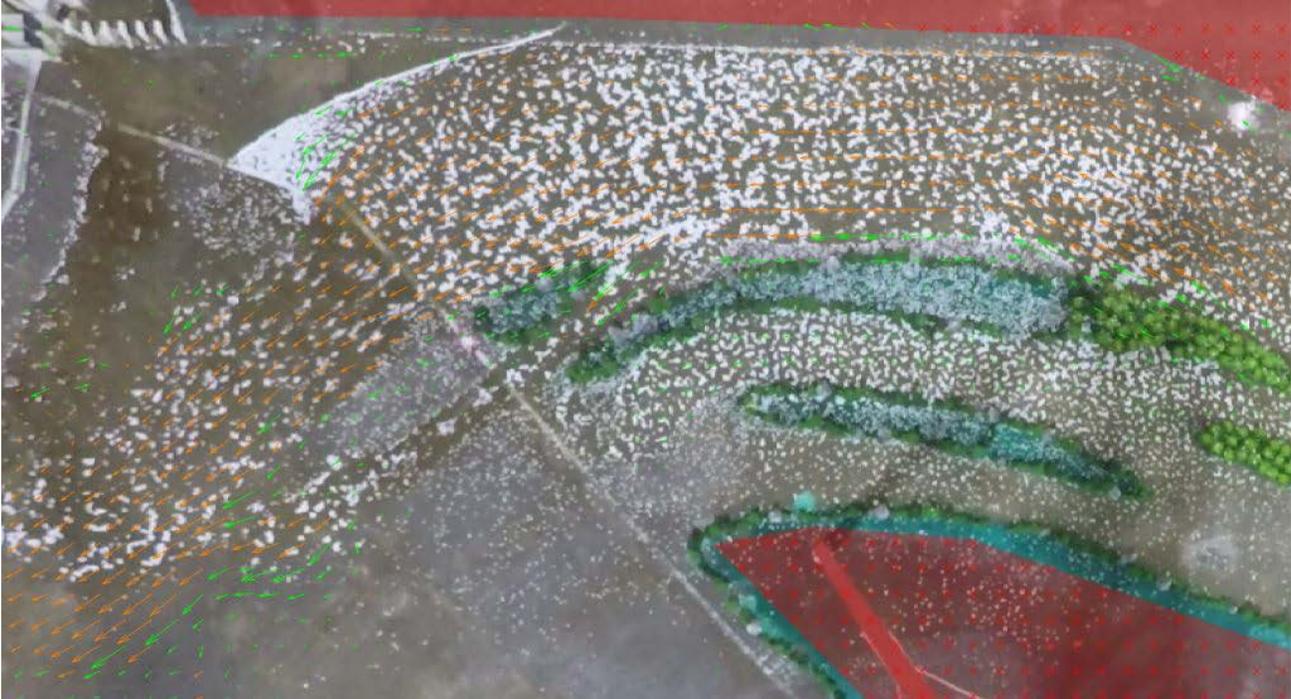
Image of LB2 with LSPIV mean velocity vector at River Q 2,500 cfs, Dam Q 2,500 cfs, Canal Q 0 cfs, with sluice gates open.

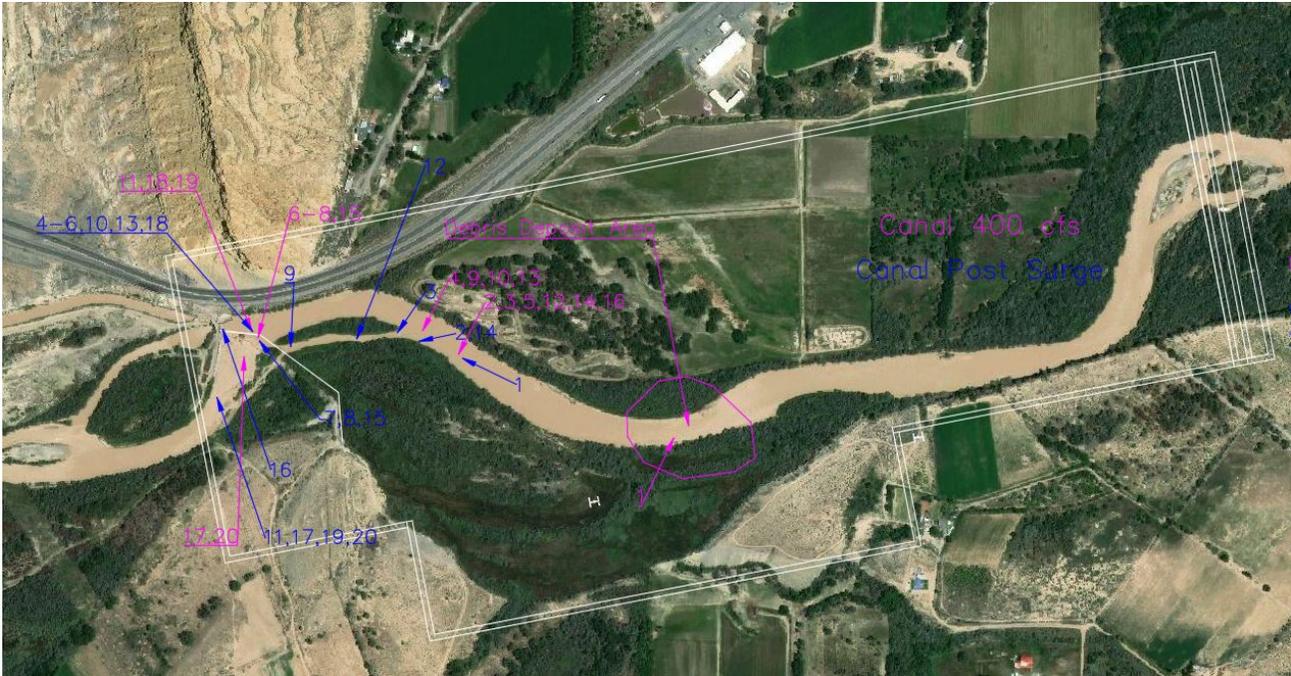
Image of debris capture location of the river modeled at the LB2 condition with River Q 2500 cfs and Canal Q 400 cfs, with sluice gates closed.

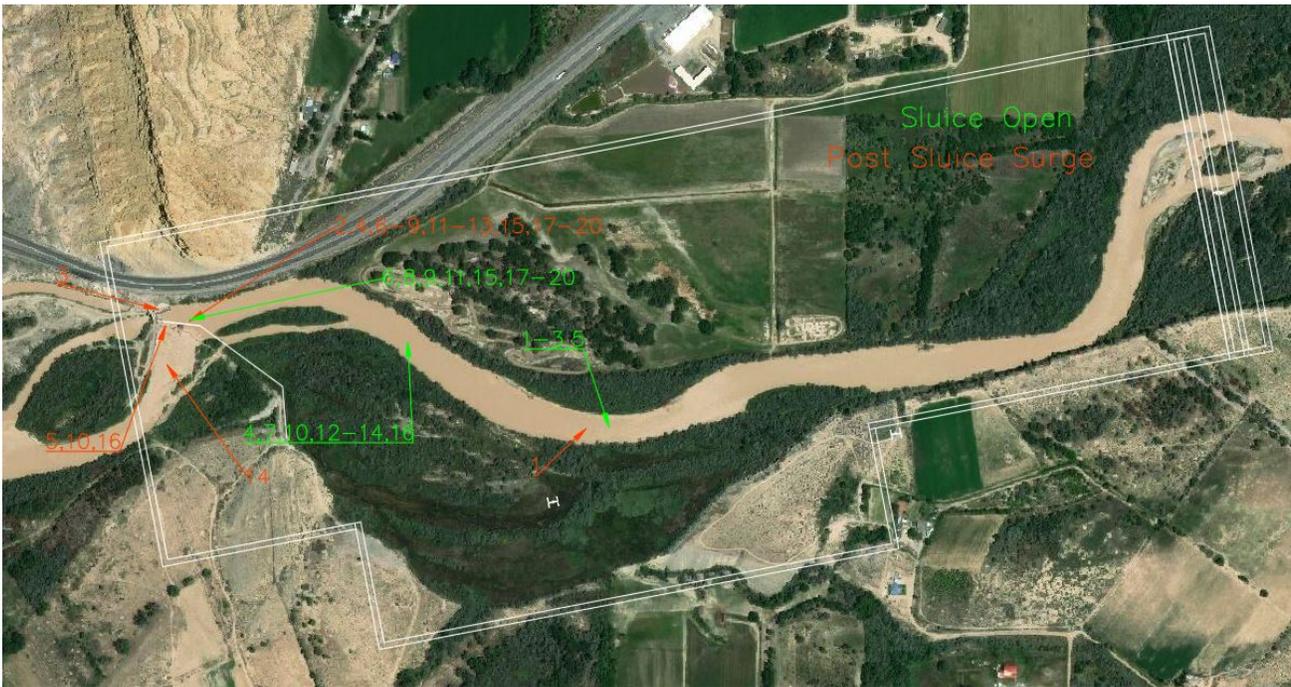
Image of debris capture location of the river modeled at the LB2 condition with River Q 2500 cfs and Canal Q 0 cfs, with sluice gates open.

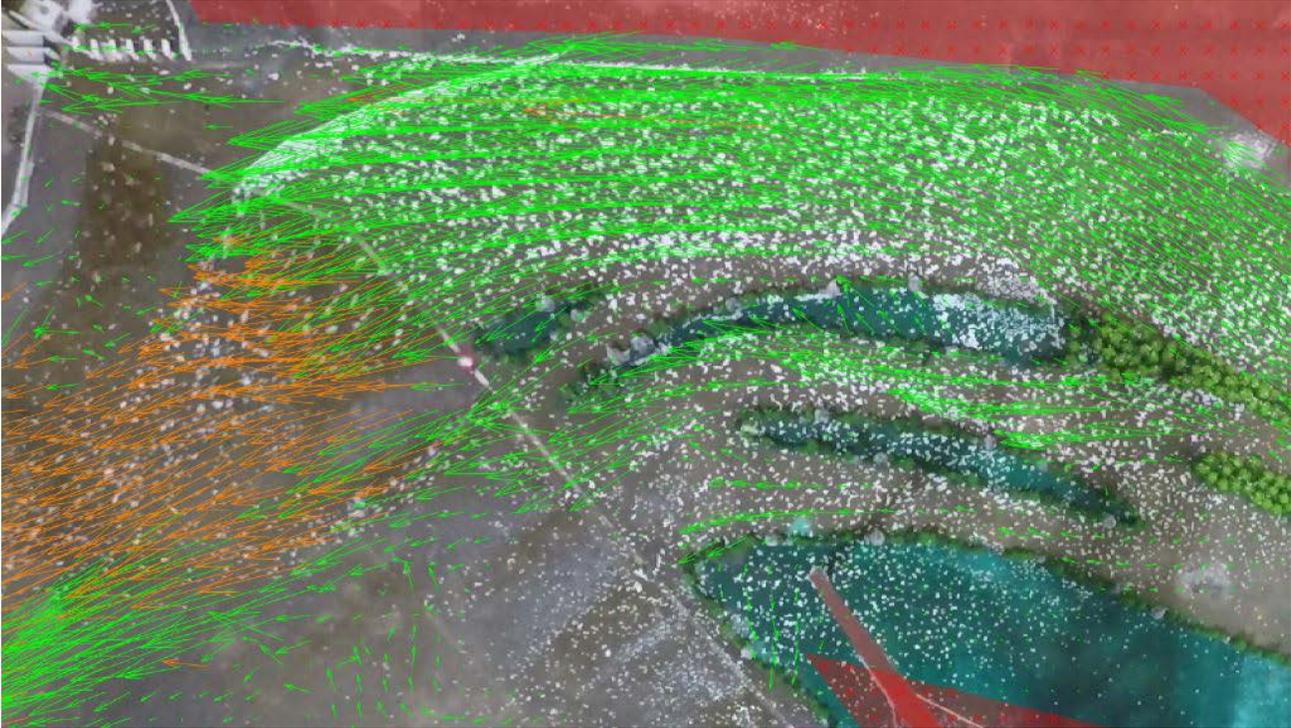
Image of LB2 with LSPIV mean velocity vector at River Q 5,000 cfs, Dam Q 4500 cfs, Canal Q 500 cfs, with sluice gates closed.

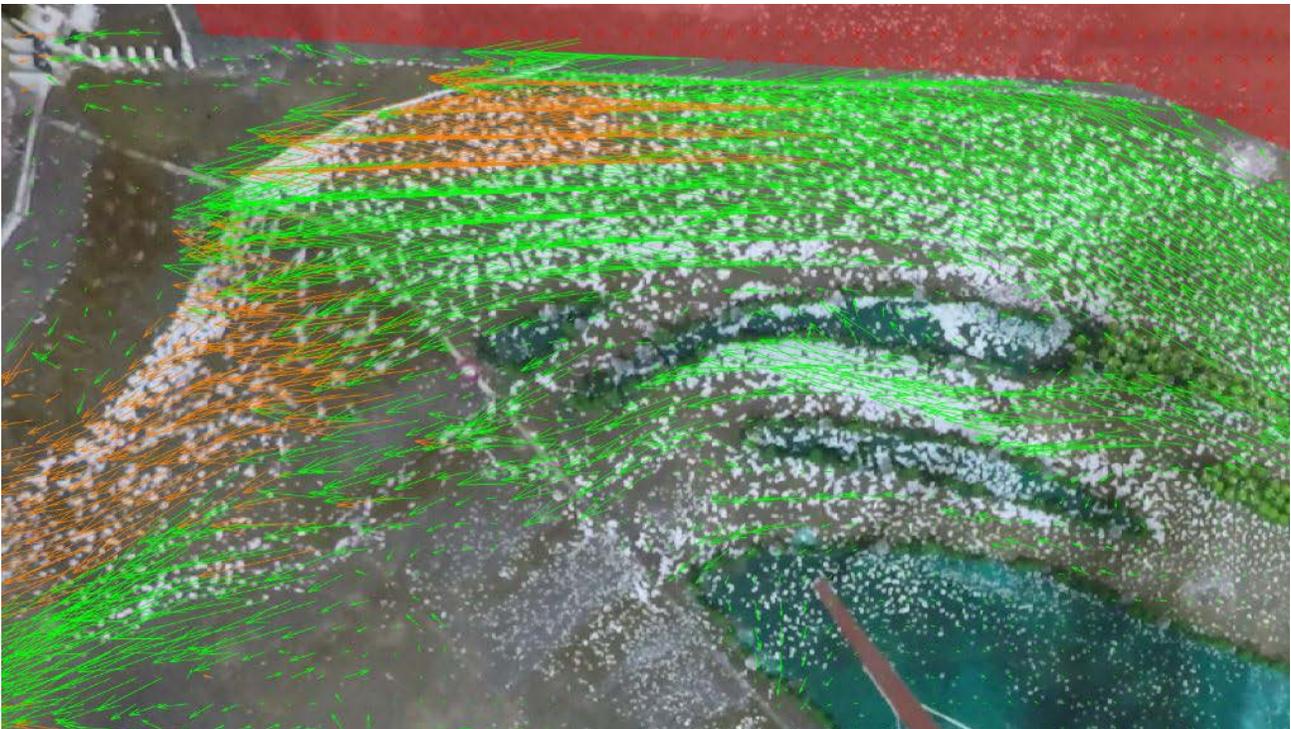
Image of LB2 with LSPIV mean velocity vector at River Q 5,000 cfs, Dam Q 5,000 cfs, Canal Q 0 cfs, with sluice gates open.

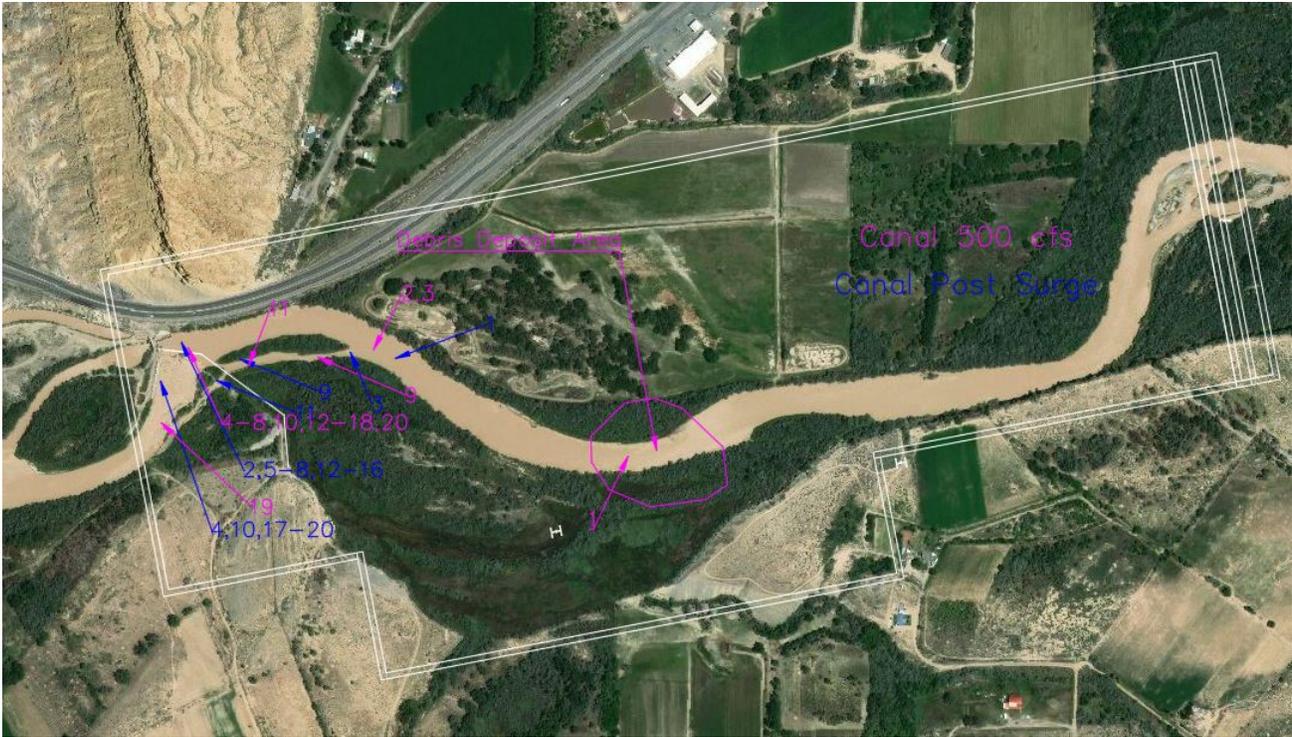
Image of debris capture location of the river modeled at the LB2 condition with River Q 5000 cfs and Canal Q 500 cfs, with sluice gates closed.

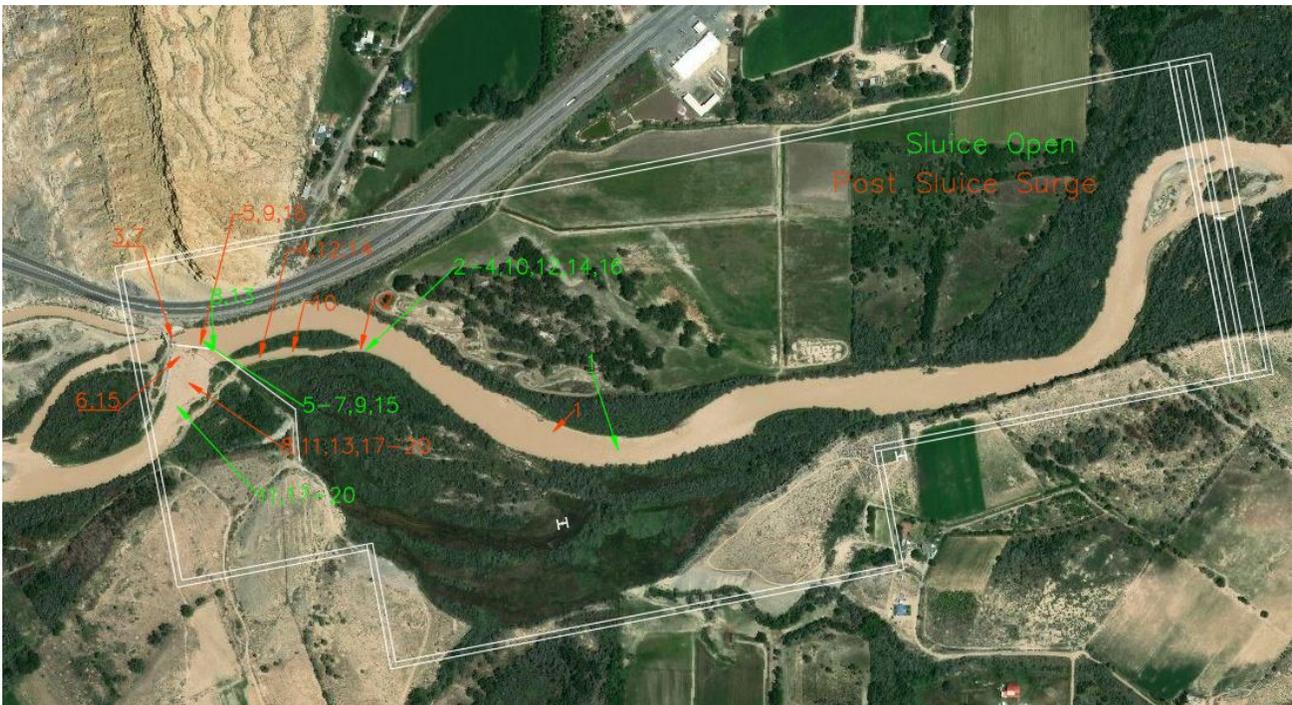
Image of debris capture location of the river modeled at the LB2 condition with River Q 5000 cfs and Canal Q 0 cfs, with sluice gates open.

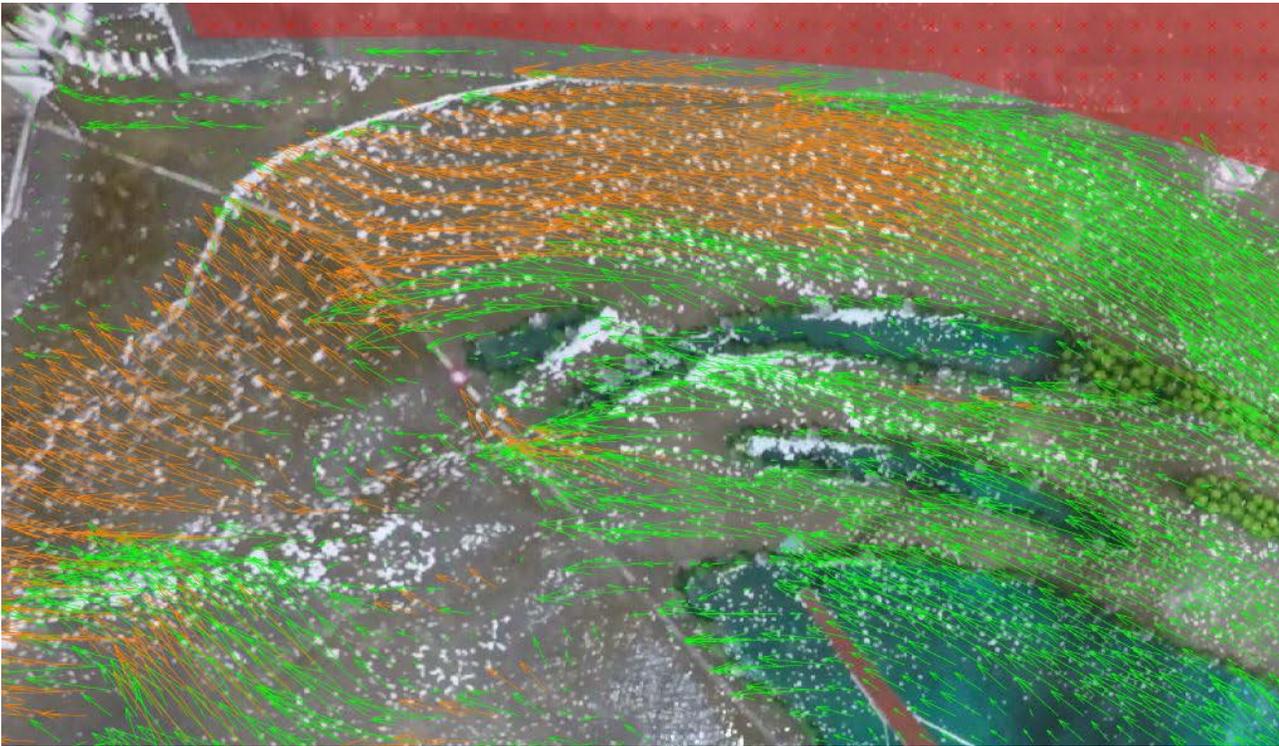
Image of LB2 with LSPIV mean velocity vector at River Q 12,000 cfs, Dam Q 11400 cfs, Canal Q 600 cfs, with sluice gates closed.

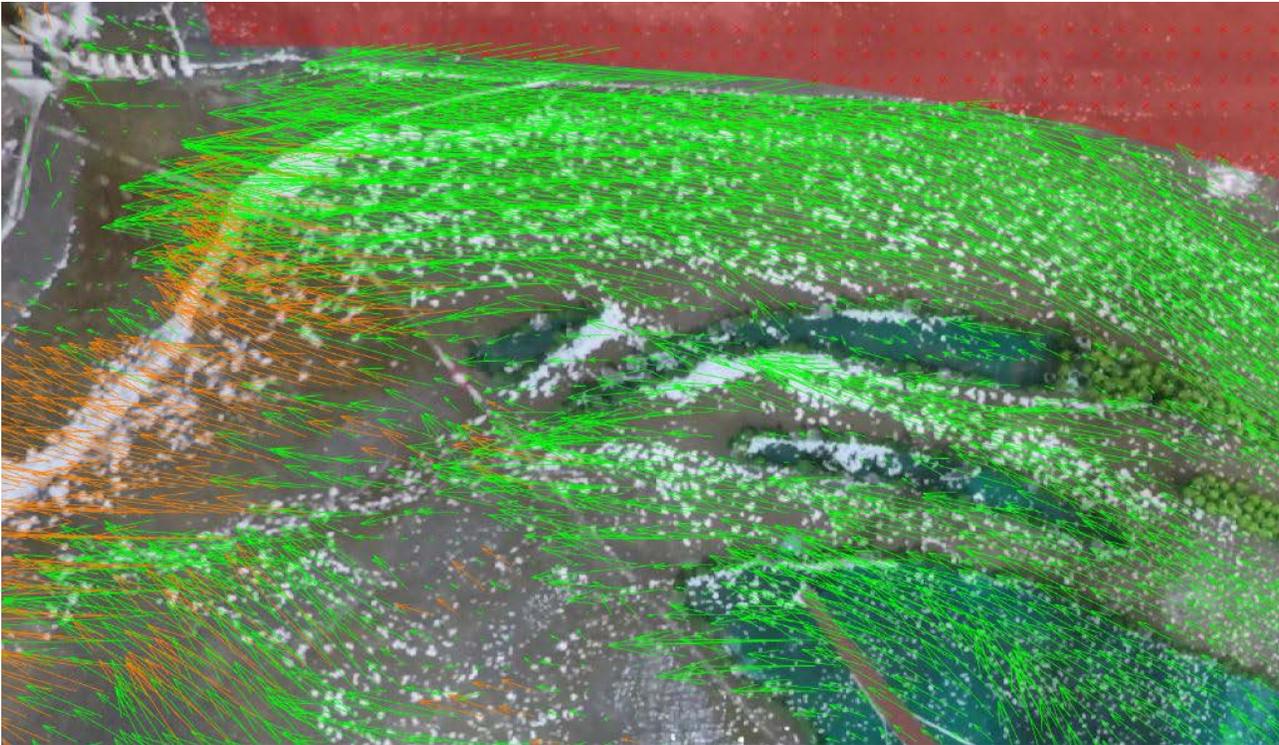
Image of LB2 with LSPIV mean velocity vector at River Q 12,000 cfs, Dam Q 12,000 cfs, Canal Q 0 cfs, with sluice gates open.

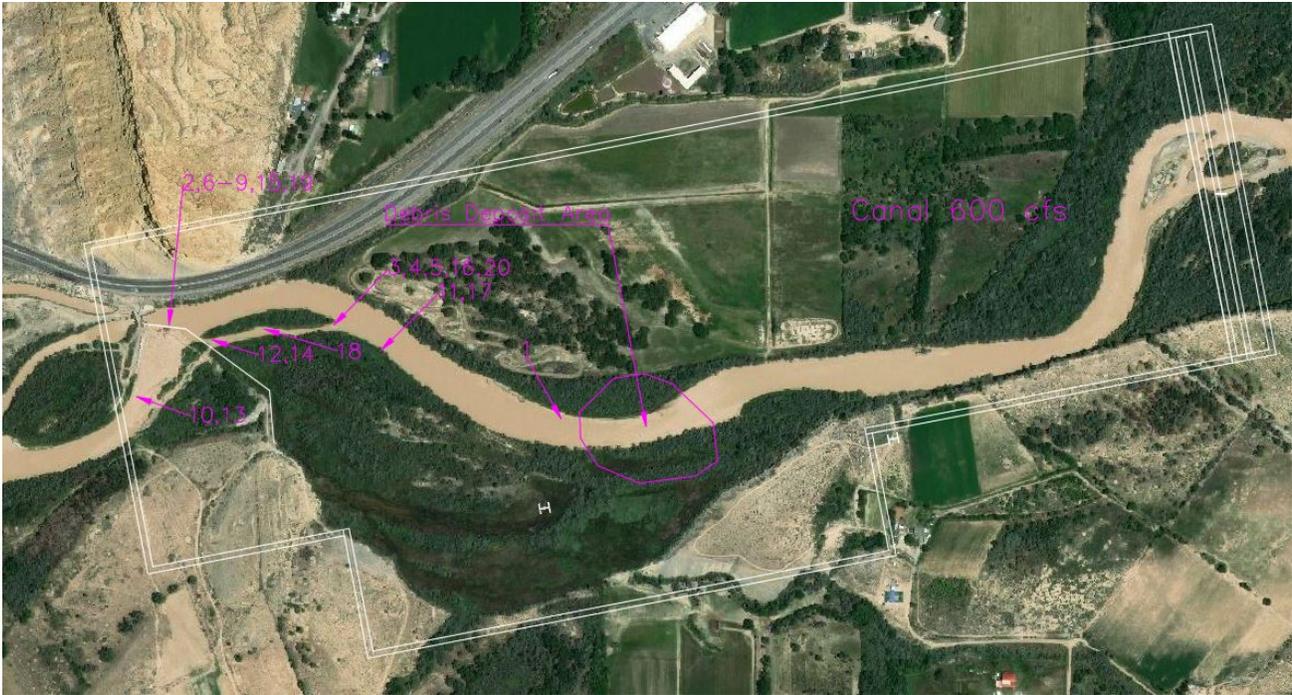
Image of debris capture location of the river modeled at the LB2 condition with River Q 12000 cfs and Canal Q 600 cfs, with sluice gates closed.

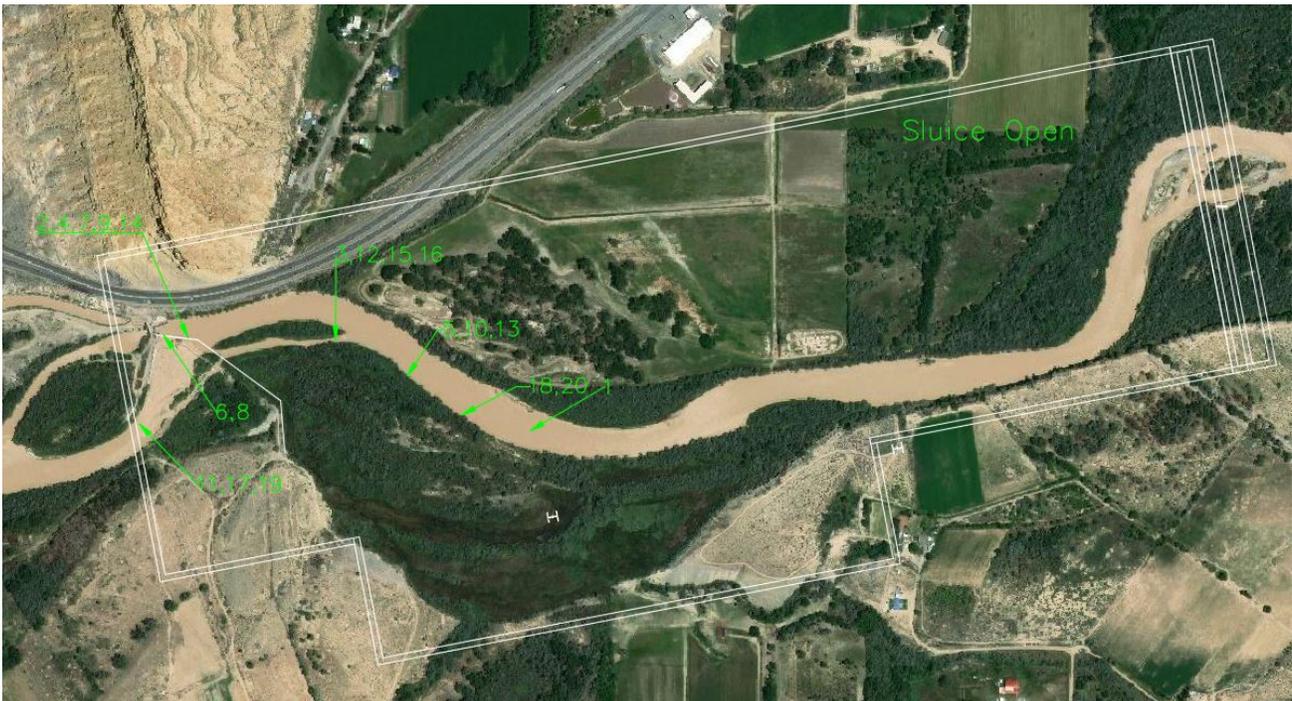
Image of debris capture location of the river modeled at the LB2 condition with River Q 12000 cfs and Canal Q 0 cfs, with sluice gates open.

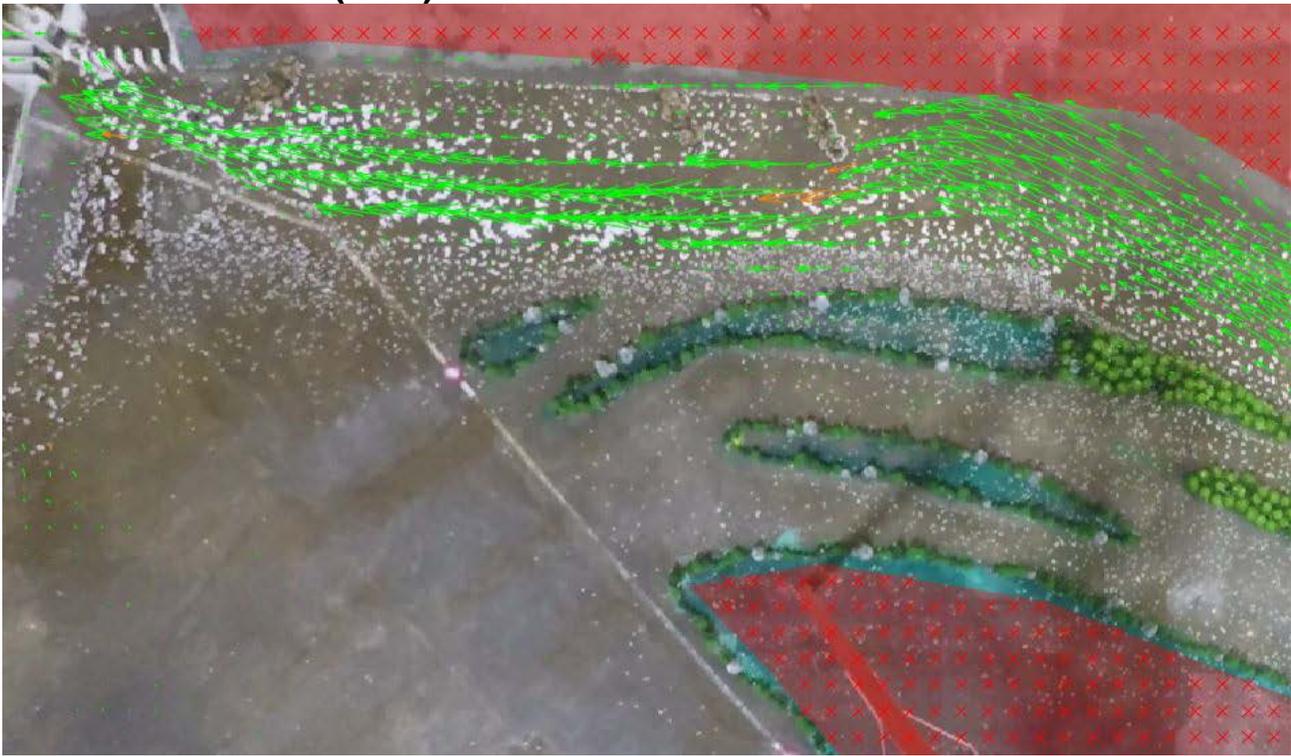
Image of RS2 with LSPIV mean velocity vector at River Q 800 cfs, Dam Q 600 cfs, Canal Q 200 cfs, with sluice gates closed.

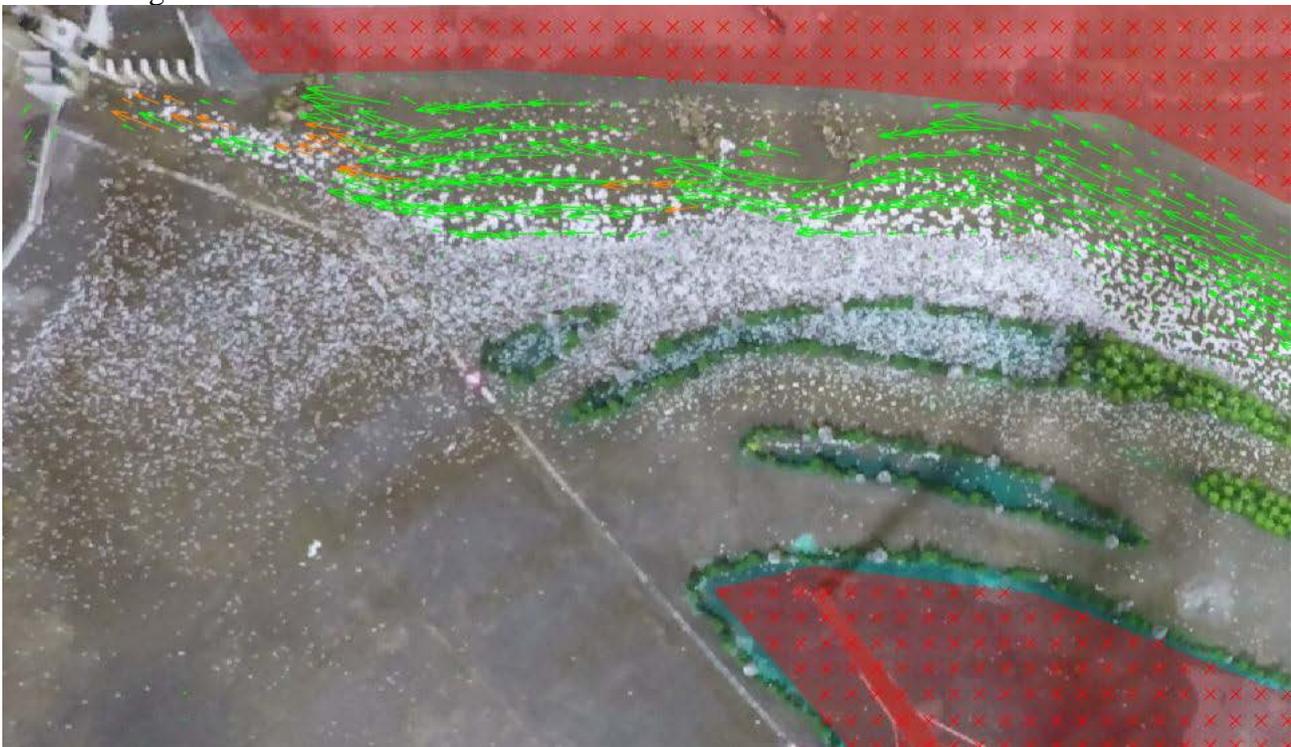
Image of RS2 with LSPIV mean velocity vector at River Q 800 cfs, Dam Q 800 cfs, Canal Q 0 cfs, with sluice gates open.

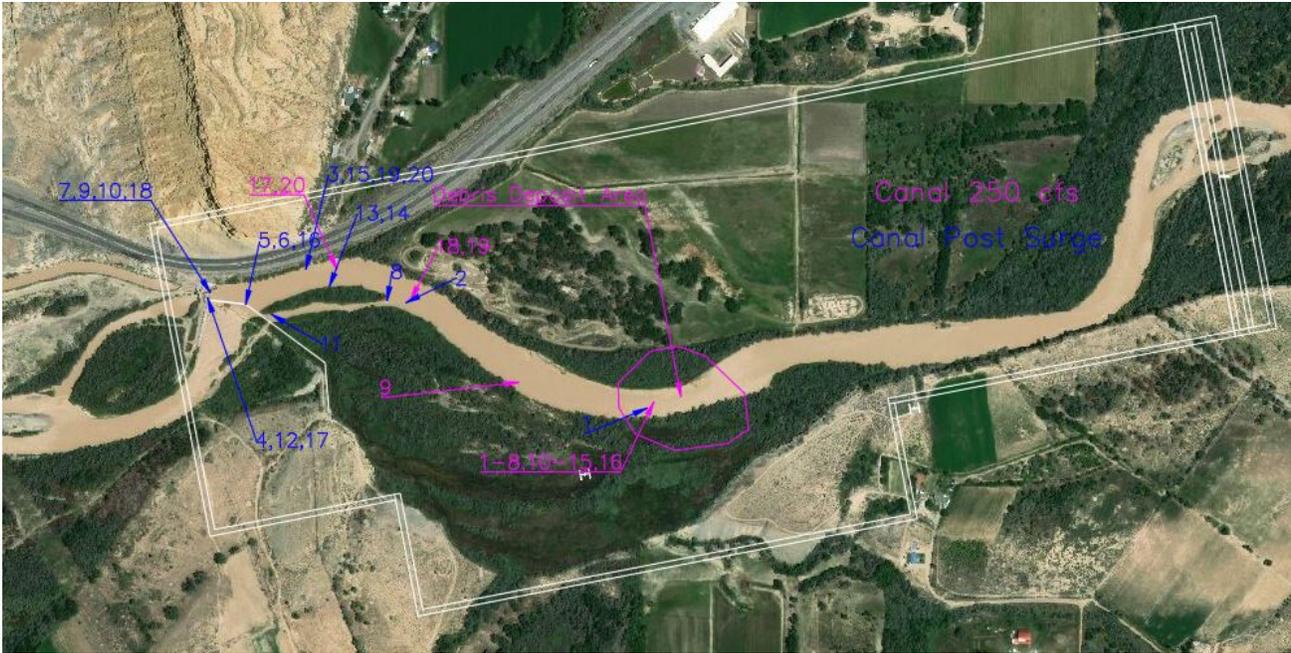
Image of debris capture location of the river modeled at the RS2 condition with River Q 800 cfs and Canal Q 250 cfs, with sluice gates closed.

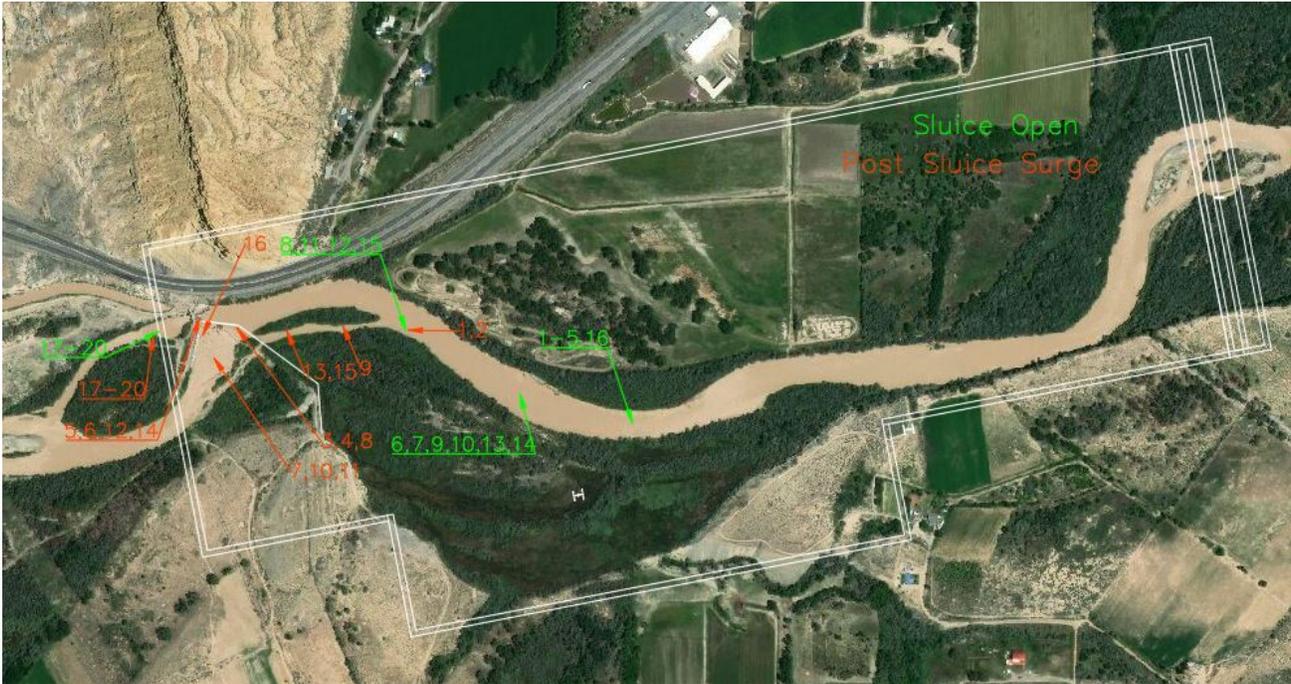
Image of debris capture location of the river modeled at the RS2 condition with River Q 800 cfs and Canal Q 0 cfs, with sluice gates open.

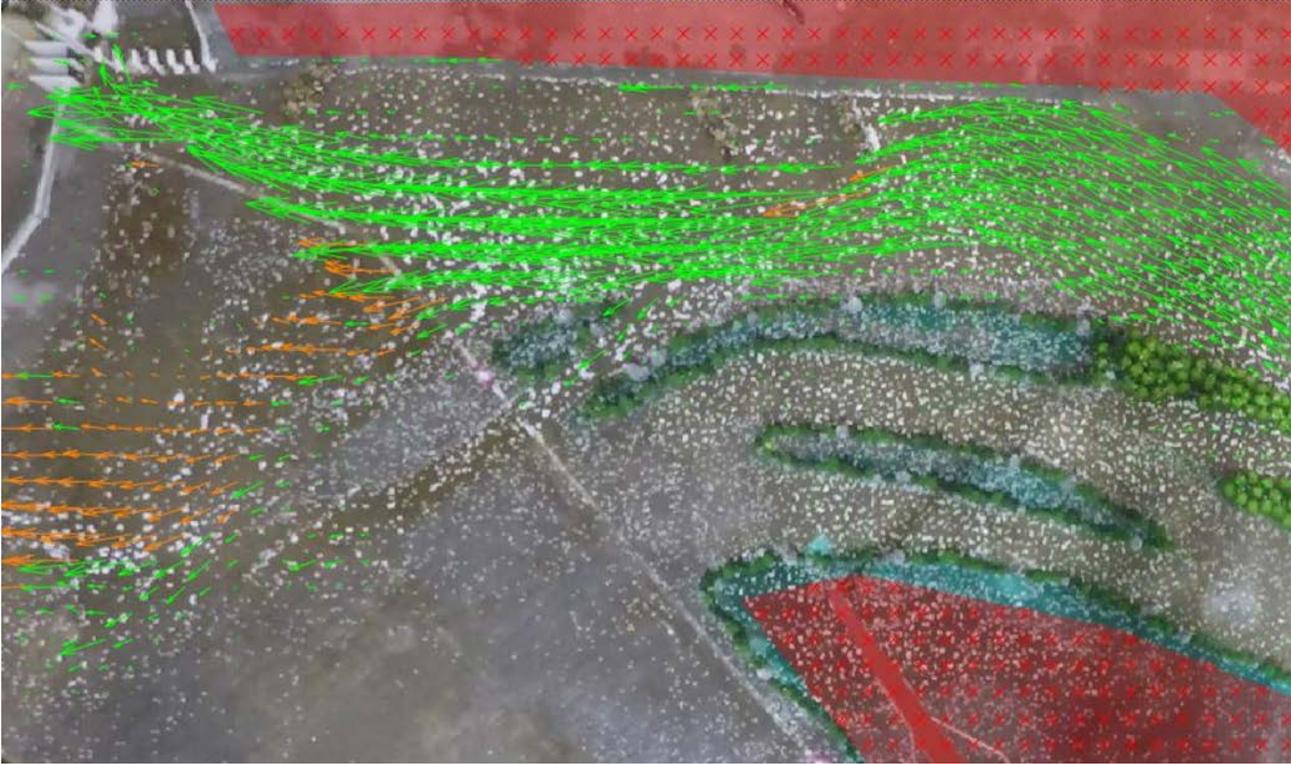
Image of RS2 with LSPIV mean velocity vector at River Q 2,500 cfs, Dam Q 2100 cfs, Canal Q 400 cfs, with sluice gates closed.

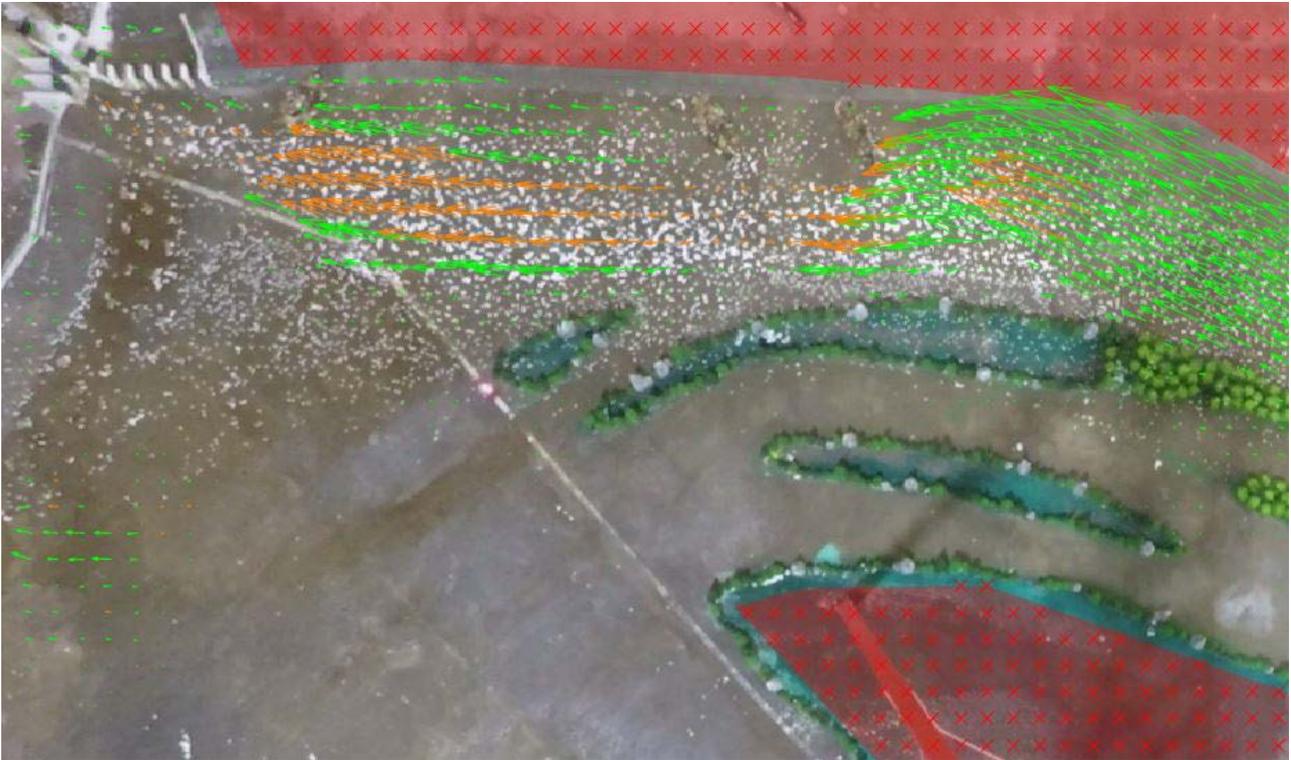
Image of RS2 with LSPIV mean velocity vector at River Q 2,500 cfs, Dam Q 2,500 cfs, Canal Q 0 cfs, with sluice gates open.

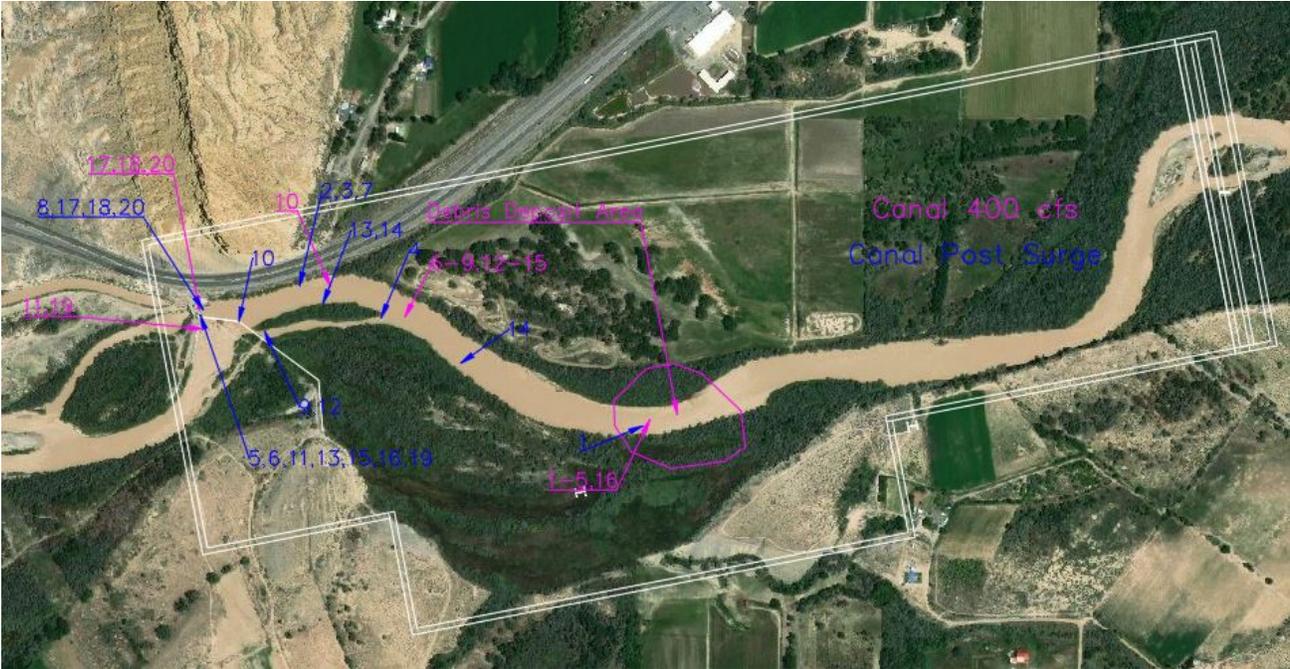
Image of debris capture location of the river modeled at the RS2 condition with River Q 2500 cfs and Canal Q 400 cfs, with sluice gates closed.
